NEVADA STATE RAILROAD MUSEUM

Site Number: 9932
STATE OF NEVADA PUBLIC WORKS DIVISION
FACILITY CONDITION ANALYSIS

Report distributed in September 2021

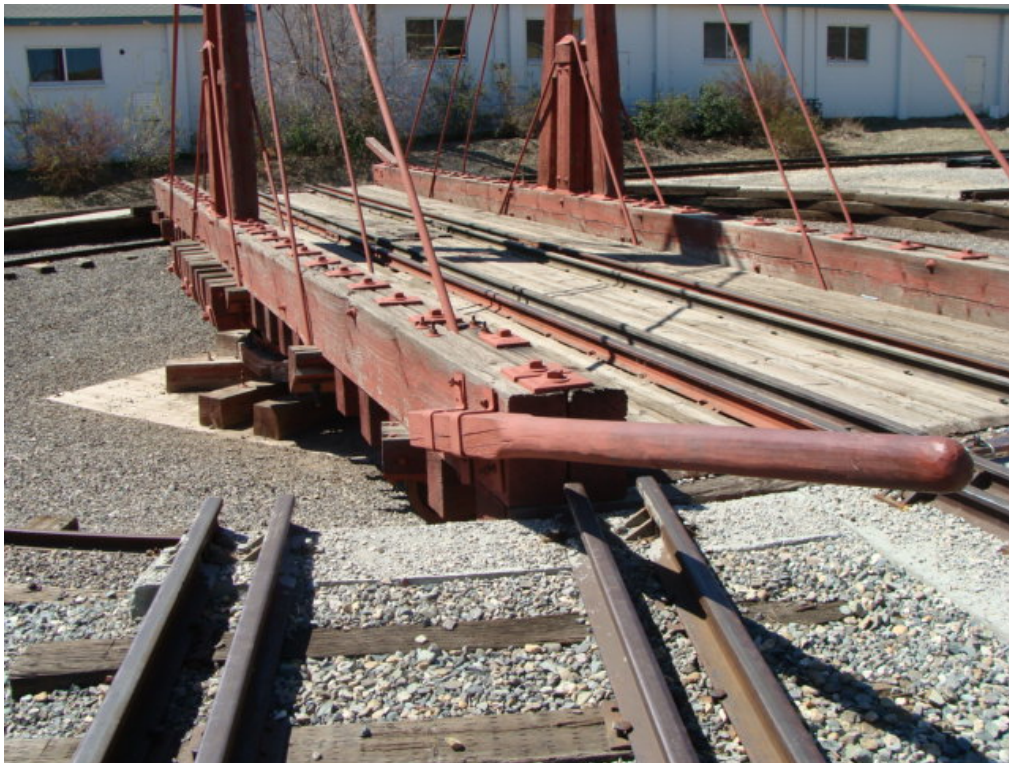
The railroad turntable located on the south side of the site is in need of re-leveling and restoration. The structure is vital to the movement of the railroad cars and engines. It is in desperate need of repair and rehabilitation. This project would provide funding to bring the structure back to a restored fully functioning condition including timber restoration or replacement and leveling.

Nevada State Railroad Museum Carson City - Site #9932
Description: Turntable Restoration.

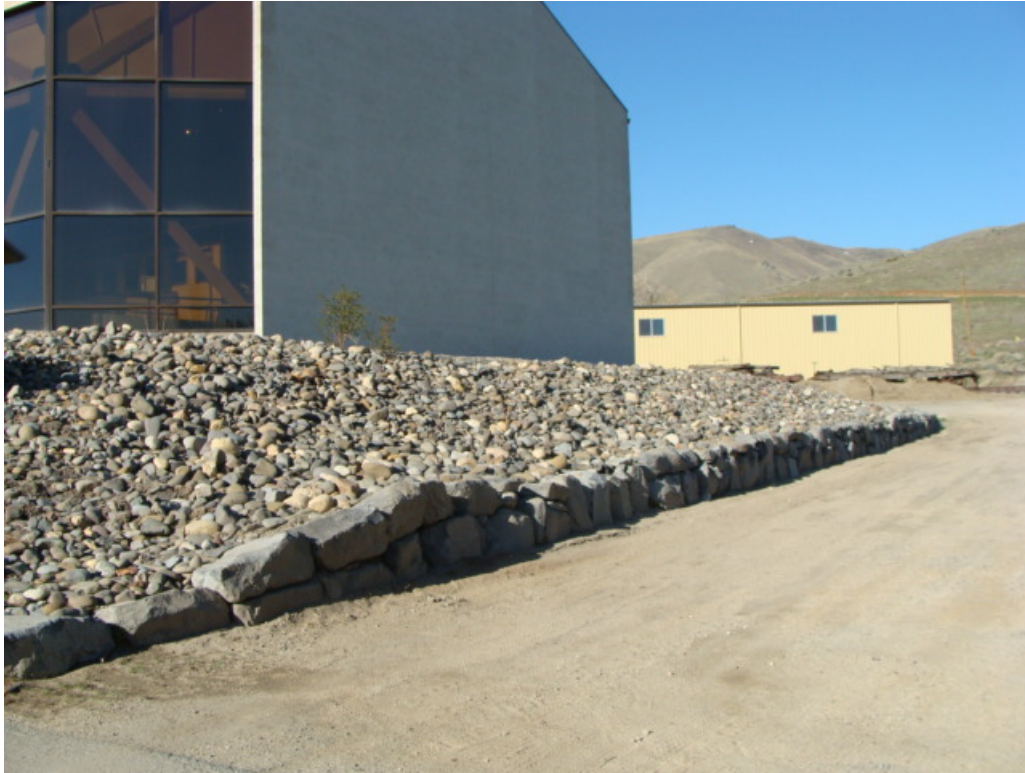
Nevada State Railroad Museum Carson City - Site #9932
Description: Pave Fire Access Roads.

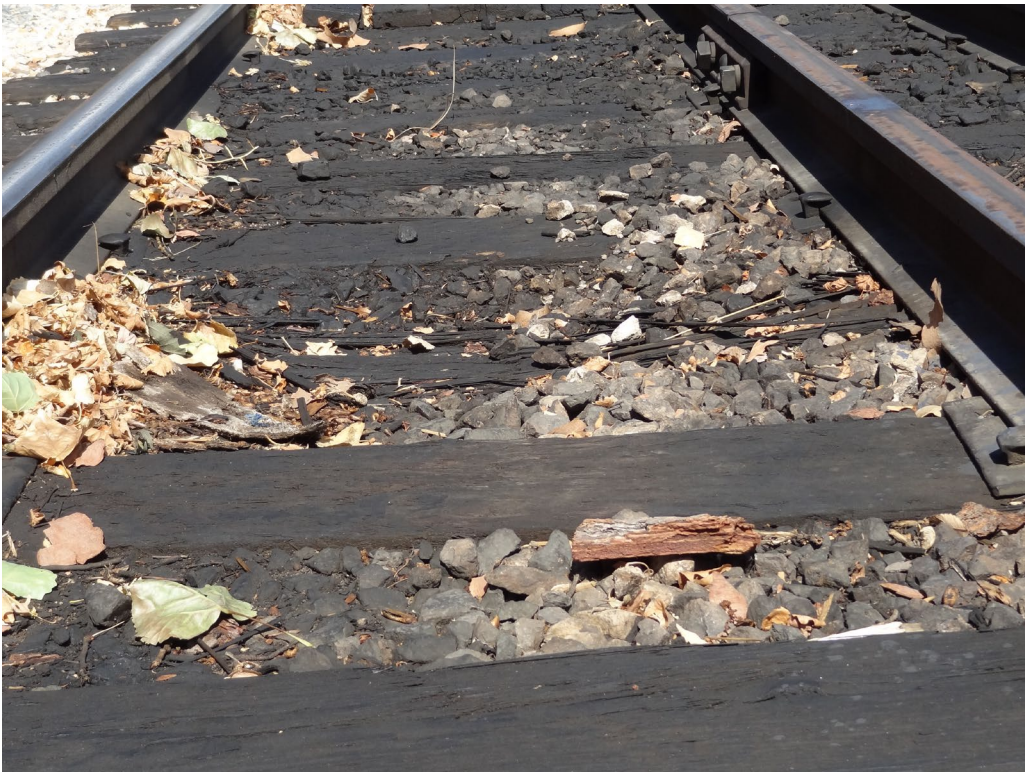
The railroad track at the Nevada State Railroad Museum was constructed in 1986. However the railroad ties used in the construction were a used material, many of which date back to the 1930's. Approximately one third of the these ties no longer meet federal track safety standards and should be replaced. This project will replace deteriorated railroad track ties at the Nevada State Railroad Museum in Carson City. The scope of work includes removal existing ties, addition of new ballast as needed and compaction of material under the existing railroad track.

Nevada State Railroad Museum Carson City - Site #9932
Description: Track Maintenance Needed.

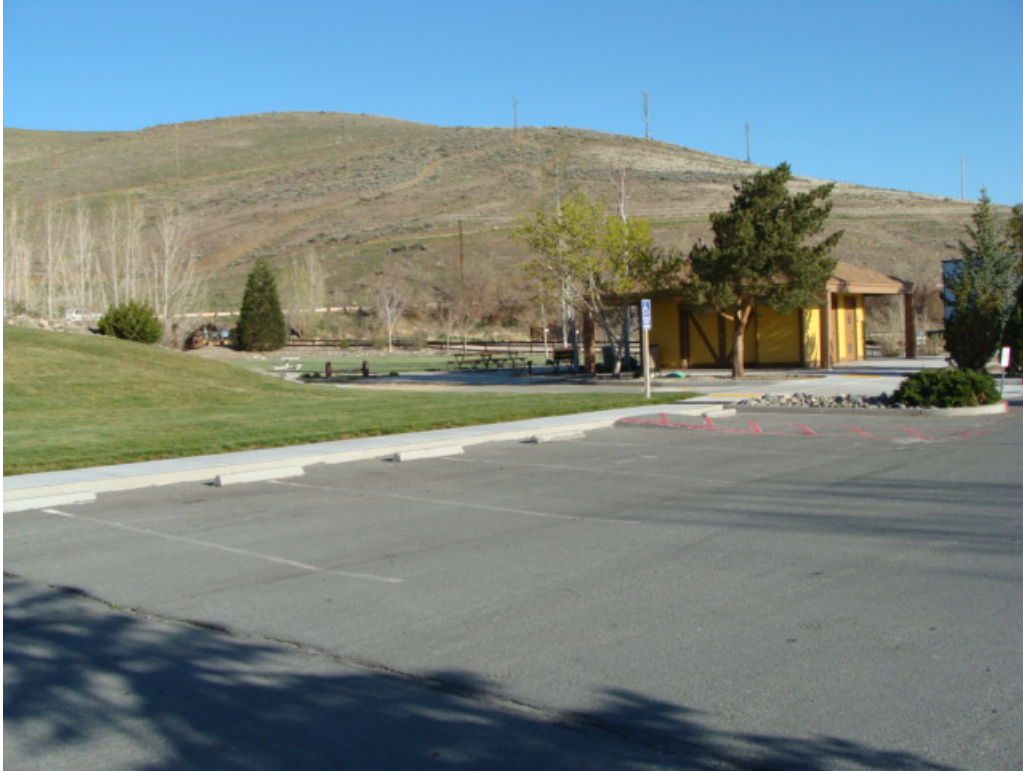
Nevada State Railroad Museum Carson City - Site #9932
Description: Needed Site Pole Lighting.

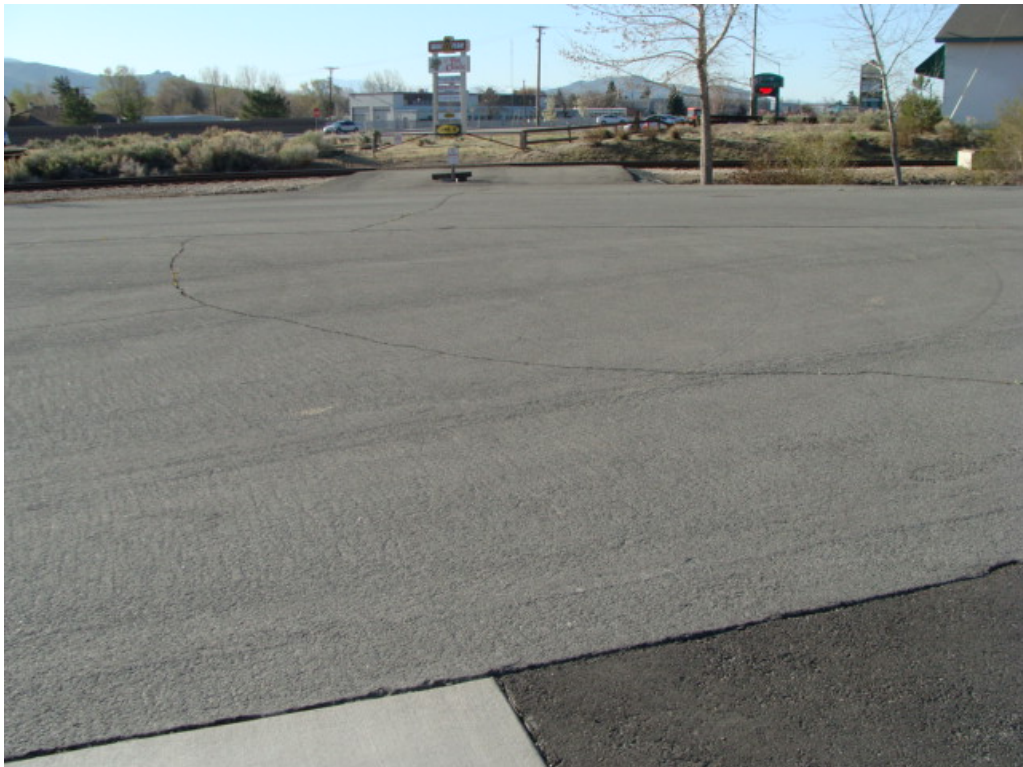
It is important to maintain the asphalt concrete paving on the site. This project would provide for minor crack filling and slurry sealing of the paving site wide including access roads and parking areas. Striping is included in this estimate. This project should be scheduled on a 5 year cyclical basis to maintain the integrity of the paving and prevent premature failure. 100,000 square feet of asphalt area was used to generate this estimate.

Nevada State Railroad Museum Carson City - Site #9932
Description: Crack Fill & Slurry Seal Asphalt Paving.

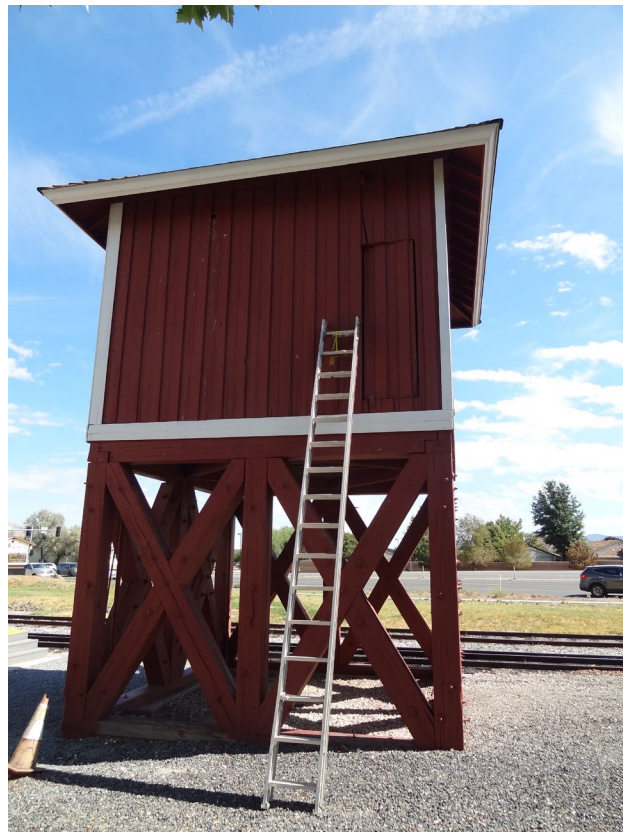
Currently, there is no access to the elevated tank platform. This project recommends the installation of an Occupational Safety and Health Administration (OSHA) compliant ladder per OSHA 1926.1053.

Water Tower - Building #1437
Description: Permanent Safety Ladder Access.

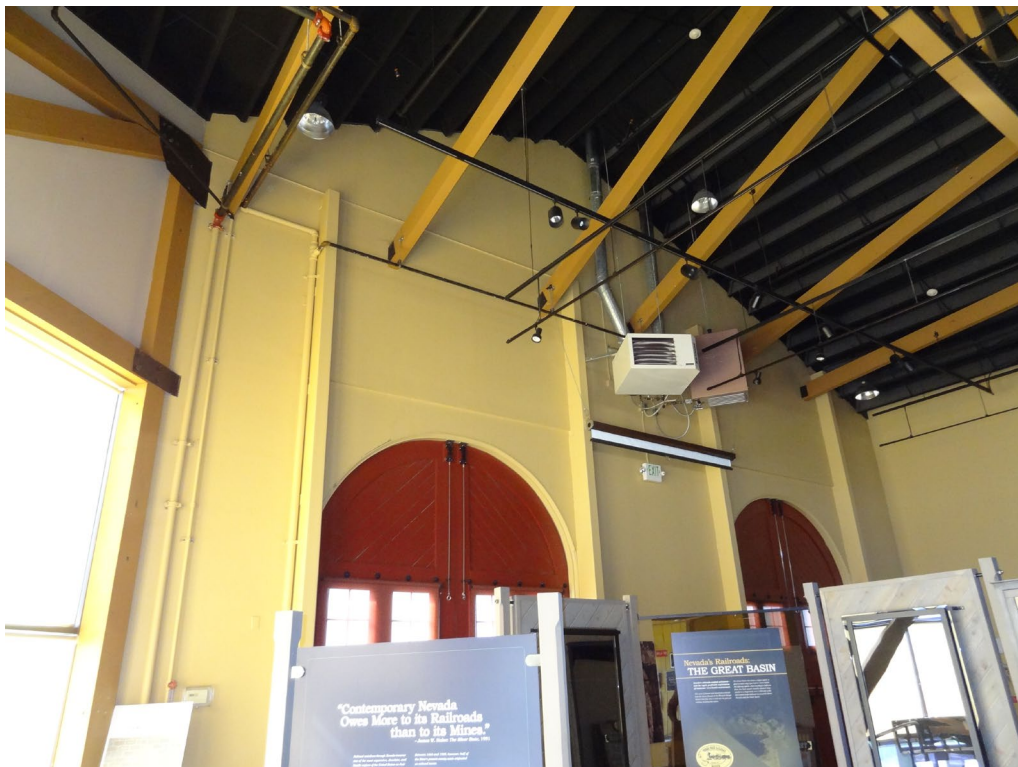
Jacobsen Interpretive Center - Building #0861
Description: View of Structure in Entry Vestibule.

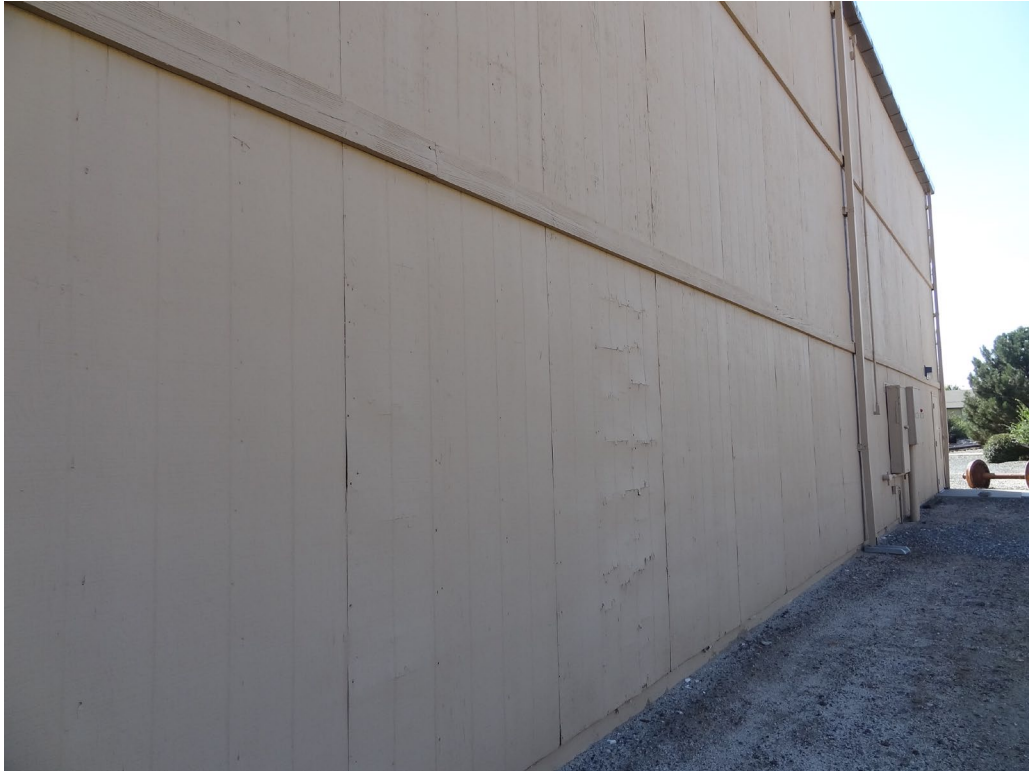
Jacobsen Interpretive Center - Building #0861
Description: Exterior Siding Replacement.

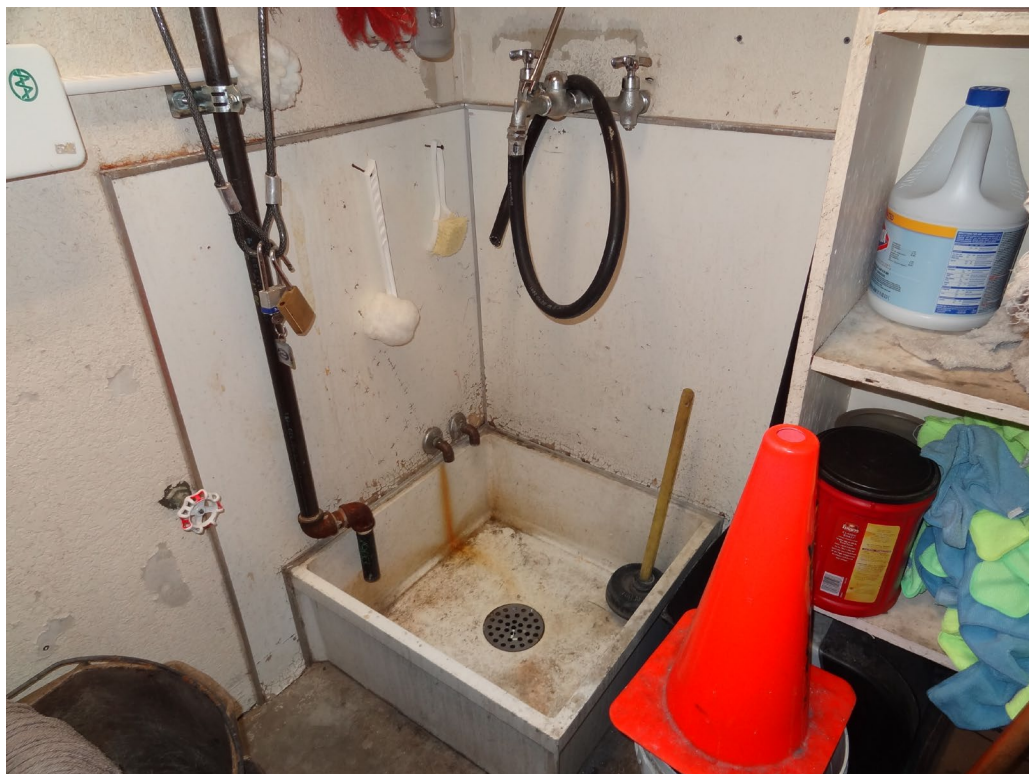
Jacobsen Interpretive Center - Building #0861
Description: Janitors Closet Repair.

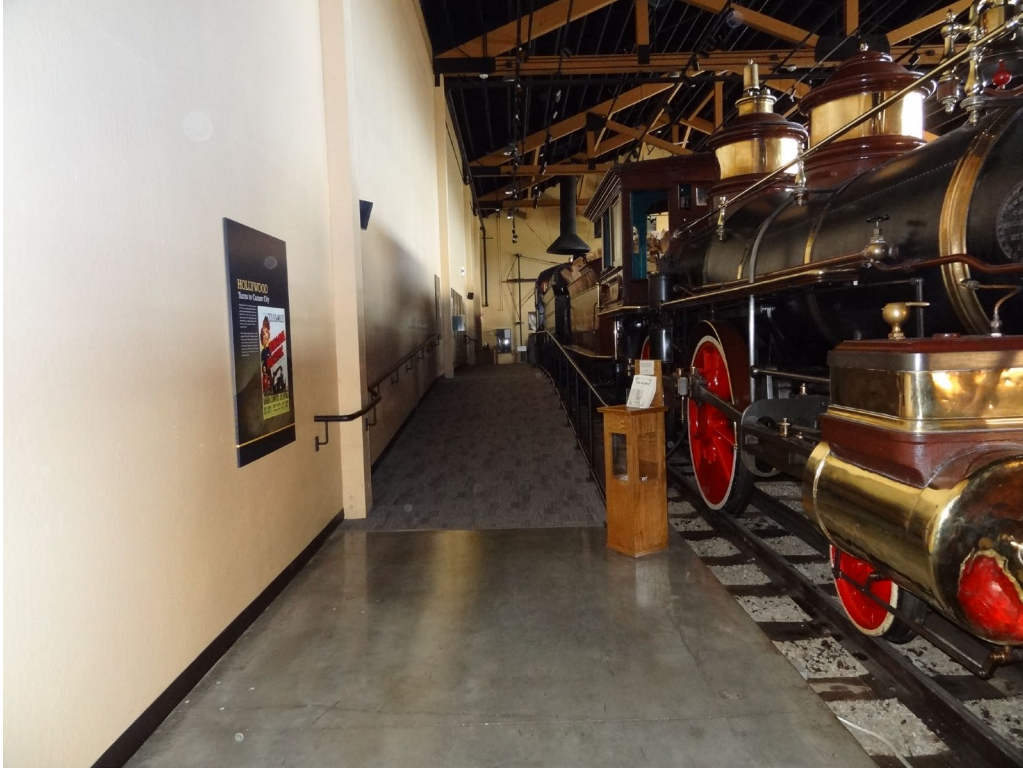
Jacobsen Interpretive Center - Building #0861
Description: Bottom of the Interior Ramp.
