STATE OF NEVADA  
STATE PUBLIC WORKS DIVISION

FACILITY CONDITION ASSESSMENT REPORT FOR:

DEPT OF CONSERVATION AND NATURAL RESOURCES  
DIVISION OF FORESTRY

SITE #: 9934 ELKO NORTHERN REGION 2 NDF HDQS. SITE  
911 FALCON WAY  
ELKO, NV 89801-4654

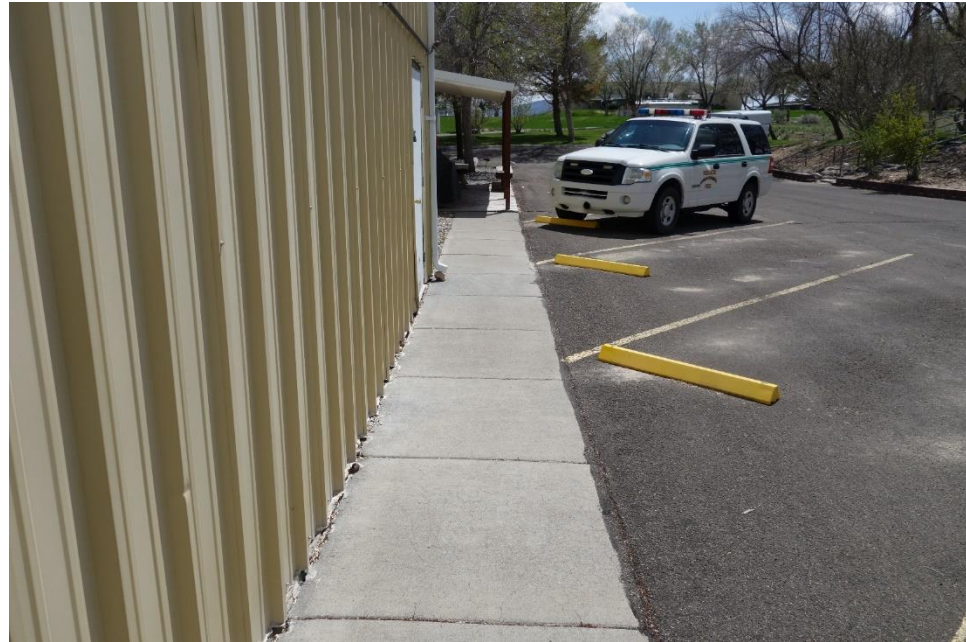
QUANTITY	UNITS	TOTAL	SF COST
The parking area drainage west of the Office-Garage was not addressed when the building was expanded in approximately 2000. The result is increased sheet flow of storm water across the paved parking areas and potential water infiltration into the west side of the Apparatus Bays. Caulking at the base of the building has attempted to stop the infiltration. The increased storm water sheet flow across the parking areas has substantially increased slip hazards during icy conditions. This project recommends a full drainage study of the site and include the drainage impact of the new Heavy Maintenance Shop currently in design under CIP 21-C01. In addition, consideration of integrating vehicle stops (or pipe bollards) into any re-grading plan to protect the west side of the Apparatus Bay is suggested. The cost to implement recommendations as a result of the Study is not included in this project.	1	Package	\$25,000.00	-

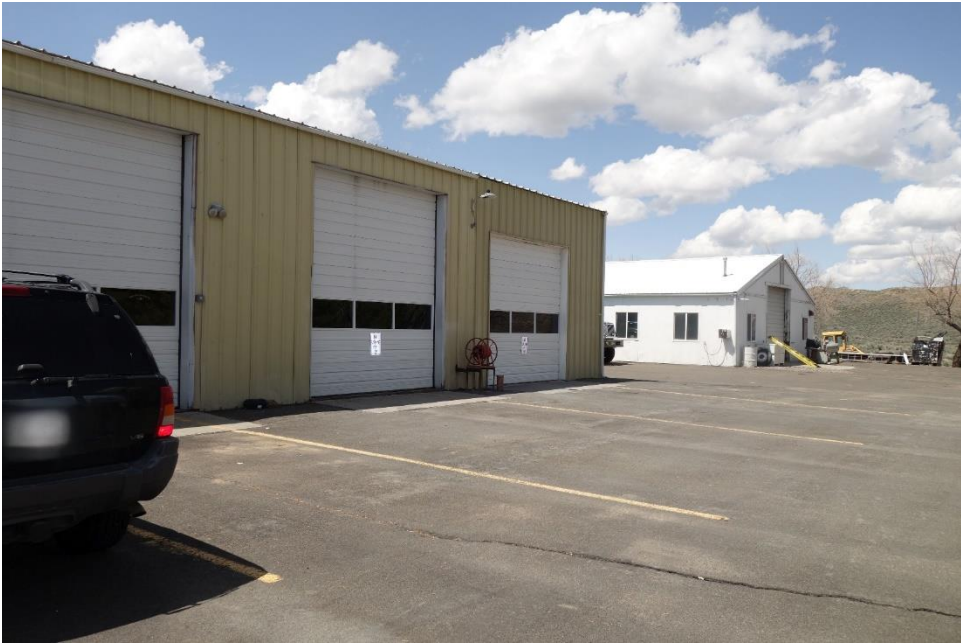
QUANTITY	UNITS	TOTAL	SF COST
The Regional Office building has three large apparatus bay doors for fire fighting equipment. The paved approach does not have any protection to prevent vehicles from damaging the building. This project would provide for six 8" diameter pipe bollards, filled with concrete at each side of the apparatus bay doors.	6	Each	\$ 9,000.00	-

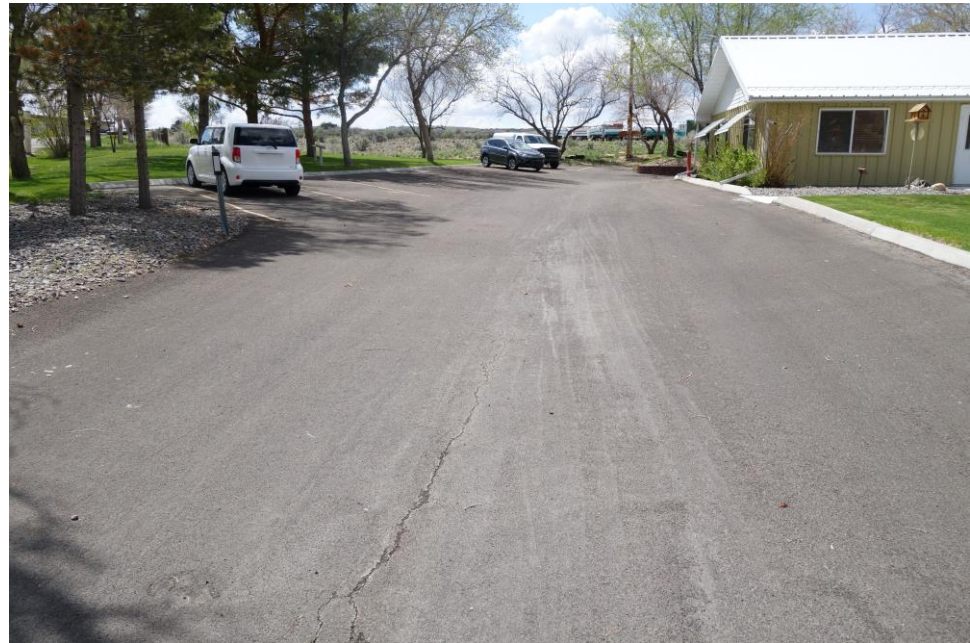
### CRACK FILL & SEAL ASPHALT PAVING

QUANTITY	UNITS	TOTAL	SF COST
The paving appeared to be in fair condition at the time of the survey. It is important to maintain the asphalt concrete paving on the site. This project would provide for minor crack filling and sealing of the paving site wide including access roads, parking areas and the maintenance yard. Striping is included in this estimate. This project should be scheduled in the next 2 - 4 years and on a 5 year cyclical basis to maintain the integrity of the paving and prevent premature failure. 25,000 square feet of asphalt area was used to generate this estimate.	25000	Square Foot	\$32,500.00	-

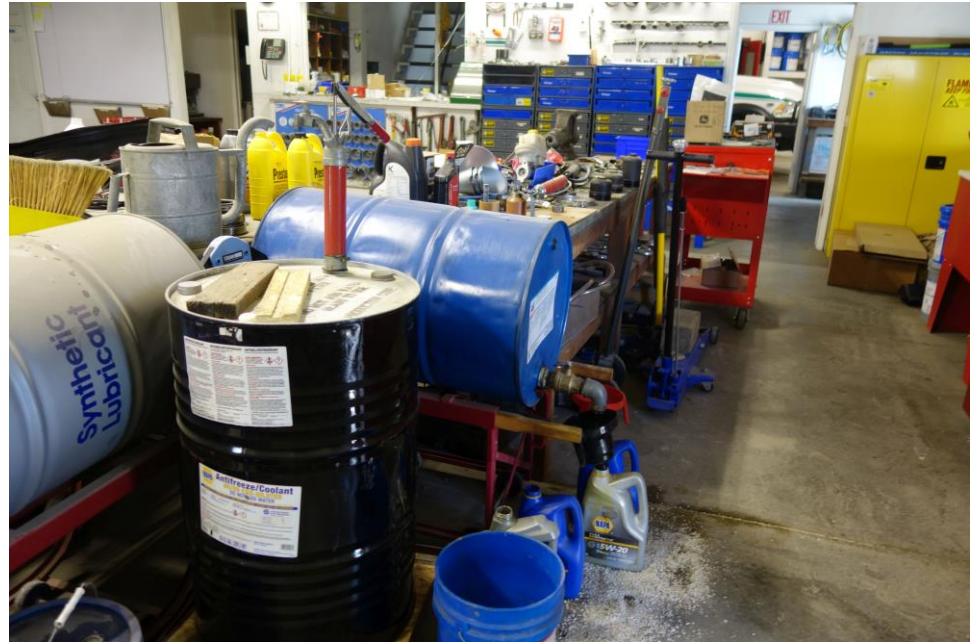
QUANTITY	UNITS	TOTAL	SF COST
The Shop does not have a method for containing spills or leakage from oil drums. This project would add secondary containment pallets for all containers in the building and install placards on the building exterior.	1	Package	\$ 7,500.00	\$ 2.00

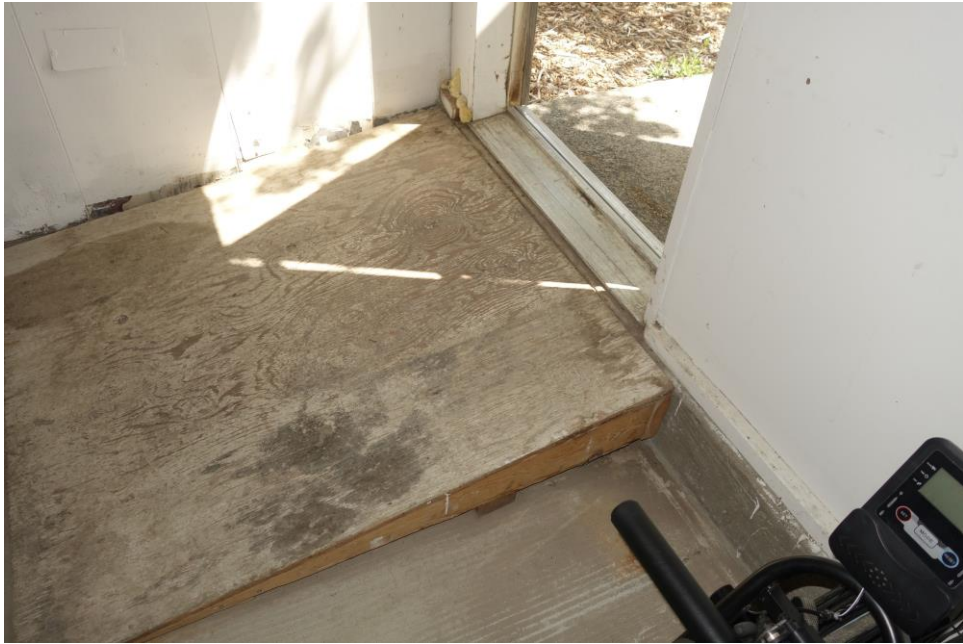
QUANTITY	UNITS	TOTAL	SF COST
The west side of the shop has an exit door with an interior landing approximately 6" below the exterior landing. Section 1008.1 of the 2012 IBC describes the requirements for doors including floor elevations and landings. The floor or landing shall be at the same elevation on each side of the door. There is a wood ramp constructed to eliminate the step down but it has created a tripping hazard and does not meet code. This project would provide funding to pour a 3'-0" x 3'-0" concrete landing on the interior of the building to eliminate the tripping hazard.	1	Package	\$ 5,000.00	\$ 1.00

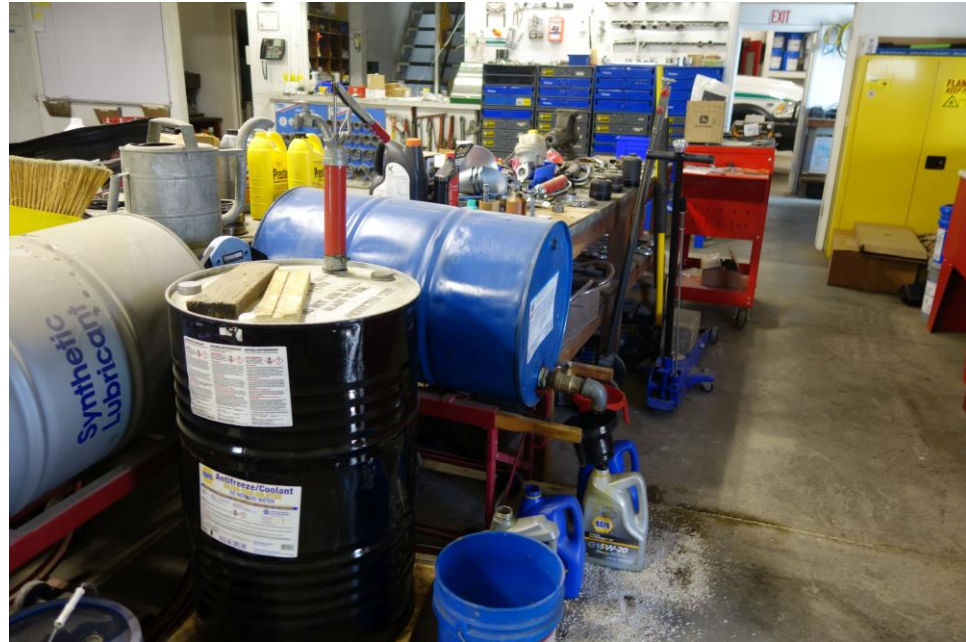
QUANTITY	UNITS	TOTAL	SF COST
The Shop contains many different paints, stains, oils, vehicle repair fluids, cleaning products and other hazardous products on open shelves and on the floor. This does not meet OSHA standards for hazardous materials containment. This project would provide two hazardous storage containers in the building and install placards on the building exterior in accordance with OSHA 1910.106 (d).	2	Each	\$10,000.00	\$ 2.00

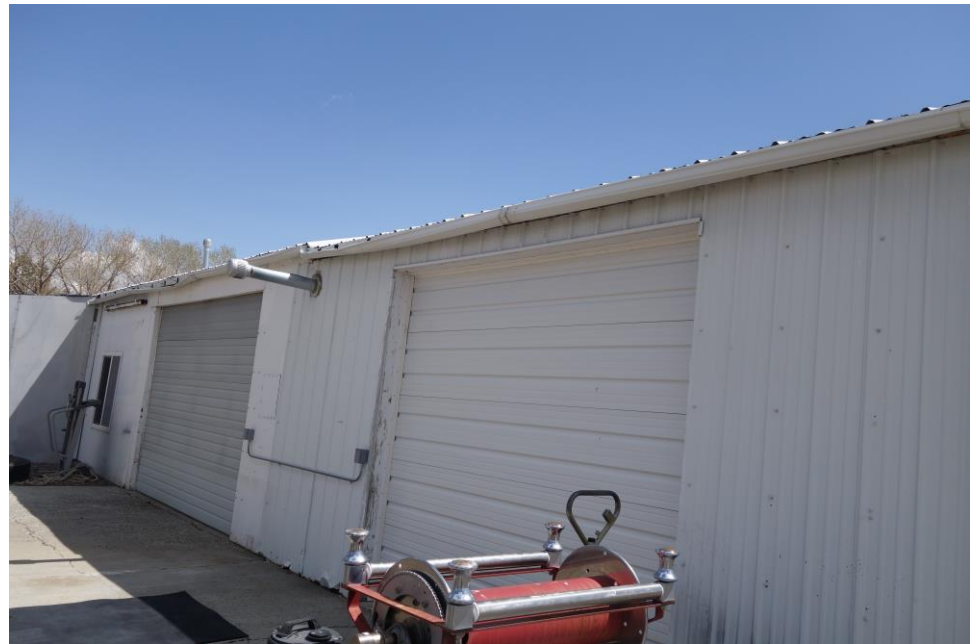
### ELECTRICAL REPAIRS

QUANTITY	UNITS	TOTAL	SF COST
There are safety issues throughout the building having to do with electrical fixtures and equipment. There are numerous electrical outlets and switches which are missing covers or are broken, extension cords being used to supply permanent electrical power, the GFCI outlet in the restroom is broken and the exterior outlets are not GFCI protected and are missing covers. This project would provide for repairs and/ or replacement of the damaged electrical outlets and removing extension cords from permanent locations.	1	Package	\$ 6,000.00	\$ 1.00

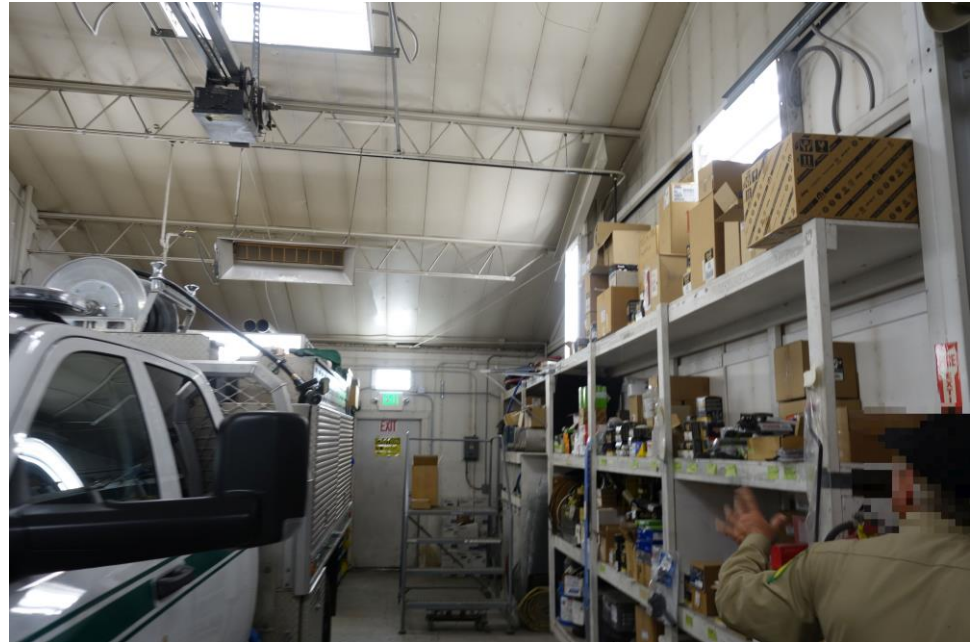
QUANTITY	UNITS	TOTAL	SF COST
The existing lighting fixtures are the older fluorescent type and are not energy efficient. This project will upgrade fixtures to higher efficiency units with a longer life cycle. 5,000K LED lamps are suggested. Occupancy sensors will be installed in low occupancy areas for additional savings. Electrical wiring upgrades are not included in this estimate.	4880	Square Foot	\$39,000.00	\$ 8.00

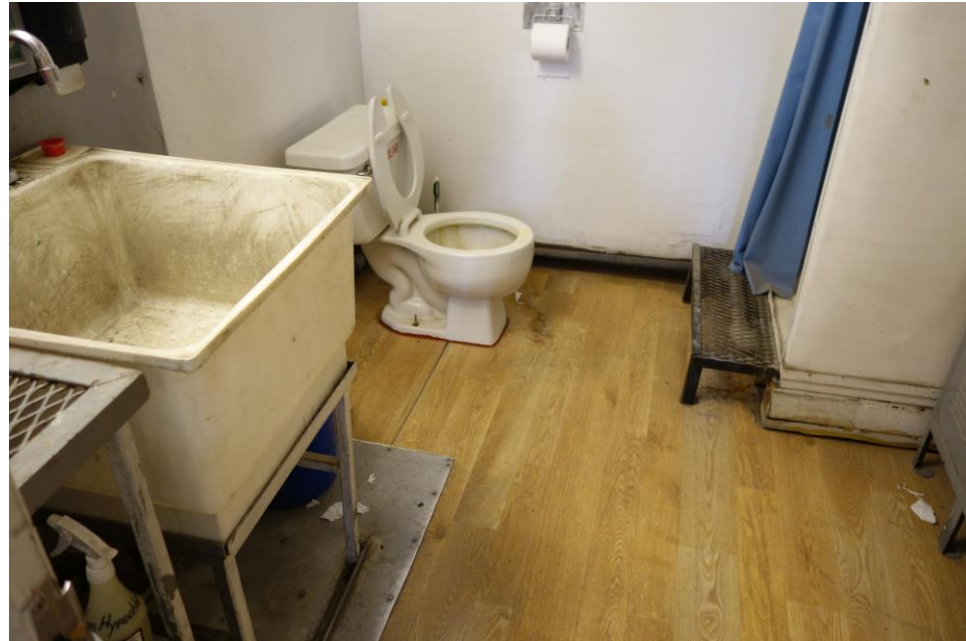
QUANTITY	UNITS	TOTAL	SF COST
The restroom in the building is original to the building and in overall poor condition. The finishes, fixtures, toilet, sink and shower are showing signs of wear and deterioration. This project would provide for a complete remodel of the restroom. The removal and disposal of the existing fixtures and finishes is included in this estimate.	1	Package	\$25,000.00	\$ 5.00

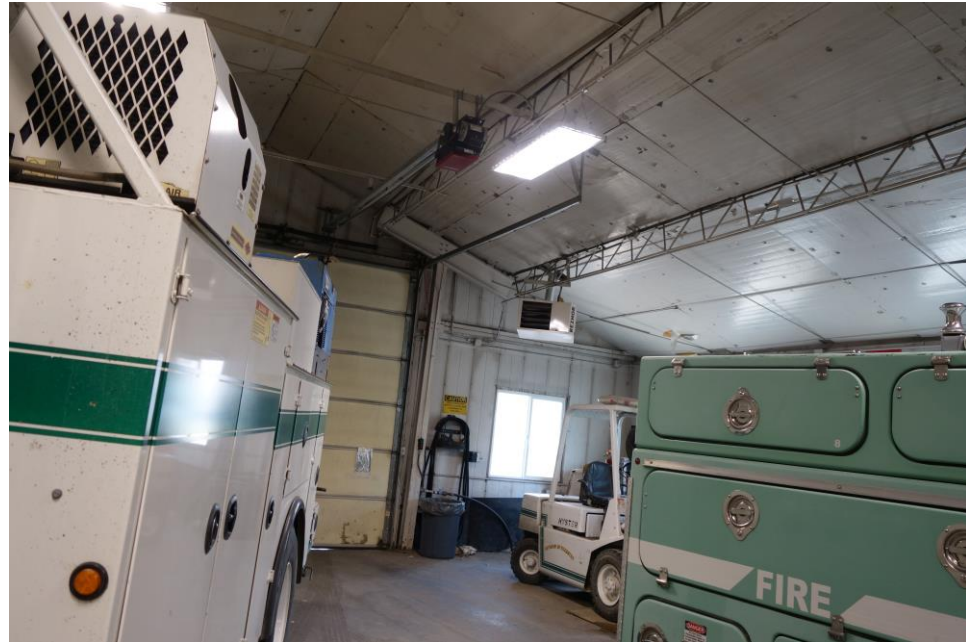
QUANTITY	UNITS	TOTAL	SF COST
The shop has a wash area for vehicles which drains into the city sewer. There is no evidence that a grease/ sand interceptor is provided. This project recommends installing a grease/ sand interceptor in accordance with state health regulations.	1	Package	\$35,000.00	\$ 7.00

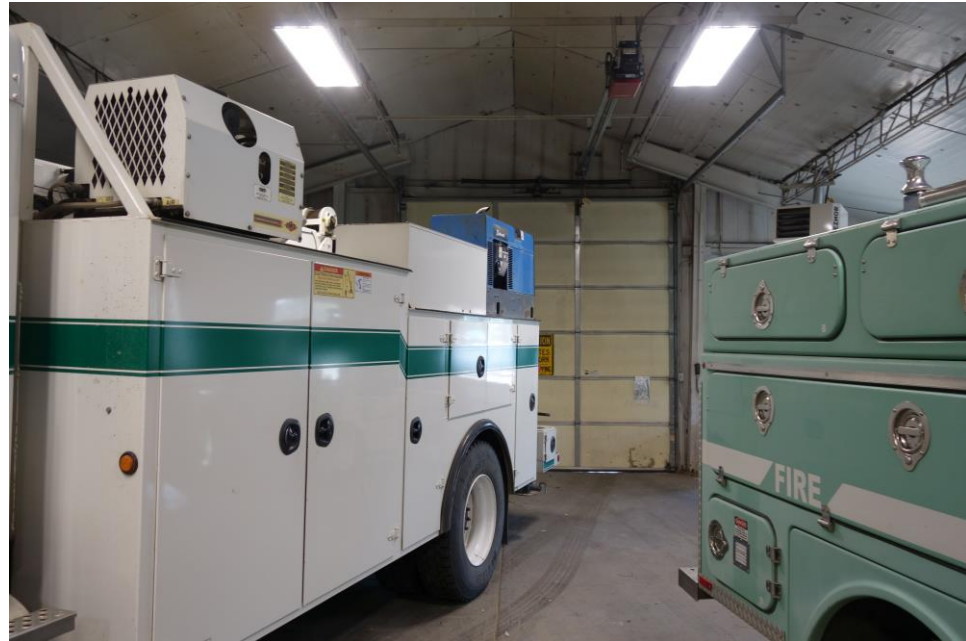
### OVERHEAD DOOR REPLACEMENT

QUANTITY	UNITS	TOTAL	SF COST
There is one 12' x 14' and two 10' x 10' overhead garage doors which are damaged and do not function properly. Exposure and wind have caused the doors to bend, crack and lose their finish. The springs, rollers and hinges are worn from general wear and tear. They are original to the building and should be scheduled for replacement. This project would provide for the removal and disposal of the manually operated overhead garage doors and replacement with new manually operated overhead garage doors.	1	Package	\$16,000.00	\$ 3.00

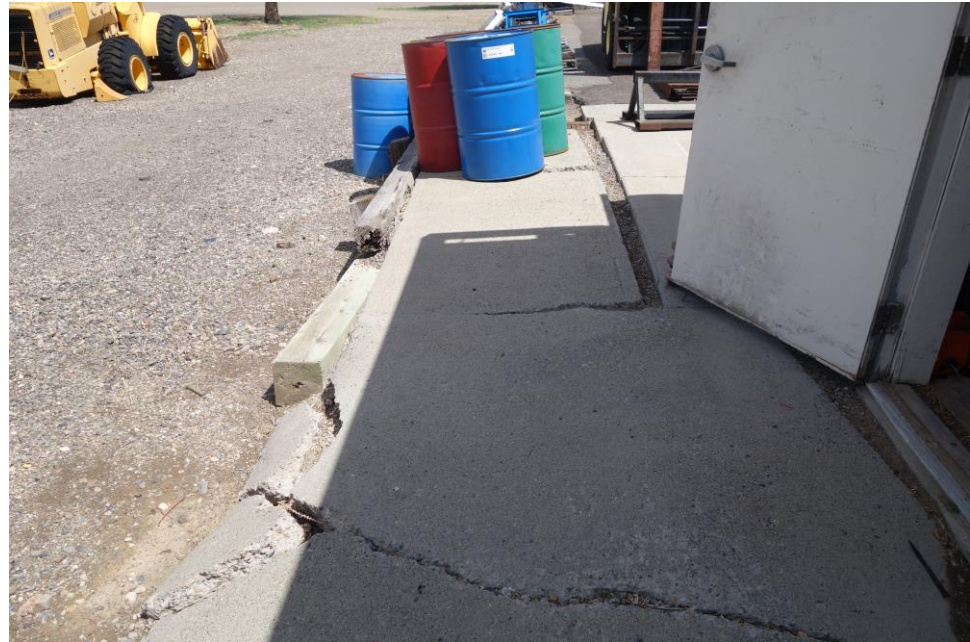
### CONCRETE APRON REPAIRS

QUANTITY	UNITS	TOTAL	SF COST
The 3 exterior concrete aprons and sidewalks around the building have extensive cracking and are due for repairs. This project would provide for crack-filling, patching and sealing the concrete aprons at the vehicle garage doors and the sidewalks and pads around the building.	1200	Square Foot	\$24,000.00	\$ 5.00

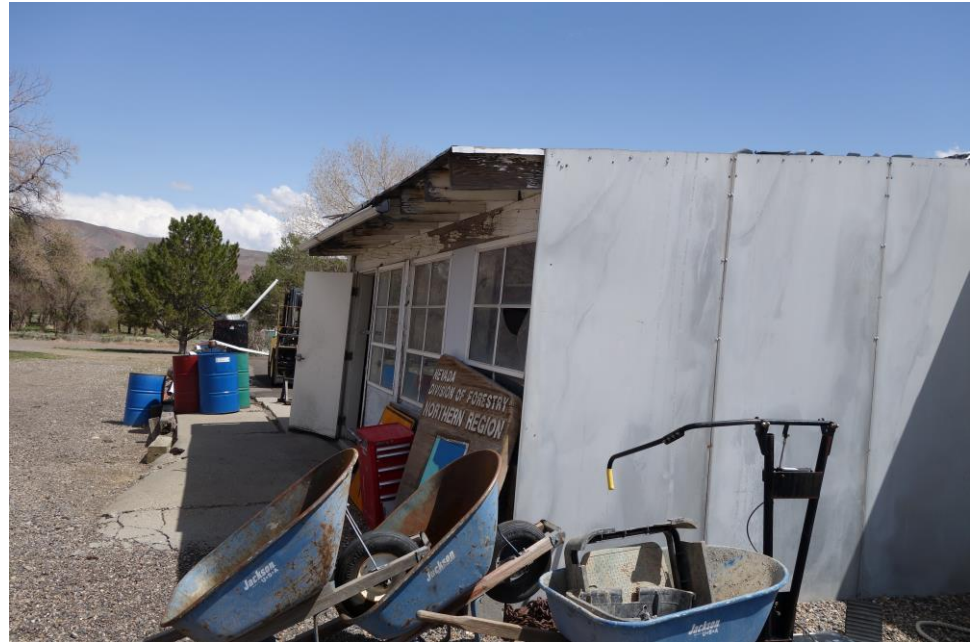
QUANTITY	UNITS	TOTAL	SF COST
The Shop has a small Cook Shed addition on the north side of the structure. It contains numerous code and safety issues including but not limited to broken windows, broken or missing electrical fixtures, temporary metal and wood flooring, dry rot, cooking and washing dishes without proper equipment or ventilation and no life safety systems. The addition is dilapidated and deteriorating and has reached the end of its useful life. This project would provide funding for the demolition of the addition.	280	Square Foot	\$ 5,600.00	\$ 1.00

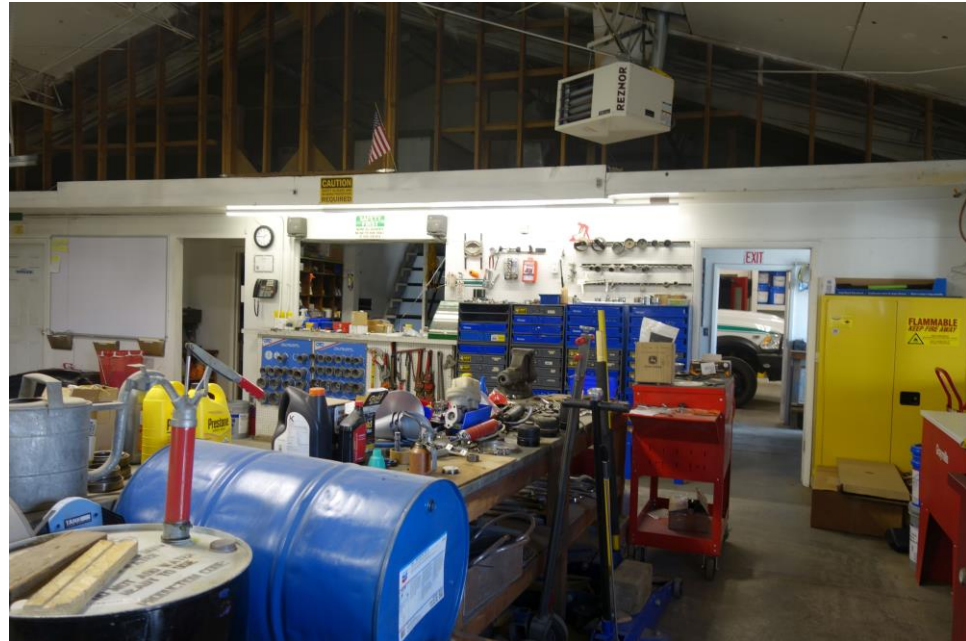
QUANTITY	UNITS	TOTAL	SF COST
The interior finishes are in fair condition. It is recommended to paint the interior walls and ceilings at least once in the next 2 - 3 years and that this project is scheduled on a cyclical basis to maintain the integrity of the structure. Prior to painting, all surfaces should be repaired and prepped. An epoxy-based paint should be utilized in wet areas for durability.	4880	Square Foot	\$24,400.00	\$ 5.00

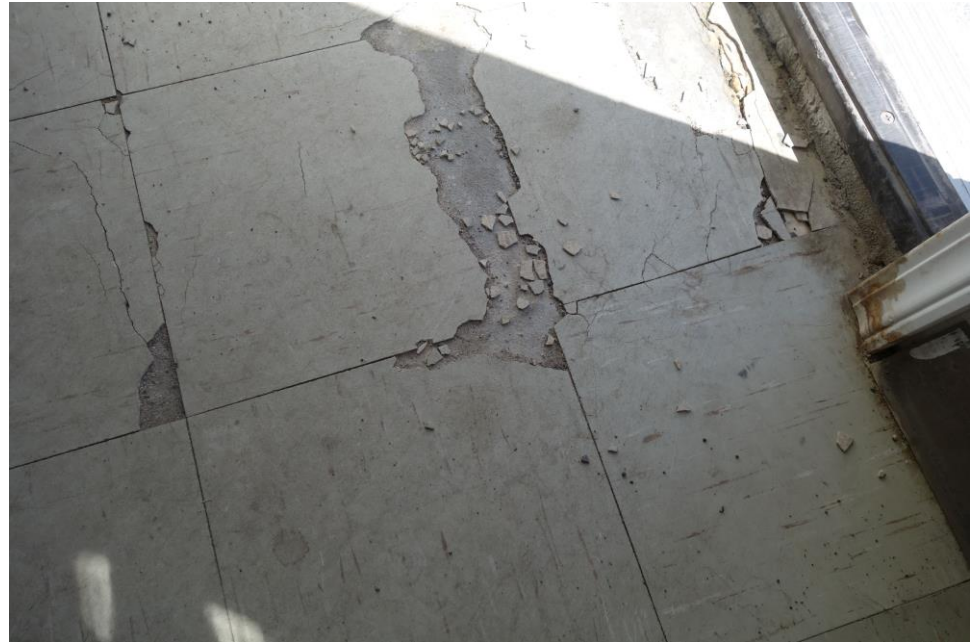
### VCT FLOORING REPLACEMENT

QUANTITY	UNITS	TOTAL	SF COST
The VCT (vinyl composite tile) flooring in the office space is damaged and reaching the end of its useful life. It is recommended that the VCT flooring be replaced. This project would provide for removal and disposal of the VCT and installation of new 12x12 VCT with a 6" base.	500	Square Foot	\$ 4,500.00	\$ 1.00

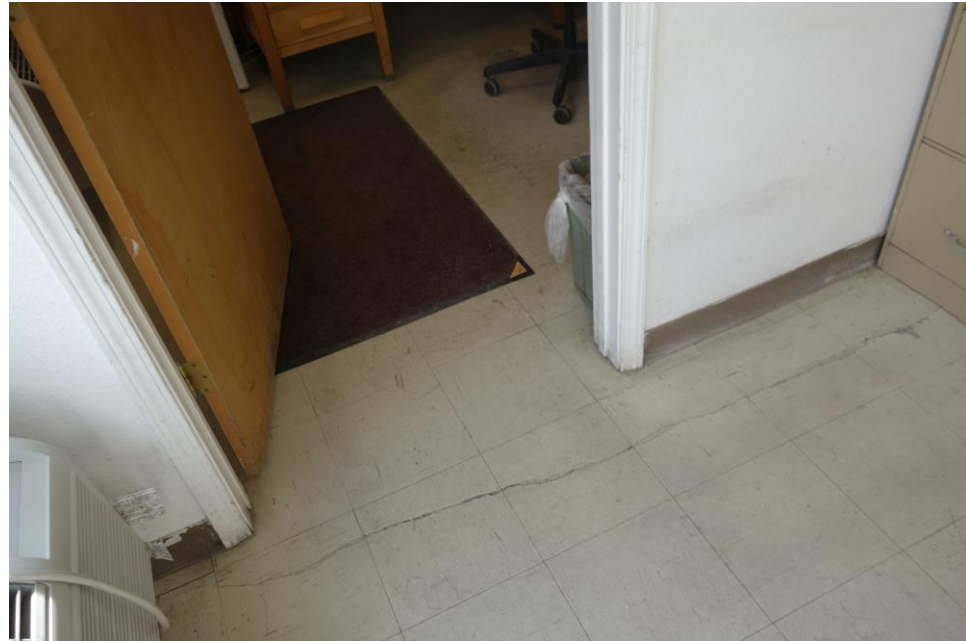
### INTERIOR DOOR REPLACEMENT

QUANTITY	UNITS	TOTAL	SF COST
The interior doors in this building are damaged and do not function properly. There are 3 hollow core wood doors and 3 hollow core metal doors. This project would provide for the installation of new metal solid core interior doors including frames, lever action door handles, hardware and paint. Removal and disposal of the existing doors is included in this cost estimate. A total of 6 interior doors was used in this estimate.	6	Each	\$ 9,000.00	\$ 2.00

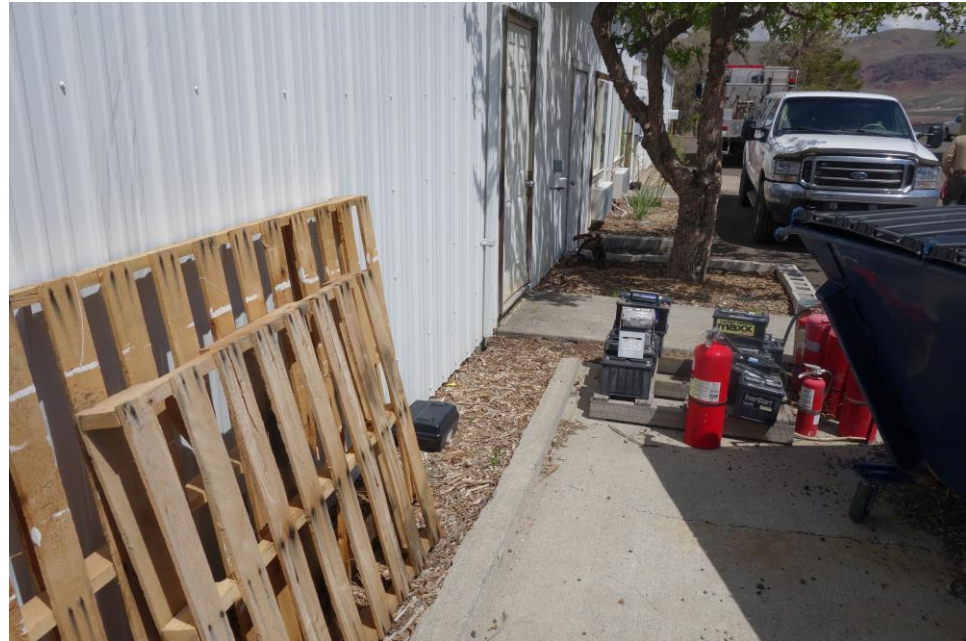
QUANTITY	UNITS	TOTAL	SF COST
The exterior finishes were in fair condition. It is important to maintain the finish, weather resistance and appearance of the building. This project would provide funding to protect the exterior of the building excluding the roof. Included in the cost is power washing, priming and painting the metal panels and caulking of the windows, flashing, fixtures and all other penetrations. It is recommended to paint the building in the next 4 - 6 years and that this project be scheduled on a cyclical basis to maintain the integrity of the structure.	4880	Square Foot	\$24,400.00	\$ 5.00

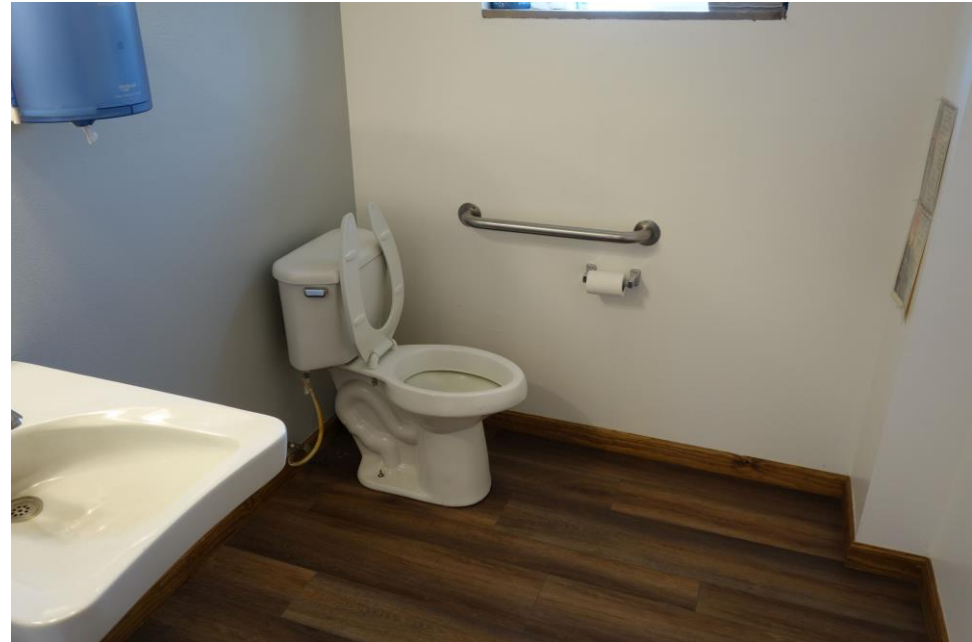
QUANTITY	UNITS	TOTAL	SF COST
The building does not have an accessible restroom. The existing restrooms do not meet the Americans with Disabilities Act (ADA) requirements. This project would provide funding for minor remodeling the Men's and Women's restrooms into ADA compliant restrooms. These items may include additional grab bars, hardware and mirror relocation. The 2018 IBC, ICC/ANSI A117.1 - 2009, NRS 338.180 and the most current version of the ADA Standards For Accessible Design were used as a reference for this project.	1	Package	\$ 5,000.00	\$ 1.00

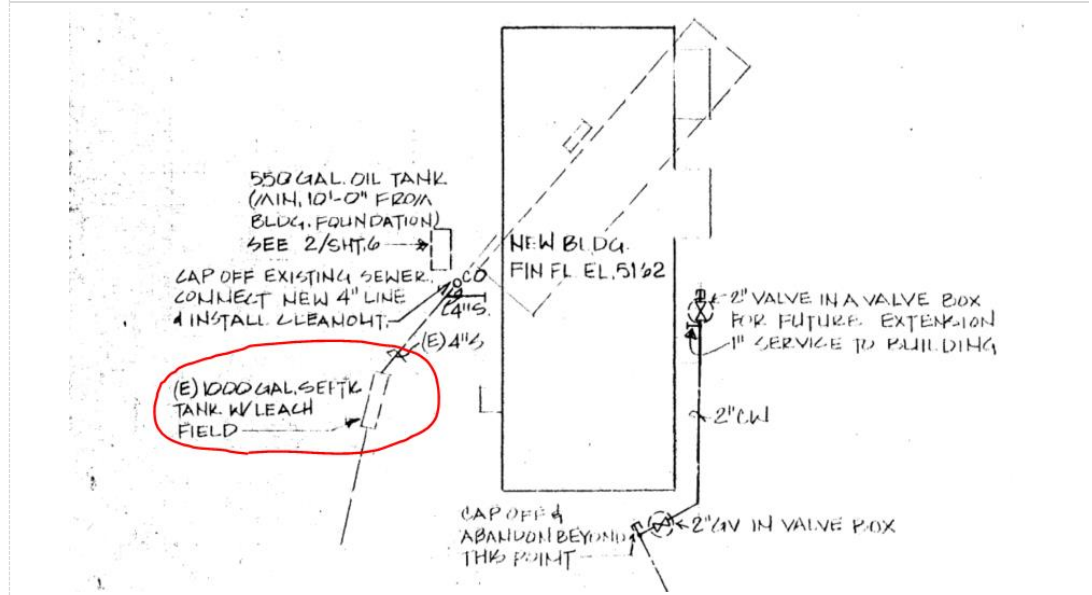
QUANTITY	UNITS	TOTAL	SF COST
The Office building was connected to the city sewer system in 1998 and disconnected from the on-site septic system. There is no record of the existing septic system having been demolished. According to Record Documents, the location of the septic tank is west of the original office footprint. This project provides funds to pump and fill the old tank in compliance with state health regulations.	1	Package	\$ 5,000.00	\$ 1.00

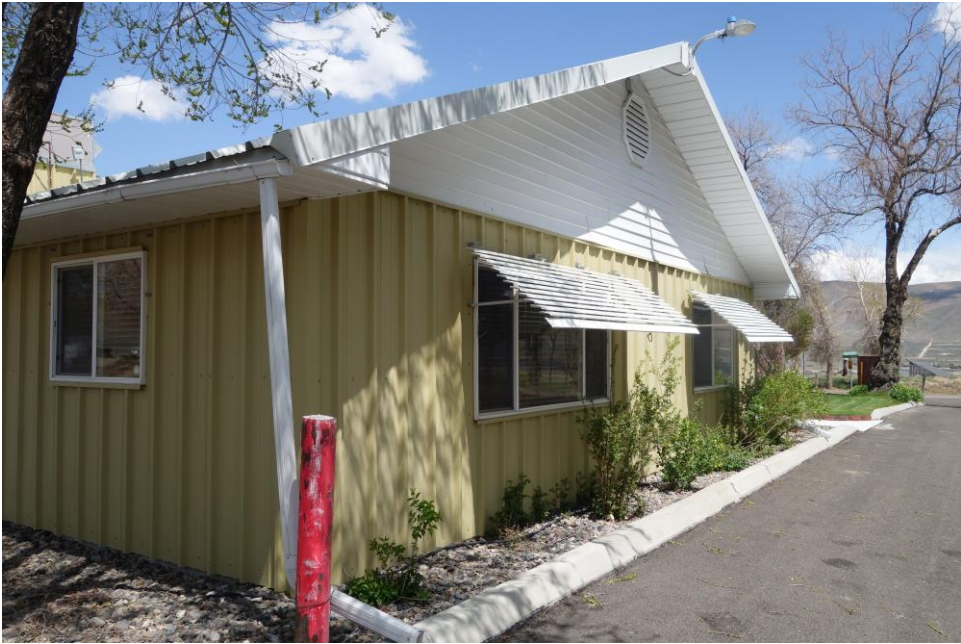
GUTTER REPLACEMENT

QUANTITY	UNITS	TOTAL	SF COST
The existing gutters and downspouts on the building are damaged and should be scheduled for replacement. They have numerous joints that have proven impossible to seal against leaks and have been bent and broken over time. The leaking gutters will cause premature deterioration to the building finishes and the site hardscape. This project would replace the existing segmented gutter with seamless gutter and new downspouts. It is recommended to extend the downspouts at least 5'-0" away from the building exterior.	350	Linear Foot	\$24,500.00	\$ 5.00

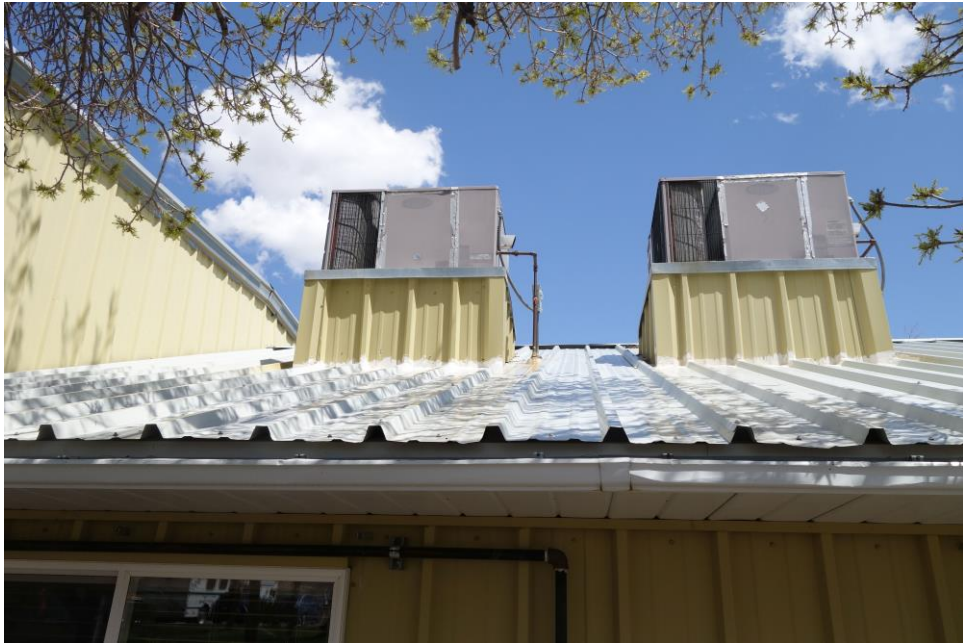
HVAC ROOFTOP REPLACEMENT

QUANTITY	UNITS	TOTAL	SF COST
There are 2 rooftop packaged gas fired HVAC units that are over 22 years old and are not energy efficient. The R-22 refrigerant in the cooling system is no longer EPA compliant and its production was phased out completely January 1, 2020. The packaged HVAC units have reached the end of their expected and useful life. This project would provide for the installation of two new packaged HVAC units. Also included in this estimate is new curb adapters, roofing modifications, 100 feet of new condensate line, crane and rigging removal and installation and all required connections to utilities. Additional features to include direct drive, economizer and DDC.	1	Each	\$50,000.00	\$ 10.00

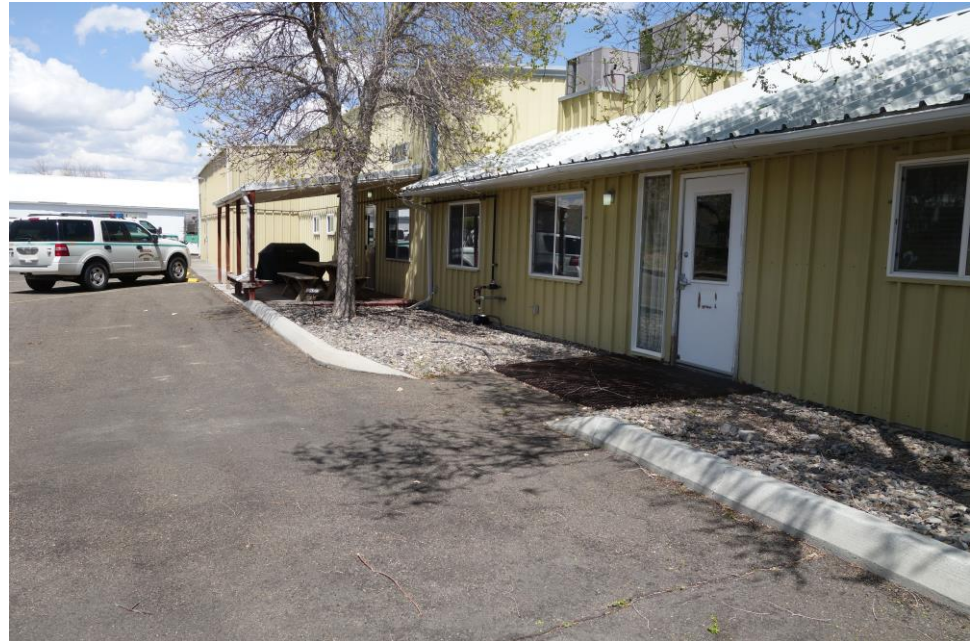
QUANTITY	UNITS	TOTAL	SF COST
The exterior finishes were in good condition. It is important to maintain the finish, weather resistance and appearance of the building. This project would provide funding to protect the exterior of the building excluding the roof. Included in the cost is the caulking and sealing of the windows, flashing, fixtures and all other penetrations. It is recommended that the building be caulked and sealed in the next 6 - 8 years and that this project be scheduled on a cyclical basis to maintain the integrity of the structure.	5084	Square Foot	\$10,200.00	\$ 2.00

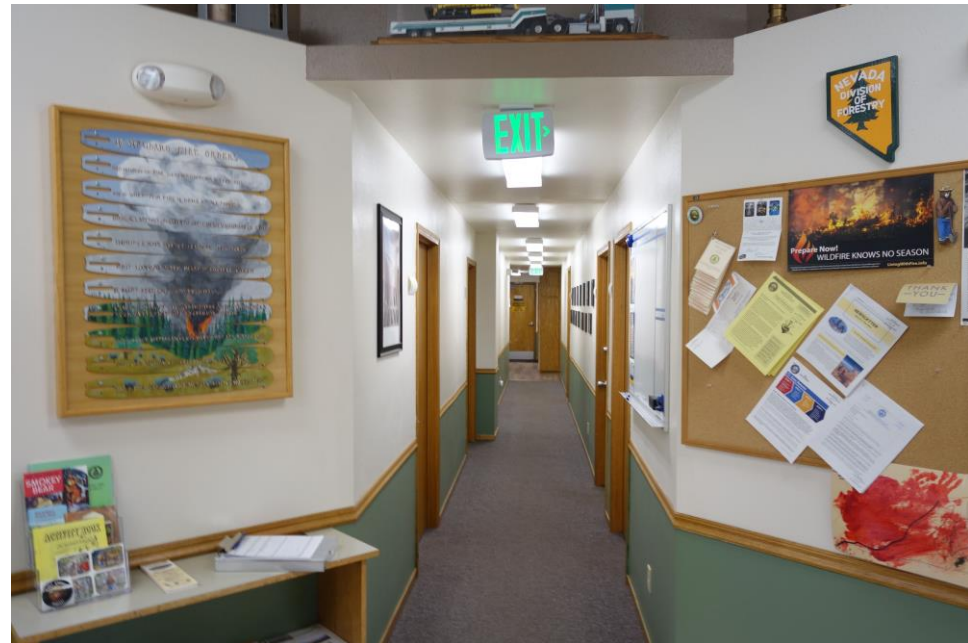
### FLOORING REPLACEMENT

QUANTITY	UNITS	TOTAL	SF COST
The carpet in the building was in fair condition at the time of the survey. However, it is reaching the end of its useful life. It is recommended that the carpeting be planned for replacement. This project would provide for removal and disposal of the existing flooring and installation of new flooring appropriate for the application (vinyl, carpet, tile) in the next 6 - 8 years.	2500	Square Foot	\$35,000.00	\$ 7.00

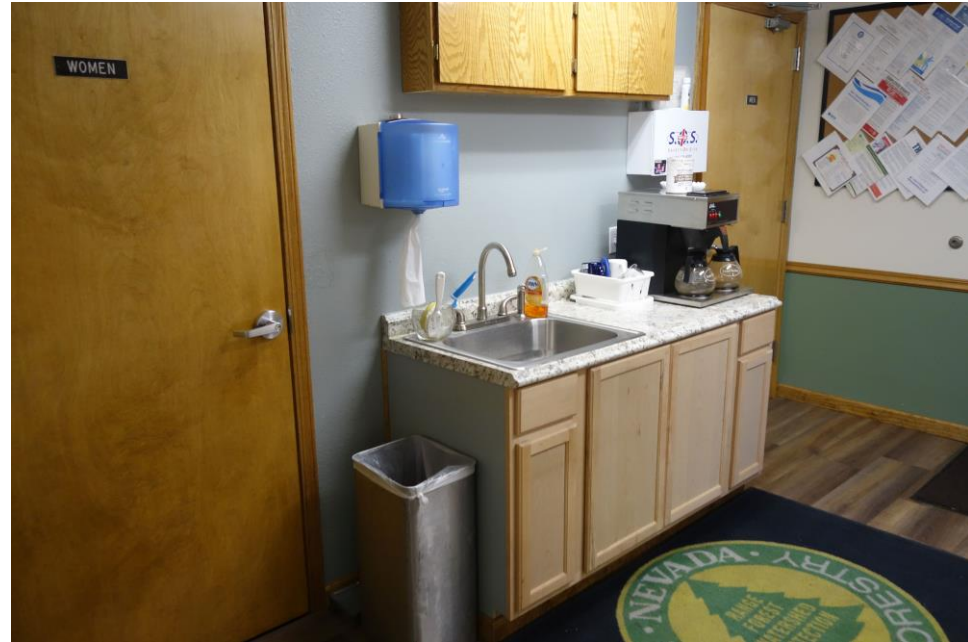
QUANTITY	UNITS	TOTAL	SF COST
The interior finishes were in good condition. It is recommended the interior walls and ceilings be painted in the next 7 - 9 years. All surfaces should be repaired and prepped prior to painting. For durability in wet areas, an epoxy-based paint should be used. Building maintenance should be scheduled on a cyclical basis to maintain the integrity of the structure.	5084	Square Foot	\$25,400.00	\$ 5.00

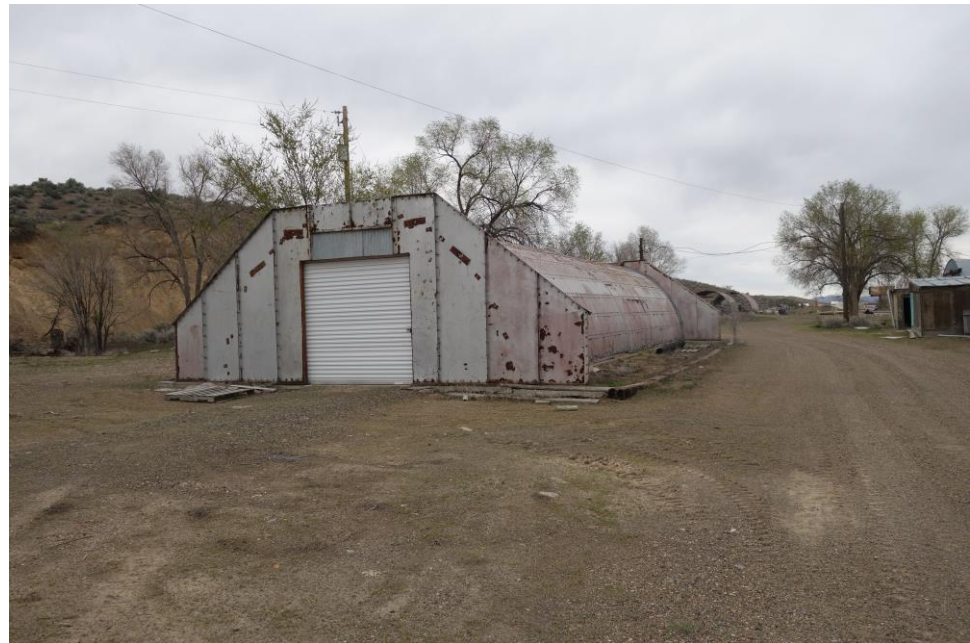
QUANTITY	UNITS	TOTAL	SF COST
The exterior finishes were in poor condition. It is important to maintain the finish, weather resistance and appearance of the building. This project would provide funding to protect the exterior of the building. Included in the cost is power washing, priming and painting the metal panels. It is recommended to paint the building in the next 2 - 3 years and that this project be scheduled on a cyclical basis to maintain the integrity of the structure.	1200	Square Foot	\$24,000.00	\$ 20.00

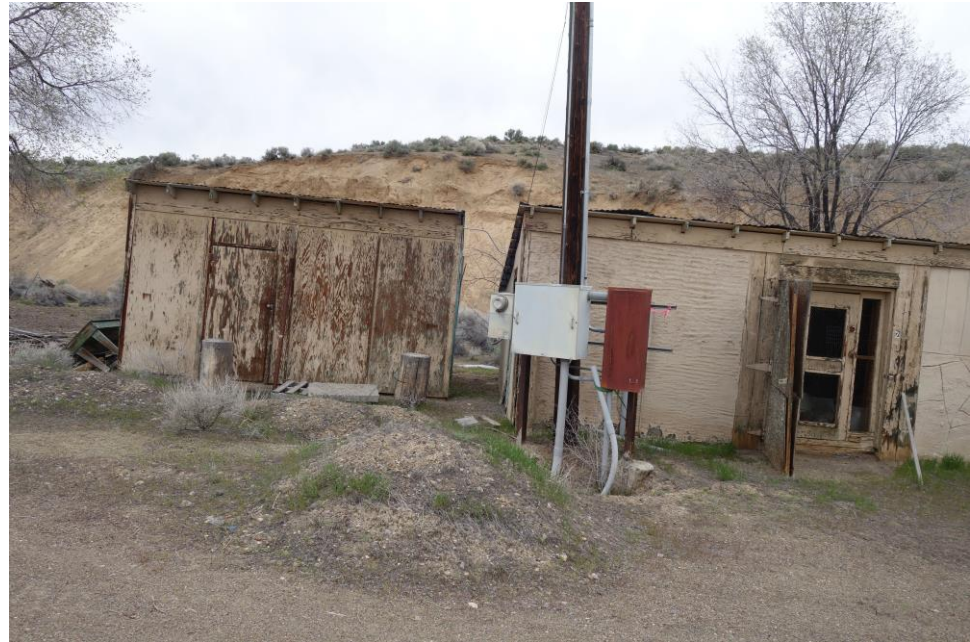
QUANTITY	UNITS	TOTAL	SF COST
The structure is dilapidated and deteriorating and has reached the end of its useful life. The structure is over 50 years of age, has had continuous roof leaks and the wood has rotted. This project would provide funding for the demolition and disposal of the building.	1	Package	\$ 5,000.00	\$ 25.00

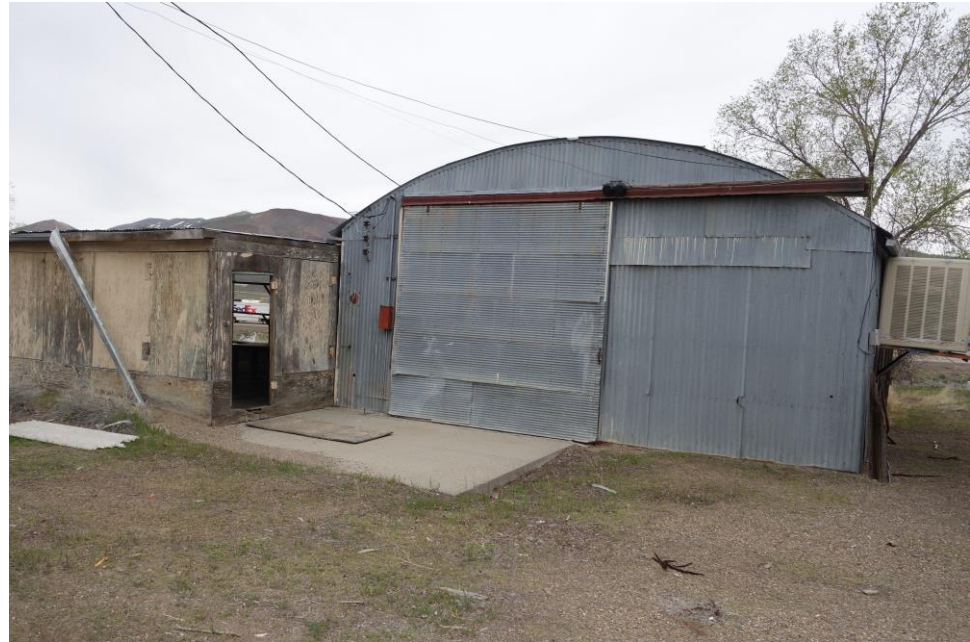
QUANTITY	UNITS	TOTAL	SF COST
The structure is dilapidated and deteriorating and has reached the end of its useful life. The structure is over 50 years of age, has had continuous roof leaks and the wood has rotted. This project would provide funding for the demolition and disposal of the building.	1	Package	\$ 5,000.00	\$ 20.00

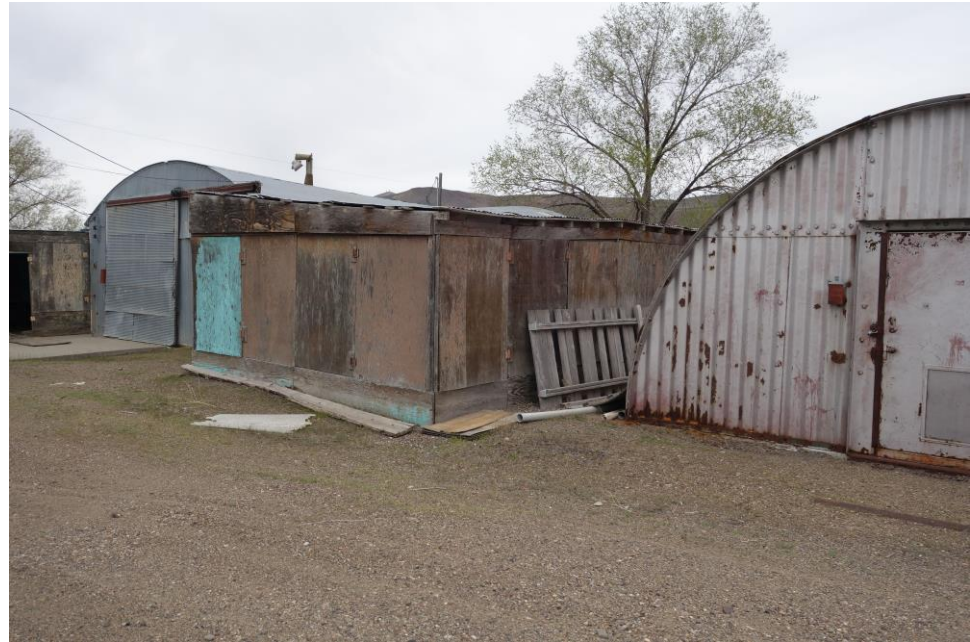
QUANTITY	UNITS	TOTAL	SF COST
The structure is dilapidated and deteriorating and has reached the end of its useful life. The structure is over 50 years of age, has had continuous roof leaks and the wood has rotted. This project would provide funding for the demolition and disposal of the building.	1	Package	\$ 5,000.00	\$ 16.00

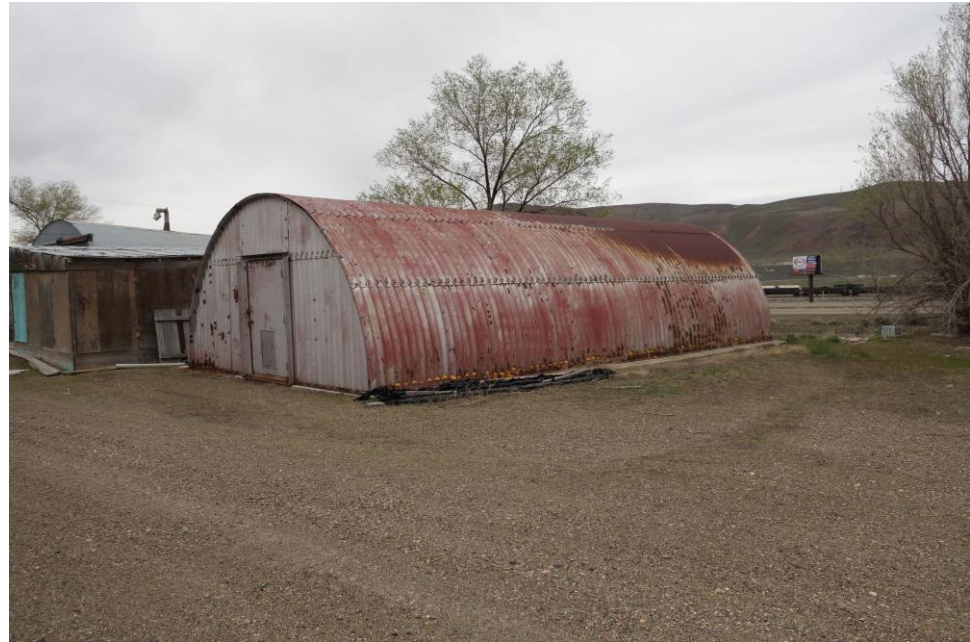
QUANTITY	UNITS	TOTAL	SF COST
The exterior finishes were in poor condition. It is important to maintain the finish, weather resistance and appearance of the building. This project would provide funding to protect the exterior of the building. Included in the cost is power washing, priming and painting the metal panels. It is recommended to paint the building in the next 2 - 3 years and that this project be scheduled on a cyclical basis to maintain the integrity of the structure.	800	Square Foot	\$16,000.00	\$ 20.00

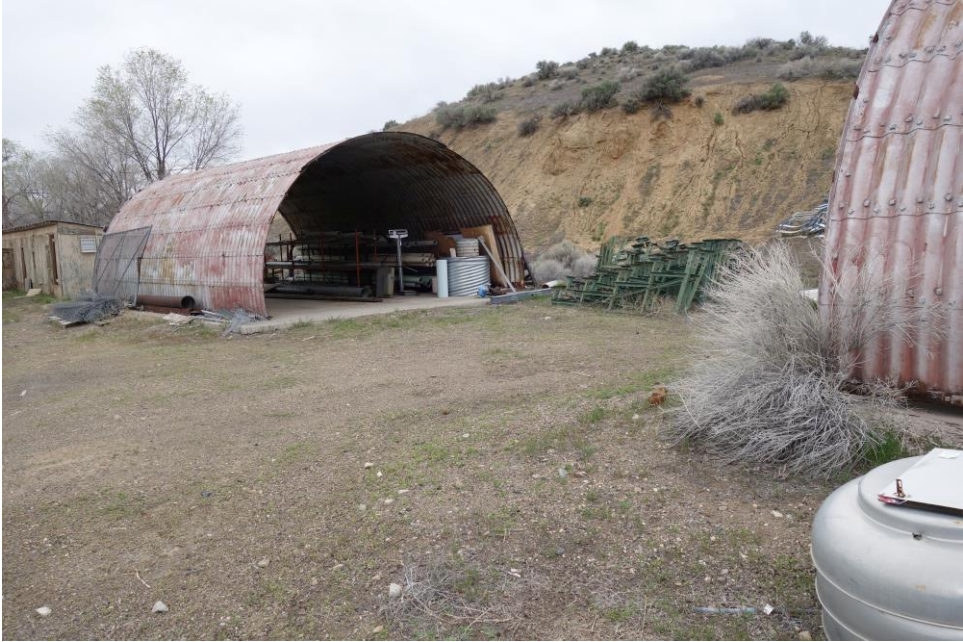
QUANTITY	UNITS	TOTAL	SF COST
The exterior finishes were in poor condition. It is important to maintain the finish, weather resistance and appearance of the building. This project would provide funding to protect the exterior of the building. Included in the cost is power washing, priming and painting the metal panels. It is recommended to paint the building in the next 2 - 3 years and that this project be scheduled on a cyclical basis to maintain the integrity of the structure.	450	Square Foot	\$ 9,000.00	\$ 20.00
