STATE OF NEVADA  
STATE PUBLIC WORKS DIVISION

FACILITY CONDITION ASSESSMENT REPORT FOR:

DEPT OF CONSERVATION AND NATURAL RESOURCES  
DIVISION OF FORESTRY

SITE #: 9934 ELKO NORTHERN REGION 2 NDF HDQS. SITE  
911 FALCON WAY  
ELKO, NV 89801-4654

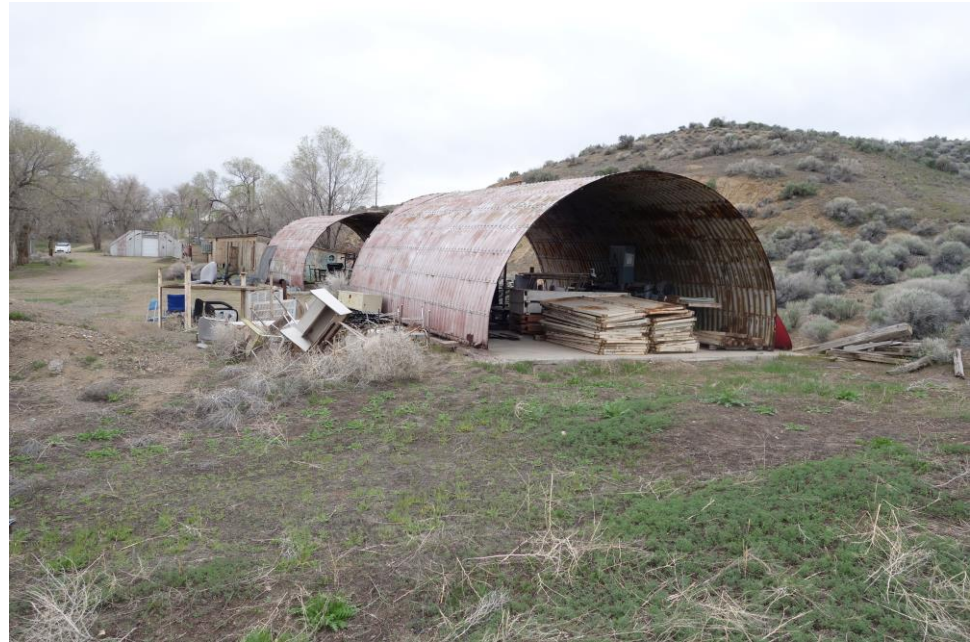
QUANTITY	UNITS	TOTAL	SF COST
The exterior finishes were in poor condition. It is important to maintain the finish, weather resistance and appearance of the building. This project would provide funding to protect the exterior of the building. Included in the cost is power washing, priming and painting the metal panels. It is recommended to paint the building in the next 2 - 3 years and that this project be scheduled on a cyclical basis to maintain the integrity of the structure.	450	Square Foot	\$ 9,000.00	\$ 20.00
