STATE OF NEVADA
STATE PUBLIC WORKS DIVISION

FACILITY CONDITION ASSESSMENT REPORT FOR:

DEPT OF CONSERVATION AND NATURAL RESOURCES
DIVISION OF STATE PARKS

SITE #: 9935 WILD HORSE STATE RECREATION AREA SITE
HC 31 BOX 265
ELKO, NV 89801-

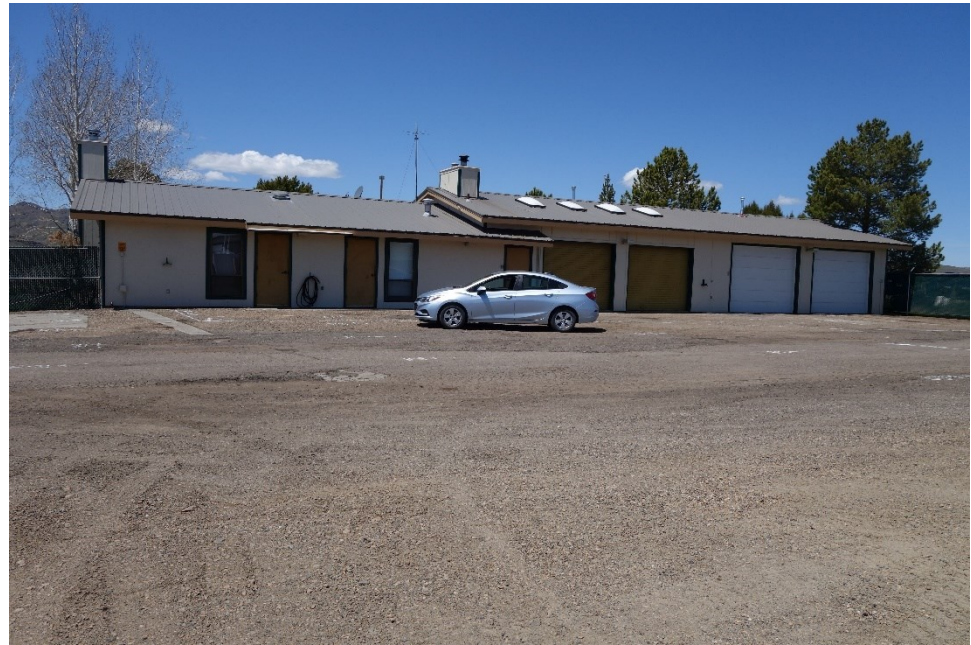
QUANTITY	UNITS	TOTAL	SF COST
<p>The AC paving behind the visitors center has failed and is in need of replacement. This project would provide for the removal of the damaged paving and installation of new 4" thick AC paving over a compacted base. It may be possible to grind in place the damaged paving and use for base which could reduce project cost.</p> <p>This project or a portion thereof was previously recommended in the FCA report dated 7/23/2014. It has been amended accordingly to reflect conditions observed during the most recent survey date of 05/17/2022.</p>	15625	SF	\$187,500.00	-

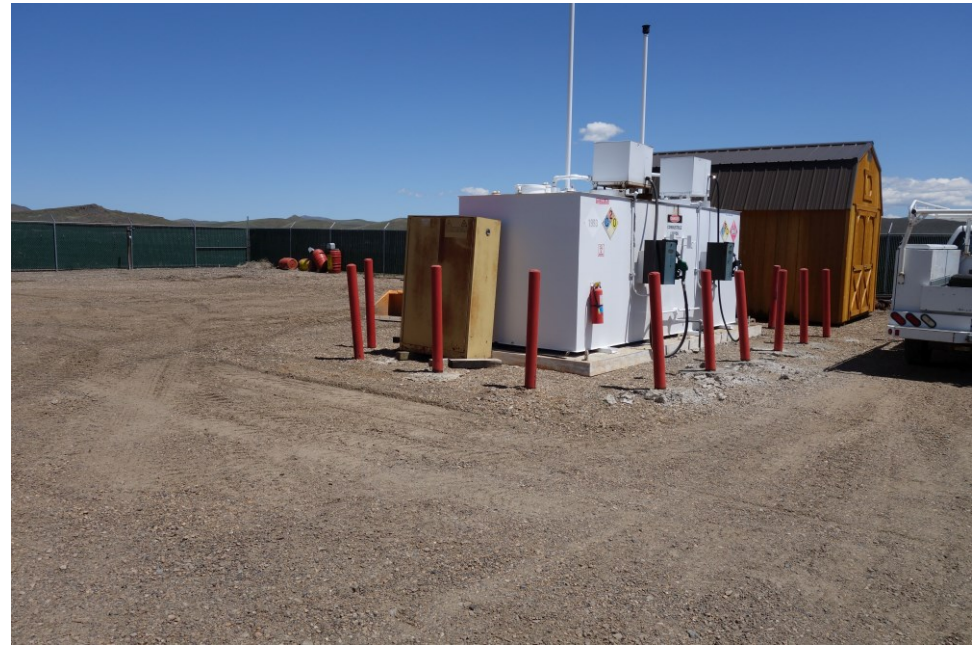
QUANTITY	UNITS	TOTAL	SF COST
The fuel dispensing equipment is aging due to the extreme weather conditions at the site. The UV radiation has faded the displays and finishes making them difficult to read. This project will fund the replacement of the fuel dispensing equipment and the installation of a shade ramada to protect the fueling station against the weather extremes.	1	PKG	\$40,000.00	-

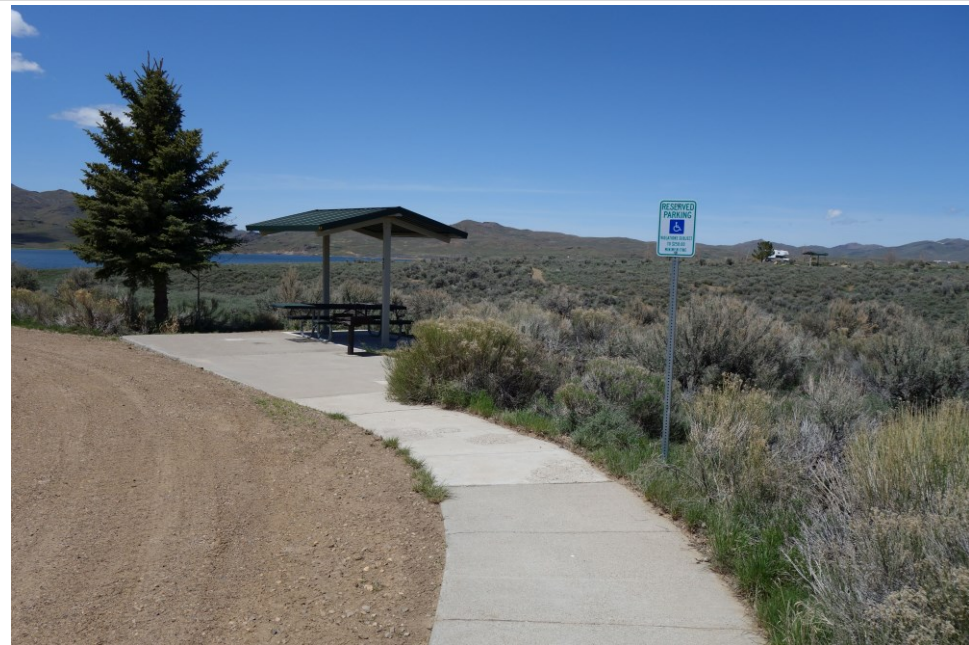
QUANTITY	UNITS	TOTAL	SF COST
The exterior finishes on the shade ramadas are in good condition. There are steel shade ramadas in different locations throughout the site which measure about 12' x 12' each. It is important to maintain the finish, weather resistance and appearance of the structures. This project would provide for painting of the structures in the next 7 - 9 years.	34	EA	\$10,200.00	-

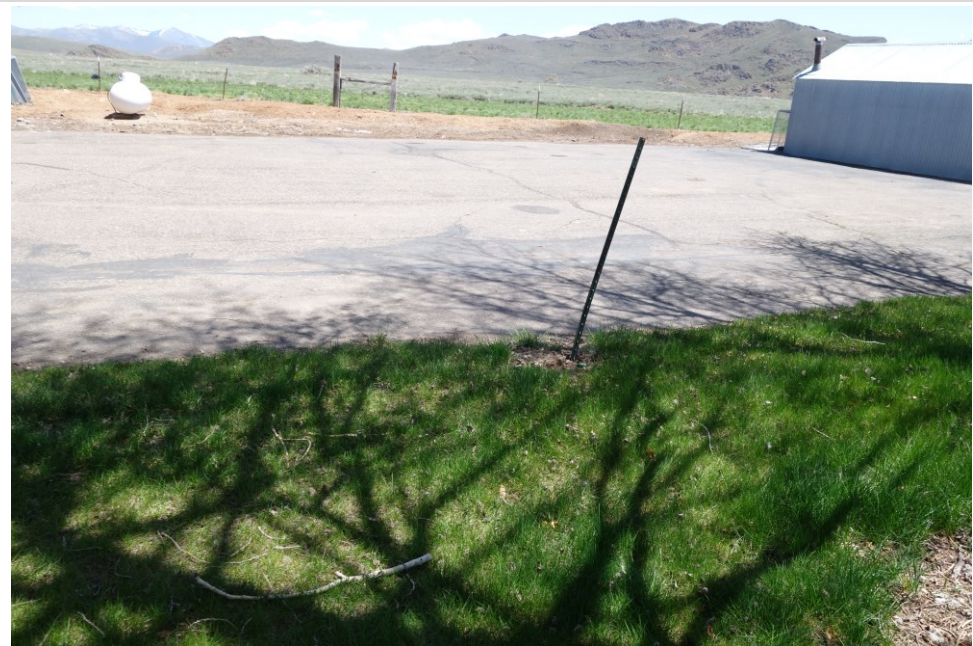
QUANTITY	UNITS	TOTAL	SF COST
The site paving was overlaid with a chip-seal in 2020 and is in good condition. It is important to maintain the asphalt concrete paving on the site. This project would provide for minor crack filling and slurry sealing of the paving site wide including access roads and parking areas. Striping is included in this estimate. This project should be scheduled in the next 5 - 6 years and on a 5 year cyclical basis to maintain the integrity of the paving and prevent premature failure. 120,000 square feet of asphalt area was used to generate this estimate which includes the new paving in the campgrounds.	120000	SF	\$144,000.00	-

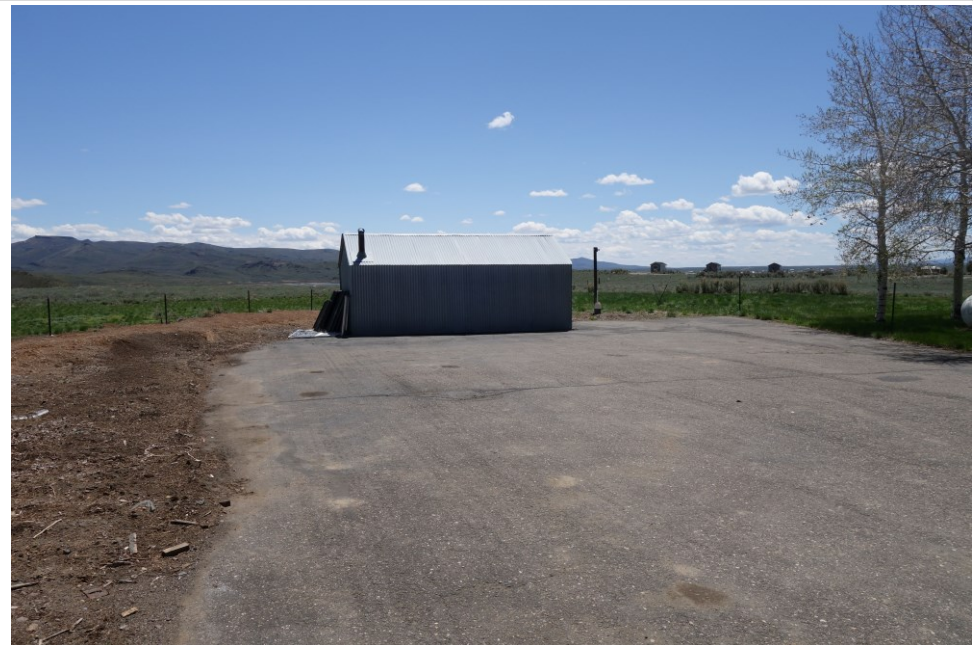
QUANTITY	UNITS	TOTAL	SF COST
The exterior finishes were in fair condition. It is important to maintain the weather resistance of the building. This project recommends work to protect the exterior building envelope including caulking seams and other penetrations to maintain the building in good, weather tight condition. It is recommended that this project be implemented in the next 4 - 6 years and is recommended on a cyclical basis based on environmental conditions	200	SF	\$ 400.00	\$ 2.00

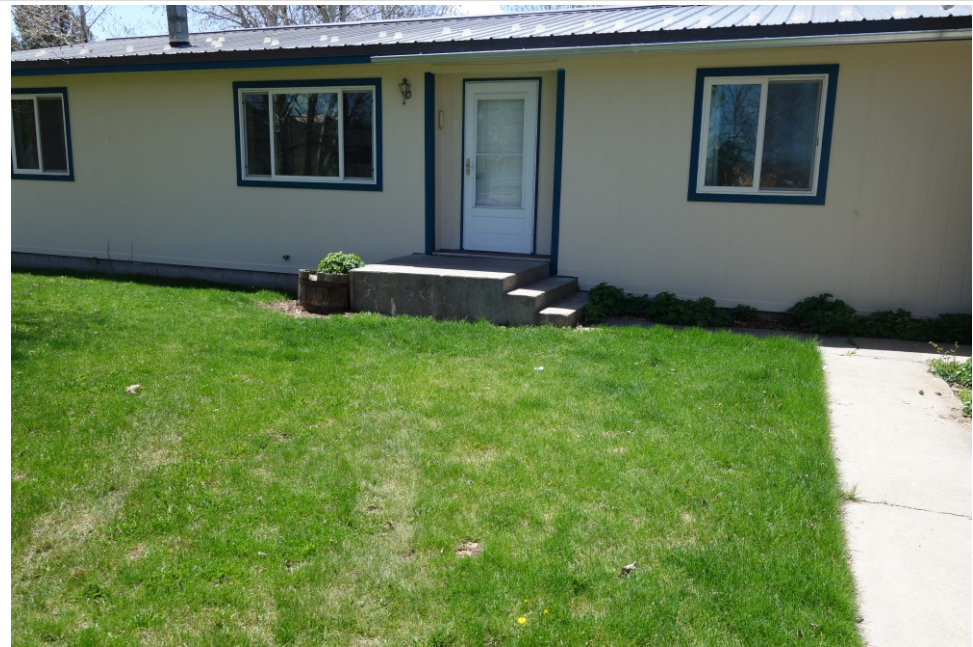
QUANTITY	UNITS	TOTAL	SF COST
The exterior finishes appeared freshly painted and were in good condition. It is important to maintain the finish, weather resistance and appearance of the building. This project recommends work to protect the exterior building envelope, other than the roof, including painting, staining, or other applied finishes, and caulking around windows, flashing, fixtures, and other penetrations to maintain the building in good, weather tight condition. It is recommended that this project be implemented in the next 7 - 9 years and is recommended on a cyclical basis based on environmental conditions.	2304	SF	\$13,800.00	\$ 6.00

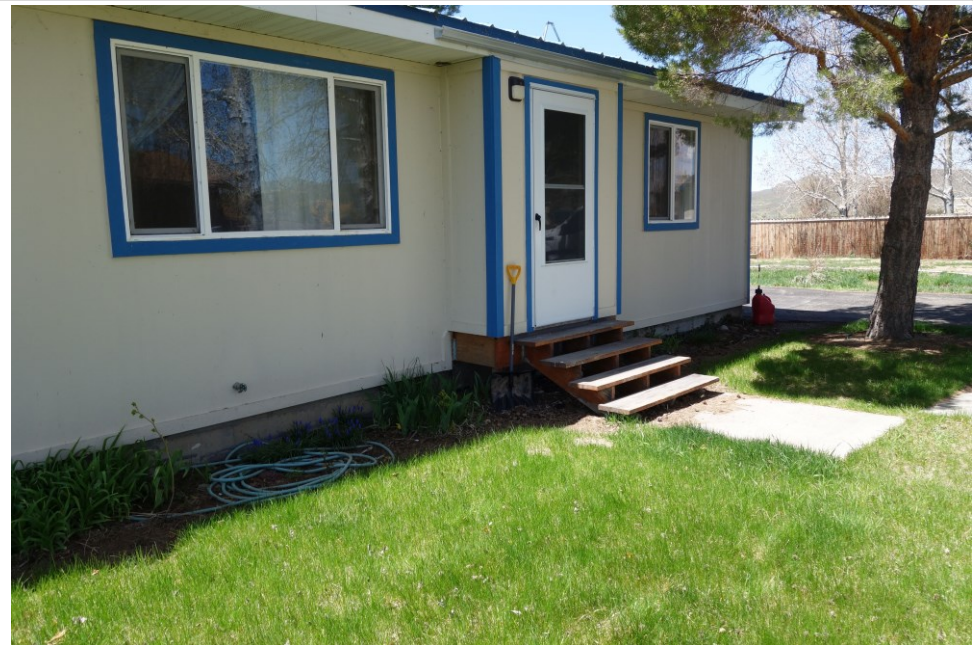
QUANTITY	UNITS	TOTAL	SF COST
The exterior finishes appear freshly painted and are in good condition. It is important to maintain the finish, weather resistance and appearance of the building. This project recommends work to protect the exterior building envelope, other than the roof, including painting, staining, or other applied finishes, and caulking around windows, flashing, fixtures, and other penetrations to maintain the building in good, weather tight condition. It is recommended that this project be implemented in the next 3 to 4 years and is recommended on a cyclical basis based on environmental conditions.	2304	SF	\$13,800.00	\$ 6.00

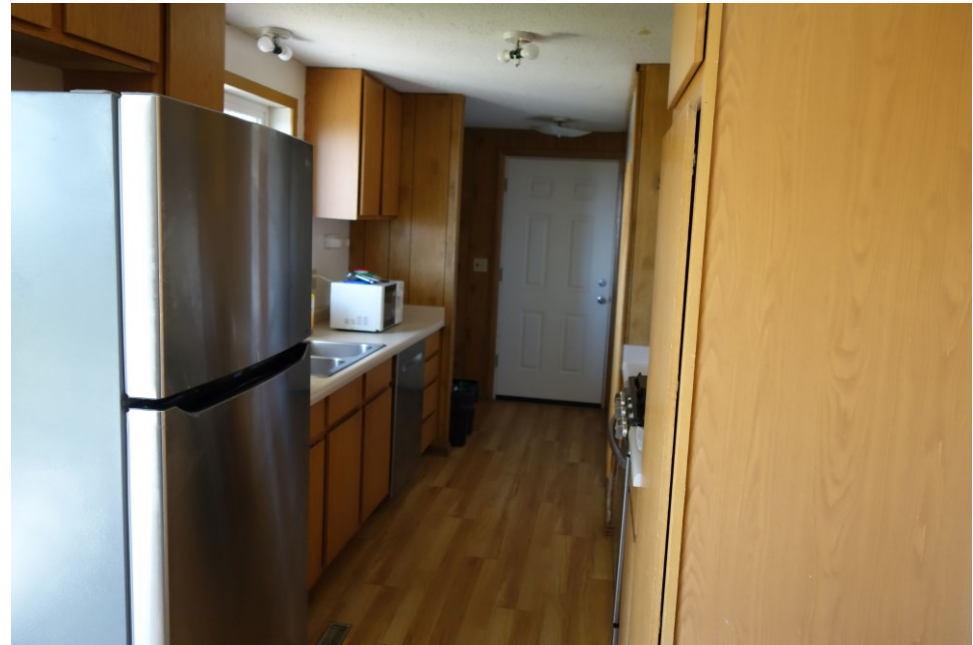
QUANTITY	UNITS	TOTAL	SF COST
The interior finishes are in good condition. It is recommended that the interior walls and ceilings be painted at least once in the next 6 - 8 years and every 7 - 9 years thereafter to maintain the integrity of the interior of the building. Prior to painting, all surfaces should be repaired and prepped. An epoxy-based paint should be utilized in wet areas for durability.	2304	SF	\$16,100.00	\$ 7.00

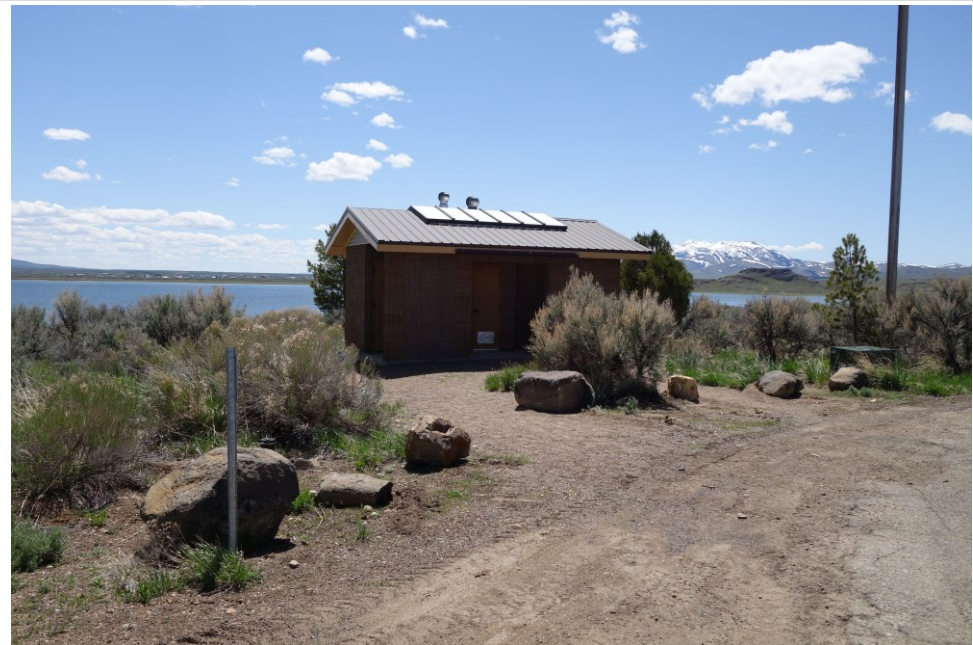
QUANTITY	UNITS	TOTAL	SF COST
The existing restroom is over 40 years old and has reached the end of its useful life. It is becoming increasingly expensive to maintain and repair. The restroom itself does not meet accessibility requirements and there is no ADA parking and path to the restroom. This project recommends removal and replacement of the restroom and installation of accessible parking and path to the restroom. A feature recommended for the restroom include shower facilities to support the 3 rental cabins which do not have showers. This will require the addition of a new septic system or, if the cabin septic system has the capacity, install lift station to the group cabin septic system.	1	PKG	\$1,120,000.00	\$ 2,800.00

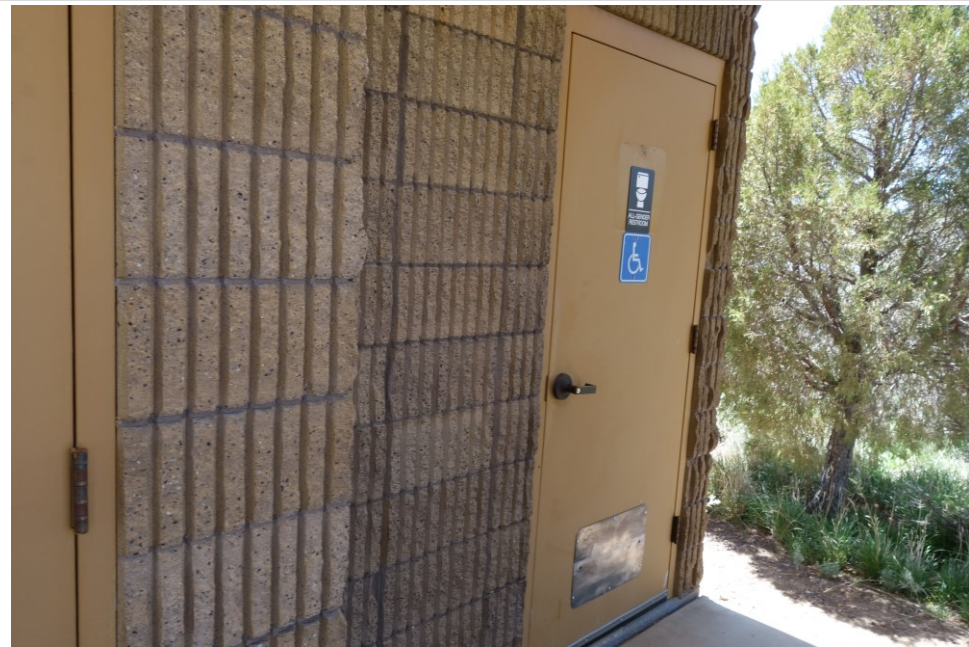
QUANTITY	UNITS	TOTAL	SF COST
The interior and exterior finishes were in fair condition. It is important to maintain the finish, weather resistance and appearance of the building. This project recommends work to protect the exterior building envelope, other than the roof, including painting, block sealing, staining, or other applied finishes, and caulking around windows, flashing, fixtures, and other penetrations to maintain the building in good, weather tight condition. It is recommended that this project be implemented in the next 4 - 6 years and is recommended on a cyclical basis based on environmental conditions.	400	SF	\$ 1,600.00	\$ 4.00

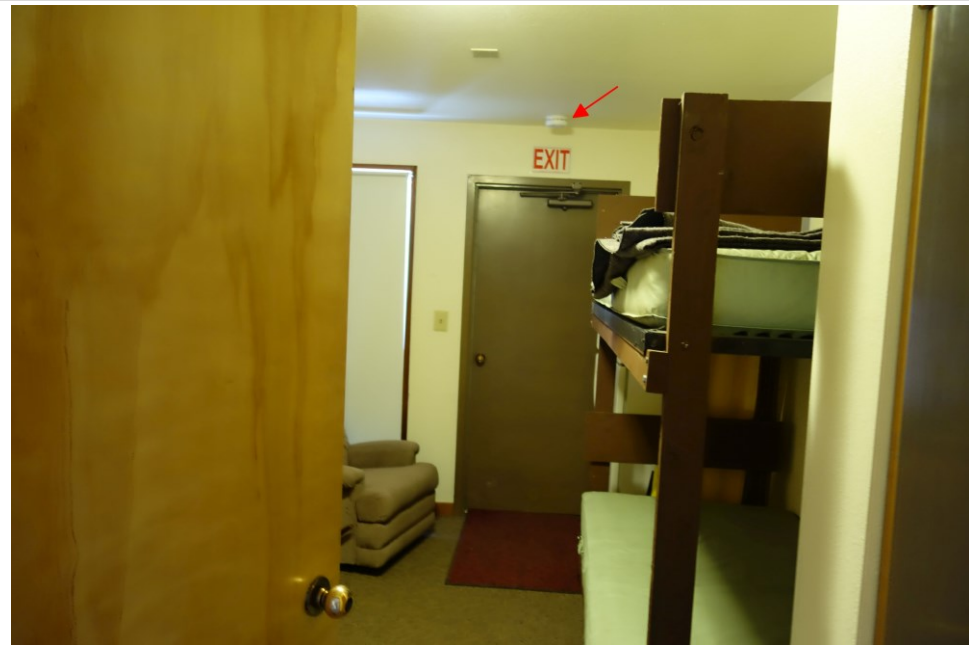
QUANTITY	UNITS	TOTAL	SF COST
The building has a sleeping quarters room. Smoke detection was noted in that room but not in the balance of the building. It is recommended that additional smoke and carbon monoxide detection and alarm system be installed outside the sleeping area. When completed, the new system will provide visual, as well as audible notification, in accordance with ADA requirements located in ICC/ANSI A117.1- 2009 Section 7 and the 2018 International Fire Code. This project or a portion thereof was previously recommended in the FCA report dated 11/07/2007 and 07/23/2014. It has been amended accordingly to reflect conditions observed during the most recent survey date of 05/17/2022.	3400	SF	\$17,000.00	\$ 5.00

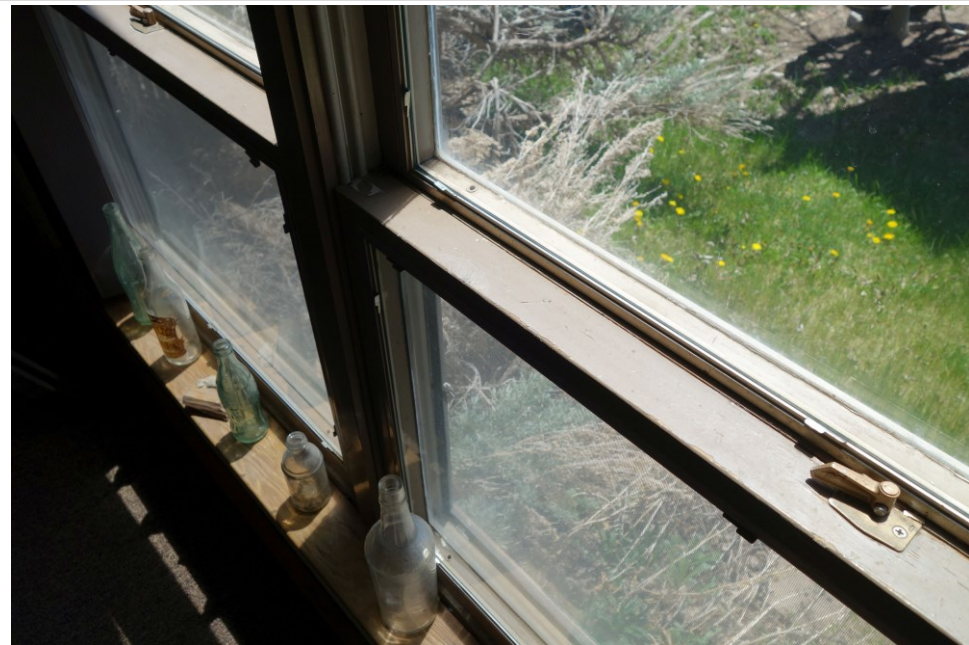
QUANTITY	UNITS	TOTAL	SF COST
There are six windows in the building approximately 3'x7' with an exposed bottom edge less than 18" above the floor. IBC 2018 - Section 2406 requires these windows to have safety glass labeled due to their hazardous location. This project recommends replacing the windows with safety glazed windows. This estimate is for the replacement of 6 units.	6	EA	\$ 9,000.00	\$ 3.00

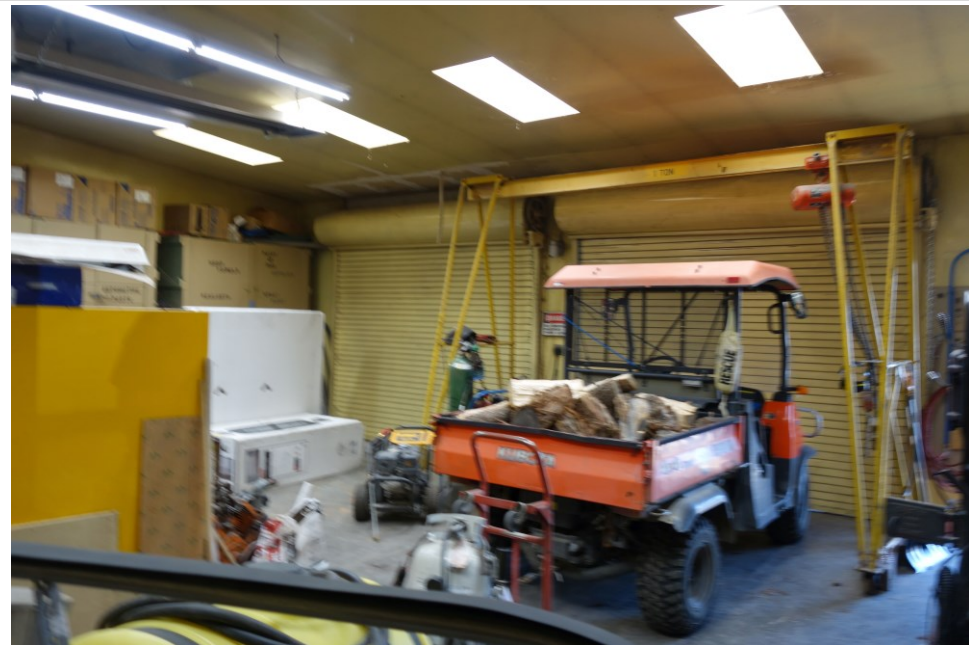
QUANTITY	UNITS	TOTAL	SF COST
There are two 12'x10' overhead coiling doors which are damaged and do not function properly. They are original to the building and should be scheduled for replacement. This project would provide for the removal and disposal of the manually operated overhead coiling doors and replacement with two motorized doors.	2	EA	\$30,000.00	\$ 9.00

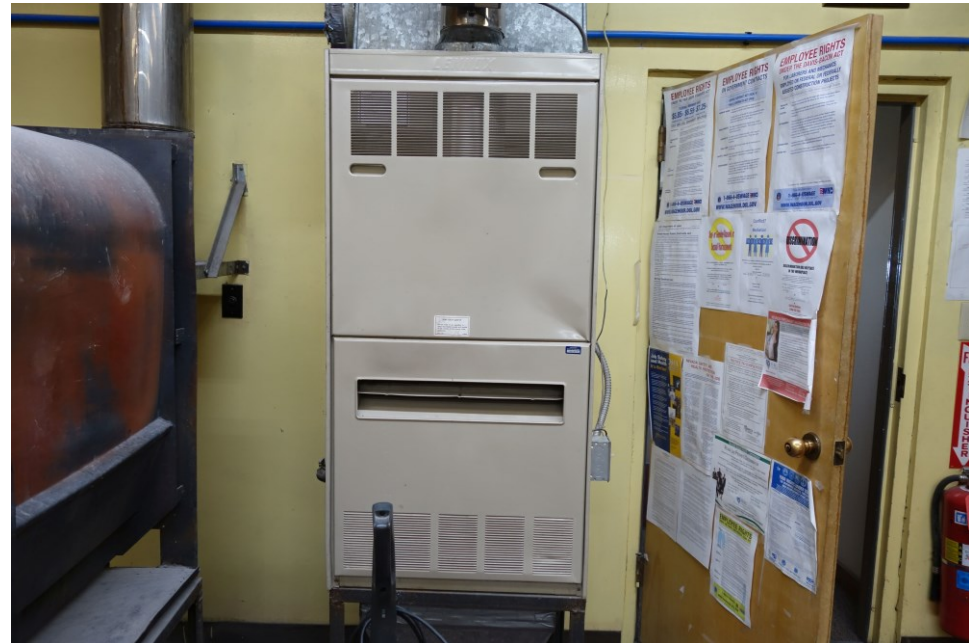
QUANTITY	UNITS	TOTAL	SF COST
The building is heated by a propane fired forced air unit installed in 1982. It is original to the building and has reached the end of its expected life. This project would provide for replacement of the heater and includes removal and disposal of the existing unit and all required connections to utilities.	1	PKG	\$20,000.00	\$ 6.00
