STATE OF NEVADA
STATE PUBLIC WORKS DIVISION

FACILITY CONDITION ASSESSMENT REPORT FOR:

SOUTH FORK STATE RECREATION AREA SITE
139 HYLTON CT
SPRING CREEK, NV 89815-

Survey Date: 5/16/2022
Distribution Date: 12/18/2023

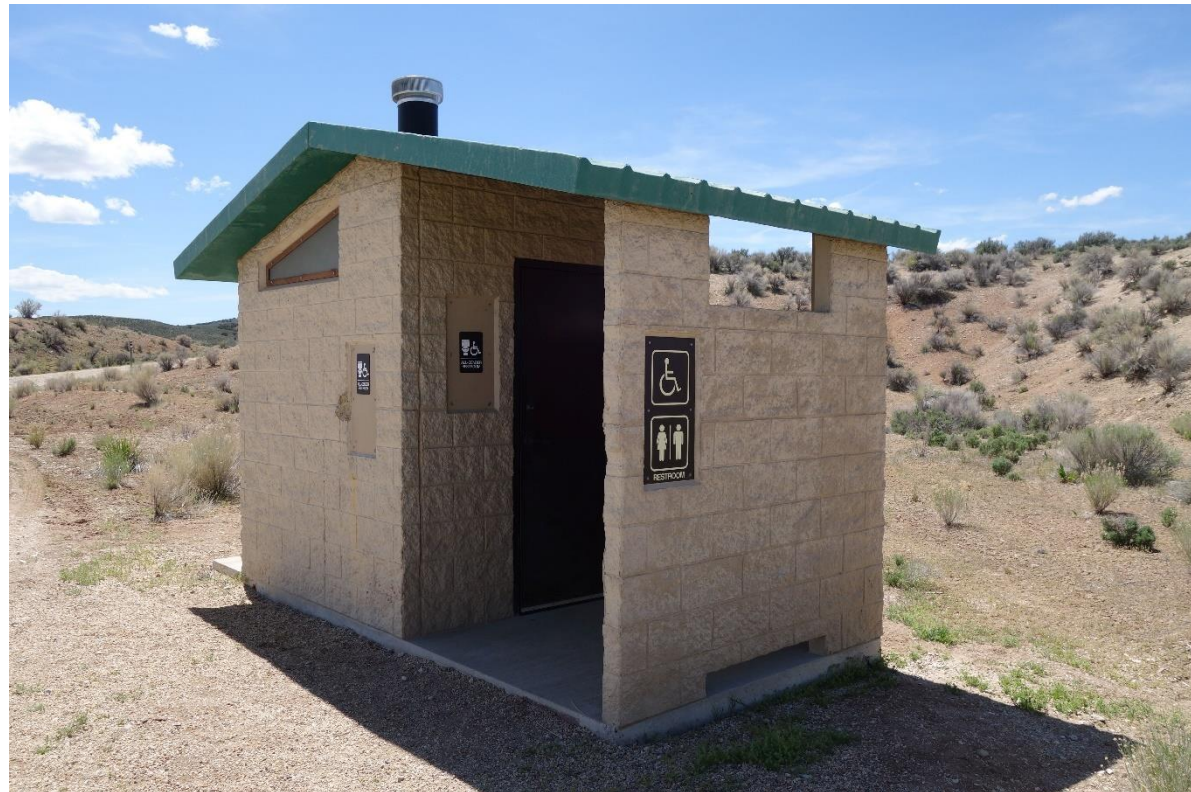
The Americans with Disabilities Act (ADA) provides for accessibility to sites and services for people with physical limitations. A concrete parking area and passenger loading area are necessary to comply with ADA requirements. This project would provide a concrete van accessible ADA parking and loading space and accessible path to the restroom. This will require regrading, installing P.C. concrete, striping, signage and any other necessary upgrades. The 2018 IBC, ICC/ANSI A117.1 - 2009, NRS 338.180 and the most current version of the *ADA Standards For Accessible Design* were used as a reference for this project. This project or a portion thereof was previously recommended in the FCA report dated 07/22/2014. It has been amended accordingly to reflect conditions observed during the most recent survey date of 05/16/2023.

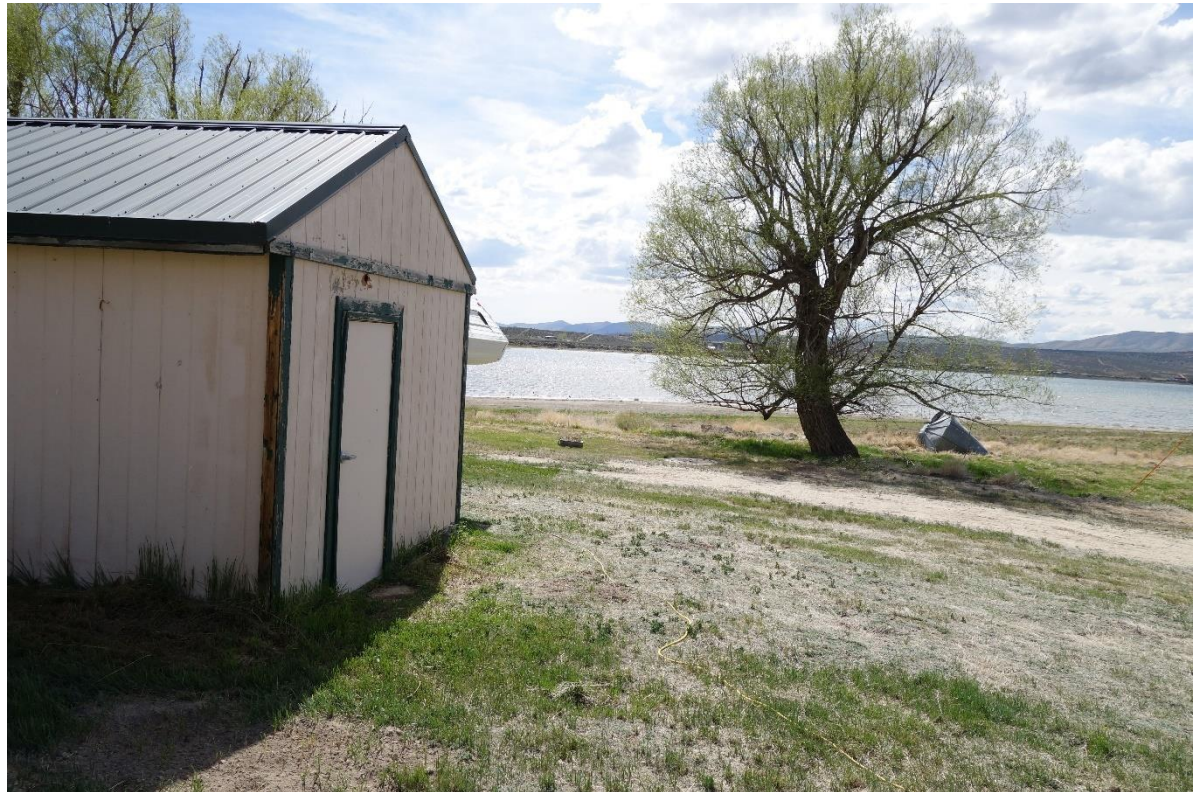
The exterior finishes were in poor condition. It is important to maintain the finish, weather resistance and appearance of the building. This project would provide funding to protect the exterior of the building excluding the roof. Included in the cost is sanding, priming and painting and caulking of the flashing, fixtures and all other penetrations. It is recommended that the building be painted in the next 2 - 3 years and that this project is scheduled on a cyclical basis to maintain the integrity of the structure.

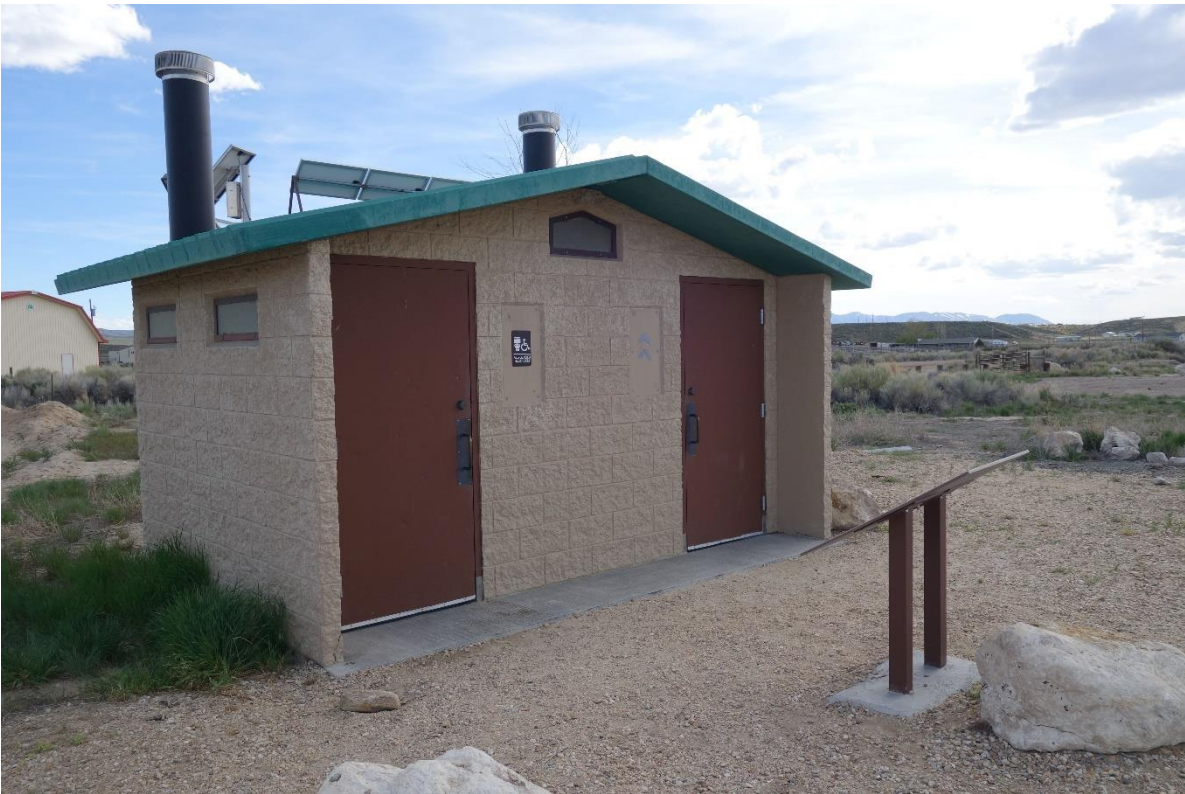
The Americans with Disabilities Act (ADA) provides for accessibility to sites and services for people with physical limitations. A concrete parking area and passenger loading area are necessary to comply with ADA requirements. This project would provide a concrete van accessible ADA parking and loading space and walkway to the existing sidewalk. This will require regrading, installing P.C. concrete, striping, signage and any other necessary upgrades. The 2018 IBC, ICC/ANSI A117.1 - 2009, NRS 338.180 and the most current version of the *ADA Standards For Accessible Design* were used as a reference for this project. This project or a portion thereof was previously recommended in the FCA report dated 11/07/2007 and 07/22/2014. It has been amended accordingly to reflect conditions observed during the most recent survey date of 05/16/2023.

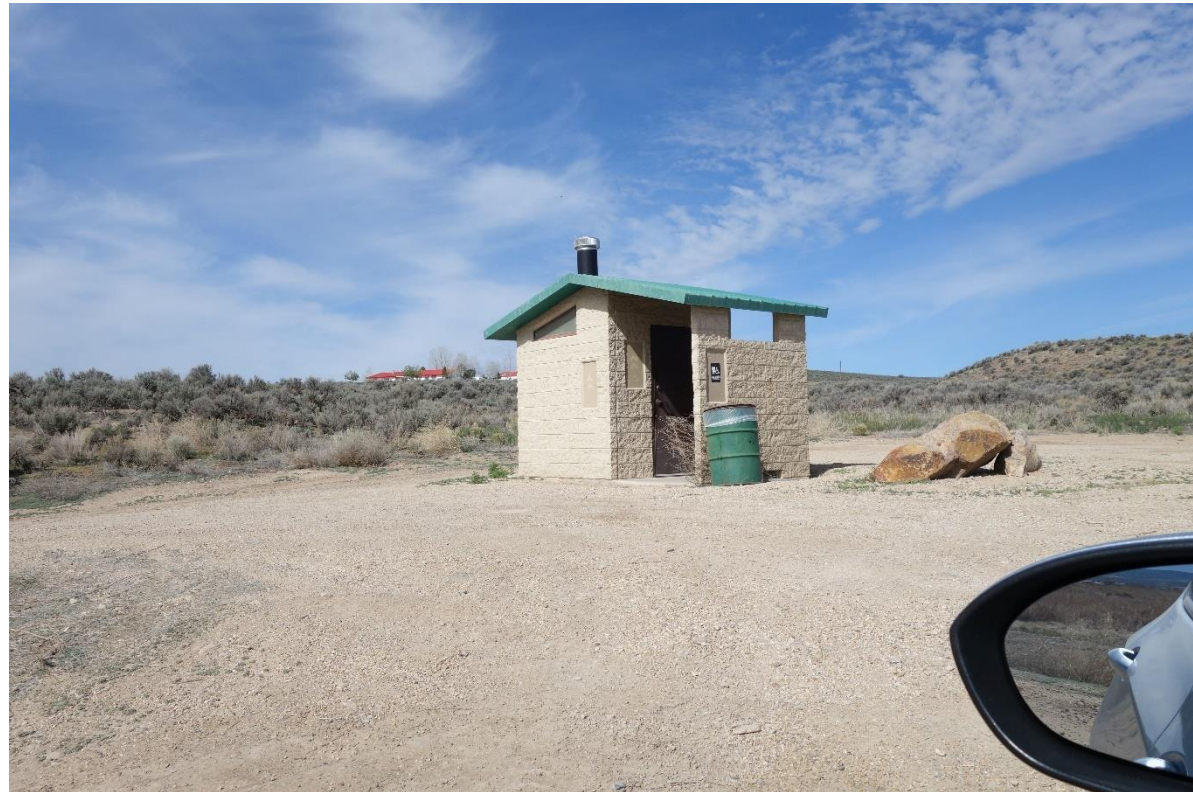
The Americans with Disabilities Act (ADA) provides for accessibility to sites and services for people with physical limitations. A concrete parking area and passenger loading area are necessary to comply with ADA requirements. This project would provide a concrete van accessible ADA parking and loading space and walkway to the existing sidewalk. This will require regrading, installing P.C. concrete, striping, signage and any other necessary upgrades. The 2018 IBC, ICC/ANSI A117.1 - 2009, NRS 338.180 and the most current version of the *ADA Standards For Accessible Design* were used as a reference for this project.

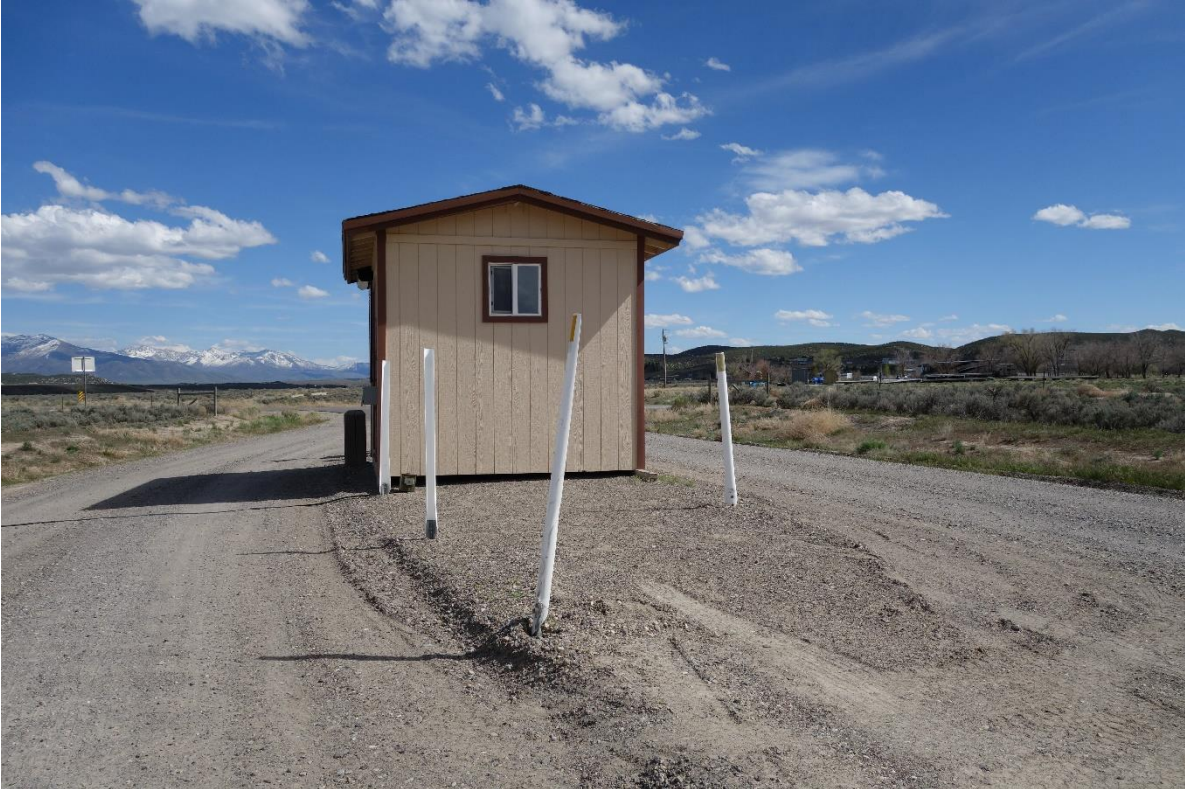
NEW PROTECTION AGAINST DECAY

The wood siding of the fee booth is in direct contact with exposed earth. 2018 IBC Section 2304.12.1.5 Protection Against Decay, Wood Siding requires a minimum of 6" clearance to exposed earth. This project provides for the installation of concrete piers in compliance with Code and concrete steps for access.

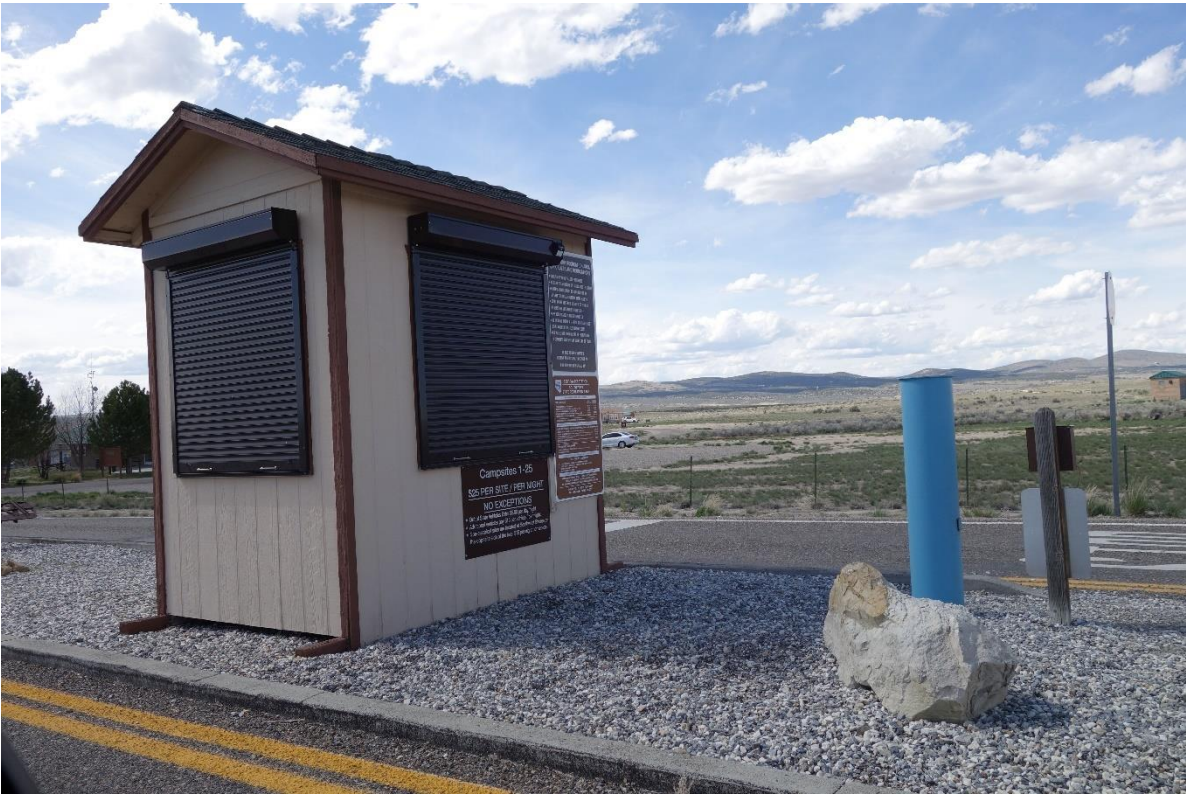
NEW PROTECTION AGAINST DECAY

The wood siding of the fee booth is in direct contact with exposed earth. 2018 IBC Section 2304.12.1.5 Protection Against Decay, Wood Siding requires a minimum of 6" clearance to exposed earth. This project provides for the installation of concrete piers in compliance with Code and concrete steps for access.

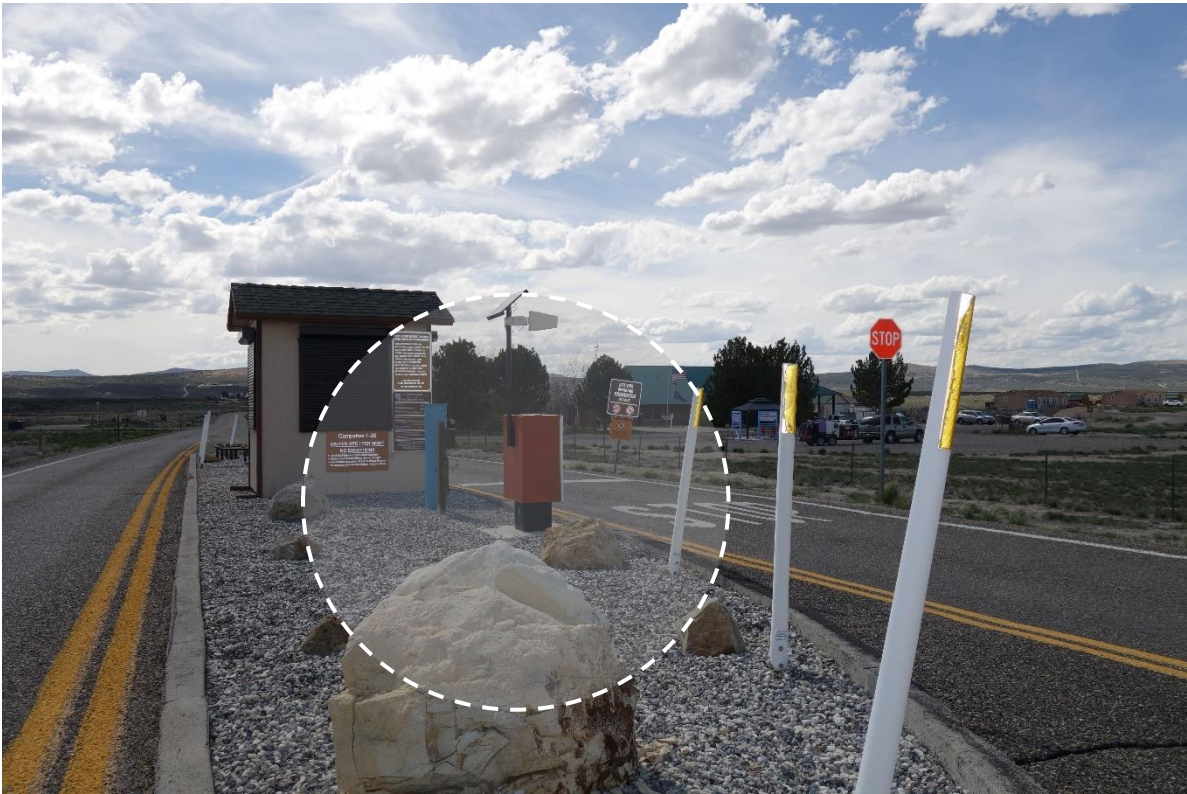
The fee booth is used seasonally during the high public traffic periods, typically summer. The fee booth, while prepped for power, does not have an electrical feed or air conditioning. This project provides for the installation of power, electrical feed to the self-serve fee station and air conditioning.

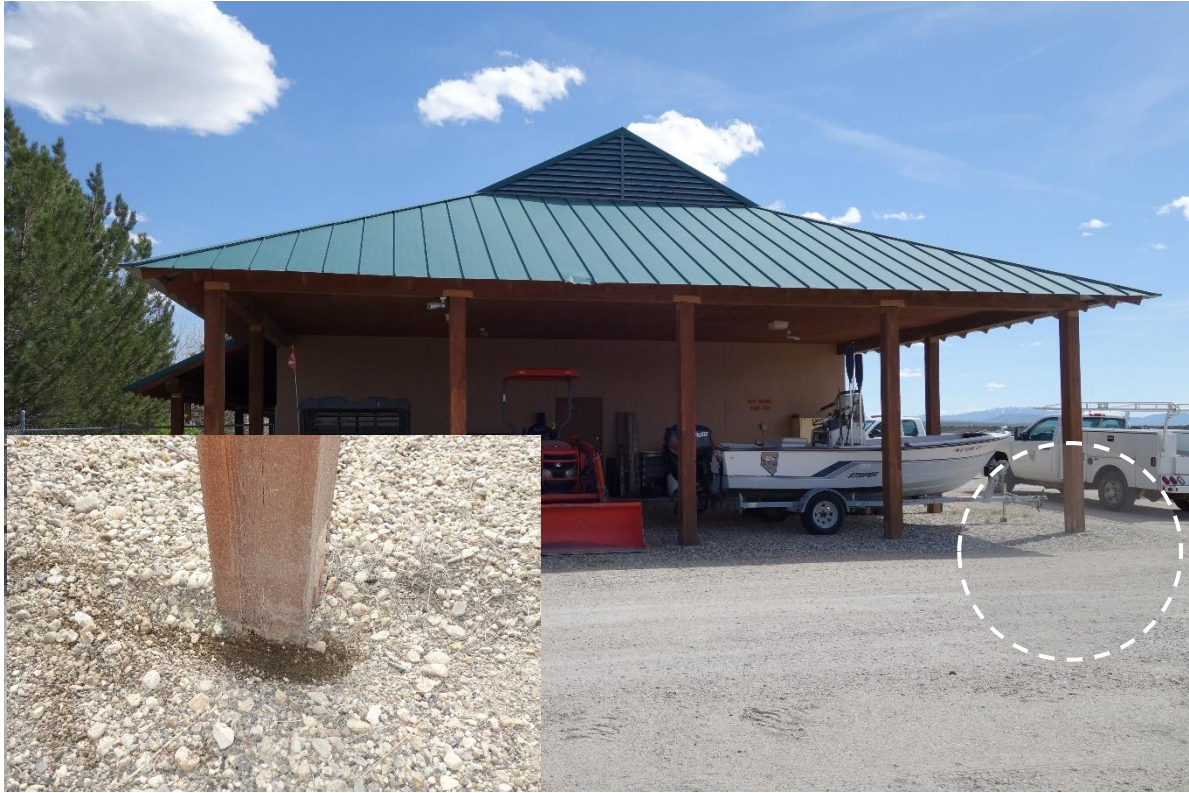
The building needs sidewalk replacement, a concrete slab under the carport and replacement of the garage door aprons. The existing concrete is cracked and failing and is due for replacement. The four-bay carport on the North side of the building is not paved and the dirt is insufficient for the heavy use and extreme climate. The drainage away from the building is also insufficient due to erosion of the dirt which also makes it difficult to remove snow from the perimeter of the building. This project would provide for 1,500 square feet of concrete to replace deteriorated concrete sidewalks and aprons, and installation of a proper parking space under the carport and improved drainage in compliance with IBC 2018 Section 2304.12.2.2 Protection Against Decay, Posts or Columns. This project should be implemented concurrently with the Structural Post Protection project.

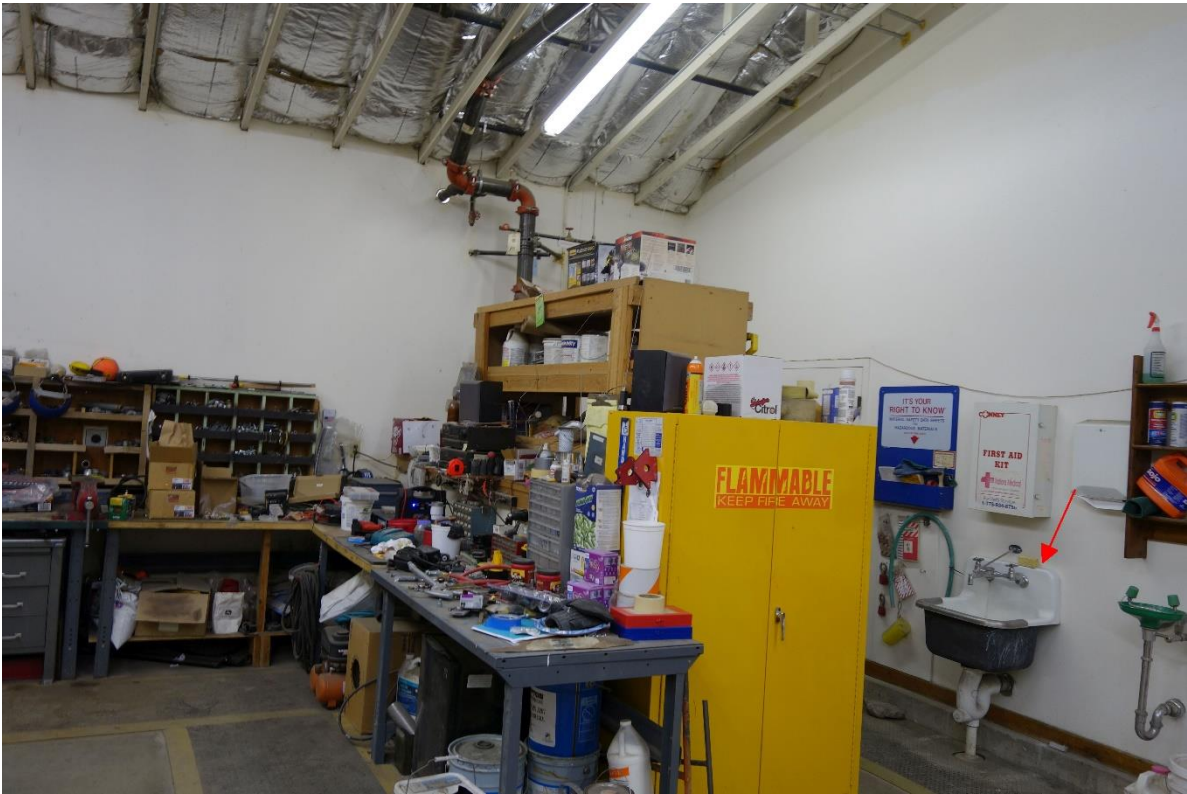
DEFERRED JANITORS CLOSET REPAIRS

The mop sink in the Janitors Closet is mounted adjacent to gypsum board and is showing signs of water damage. This project would provide fiberglass reinforced panels (FRP) to be installed on the walls adjacent to the mop sink. The FRP shall extend two feet beyond the edge of the sink and a minimum of 54" above the floor finish.

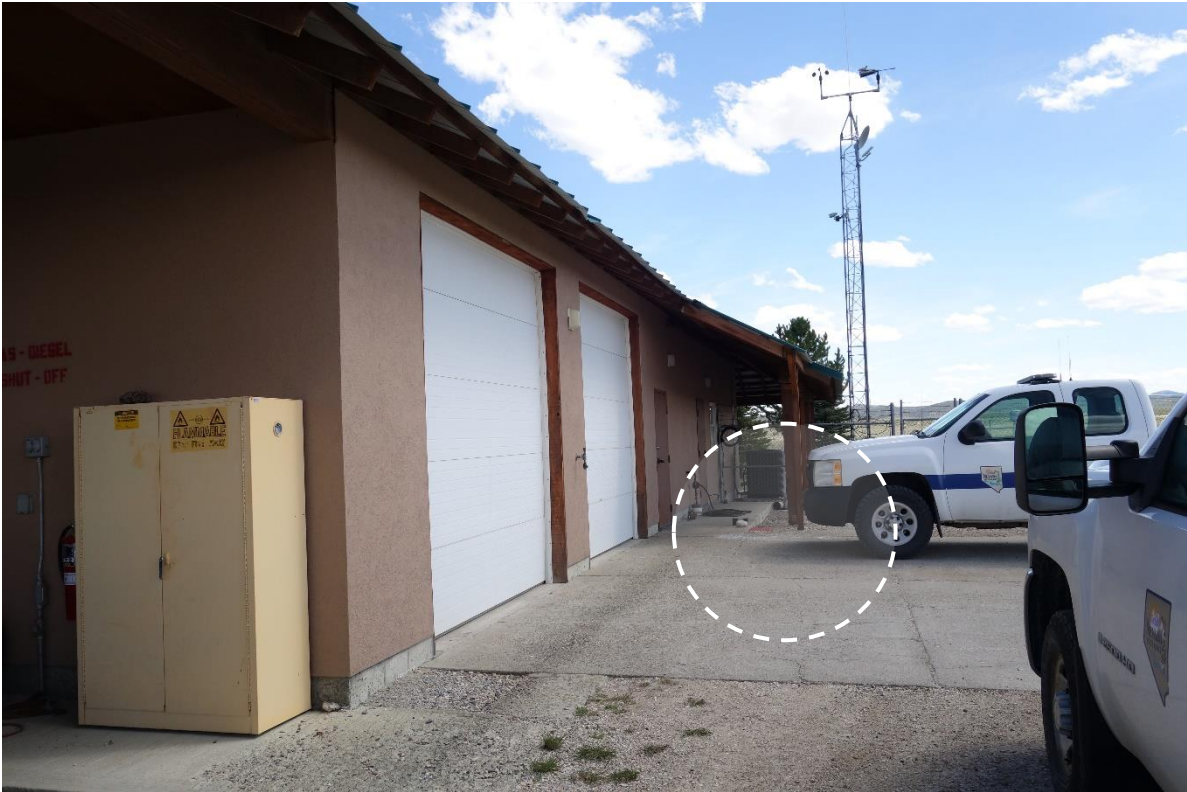
The wood posts supporting the roof overhang around the building are in direct contact with exposed earth. 2018 IBC Section 2304.12.2.2 Protection Against Decay, Posts or Columns requires a minimum of 8" clearance to exposed earth and/or 1 inch above a slab or deck and separated from the concrete by an impervious moisture barrier. This project provides for the installation of a concrete slab at the required 1" elevation below the posts in compliance with Code. A more economical alternative may be to re-grade soils to the required 8" clearance. This project excludes the carport area which is covered under a separate project. This project should be implemented concurrently with the Concrete Paving Installation in the project. This project or a portion thereof was previously recommended in the FCA report dated 07/22/2014. It has been amended accordingly to reflect conditions observed during the most recent survey date of 05/16/2022.

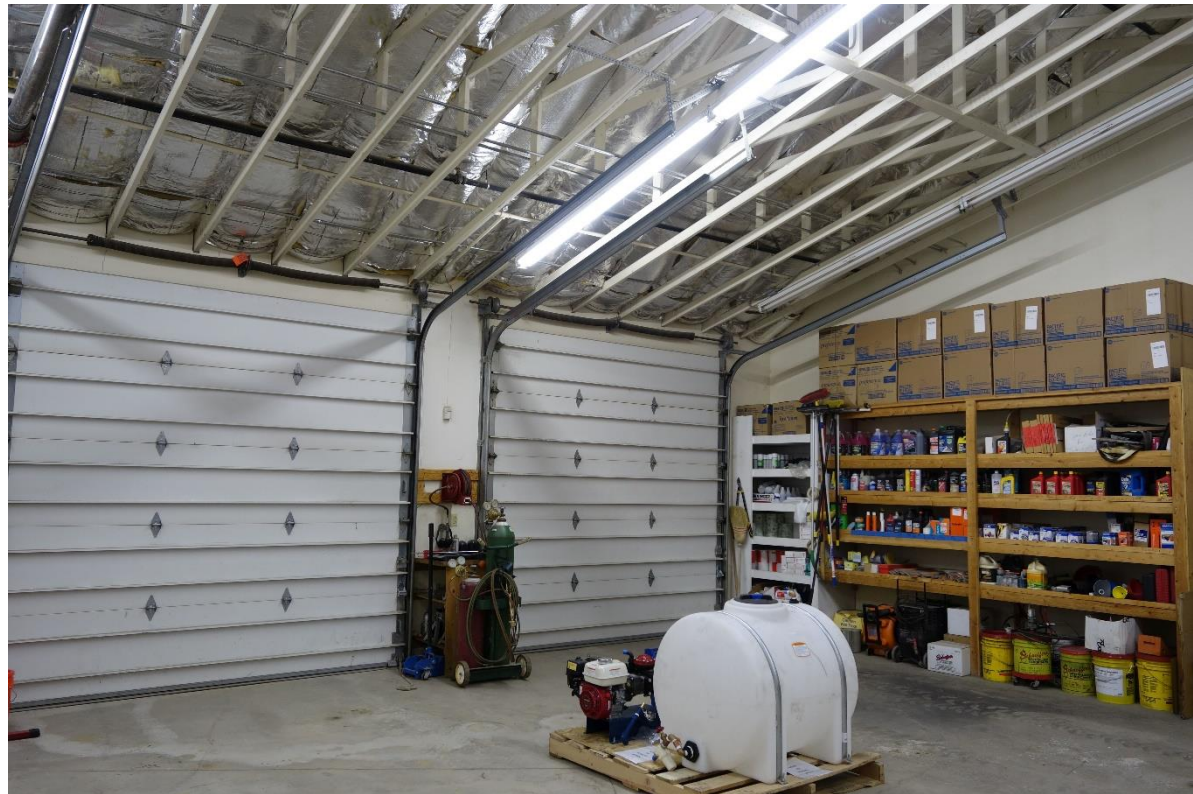
The existing lighting fixtures are the older fluorescent type and are not energy efficient. This project will replace the existing fixtures with higher efficiency LED fixtures. Electrical wiring upgrades are not included in this estimate. This project or a portion thereof was previously recommended in the FCA report dated 07/22/2014. It has been amended accordingly to reflect conditions observed during the most recent survey date of 05/16/2022.

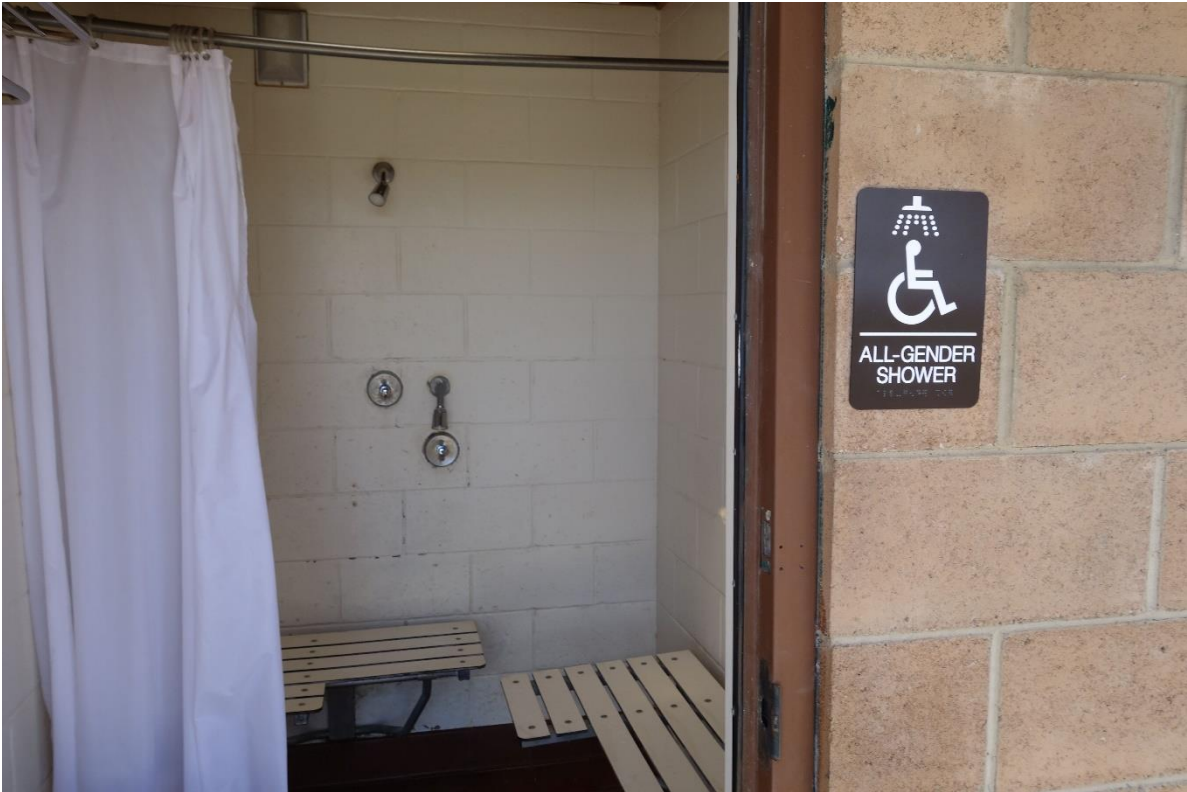
The interior finishes were in fair condition; however, the shower rooms needed new finishes. It is recommended to paint the shower rooms and ceilings at least once in the next 4 - 6 years and that this project is scheduled on a cyclical basis to maintain the integrity of the structure. Prior to painting, all surfaces should be repaired and prepped. An epoxy-based paint should be utilized in wet areas for durability.

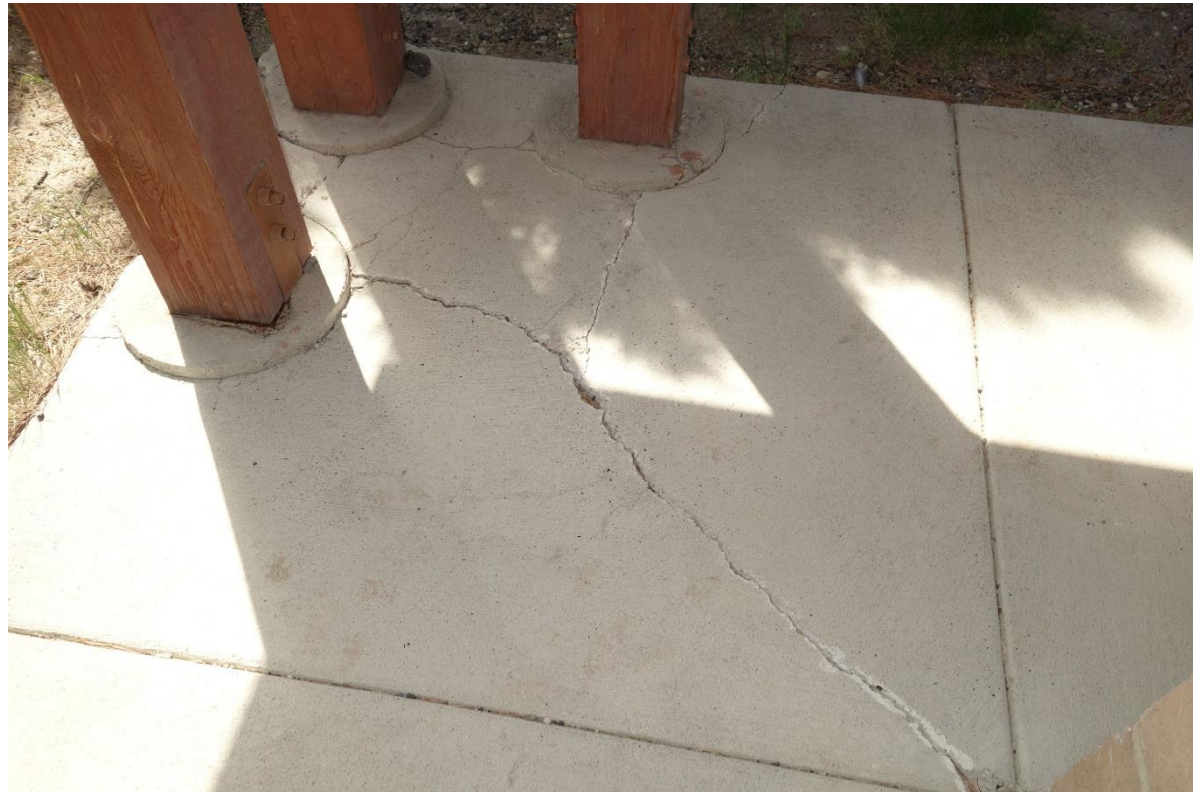
NEW SIDEWALK REPAIRS

The section of the perimeter sidewalk under the comfort station awning is failing and needs replacement. The sidewalk provides access to accessible restrooms and showers. Repairs are important to be completed before deterioration impacts accessibility.

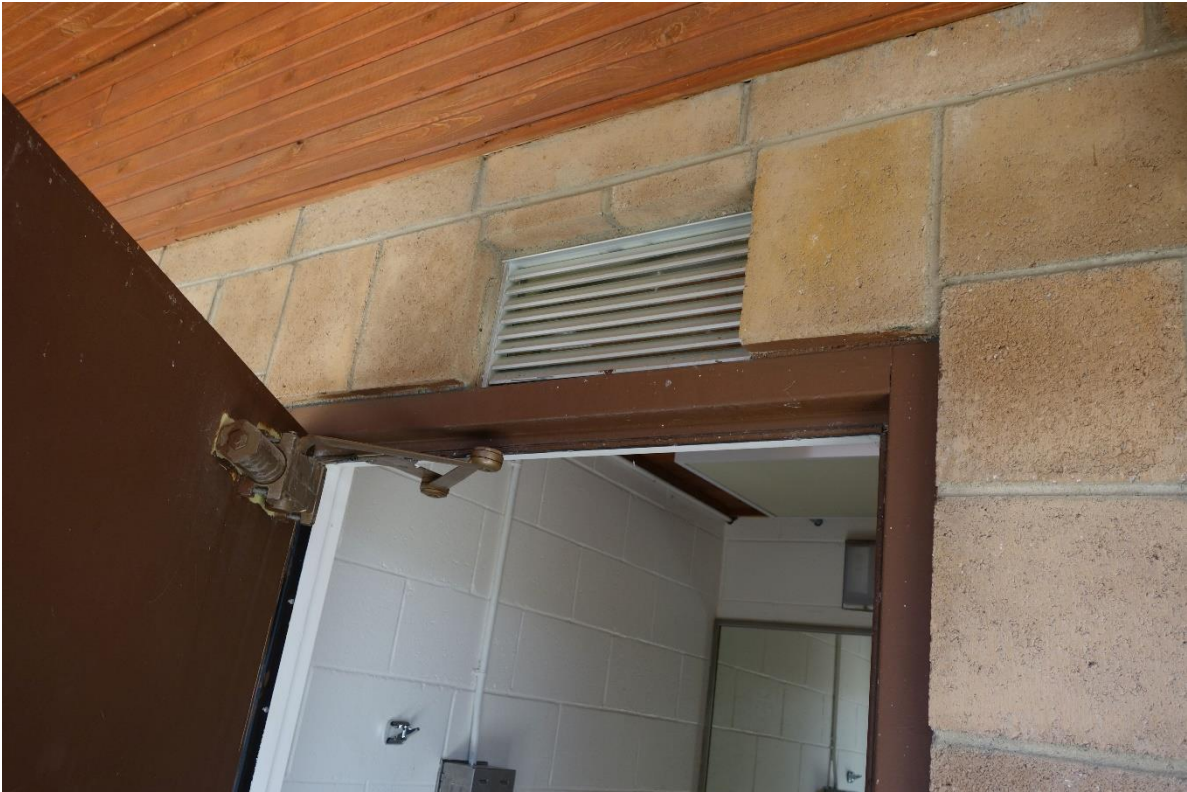
The comfort station is open year around to support the year around campground. Half of the building is unheated, and the entire structure is not insulated. Additionally, each restroom stall is directly vented to the outdoors creating freeze risks. This project recommends the installation of an Exterior Insulation Finishing System (EIFS), install new heating and ventilation systems, fixtures and paint.
