STATE OF NEVADA STATE PUBLIC WORKS DIVISION

FACILITY CONDITION ASSESSMENT REPORT FOR:

DEPT OF HEALTH AND HUMAN SERVICES
DIVISION OF CHILD AND FAMILY SERVICES
NYTC

SITE #: 9938 NEVADA YOUTH TRAINING CENTER SITE - ELKO
100 YOUTH CENTER RD
ELKO, NV 89801-9565

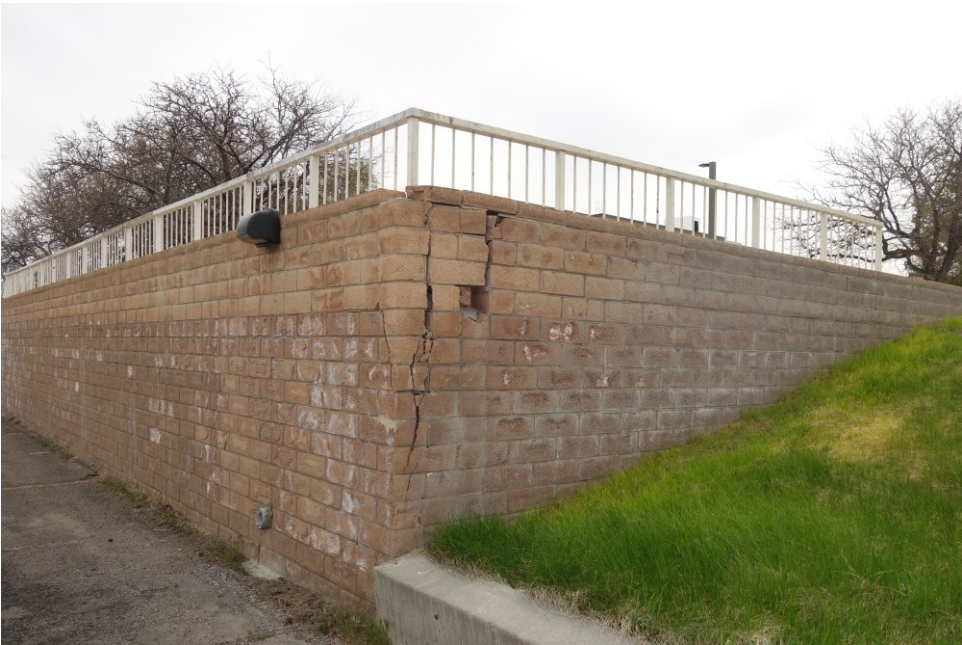
QUANTITY	UNITS	TOTAL	SF COST
The retaining wall separating the Gymnasium and football field from the adjacent parking lot is beginning to fail due to the weight and exposure to weather. Freeze and thaw cycles appear to be causing the wall to fracture. Additionally, the guard railing at the top of the wall is failing due to corrosion, possibly from the heavy use of ice melt. This project would fund the replacement of the retaining walls, guard rails and include concrete paving replacement in the next 2 -3 years.	1	Package	\$1,117,000.00	-

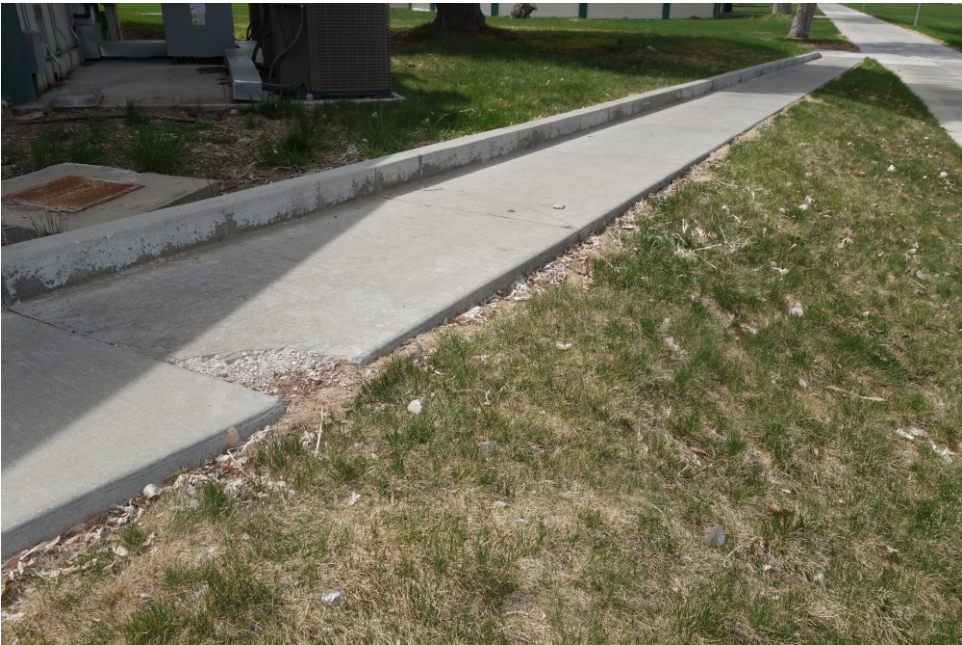
0223 ADMINISTRATION

QUANTITY	UNITS	TOTAL	SF COST
<p>This facility has an ADA accessible ramp located in front of the building. This ramp is on the accessible path of travel from the accessible parking space to the entrance of the building. The ramp does not have compliant landings, handrails or curbs. This project would provide for replacing the ramp with a fully ADA compliant ramp. The 2018 IBC, ICC/ANSI A117.1 - 2009, NRS 338.180 and the most current version of the ADA Standards For Accessible Design were used as a reference for this project.</p> <p>This project or a portion thereof was previously recommended in the FCA report dated 09/18/2013. It has been amended accordingly to reflect conditions observed during the most recent survey date of 05/09/2023.</p>	1	Package	\$60,000.00	\$ 16.00

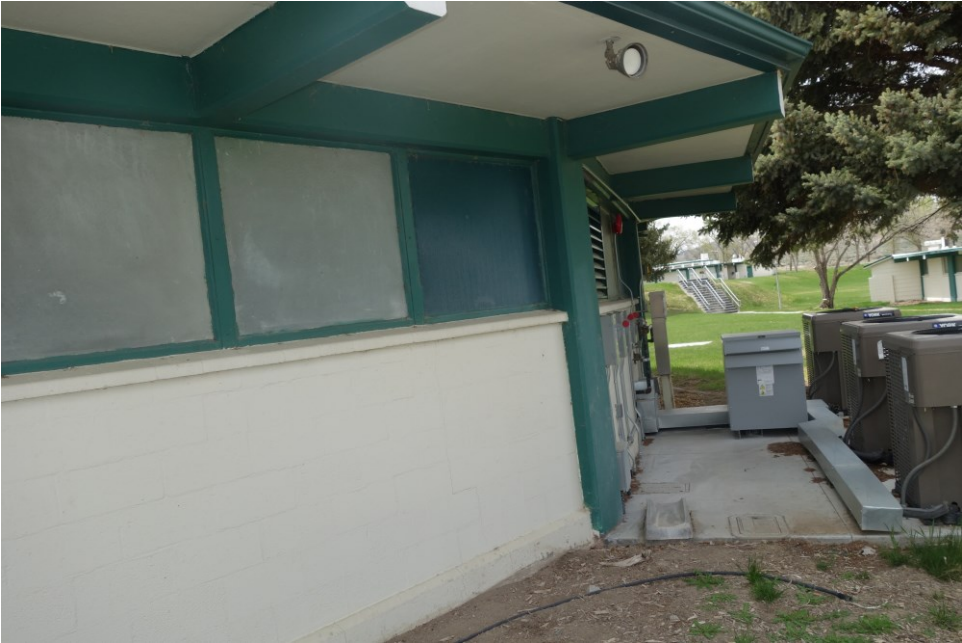
0223 ADMINISTRATION

QUANTITY	UNITS	TOTAL	SF COST
<p>The building is constructed of concrete masonry units (CMU) with no insulation. The windows are original to the building, and of single pane construction. Buildings of this type are not energy efficient. This project recommends adding an exterior insulating finish system (EIFS) over the CMU and replacing the windows with new dual-pane, higher efficiency units. This estimate includes removal and disposal of the existing windows.</p> <p>This project or a portion thereof was previously recommended in the FCA reports dated 08/19/2002, 08/22/2007, 09/18/2013. It has been amended accordingly to reflect conditions observed during the most recent survey date of 05/09/2023.</p>	1	Package	\$434,300.00	\$ 113.00

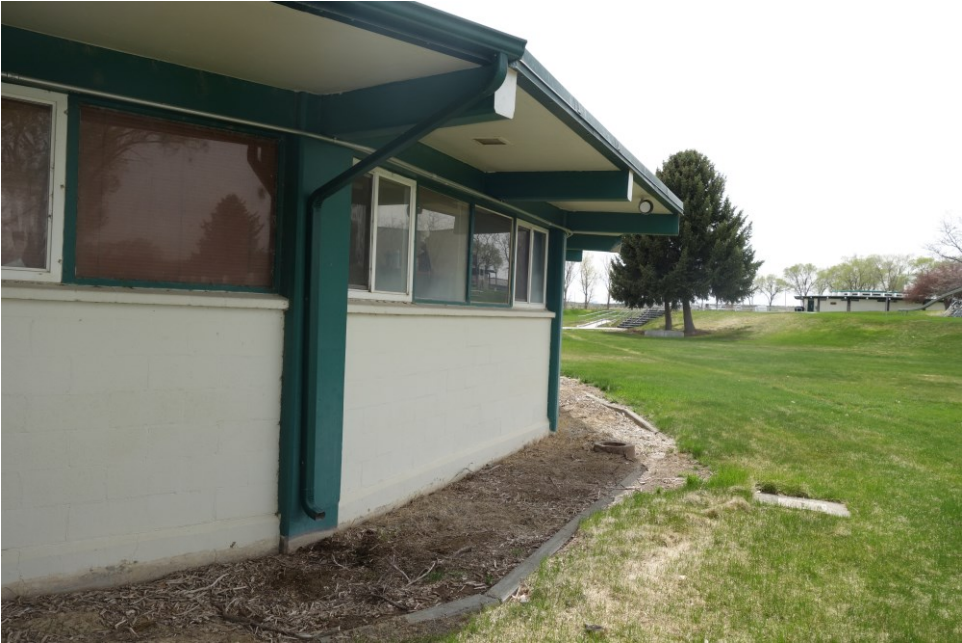
0223 ADMINISTRATION

QUANTITY	UNITS	TOTAL	SF COST
The exterior finishes were in fair condition. It is important to maintain the finish, weather resistance and appearance of the building. This project would provide funding to protect the exterior of the building excluding the roof. Included in the cost is sanding, priming and painting and caulking of the windows, flashing, fixtures and all other penetrations. It is recommended that the building be painted in the next 5-7 years and that this project be scheduled on a cyclical basis to maintain the integrity of the structure.	3847	Square Foot	\$19,200.00	\$ 5.00

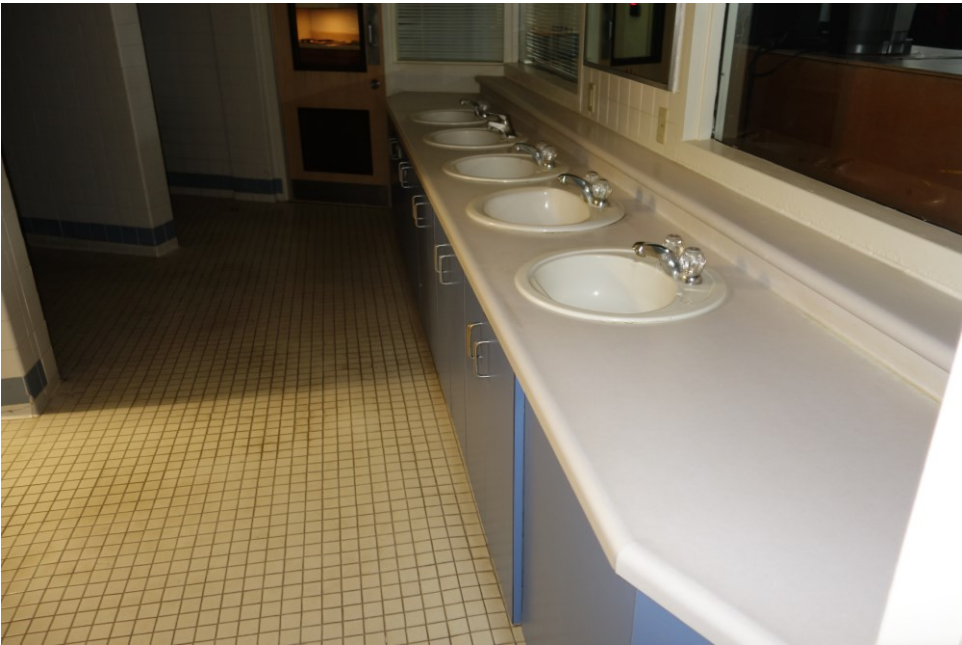
0224 FORESTER COTTAGE #1

QUANTITY	UNITS	TOTAL	SF COST
<p>The exhaust fans in the showers and restroom areas are inadequate for their application contributing to moisture accumulation and possible mold infiltration. This project would provide for the removal of the existing exhaust fan assemblies and the purchase and installation of new exhaust fan assemblies including ducting and connections to utilities. This report recommends the installation of high efficiency exhaust fans with humidity detection and delayed shut-off to exhaust all moisture and prevent future accumulation issues.</p> <p>This project or a portion thereof was previously recommended in the FCA report dated 08/22/2007, 09/18/2013. It has been amended accordingly to reflect conditions observed during the most recent survey date of 05/09/2023.</p>	1	Each	\$ 5,000.00	\$ 1.00

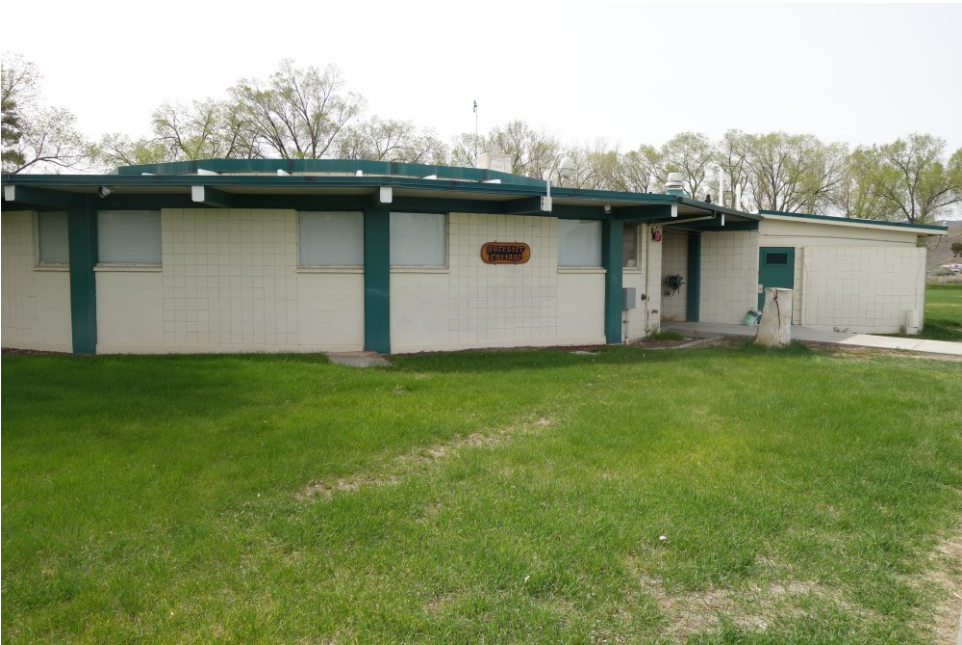
0224 FORESTER COTTAGE #1

QUANTITY	UNITS	TOTAL	SF COST
The exterior finishes were in fair condition. It is important to maintain the finish, weather resistance and appearance of the building. This project would provide funding to protect the exterior of the building excluding the roof. Included in the cost is sanding, priming and painting and caulking of the windows, flashing, fixtures and all other penetrations. It is recommended that the building be painted in the next 5 - 7 years and that this project be scheduled on a cyclical basis to maintain the integrity of the structure.	3847	Square Foot	\$23,000.00	\$ 6.00

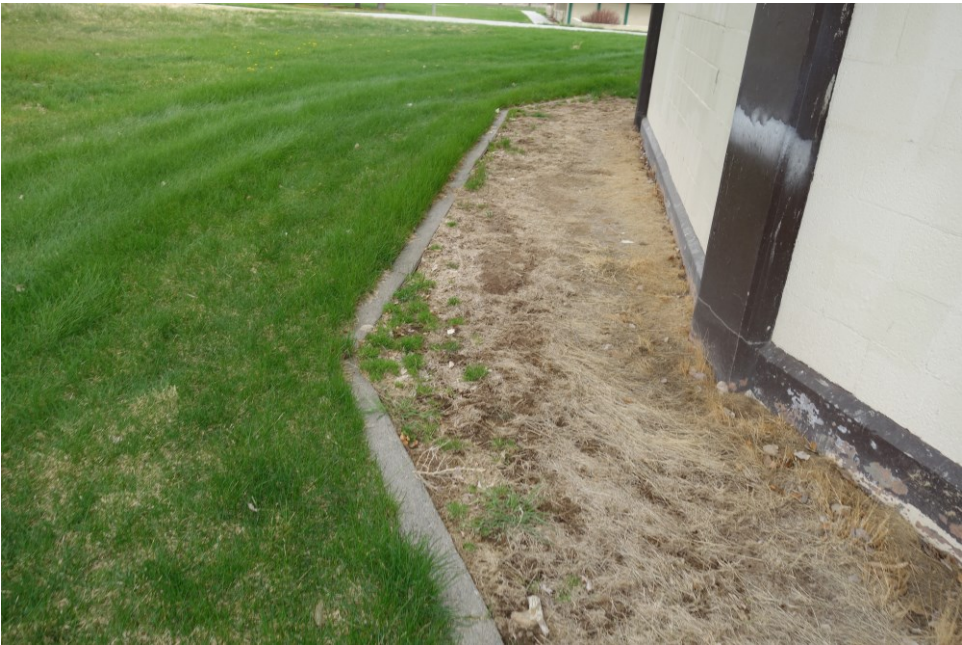
0225 MOUNTAINEER COTTAGE #2

QUANTITY	UNITS	TOTAL	SF COST
The exterior finishes were in fair condition. It is important to maintain the finish, weather resistance and appearance of the building. This project would provide funding to protect the exterior of the building excluding the roof. Included in the cost is sanding, priming and painting and caulking of the windows, flashing, fixtures and all other penetrations. It is recommended that the building be painted in the next 5 - 7 years and that this project be scheduled on a cyclical basis to maintain the integrity of the structure.	3847	Square Foot	\$23,000.00	\$ 6.00

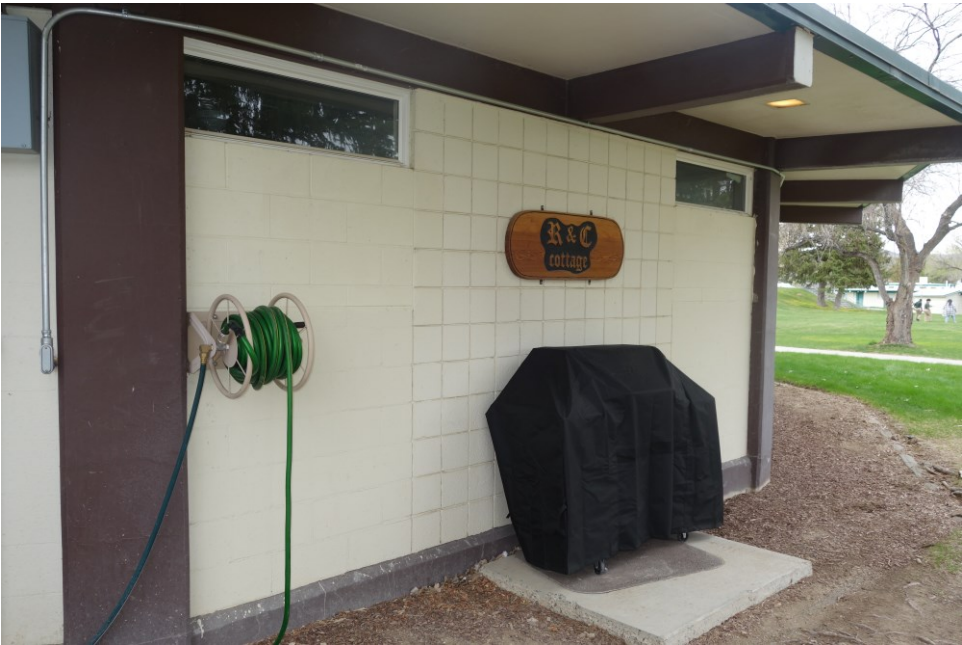
0226 EXPLORER R & C COTTAGE #3

QUANTITY	UNITS	TOTAL	SF COST
<p>The building is constructed of concrete masonry units (CMU) with no insulation. The windows are original to the building, and of single pane construction. Buildings of this type are not energy efficient. This project recommends adding an exterior insulating finish system (EIFS) over the CMU and replacing the windows with new dual-pane, higher efficiency units.</p> <p>This project or a portion there of was previously recommended in the FCA reports dated 08/19/2002, 08/22/2007 and 09/18/2013. It has been amended accordingly to reflect conditions observed during the most recent survey date of 05/09/2023.</p>	1	Package	\$434,300.00	\$ 113.00

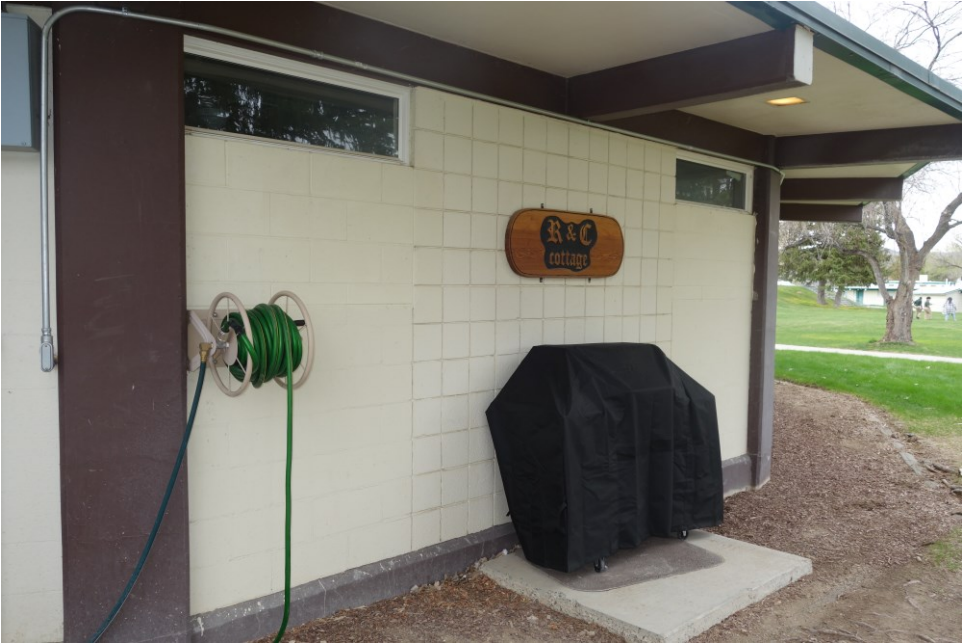
0226 EXPLORER R & C COTTAGE #3

QUANTITY	UNITS	TOTAL	SF COST
It is important to maintain the finish, weather resistance and appearance of the building. This project would provide funding to protect the exterior of the building excluding the roof. Included in the cost is sanding, priming and painting and caulking of the windows, flashing, fixtures and all other penetrations. It is recommended that the building be painted in the next 5-7 years and that this project be scheduled on a cyclical basis to maintain the integrity of the structure.	3847	Square Foot	\$23,000.00	\$ 6.00

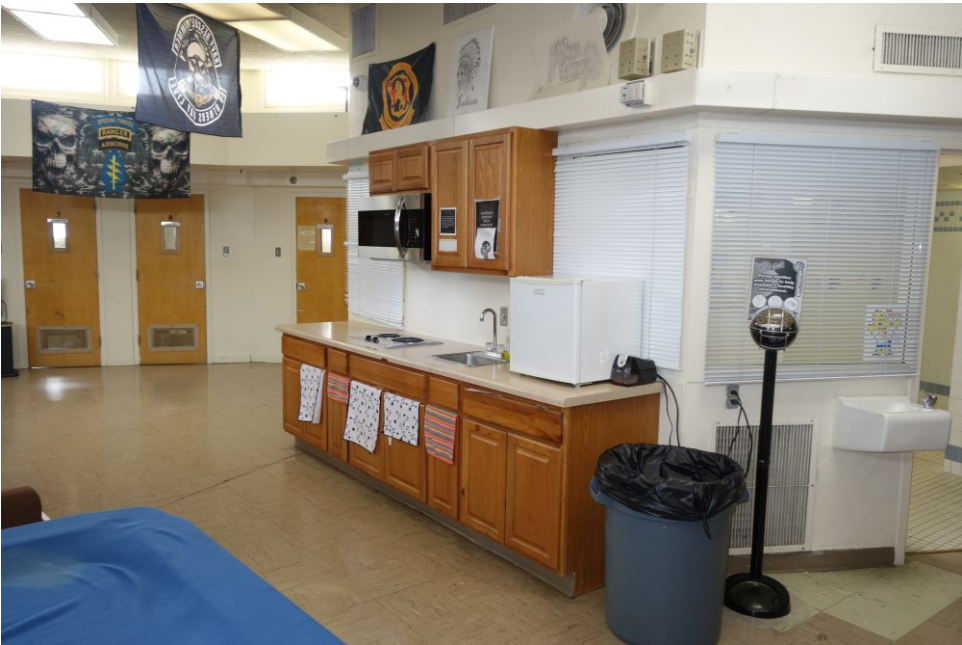
0227 INDIAN COTTAGE #4

QUANTITY	UNITS	TOTAL	SF COST
<p>The existing lighting fixtures are the older fluorescent type, and are not energy efficient. This project will upgrade fixtures to higher efficiency units with a longer life cycle T-8 LED lamps. Occupancy sensors will be installed in restrooms, utility closets and other low occupancy areas for additional savings. Any electrical wiring upgrades are not included in this estimate.</p> <p>This project is in design under CIP 21-S08(6).</p> <p>This project or a portion there of was previously recommended in the FCA reports dated 08/19/2002, 08/22/2007 and 09/18/2013. It has been amended accordingly to reflect conditions observed during the most recent survey date of 05/09/2023.</p>	3847	Square Foot	\$ 7,700.00	\$ 2.00

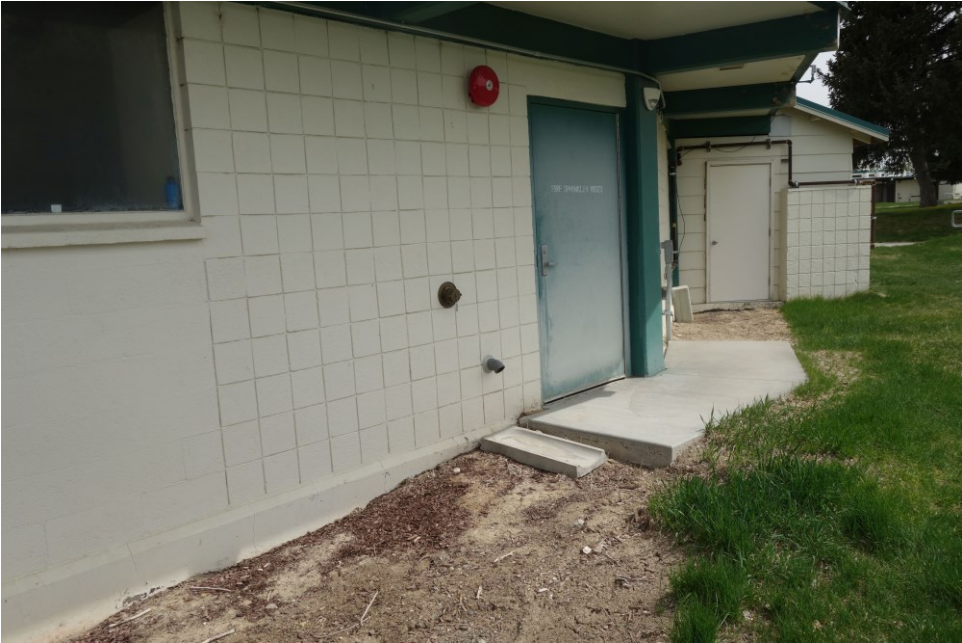
0227 INDIAN COTTAGE #4

QUANTITY	UNITS	TOTAL	SF COST
<p>The exterior metal door at the rear entrance is damaged from age and general wear and tear and has reached the end of its expected life. This project would provide for the replacement of the door assembly with new a metal door, frame and hardware. Removal and disposal of the existing door is included in this estimate.</p> <p>This project or a portion thereof was previously recommended in the FCA report dated 08/22/2007. It has been amended accordingly to reflect conditions observed during the most recent survey date of 09/18/2013.</p>	1	Package	\$ 8,000.00	\$ 2.00

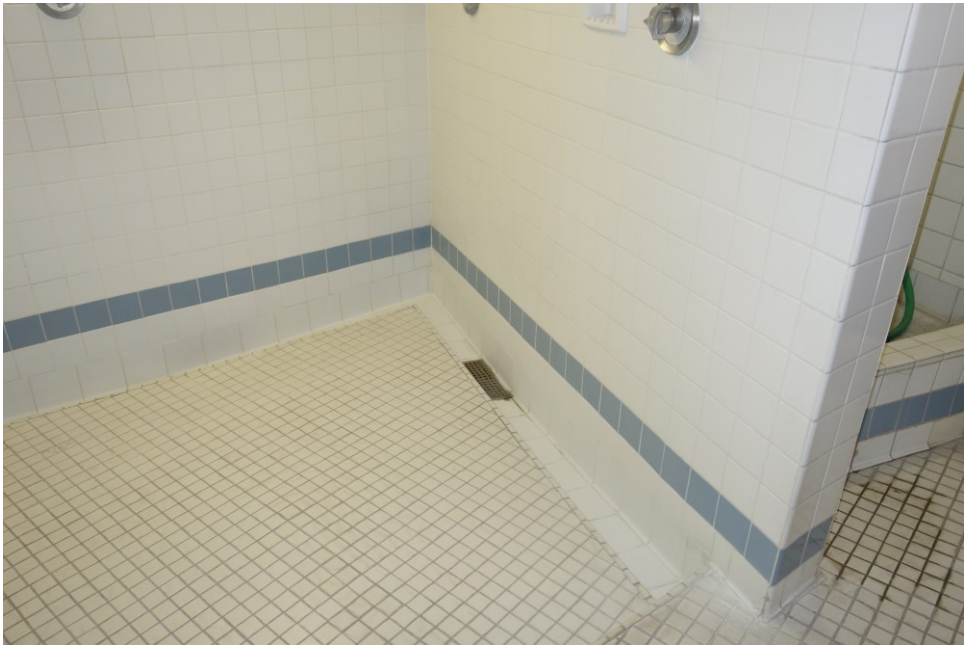
0227 INDIAN COTTAGE #4

QUANTITY	UNITS	TOTAL	SF COST
<p>The exhaust fans in the showers and restroom areas are inadequate for their application contributing to moisture accumulation and possible mold infiltration. This project would provide for the removal of the existing exhaust fan assemblies and the purchase and installation of new exhaust fan assemblies including ducting and connections to utilities. This report recommends the installation of high efficiency exhaust fans with humidity detection and delayed shut-off to exhaust all moisture and prevent future accumulation issues.</p> <p>This project or a portion thereof was previously recommended in the FCA report dated 08/22/2007, 09/18/2013. It has been amended accordingly to reflect conditions observed during the most recent survey date of 05/09/2023.</p>	1	Each	\$ 5,000.00	\$ 1.00

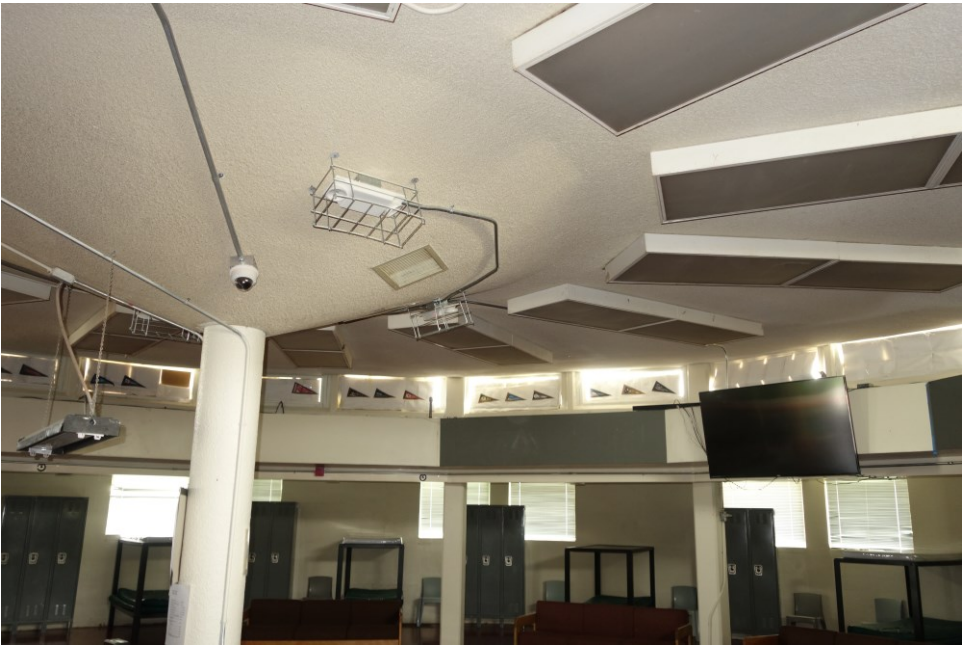
0228 PIONEER COTTAGE #5

QUANTITY	UNITS	TOTAL	SF COST
<p>The existing lighting fixtures are the older fluorescent type, and are not energy efficient. This project will upgrade fixtures to higher efficiency units with a longer life cycle T-8 LED lamps. Occupancy sensors will be installed in restrooms, utility closets and other low occupancy areas for additional savings. Any electrical wiring upgrades are not included in this estimate.</p> <p>This project is in design under CIP 21-S08(6).</p> <p>This project or a portion there of was previously recommended in the FCA reports dated 08/19/2002, 08/22/2007 and 09/18/2013. It has been amended accordingly to reflect conditions observed during the most recent survey date of 05/09/2023.</p>	3847	Square Foot	\$ 7,700.00	\$ 2.00

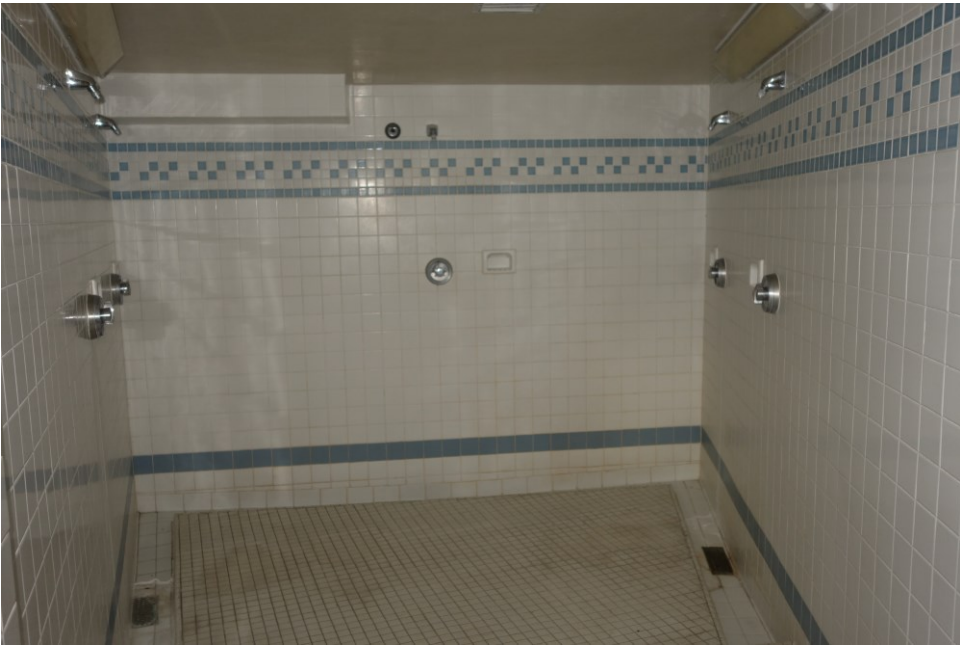
0228 PIONEER COTTAGE #5

QUANTITY	UNITS	TOTAL	SF COST
<p>The exhaust fans in the showers and restroom areas are inadequate for their application contributing to moisture accumulation and possible mold infiltration. This project would provide for the removal of the existing exhaust fan assemblies and the purchase and installation of new exhaust fan assemblies including ducting and connections to utilities. This report recommends the installation of high efficiency exhaust fans with humidity detection and delayed shut-off to exhaust all moisture and prevent future accumulation issues.</p> <p>This project or a portion thereof was previously recommended in the FCA report dated 08/22/2007, 09/18/2013. It has been amended accordingly to reflect conditions observed during the most recent survey date of 05/09/2023.</p>	5	Each	\$ 2,500.00	\$ 1.00

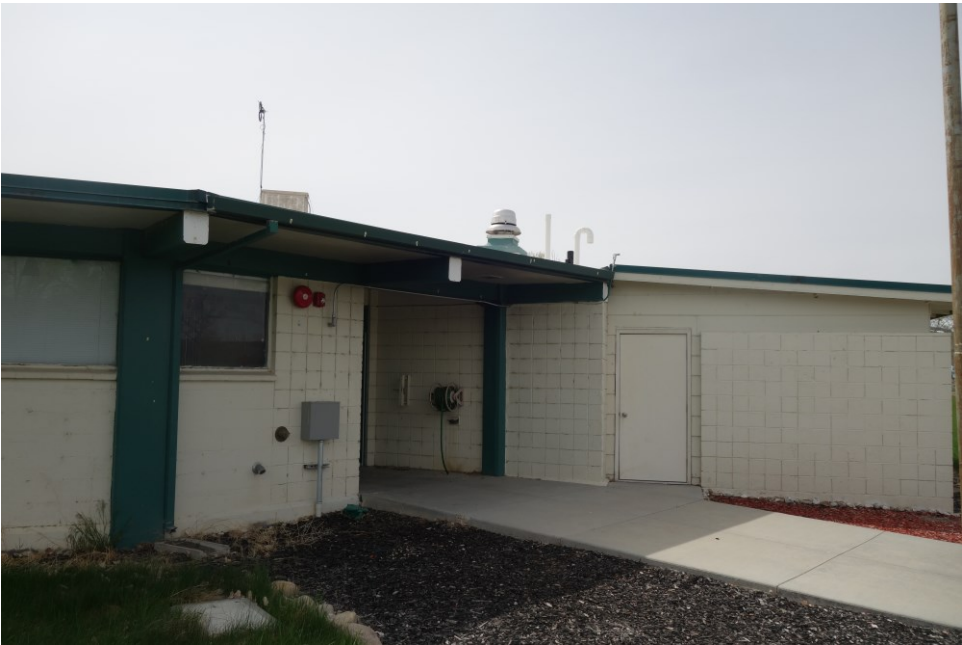
0228 PIONEER COTTAGE #5

QUANTITY	UNITS	TOTAL	SF COST
The exterior finishes were in fair condition. It is important to maintain the finish, weather resistance and appearance of the building. This project would provide funding to protect the exterior of the building excluding the roof. Included in the cost is sanding, priming and painting and caulking of the windows, flashing, fixtures and all other penetrations. It is recommended that the building be painted in the next 5 - 7 years and that this project be scheduled on a cyclical basis to maintain the integrity of the structure.	3847	Square Foot	\$23,000.00	\$ 6.00

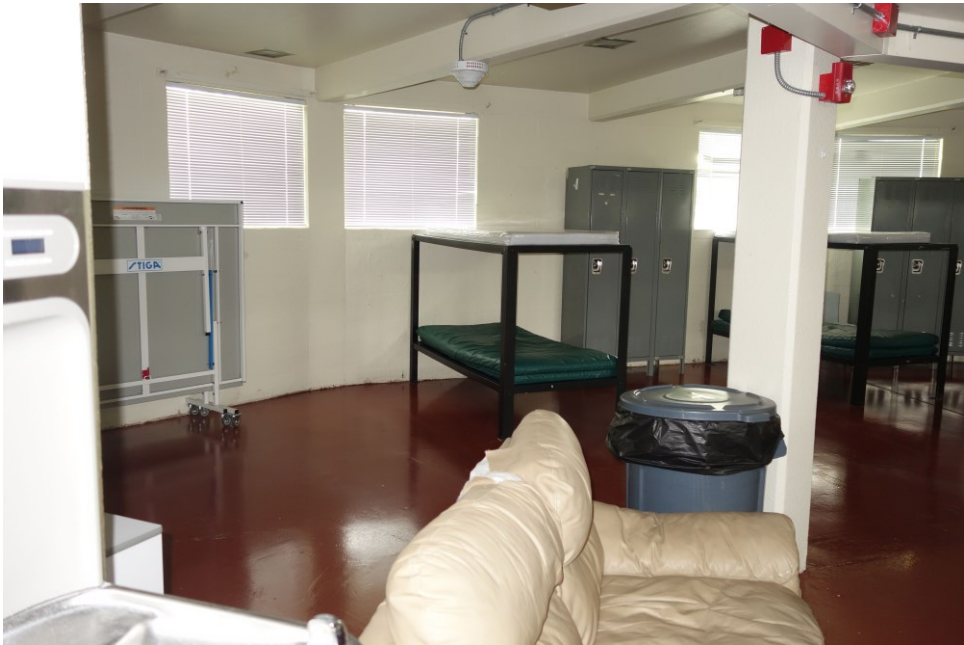
0229 FRONTIER COTTAGE #6

QUANTITY	UNITS	TOTAL	SF COST
The interior finishes were in fair condition. It is recommended that the interior walls and ceilings be painted at least once in the next 4 - 6 years and that this project be scheduled on a cyclical basis to maintain the integrity of the structure. Prior to painting, all surfaces should be repaired and prepped. An epoxy-based paint should be utilized in wet areas for durability.	3847	Square Foot	\$19,235.00	\$ 5.00

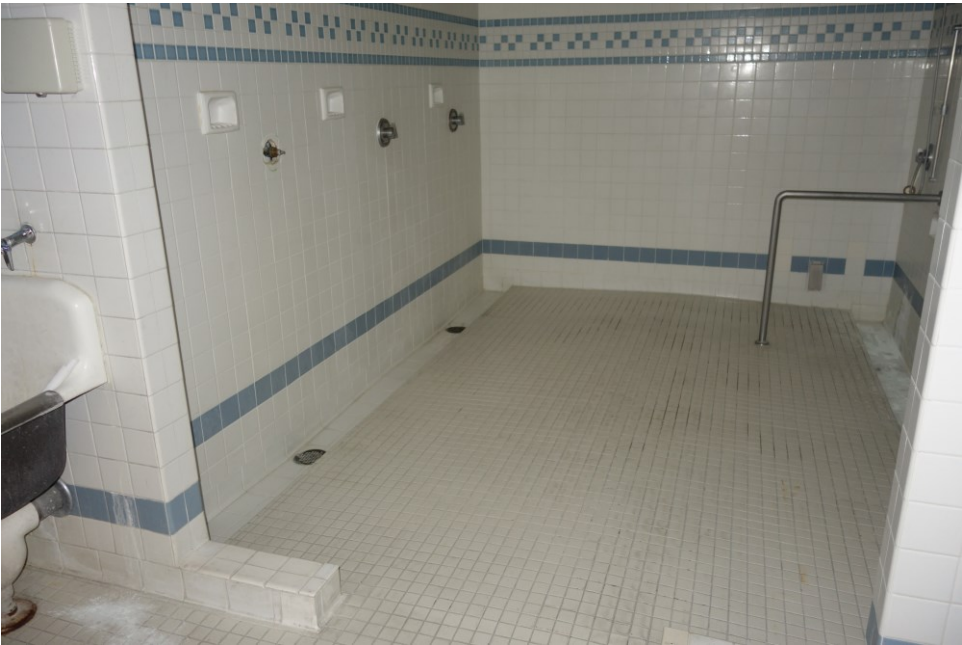
0229 FRONTIER COTTAGE #6

QUANTITY	UNITS	TOTAL	SF COST
<p>The exhaust fans in the showers and restroom areas are inadequate for their application contributing to moisture accumulation and possible mold infiltration. This project would provide for the removal of the existing exhaust fan assemblies and the purchase and installation of new exhaust fan assemblies including ducting and connections to utilities. This report recommends the installation of high efficiency exhaust fans with humidity detection and delayed shut-off to exhaust all moisture and prevent future accumulation issues.</p> <p>This project or a portion thereof was previously recommended in the FCA report dated 08/22/2007, 09/18/2013. It has been amended accordingly to reflect conditions observed during the most recent survey date of 05/09/2023.</p>	1	Each	\$ 5,000.00	\$ 1.00

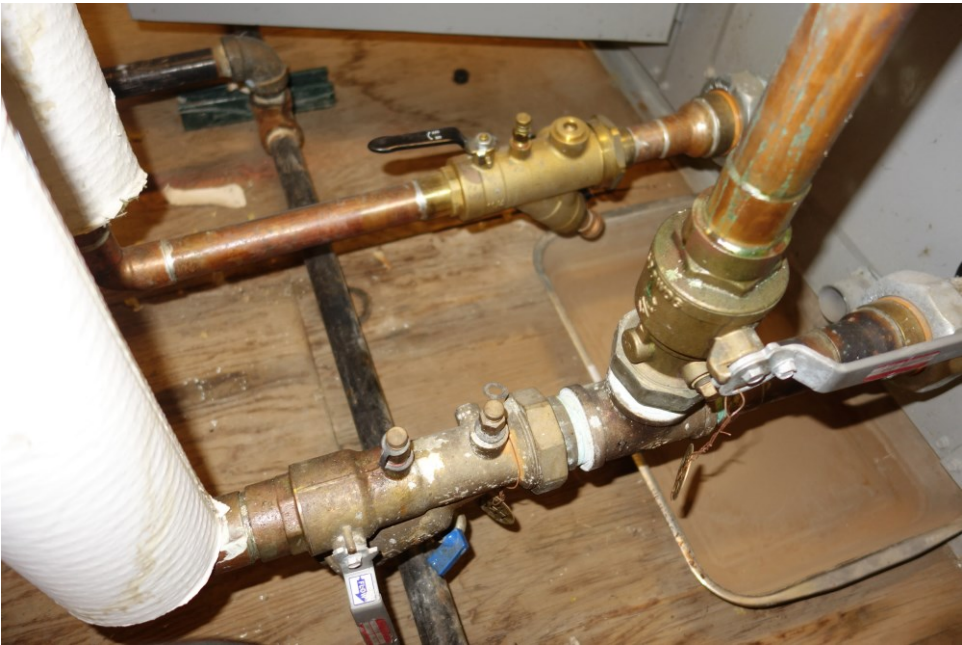
0230 MULTIPURPOSE, DINING & CULINARY

QUANTITY	UNITS	TOTAL	SF COST
The mechanical mezzanine contains a 4-pipe (hot & chilled water) air handling unit and a water heater. With these systems, there are multiple sources of leaks including control valve and manual valve packing, threaded pipe connections and coil cleaning maintenance. Hot water piping and connections are most prone to leaking due to seasonal thermal cycling. In addition, there is no water proofing or floor protection and the floor sink is raised off the floor plane. This project recommends installing an additional floor sink and relocating the existing sink to the plane of the floor and install a water resistant flooring system in the mezzanine over the exposed wood sub-floor.	1	Package	\$25,000.00	\$ 2.00

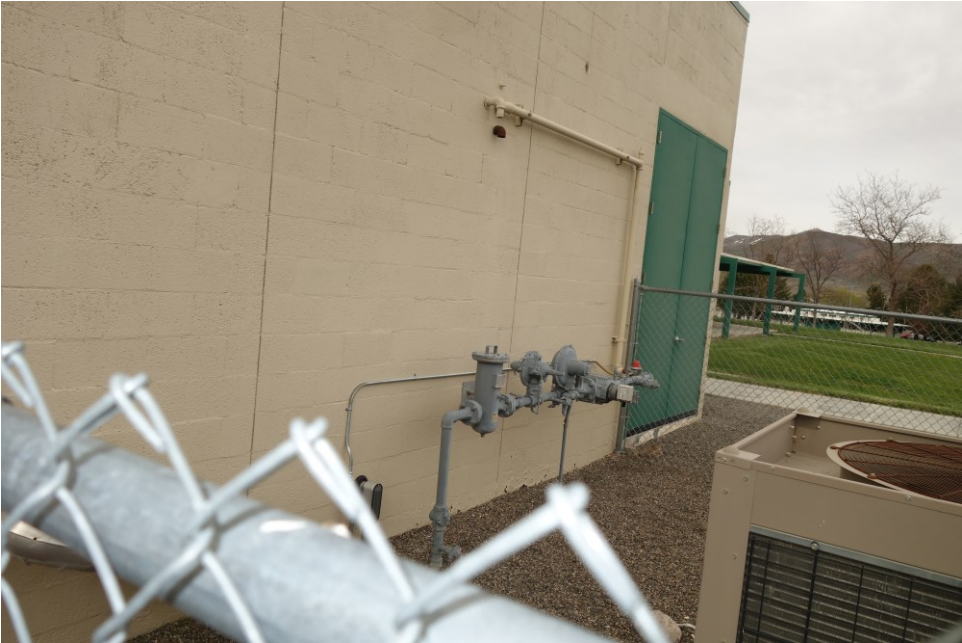
0230 MULTIPURPOSE, DINING & CULINARY

QUANTITY	UNITS	TOTAL	SF COST
The exterior finishes were in fair condition. It is important to maintain the finish, weather resistance and appearance of the building. This project would provide funding to protect the exterior of the building excluding the roof. Included in the cost is painting the concrete masonry unit walls and caulking of the windows, flashing, fixtures and all other penetrations. It is recommended that the building be painted and caulked in the next 4 - 6 years and that this project be scheduled on a cyclical basis to maintain the integrity of the structure.	15856	Square Foot	\$95,100.00	\$ 6.00

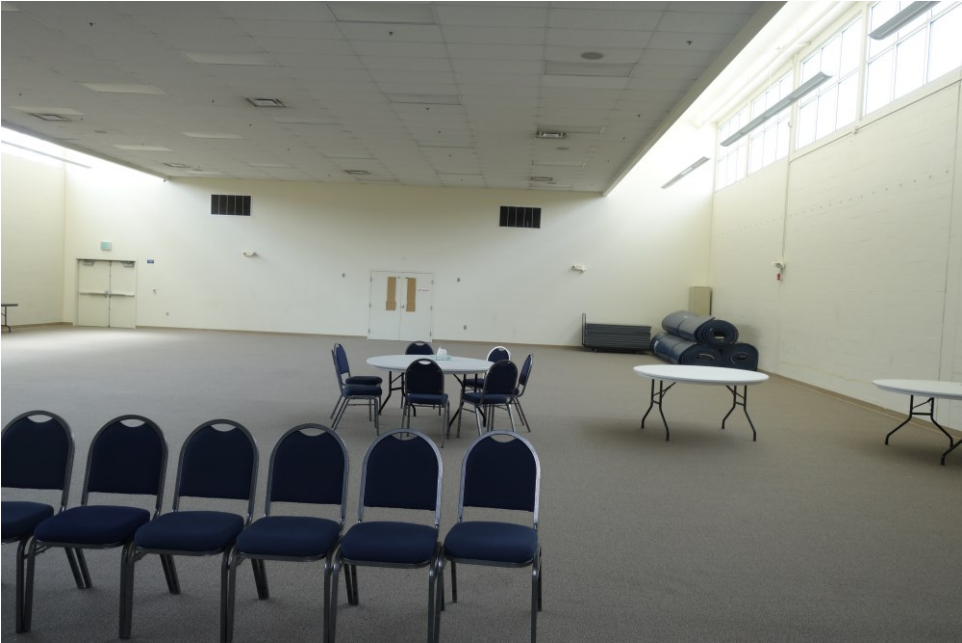
0230 MULTIPURPOSE, DINING & CULINARY

QUANTITY	UNITS	TOTAL	SF COST
The interior finishes are in fair condition. It is recommended that the interior walls and ceilings be painted at least once in the next 4 - 6 years and that this project be scheduled on a cyclical basis to maintain the integrity of the structure. Prior to painting, all surfaces should be repaired and prepped. An epoxy-based paint should be utilized in wet areas for durability.	15856	Square Foot	\$79,280.00	\$ 5.00

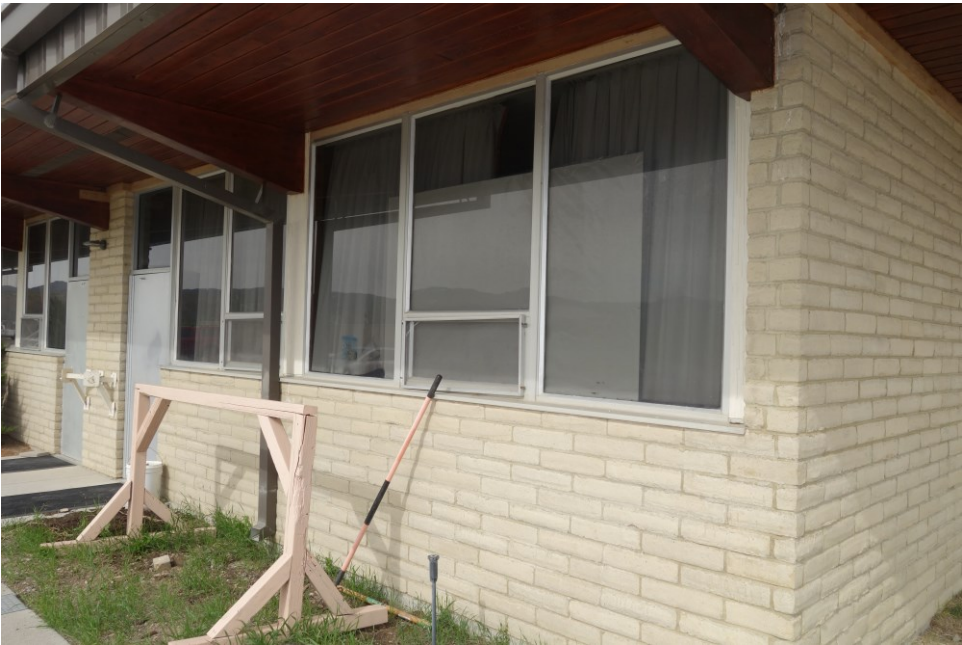
0231 CLASSROOMS & INFIRMARY

QUANTITY	UNITS	TOTAL	SF COST
<p>The windows are original, single pane construction in metal frames. These older windows are drafty and not energy efficient. This project recommends replacing the windows with dual pane, higher efficiency units. This estimate is for the replacement of 125 units. Removal and disposal of the existing windows is included in this estimate.</p> <p>This project or a portion there of was previously recommended in the FCA reports dated 08/19/2002 and 08/23/2007. It has been amended accordingly to reflect conditions observed during the most recent survey date of 09/18/2013.</p>	125	Each	\$250,000.00	\$ 12.00

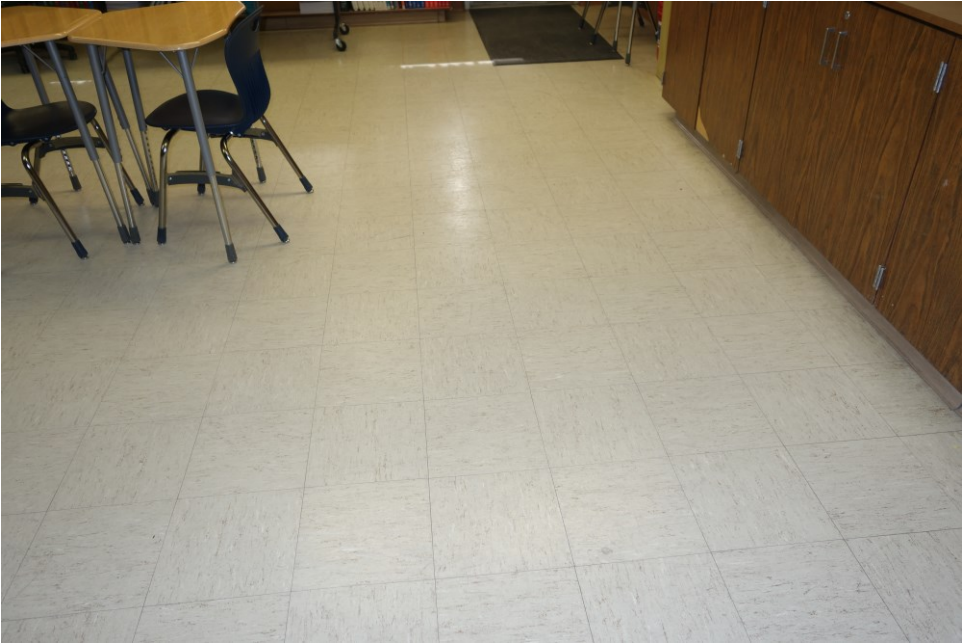
0231 CLASSROOMS & INFIRMARY

QUANTITY	UNITS	TOTAL	SF COST
<p>The VCT (vinyl composite tile), carpet and ceramic tile flooring in the building are damaged and reaching the end of their useful life. It is recommended that the flooring be replaced. This project would provide for removal and disposal of the existing flooring and installation of new 12x12 VCT with a 6" base, heavy duty commercial grade carpet and new ceramic tile in the next 2 - 3 years.</p> <p>This project or a portion there of was previously recommended in the FCA reports dated 08/19/2002, 08/23/2007 and 09/18/2013. It has been amended accordingly to reflect conditions observed during the most recent survey date of 05/09/2023.</p>	20590	Square Foot	\$663,400.00	\$ 32.00

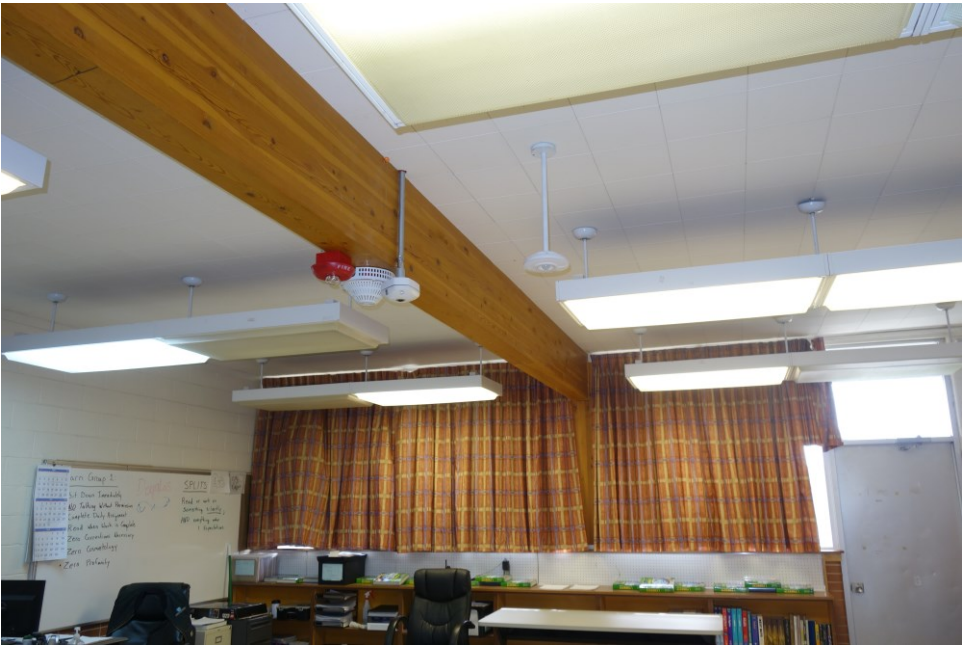
0231 CLASSROOMS & INFIRMARY

QUANTITY	UNITS	TOTAL	SF COST
<p>The ceilings in the building consist of a 12x12 acoustical tile installed over wood T & G decking. The acoustical tiles are stained and falling off due to roof leaks. This project would provide for removal and disposal of damaged sections of drywall and acoustical tiles and re-installation of drywall and surface mounted acoustical tiles.</p> <p>This project should be implemented concurrently with the ROOF REPLACEMENT project.</p> <p>This project or a portion thereof was previously recommended in the FCA report dated 08/23/2007 and 09/18/2013. It has been amended accordingly to reflect conditions observed during the most recent survey date of 05/09/2023.</p>	20590	Square Foot	\$205,900.00	\$ 10.00

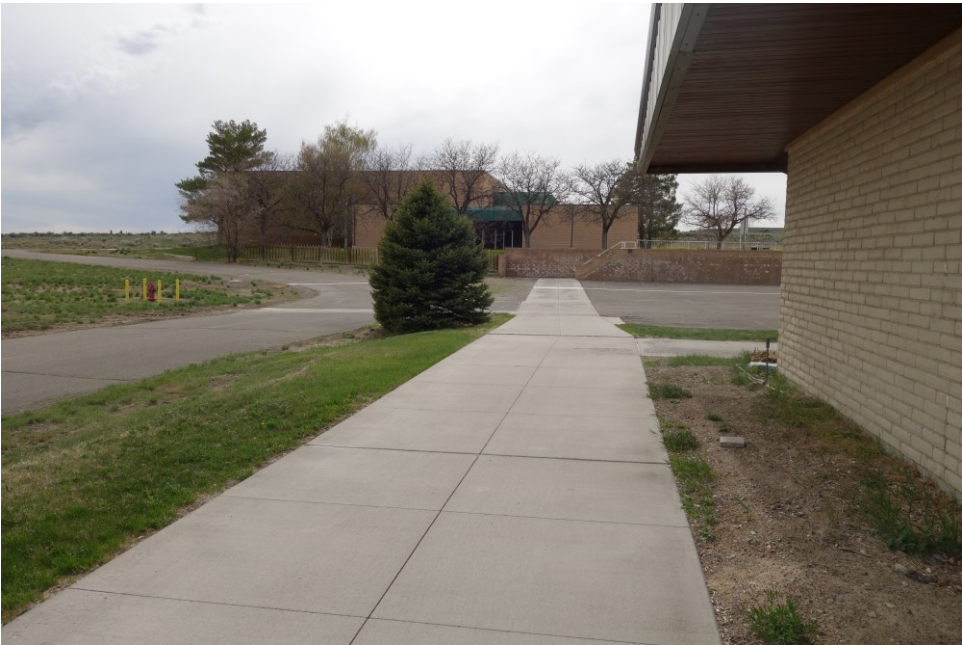
0231 CLASSROOMS & INFIRMARY

QUANTITY	UNITS	TOTAL	SF COST
The exterior finishes were in good condition. It is important to maintain the finish, weather resistance and appearance of the building. This project would provide funding to protect the exterior of the building excluding the roof. Included in the cost are cleaning and sealing the brick masonry and caulking of the windows, flashing, fixtures and all other penetrations. It is recommended that the building be sealed and caulked in the next 7 - 9 years and that this project be scheduled on a cyclical basis to maintain the integrity of the structure.	20590	Square Foot	\$103,000.00	\$ 5.00
