State of Nevada
Department of Wildlife

STEPTOE VALLEY WILDLIFE MANAGEMENT AREA SITE

Site Number: 9940
STATE OF NEVADA PUBLIC WORKS DIVISION
FACILITY CONDITION ANALYSIS

Report distributed in October 2021

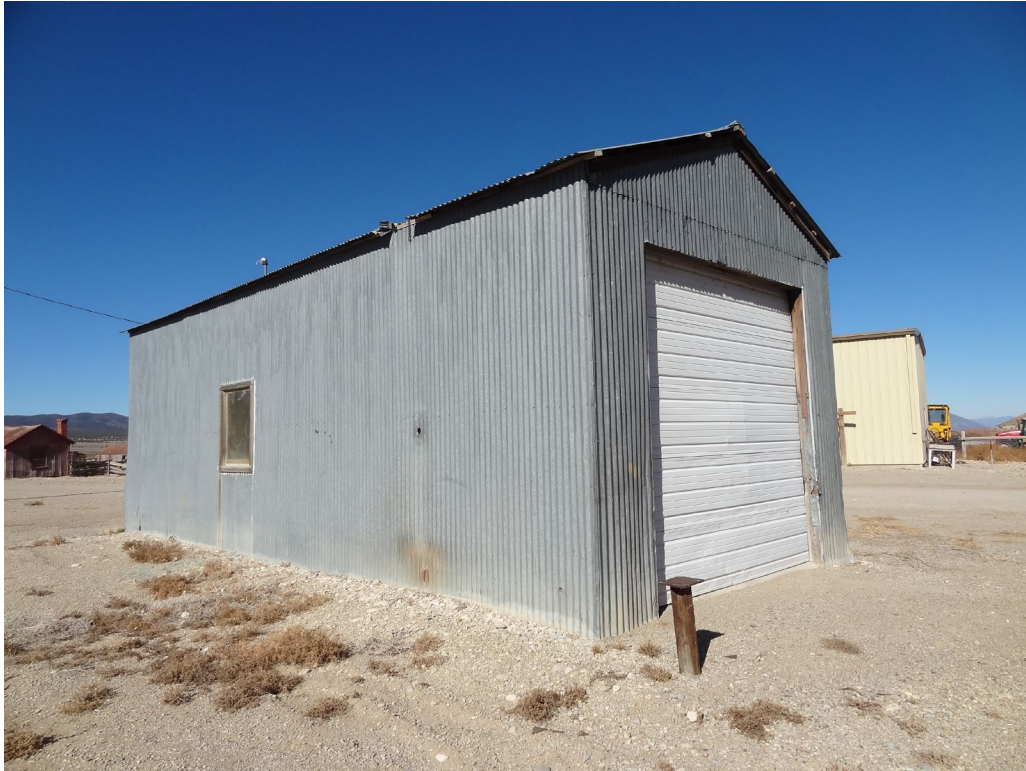
Storage Building - Building #3027
Description: Exterior of the Structure.

The unpainted exterior finishes are in poor condition. It is important to maintain the finish, weather resistance and appearance of the building. This project would provide funding to protect the exterior of the building. Included in the cost is the caulking and sealing of the windows, flashing, fixtures and all other penetrations. Also, it is recommended that the earth to metal contact be removed to prevent premature failure of the siding. It is recommended that the building be caulked and sealed in the next 2 - 3 years and that this project be scheduled on a cyclical basis to maintain the integrity of the structure.

The corrugated metal roof is showing signs of leaking and should be repaired and resealed. The corrugated metal siding is damaged in multiple locations and need to be repaired and or panels replaced as needed to minimize rodent and weather infiltration.

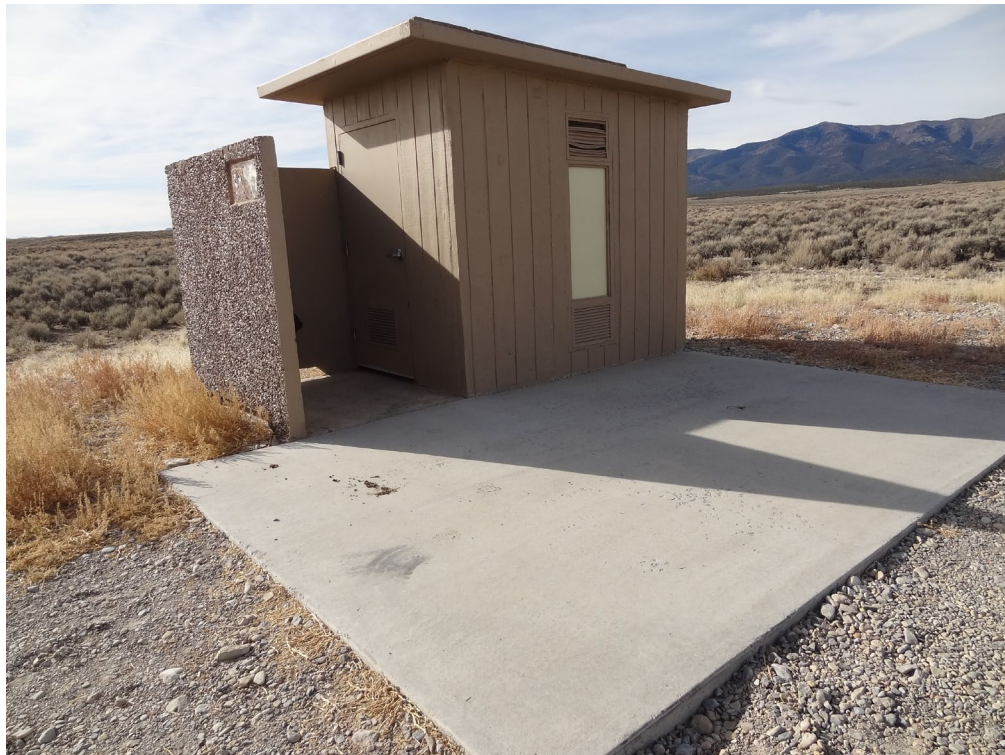
Typical CXT Restrooms – Buildings #3023-3026
Description: Typical Exterior of the Structure.

The ventilation louvers on the side of the building are damaged and should be replaced. This project should be implemented concurrently with the Exterior Finishes project.

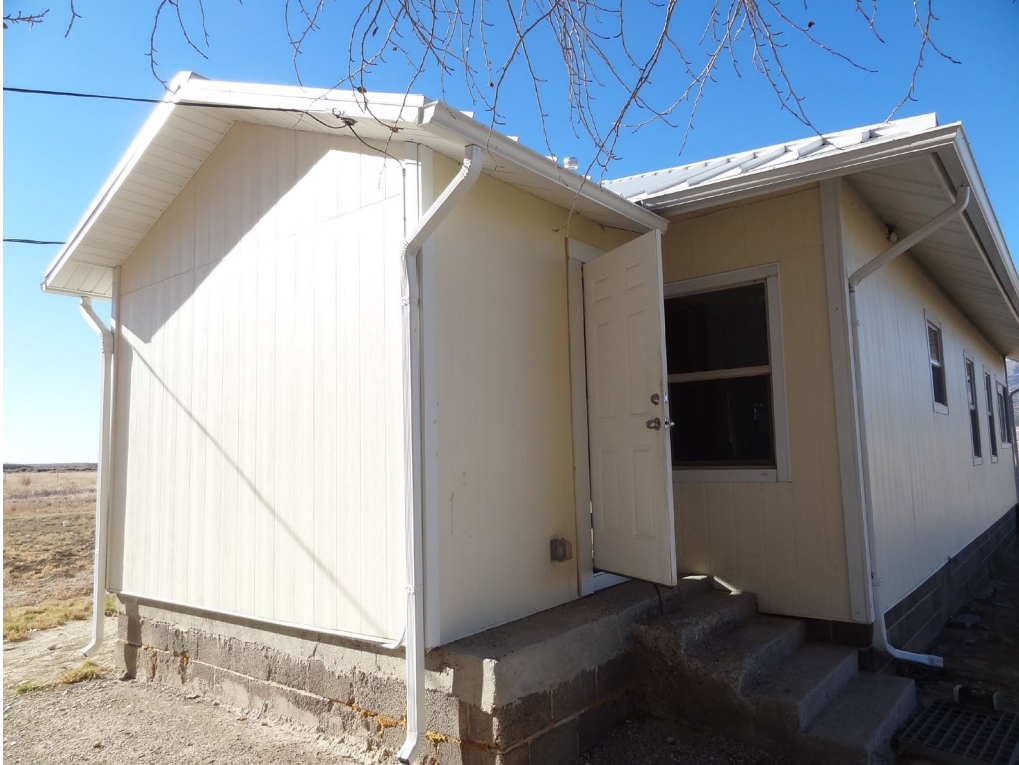
Steptoe Valley WMA Office - Building #2241
Description: ADA Accessible Entrance Upgrades Needed.

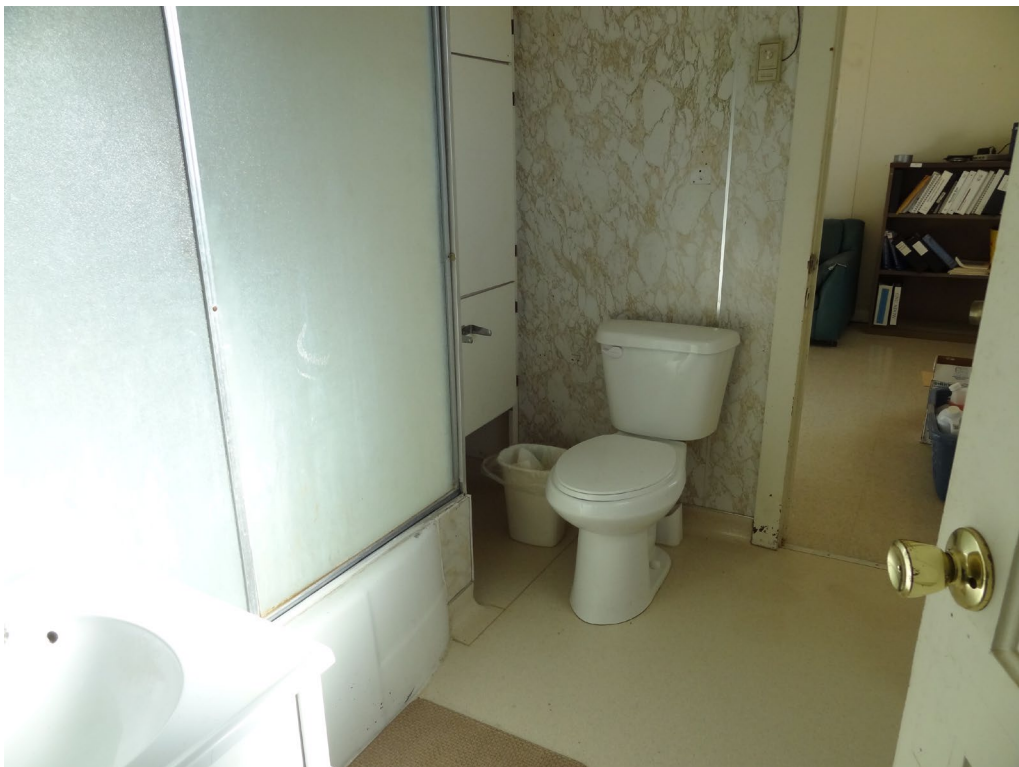
Steptoe Valley WMA Office - Building #2241
Description: ADA Unisex Restroom Upgrade Needed.

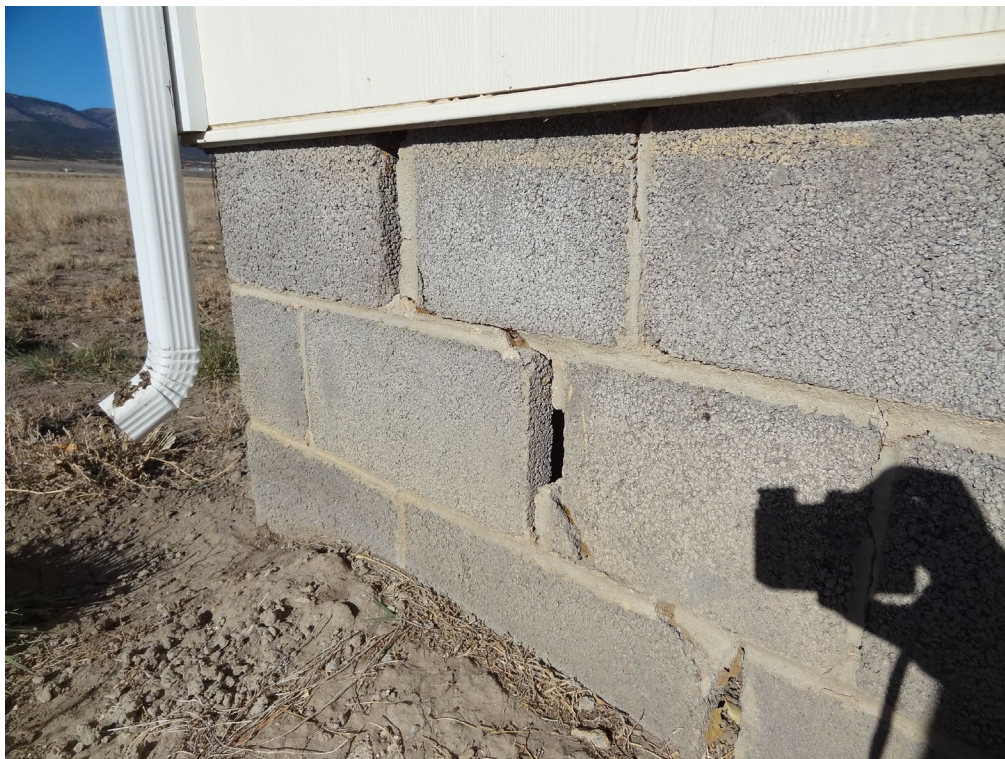
A visual survey of the CMU concrete foundation appears to have failed at one corner. The crack runs vertical from the top of the stemwall to the footing. This project would provide funding to analyze the failure and fund the needed repairs.

Steptoe Valley WMA Office - Building #2241
Description: CMU Foundation Repairs Needed.

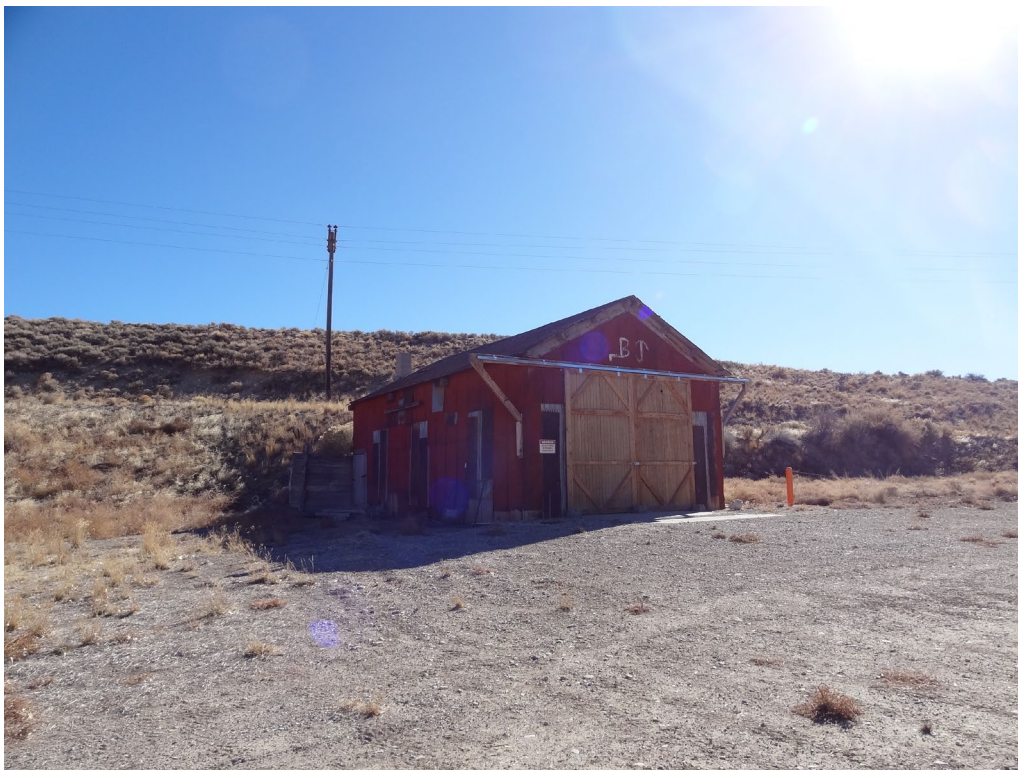
Equipment Storage / Garage - Building #2238
Description: Exterior of the Structure.

The existing building is in poor condition. This project would provide for the sealing and protection of the exterior of the structure including roof and siding repairs and boarding up the large openings. It is recommended that this building be left in a state of arrested decay and not be used.

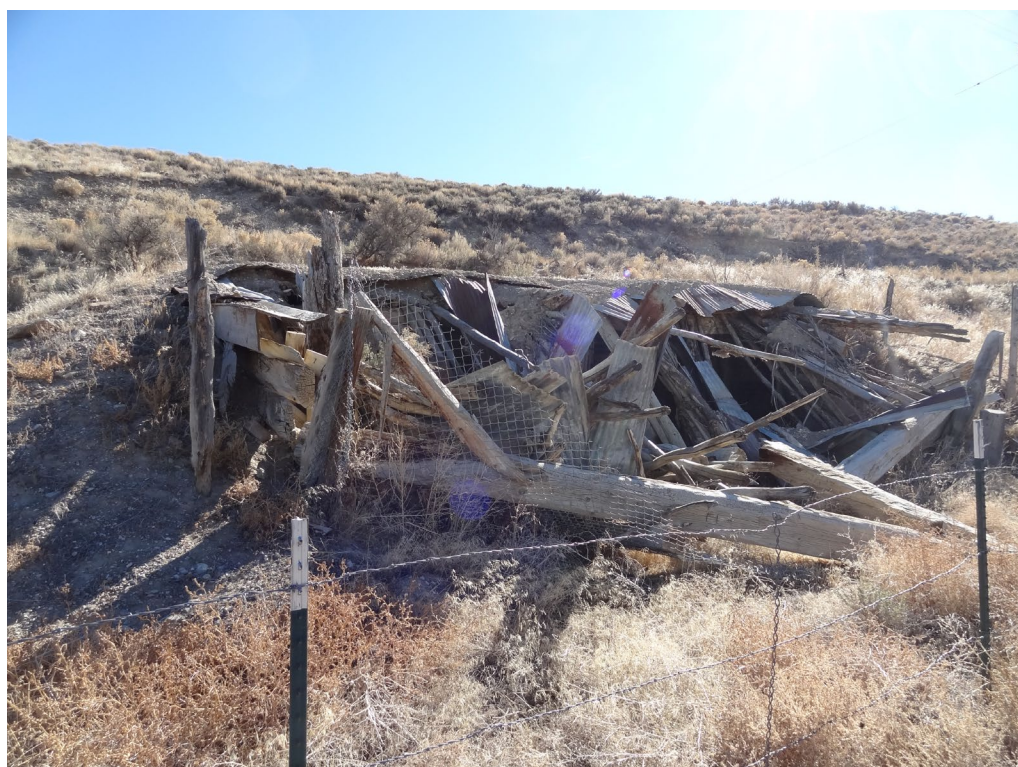
Log Dugout - Building #2237
Description: Exterior of the Structure.

The Dugout is an old wood and log framed structure that was part of the original ranch site. It is partially built into the side of the hill and is showing signs of structural failure.

The Log Dugout is over 100 years old and the structure has failed. The building is dilapidated and deteriorating and has reached the end of its useful life. This project would provide funding for the demolition of the building. Before demolition, the State Historic Preservation Office should be consulted due to the age of the structure.

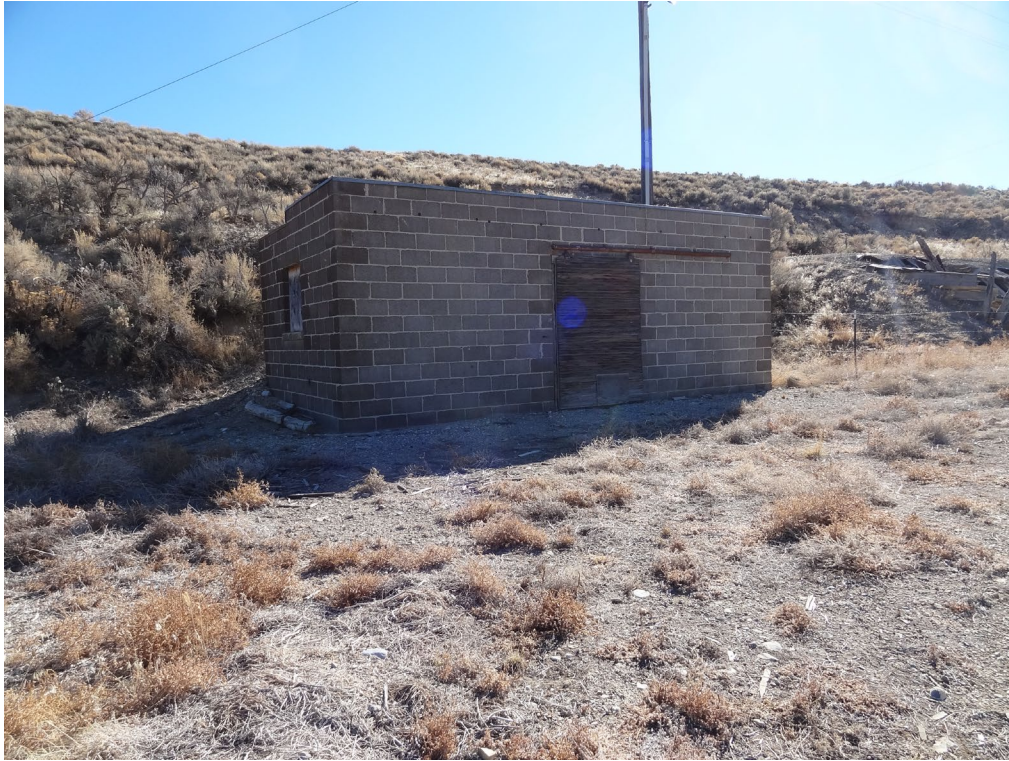
Old Generator / Wood Storage - Building #2236
Description: Exterior of the Structure.

The rolled asphalt roofing on this building was in poor condition at the time of the survey. It is recommended that this building be re-roofed in the next two to three years with new rolled asphalt roofing and new underlayments. This estimate includes removal and disposal of the old roofing.

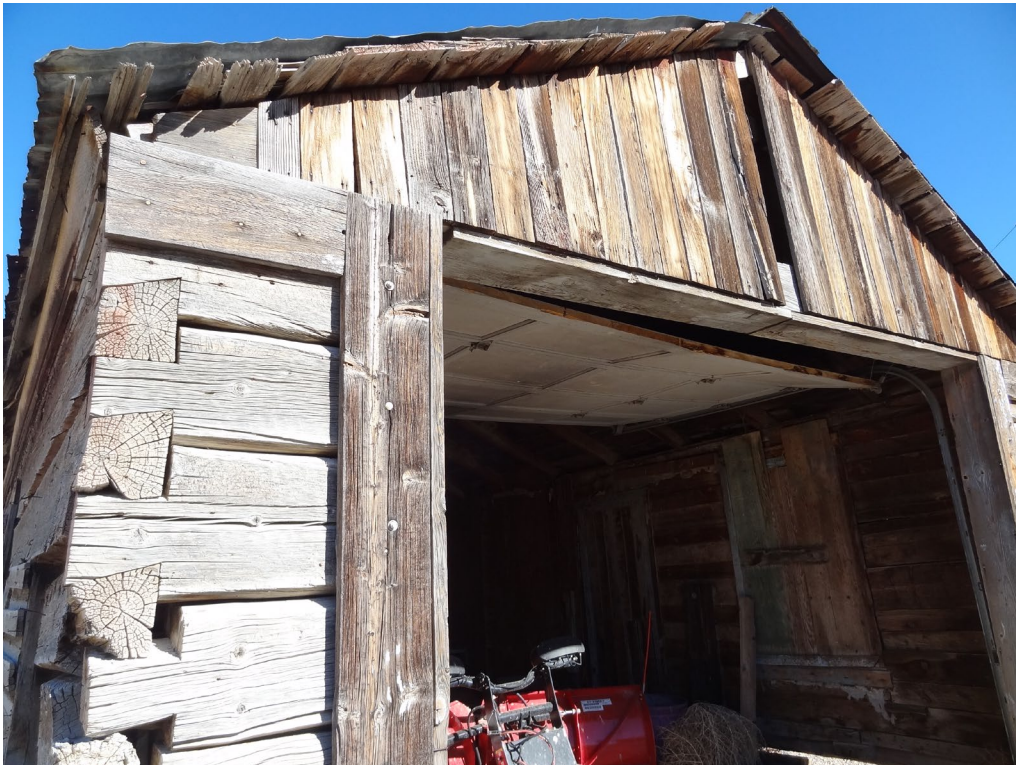
Log Cabin - Building #2235
Description: Exterior of the Structure.

The Log Cabin is an original ranch structure located south of the Ice House. It has a metal roofing system and log siding. The structure is no longer in use and in poor condition.

The existing building is in poor condition. This project would provide for the sealing and protection of the exterior of the structure including roof and siding repairs and boarding up the large openings. It is recommended that this building be left in a state of arrested decay and not be used.
