State of Nevada
Department of Wildlife
Steptoe Valley Wildlife Management Area
Facility Condition Analysis

STEPTOE VALLEY WILDLIFE MANAGEMENT AREA

Site Number: 9940
STATE OF NEVADA PUBLIC WORKS DIVISION
FACILITY CONDITION ANALYSIS

Report Printed in October 2011

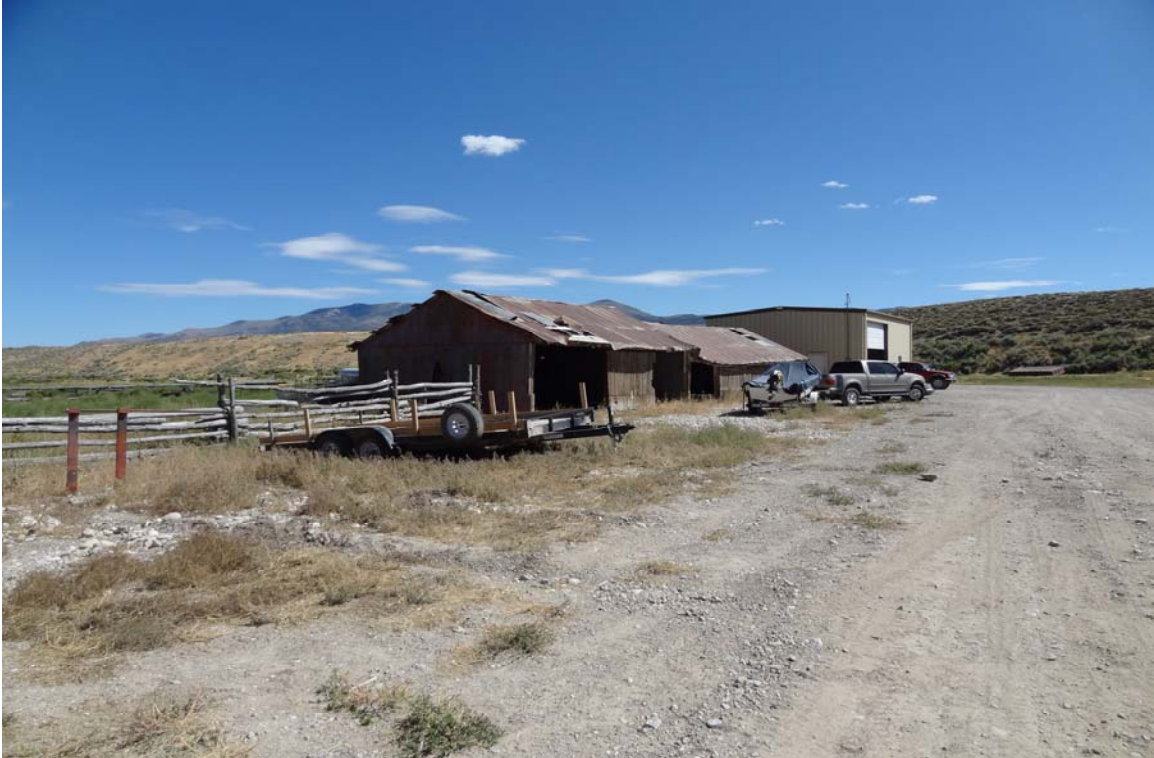
Shearing Shed - Building #2232
Description: Exterior of the structure.

The Shearing Shed is an original ranch structure located along the northwest portion of the main Wildlife Management Area Office complex east of the CCC Office. It has a metal roofing system and metal and wood siding. It is now used as equipment storage by WMA staff and is poor to fair condition.

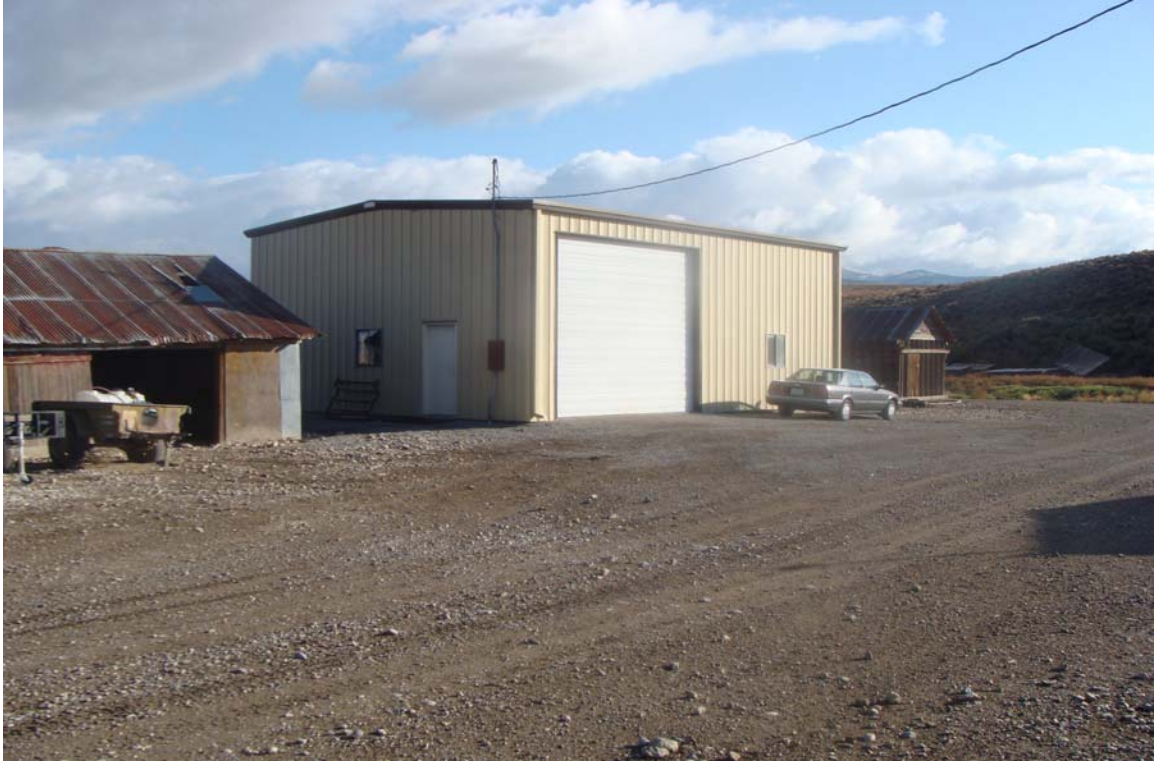
Shop Building - Building #2233
Description: Exterior of the structure.

The Shop is an insulated prefabricated steel structure with metal siding and roofing. It is used by staff for maintenance, storage and repair of equipment at the WMA. I has a new (2009) propane fired gas heater for heat but lacks cooling. The facility is in good shape.

The vehicle garage door does not have an exterior concrete apron. The dirt in front of the door gets muddy and rutted requiring constant maintenance. This project would provide for the installation of a new 4" thick concrete slab-on-grade apron at the vehicle garage door. 200 square feet of concrete was used to generate this estimate. This project or a portion thereof was previously recommended in the FCA report dated 09/30/2009. It has been amended accordingly to reflect conditions observed during the most recent survey date of 08/24/2011.

The windows are original, single pane construction in a metal frame. These older windows are drafty and not energy efficient. This project recommends replacing the windows with dual pane, higher efficiency units. This estimate is for the replacement of 4 units. Removal and disposal of the existing windows is included in this estimate. This project or a portion thereof was previously recommended in the FCA report dated 09/30/2009. It has been amended accordingly to reflect conditions observed during the most recent survey date of 08/24/2011.

Section 1008.1 of the 2006 IBC describes the requirements for doors including floor elevations and landings. The floor or landing shall be at the same elevation on each side of the door, the exterior landing shall not exceed a 2-percent slope and shall have a length measured in the direction of travel equal to or greater than the size of the door. The exterior man door does not have a landing and poses a safety hazard. This project would provide for the installation of a building code compliant landing for the door. This project or a portion thereof was previously recommended in the FCA report dated 09/30/2009. It has been amended accordingly to reflect conditions observed during the most recent survey date of 08/24/2011.

It is important to maintain the finish, weather resistance and appearance of the building. This project would provide funding to protect the exterior of the building. Included in the cost is the caulking and sealing of the doors, windows, flashing, fixtures and all other penetrations. It is recommended that the building be caulked and sealed in the next 5-7 years and that this project be scheduled on a cyclical basis to maintain the integrity of the structure. This project or a portion thereof was previously recommended in the FCA report dated 09/30/2009. It has been amended accordingly to reflect conditions observed during the most recent survey date of 08/24/2011.

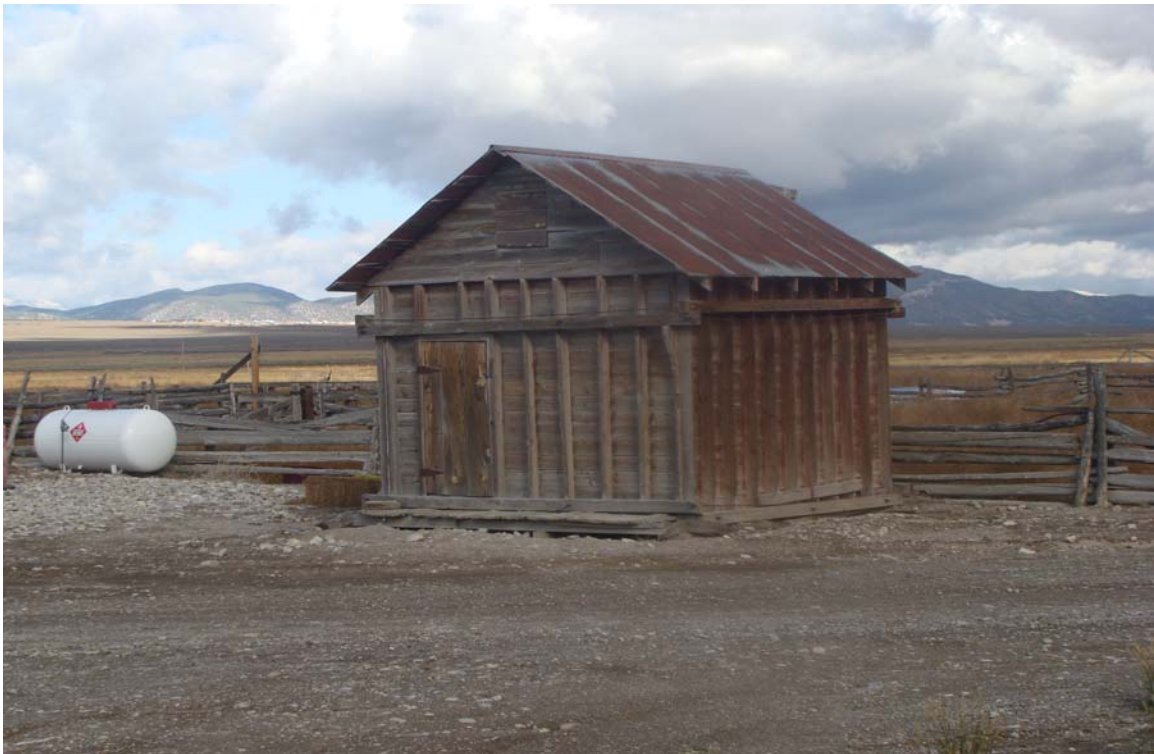
Ice House - Building #2234
Description: Exterior of the structure.

The Ice House is an original ranch structure located due east of the metal Shop Building. It has a metal roofing system and wood siding. The structure is no longer in use and in fair condition.

The existing building is in poor condition. This project would provide for the sealing and protection of the exterior of the structure including roof and siding repairs and boarding up the large openings. It is recommended that this building be left in a state of arrested decay and not be used. This project or a portion thereof was previously recommended in the FCA report dated 09/30/2009. It has been amended accordingly to reflect conditions observed during the most recent survey date of 08/24/2011.

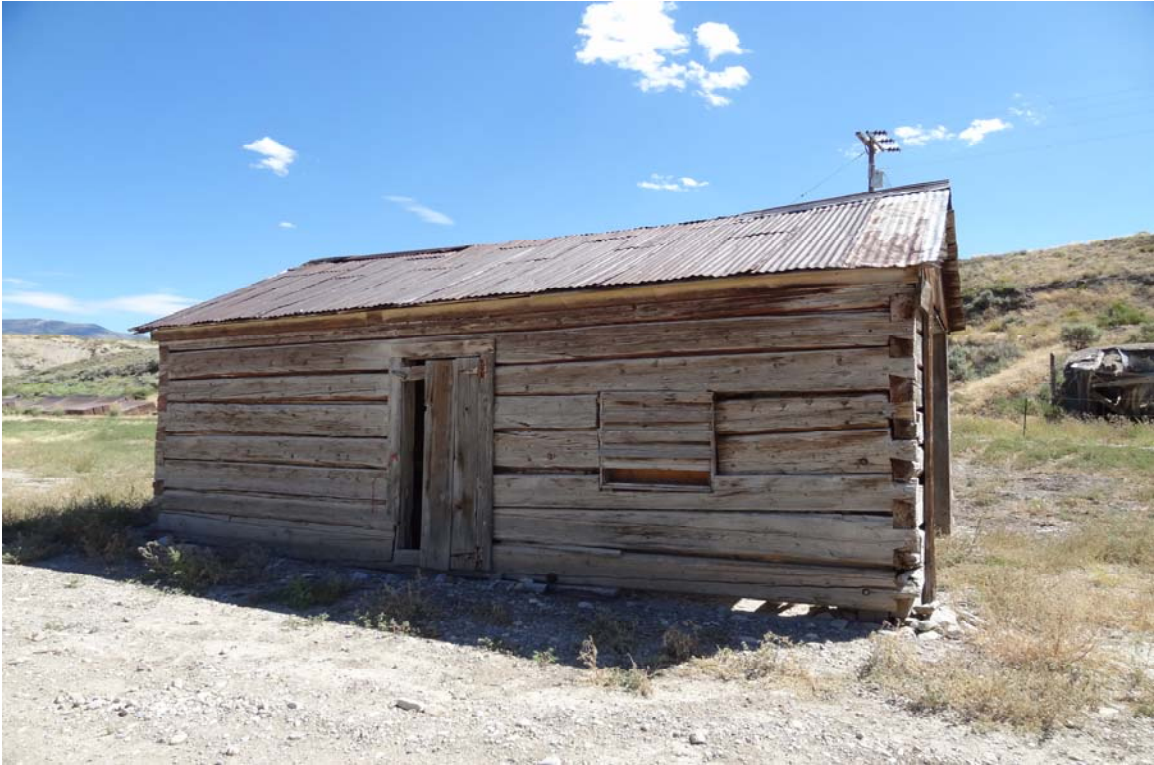
Log Cabin - Building #2235
Description: Exterior of the structure.

The Log Cabin is an original ranch structure located south of the Ice House. It has a metal roofing system and log siding. The structure is no longer in use and in poor condition.

The existing building is in poor condition. This project would provide for the sealing and protection of the exterior of the structure including roof and siding repairs and boarding up the large openings. It is recommended that this building be left in a state of arrested decay and not be used. This project or a portion thereof was previously recommended in the FCA report dated 09/30/2009. It has been amended accordingly to reflect conditions observed during the most recent survey date of 08/24/2011.

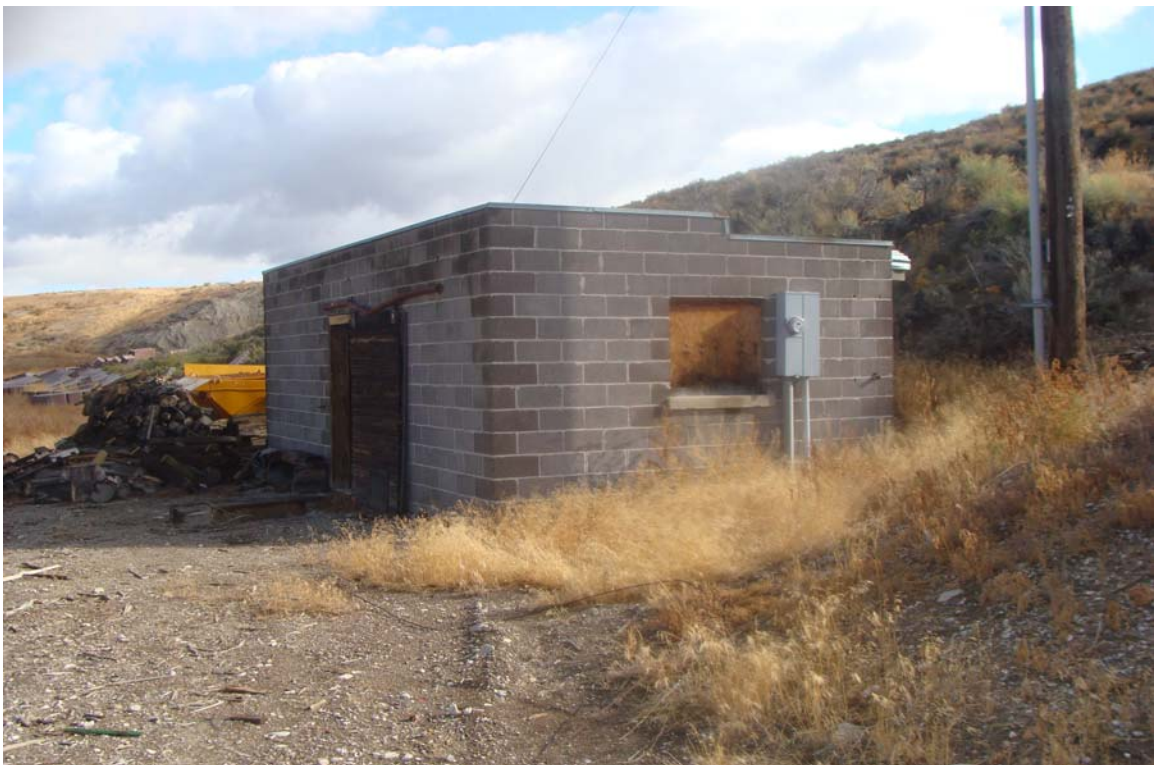
Old Generator / Wood Storage - Building #2236
Description: Exterior of the structure.

The rolled asphalt roofing on this building was in poor condition at the time of the survey. It is recommended that this building be re-roofed in the next two to three years with new rolled asphalt roofing and new underlayments. This estimate includes removal and disposal of the old roofing. This project or a portion thereof was previously recommended in the FCA report dated 09/30/2009. It has been amended accordingly to reflect conditions observed during the most recent survey date of 08/24/2011.

It is important to maintain the finish, weather resistance and appearance of the building. This project would provide funding to protect the exterior of the building. Included in the cost are cleaning and sealing the masonry and caulking of the windows, flashing, fixtures and all other penetrations. It is recommended that the building be sealed and caulked in the next 2-3 years and that this project be scheduled on a cyclical basis to maintain the integrity of the structure. This project or a portion thereof was previously recommended in the FCA report dated 09/30/2009. It has been amended accordingly to reflect conditions observed during the most recent survey date of 08/24/2011.

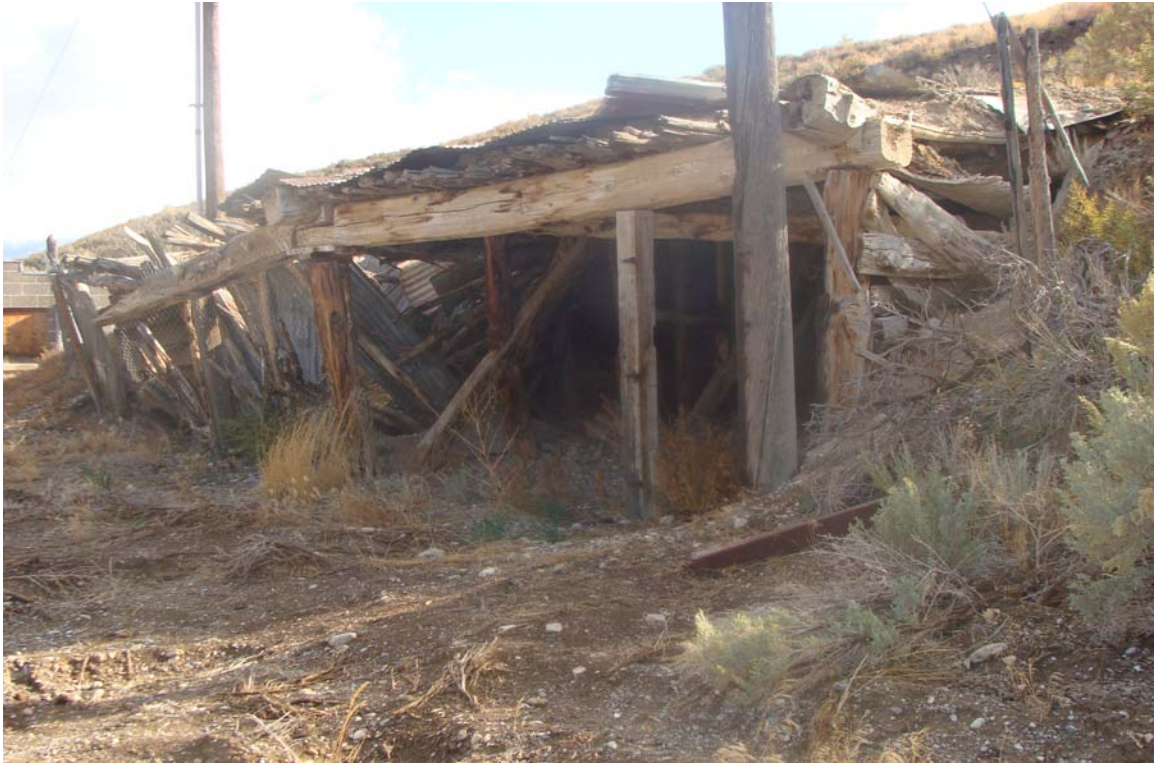
Log Dugout - Building #2237
Description: Exterior of the structure.

The Dugout is an old wood and log framed structure that was part of the original ranch site. It is partially built into the side of the hill and is showing signs of structural failure.

The Log Dugout is over 100 years old and the structure has failed. The building is dilapidated and deteriorating and has reached the end of its useful life. This project would provide funding for the demolition of the building. Before demolition, the State Historic Preservation Office should be consulted due to the age of the structure. This project or a portion thereof was previously recommended in the FCA report dated 09/30/2009. It has been amended accordingly to reflect conditions observed during the most recent survey date of 08/24/2011.

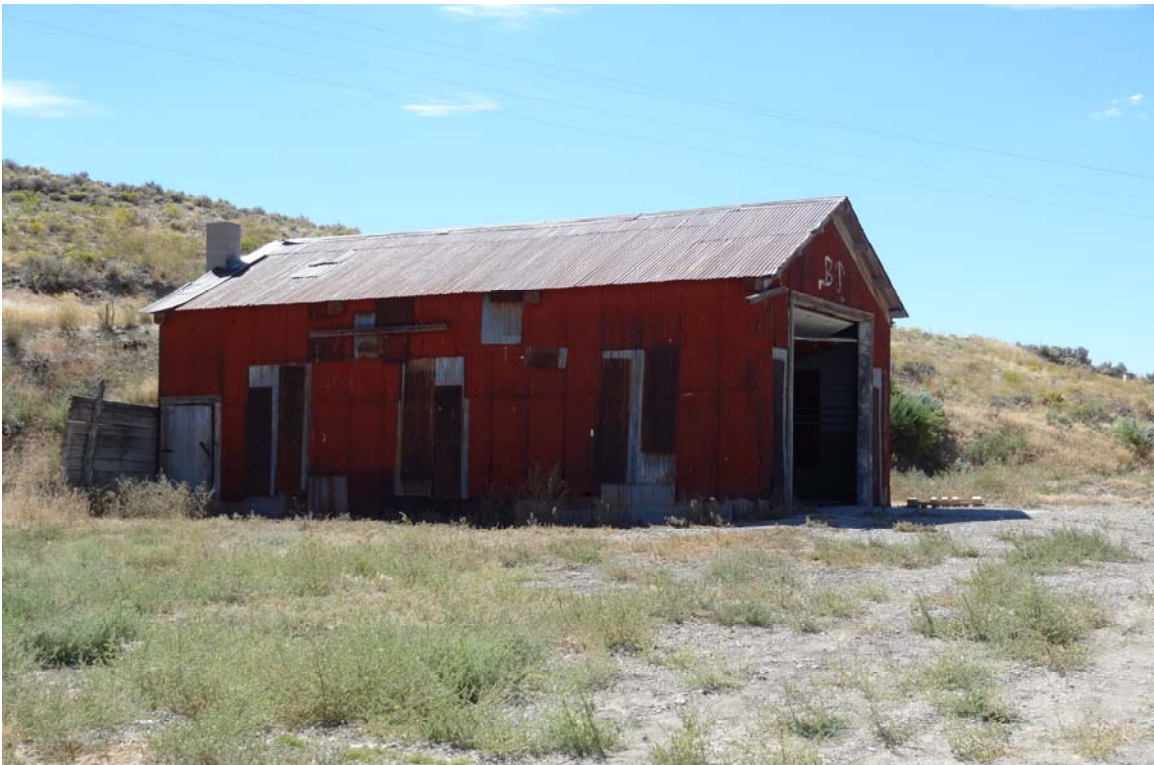
Equipment Storage / Garage - Building #2238
Description: Exterior of the structure.

The existing building is in poor condition. This project would provide for the sealing and protection of the exterior of the structure including roof and siding repairs and boarding up the large openings. It is recommended that this building be left in a state of arrested decay and not be used. This project or a portion thereof was previously recommended in the FCA report dated 09/30/2009. It has been amended accordingly to reflect conditions observed during the most recent survey date of 08/24/2011.

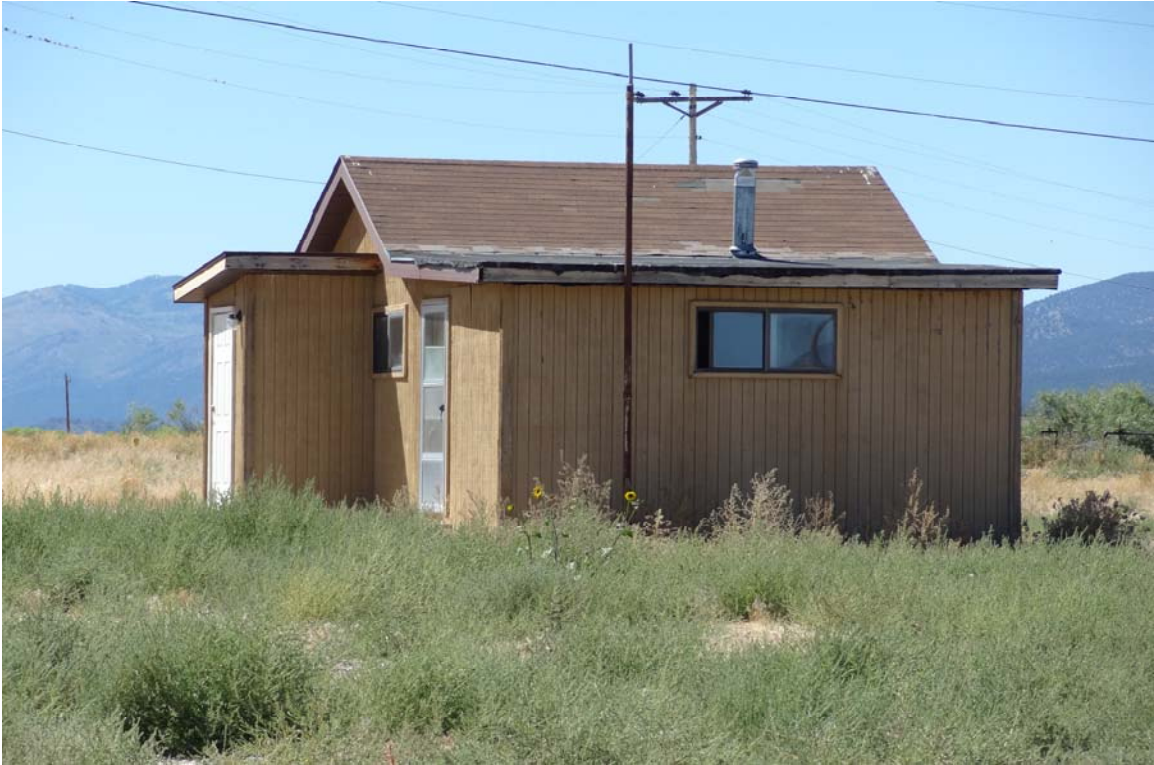
Bunk House / Storage - Building #2239
Description: Exterior of the structure.

The Bunk House is a wood framed structure with an asphalt composition roofing system on a concrete foundation. The building is no longer occupied and is used for storage. It is in fair to good shape.

The asphalt composition shingle roof on this building was in poor condition at the time of the survey. It is recommended that this building be re-roofed in the next two to three years with a new 50 year asphalt composition roofing shingle and new underlayments. This estimate includes removal and disposal of the old roofing. This project or a portion thereof was previously recommended in the FCA report dated 09/30/2009. It has been amended accordingly to reflect conditions observed during the most recent survey date of 08/24/2011.

Section 1008.1 of the 2006 IBC describes the requirements for doors including floor elevations and landings. The floor or landing shall be at the same elevation on each side of the door, the exterior landing shall not exceed a 2-percent slope and shall have a length measured in the direction of travel of not less than 44 inches. The two exterior man doors do not have landings and pose a safety hazard. This project would provide for the installation of compliant landings for each door. This project or a portion thereof was previously recommended in the FCA report dated 09/30/2009. It has been amended accordingly to reflect conditions observed during the most recent survey date of 08/24/2011.

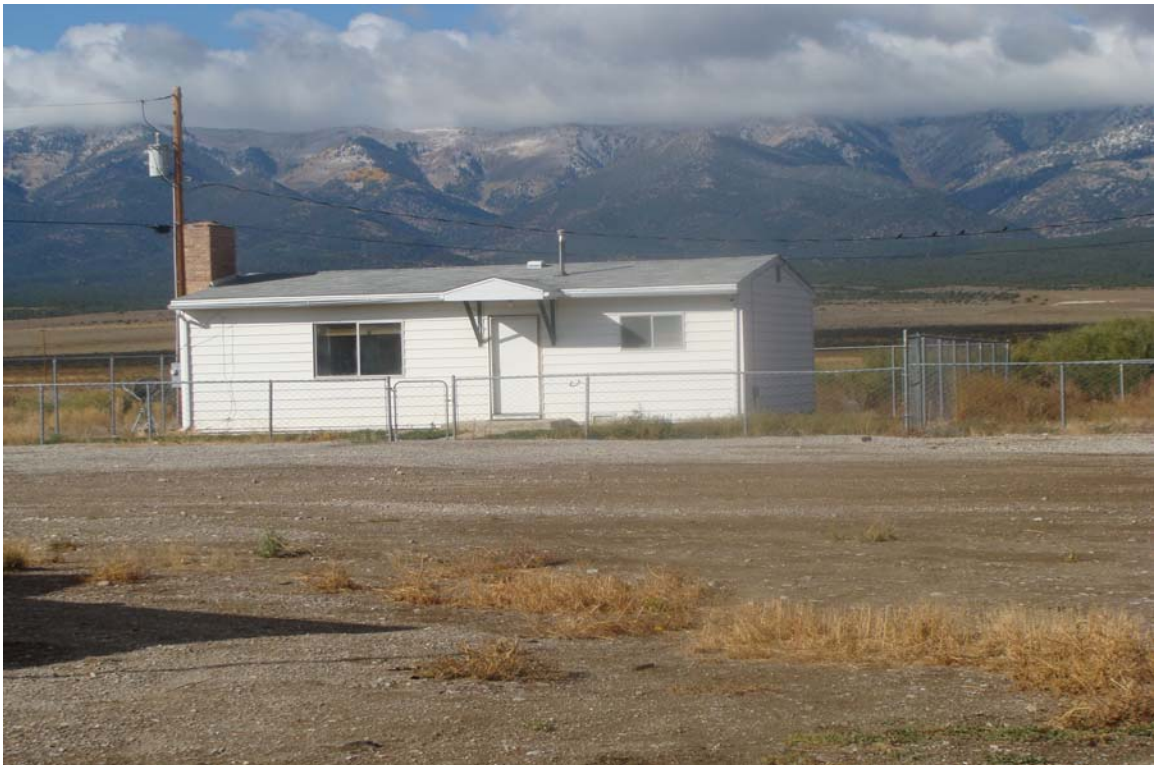
Residence / Bunk House - Building #2240
Description: Exterior of the structure.

The VCT (vinyl composite tile) and carpet in the building are damaged and reaching the end of their useful life. It is recommended that the flooring be replaced. This project would provide for removal and disposal of the existing flooring and installation of new 12x12 VCT with a 6" base and heavy duty commercial grade carpet in the next two to three years. Additional costs have been added for abatement of any asbestos containing materials that may be present. This project or a portion thereof was previously recommended in the FCA report dated 09/30/2009. It has been amended accordingly to reflect conditions observed during the most recent survey date of 08/24/2011.

The asphalt composition shingle roof on this building was in fair condition at the time of the survey. It is recommended that this building be re-roofed in the next two to three years with a new 50 year asphalt composition roofing shingle and new underlayments. This estimate includes removal and disposal of the old roofing.

The windows are original, dual pane construction in a metal frame. These older windows are drafty and not energy efficient. This project recommends replacing the windows with dual pane, higher efficiency units. This estimate is for the replacement of 5 units. Removal and disposal of the existing windows is included in this estimate. This project or a portion thereof was previously recommended in the FCA report dated 09/30/2009. It has been amended accordingly to reflect conditions observed during the most recent survey date of 08/24/2011.

It is important to maintain the finish, weather resistance and appearance of the building. This project would provide funding to protect the exterior of the building. Included in the cost is cleaning the vinyl siding and caulking of the windows, flashing, fixtures and all other penetrations as well as repairing some damaged siding. It is recommended that the building be cleaned and caulked in the next 2-3 years and that this project is scheduled on a cyclical basis to maintain the integrity of the structure. This project or a portion thereof was previously recommended in the FCA report dated 09/30/2009. It has been amended accordingly to reflect conditions observed during the most recent survey date of 08/24/2011.

The interior finishes are in fair condition. It is recommended that the interior walls and ceiling be painted at least once in the next two to four years. Prior to painting, all surfaces should be repaired and prepped. An epoxy-based paint should be utilized in wet areas for durability. This project or a portion thereof was previously recommended in the FCA report dated 09/30/2009. It has been amended accordingly to reflect conditions observed during the most recent survey date of 08/24/2011.

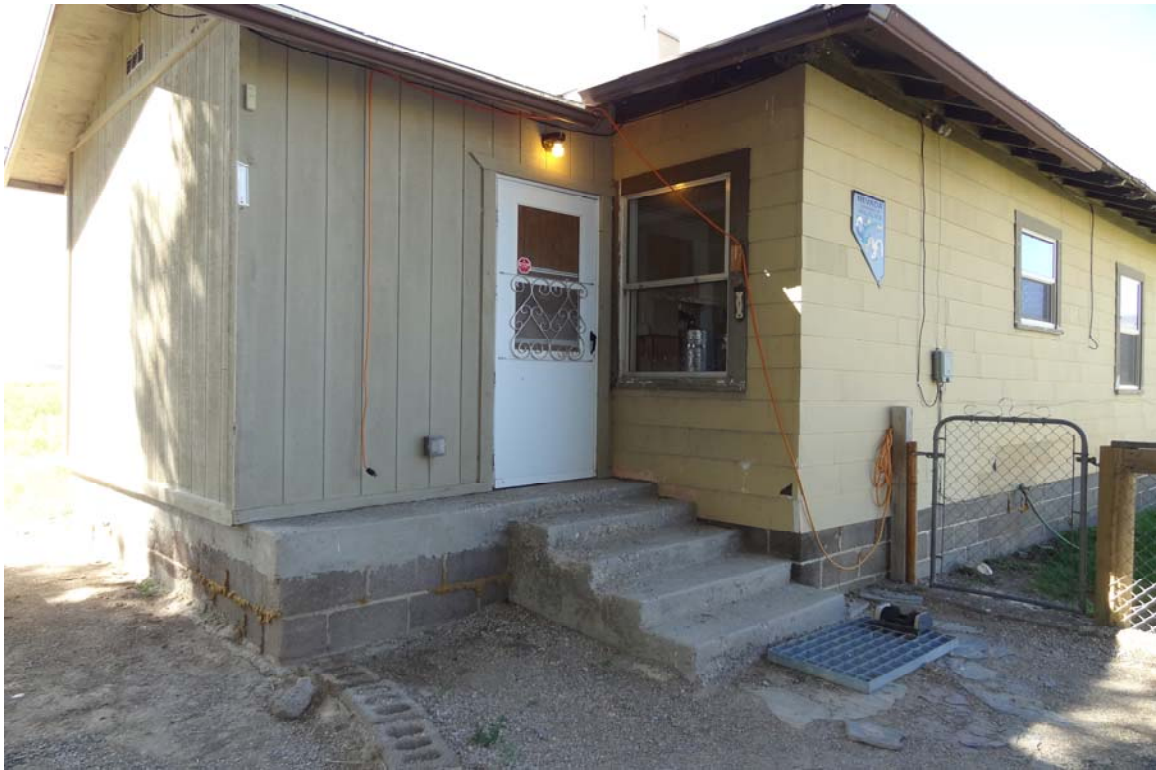
Steptoe Valley WMA Office - Building #2241
Description: Exterior of the structure & public entrance.

The Steptoe WMA Office is a wood framed structure with an asphalt composition roofing system on a concrete masonry unit foundation. According to staff, it was relocated sometime in the 1950's to its current location. It is the main office for staff and the public and has a small restroom and public display area. It has propane heat and no cooling and water is supplied by a well. The main entrance to the office has a set of stairs that are in need of replacement and will be addressed in the report. Also, the exterior siding appears to be a transite siding which may contain asbestos.

The asphalt composition shingle roof on this building was in poor condition at the time of the survey. It is recommended that this building be re-roofed in the next one to two years with a new 50 year asphalt composition roofing shingle and new underlayments. This estimate includes removal and disposal of the old roofing. This project or a portion thereof was previously recommended in the FCA report dated 09/30/2009. It has been amended accordingly to reflect conditions observed during the most recent survey date of 08/24/2011.

The existing bathroom fixtures and finishes appear to be original and are in poor condition. This project would provide for the replacement of the bathroom fixtures including a toilet, sink, faucets and bathtub / shower combination unit. New flooring is included in this estimate. This bathroom would not need to be ADA accessible if the project for a new CXT comfort station is installed for public use adjacent to the office. This project or a portion thereof was previously recommended in the FCA report dated 09/30/2009. It has been amended accordingly to reflect conditions observed during the most recent survey date of 08/24/2011.

Some of the windows are original, single pane construction in a metal frame. These older windows are drafty and not energy efficient. This project recommends replacing the windows with dual pane, higher efficiency units. This estimate is for the replacement of 5 units. Removal and disposal of the existing windows is included in this estimate. This project or a portion thereof was previously recommended in the FCA report dated 09/30/2009. It has been amended accordingly to reflect conditions observed during the most recent survey date of 08/24/2011.

It is important to maintain the finish, weather resistance and appearance of the building. This project would provide funding to protect the exterior of the building. Included in the cost is, priming and painting and caulking of the windows, flashing, fixtures and all other penetrations. Also included is repairing the wood eaves and soffits as needed. It is recommended that the building be painted and repaired in the next 2-3 years and that this project be scheduled on a cyclical basis to maintain the integrity of the structure. Please note that the siding appears to be a transite siding which may contain asbestos. Do not sand or otherwise disturb the siding without consulting a professional familiar with asbestos. This project or a portion thereof was previously recommended in the FCA report dated 09/30/2009. It has been amended accordingly to reflect conditions observed during the most recent survey date of 08/24/2011.

The interior finishes are in fair condition. It is recommended that the interior walls and ceilings be painted at least once in the next two to four years. Prior to painting, all surfaces should be repaired and prepped. An epoxy-based paint should be utilized in wet areas for durability. This project or a portion thereof was previously recommended in the FCA report dated 09/30/2009. It has been amended accordingly to reflect conditions observed during the most recent survey date of 08/24/2011.

The existing lighting fixtures are the older incandescent or fluorescent type, and are not energy efficient. This project will upgrade fixtures to higher efficiency units with a longer life cycle. Compact fluorescent lamps and F28 T-8 lamps with electronic ballasts are suggested. Occupancy sensors will be installed in restrooms, closets and other low occupancy areas for additional savings. Any electrical wiring upgrades are not included in this estimate. This project or a portion thereof was previously recommended in the FCA report dated 09/30/2009. It has been amended accordingly to reflect conditions observed during the most recent survey date of 08/24/2011.

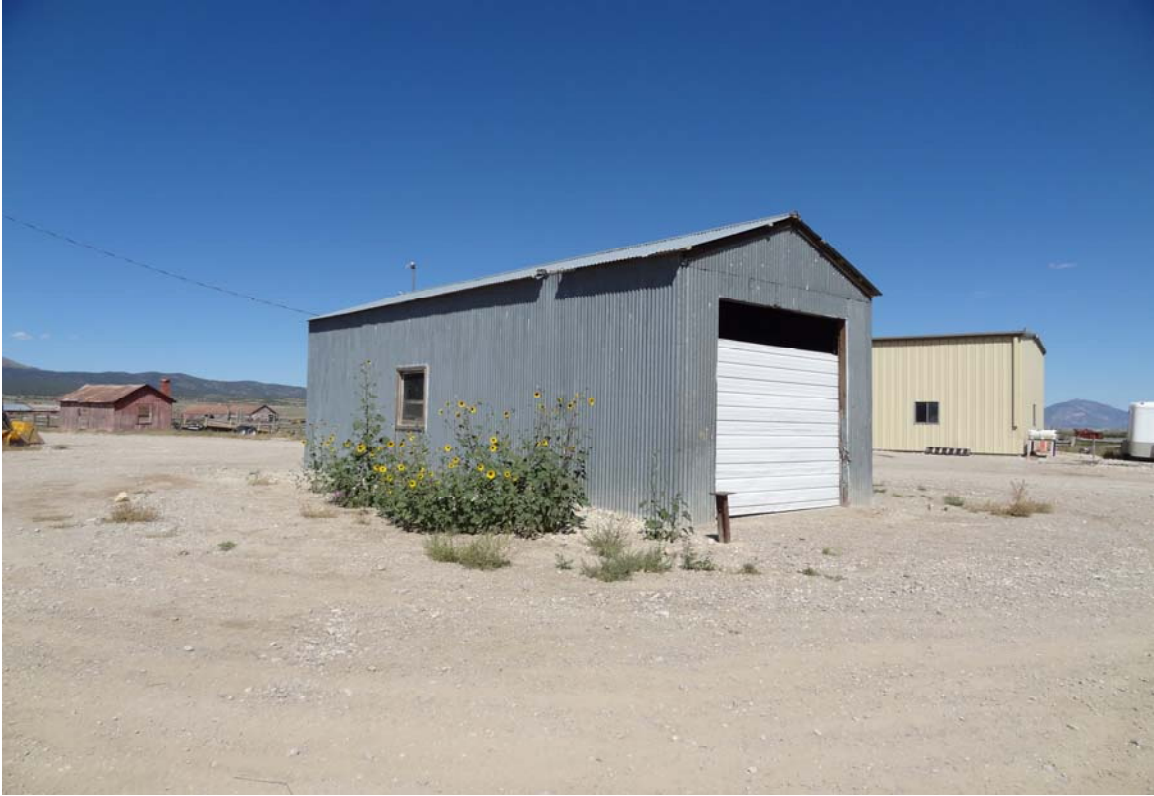
Storage Building - Building #3027
Description: Exterior of the structure.

The Storage building is a wood framed structure with a corrugated metal roofing and siding system on a concrete foundation. It is located in the main office yard area and appears to be one of the old ranch structures. It is currently used as storage and is in poor to fair shape.

The storage building contains many different paints, stains, pesticides and other hazardous products on open shelves and on the floor. This does not meet OSHA standards for hazardous materials containment. This project would provide two hazardous storage containers in the building and install placards on the building exterior in accordance with OSHA 1910.106 (d). This project or a portion thereof was previously recommended in the FCA report dated 09/30/2009. It has been amended accordingly to reflect conditions observed during the most recent survey date of 08/24/2011.

It is important to maintain the finish, weather resistance and appearance of the building. This project would provide funding to protect the exterior of the building. Included in the cost is the caulking and sealing of the windows, flashing, fixtures and all other penetrations. Also, it is recommended that the earth to metal contact be removed to prevent premature failure of the siding. It is recommended that the building be caulked and sealed in the next 2-3 years and that this project be scheduled on a cyclical basis to maintain the integrity of the structure. This project or a portion thereof was previously recommended in the FCA report dated 09/30/2009. It has been amended accordingly to reflect conditions observed during the most recent survey date of 08/24/2011.
