State of Nevada  
Department of Corrections  
Ely State Prison  
Facility Condition Analysis

# ELY STATE PRISON

**Site Number: 9941**  
**STATE OF NEVADA PUBLIC WORKS DIVISION**  
**FACILITY CONDITION ANALYSIS**

Report Printed in February 2016

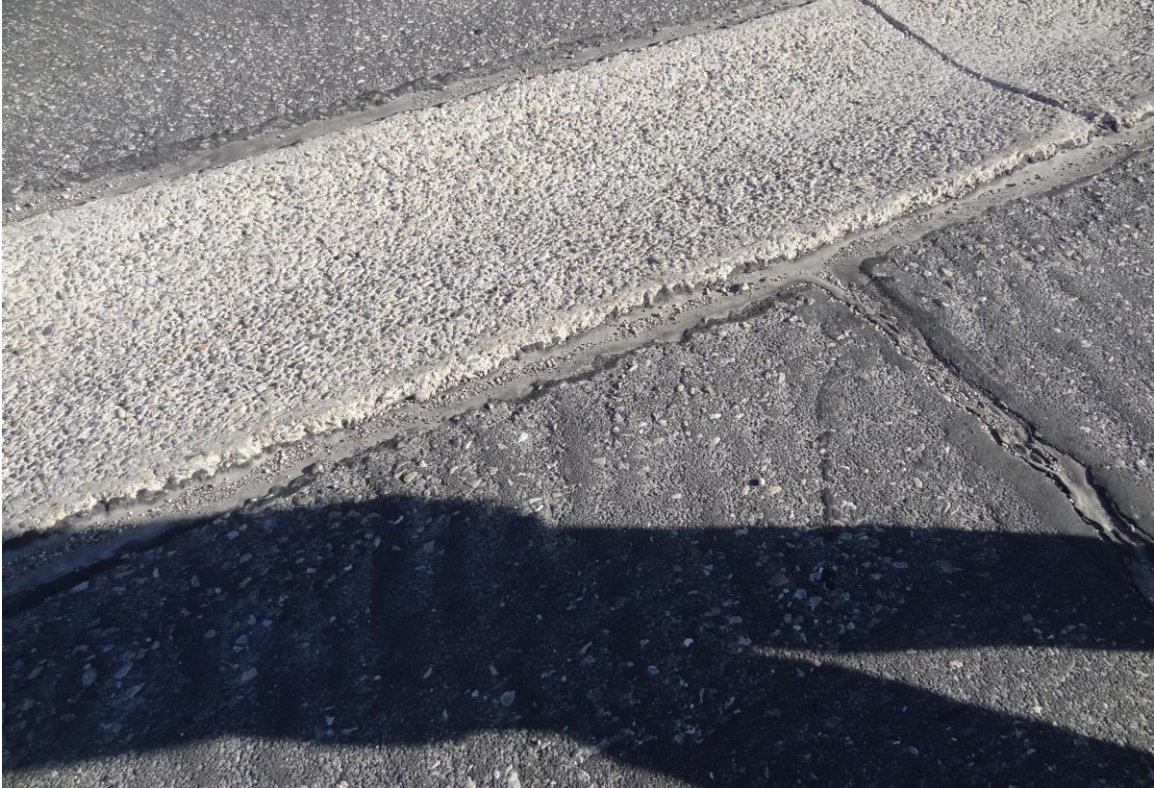
Ely State Prison Site – FCA Site #9941  
Description: Damaged valley gutter in parking lot.

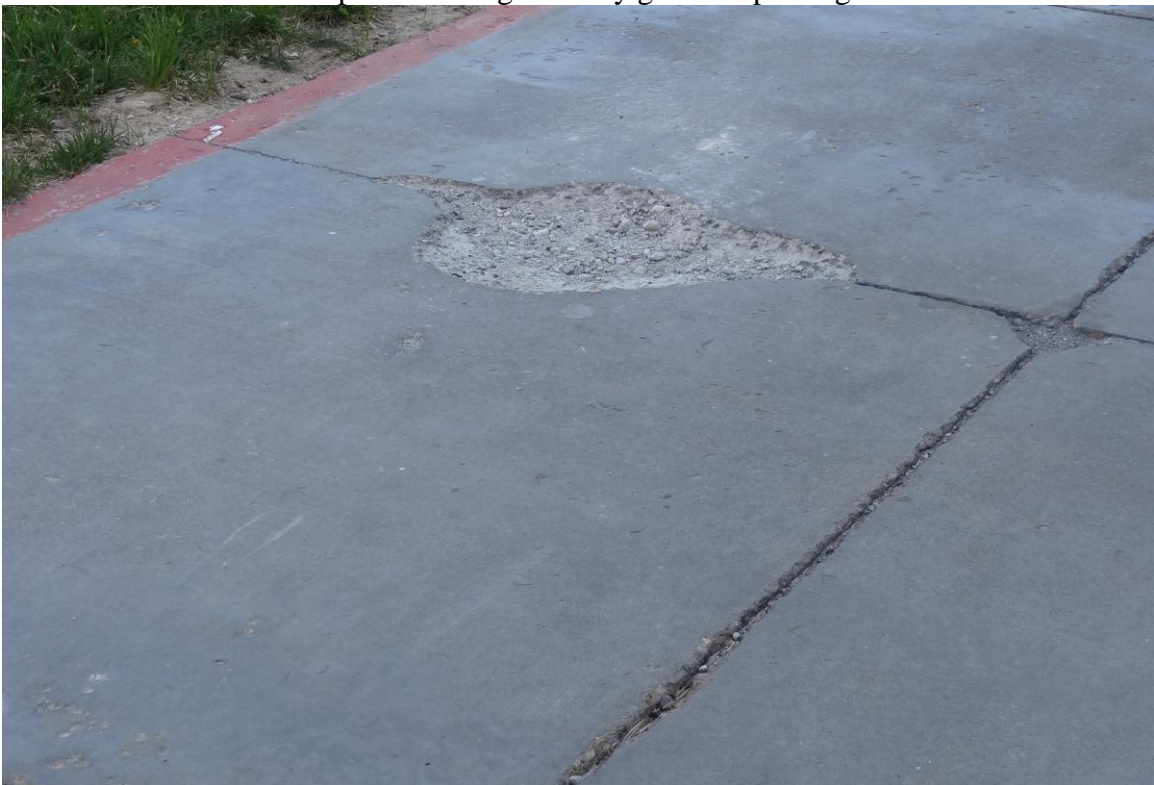
Ely State Prison Site – FCA Site #9941  
Description: Damaged concrete walkway.

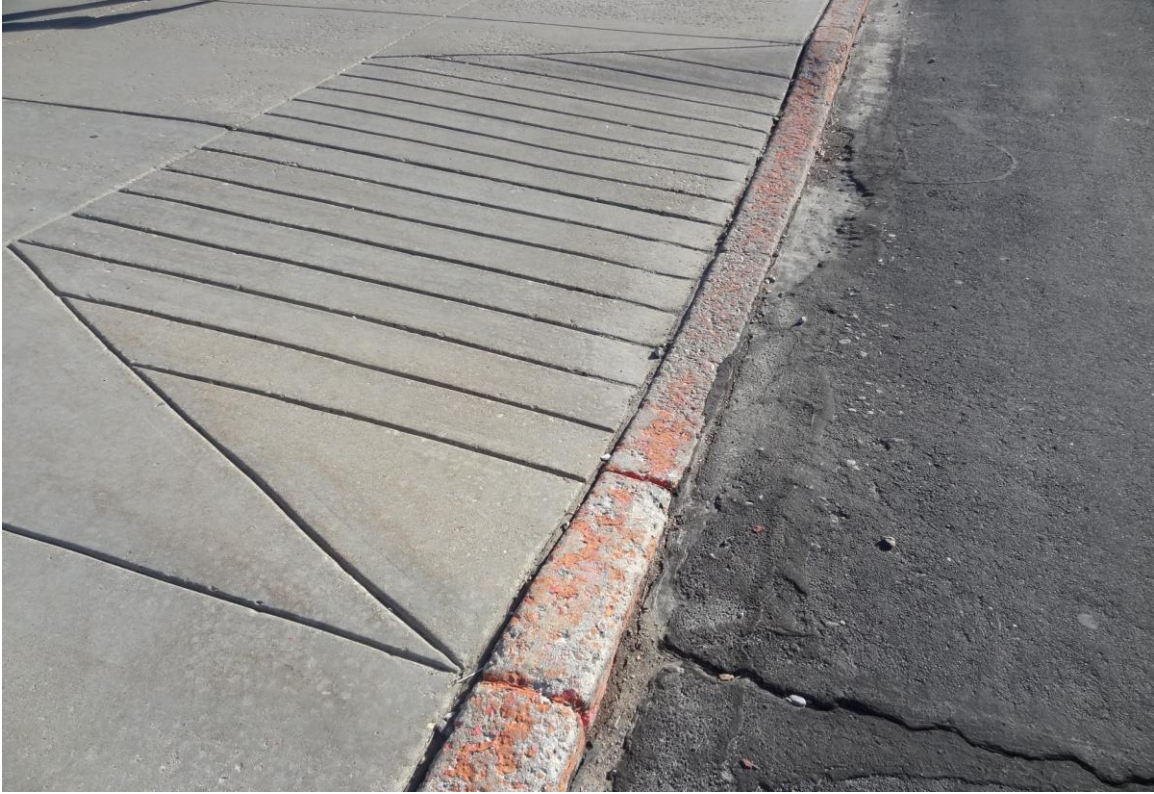
Ely State Prison Site – FCA Site #9941  
Description: ADA accessible curb cut / paving damage.

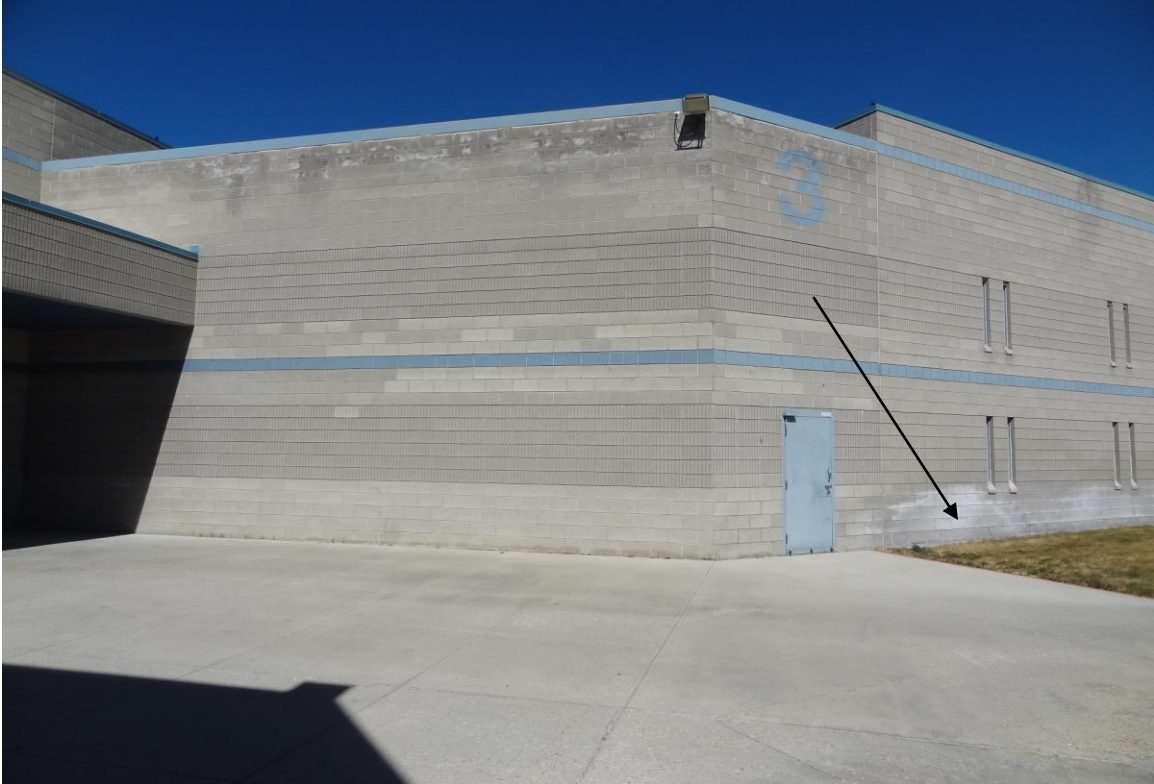
Housing Unit #3 – FCA Building #1417  
Description: Typical exterior of housing unit, note water damaged CMU.

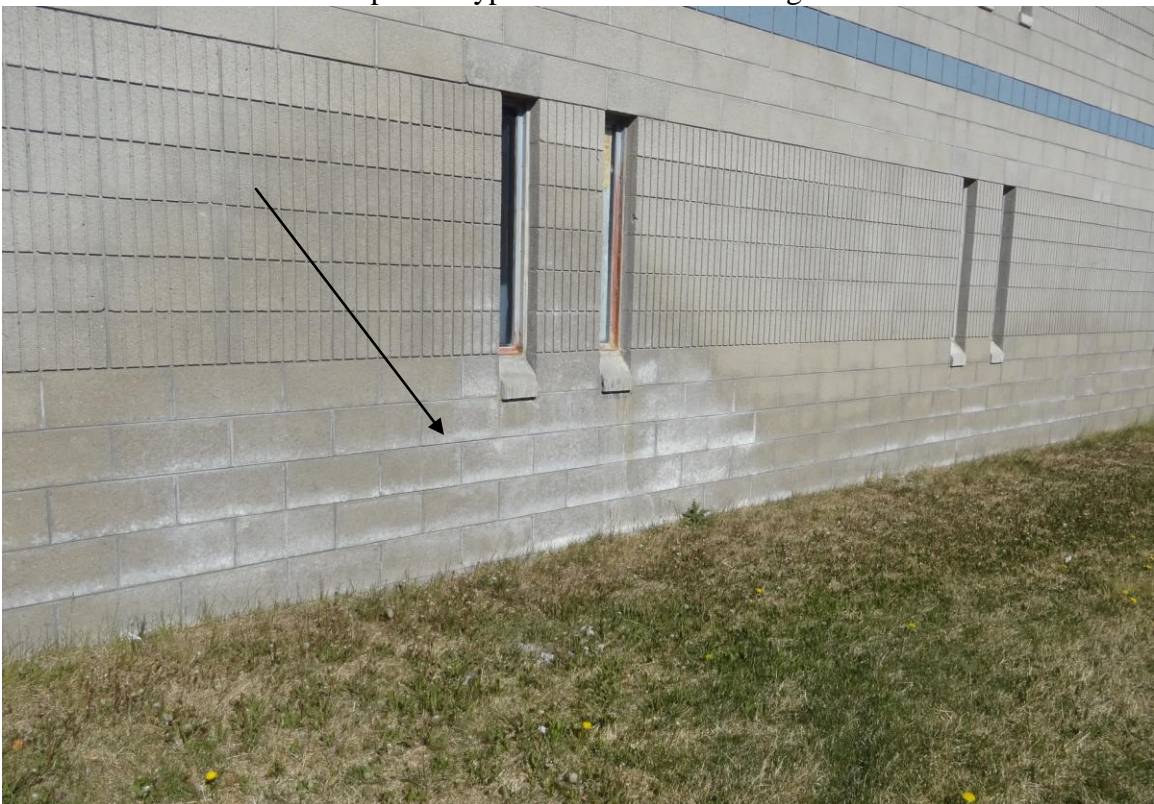
Housing Unit #7 – FCA Building #1421  
Description: Typical exterior of housing unit, note water damaged CMU.

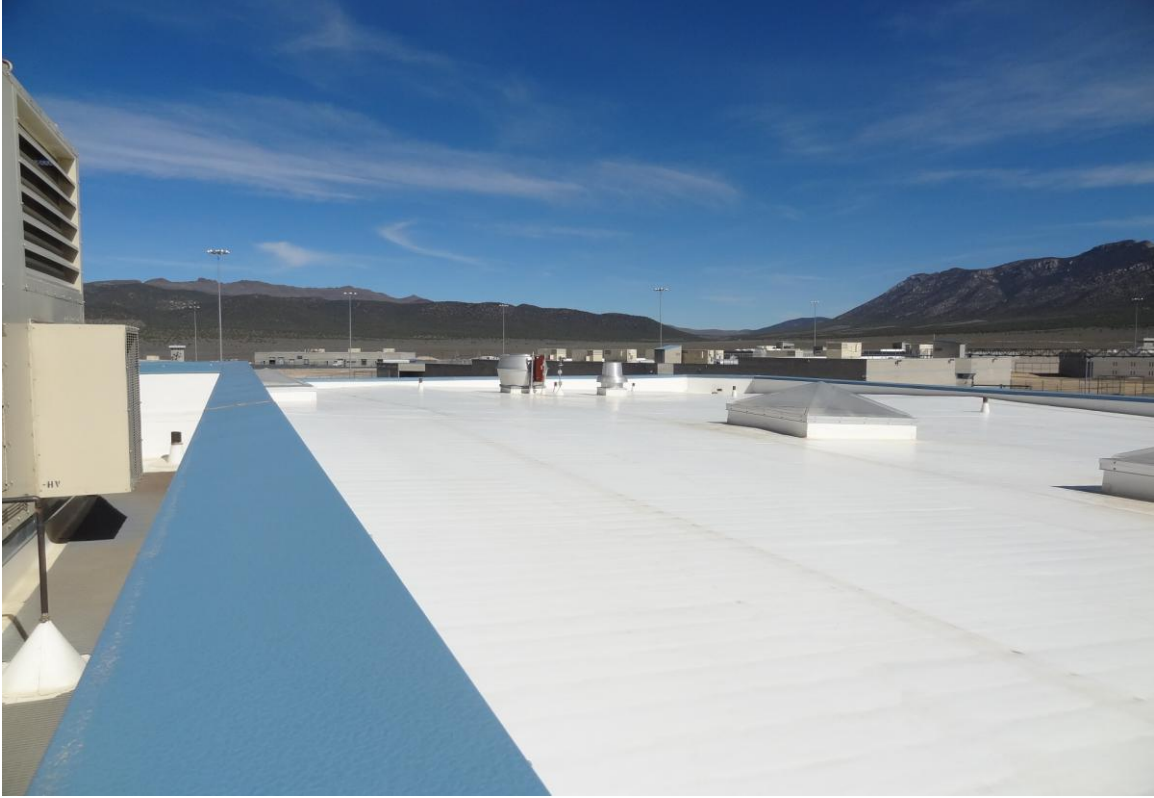
Housing Unit #8 – FCA Building #1422  
Description: Roof of HU #8, typical of all housing units.

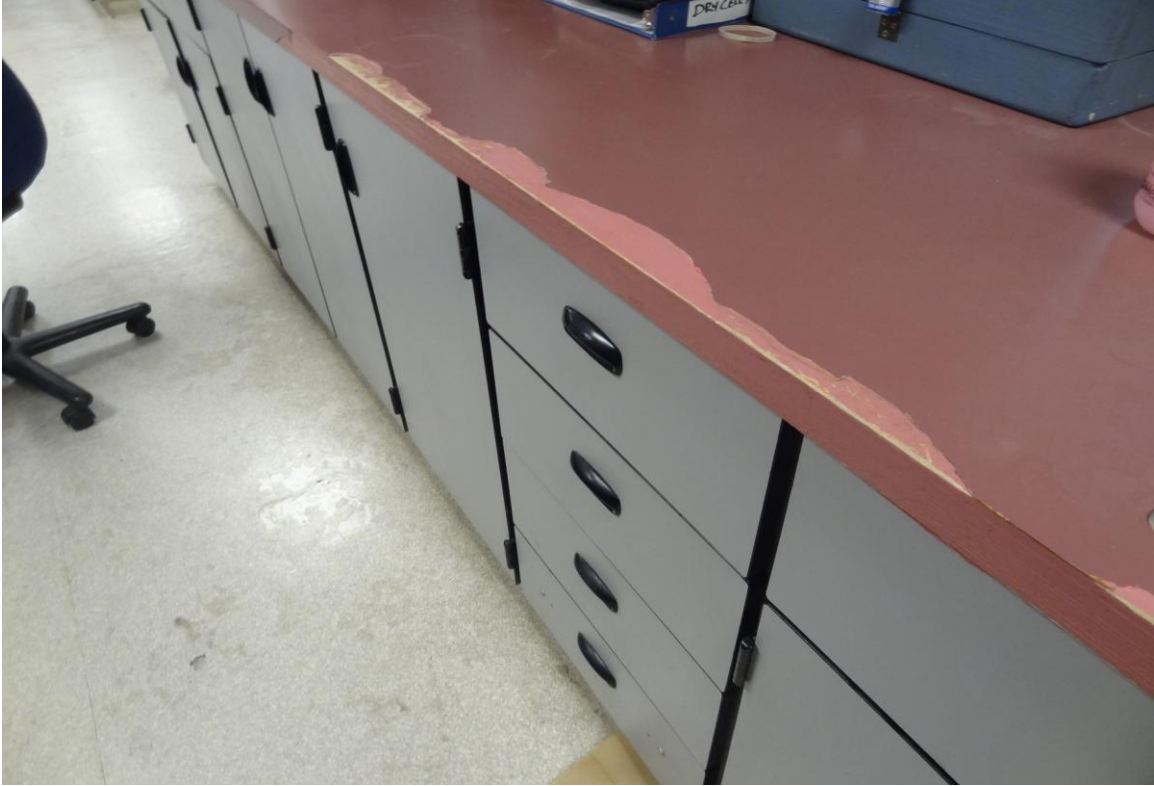
Building #9 Scheduled Services – FCA Building #1423  
Description: Damaged laminate countertops, typical throughout.

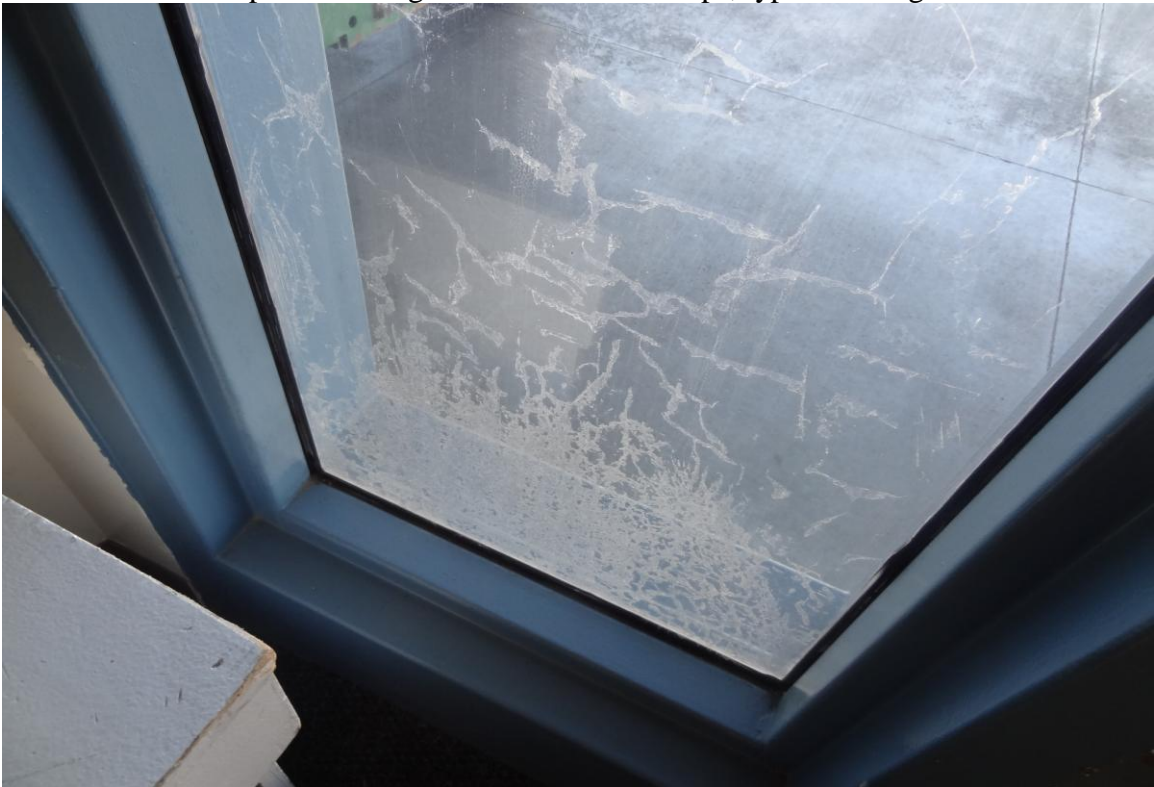
Building #9 Scheduled Services – FCA Building #1423  
Description: Damaged glazing panel.

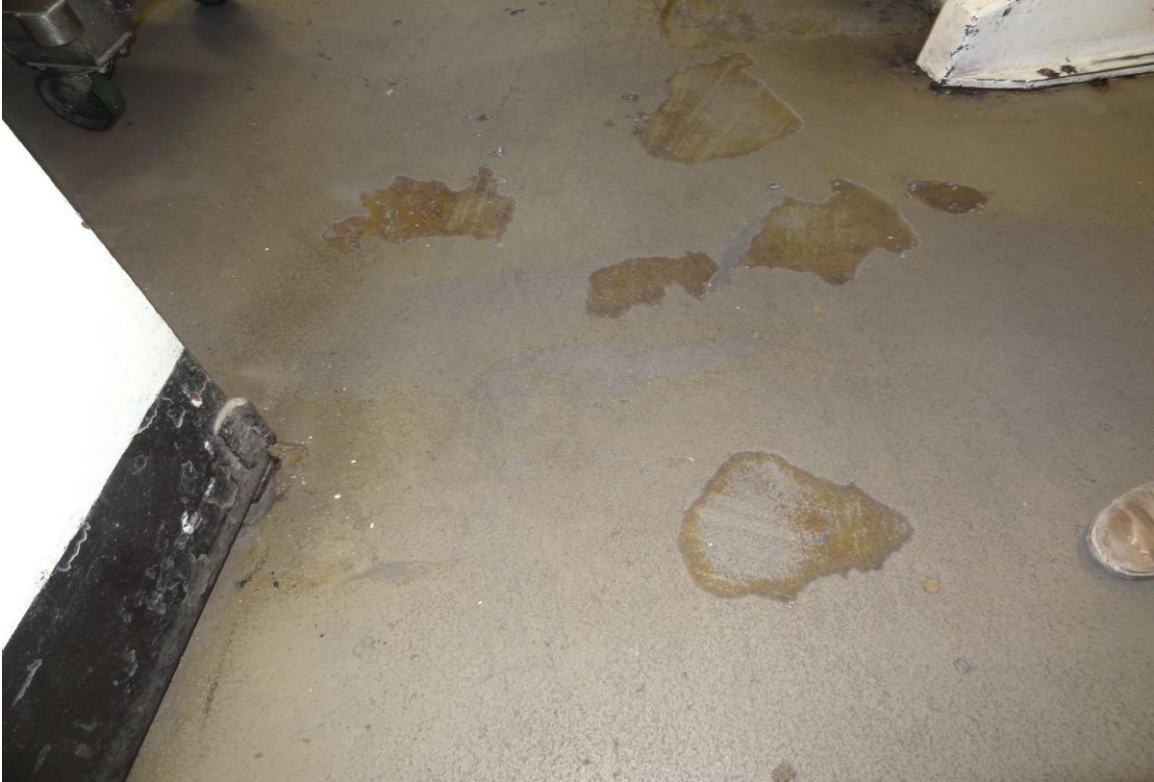
Building #10 Work & Recreation – FCA Building #1424  
Description: Culinary floor damage.

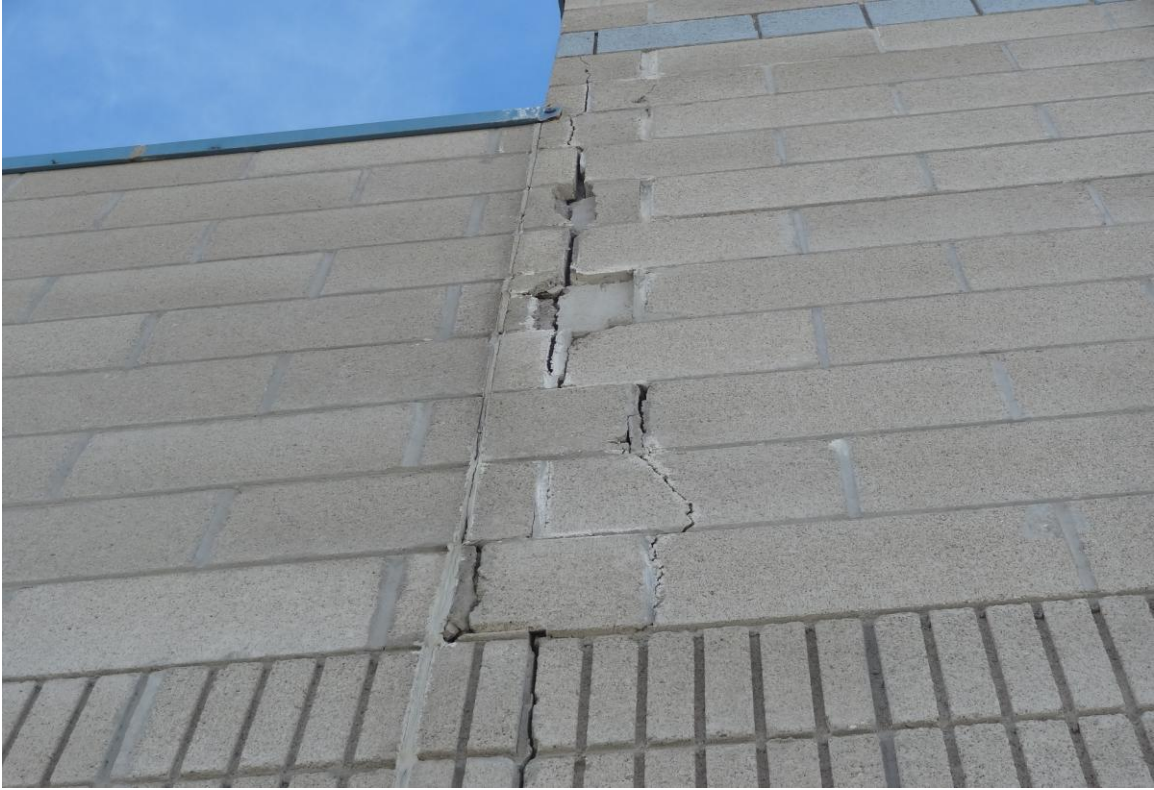
Building #10 Work & Recreation – FCA Building #1424  
Description: Damaged CMU wall.

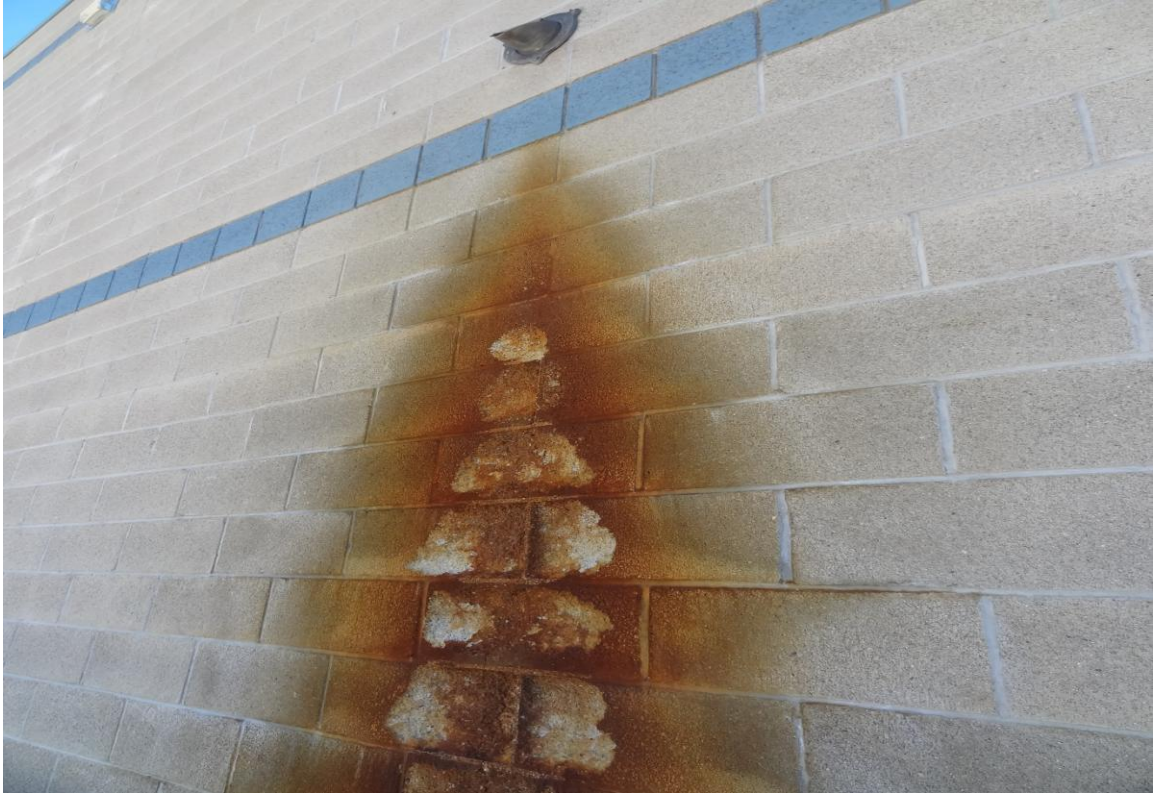
**Building #11 Warehouse / Central Plant – FCA Building #1425**  
Description: Water damage to the exterior of the building.

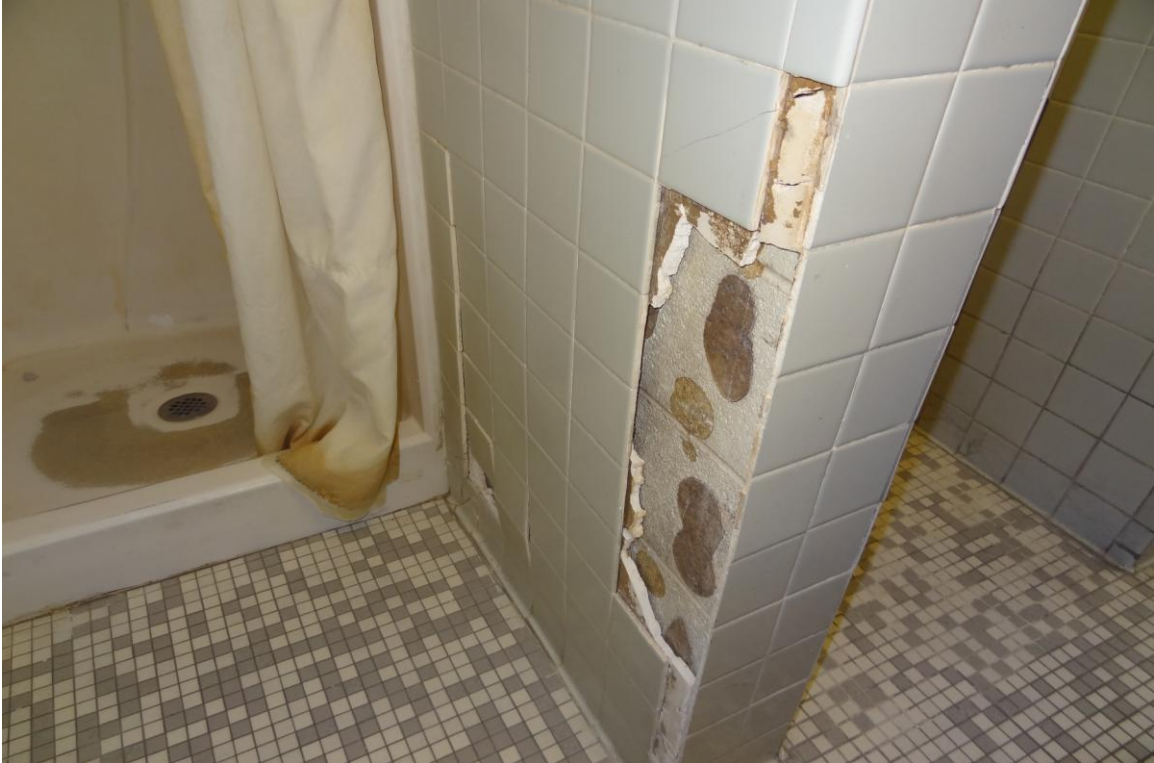
**Building #12 Trustee Dormitory – FCA Building #1426**  
Description: Damaged tile in shower area.
