DEPARTMENT OF ADMINISTRATION
STATE PUBLIC WORKS DIVISION
FACILITY CONDITION ASSESSMENT

PROPERTY PORTFOLIO REVIEW PROJECT ADDENDUM

NORTHEAST REGION
ELY STATE PRISON COMPLEX
9941 - ELY STATE PRISON SITE
4569 N STATE ROUTE 490
ELY, NV 89301-
WHITE PINE COUNTY

SURVEY DATE: 04/23/2024

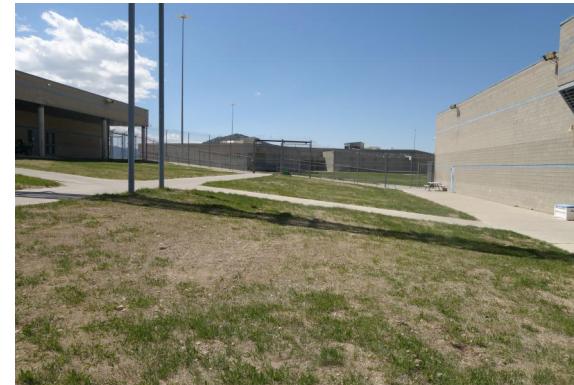
9941-SIT-9: SIDEWALK REPLACEMENT

The campus includes a network of concrete pedestrian pathways, including accessible routes to each building. However, many sections have deteriorated or settled over time, resulting in noncompliant slopes and trip hazards. Additionally, ADA-compliant parking and accessible routes to public entrances are limited. This project proposes the replacement of damaged sidewalks, incorporating all necessary accessibility upgrades in accordance with a professionally developed, sitewide accessibility plan. The construction estimate is based on an assumed area of 20,000 square feet.

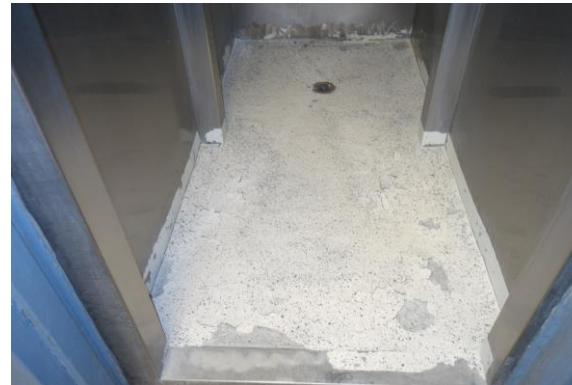
NEW BUILDING INTERIOR - 10/24/2025 1417-INT-2: OFFENDER SHOWER REPLACEMENT

The existing showers, original to the facility and nearly 40 years old, have inadequately supported steel pans that have sagged over time, causing leaks into adjacent areas and ongoing maintenance issues. Complete demolition and replacement are recommended with new stainless-steel shower stalls designed to meet Prison Rape Elimination Act (PREA) standards, including individual shower gate doors with electronic locks to improve safety, security, and hygiene.

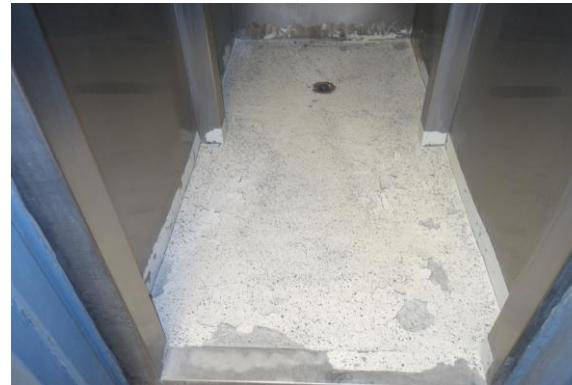
NEW BUILDING INTERIOR - 10/24/2025 1420-INT-2: OFFENDER SHOWER REPLACEMENT

The existing showers, original to the facility and nearly 40 years old, have inadequately supported steel pans that have sagged over time, causing leaks into adjacent areas and ongoing maintenance issues. Complete demolition and replacement are recommended with new stainless-steel shower stalls designed to meet Prison Rape Elimination Act (PREA) standards, including individual shower gate doors with electronic locks to improve safety, security, and hygiene.

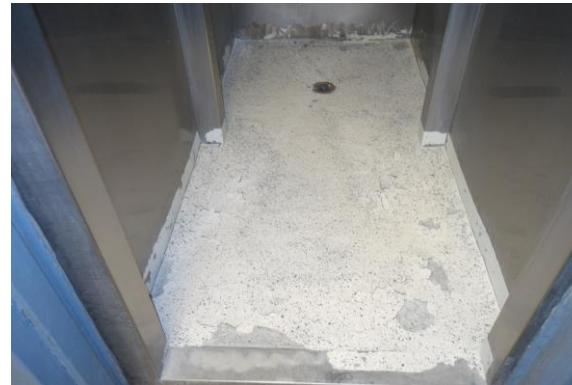
NEW BUILDING INTERIOR - 10/24/2025 1419-INT-2: OFFENDER SHOWER REPLACEMENT

The existing showers, original to the facility and nearly 40 years old, have inadequately supported steel pans that have sagged over time, causing leaks into adjacent areas and ongoing maintenance issues. Complete demolition and replacement are recommended with new stainless-steel shower stalls designed to meet Prison Rape Elimination Act (PREA) standards, including individual shower gate doors with electronic locks to improve safety, security, and hygiene.

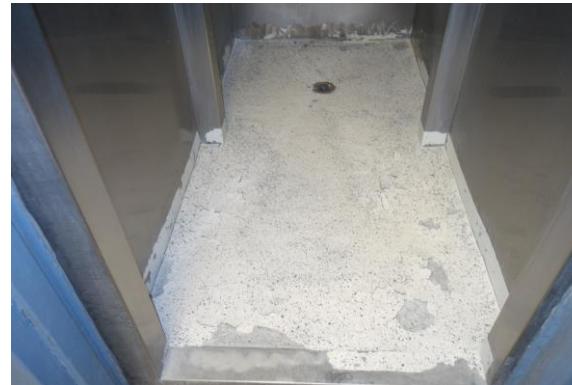
NEW BUILDING INTERIOR - 10/24/2025 1418-INT-2: OFFENDER SHOWER REPLACEMENT

The existing showers, original to the facility and nearly 40 years old, have inadequately supported steel pans that have sagged over time, causing leaks into adjacent areas and ongoing maintenance issues. Complete demolition and replacement are recommended with new stainless-steel shower stalls designed to meet Prison Rape Elimination Act (PREA) standards, including individual shower gate doors with electronic locks to improve safety, security, and hygiene.

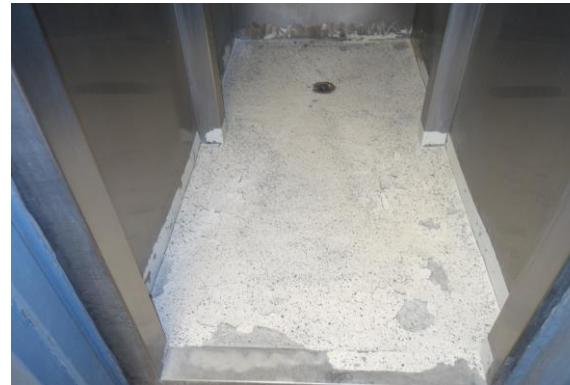
NEW BUILDING INTERIOR - 10/24/2025 1421-INT-2: OFFENDER SHOWER REPLACEMENT

The existing showers, original to the facility and nearly 40 years old, have inadequately supported steel pans that have sagged over time, causing leaks into adjacent areas and ongoing maintenance issues. Complete demolition and replacement are recommended with new stainless-steel shower stalls designed to meet Prison Rape Elimination Act (PREA) standards, including individual shower gate doors with electronic locks to improve safety, security, and hygiene.

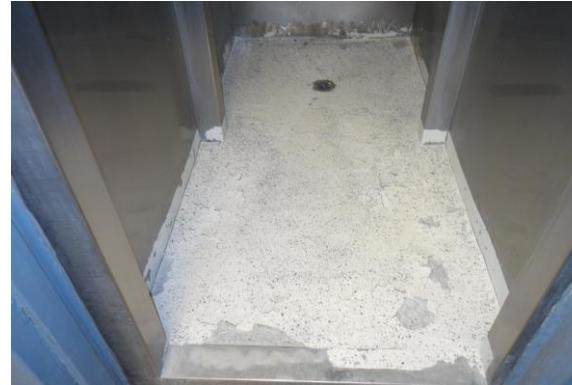
NEW BUILDING INTERIOR - 10/24/2025 0699-INT-2: OFFENDER SHOWER REPLACEMENT

The existing showers, original to the facility and nearly 40 years old, have inadequately supported steel pans that have sagged over time, causing leaks into adjacent areas and ongoing maintenance issues. Complete demolition and replacement are recommended with new stainless-steel shower stalls designed to meet Prison Rape Elimination Act (PREA) standards, including individual shower gate doors with electronic locks to improve safety, security, and hygiene.

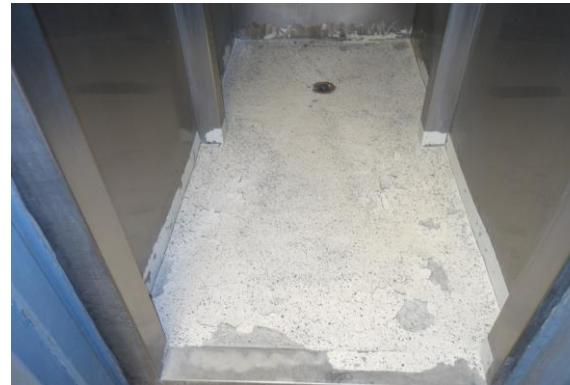
NEW BUILDING INTERIOR - 10/24/2025 0123-INT-2: OFFENDER SHOWER REPLACEMENT

The existing showers, original to the facility and nearly 40 years old, have inadequately supported steel pans that have sagged over time, causing leaks into adjacent areas and ongoing maintenance issues. Complete demolition and replacement are recommended with new stainless-steel shower stalls designed to meet Prison Rape Elimination Act (PREA) standards, including individual shower gate doors with electronic locks to improve safety, security, and hygiene.

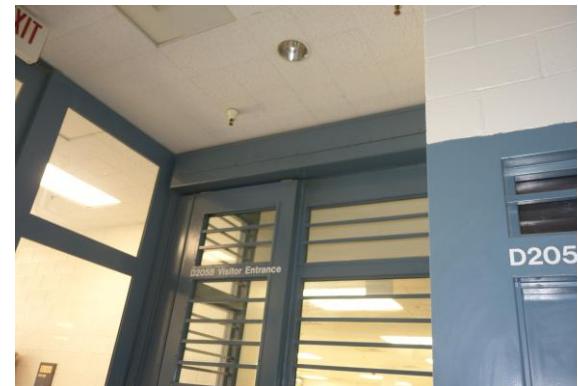
1423-INT-8: SALLY PORT DOORS & CONTROLS REPLACEMENT

The Sallyport doors are original and approaching 40 years old. They are a main point of personnel traffic in and out of the prison and heavily used. Door tracks are worn and replacement parts are difficult to source. This project will design and construct replacement door motors, tracks and controls.

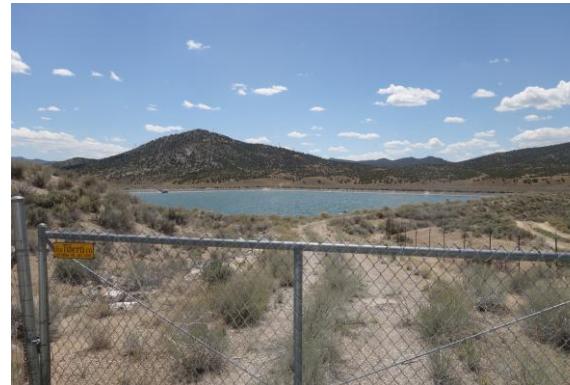
9941-ENV-3: WASTEWATER TREATMENT REPAIRS

The waste water treatment systems is approaching 40 years old and in need of upgrades. One of the retention pond liners is torn and aerator inoperable reducing the capacity and redundancy of the plant. Sewage treatment equipment is also original and reaching the end of life. This project will replace the aerators and pond liners.

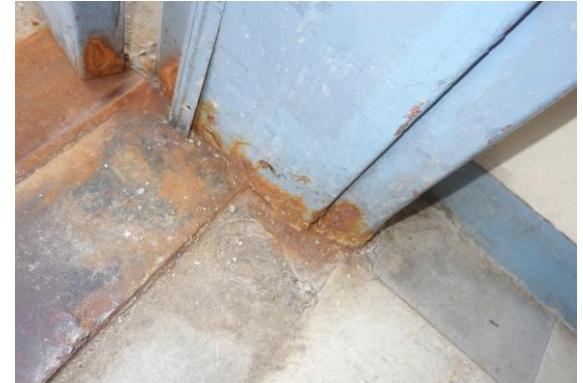
1428-SEC-1: SALLY PORT DOORS & CONTROLS REPLACEMENT

The Sallyport doors are original and approaching 40 years old. They are a main point of personnel traffic in and out of the prison and heavily used. Door are worn and replacement parts are difficult to source. This project will design and construct replacement doors and controls.

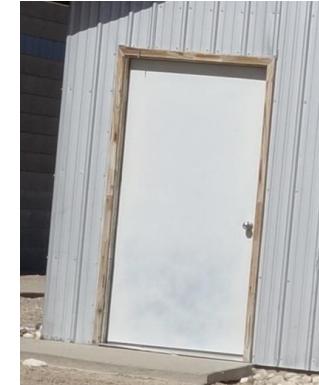
REINSTATED BUILDING EXTERIOR - 10/29/2025 2242-EXT-3: EXTERIOR DOOR REPLACEMENT

The existing exterior door is hung on a wood jamb with wood trim that weathers and creates additional maintenance. The project recommends the removal and replacement of the exterior door with a metal door system suitable for a pre-engineered metal building which provides a prefinished metal door & jamb system that requires no maintenance.
