# WARD CHARCOAL OVENS STATE HISTORIC PARK

Site Number: 9942 STATE OF NEVADA PUBLIC WORKS DIVISION FACILITY CONDITION ANALYSIS

Report distributed in May 2021

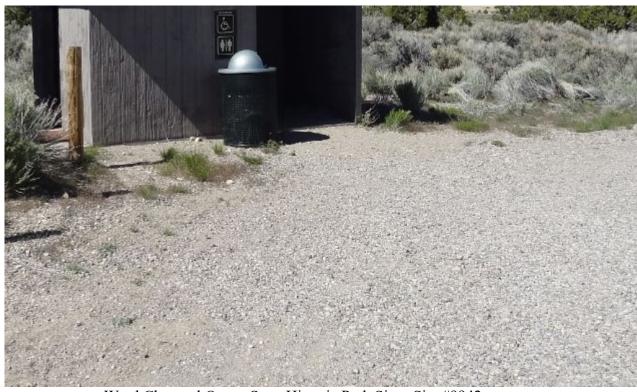
Ward Charcoal Ovens State Historic Park Site - Site #9942 Description: ADA Upgrades Day Use CXT.

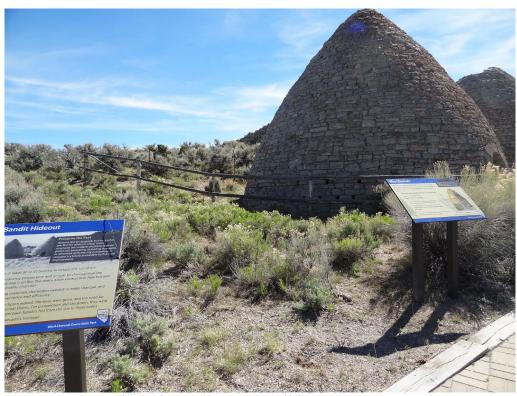
The structure is made of unreinforced stone masonry. It is over 100 years old and there are numerous areas where the mortar is failing, missing and not sealed properly. This is also an exhibit for the park and requires maintenance time to display the artifacts and maintain the signage. This project would provide for the cleaning, repair and re-pointing of the stone work and maintaining the exhibit. This project should be coordinated with the Nevada State Historical Preservation Office for possible restrictions or requirements which are not included in this estimate. It is recommended that the work be done in the next 2-3 years and that this project be scheduled on a cyclical basis to maintain the integrity of the structure.

Typical Charcoal Ovens - Buildings #2279 - #2274 Description: Exterior of the Structure.

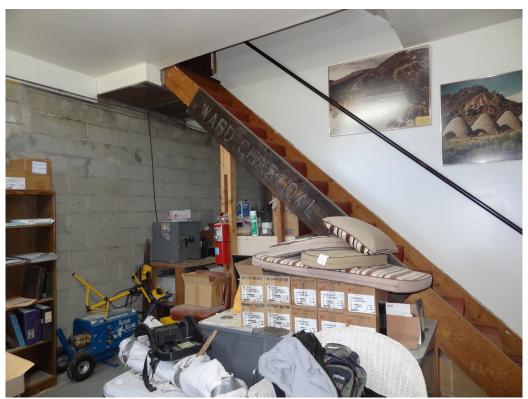
The stairs and handrails between the first floor and the basement do not meet the sections 1009 and 1012 requirements of the 2018 IBC. This project would provide for the rebuilding of the stairway to provide for a code compliant stairway. This project or a portion thereof was previously recommended in the FCA report dated 09/29/2009. It has been amended accordingly to reflect conditions observed during the most recent survey date of 07/11/2017.

Ranger Residence - Building #2270
Description: Interior Stair Replacement.

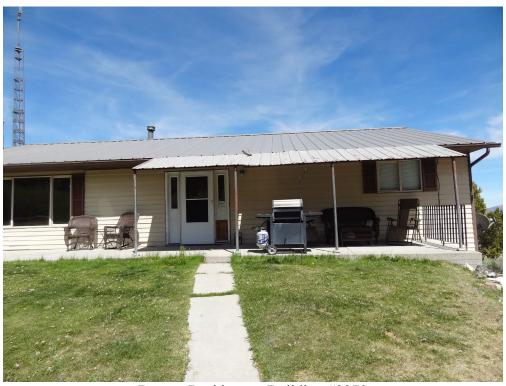
There is a metal awning attached to the roof on the west side of the building near the front door. The main structure was not designed to carry this additional lateral load and the awning structure itself is not in good condition. It is recommended to remove and dispose of the structure. Included in the estimate is removing and disposing of the awning as well as patching the roof and concrete patio where attachments were made.

Ranger Residence - Building #2270 Description: Remove Awning.
