State of Nevada  
Department of Conservation and Natural Resources  
Division of State Parks  
Facility Condition Analysis

# SPRING VALLEY STATE PARK

**Site Number: 9943**  
**STATE OF NEVADA PUBLIC WORKS DIVISION**  
**FACILITY CONDITION ANALYSIS**

Report distributed in April 2017

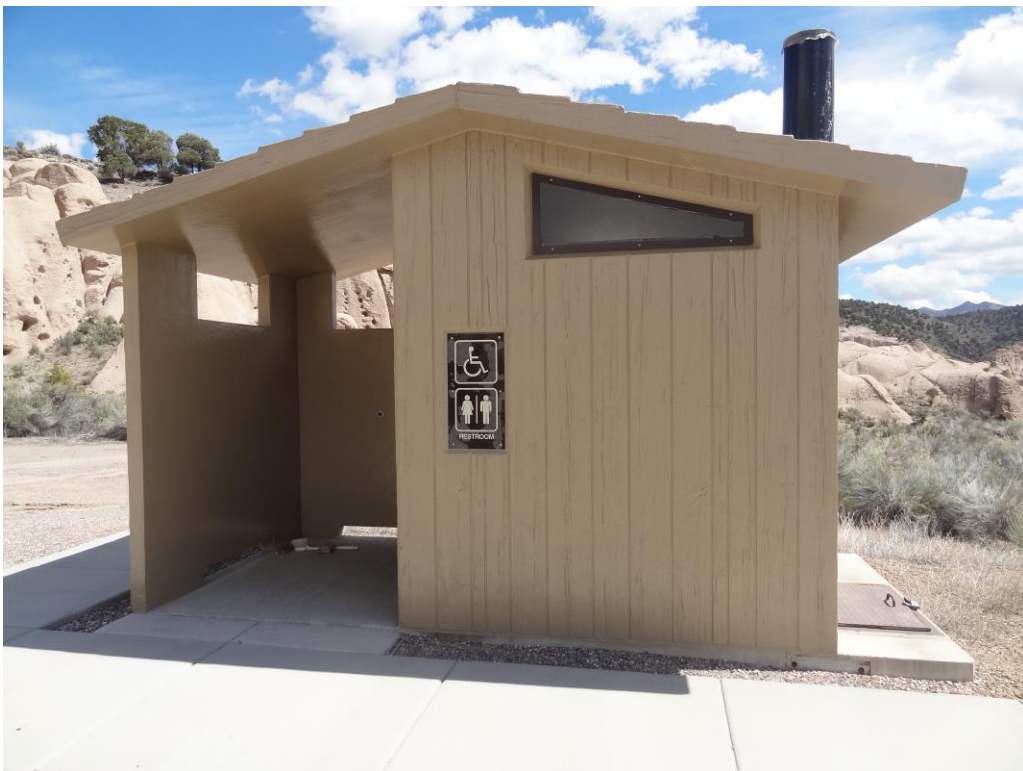
CXT Comfort Station #2 - Building #3726  
Description: Exterior elevation.

It is important to maintain the finish, weather resistance and appearance of the building. This project would provide funding to protect the interior and exterior of the building. Included in the cost are cleaning and sealing the precast concrete and caulking of the windows, flashing, fixtures and all other penetrations. An epoxy paint is recommended on the interior precast concrete. It is recommended that the building be sealed and caulked in the next 4-5 years and for this project to be scheduled on a cyclical basis to maintain the integrity of the structure.

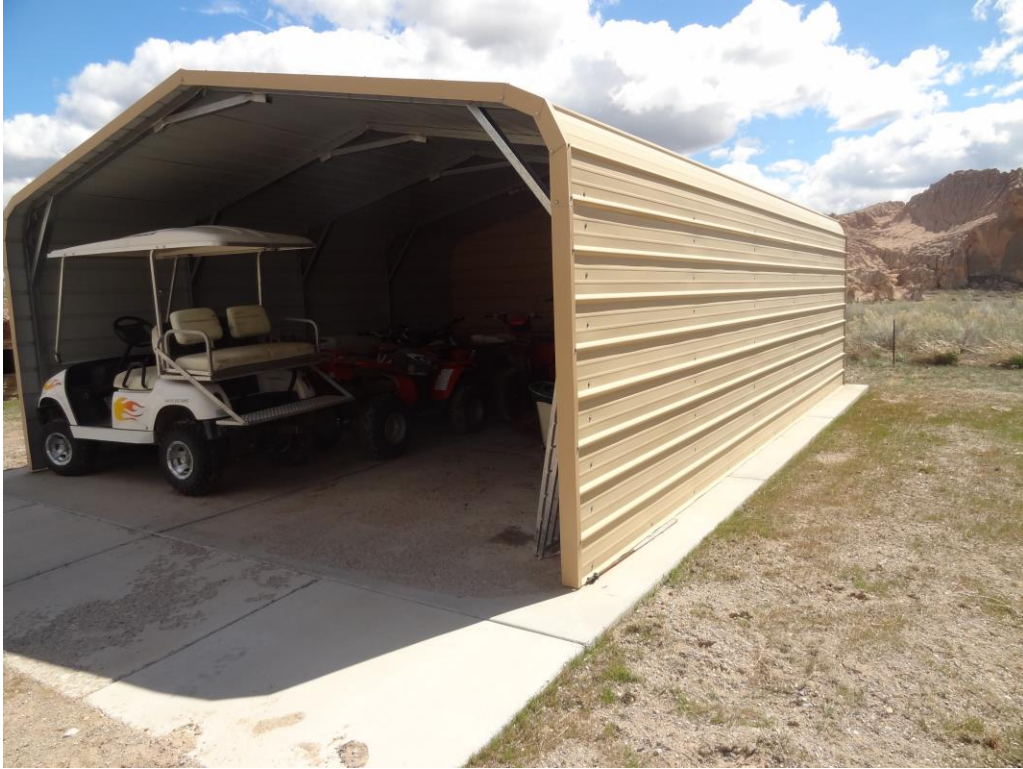
Park Headquarters Carport - Building #2920  
Description: Exterior elevation.

It is important to maintain the finish, weather resistance and appearance of the structure. This project recommends work to protect the exterior building envelope, other than the roof including sealing and caulking around penetrations to maintain the building in good, weather tight condition. It is recommended that this project be scheduled on a cyclical basis to maintain the integrity of the structure.

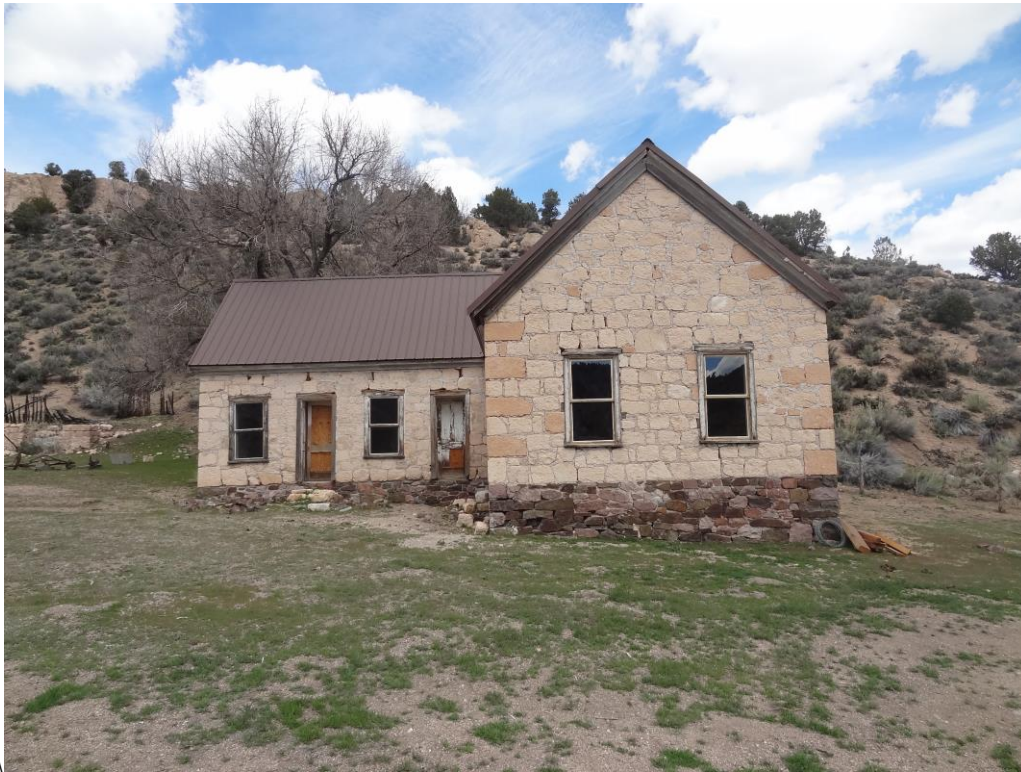
The structure is made of unreinforced stone masonry. It is over 100 years old and there are numerous areas where the mortar is failing, missing and not sealed properly. This is also an exhibit for the park and requires maintenance time to display the artifacts and maintain the signage. This project would provide for the cleaning, repair and re-pointing of the stone work and maintaining the exhibit. This project should be coordinated with the Nevada State Historical Preservation Office for possible restrictions or requirements which are not included in this estimate. It is recommended that the work be done in the next 2-3 years and that this project be scheduled on a cyclical basis to maintain the integrity of the structure.

Hammond Cabin - Building #2267  
Description: Exterior elevation.

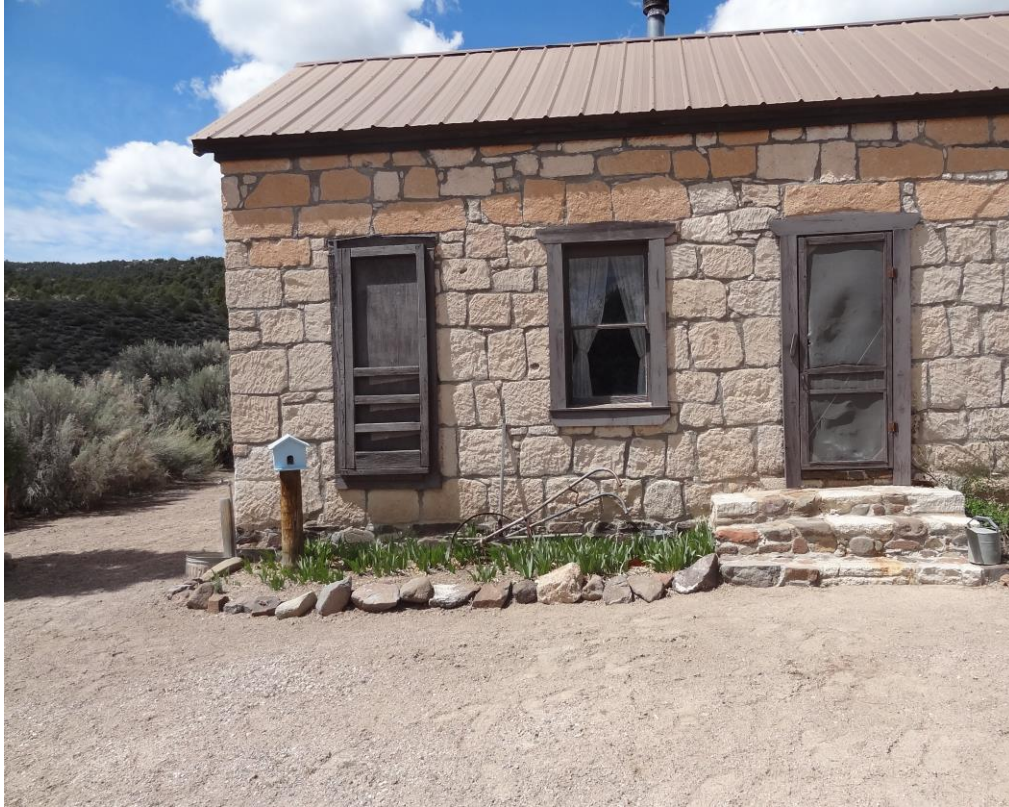
The site has a drainage problem around the Historic Stone Cabin where the grade does not properly slope away from the building. The rain accumulates in several areas adjacent to the building creating a water problem which may infiltrate the interior during inclement weather. This standing water also causes premature deterioration of the landscape improvements. This project would provide for a site survey and drainage report to be completed by a licensed professional and for that work to be performed by a licensed contractor.

The structure is made of unreinforced stone masonry. It is over 100 years old and there are numerous areas where the mortar is failing, missing and not sealed properly. This is also an exhibit for the park and requires maintenance time to display the artifacts and maintain the signage. This project would provide for the cleaning, repair and re-pointing of the stone work and maintaining the exhibit. This project should be coordinated with the Nevada State Historical Preservation Office for possible restrictions or requirements which are not included in this estimate. It is recommended that the work be done in the next 2-3 years and that this project be scheduled on a cyclical basis to maintain the integrity of the structure.

Historic Stone Cabin - Building #2266  
Description: Exterior finishes.

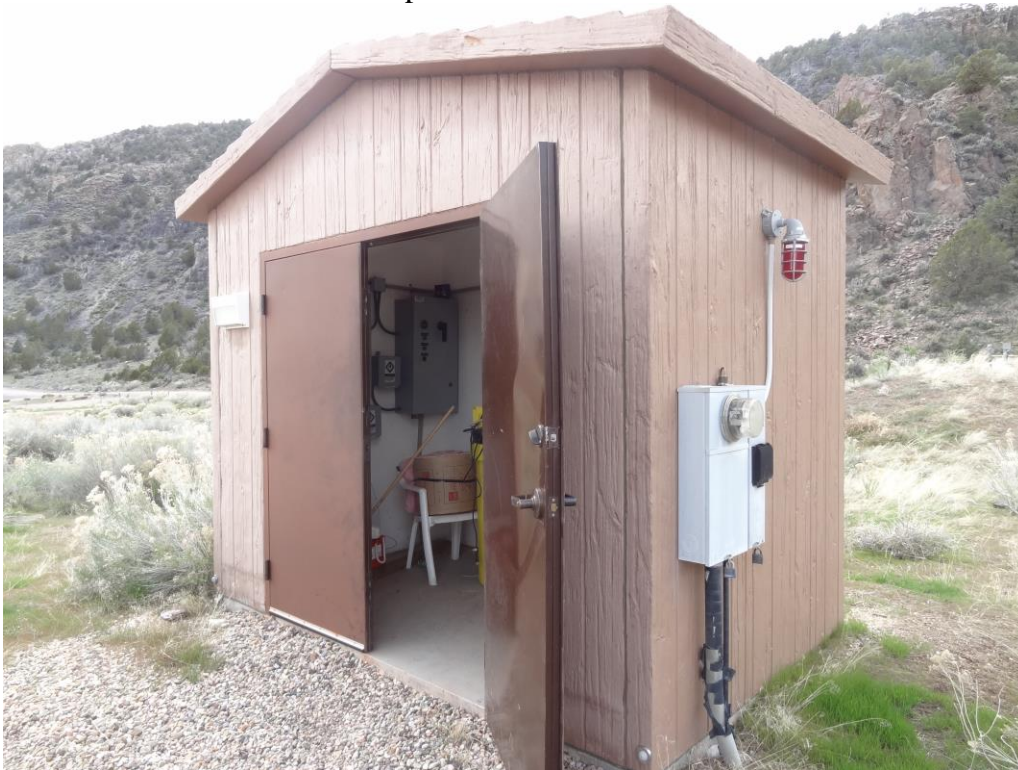
New Well/ Pump House - Building #2262  
Description: Exterior elevation.

It is important to maintain the finish, weather resistance and appearance of the building. This project would provide funding to protect the interior and exterior of the building. Included in the cost are cleaning and sealing the precast concrete and caulking of the windows, flashing, fixtures and all other penetrations. An epoxy paint is recommended on the interior precast concrete. It is recommended that the building be sealed and caulked in the next 4-5 years and for this project to be scheduled on a cyclical basis to maintain the integrity of the structure.

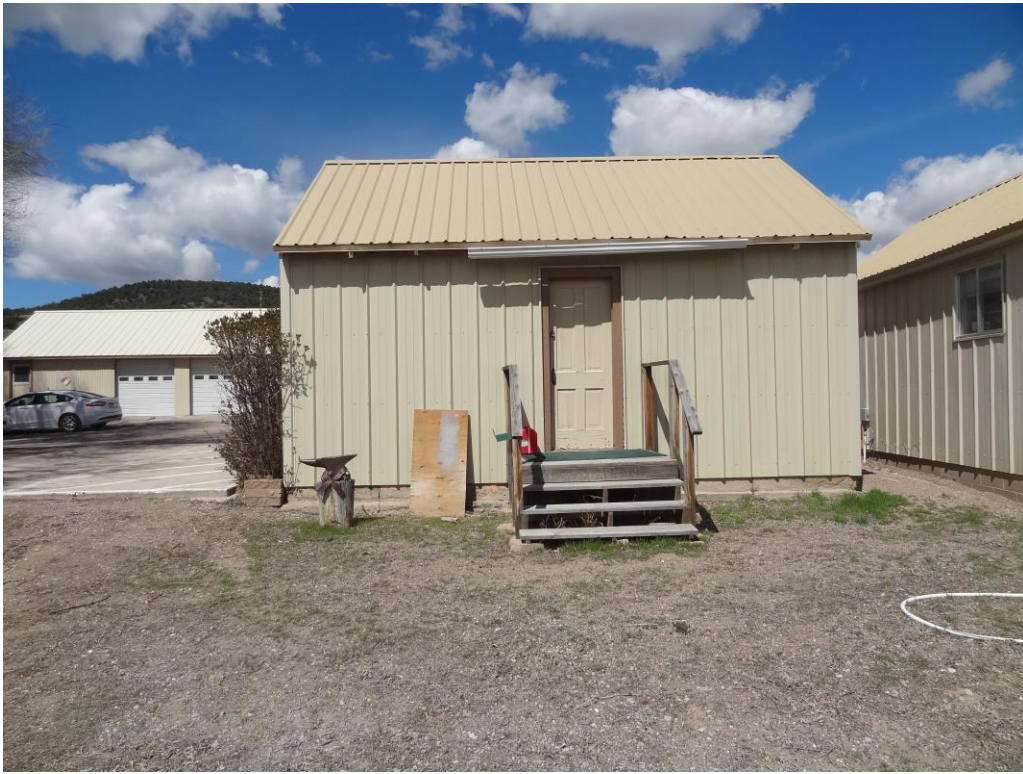
Park Headquarters Supply Room - Building #1220  
Description: Exterior finishes.

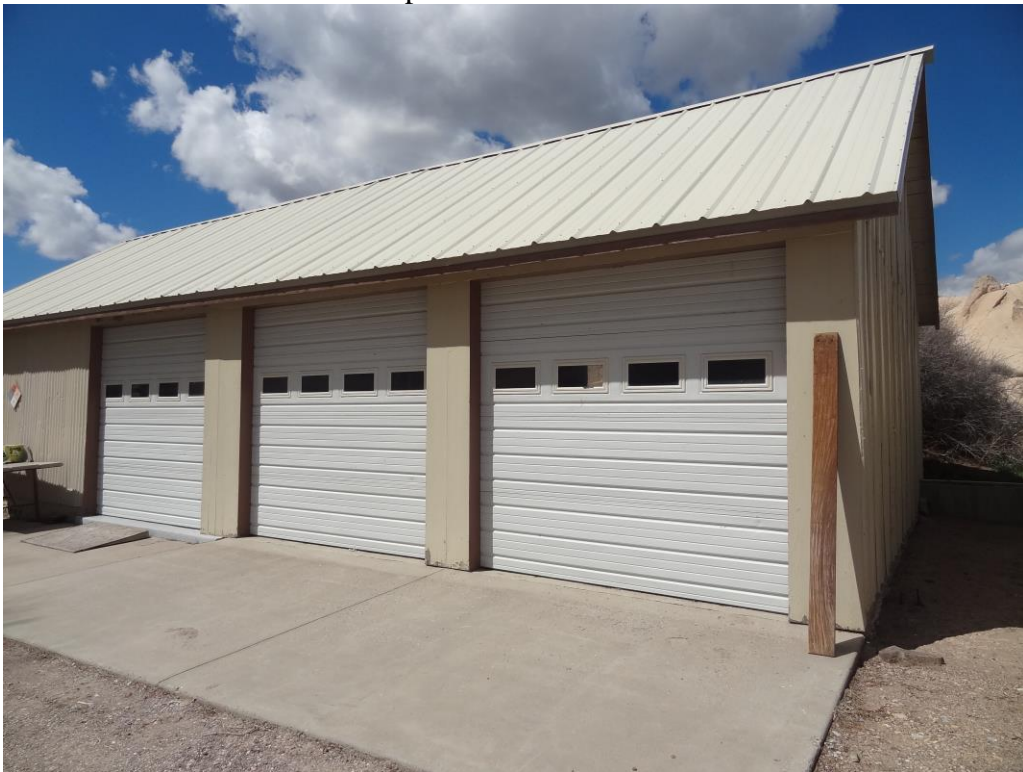
Park Headquarters Shop/ Garage - Building #1218  
Description: Exterior finishes.

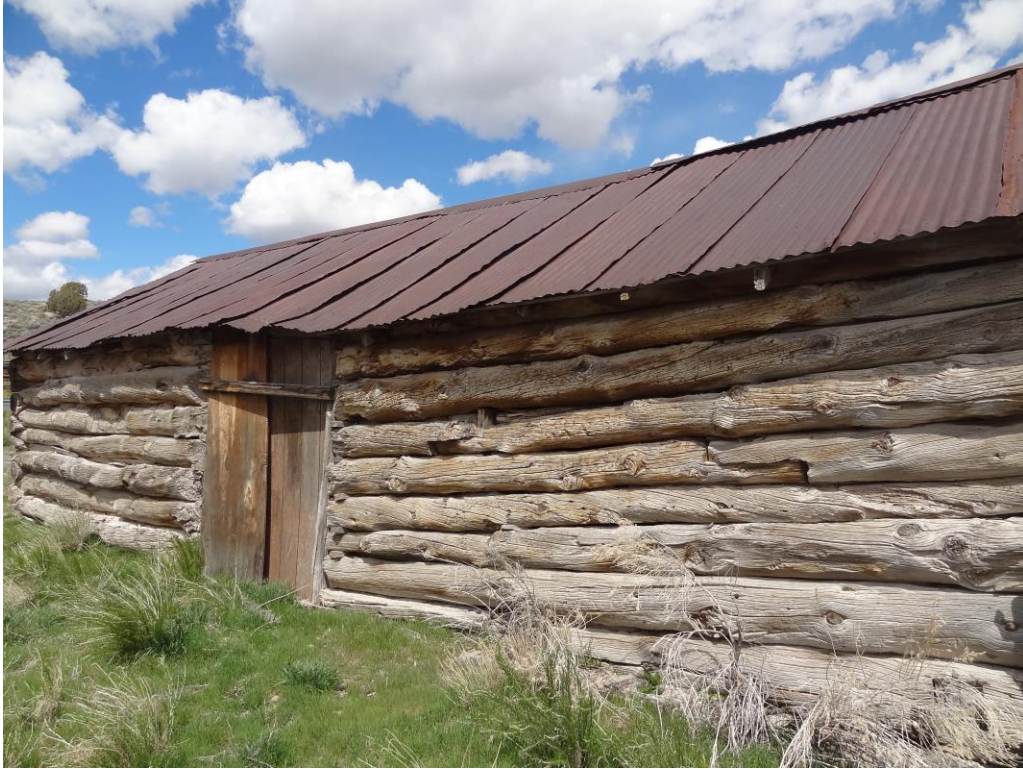
Timber Horse Barn - Building #1180  
Description: Exterior finishes.

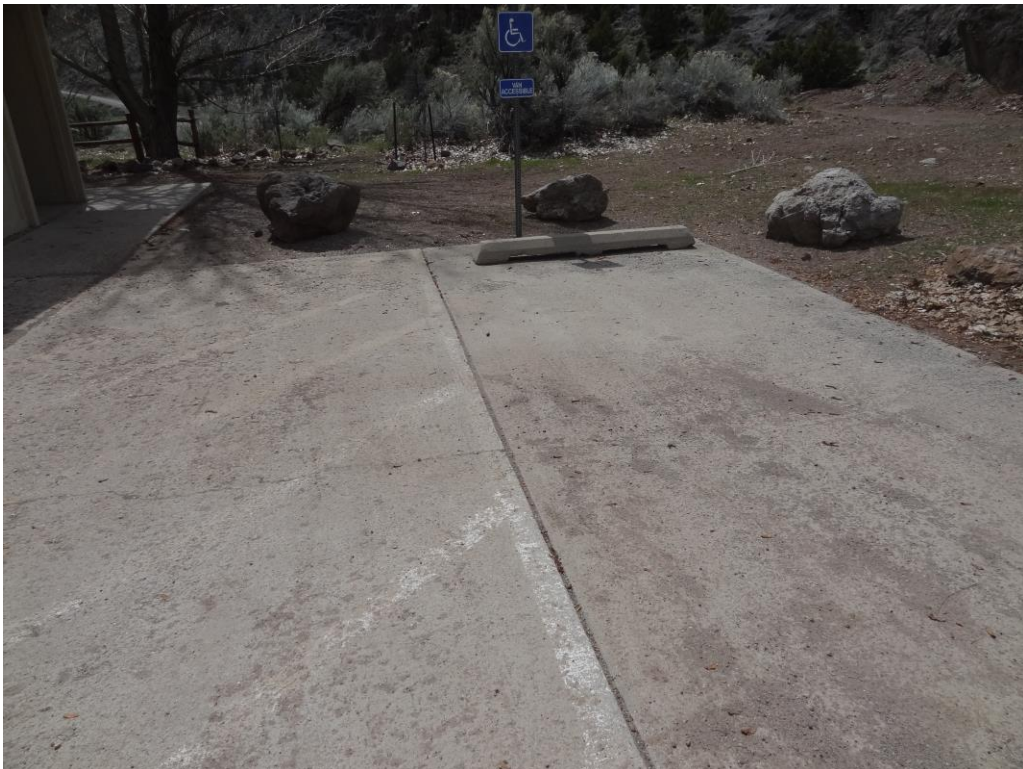
Comfort Station #1 - Building #1177  
Description: Deteriorated and non-compliant ADA Parking Space.

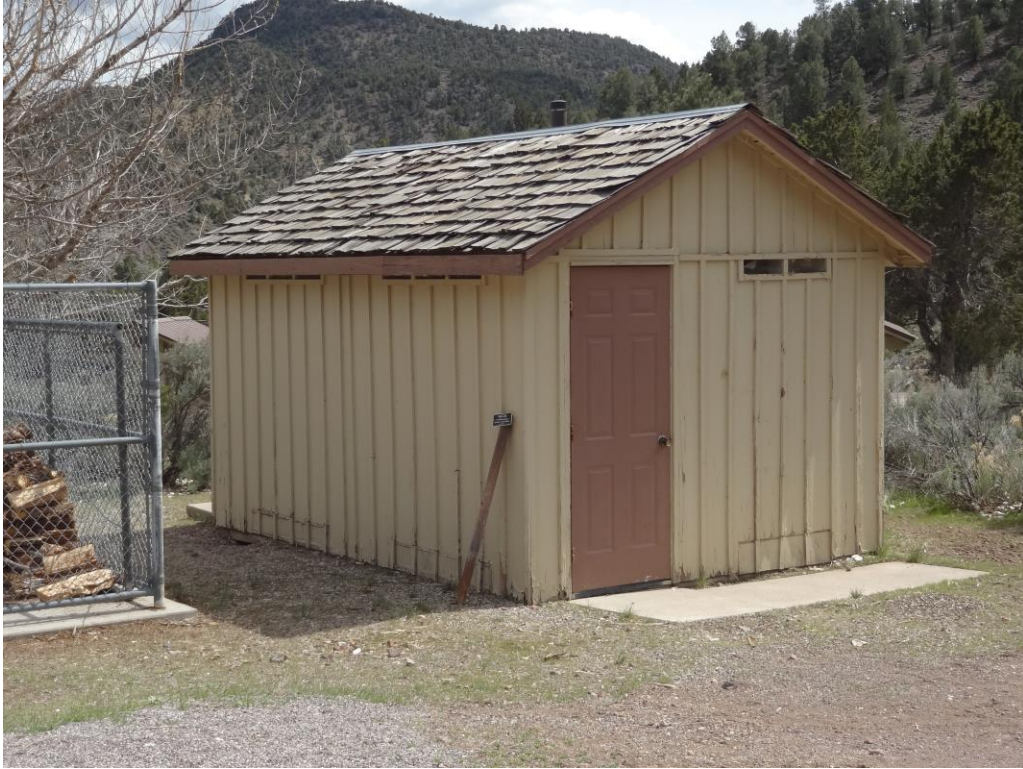
Campground Storage #1 - Building #0528  
Description: Exterior finishes.

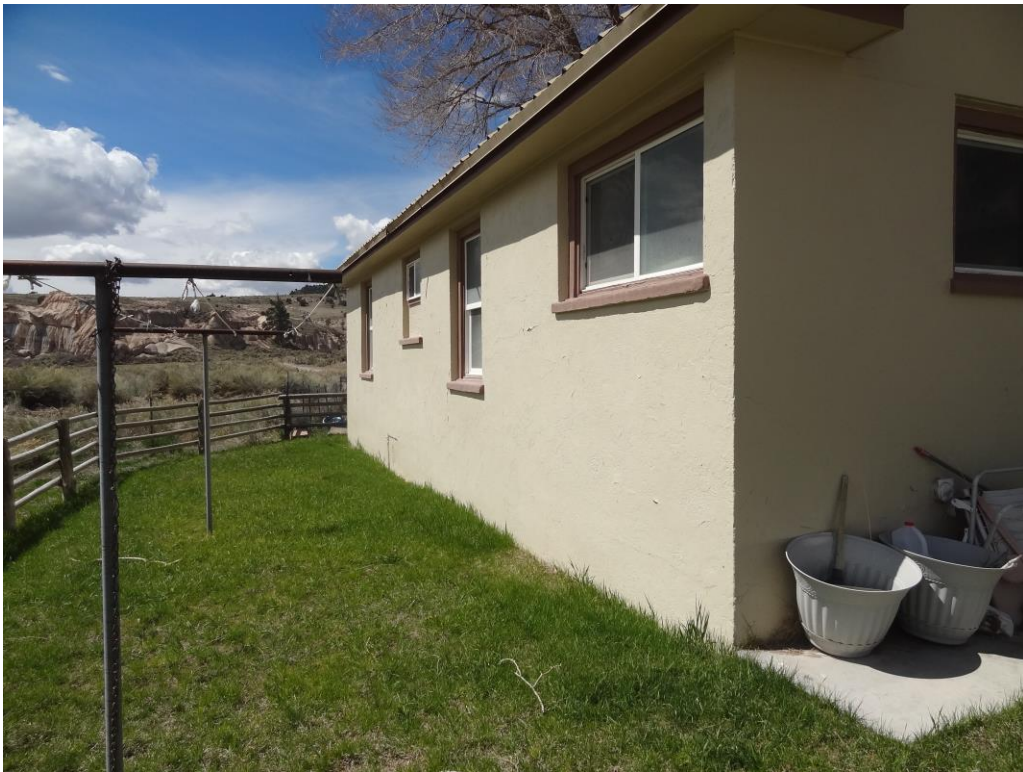
Park Ranger Residence - Building #0525  
Description: Exterior finishes.
