State of Nevada
Department of Conservation and Natural Resources
Division of State Parks
Facility Condition Analysis

ECHO CANYON STATE PARK

Site Number: 9945
STATE OF NEVADA PUBLIC WORKS DIVISION
FACILITY CONDITION ANALYSIS

Report distributed in April 2017

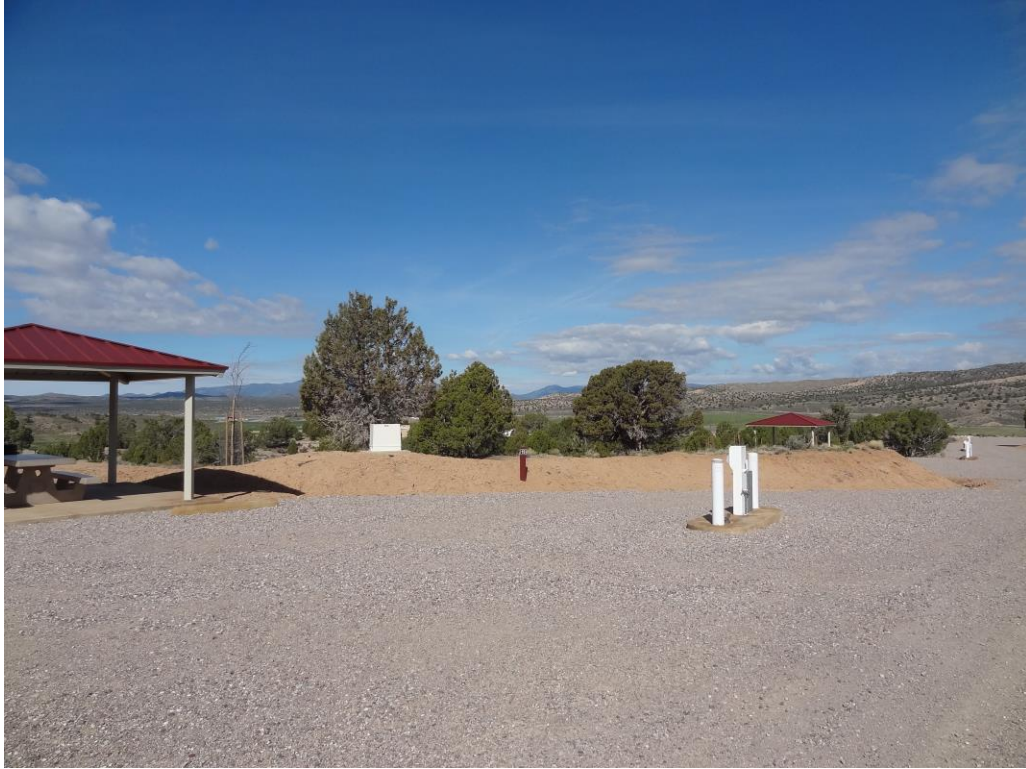
Echo Canyon State Park Site - Site #9945

Description: New campground with shade ramadas, utility hook-ups and a comfort station.

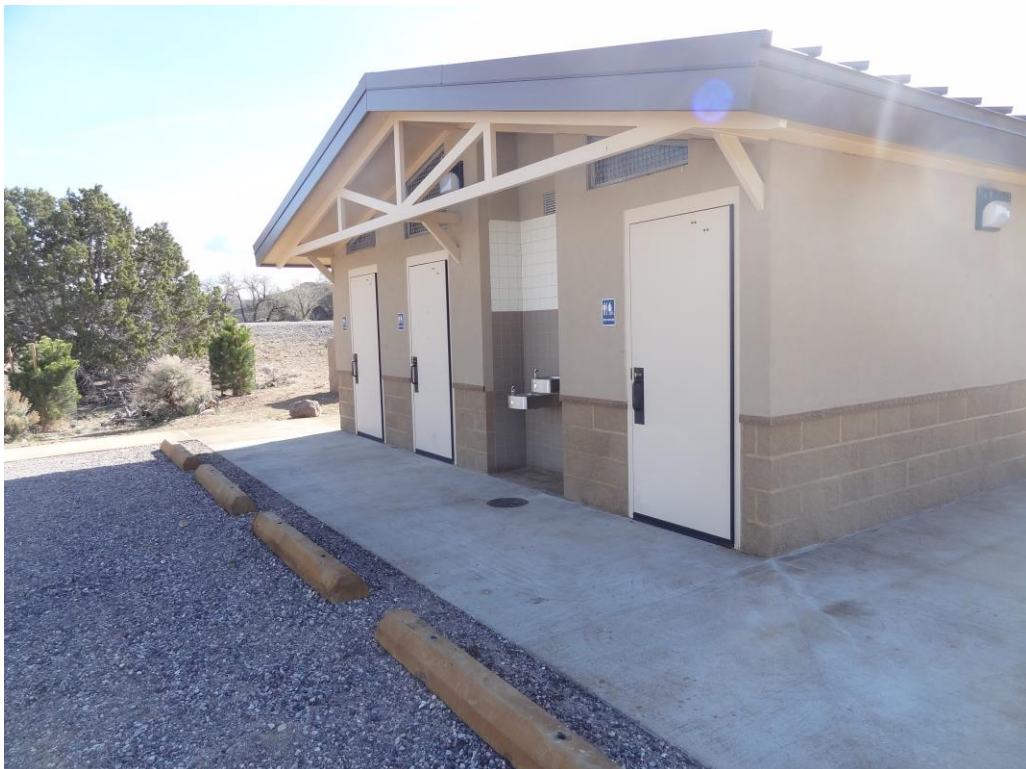
ADA CXT Comfort Station #1 – Building #3729

Description: Exterior finishes.

It is important to maintain the finish, weather resistance and appearance of the building. This project would provide funding to protect the interior and exterior of the building. Included in the cost are cleaning and sealing the precast concrete and caulking of the windows, flashing, fixtures and all other penetrations. An epoxy paint is recommended on the interior precast concrete. It is recommended that the building be sealed and caulked in the next 4-5 years and that this project be scheduled on a cyclical basis to maintain the integrity of the structure.

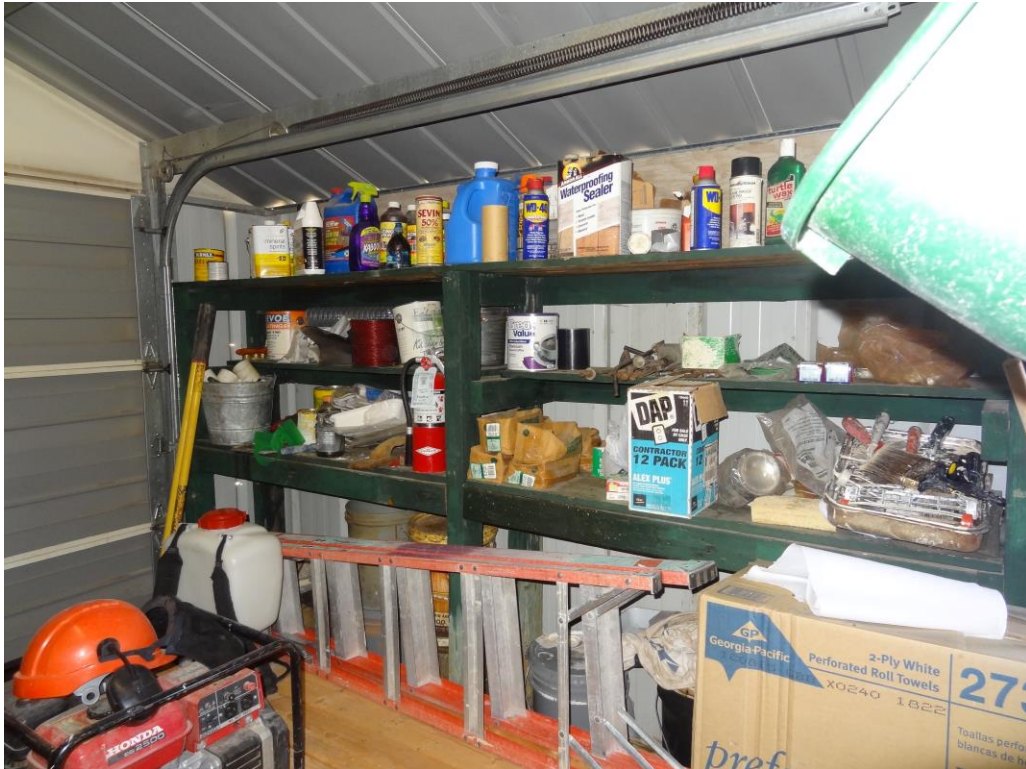
The building contains many different paints, stains, and other hazardous products located on open shelves and on the floor. This does not meet Occupational Safety and Health Administration (OSHA) standards or International Fire Code (IFC) for hazardous materials containment. This project would provide for a self-closing hazardous storage container in the building and the installation of placards on the building's exterior in accordance with OSHA 1910.106 (d) and IFC Chapter 57 Section 5704.3.2.1.3.

Park Residence Metal Shed #1 - Building #3727
Description: Safety cabinet needed.

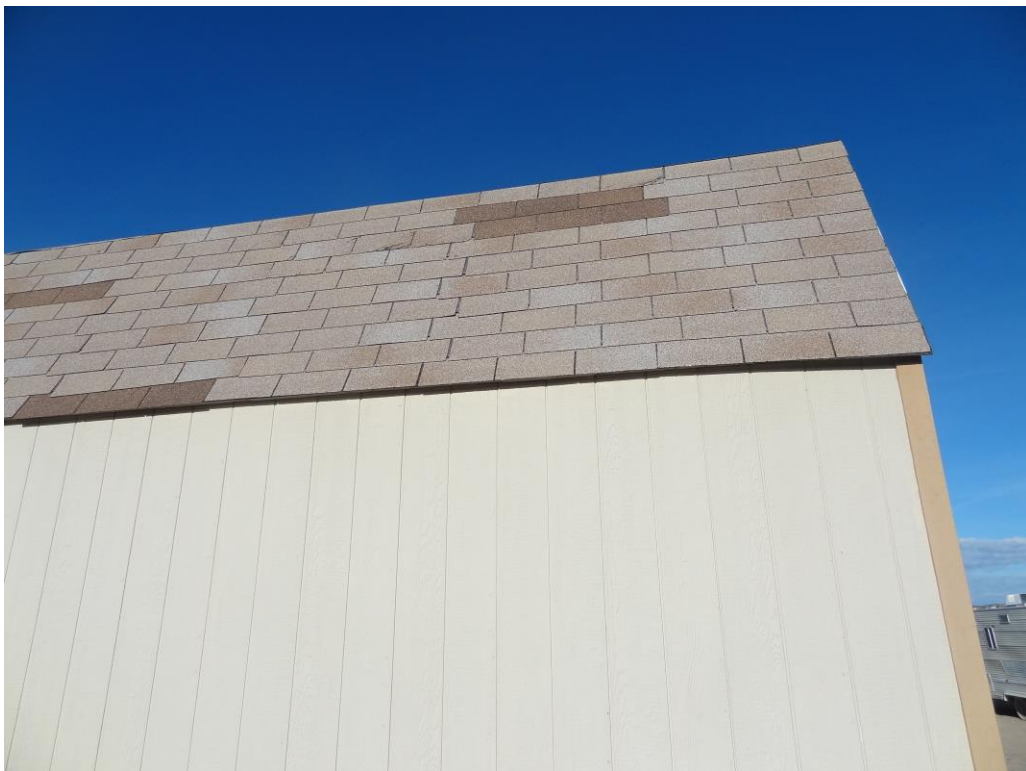
The asphalt composition shingle roof on this building was in poor condition at the time of the survey. It is recommended that this building be re-roofed in the next 2-3 years with a new 50 year asphalt composition roofing shingle and new underlayment. This estimate includes the installation of a new roof and the removal and disposal of the old roofing.

Park Office Storage Shed #2 - Building #3082
Description: Roofing replacement needed.

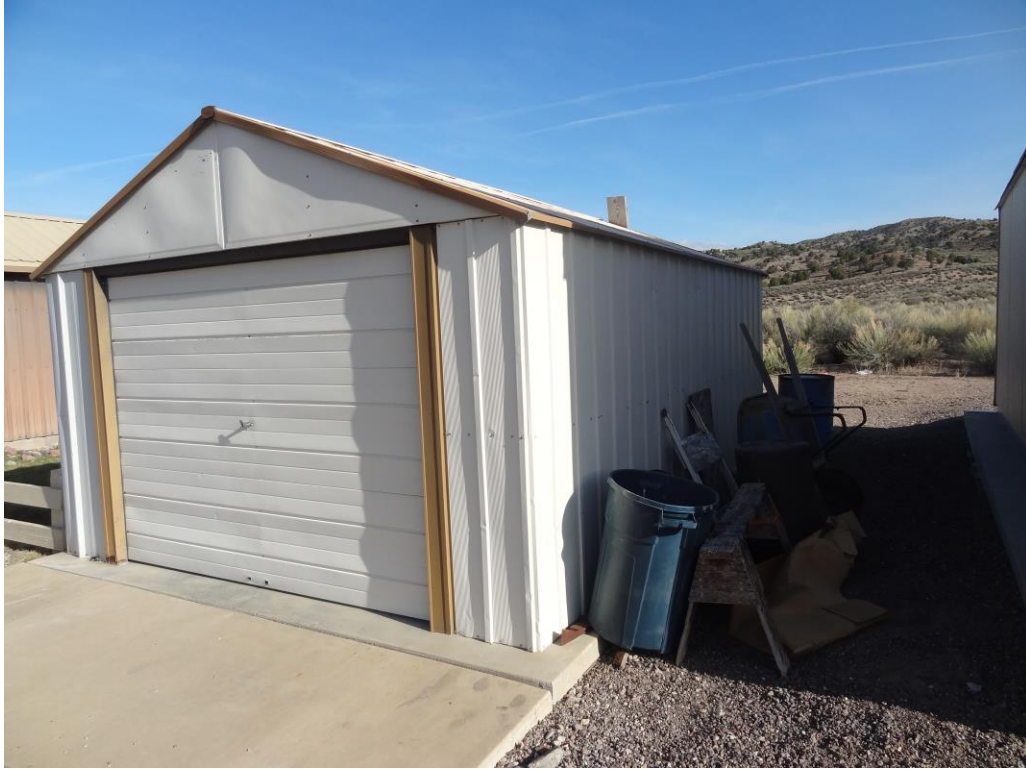
Park Office Storage Shed - Building #1101
Description: Exterior finishes needed.

It is important to maintain the finish, weather resistance and appearance of the building. This project would provide funding to protect the exterior of the building excluding the roof. Included in the cost is caulking and sealing the flashing, fixtures and all other penetrations. It is recommended that the building be caulked and sealed in the next 2-3 years and that this project be scheduled on a cyclical basis to maintain the integrity of the structure.

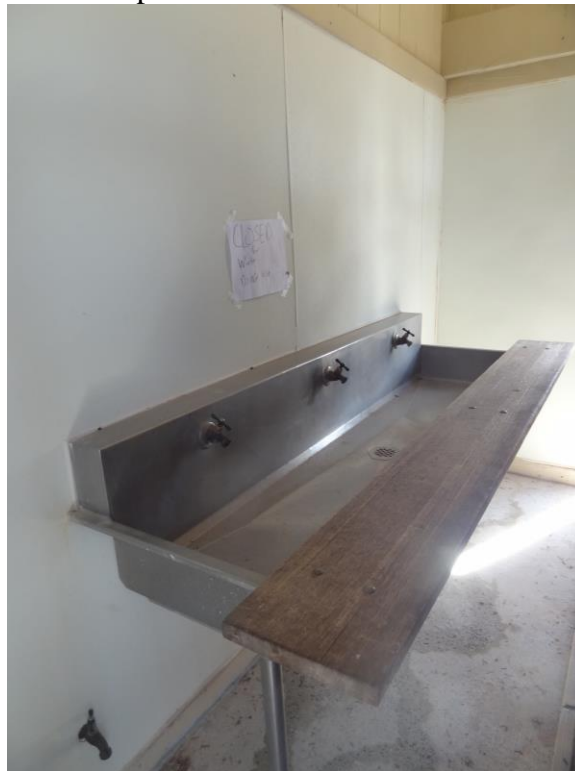
The Fish Cleaning Station is original to the building, has reached the end of its expected life and does not meet the Americans with Disabilities Act (ADA) requirements. A complete replacement of the fish cleaning equipment is necessary. This project would provide for removal and disposal of the existing equipment and the replacement with a new accessible fish cleaning station equipped with a grinder and sprayer. Nevada Revised Statutes (NRS) 338.180, International Building Code (IBC) 2012, ICC/ANSI A117.1 - 2009 and the most current version of the Americans with Disabilities Act Accessible Guidelines (ADAAG) were used as references for this project.

Fish Cleaning Station – Boat Ramp #0510
Description: ADA Fish Cleaning Station replacement needed.

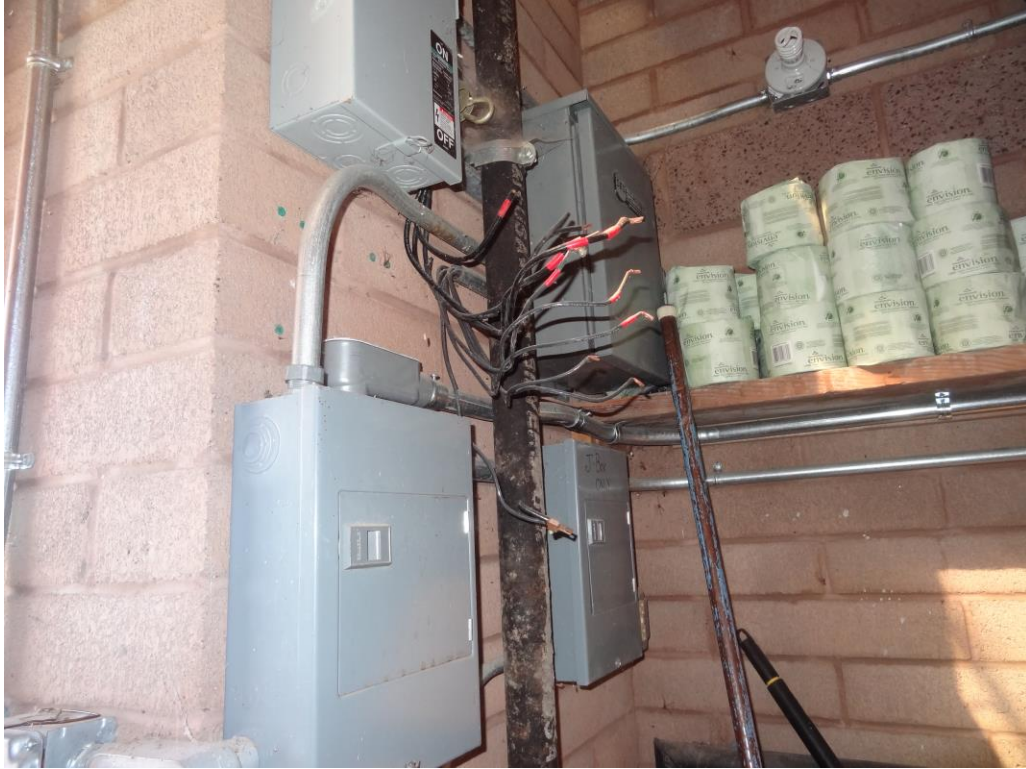
Comfort Station #3 - Building #0509
Description: Wiring cleanup needed.

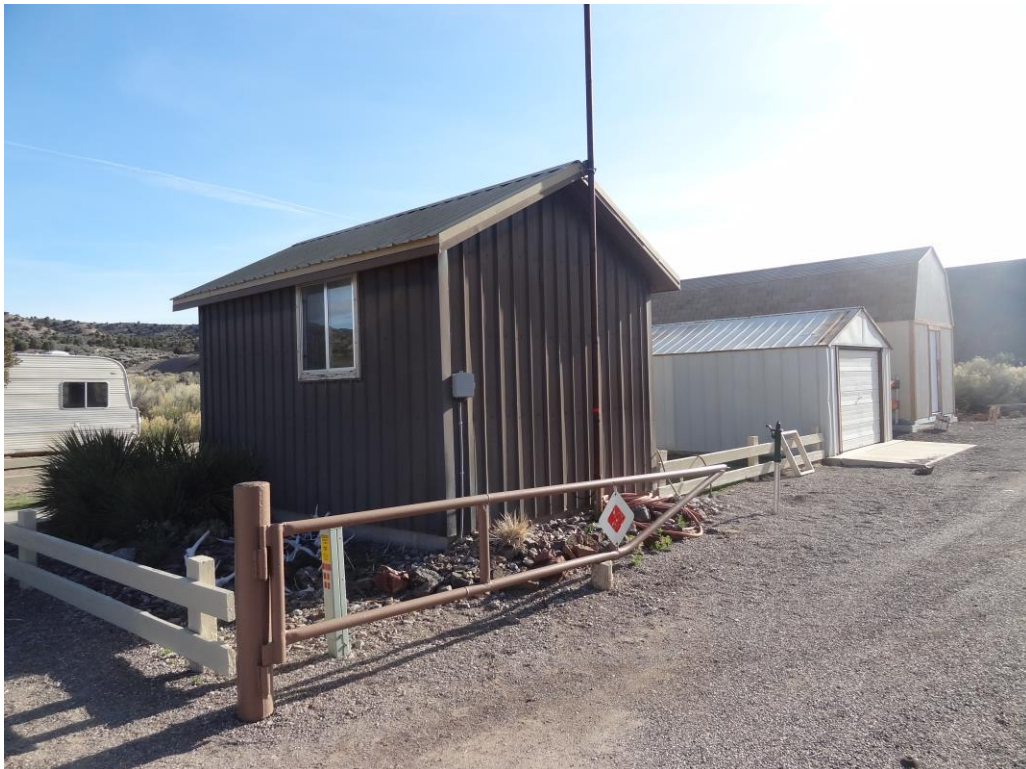
Park Office - Building #0508
Description: ADA upgrades needed.

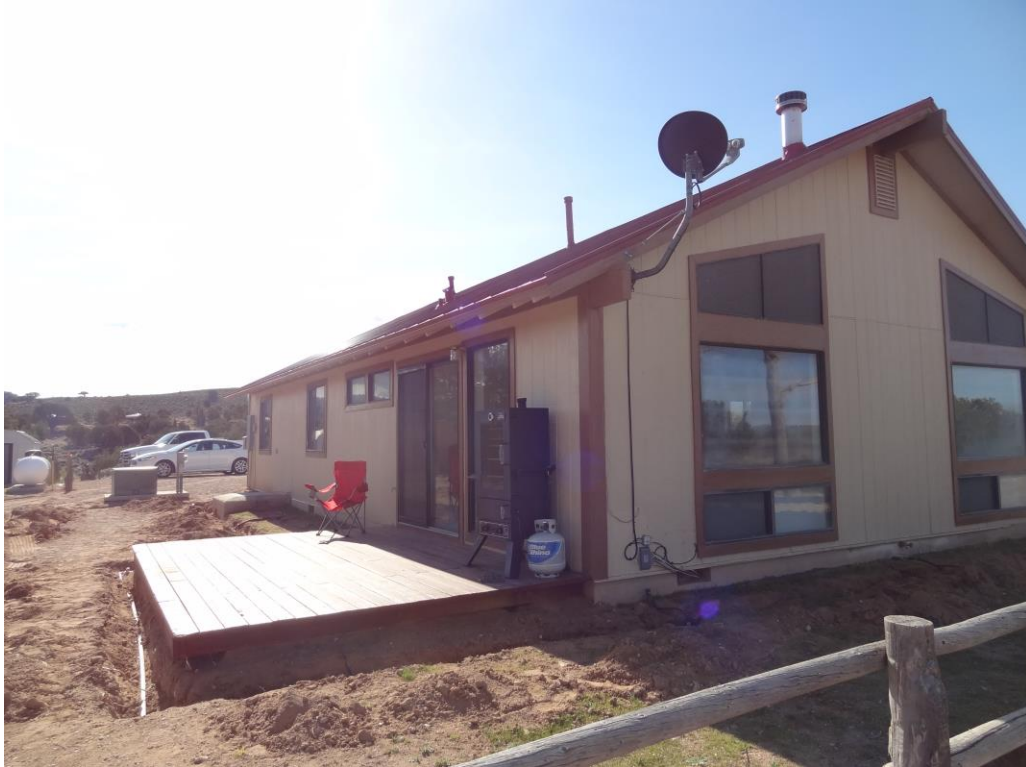
Park Residence - Building #0507
Description: Exterior finishes needed.

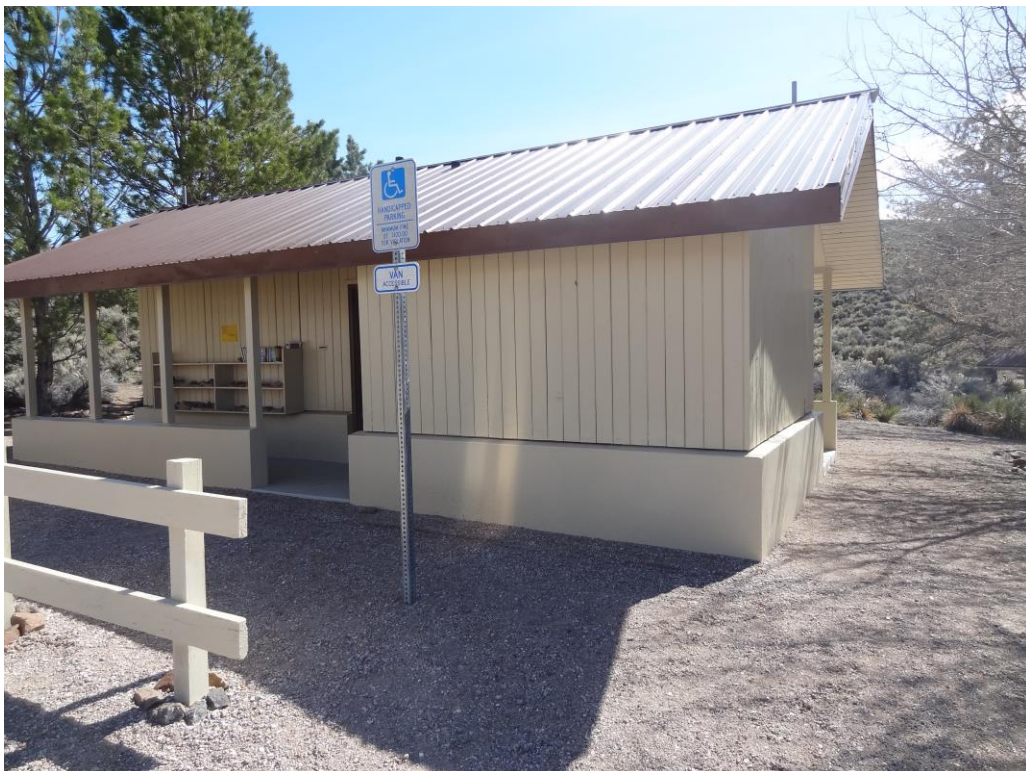
Comfort Station #1 – North Campground #1064
Description: ADA parking and path of travel needed.

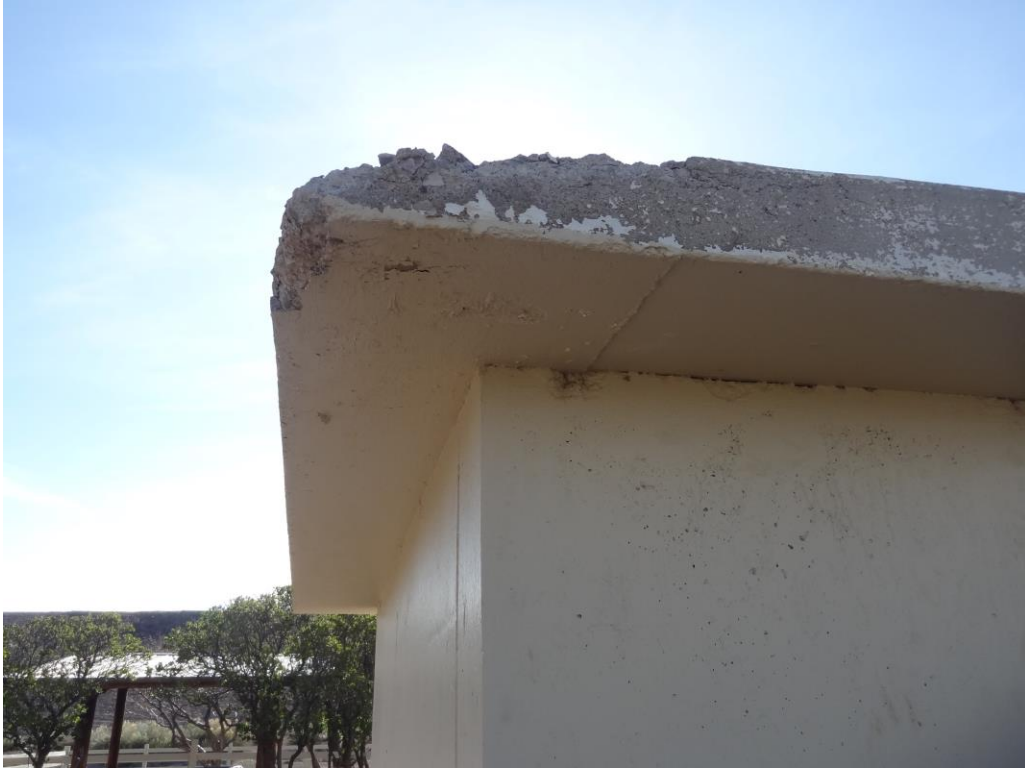
It is important to maintain the water proofing and structural integrity of the concrete roof deck on the building. This project would provide funding to repair the spalling concrete using an epoxy patch (to repair and seal) and then painting with an epoxy-based paint on the concrete roof decking. Included in the cost is the preparation of the concrete roof decking by cleaning, sanding, and removing all paint, loose concrete and aggregate from the roof decking. Per 2012 International Energy Conservation Code (IECC), the minimum insulation in a zone 5 entirely above the deck per Table C402.2 is R-25. After the concrete roof decking is completely repaired, an R-25 insulation is to be fastened to the concrete roof decking, and a fully adhered single ply membrane should be installed over the insulation. The current roof decking was installed in 1970 and it is recommended that the work be performed in the next year.

Park Well House - Building #1065
Description: Concrete patch/ roofing needed.
