State of Nevada  
Department of Conservation & Natural Resources  
Division of State Parks

# CAVE LAKE STATE PARK SITE

**Site Number: 9946**  
**STATE OF NEVADA PUBLIC WORKS DIVISION**  
**FACILITY CONDITION ANALYSIS**

Report distributed in May 2021

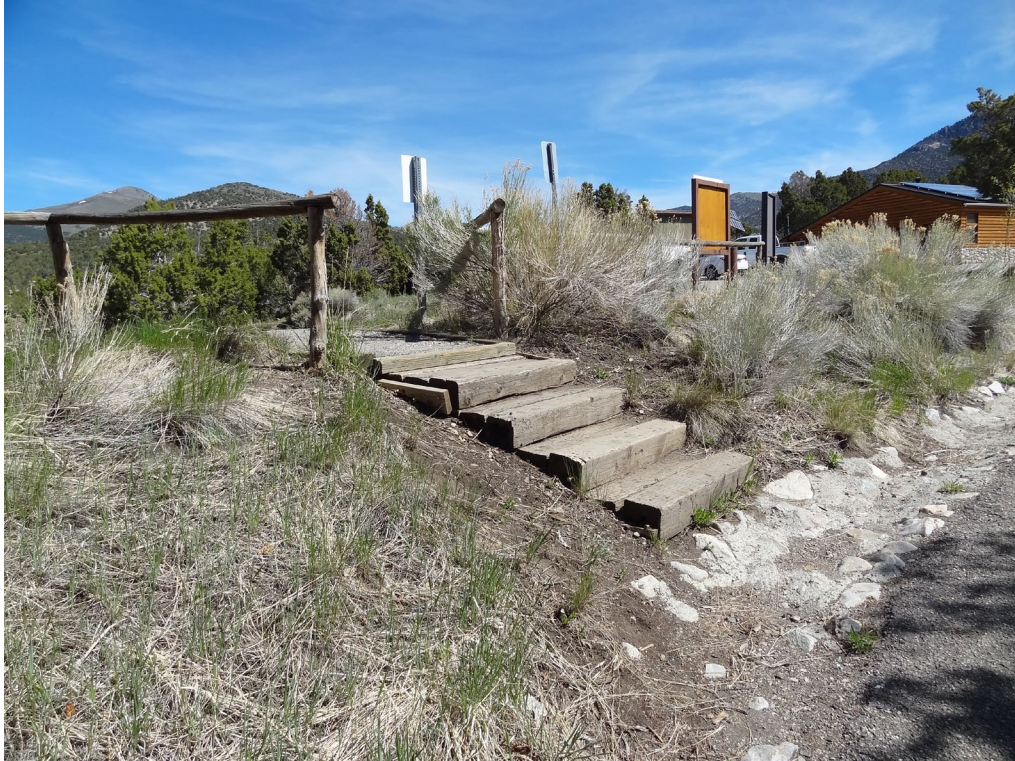
The ADA provides for accessibility to sites and services for people with physical limitations. The existing ADA parking space at the boat dock does not meet the ADA requirements. The boat dock has a picnic area that should be ADA accessible. This project provides funding to bring the existing ADA parking space up to code including the removal of the asphalt and replacement with P.C. concrete, updated signage, re-striping, re-grading and any other necessary upgrades. The project funding will also provide for an accessible path of travel from the parking space and an accessible picnic table at the picnic area. NRS 338.180, IBC - 2018, ICC/ANSI A117.1 - 2009 and ADAAG - 2010 were referenced for this project. This project should be implemented concurrently with the BOAT DOCK REPAIRS project.

Cave Lake State Park Site - Site #9946  
Description: Boat Dock ADA Upgrades, Path of Travel.

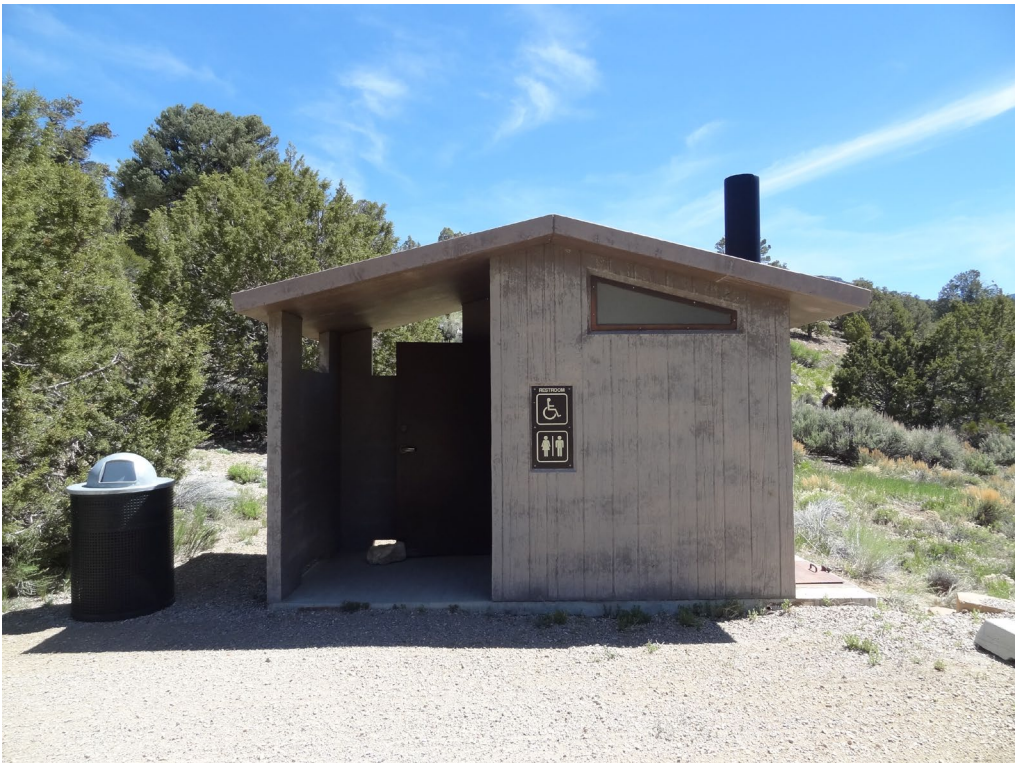
The ADA provides for accessibility to sites and services for people with physical limitations. A compliant path of travel from the accessible parking space to the restroom and picnic area and an accessible picnic table are necessary to comply with ADA accessibility requirements. This project provides funding for a compliant path of travel and an accessible picnic table. NRS 338.180, IBC - 2018, ICC/ANSI A117.1 - 2009 and ADAAG - 2010 were referenced for this project. This project or a portion thereof was previously recommended in the FCA report dated 09/29/2009. It has been amended accordingly to reflect conditions observed during the most recent survey date of 05/23/2017.

Cave Lake State Park Site - Site #9946  
Description: Group Use ADA Upgrades, Path of Travel.

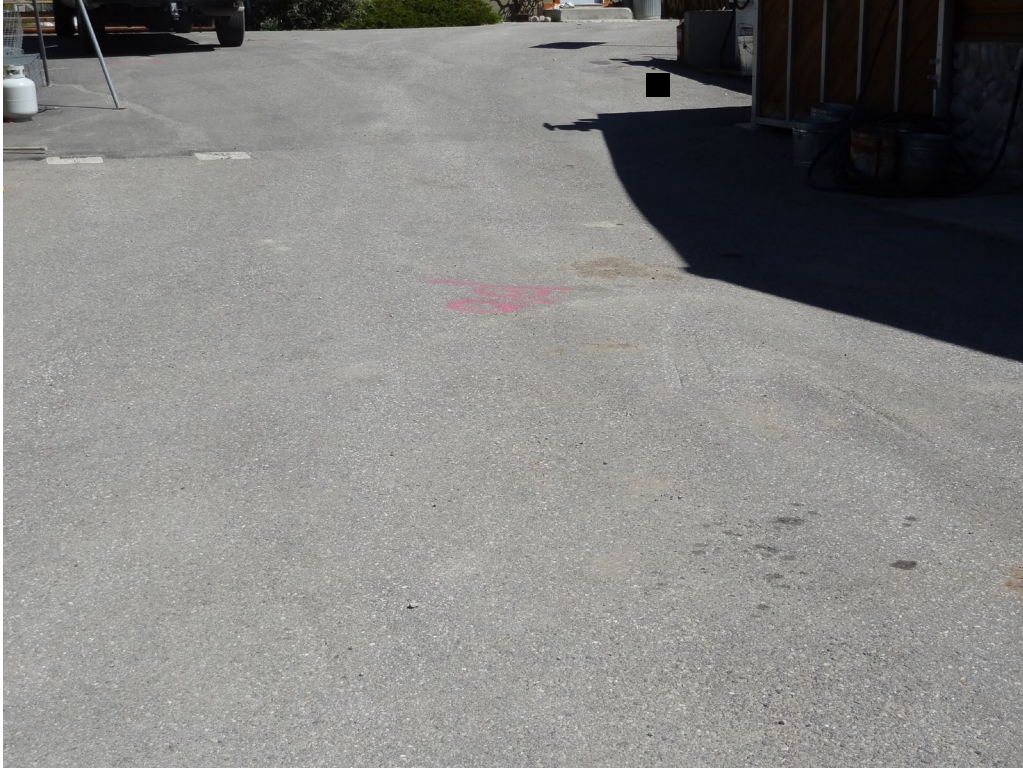
It is important to maintain the asphalt concrete paving on the site. This project would provide for: minor crack filling; slurry sealing of the paving site wide, including parking areas; the turnout at the information kiosk; the boat ramp access, the maintenance yard and striping. All other paving is maintained by NDOT. This project should be scheduled on a 5 year cyclical basis to maintain the integrity of the paving and prevent premature failure. 50,000 square feet of asphalt area was used to generate this estimate.

Cave Lake State Park Site - Site #9946  
Description: Crack Fill & Slurry Seal Asphalt Paving.

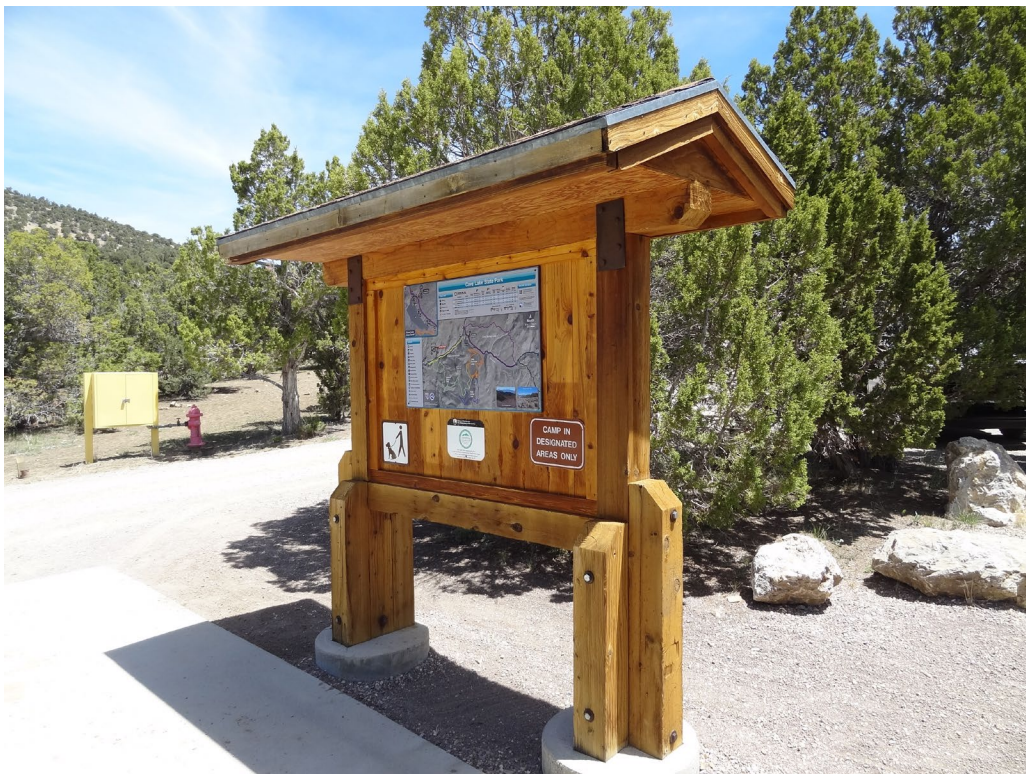
Elk Flat Information Kiosk - Building #3022  
Description: View of the Information Kiosk.

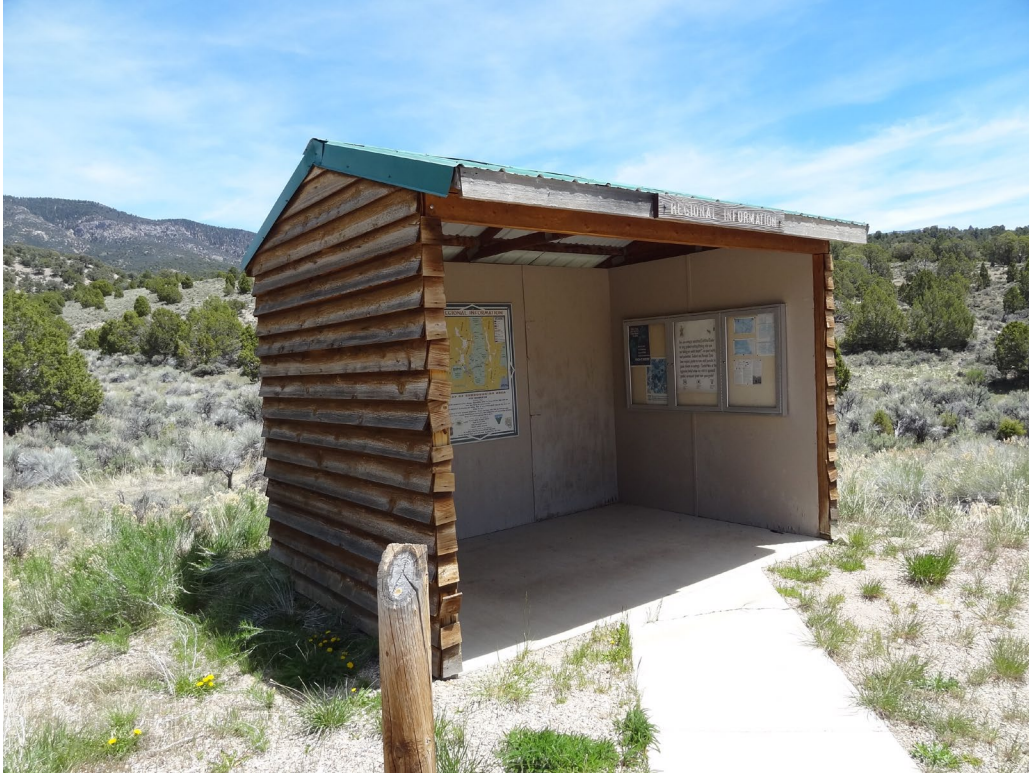
It is important to maintain the finish, weather resistance and appearance of the building. This project would provide funding to protect the exterior of the building. Included in the cost is sanding and sealing the wood and caulking of the flashing, fixtures and all other penetrations. It is recommended that the building be painted in the next 2-3 years and that this project be scheduled on a cyclical basis to maintain the integrity of the structure.

Cave Lake Information Booth - Building #3021  
Description: Exterior Finishes of the Structure.

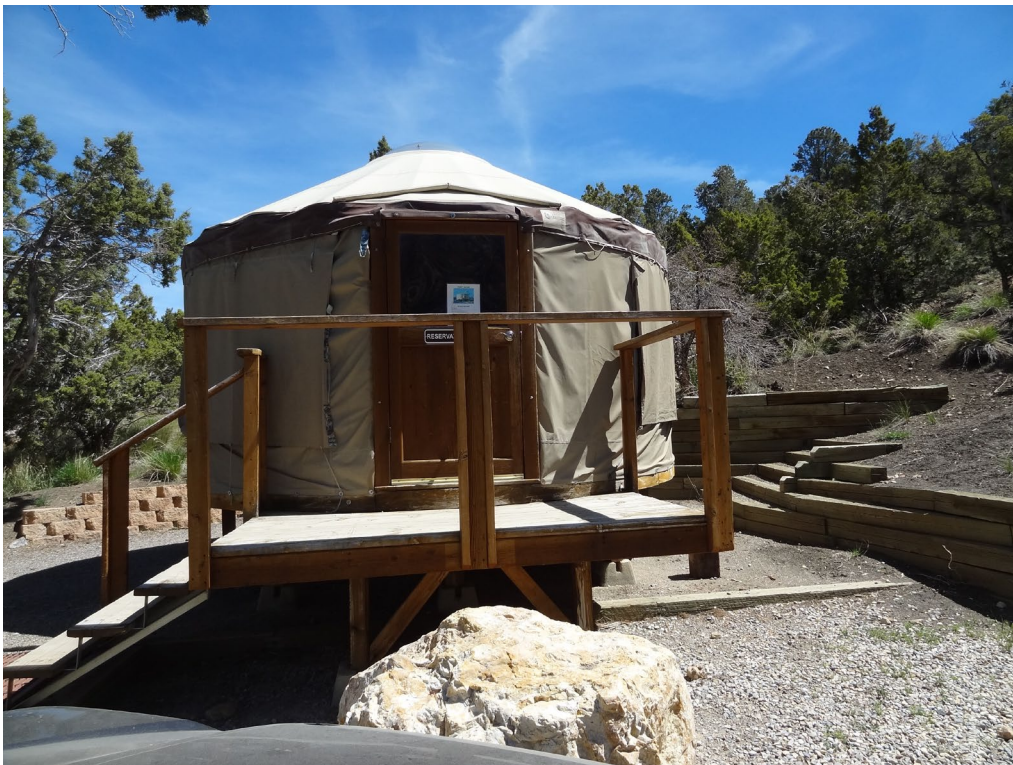
The exterior stairs and deck have handrails and a guardrail that do not meet building code requirements for safety. The gripping surfaces are incorrect, they are not continuous from the top to bottom landings and the deck is lacking a guardrail. This project recommends the installation of guardrails and handrails in accordance with the 2018 IBC Section 1012 and 1013.

Lakeview Campground Yurt - Building #3020  
Description: Exterior Handrail Replacement.

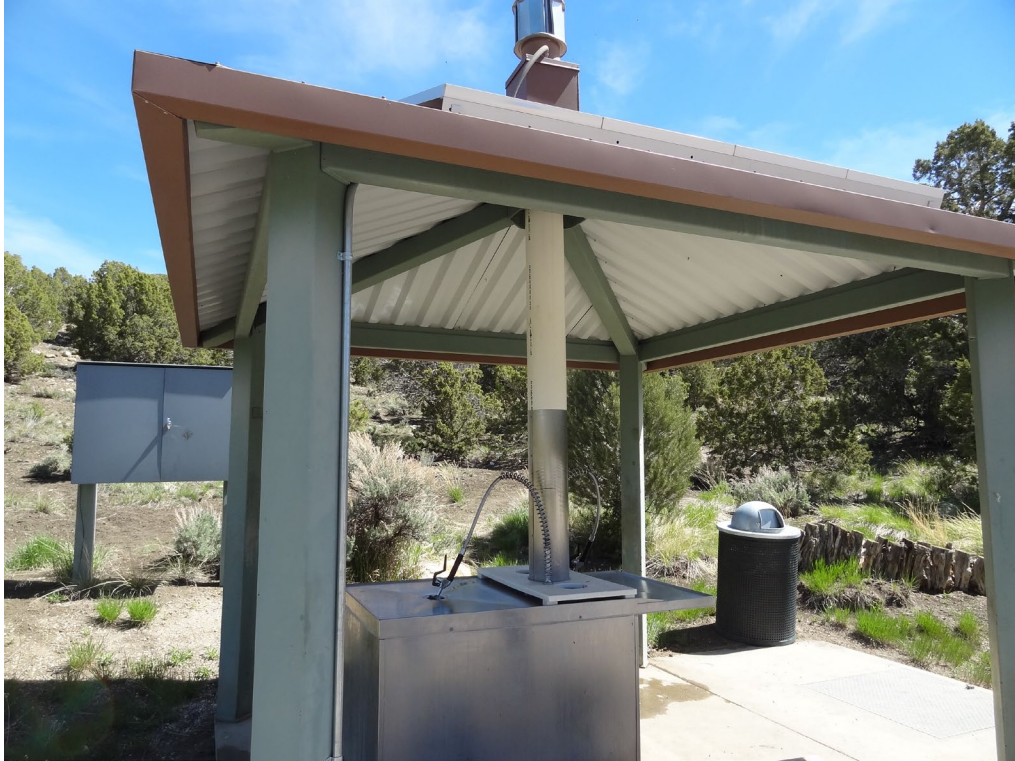
It is important to maintain the finish, weather resistance and appearance of the structure. This project would provide for painting of the structure and it is recommended that this project be scheduled on a cyclical basis to maintain the integrity of the structure.

Fish Cleaning Station - Building #3019  
Description: Exterior Finishes of the Structure.

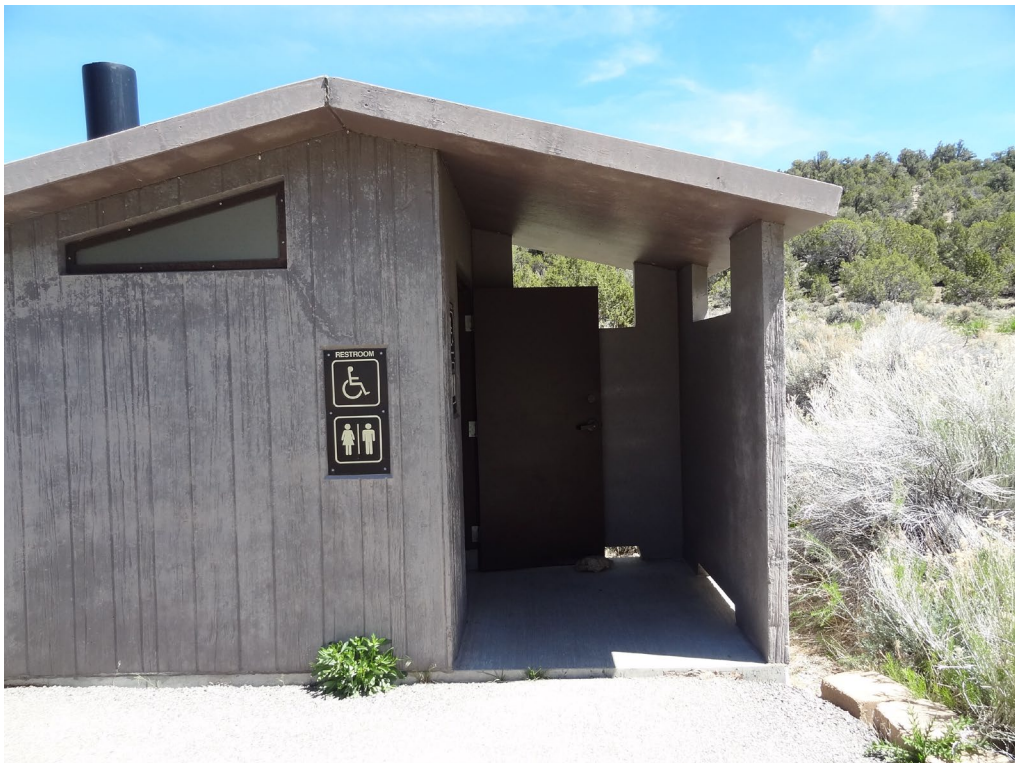
CXT Restroom #3 – Overlook Trailhead - Building #2259  
Description: Exterior of the Structure.

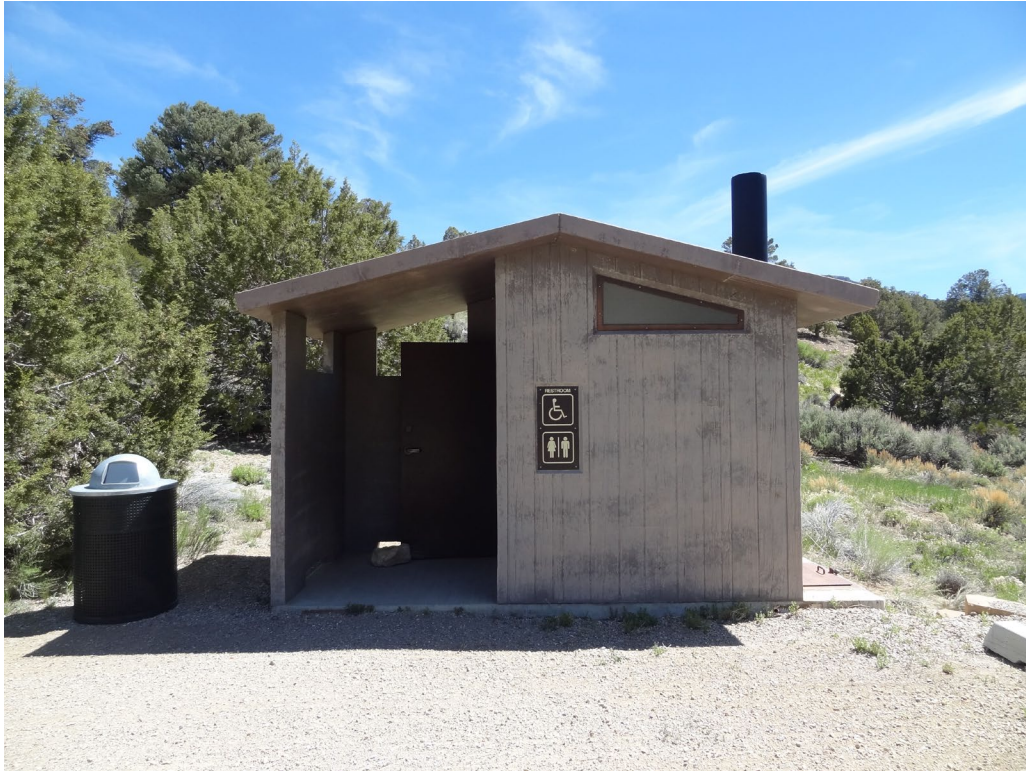
CXT Restroom #2 – Group Use Area - Building #2258  
Description: Exterior of the Structure.

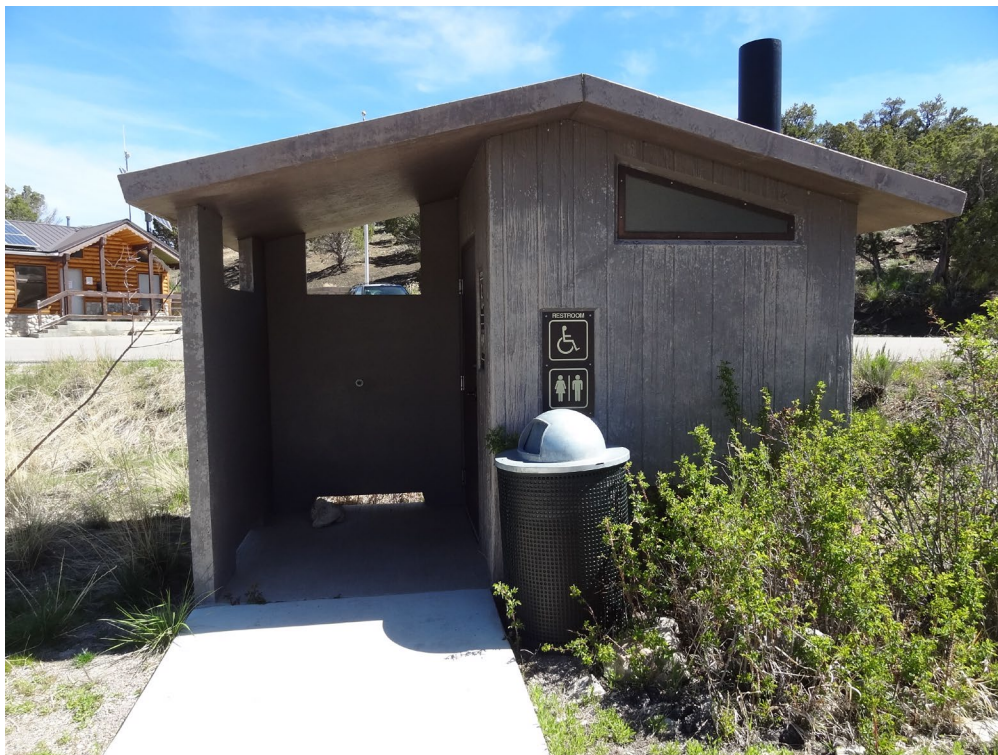
CXT Restroom #1 – Boat Ramp – Building #2257  
Description: Exterior of the Structure.

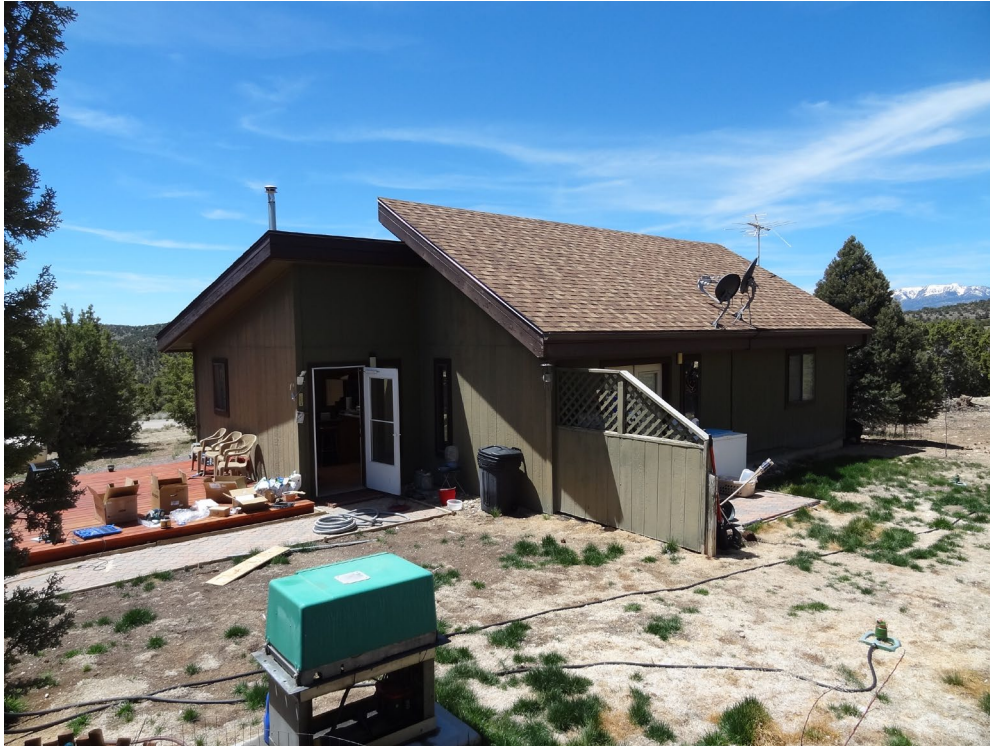
Residence #2 – Elk Flat - Building #1295  
Description: View of the Residence.

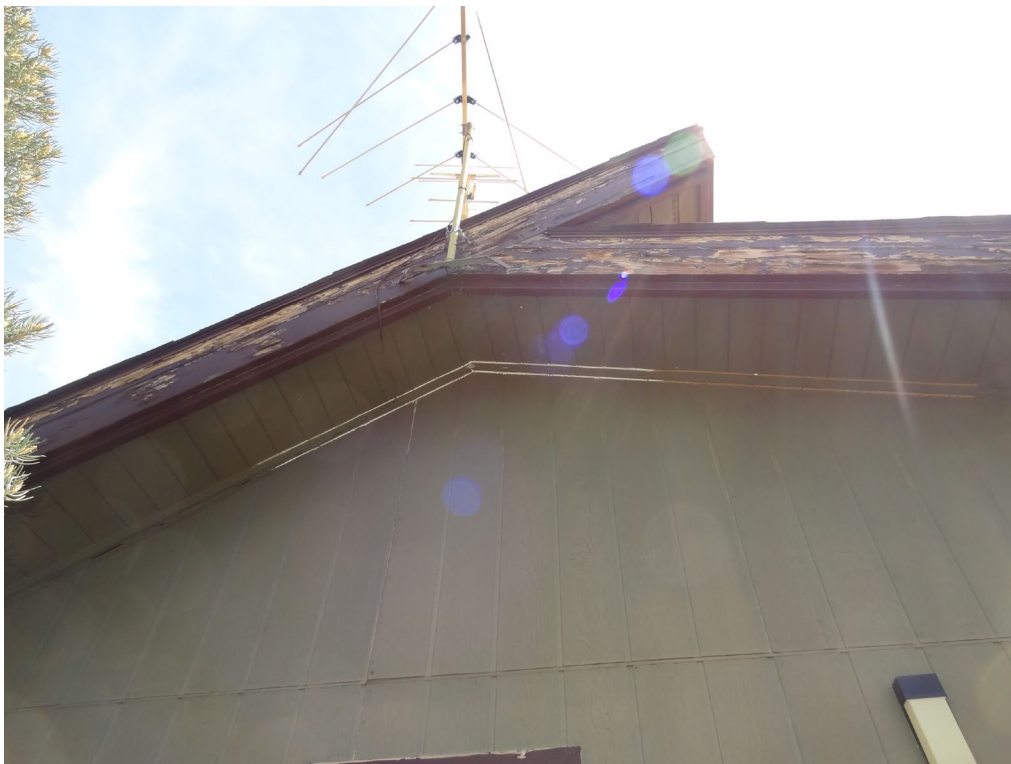
It is important to maintain the finish, weather resistance and appearance of the building. This project would provide funding to protect the exterior of the building. Included in the cost is sanding, priming and painting and caulking of the windows, flashing, fixtures and all other penetrations. It is recommended that the building be painted in the next 2-3 years and that this project be scheduled on a cyclical basis to maintain the integrity of the structure.

Residence #2 – Elk Flat - Building #1295  
Description: Exterior Finishes of the Residence.

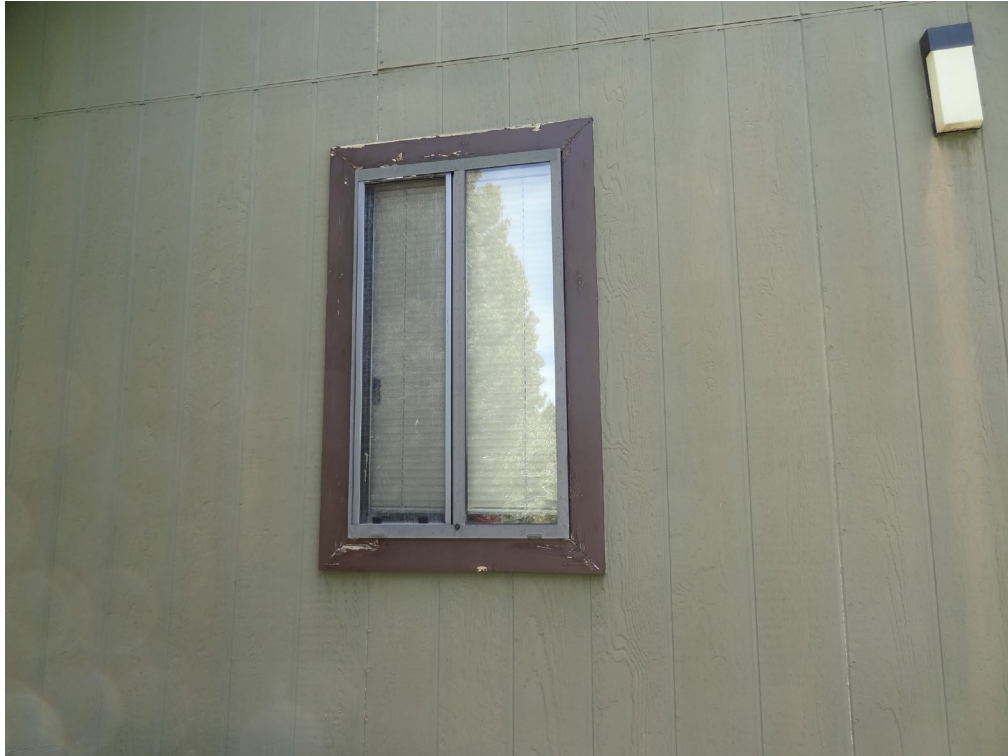
The windows are original, dual pane construction in a metal frame. These older windows have damaged seals, are drafty and not energy efficient. This project recommends replacing the windows with dual pane, higher efficiency units. This estimate is for the replacement of 8 units. Removal and disposal of the existing windows is included in this estimate.

Residence #2 – Elk Flat - Building #1295  
Description: Window Replacement.

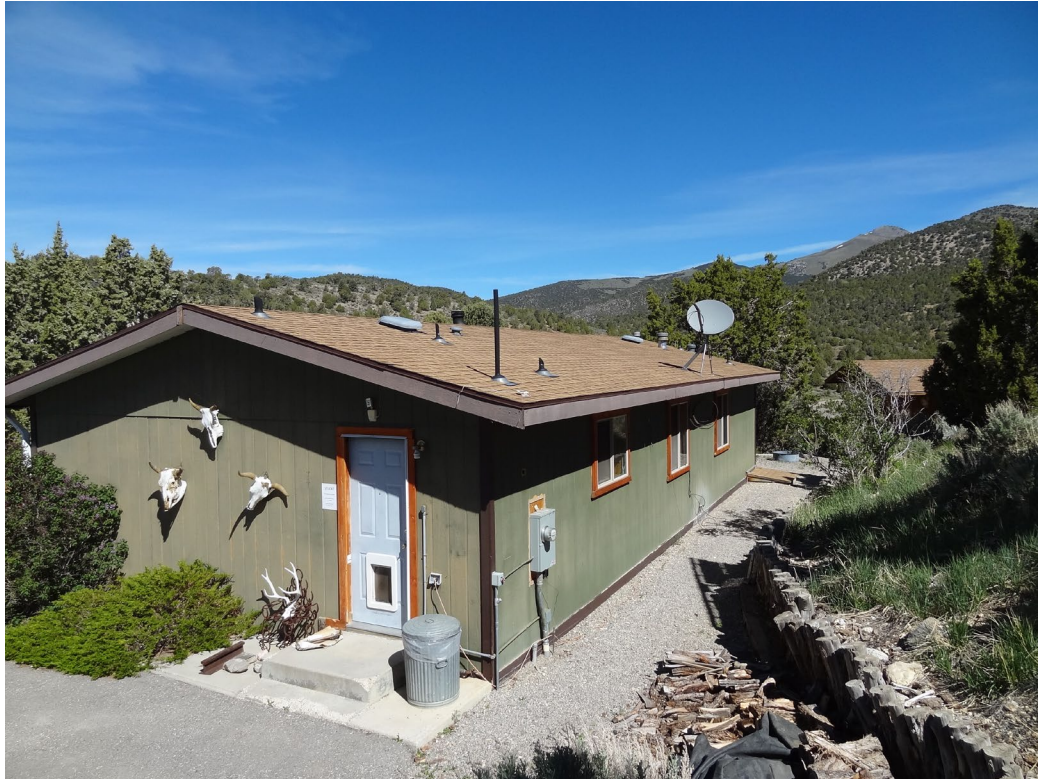
Residence #1 – Lakeview - Building #1294  
Description: Exterior of the Structure.

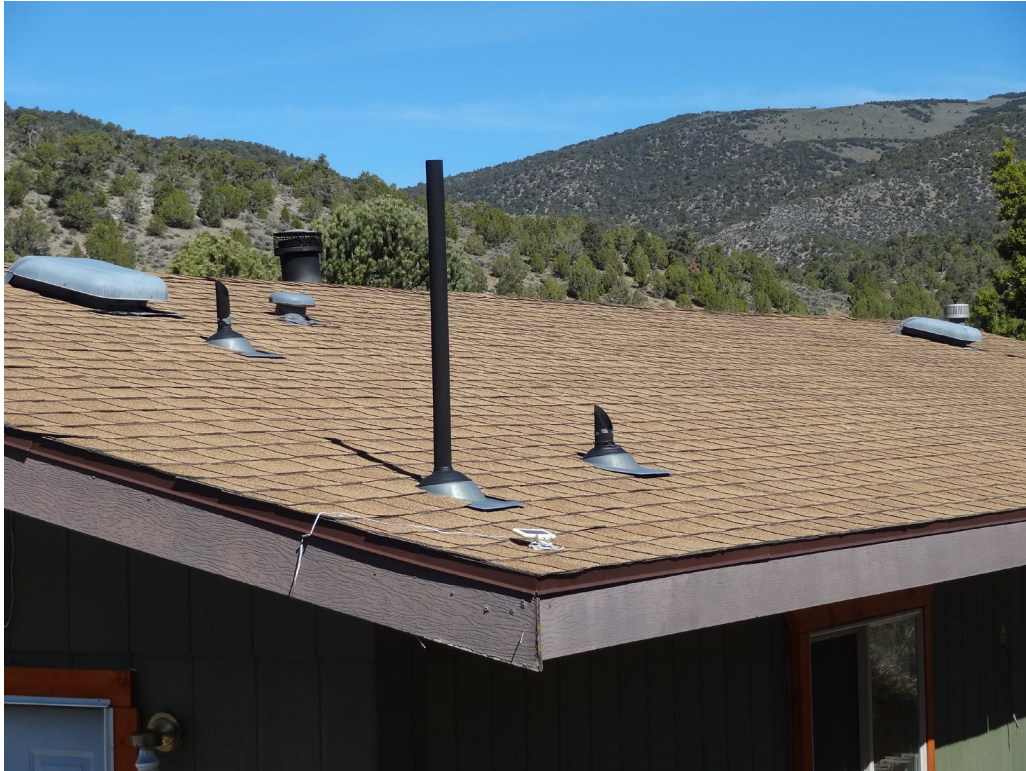
Residence #1 – Lakeview - Building #1294  
Description: Roof Replacement.

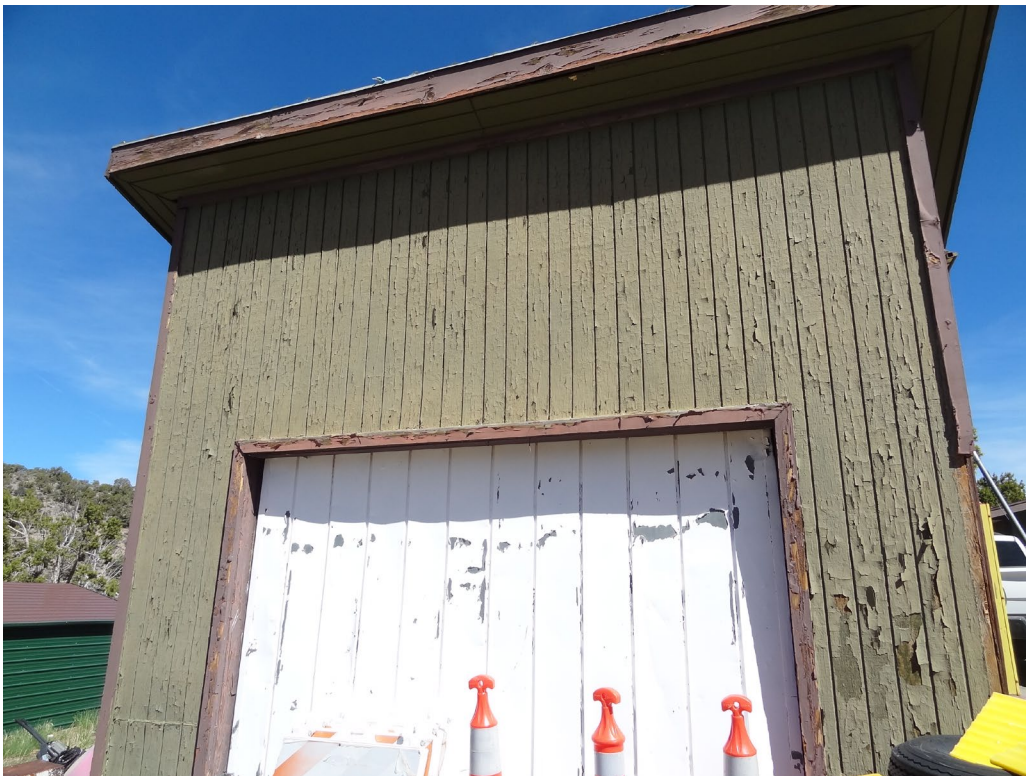
Equipment Storage Building - Building #1293  
Description: Exterior Finishes of the Structure.

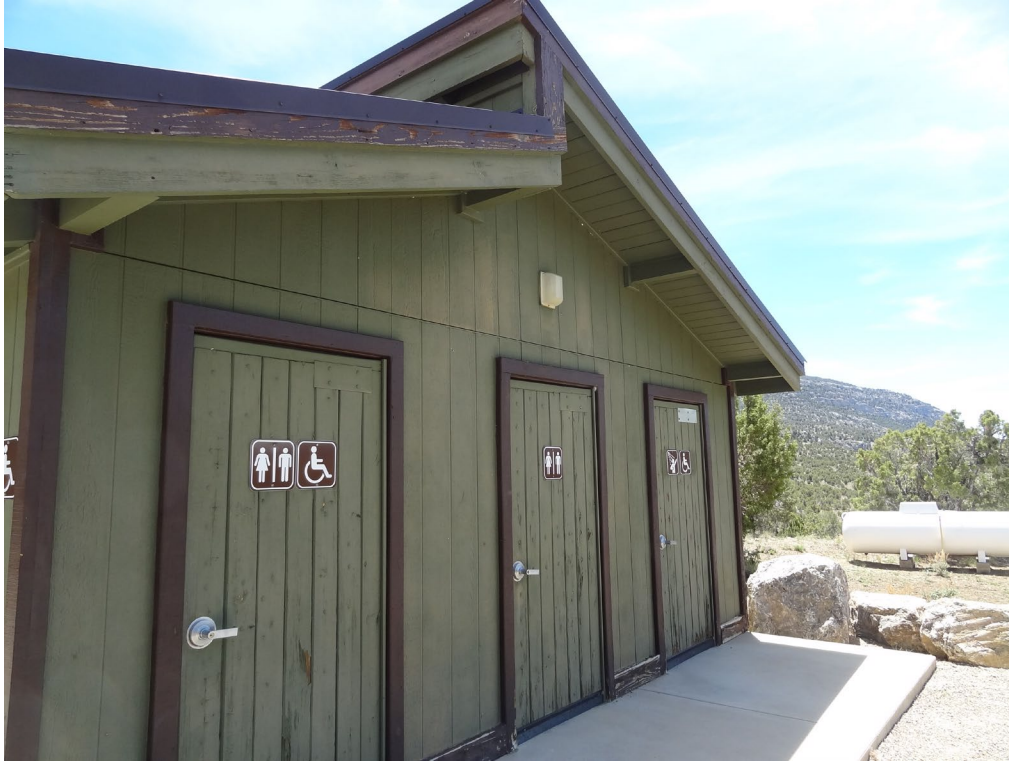
Restroom #3 – Elk Flat - Building #1289  
Description: Exterior Finishes of the Structure.

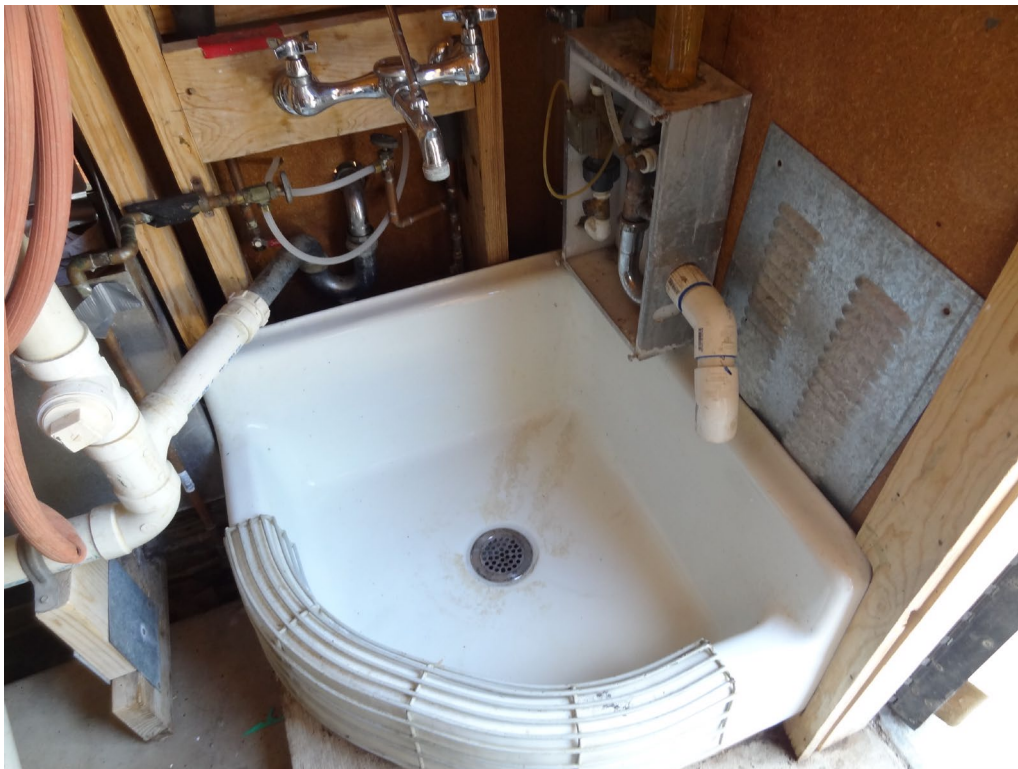
Restroom #3 – Elk Flat - Building #1289  
Description: Janitors Closet Repairs.

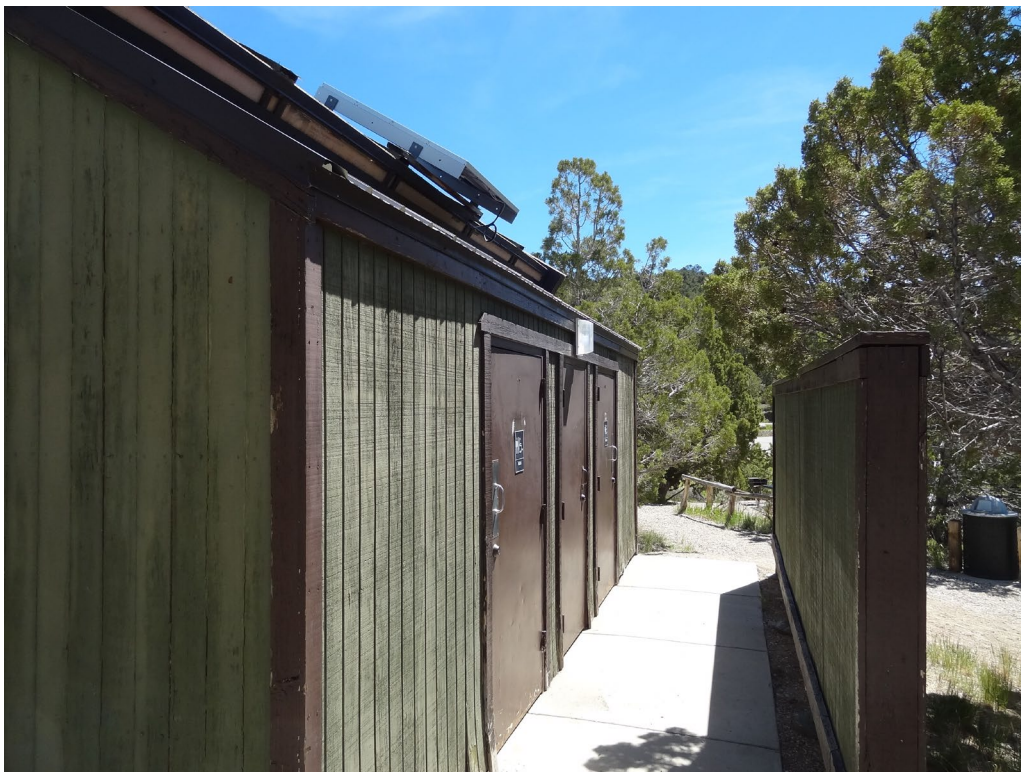
Restroom #2 – Day Use - Building #1288  
Description: Exterior Finishes of the Structure.

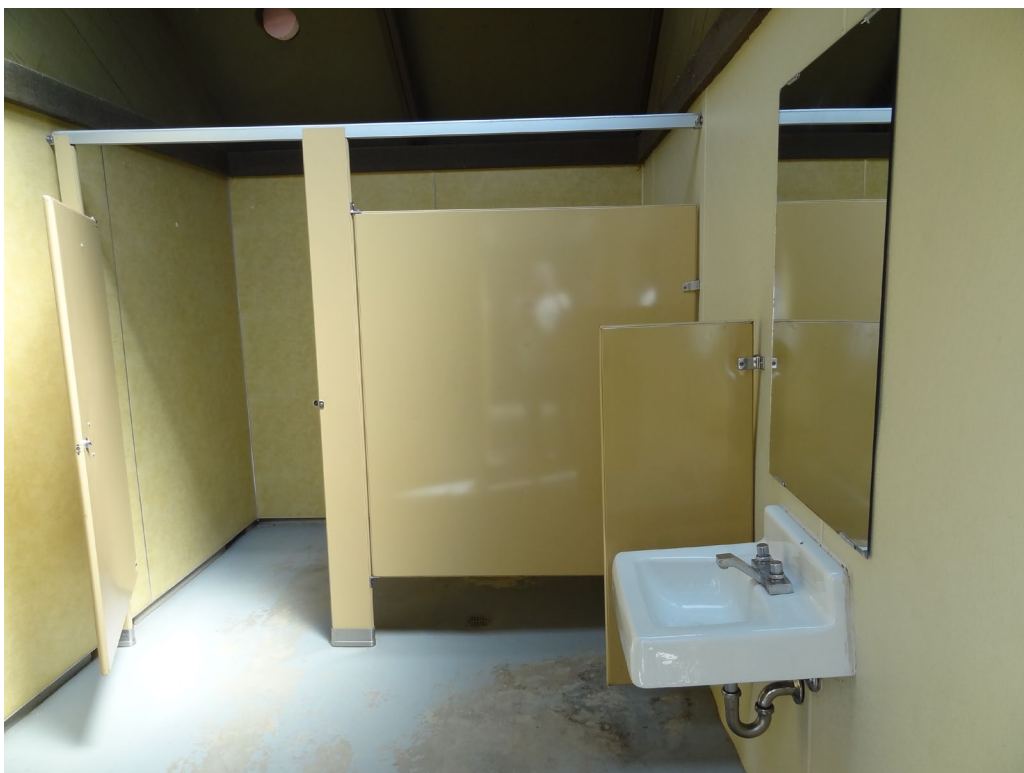
Restroom #2 – Day Use - Building #1288  
Description: Interior of the restroom.

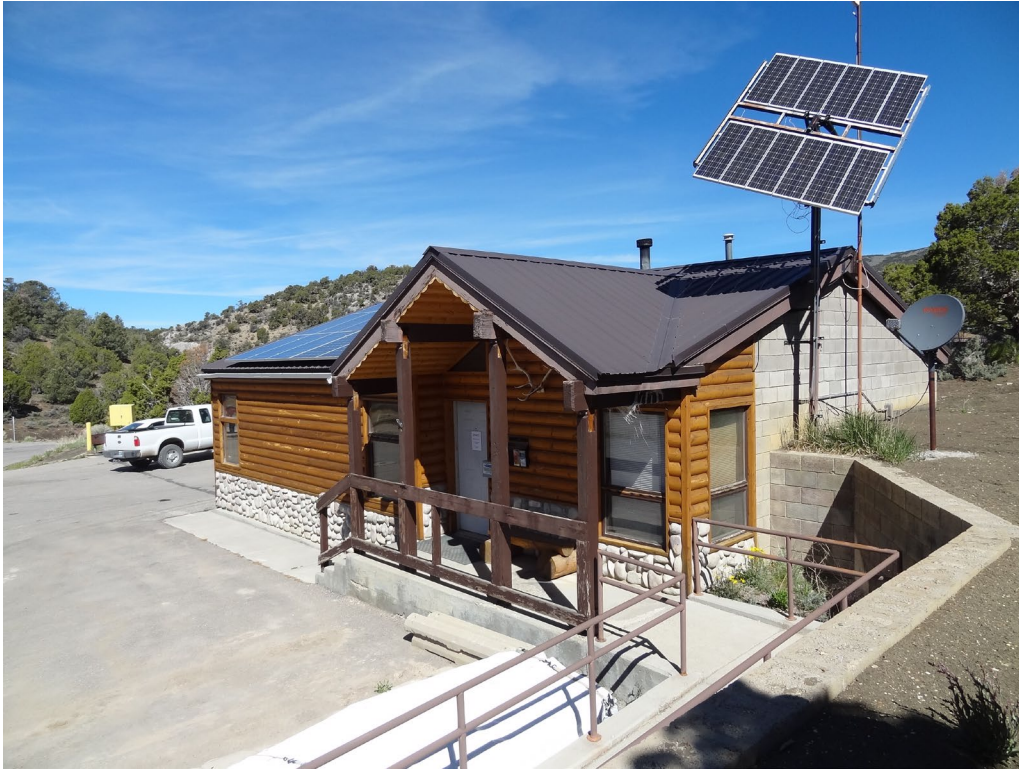
Cave Lake Office / Shop - Building #1284  
Description: Exterior of the Structure.

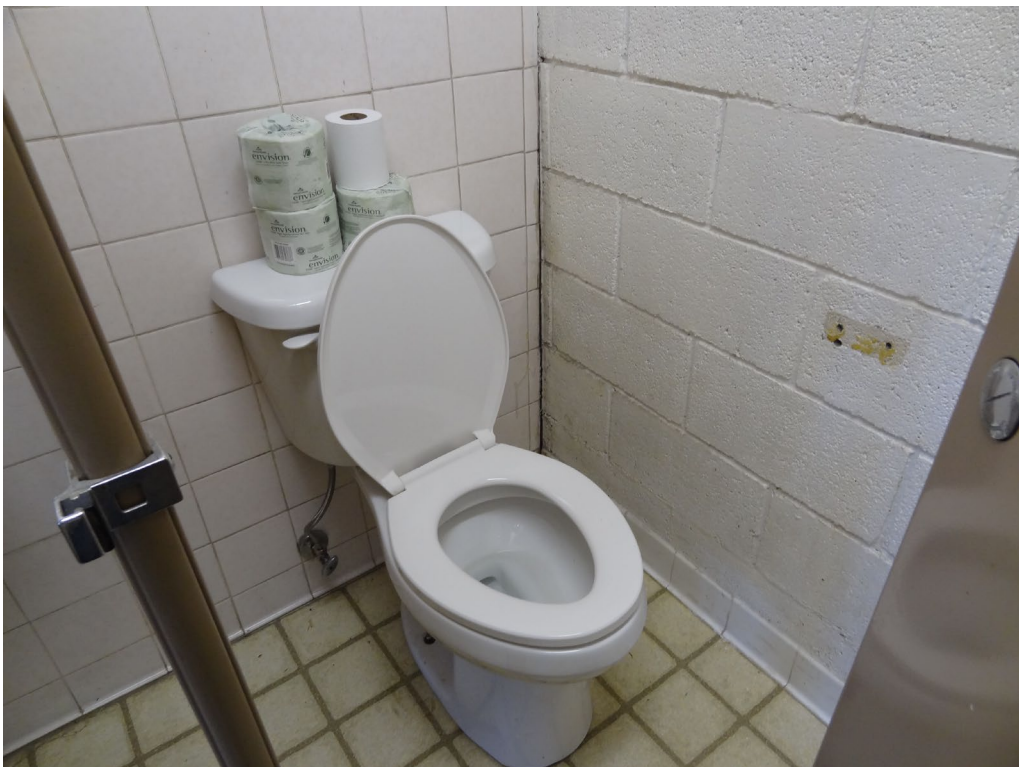
Cave Lake Office / Shop - Building #1284  
Description: ADA Restroom Upgrade.

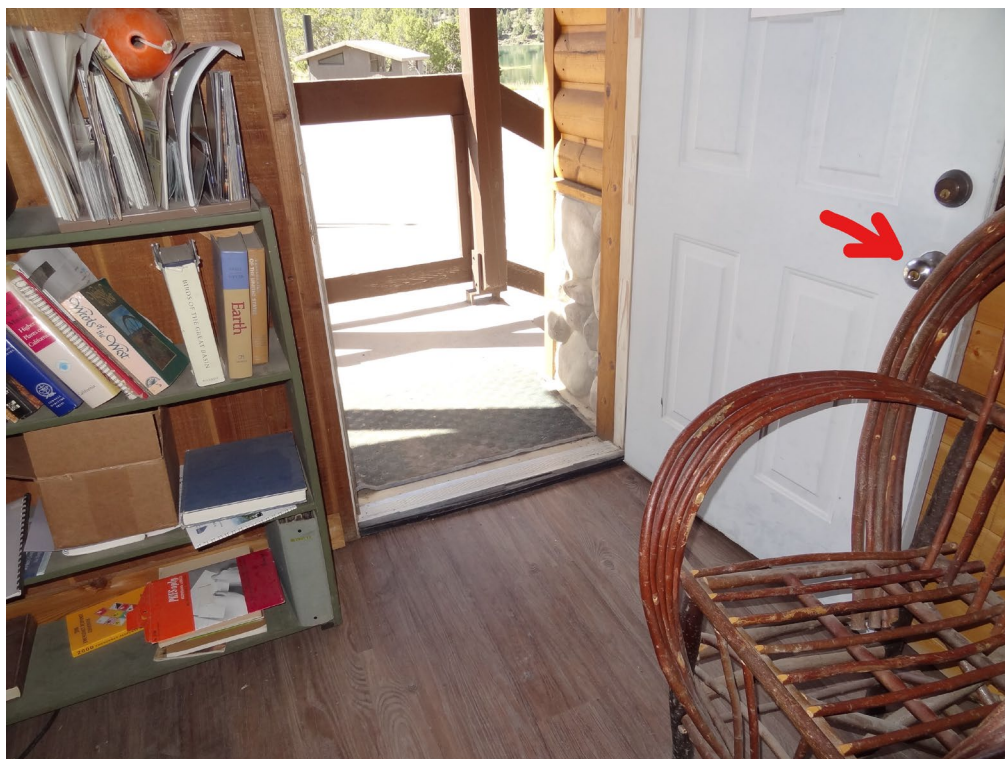
Cave Lake Office / Shop - Building #1284  
Description: ADA Upgrades, Lever Handles Needed.

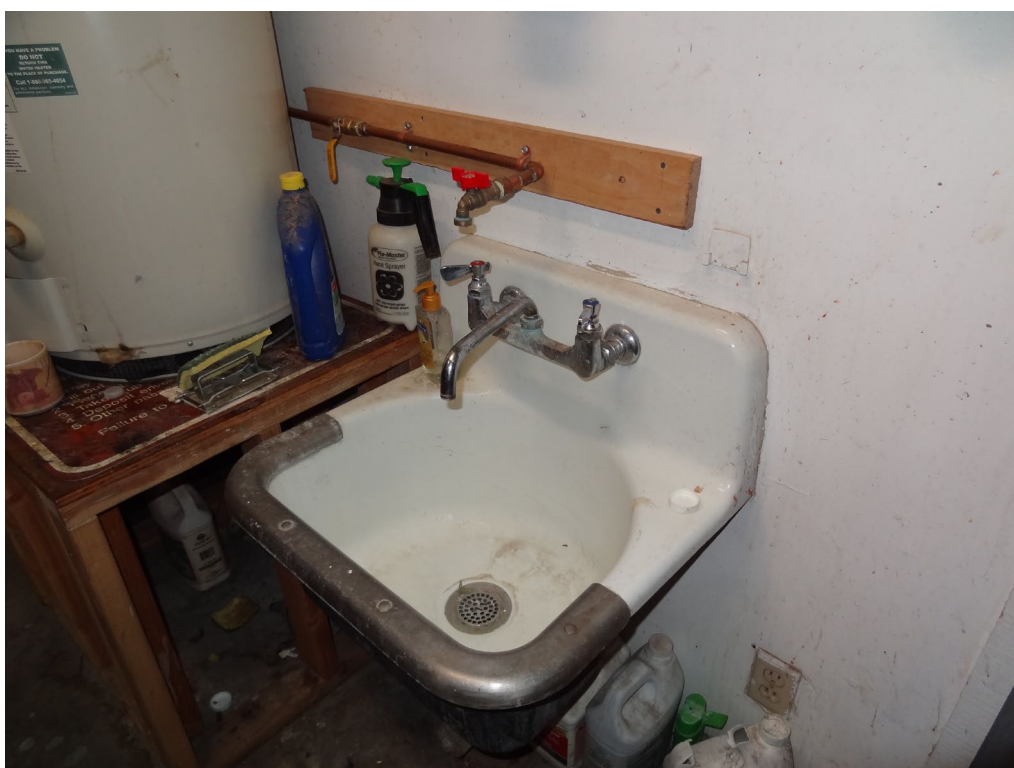
Cave Lake Office / Shop - Building #1284  
Description: Janitors Closet Repairs.

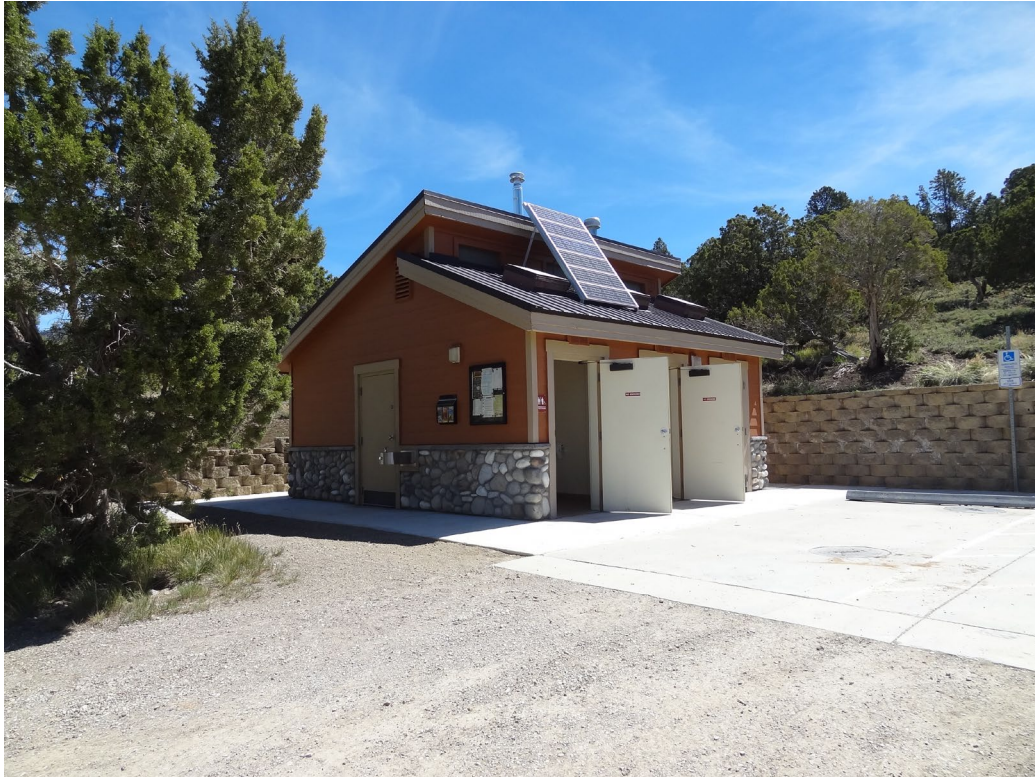
Restroom #1 – Lakeview Campground - Building #1280  
Description: Exterior of the Structure.

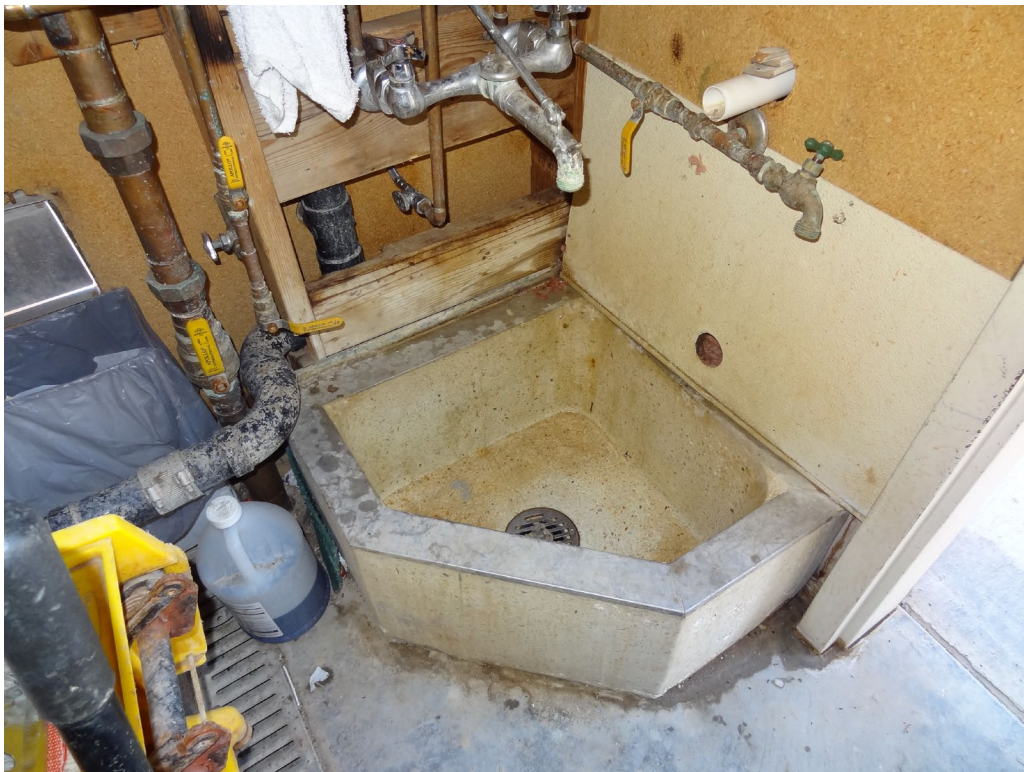
Restroom #1 – Lakeview Campground - Building #1280  
Description: Janitors Closet Repairs.
