# **PIOCHE CONSERVATION CAMP SITE**

**Site Number: 9949**

**STATE OF NEVADA PUBLIC WORKS DIVISION  
FACILITY CONDITION ANALYSIS**

Report distributed in March 2021

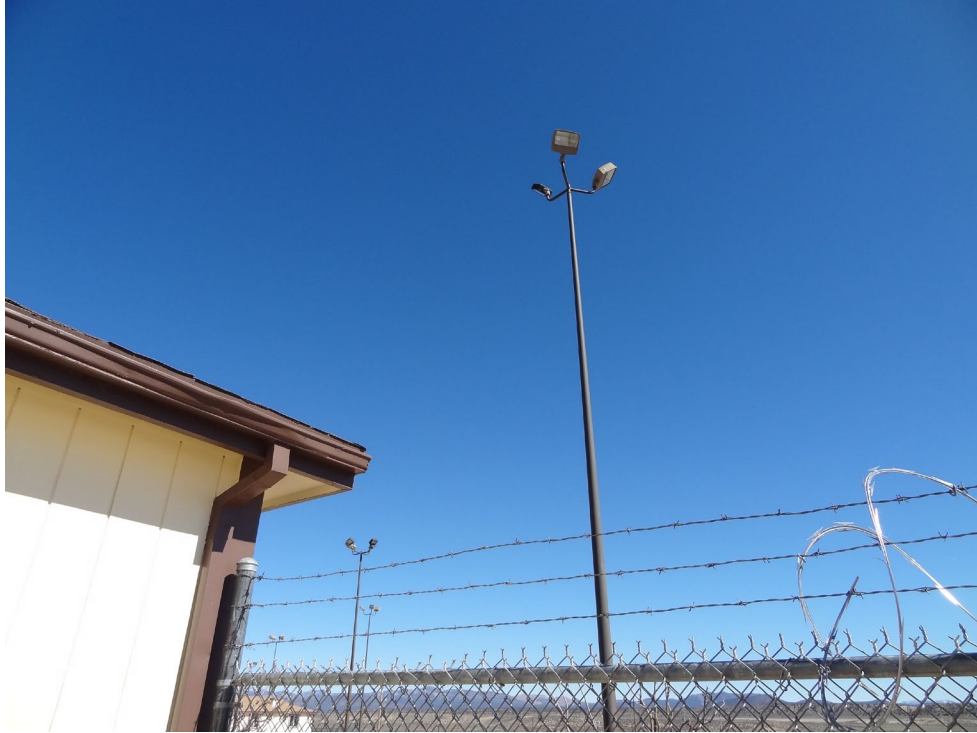
The 13 perimeter light poles that surround the site have a total of 52 light fixtures. These light fixtures are metal halide and are not energy efficient. This project would provide for the replacement of the exterior light fixtures with new LED light fixtures and will utilize the existing wiring.

Pioche Conservation Camp Site - Site #9949  
Description: Exterior Lighting Replacement.

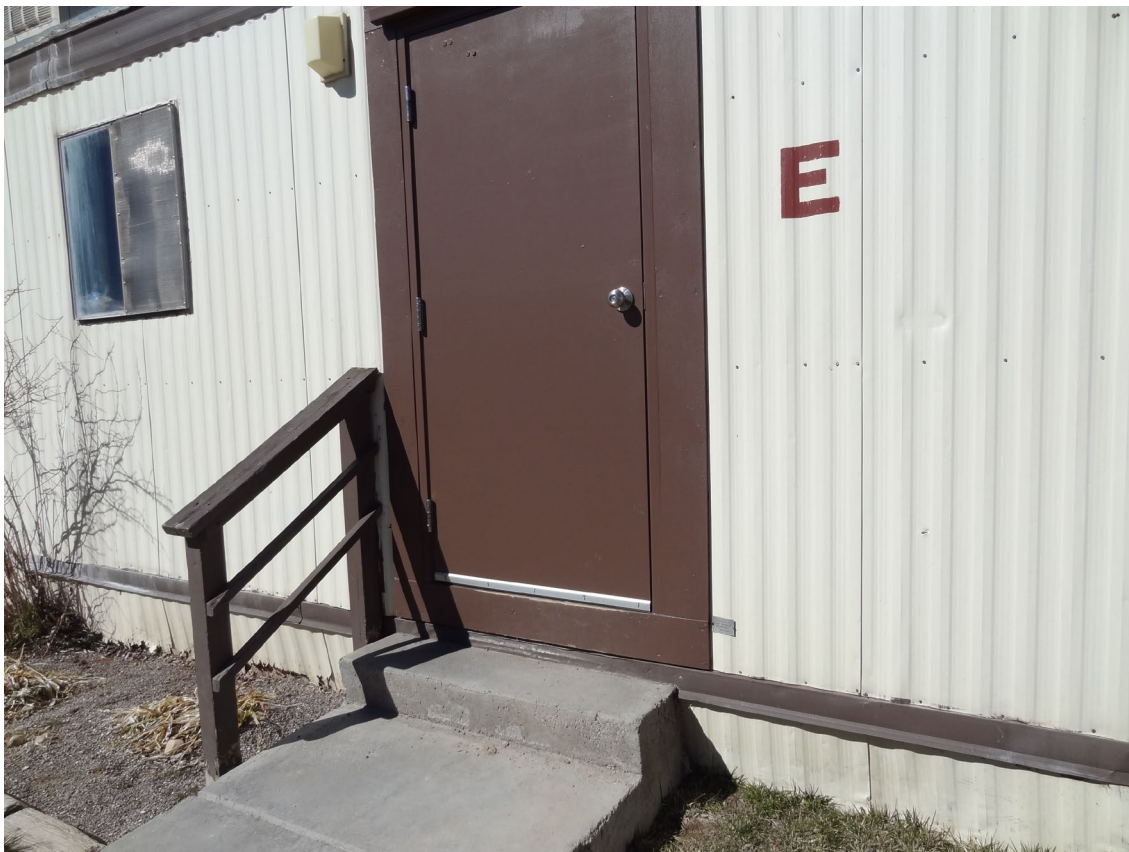
Chapter 10 of the 2012 IBC describes the requirements for doors including floor elevations, landings and handrails. The floor or landing shall be at the same elevation on each side of the door. The exterior landing shall not exceed a 2-percent slope and a length measured in the direction of travel of not less than 44 inches. Stairways shall have handrails on each side of the stairs. The landing and stairway at both exterior doors do not comply with this code and pose a safety hazard. This project would provide for the installation of two compliant landings and handrails for each door.

Preferred Housing Unit E - Building #2212  
Description: Exterior Landing Required.

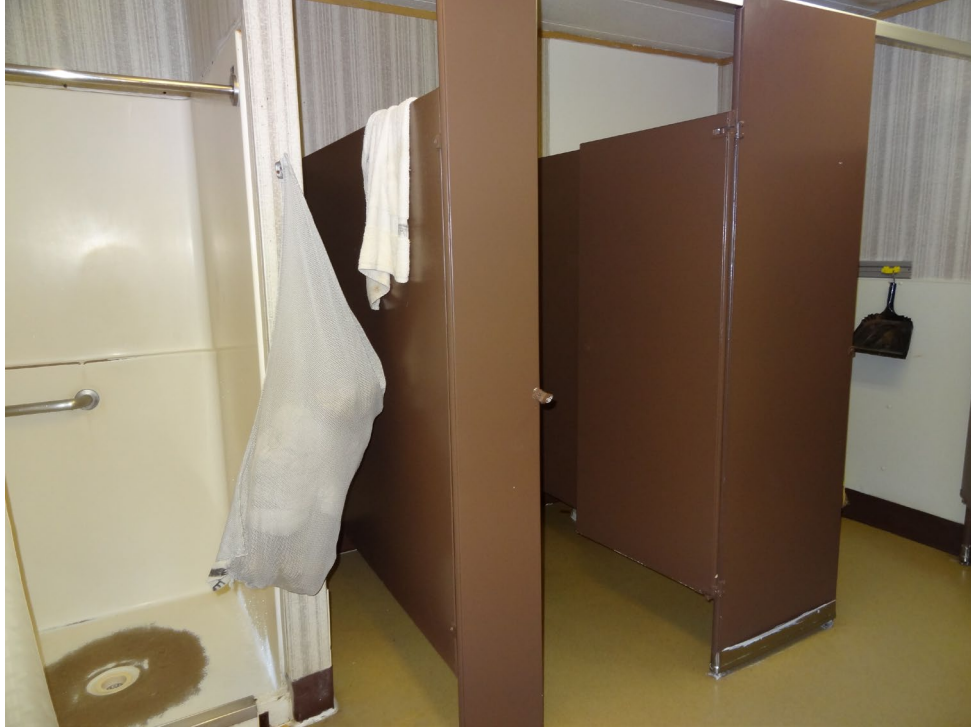
Preferred Housing Unit E - Building #2212  
Description: Complete ADA Retrofit.

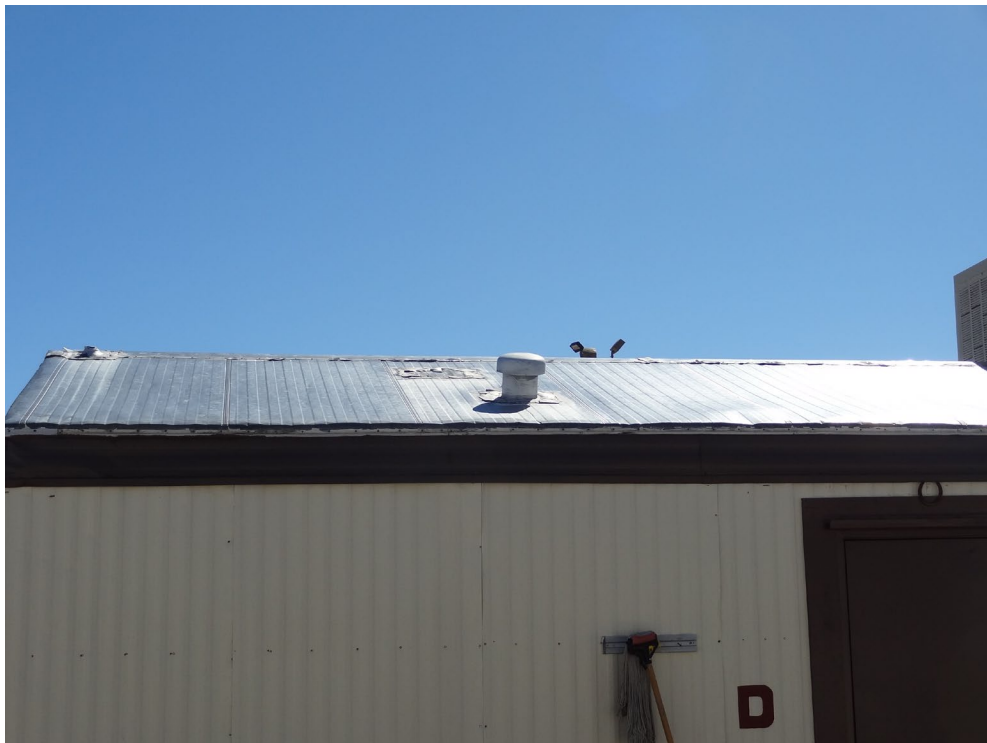
The standing seam metal roof on this building was in poor condition at the time of the survey and had active leaks. It is recommended that this building be re-roofed in the next 2-3 years with a new single-ply roofing system which will be installed directly over the existing metal roof. This will allow the roof to qualify for the statewide roofing program warranty and preventative maintenance agreement.

Preferred Housing Unit D - Building #2211  
Description: Roof Replacement.

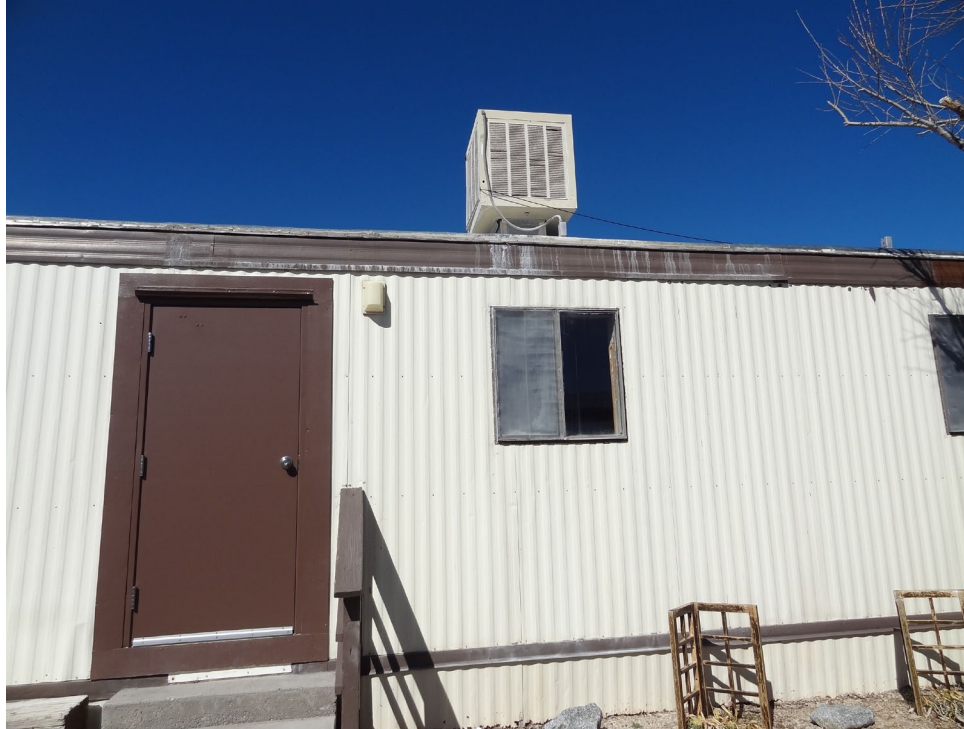
The windows are original, single pane construction in a metal frame. These older windows are drafty and not energy efficient. This project recommends replacing the windows with dual pane, higher efficiency units. This estimate is for the replacement of 4 units. Removal and disposal of the existing windows is included in this estimate.

Preferred Housing Unit D - Building #2211  
Description: Evaporative Cooler & Window Replacement.

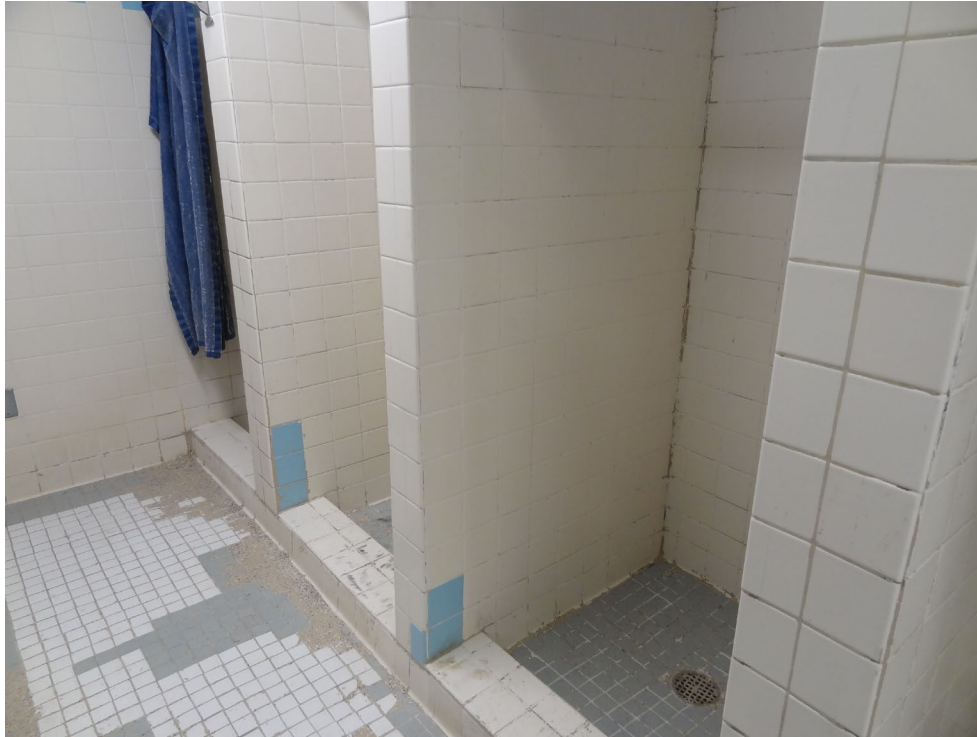
Housing A B C / Culinary Unit - Building #2210  
Description: ADA Restroom Upgrade.

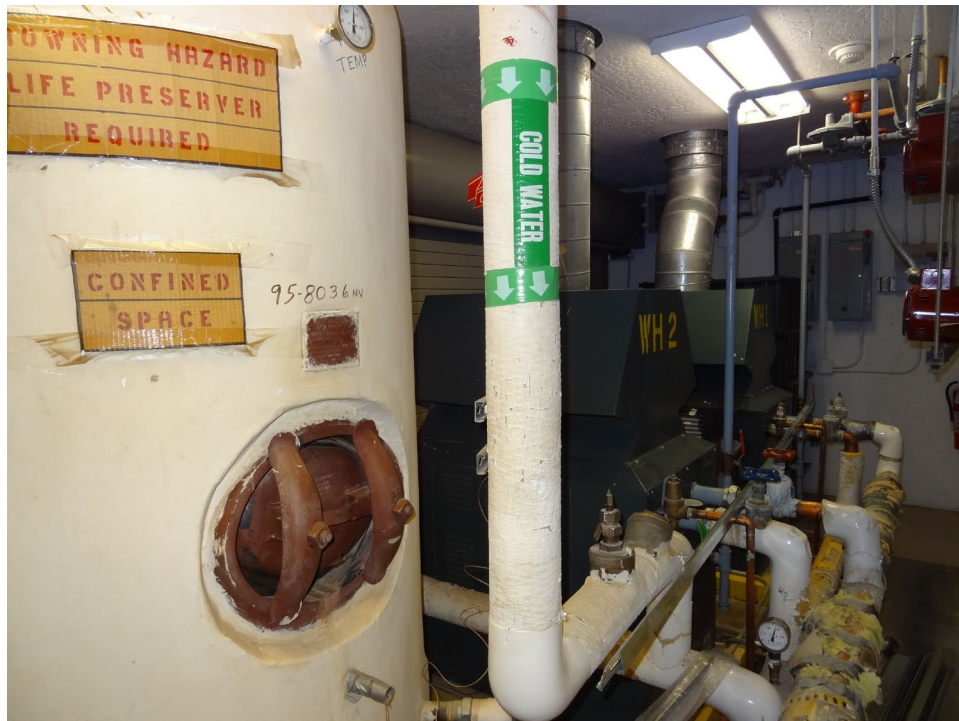
The hot water boilers, controls and mixing valves servicing the building are original dating back to 1995. The life expectancy of these units is 20 to 25 years with proper maintenance and with a water treatment program in place. Replacement parts for performing routine and emergency maintenance are hard to find for this old equipment. This project would provide for the removal and the disposal of the existing boilers, controls and mixing valves and will replace with all new equipment. This estimate includes all required connections to utilities and equipment. The estimate is based on 505 MBH output hot water boilers. The existing chemical water treatment system will need to be tested and adjusted once equipment is operational. \$2,000 is included in this estimate for testing of the chemical water treatment system.

Housing A B C / Culinary Unit - Building #2210  
Description: Hot Water Boiler Replacement.

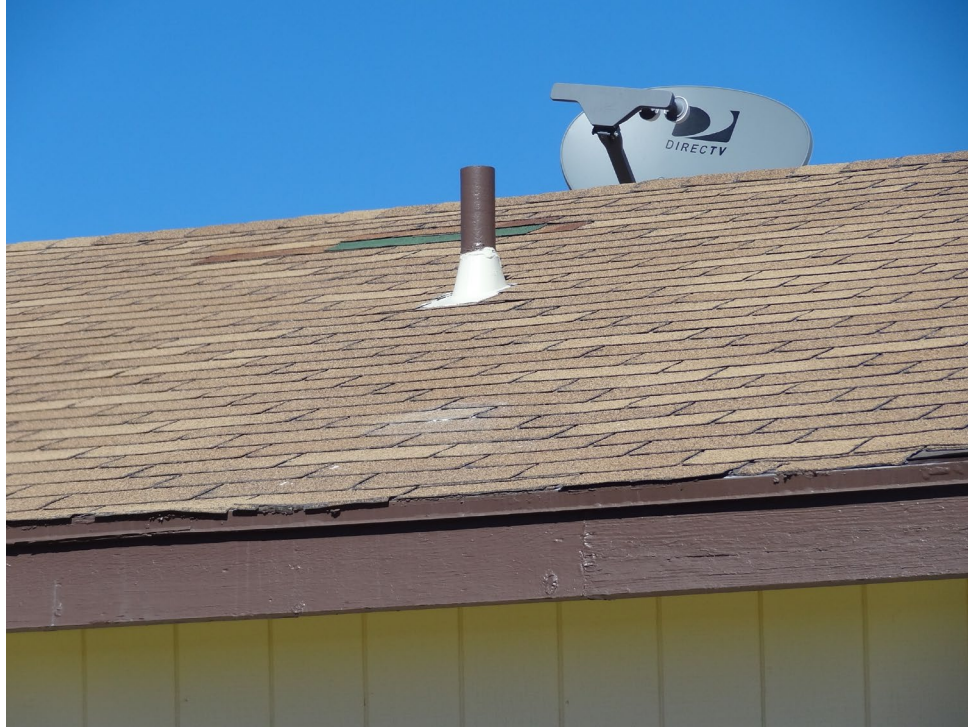
The asphalt composition shingle roof on this building was in poor condition at the time of the survey. It is recommended that this building be re-roofed in the next 2-3 years with a new 50 year asphalt composition shingle roof and new underlayment. This estimate includes the removal and the disposal of the old roof.

Housing A B C / Culinary Unit - Building #2210  
Description: Roof Replacement.

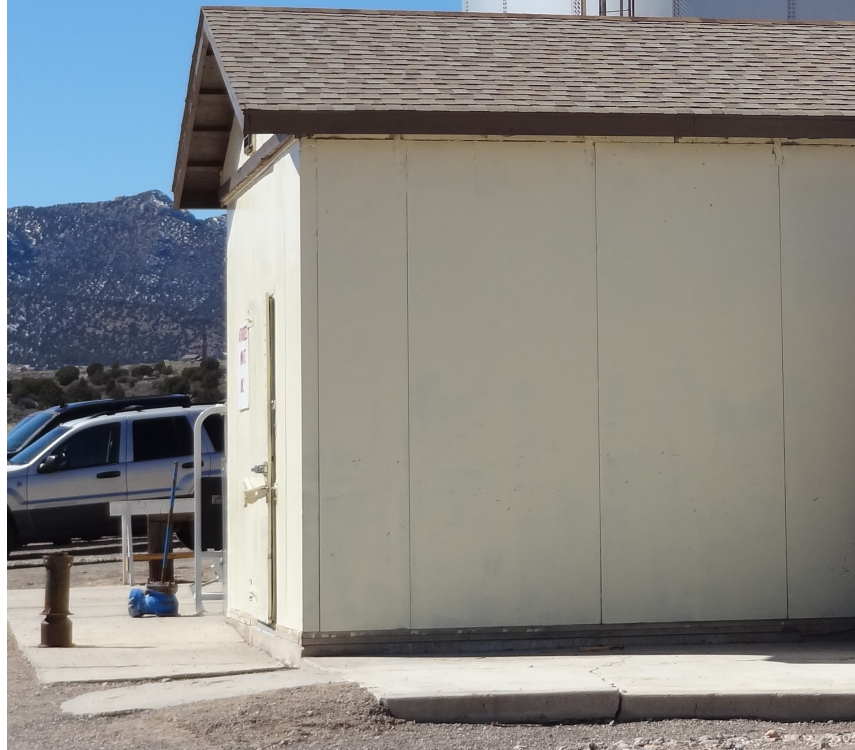
Walk-In Cooler Storage - Building #1366  
Description: Exterior Landing Installation.

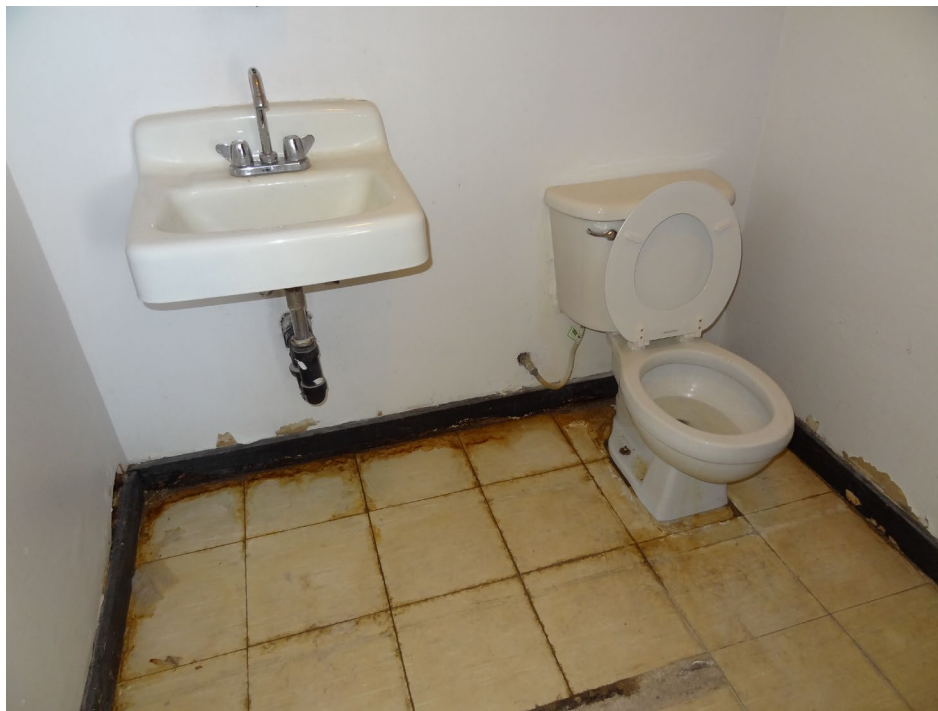
Multi-purpose / Shop - Building #1364  
Description: ADA Restroom Upgrade.

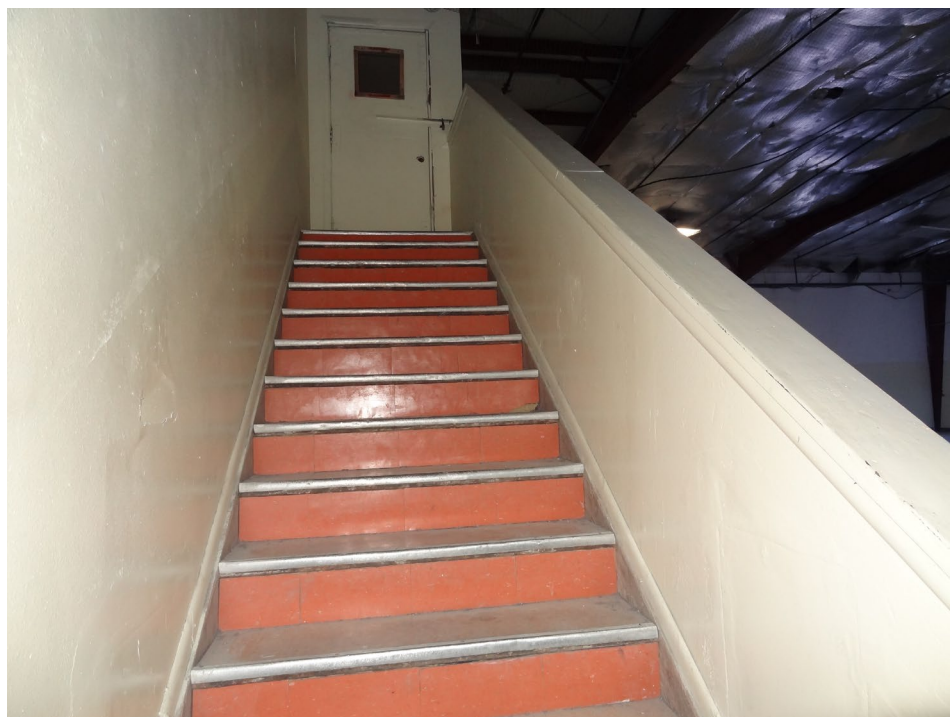
Multi-purpose / Shop - Building #1364  
Description: Interior Stair Handrail Replacement.

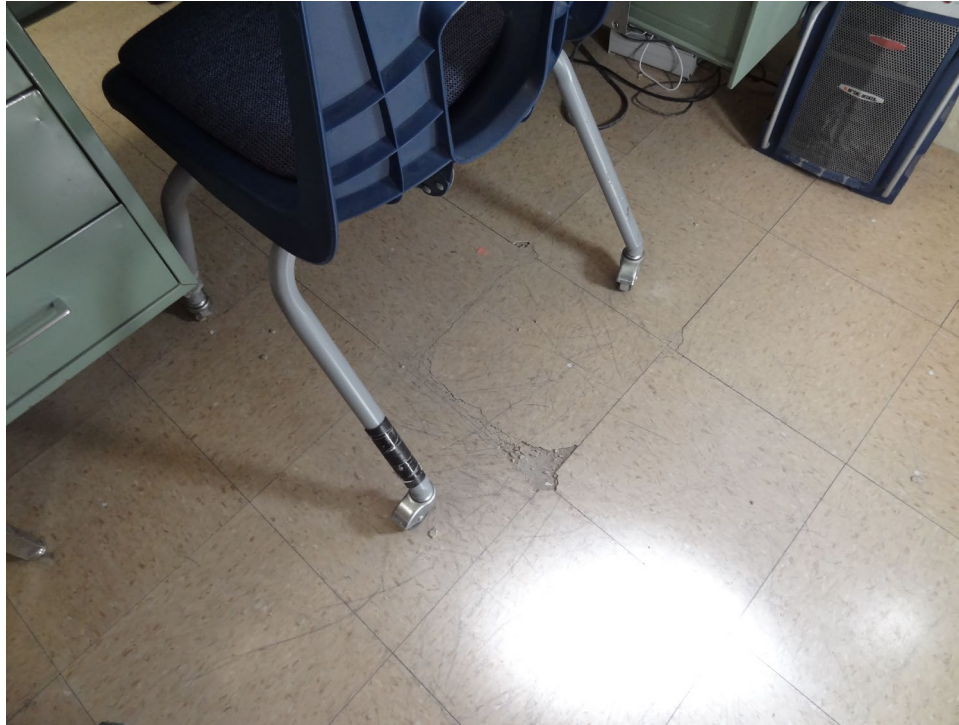
Multi-purpose / Shop - Building #1364  
Description: VCT Floor Replacement.

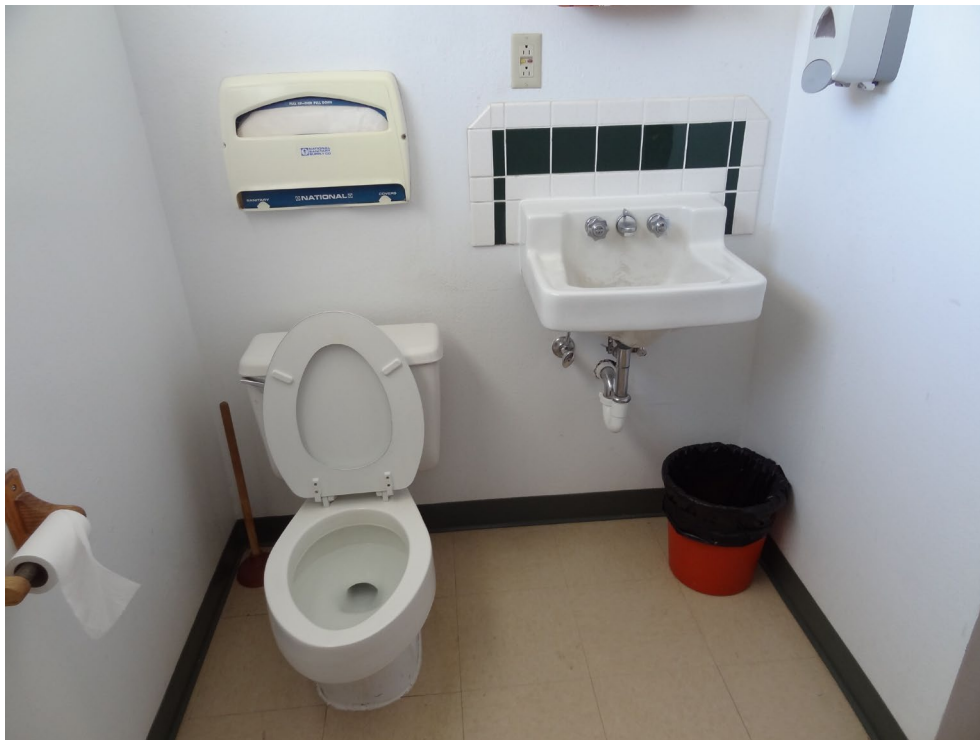
PCC NDF Office - Building #0863  
Description: Non-ADA Compliant Restroom.

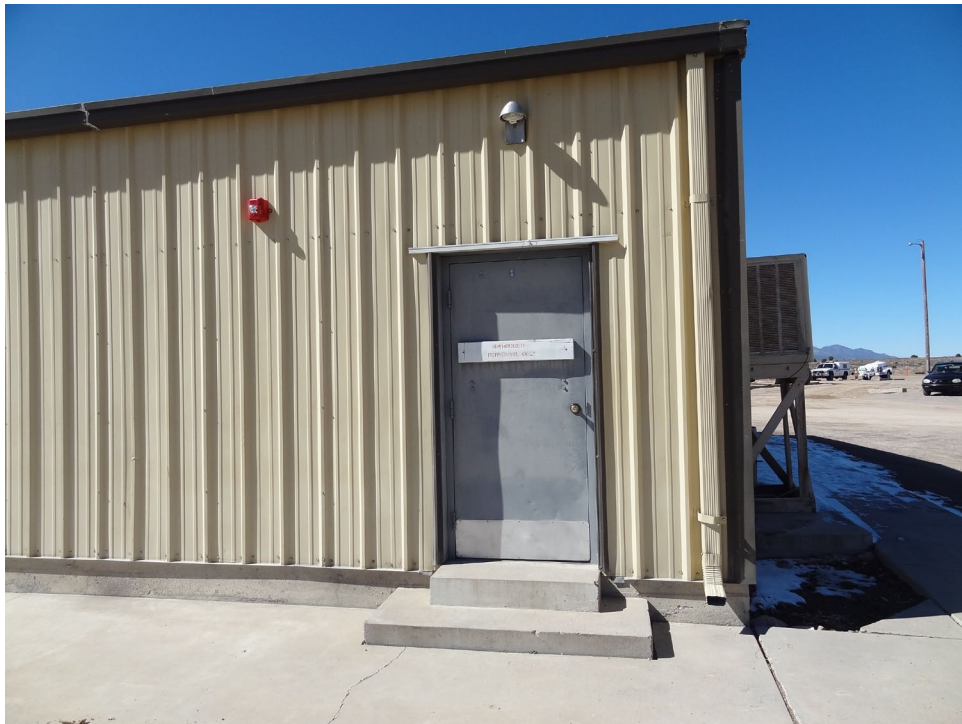
PCC NDF Office - Building #0863  
Description: Exterior Landing Upgrade.
