State of Nevada  
Department of Health & Human Services  
Division of Child & Family Services  
Caliente Youth Center  
Facility Condition Analysis

# CALIENTE YOUTH CENTER

U. S. Highway 93 North  
Caliente, Nevada 89008

**Site Number: 9950**  
**STATE OF NEVADA PUBLIC WORKS BOARD**  
**FACILITY CONDITION ANALYSIS**

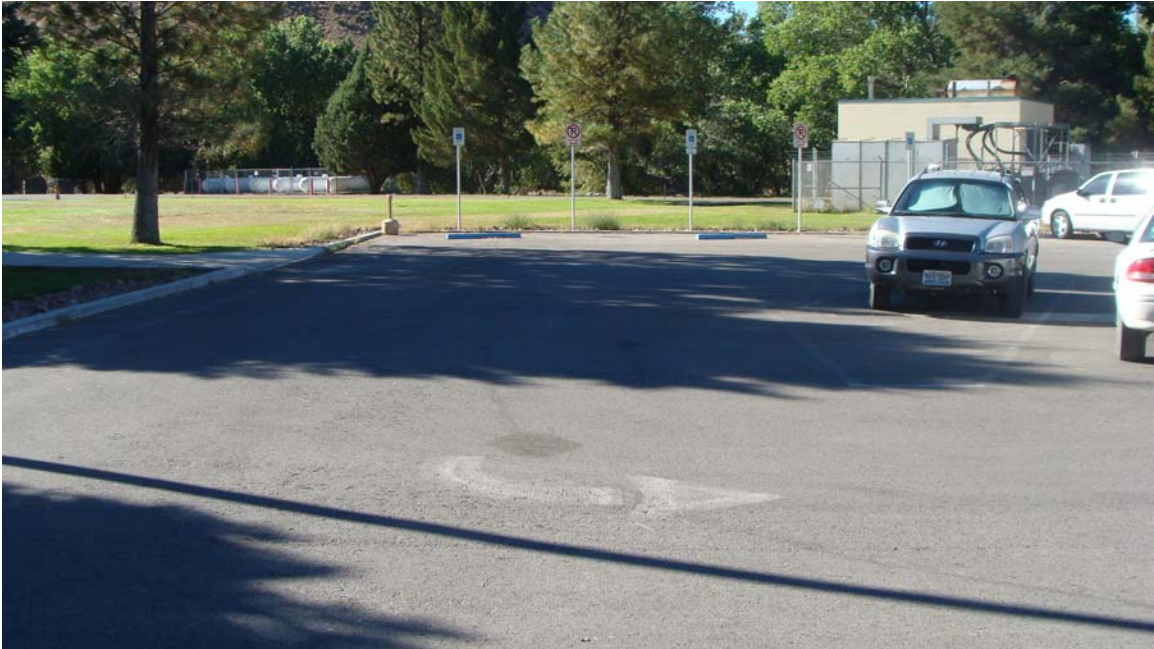
Caliente Youth Center Site - Site #9950  
Description: ADA accessible parking.

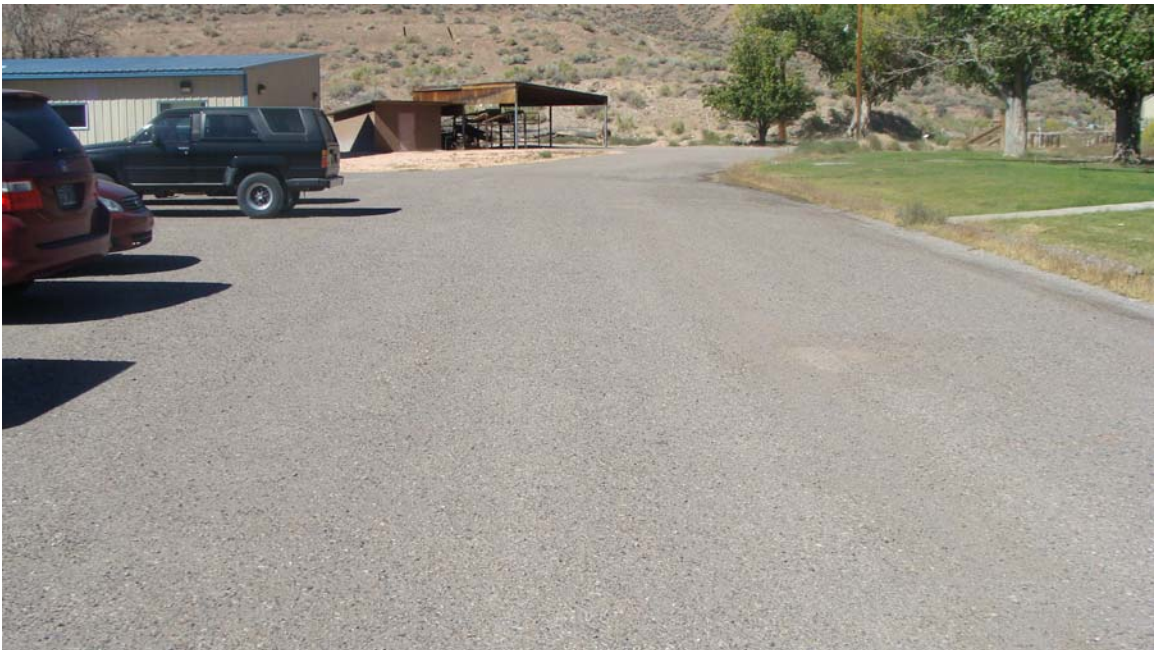
Caliente Youth Center Site - Site #9950  
Description: Old School parking area / driveway in need of a slurry seal.

It is important to maintain the asphalt concrete paving on the site. This project would provide for minor crack filling and slurry sealing of the paving site wide including access roads, parking areas and the maintenance yard. Striping is included in this estimate. This project should be scheduled on a 5 year cyclical basis to maintain the integrity of the paving and prevent premature failure. 125,000 square feet of asphalt area was used to generate this estimate.

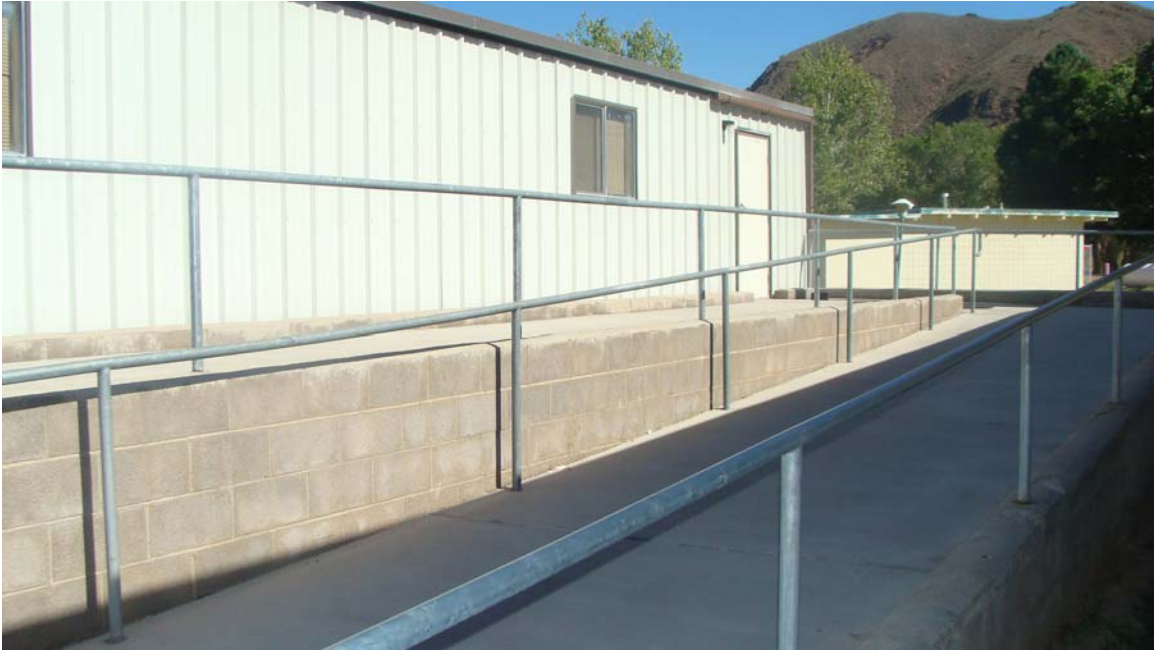
CYC Modular Offices - Building #0199  
Description: Exterior of structure and ADA ramp.

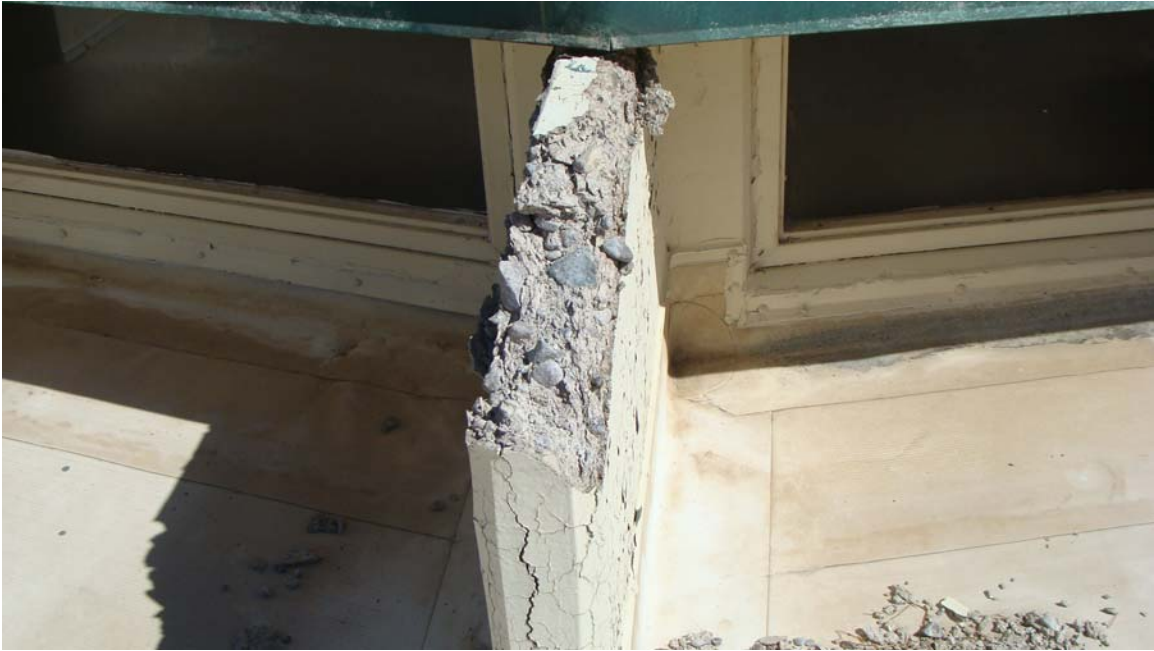
CYC Aurora Dormitory - Building #0211  
Description: Damaged concrete roof support.

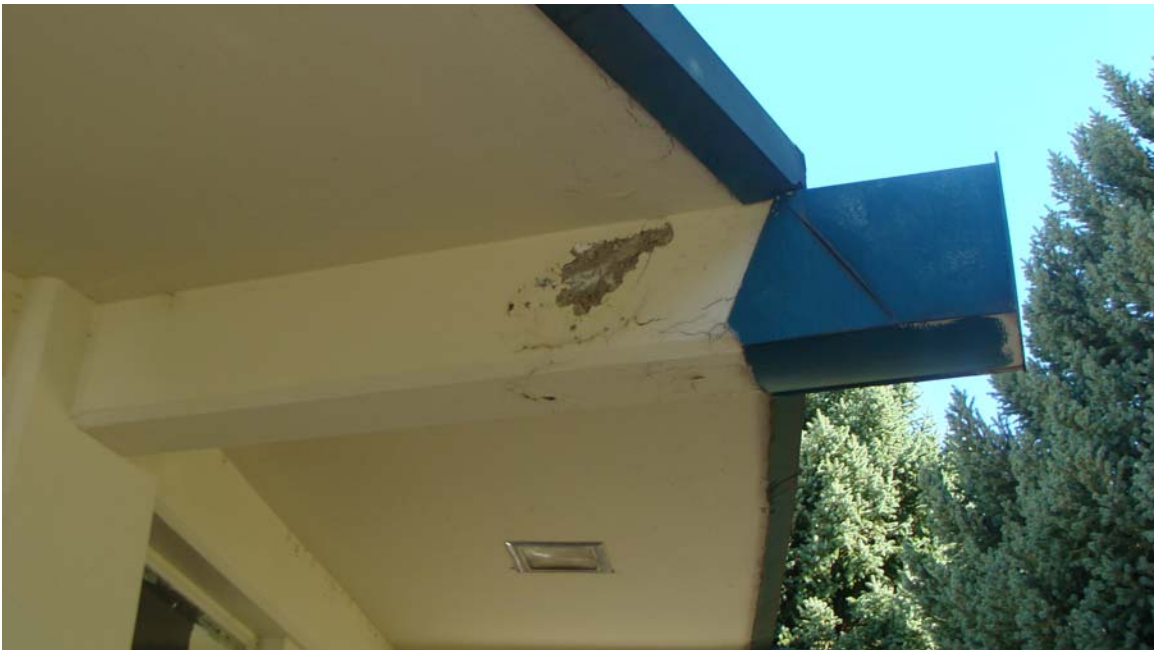
CYC Beowawe Dormitory - Building #0212  
Description: Damaged concrete roof support.

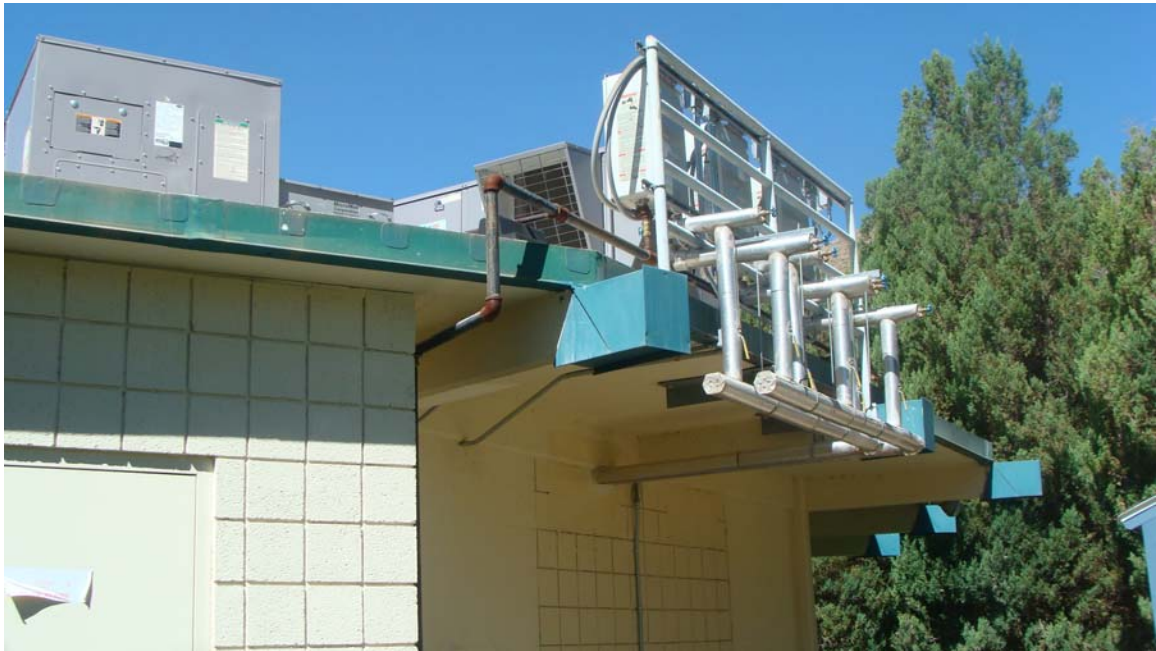
CYC Jarbidge Dormitory - Building #0215  
Description: Roof mounted HVAC and water heating systems.

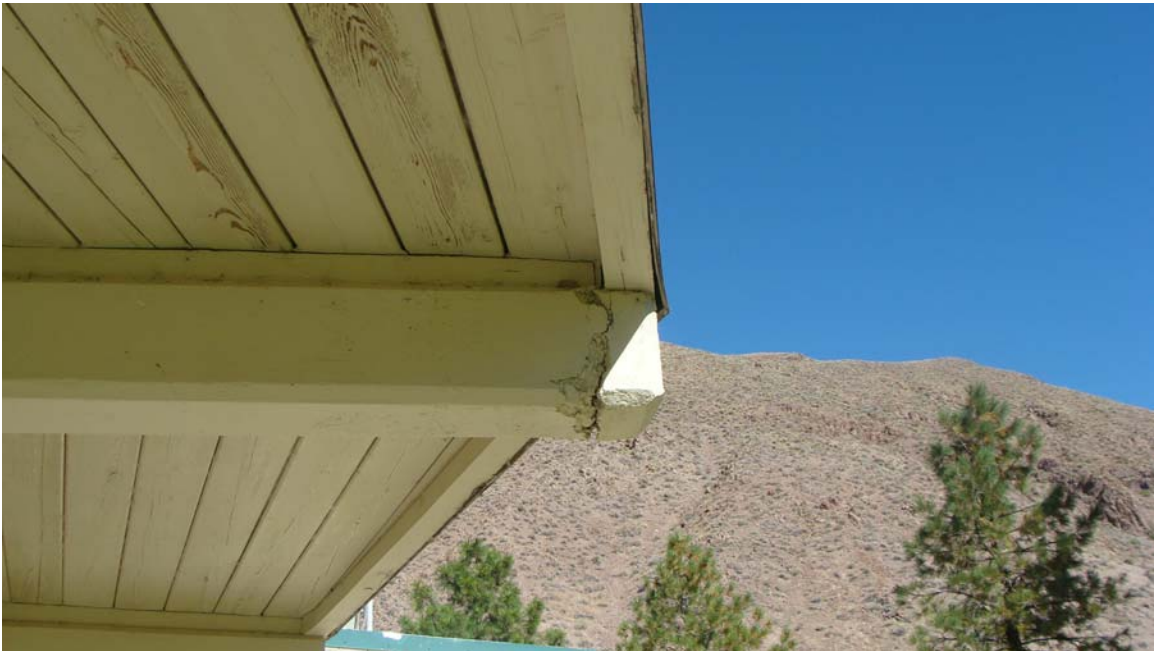
CYC Lincoln Dormitory - Building #0217  
Description: Damaged concrete roof support.

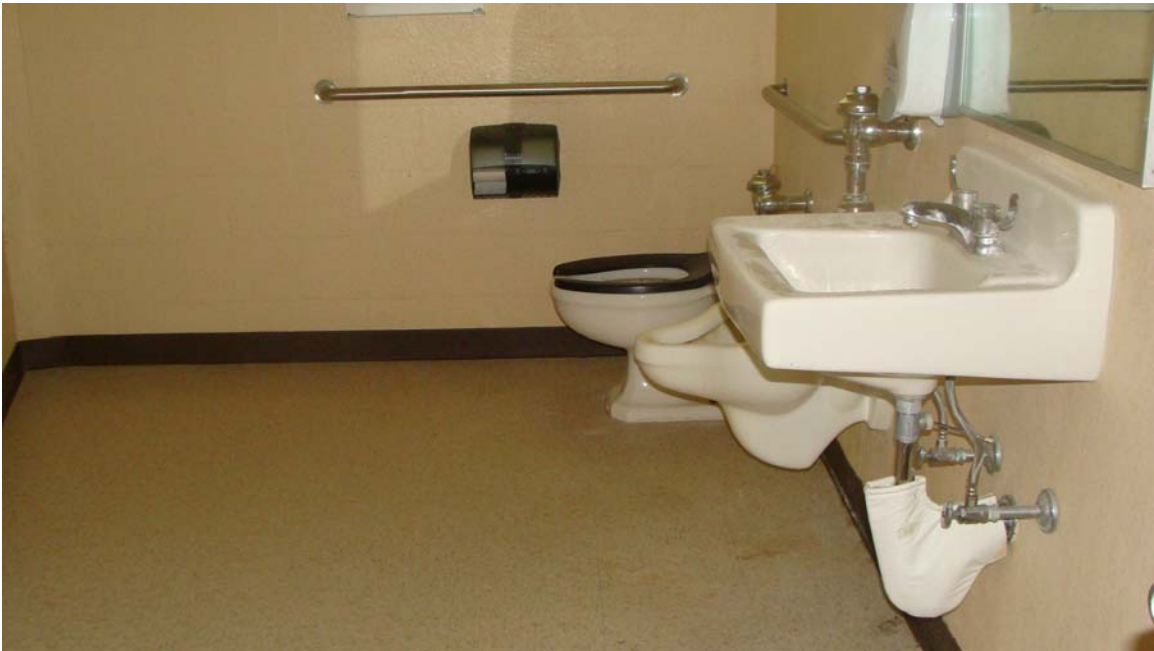
CYC Administration - Building #0218  
Description: Public restrooms in need of an ADA upgrade.

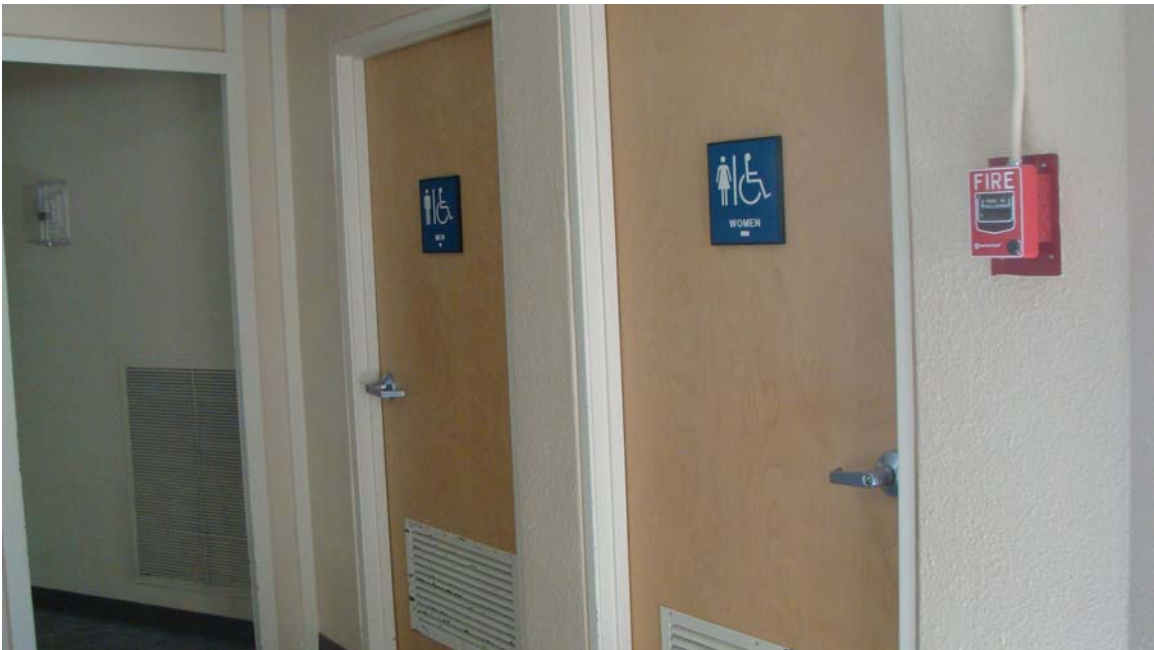
CYC Administration - Building #0218  
Description: ADA signage in need of modifications.

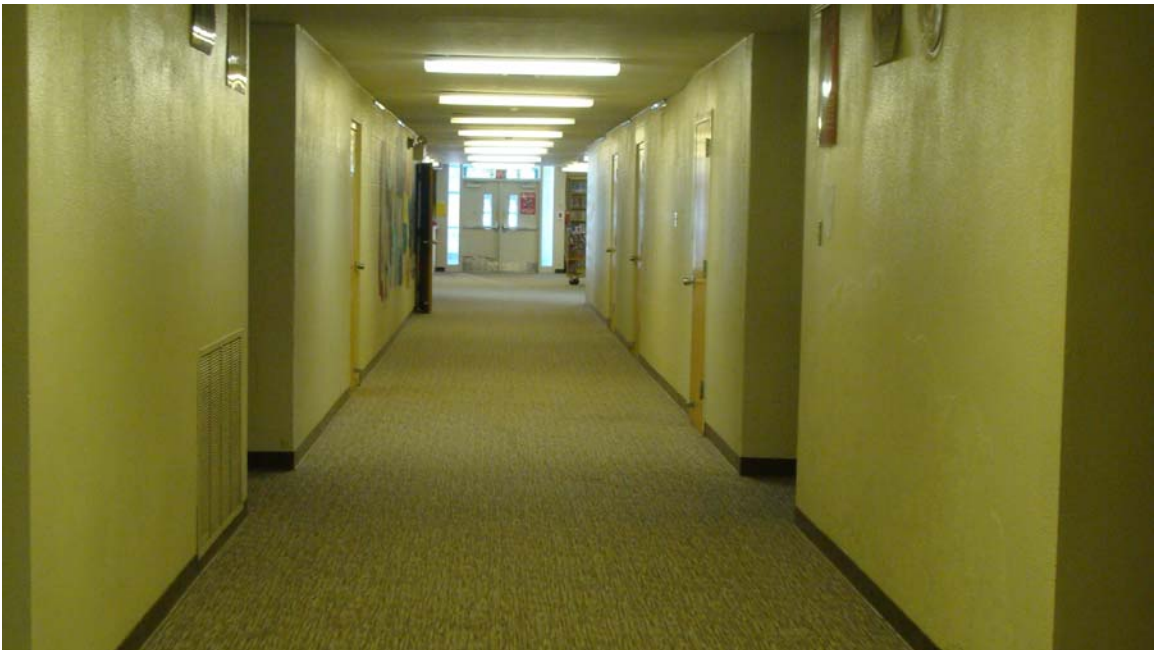
CYC School - Old - Building #0219  
Description: View of the corridor.

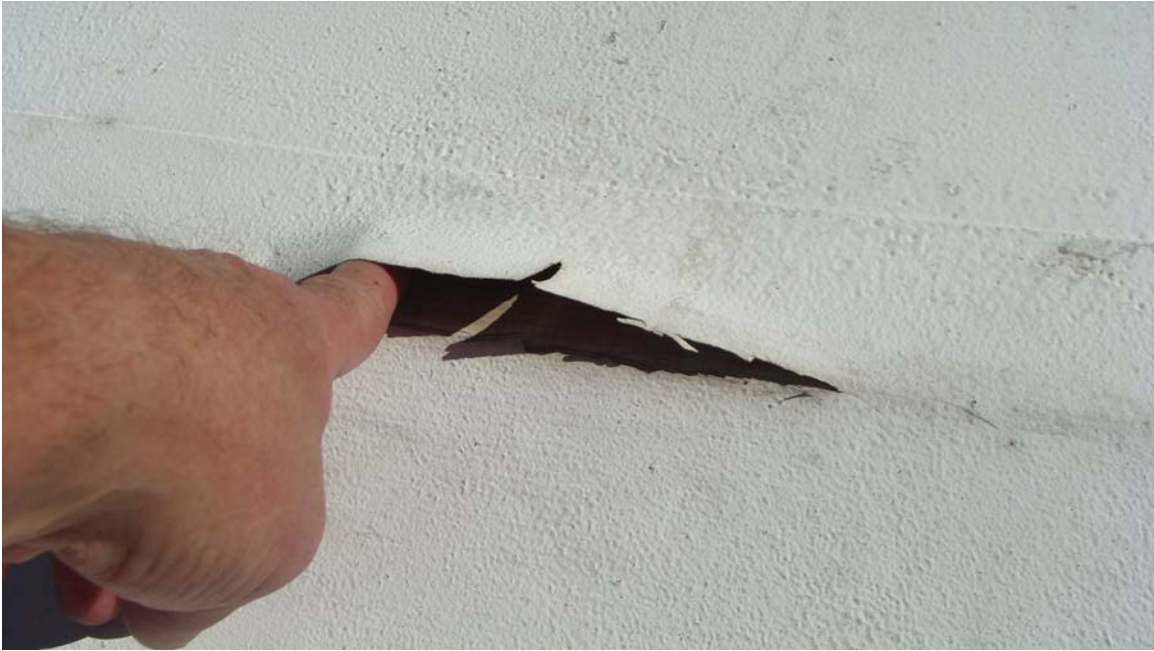
CYC Culinary / Dining / Gym / Laundry - Building #0221  
Description: Damaged roof membrane.

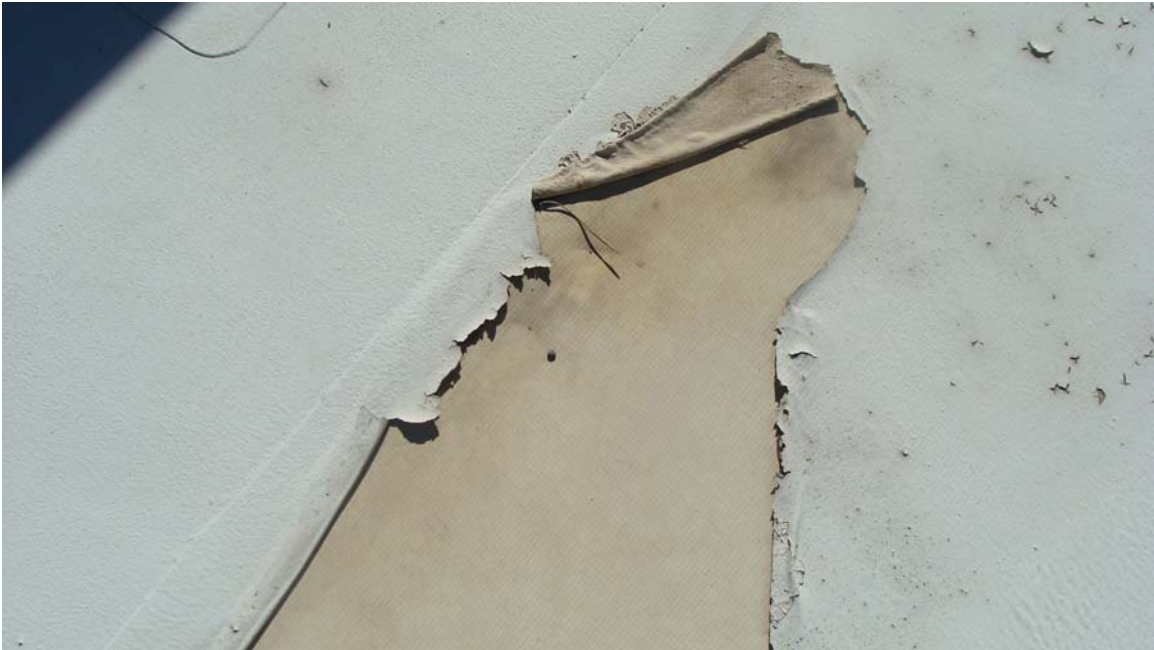
CYC Culinary / Dining / Gym / Laundry - Building #0221  
Description: Damaged roof membrane.

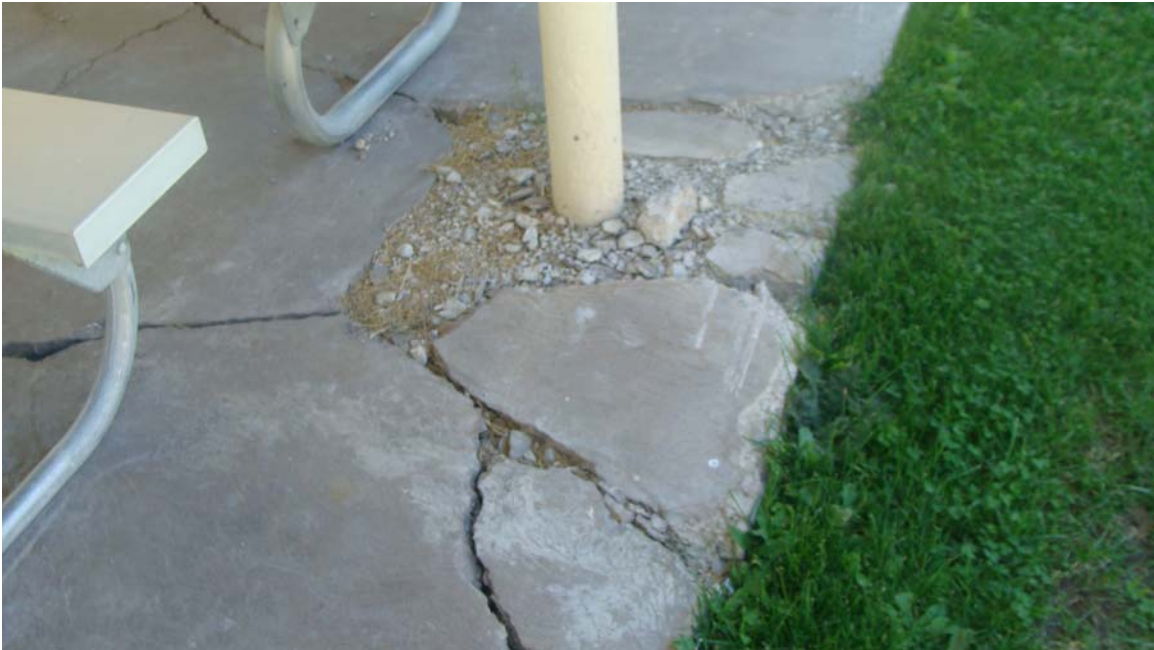
CYC Ramada - Building #0514  
Description: Damaged concrete.

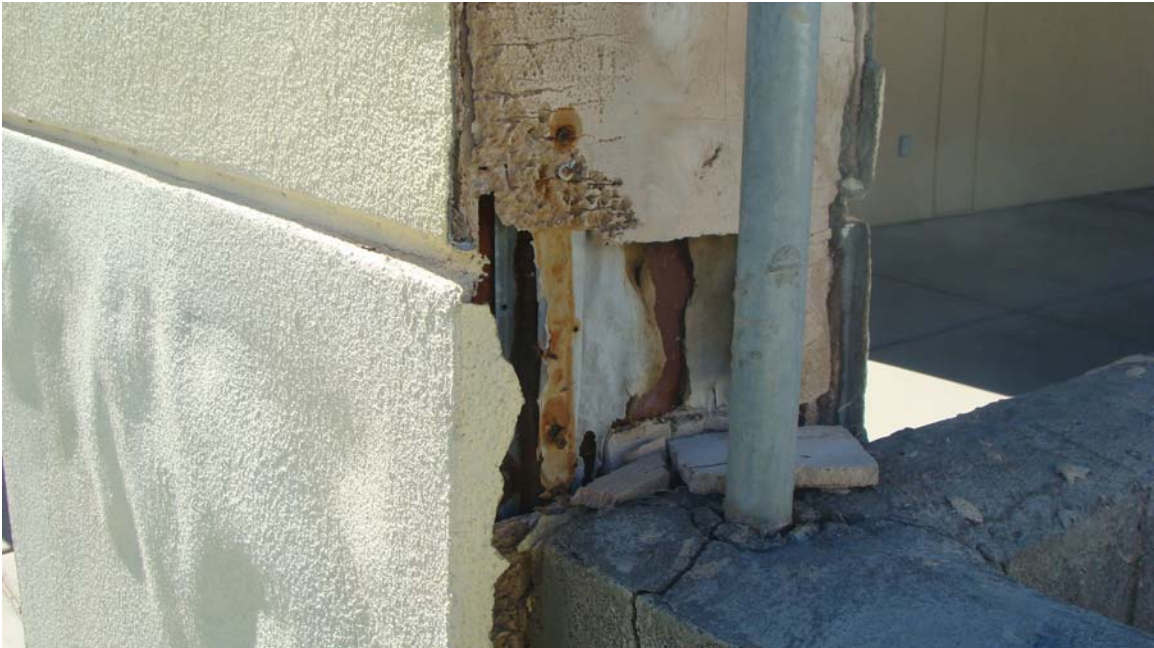
CYC School - New - Building #2001  
Description: Water damaged EIFS.

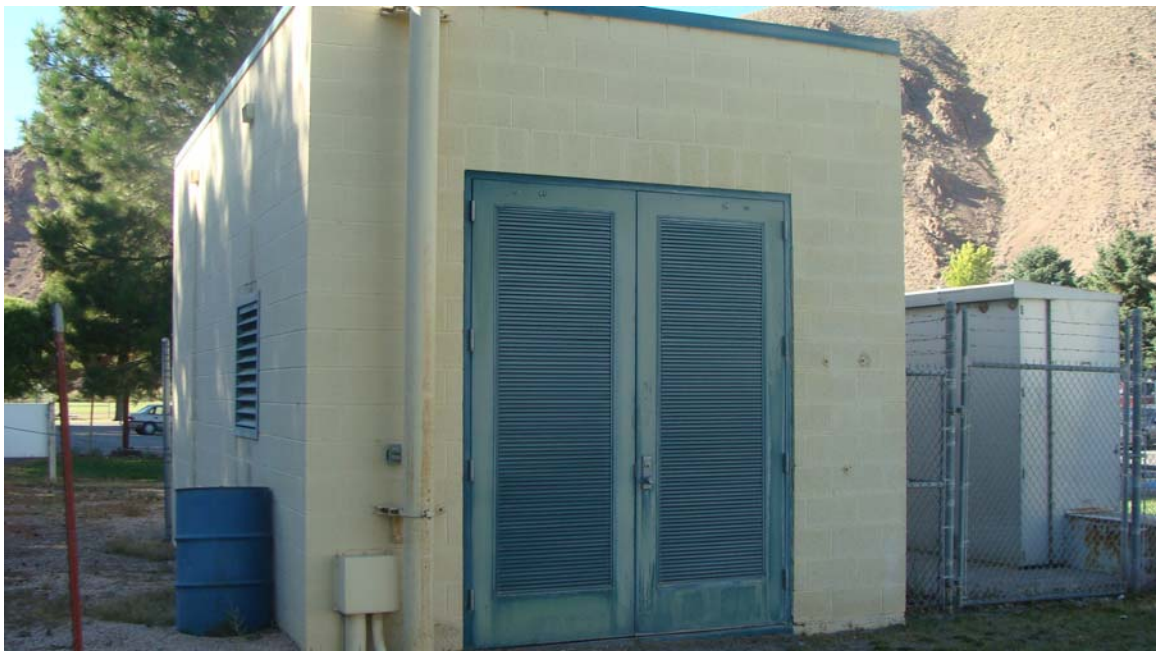
The CYC Generator Building is a concrete masonry unit and steel framed structure with a single-ply roofing system on a concrete foundation. It has a 900 KVA diesel powered generator inside along with automatic switch gear which will power the entire facility in the event of a power outage. The main switchgear for the site is located adjacent to the building.

The exterior metal doors are damaged from age and general wear and tear and have reached the end of their expected life. This project would provide for the replacement of the double door assembly with new metal doors, frame and hardware. Removal and disposal of the existing doors is included in this estimate.

CYC Generator Building - Building #2166  
Description: Exterior of the building.

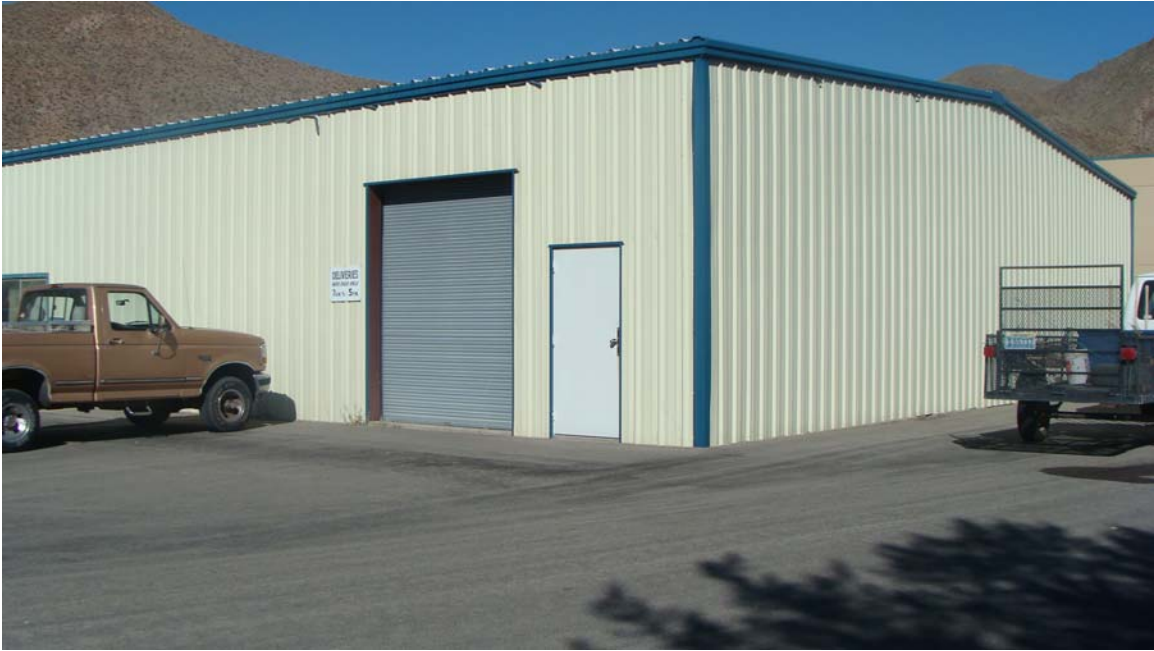
The CYC Maintenance Building is an insulated engineered steel structure on a concrete foundation. It has a storage area as well as vehicle bays with overhead coiling doors which provides indoor space for maintenance and servicing of equipment. There are two small ceiling mounted heating units but the facility is lacking a cooling system, fire alarms and fire sprinklers.

This building is lacking a fire detection and alarm system. It is recommended that a fire detection and alarm system be installed. When completed, the new system will provide visual, as well as audible notification, in accordance with ADA requirements located in ICC/ANSI A117.1- 2006 Section 7 and the 2006 International Fire Code.

The existing HVAC system consists of ceiling mounted electric heaters and does not have any cooling equipment. The electricity powered heaters are inefficient and should be replaced with propane fired heaters. There is a need for cooling equipment as well to provide a comfortable work environment in the summer. This project would provide for replacing the existing heaters with exterior ground mounted packaged units that provide propane fired heating as well as air conditioning. Propane gas service will be required and is included in the cost.

The windows are original, single pane construction in a metal frame. These older windows are drafty and not energy efficient. This project recommends replacing the windows with dual pane, higher efficiency units. This estimate is for the replacement of 2 units. Removal and disposal of the existing windows is included in this estimate.

CYC Maintenance Building - Building #2168  
Description: Exterior of the building.

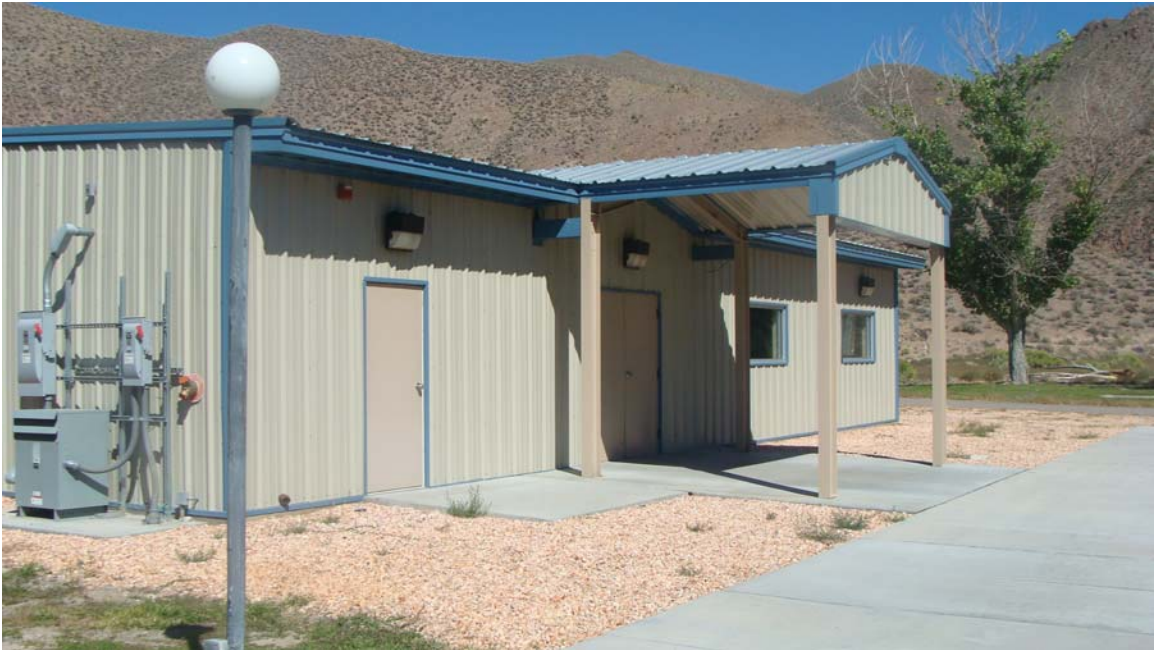
The CYC Recreation Center is an insulated engineered structure on a concrete foundation which provides space for recreational activities. There are Men's and Women's designated ADA restrooms which are mostly compliant, fire alarm and sprinklers and two exterior mounted HVAC packaged units.

There are no occupancy sensors installed in the restrooms to control lighting. It is recommended to install sensors in the Men's and Women's restrooms in order to reduce energy costs. This project provides for purchase and installation of 2 sensors.

CYC Recreational Building - Building #2943  
Description: Exterior of the building.

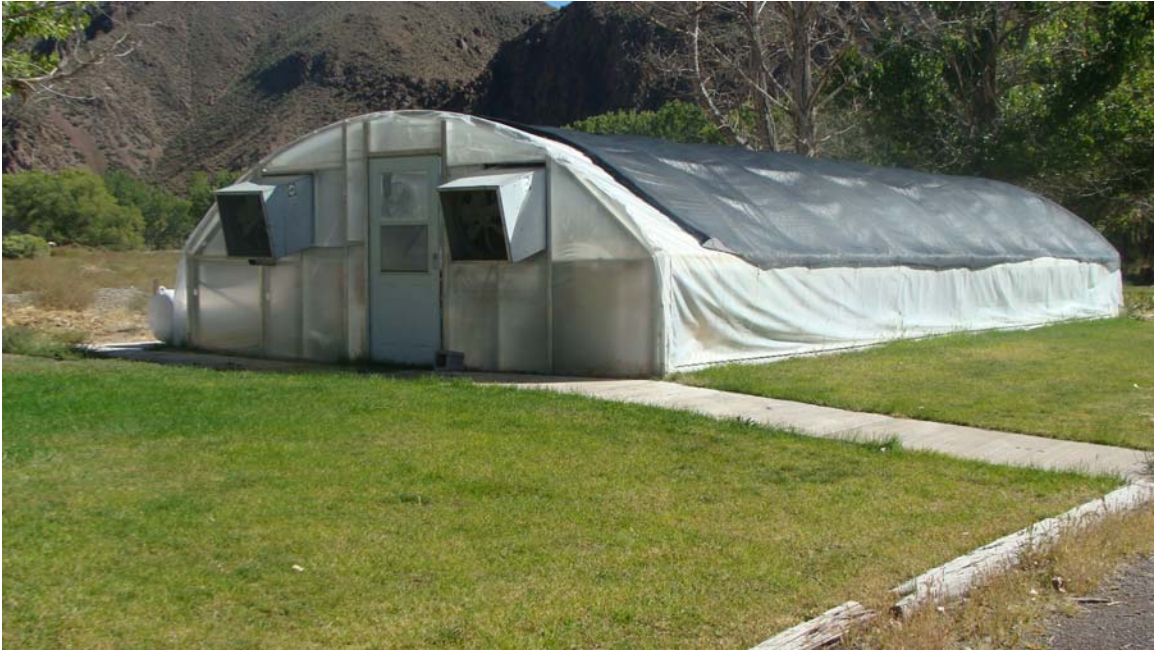
The CYC Greenhouse is a steel and polycarbonate framed structure on a concrete foundation. It is located along the eastern side of the site and is in good condition.

CYC Greenhouse - Building #3071  
Description: Exterior of the building.

It is important to maintain the finish, weather resistance and appearance of the structure. This project recommends work to protect the exterior building envelope including repair or replacement to the exterior membrane, repair or replacement of the polycarbonate wall panels and caulking around the flashing, fixtures, and other penetrations to maintain the building in good, weather tight condition. It is recommended that this project be implemented in the next 2-3 years and it is also recommended that this project be scheduled on a cyclical basis to maintain the integrity of the structure.

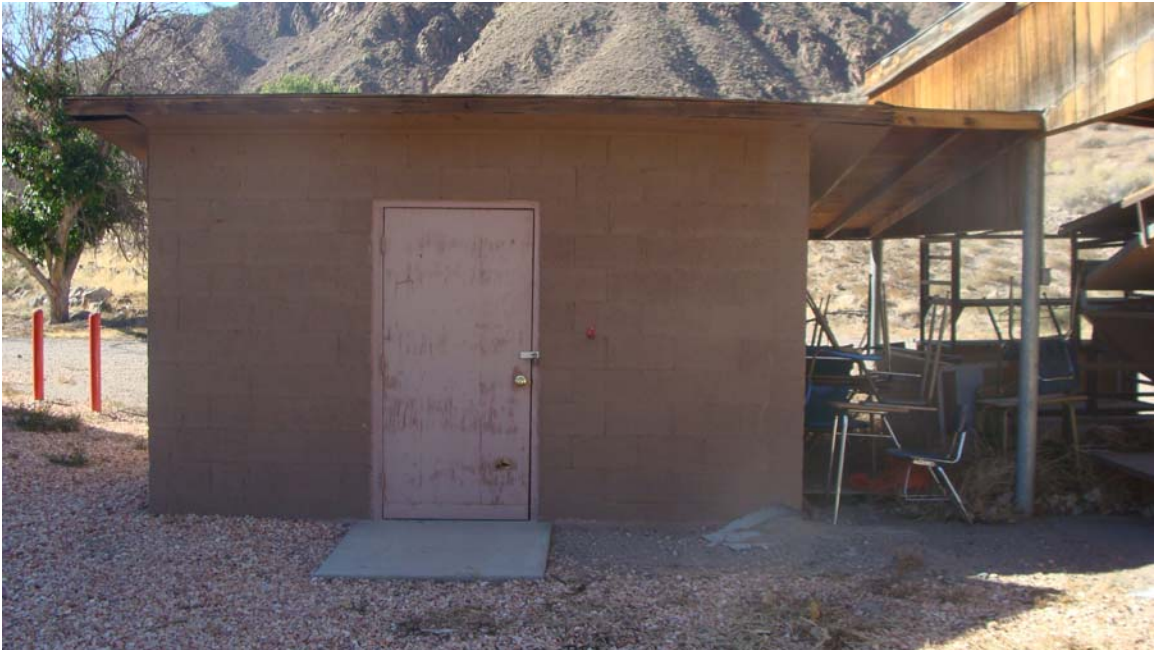
The CYC Work Crew Storage is a concrete masonry unit and wood framed structure with a rolled asphalt roofing system on a concrete foundation. The building is in fair condition.

CYC Work Crew Storage- Building #3074  
Description: Exterior of the building.

It is important to maintain the finish, weather resistance and appearance of the building. This project would provide funding to protect the exterior of the building excluding the roof. Included in the cost is sealing the concrete masonry units, sanding, priming and painting the wood siding and caulking of the windows, flashing, fixtures and all other penetrations. It is recommended that the building be painted in the next 2-3 years and that this project be scheduled on a cyclical basis to maintain the integrity of the structure.

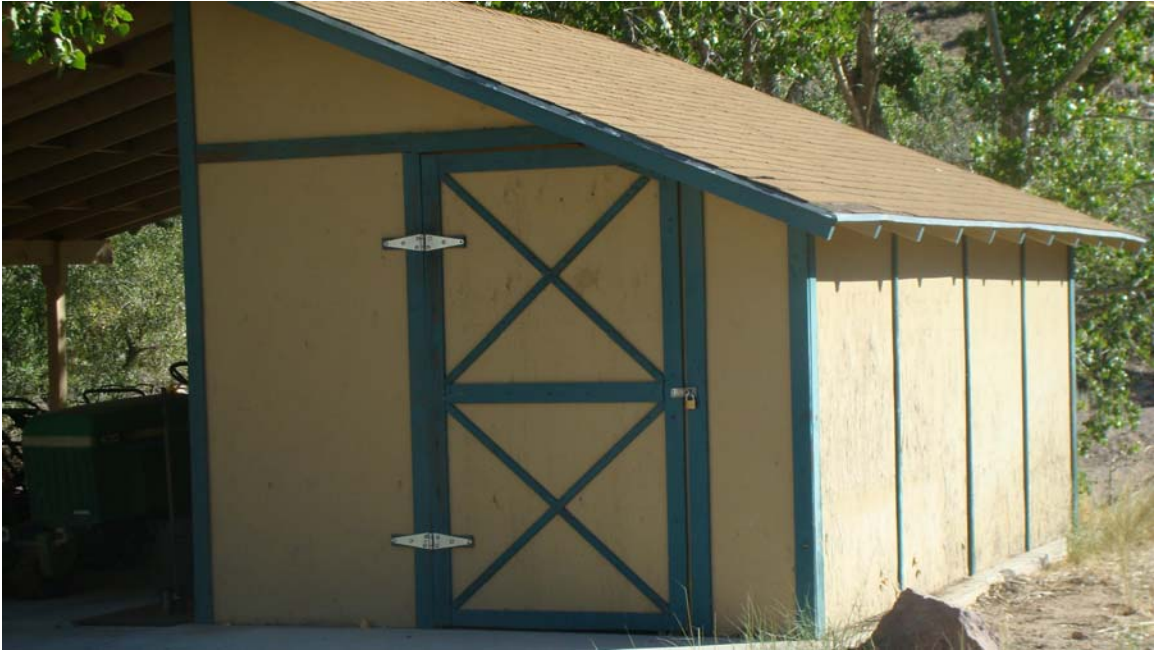
The CYC Industrial Arts Storage building is a wood framed structure with a composition roofing system on a concrete foundation. The building is in good shape.

The asphalt composition shingle roof on this building was in poor condition at the time of the survey. It is recommended that this building be re-roofed in the next 2-3 years with a new 50 year asphalt composition roofing shingle and new underlayments. This estimate includes removal and disposal of the old roofing.

CYC Industrial Arts Storage- Building #3075  
Description: Exterior of the building.

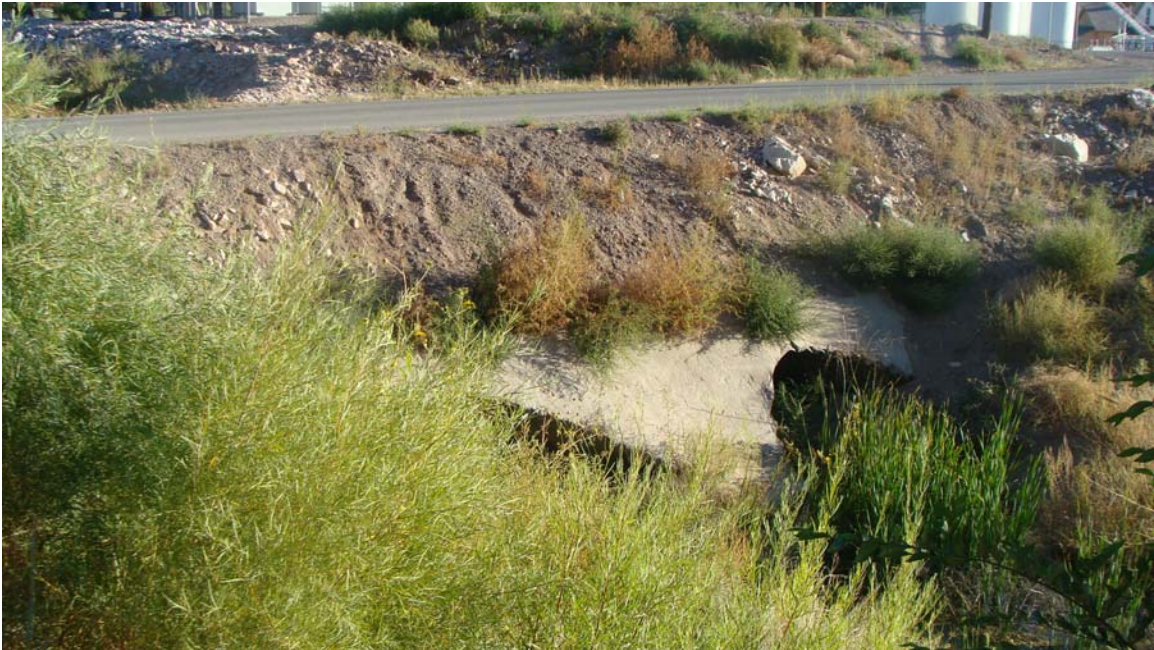
The main entrance to the Caliente Youth Center crosses a local waterway. Two large (10-12 foot diameter) culverts were installed when laying the road base to the site. Over the years, these culverts have silted in, which could damage the road during a flash flood, destroying access to the site. Alternately, the culverts could act as a dam, resulting in flooding of the entire site, property damage and possibly injury or death. This project recommends cleaning the culverts, to return them to good operational condition and minimize damage to the road and site. Hydraulic dredging was used to determine the cost basis for this project, but other methods may be available to mitigate the silt accumulations.

CYC Access Road- Building #9950  
Description: Culverts under roadway.
