# STATE OF NEVADA STATE PUBLIC WORKS DIVISION

## FACILITY CONDITION ASSESSMENT REPORT FOR:

DEPT OF HEALTH AND HUMAN SERVICES  
DIVISION OF CHILD AND FAMILY SERVICES  
CYC

Survey Date: 3/6/2024  
Distribution Date: 8/21/2024

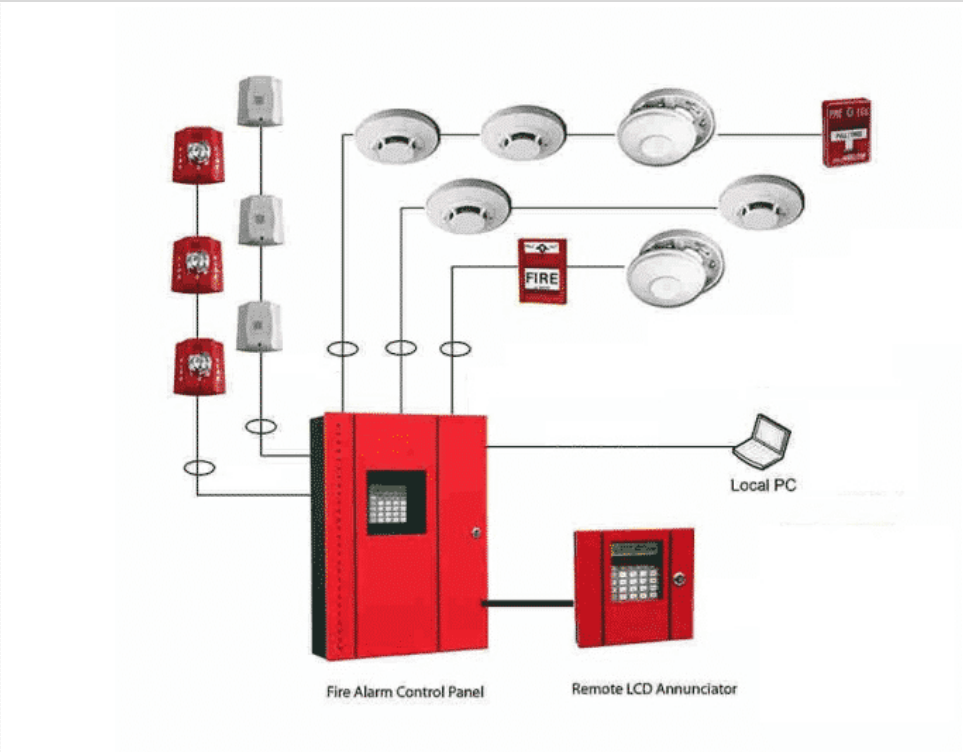
INTERNET IMAGE

QUANTITY	UNITS	TOTAL	SF COST
The fire alarm system protecting all buildings was replaced in 2020. All individual building systems are fully operational. However, the inter-building communication is non-functional. Without this, remote monitoring of the system is not possible. This project will fund the required repairs to restore the fire alarm to full functionality.	1	Package	\$15,000.00	-

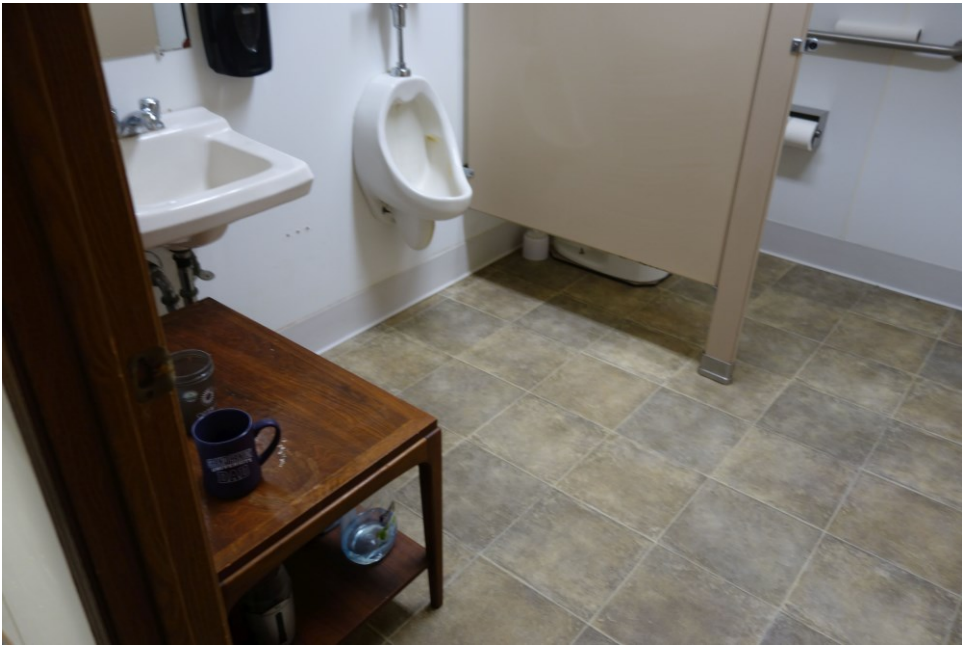
0199 CYC MENTAL HEALTH BUILDING

QUANTITY	UNITS	TOTAL	SF COST
<p>The men's and women's designated ADA restrooms do not meet the ADA requirements. A complete retrofit is necessary. This project would provide funding for construction of two unisex accessible restrooms. These items may include a new sink, toilet, hardware, mirrors, fixtures, flooring and paint. The 2018 IBC, ICC/ANSI A117.1 - 2009, NRS 338.180 and the most current version of the ADA Standards for Accessible Design were used as references for this project.</p> <p>This project or a portion thereof was previously recommended in the FCA report dated 09/21/2010 and 03/01/2017. It has been amended accordingly to reflect conditions observed during the most recent survey date of 03/06/2024.</p>	1	Package	\$25,000.00	\$ 14.00

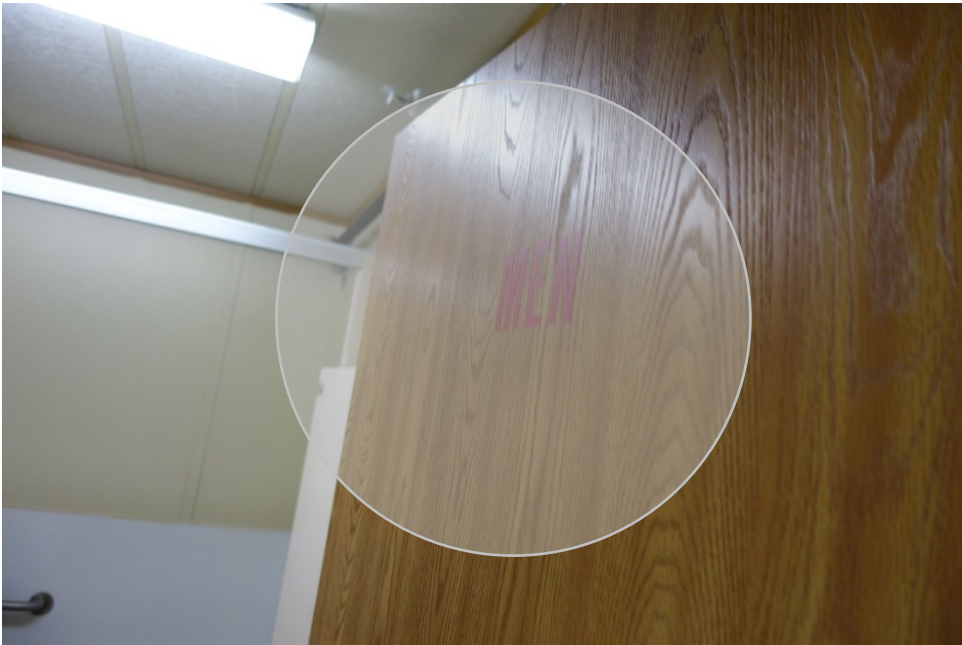
0199 CYC MENTAL HEALTH BUILDING

QUANTITY	UNITS	TOTAL	SF COST
<p>ADA regulations pertaining to building access has established building signage criteria for permanent spaces in buildings. The criteria includes: sign mounting heights and locations; character heights and proportions; raised and Braille characters/pictograms; and sign contrast and finish. The signage in this facility does not comply with these criteria. It is recommended that applicable signage be installed where required. NRS 338.180, IBC - 2018, ICC/ANSI A117.1 - 2009 and the most current version of the ADAAG were used as references for this project.</p> <p>This project or a portion thereof was previously recommended in the FCA report dated 09/21/2010 and 03/01/2017. It has been amended accordingly to reflect conditions observed during the most recent survey date of 03/06/2024.</p>	1	Package	\$ 1,500.00	\$ 1.00

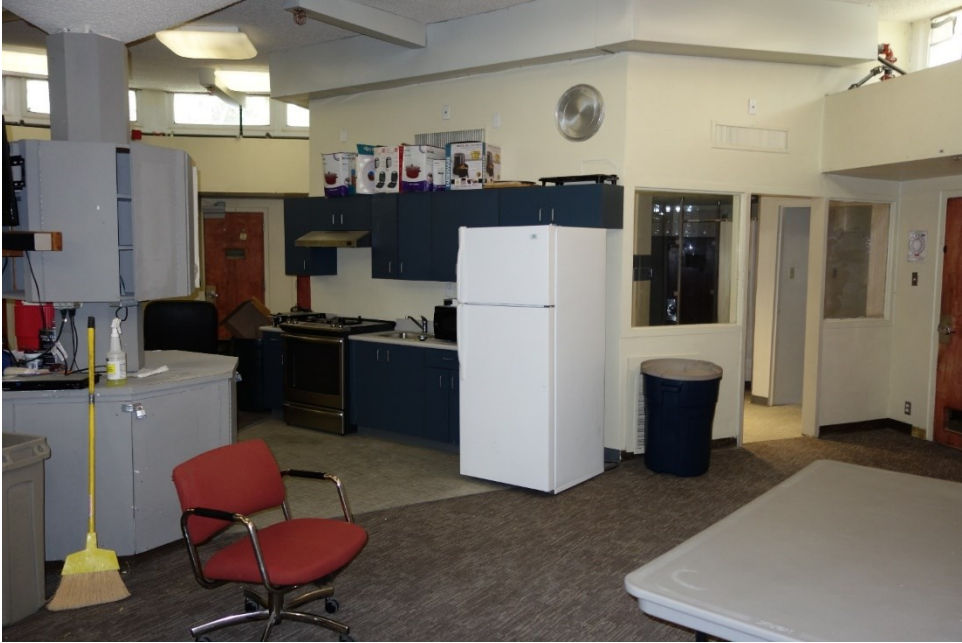
0211 CYC CURRIE DORMITORY

QUANTITY	UNITS	TOTAL	SF COST
The VCT (vinyl composite tile) and carpet in the building are damaged and reaching the end of their useful life. It is recommended that the flooring be replaced. This project would provide for removal and disposal of the existing flooring and installation of new 12x12 VCT with a 4" base and heavy duty commercial grade carpet in the next 2 - 3 years.	4185	Square Foot	\$59,600.00	\$ 14.00

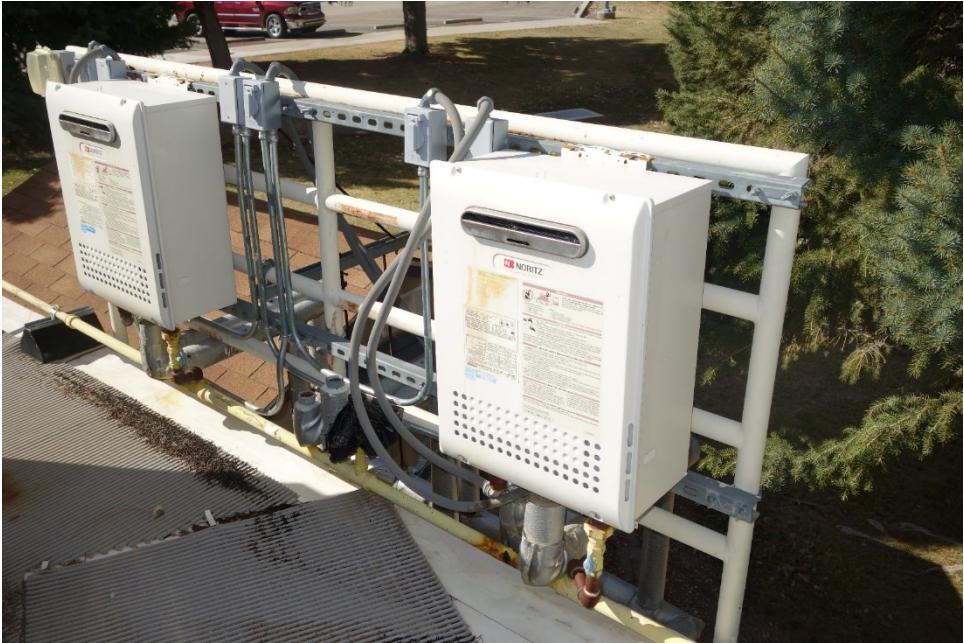
IMAGE FROM 0212 CYC BEOWAWE DORMITORY

QUANTITY	UNITS	TOTAL	SF COST
There are 2 gas fired tankless water heaters located on the roof installed in 2016. They are in fair condition but will be reaching the end of their expected life in the next 8 - 10 years. This project recommends the water heaters be replaced in the next 8 - 10 years. This project also includes removal and disposal of the existing system and all required connections to utilities.	4185	Square Foot	\$20,900.00	\$ 5.00

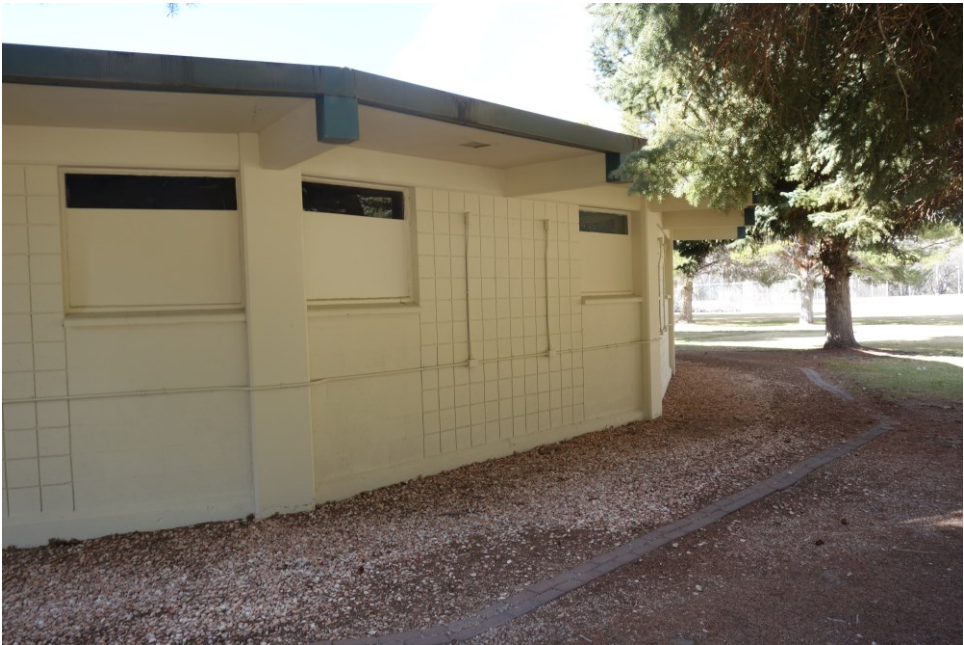
0212 CYC BEOWAWE DORMITORY

QUANTITY	UNITS	TOTAL	SF COST
<p>The building exterior is constructed of Concrete Masonry Unit (CMU) with no insulation. The windows are original to the building and single pane construction. Buildings of this type are not energy efficient. This project recommends adding an Exterior Insulation Finish System (EIFS) over the CMU and replacing the windows with a behavior health rated polycarbonate safety glazing, dual pane, high efficiency units.</p> <p>This project or a portion thereof was previously recommended in the FCA report dated 09/21/2010 and 03/01/2017. It has been amended accordingly to reflect conditions observed during the most recent survey date of 03/06/2024.</p>	1	Package	\$1,008,300.00	\$ 241.00

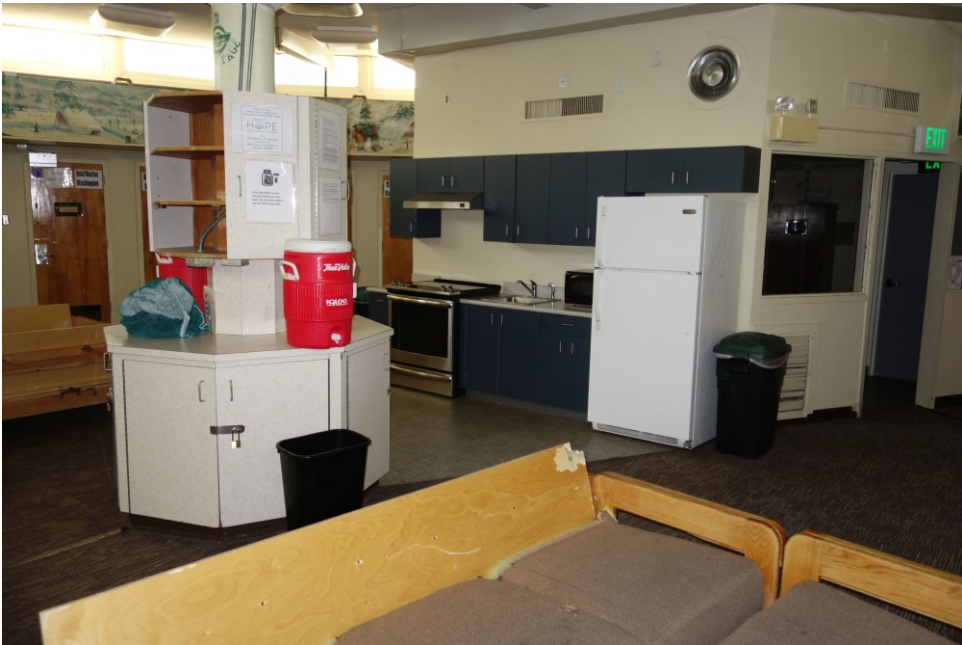
0212 CYC BEOWAWE DORMITORY

QUANTITY	UNITS	TOTAL	SF COST
The VCT (vinyl composite tile) and carpet in the building are damaged and reaching the end of their useful life. It is recommended that the flooring be replaced. This project would provide for removal and disposal of the existing flooring and installation of new 12x12 VCT with a 4" base and heavy duty commercial grade carpet in the next 2 - 3 years.	4185	Square Foot	\$59,600.00	\$ 14.00

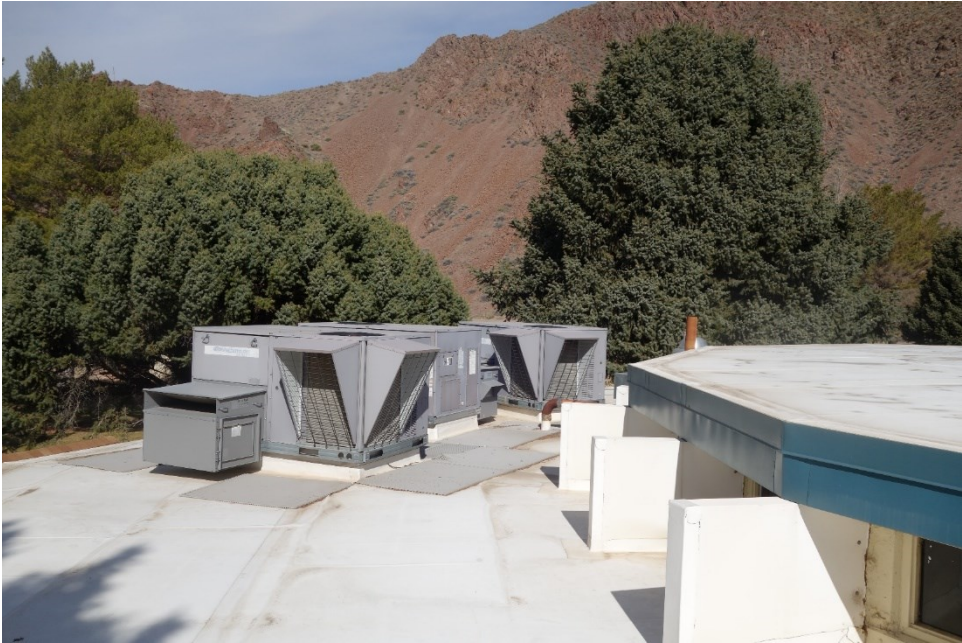
IMAGE FROM 0212 CYC BEOWAWE DORMITORY

QUANTITY	UNITS	TOTAL	SF COST
There are 3 HVAC gas fired rooftop packaged units (RTU's) installed on the roof in 2007. They are in fair condition but will be reaching the end of their expected life in the next 3 - 5 years. The R-22 refrigerant in the cooling system is no longer EPA compliant and its production was phased out completely January 1, 2020. This project recommends the RTU's be replaced in the next 2 - 4 years. This project estimate includes installation of the new HVAC units, and cleaning of the existing duct work and grilles. This project also includes removal and disposal of the existing HVAC system and all required connections to utilities.	4592	Square Foot	\$159,400.00	\$ 35.00

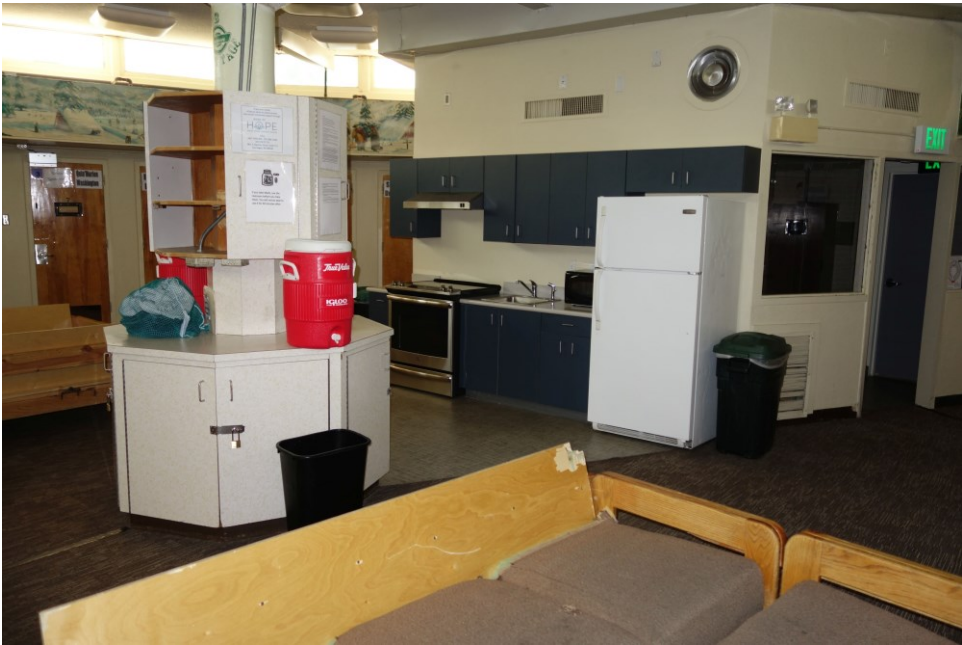
IMAGE FROM 0212 CYC BEOWAWE DORMITORY

QUANTITY	UNITS	TOTAL	SF COST
The kitchenettes and associated cabinets in the kitchen area are deteriorating and reaching the end of their useful life. A complete replacement of the existing kitchen countertops, cabinets, and associated equipment with heavy duty, quality components is recommended. Additionally, the restroom and shower areas are old and deteriorating from heavy use. This project recommends the complete replacement of the kitchen and restroom areas including flooring. ADA compliance according to NRS 338.180, IBC - 2018, ICC/ANSI A117.1 - 2009 and the most current version of the ADA Standards for Accessible Design should be incorporated into the design. Additionally, Prison Rape Elimination Act (PREA) compliance is required for the restroom. This estimate includes removal and disposal of the existing materials.	1	Package	\$436,300.00	\$ 95.00

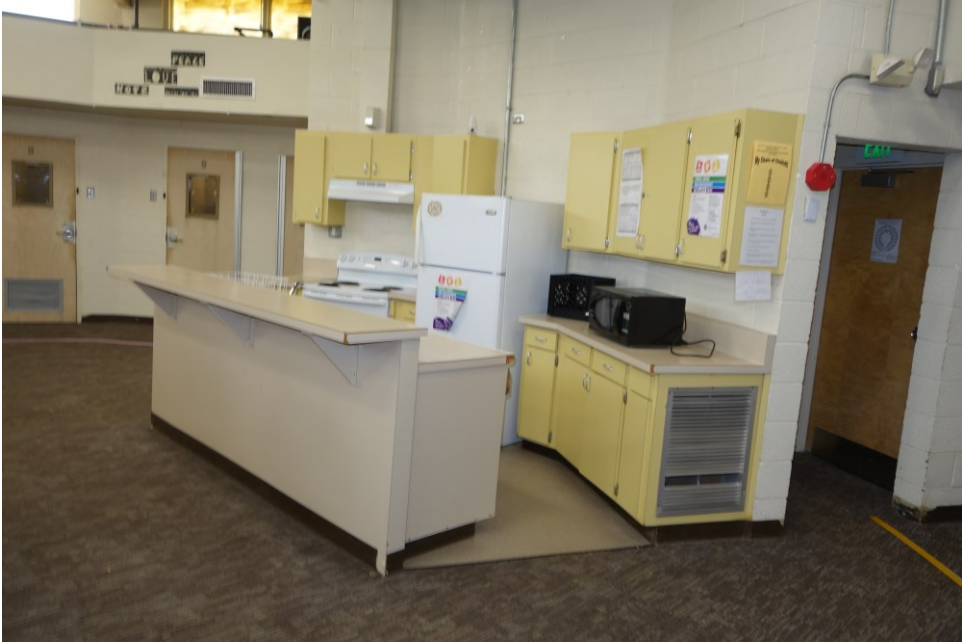
0213 CYC KIMBERLY DORMITORY

QUANTITY	UNITS	TOTAL	SF COST
The VCT (vinyl composite tile) and carpet in the building are damaged and reaching the end of their useful life. It is recommended that the flooring be replaced. This project would provide for removal and disposal of the existing flooring and installation of new 12x12 VCT with a 4" base and heavy duty commercial grade carpet in the next 2 - 3 years.	4592	Square Foot	\$65,400.00	\$ 14.00

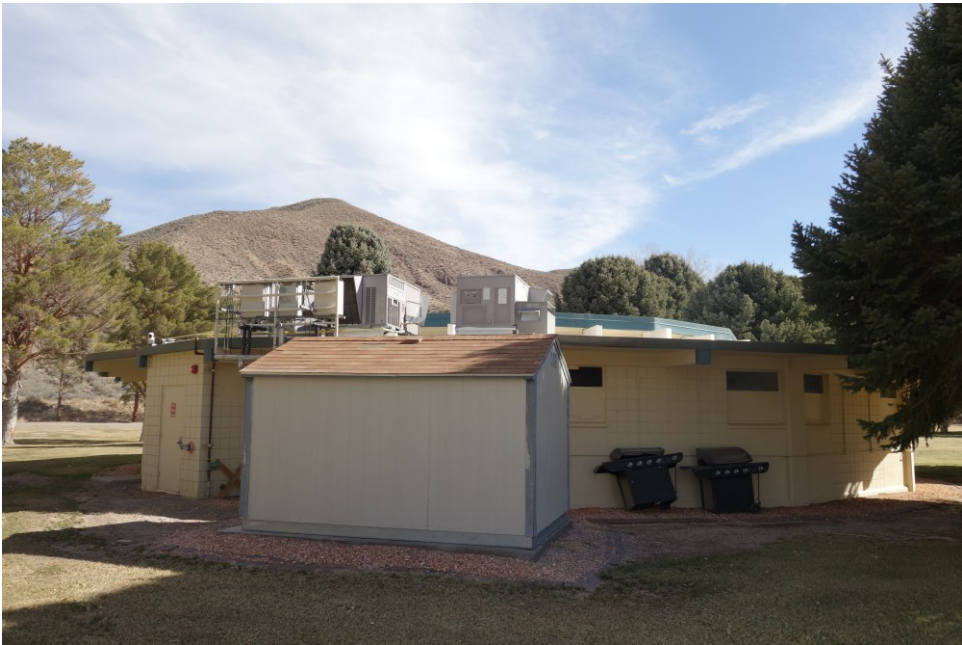
0214 CYC AURORA DORMITORY

QUANTITY	UNITS	TOTAL	SF COST
There are 3 HVAC gas fired rooftop packaged units (RTU's) installed on the roof in 2007. They are in fair condition but will be reaching the end of their expected life in the next 3 - 5 years. The R-22 refrigerant in the cooling system is no longer EPA compliant and its production was phased out completely January 1, 2020. This project recommends the RTU's be replaced in the next 5 - 10 years. This project estimate includes installation of the new HVAC units, and cleaning of the existing duct work and grilles. This project also includes removal and disposal of the existing HVAC system and all required connections to utilities.	4185	Square Foot	\$159,400.00	\$ 38.00

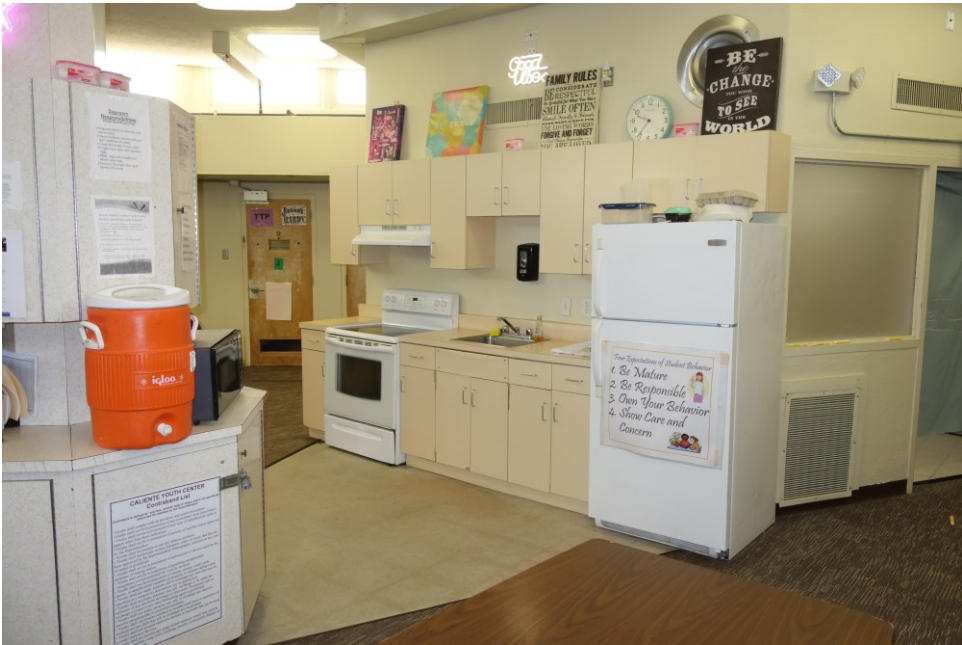
0214 CYC AURORA DORMITORY

QUANTITY	UNITS	TOTAL	SF COST
<p>The kitchenettes and associated cabinets in the kitchen area are deteriorating and reaching the end of their useful life. A complete replacement of the existing kitchen countertops, cabinets, and associated equipment with heavy duty, quality components is recommended. Additionally, the restroom and shower areas are old and deteriorating from heavy use. This project recommends the complete replacement of the kitchen and restroom areas including flooring. ADA compliance according to NRS 338.180, IBC - 2018, ICC/ANSI A117.1 - 2009 and the most current version of the ADA Standards for Accessible Design should be incorporated into the design. Additionally, Prison Rape Elimination Act (PREA) compliance is required for the restroom. This estimate includes removal and disposal of the existing materials.</p>	1	Package	\$436,300.00	\$ 104.00

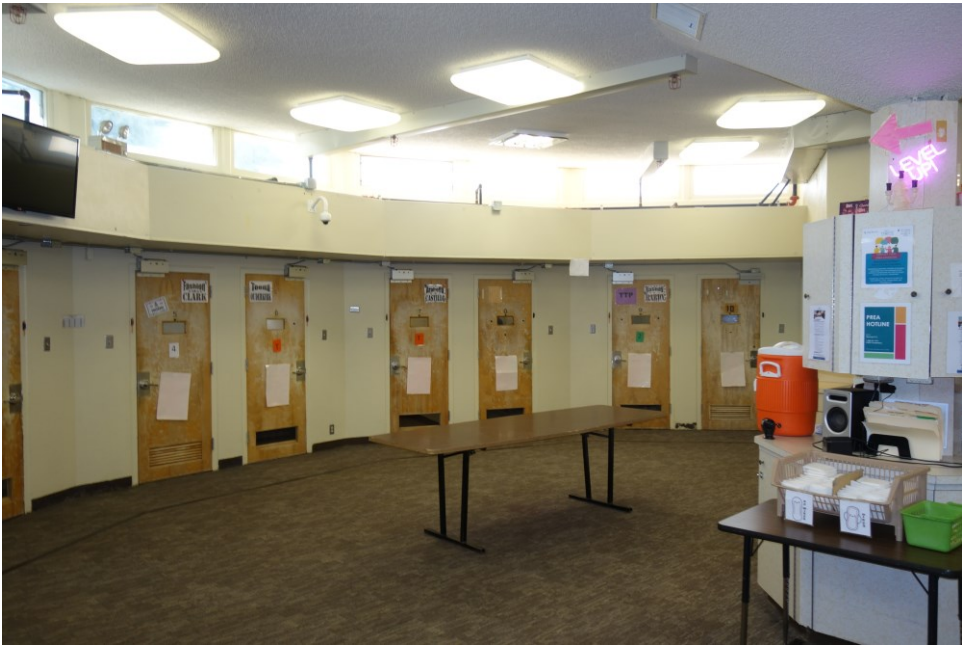
0214 CYC AURORA DORMITORY

QUANTITY	UNITS	TOTAL	SF COST
The VCT (vinyl composite tile) and carpet in the building are damaged and reaching the end of their useful life. It is recommended that the flooring be replaced. This project would provide for removal and disposal of the existing flooring and installation of new 12x12 VCT with a 4" base and heavy duty commercial grade carpet in the next 2 - 3 years.	4185	Square Foot	\$59,600.00	\$ 14.00

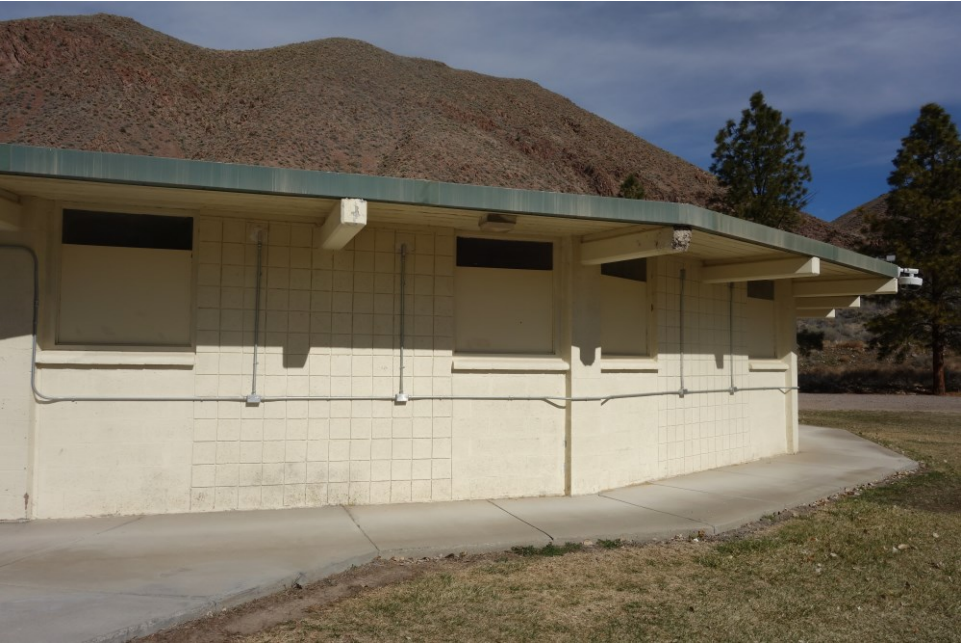
0215 CYC LINCOLN DORMITORY

QUANTITY	UNITS	TOTAL	SF COST
<p>The building exterior is constructed of Concrete Masonry Unit (CMU) with no insulation. The windows are original to the building and single pane construction. Buildings of this type are not energy efficient. This project recommends adding an Exterior Insulation Finish System (EIFS) over the CMU and replacing the windows with a behavior health rated polycarbonate safety glazing, dual pane, high efficiency units.</p> <p>This project or a portion thereof was previously recommended in the FCA report dated 09/21/2010 and 03/01/2017. It has been amended accordingly to reflect conditions observed during the most recent survey date of 03/06/2024.</p>	1	Package	\$1,008,300.00	\$ 220.00

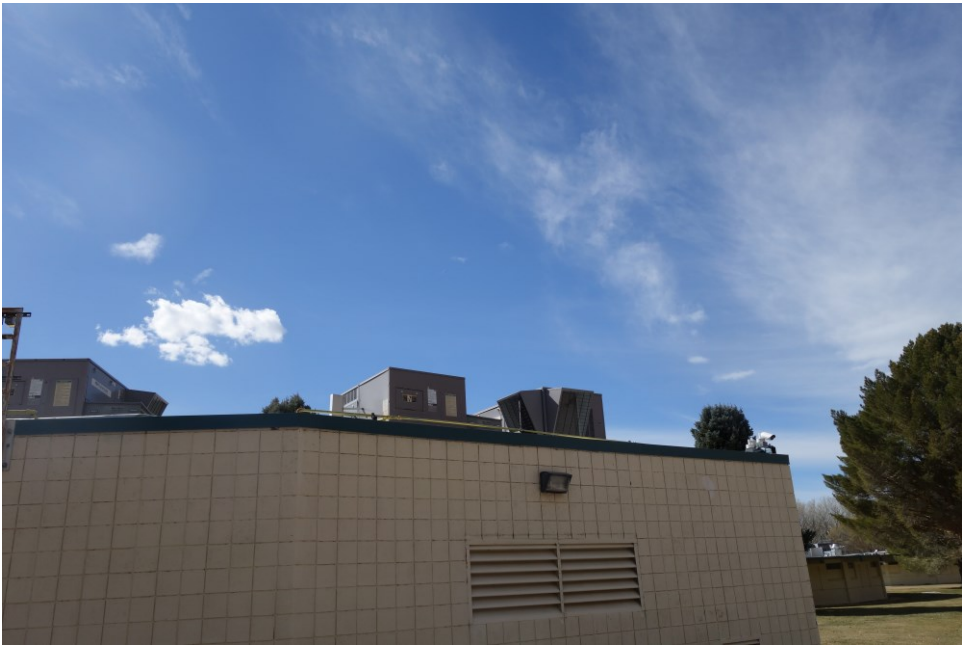
0215 CYC LINCOLN DORMITORY

QUANTITY	UNITS	TOTAL	SF COST
There are 3 HVAC gas fired rooftop packaged units (RTU's) installed on the roof in 2007. They are in fair condition but will be reaching the end of their expected life in the next 3 - 5 years. The R-22 refrigerant in the cooling system is no longer EPA compliant and its production was phased out completely January 1, 2020. This project recommends the RTU's be replaced in the next 5 - 10 years. This project estimate includes installation of the new HVAC units, and cleaning of the existing duct work and grilles. This project also includes removal and disposal of the existing HVAC system and all required connections to utilities.	4592	Square Foot	\$159,400.00	\$ 35.00

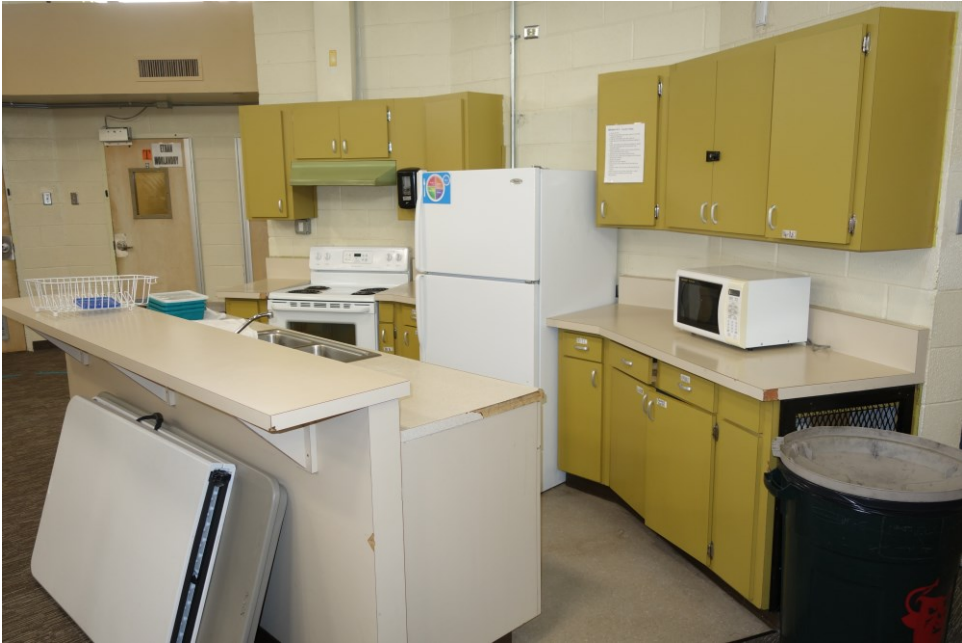
0215 CYC LINCOLN DORMITORY

QUANTITY	UNITS	TOTAL	SF COST
The kitchenettes and associated cabinets in the kitchen area are deteriorating and reaching the end of their useful life. A complete replacement of the existing kitchen countertops, cabinets, and associated equipment with heavy duty, quality components is recommended. Additionally, the restroom and shower areas are old and deteriorating from heavy use. This project recommends the complete replacement of the kitchen and restroom areas including flooring. ADA compliance according to NRS 338.180, IBC - 2018, ICC/ANSI A117.1 - 2009 and the most current version of the ADA Standards for Accessible Design should be incorporated into the design. Additionally, Prison Rape Elimination Act (PREA) compliance is required for the restroom. This estimate includes removal and disposal of the existing materials.	1	Package	\$436,300.00	\$ 95.00

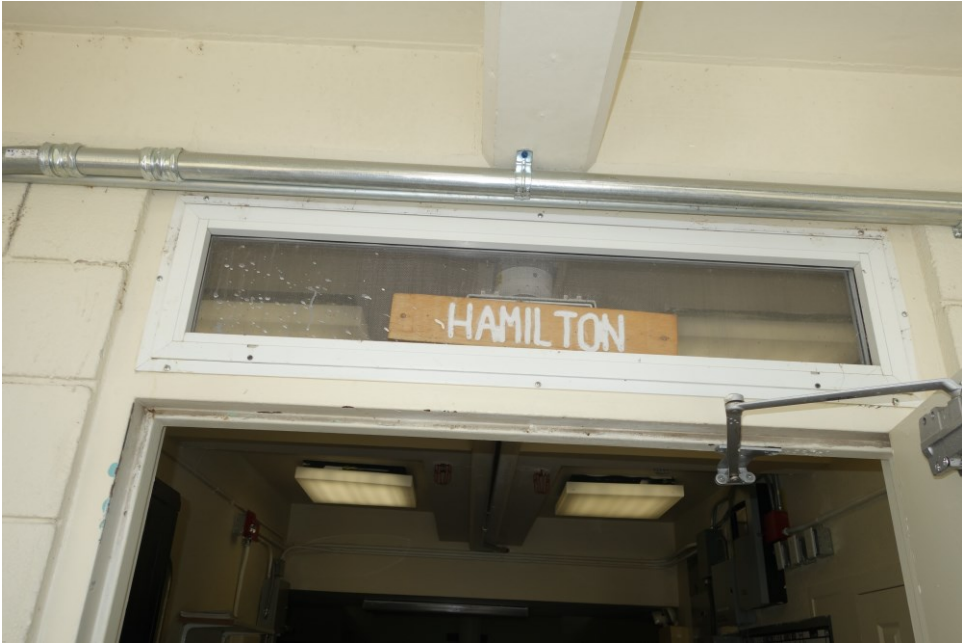
0216 CYC HAMILTON DORMITORY

QUANTITY	UNITS	TOTAL	SF COST
<p>The sprinkler piping is hung from the ceiling of the dormitory and is exposed to the occupants. This creates a safety hazard in two ways. One is that the occupants could damage the piping and cause flooding in the building. The other is that the occupants can tie things around the pipes and cause harm to themselves. This project recommends encapsulating the piping with wallboard and texturing and painting to match the adjacent ceiling finishes.</p> <p>This project or a portion thereof was previously recommended in the FCA report dated 09/21/2010 and 03/01/2017. It has been amended accordingly to reflect conditions observed during the most recent survey date of 03/06/2024.</p>	1	Package	\$35,000.00	\$ 8.00

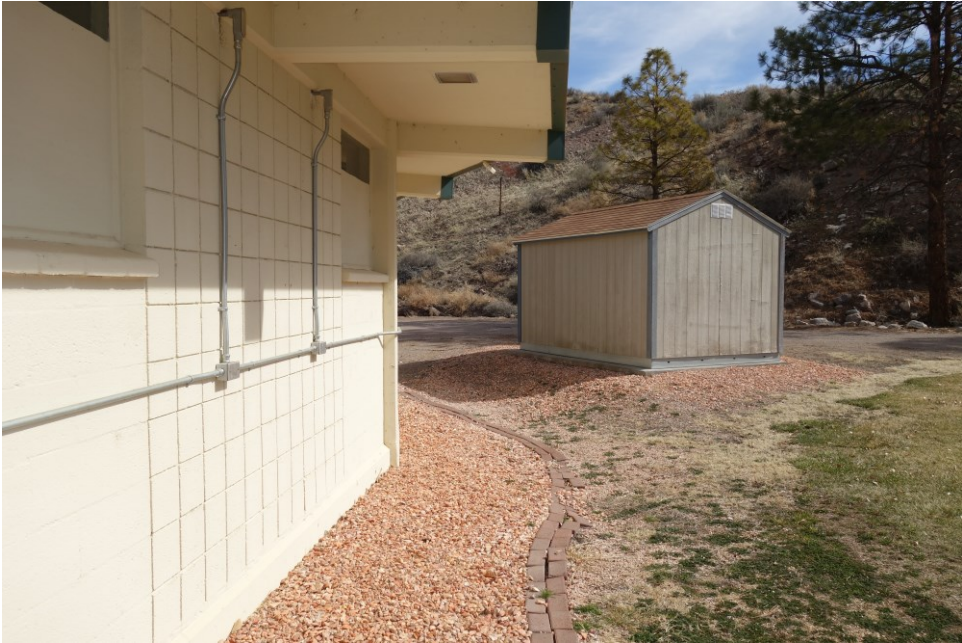
0216 CYC HAMILTON DORMITORY

QUANTITY	UNITS	TOTAL	SF COST
<p>The building exterior is constructed of Concrete Masonry Unit (CMU) with no insulation. The windows are original to the building and single pane construction. Buildings of this type are not energy efficient. This project recommends adding an Exterior Insulation Finish System (EIFS) over the CMU and replacing the windows with a behavior health rated polycarbonate safety glazing, dual pane, high efficiency units.</p> <p>This project or a portion thereof was previously recommended in the FCA report dated 09/21/2010 and 03/01/2017. It has been amended accordingly to reflect conditions observed during the most recent survey date of 03/06/2024.</p>	1	Package	\$1,008,300.00	\$ 241.00

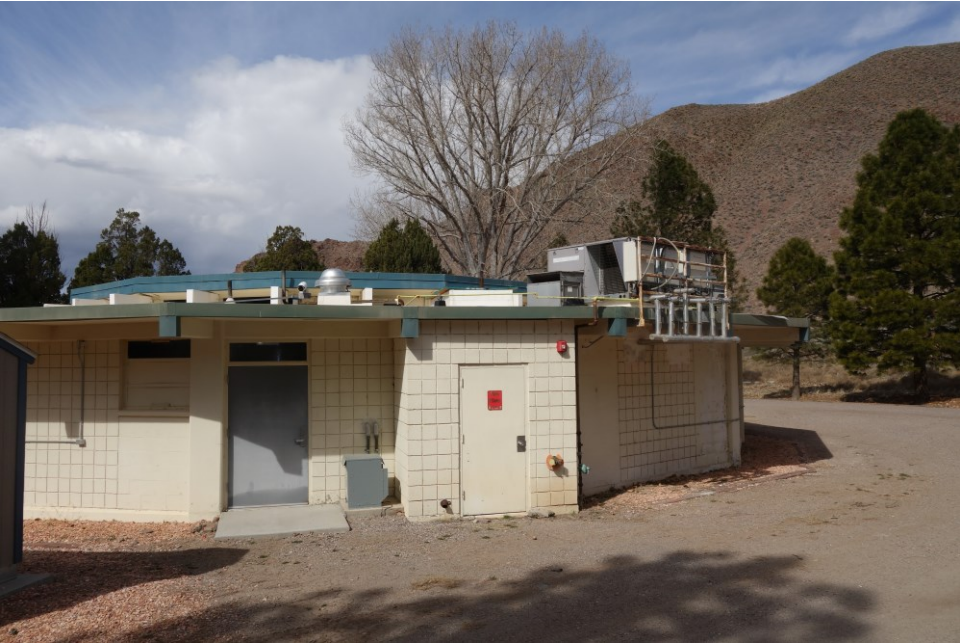
0216 CYC HAMILTON DORMITORY

QUANTITY	UNITS	TOTAL	SF COST
There are 3 HVAC gas fired rooftop packaged units (RTU's) installed on the roof in 2007. They are in fair condition but will be reaching the end of their expected life in the next 3 - 5 years. The R-22 refrigerant in the cooling system is no longer EPA compliant and its production was phased out completely January 1, 2020. This project recommends the RTU's be replaced in the next 5 - 10 years. This project estimate includes installation of the new HVAC units, and cleaning of the existing duct work and grilles. This project also includes removal and disposal of the existing HVAC system and all required connections to utilities.	4185	Square Foot	\$159,400.00	\$ 38.00

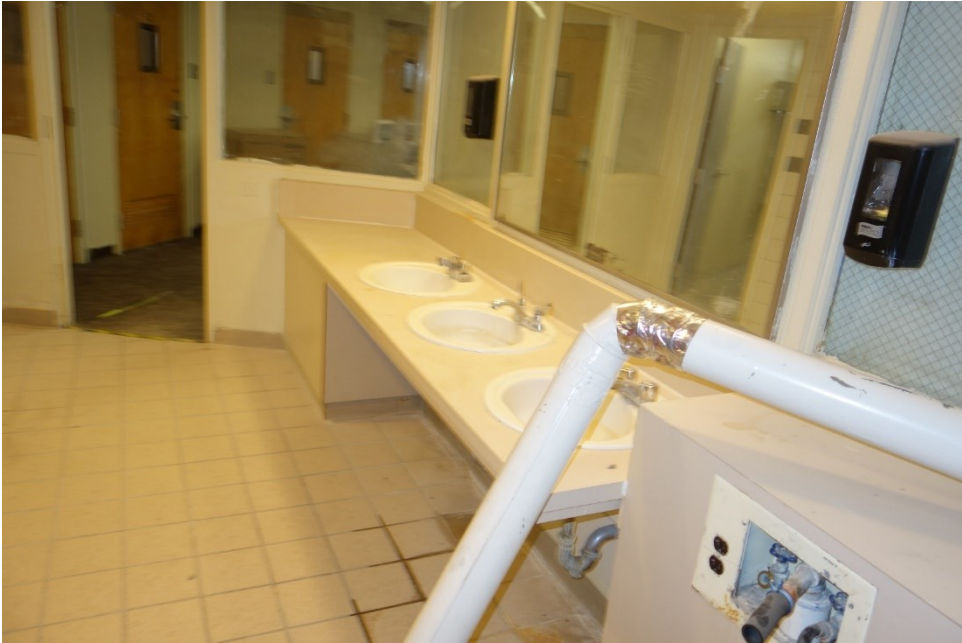
0216 CYC HAMILTON DORMITORY

QUANTITY	UNITS	TOTAL	SF COST
<p>The kitchenettes and associated cabinets in the kitchen area are deteriorating and reaching the end of their useful life. A complete replacement of the existing kitchen countertops, cabinets, and associated equipment with heavy duty, quality components is recommended. Additionally, the restroom and shower areas are old and deteriorating from heavy use. This project recommends the complete replacement of the kitchen and restroom areas including flooring. ADA compliance according to NRS 338.180, IBC - 2018, ICC/ANSI A117.1 - 2009 and the most current version of the ADA Standards for Accessible Design should be incorporated into the design. Additionally, Prison Rape Elimination Act (PREA) compliance is required for the restroom. This estimate includes removal and disposal of the existing materials.</p>	1	Package	\$436,300.00	\$ 104.00

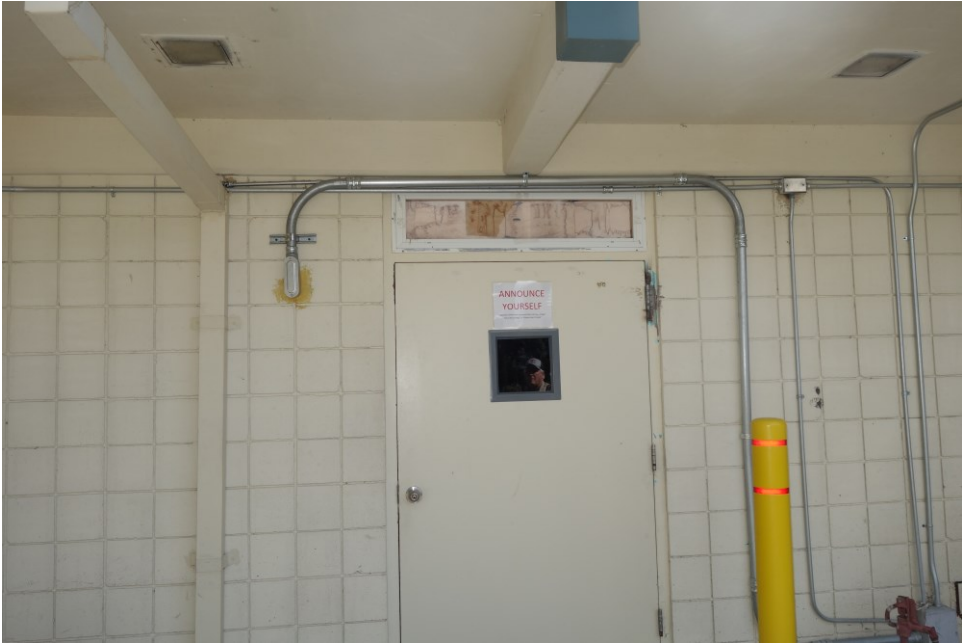
0217 CYC JARBIDGE DORMITORY

QUANTITY	UNITS	TOTAL	SF COST
<p>The building exterior is constructed of Concrete Masonry Unit (CMU) with no insulation. The windows are original to the building and single pane construction. Buildings of this type are not energy efficient. This project recommends adding an Exterior Insulation Finish System (EIFS) over the CMU and replacing the windows with a behavior health rated polycarbonate safety glazing, dual pane, high efficiency units.</p> <p>This project or a portion thereof was previously recommended in the FCA report dated 09/21/2010 and 03/01/2017. It has been amended accordingly to reflect conditions observed during the most recent survey date of 03/06/2024.</p>	1	Package	\$1,008,300.00	\$ 241.00

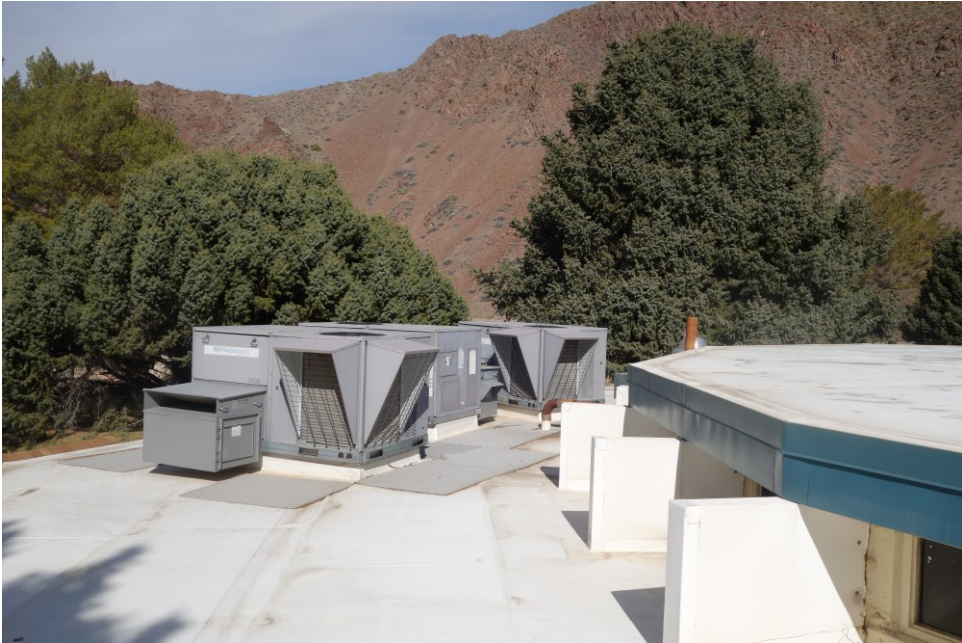
IMAGE FROM 0212 CYC BEOWAWE DORMITORY

QUANTITY	UNITS	TOTAL	SF COST
There are 3 HVAC gas fired rooftop packaged units (RTU's) installed on the roof in 2007. They are in fair condition but will be reaching the end of their expected life in the next 3 - 5 years. The R-22 refrigerant in the cooling system is no longer EPA compliant and its production was phased out completely January 1, 2020. This project recommends the RTU's be replaced in the next 5 - 10 years. This project estimate includes installation of the new HVAC units, and cleaning of the existing duct work and grilles. This project also includes removal and disposal of the existing HVAC system and all required connections to utilities.	4185	Square Foot	\$159,400.00	\$ 38.00

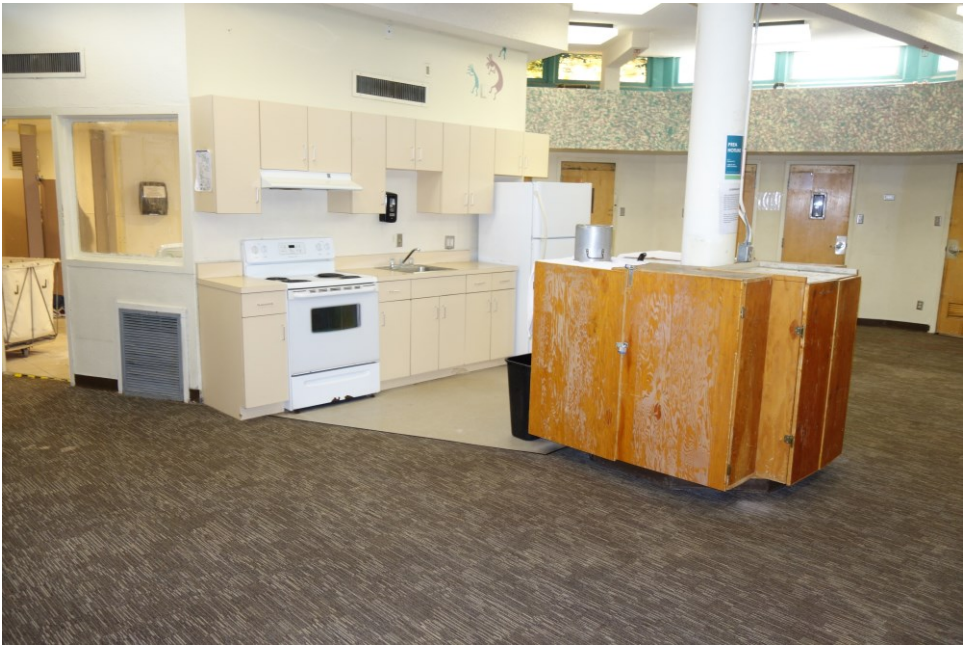
0217 CYC JARBIDGE DORMITORY

QUANTITY	UNITS	TOTAL	SF COST
The kitchenettes and associated cabinets in the kitchen area are deteriorating and reaching the end of their useful life. A complete replacement of the existing kitchen countertops, cabinets, and associated equipment with heavy duty, quality components is recommended. Additionally, the restroom and shower areas are old and deteriorating from heavy use. This project recommends the complete replacement of the kitchen and restroom areas including flooring. ADA compliance according to NRS 338.180, IBC - 2018, ICC/ANSI A117.1 - 2009 and the most current version of the ADA Standards for Accessible Design should be incorporated into the design. Additionally, Prison Rape Elimination Act (PREA) compliance is required for the restroom. This estimate includes removal and disposal of the existing materials.	1	Package	\$436,300.00	\$ 104.00

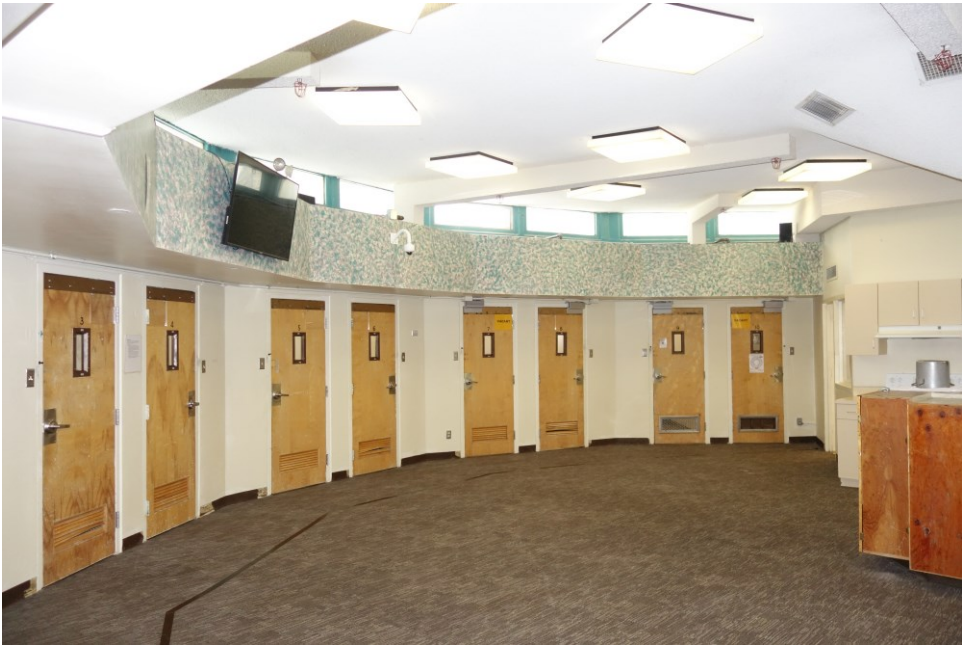
0217 CYC JARBIDGE DORMITORY

QUANTITY	UNITS	TOTAL	SF COST
The VCT (vinyl composite tile) and carpet in the building are damaged and reaching the end of their useful life. It is recommended that the flooring be replaced. This project would provide for removal and disposal of the existing flooring and installation of new 12x12 VCT with a 4" base and heavy duty commercial grade carpet in the next 2 - 3 years.	4185	Square Foot	\$59,600.00	\$ 14.00

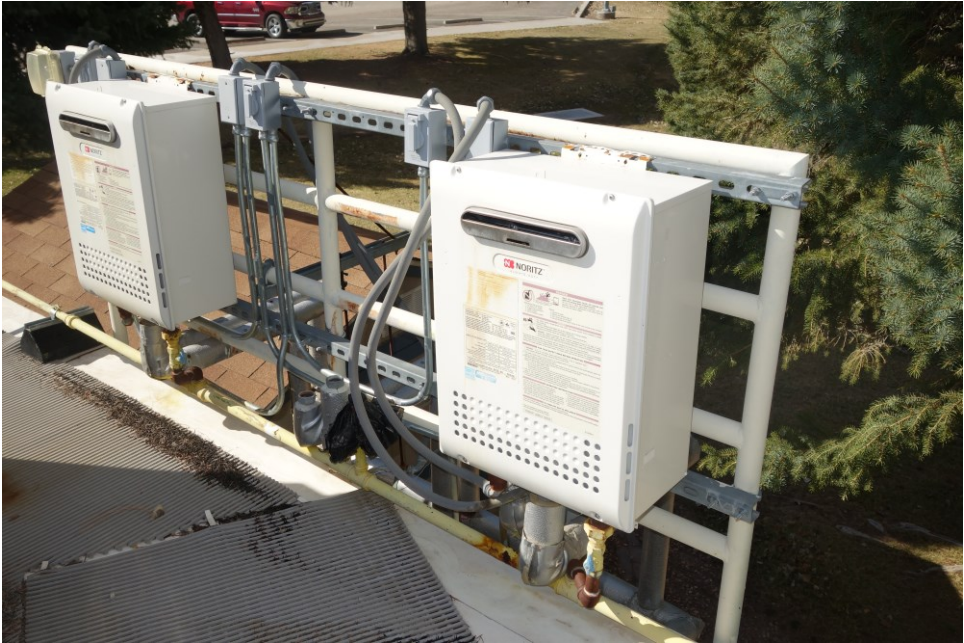
IMAGE FROM 0212 CYC BEOWAWE DORMITORY

QUANTITY	UNITS	TOTAL	SF COST
There are 2 gas fired tankless water heaters located on the roof installed in 2016. They are in fair condition but will be reaching the end of their expected life in the next 8 - 10 years. This project recommends the water heaters be replaced in the next 8 - 10 years. This project also includes removal and disposal of the existing system and all required connections to utilities.	4185	Square Foot	\$20,900.00	\$ 5.00

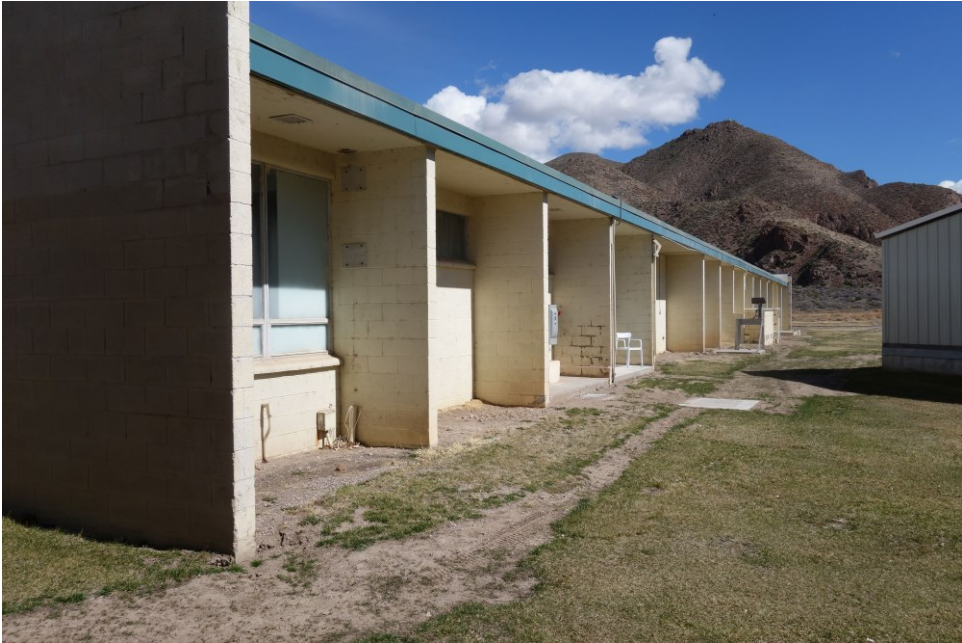
0219 CYC SCHOOL - OLD

QUANTITY	UNITS	TOTAL	SF COST
<p>The building exterior is constructed of Concrete Masonry Unit (CMU) with no insulation. The windows are original to the building and single pane construction. Buildings of this type are not energy efficient. This project recommends adding an Exterior Insulation Finish System (EIFS) over the CMU and replacing the windows with a behavior health rated polycarbonate safety glazing, dual pane, high efficiency units.</p> <p>This project or a portion thereof was previously recommended in the FCA report dated 09/21/2010 and 03/01/2017. It has been amended accordingly to reflect conditions observed during the most recent survey date of 03/06/2024.</p>	11760	Package	\$2,749,300.00	\$ 234.00

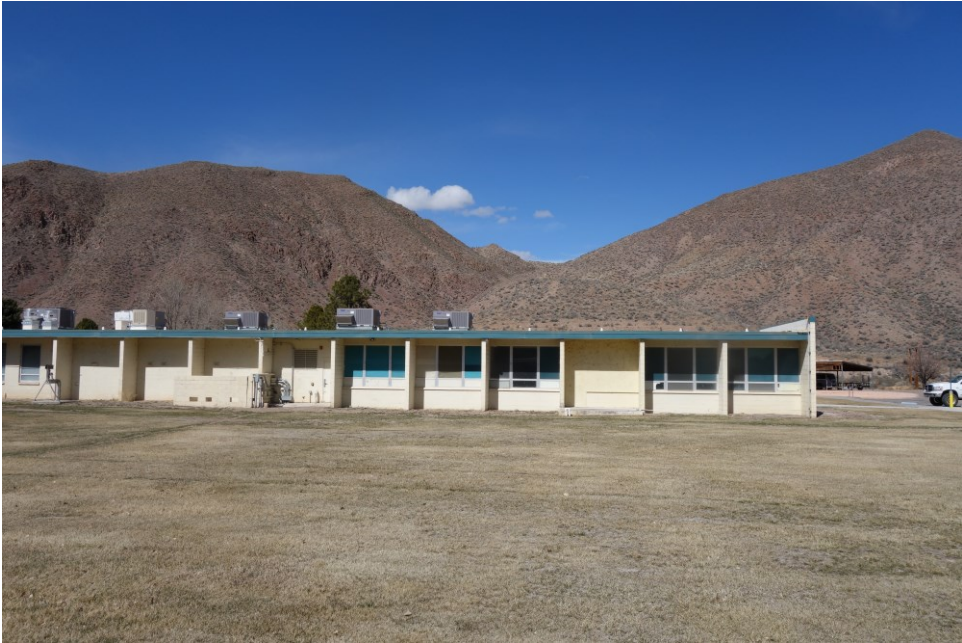
0219 CYC SCHOOL - OLD

QUANTITY	UNITS	TOTAL	SF COST
The exterior finishes were in poor condition. It is important to maintain the finish, weather resistance and appearance of the building. This project would provide funding to protect the exterior of the building excluding the roof. Included in the cost is painting the concrete masonry unit walls and caulking of the windows, flashing, fixtures and all other penetrations. Also included is repairing and painting the wood fascia as needed. It is recommended that the building be painted and caulked in the next 2 - 3 years and that this project be scheduled on a cyclical basis to maintain the integrity of the structure.	11760	Square Foot	\$117,600.00	\$ 10.00
