# STATE OF NEVADA STATE PUBLIC WORKS DIVISION

## FACILITY CONDITION ASSESSMENT REPORT FOR:

DEPT OF HEALTH AND HUMAN SERVICES  
DIVISION OF CHILD AND FAMILY SERVICES  
CYC

Survey Date: 3/6/2024  
Distribution Date: 8/21/2024

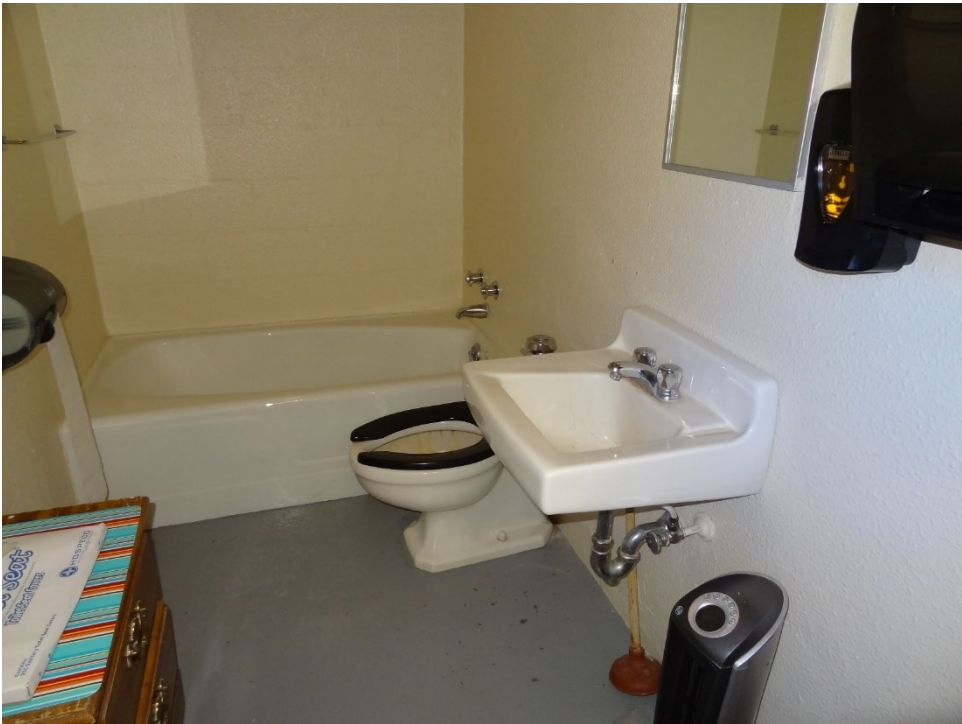
2017 SURVEY IMAGE

QUANTITY	UNITS	TOTAL	SF COST
<p>The building does not have an accessible restroom. The existing restroom does not meet the ADA requirements. A complete retrofit is necessary. This project would provide funding for remodeling the unisex restroom per ADA regulations. Items may include a new sink, toilet, hardware, mirrors, fixtures, flooring and paint. The 2018 IBC, ICC/ANSI A117.1 - 2009, NRS 338.180 and the most current version of the ADA Standards for Accessible Design were used as references for this project.</p> <p>This project or a portion thereof was previously recommended in the FCA report dated 04/09/2002, 09/21/2010 and 03/01/2017. It has been amended accordingly to reflect conditions observed during the most recent survey date of 03/06/2024.</p>	1	Package	\$30,000.00	\$ 19.00
