CALIENTE YOUTH CENTER SITE

500 Youth Center Drive
Caliente, Nevada 89008

Site Number: 9950
STATE OF NEVADA PUBLIC WORKS DIVISION
FACILITY CONDITION ANALYSIS

Report distributed in March 2021

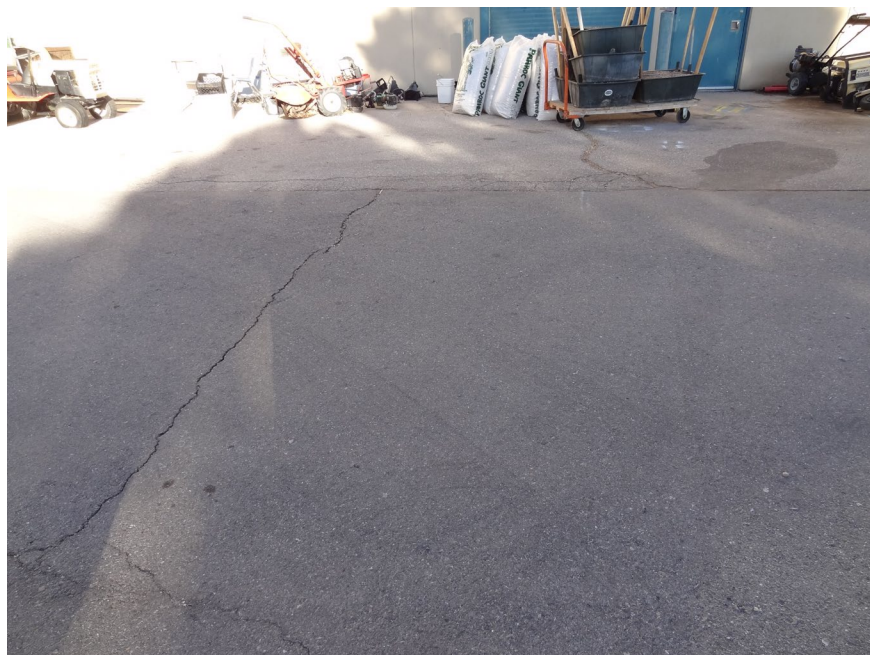
It is important to maintain the asphalt concrete paving on the site. This project would provide for minor crack filling and slurry sealing of the paving site wide including access roads, parking areas and the maintenance yard. Striping is included in this estimate. This project should be scheduled on a 5 year cyclical basis to maintain the integrity of the paving and prevent premature failure. 125,000 square feet of asphalt area was used to generate this estimate.

Caliente Youth Center Site - Site #9950
Description: Crack Fill & Seal Asphalt Paving

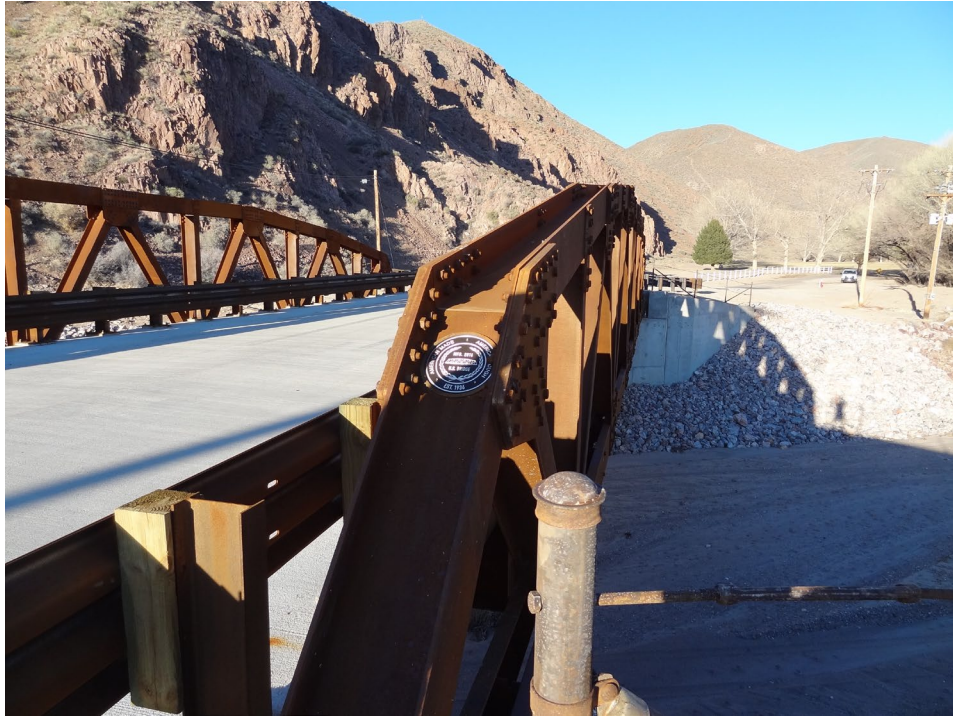
CYC Caliente Bridge - Building #3246
Description: Bridge View East Toward CYC.

Inspect and tighten all attachment hardware on the bridge guardrails. At many locations loose fasteners were detected per NDOT Maintenance & Inspection Report dated 10-11-2017. A copy of the report was provided to the CYC Superintendent.

Tighten loose fastener located on north and east side of the bridge on the lateral floor brace at bridge floor beam per NDOT Maintenance & Inspection Report dated 10-11-2017. A copy of the report was provided to the CYC Superintendent.

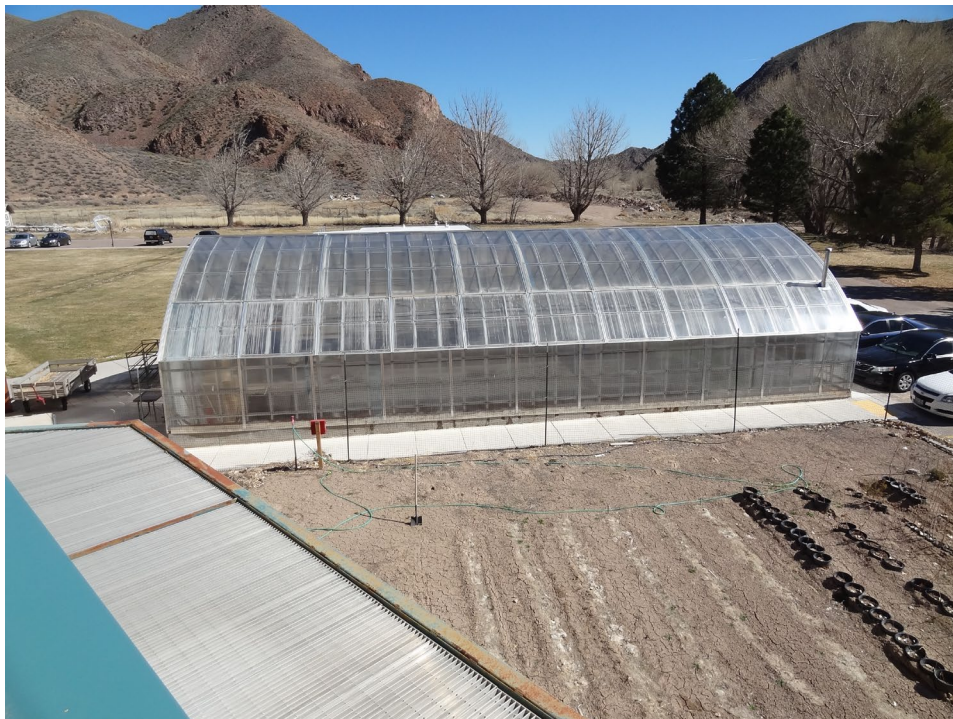
CYC Green House - Building #3159
Description: View of CYC Green House.

The building has at least one electrical panel which is missing the panel cover. This project would provide for the inspection of all electrical devices to repair and/or replacement of missing or damaged panel and device covers.

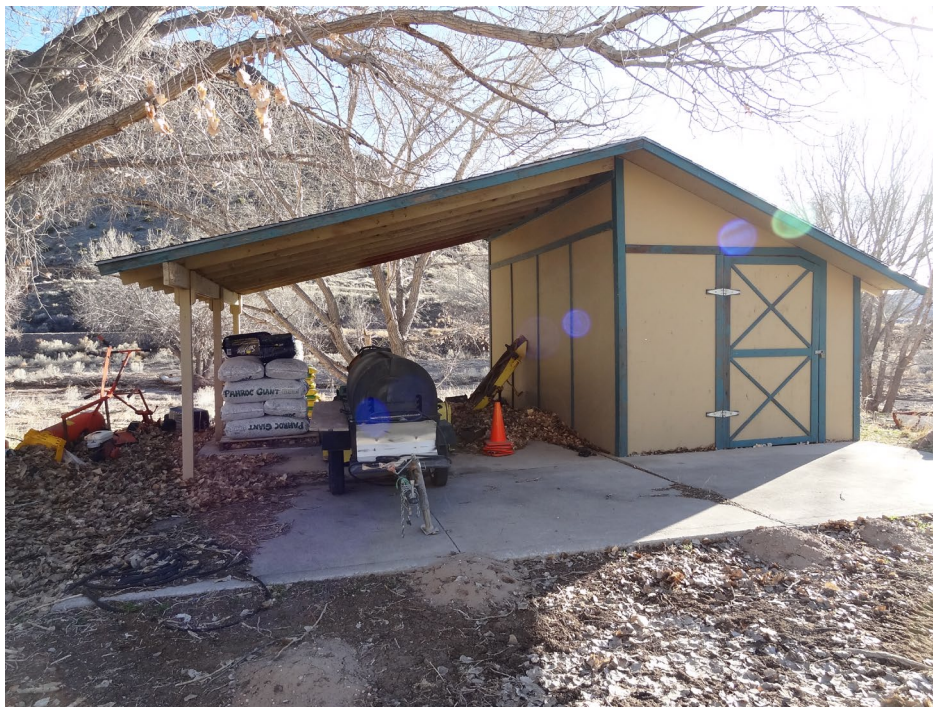
The asphalt composition shingle roof on this building was in poor condition at the time of the survey. It is recommended that this building be re-roofed in the next 2-3 years with a new 50 year asphalt composition shingle roof and new underlayment. This estimate includes removal and disposal of the old roof.

CYC Industrial Arts Storage- Building #3075
Description: Exterior of the Building.

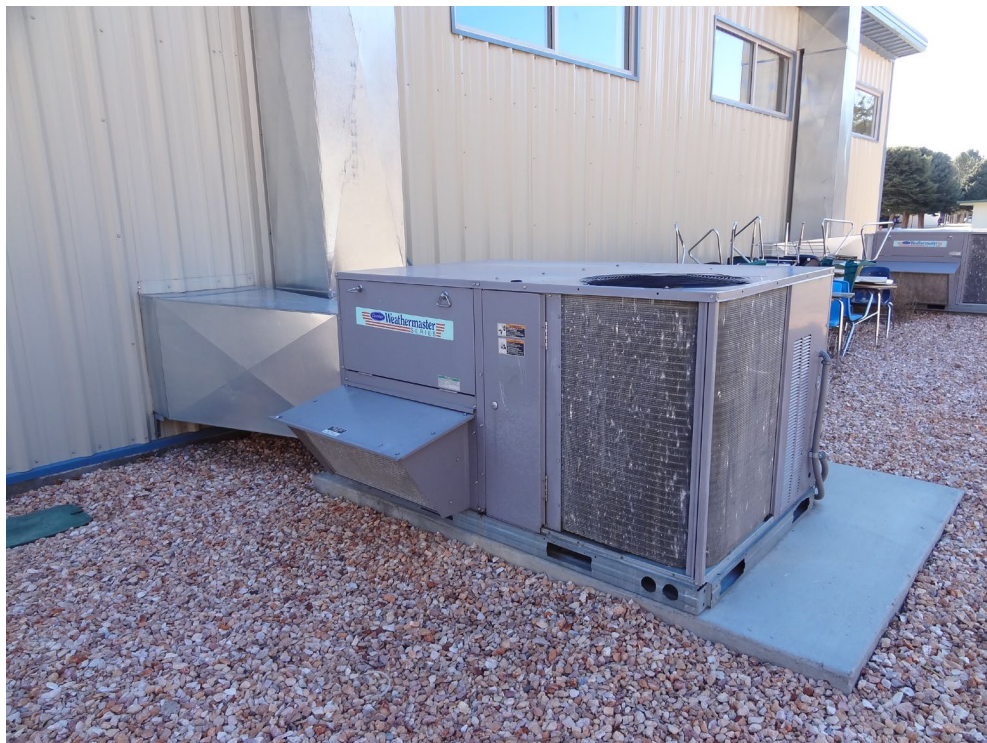
CYC Recreation Center - Building #2943
Description: HVAC Equipment Replacement.

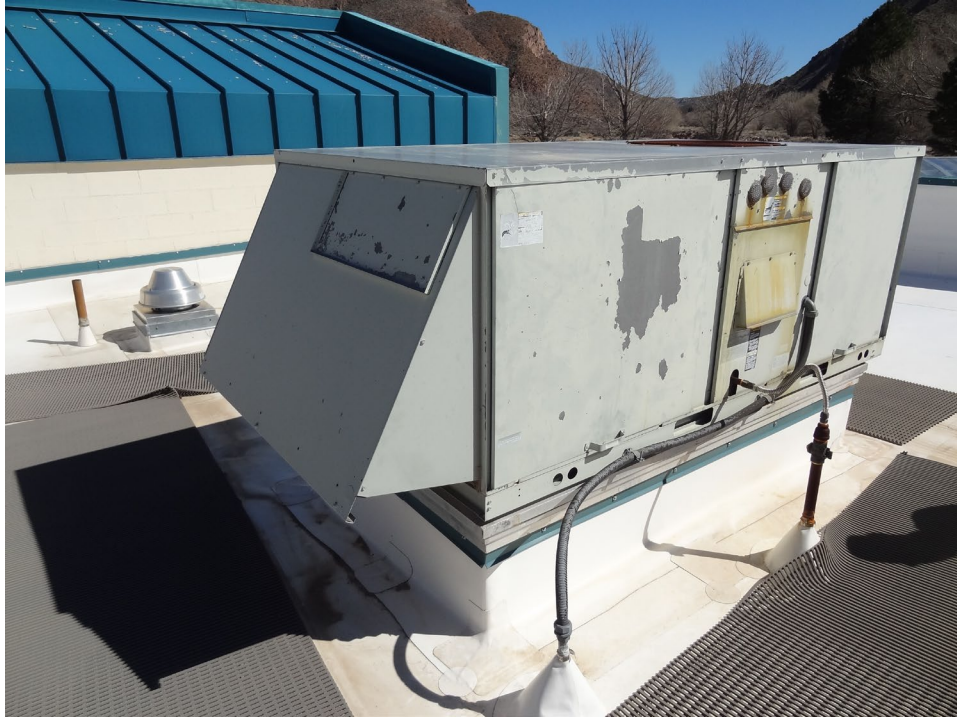
CYC School - New - Building #2001
Description: HVAC Equipment Replacement.

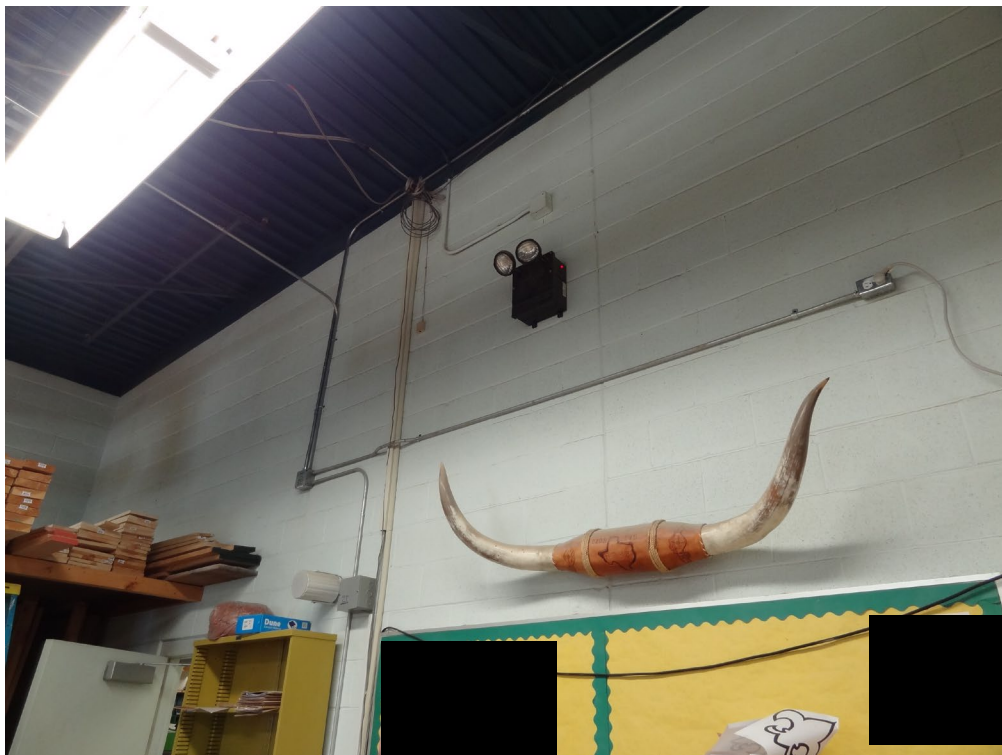
CYC School - New - Building #2001
Description: Exit Sign and Egress Lighting Installation.

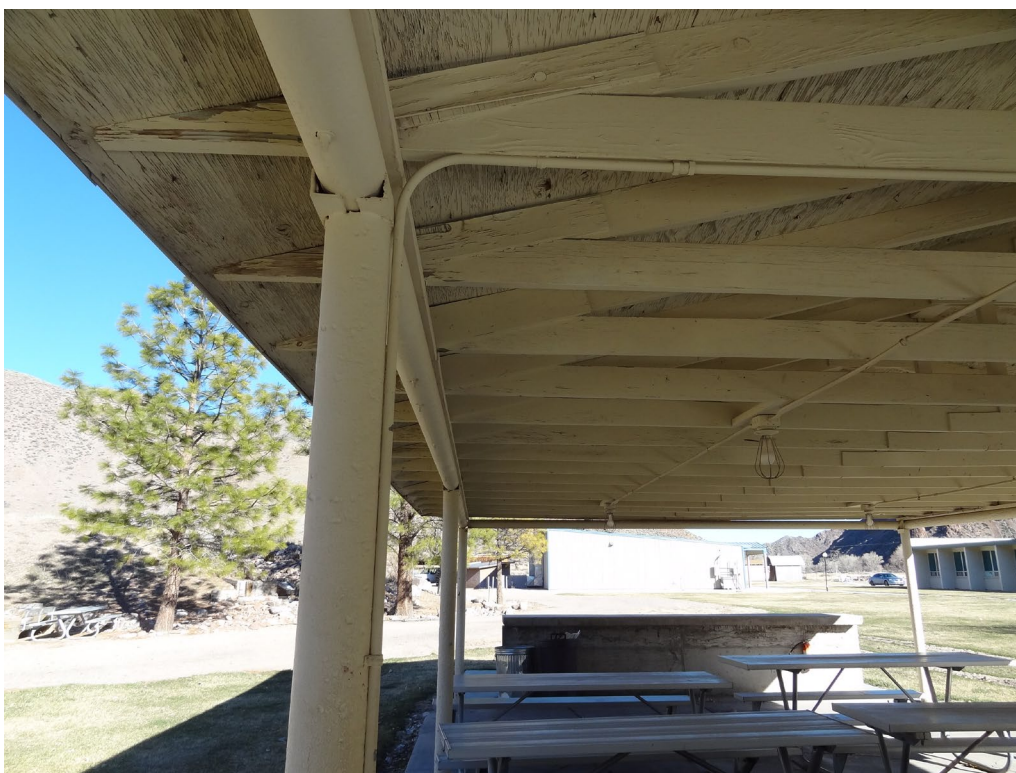
CYC Ramada - Building #0514
Description: Demolish Structure.

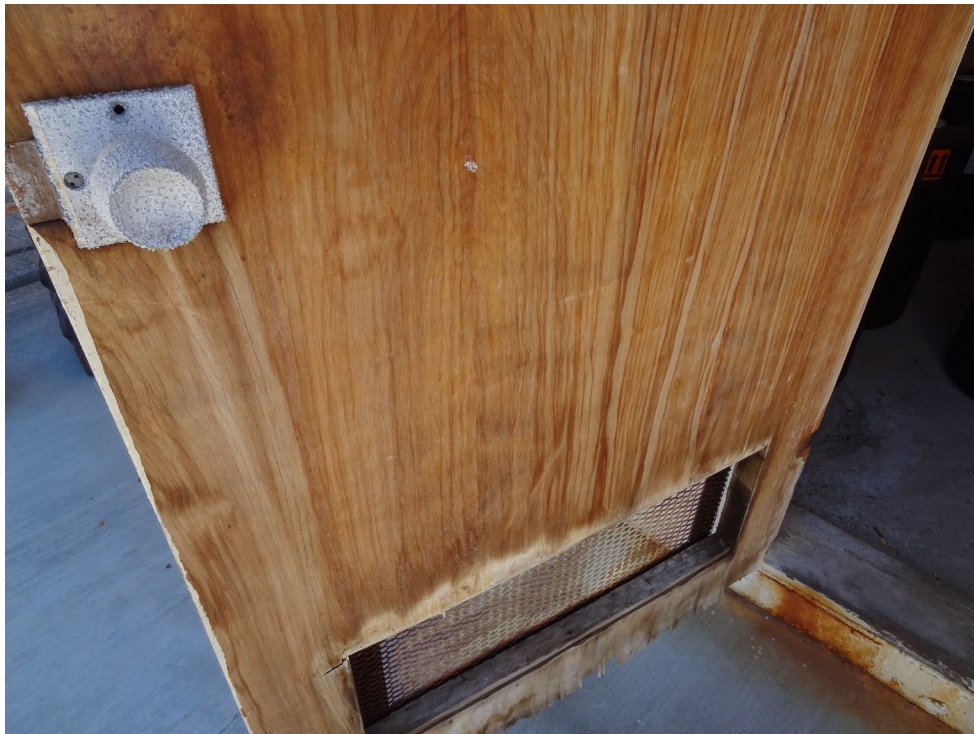
CYC Pool House & Pool - Building #0292
Description: Hazardous Materials Storage (Corrosive).

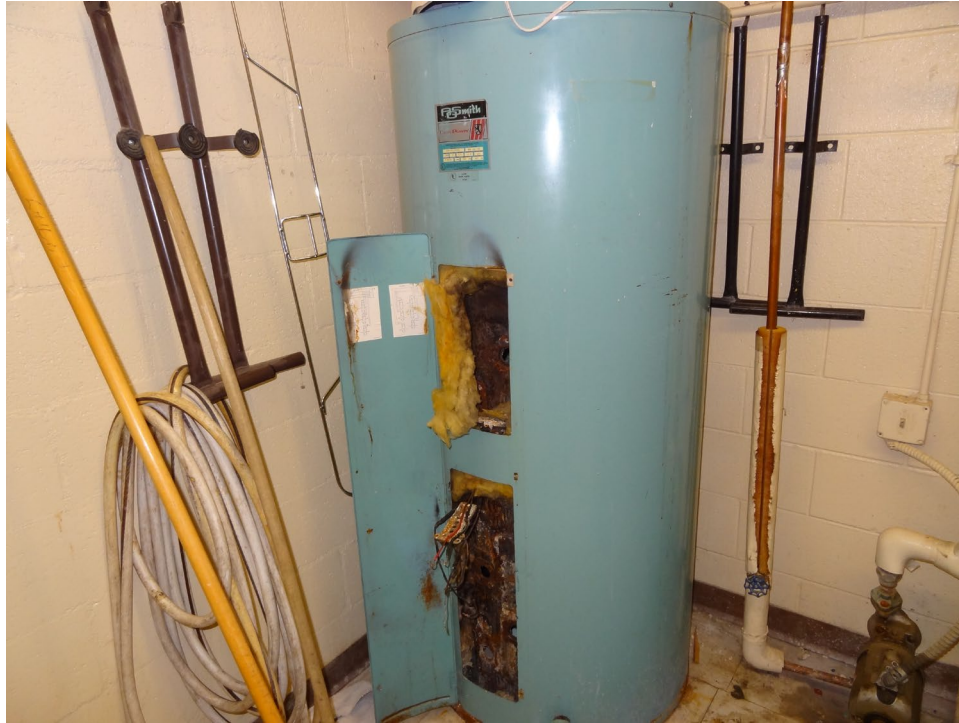
CYC Multi-Purpose Building - Building #0221
Description: Water Heater Replacement.

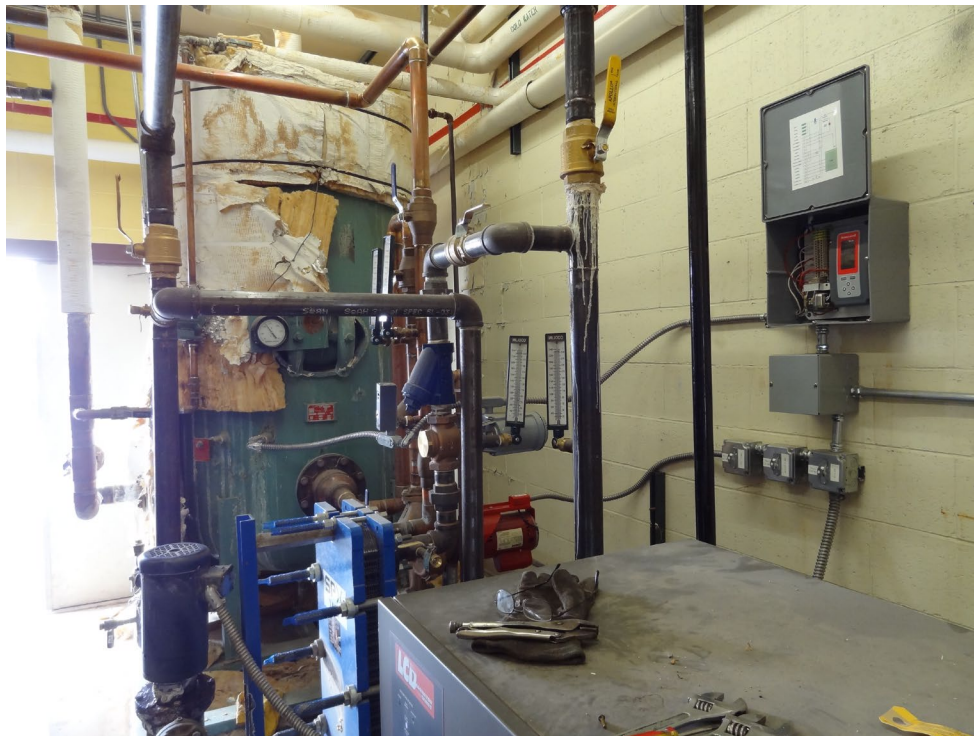
CYC Multi-Purpose Building - Building #0221
Description: HVAC System Upgrade.

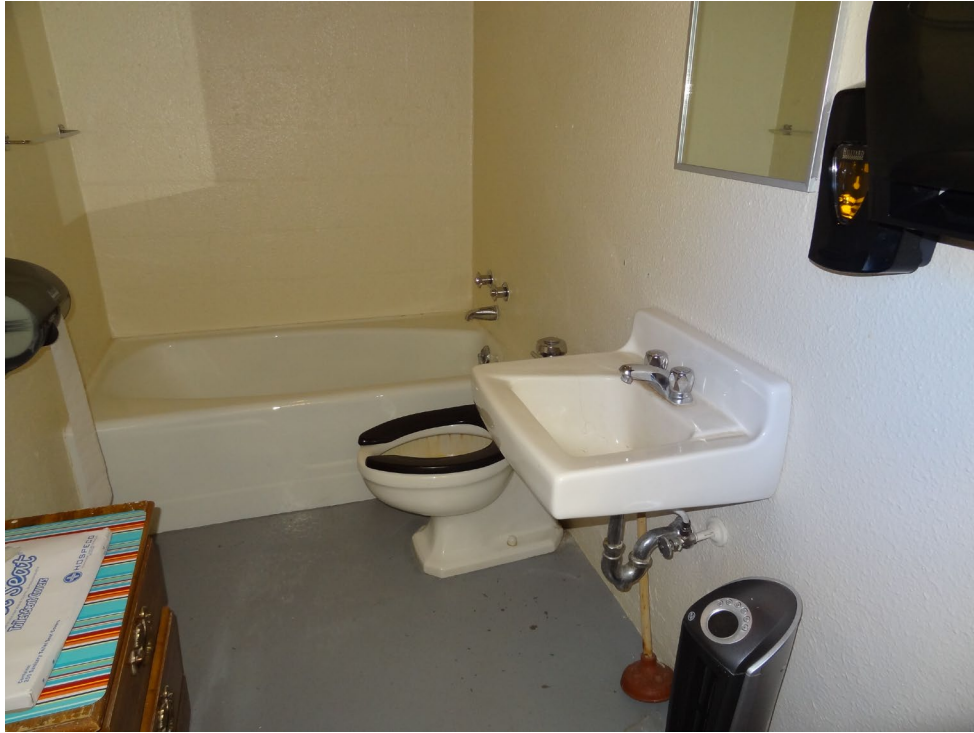
CYC Evaluation / Infirmary - Building #0220
Description: ADA Restroom Upgrade.

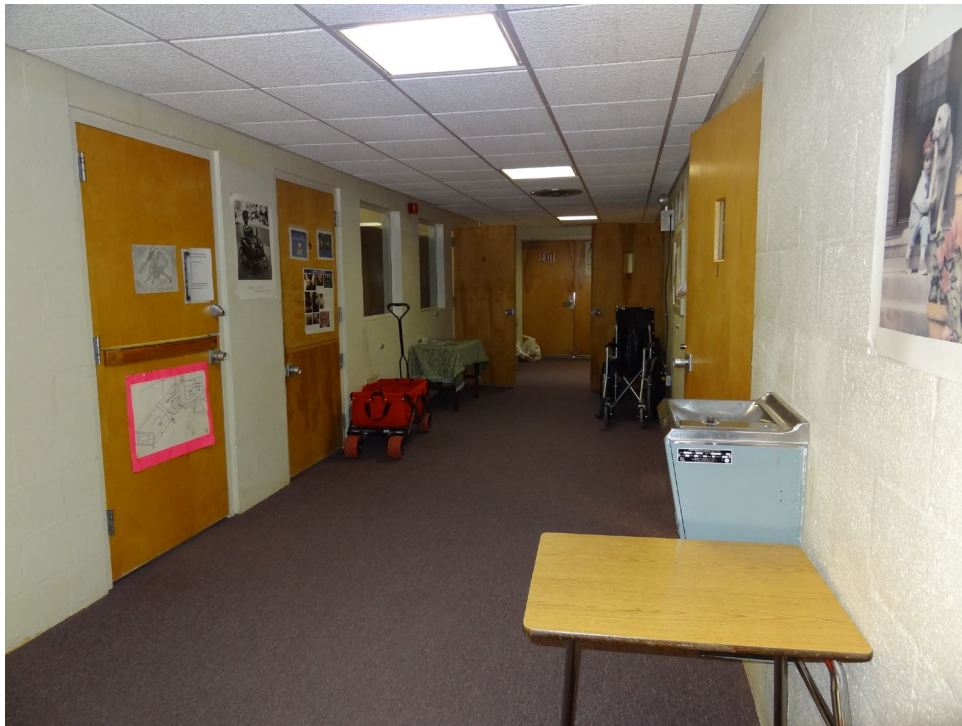
CYC Evaluation / Infirmary - Building #0220
Description: Install Lever Action Door Hardware.

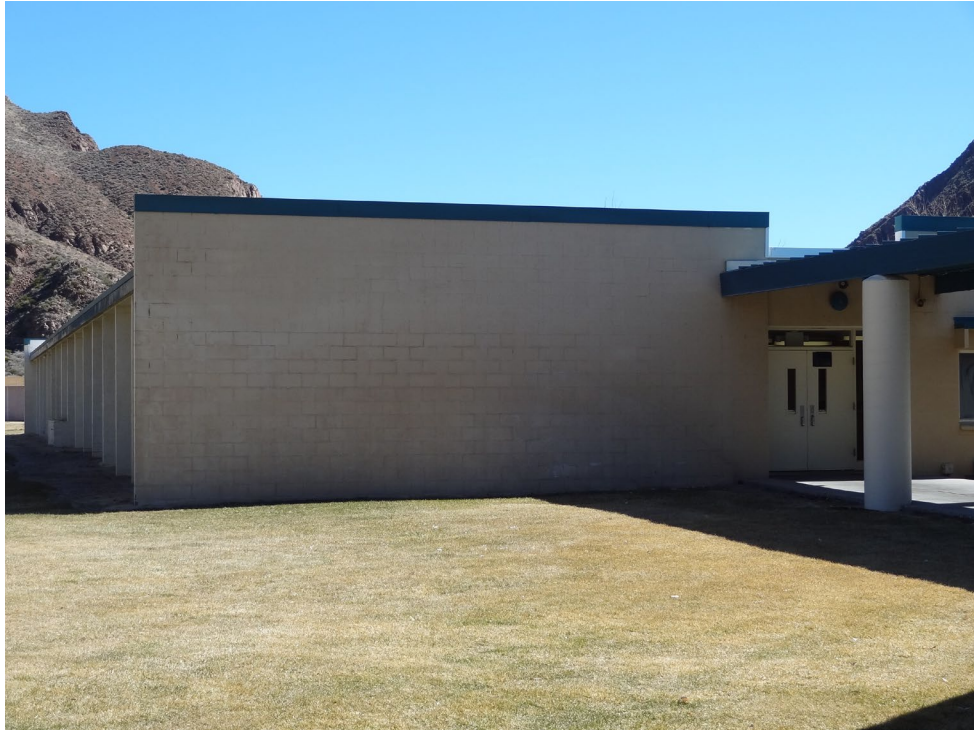
CYC School - Old - Building #0219
Description: Exterior Energy Retrofit (non-insulated CMU Walls).

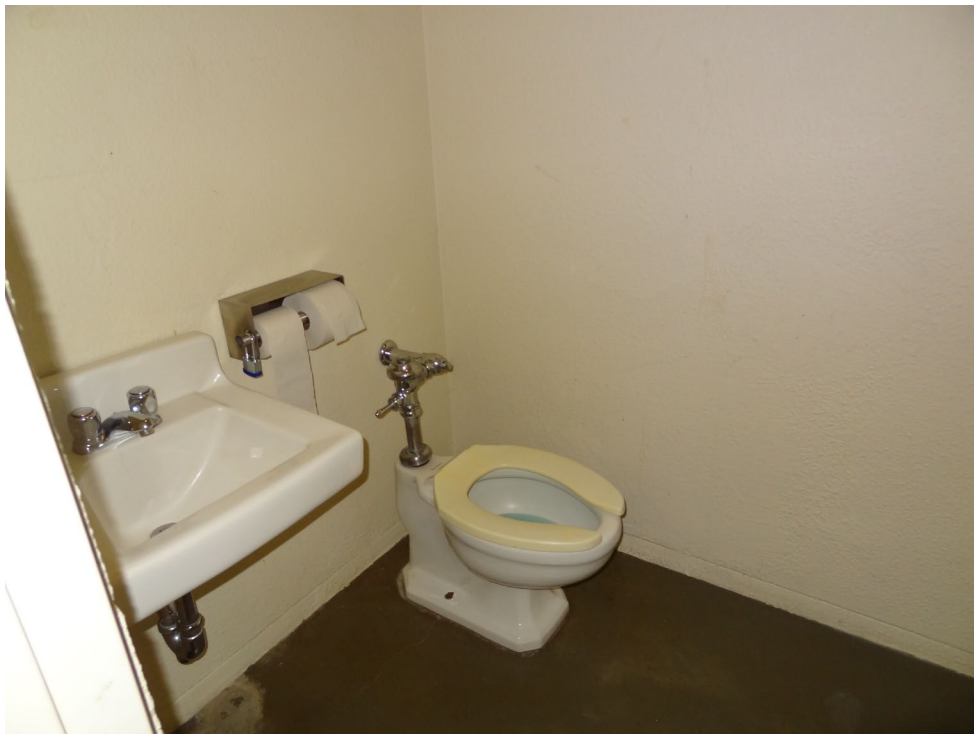
CYC School - Old - Building #0219
Description: ADA Restroom Upgrade.

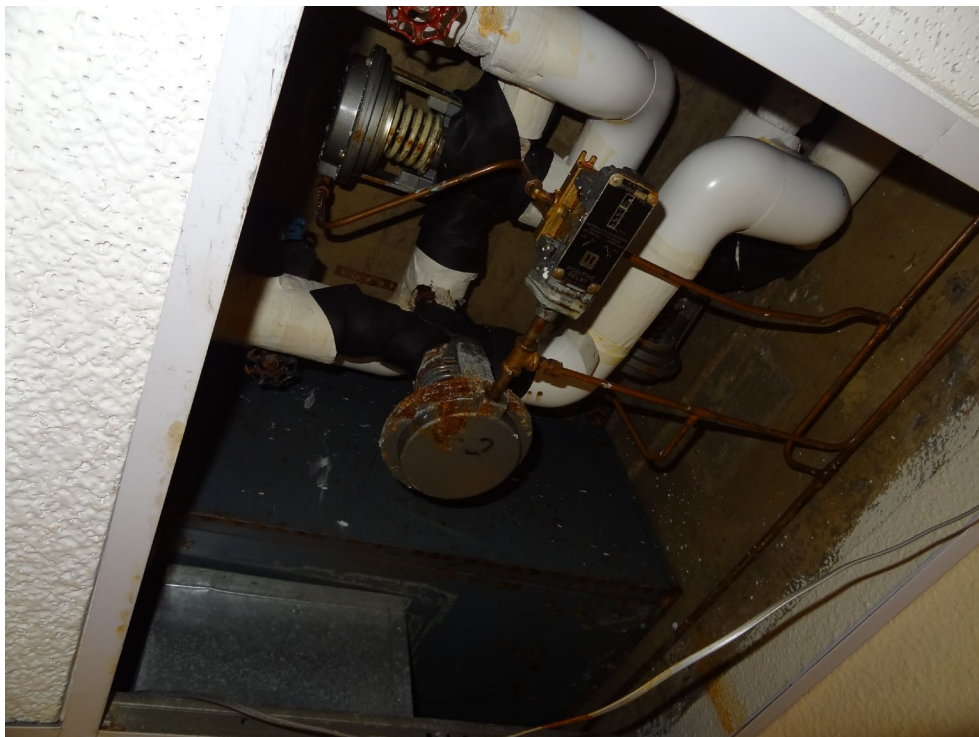
CYC Administration - Building #0218
Description: HVAC Equipment Replacement.

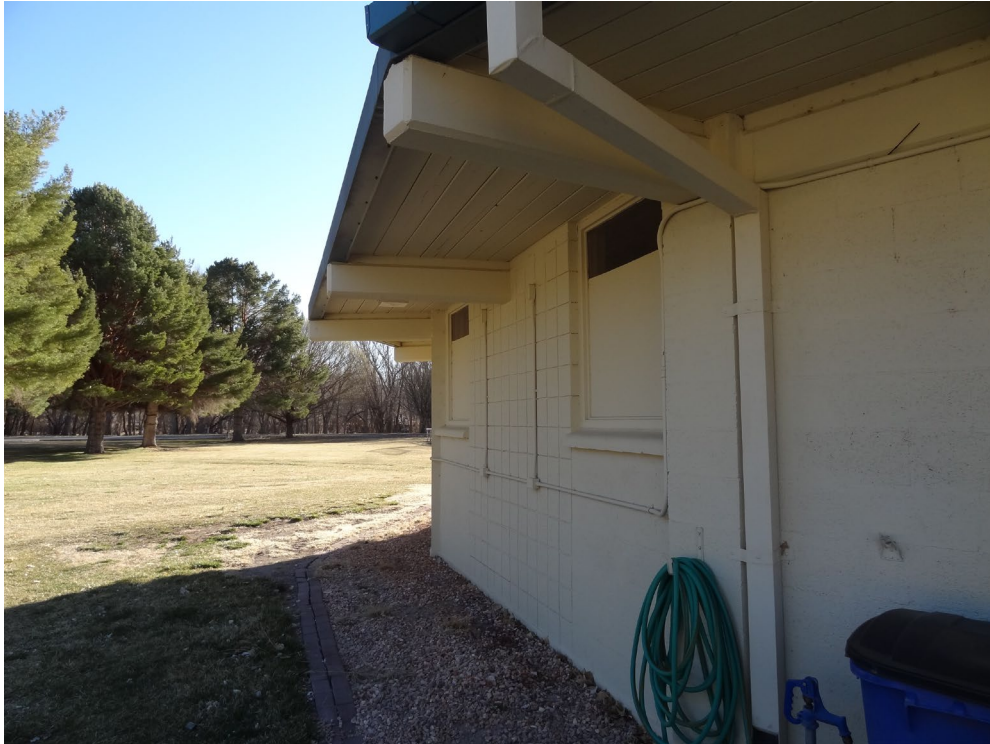
CYC Kimberly Dormitory - Building #0216
Description: Exterior Energy Retrofit.

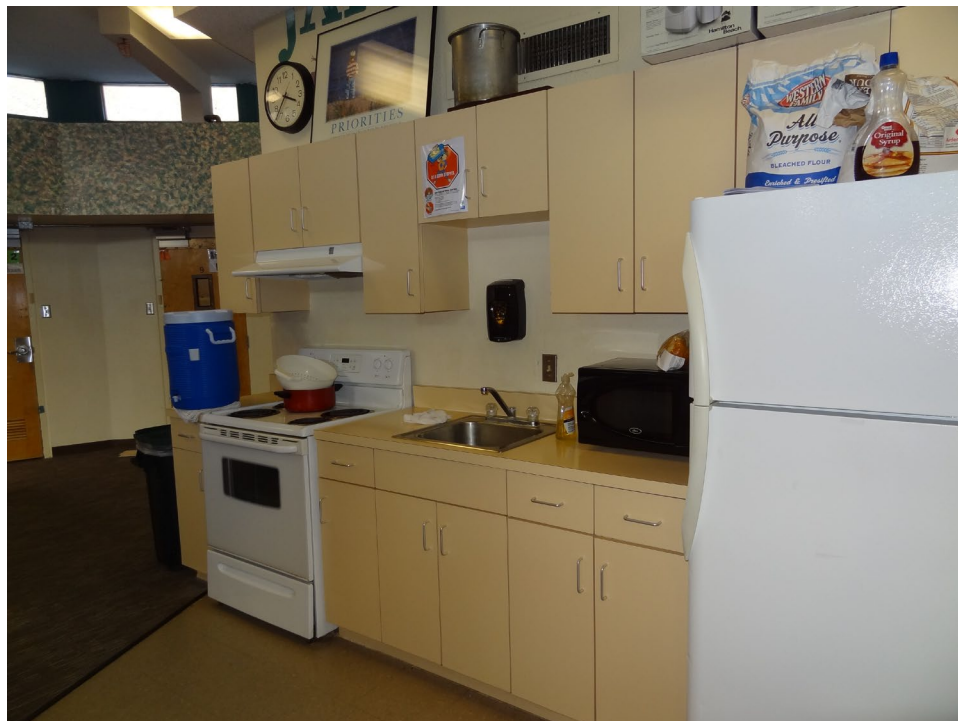
CYC Jarbidge Dormitory - Building #0215
Description: Kitchen Remodel.

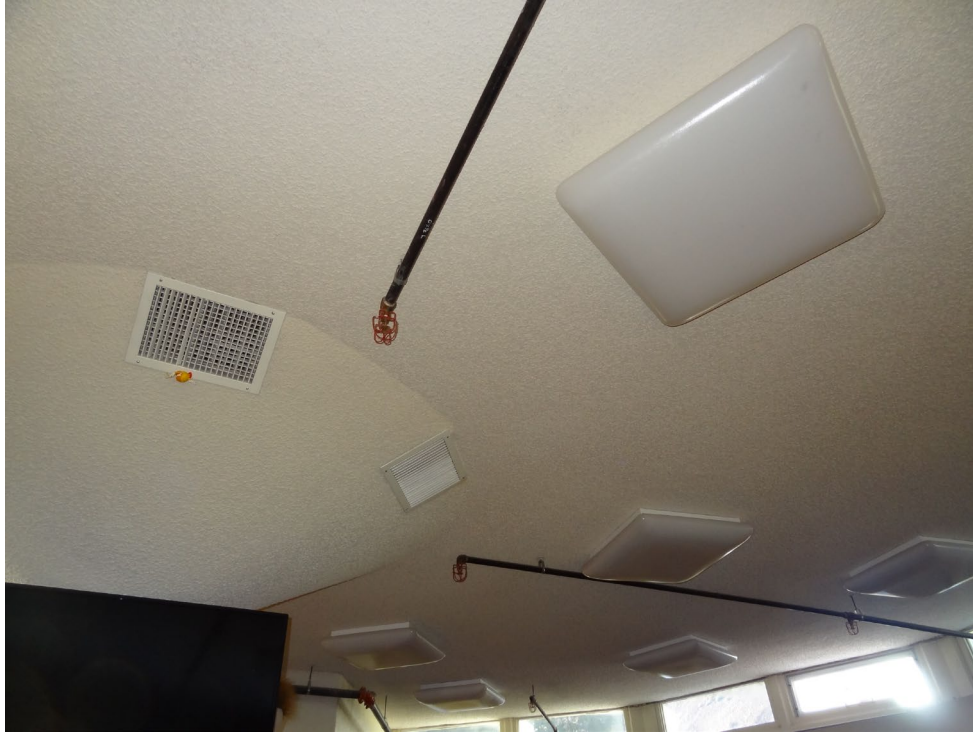
CYC Aurora Dormitory - Building #0211
Description: Sprinkler Pipe Encapsulation.

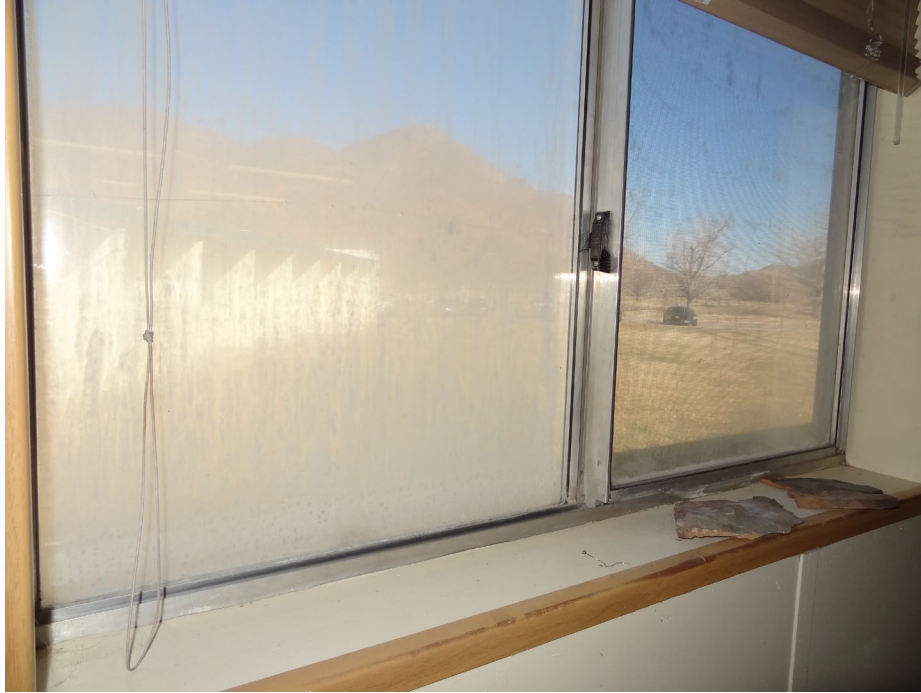
CYC Mental Health Building - Building #0199
Description: Window Replacement.
