State of Nevada
Department of Corrections
Facility Condition Analysis

HIGH DESERT STATE PRISON

**STATE OF NEVADA PUBLIC WORKS DIVISION
FACILITY CONDITION ANALYSIS**

Report distributed in August, 2017

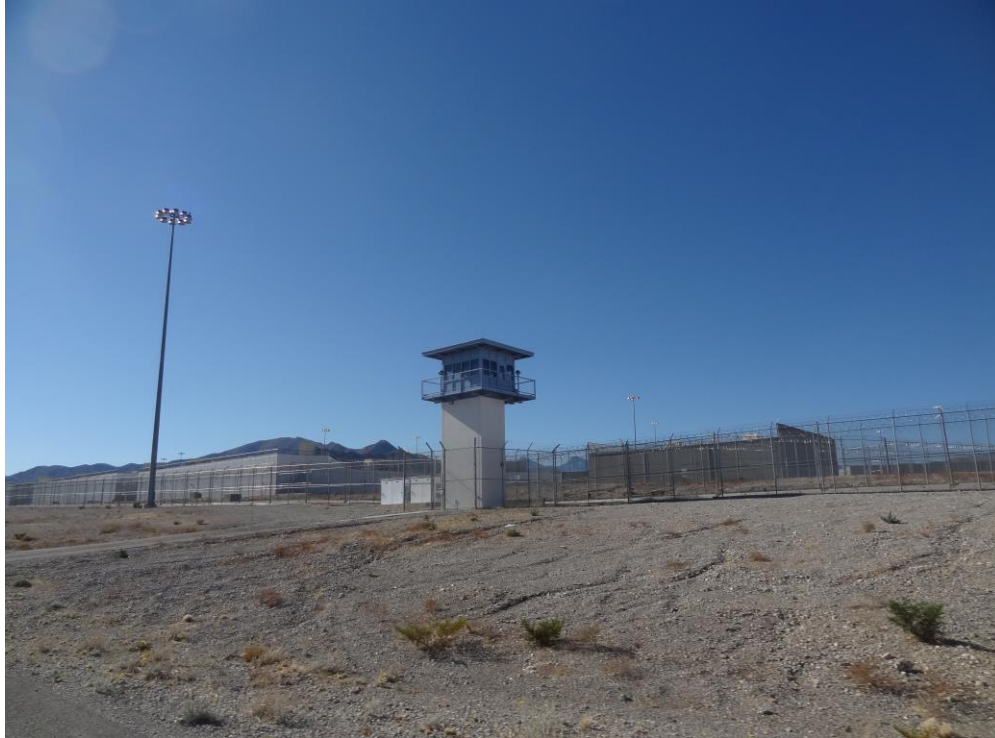
Tower #4 - Building #2177
Description: Exterior finishes.

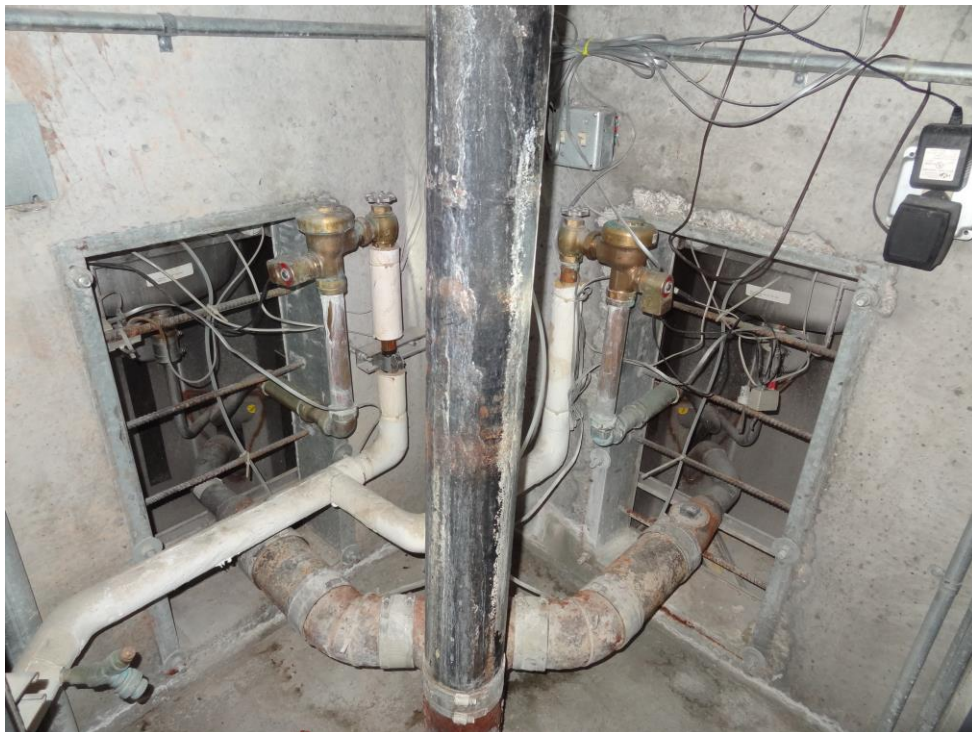
Housing Unit #7 – Building #2173
Description: Cell water controls system replacement needed.

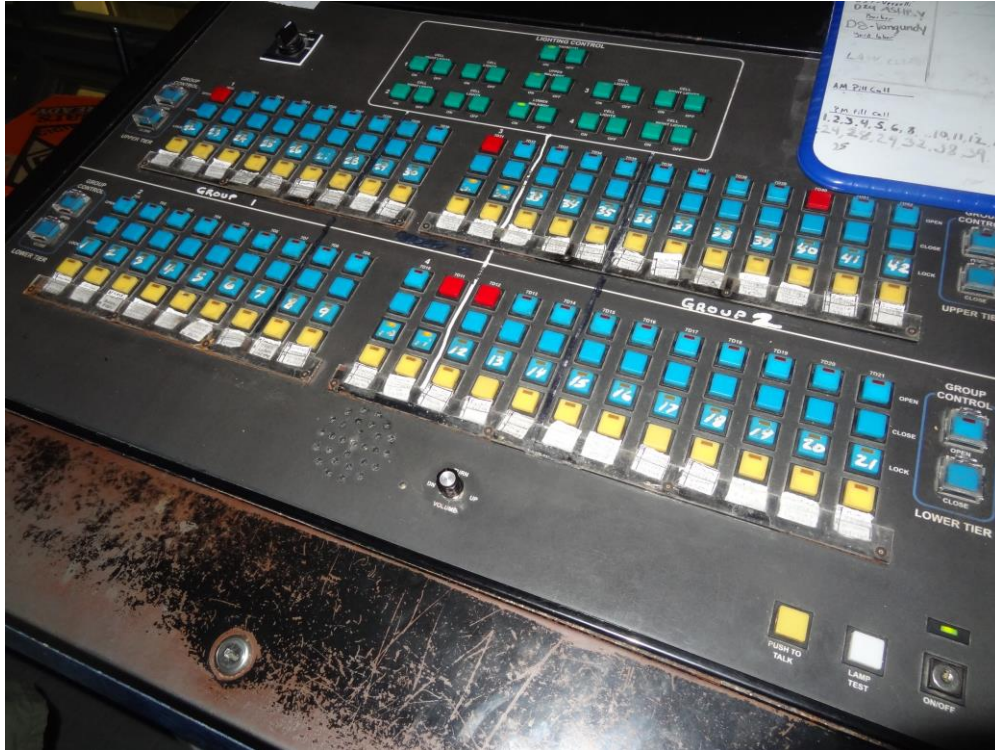
Housing Unit #7 - Building #2173
Description: Door controls system replacement needed.

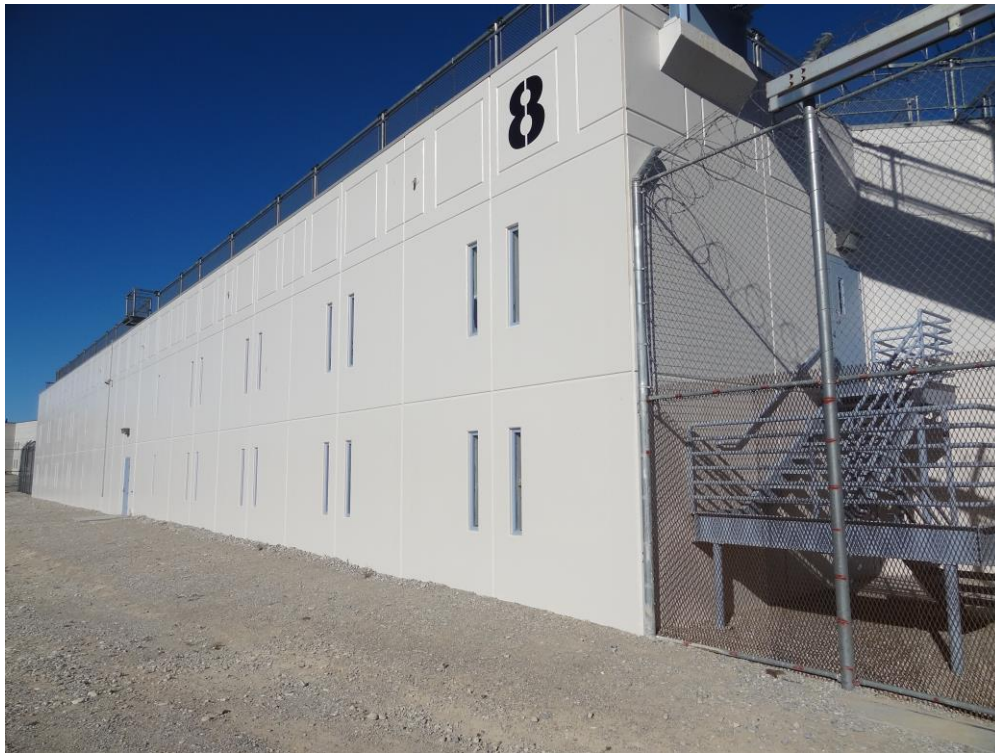
Housing Unit #8 - Building #2172
Description: Exterior finishes.

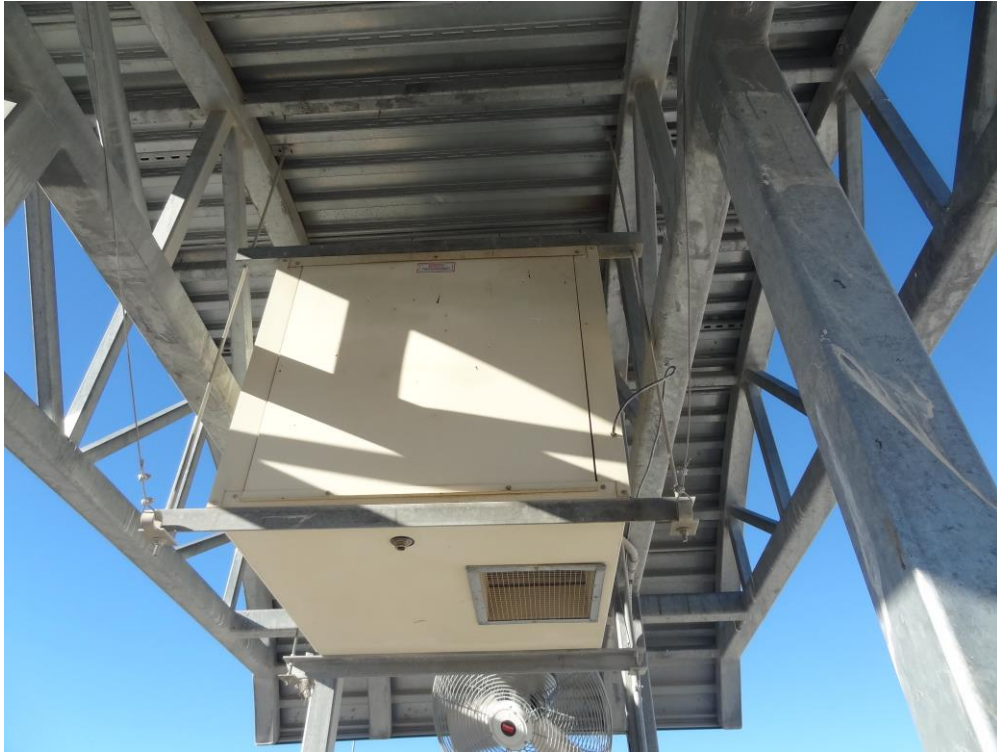
Housing Unit #8 - Building #2172
Description: Evaporative cooler replacement needed.

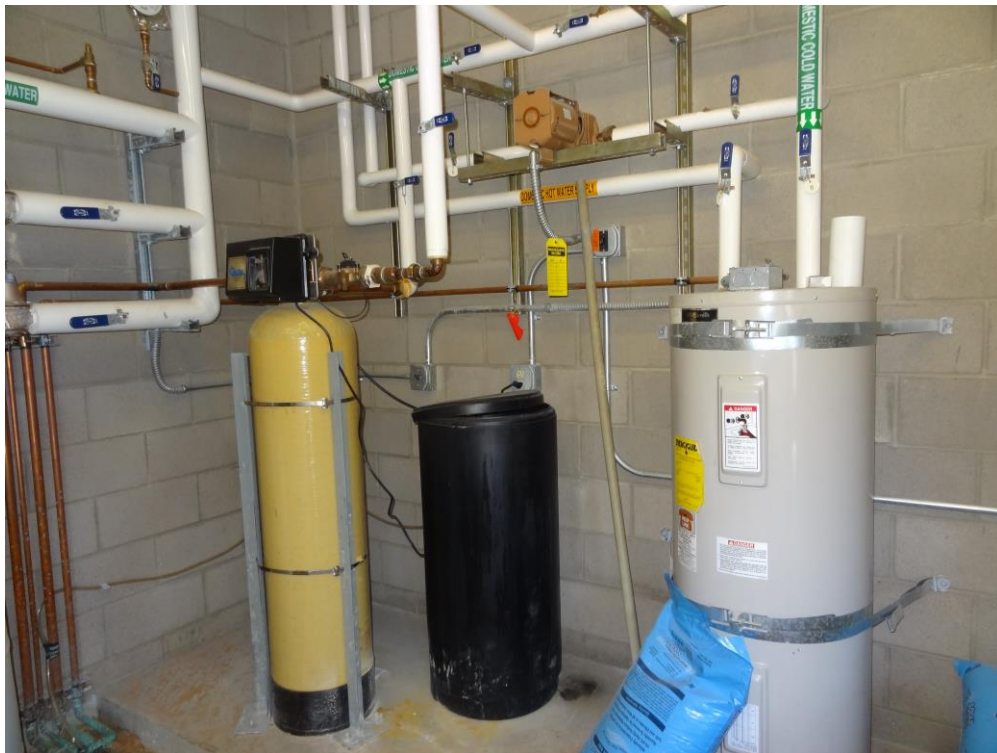
Security/ Administration - Building #2099
Description: Water heater replacement needed.

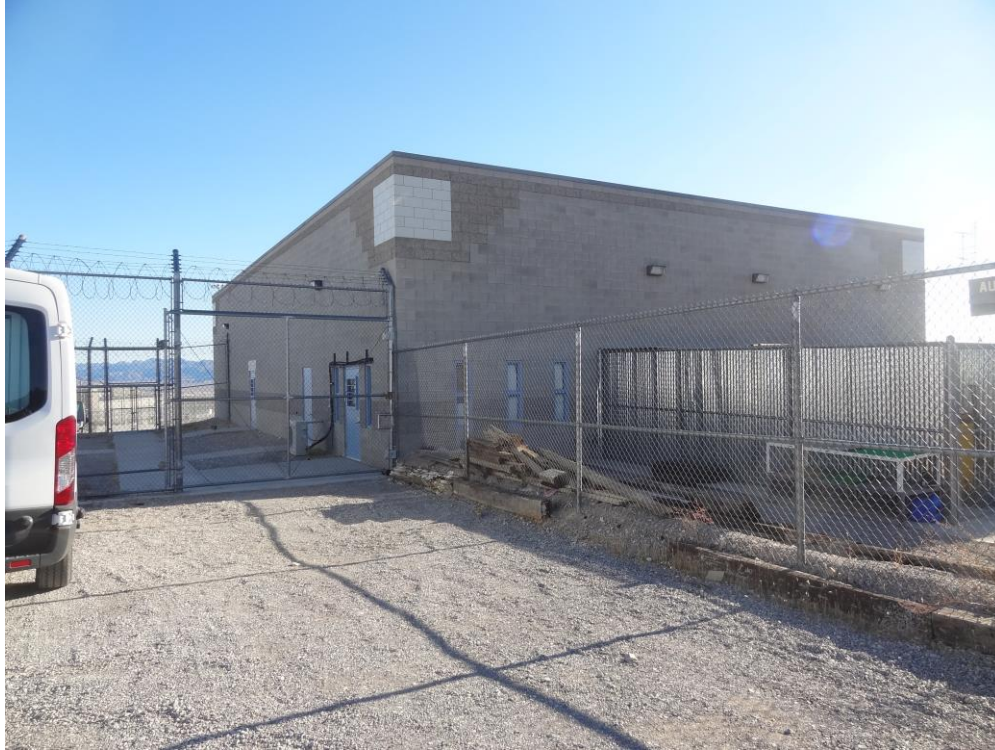
Armory/ Emergency Response - Building #2098
Description: Exterior finishes.

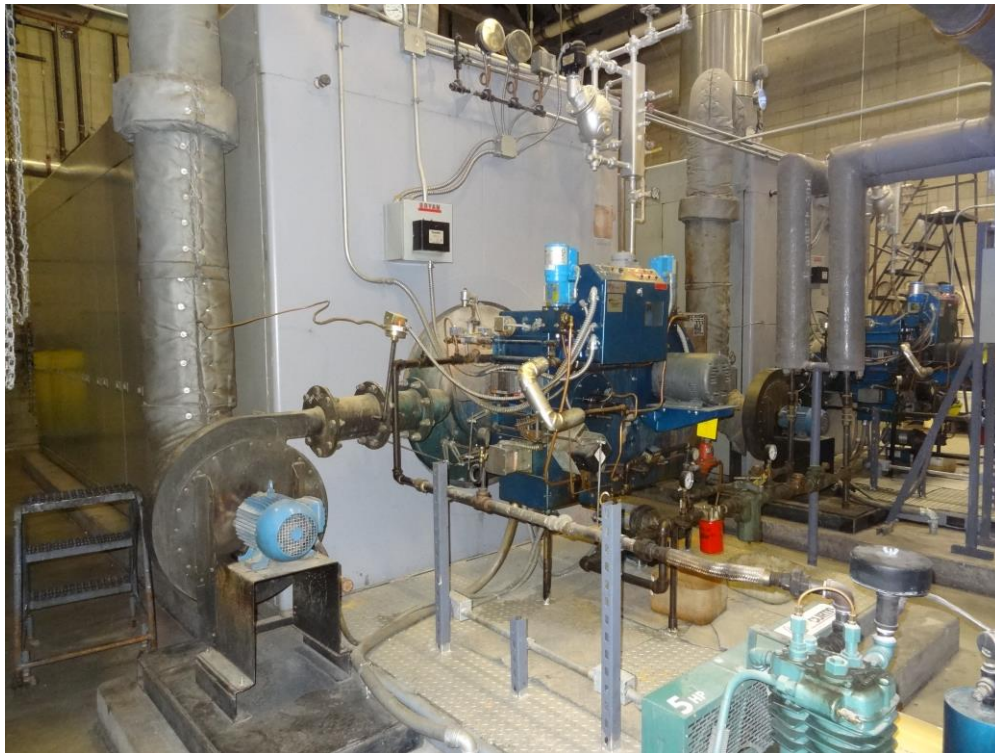
Maintenance/ Central Plant - Building #2097
Description: Boiler burner replacement needed.

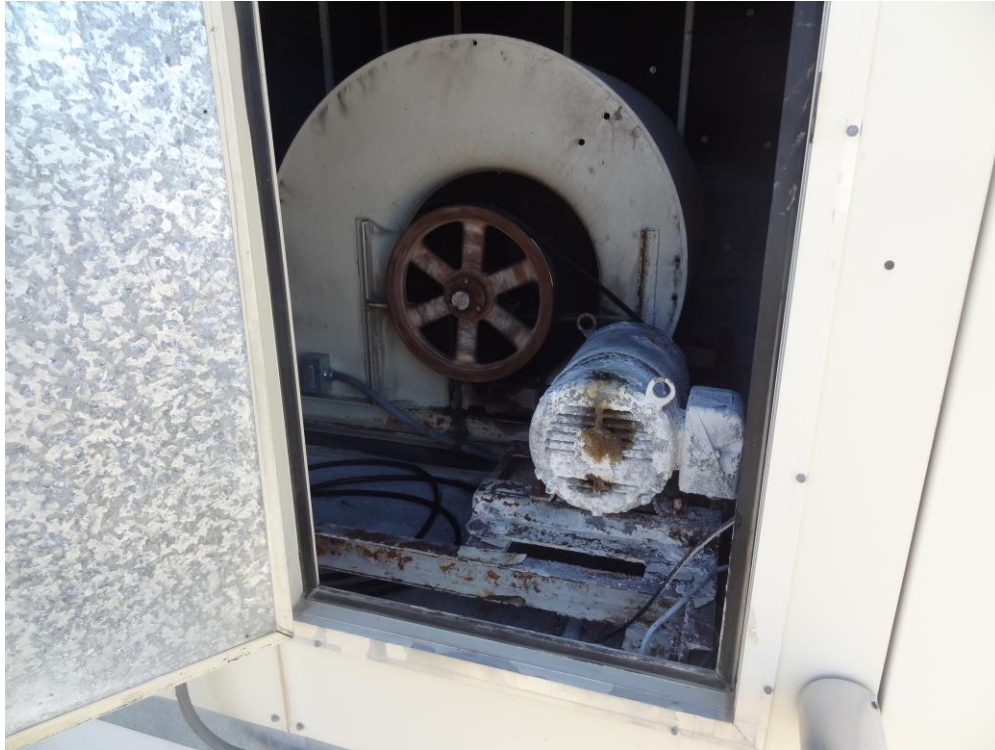
Maintenance/ Central Plant - Building #2097
Description: HVAC replacement needed.

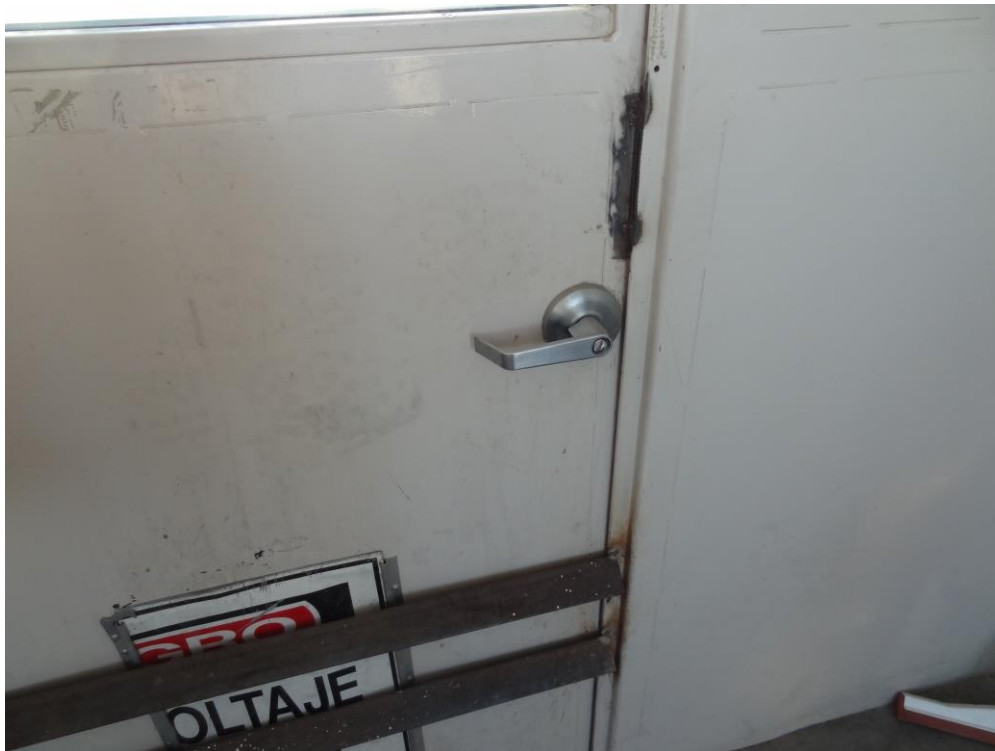
Sallyport - Building #2096
Description: Egress door upgrade needed.

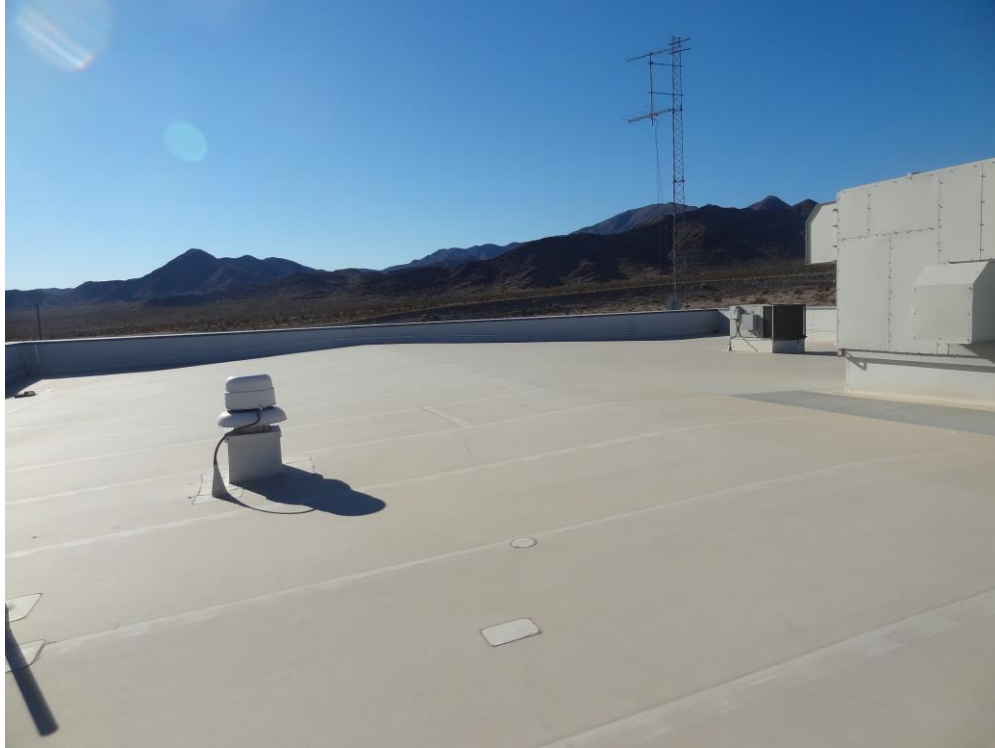
Administration - Building #2094
Description: Roof replacement needed.

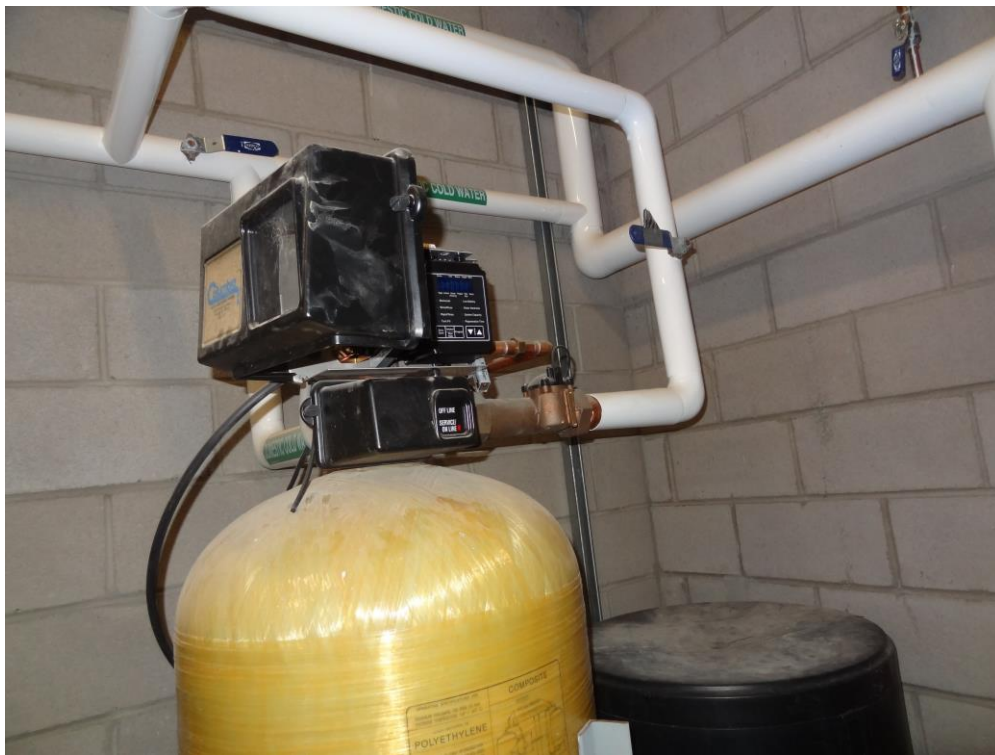
Visitation - Building #2093
Description: Water treatment system replacement needed.

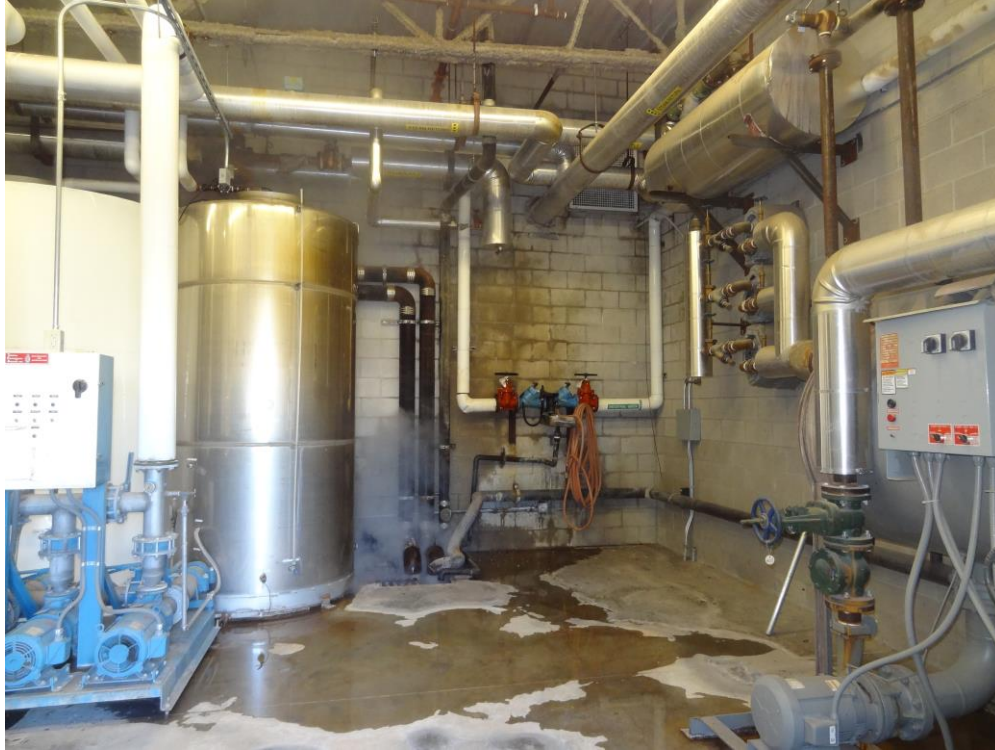
Inmate Services/ Culinary/ Dining - Building #2091
Description: Hot water re-use room remodel needed.

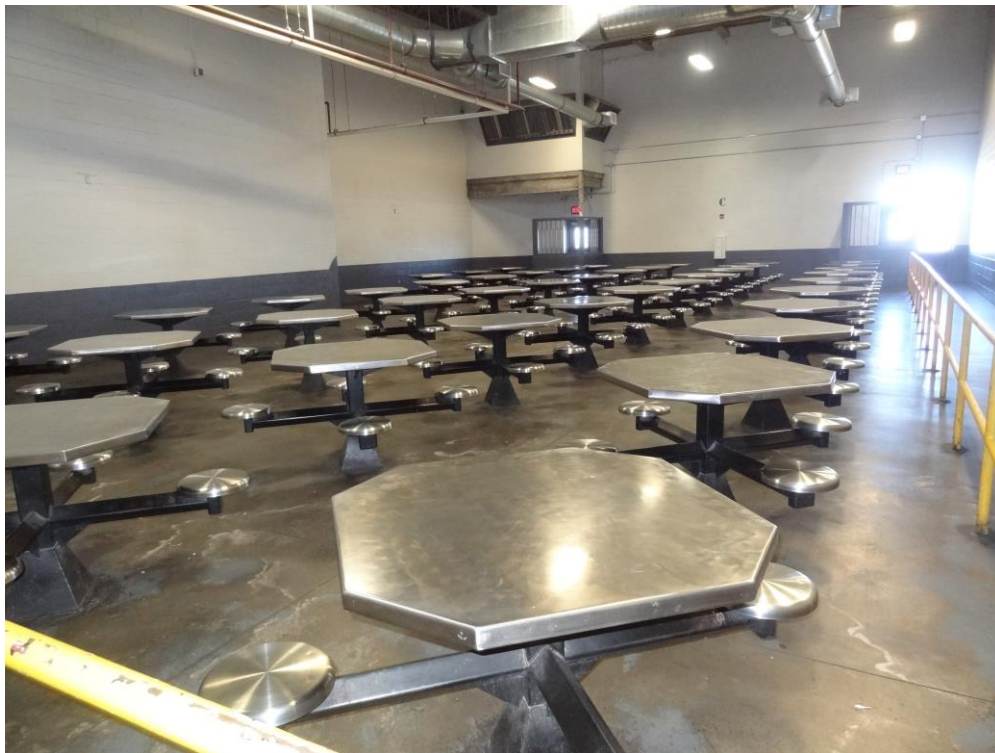
Inmate Services/ Culinary/ Dining - Building #2091
Description: ADA table upgrade needed.

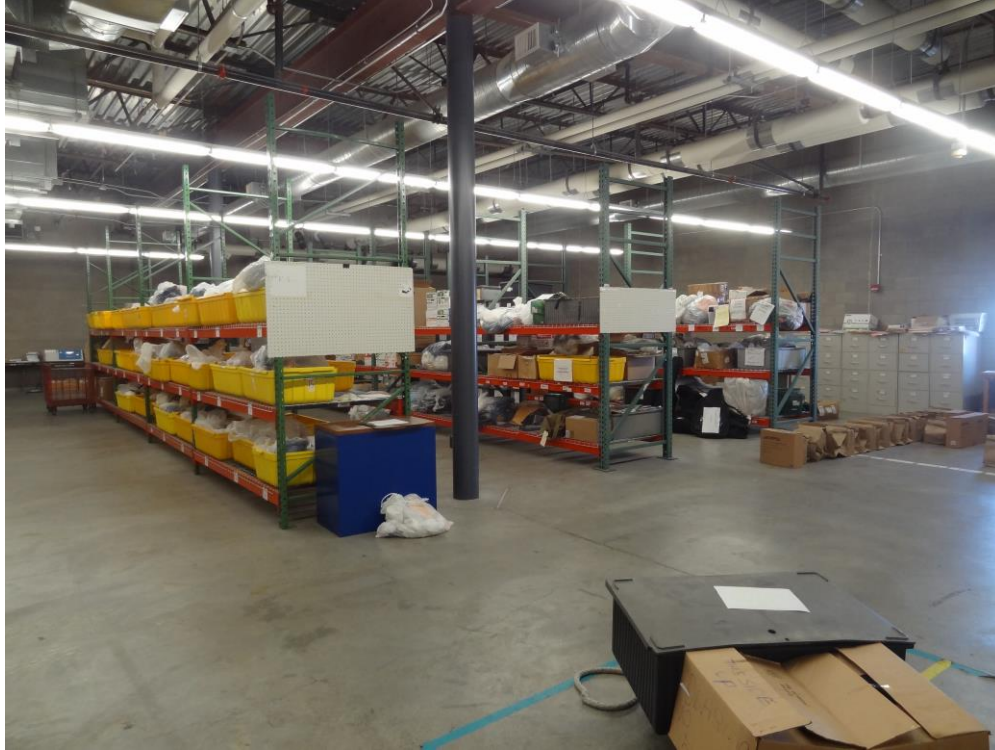
Infirmery/ Intake – Building #2090
Description: Shelves missing proper anchoring.

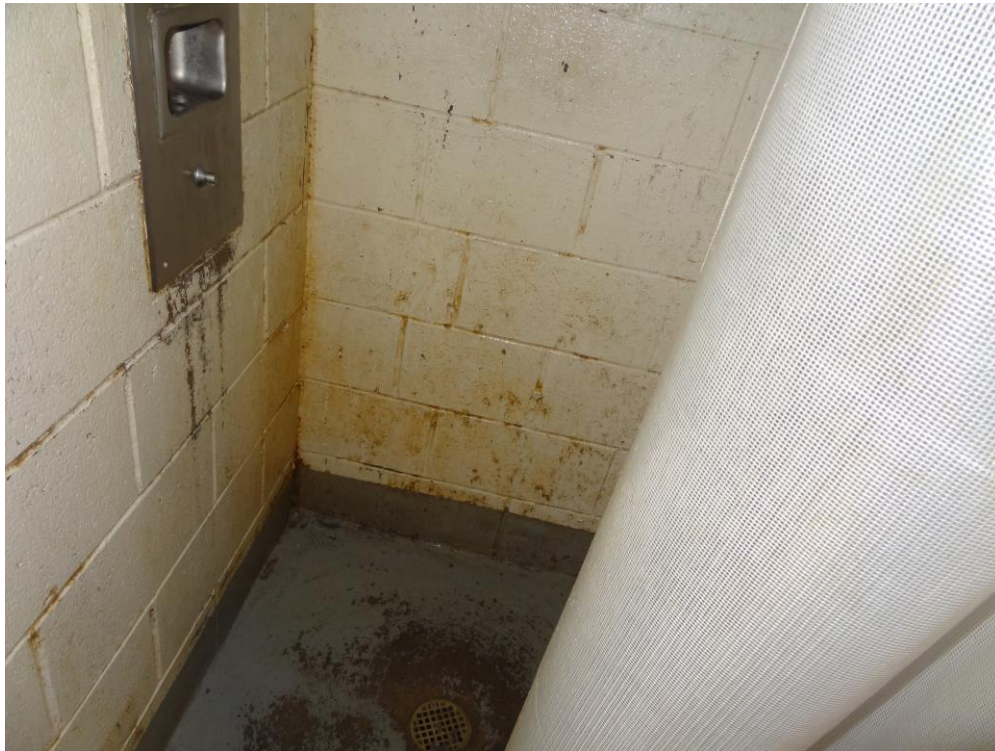
Infirmery/ Intake – Building #2090
Description: ADA shower upgrade needed.
