DEPARTMENT OF ADMINISTRATION
STATE PUBLIC WORKS DIVISION
FACILITY CONDITION ASSESSMENT

PROPERTY PORTFOLIO REVIEW PROJECT ADDENDUM

SOUTH REGION
INDIAN SPRINGS CORRECTIONAL CENTER COMPLEX
9952 - HIGH DESERT STATE PRISON SITE
22010 COLD CREEK RD
INDIAN SPRINGS, NV 89018-
CLARK COUNTY

SURVEY DATE: 01/22/2025

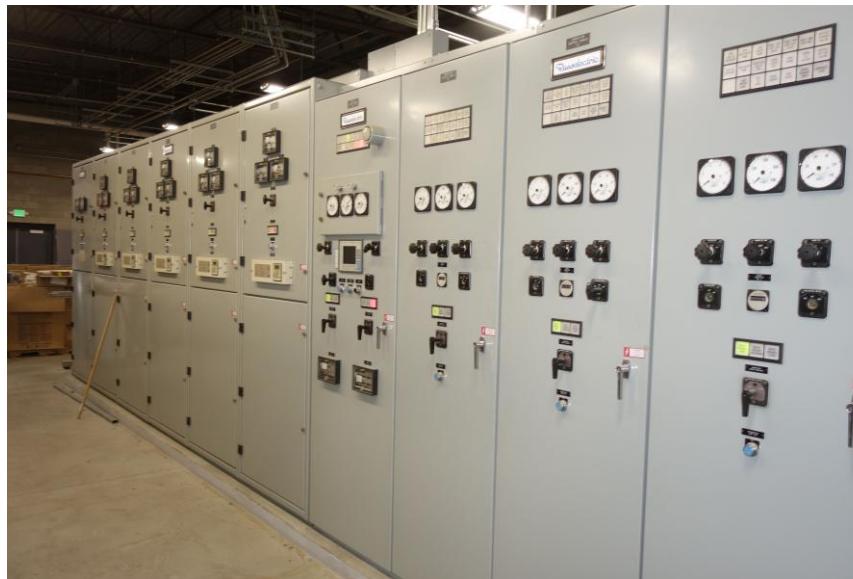
HIGH DESERT STATE PRISON SITE

Arc flash and electrical breaker coordination studies have not been performed or it has been more than 5 years since the last coordination study. Safety requirements for maintenance personnel and the latest electrical code require coordination studies to be verified and performed every 5 years, along with arc flash labeling on all electrical panels. This project recommends performing the required coordination study, evaluation, adjustments and labeling sitewide for the electrical distribution system.

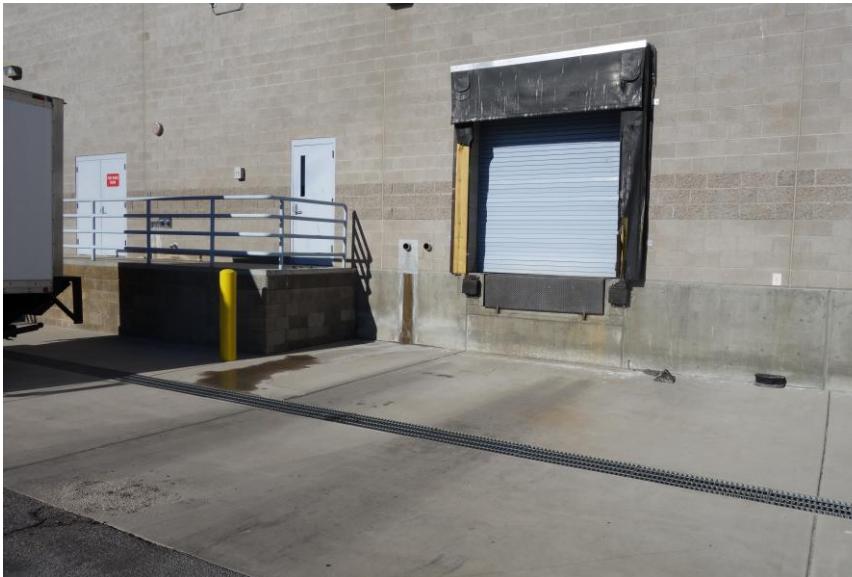
WAREHOUSE/ MOTOR POOL

The Warehouse/ Motor Pool has a loading dock. The loading dock is used by large trucks and tractor trailers to back in for loading and unloading supplies needed for the High Desert State Prison. There are no wheel blocks installed to prevent the movement of trucks or trailers loading or unloading, per OSHA 1910.178(m)(7) requirements. The forklifts are battery operated. Per OSHA 1910.178(g)(2), the charging area for the forklifts do not provide an area for; flushing and neutralizing spilled electrolytes; for fire protection; for protecting charging apparatus; from damage by trucks, and for adequate ventilation for

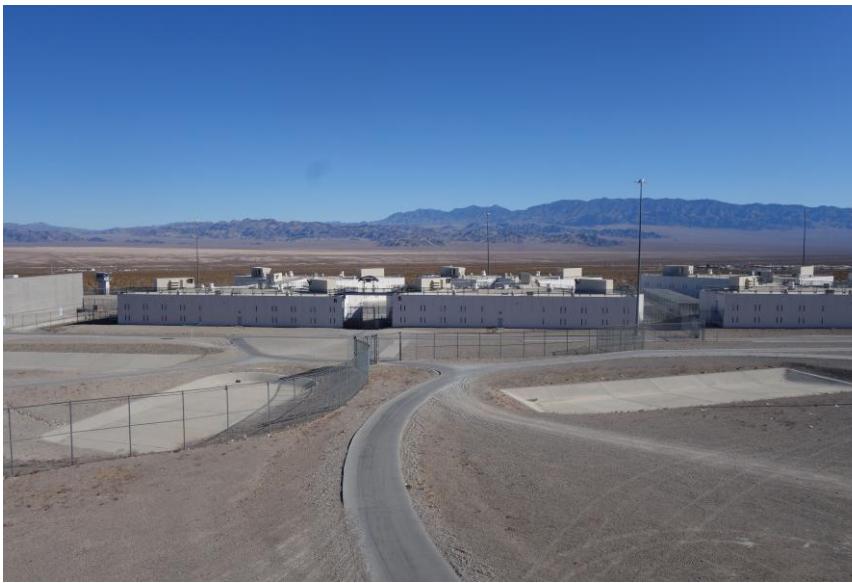
HOUSING UNIT #5

The perimeter roof walkway guardrail is failing. The railing is loose or not attached and is posing a potential safety problem. This project recommends an assessment be performed by a Structural Engineer to determine the cause and provide a design solution. Future projects will be based on the design solution recommendation.

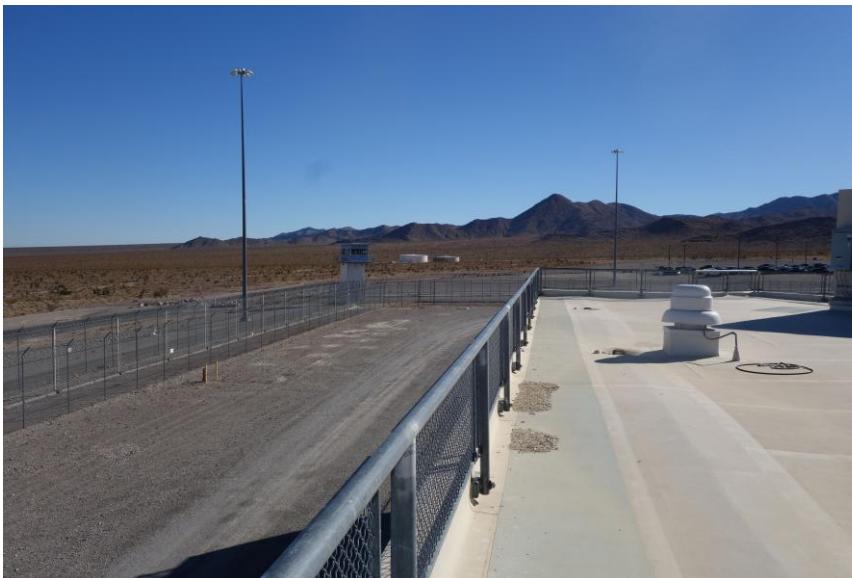
HOUSING UNIT #8

The perimeter roof walkway guardrail is failing. The railing is loose or not attached and is posing a potential safety problem. This project recommends an assessment be performed by a Structural Engineer to determine the cause and provide a design solution. Future projects will be based on the design solution recommendation.

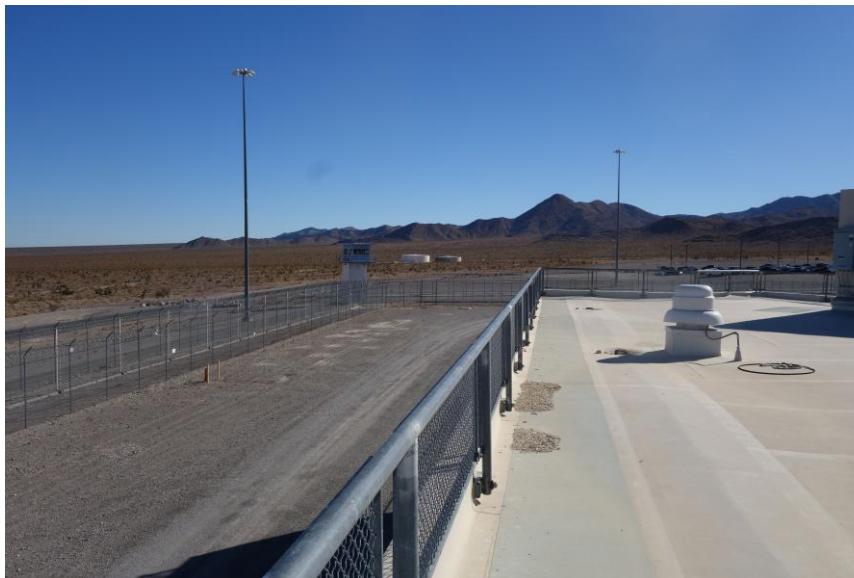
HOUSING UNIT #7

The perimeter roof walkway guardrail is failing. The railing is loose or not attached and is posing a potential safety problem. This project recommends an assessment be performed by a Structural Engineer to determine the cause and provide a design solution. Future projects will be based on the design solution recommendation.

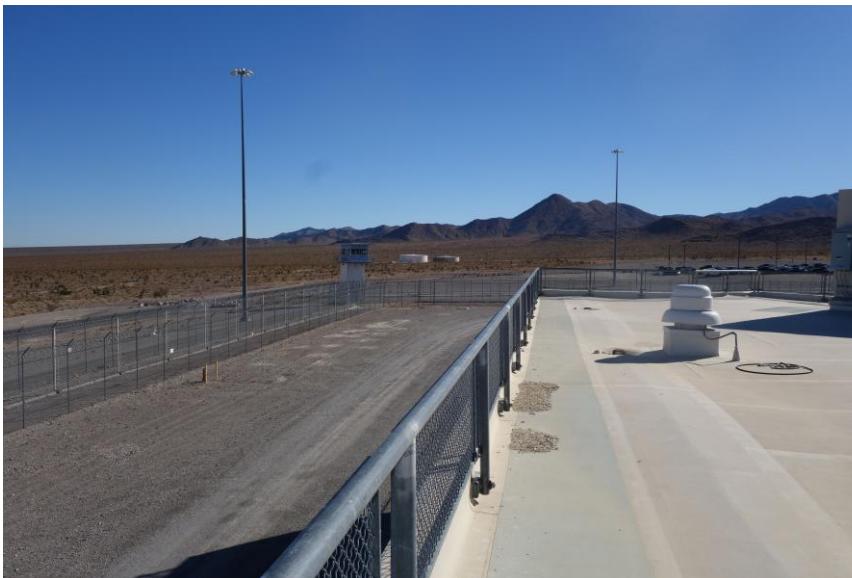
HOUSING UNIT #2

The perimeter roof walkway guardrail is failing. The railing is loose or not attached and is posing a potential safety problem. This project recommends an assessment be performed by a Structural Engineer to determine the cause and provide a design solution. Future projects will be based on the design solution recommendation.

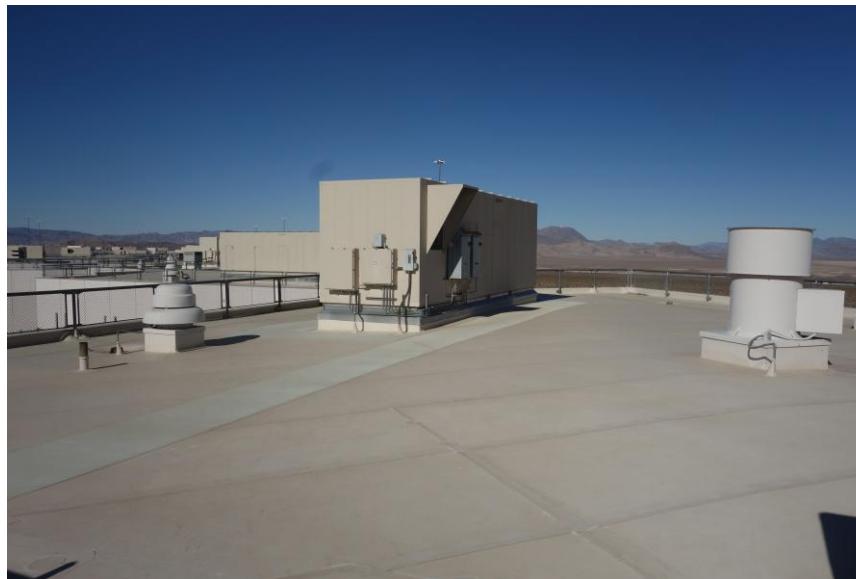
HOUSING UNIT #11

The air handlers, fan coils and related equipment are original to the building, dating back to 2000. The equipment has consistent problems and has reached its expected life span. This project recommends the replacement of all air handlers, rooftop units, and exhaust fans. It is recommended that this project be implemented in the next 2 - 3 years to avoid possible failure and emergency funding for replacement.

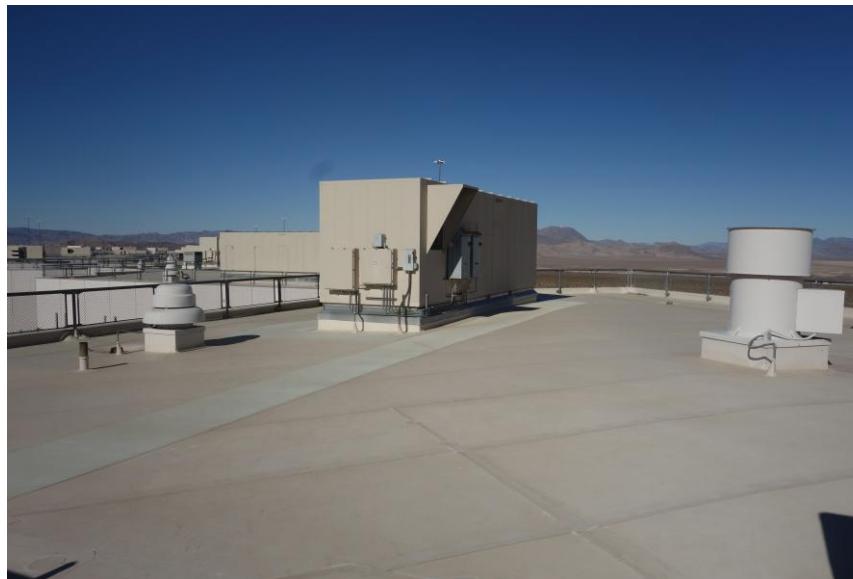
HOUSING UNIT #12

The air handlers, fan coils and related equipment are original to the building, dating back to 2000. The equipment has consistent problems and has reached its expected life span. This project recommends the replacement of all air handlers, rooftop units, and exhaust fans. It is recommended that this project be implemented in the next 2 - 3 years to avoid possible failure and emergency funding for replacement.

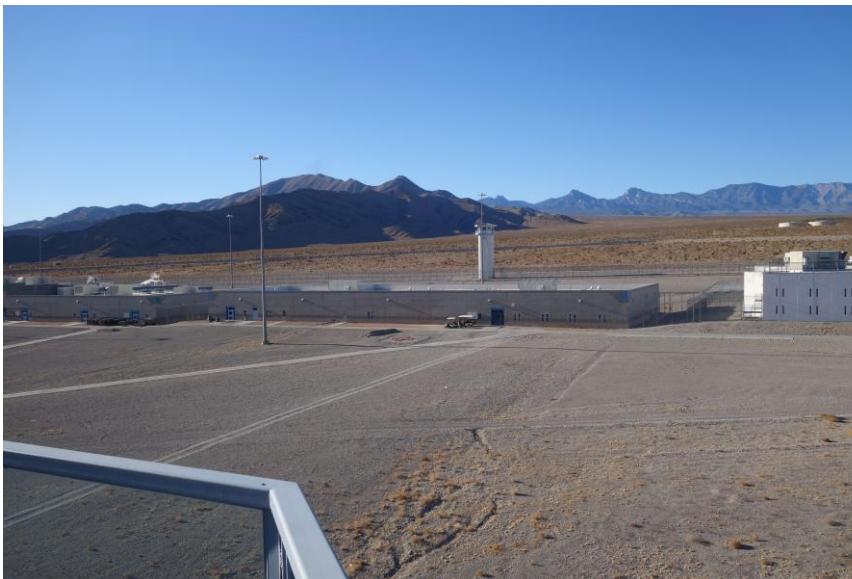
INFIRMARY/ INTAKE

The air handlers, fan coils and related equipment are original to the building, dating back to 2000. The equipment has consistent problems and has reached its expected life span. This project recommends replacement of the air handlers, fan coils, ventilation equipment and exhaust fans. It is recommended that this project be implemented in the next 2-3 years to avoid possible failure and emergency funding for replacement.

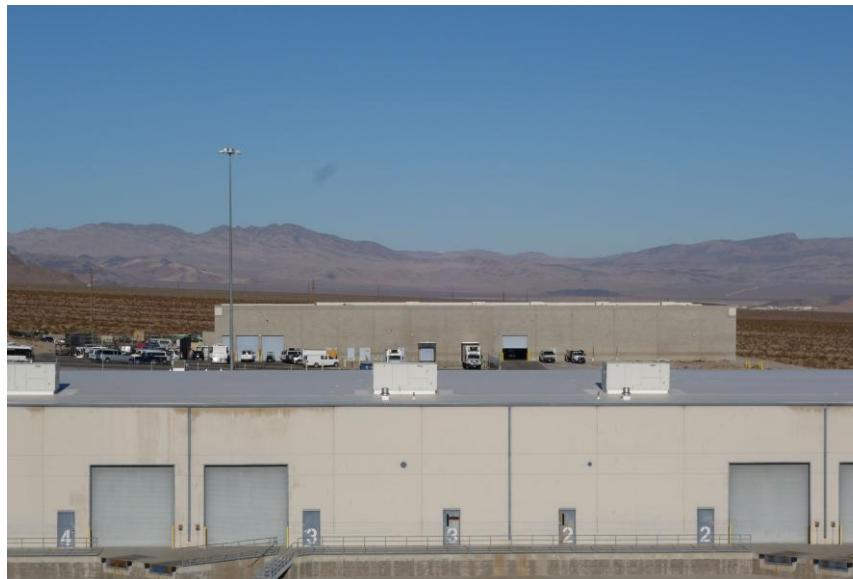
WAREHOUSE/ MOTOR POOL

The air handlers, fan coils and related equipment are original to the building, dating back to 2000. The equipment has consistent problems and has reached its expected life span. This project recommends replacement of the air handlers, fan coils, ventilation equipment and exhaust fans. It is recommended that this project be implemented in the next 2 - 3 years to avoid possible failure and emergency funding for replacement.

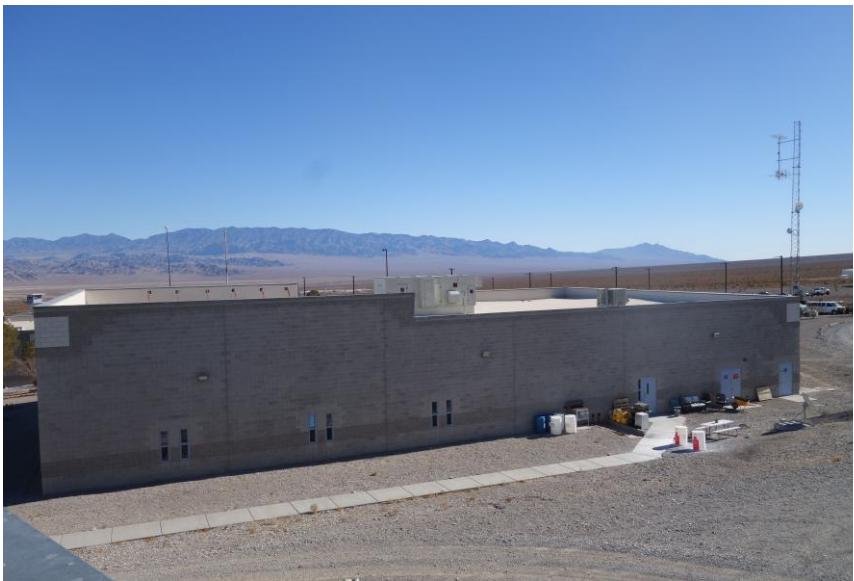
ADMINISTRATION

The air handlers, fan coils and related equipment are original to the building, dating back to 2000. The equipment has consistent problems and has reached its expected life span. This project recommends replacement of the air handlers, fan coils, ventilation equipment and exhaust fans. It is recommended that this project be implemented in the next 2 - 3 years to avoid possible failure and emergency funding for replacement.

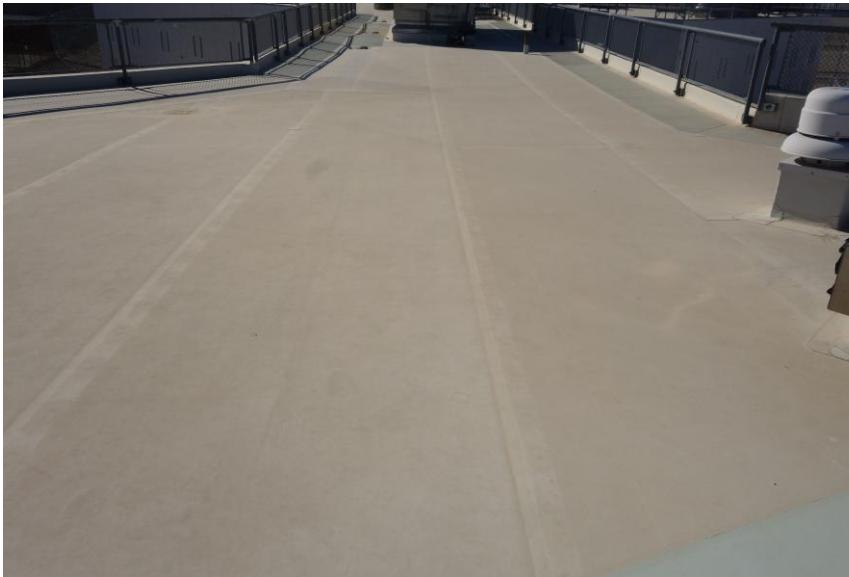
HOUSING UNIT #1

The roof on this building was in fair condition at the time of the survey. The statewide roofing program has set the useful life of an average roof at 20 years. The roof warranty expires at the end of the same time frame. The temperature fluctuations throughout the year, consistent wind which blows sand and dirt on to the roof membrane, and constant exposure to the sun are contributing factors to wear and deterioration. The current roofing system was installed in 2000. It is recommended that this building be re-roofed in the next 2-3 years to be consistent with the roofing program and the end of the warranty period.

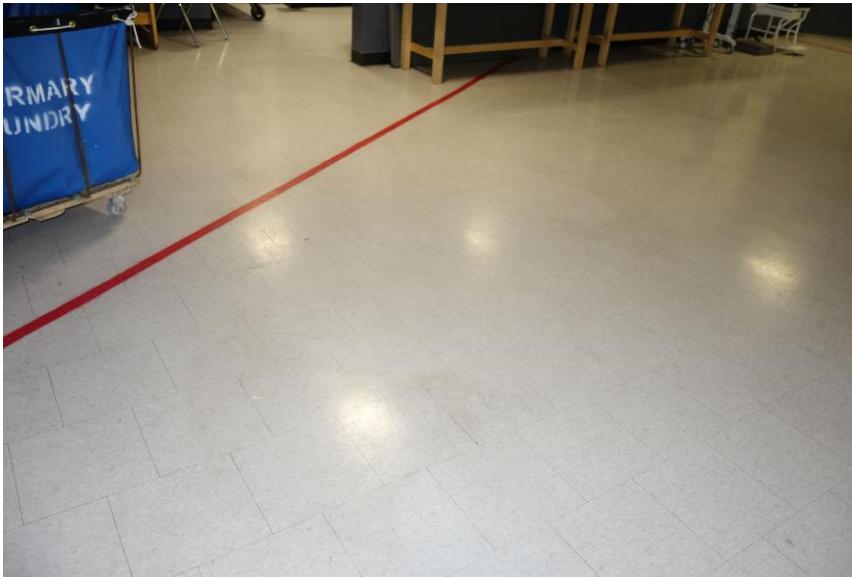
INFIRMARY/ INTAKE

This building is equipped with cell water control systems that are outdated and should be scheduled for replacement. Problems exist with the current water control systems. It is increasingly difficult to find replacement parts and experienced repairmen to service the equipment. It is recommended to replace the water control systems. This project includes the replacement of the water controllers, piping, valves, access panels and all connections to the existing utilities.

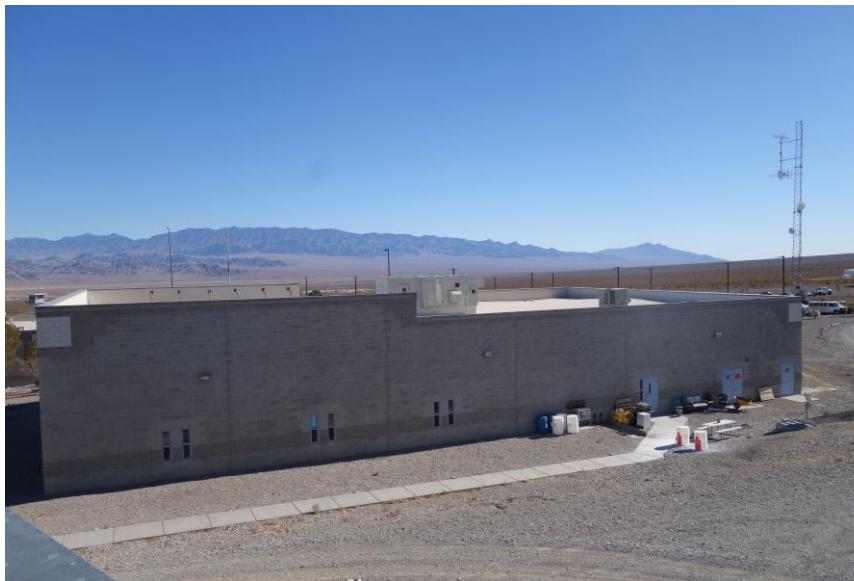
ADMINISTRATION

The roof on this building was in fair condition at the time of the survey. The statewide roofing program has set the useful life of an average roof at 20 years. The roof warranty expires at the end of the same time frame. The temperature fluctuations throughout the year, consistent wind which blows sand and dirt on to the roof membrane, and constant exposure to the sun are contributing factors to wear and deterioration. The current roofing system was installed in 2000. It is recommended that this building be re-roofed in the next 2 - 3 years to be consistent with the roofing program and the end of the warranty period.

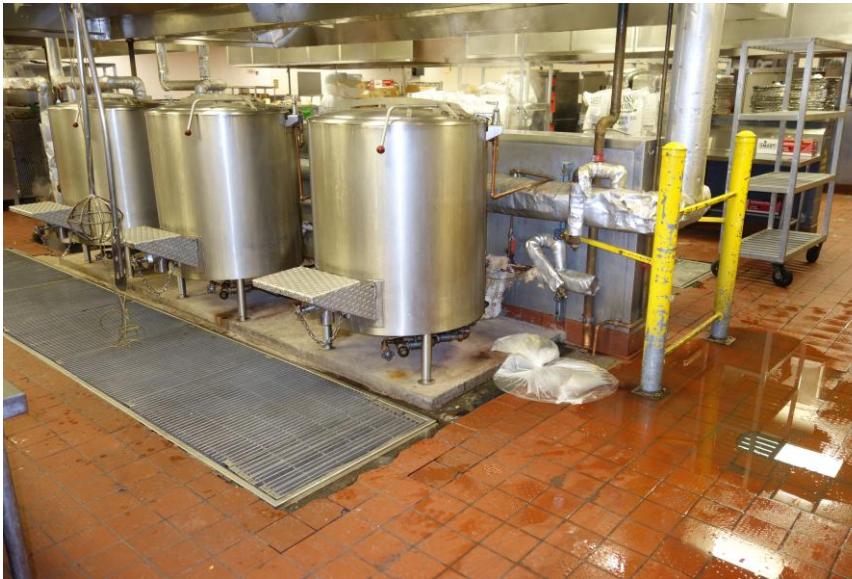
Areas of the floor tile in the culinary area are damaged around drains and cooking equipment. Portions of the tile grout is missing. It is recommended that the tile and grout in these areas be replaced. This project would provide for removal and disposal of the existing flooring and installation of new culinary grade tile in the next 2 - 4 years.
