State of Nevada
Department of Wildlife
Habitat Division

KEY PITTMAN WILDLIFE MANAGEMENT AREA

Site Number: 9954
STATE OF NEVADA PUBLIC WORKS DIVISION
FACILITY CONDITION ANALYSIS

Report distributed in May 2021

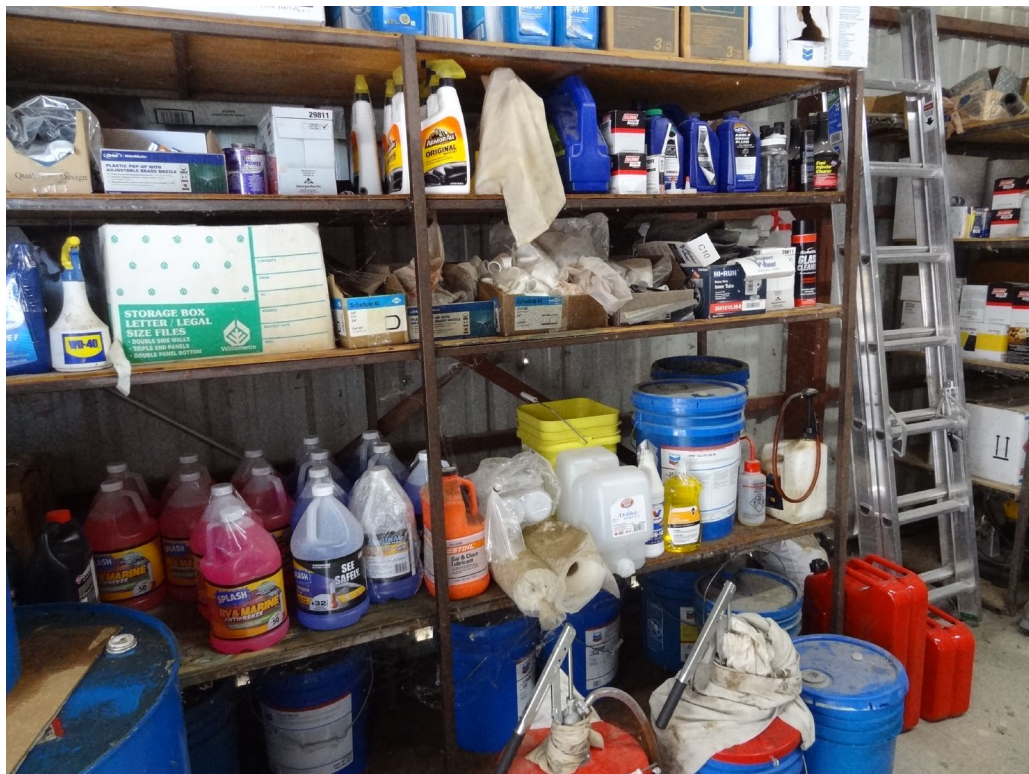
The storage building contains many different paints, stains, pesticides, and other hazardous products on open shelves and on the floor. This does not meet OSHA standards for hazardous materials containment. This project would provide two hazardous storage containers in the building and install placards on the building exterior in accordance with OSHA 1910.106 (d).

Storage Building - Building #3029
Description: Building Interior and need for Safety Cabinets.

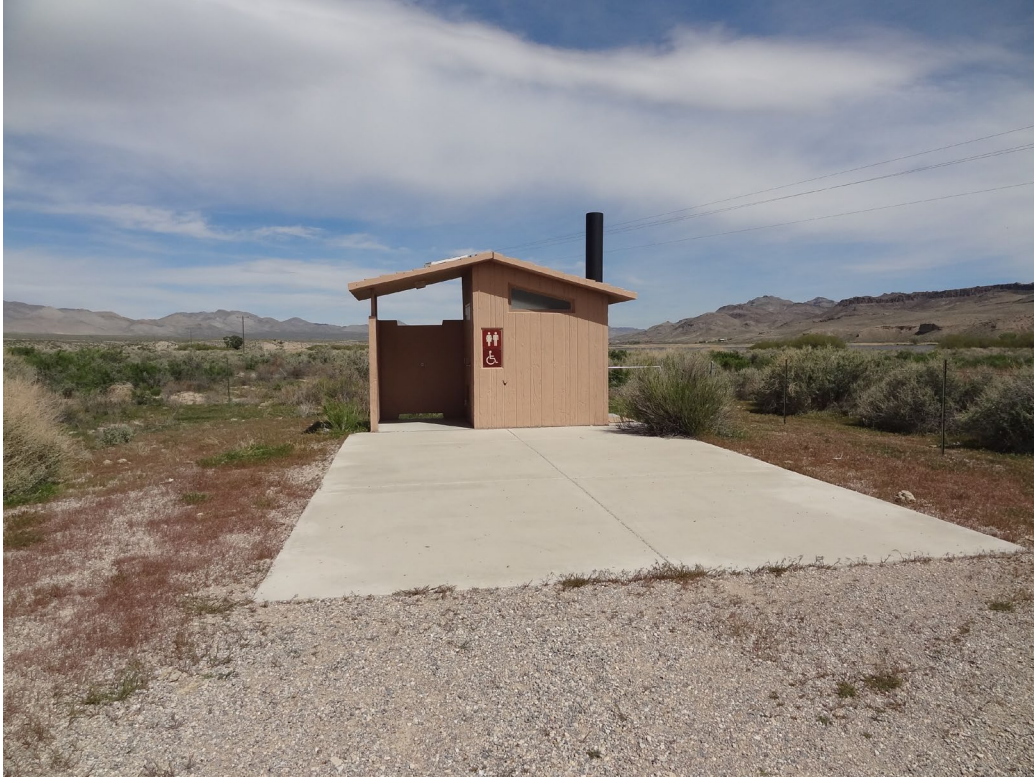
The ADA provides for accessibility to sites and services for people with physical limitations. The concrete parking area and passenger loading area are missing proper signage and striping to comply with ADA requirements. This project would provide for striping, signage and any other necessary upgrades to the parking space. NRS 338.180, IBC - 2018, ICC/ANSI A117.1 and Americans with ADAAG were referenced for this project.

CXT Comfort Station #2 - North - Building #3028
Description: Building Exterior and need for ADA Signage and Striping.

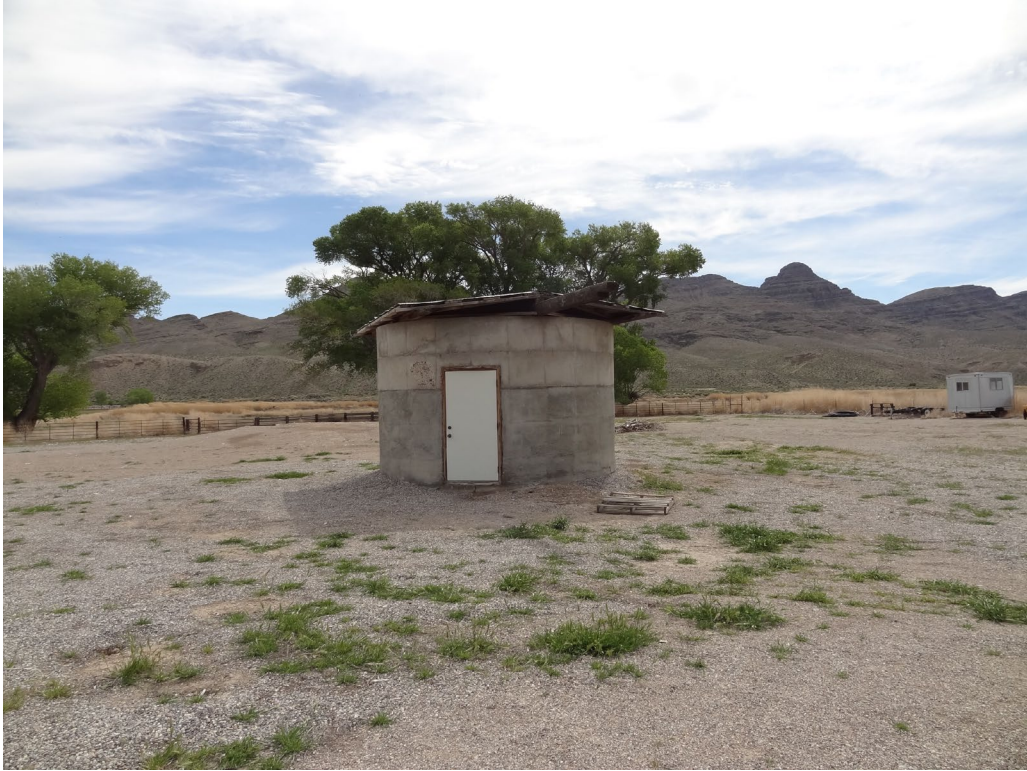
Granary - Building #0904
Description: Exterior of the Structure.

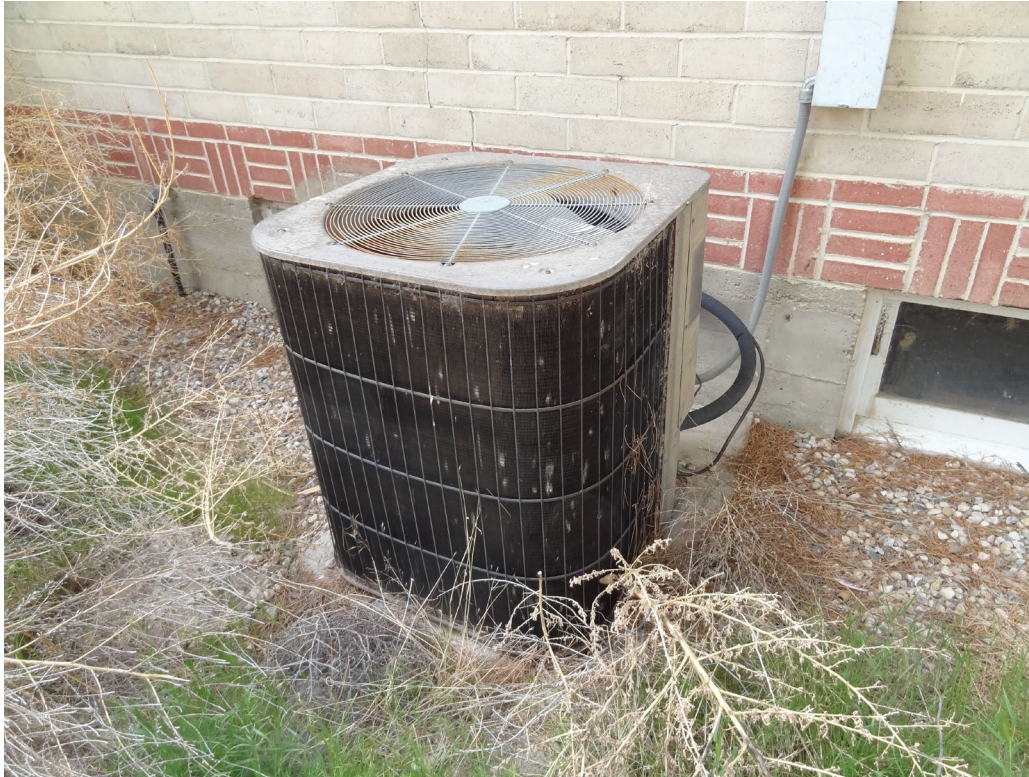
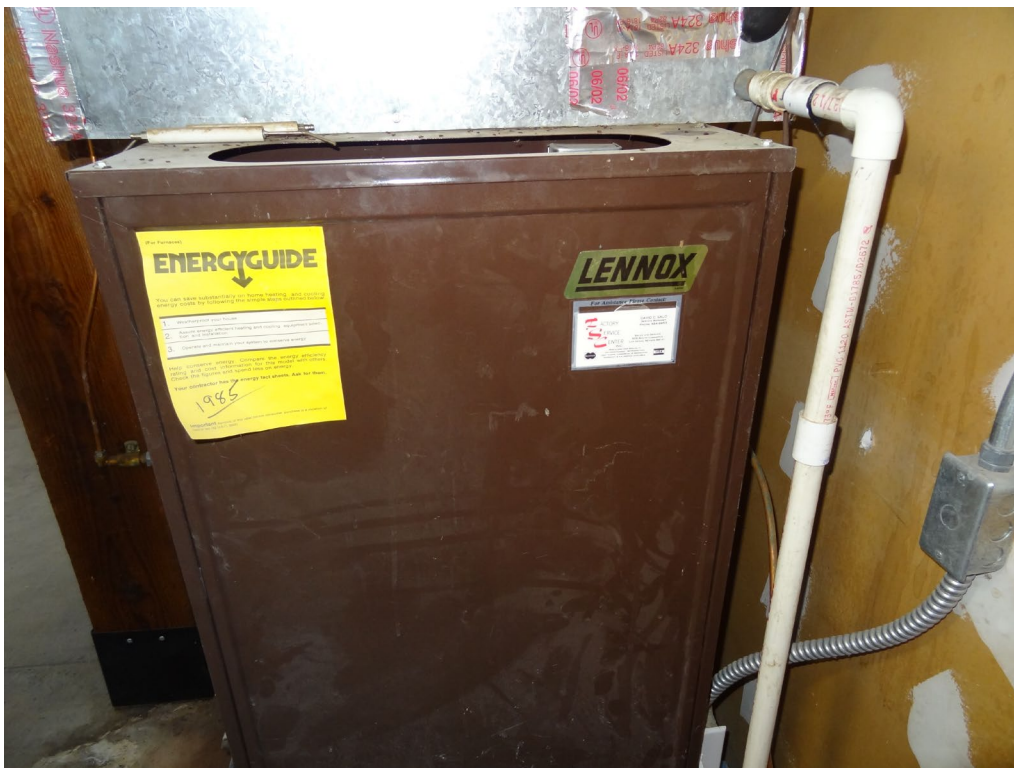
The HVAC system is original to the building and should be scheduled for replacement. It is not energy efficient and has reached the end of its expected and useful life. The R-22 refrigerant in the cooling system is no longer EPA compliant and its production is mandated to be phased out completely by January 1, 2020. This project would provide for installation of a new HVAC system and cleaning of the existing duct work and grilles. This project includes the removal and disposal of the existing HVAC system and all required connections to utilities.

Supervisor's Residence - Building #0903
Description: HVAC Equipment Replacement.

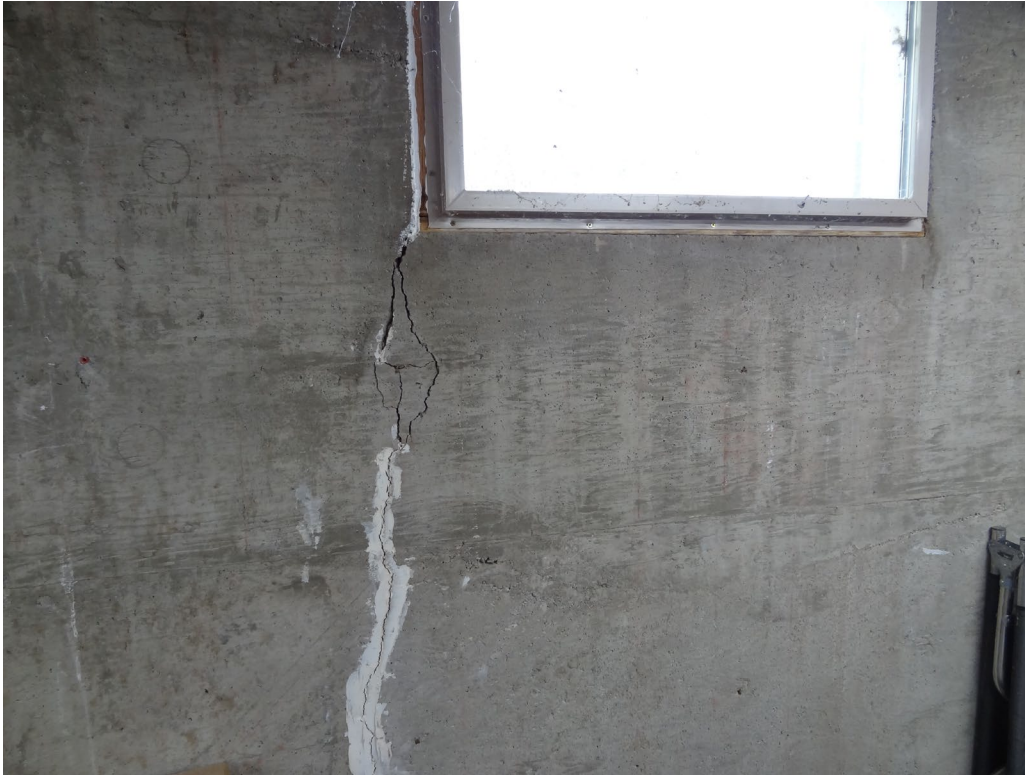
The concrete floor and walls in the basement are damaged from water infiltration and heaving. There are cracks and stains that should be repaired and cleaned. It is recommended that the concrete be cleaned and repaired in order to extend its useful life. This project would provide for cleaning the concrete, filling in the cracks, and applying a coat of sealant. It is recommended that this project be completed in the next 2-3 years.

Supervisor's Residence - Building #0903
Description: Basement Concrete Repairs.

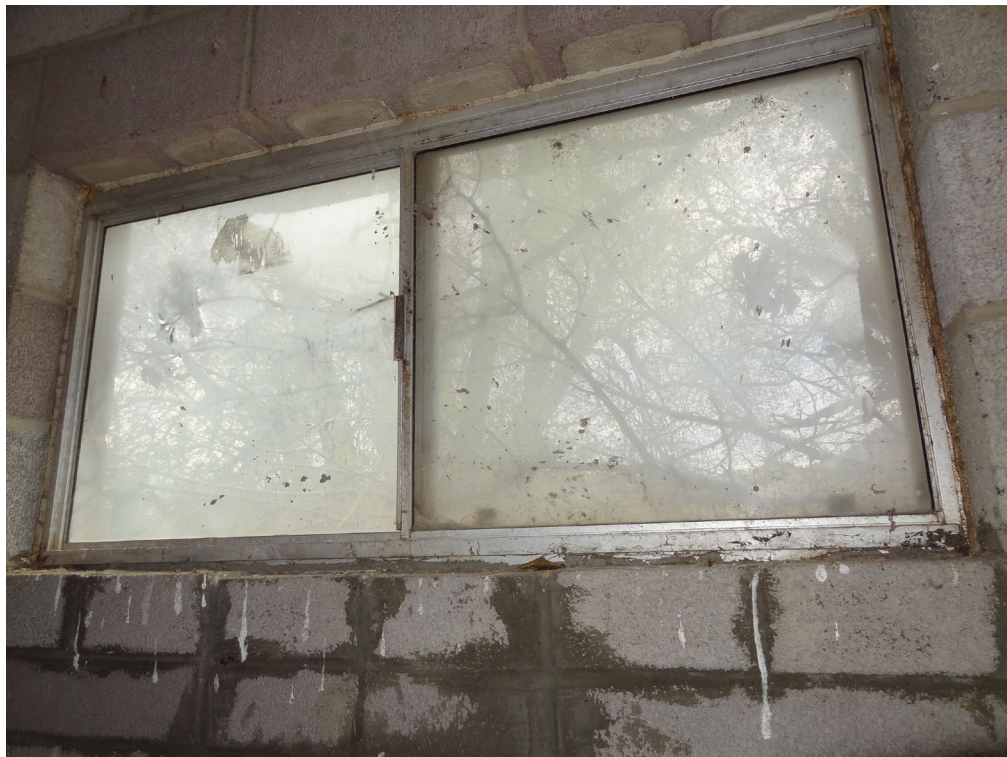
The windows are original, single pane construction in a metal frame. These older windows are drafty and not energy efficient. This project recommends replacing the windows with dual pane, higher efficiency units. This estimate is for the replacement of 3 units. Removal and disposal of the existing windows is included in this estimate.

Maintenance Shop - Building #0647
Description: Window Replacement.

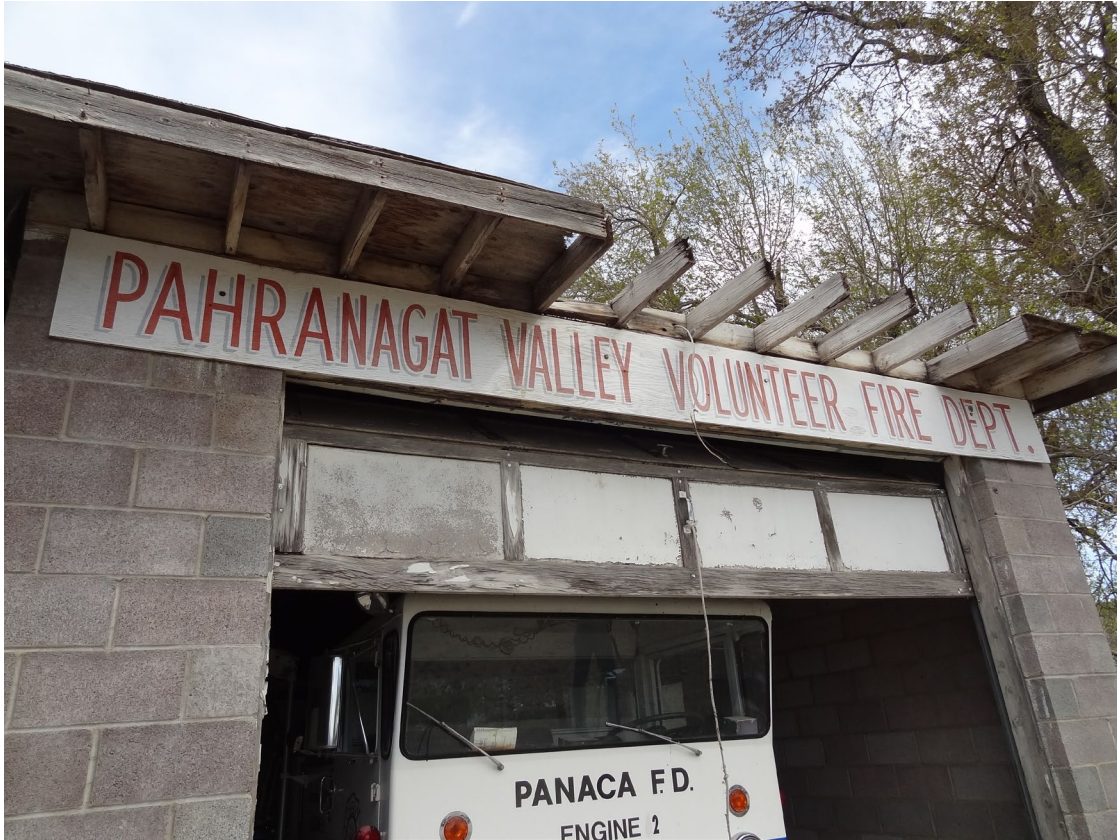
Maintenance Shop - Building #0647

There are two overhead coiling doors which are damaged and do not function properly. Exposure and wind have caused the doors to bend, crack, and lose their finish. They are original to the building and should be scheduled for replacement. This project would provide for the removal and disposal of the manually operated overhead coiling doors and the replacement with new manually operated overhead coiling doors.

The roof framing and the rolled asphalt roofing on this building were in poor condition at the time of the survey. The framing is rotted and failing. It is particularly noticeable at the main ridge beam which is cracked. It is recommended that the entire roof structure be replaced including structural supports replacing it with a new composition roofing system including the underlayment. This estimate includes removal and disposal of the old framing and roofing system.

Description: Overhead Door and Roof / Structure Replacement.
