State of Nevada Department of Human Resources  
Child & Family Services Division  
Facility Condition Analysis

711 E. Fifth Street, Carson City, NV 89701

SITE NUMBER: 9955

### FACILITY CONDITION ANALYSIS

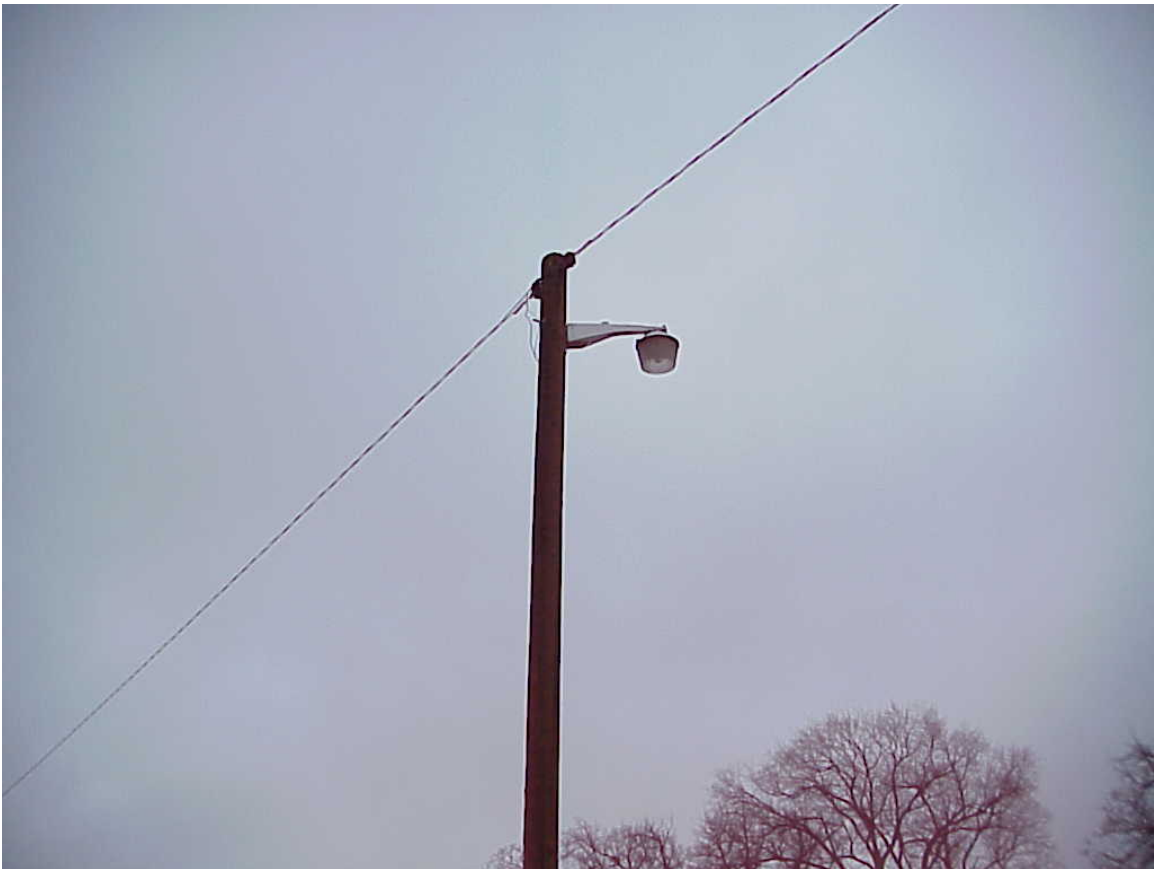
Description: Site security lighting pole.

This project recommends installing general security lighting fixtures around the parking areas and paved portions of the site. Cost includes light fixtures, wiring, trenching and installation, based on a 20 foot pole. Work should be performed prior to or concurrent with parking lot replacement.

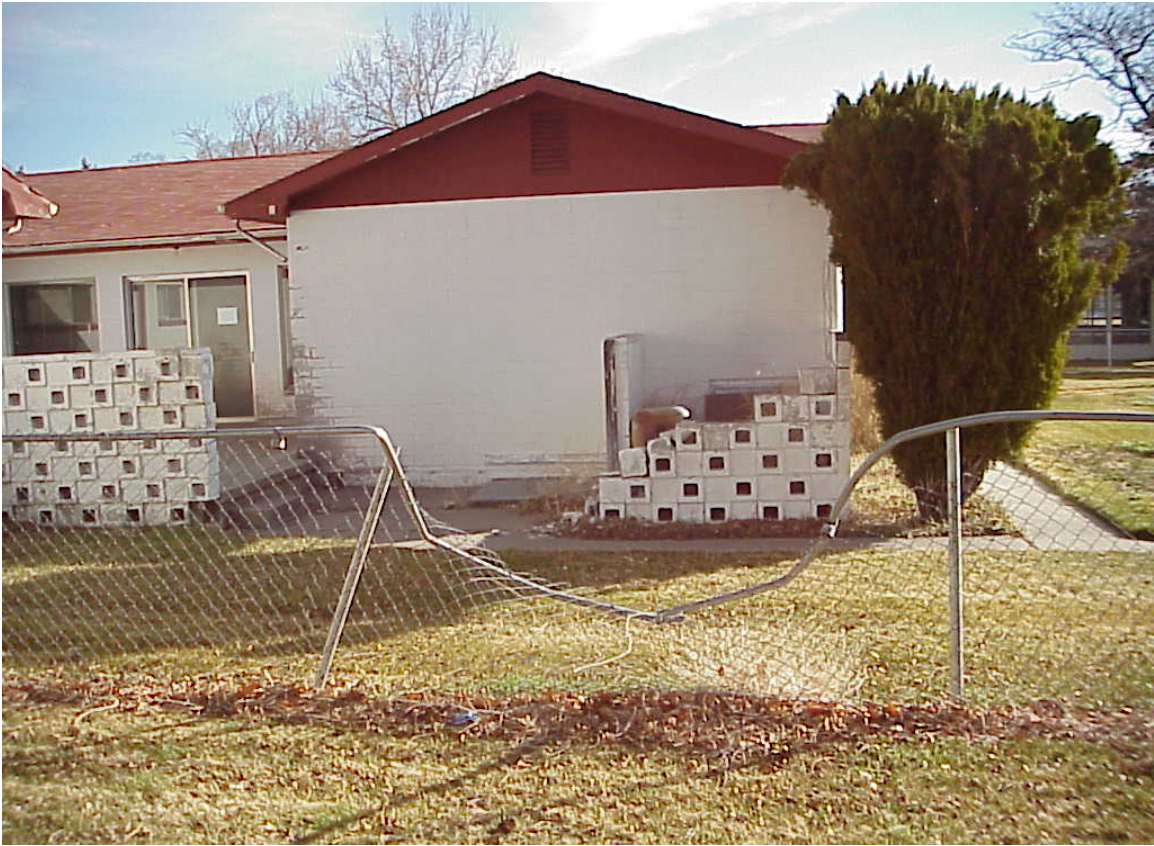
There are also several large trees that are in need of trimming. This lack of maintenance could become a safety issue. There were numerous branches on the ground at the time of survey and damage to a fence had occurred due to a falling tree.

Description: The fence damage that a fallen tree caused.

This project recommends that these issues be addressed, before additional damage is done.

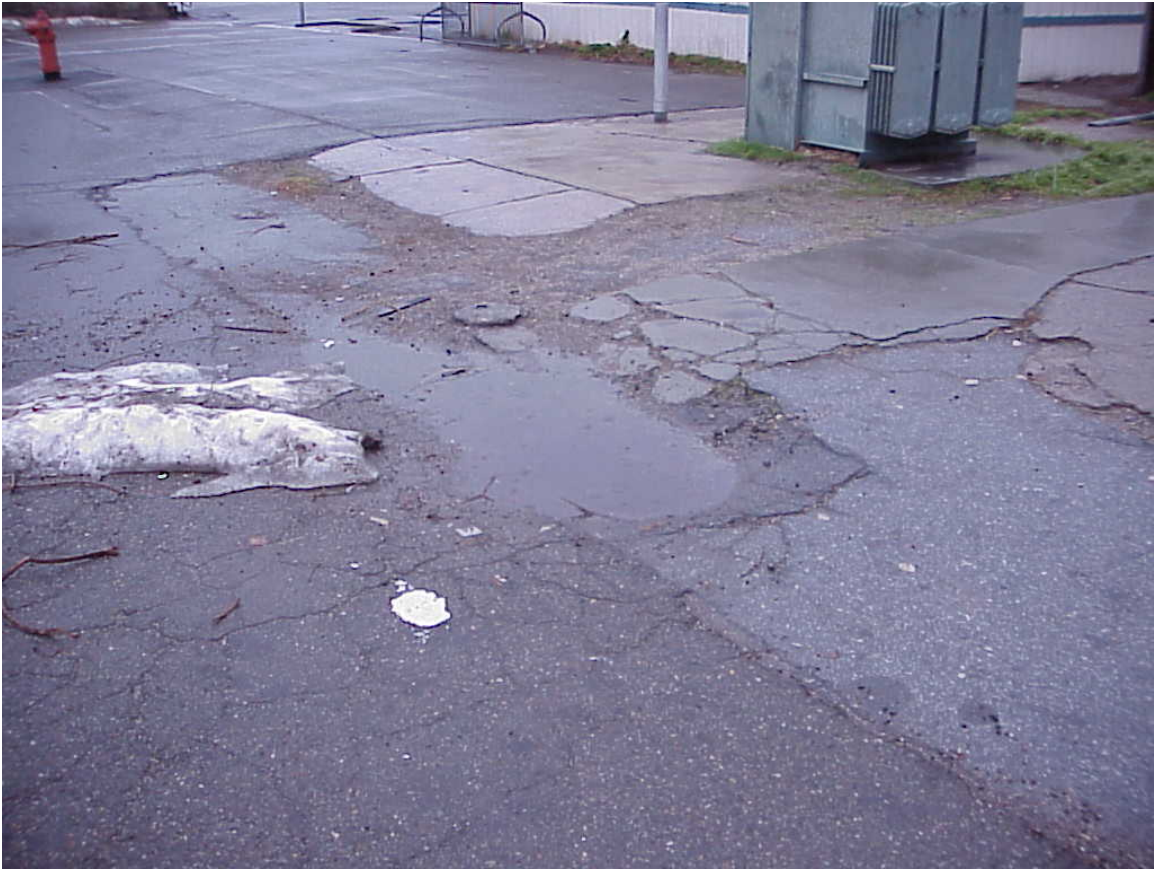
The asphalt at the site is failing, with significant alligating and cracks observed. The macadam has deteriorated to the point that it is no longer viable. This project covers the removal and replacement of existing blacktop for parking and site access, and additional parking at the main parking areas.

Description: Typical paving conditions at site (behind Boys & Girls Club).

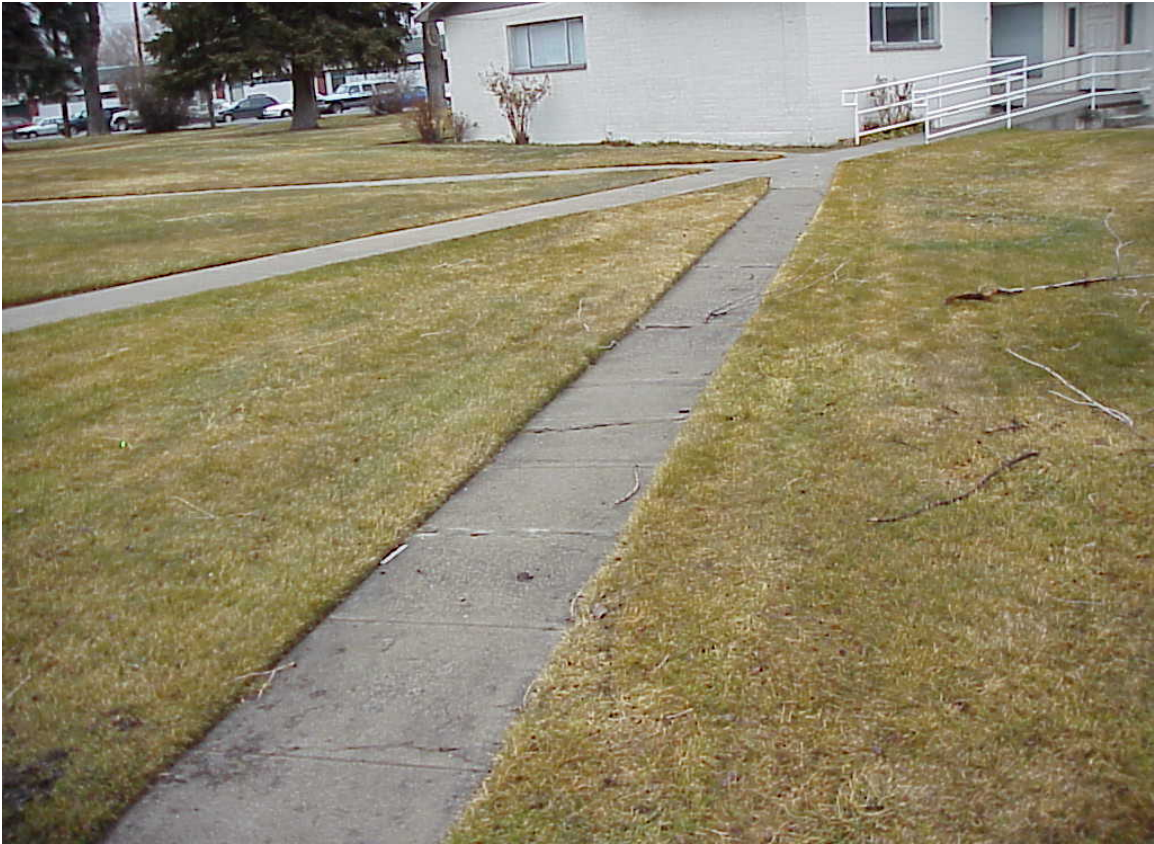
The existing sidewalks serving buildings on this site have deteriorated and are failing. In some areas cracks wider than four inches have been identified, and there is substantial settling in a number of locations. This project addresses removal and replacement of existing sidewalks as needed.

Child & Family Services Division Site #9955  
Description: Typical sidewalk at site.

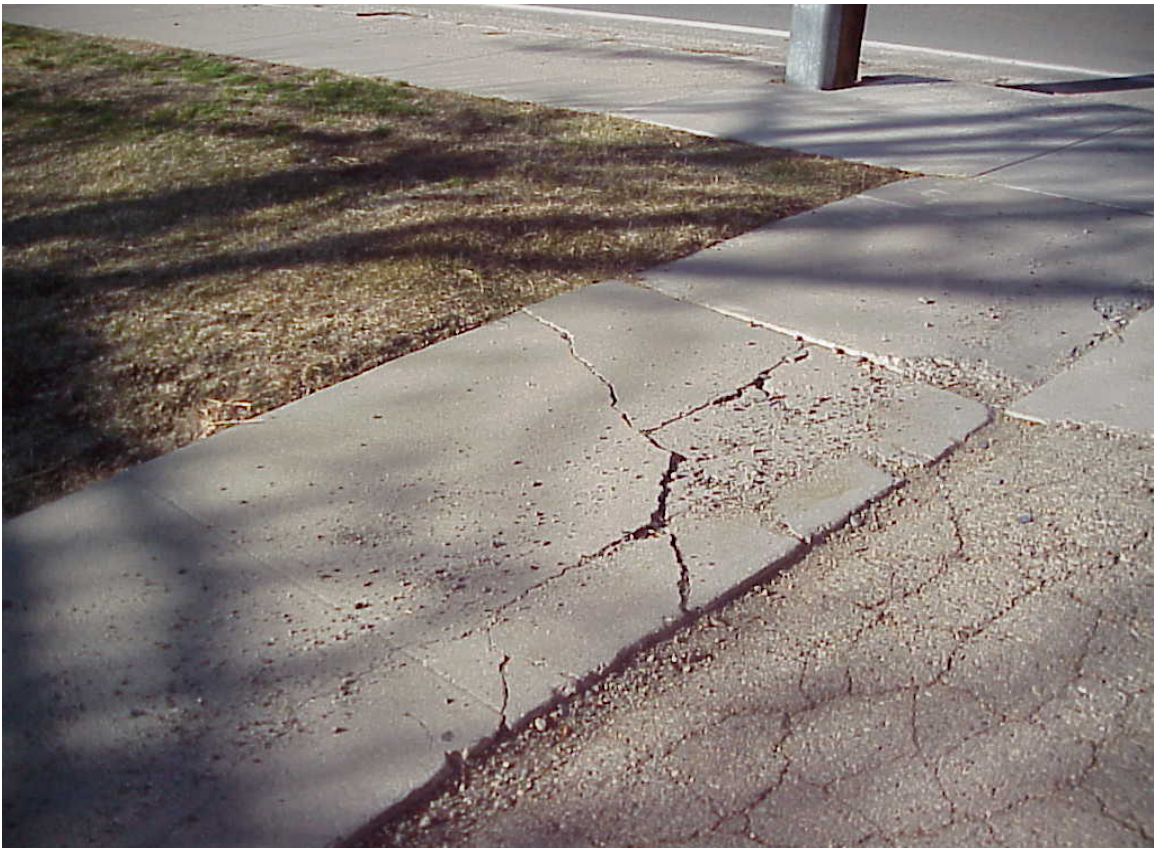
Child & Family Services Division Site #9955  
Description: Typical sidewalk condition.

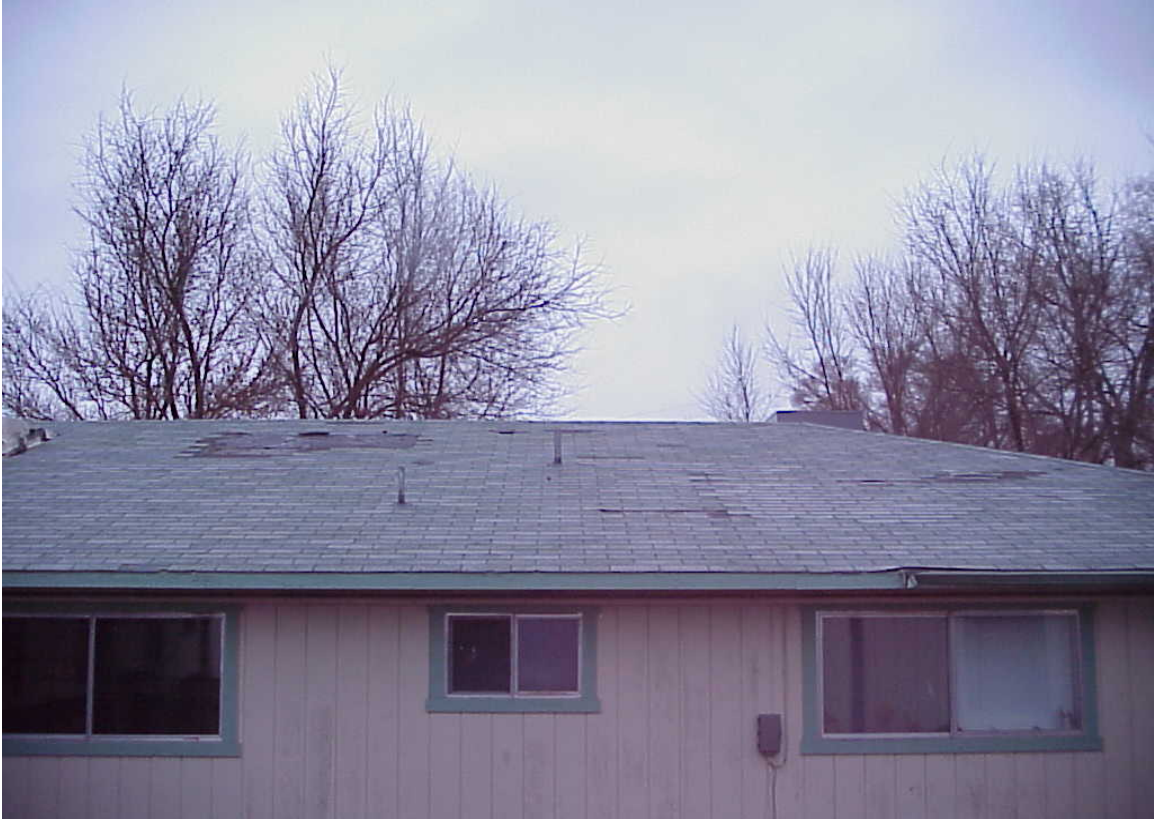
The roof on this building was in poor condition at the time of the survey. Recent storms damaged the roof, there are missing shingles, and active leaks are reported by the occupants. The statewide roofing program has set the useful life of an average roof at 15 years. The roof warranty expires at the end of the same time frame. It is recommended that this building be re-roofed in the next year to be consistent with the roofing program and the end of the warranty period.

Child & Family Serv. Division/Boys & Girls Club/Hispanic Services - Building #0303  
Description: Roof shingles missing, exterior of building.

Additional monies are included to replace some fascia and missing attic vent screens.

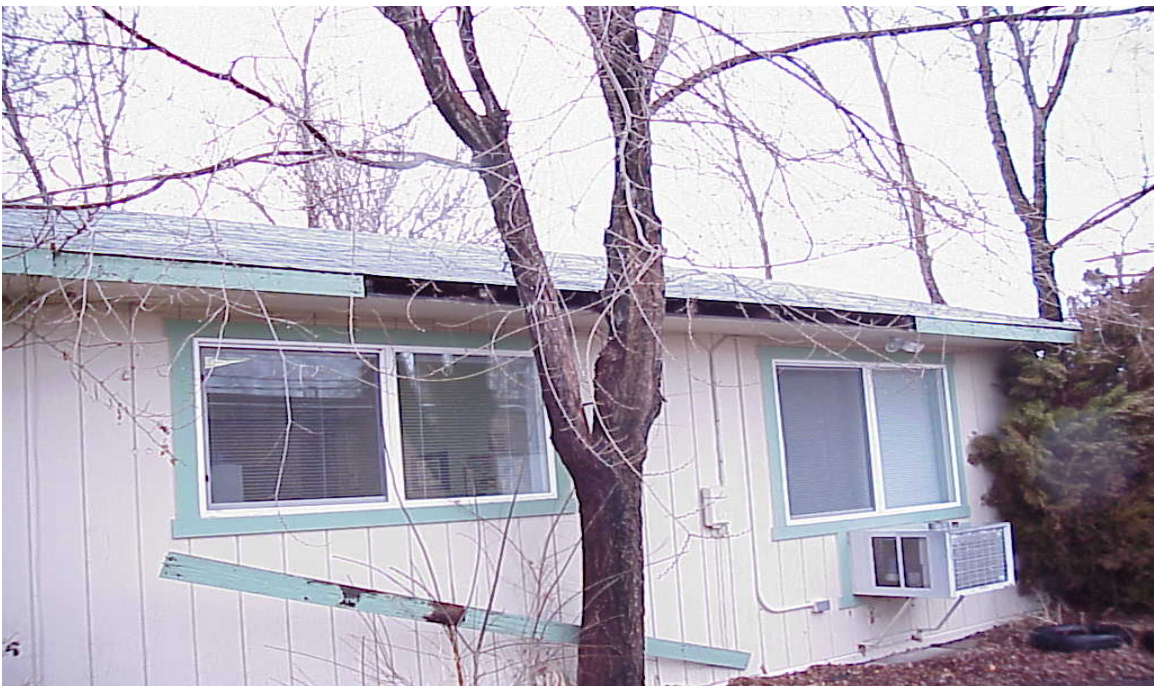
Child & Family Serv. Division/Boys & Girls Club/Hispanic Services - Building #0303  
Description: Wind damage, exterior of building.

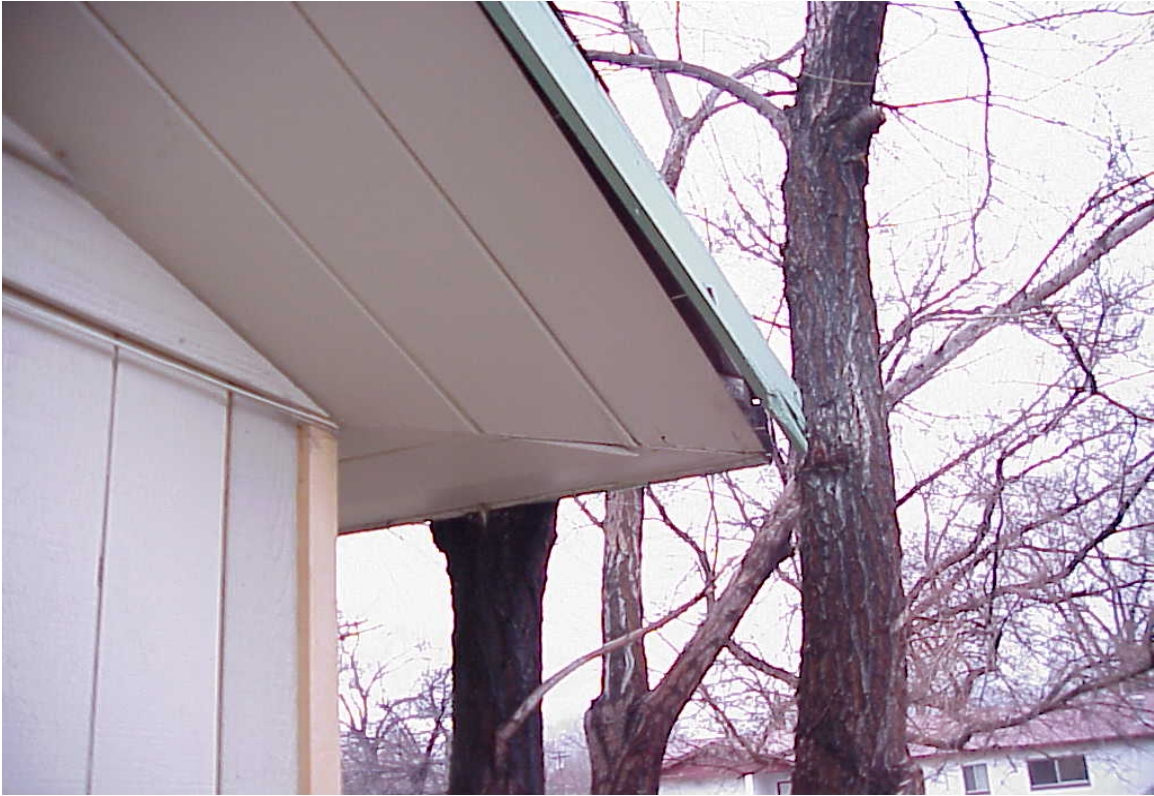
Several of the buildings have trees which are growing up against the structures. The trees move in windy conditions, rubbing the roofs, which can cause premature failure of system and voiding roof warranties. The root systems are causing shifting and heaving of foundations and sidewalks, creating unsafe conditions.

Child & Family Serv. Division/Boys & Girls Club/Hispanic Services - Building #0303  
Description: Tree damaging the overhand of building.

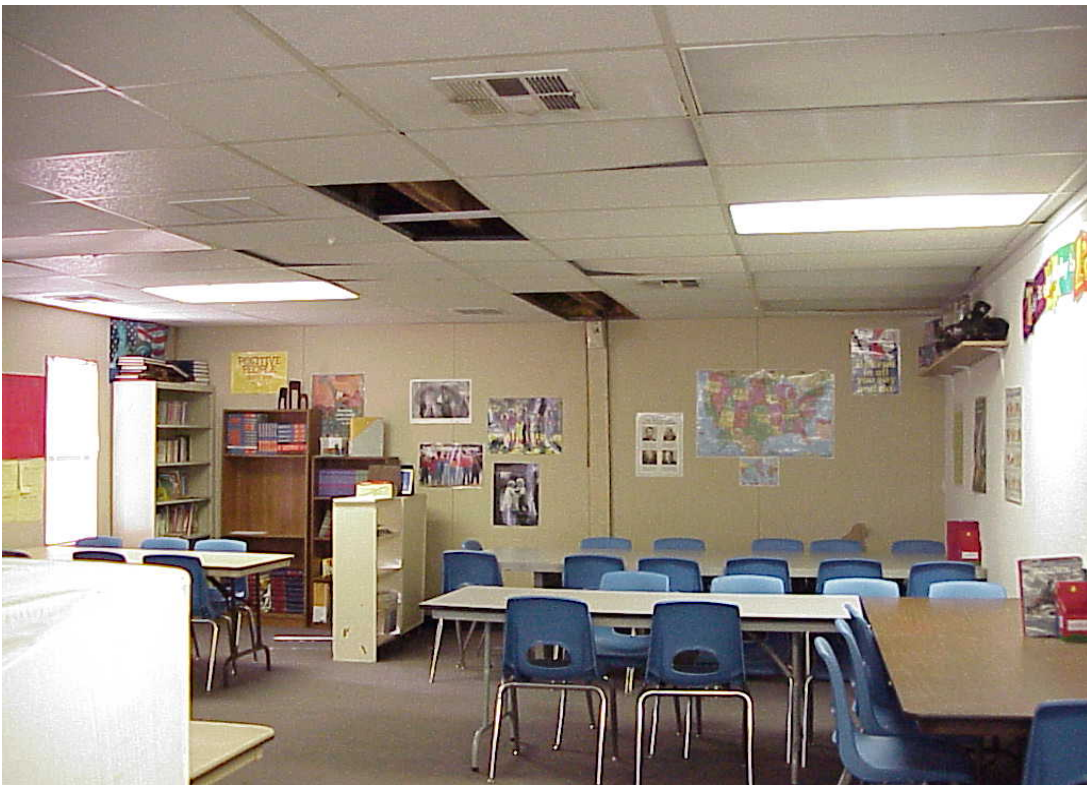
Child & Family Services Division/Education Center - Building #2309 1,650 square feet  
Description: The interior of the building with ceiling damage.
