NDF WESTERN AREA HEADQUARTERS SITE

Site Number: 9957
STATE OF NEVADA PUBLIC WORKS DIVISION
FACILITY CONDITION ANALYSIS

Report distributed in January 2022

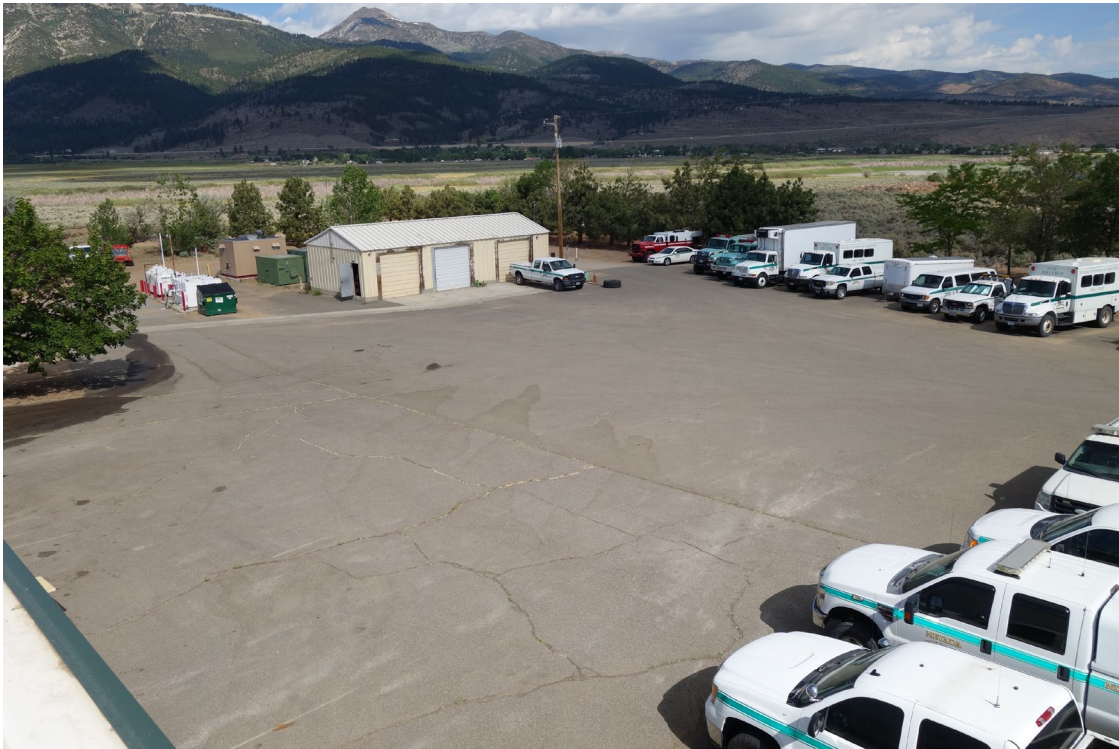
It is important to maintain the asphalt concrete paving on the site. This project would provide for minor crack filling and sealing of the paving site wide including access roads, parking areas and driving test areas. Striping is included in this estimate. This project should be scheduled on a 5 year cyclical basis to maintain the integrity of the paving and prevent premature failure. 50,000 square feet of asphalt area was used to generate this estimate.

NDF Western Area Headquarters Site – FCA Site #9957
Description: Crack Fill & Seal Parking Areas Needed.

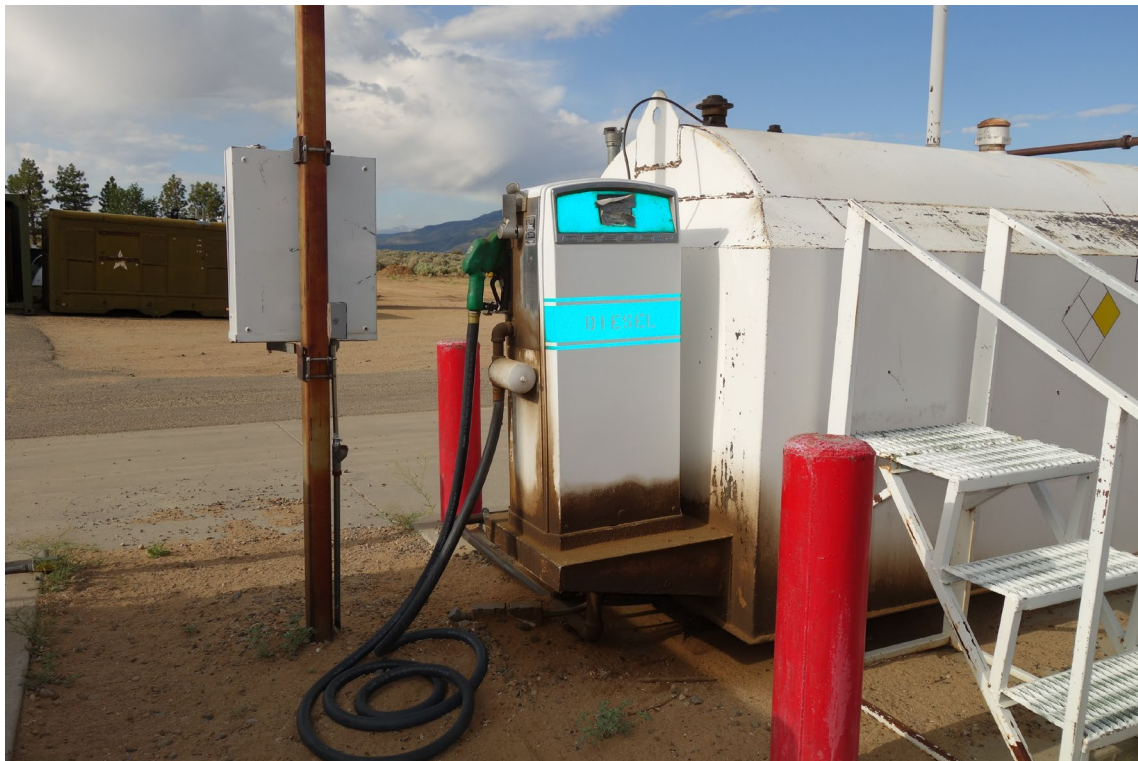
The diesel fuel dispensing station appears to have a slight leak and has reached the end of its useful life. Both diesel and gas tanks appear to be in fair condition however they should be inspected and refinishes to extend their life. This project will fund the inspections and refurbishment of both tanks, replacement of fuel lines and the diesel dispensing pump.

NDF Western Area Headquarters Site – FCA Site #9957
Description: Fuel Dispensing Replacement Needed.

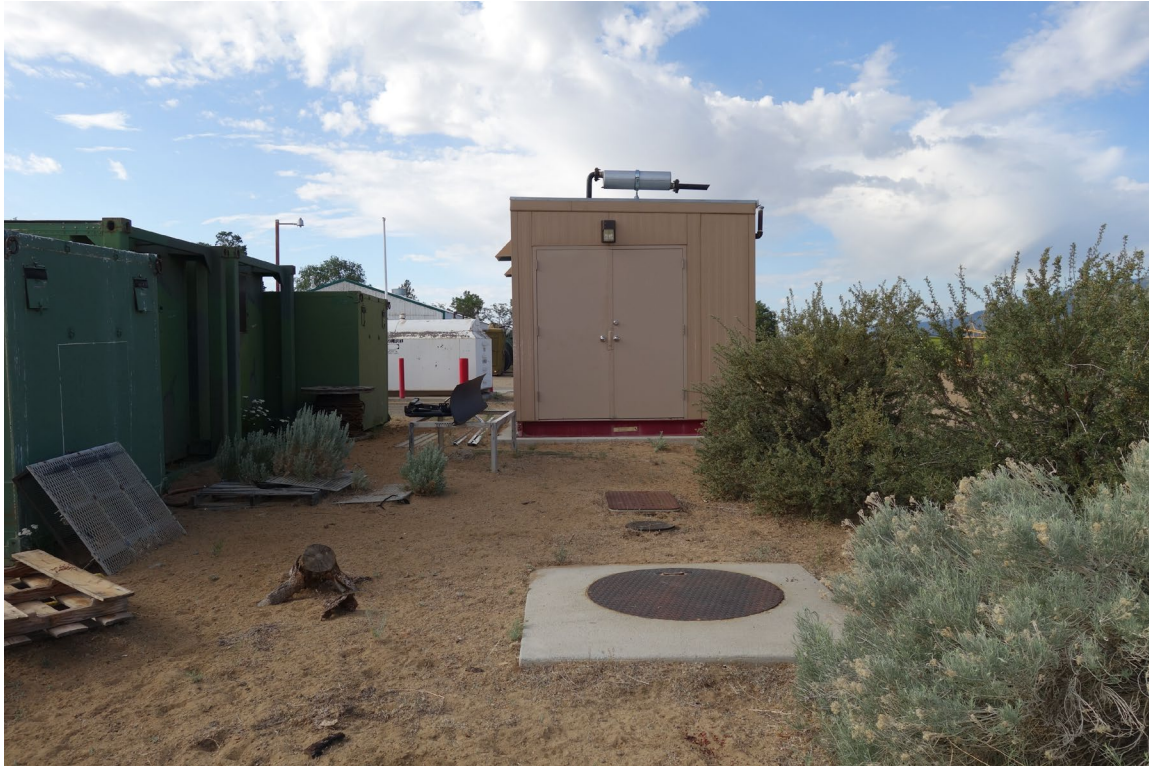
The exterior finishes were in good condition. It is important to maintain the finish, weather resistance and appearance of the building. This project would provide funding for the maintenance of the exterior of the building. Included in the cost is the sealing and caulking of the flashing, fixtures and all other penetrations. It is recommended that the building be caulked and sealed in the next 4-5 years and that this project be scheduled on a cyclical basis to maintain the integrity of the structure.

Pump House – FCA Building #2966
Description: Exterior of Building.

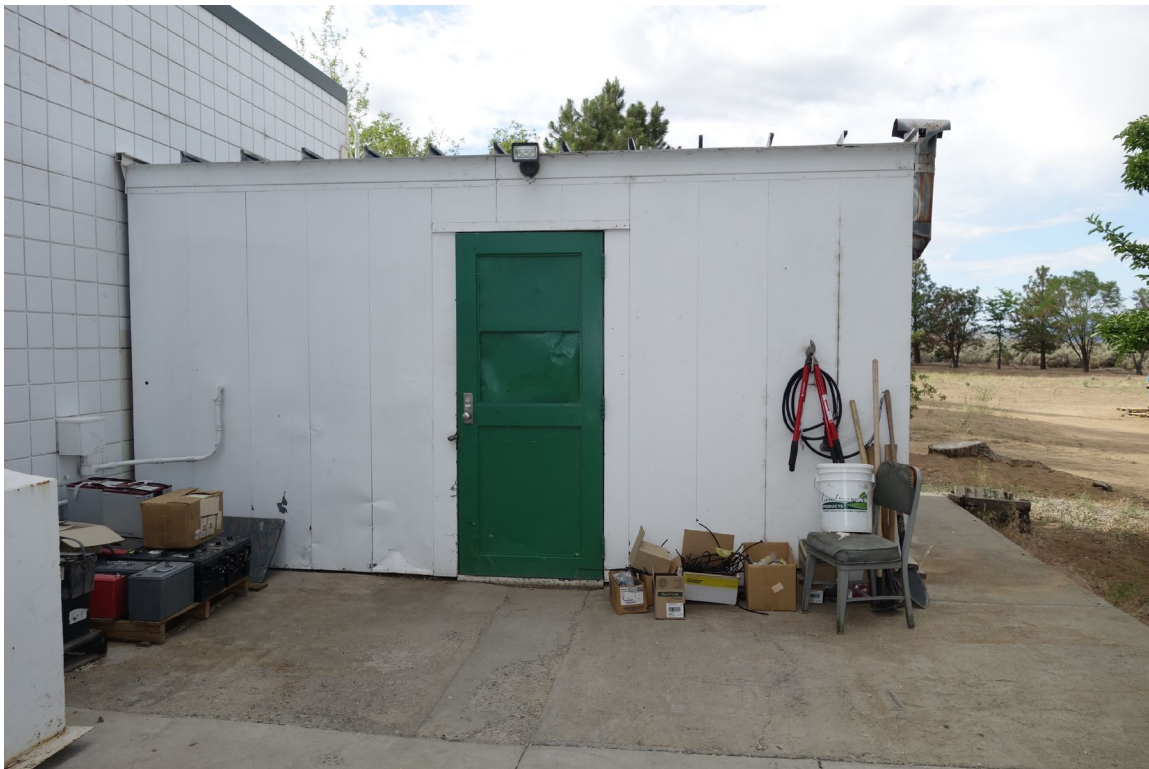
The exterior finishes were in fair condition. It is important to maintain the finish, weather resistance and appearance of the building. This project would provide funding for the maintenance of the exterior of the building. Included in the cost is the painting, sealing and caulking of the flashing, fixtures and all other penetrations. It is recommended that the building be painted, caulked and sealed in the next 4 - 6 years and that this project be scheduled on a cyclical basis to maintain the integrity of the structure.

HQ Garden Equipment Storage – FCA Building #2348
Description: Exterior of Building.

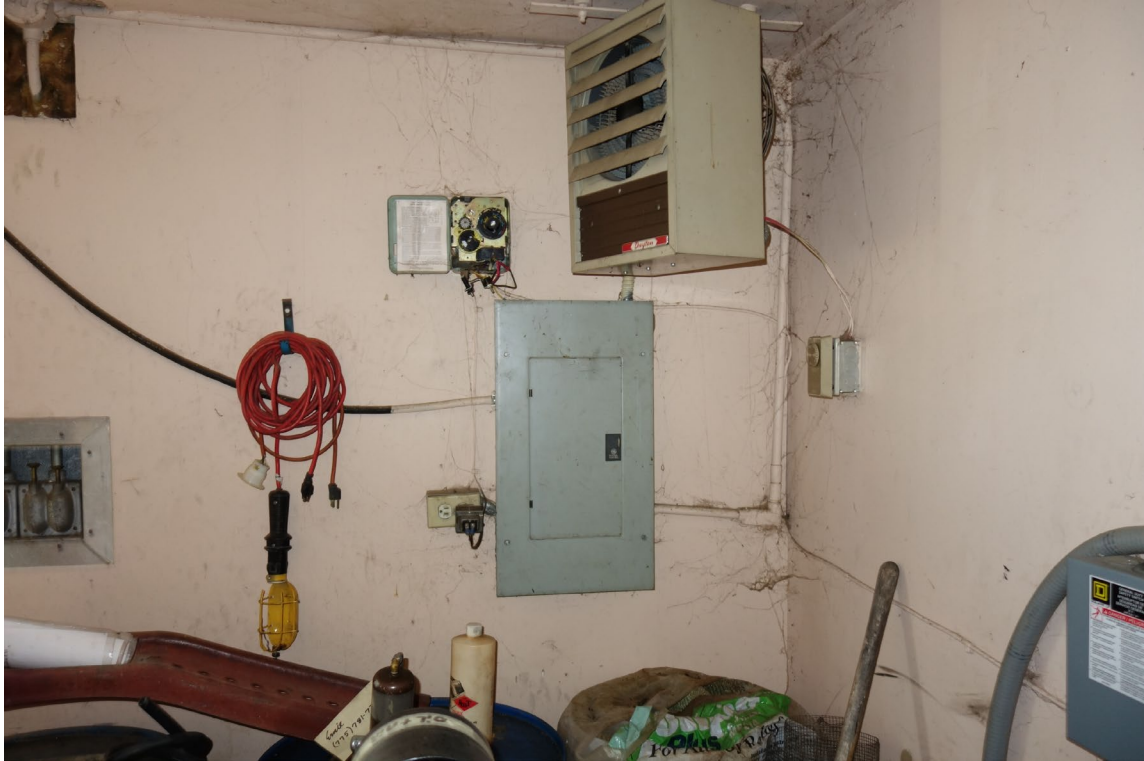
HQ Garden Equipment Storage – FCA Building #2348
Description: Improper Non-Metallic Sheathed Electrical Cable.

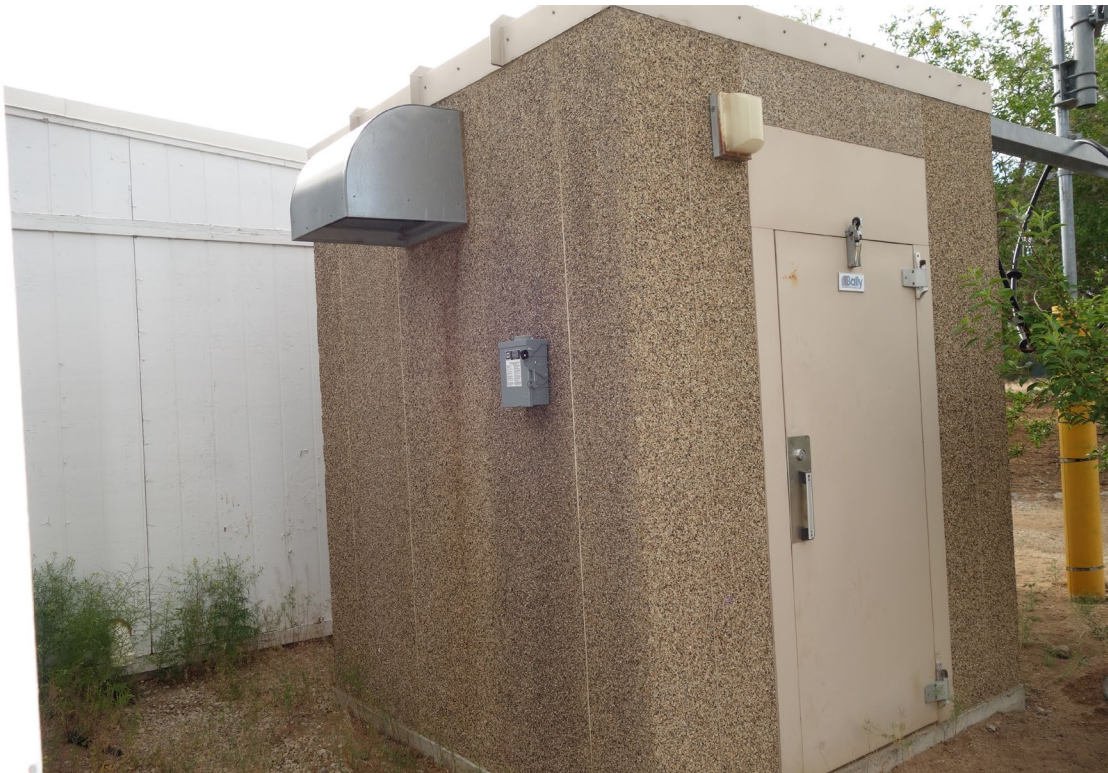
The exterior finishes were in good condition. It is important to maintain the finish, weather resistance and appearance of the building. This project would provide funding to protect the exterior of the building. Included in the cost are sealing and caulking of the flashing, fixtures and all other penetrations. It is recommended that the building be sealed and caulked in the next 8 - 10 years and that this project be scheduled on a cyclical basis to maintain the integrity of the structure.

HQ Radio Equipment Storage – FCA Building #2347
Description: Exterior of Building.

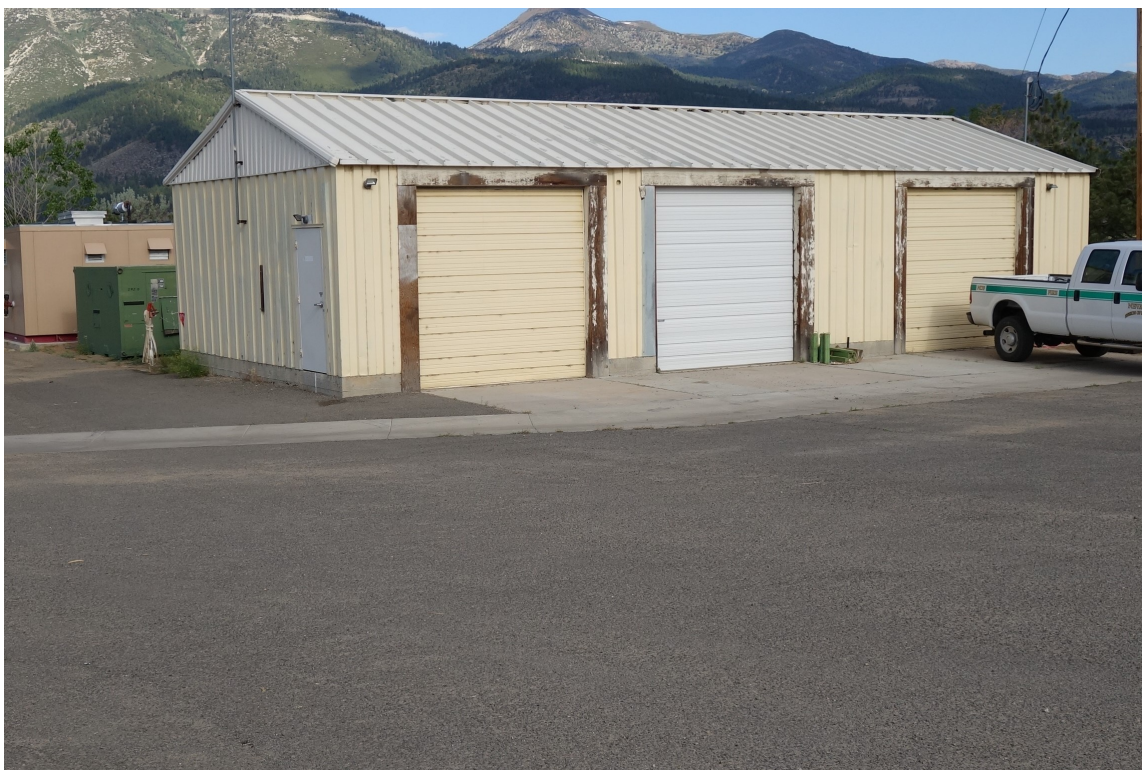
HQ Welding Shop – FCA Building #2339
Description: Exterior of Building and Missing Door Landing.

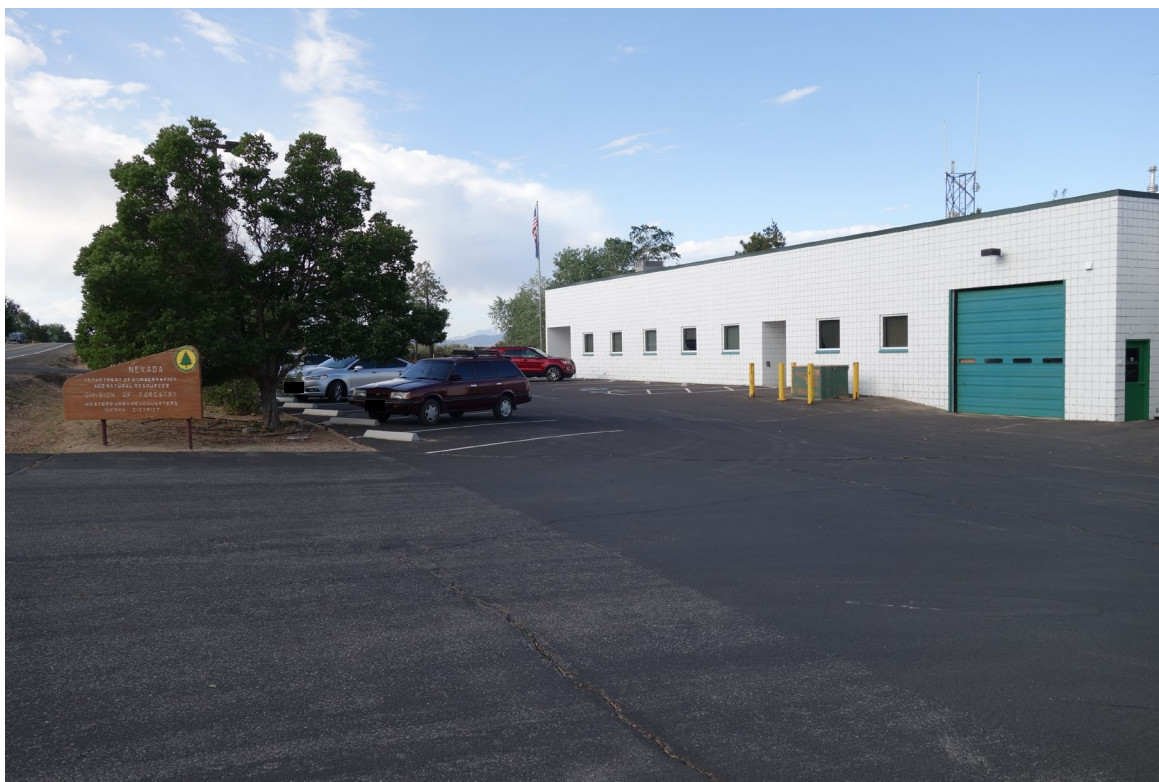
The exterior finishes were in poor condition. It is important to maintain the finish, weather resistance and appearance of the building. This project would provide funding to protect the exterior of the building. Included in the cost is painting the masonry and caulking of the windows, flashing, fixtures and all other penetrations. It is recommended that the building be painted, sealed and caulked in the next 2 - 3 years and that this project be scheduled on a cyclical basis to maintain the integrity of the structure.

Western Area Headquarters – FCA Building #1655
Description: Exterior of Building.

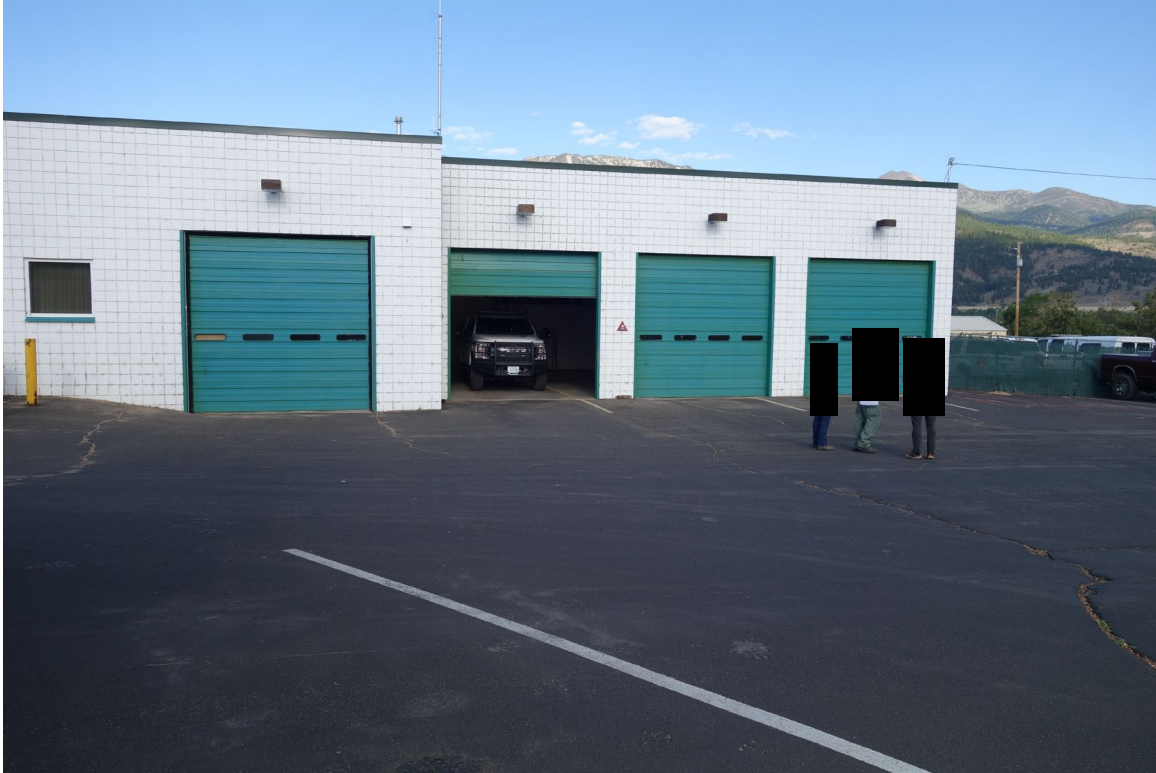
Western Area Headquarters – FCA Building #1655
Description: Bollard Protection at Overhead Doors Needed.

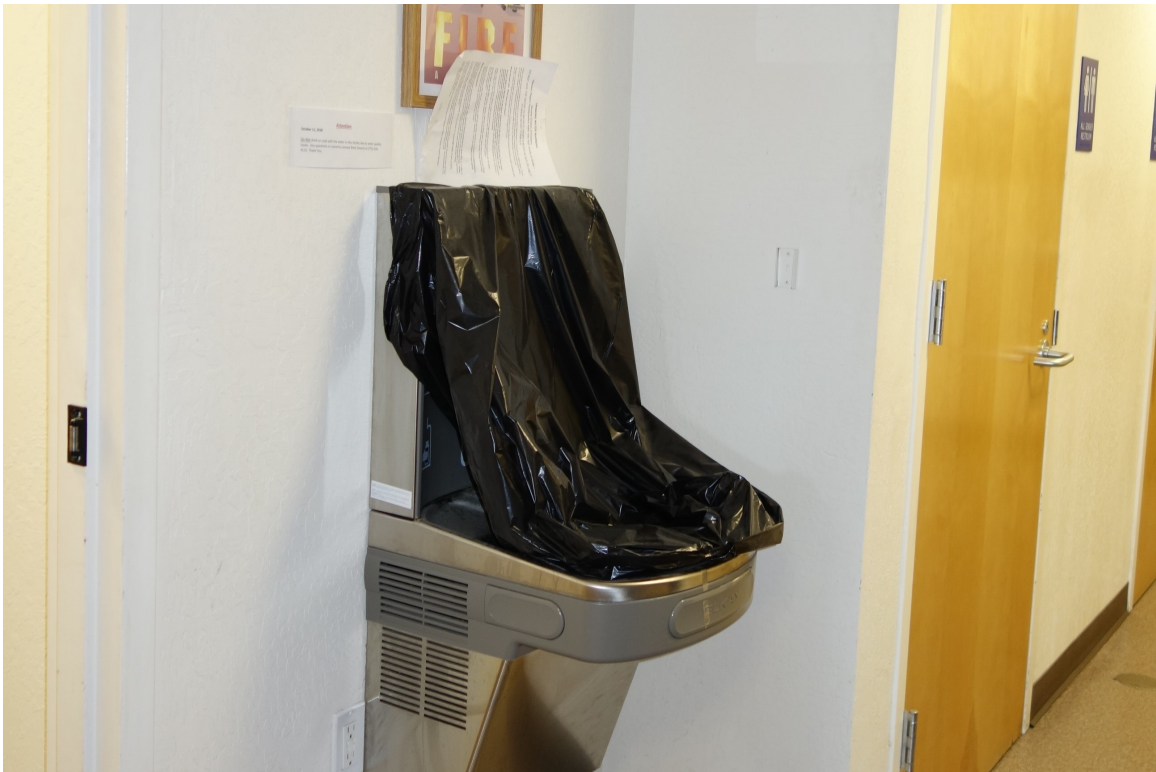
The domestic well water has been tested and found to contain nitrates. This project would provide for the purchase and installation of a domestic supply water treatment system that includes nitrate removal.

Western Area Headquarters – FCA Building #1655
Description: Drinking Fountains Removed from Service due to Water Quality.

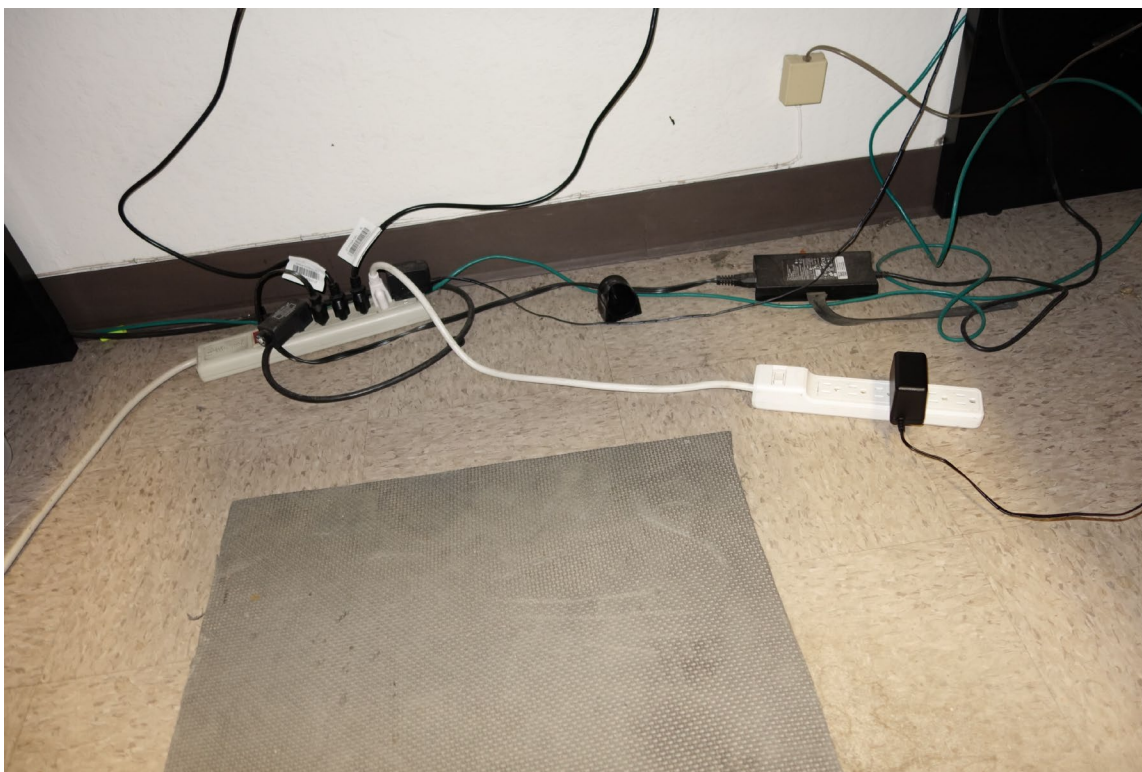
The office areas and exterior walls outside of the shop need additional electrical outlets. The office space has daisy chained multi-outlet strips which are a UL & NEC Code violation. The exterior areas outside of the shop do not have any exterior outlets. This project would provide for the installation of 10 outlets in the office space and 4 GFCI protected outlets on the building exterior.

Western Area Headquarters – FCA Building #1655
Description: Additional Electrical Outlets Needed.

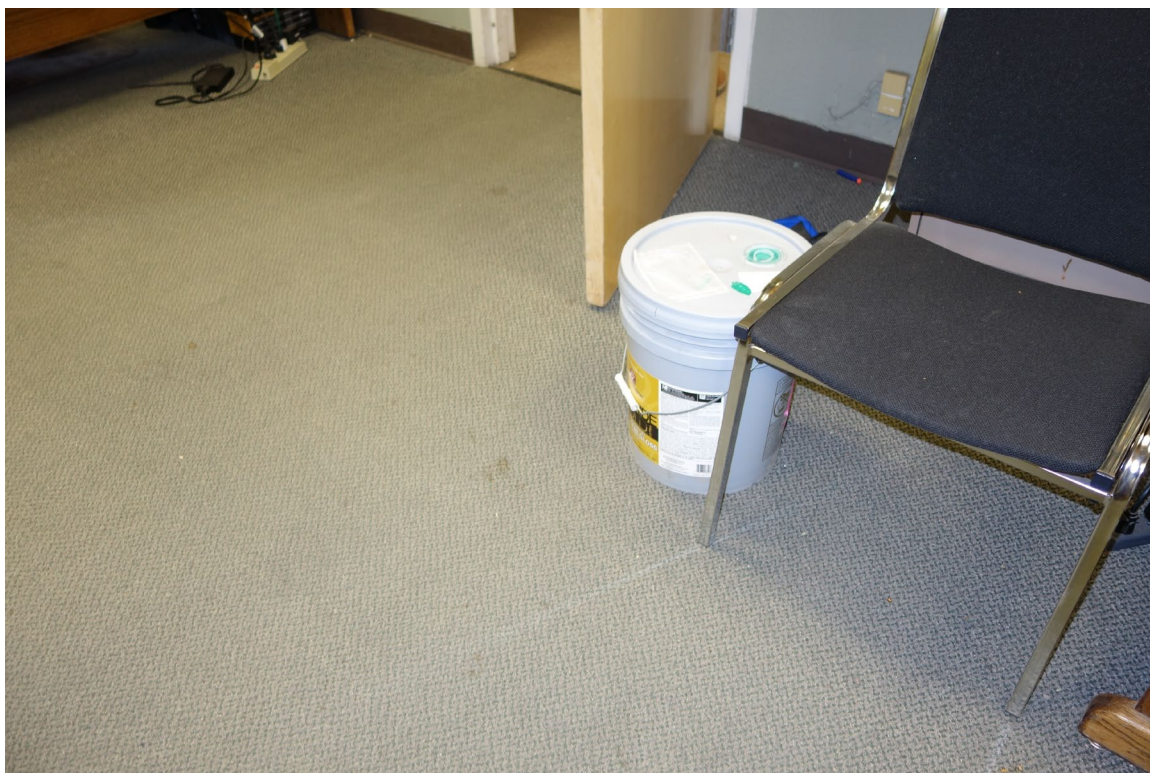
The carpet in the building is damaged and reaching the end of their useful life. It is recommended that the flooring be replaced. This project would provide for removal and disposal of the existing flooring and installation of new heavy duty commercial grade carpet in the next 2 - 3 years.

Western Area Headquarters – FCA Building #1655
Description: Carpet Replacement Needed.

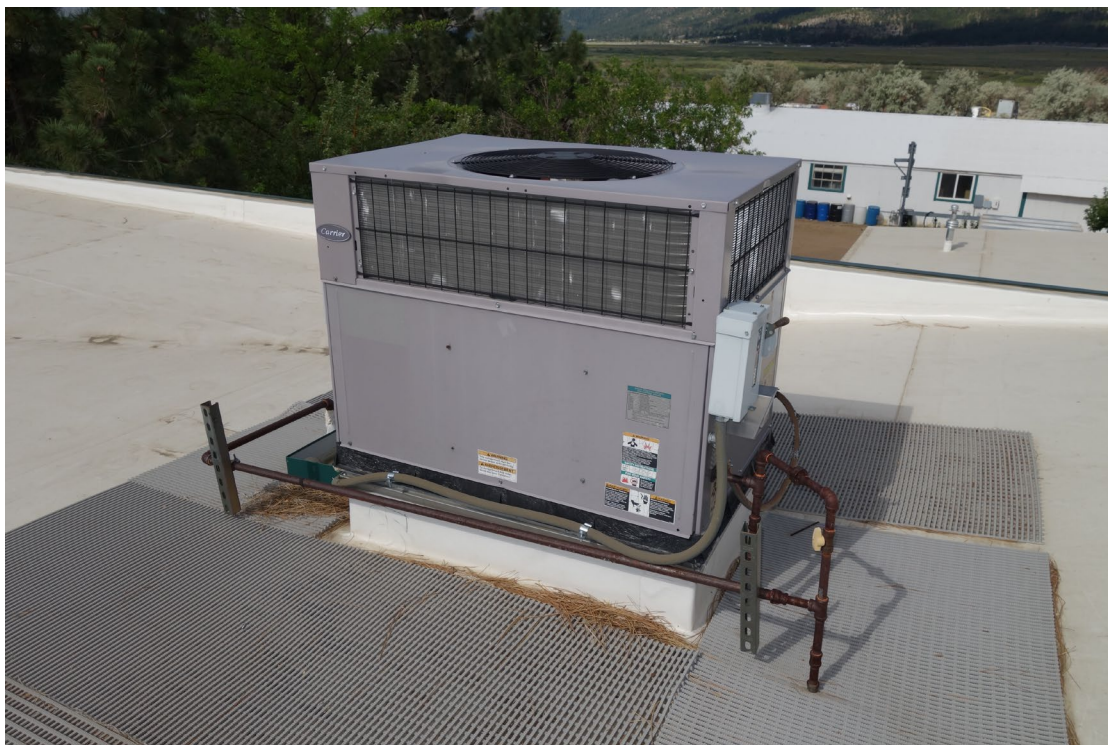
Western Area Headquarters – FCA Building #1655
Description: HVAC Rooftop Unit Replacement Planning Needed.

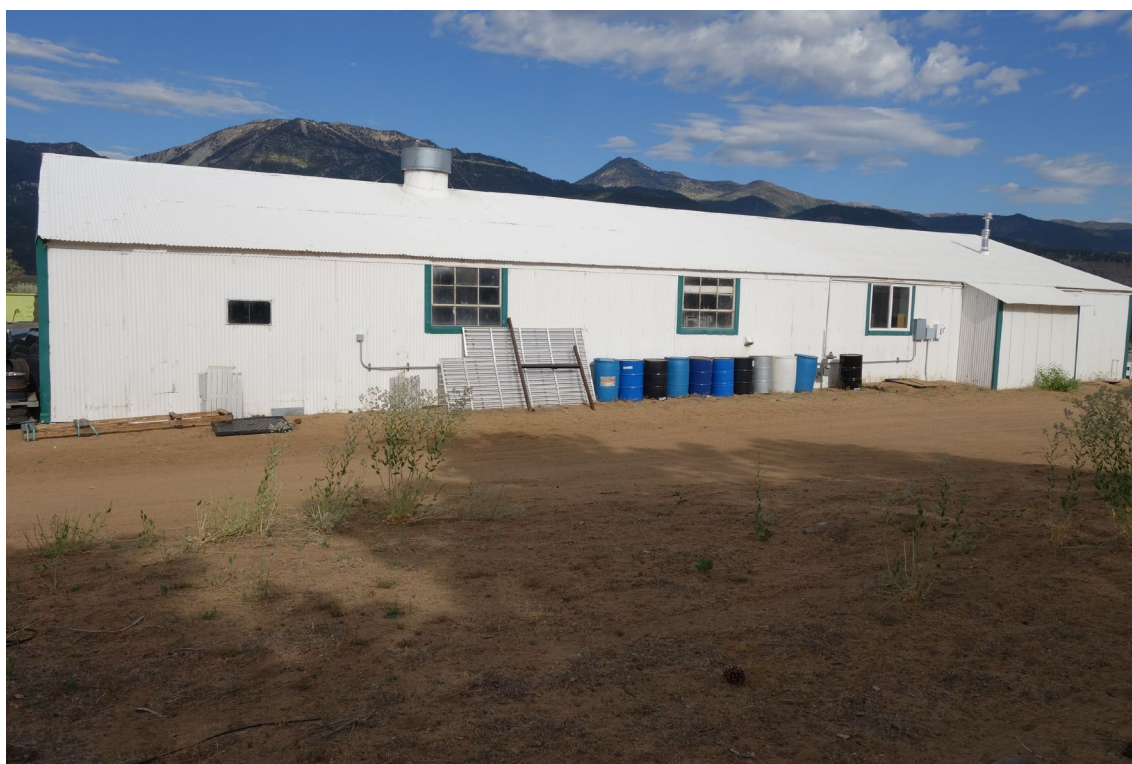
HQ Paint Shop – FCA Building #0895
Description: Exterior of Building.
