# CHILDREN'S BEHAVIORAL SERVICES

2655 Enterprise Road  
Reno, Nevada

**Site Number: 9958**

**STATE OF NEVADA PUBLIC WORKS DIVISION  
FACILITY CONDITION ANALYSIS**

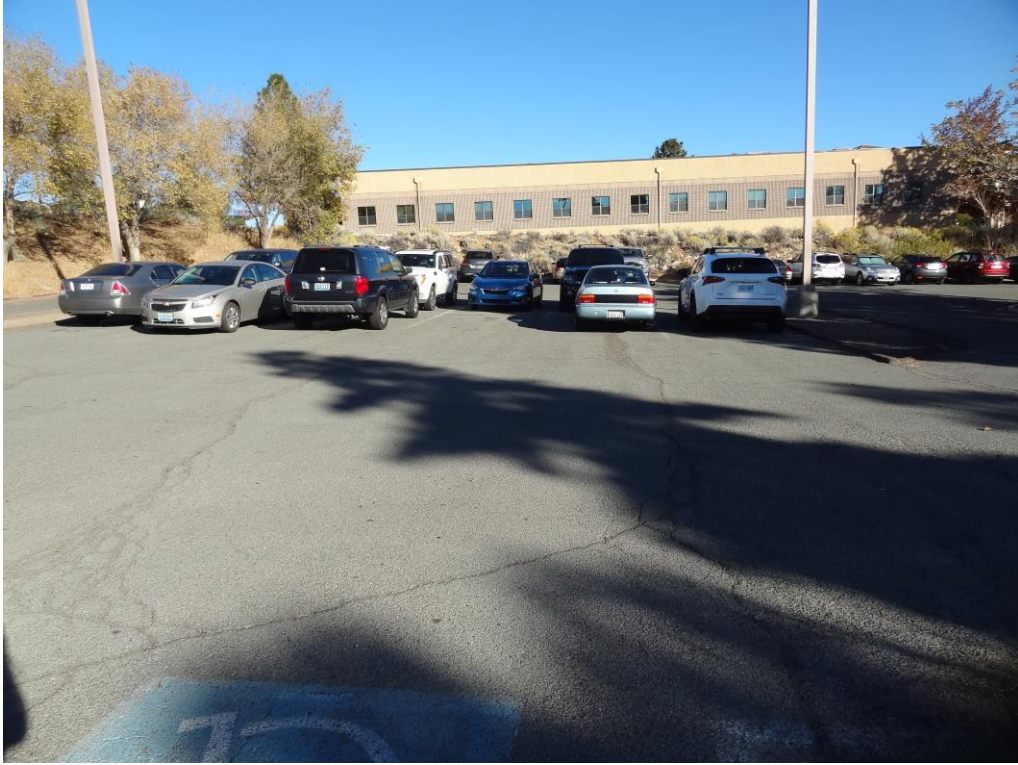
Children's Behavioral Services - Site #9958  
Description: Upper Parking Area & Needed Slurry Seal.

It is important to maintain the asphalt concrete paving on the site. This project would provide for minor crack filling and slurry sealing of the paving site wide. Striping is included in this estimate. This project should be scheduled on a 5 year cyclical basis to maintain the integrity of the paving and prevent premature failure. 70,000 square feet of asphalt area was used to generate this estimate. It is recommended that the site drainage project be completed prior to this project.

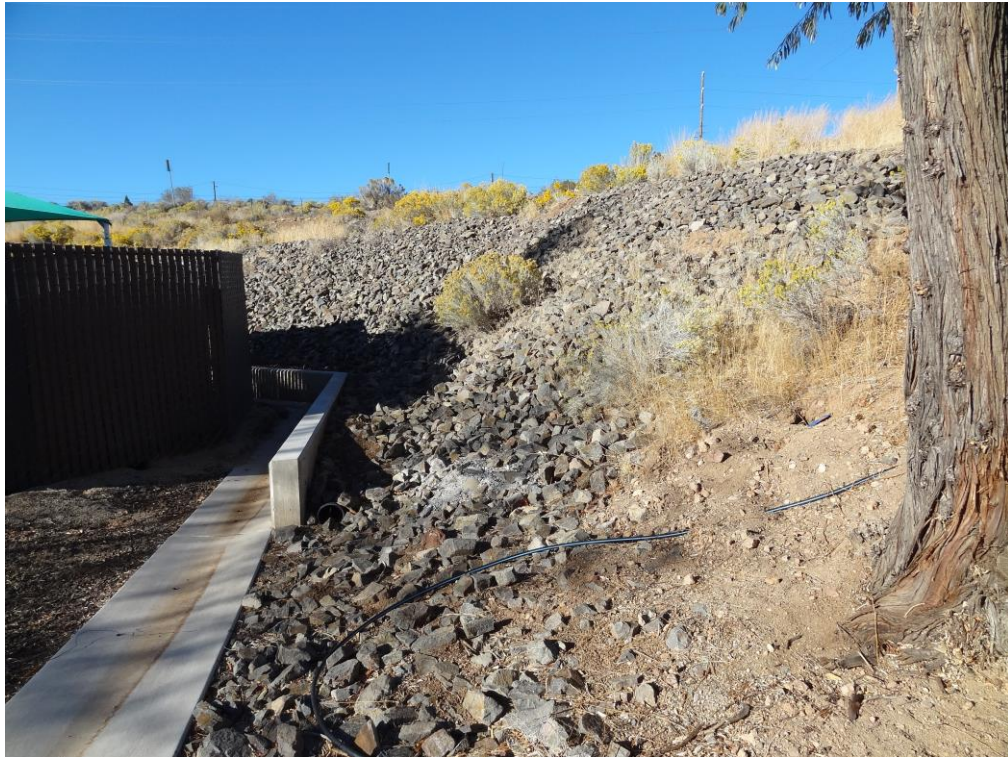
On the north side of the Administration / Classroom Building, a retaining wall and rubble rock have been installed to protect the building from the slope up to McCarran Blvd. However, soil and debris have accumulated behind the wall allowing water and debris to flow over the wall. Sandbags have been installed to limit the overflow. This project recommends removing the accumulated soil and debris behind the retaining wall and re-establish drainage grade behind the wall to allow water to flow behind the wall.

Children's Behavioral Services - Site #9958  
Description: Erosion Control Retaining Wall Upgrades.

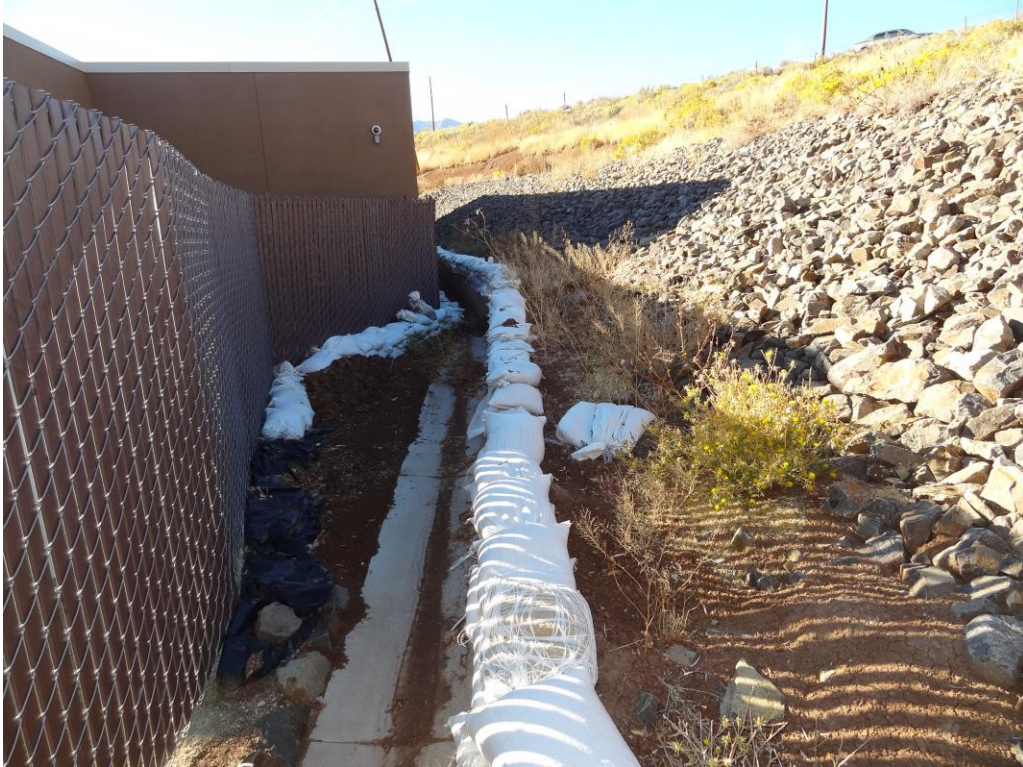
Description: Erosion Control Soil & Debris Cleanup Behind Retaining Wall.

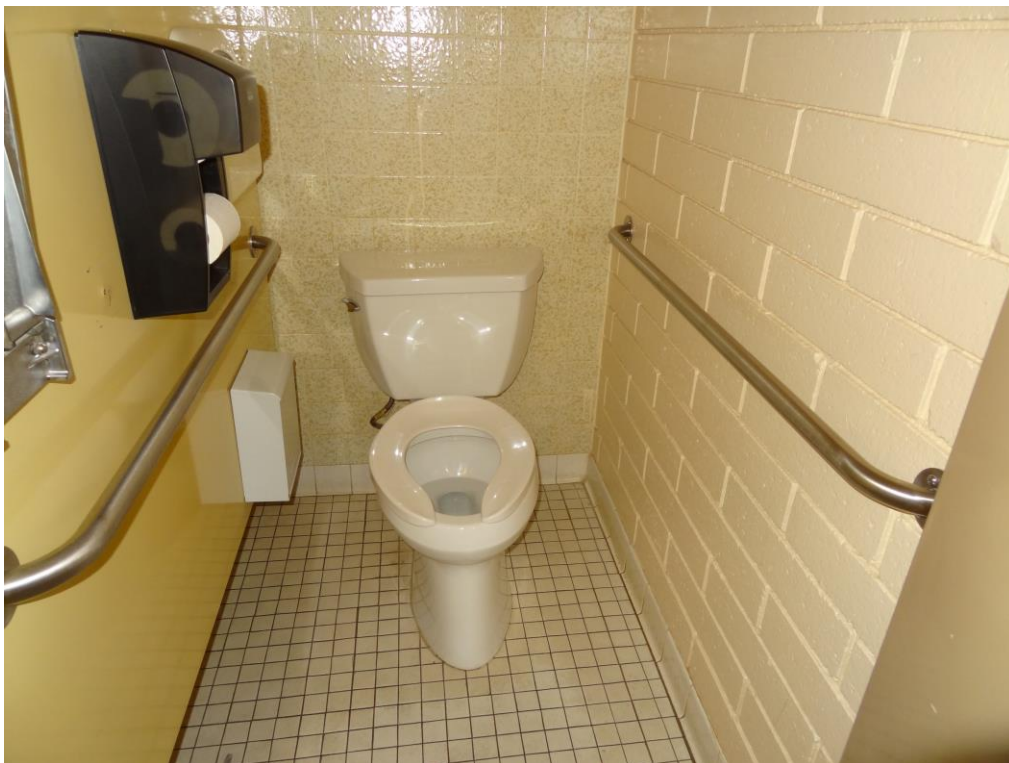
Administration / Classroom - Building #1466

The Men's and Women's designated ADA restrooms do not meet the Americans with Disabilities Act (ADA) regulations. A retrofit is necessary to comply with 2018 IBC Chapter 11, ICC/ANSI A117.1 Sections 603 - 604 and the Americans with Disabilities Act Accessibility Guidelines (ADAAG). Given the current configuration of the restrooms, the work will include the installation of a new toilet, sink, grab bars, faucets, mirrors, dispensers and hardware. Some minor design work will be required and may impact the final cost estimate. This estimate is for 5 restroom facilities. The removal and disposal of the old restroom fixtures is included in this estimate.

Description: ADA Restroom Upgrades for Required Clearances.

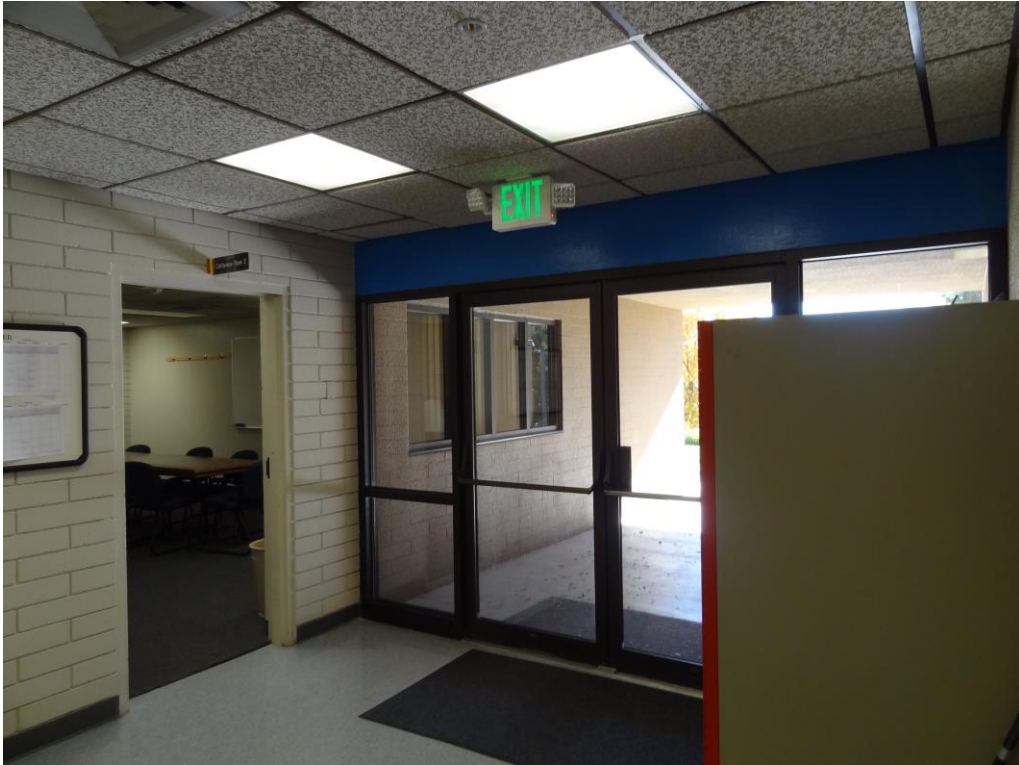
The main entrances to this building are dual leaf, commercial grade aluminum and glass door assemblies. The hardware and configuration of the doors does not fully meet ADA requirements. This project recommends the installation of a power-assisted door opener for the main entrance and side entrance and includes the installation, related wiring and hardware.

Administration / Classroom - Building #1466  
Description: Power Door Opener & Hardware Recommended.

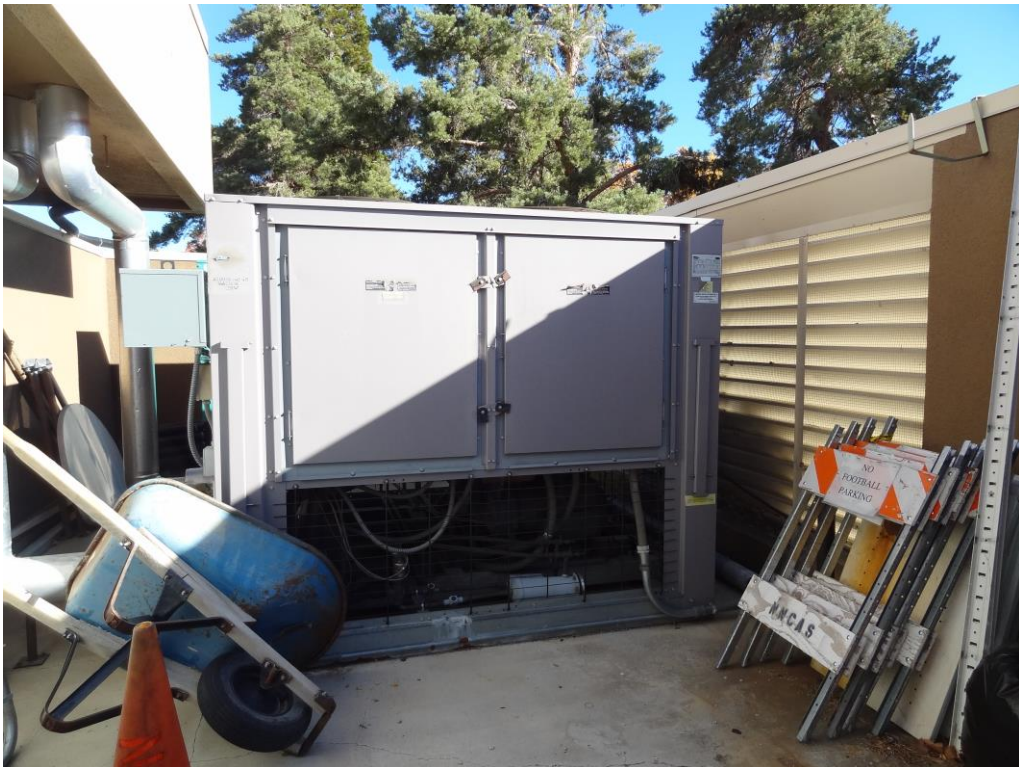
The HVAC system controls are older and not efficient. There have been ongoing problems with the zone control valves, and a number have had to be replaced. The second floor is reported as too warm, and the main floor too cold. This project recommends the installation of an Energy Management System (EMS) for the entire site. This system will monitor and control the heating, ventilation, air conditioning and lighting equipment in the building through a central computer system. Electronic sensors will be installed on each piece of equipment which will feed information into the computer system. The maintenance staff can then control and monitor the equipment remotely which will significantly lower energy costs. Along with electricity, gas and water meters, this system will provide detailed reports on energy consumption allowing the maintenance staff to analyze and customize the energy used by the facility. This work should be performed concurrently with the "HVAC Upgrade" project.

The HVAC system is largely original to the building and is due for a major upgrade. This equipment has reached the end of its serviceable and expected life span and should be scheduled for replacement within the next two to three years. This project would provide for replacement of the two Weil-McLain boilers, the water treatment system and several other parts of the HVAC system including a broken gate valve and the boiler exhaust system. Cleaning of the existing ductwork, grills and diffusers, and balancing is included in the project. The estimate includes all utility connections as well as removal and disposal of the existing equipment. This work should be performed concurrently with the "HVAC Controls Upgrade" project.

Administration / Classroom - Building #1466  
Description: HVAC Systems & Controls Upgrade.

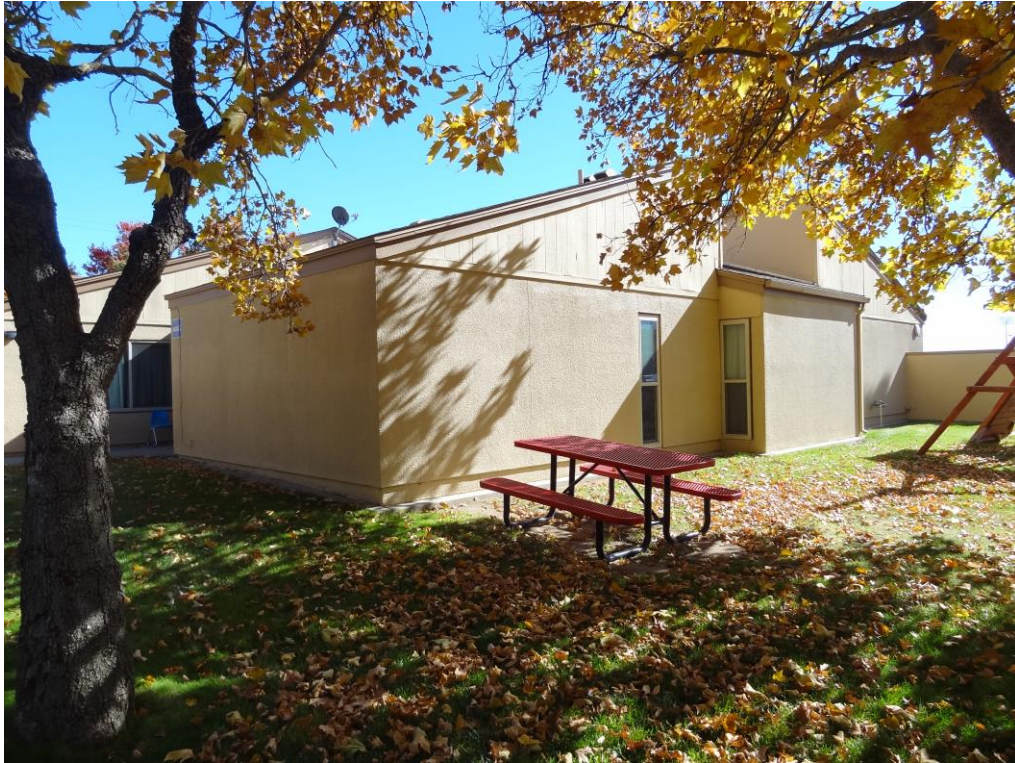
The exterior finishes are in fair condition. It is important to maintain the finish, weather resistance and appearance of the building. This project recommends work to protect the exterior building envelope, other than the roof, including painting, staining, or other applied finishes, and caulking around windows, flashing, fixtures, and other penetrations to maintain the building in good, weather tight condition. It is recommended that this project be implemented in the next 5 to 6 years and is recommended on a cyclical basis based on environmental conditions. Elastomeric paint is recommended for the stucco portion of the building.

Behavioral Services Housing Unit A - Building #1467  
Description: Exterior Finishes of the Building.

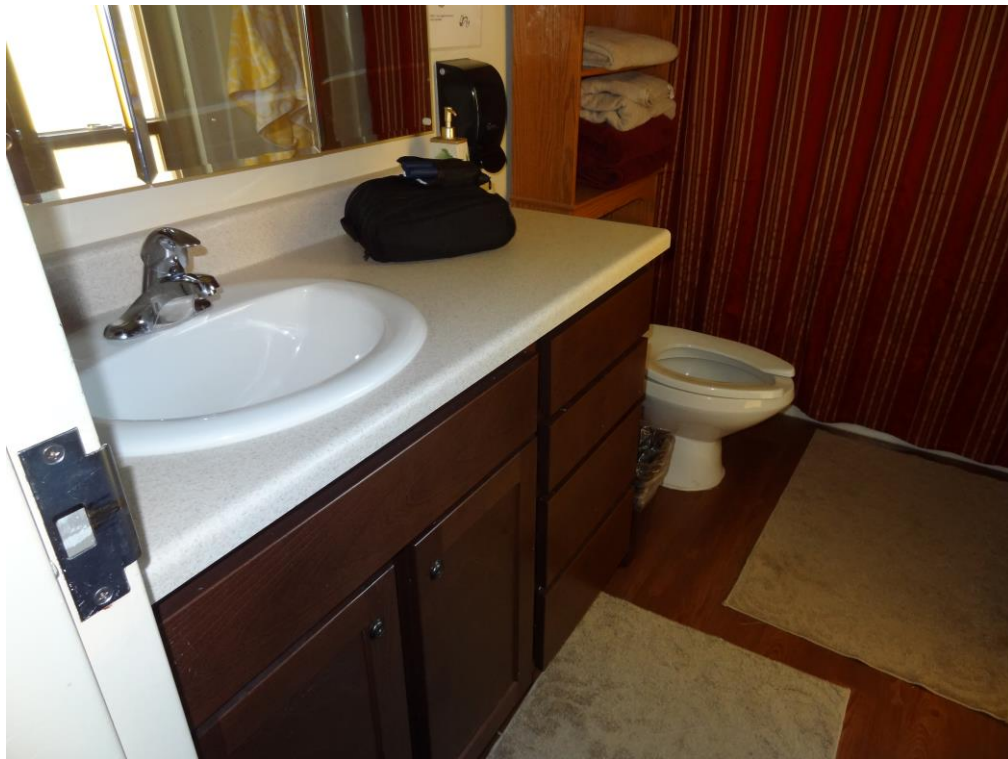
The building does not have accessible restrooms or showers. The existing restrooms do not meet the ADA requirements. A complete retrofit including reconfiguring walls is necessary. This project would provide funding for remodeling the three restrooms per ADA regulations. Items may include a new sink, toilet, shower, hardware, mirrors, fixtures, flooring and paint. The 2018 IBC, ICC/ANSI A117.1, NRS 338.180 and the most current version of the ADA Standards for Accessible Design were used as a reference for this project.

Behavioral Services Housing Unit A - Building #1467  
Description: Typical Restroom Needing ADA Upgrade.

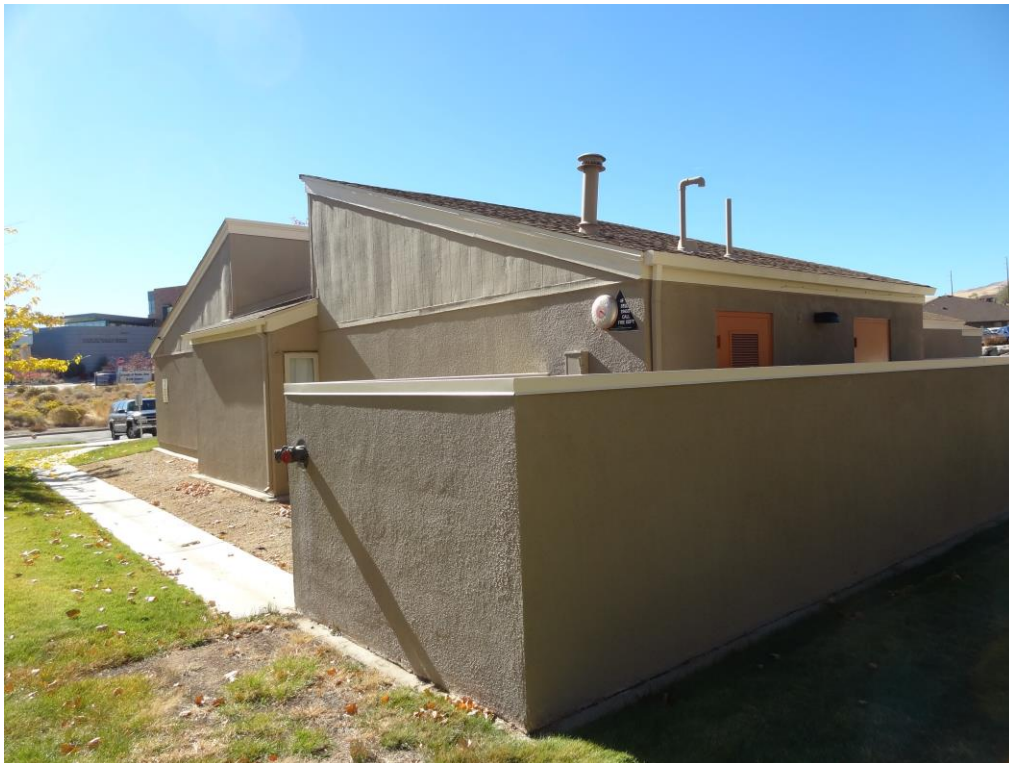
The exterior finishes are in fair condition. It is important to maintain the finish, weather resistance and appearance of the building. This project recommends work to protect the exterior building envelope, other than the roof, including painting, staining, or other applied finishes, and caulking around windows, flashing, fixtures, and other penetrations to maintain the building in good, weather tight condition. It is recommended that this project be implemented in the next 5 to 6 years and is recommended on a cyclical basis based on environmental conditions. Elastomeric paint is recommended for the stucco portion of the building.

Behavioral Services Housing Unit B - Building #1468  
Description: Exterior Finishes of the Building.

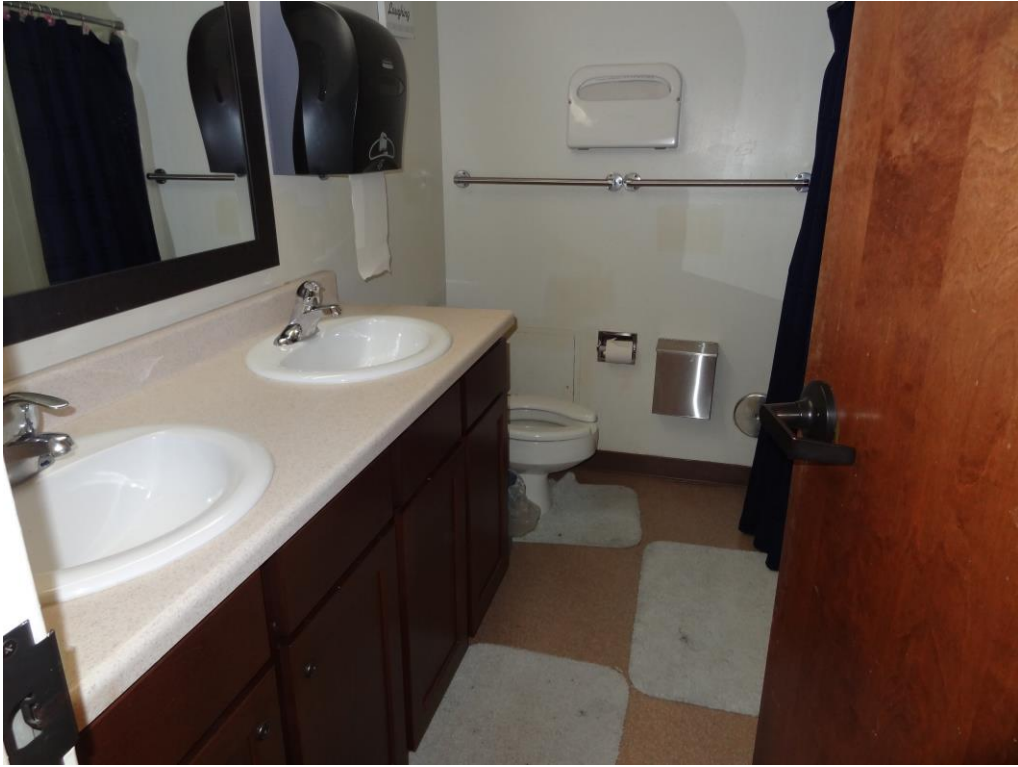
The building does not have accessible restrooms or showers. The existing restrooms do not meet the ADA requirements. A complete retrofit including reconfiguring walls is necessary. This project would provide funding for remodeling the three restrooms per ADA regulations. Items may include a new sink, toilet, shower, hardware, mirrors, fixtures, flooring and paint. The 2018 IBC, ICC/ANSI A117.1, NRS 338.180 and the most current version of the ADA Standards for Accessible Design were used as a reference for this project.

Behavioral Services Housing Unit B - Building #1468  
Description: Typical Restroom Needing ADA Upgrade.

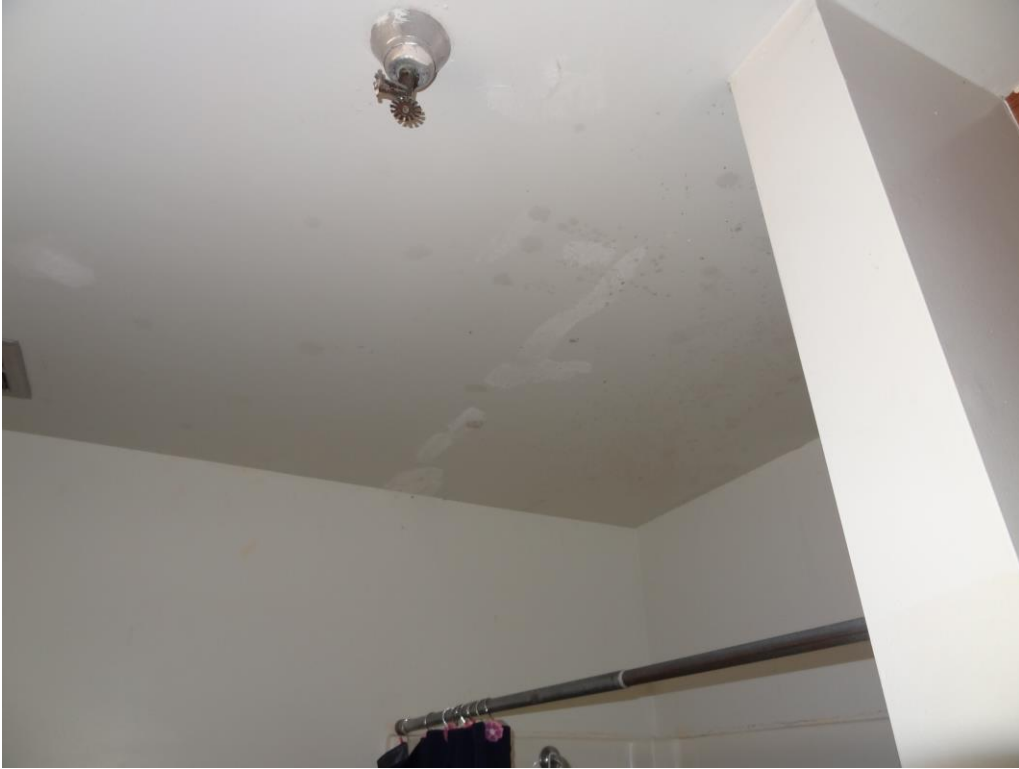
The exhaust fans in the restrooms and shower areas were inoperative and/or damaged at the time of the survey. Due to building code requirements and excessive humidity concerns, this project would provide funding for the purchase and installation of commercial exhaust fans.

Behavioral Services Housing Unit B - Building #1468  
Description: Replace Restroom/Shower Exhaust Fans.
