LAHONTAN STATE RECREATION AREA SITE

Site Number: 9959
STATE OF NEVADA PUBLIC WORKS DIVISION
FACILITY CONDITION ANALYSIS

Report distributed in October 2021

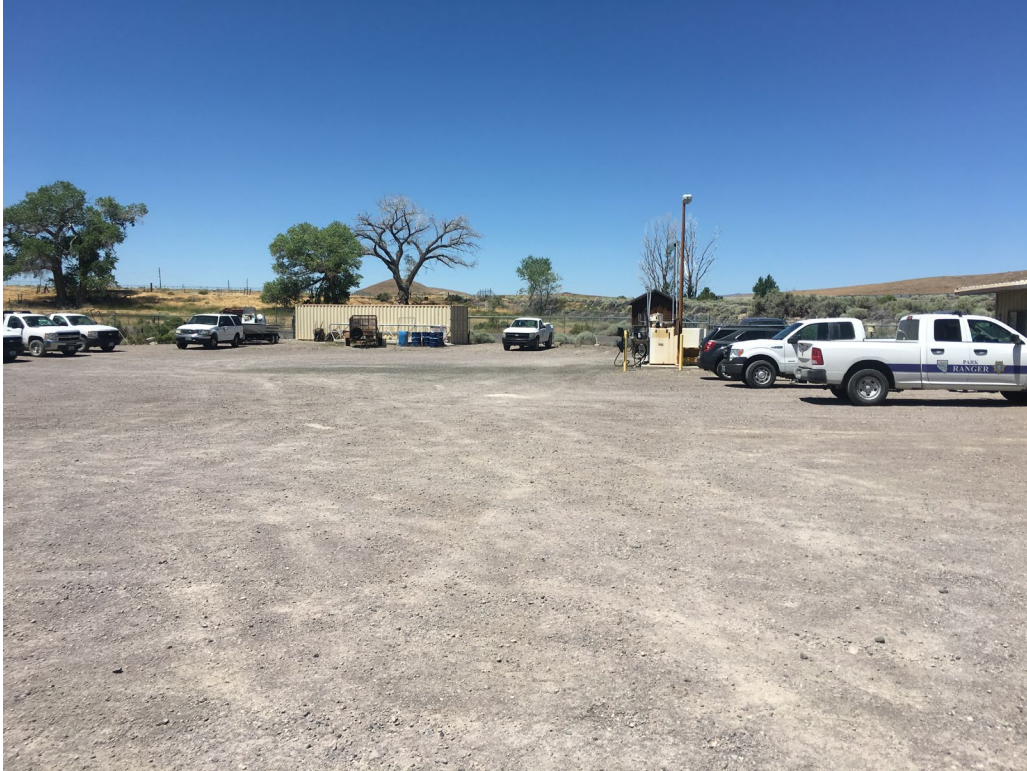
It is important to maintain the asphalt concrete paving on the site. This project would provide for minor crack filling and slurry sealing of the paving site wide including access roads and parking areas at the LD1 Day Use Comfort Station, Overlook Comfort Station, Silver Springs Boat Launch and the Silver Springs Ranger Residence. Striping is included in this estimate. This project should be scheduled on a 5 year cyclical basis to maintain the integrity of the paving and prevent premature failure. 200,000 square feet of asphalt area was used to generate this estimate.

Lahontan State Recreation Area - Site #9959
Description: Maintenance Yard - Asphalt Pavement Recommended.

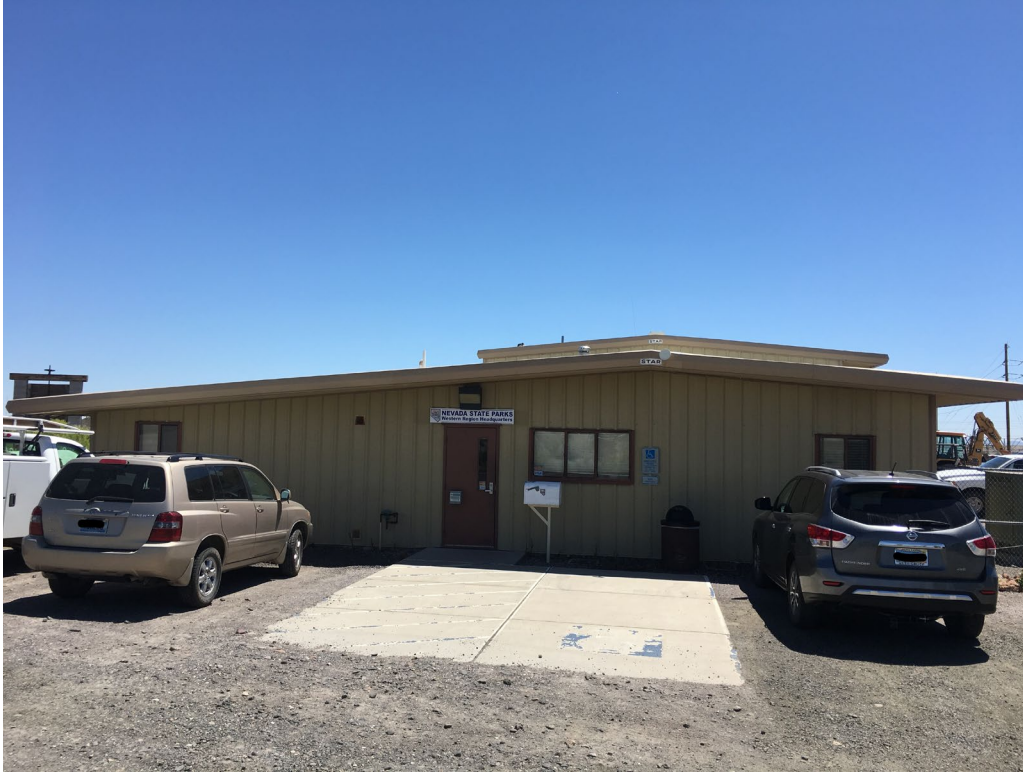
Regional Headquarters / Maintenance Shop - Building #0493
Description: ADA Accessible Entrance – Needing Signage & Striping

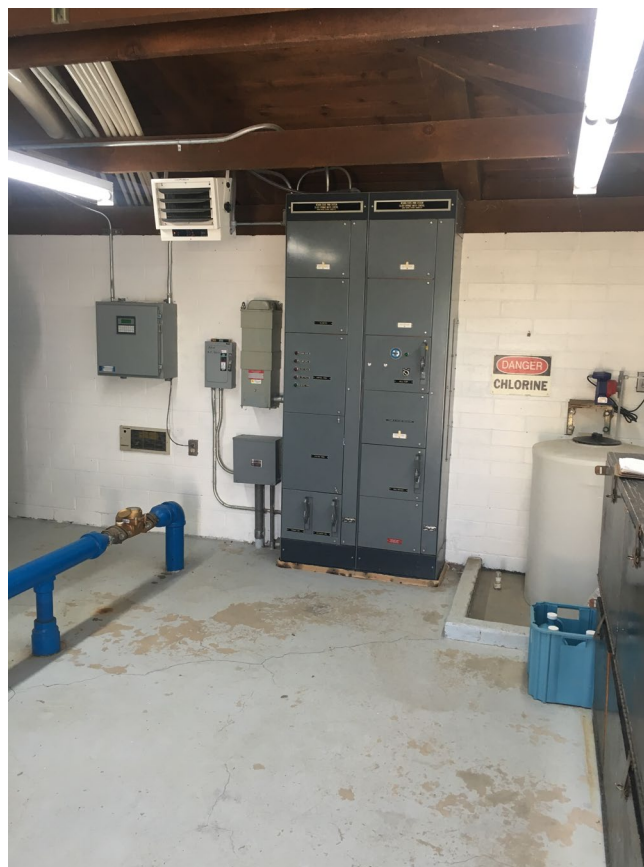
SS Mechanical Building North - Building #1347
Description: Arc Flash & Breaker Coordination Study Needed.

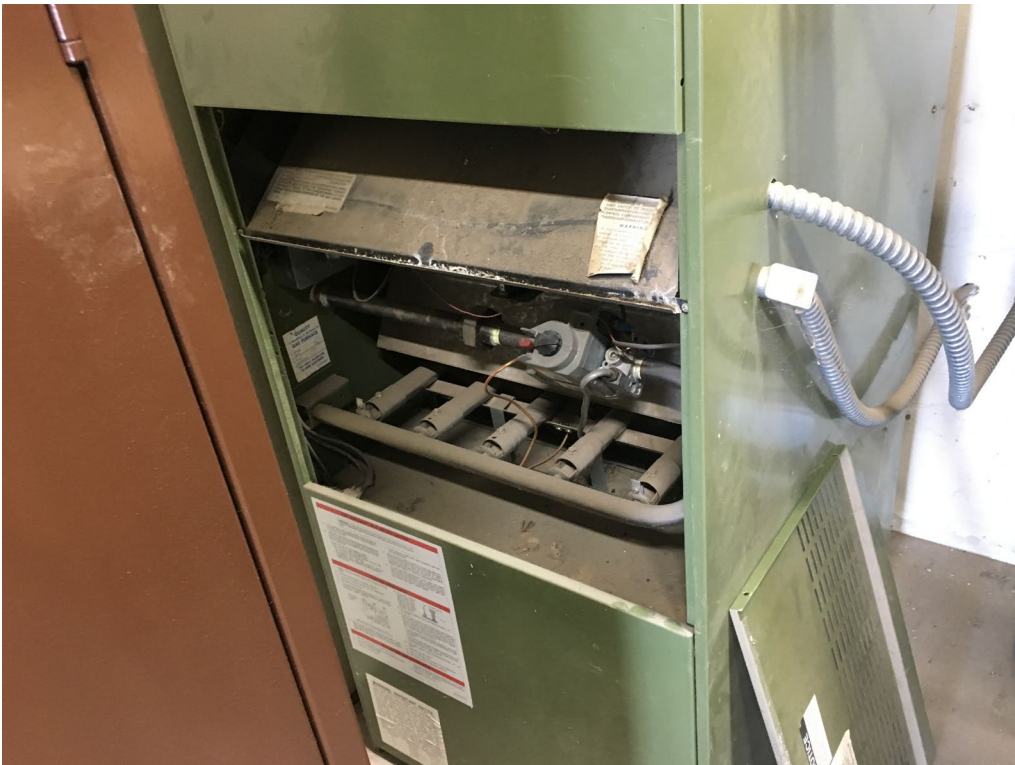
SS Maintenance Shop - Building #1351
Description: Furnace Replacement Needed.

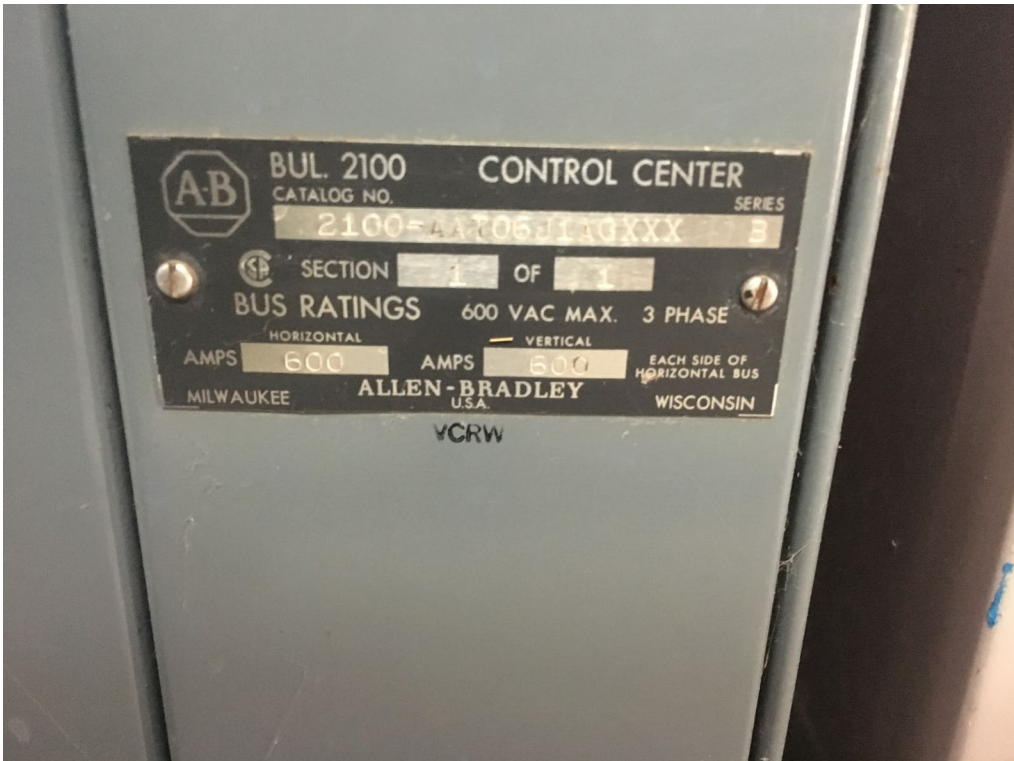
SS Mechanical Building South- Building #3052
Description: Arc Flash & Breaker Coordination Study Needed.

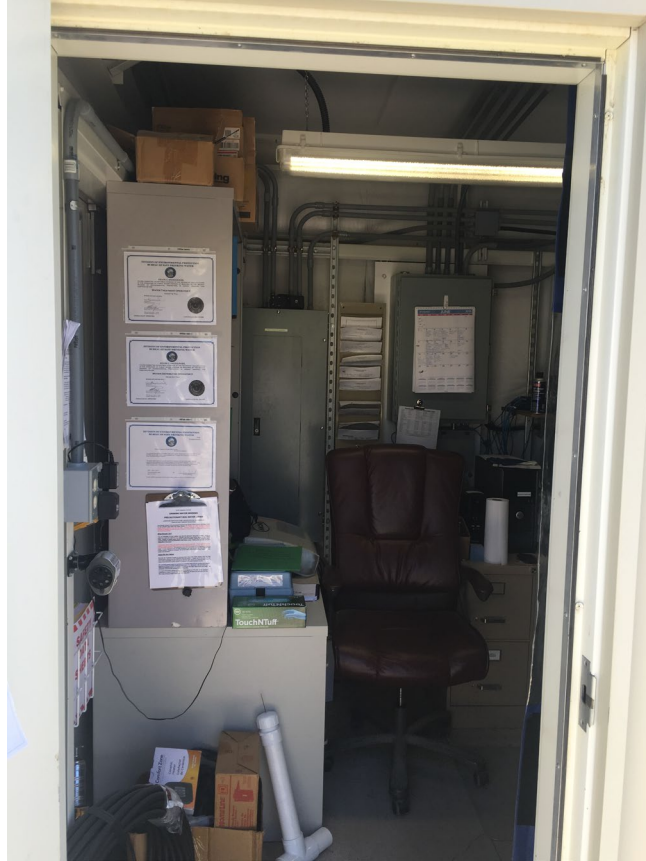
Water Treatment Plant- Building #3054
Description: Arc Flash & Breaker Coordination Study Needed.

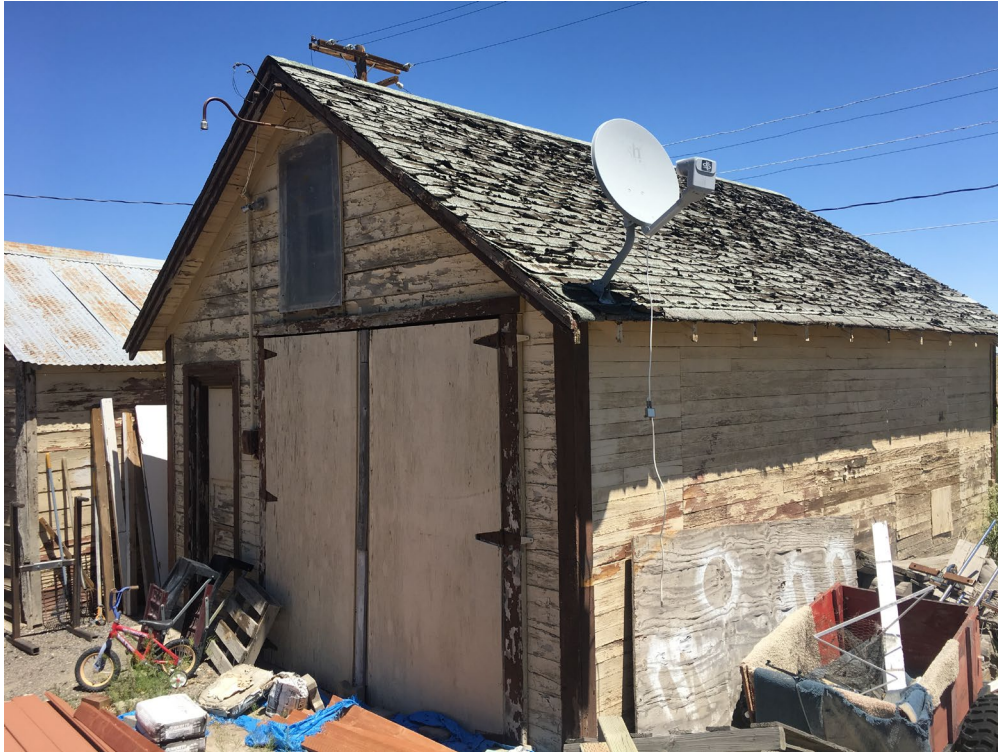
LD Garage #4- Building #3056
Description: Exterior of the Structure.

The LD Garage #4 is an old wood framed structure located in the Lahontan Dam residence area. It has an old composition roofing system that is severely damaged and is currently used for storage.

The asphalt composition shingle roof on this building was in poor condition at the time of the survey. It is recommended that this building be re-roofed in the next 2 - 3 years with a new 50 year asphalt composition roofing shingle and new underlayment. This estimate includes probable sheathing replacement, removal and disposal of the old roofing.

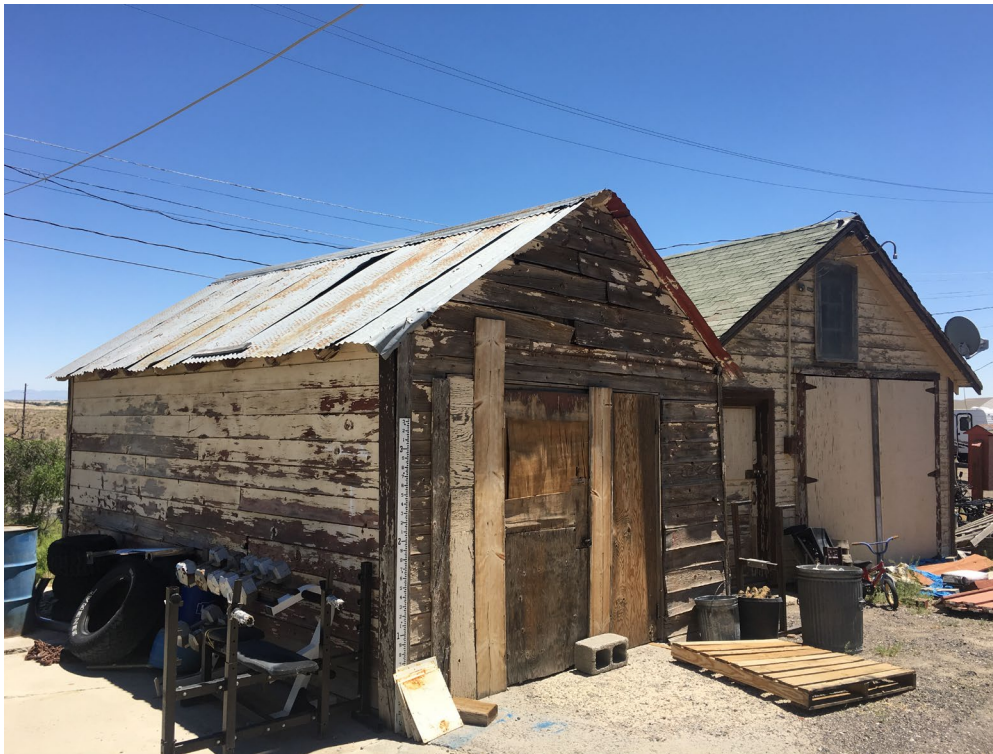
LD Garage #5- Building #3057
Description: Exterior of the Structure.

The corrugated metal roof on this building was in poor condition at the time of the survey. It is recommended that this building be re-roofed in the next 2 - 3 years with a standing seam metal roofing system. This estimate includes removal and disposal of the old roofing.
