# STATE OF NEVADA STATE PUBLIC WORKS DIVISION

FACILITY CONDITION ASSESSMENT REPORT FOR:

DEPT OF CORRECTIONS  
LOVELOCK CORRECTIONAL CENTER

Survey Date: 4/04/2023  
Distribution Date: 11/20/2024

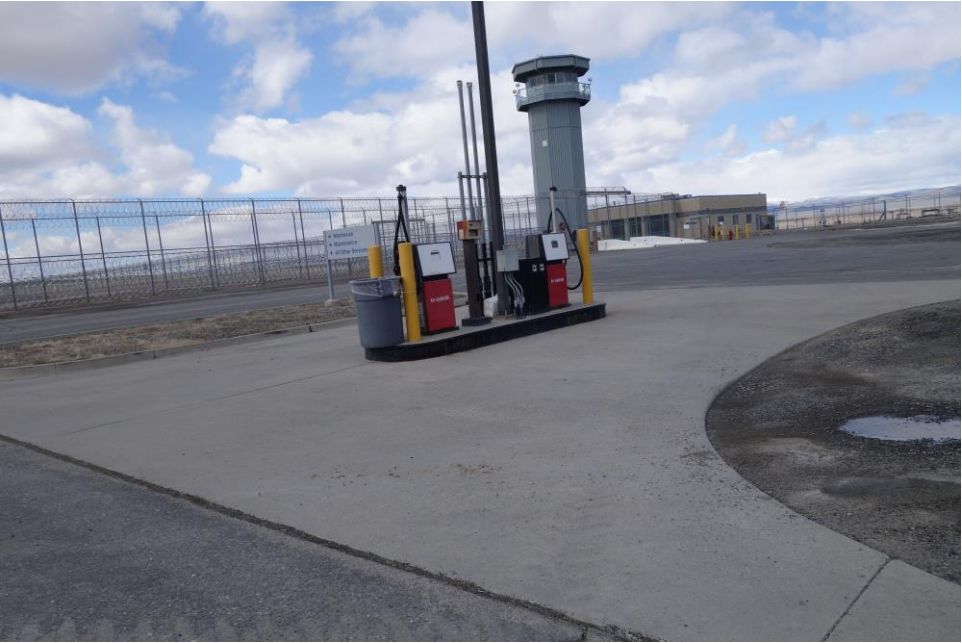
UNDERGROUND FUEL TANK REMOVAL AND REPLACEMENT

QUANTITY	UNITS	TOTAL	SF COST
The three underground fuel tanks appear to be original construction installed in 1993. The fuel monitoring system, tank and fuel piping inspections have failed inspection tests and a 2nd notice of violation from NDEP has been logged. The fuel dispensing systems are also original and have reached the end of their service life. Due to the existing conditions, the entire system is recommended to be replaced with an above ground fuel storage system suitable for a corrections site. Soil contaminant removal and remediation are not included in this estimate.	1	PKG	\$1,066,000.00	-

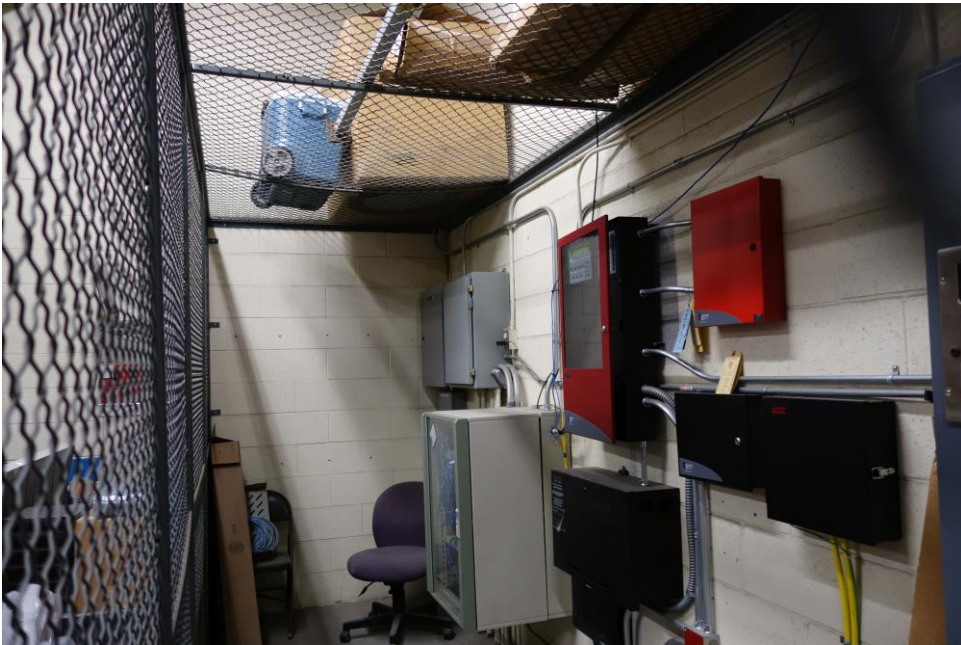
FIRE ALARM REPLACEMENT

QUANTITY	UNITS	TOTAL	SF COST
The fire alarm systems site wide have systemic communication problems. Portions of the equipment are obsolete and in disrepair. In addition, the fire pump communication and control equipment and building flow switch devices that interface with the fire alarm systems are also failing. A complete replacement is needed.	405000	SF	\$1,417,500.00	-

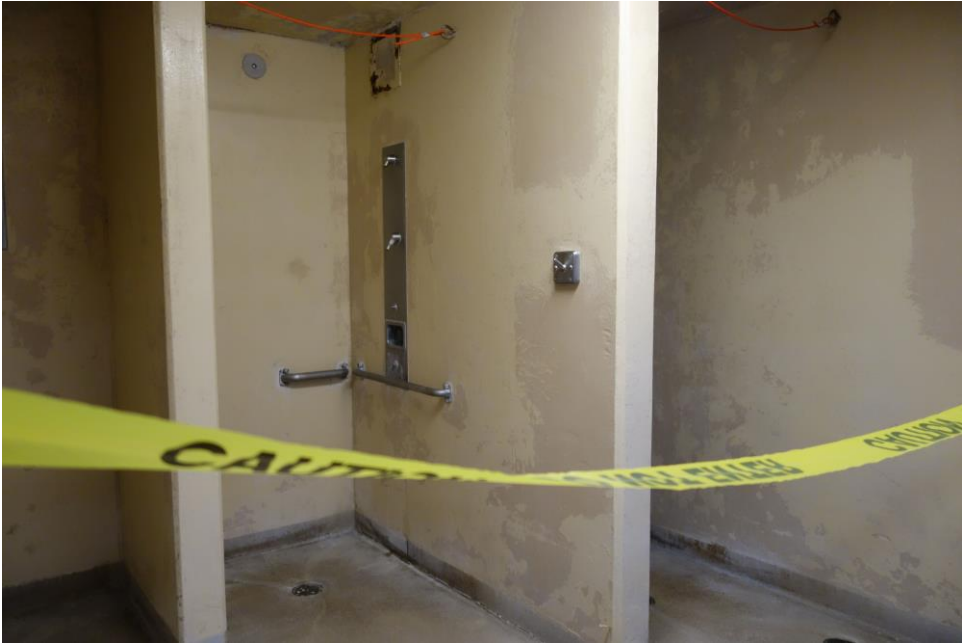
SHOWER REPLACEMENT SITEWIDE

QUANTITY	UNITS	TOTAL	SF COST
The shower stalls in all housing units have reached the end of their serviceable life. They are difficult to maintain and are easily damaged. This project recommends to replace all 120 shower stalls with stainless steel enclosures, new fixtures with water controls and epoxy flooring in the shower areas.	1	PKG	\$4,857,200.00	-

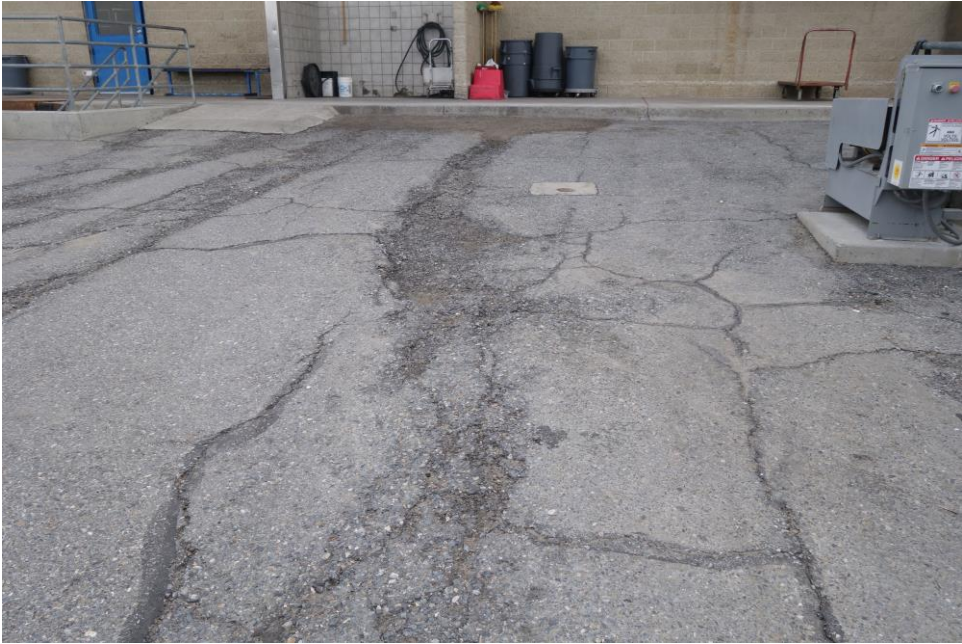
PATCH, CRACK & SLURRY SEAL ASPHALT PAVING

QUANTITY	UNITS	TOTAL	SF COST
It is important to maintain the asphalt concrete paving on the site. This project would provide for minor crack filling and slurry sealing of the paving site wide including access roads, parking areas, the maintenance yard, and the basketball court at Building #8. Striping is included in this estimate. This project should be scheduled on a 5 year cyclical basis to maintain the integrity of the paving and prevent premature failure. 325,000 square feet of asphalt area was used to generate this estimate.	325000	SF	\$432,600.00	-

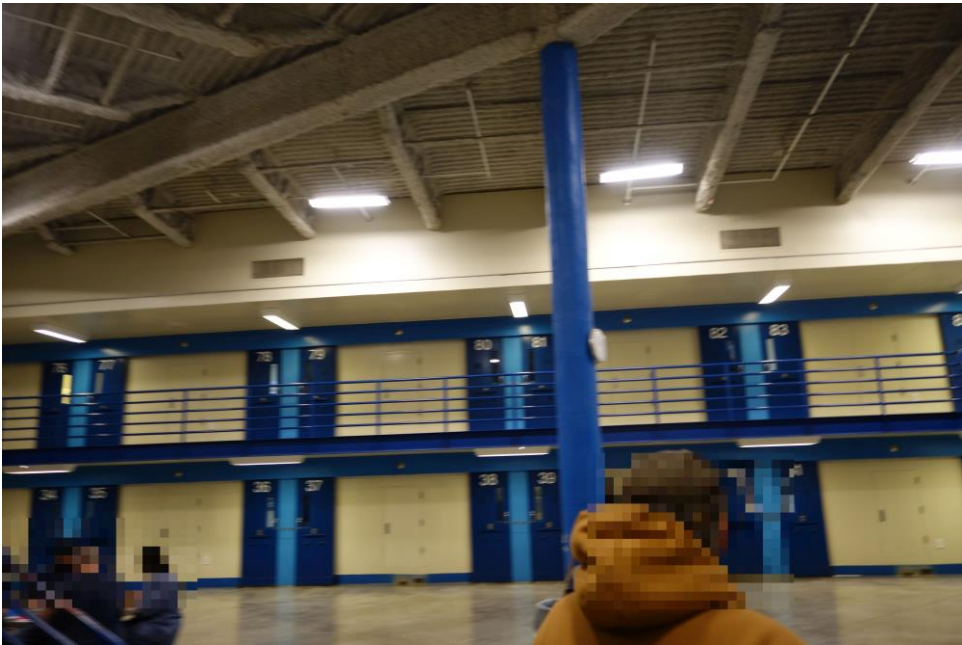
REPLACE DOOR LOCKS AND CONTROLS SITEWIDE

QUANTITY	UNITS	TOTAL	SF COST
The Housing Unit cell door locks and controls are approaching 8 years in service and should be planned for replacement in 6 - 8 years. The previous replacement was done under CIP's 13-MO6 & 15-M04. This project will replace the intercoms, locks and controls for the doors in all housing units including gate controls and software licensing.	1	PKG	\$9,840,000.00	-

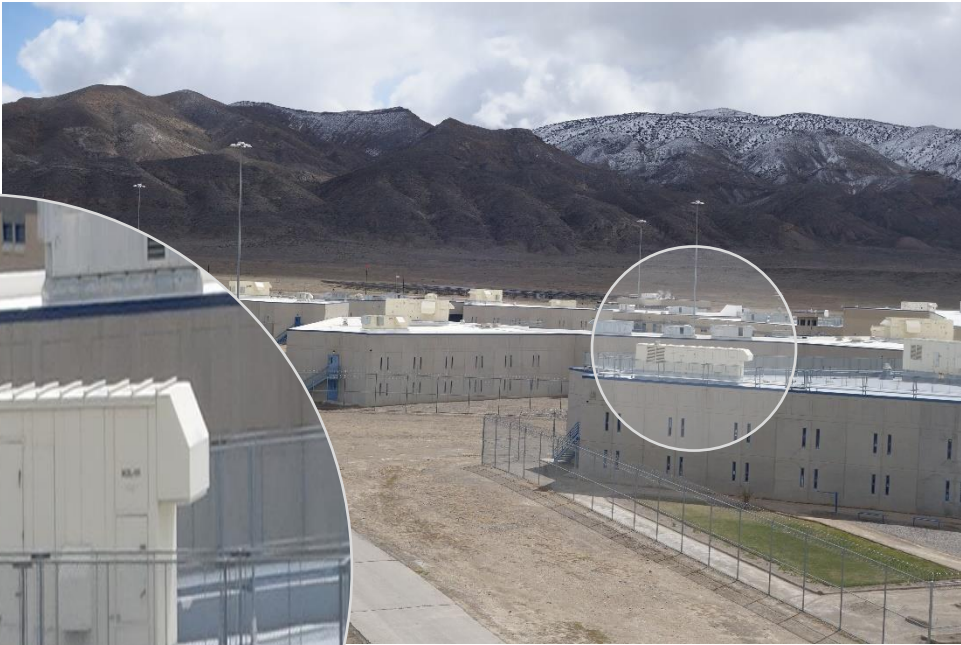
HVAC SYSTEMS REPLACEMENT

The large rooftop air handling units were replaced approximately 6 years ago. However the balance of smaller AHU's, exhaust fans and VAV boxes with re-heat coils are original and have reached the end of their useful life. This project recommends replacement of the balance of mechanical equipment including fan coil units, exhaust fans, reheat coils.

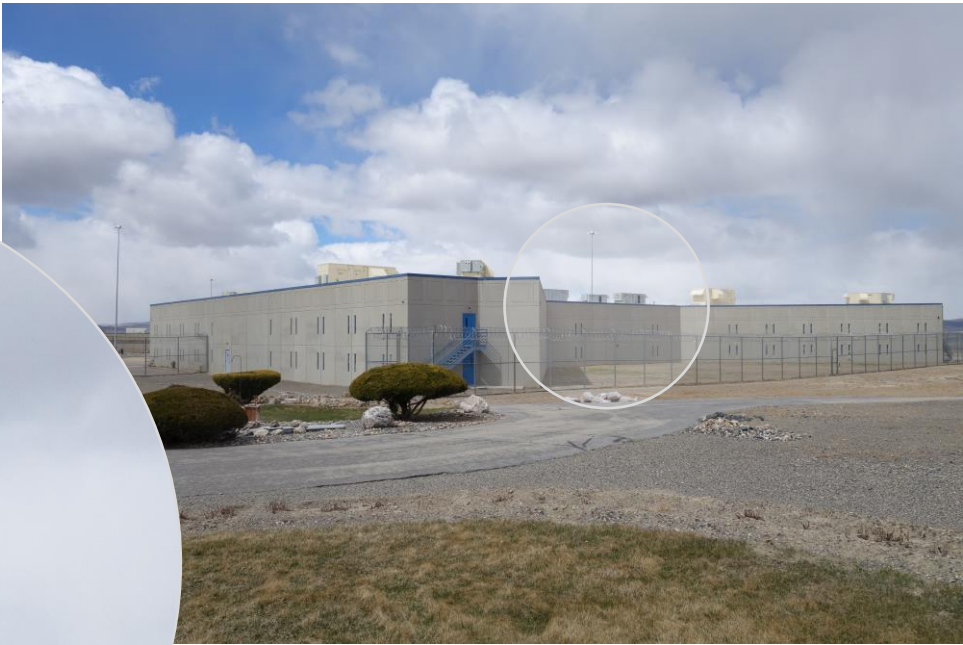
HVAC SYSTEMS REPLACEMENT

QUANTITY	UNITS	TOTAL	SF COST
The large rooftop air handling units were replaced approximately 6 years ago. However the balance of smaller AHU's, exhaust fans and VAV boxes with re-heat coils are original and have reached the end of their useful life. This project recommends replacement of the balance of mechanical equipment including fan coil units, exhaust fans, reheat coils.	1	PKG	\$97,500.00	\$ 2.00

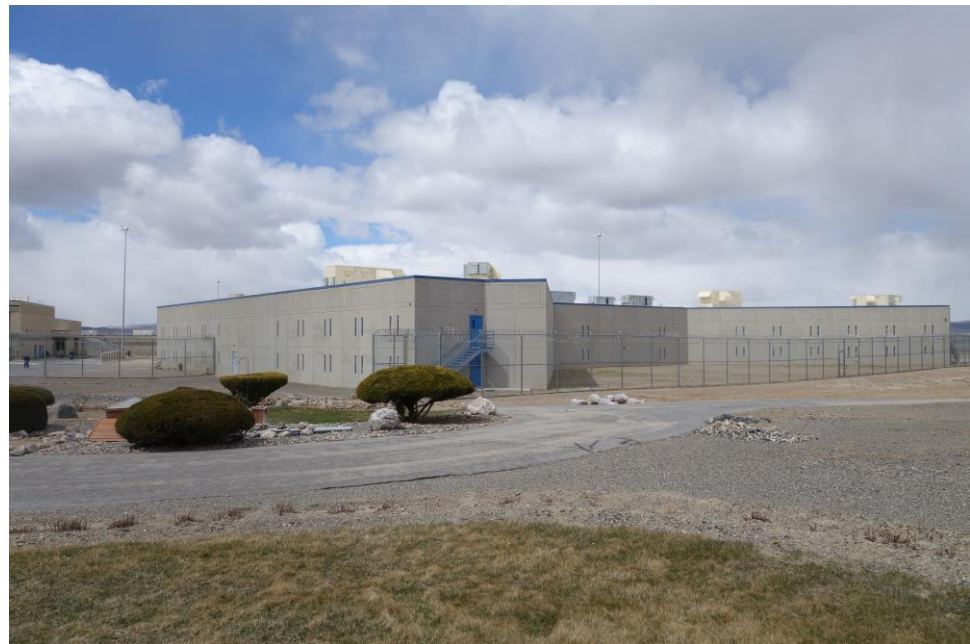
QUANTITY	UNITS	TOTAL	SF COST
The exterior finishes were in fair condition. It is important to maintain the finish, weather resistance and appearance of the building. This project would provide funding to protect the exterior of the building. Included in the cost are cleaning and sealing the concrete walls, painting the window frames and flashing and caulking the windows, flashing, fixtures and all other penetrations. It is recommended that the building be sealed, painted and caulked in the next 2-3 years and that this project be scheduled on a cyclical basis to maintain the integrity of the structure.	44500	SF	\$89,000.00	\$ 2.00

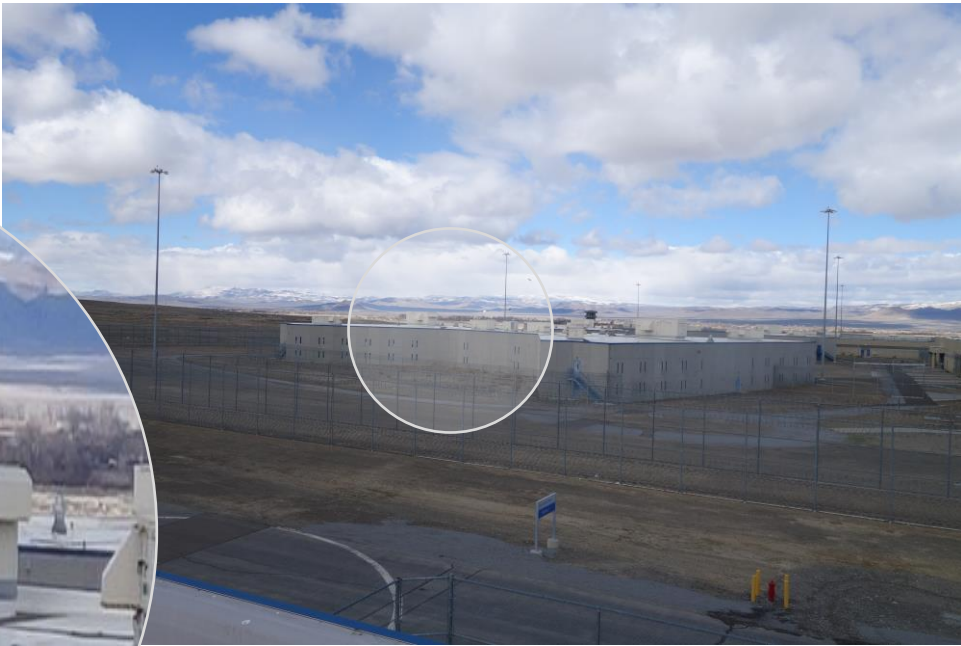
HVAC SYSTEMS REPLACEMENT

QUANTITY	UNITS	TOTAL	SF COST
The large rooftop air handling units were replaced approximately 6 years ago. However the balance of smaller AHU's, exhaust fans and VAV boxes with re-heat coils are original and have reached the end of their useful life. This project recommends replacement of the balance of mechanical equipment including fan coil units, exhaust fans, reheat coils.	1	PKG	\$97,500.00	\$ 2.00

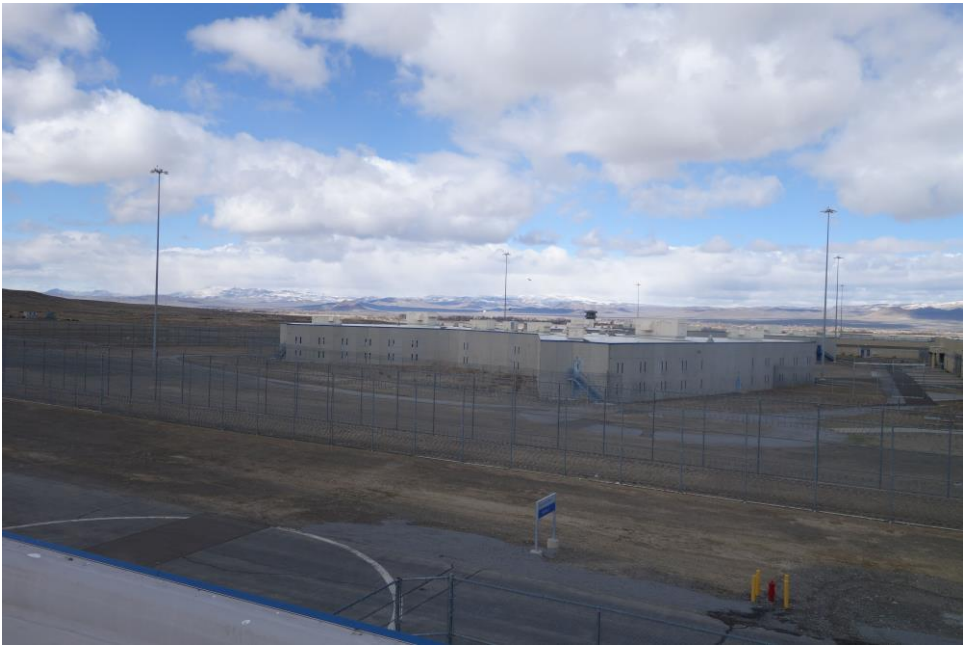
QUANTITY	UNITS	TOTAL	SF COST
The exterior finishes were in fair condition. It is important to maintain the finish, weather resistance and appearance of the building. This project would provide funding to protect the exterior of the building. Included in the cost are cleaning and sealing the concrete walls, painting the window frames and flashing and caulking the windows, flashing, fixtures and all other penetrations. It is recommended that the building be sealed, painted and caulked in the next 6 - 8 years and that this project be scheduled on a cyclical basis to maintain the integrity of the structure.	44500	SF	\$89,000.00	\$ 2.00

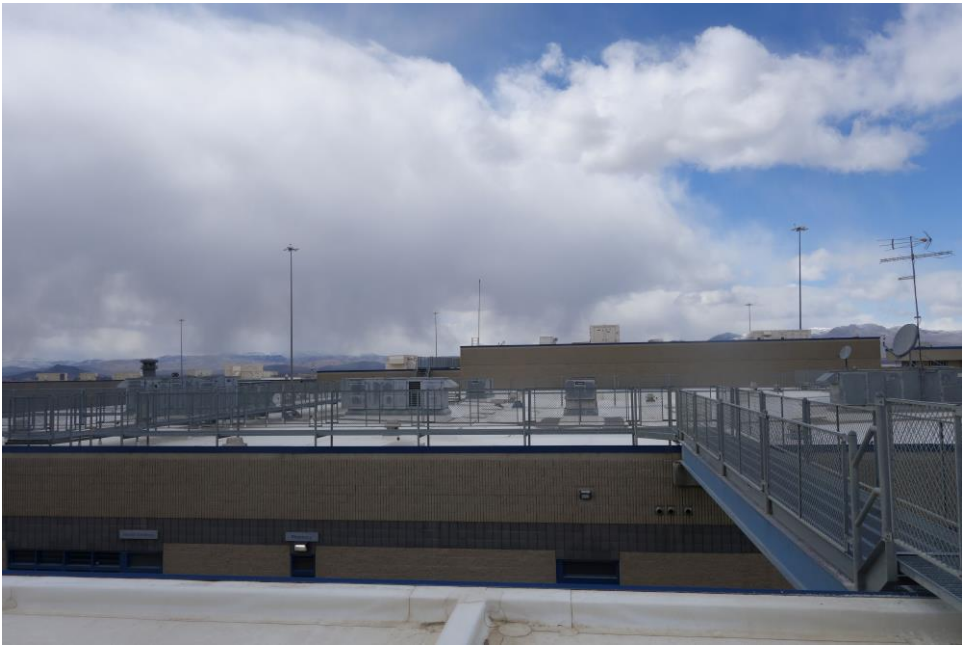
HVAC SYSTEMS REPLACEMENT

QUANTITY	UNITS	TOTAL	SF COST
The HVAC equipment is approaching 30 years of operation and has reached the end of it's serviceable life. This project recommends replacement of the air handling units, fan coil units, exhaust fans and reheat coils in the next 2 - 3 years.	1	PKG	\$1,718,000.00	\$ 64.00

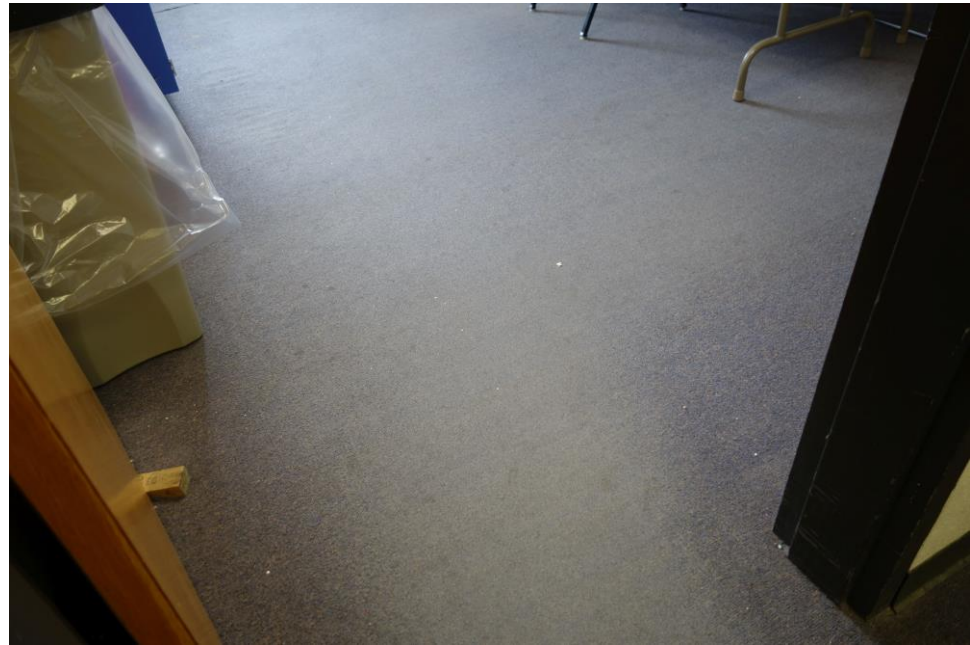
### FLOORING REPLACEMENT

QUANTITY	UNITS	TOTAL	SF COST
<p>Approximately 4,000 square feet of the building is covered by carpet and VCT tile. The flooring is showing signs of extreme wear and should be scheduled for replacement. It is recommended that the flooring be replaced with heavy duty commercial grade carpet and VCT tile in the next 2 - 3 years.</p> <p>This project or a portion thereof was previously recommended in the FCA report dated 7/10/2003 and 3/17/2010. It has been amended accordingly to reflect conditions observed during the most recent survey date of 04/04/2023.</p>	4000	SF	\$57,000.00	\$ 2.00

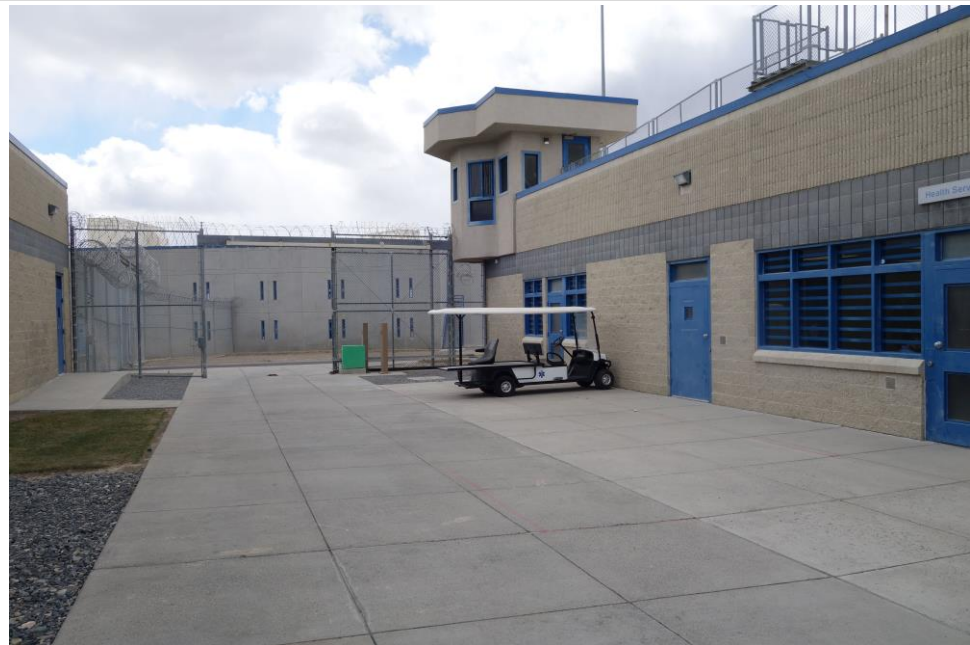
QUANTITY	UNITS	TOTAL	SF COST
The exterior finishes were in good condition. It is important to maintain the finish, weather resistance and appearance of the building. This project would provide funding to protect the exterior of the building. Included in the cost are cleaning and sealing the concrete masonry walls, painting the window frames and flashing and caulking the windows, flashing, fixtures and all other penetrations. It is recommended that the building be sealed, painted and caulked in the next 6 - 8 years and that this project be scheduled on a cyclical basis to maintain the integrity of the structure.	27000	SF	\$54,000.00	\$ 2.00

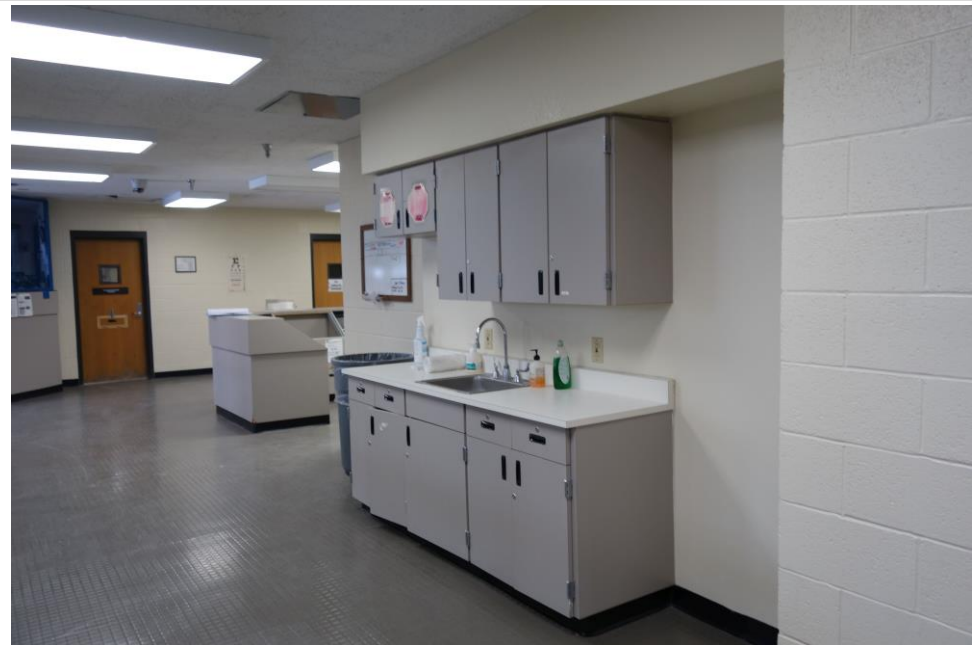
The interior finishes are in fair condition. This project would provide funding to maintain the interior of the building. Included in the cost is painting the walls and ceilings, sealing the exposed masonry, repairing cracks in the masonry and replacing grout and caulk as needed. An epoxy-based paint should be utilized in wet areas for durability. It is recommended that the interior of the building be painted, sealed and repaired in the next 4 - 6 years and that this project be scheduled on a cyclical basis to maintain the integrity of the structure.

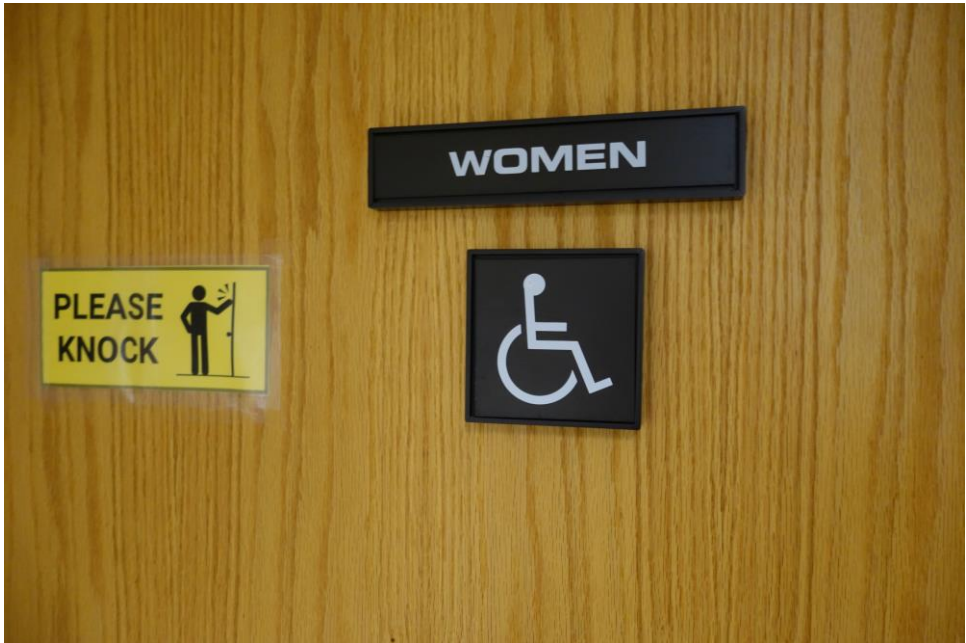
QUANTITY	UNITS	TOTAL	SF COST
<p>The restrooms and signage in the visitation area are not fully ADA compliant. This project would provide for proper signage to be installed on the walls adjacent to the restroom and also provide for minor restroom fixture adjustments including relocating the flush valve on the toilet.</p> <p>The 2018 IBC, ICC/ANSI A117.1 - 2009, NRS 338.180 and the most current version of the Americans with Disabilities Act Accessible Guidelines (ADAAG) was used as a reference for this project.</p> <p>This project or a portion thereof was previously recommended in the FCA report dated 3/17/2010. It has been amended accordingly to reflect conditions observed during the most recent survey date of 04/04/2023.</p>	1	PKG	\$ 3,000.00	\$ 0.00

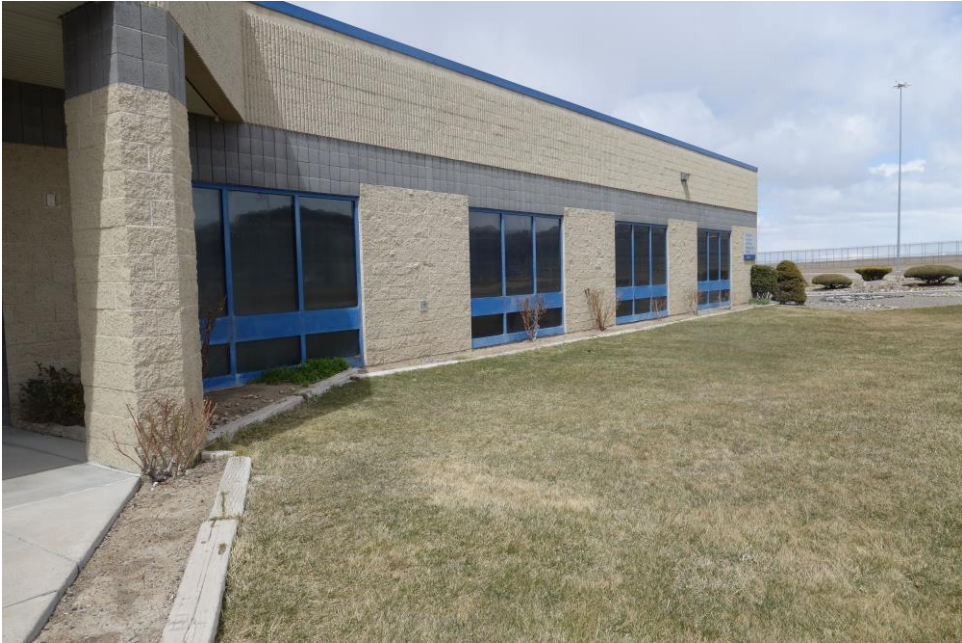
WINDOW SYSTEMS REPLACEMENT

QUANTITY	UNITS	TOTAL	SF COST
There are six large window systems, approximately 12' x 9' in size, located on the front and northeast side of the building starting to fail and in need of replacement. The seals are failing allowing air and water infiltration. A repair may be possible if replacement parts are available. It is recommended that a complete replacement is needed. This estimate is based on a complete replacement.	648	SF	\$139,300.00	\$ 5.00

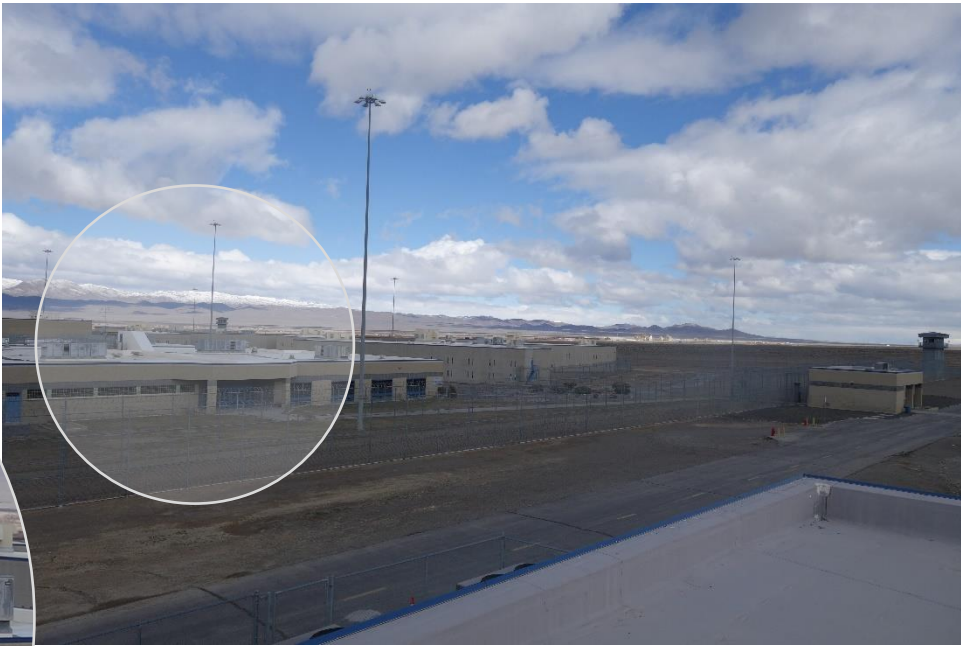
HVAC SYSTEMS REPLACEMENT

QUANTITY	UNITS	TOTAL	SF COST
The HVAC equipment is approaching 30 years of operation and has reached the end of it's serviceable life. This project recommends replacement of the air handling units, fan coil units, exhaust fans, reheat coils and water heaters in the next 2 - 3 years.	1	PKG	\$1,922,000.00	\$ 63.00

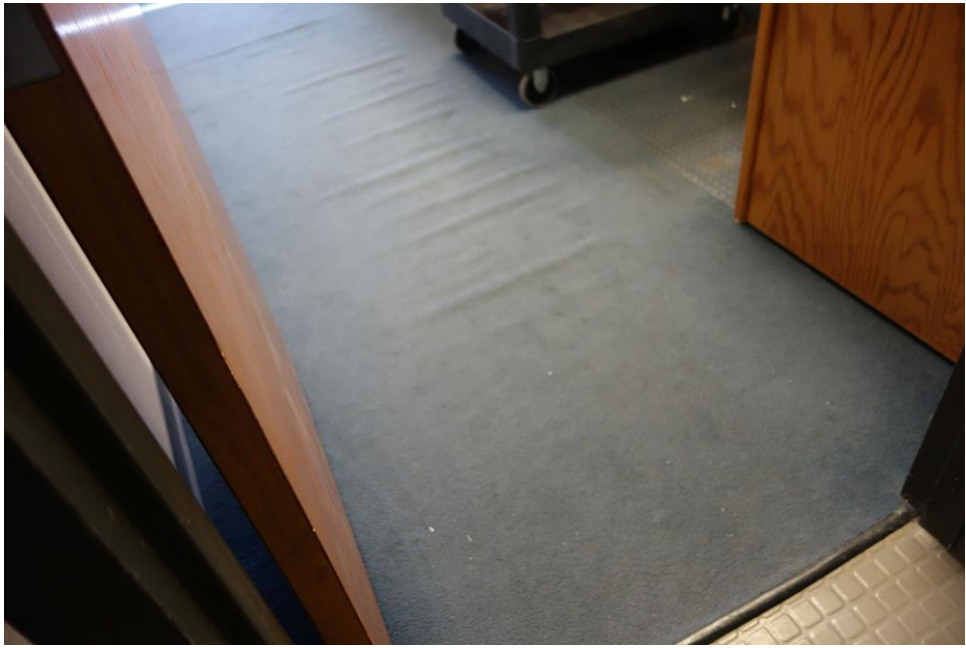
QUANTITY	UNITS	TOTAL	SF COST
<p>The VCT (vinyl composite tile), sheet vinyl and carpet in the building are damaged and reaching the end of their useful life. It is recommended that the flooring be replaced. This project would provide for removal and disposal of the existing flooring and installation of new 12x12 VCT with a 6" base, heavy duty sheet vinyl and heavy duty commercial grade carpet in the next 2-3 years.</p> <p>This project or a portion thereof was previously recommended in the FCA report dated 7/10/2003 and 3/17/2010. It has been amended accordingly to reflect conditions observed during the most recent survey date of 4/4/2023.</p>	28000	SF	\$399,000.00	\$ 13.00

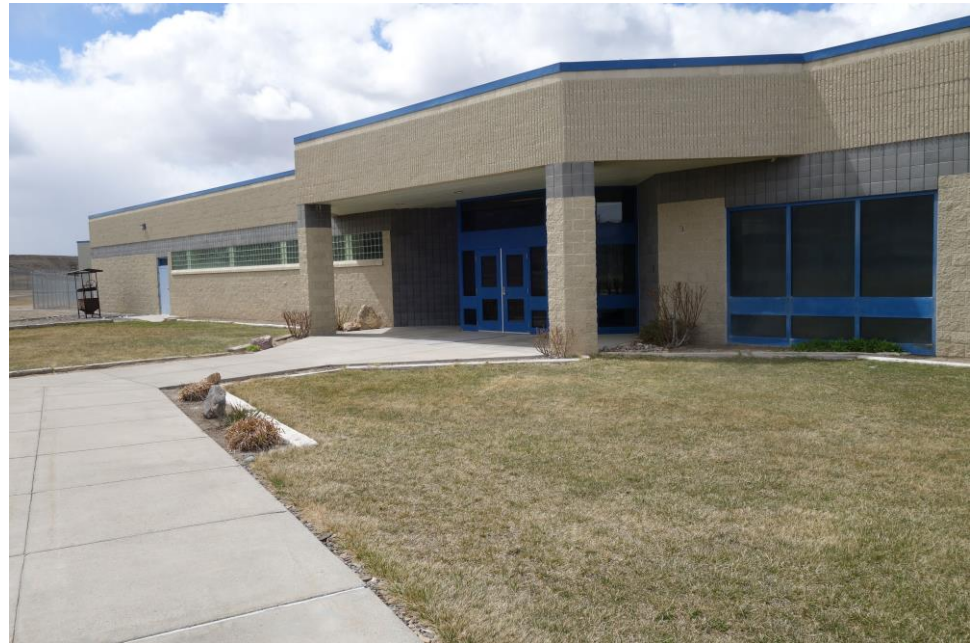
QUANTITY	UNITS	TOTAL	SF COST
The exterior finishes were in good condition. It is important to maintain the finish, weather resistance and appearance of the building. This project would provide funding to protect the exterior of the building. Included in the cost are cleaning and sealing the concrete masonry walls, painting the window frames and flashing and caulking the windows, flashing, fixtures and all other penetrations. It is recommended that the building be sealed, painted and caulked in the next 6 - 8 years and that this project be scheduled on a cyclical basis to maintain the integrity of the structure.	30700	SF	\$61,400.00	\$ 2.00

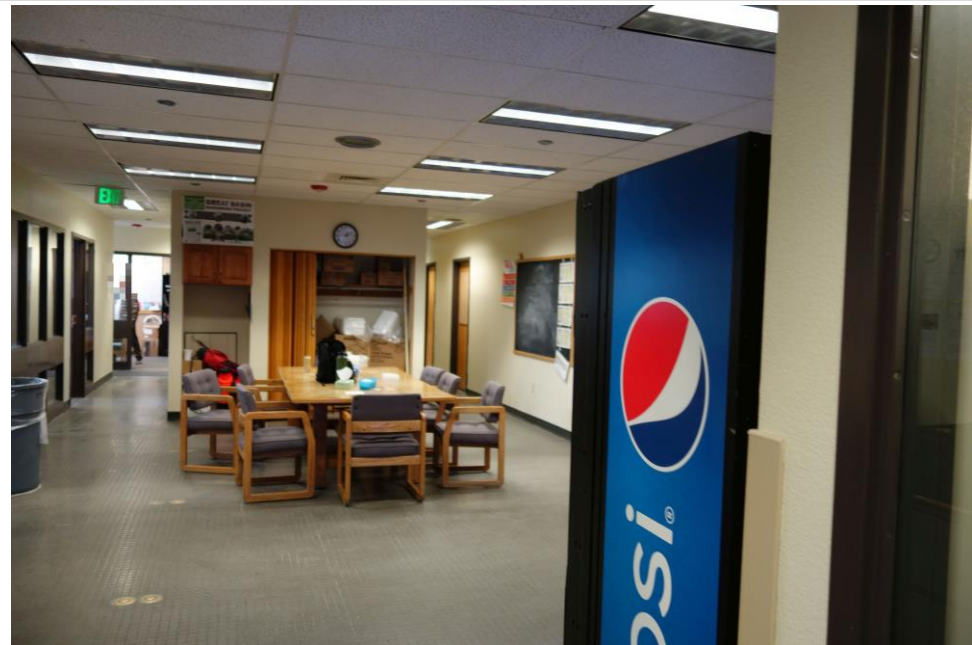
The interior finishes are in fair condition. This project would provide funding to maintain the interior of the building. Included in the cost is painting the walls and ceilings, sealing the exposed masonry, repairing cracks in the masonry and replacing grout and caulk as needed. An epoxy-based paint should be utilized in wet areas for durability. It is recommended that the interior of the building be painted, sealed and repaired in the next 2-3 years and that this project be scheduled on a cyclical basis to maintain the integrity of the structure.

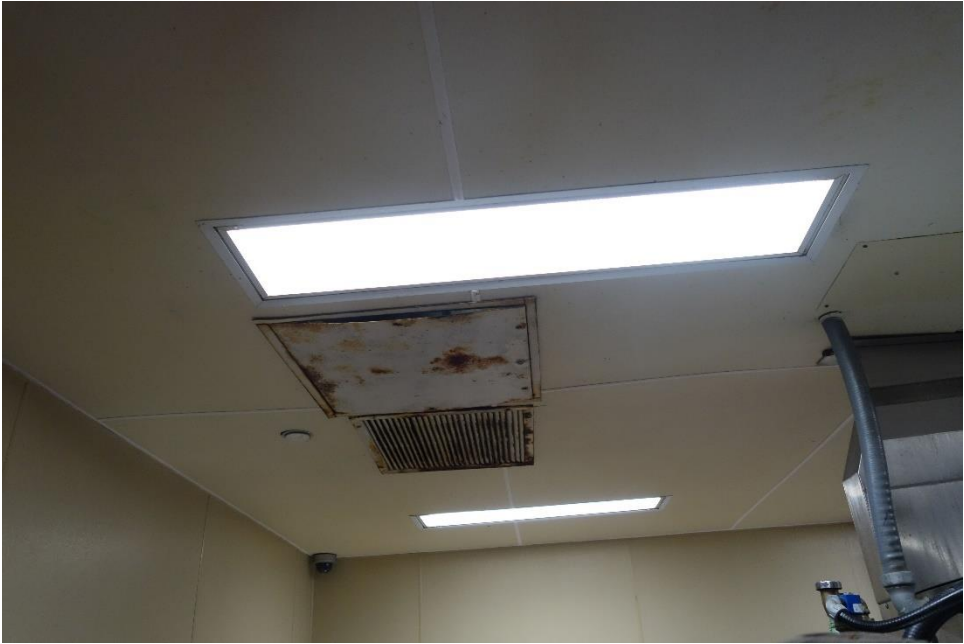
QUANTITY	UNITS	TOTAL	SF COST
The large rooftop HVAC units have been recently replaced. However, the HVAC equipment located on the interior of the building is approaching 30 years of operation and has reached the end of it's serviceable life. This project recommends replacement of the fancoil units, exhaust fans and reheat coils in the next 2 - 3 years.	1	PKG	\$247,500.00	\$ 8.00

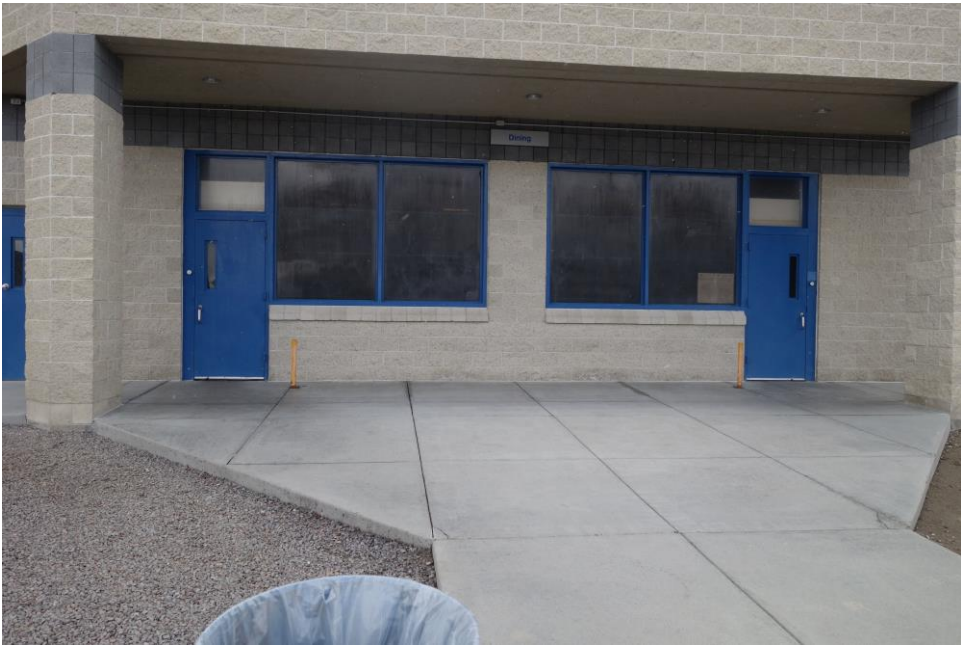
The exterior finishes were in fair condition. It is important to maintain the finish, weather resistance and appearance of the building. This project would provide funding to protect the exterior of the building. Included in the cost are cleaning and sealing the concrete masonry walls, painting the window frames and flashing and caulking the windows, flashing, fixtures and all other penetrations. It is recommended that the building be sealed, painted and caulked in the next 6 - 8 years and that this project be scheduled on a cyclical basis to maintain the integrity of the structure.

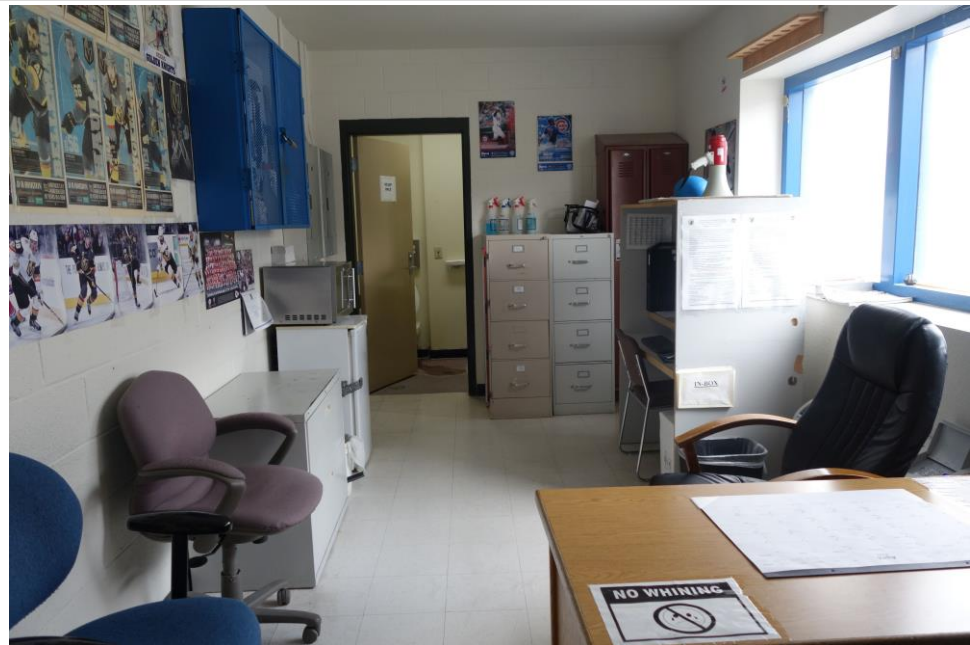
QUANTITY	UNITS	TOTAL	SF COST
The interior finishes are in fair condition. This project would provide funding to maintain the interior of the building. Included in the cost is painting the walls and ceilings, sealing the exposed masonry, repairing cracks in the masonry and replacing grout and caulk as needed. An epoxy-based paint should be utilized in wet areas for durability. It is recommended that the interior of the building be painted, sealed and repaired in the next 4 - 6 years and that this project be scheduled on a cyclical basis to maintain the integrity of the structure.	32000	SF	\$160,000.00	\$ 5.00

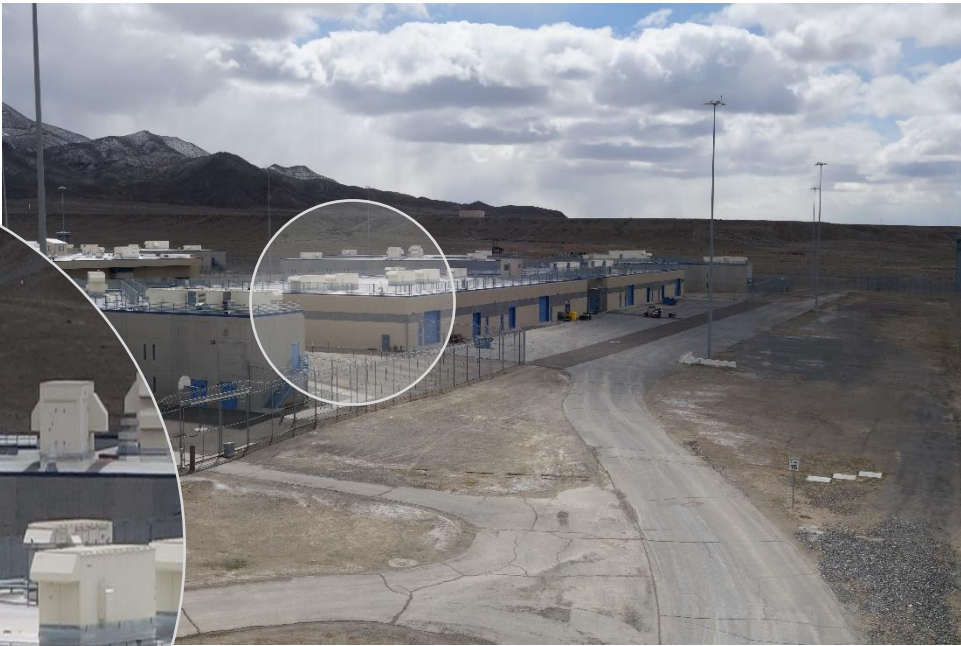
QUANTITY	UNITS	TOTAL	SF COST
The rooftop air handling units (AHU's) over the laundry area were replaced approximately 6 years ago. However the balance of rooftop AHU's, exhaust fans are original are have reached the end of their useful life. This project recommends replacement of the balance of mechanical equipment including 4 RTU's, exhaust fans and other miscellaneous mechanical equipment.	1	PKG	\$1,046,000.00	\$ 39.00

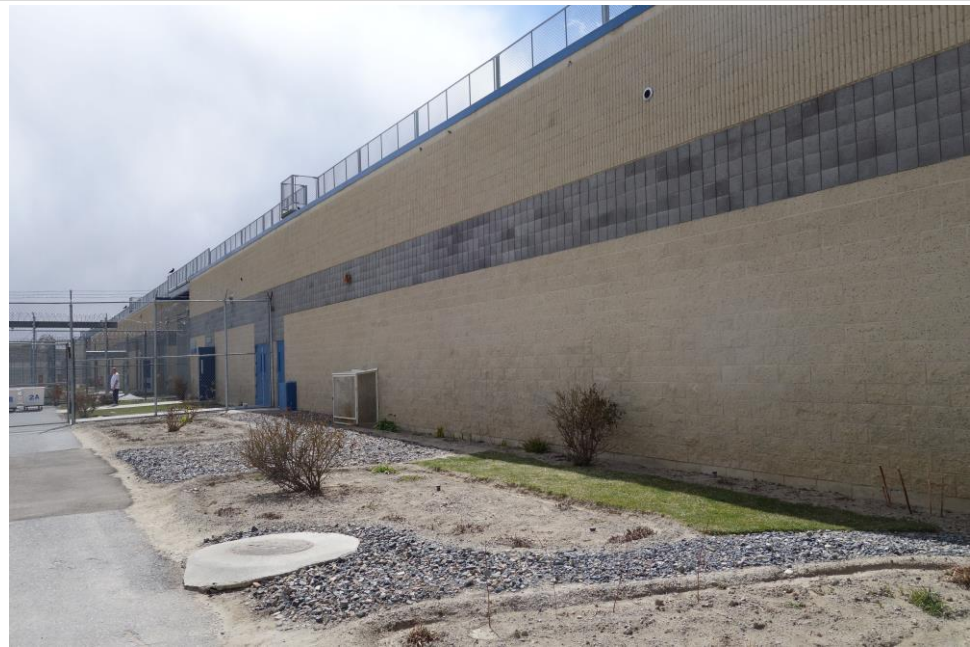
The exterior finishes were in fair condition. It is important to maintain the finish, weather resistance and appearance of the building. This project would provide funding to protect the exterior of the building. Included in the cost are cleaning and sealing the concrete masonry walls, painting the window frames and flashing and caulking the windows, flashing, fixtures and all other penetrations. It is recommended that the building be sealed, painted and caulked in the next 6 - 8 years and that this project be scheduled on a cyclical basis to maintain the integrity of the structure.

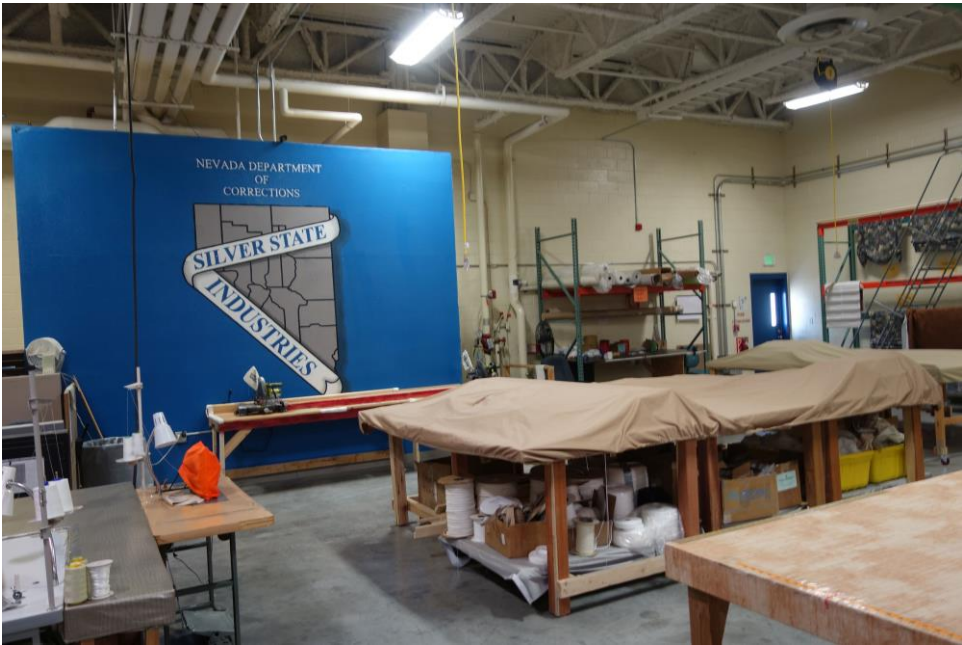
QUANTITY	UNITS	TOTAL	SF COST
The interior finishes are in fair condition. This project would provide funding to maintain the interior of the building. Included in the cost is painting the walls and ceilings, sealing the exposed masonry, repairing cracks in the masonry and replacing grout and caulk as needed. An epoxy-based paint should be utilized in wet areas for durability. It is recommended that the interior of the building be painted, sealed and repaired in the next 6 - 8 years and that this project be scheduled on a cyclical basis to maintain the integrity of the structure.	27000	SF	\$135,000.00	\$ 5.00

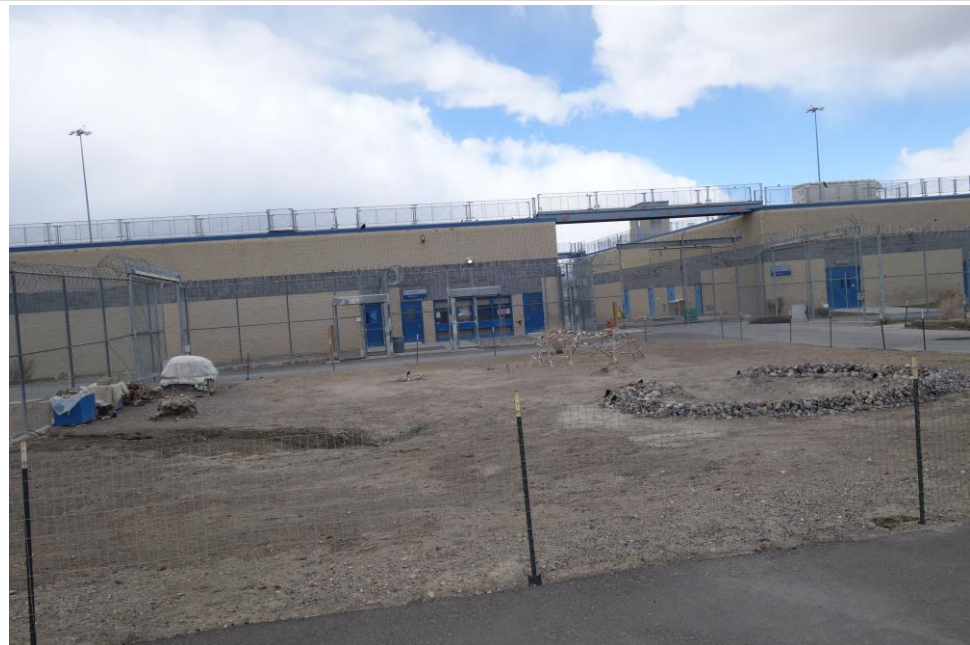
QUANTITY	UNITS	TOTAL	SF COST
The exterior finishes were in fair condition. It is important to maintain the finish, weather resistance and appearance of the building. This project would provide funding to protect the exterior of the building. Included in the cost are cleaning and sealing the concrete masonry walls, painting the window frames and flashing and caulking the windows, flashing, fixtures and all other penetrations. It is recommended that the building be sealed, painted and caulked in the next 6 - 8 years and that this project be scheduled on a cyclical basis to maintain the integrity of the structure.	24700	SF	\$123,500.00	\$ 5.00
