State of Nevada
Department of Conservation & Natural Resources
Division of State Parks

VALLEY OF FIRE STATE PARK SITE

Site Number: 9963
STATE OF NEVADA PUBLIC WORKS DIVISION
FACILITY CONDITION ANALYSIS

Report distributed in November 2021

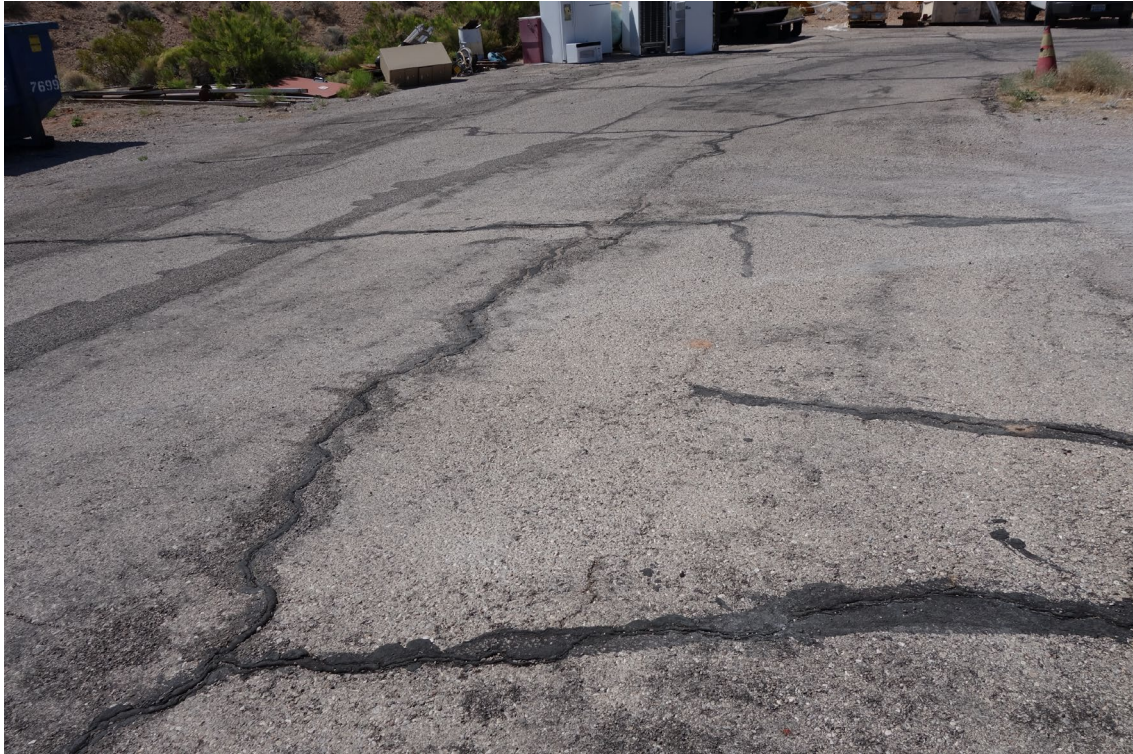
The asphalt paving in the maintenance yard area is failing, with significant alligatoring, settling and cracks observed. This project covers the removal and replacement of the existing asphalt in the maintenance yard up to the access road that NDOT maintains. Striping for safety, parking and loading zones is included in this estimate. 24,000 square feet was used to generate this estimate.

Valley of Fire State Park – FCA Site #9963
Description: Maintenance Area Pavement Replacement Needed.

PRIORITY CLASS 2 PROJECTS**Total Construction Cost for Priority 2 Projects: \$1,371,780****Necessary - Not Yet Critical****Two to Four Years****ASPHALT PAVING REPLACEMENT (MAINTENANCE YARD)****Project Index #: 9963SIT6****Construction Cost \$216,000**

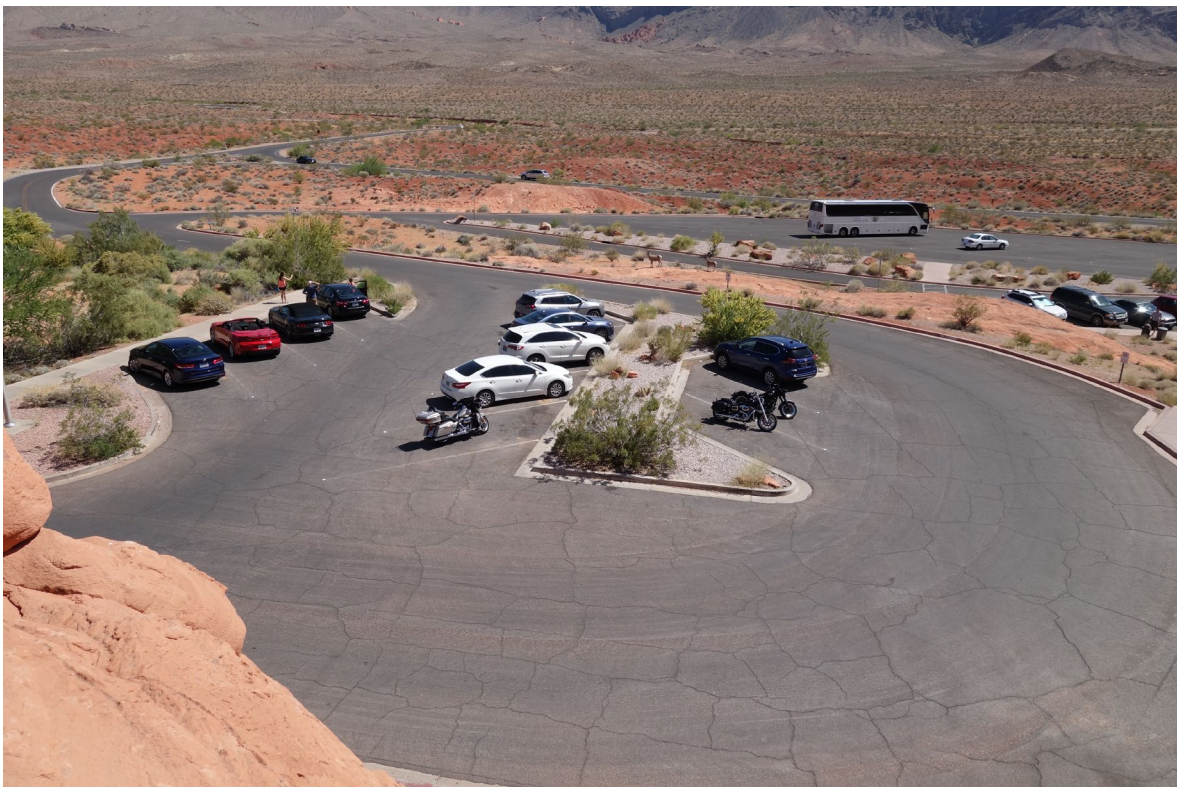
Valley of Fire State Park – FCA Site #9963
Description: Crack Fill & Slurry Seal Asphalt Paving Areas Sitewide.

CRACK FILL & SEAL ASPHALT PAVING**Project Index #: 9963SIT8****Construction Cost \$125,000**

It is important to maintain the asphalt concrete paving on the site. This project would provide for minor crack filling and sealing of the paving site wide including access roads, parking areas in the next 2 -3 years. Striping is included in this estimate. This project should be scheduled on a 5 year cyclical basis to maintain the integrity of the paving and prevent premature failure. 100,000 square feet of asphalt area was used to generate this estimate. It is recommended that this project coincide with the ADA Parking Space project.

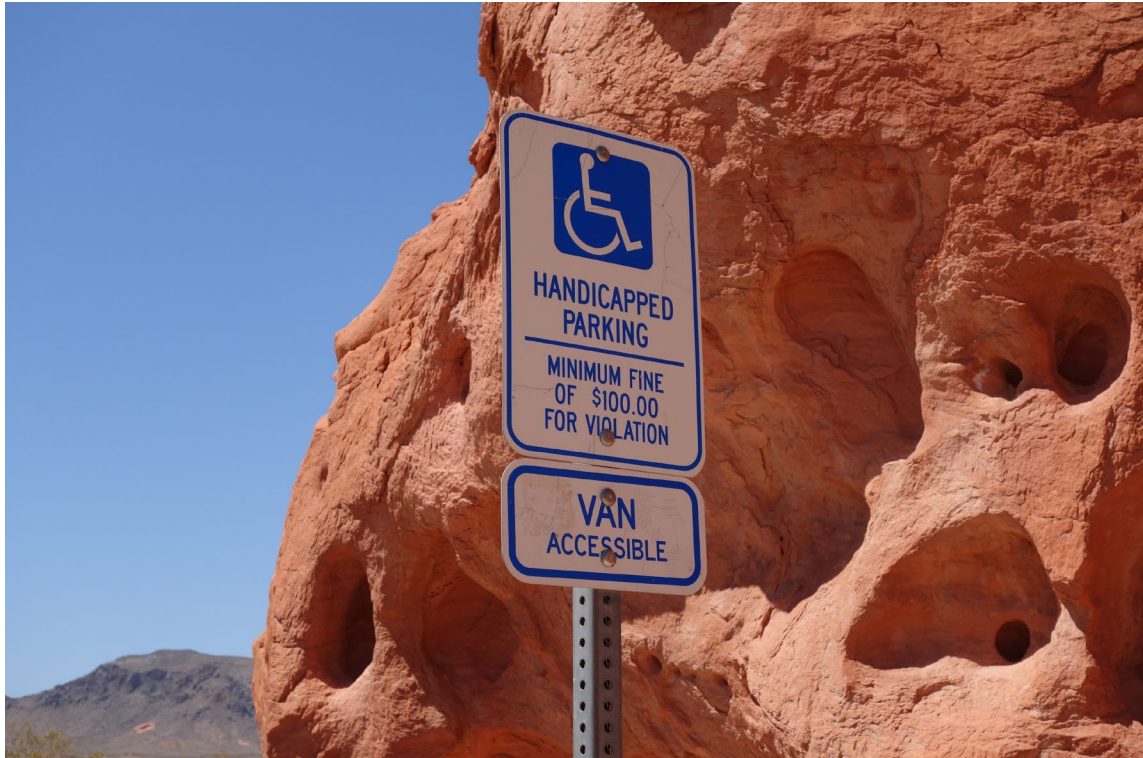
Valley of Fire State Park – FCA Site #9963
Description: Typical ADA Signage Needing Upgrade Sitewide.

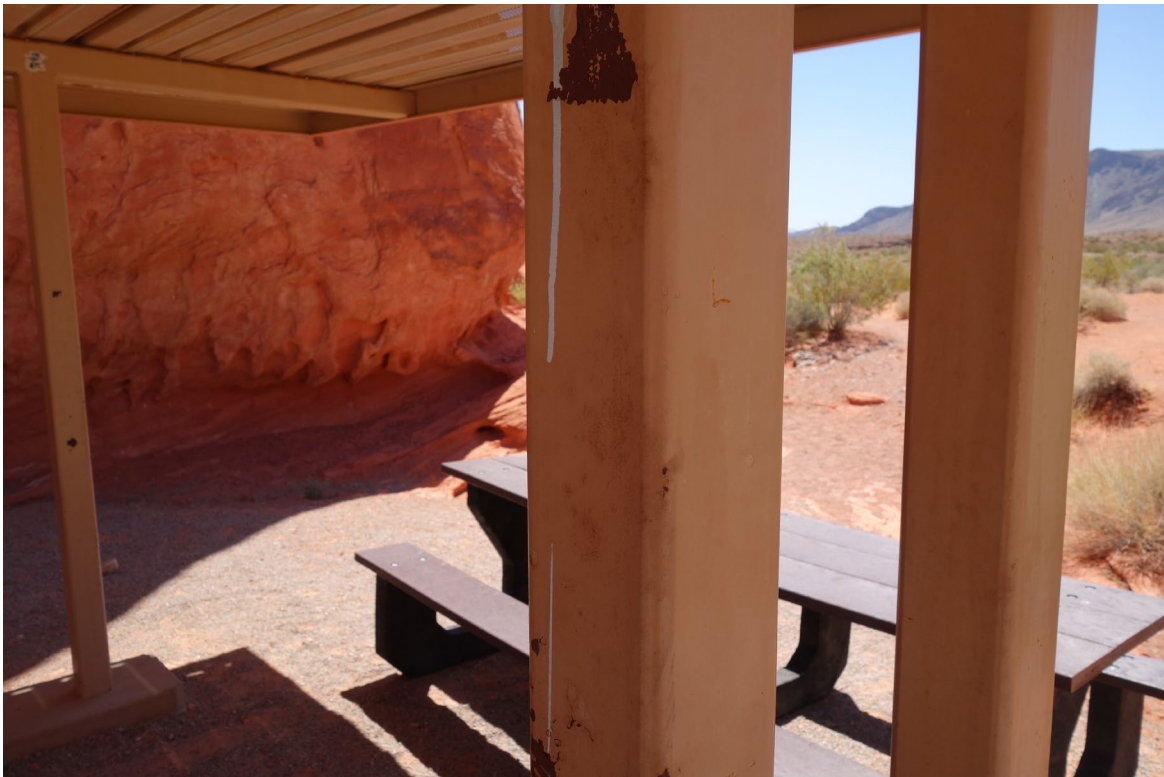
There are 80 steel shade ramadas and 4 steel carports in different locations throughout the site which add up to a total of 28,890 square feet. There are some that need re-painting. It is important to maintain the finish, weather resistance and appearance of the structures. This project would provide for painting of the structures and it is recommended that this project be scheduled on a cyclical basis to maintain the integrity of the structures.

Valley of Fire State Park – FCA Site #9963
Description: Older Shade Ramadas Need Refinishing.

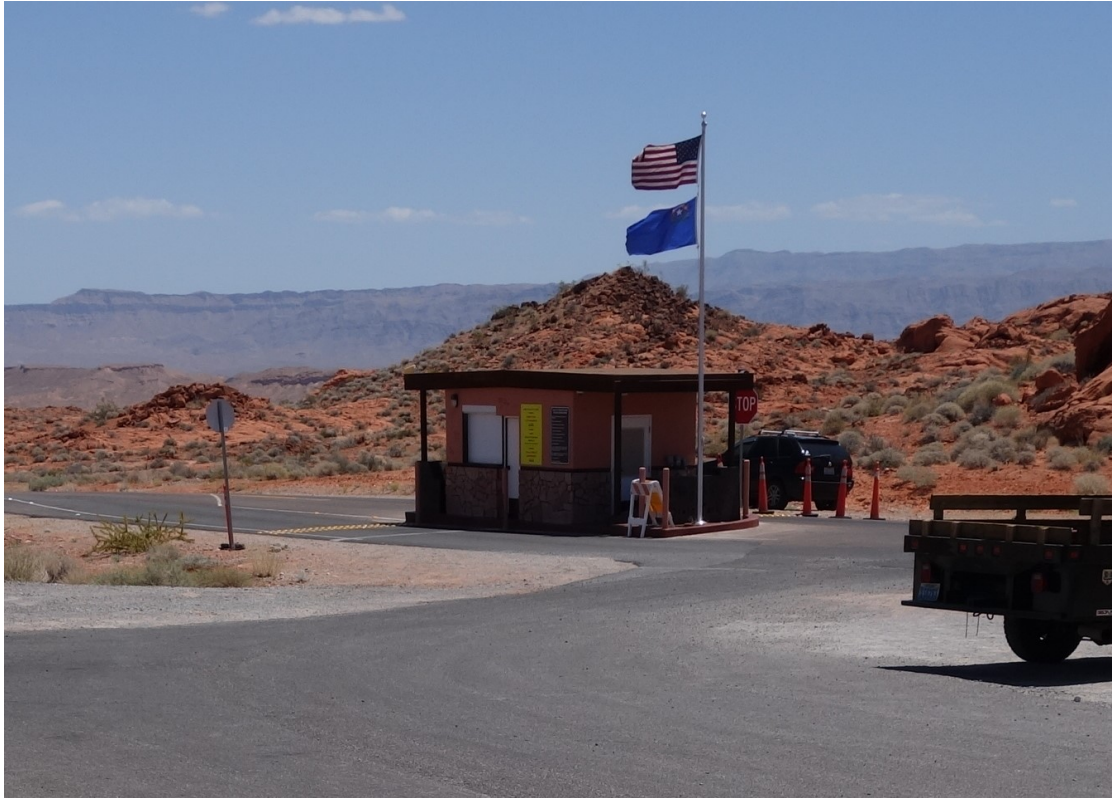
East Entrance Fee Booth – FCA Building #3811
Description: Exterior of the Building.

The exterior finishes are in good condition. It is important to maintain the finish, weather resistance and appearance of the building. This project would provide funding to protect the exterior of the building excluding the roof. Included in the cost are cleaning and sealing the concrete masonry units, painting the metal panels and caulking of the windows, flashing, fixtures and all other penetrations. It is recommended that the building be sealed, painted and caulked in the next 7 - 9 years and that this project be scheduled on a cyclical basis to maintain the integrity of the structure.

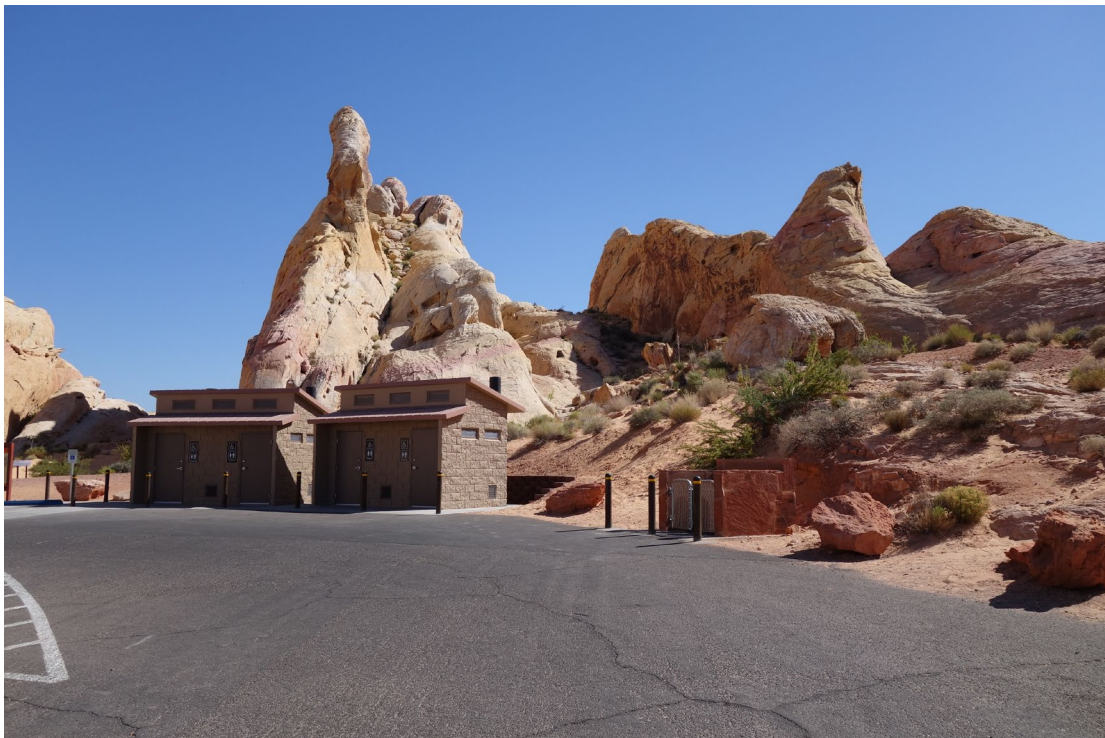
White Dome Comfort Station – FCA Building #3154
Description: Exterior of the Building.

The exterior finishes are in good condition. It is important to maintain the finish, weather resistance and appearance of the building. This project would provide funding to protect the exterior of the building excluding the roof. Included in the cost are cleaning and sealing the brick masonry and caulking of the windows, flashing, fixtures and all other penetrations. It is recommended that the building be sealed and caulked in the next 7 - 9 years and that this project be scheduled on a cyclical basis to maintain the integrity of the structure.

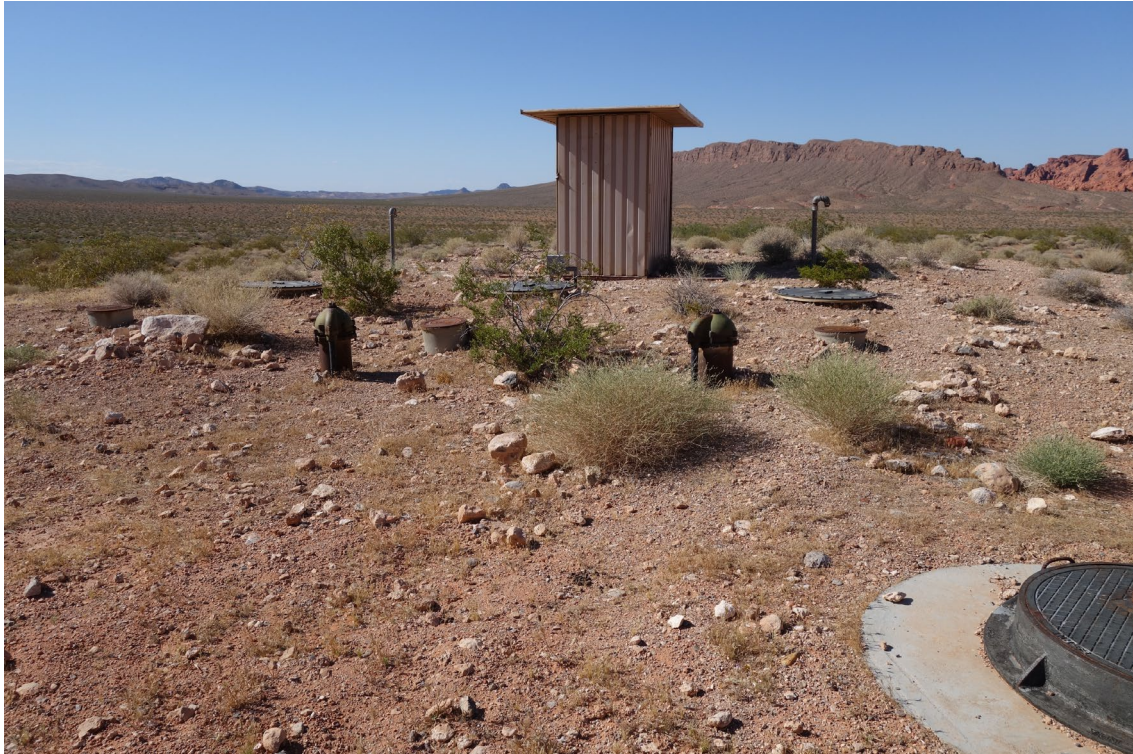
Water Treatment Shed – FCA Building #3153
Description: Exterior of the Building.

The existing automatic chlorine injection system in the building is older and the State Health Department has recommended an upgrade to the system. Poor production from the system causes wear and tear on the domestic water supply lines, plumbing fixtures and HVAC equipment. This project would provide for the replacement of the existing system with new equipment. This project would also provide for a chemical treatment program including an updated chemicals control system, service and employee training provided by a qualified water treatment vendor. The annual maintenance fee charged by the water treatment vendor would be determined after an investigation of the water system is complete. These annual costs are not included in this project cost. For budgeting purposes, a \$12,000 fee is suggested. This project or a portion thereof was previously recommended in the FCA report dated 10/16/2012. It has been amended accordingly to reflect conditions observed during the most recent survey date of 05/23/2018.

The exterior finishes are in fair condition. It is important to maintain the finish, weather resistance and appearance of the building. This project would provide funding to protect the exterior of the building excluding the roof. Included in the cost is the caulking and sealing of the flashing, fixtures and all other penetrations. It is recommended that the building be caulked and sealed in the next 4 - 5 years and that this project be scheduled on a cyclical basis to maintain the integrity of the structure.

PRIORITY CLASS 2 PROJECTS**Total Construction Cost for Priority 2 Projects: \$24,600****Necessary - Not Yet Critical****Two to Four Years****Project Index #: 3153PLM1****Construction Cost \$24,600****WATER TREATMENT SYSTEM REPLACEMENT**

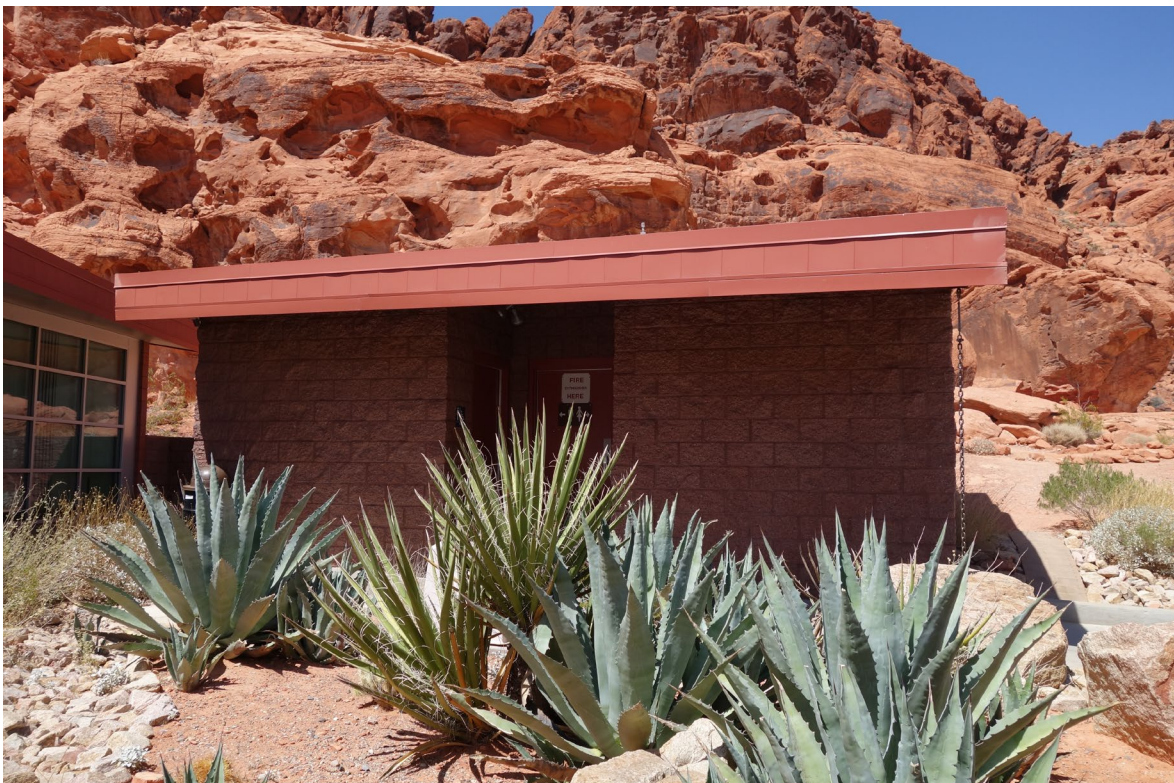
Visitors Center Comfort Station – FCA Building #3152
Description: Exterior of the Building.

The exterior finishes are in good condition. It is important to maintain the finish, weather resistance and appearance of the building. This project would provide funding to protect the exterior of the building excluding the roof. Included in the cost are cleaning and sealing the concrete masonry units, painting the metal trim and caulking of the windows, flashing, fixtures and all other penetrations. It is recommended that the building be sealed and caulked in the next 7 - 9 years and that this project be scheduled on a cyclical basis to maintain the integrity of the structure.

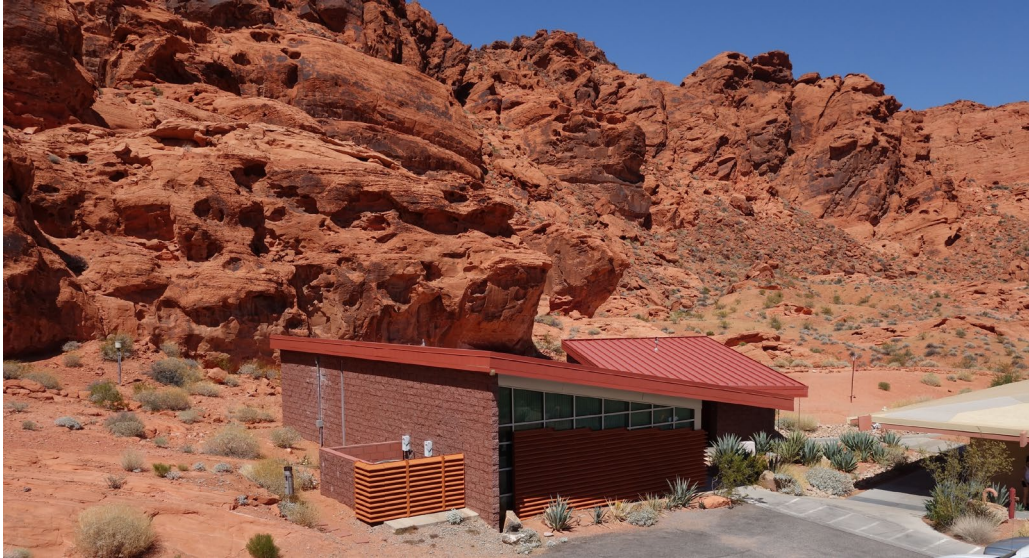
VOF Administration Building – FCA Building #3151
Description: Exterior of the Building.

The exterior finishes are in good condition. It is important to maintain the finish, weather resistance and appearance of the building. This project would provide funding to protect the exterior of the building excluding the roof. Included in the cost are cleaning and sealing the concrete masonry units, painting the metal trim and caulking of the windows, flashing, fixtures and all other penetrations. It is recommended that the building be sealed and caulked in the next 7 - 9 years and that this project be scheduled on a cyclical basis to maintain the integrity of the structure.

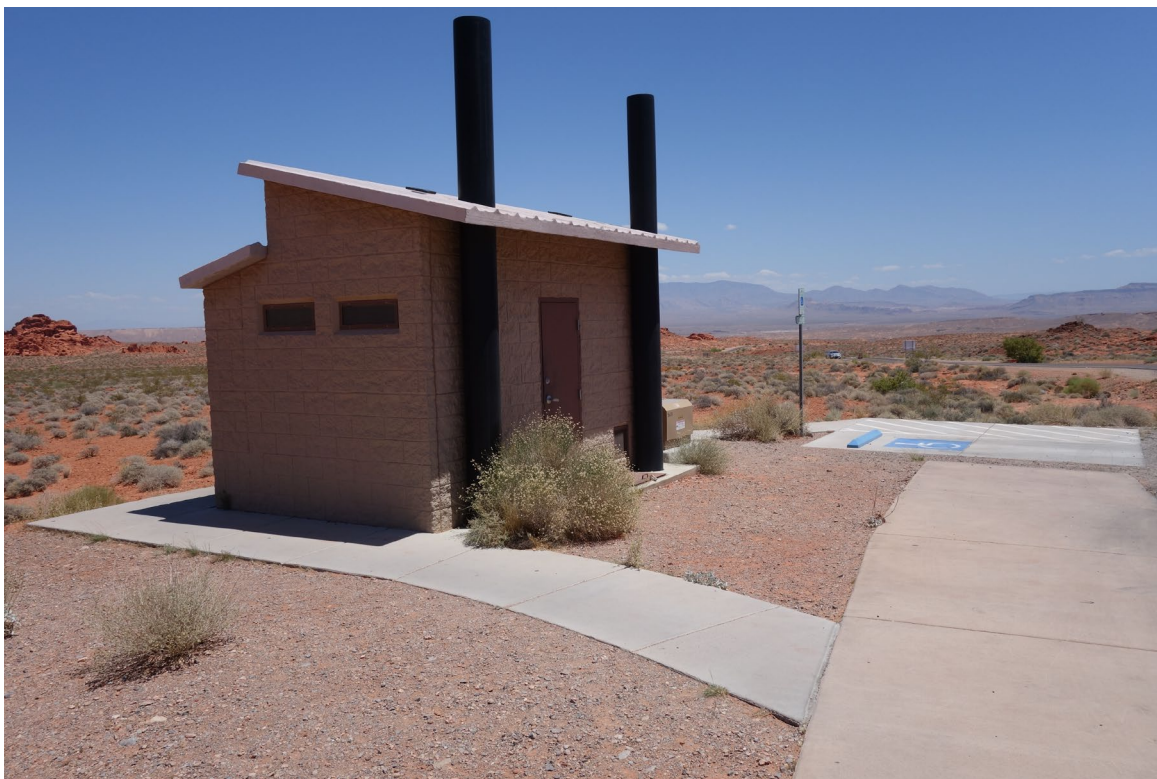
East Entrance SST Comfort Station – FCA Building #2899
Description: Exterior of the Building.

The interior finishes are in poor condition. It is important to maintain the finish, weather resistance and appearance of the building. This project would provide funding to protect the interior and exterior of the building. Included in the cost are cleaning and sealing the precast concrete and caulking of the windows, flashing, fixtures and all other penetrations. An epoxy paint is recommended on the interior precast concrete. It is recommended that the building be sealed and caulked in the next 4-5 years and that this project be scheduled on a cyclical basis to maintain the integrity of the structure.

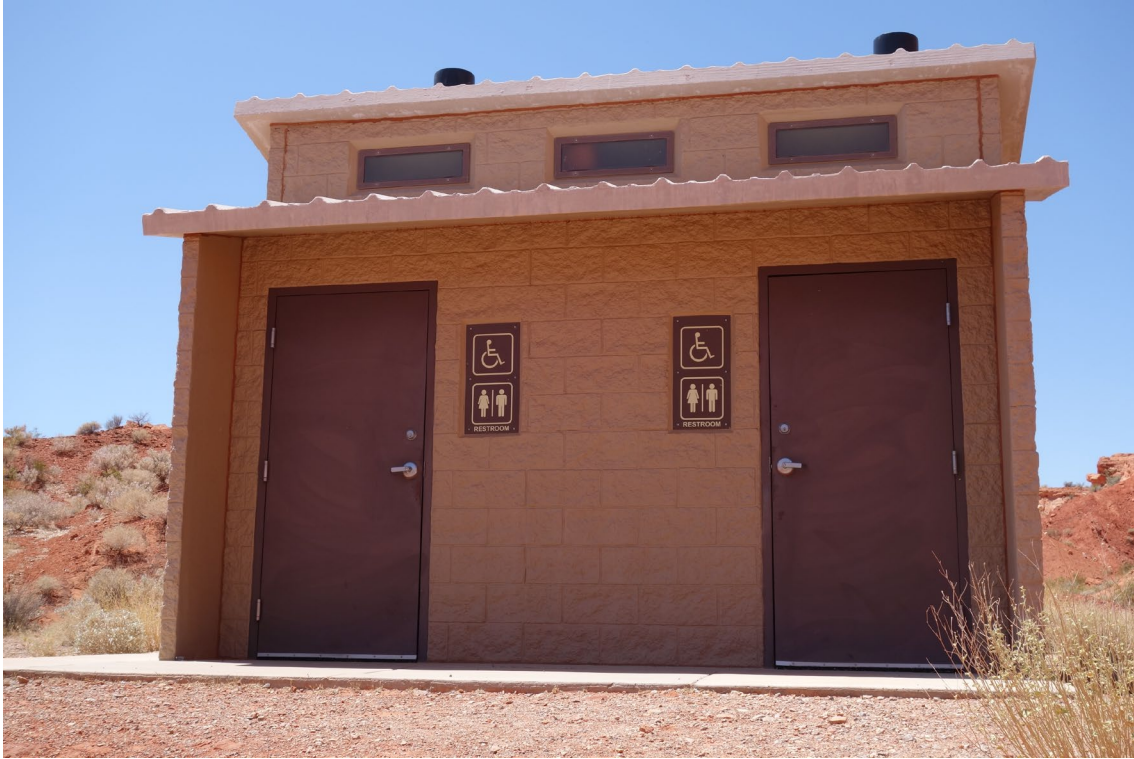
Cabins SST Comfort Station – FCA Building #2898
Description: Exterior of the Building.

The interior finishes were in fair condition. It is important to maintain the finish, weather resistance and appearance of the building. This project would provide funding to protect the interior and exterior of the building. Included in the cost are cleaning and sealing the precast concrete and caulking of the windows, flashing, fixtures and all other penetrations. An epoxy paint is recommended on the interior precast concrete. It is recommended that the building be sealed and caulked in the next 4 - 5 years and that this project be scheduled on a cyclical basis to maintain the integrity of the structure.

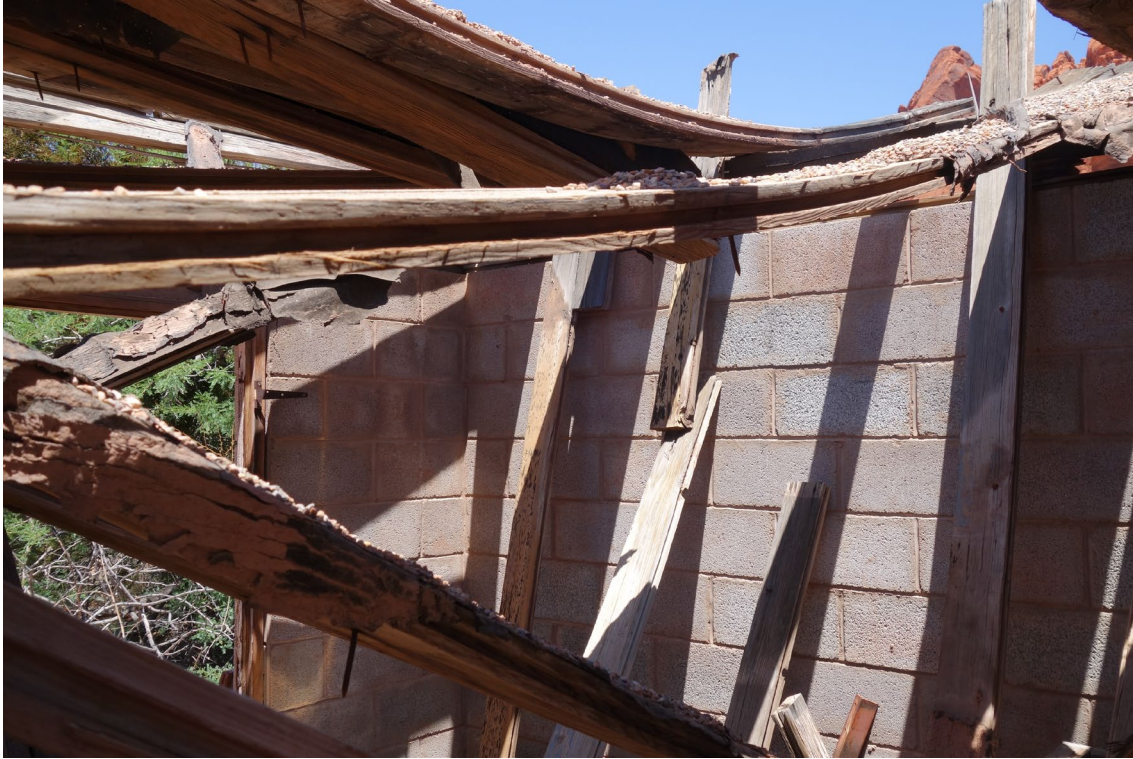
VOF Storage #2 – FCA Building #0557
Description: Interior of the Building – Recommend Demolishing.
