STATE OF NEVADA
STATE PUBLIC WORKS DIVISION

FACILITY CONDITION ASSESSMENT REPORT FOR:

DEPT OF TOURISM & CULTURAL AFFAIRS
MUSEUMS & HISTORY
MUSEUMS
LOSTCITY

Survey Date: 2/7/2023
Distribution Date: 8/15/2023

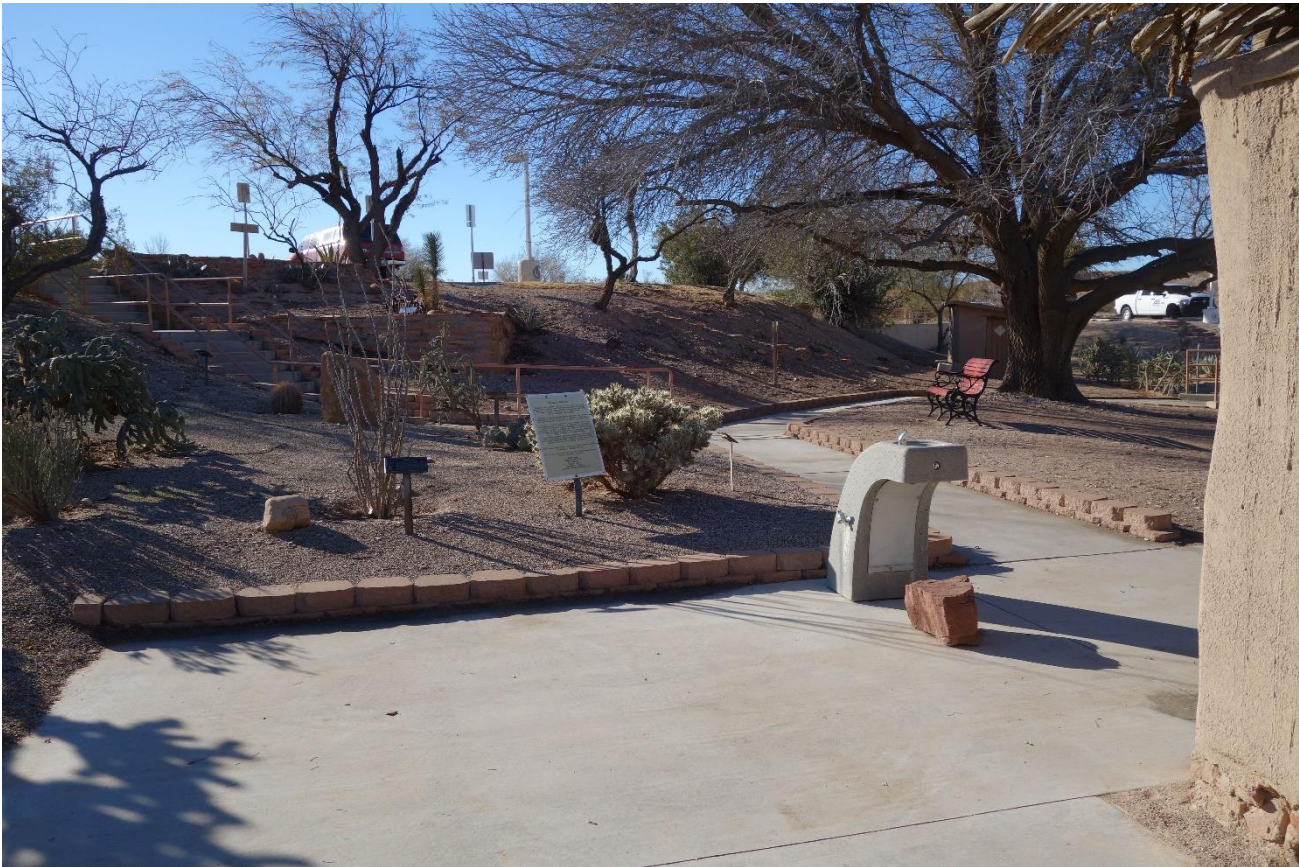
9964 LOST CITY MUSEUM SITE
PROJECT ID: 9964-ADA-2
CONST COST: \$7,500

The Picnic Area contains a water fountain that is not ADA compliant. The 2018 IBC Section 1109.5 states where drinking fountains are provided on an exterior site, on a floor or within a secured area, no fewer than two drinking fountains shall be provided. One shall comply with the requirements for people who use a wheelchair and one shall comply with the requirements for standing people. This project would provide funding for the purchase and installation of a second drinking fountain to meet ADA requirements.

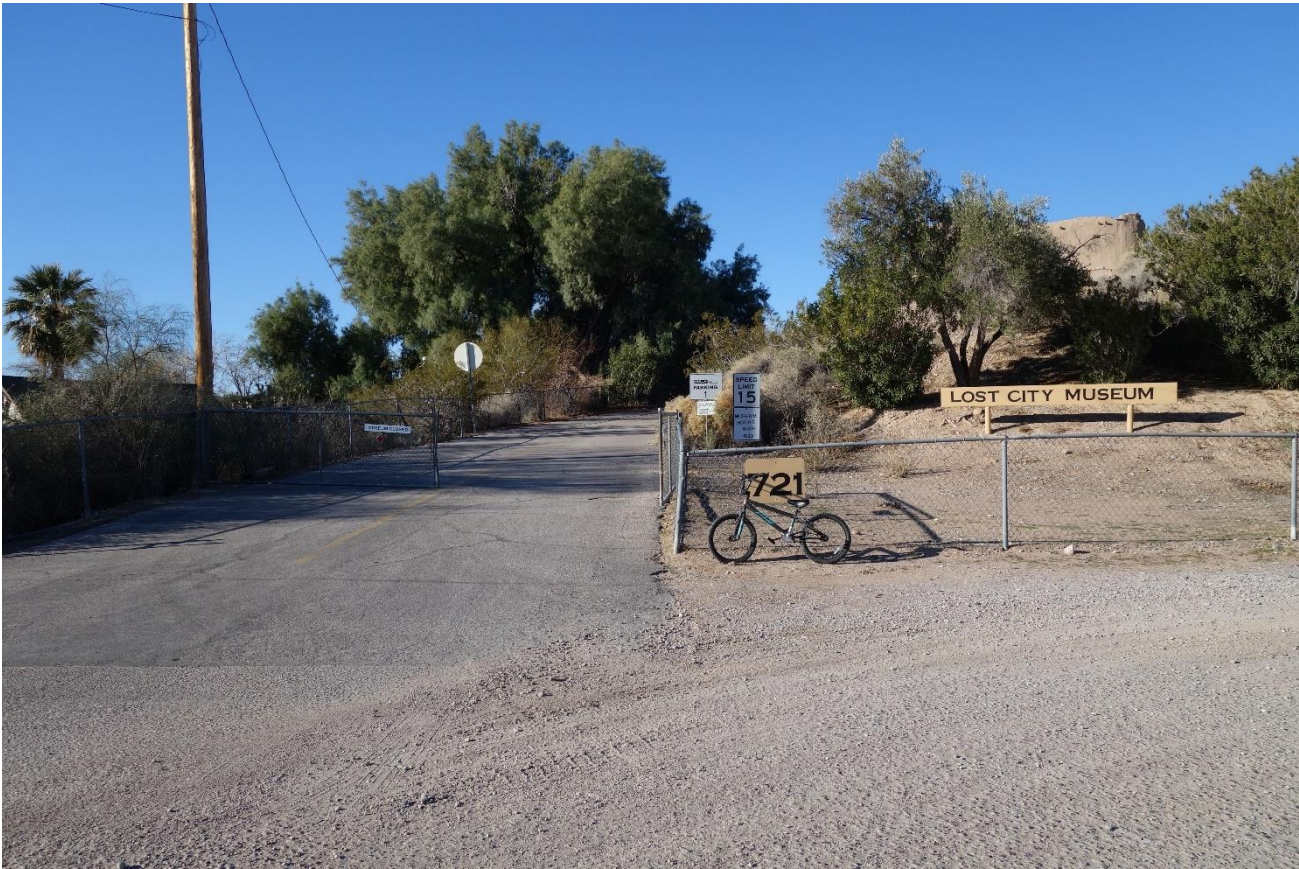
9964 LOST CITY MUSEUM SITE
PROJECT ID: 9964-SIT-5
CONST COST: \$133,000

The site entry gate is a failing chain link manual gate with a chain and padlock. It is unsightly and does not give a positive first impression of the museum and grounds. This project would provide for the design and installation of a powered entry gate. Included in this project are trenching, access control, power and communication.

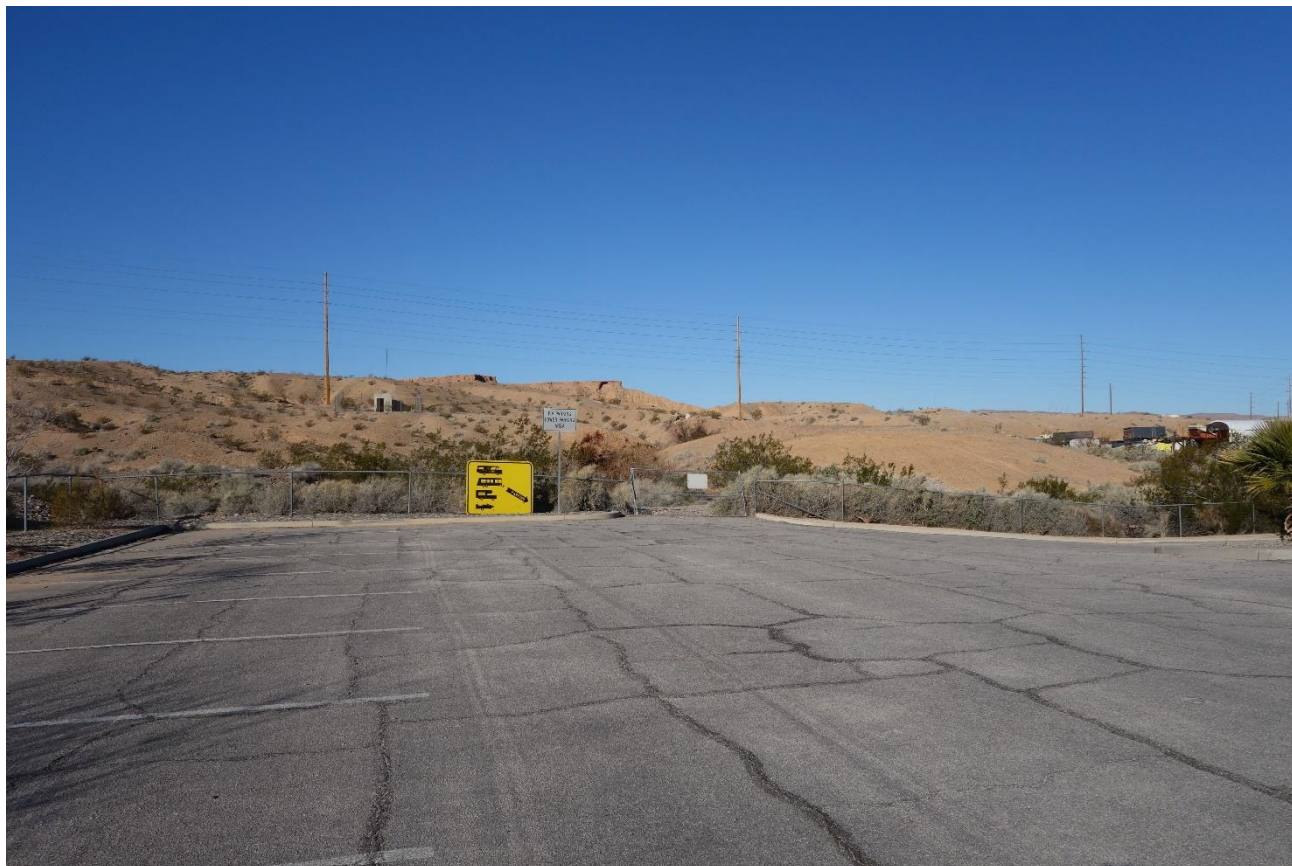
9964 LOST CITY MUSEUM SITE
PROJECT ID: 9964-SEC-1
CONST COST: \$221,400

The site has minimal site lighting in the parking lots and between the buildings, which is a security and safety concern. This project would provide for the installation of 16 LED light poles with concrete bases and upgrade the existing site lighting fixtures to LED. Trenching and electrical are included in this project. This project or a portion thereof was previously recommended in the FCA report dated 11/04/2009 and 01/29/2014. It has been amended accordingly to reflect conditions observed during the most recent survey date of 02/07/2023.

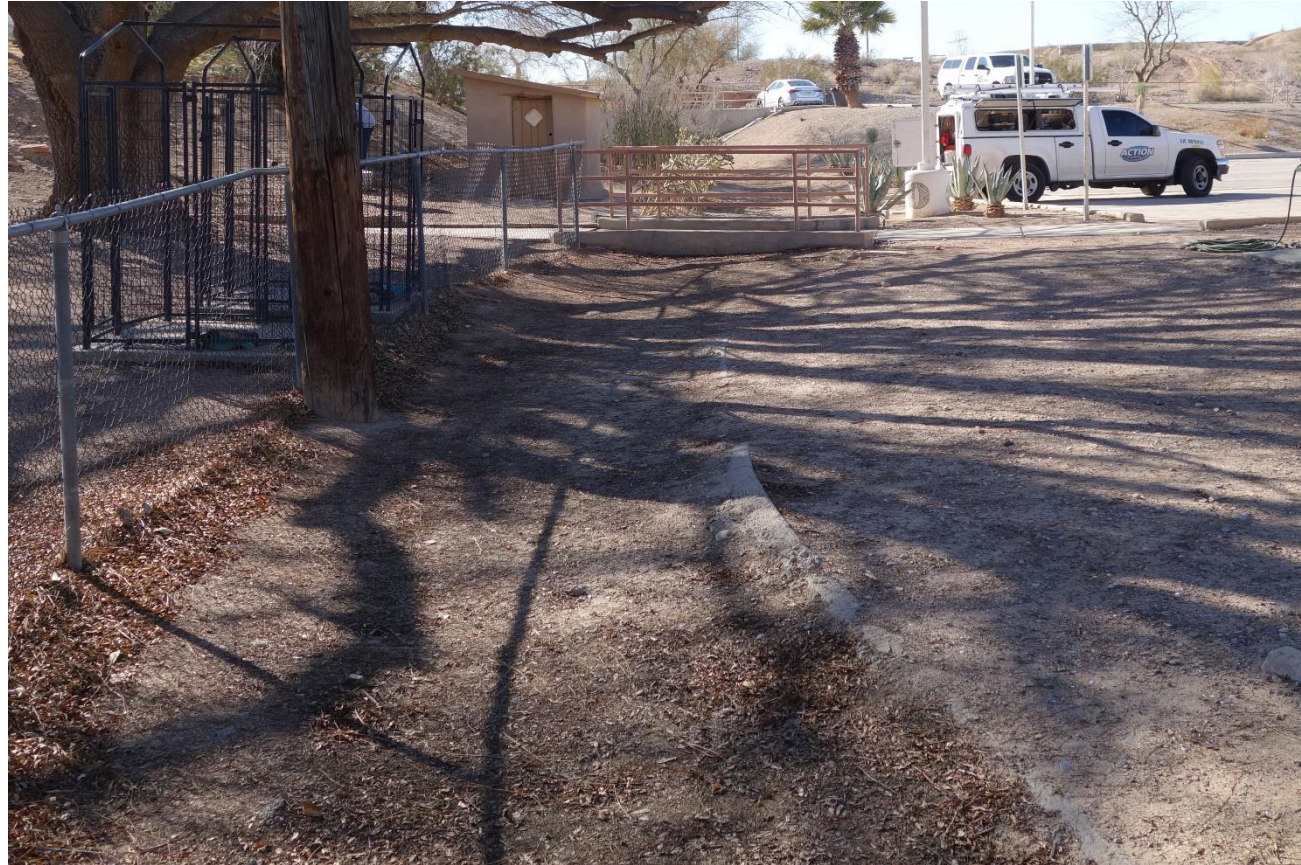
9964 LOST CITY MUSEUM SITE
PROJECT ID: 9964-SIT-6
CONST COST: \$719,400

The site has a drainage problem on the north side of the site between the lower parking lot and the Museum. Site drainage from the lower parking lot was historically directed towards a Muddy Valley Irrigation Company (MVIC) irrigation ditch that crosses the property and which satisfactorily drained property for several decades. In 2017, the MVIC replaced the open water ditch with a water pipeline and filled in the irrigation ditch. Filling the ditch has caused flooding in the Workshop and Storage buildings during heavy rain events. This project scope follows the estimate created in 2021 under CIP project 21203. Included in this scope is regrade & replace the lower parking lot, adjust drainage grades around the Workshop and Storage buildings, construct retention basin, install storm drain and miscellaneous site and landscape repairs.

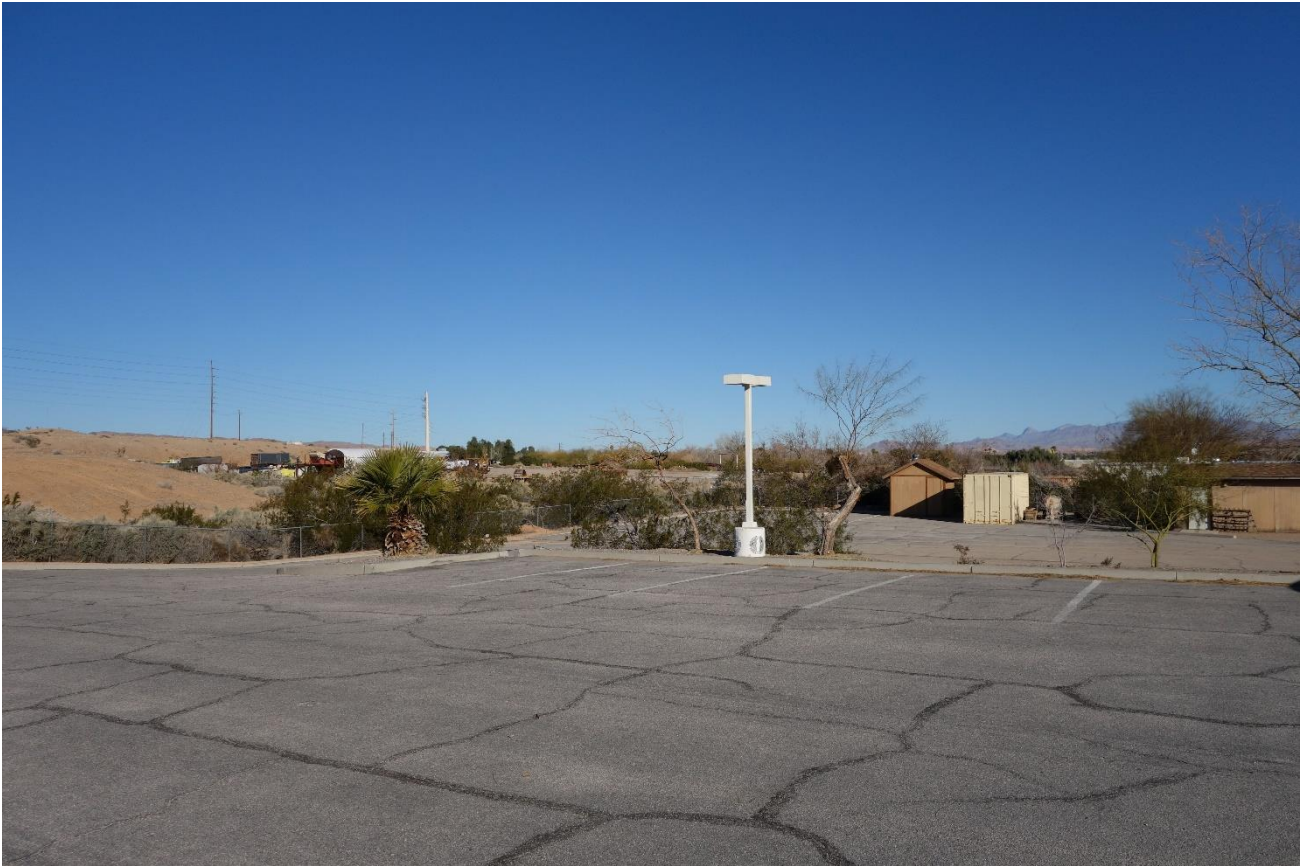
9964 **LOST CITY MUSEUM SITE**
PROJECT ID: **9964-SIT-1**
CONST COST: **\$42,000**

It is important to maintain the asphalt concrete paving on the site. This project would provide for minor crack filling and slurry sealing of the paving site wide including access roads and parking areas. Striping is included in this estimate. This project should be scheduled on a 5-year cyclical basis to maintain the integrity of the paving and prevent premature failure. 41,156 square feet of asphalt area was used to generate this estimate.

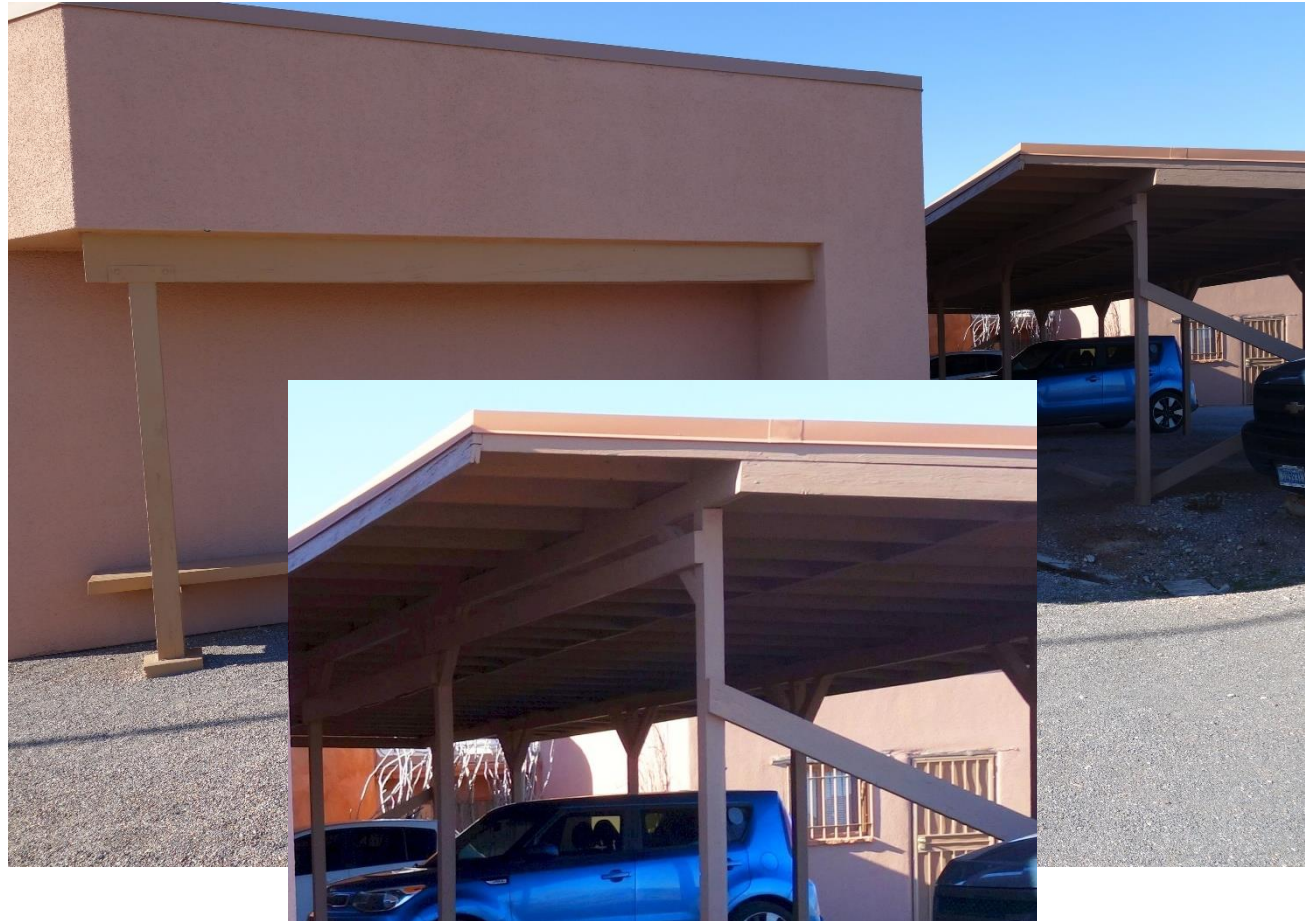
3032 MUSEUM CARPORT
PROJECT ID: 3032-EXT-1
CONST COST: \$5,000

The exterior finishes are in good condition. It is important to maintain the finish, weather resistance and appearance of the structure. This project would provide for painting of the structure, and it is recommended that this project is scheduled on a cyclical basis to maintain the integrity of the structure.

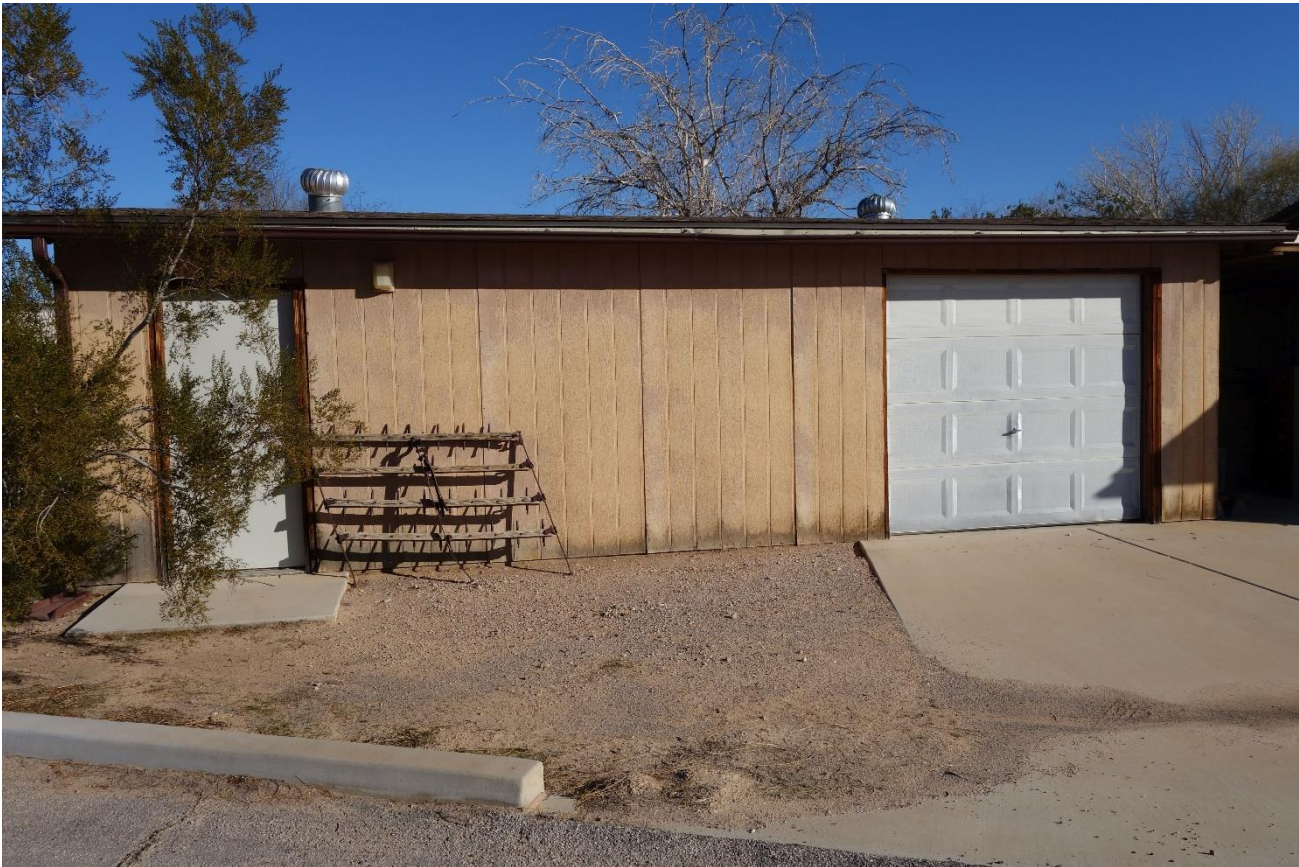
0974 **LOST CITY STORAGE BUILDING**
PROJECT ID: **0974-EXT-1**
CONST COST: **\$11,600**

The exterior finishes were in poor condition. It is important to maintain the finish, weather resistance and appearance of the building. This project would provide funding to protect the exterior of the building excluding the roof. Included in the cost is sanding, priming and painting and caulking of the windows, flashing, fixtures and all other penetrations. It is recommended that the building be painted in the next 2 - 4 years and that this project is scheduled on a cyclical basis to maintain the integrity of the structure.

This project should be implemented concurrently with the Exterior Siding Replacement project.

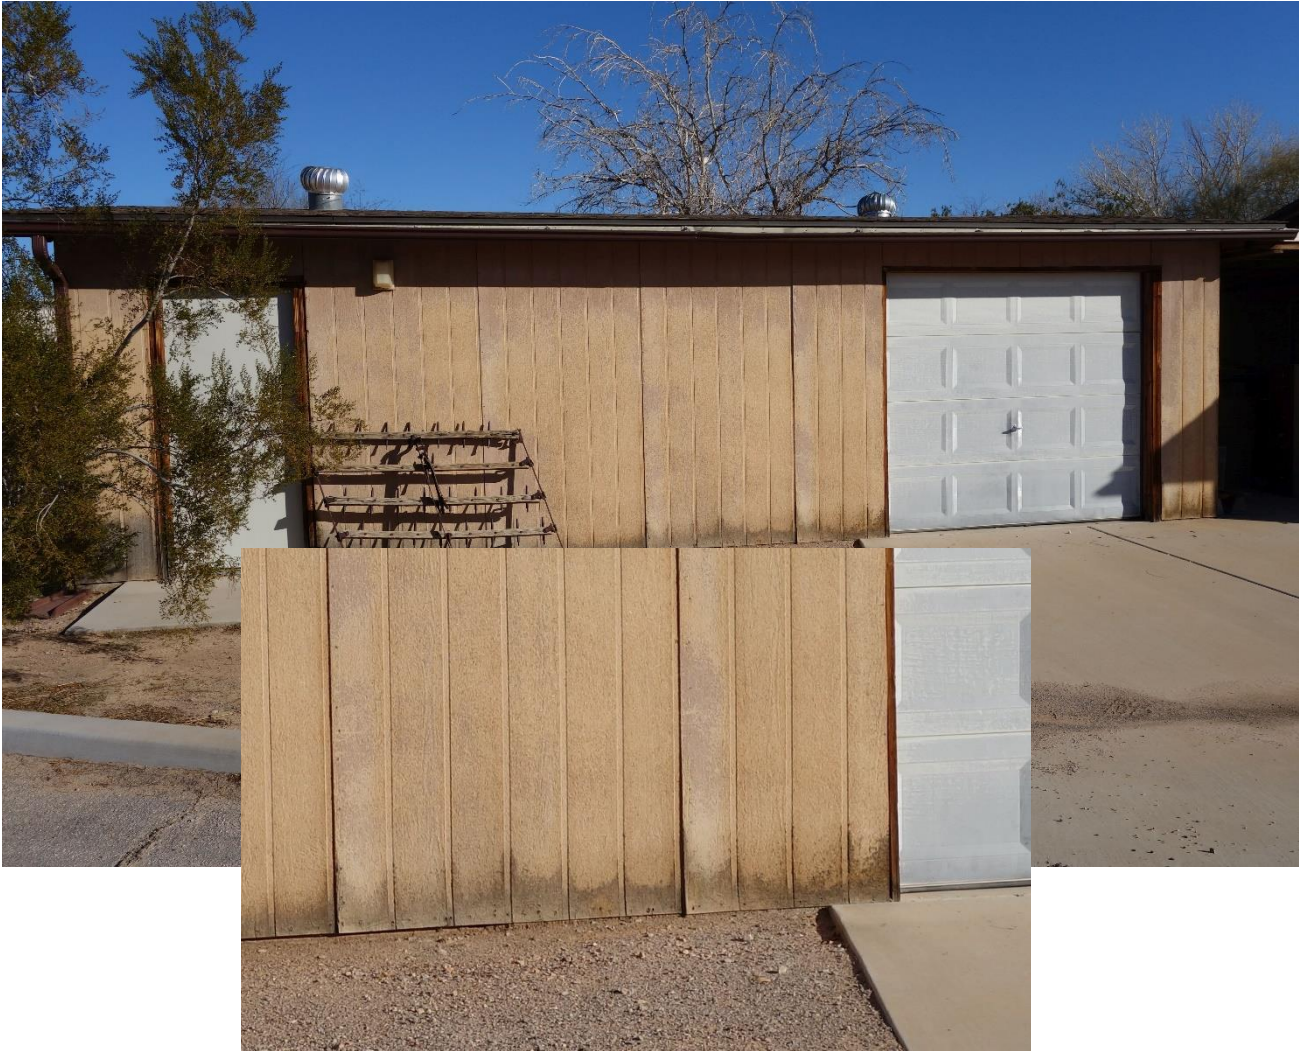
0974 **LOST CITY STORAGE BUILDING**
PROJECT ID: **0974-EXT-3**
CONST COST: **\$23,200**

The building has a painted masonite siding that is due for replacement. The existing siding is in poor condition and will no longer hold paint. This project recommends removing the masonite siding and replacing it with T1-11 panels finished with an oil-based stain.

This project should be implemented concurrently with the Exterior Finishes project. This project or a portion thereof was previously recommended in the FCA report dated 11/04/2009 and 01/29/2014. It has been amended accordingly to reflect conditions observed during the most recent survey date of 02/07/2023.

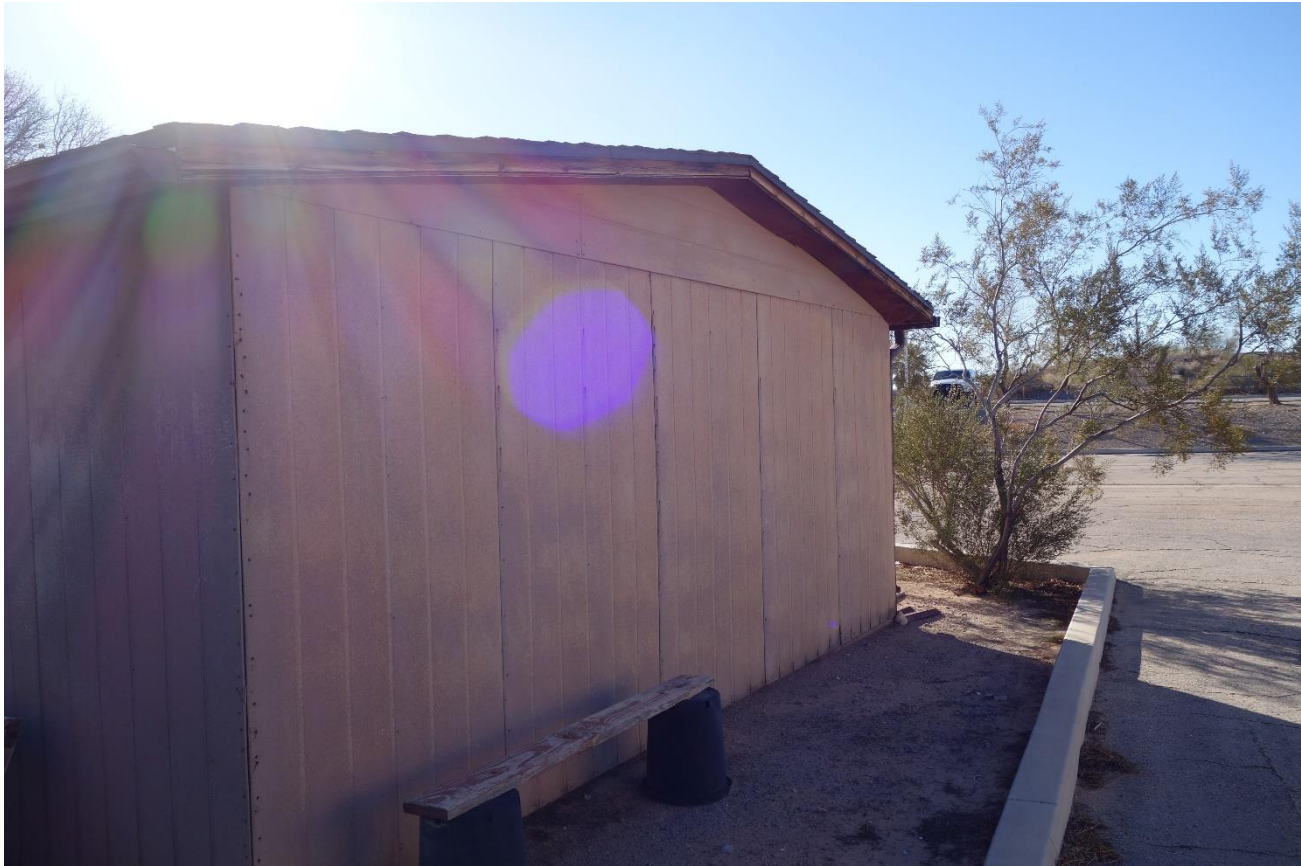
0974 LOST CITY STORAGE BUILDING
PROJECT ID: 0974-SIT-1
CONST COST: \$15,000

There are continuous locations on the building perimeter where soils are in contact with wood and siding materials. 2018 IBC Section 2304.12 Protection Against Decay and Termites requires a minimum of 8" clearance between the earth and wood structural members. This project provides for the removal of excess soil and to provide the required soil clearances.

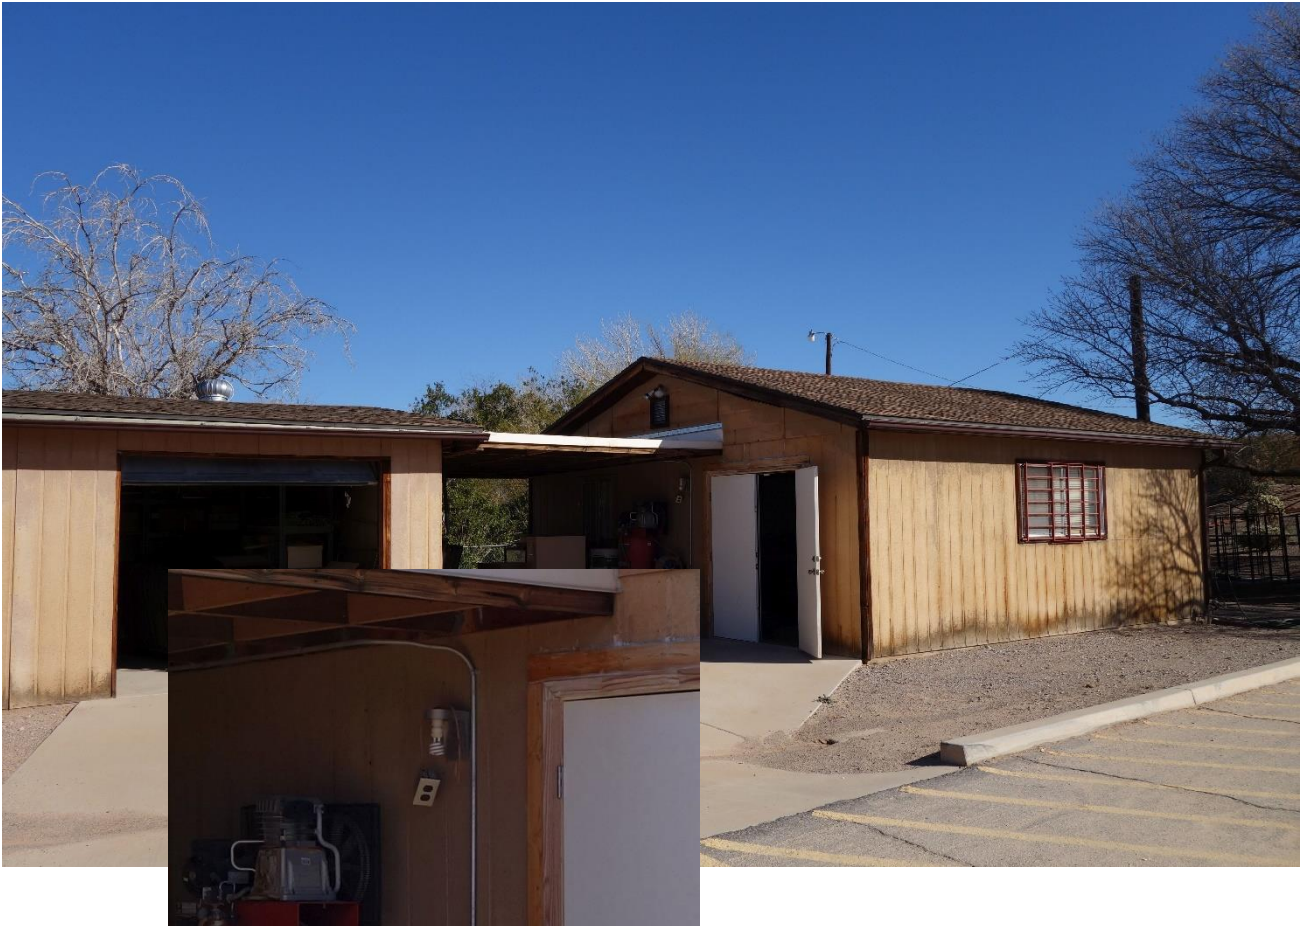
The wiring in the breezeway between the Workshop and Storage building has exposed non-metallic sheathed (NM or tradename Romex) wiring. This creates a safety issue. This project would provide for replacing the exposed electrical wiring with an alternate wiring method compliant with NEC 2017.

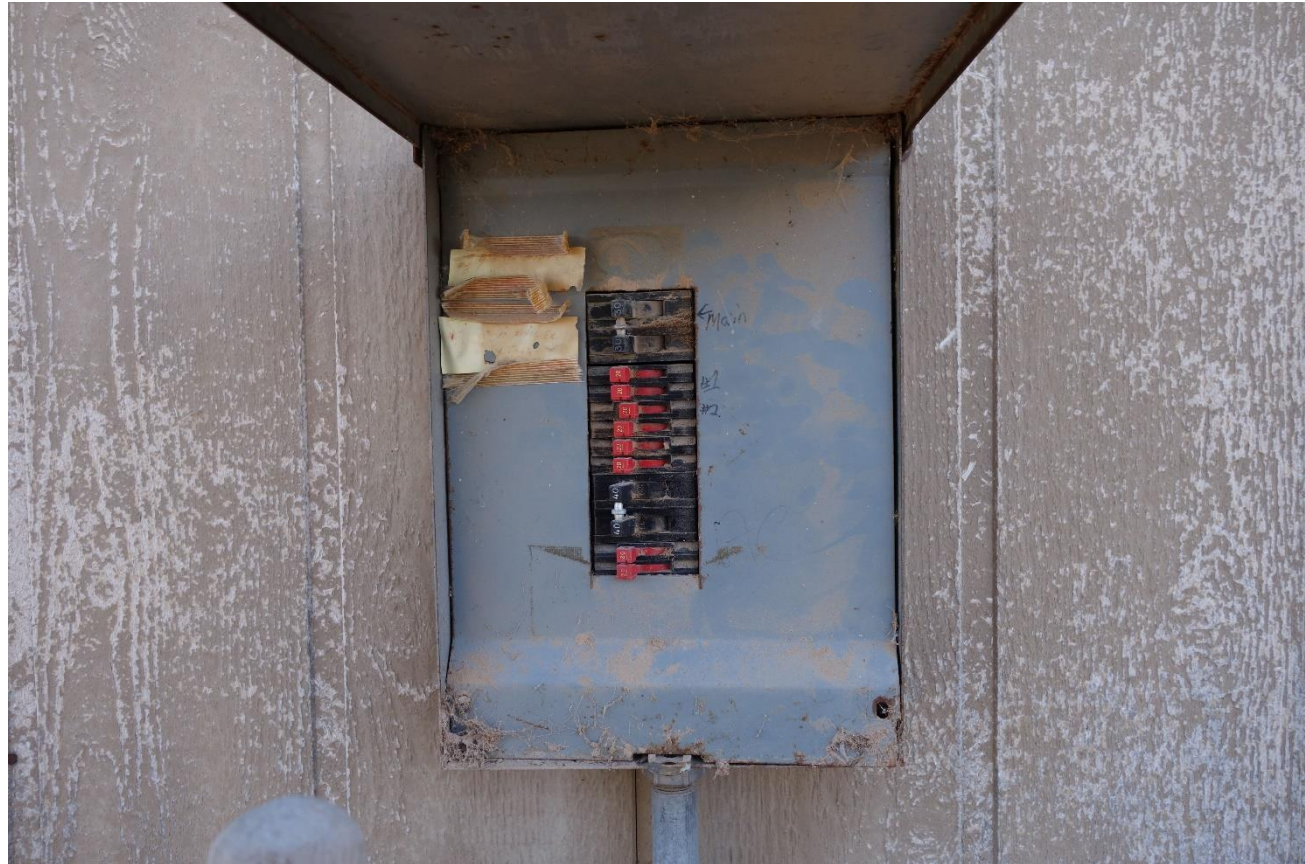
The electrical panel at this facility is recognized as a potential hazard. Sylvania Zinsco and Federal Pacific Stab-Loc panels were part of a recall and should be replaced. This project would provide funding for the removal and replacement of the Zinsco electrical panel.

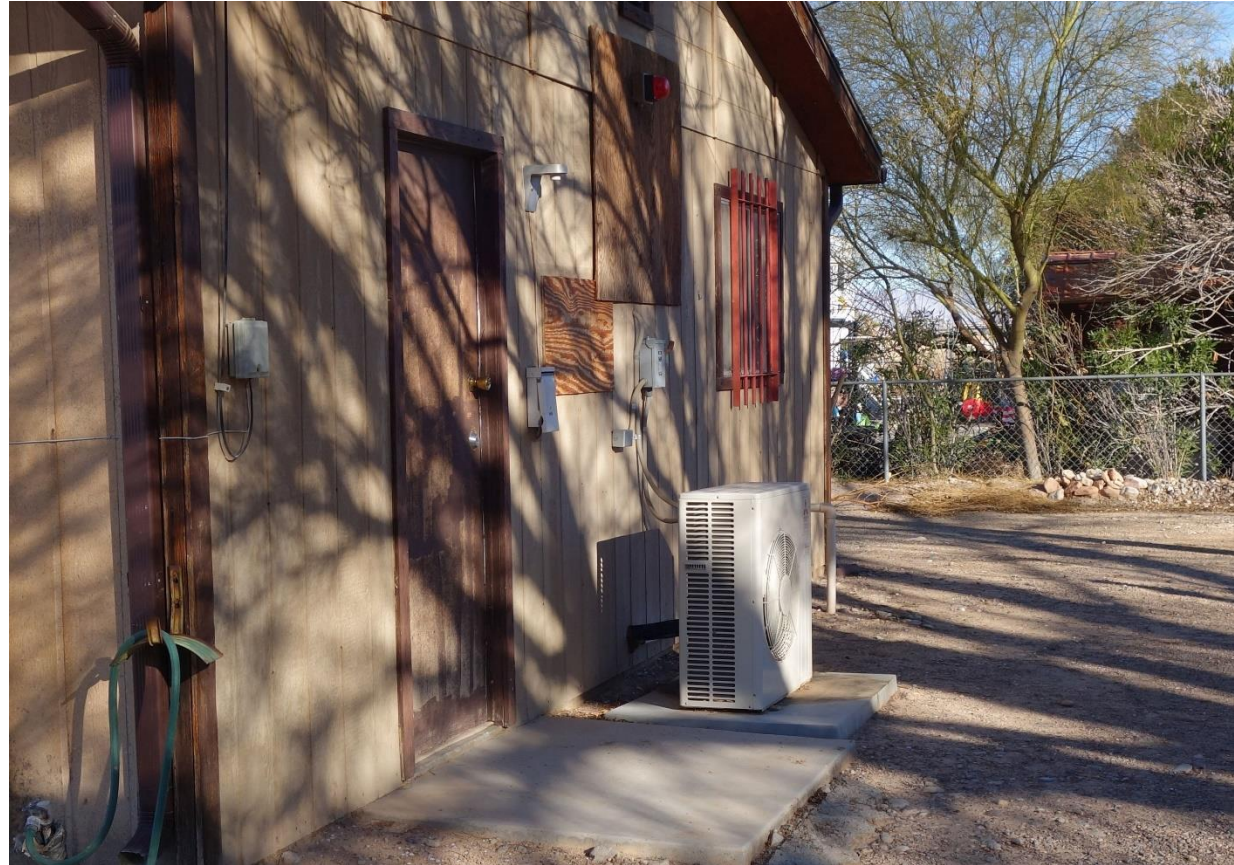
0973 LOST CITY MUSEUM WORKSHOP
PROJECT ID: 0973-EXT-4
CONST COST: \$2,500

One of the two exterior wood man doors appear to be original to the building. They are damaged from age and general wear and tear. This project would provide for the replacement of the wood doors with new metal doors, frames and hardware. Removal and disposal of the existing doors and painting of the new doors is included in this estimate. This project or a portion thereof was previously recommended in the FCA reports dated 01/29/2023. It has been amended accordingly to reflect conditions observed during the most recent survey date of 02/07/2023.

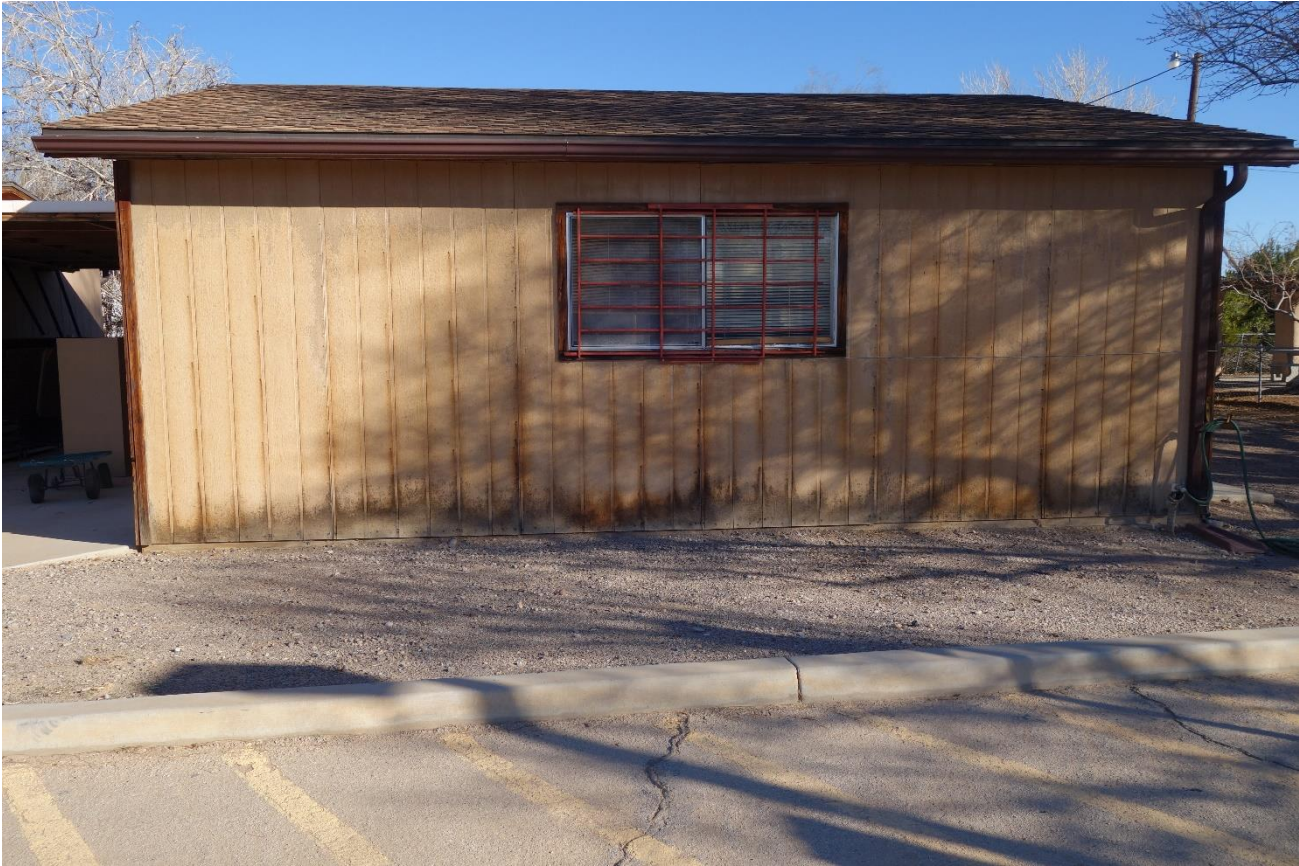
0973 **LOST CITY MUSEUM WORKSHOP**
PROJECT ID: **0973-EXT-1**
CONST COST: **\$11,600**

The exterior finishes were in very poor condition. It is important to maintain the finish, weather resistance and appearance of the building. This project would provide funding to protect the exterior of the building excluding the roof. Included in the cost is sanding, priming and painting and caulking of the windows, flashing, fixtures and all other penetrations. It is recommended that the building be painted in the next 2 - 4 years and that this project is scheduled on a cyclical basis to maintain the integrity of the structure.

This project should be implemented concurrently with the Exterior Siding Replacement project.

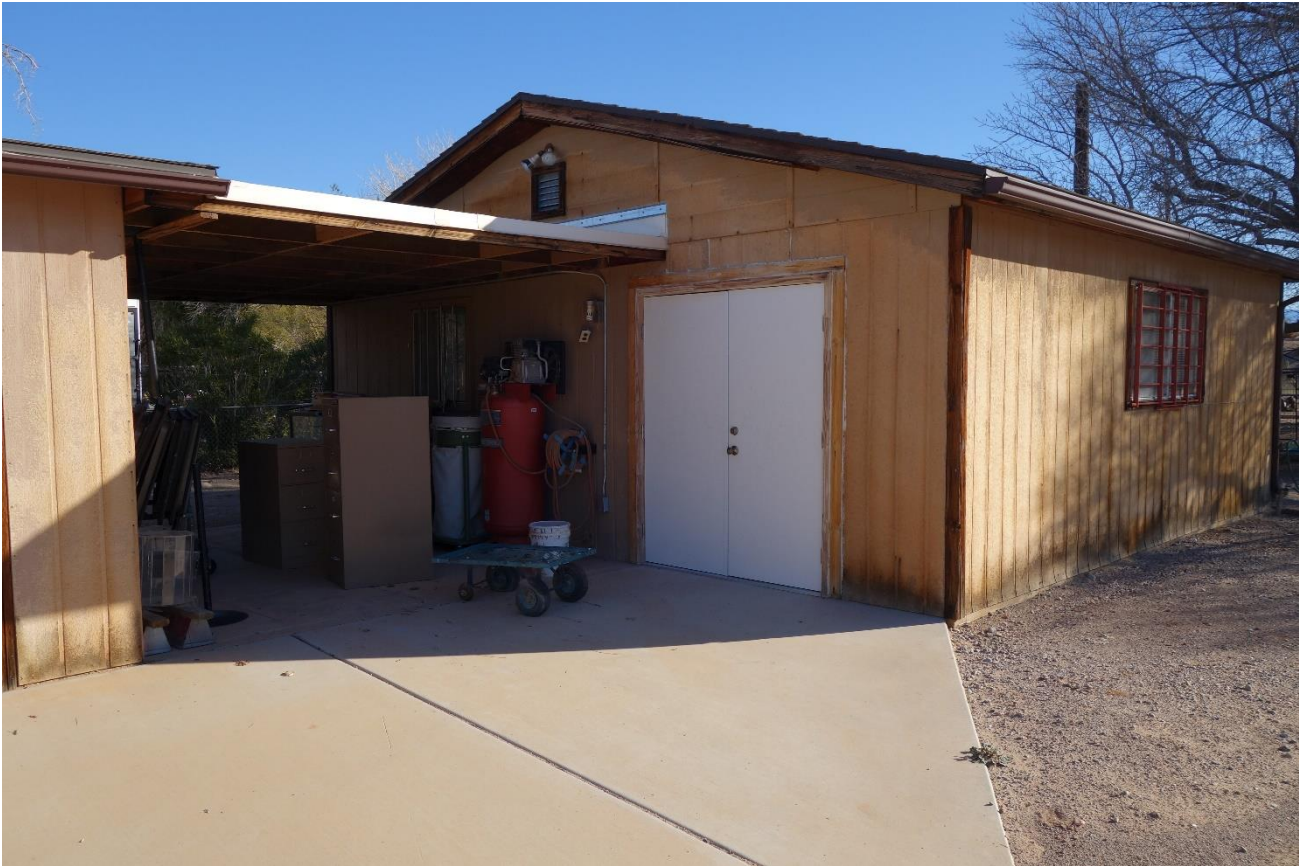
0973 **LOST CITY MUSEUM WORKSHOP**
PROJECT ID: 0973-EXT-3
CONST COST: \$23,200

The shop has a painted masonite siding that is due for replacement. The existing siding is in poor condition and will no longer hold paint. This project recommends removing the masonite siding and replacing it with T1-11 panels finished with an oil-based stain.

This project should be implemented concurrently with the Exterior Finishes project. This project or a portion thereof was previously recommended in the FCA report dated 11/04/2009 and 01/29/2014. It has been amended accordingly to reflect conditions observed during the most recent survey date of 02/07/2023.

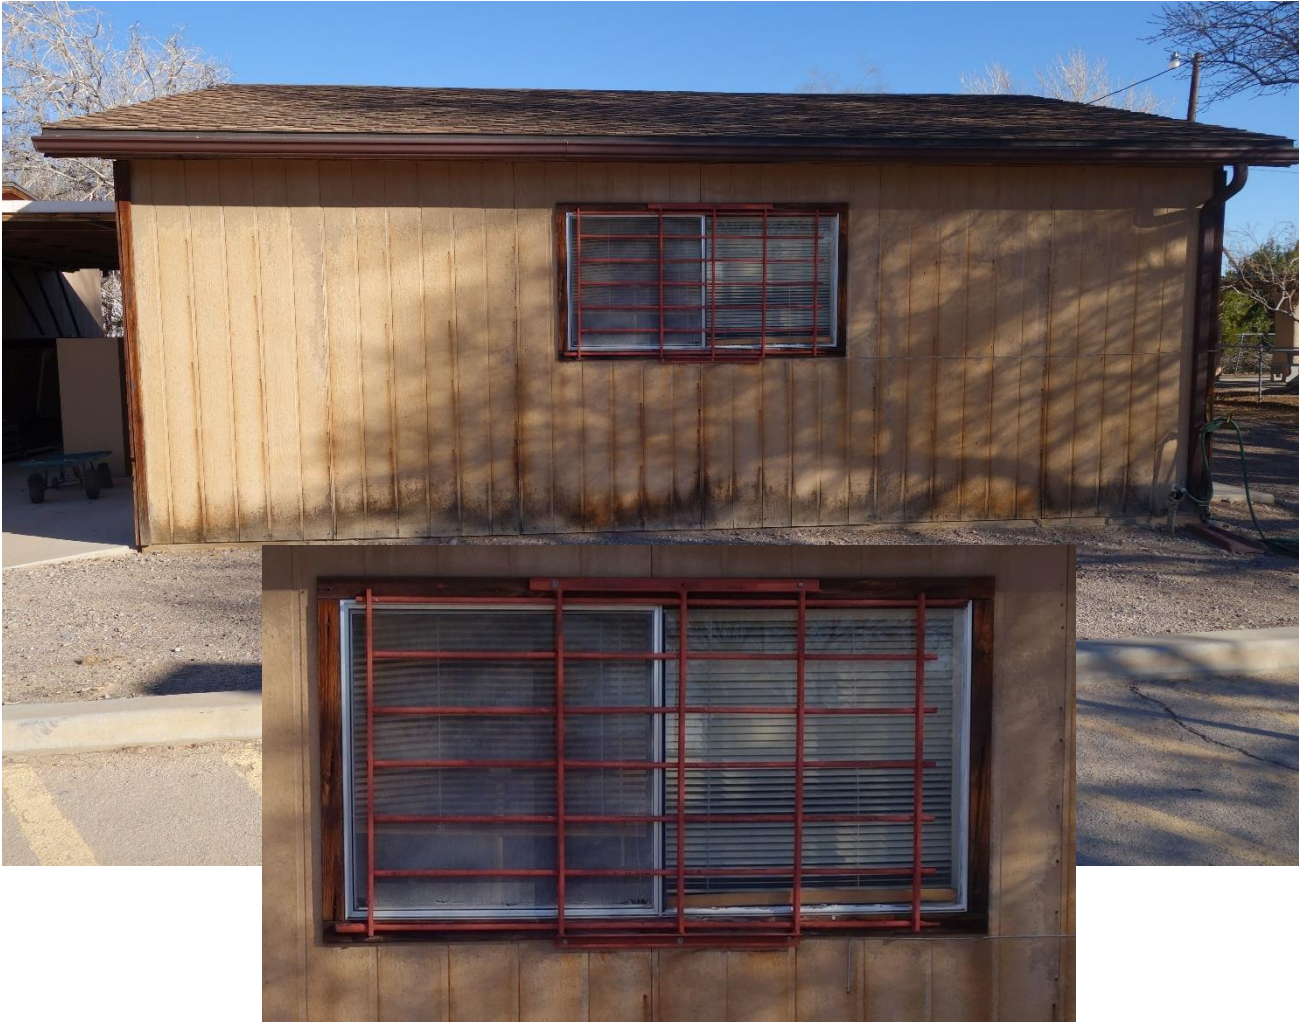
0973 **LOST CITY MUSEUM WORKSHOP**
PROJECT ID: **0973-EXT-5**
CONST COST: **\$5,000**

The windows are original, single pane construction in metal frames. These older windows are drafty and not energy efficient. This project recommends replacing the windows with dual pane, higher efficiency units. This estimate is for the replacement of 3 units. Removal and disposal of the existing windows is included in this estimate. This project or a portion thereof was previously recommended in the FCA report dated 01/29/2014. It has been amended accordingly to reflect conditions observed during the most recent survey date of 02/07/2023.

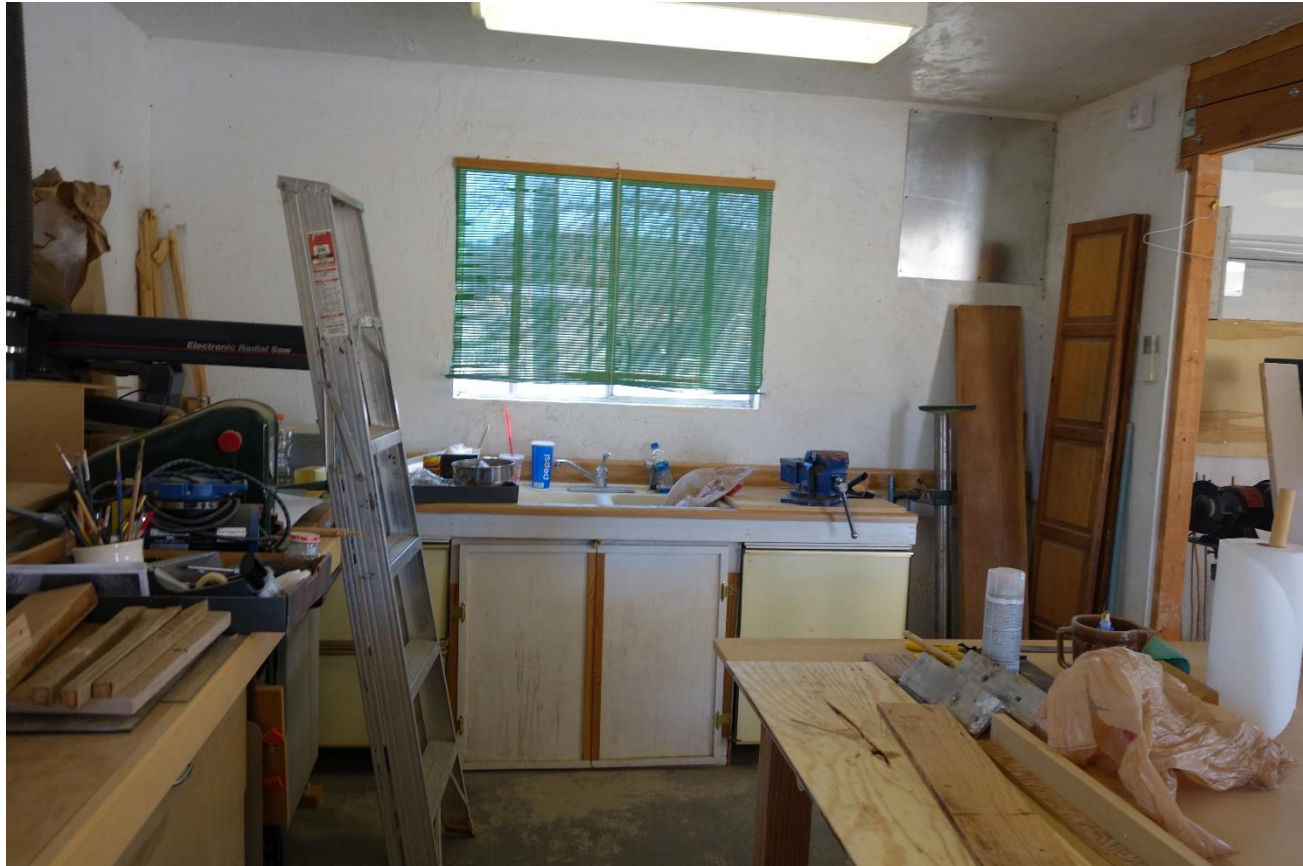
The interior finishes are in fair condition. It is recommended to paint the interior walls and ceilings at least once in the next 4 - 6 years and that this project is scheduled on a cyclical basis to maintain the integrity of the structure. Prior to painting, all surfaces should be repaired and prepped.

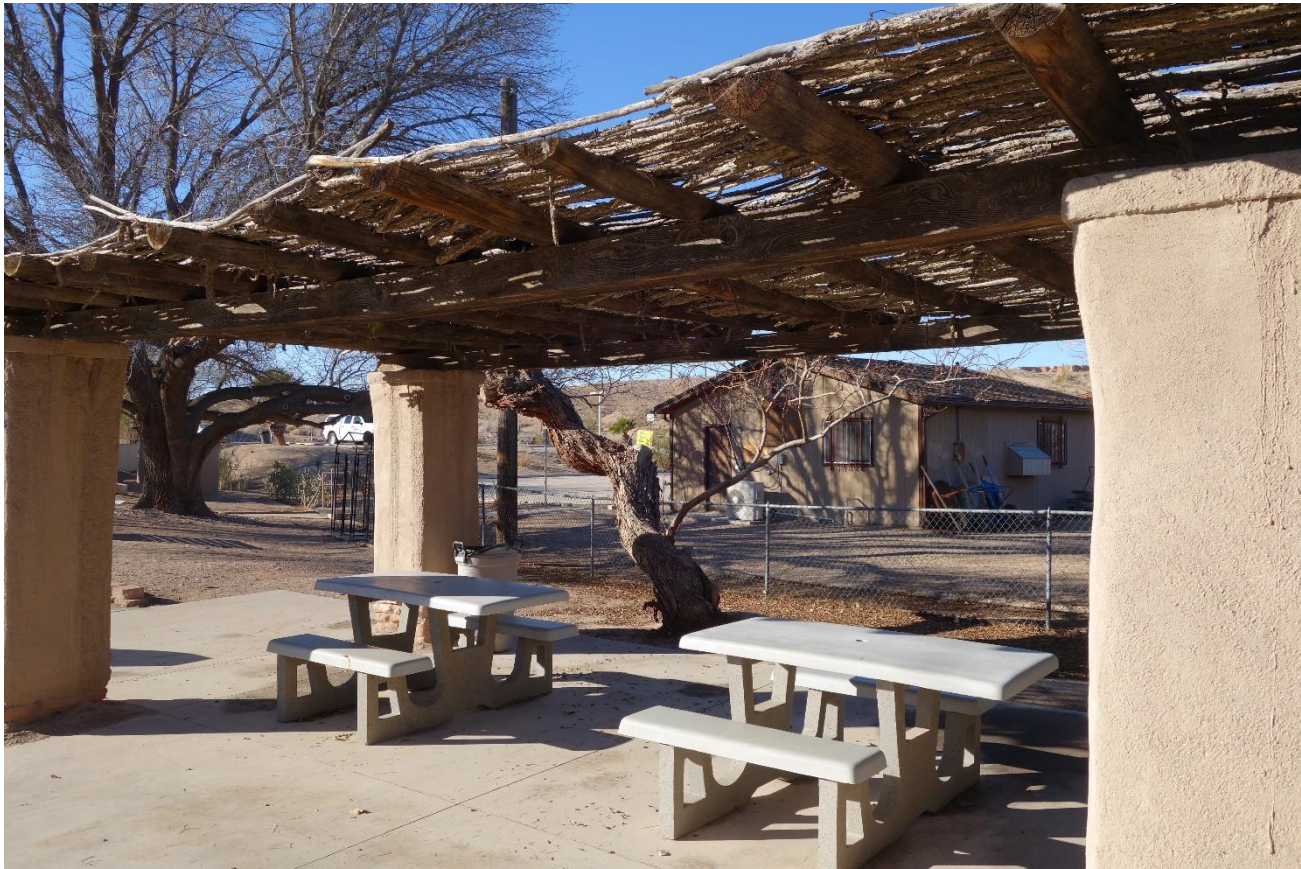
It is important to maintain the finish, weather resistance and appearance of the structure. This project would provide for repairing the adobe coating, sealing and staining the wood beams and refurbishing the ocatillo branch shade material. It is recommended that this project is scheduled on a cyclical basis to maintain the integrity of the structure.

Due to the historical nature of the facility, this project is subject to review and approval from the State Historical Preservation Office.
