STATE OF NEVADA
STATE PUBLIC WORKS DIVISION

FACILITY CONDITION ASSESSMENT REPORT FOR:

DEPT OF TOURISM & CULTURAL AFFAIRS
MUSEUMS & HISTORY
MUSEUMS
LOSTCITY

Survey Date: 2/7/2023
Distribution Date: 8/15/2023

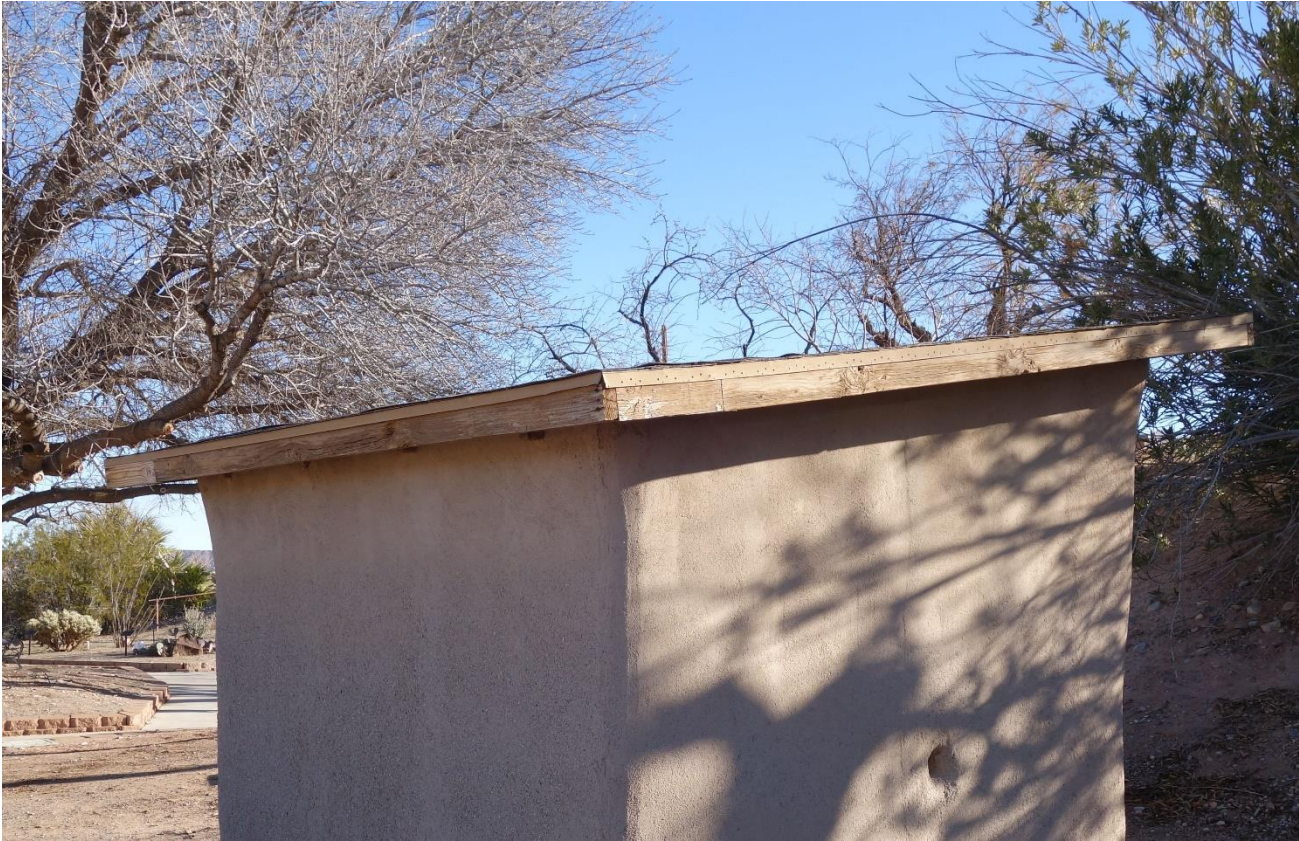
The exterior finishes were in good condition with the exception of the roof fascia. It is important to maintain the finish, weather resistance and appearance of the building. This project would provide funding to replace or refinish the roof fascia that is cracked and weathered. Included in the cost is repairing the cracks and applying a new layer of adobe coating over the masonry. It is recommended that the building be repaired in the next 6 - 8 years and that this project be scheduled on a cyclical basis to maintain the integrity of the structure.

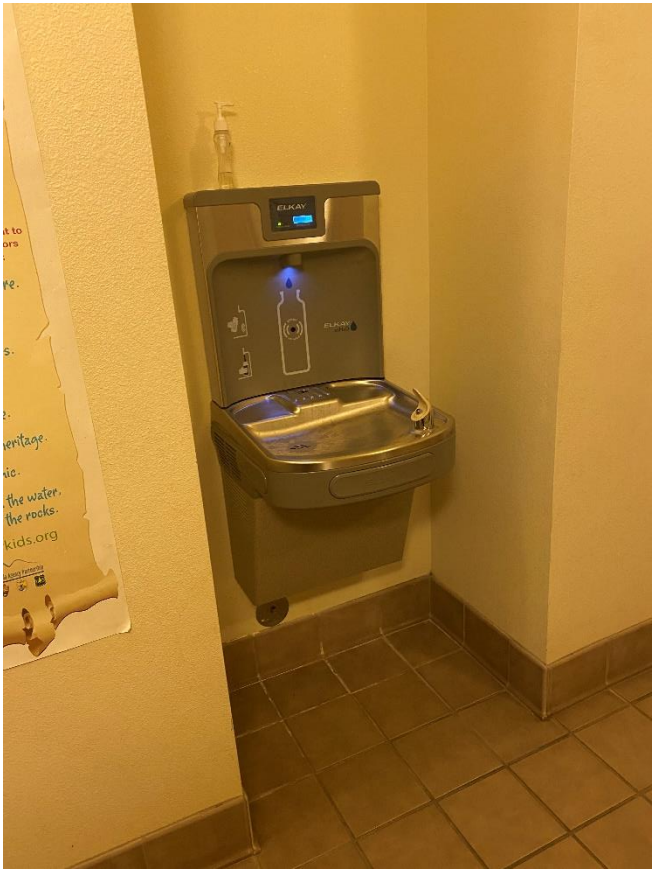
This building contains a water fountain that is not ADA compliant. The 2018 IBC Section 1109.5 states where drinking fountains are provided on an exterior site, on a floor or within a secured area, no fewer than two drinking fountains shall be provided. One shall comply with the requirements for people who use a wheelchair and one shall comply with the requirements for standing people. This project would provide funding for the purchase and installation of one drinking fountain to meet the ADA requirements. Note that a bottle filler integrated into a drinking fountain does not make the water fountain accessible.

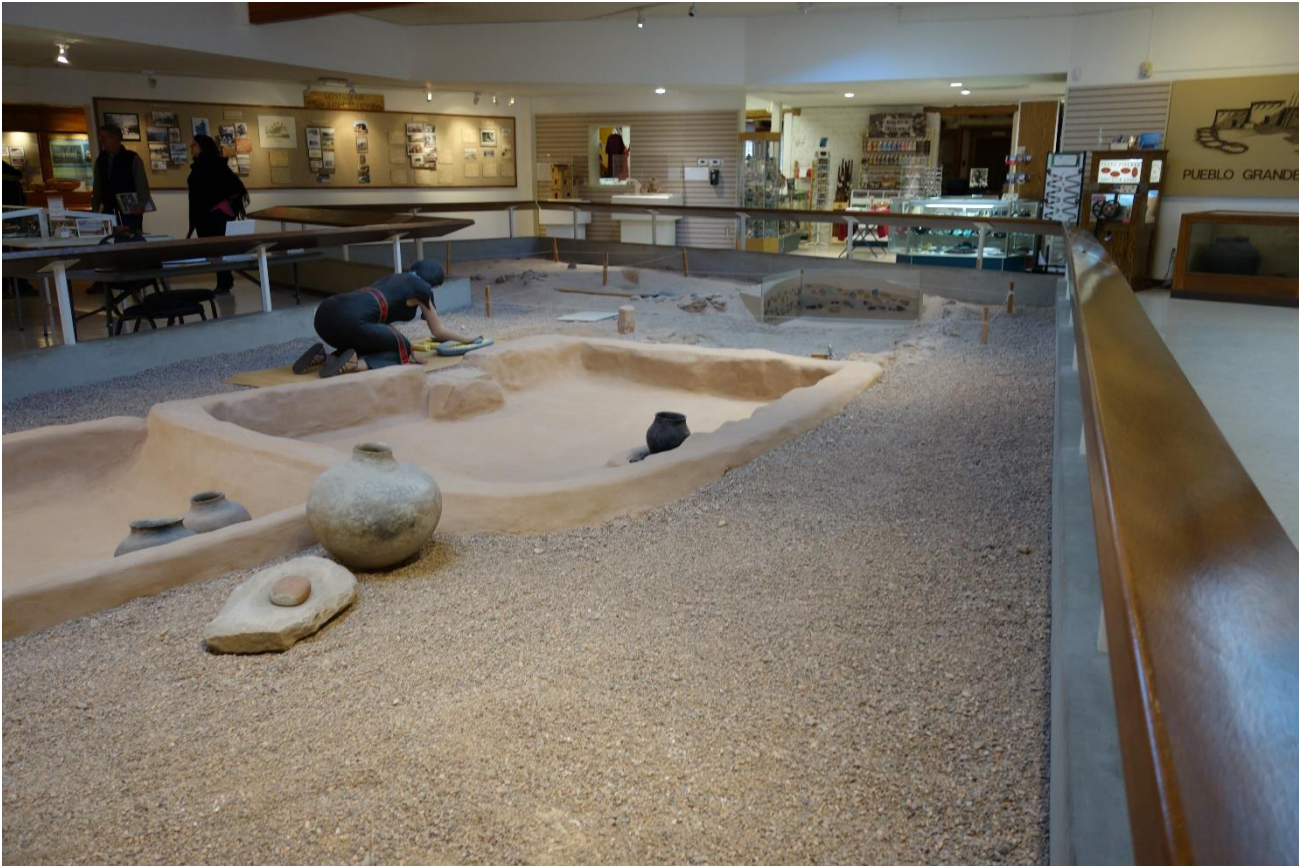
0267 LOST CITY MUSEUM
PROJECT ID: 0267-ADA-2
CONST COST: \$80,000

The Lost City Museum is designed to be a self-guided experience. Many of the exhibits and displays would benefit from a further explanation or clarification, but staffing and budget limitations impact those efforts. This project recommends the installation of a public address type system with a listening system that would activate when the visitor approaches the display or activates a switch. This would greatly enhance the experience and provide compliance with ADA requirements for assistive listening devices for the hearing and visually impaired. Prices quoted are for an infrared system. A radio frequency system may prove more appropriate for this application, and both should be evaluated. This project does include costs for developing the material and recording media for the exhibits. These efforts could

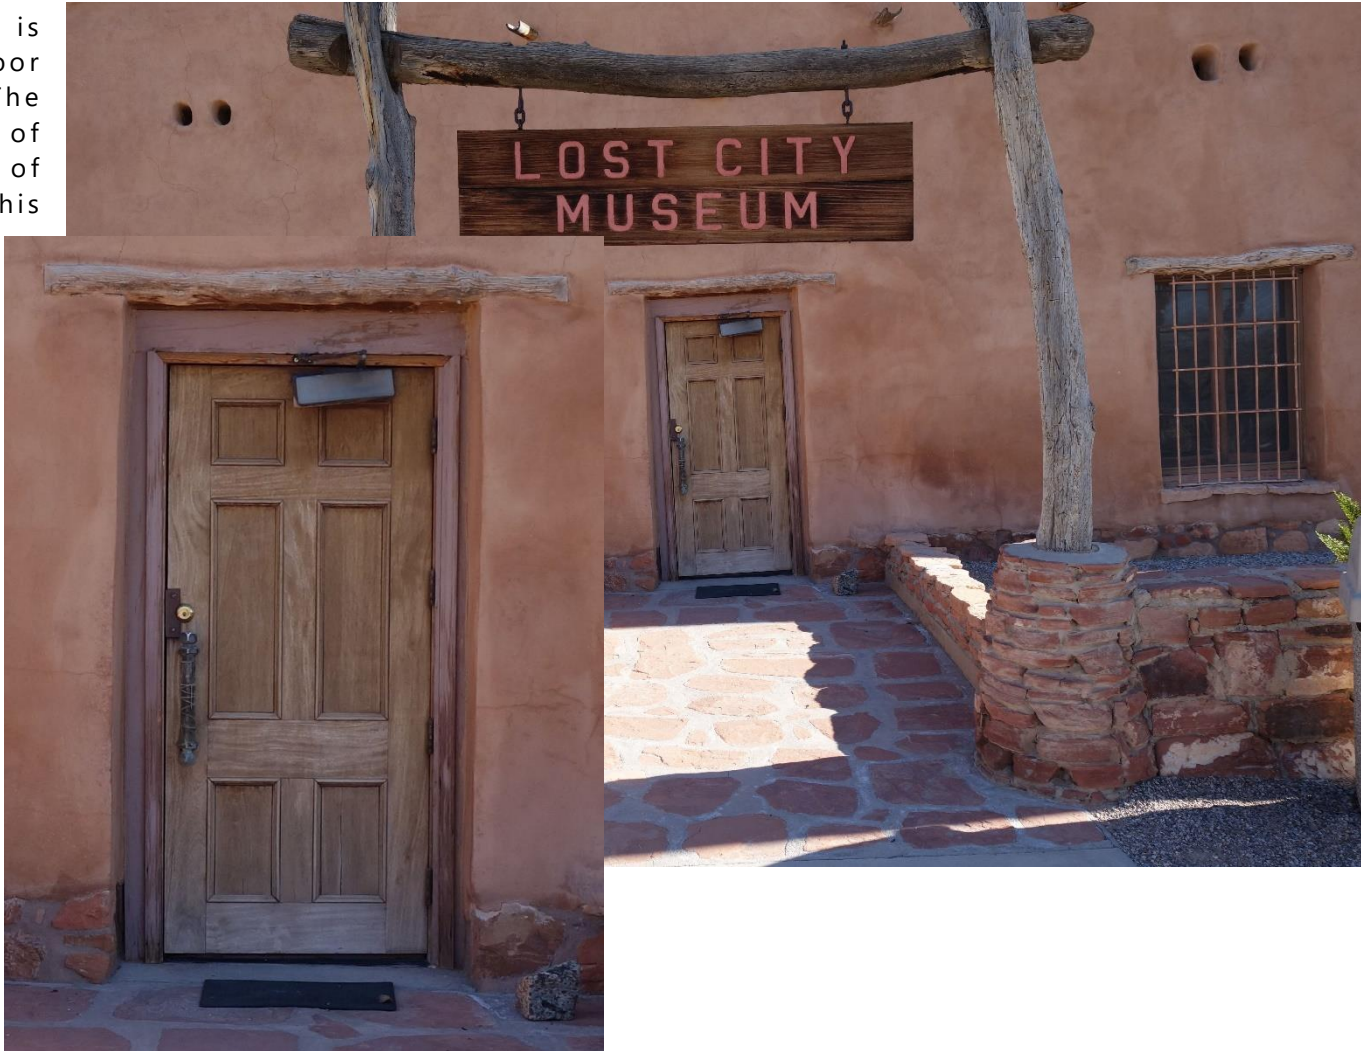
The front exterior door is severely weathered, and the door closure appears to be failing. The door is part of the means of egress and accessible path of travel. It is important that this door functions properly. This project would fund the replacement of the door closure, re-finish the door and any additional required maintenance in order to properly function. Also included is the installation of a temporary front door while the current door is being refurbished.

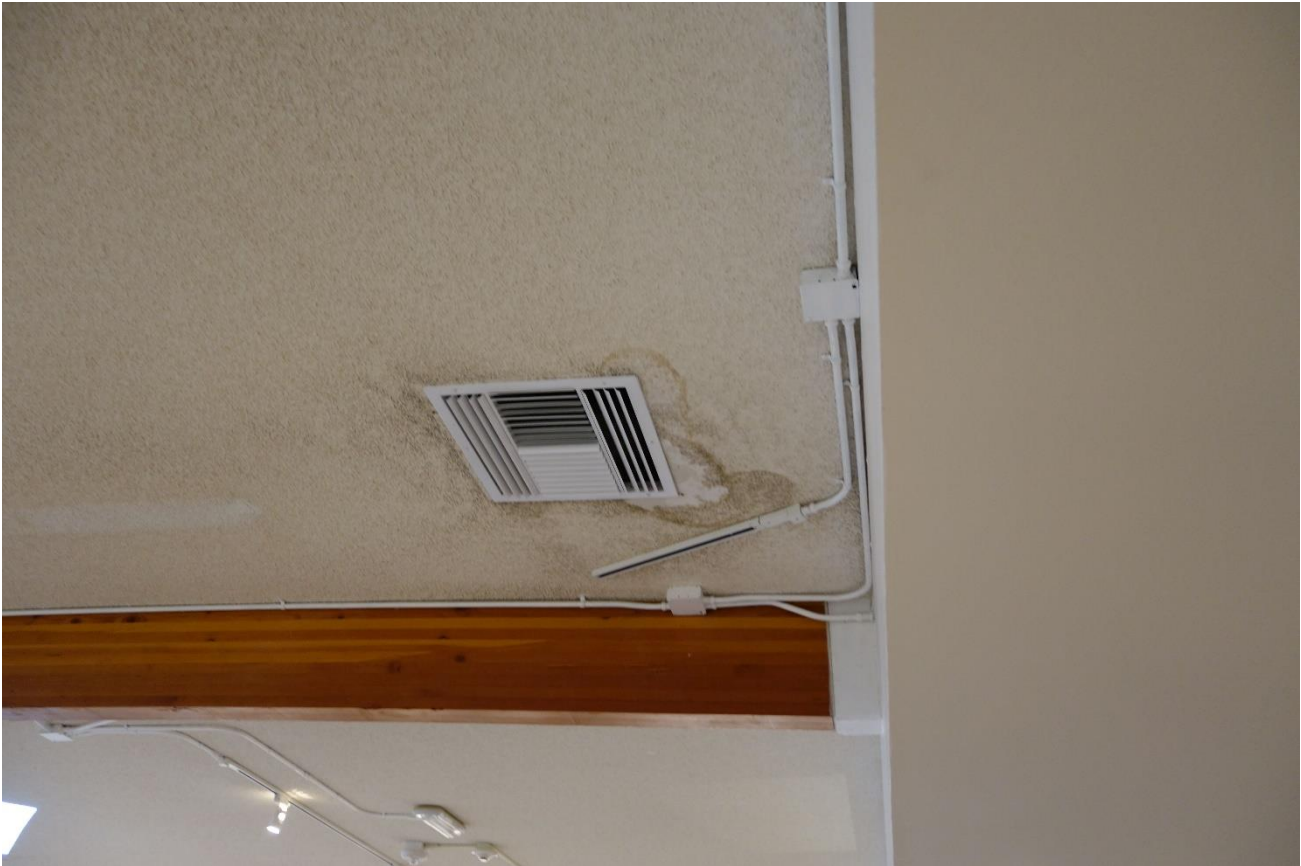
0267 **LOST CITY MUSEUM**
PROJECT ID: **0267E-EXT1-10**
CONST COST: **\$1,500**

There is evidence of roof leaks in proximity to roof penetrations around skylights and HVAC ductwork. The ceiling is stained in multiple areas. Roof repairs or re-caulking roof penetrations are needed. This project would fund the required maintenance and/or roof repairs.

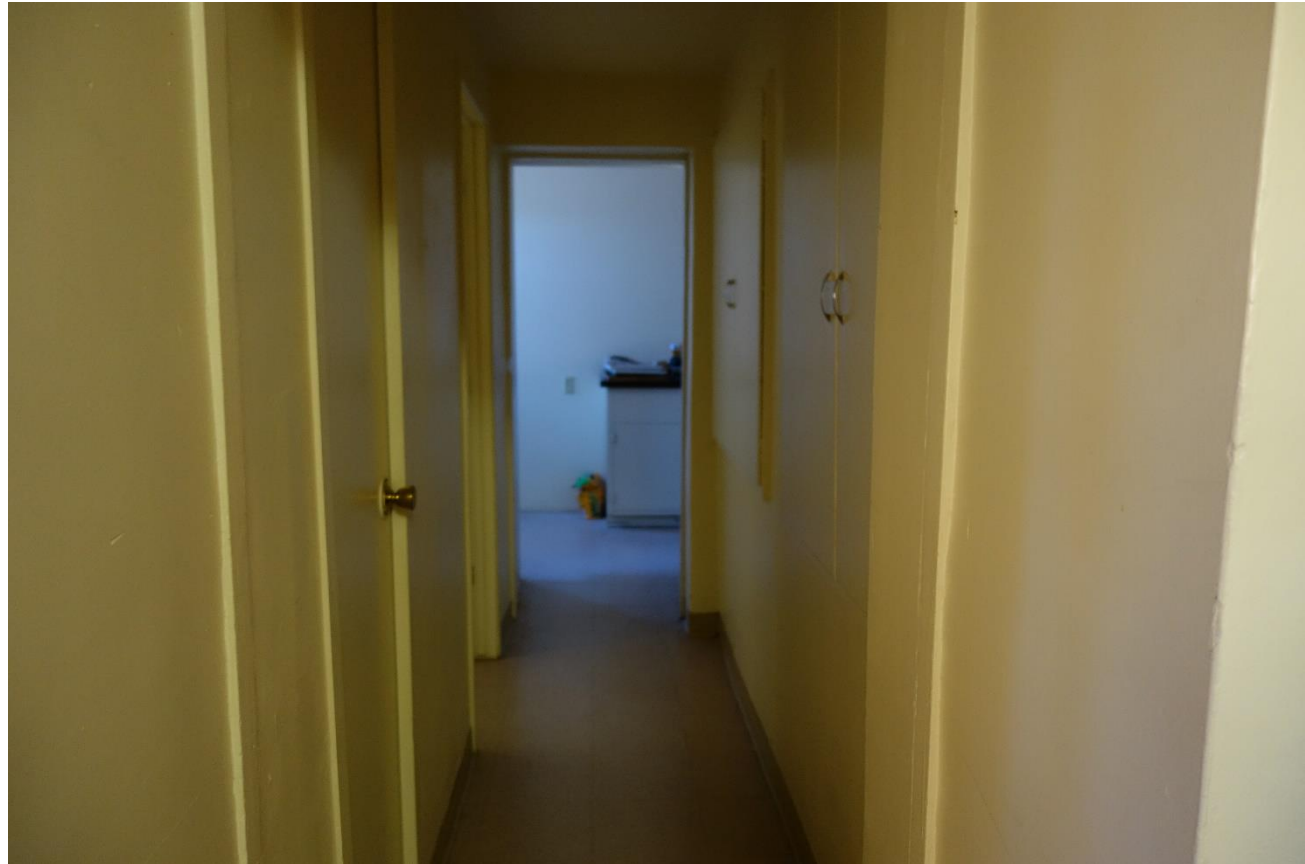
The back office, storage and research areas are old, and these portions of the building need a remodel. The break area counters, and sink are not ADA compliant, flooring is in extremely poor condition and all doors (interior and exterior) are in poor condition and lacking accessible hardware. This project would provide for removal and replacement of the flooring, door(s) and frames, cabinetry, trim and baseboards and other interior finishes and fixtures in need of replacement. Excluded from this project are the restrooms that were recently remodeled under 19-M33. Due to the historical nature of the facility, this project is subject to review and approval from the State Historical Preservation Office.

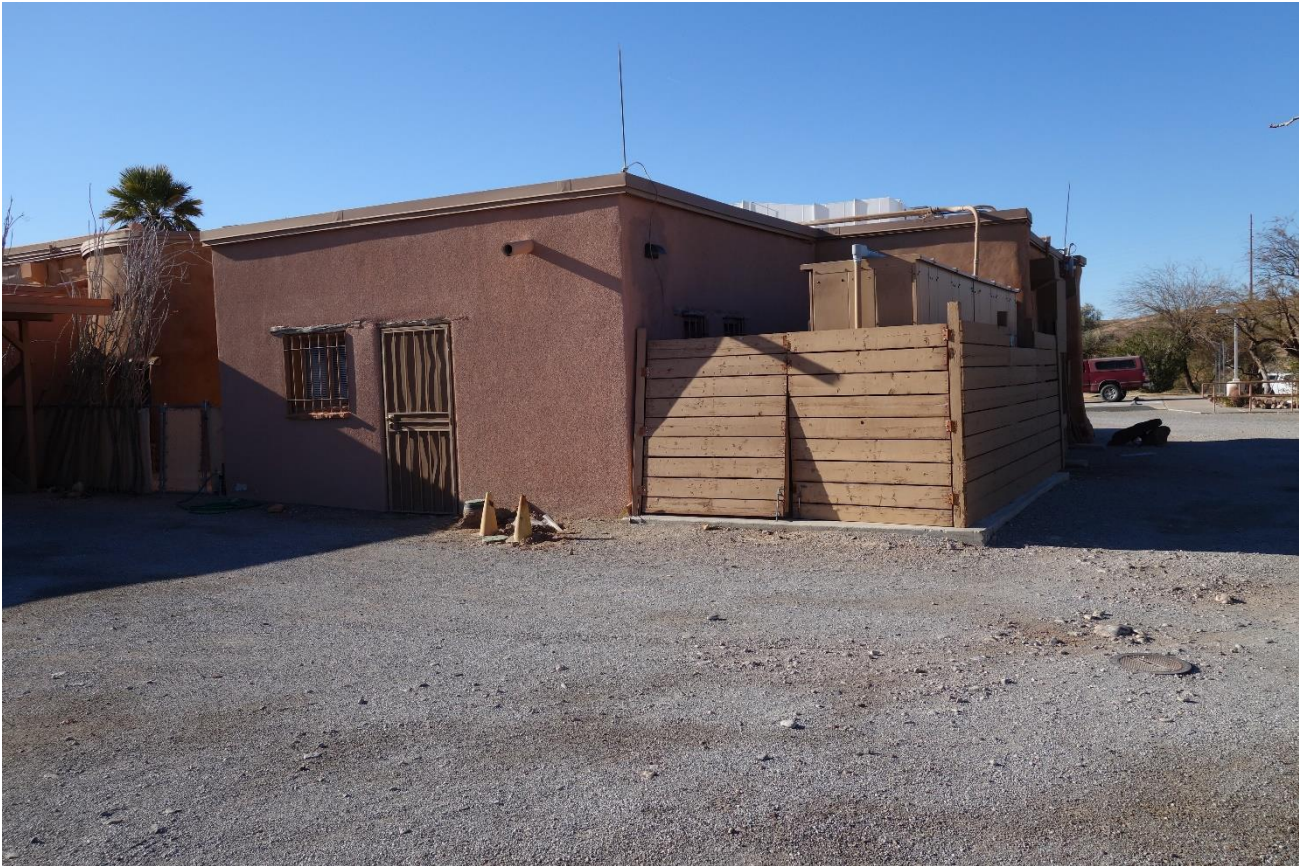
0267 LOST CITY MUSEUM
PROJECT ID: 0267-SIT-1
CONST COST: \$7,500

The electrical service entrance screen walls located on the northeast side of the building have access gates that have failed. The gates need to be completely replaced. This project would fund the removal and replacement of these gates.

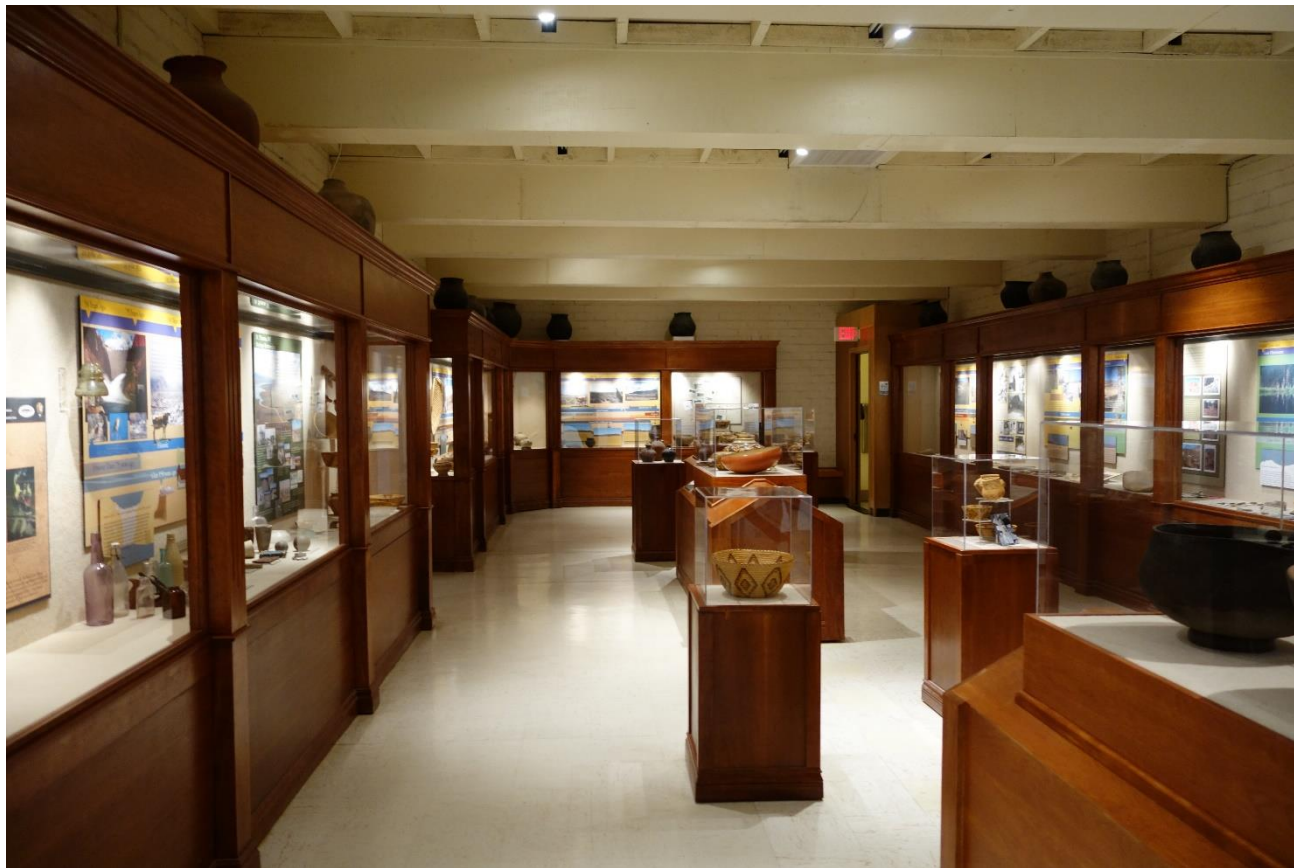
0267 **LOST CITY MUSEUM**
PROJECT ID: **0267-ELE-3**
CONST COST: **\$40,000**

The existing lighting fixtures in the artifact cabinets are older and costly to maintain. Replacement bulbs are as much as \$75.00 each and the Museum's budget cannot support this costly system. This project will upgrade fixtures to an LED display lighting system with lower cost replacement bulbs. Any electrical wiring upgrades are not included in this estimate. This project or a portion thereof was previously recommended in the FCA reports dated 01/29/2014. It has been amended accordingly to reflect conditions observed during the most recent survey date of 02/07/2023.

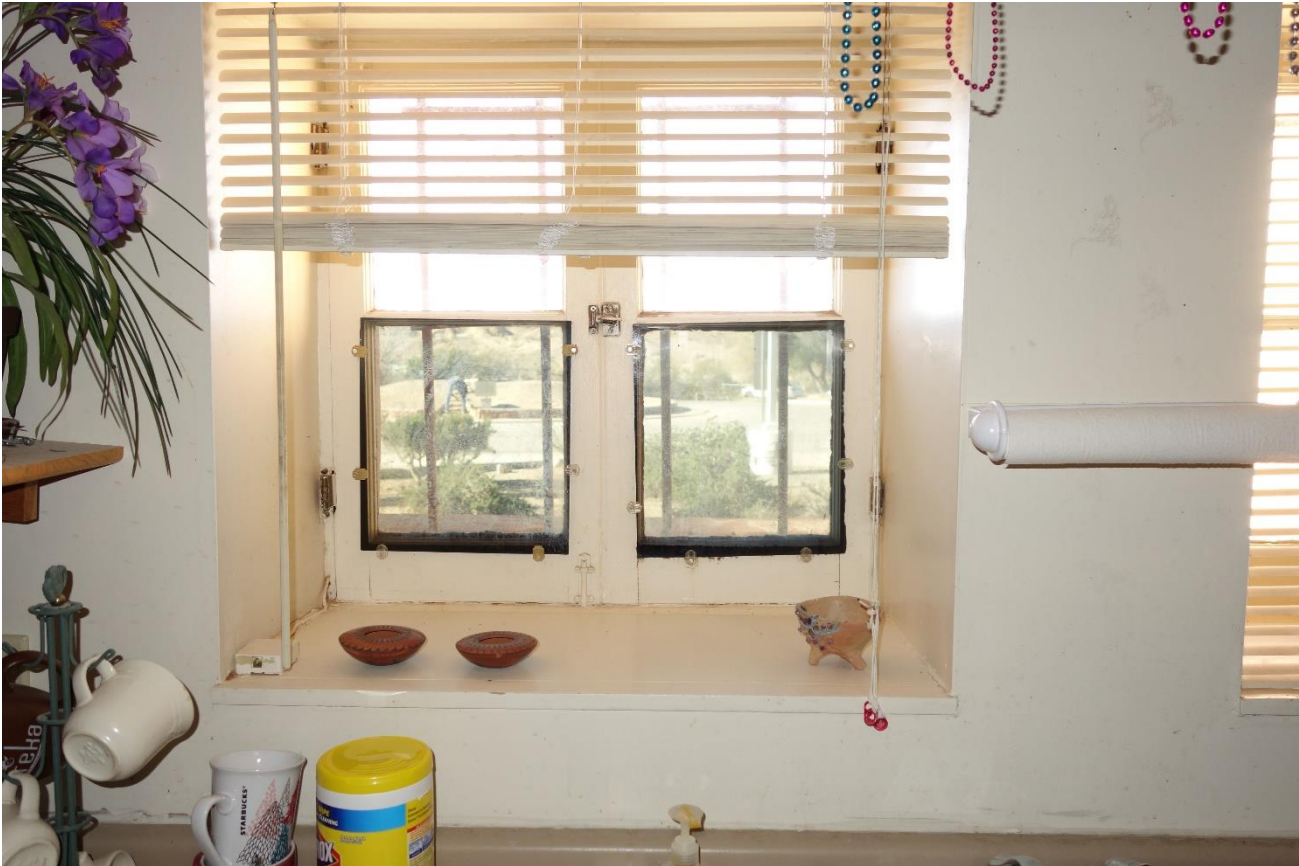
0267 LOST CITY MUSEUM
PROJECT ID: 0267-ENR-3
CONST COST: \$42,500

The windows are original, single pane construction in a wooden frame. These older windows are drafty, not energy efficient and the wooden frames have deteriorated significantly. This project recommends replacing the windows with dual pane, higher efficiency units. This estimate is for the replication of 17 units including wooden frames to maintain the historic character of the building. Removal and disposal of the existing windows is included in this estimate.

Due to the historical nature of the facility, this project is subject to review and approval from the State Historical Preservation Office.

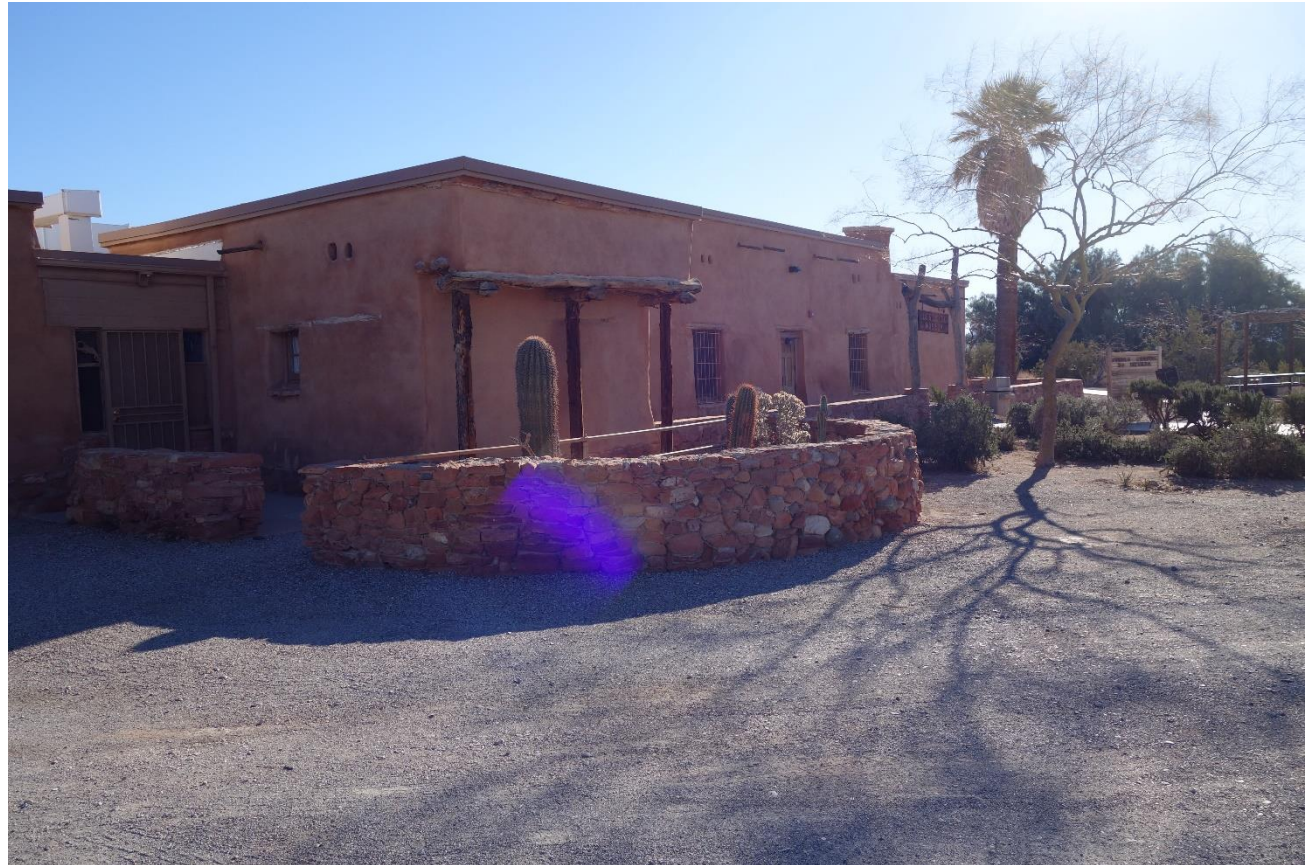
It is important to maintain the finish, weather resistance and appearance of the building. This project would provide funding to protect the exterior of the building excluding the roof. Included in the cost is power washing and painting the stucco, patching the adobe and caulking of the windows, flashing, fixtures and all other penetrations. It is recommended that the building finishes be treated in the next 7 - 9 years and that this project is scheduled on a cyclical basis to maintain the integrity of the structure. Due to the historical nature of the facility, this project is subject to review and approval from the State Historical Preservation Office.

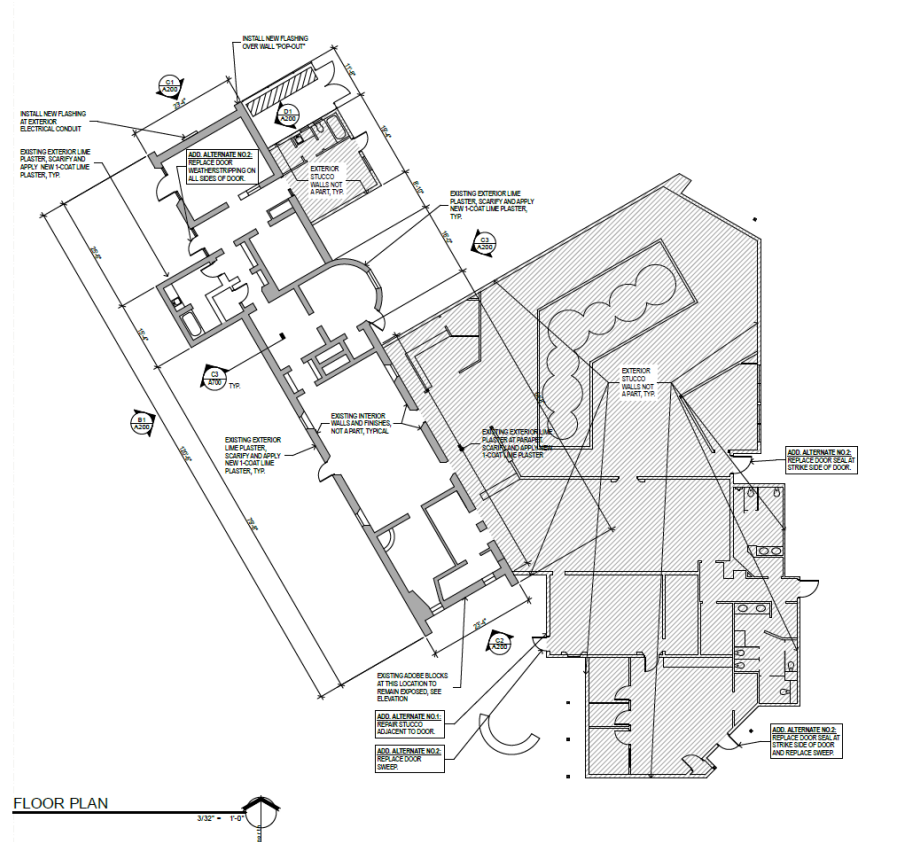
0267 LOST CITY MUSEUM
 PROJECT ID: 0267-SFT-3
 CONST COST: \$497,100

This building exceeds 12,000/24,000 square feet on a single/all floor(s). Pursuant to the Nevada State Fire Marshal Regulation, NAC 477.915 1.(c)(1) states, that every building owned or occupied by the state regardless of occupancy having a floor area greater than 12,000 square feet on any floor or 24,000 square feet on all floors or is an "R" occupancy, must have sprinklers installed when the building is remodeled, or an addition is proposed. This project would provide funding for the installation of a fire sprinkler system and backflow prevention in the event the building is remodeled, or an addition is undertaken. This project or a portion thereof was previously recommended in the FCA reports dated 01/29/2014. It has been amended accordingly to reflect conditions observed during the most recent survey date of 02/07/2023.

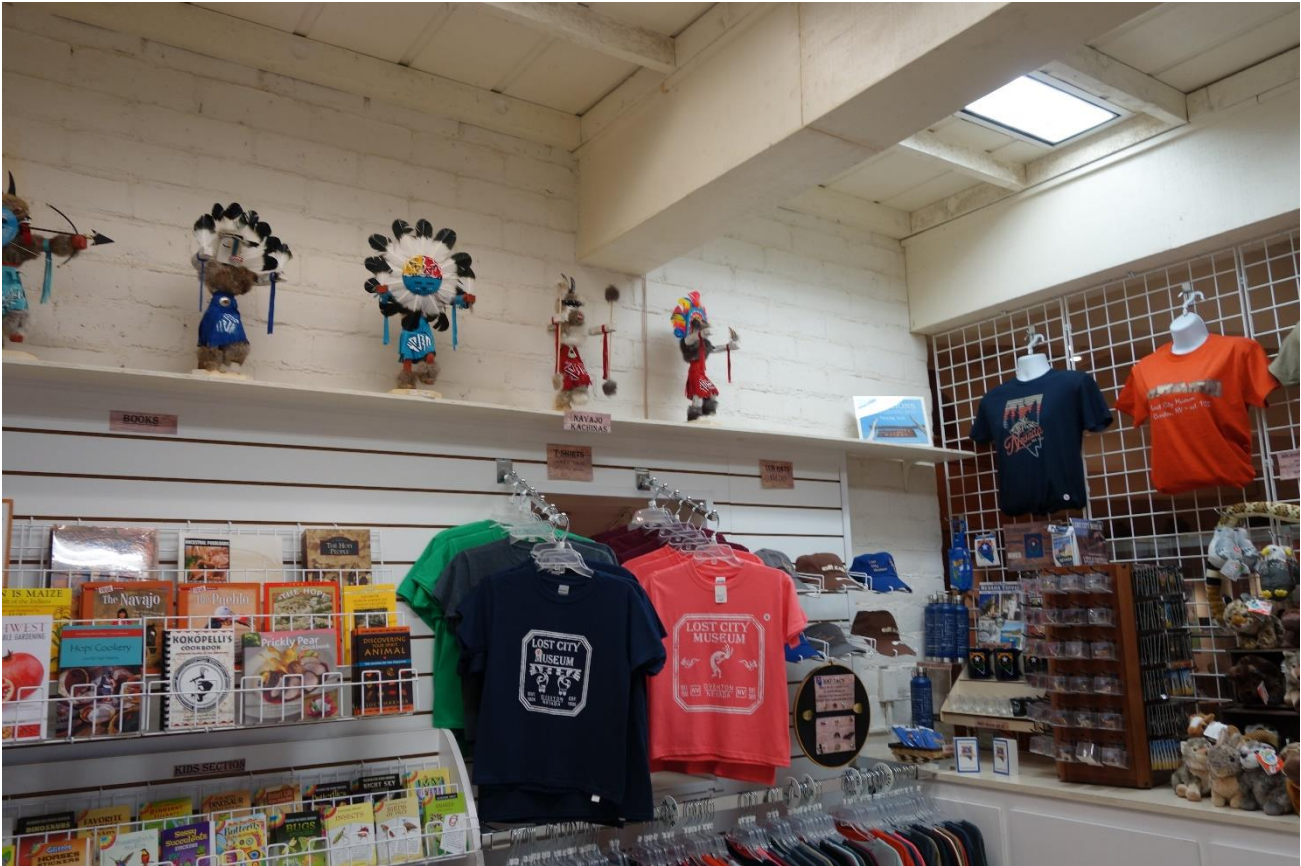
0267 LOST CITY MUSEUM
PROJECT ID: 0267-INT-1
CONST COST: \$168,300

The interior finishes in the museum were in fair condition. The office and storage areas will be under a separate project. It is recommended to paint the interior walls and ceilings at least once in the next 4 - 6 years and that this project is scheduled on a cyclical basis to maintain the integrity of the structure. Prior to painting, all surfaces should be repaired and prepped. Additional costs are included due to the historic nature of the building and for treating complicated areas such as the wood framing members on the ceiling. An epoxy-based paint should be utilized in wet areas for durability.

Due to the historical nature of the facility, this project is subject to review and approval from the State Historical Preservation Office.
