State of Nevada  
Department of Tourism & Cultural Affairs  
Division of Museums & History  
Lost City Museum  
Facility Condition Analysis

# LOST CITY MUSEUM

721 South Moapa Valley Blvd.  
Overton, Nevada 89040

## **STATE OF NEVADA PUBLIC WORKS DIVISION FACILITY CONDITION ANALYSIS**

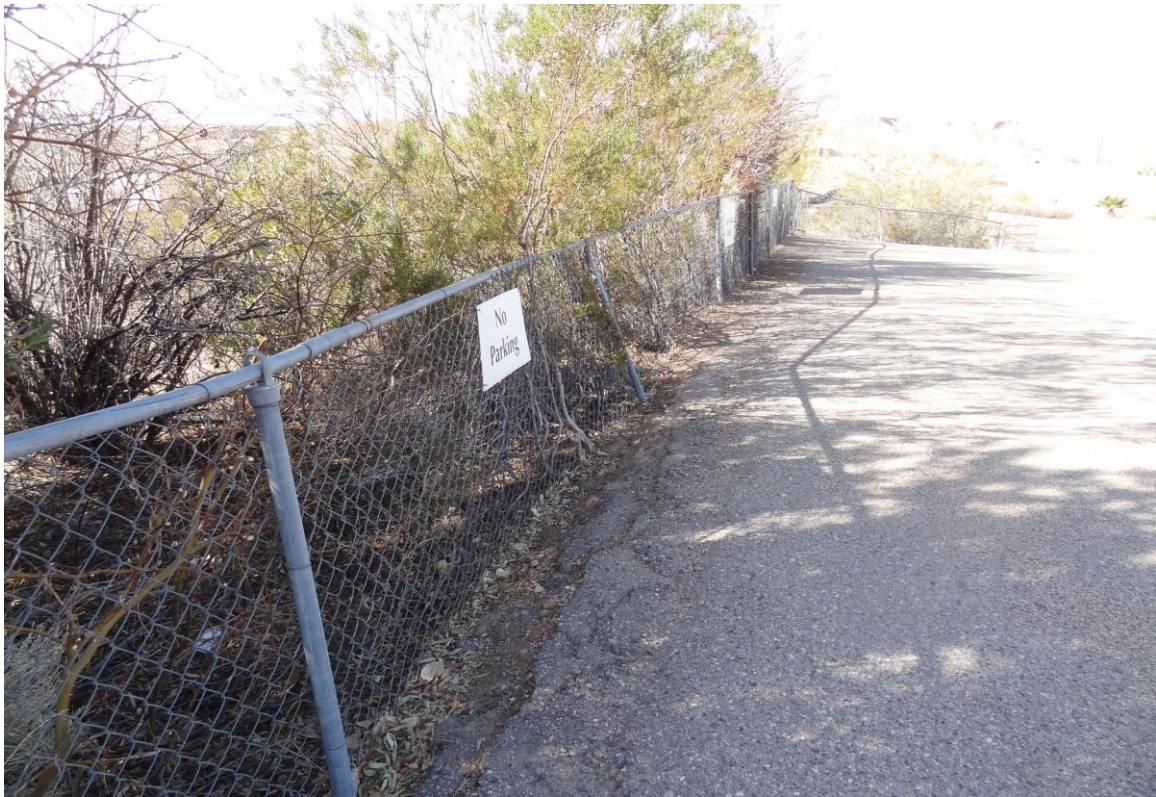
Lost City Museum Site – FCA Site #9964  
Description: Damaged fence along parking.

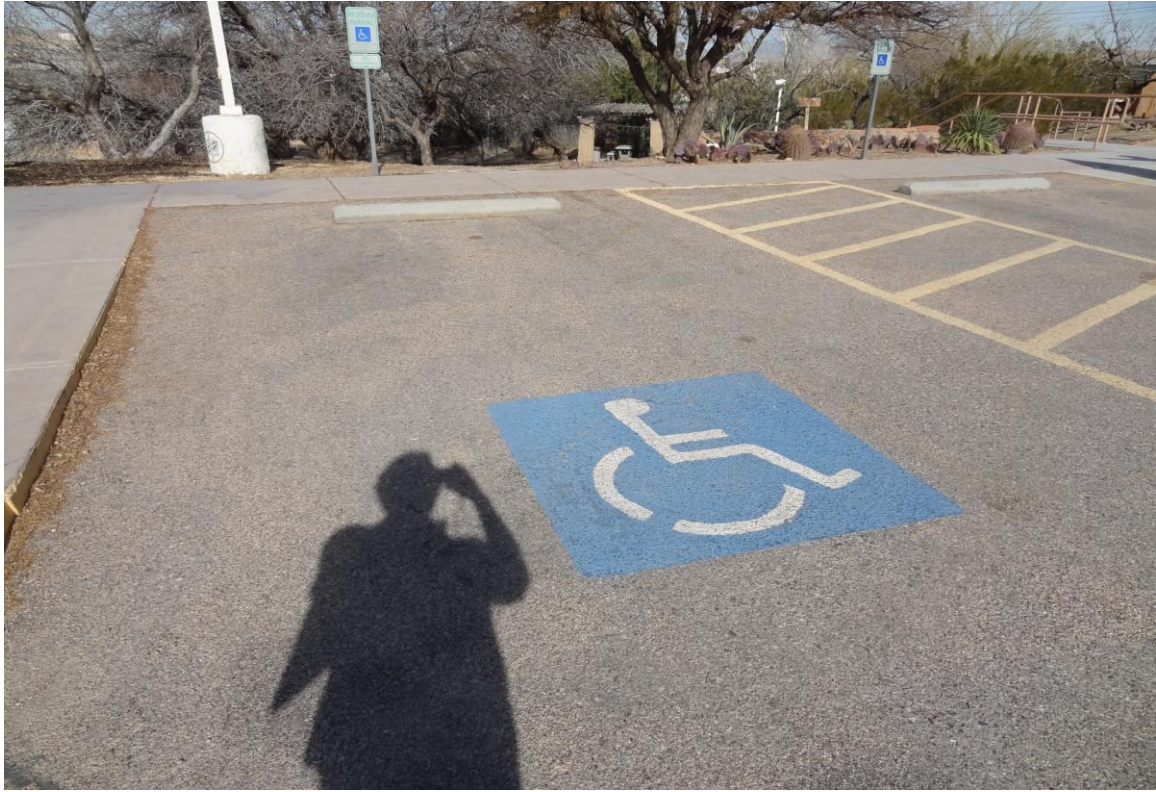
Lost City Museum Site – FCA Site #9964  
Description: ADA accessible parking prior to slurry sealing.

It is important to maintain the asphalt concrete paving on the site. This project would provide for minor crack filling and slurry sealing of the paving site wide including access roads and parking areas. Striping is included in this estimate. This project should be scheduled on a 5 year cyclical basis to maintain the integrity of the paving and prevent premature failure. 41,156 square feet of asphalt area was used to generate this estimate. This project was completed in 2014 but should be scheduled every 5 or so years as stated above.

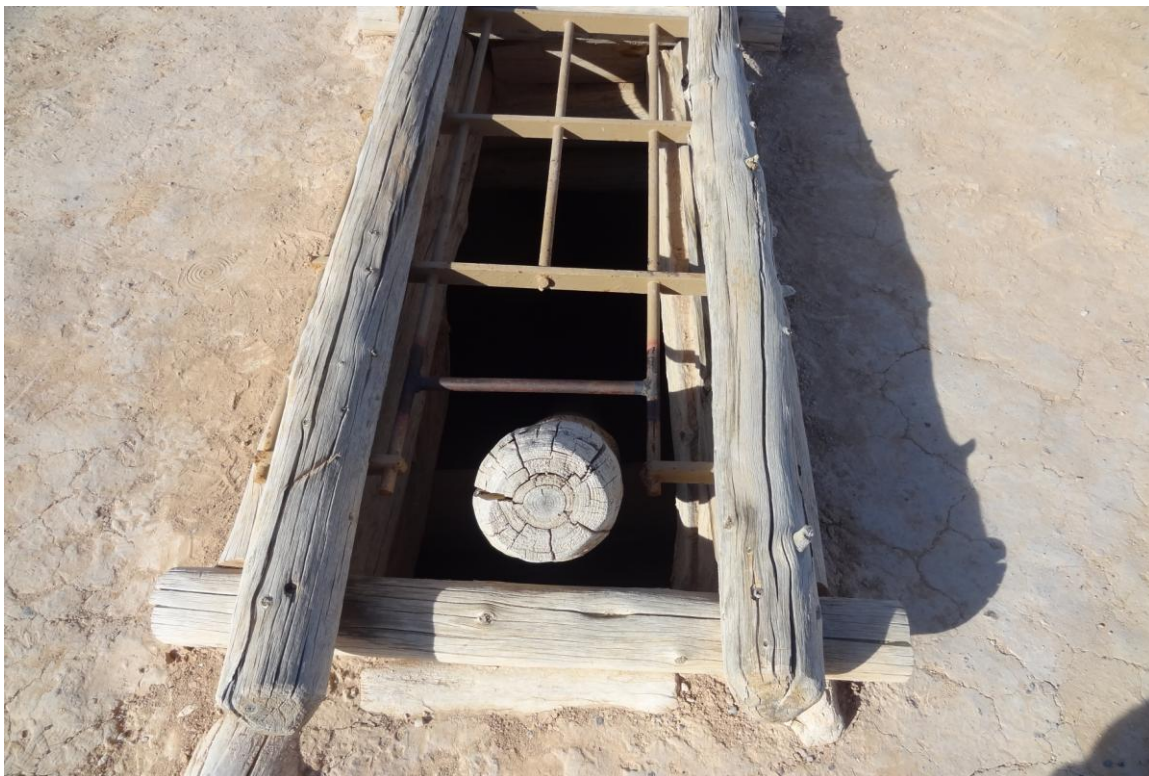
Lost City Museum Pit House – FCA Building #0268  
Description: Exterior of the structure.

This unique structure consists of wood poles and beams covered with reeds and finally packed with soil. It is largely underground and accessed from a hole in the ground with a ladder going down into the Pit House. This type of structure deteriorates over time and requires refurbishment every couple of years. This project provides for removing the soil and reeds, replacing any poles or beams as needed and rebuilding the roof structure. It is recommended that the Pit House be refurbished in the next 2-3 years and that this project is scheduled on a cyclical basis to maintain the integrity of the structure.

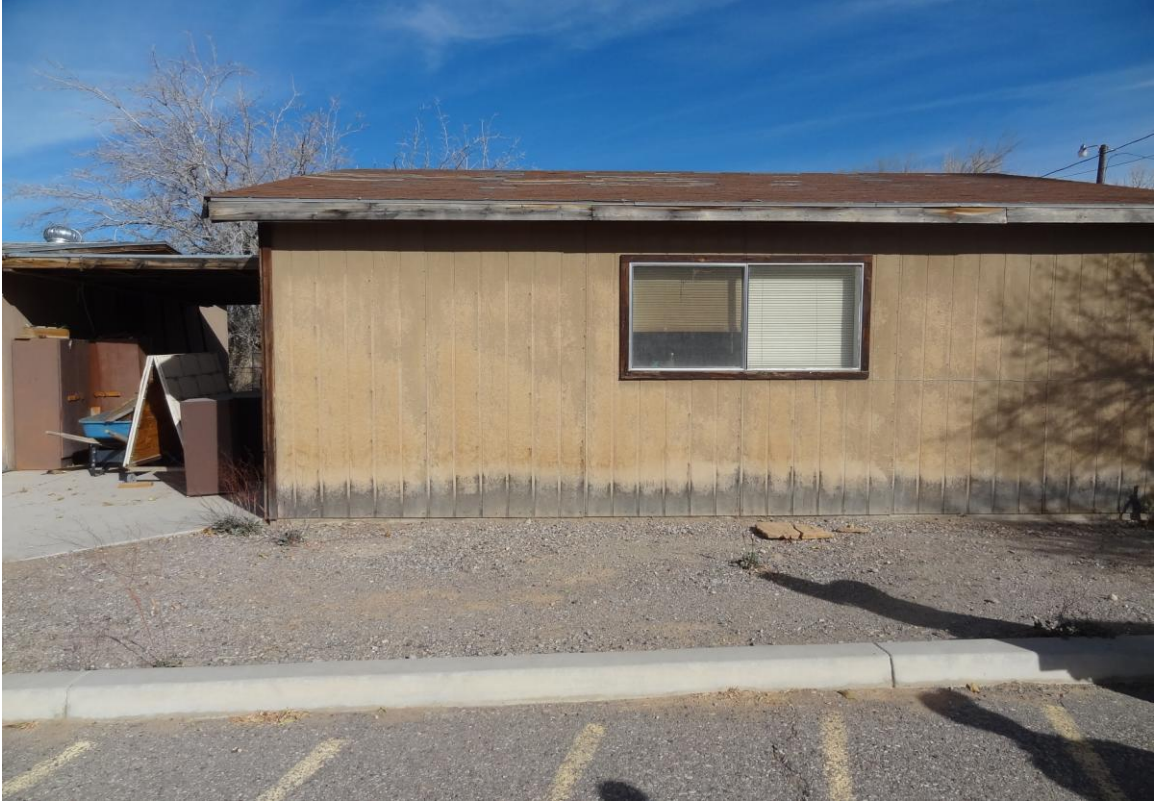
Lost City Museum Workshop – FCA Building #0973  
Description: Exterior of the structure.

The shop has a painted masonite siding that is due for replacement. The existing siding is in poor condition and will no longer hold paint. This project recommends removing the masonite siding and replacing it with T1-11 panels finished with an oil-based stain.

The 2 exterior wood man doors appear to be original to the building. They are damaged from age and general wear and tear. This project would provide for the replacement of the wood doors with new metal doors, frames and hardware. Removal and disposal of the existing doors and painting of the new doors is included in this estimate.

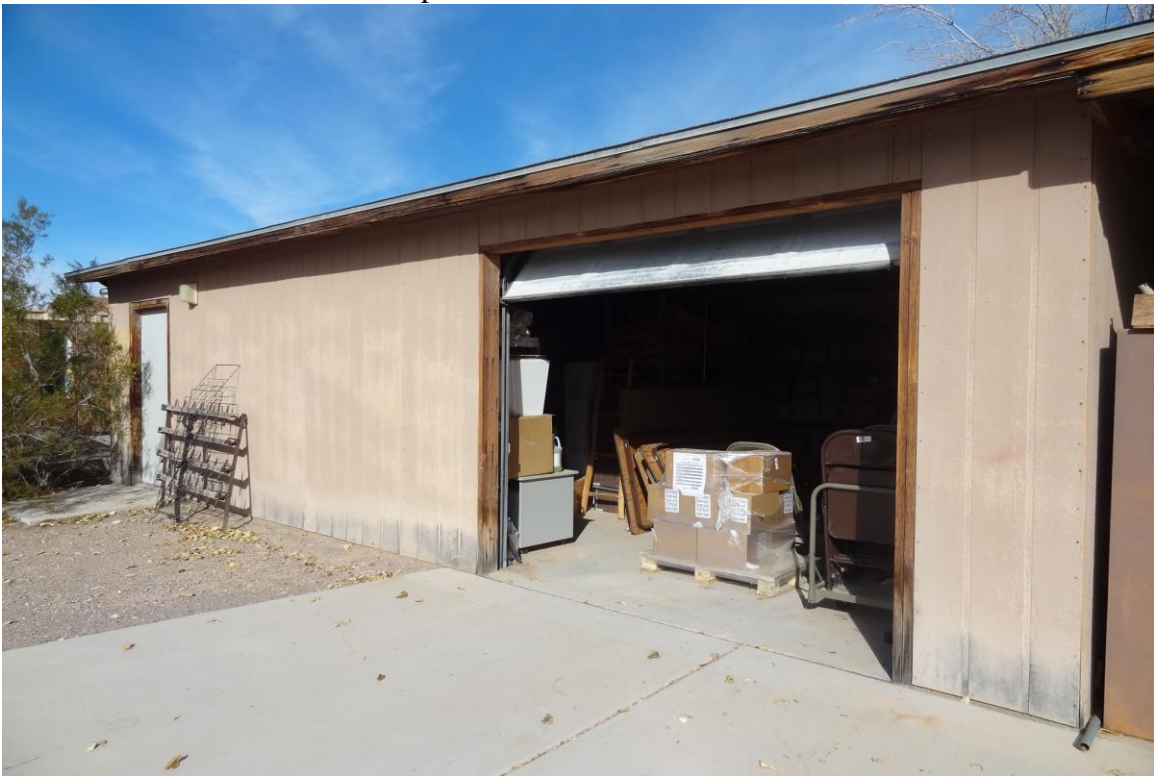
Lost City Storage Building – FCA Building #0974  
Description: Exterior of the structure.

The building has a painted masonite siding that is due for replacement. The existing siding is in poor condition and will no longer hold paint. This project recommends removing the masonite siding and replacing it with T1-11 panels finished with an oil-based stain.
