State of Nevada  
Department of Wildlife  
Overton Wildlife Management Area  
Facility Condition Analysis

# OVERTON WILDLIFE MANAGEMENT AREA

**Site Number: 9965**  
**STATE OF NEVADA PUBLIC WORKS DIVISION**  
**FACILITY CONDITION ANALYSIS**

Report Printed in August 2014

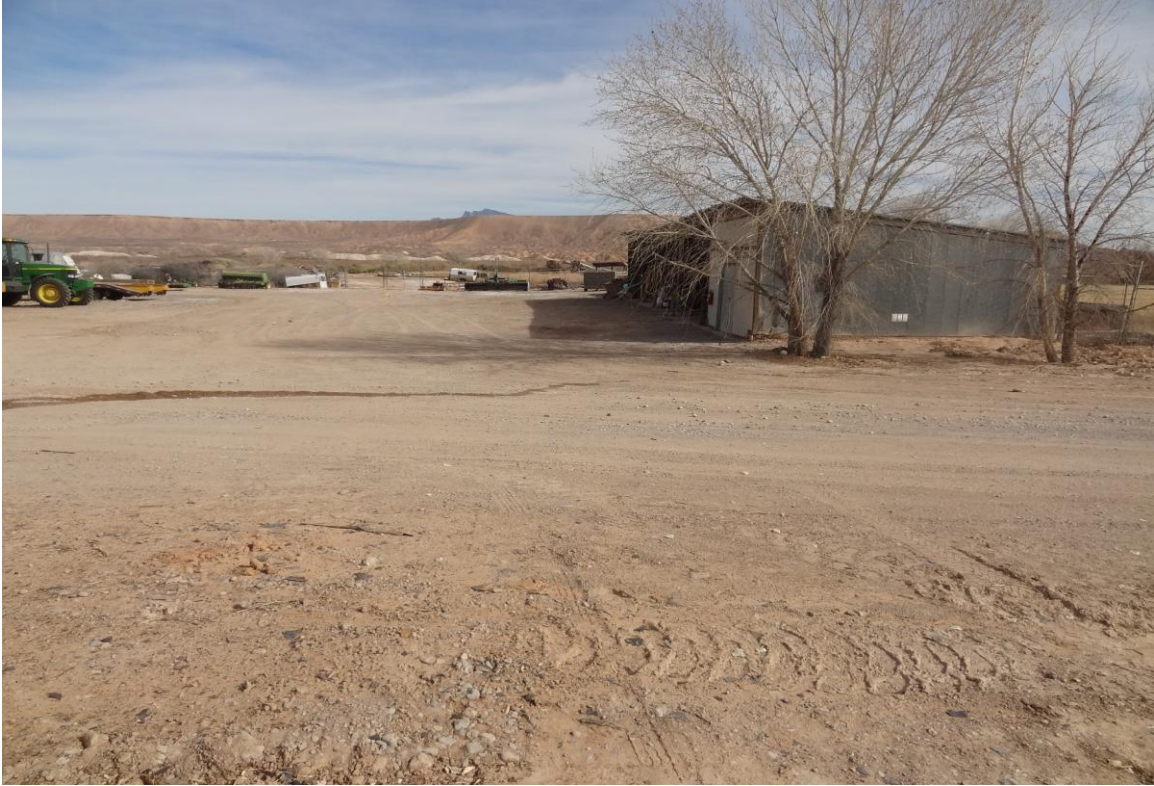
Overton Wildlife Management Area Site – FCA Site #9965  
Description: View of the maintenance yard area.

The majority of the fencing around the maintenance yard has failed and is due for replacement. This project recommends the installation of a 6 foot high 6 gauge wire perimeter chain link fence around the entire site with two 14' wide gates with hardware. The cost estimate also includes demolition and disposal of the existing fence.

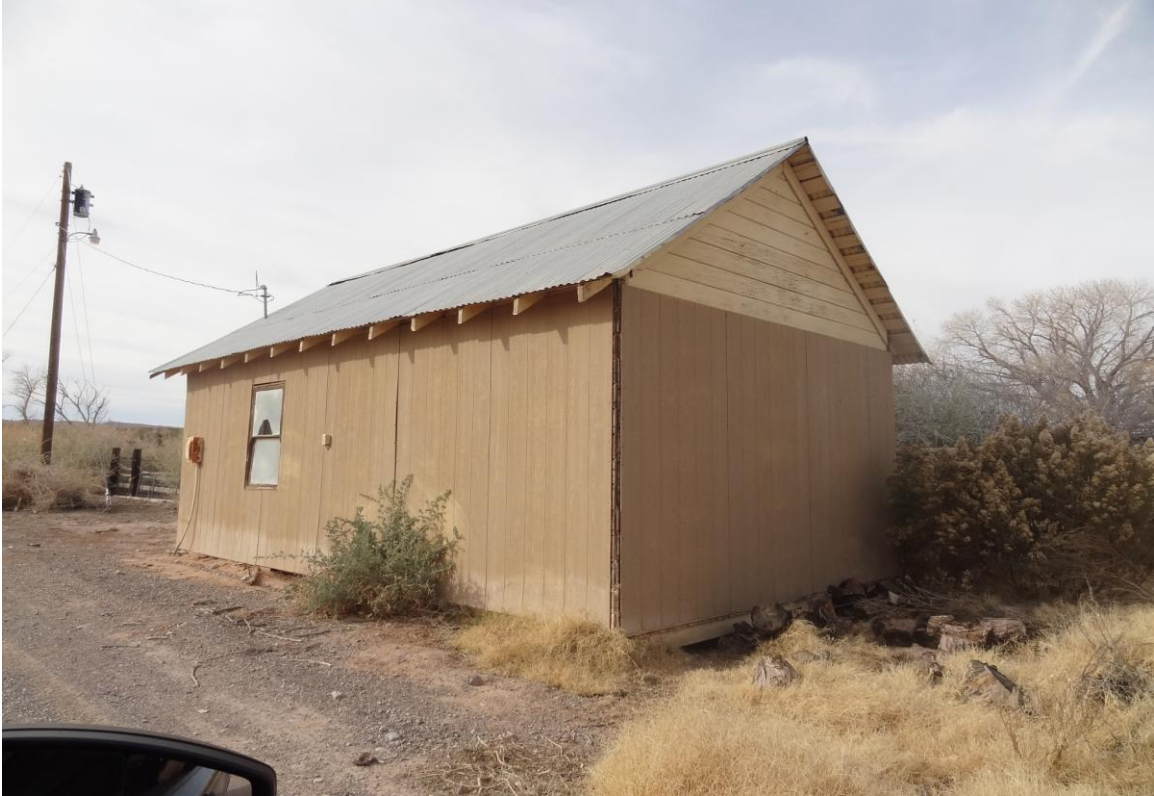
Employee Storage – FCA Building #0640  
Description: Exterior of the building.

The Employee Storage is a wood framed structure with a metal roofing system on a temporary foundation. It appears that it is an old ranch outbuilding that is now used for storage.

The existing exterior wood door appears to be original to the building. It is damaged from age and general wear and tear. This project would provide for the replacement of the wood door with a new metal door, frame and hardware. Removal and disposal of the existing door and painting of the new door is included in this estimate.

The corrugated metal roof on this building was in poor condition at the time of the survey. It is recommended that this building be re-roofed in the next 2-3 years with a standing seam metal roofing system. This estimate includes removal and disposal of the old roofing.

The windows are original, single pane construction in a wooden frame. These older windows are drafty, not energy efficient and the wooden frames have deteriorated significantly. This project recommends replacing the windows with dual pane, higher efficiency units. This estimate is for the replacement of 3 units including wooden frames. Removal and disposal of the existing windows is included in this estimate.

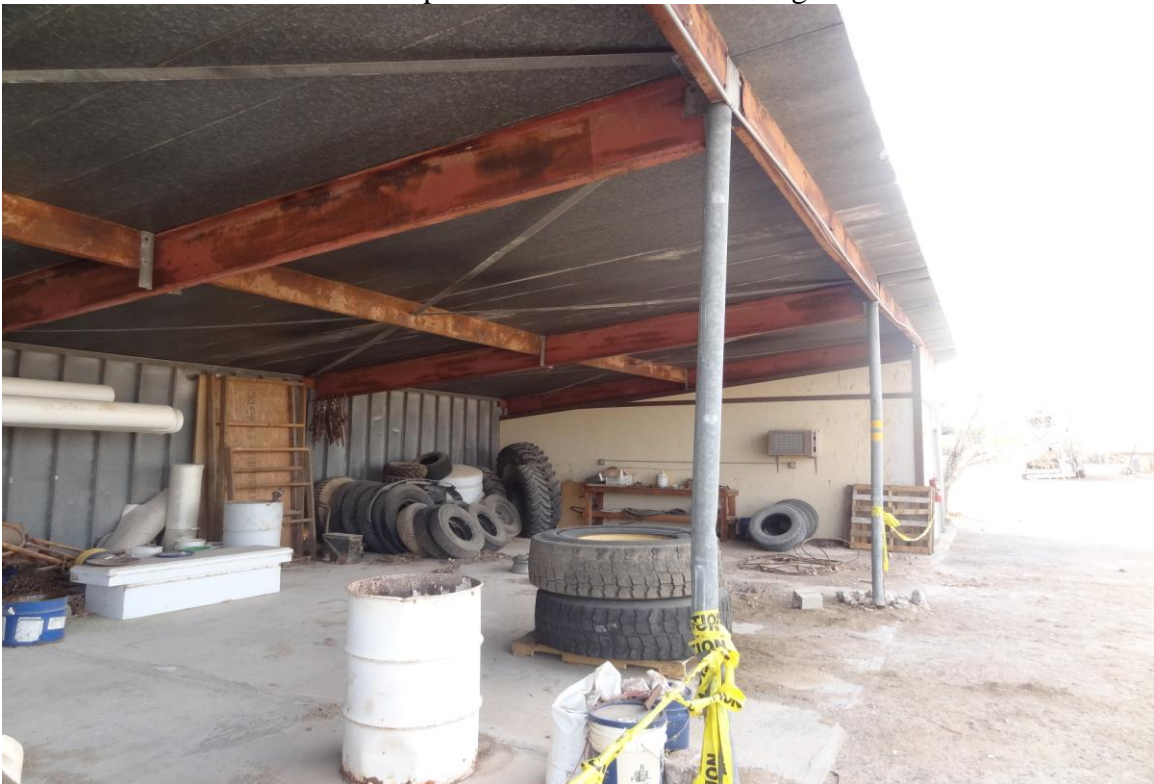
Equipment Storage – FCA Building #0641  
Description: Exterior of the structure.

The Equipment Storage is an old steel framed structure with a small enclosed storage room on the west side of building. It has metal roofing and a concrete foundation. The structure has several damaged support columns which will be addressed in the report.

The structure is over 70 years of age and is a safety hazard. The structural system has failed and the building should no longer be in use in any way. The main structural posts have detached from their footings, bolts are missing from the structural attachments, and the roof system has failed. This project would provide funding for the demolition and disposal of the building.

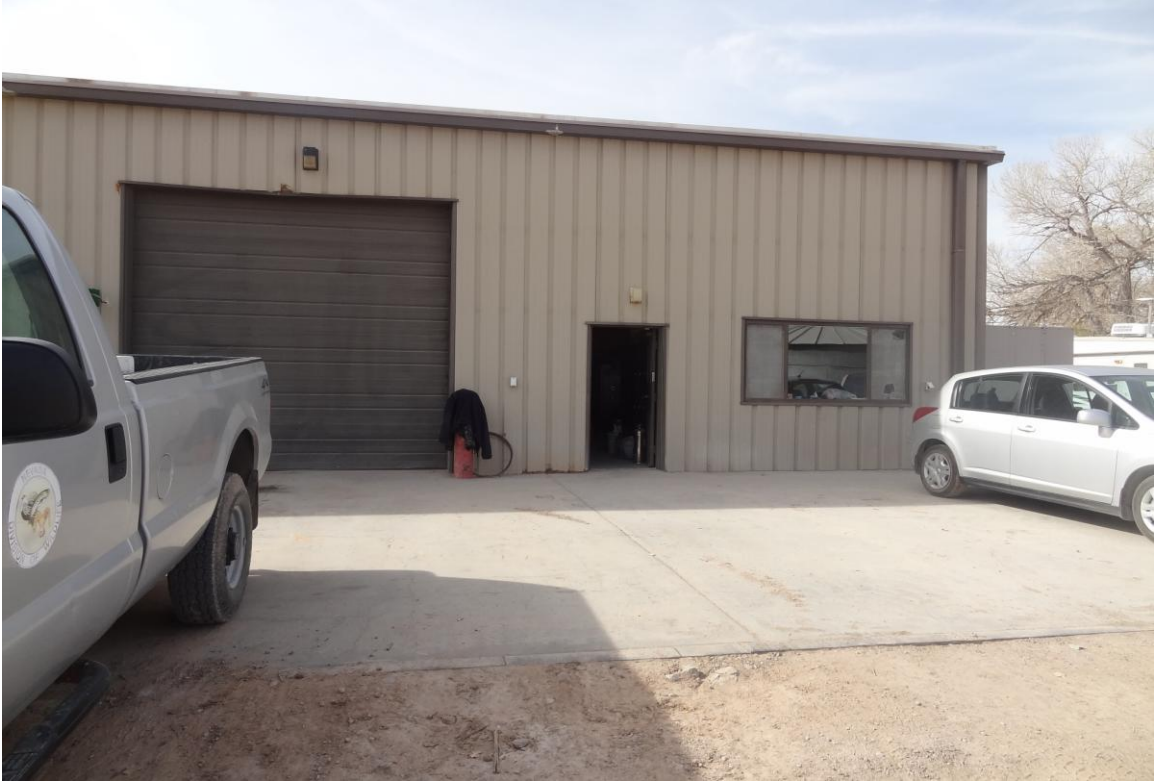
WMA Maintenance Shop – FCA Building #0660  
Description: Exterior of the building.

The Maintenance Shop is an engineered steel structure on a concrete foundation. There are 4 evaporative coolers and 2 ceiling hung heating units for the HVAC system. The facility is used for the storage, repair and maintenance of wildlife management area equipment.

There are two 10'x14' and one 10'x12' overhead doors which are damaged and do not function properly. Exposure and wind have caused the doors to bend, crack and lose their finish. They are original to the building and should be scheduled for replacement. This project would provide for the removal and disposal of the manually operated overhead coiling doors and replacement with new manually operated overhead coiling doors.

The windows are original, dual pane construction in a metal frame. These older windows are drafty and not energy efficient. This project recommends replacing the windows with dual pane, higher efficiency units. This estimate is for the replacement of 4 units. Removal and disposal of the existing windows is included in this estimate.

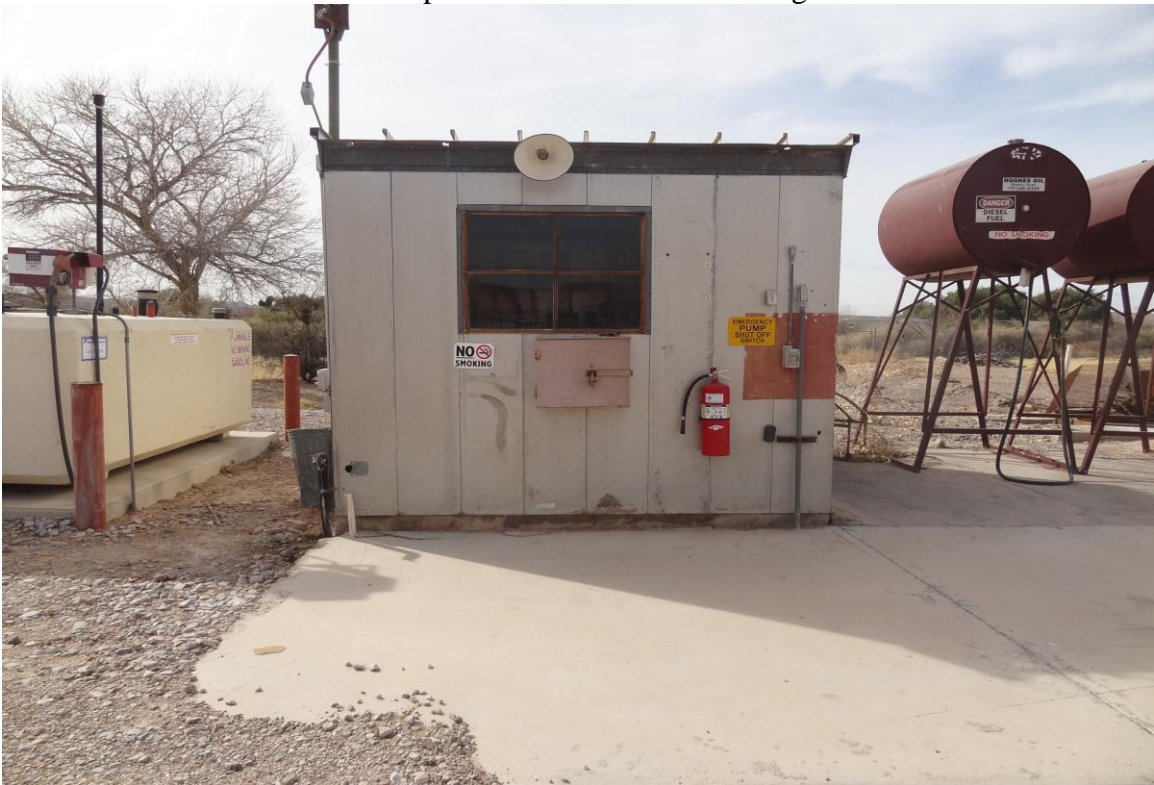
Oil Storage Shed – FCA Building #0915  
Description: Exterior of the building.

The existing sodium halide pole light on the exterior of the building is broken and is not energy efficient. This project will upgrade the fixture to a more energy efficient high-pressure sodium or LED lamp. These types of lights will provide better illumination and save energy.

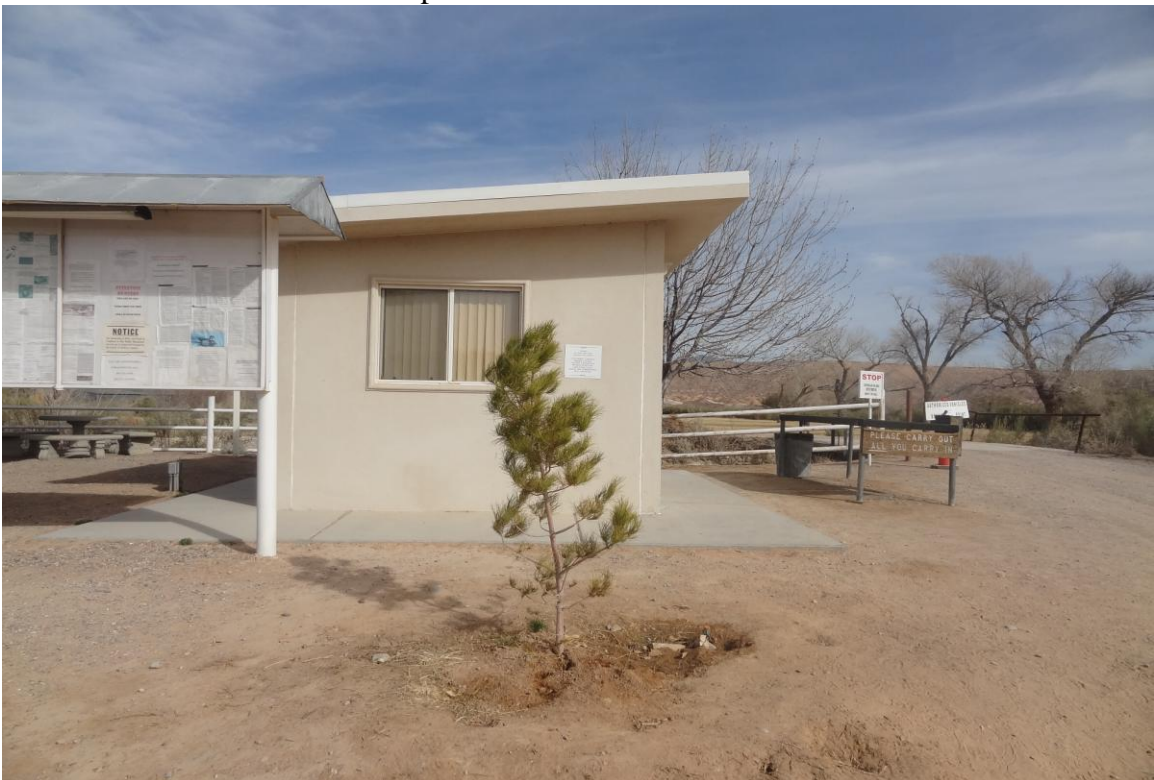
Check Station Fee Booth – FCA Building #0918  
Description: Exterior of the building.

The Check Station - Fee Booth is a prefabricated structure with EIFS panels on the exterior, a rolled composition roofing system on a concrete foundation. There is a wall mounted split HVAC system in the interior and the building is primarily used during hunting season only for tracking hunters and hunting activity. It is located along the main entrance road to the wildlife management area.

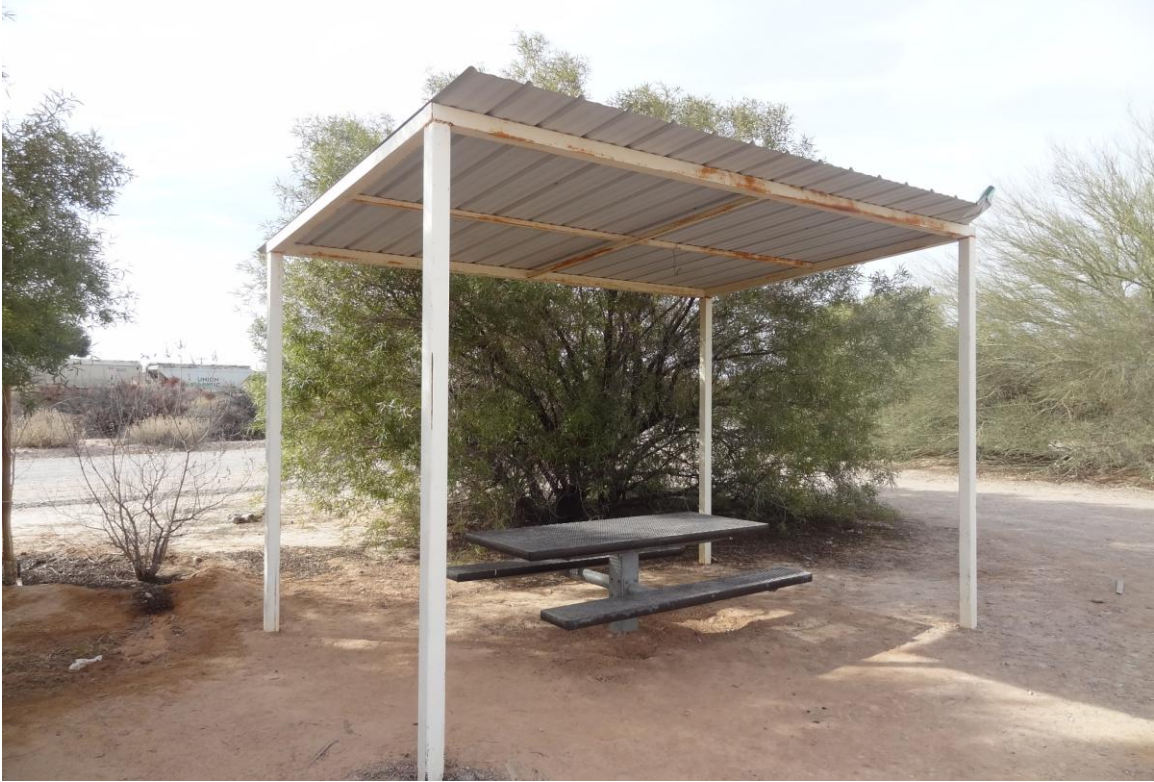
Typical Shade Ramada – FCA Building #2215-2220  
Description: Exterior of the structure.

There are 7 steel shade ramadas throughout the site which are either 120 s.f., 240 s.f. or 576 s.f. for a total of 1,416 square feet. It is important to maintain the finish, weather resistance and appearance of the structures. This project would provide for painting of the structures and it is recommended that this project is scheduled on a cyclical basis to maintain the integrity of the structures.

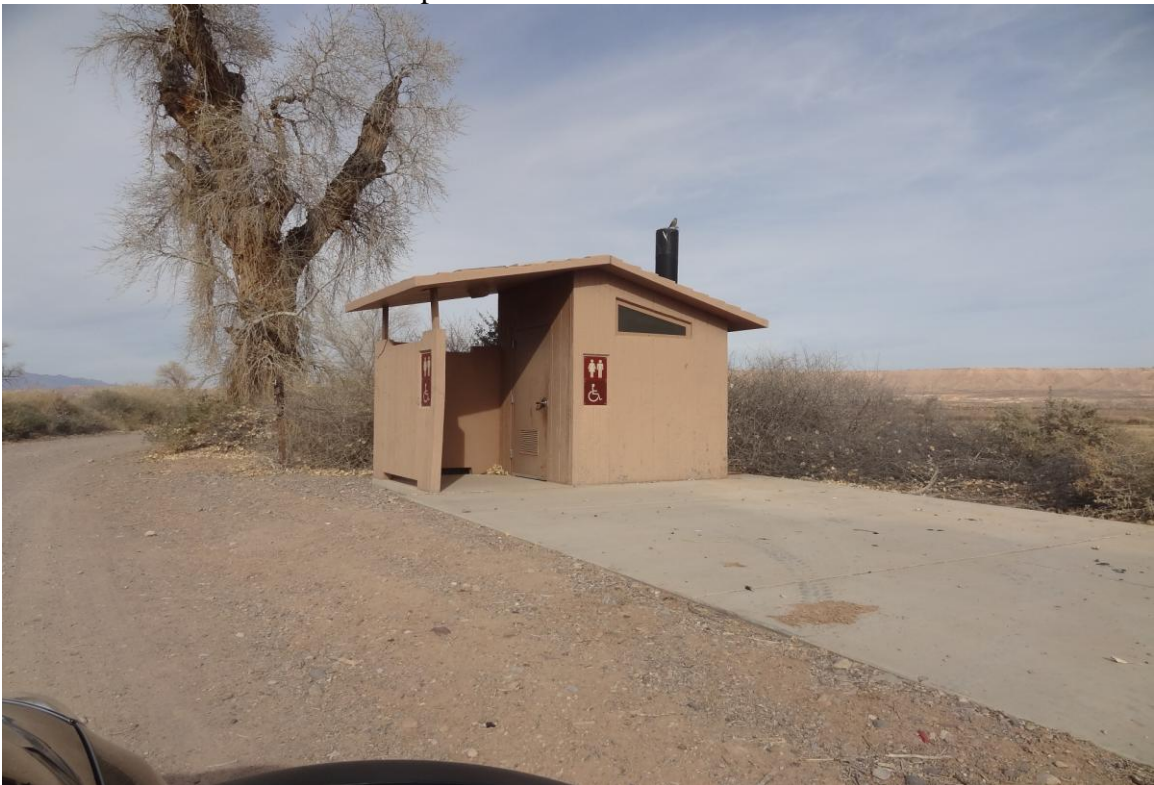
CXT ADA Comfort Station – FCA Building #2221  
Description: Exterior of the building.

The Comfort Station is a precast unisex ADA compliant restroom located in the wildlife management area. It has a concrete parking area but is lacking signage and striping. There is some damage to the privacy wall and roof.

The Americans with Disabilities Act (ADA) provides for accessibility to sites and services for people with physical limitations. The concrete parking area and passenger loading area are missing proper signage and striping to comply with ADA requirements. This project would provide for striping, signage and any other necessary upgrades to the parking space. The 2012 IBC, ICC/ANSI A117.1 - 2009, NRS 338.180 and the most current version of the ADA Standards For Accessible Design were used as a reference for this project.

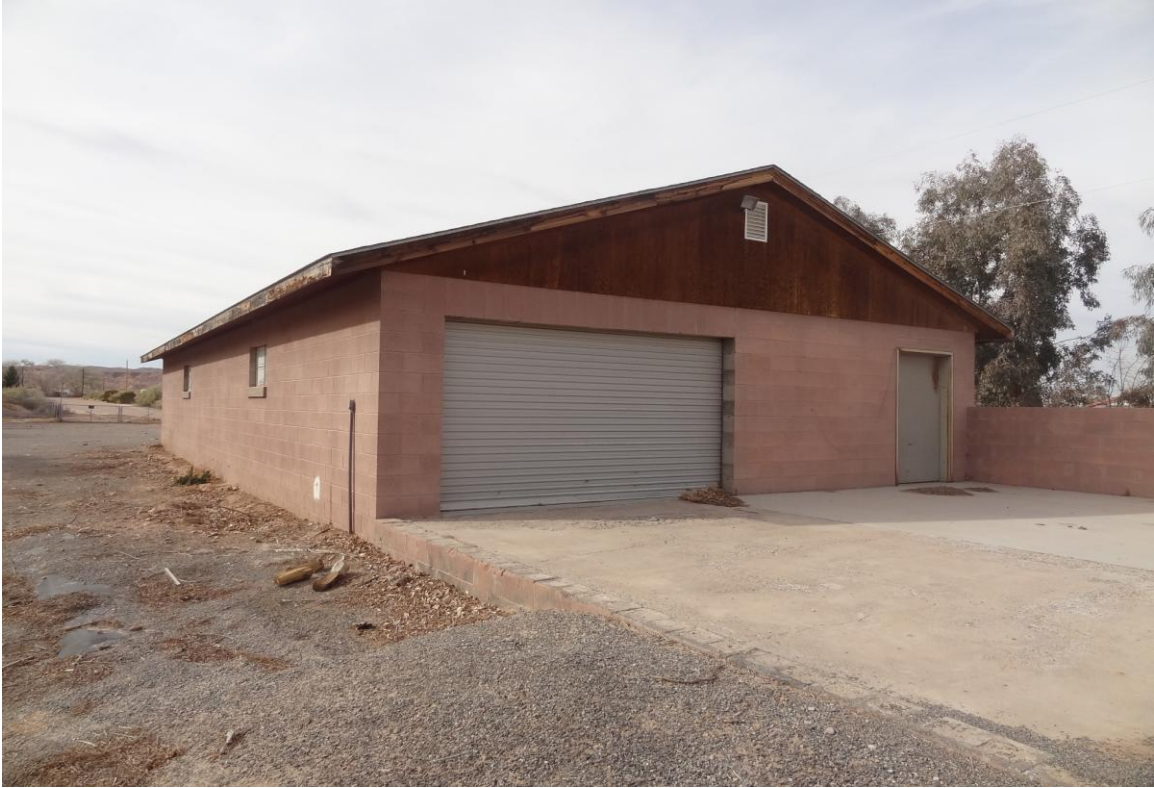
Employee Storage – Field Shop – FCA Building #3030  
Description: Exterior of the building.

The Employee Storage - Field Shop is a concrete masonry unit and wood framed structure with an asphalt composition roofing system on a concrete slab-on-grade foundation. It is primarily used for storage of equipment used by the staff of the wildlife management area.

The asphalt composition shingle roof on this building was in poor condition at the time of the survey. Several shingles had blown off and many others were partially detached and failing. It is recommended that this building be re-roofed in the next 1-2 years with a new 50 year asphalt composition roofing shingle and new underlayments. This estimate includes removal and disposal of the old roofing.

The exterior metal doors are damaged from age and general wear and tear and have reached the end of their expected life. This project would provide for the replacement of the two door assemblies with new metal doors, frames and hardware. Removal and disposal of the existing doors is included in this estimate.
