STATE OF NEVADA  
STATE PUBLIC WORKS DIVISION

FACILITY CONDITION ASSESSMENT REPORT FOR:

DEPT OF CORRECTIONS  
THREE LAKES VALLEY CONSERVATION CAMP

Survey Date: 4/19/2022  
Distribution Date: 8/24/2023

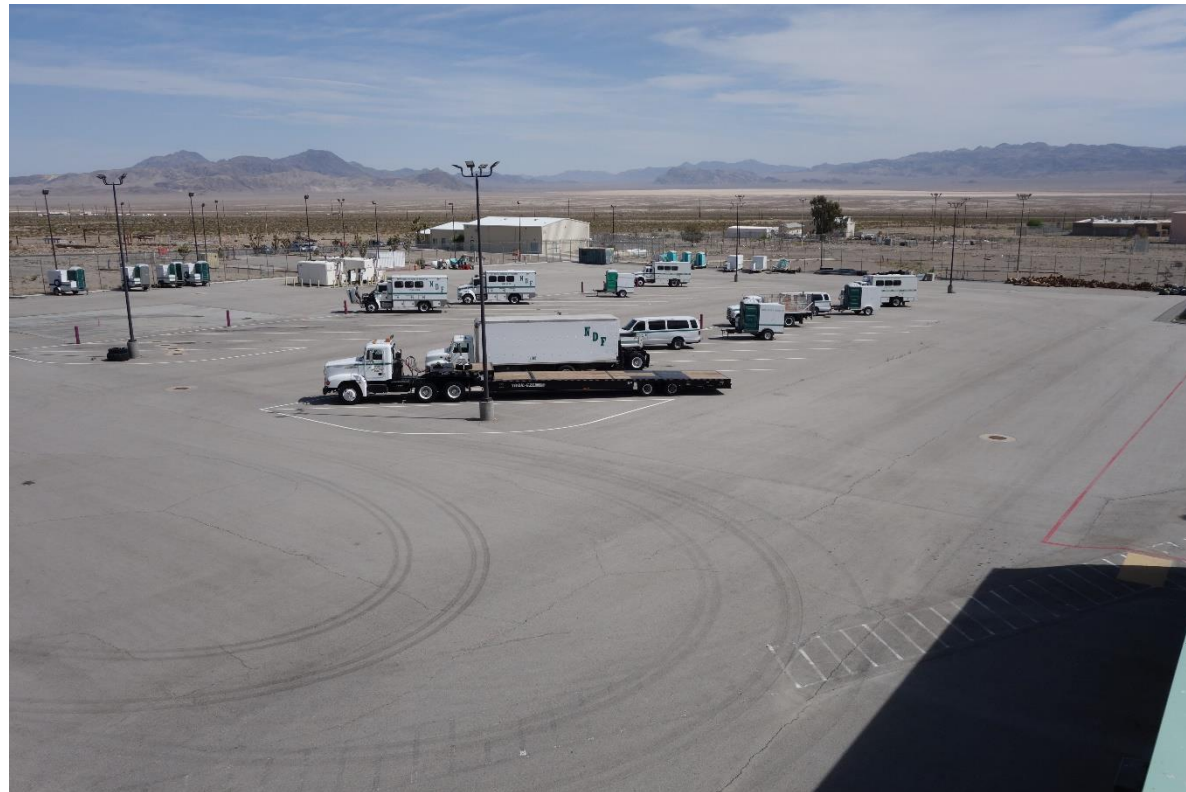
**CRACK FILL & SEAL ASPHALT PAVING**

It is important to maintain the asphalt concrete paving on the site. This project would provide for minor crack filling and sealing of the paving site wide including access roads, parking areas and the maintenance yard. Striping is included in this estimate. This project should be scheduled on a 5-year cyclical basis to maintain the integrity of the paving and prevent premature failure. 415,000 square feet of asphalt area was used to generate this estimate.

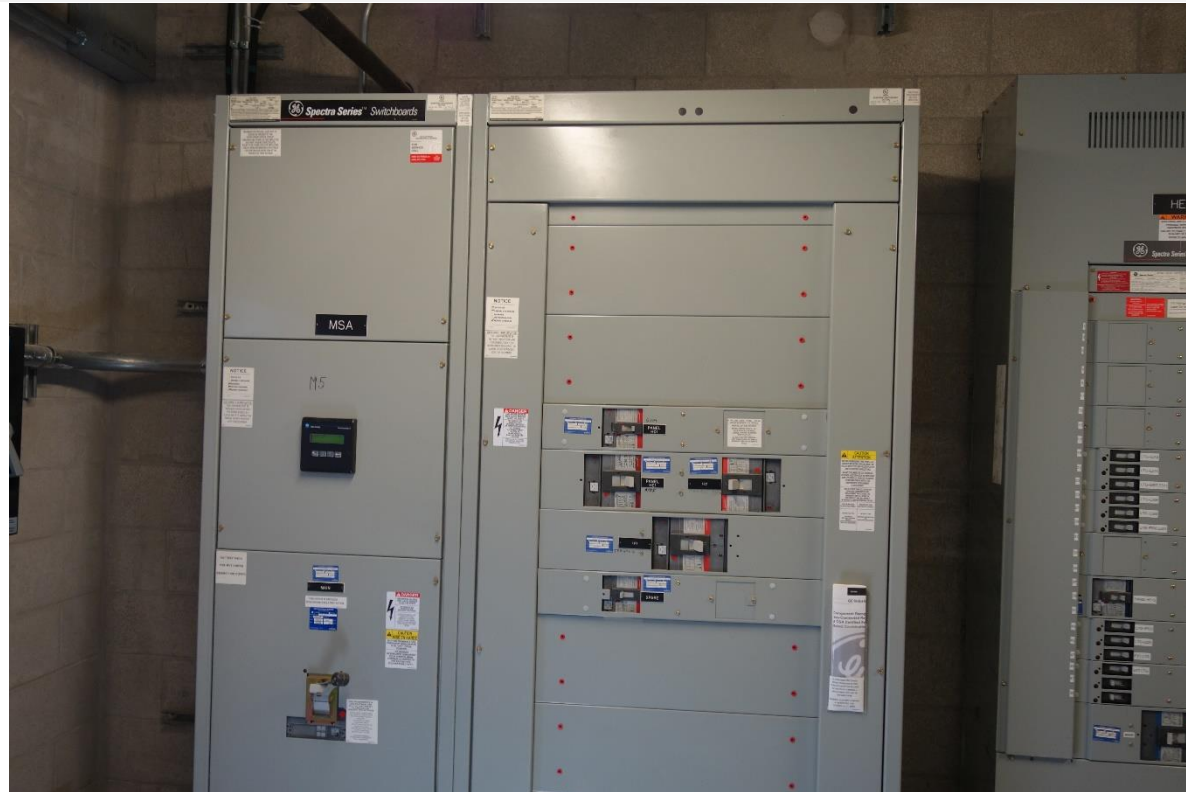
Arc flash and electrical breaker coordination studies have not been performed or it has been more than 5 years since the last coordination study. Safety requirements for maintenance personnel and the latest electrical code require coordination studies to be verified and performed every 5 years, along with arc flash labeling on all electrical panels. This project will perform the required coordination study, evaluation, adjustments and labeling for the building's electrical distribution system.

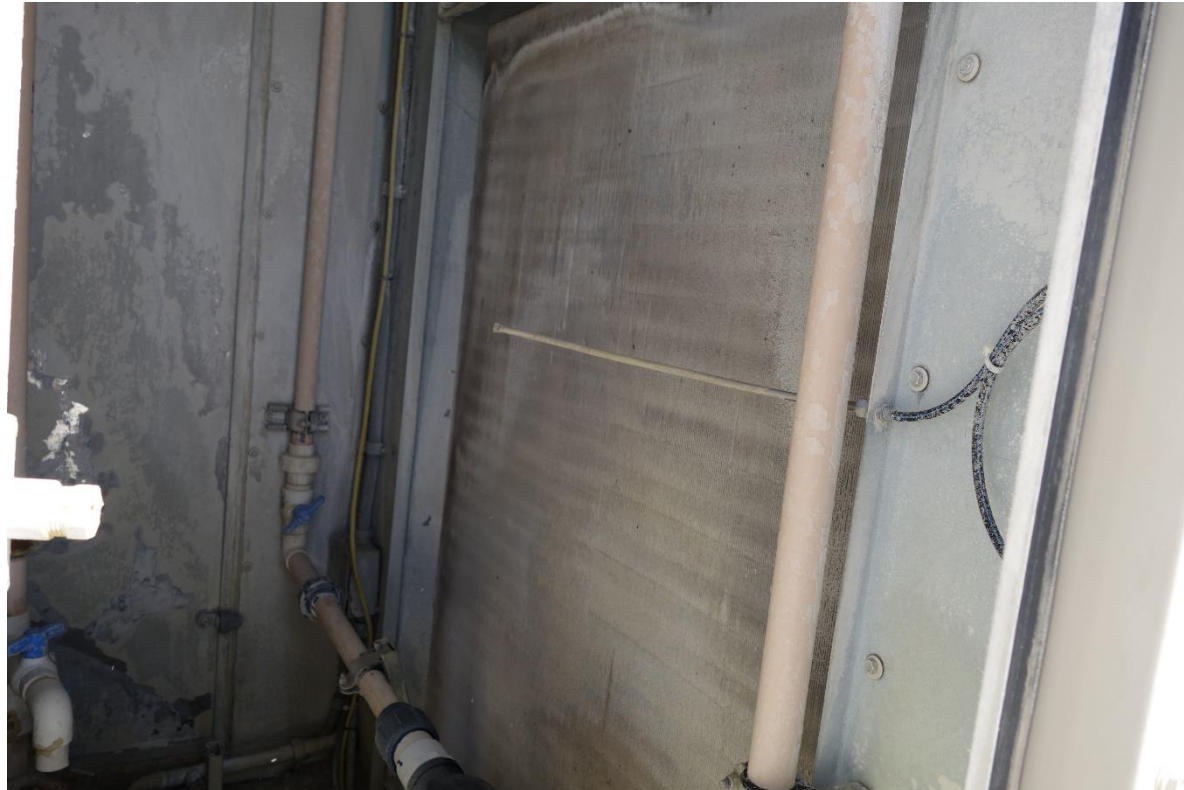
A visual survey of the two evaporatively cooled air handling units (AHU's) are failing prematurely and reducing their expected life. Lack of maintenance has caused the heating coil to plug with mineral scale due to moisture carry-over from the evaporative cooling section. Moisture carry-over is indicative of air velocities well above the unit specifications caused by a lack of air balance. The severe degree of scaling renders coil cleaning ineffective and a complete replacement of the heating coil is recommended.

Additionally, the AHU's exterior surfaces are

showing signs of corrosion likely caused by the same moisture carry-over. This project will fund the removal and replacement of the heating coils, a full AHU maintenance rehabilitation, new blow-down controls on the evaporative sump, water treatment (Nu-Calgon slow dissolving scale and corrosion inhibitor) and air balance. With proper maintenance, this project should restore the AHU to its expected useful life.

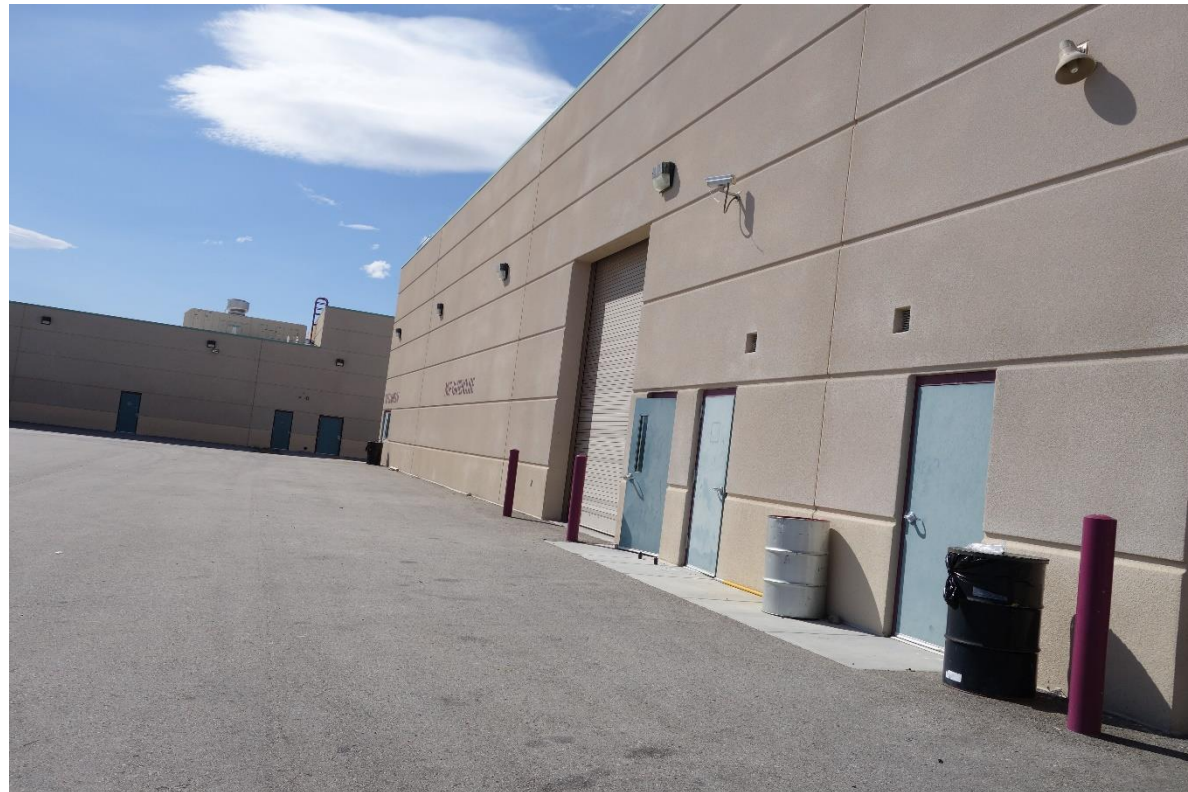
The exterior finishes were in fair condition. It is important to maintain the finish, weather resistance and appearance of the building. This project would provide funding to protect the exterior of the building excluding the roof. Included in the cost is power washing, priming and painting and caulking of the windows, flashing, fixtures and all other penetrations. It is recommended that the building be painted in the next 4 - 6 years and that this project be scheduled on a cyclical basis to maintain the integrity of the structure.

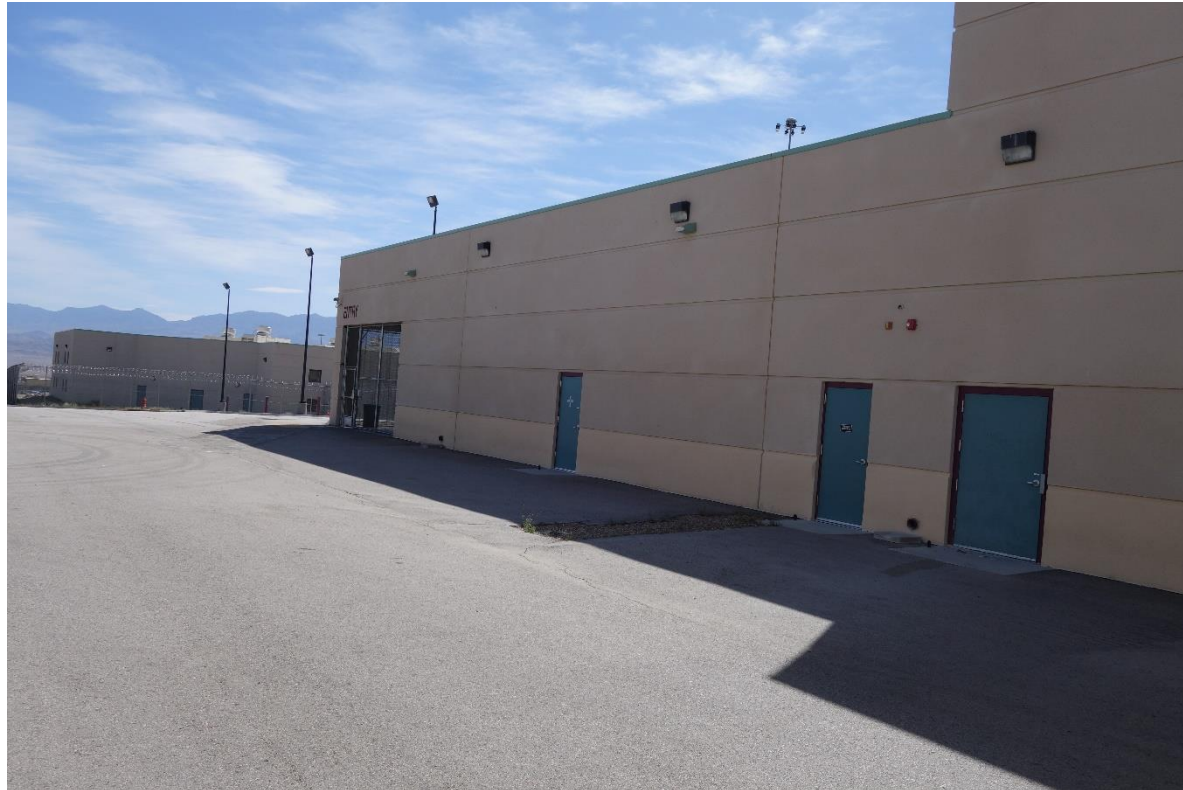
The building mounted wall pack lights appear to be original to the building. These fixtures have high pressure sodium (HPS) lamps and are less efficient. This project would provide for the replacement of the existing wall pack fixtures with LED wall packs using the existing wiring.

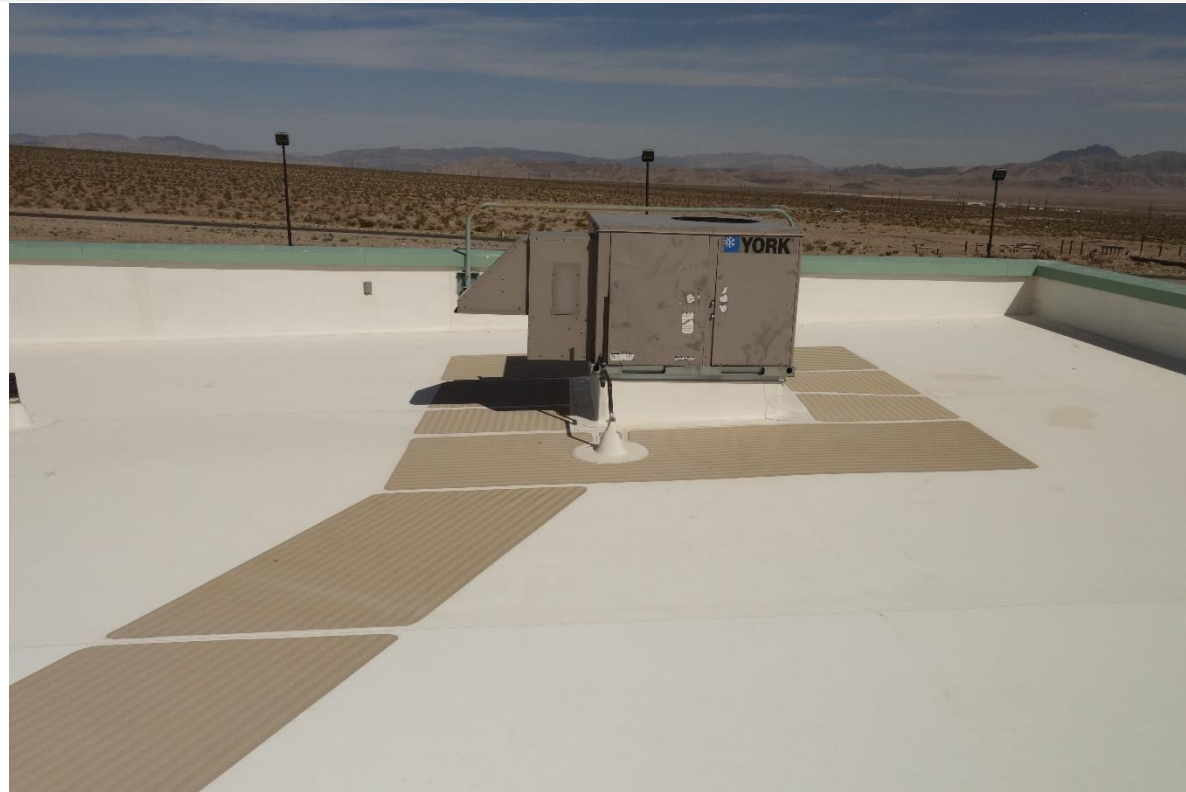
**HVAC EQUIPMENT REPLACEMENT**

There are 3 rooftop packaged HVAC heat pump units and 2 mini splits installed in 2010 recommended to be replaced in the next 10 years. Included in this estimate are new curb adapters, crane and rigging for removal and installation and all required connections to utilities.

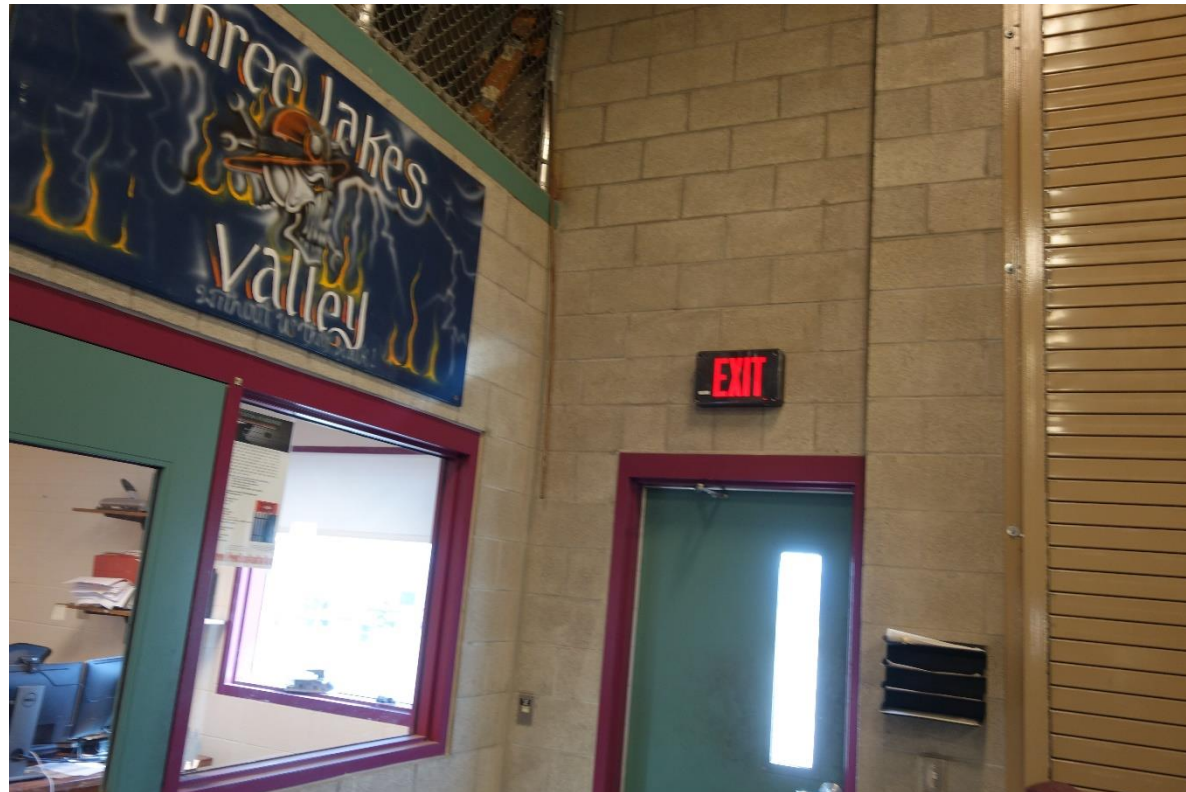
The interior finishes were in good condition. It is recommended that the interior walls and ceilings be painted at least once in the next 7 - 9 years and that this project be scheduled on a cyclical basis to maintain the integrity of the structure. Prior to painting, all surfaces should be repaired and prepped. An epoxy-based paint should be utilized in wet areas for durability.

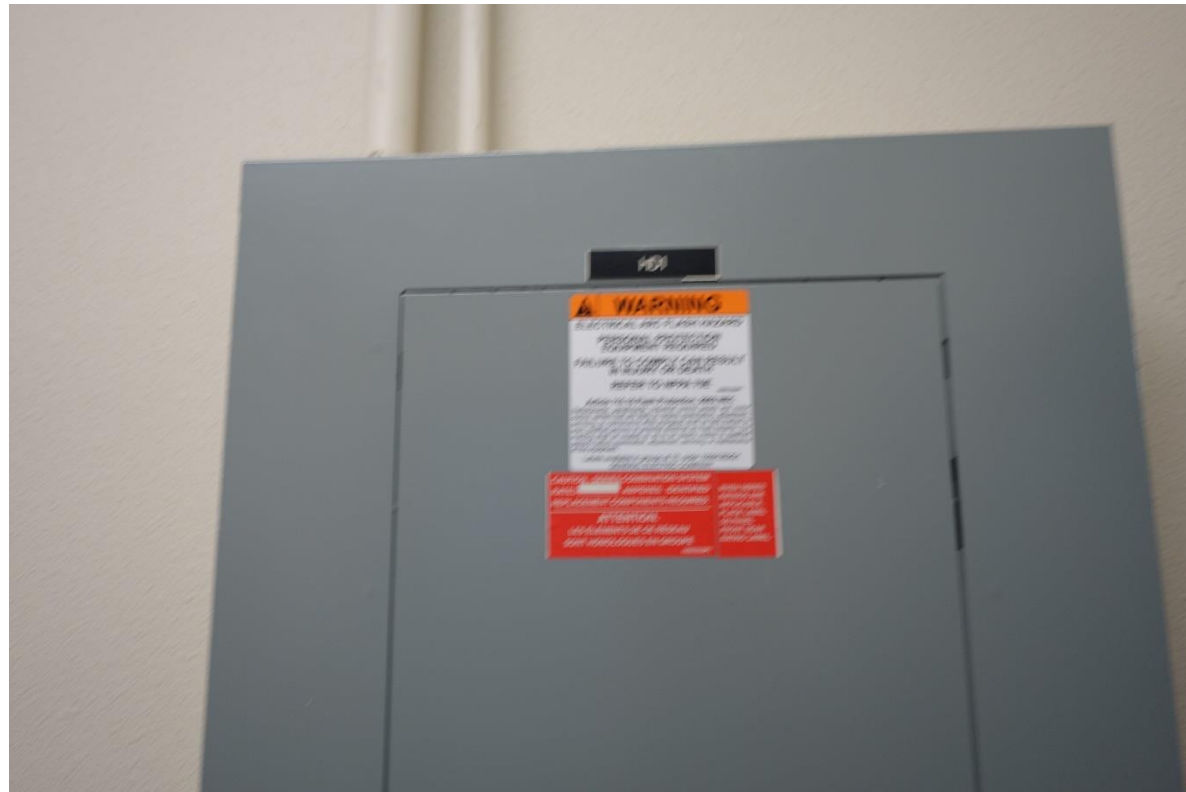
Arc flash and electrical breaker coordination studies have not been performed or it has been more than 5 years since the last coordination study. Safety requirements for maintenance personnel and the latest electrical code require coordination studies to be verified and performed every 5 years, along with arc flash labeling on all electrical panels. This project will perform the required coordination study, evaluation, adjustments and labeling for the building's electrical distribution system.

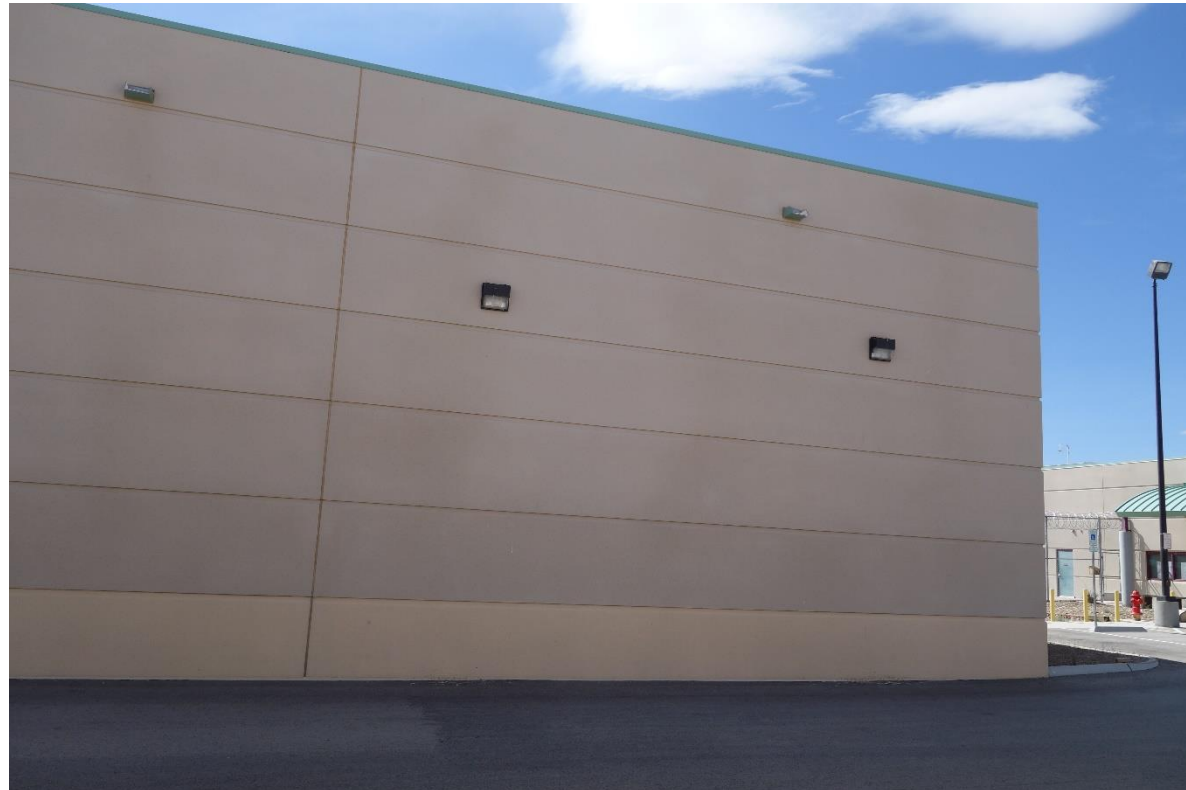
The exterior finishes were in fair condition. It is important to maintain the finish, weather resistance and appearance of the building. This project would provide funding to protect the exterior of the building excluding the roof. Included in the cost is power washing, priming and painting and caulking of the windows, flashing, fixtures and all other penetrations. It is recommended that the building be painted in the next 4 - 6 years and that this project be scheduled on a cyclical basis to maintain the integrity of the structure.

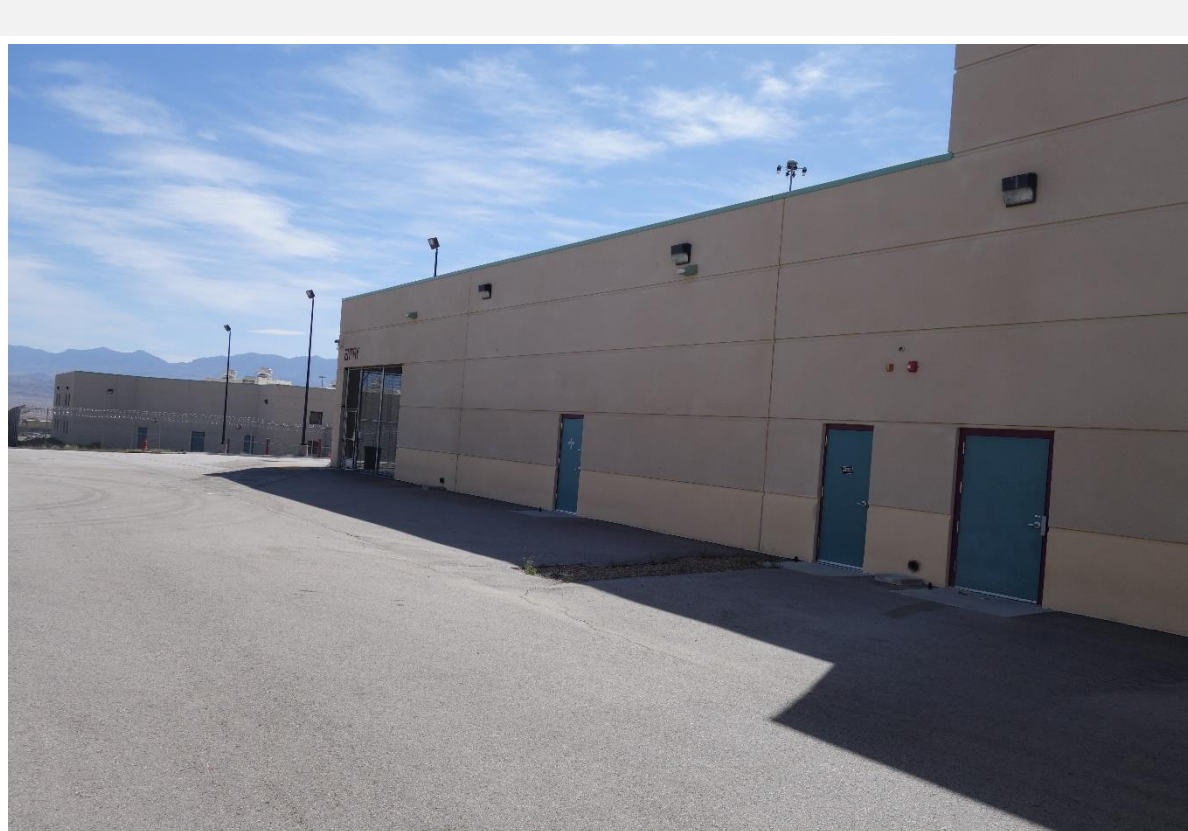
The building mounted wall pack lights appear to be original to the building. These fixtures have high pressure sodium (HPS) lamps and are less efficient. This project would provide for the replacement of the existing wall pack fixtures with LED wall packs using the existing wiring.

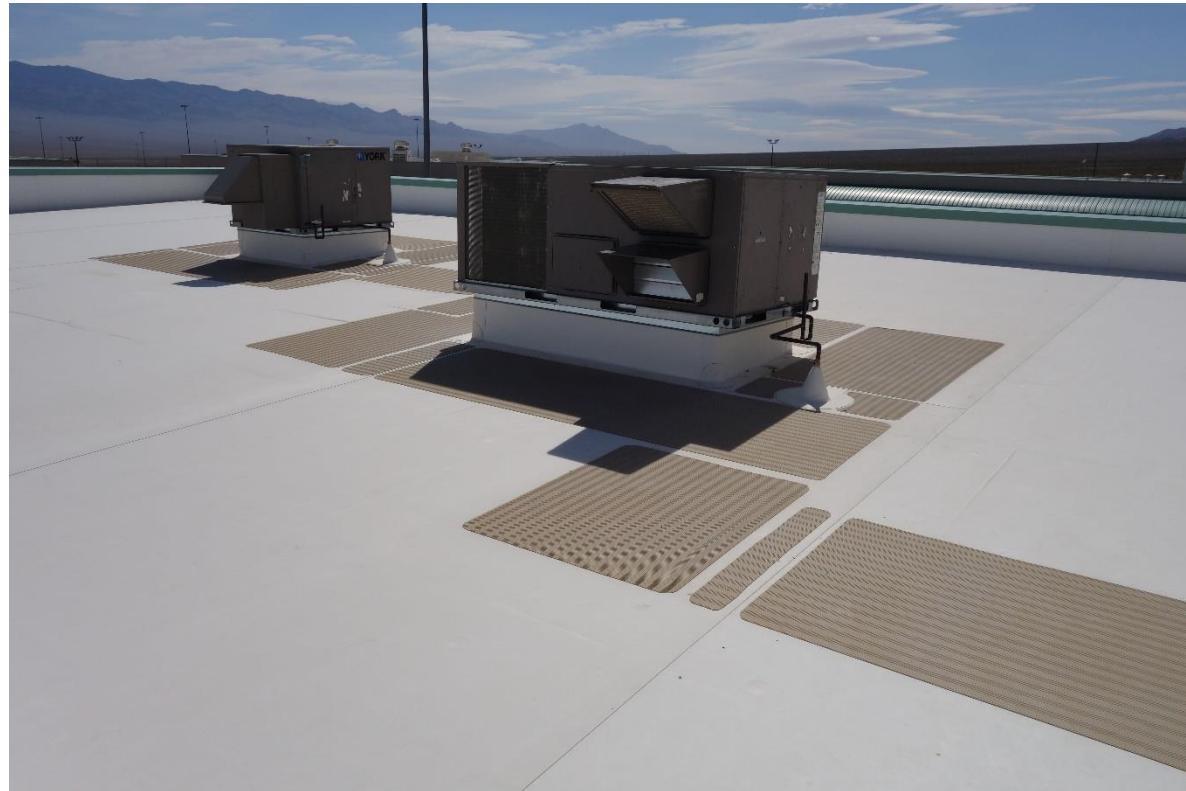
**HVAC EQUIPMENT REPLACEMENT**

There are 4 rooftop packaged HVAC heat pump units and 1 mini split installed in 2010 recommended to be replaced in the next

10 years. Included in this estimate are new curb adapters, crane and rigging for removal and installation and all required connections to utilities.

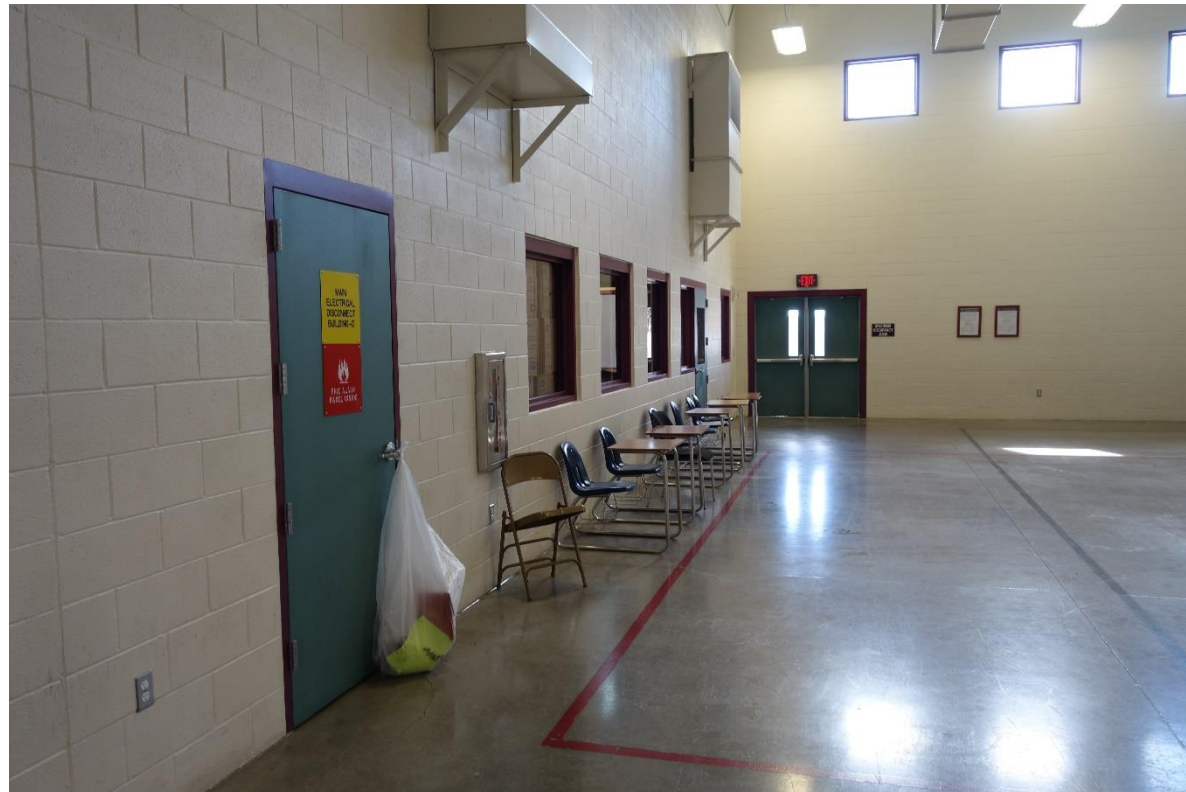
The interior finishes are in good condition. It is recommended that the interior walls and ceilings be painted at least once in the next 7 - 9 years and that this project be scheduled on a cyclical basis to maintain the integrity of the structure. Prior to painting, all surfaces should be repaired and prepped. An epoxy-based paint should be utilized in wet areas for durability.

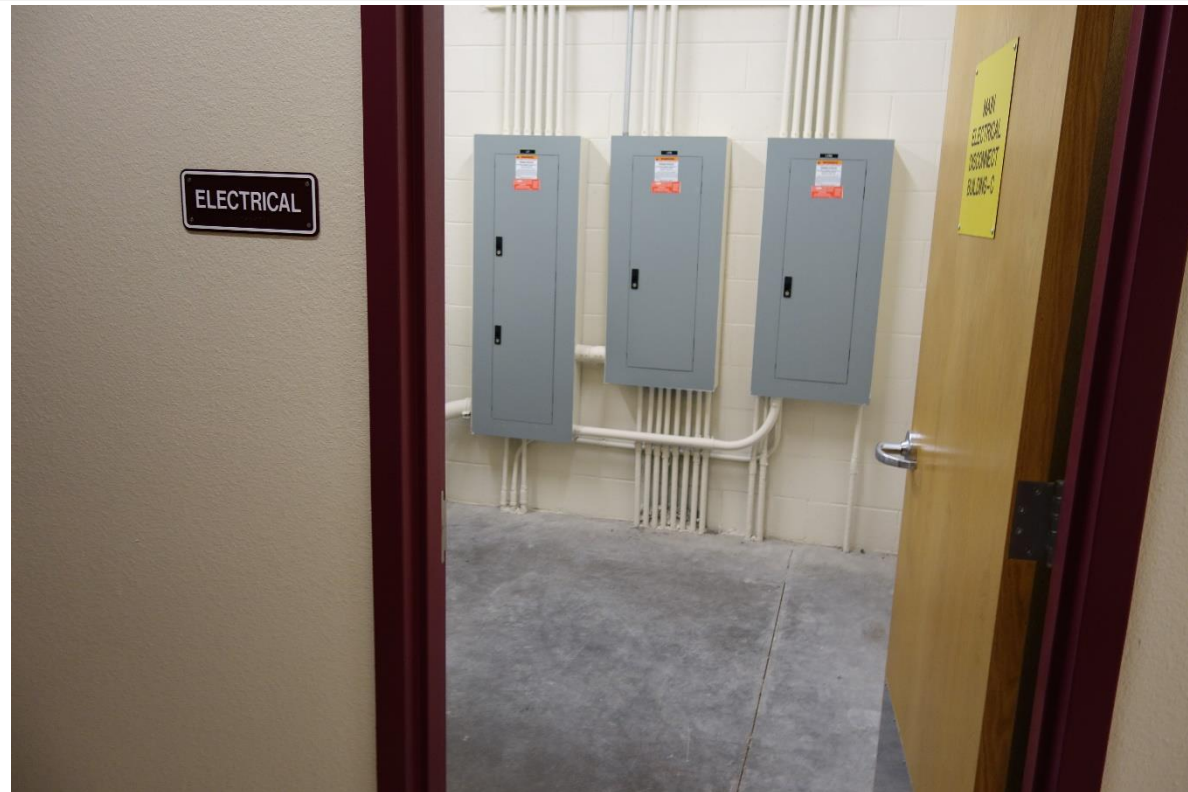
Arc flash and electrical breaker coordination studies have not been performed or it has been more than 5 years since the last coordination study. Safety requirements for maintenance personnel and the latest electrical code require coordination studies to be verified and performed every 5 years, along with arc flash labeling on all electrical panels. This project will perform the required coordination study, evaluation, adjustments and labeling for the building's electrical distribution system.

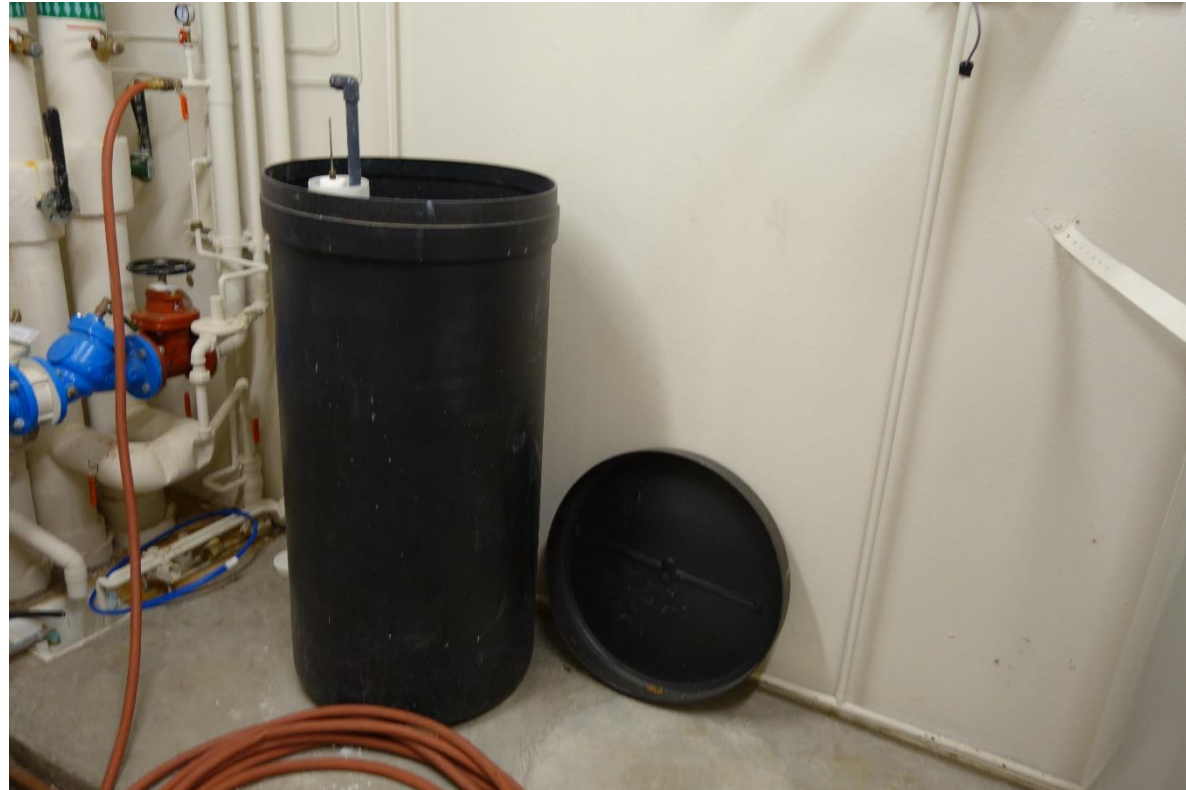
**WATER TREATMENT SYSTEM REPLACEMENT**

The existing water softening treatment system in the building was not operational at the time of the survey. Failure of the water softening/ treatment system causes additional wear and tear on the domestic water supply lines, water heaters and plumbing fixtures. This project would replace the existing water softener / treatment system with new equipment.

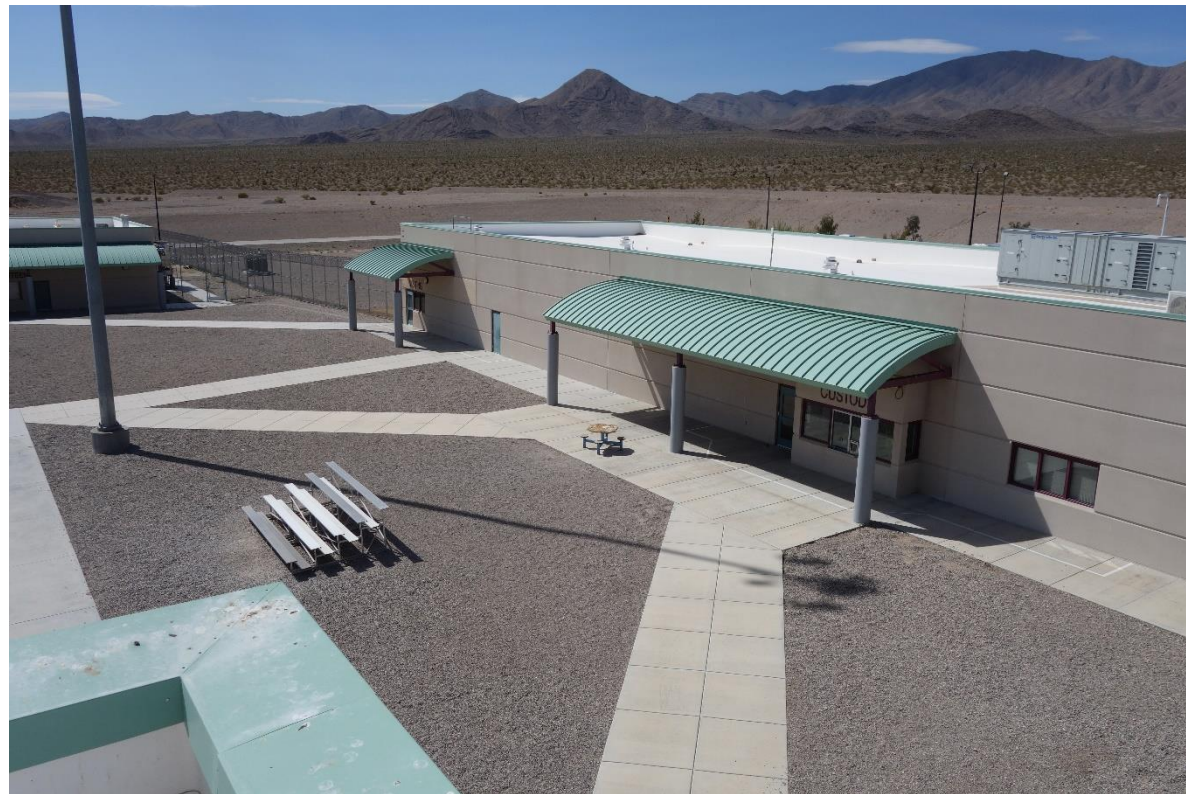
The exterior finishes were in good condition. It is important to maintain the finish, weather resistance and appearance of the building. This project would provide funding to protect the exterior of the building excluding the roof. Included in the cost is power washing, priming and painting and caulking of the windows, flashing, fixtures and all other penetrations. It is recommended that the building be painted in the next 7 - 9 years and that this project be scheduled on a cyclical basis to maintain the integrity of the structure.

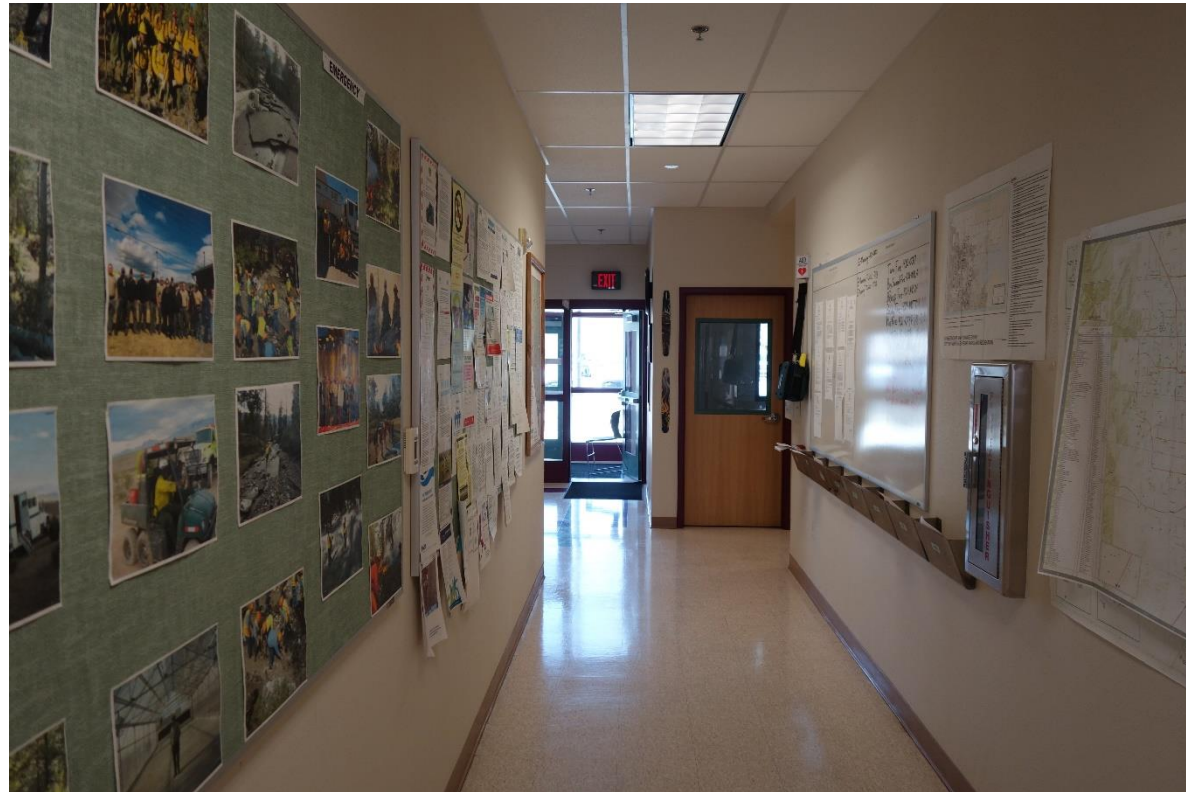
The interior finishes are in good condition. It is recommended that the interior walls and ceilings be painted at least once in the next 6 - 8 years and that this project be scheduled on a cyclical basis to maintain the integrity of the structure. Prior to painting, all surfaces should be repaired and prepped. An epoxy-based paint should be utilized in wet areas for durability.

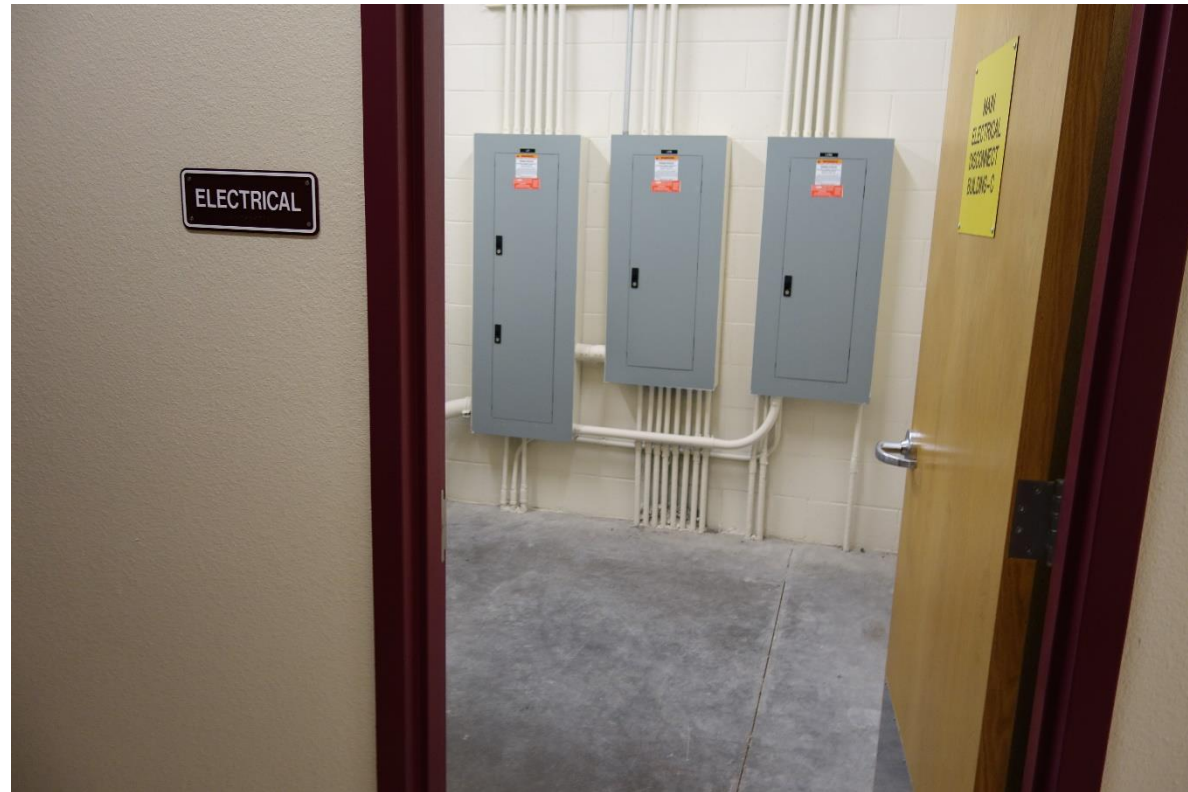
Arc flash and electrical breaker coordination studies have not been performed or it has been more than 5 years since the last coordination study. Safety requirements for maintenance personnel and the latest electrical code require coordination studies to be verified and performed every 5 years, along with arc flash labeling on all electrical panels. This project will perform the required coordination study, evaluation, adjustments and labeling for the building's electrical distribution system.

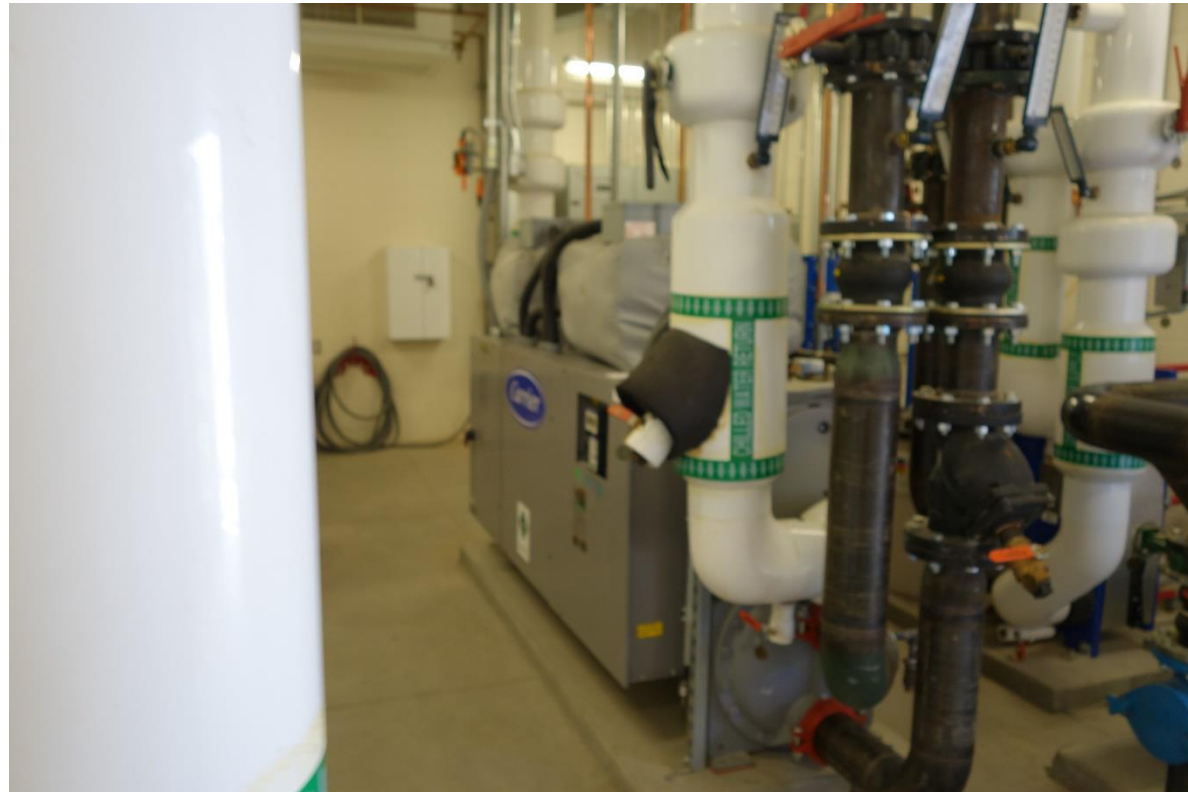
**CENTRAL PLANT REPLACEMENT**

Most of the major components of the HVAC central plant are original equipment and are approximately 12 years old. The equipment is halfway through its serviceable life and should be planned for replacement.

Replacement equipment will be more reliable, efficient, and will include code-required safety provisions that are not currently installed. The temperature controls will be upgraded to improve energy efficiency. This project will replace the

existing central plant equipment including chiller, cooling tower, chilled water heat exchanger, boilers, water heaters and associated pumps and accessories.

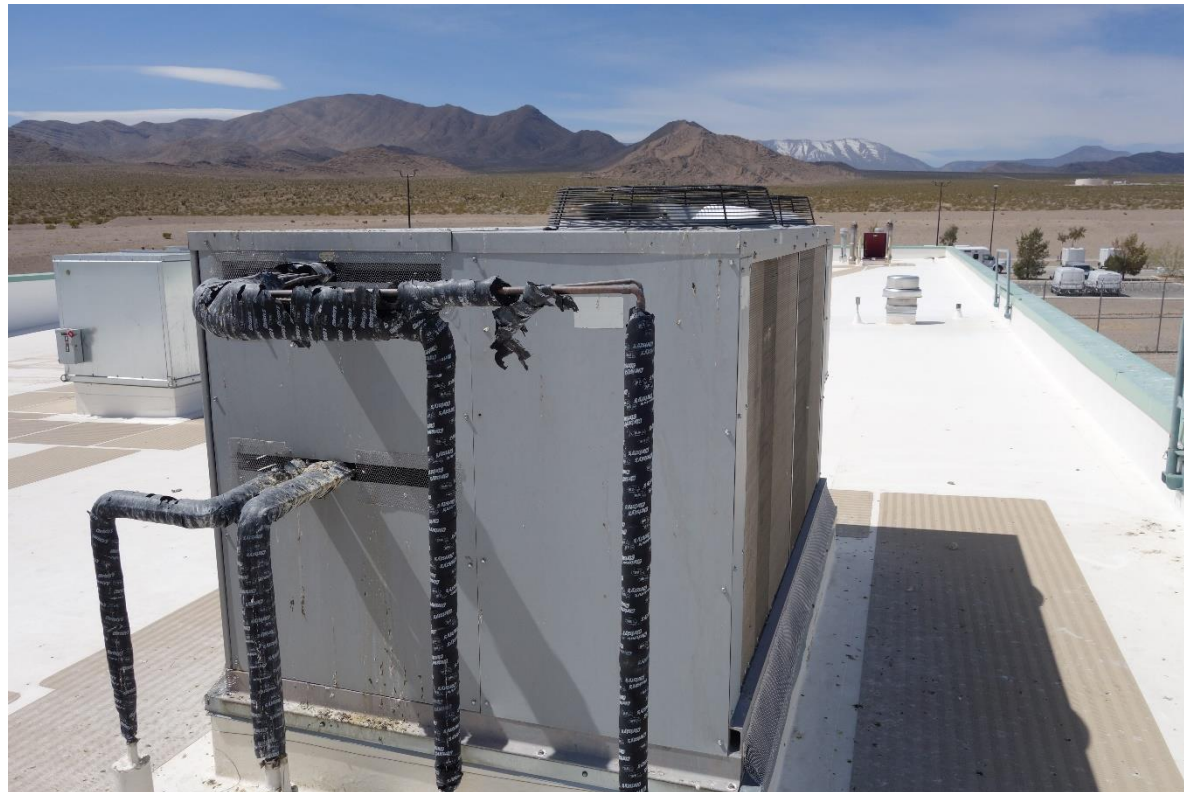
**CULINARY REFRIGERATION EQUIPMENT REPLACEMENT**

The culinary refrigeration systems for the walk-in coolers and freezers have reached the mid-point of their expected life and should be planned for replacement in the next 10 years. This project will replace the refrigeration components of the walk-in freezer and coolers. Removal of existing equipment and connection to the required utilities is included in this estimate.

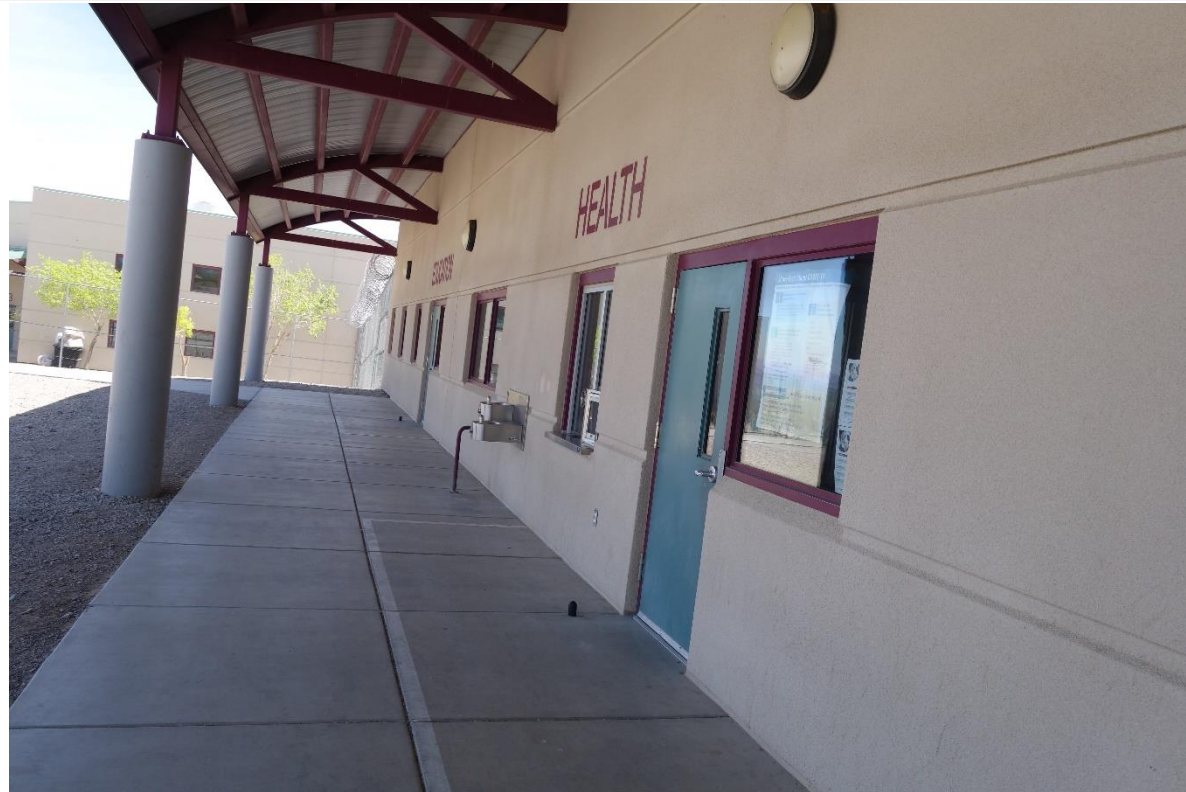
The exterior finishes were in good condition. It is important to maintain the finish, weather resistance and appearance of the building. This project would provide funding to protect the exterior of the building excluding the roof. Included in the cost is power washing, priming and painting and caulking of the windows, flashing, fixtures and all other penetrations. It is recommended that the building be painted in the next 7 - 9 years and that this project be scheduled on a cyclical basis to maintain the integrity of the structure.

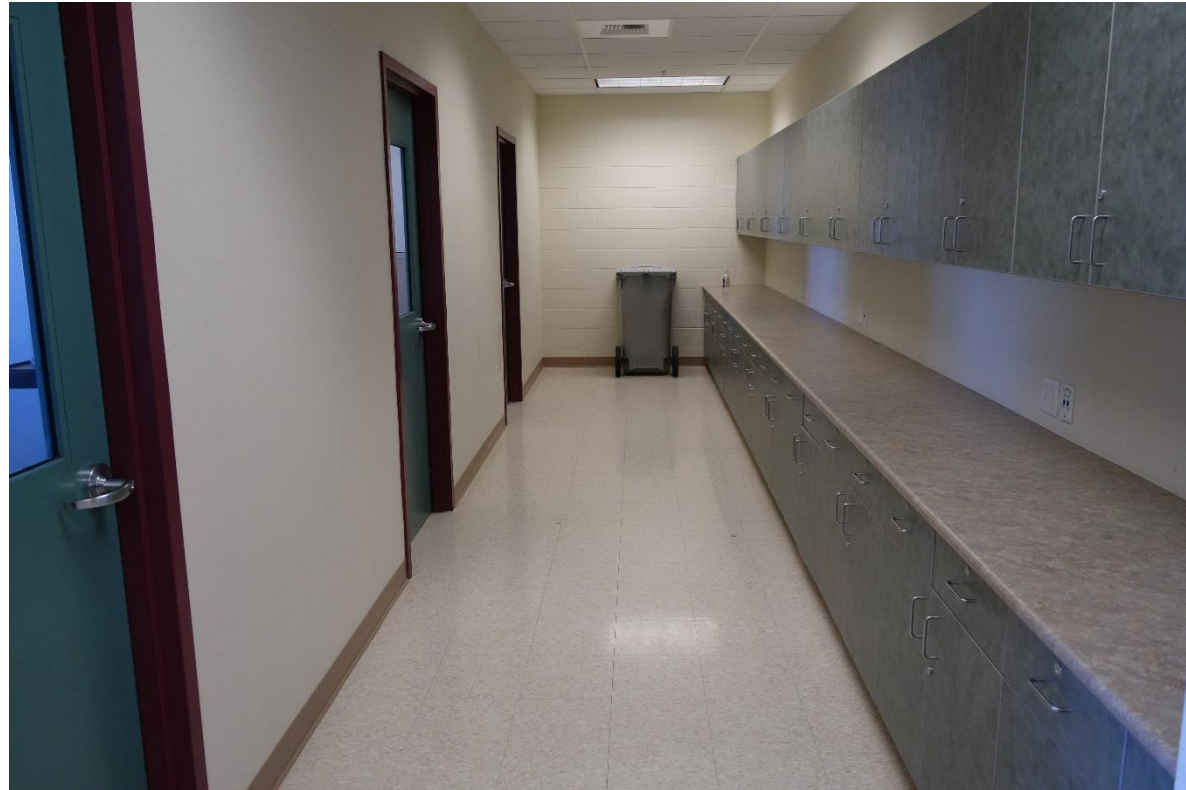
The interior finishes are in fair condition. It is recommended that the interior walls and ceilings be painted at least once in the next 4 - 5 years and that this project be scheduled on a cyclical basis to maintain the integrity of the structure. Prior to painting, all surfaces should be repaired and prepped. An epoxy-based paint should be utilized in wet areas for durability.
