STATE OF NEVADA  
STATE PUBLIC WORKS DIVISION

FACILITY CONDITION ASSESSMENT REPORT FOR:

DEPT OF CORRECTIONS  
THREE LAKES VALLEY CONSERVATION CAMP

Survey Date: 4/19/2022  
Distribution Date: 8/24/2023

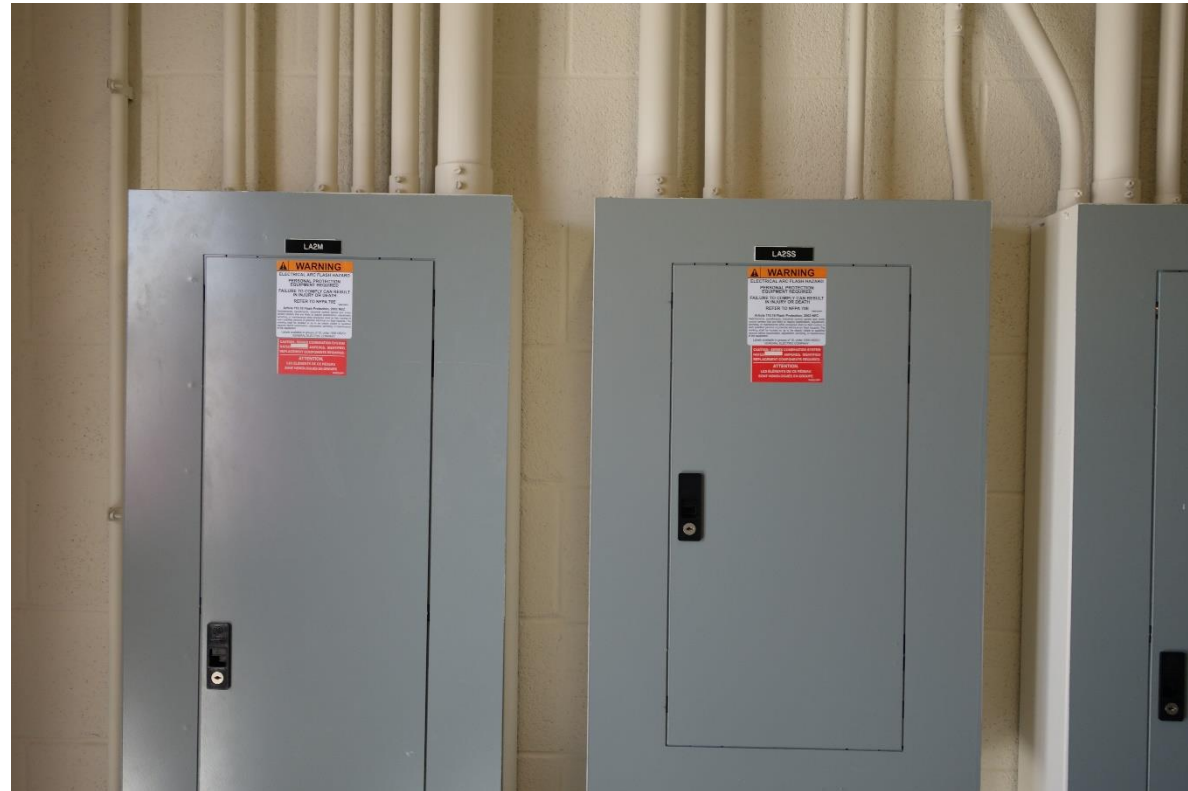
Arc flash and electrical breaker coordination studies have not been performed or it has been more than 5 years since the last coordination study. Safety requirements for maintenance personnel and the latest electrical code require coordination studies to be verified and performed every 5 years, along with arc flash labeling on all electrical panels. This project will perform the required coordination study, evaluation, adjustments and labeling for the building's electrical distribution system.

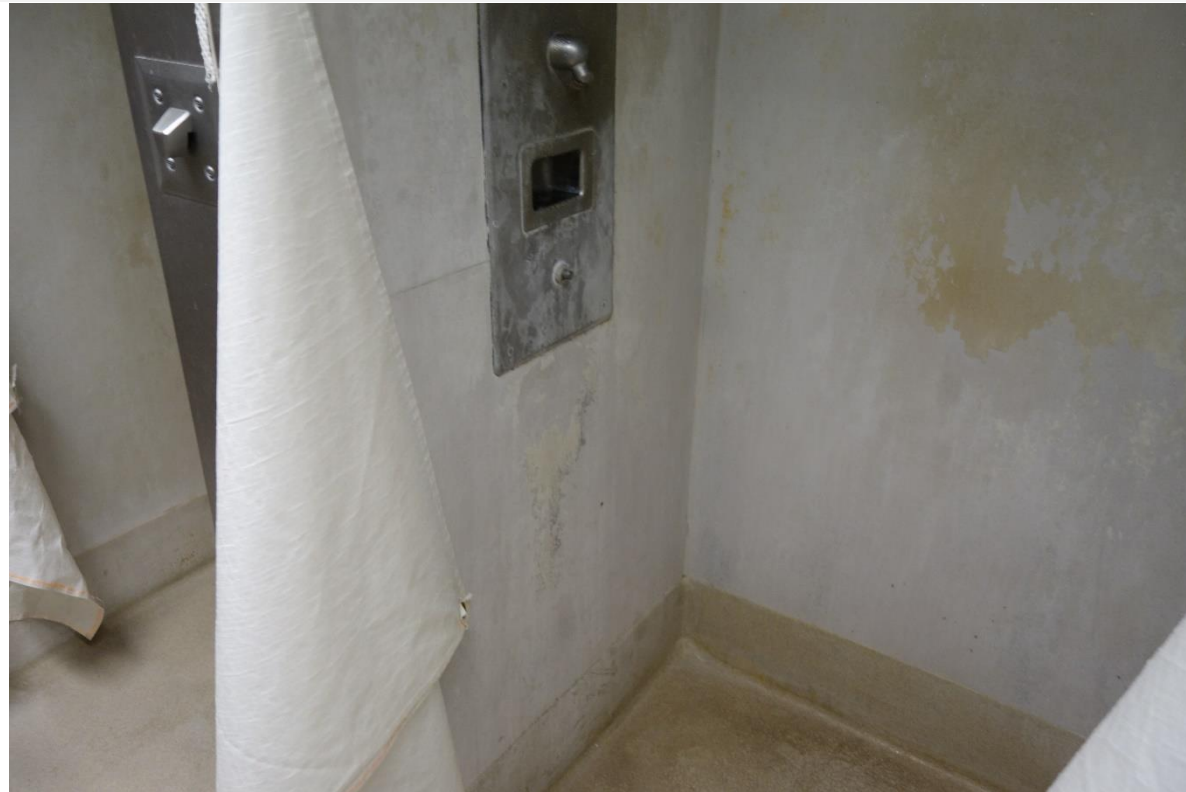
Some of the 20 shower stalls in the Housing Unit are damaged allowing water penetration into the wall cavities behind the shower units. Water in the wall cavity facilitates mold growth. Stainless steel shower liners are recommended.

Additionally, paint is peeling from the walls and ceilings due to apparent lack of ventilation. This project scope includes demolition of the existing showers and installation of stainless-steel shower enclosures. Upgraded exhaust ventilation, epoxy flooring, wall and ceiling paint and new shower fixtures are included in this estimate.

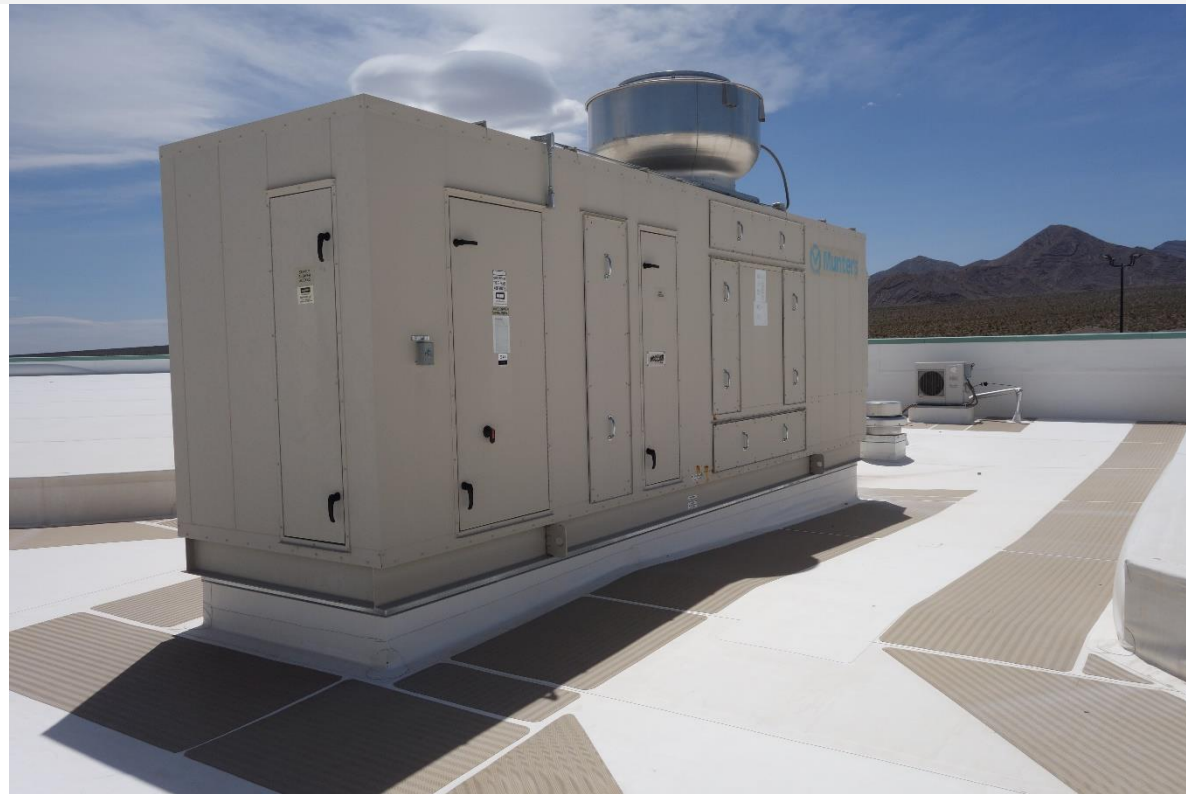
A visual survey of the evaporatively cooled air handling units (AHU's) are failing prematurely and reducing their expected life. Lack of maintenance has caused the heating coil to plug with mineral scale due to moisture carry-over from the evaporative cooling section. Moisture carry-over is indicative of air velocities well above the unit specifications caused by a lack of air balance. The severe degree of scaling renders coil cleaning ineffective and a complete replacement of the heating coil is recommended.

showing signs of corrosion likely caused by the same moisture carry-over. This project will fund the removal and replacement of the heating coil, a full AHU maintenance rehabilitation, new blow-down controls on the evaporative sump, water treatment (Nu-Calgon slow dissolving scale and corrosion inhibitor) and air balance. With proper maintenance, this project should restore the AHU to its expected useful life.

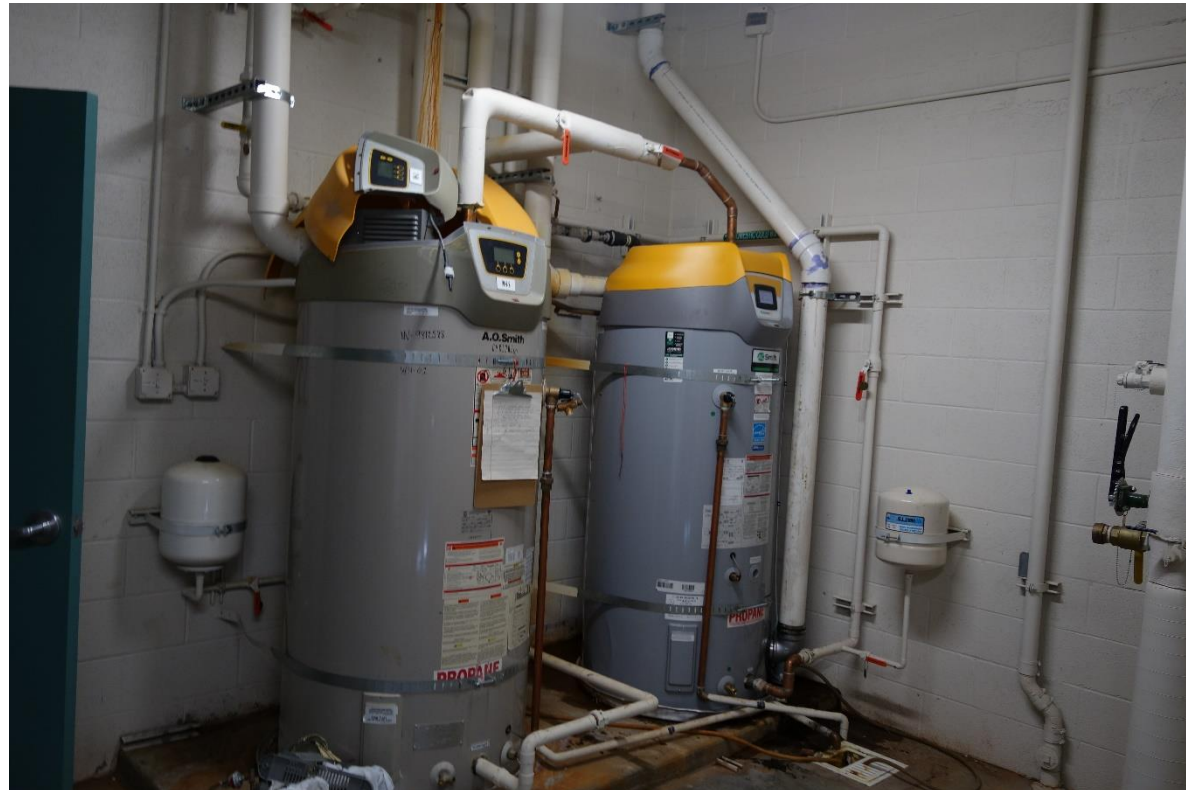
**WATER HEATER REPLACEMENT**

There are two 130-gallon propane water heaters in the building. The average life span of a water heater is eight to ten years. With the passage of time and constant use, these units are showing signs of wear and should be scheduled for replacement in the next 2 - 4 years. It is recommended that two new propane fired water heaters be installed. This estimate includes 100 feet of gas pipe, fittings, couplers, and labor for installation. Removal and disposal of the existing equipment is included in this estimate.

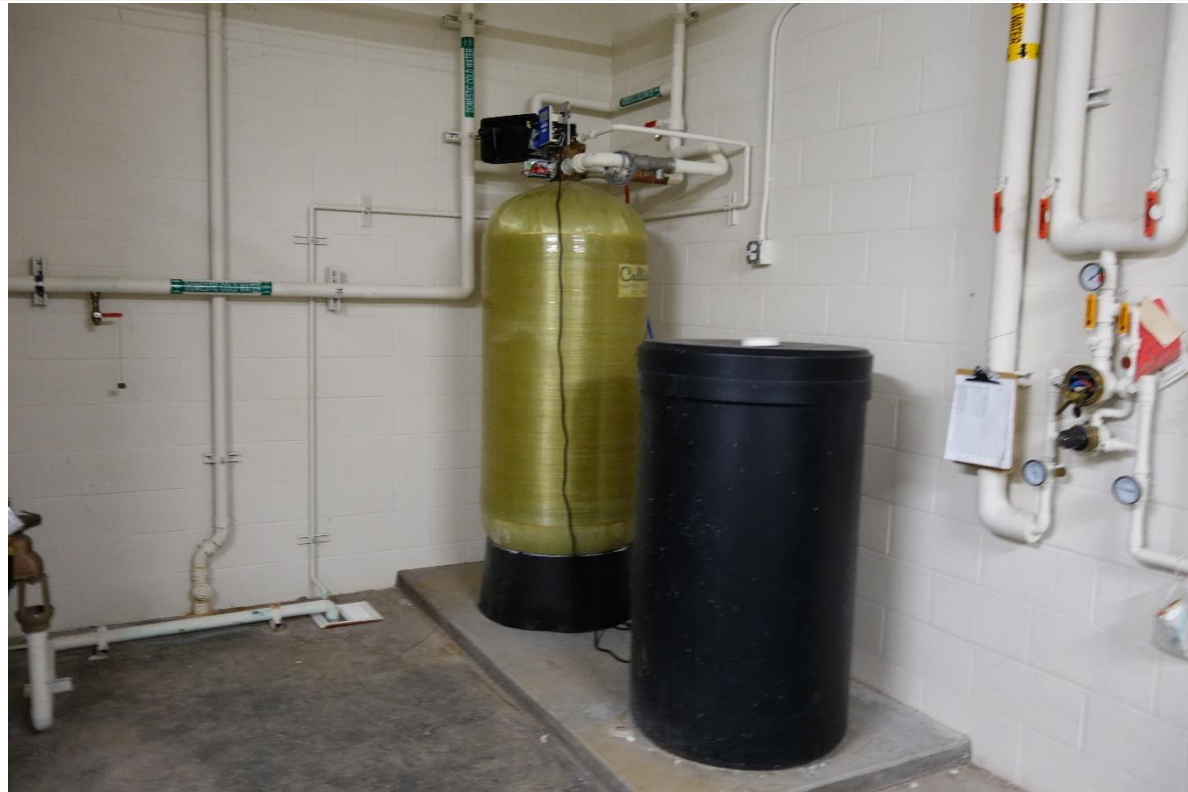
**WATER TREATMENT SYSTEM REPLACEMENT**

The existing water softening treatment system in the building was not operational at the time of the survey. Failure of the water softening/ treatment system causes additional wear and tear on the domestic water supply lines, water heaters and plumbing fixtures. This project would replace the existing water softener / treatment system with new equipment.

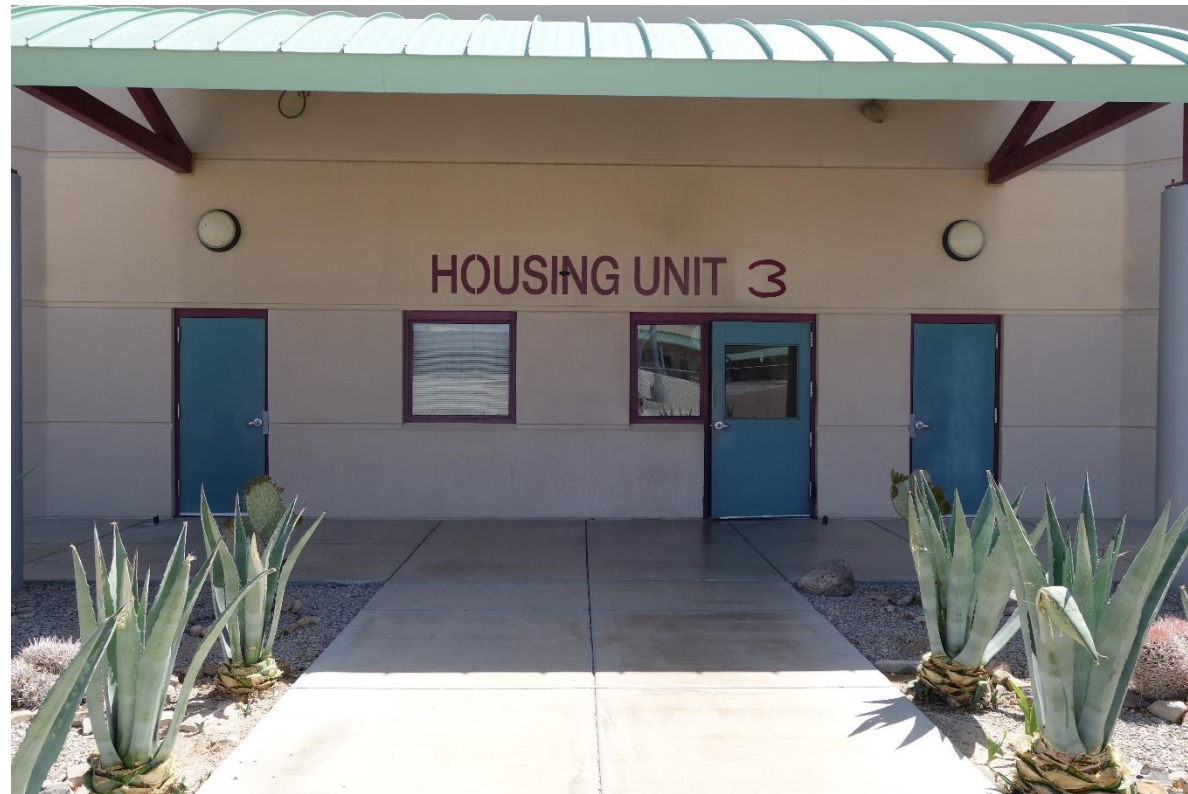
The exterior finishes were in good condition. It is important to maintain the finish, weather resistance and appearance of the building. This project would provide funding to protect the exterior of the building excluding the roof. Included in the cost is power washing, priming and painting and caulking of the windows, flashing, fixtures and all other penetrations. It is recommended that the building be painted in the next 7 - 9 years and that this project be scheduled on a cyclical basis to maintain the integrity of the structure.

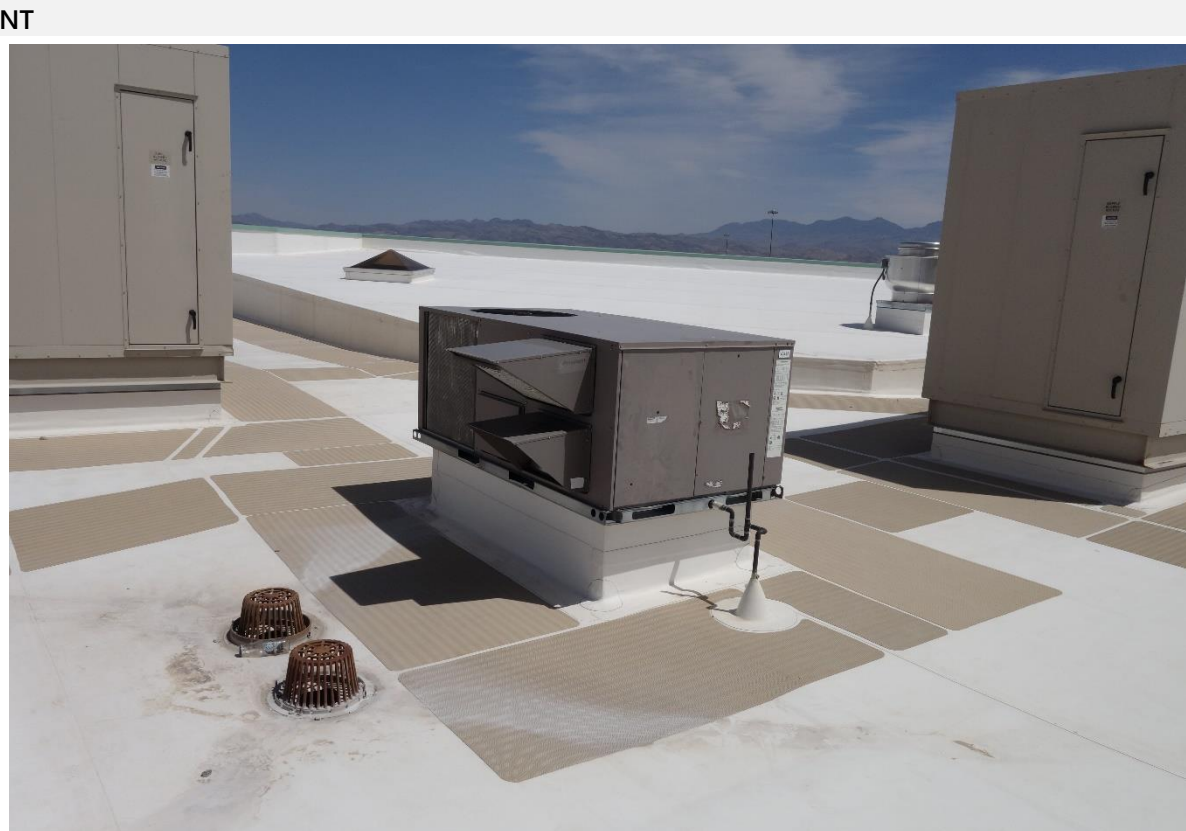
**HVAC EQUIPMENT REPLACEMENT**

There are 2 rooftop packaged HVAC heat pump units installed in 2010 recommended to be replaced in the next 10 years. Included in this estimate are new curb adapters, crane and rigging for removal and installation and all required connections to utilities.

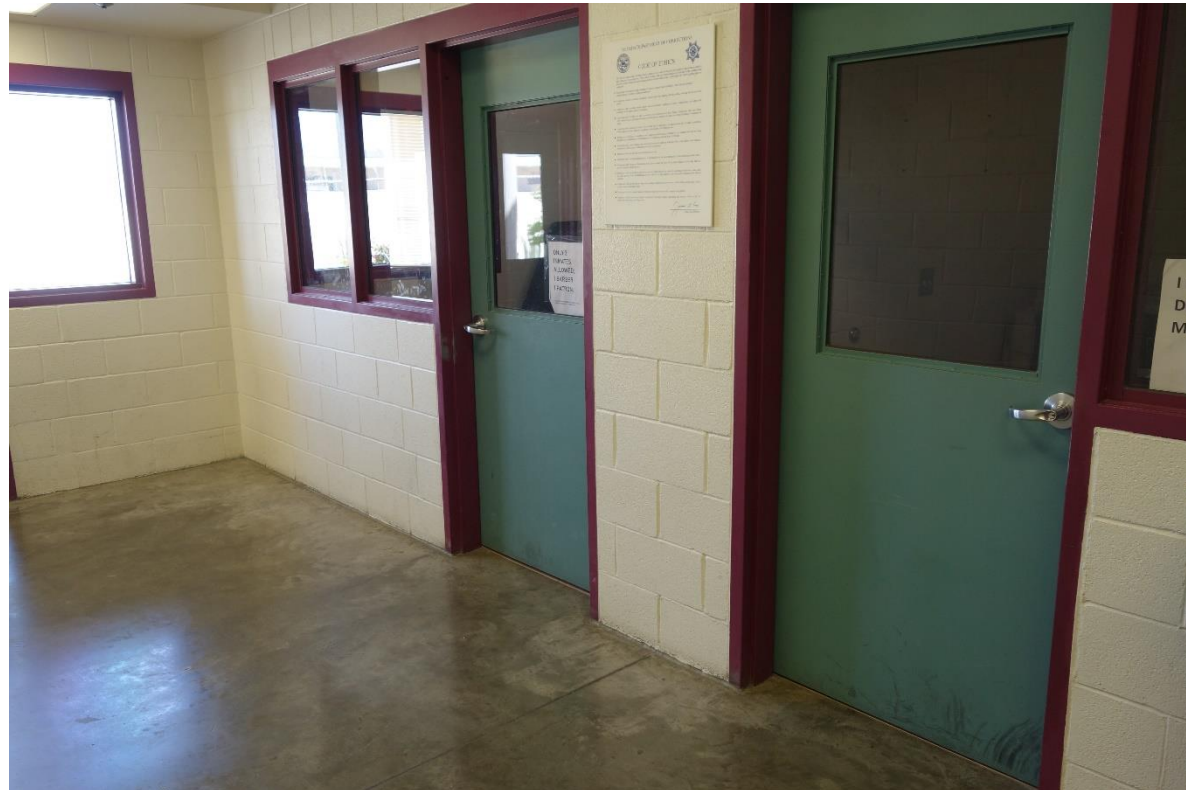
The interior finishes are in fair condition. It is recommended that the interior walls and ceilings be painted at least once in the next 4 - 6 years and that this project be scheduled on a cyclical basis to maintain the integrity of the structure. Prior to painting, all surfaces should be repaired and prepped. An epoxy-based paint should be utilized in wet areas for durability.

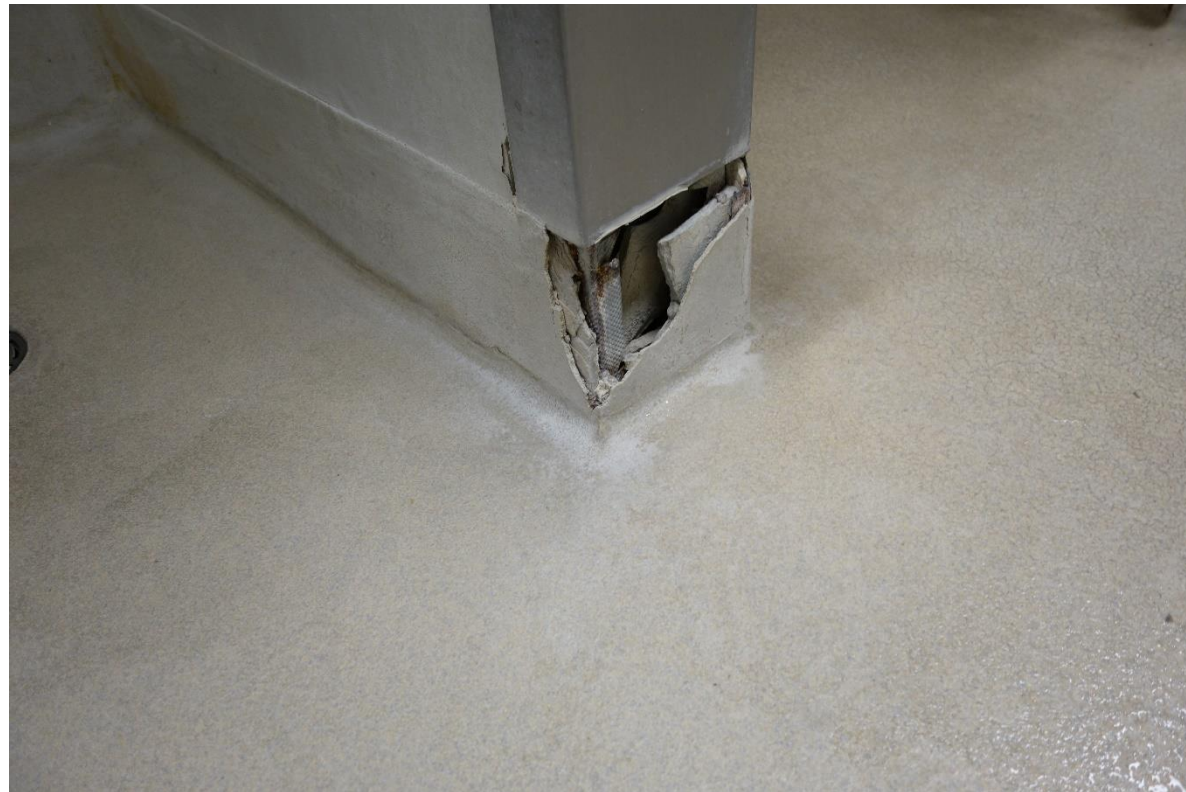
Some of the 20 shower stalls in the Housing Unit are damaged allowing water penetration into the wall cavities behind the shower units. Water in the wall cavity facilitates mold growth. Stainless steel shower liners are recommended.

Additionally, paint is peeling from the walls and ceilings due to apparent lack of ventilation. This project scope includes demolition of the existing showers and installation of stainless-steel shower enclosures. Upgraded exhaust ventilation, epoxy flooring, wall and ceiling paint and new shower fixtures are included in this estimate.

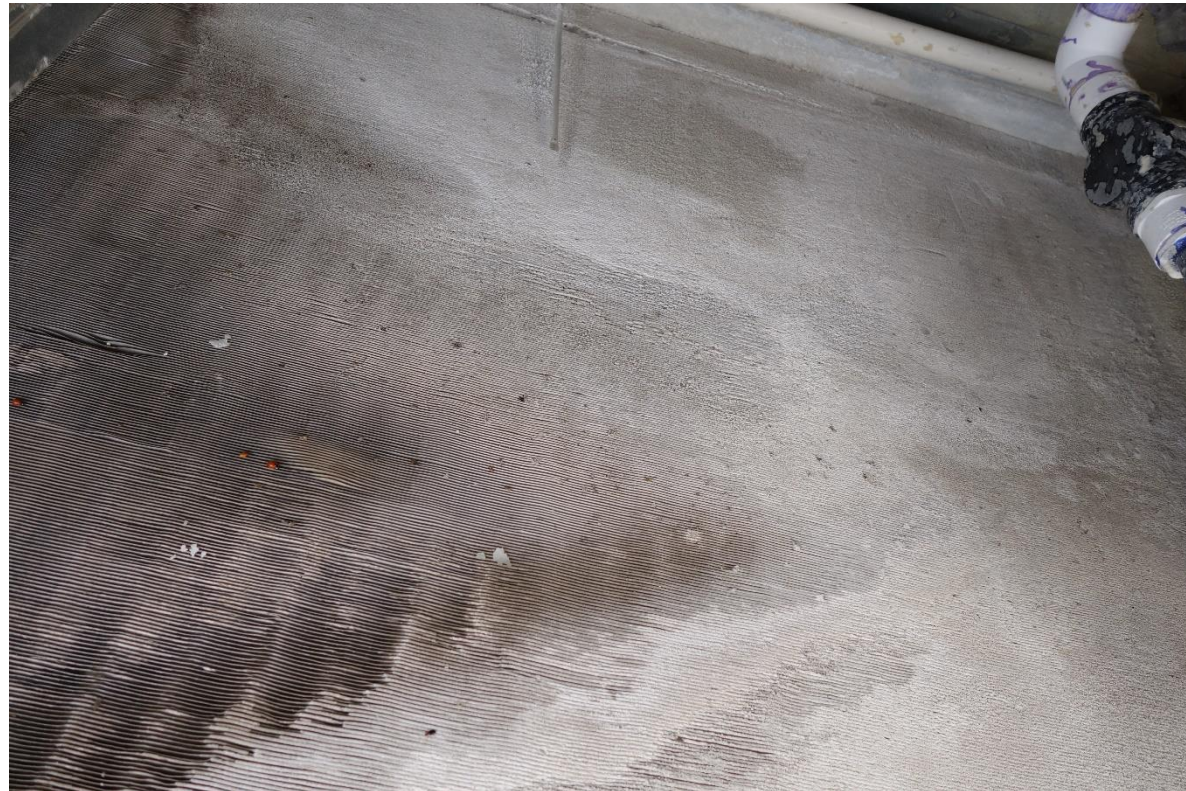
A visual survey of the evaporatively cooled air handling units (AHU's) are failing prematurely and reducing their expected life. Lack of maintenance has caused the heating coil to plug with mineral scale due to moisture carry-over from the evaporative cooling section. Moisture carry-over is indicative of air velocities well above the unit specifications caused by a lack of air balance. The severe degree of scaling renders coil cleaning ineffective and a complete replacement of the heating coil is recommended.

Additionally, the AHU's exterior surfaces are

showing signs of corrosion likely caused by the same moisture carry-over. This project will fund the removal and replacement of the heating coil, a full AHU maintenance rehabilitation, new blow-down controls on the evaporative sump, water treatment (Nu-Calgon slow dissolving scale and corrosion inhibitor) and air balance. With proper maintenance, this project should restore the AHU to its expected useful life.

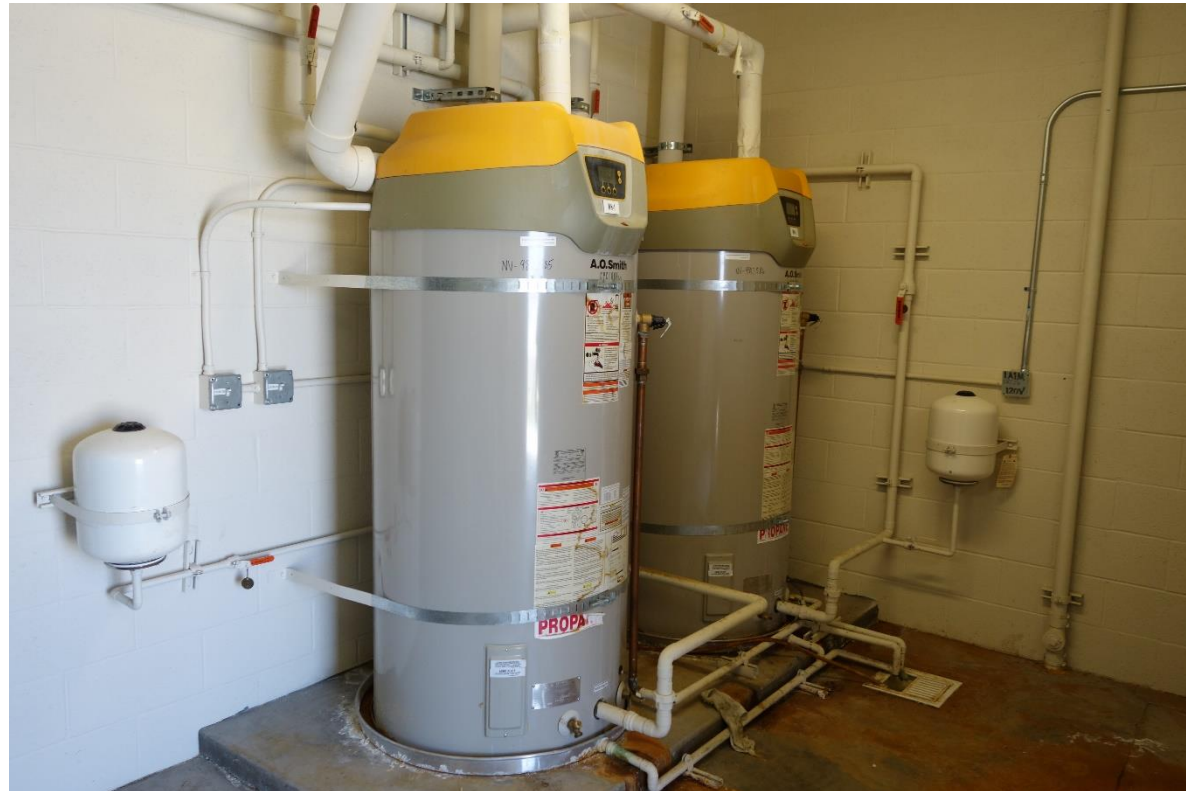
**WATER HEATER REPLACEMENT**

There are two 130-gallon propane water heaters in the building. The average life span of a water heater is eight to ten years. With the passage of time and constant use, these units are showing signs of wear and should be scheduled for replacement in the next 2 - 4 years. It is recommended that two new propane fired water heaters be installed. This estimate includes 100 feet of gas pipe, fittings, couplers, and labor for installation. Removal and disposal of the existing equipment is included in this estimate.

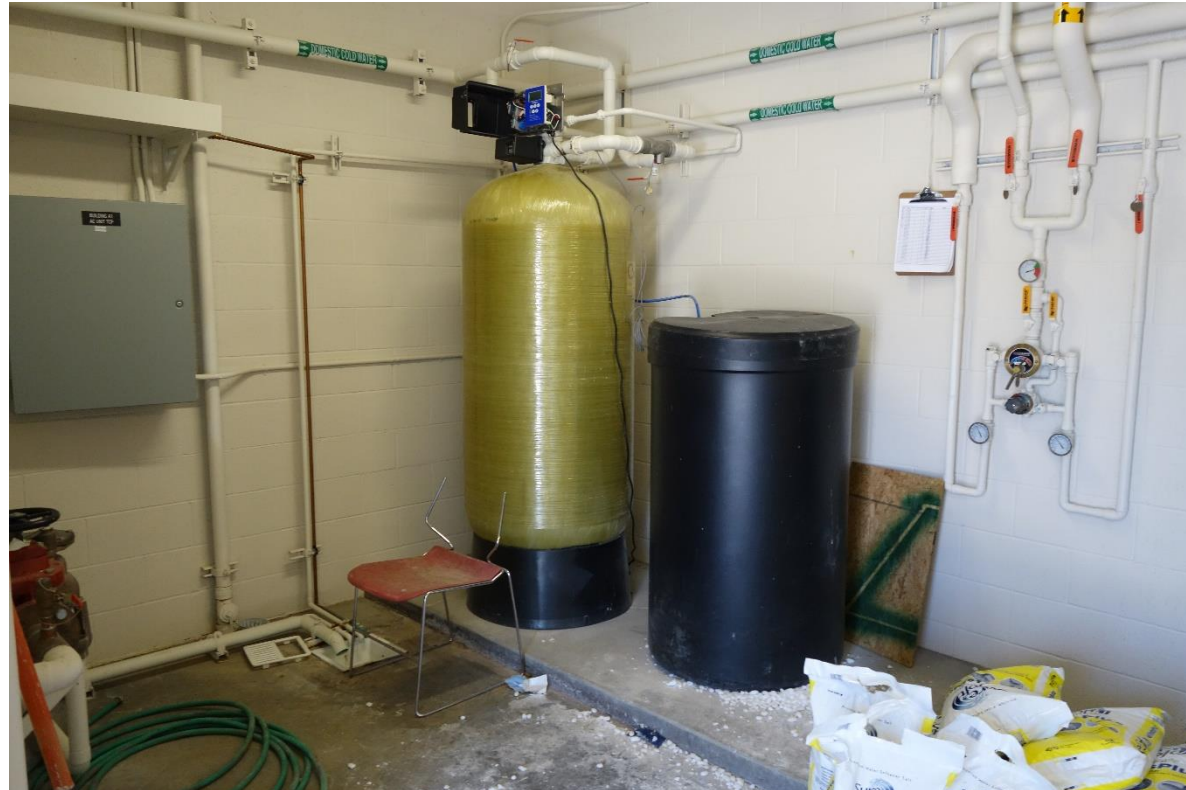
**WATER TREATMENT SYSTEM REPLACEMENT**

The existing water softening treatment system in the building was not operational at the time of the survey. Failure of the water softening/ treatment system causes additional wear and tear on the domestic water supply lines, water heaters and plumbing fixtures. This project would replace the existing water softener / treatment system with new equipment.

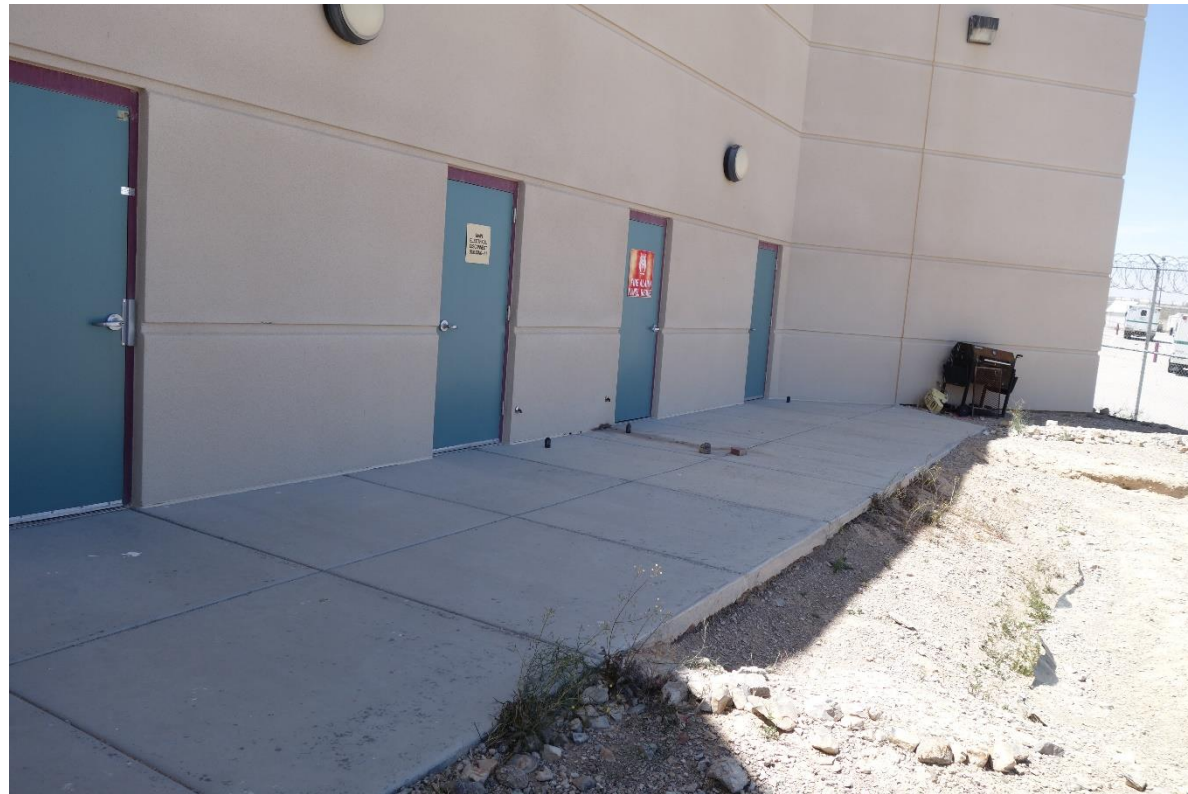
The exterior finishes were in good condition. It is important to maintain the finish, weather resistance and appearance of the building. This project would provide funding to protect the exterior of the building excluding the roof. Included in the cost is power washing, priming and painting and caulking of the windows, flashing, fixtures and all other penetrations. It is recommended that the building be painted in the next 7 - 9 years and that this project be scheduled on a cyclical basis to maintain the integrity of the structure.

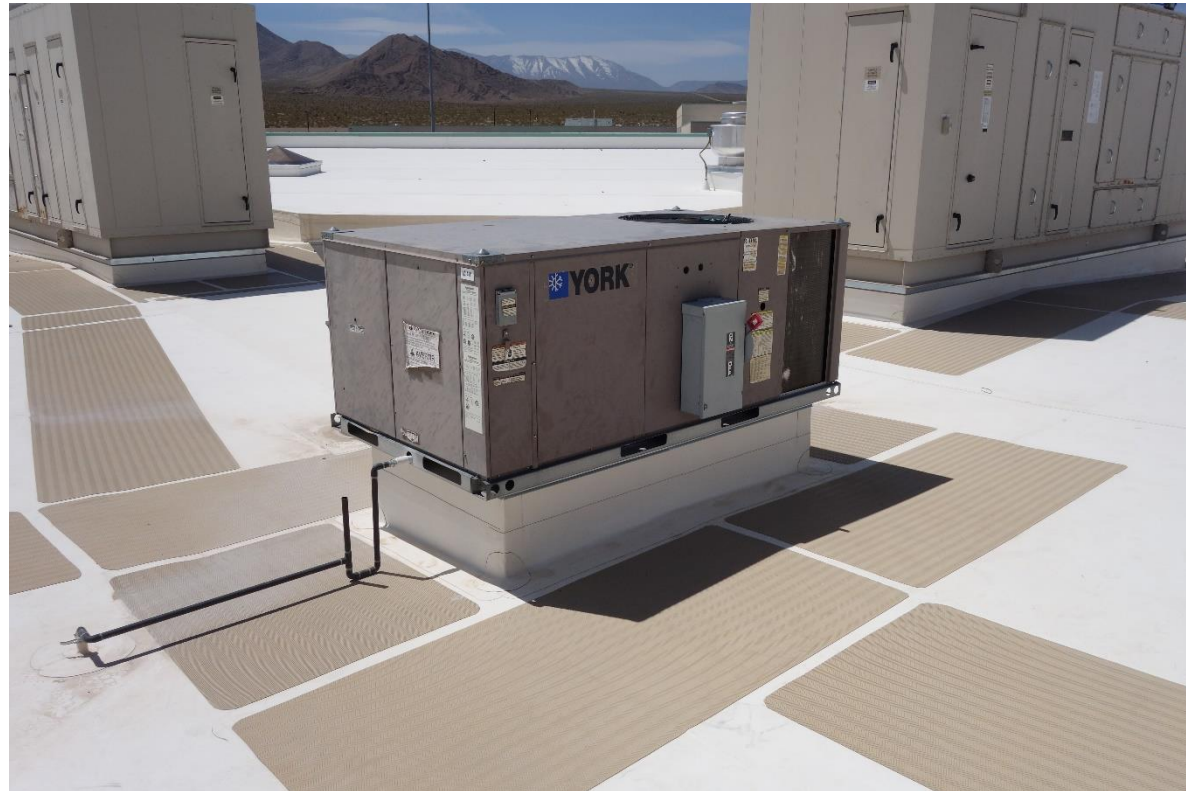
**HVAC EQUIPMENT REPLACEMENT**

There are 2 rooftop packaged HVAC heat pump units installed in 2010 recommended to be replaced in the next 10 years. Included in this estimate are new curb adapters, crane and rigging for removal and installation and all required connections to utilities.

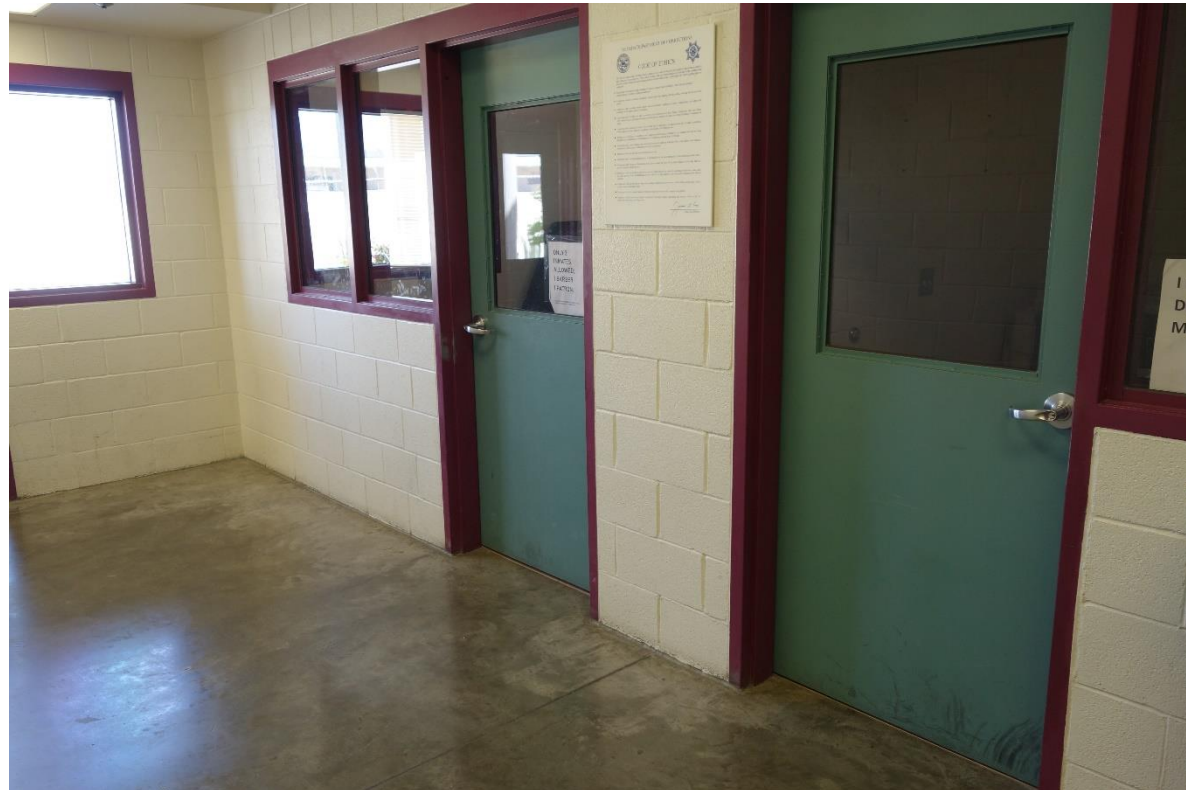
The interior finishes are in fair condition. It is recommended that the interior walls and ceilings be painted at least once in the next 4 - 6 years and that this project be scheduled on a cyclical basis to maintain the integrity of the structure. Prior to painting, all surfaces should be repaired and prepped. An epoxy-based paint should be utilized in wet areas for durability.
