STATE OF NEVADA
STATE PUBLIC WORKS DIVISION

FACILITY CONDITION ASSESSMENT REPORT FOR:

DEPT OF CONSERVATION & NATURAL RESOURCES
DIVISION OF FORESTRY

SITE #: 9969 THREE LAKES VALLEY UTILITIES SITE
21055 COLD CREEK RD
INDIAN SPRINGS, NV 89070-0001

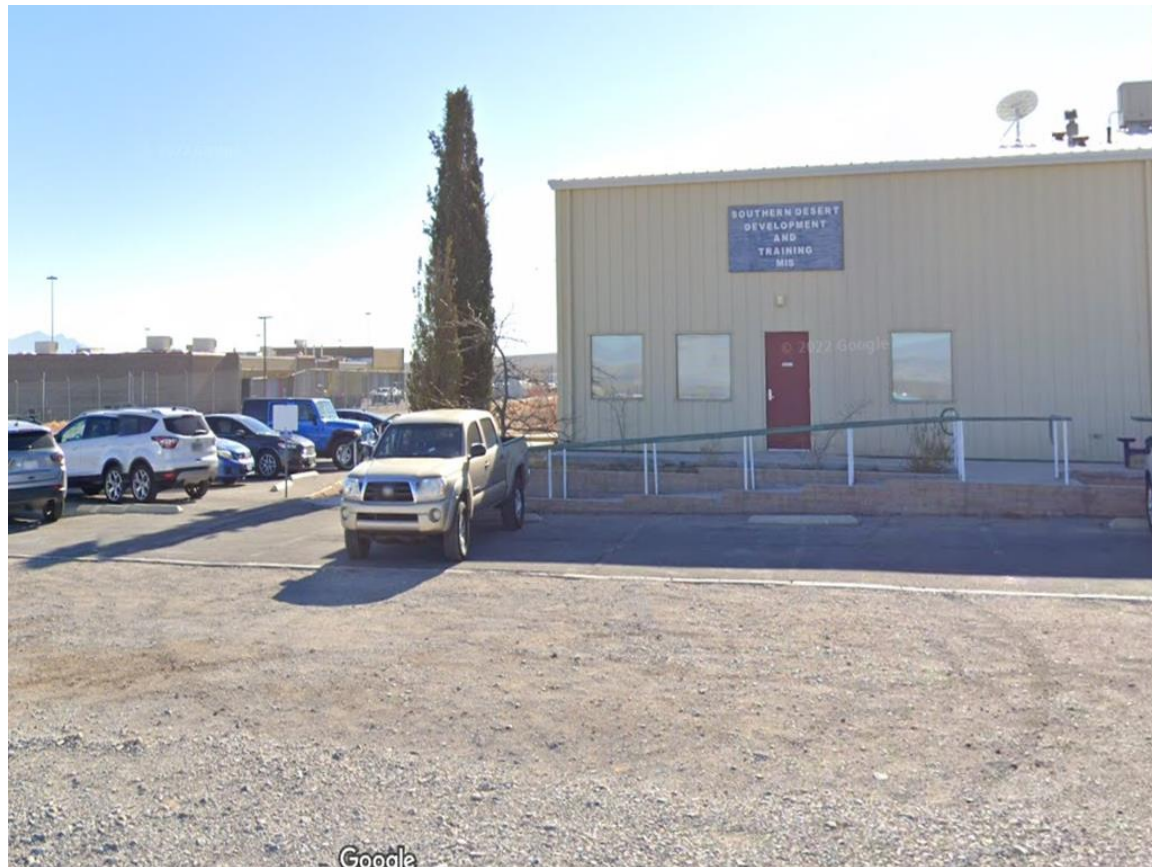
PROJECT #: 9969ADA1

ADA PARKING STRIPING AND SIGN

The ADA provides for accessibility to sites and services for people with physical limitations. The concrete parking area and passenger loading area lack proper signage and striping to comply with ADA requirements. This project would provide for striping, signage and any other necessary upgrades to the parking space. The 2018 IBC, ICC/ANSI A117.1, NRS 338.180 and the most current version of the ADA Standards for Accessible Design were used as a reference for this project.

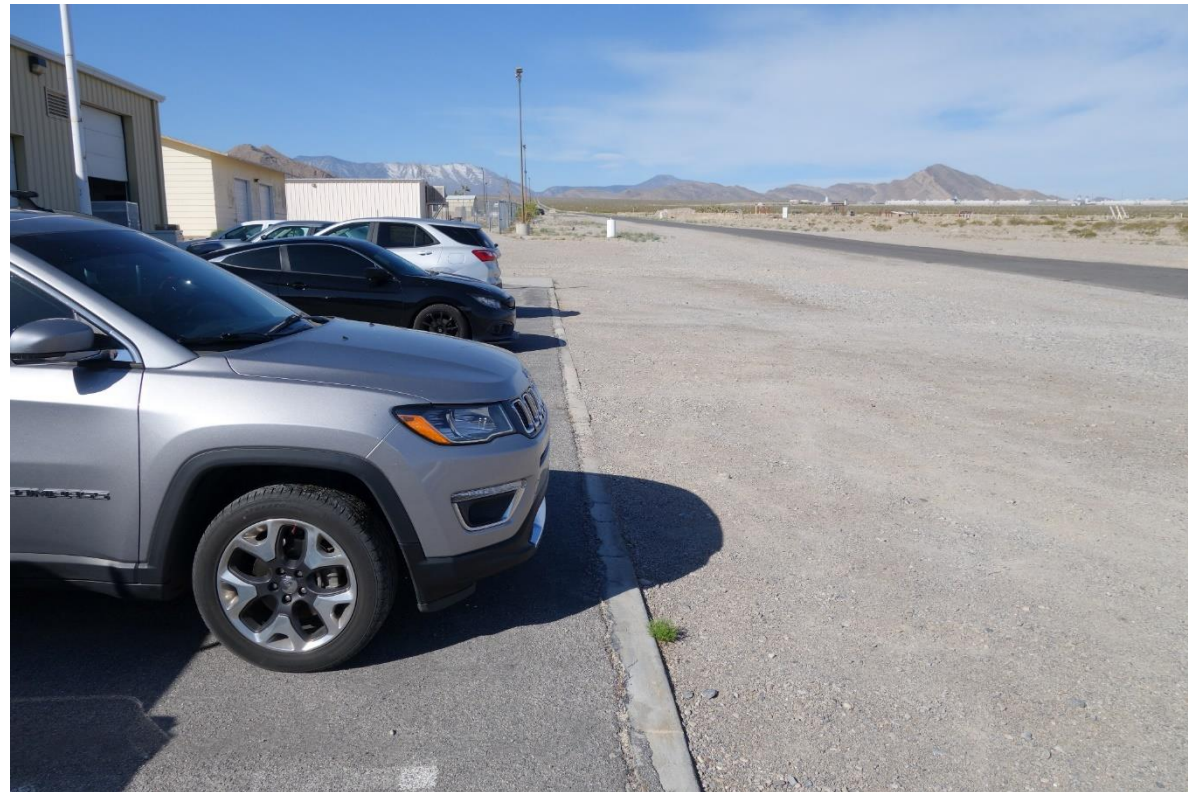
PROJECT #: 9969SIT1

REPAIR AND RESEAL ASPHALT PARKING AREAS

The existing paving is in fair condition. Climate and constant use will accelerate deterioration. For proper maintenance it is recommended the entire parking area and driveway be resealed and re-striped. This type of maintenance will extend the life of the asphalt.

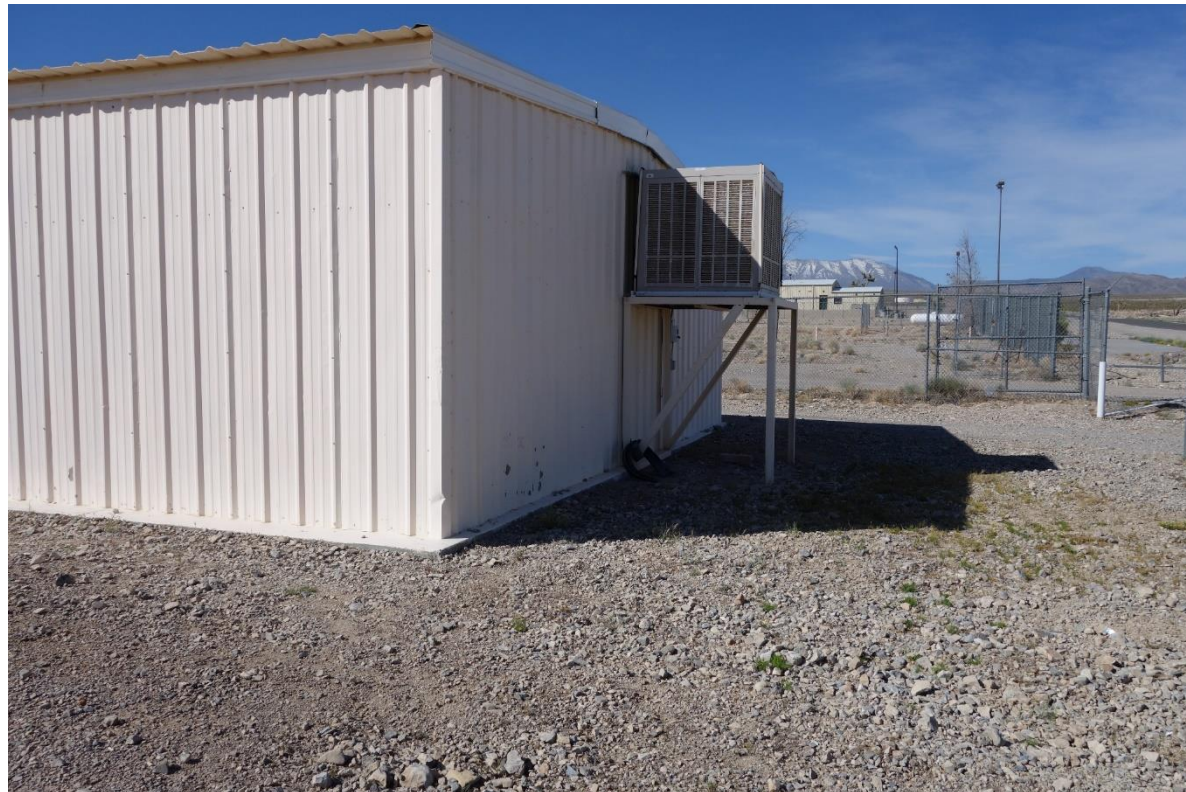
PROJECT #: 4282EXT1

EXTERIOR FINISHES

The pre-finished metal exterior finishes were in fair condition. It is important to maintain the finish, weather resistance and appearance of the building. This project would provide funding to protect the exterior of the building excluding the roof. Included in the cost is caulking and sealing windows, flashing, fixtures and all other penetrations. It is recommended that the building be caulked and sealed in the next 6 - 8 years and that this project be scheduled on a cyclical basis to maintain the integrity of the structure.

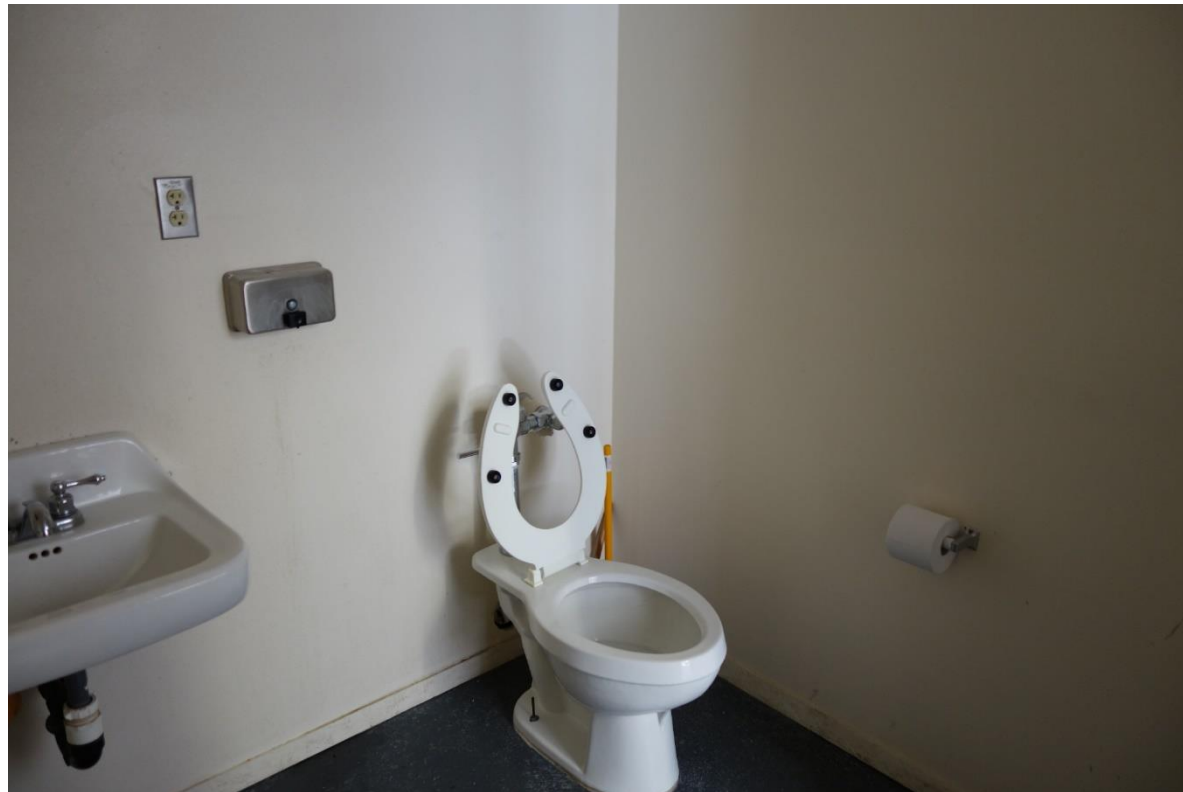
PROJECT #: 4282INT2

INTERIOR FINISHES

The interior finishes were in good condition. It is recommended the interior walls and ceilings be painted in the next 7 - 9 years. All surfaces should be repaired and prepared prior to painting. For durability in wet areas, an epoxy-based paint should be used. Building maintenance should be scheduled on a cyclical basis to maintain the integrity of the structure.

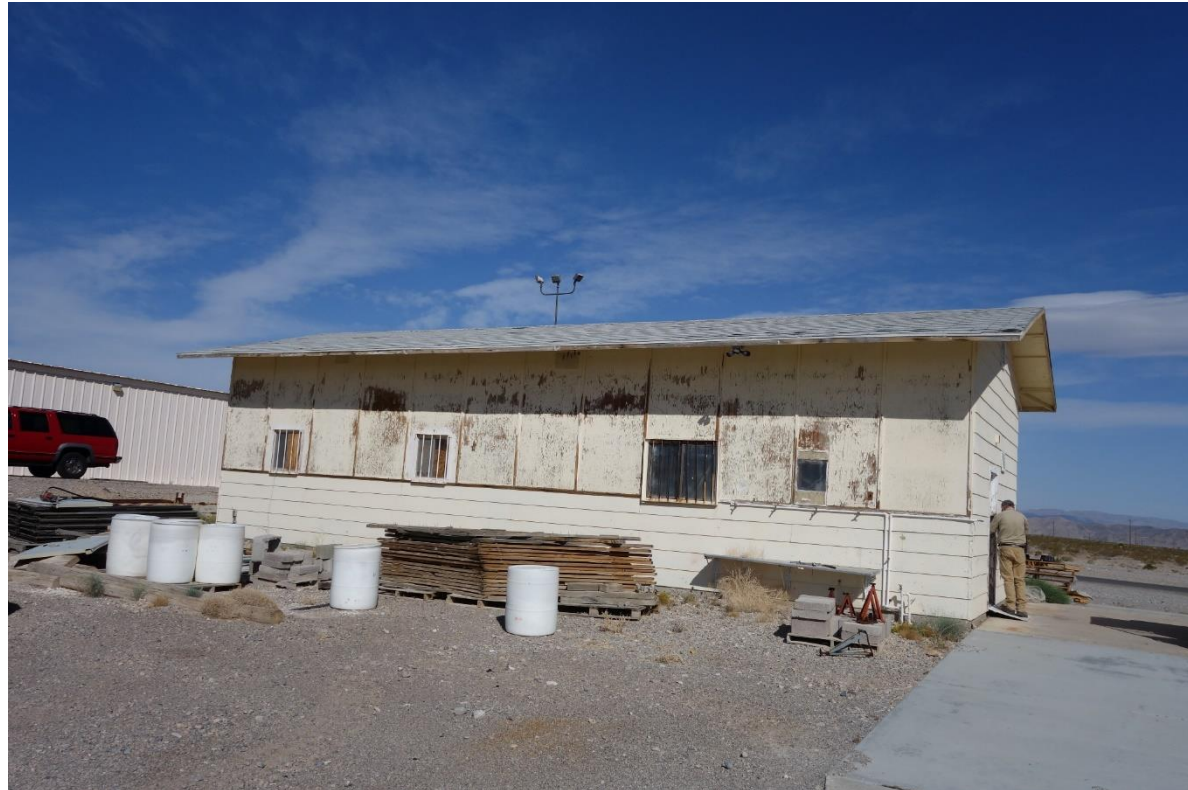
PROJECT #: 2190EXT1

EXTERIOR FINISHES

The exterior finishes were in poor condition. It is important to maintain the finish, weather resistance and appearance of the building. This project would provide funding to protect the exterior of the building excluding the roof. Included in the cost is sanding, priming, painting and caulking the windows, flashing, fixtures and all other penetrations. It is recommended that the building be painted in the next 2 - 4 years and that this project be scheduled on a cyclical basis to maintain the integrity of the structure.

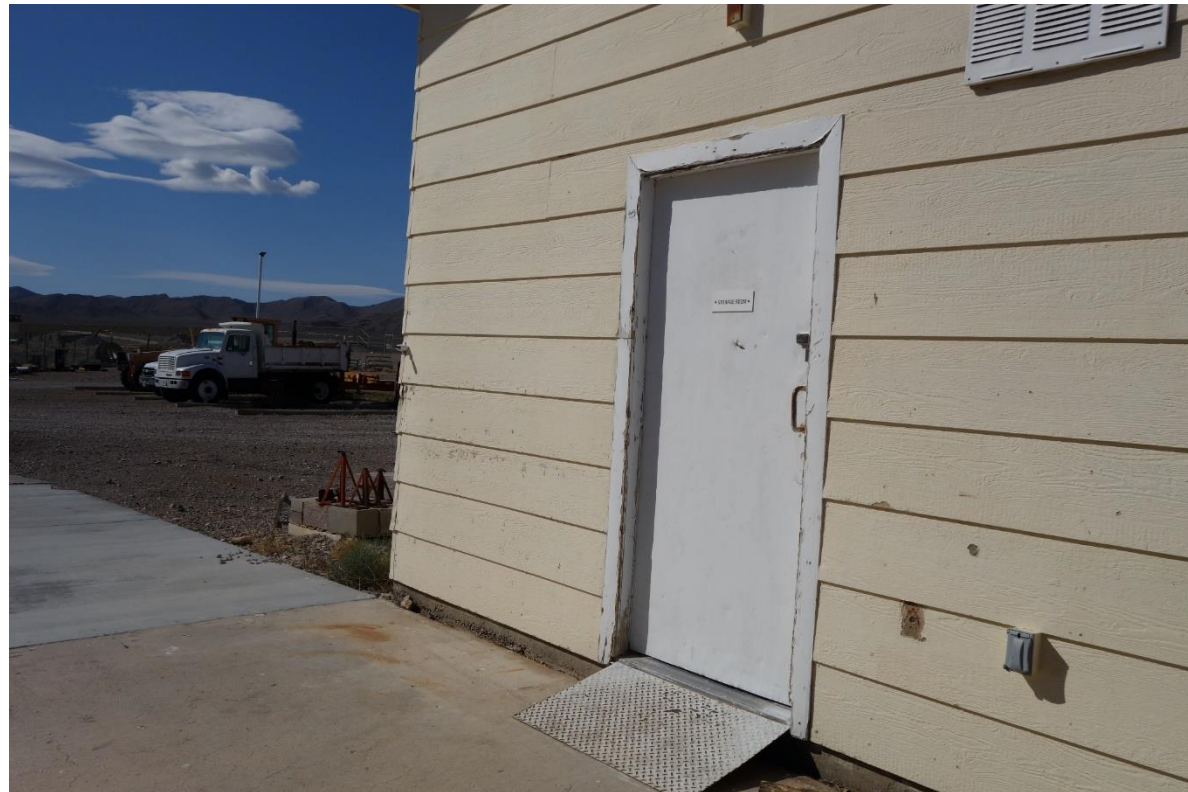
PROJECT #: 2190SFT1

EXTERIOR LANDING INSTALLATION

Section 1010.1.5 & 1010.1.6 of the 2018 IBC describes the requirements for a floor or landing on each side of a door regardless of door swing. The floor or landing shall be at the same elevation on each side of the door. Exterior landings are permitted to have a slope not to exceed 2%. The exterior doors on this building do not have landings. This project would provide for the installation of compliant landings, including ramps to facilitate material handling requirements.

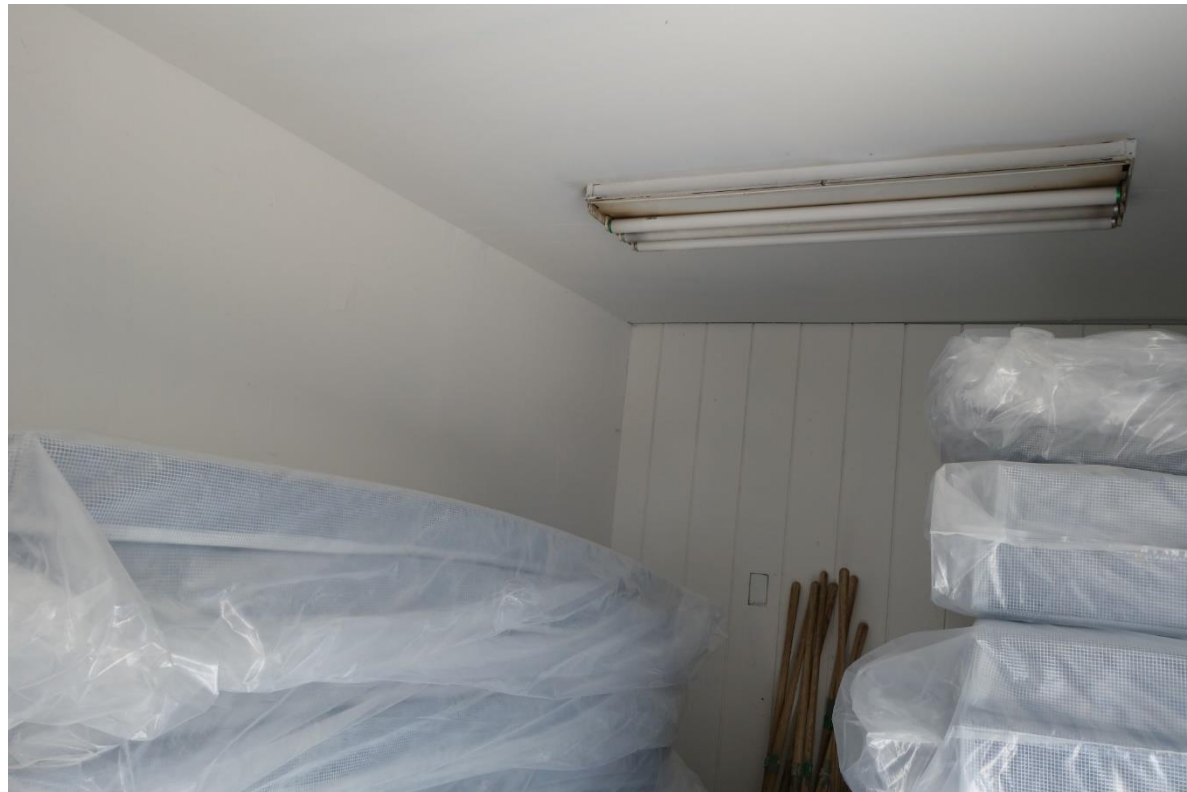
PROJECT #: 2190ENR1

LIGHTING UPGRADE

The existing lighting fixtures are the older fluorescent type and are not energy efficient. This project will replace the existing fixtures with higher efficiency LED fixtures. Electrical wiring upgrades are not included in this estimate.

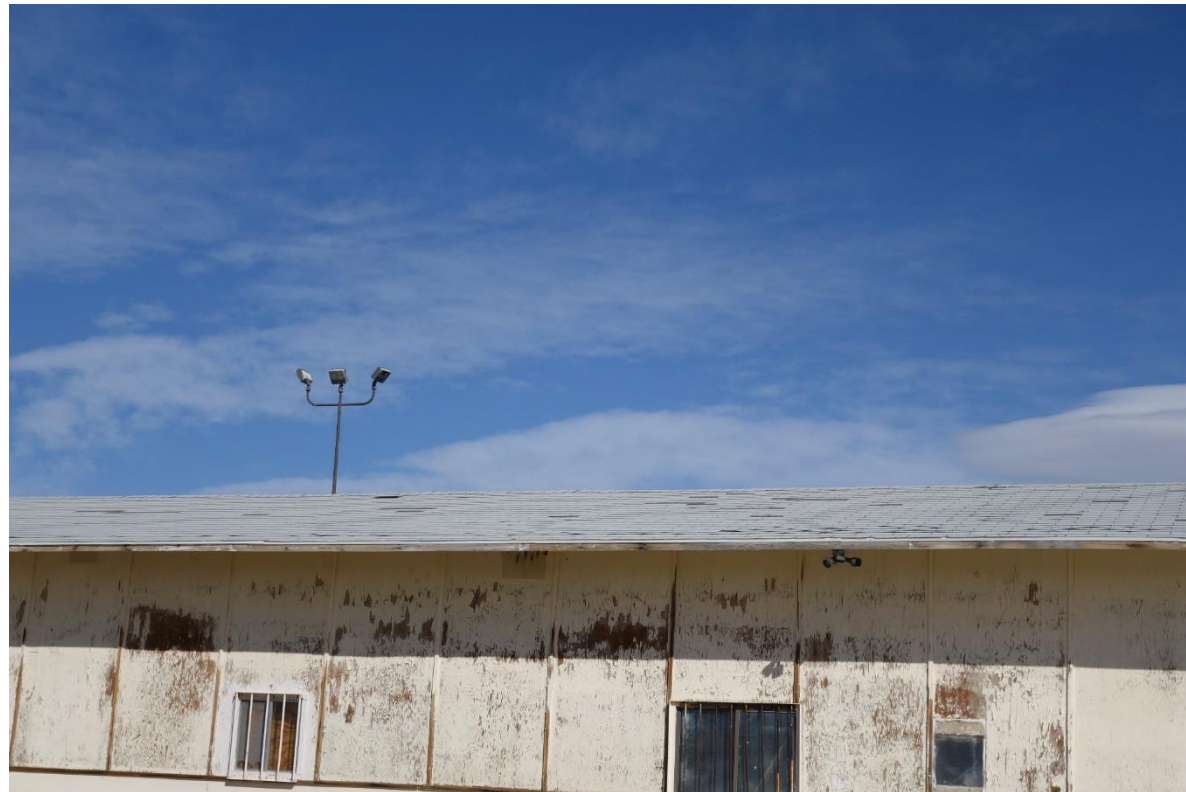
PROJECT #: 2190EXT2

ROOF REPLACEMENT

The asphalt composition shingle roof on this building was in poor condition at the time of the survey. It is recommended that this building be re-roofed in the next 2 - 3 years with a new 50-year asphalt composition roofing shingle and new underlayment. This estimate includes removal and disposal of the old roofing system.

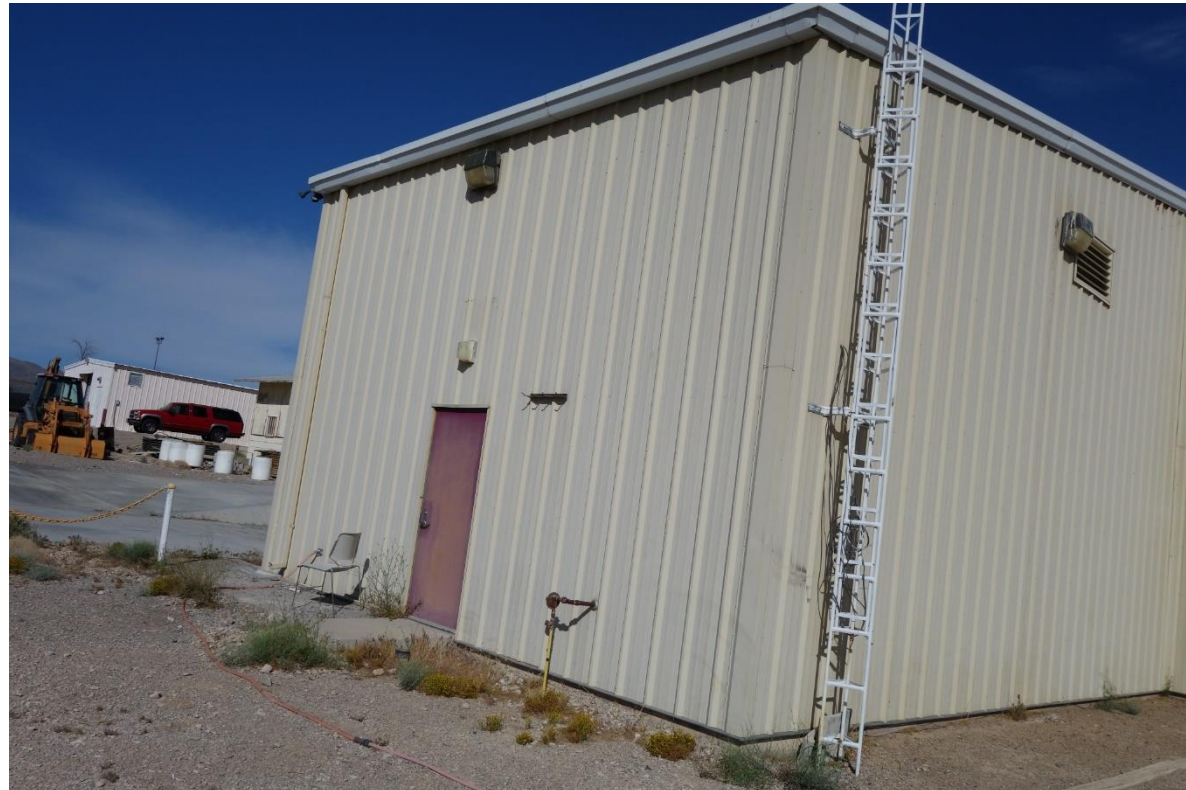
PROJECT #: 0864SFT3

SEISMIC GAS SHUT-OFF VALVE INSTALLATION

This project would provide for the installation of a seismic gas shut-off valve on the main gas service piping prior to entering the building. Alternately, for propane services or a site gas services with a single site metering station, consider installation at the tank or main meter service if it feeds multiple buildings.

This estimate is based on the manufacturer Pacific Seismic Products or approved equal, equipped with the optional Model MS remote monitoring

switch (to be interfaced with the direct digital control system and/or with an audible alarm). The gas piping immediately adjacent to the seismic gas valve shall be secured to the building utilizing unistrut channel bracing.

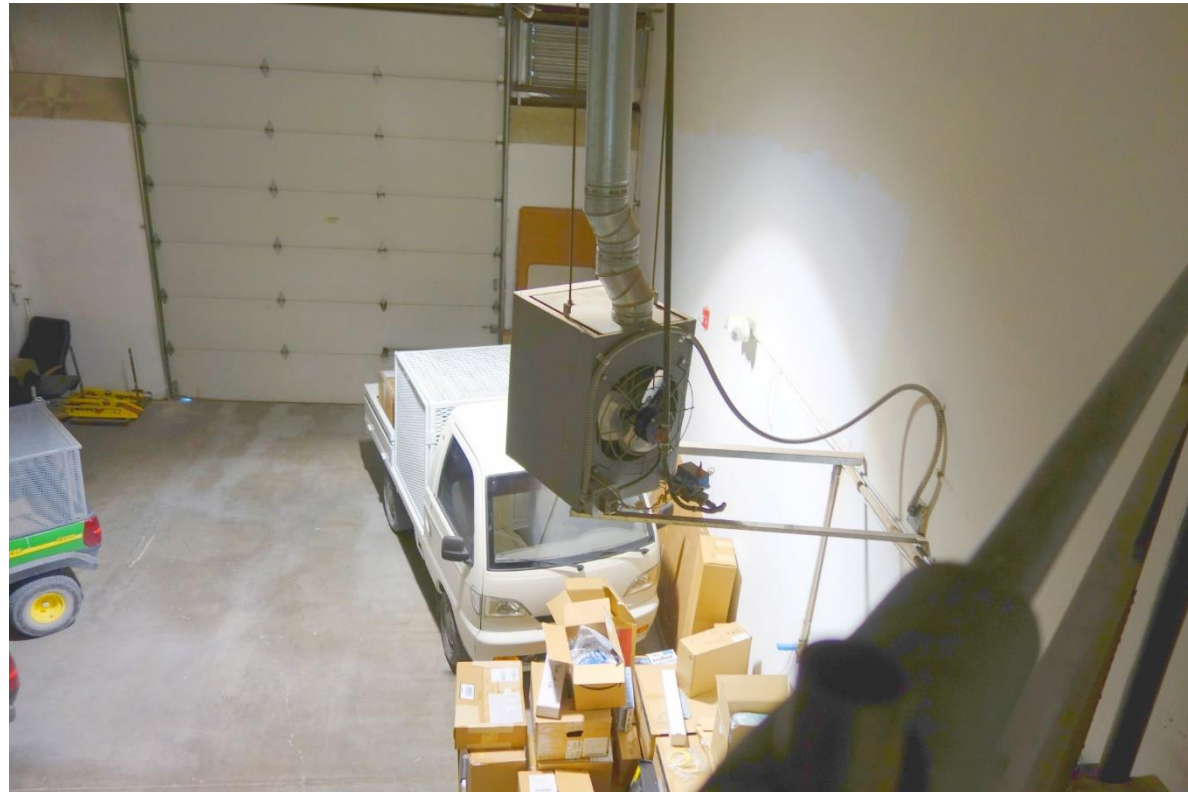
PROJECT #: 0864HVA1

HEATER REPLACEMENT

The existing heating system in the storage areas consists of 3 ceiling suspended propane heaters. Two of three heaters are inoperable and all three should be replaced. This project would provide for disposal of the existing units and replacement with new propane fired units including connections to utilities.

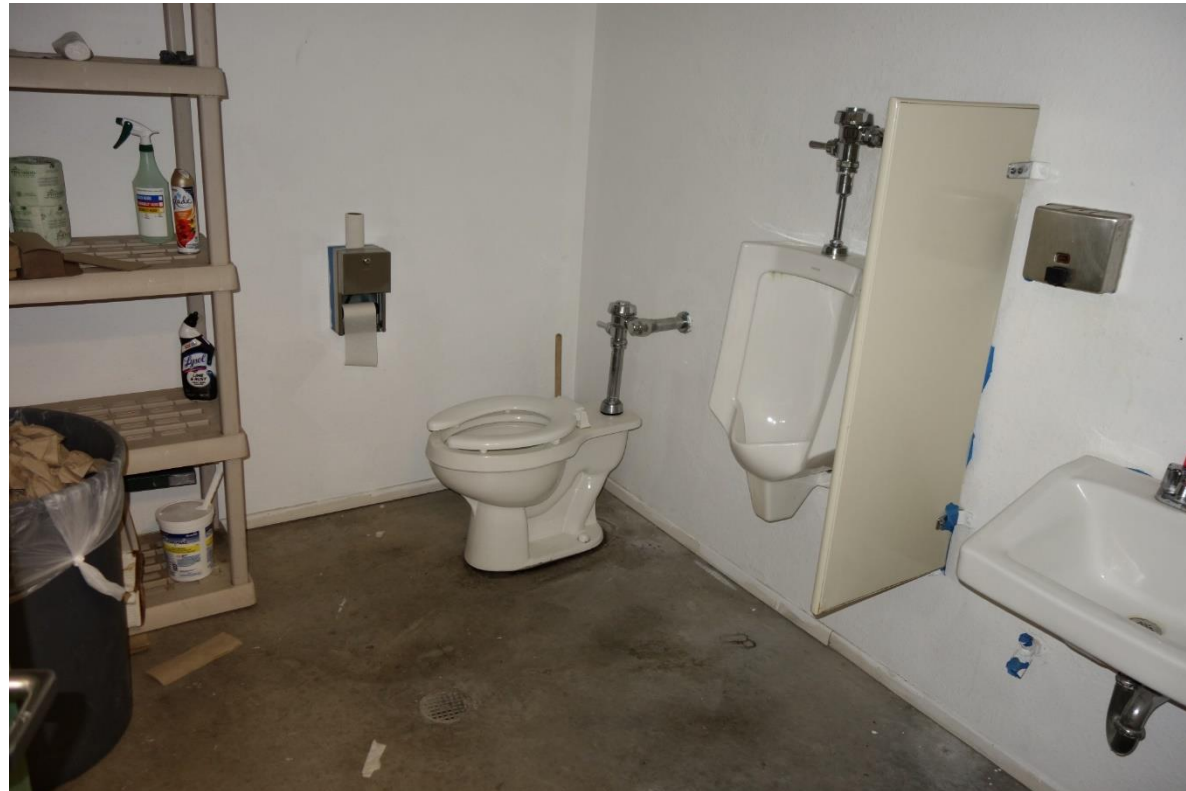
PROJECT #: 0864INT2

NONABSORBENT FINISHES

2018 IBC Section 1210 requires the installation of smooth, hard, nonabsorbent surfaces in the following restroom areas: on floors in toilet, bathing and shower rooms that extend upward onto the walls at least 4 inches, within 2 feet of the sides of urinals and water closets to a height of not less than 4 feet above the floor and in shower compartments to a height not less than 70 inches above the drain inlet. Accessories such as grab bars, towel bars, paper dispensers and soap dishes, provided on or within walls, shall be installed and sealed to protect structural elements from moisture. This project recommends the installation of Fiberglass Reinforced Panel (FRP) or an equal material to comply with this code Section in the restroom located in the storage area.

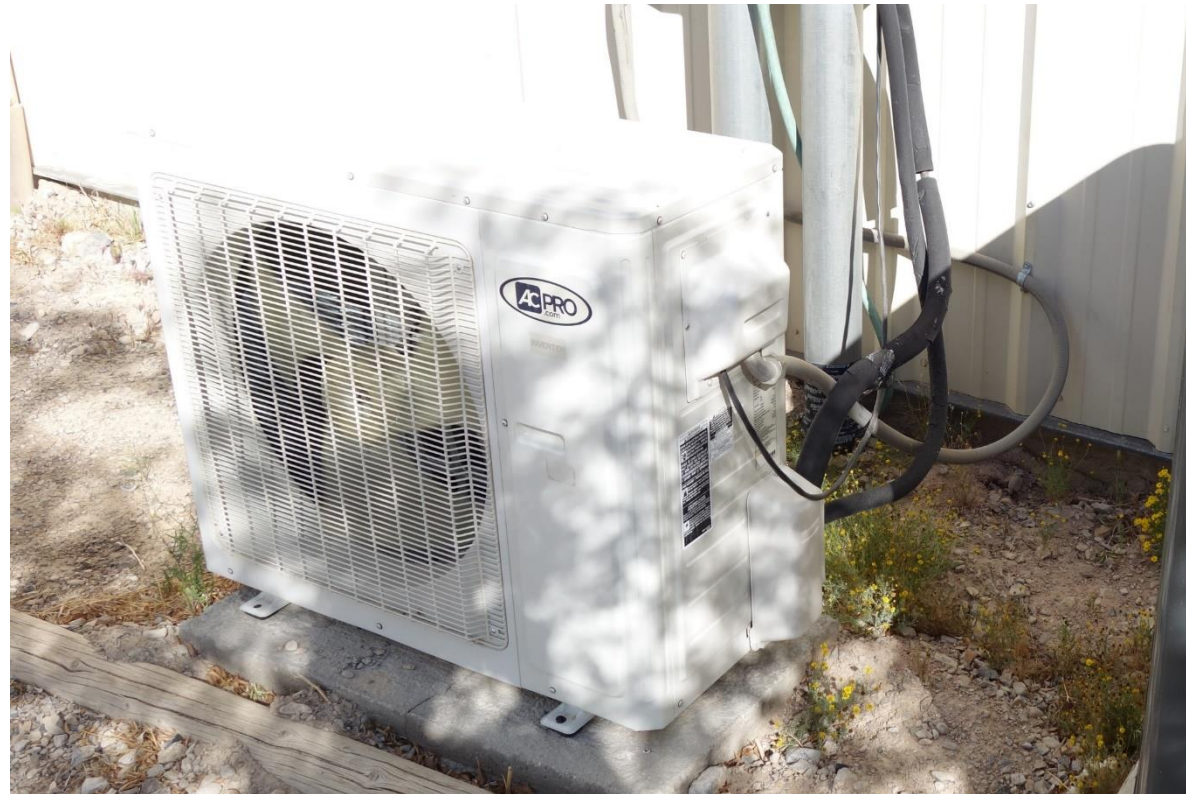
PROJECT #: 0864HVA2

DATA ROOM AIR CONDITIONING REDUNDANCY

The data room is cooled by the existing mini-split HVAC system. However, planning should take place to add redundancy to limit the risk to network systems if the existing air conditioning system fails. The existing system was recently replaced in 2020 so redundancy is not urgent. It is recommended to install a redundant mini-split system in the room to ensure cooling reliability. This project would provide for the purchase and installation of an air conditioner including all required connections to existing utilities.

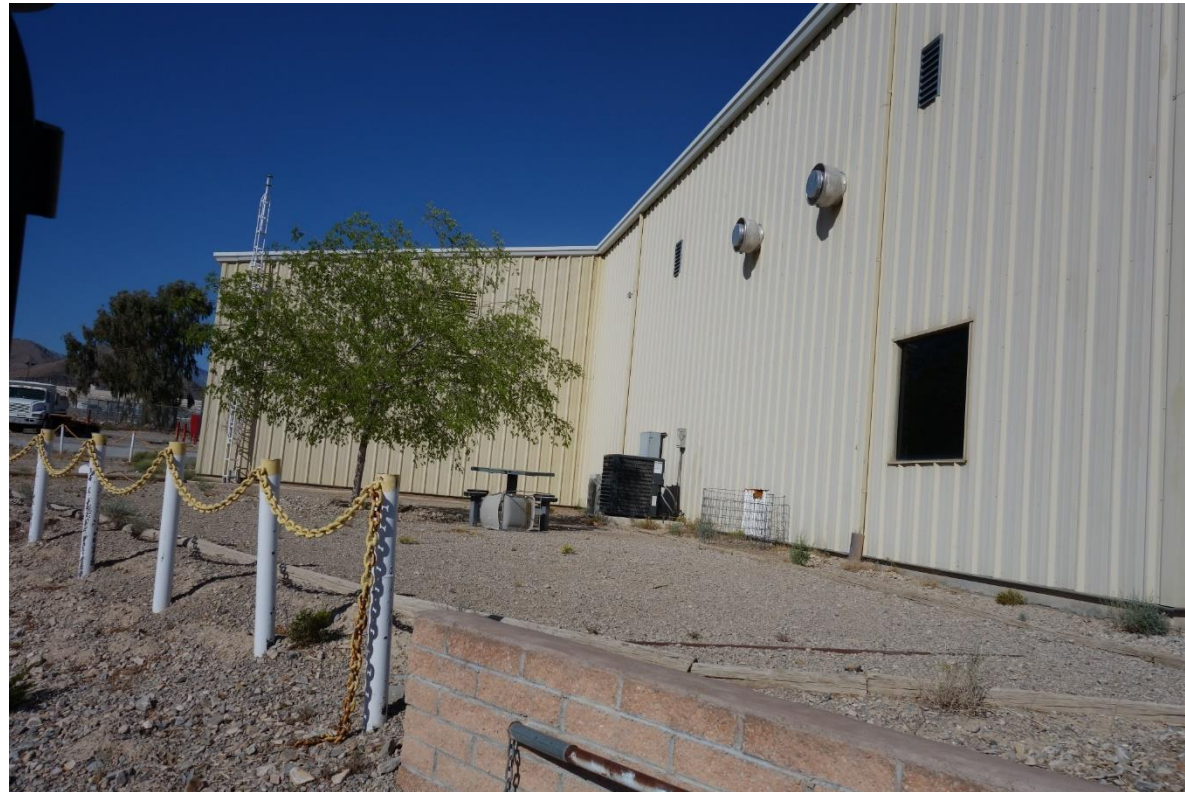
PROJECT #: 0864EXT1

EXTERIOR FINISHES

The pre-finished metal exterior finishes were in good condition. It is important to maintain the finish, weather resistance and appearance of the building. This project would provide funding to protect the exterior of the building excluding the roof. Included in the cost is caulking and sealing windows, flashing, fixtures and all other penetrations. It is recommended that the building be caulked and sealed in the next 8 - 10 years and that this project be scheduled on a cyclical basis to maintain the integrity of the structure.

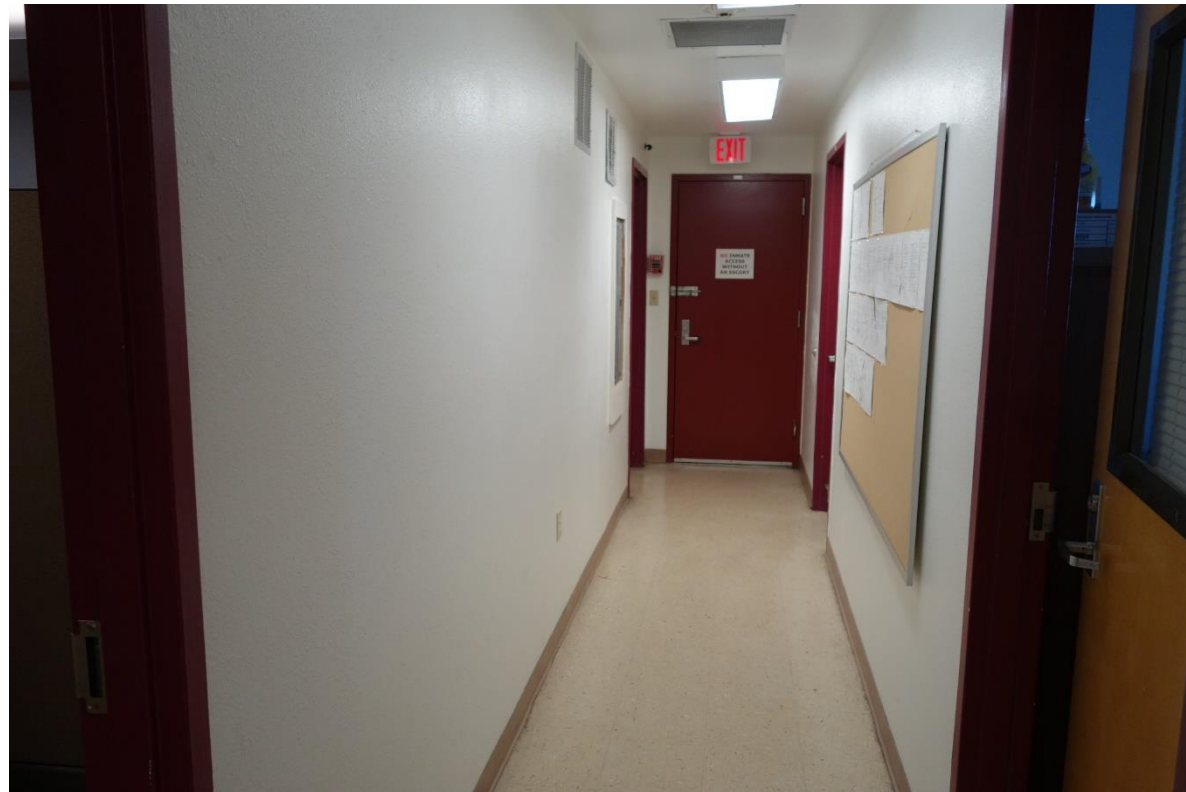
PROJECT #: 0864INT1

INTERIOR FINISHES

The interior finishes are in good condition. It is recommended that the interior walls be painted at least once in the next 7 - 9 years. Prior to painting, all surfaces should be repaired and prepped. An epoxy-based paint should be utilized in wet areas for durability.
