# STEWART CAMPUS SITE

5500 Snyder Ave.  
Carson City, Nevada 89701

**Site Number: 9971**  
**STATE OF NEVADA PUBLIC WORKS DIVISION**  
**FACILITY CONDITION ANALYSIS**

Report Printed in February 2021

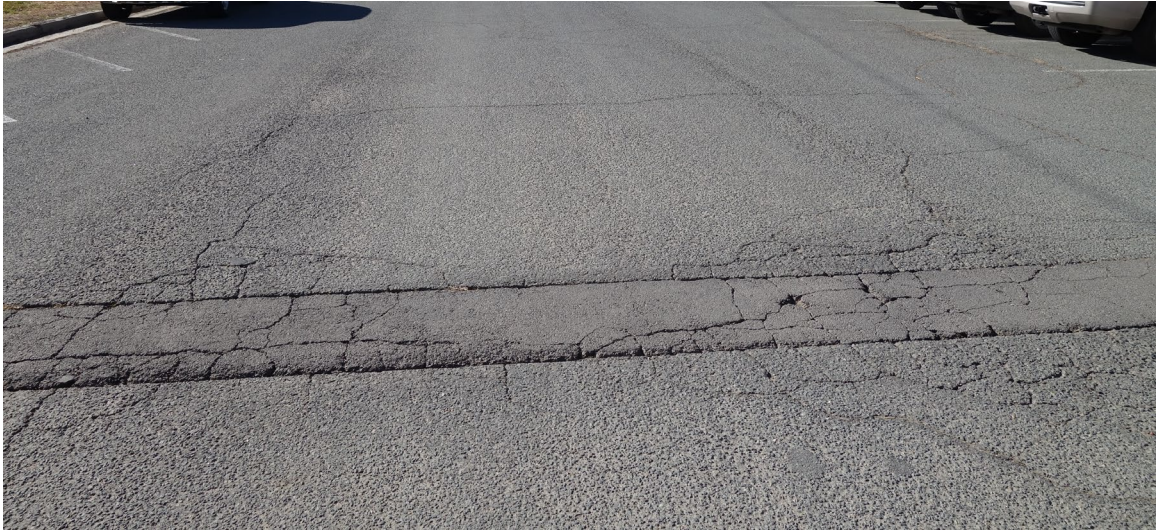
It is important to maintain the asphalt concrete paving on the site. This project would provide for minor crack filling and sealing of the paving sitewide including access roads and parking areas. Striping is included in this estimate. This project should be scheduled on a 5 year cyclical basis to maintain the integrity of the paving and prevent premature failure.

Stewart Campus Site – FCA Site #9971  
Description: Crack fill and seal site wide.

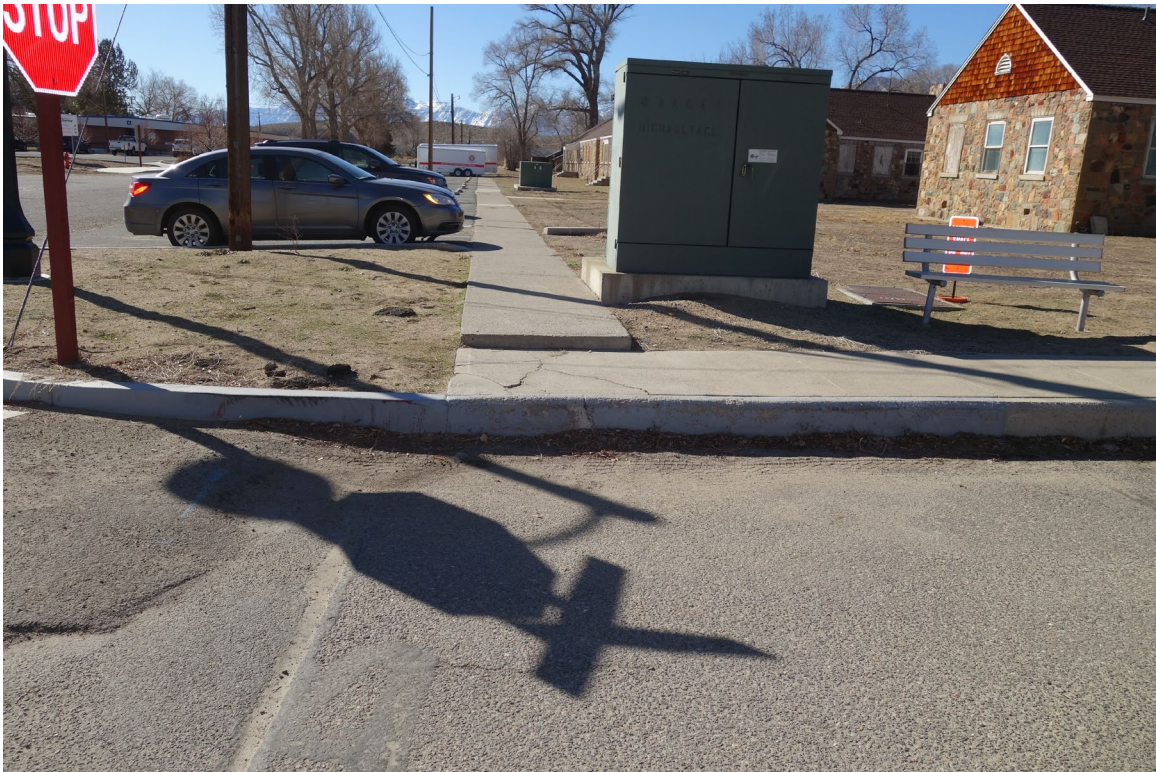
Some of the sidewalks serving the buildings and recreation areas on this site have deteriorated and are failing. In some areas cracks wider than four inches have been identified, and there is settling in many locations. This project addresses removal and replacement of existing sidewalks as needed. 5,000 SF of 4" thick concrete sidewalk was used for this estimate.

Stewart Campus Site – FCA Site #9971  
Description: Damaged concrete walkway.

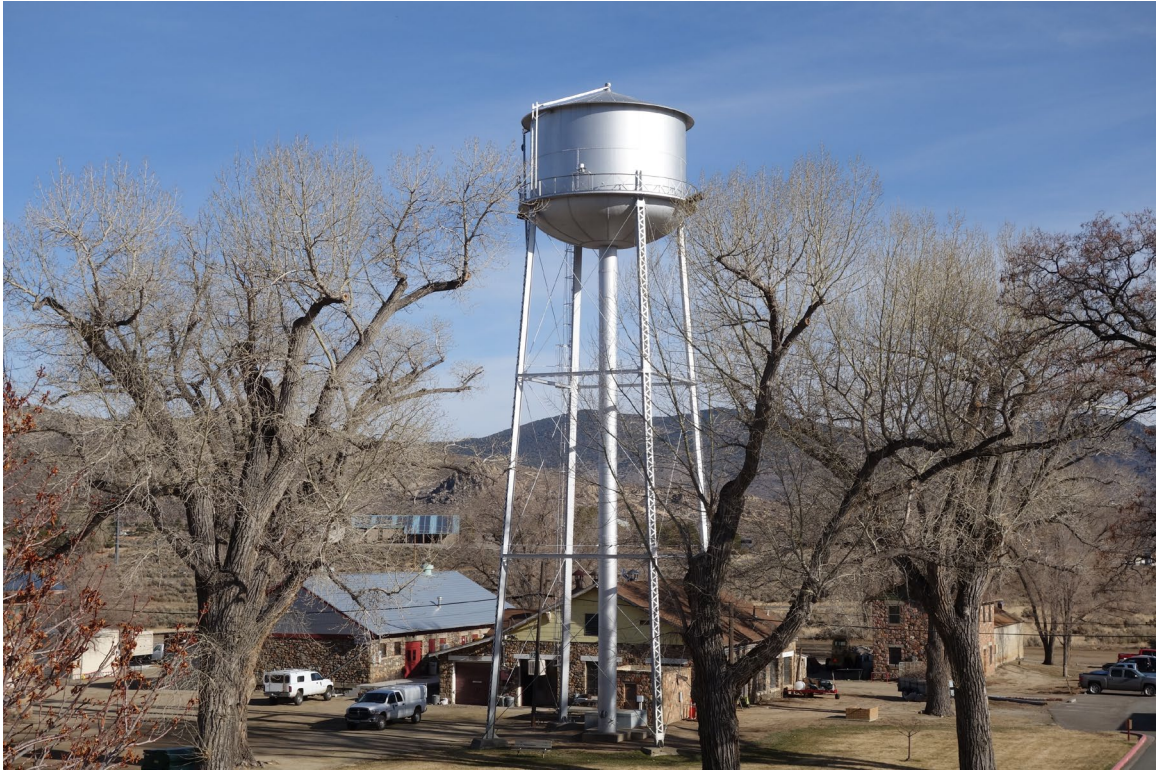
The Water Tower is approximately 75,000 gallon elevated water storage structure which supplies irrigation water to the Stewart Campus Site. The tank's water is pumped from an on-site well and gravity feeds the irrigation system. Based on structural analysis of the tower under CIP 03-S04D, the tower required a retrofit at all water levels in the tank. It is noted that the seismic analysis did not calculate if structural improvements were necessary for a decommissioned empty water tower.

A seismic analysis was performed on the water tower under CIP 03-S04D in which structural improvements were necessary at all levels of water stored in the tower. In order to remain operational and prevent collapse in a major earthquake, the seismic retrofitting will address the tower's structure and foundations. This project will provide the funding to structurally retrofit the existing water tower and foundation.

Water Tower – FCA Building #2704  
Description: View of the tower.

The finish is in good condition. It is important to maintain the finish, weather resistance and appearance of the water tower. This project would provide for the painting of the water tower and caulking of the joints to maintain it in a good, weather tight condition. It is recommended that this project be implemented in the next 8 - 9 years and is recommended on a cyclical basis based on environmental conditions.

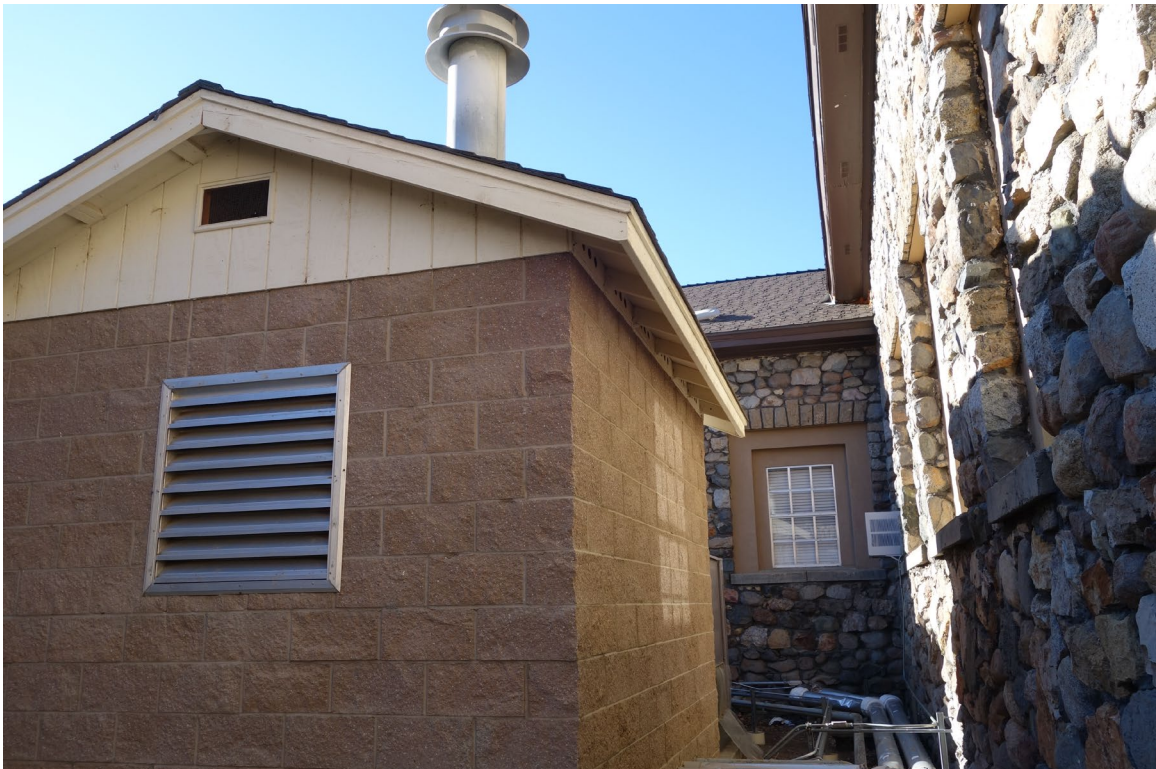
The Utility Room building is located in the courtyard of Building #089. It is a concrete masonry unit and wood framed structure which houses the mechanical equipment for Building #089. The building has an asphalt composition roofing system and a concrete slab-on-grade foundation. It is in good condition.

The exterior finishes are in good condition. It is important to maintain the finish, weather resistance and appearance of the building. This project would provide funding to protect the exterior of the building excluding the roof. Included in the cost are painting the wood finishes, cleaning and sealing the concrete masonry units and caulking of the flashing, fixtures and all other penetrations. It is recommended that the building be sealed and caulked in the next 8 - 9 years and that this project be scheduled on a cyclical basis to maintain the integrity of the structure.

The interior finishes are in fair condition. It is recommended that the interior CMU walls be sealed at least once in the next 5 - 6 years and that this project be scheduled on a cyclical basis to maintain the integrity of the structure.

Building #89 Utility Room – FCA Building #2703  
Description: Exterior of the Building.

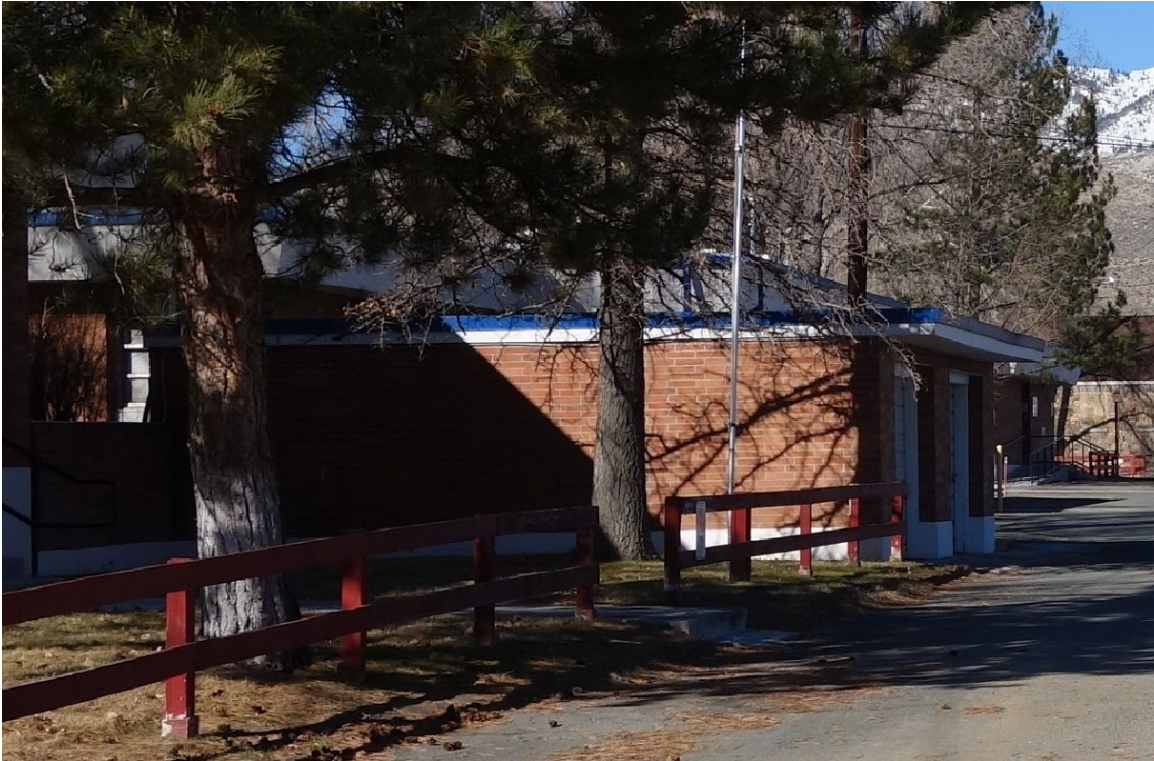
Building #107 Garage is a brick masonry structure with a low slope single-ply roofing system on a concrete slab-on-grade foundation. It is located on the north side of Building #107 State Fire Marshal building and is in good condition.

The exterior finishes are in good condition. It is important to maintain the finish, weather resistance and appearance of the building. This project would provide funding to protect the exterior of the building excluding the roof. Included in the cost are cleaning and sealing the brick masonry, painting the concrete roof eaves and caulking of the flashing, fixtures and all other penetrations. It is recommended that the building be sealed, painted and caulked in the next 8 - 9 years and that this project be scheduled on a cyclical basis to maintain the integrity of the structure.

The interior finishes are in fair condition. It is recommended that the interior walls and ceilings be painted at least once in the next 5 - 6 years and that this project be scheduled on a cyclical basis to maintain the integrity of the structure. Prior to painting, all surfaces should be repaired and prepped.

Building #107 - Garage – FCA Building #2702  
Description: Exterior of the Building.

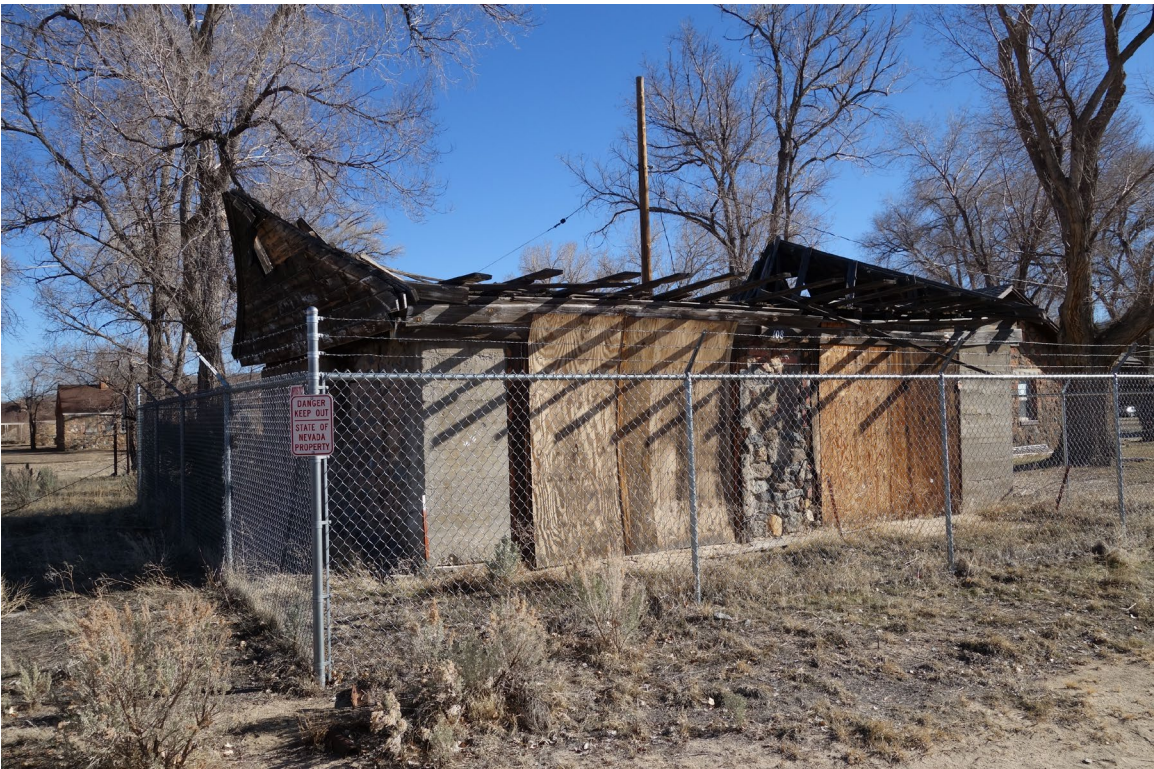
Building #108 Garage is an unreinforced stone masonry and wood framed structure located at the south end of the Stewart Campus Site. No seismic retrofit improvements have been done on this structure. This building is in an extremely poor condition and is showing signs of possible structural collapse. These issues will be addressed with a project recommendation in the report.

The building is an old garage that is no longer in use. It has significant structural failures and the roof has completely deteriorated. It is recommended that this structure be demolished.

Building #108 – Garage (Vacant) – FCA Building #2163  
Description: Exterior of the Building.

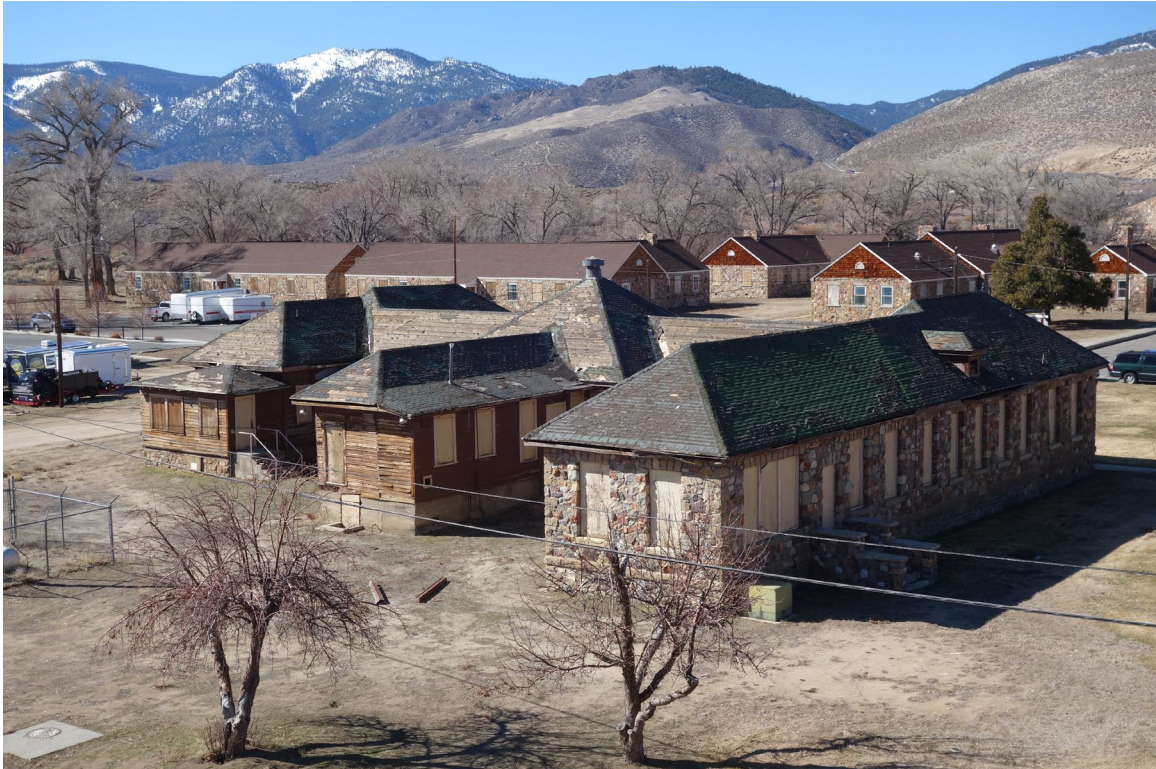
Building #102 Infirmary is an unreinforced stone masonry and wood framed structure located at the southeast end of the Stewart Campus Site. No seismic retrofit improvements have been done on this structure. This building is in poor condition. It is not occupied and there are no plans for future occupation.

This building is an unreinforced masonry (URM) structure which requires seismic strengthening to comply with current codes. Visual analysis during the survey found no indication of seismic strengthening of the roof structure. The roof structure should be seismically retrofitted during the next remodel or change of occupancy. The estimate is for construction costs only.

This building is an unreinforced masonry (URM) structure which requires seismic strengthening to comply with current code. Visual analysis during the survey found no indication of seismic strengthening of the URM walls. The walls should be seismically retrofitted during the next remodel or change of occupancy. The estimate is for construction costs only.

Building #102 – Infirmary (Vacant) – FCA Building #2162  
Description: Exterior of the Building.

In order to preserve the building for future rehabilitation and reuse, this project recommends mothballing it in accordance with the U. S. Department of Interior Recommended Guidelines in Preservation Brief 31. Costs related to removing water in the basement or crawlspace, providing drainage away from the building to prevent future water accumulation, pest control and removal of accumulated waste are included. Windows and doors will be secured or covered, and some will include louvers to permit ventilation of the structure.

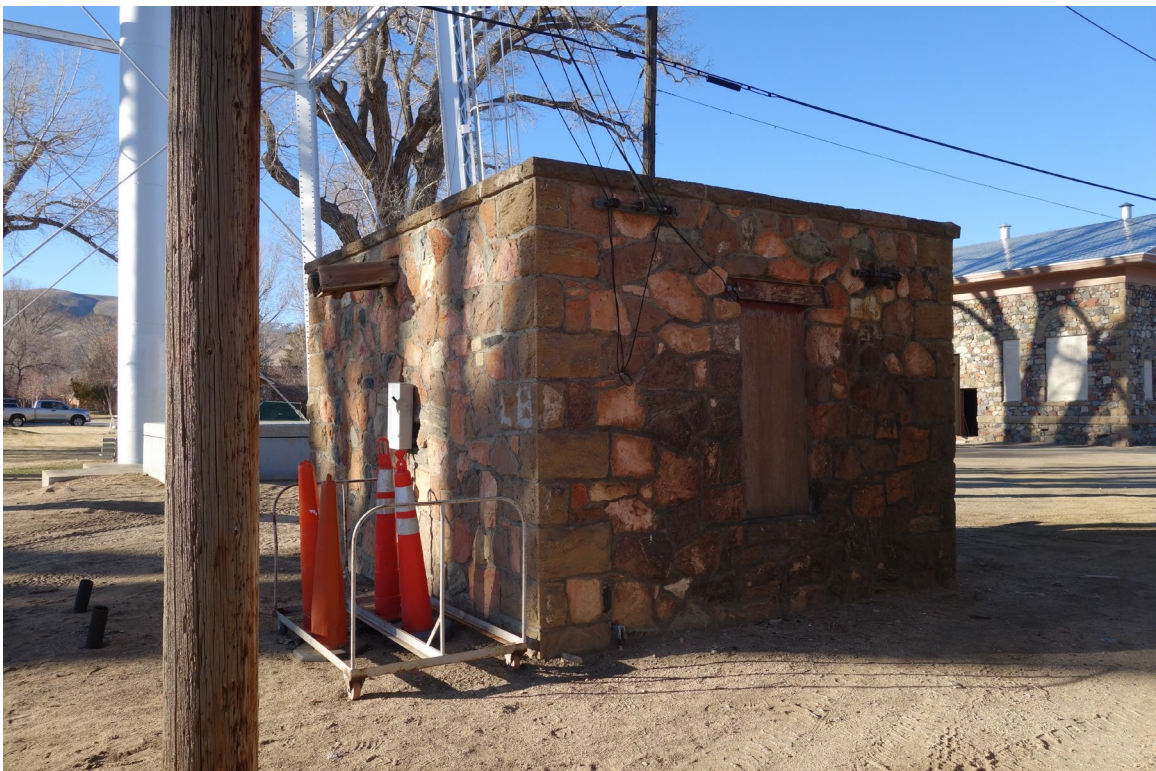
This building is an unreinforced masonry (URM) structure which requires seismic strengthening to comply with current code. Visual analysis during the survey found no indication of seismic strengthening of the URM walls. The walls should be seismically retrofitted during the next remodel or change of occupancy. The estimate is for construction costs only.

Building #94 – Pump House – FCA Building #2161  
Description: Exterior of the Building.

It is important to maintain the finish, weather resistance and appearance of the building. This project would provide funding to protect the exterior of the building excluding the roof. Included in the cost is sanding, priming and painting the wood finishes, re-pointing the stone where needed and caulking of the windows, flashing, fixtures and all other penetrations. It is recommended that the building be painted in the next 2-3 years and that this project be scheduled on a cyclical basis to maintain the integrity of the structure.

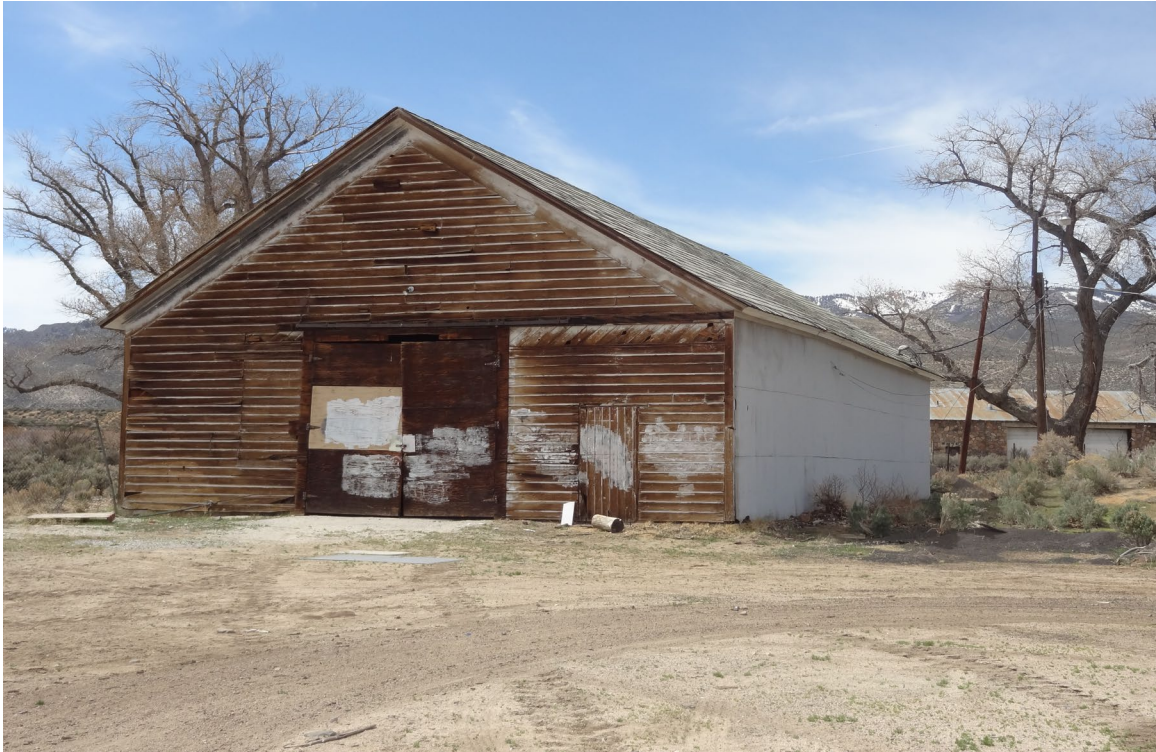
Building #070 Barn is used by Building and Grounds for storage. It is a wood framed structure located in the southwest area of the Stewart Campus Site. The uninsulated building is in poor condition inside and out.

The transite shingle roof on this building was in poor condition at the time of the survey. It is recommended that this building be re-roofed in the next 2-3 years with a new 50 year asphalt composition roofing shingle and new underlayments. This estimate includes removal and disposal of the old roof.

The exterior finishes are in poor condition. It is important to maintain the finish, weather resistance and appearance of the building. This project would provide funding to protect the exterior of the building excluding the roof. Included in the cost is sanding, priming and painting and caulking of the flashing, fixtures and all other penetrations. It is recommended that the building be painted in the next 2 - 3 years and that this project be scheduled on a cyclical basis to maintain the integrity of the structure.

Building #70 – Barn B&G Storage – FCA Building #2160  
Description: Exterior of the Building.

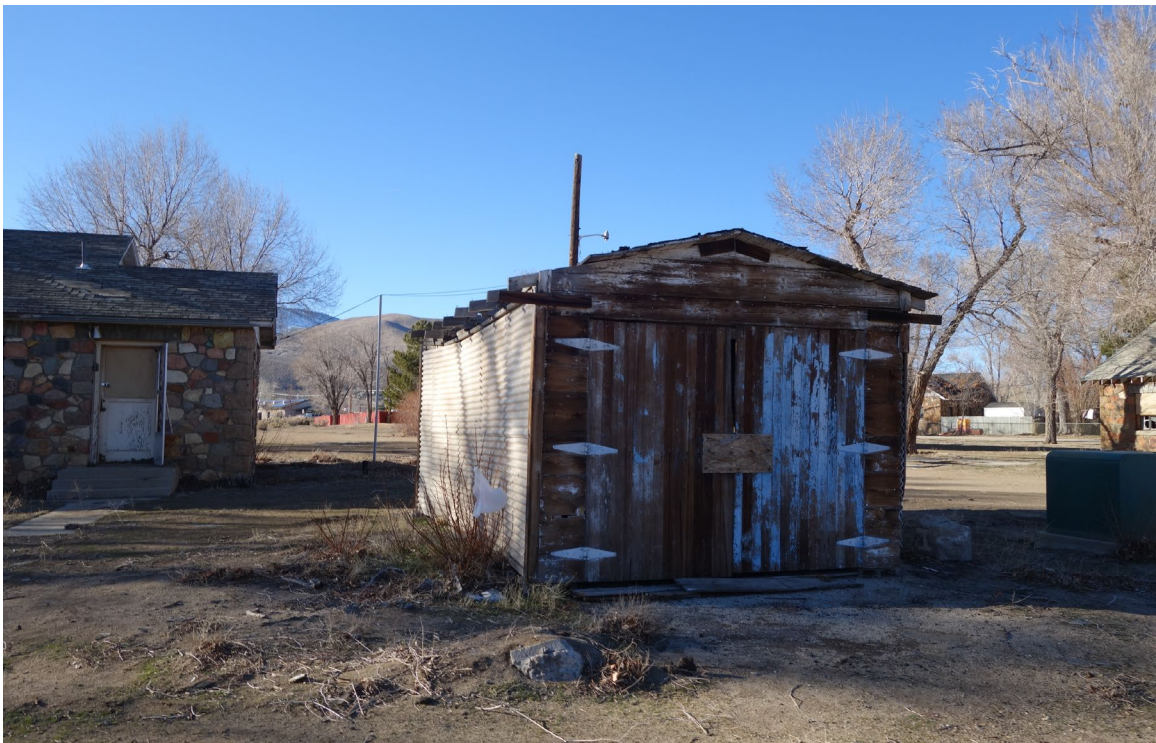
Building #055 Storage is an old garage or shop style structure which is wood framed. It has a dirt floor and has a corrugated composite siding which may contain asbestos. The roof is leaking, and it appears that it is not used any longer. The building is in poor condition and should be demolished.

This building is dilapidated, damaged and is no longer being used. This project would provide for the removal of the structure. This site is on the National Registrar of Historic Places and any request to remove this structure will have to be approved by them prior to proceeding with any demolition.

Building #55 – Storage (Vacant) – FCA Building #2159  
Description: Exterior of the Building.

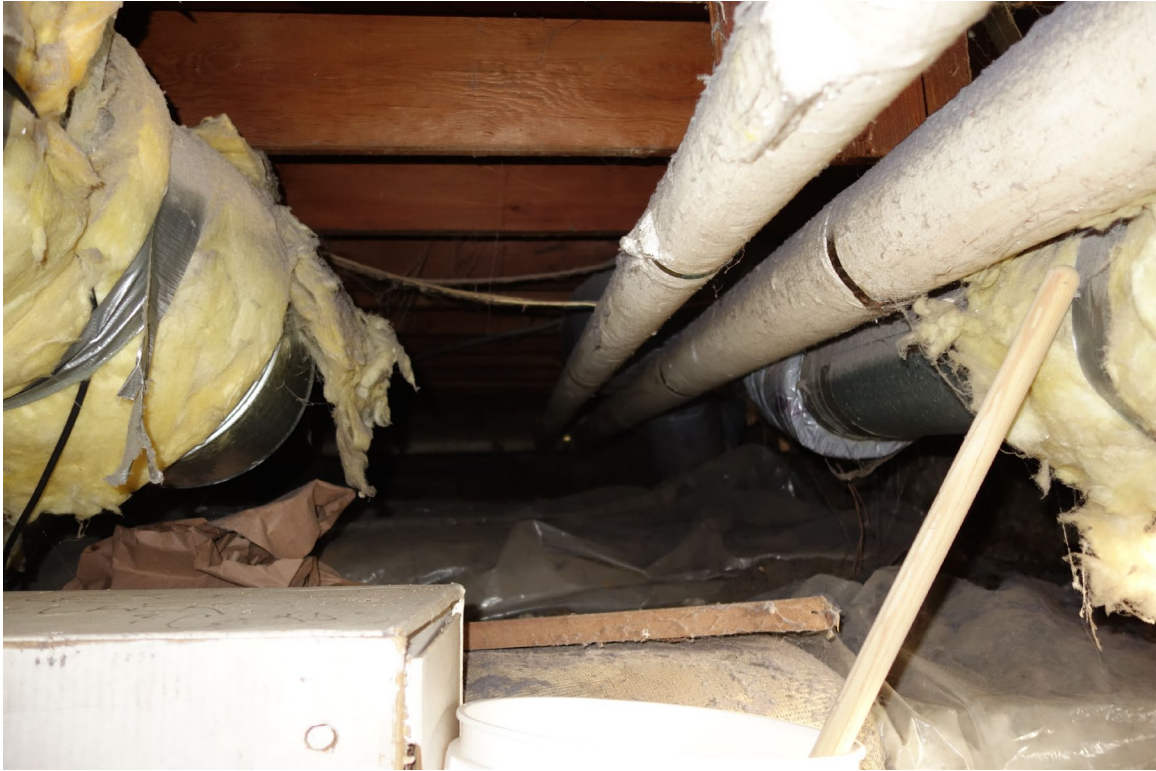
Building #65 Non-Profit – FCA Building #0735  
Description: View of basement piping and duct insulation.

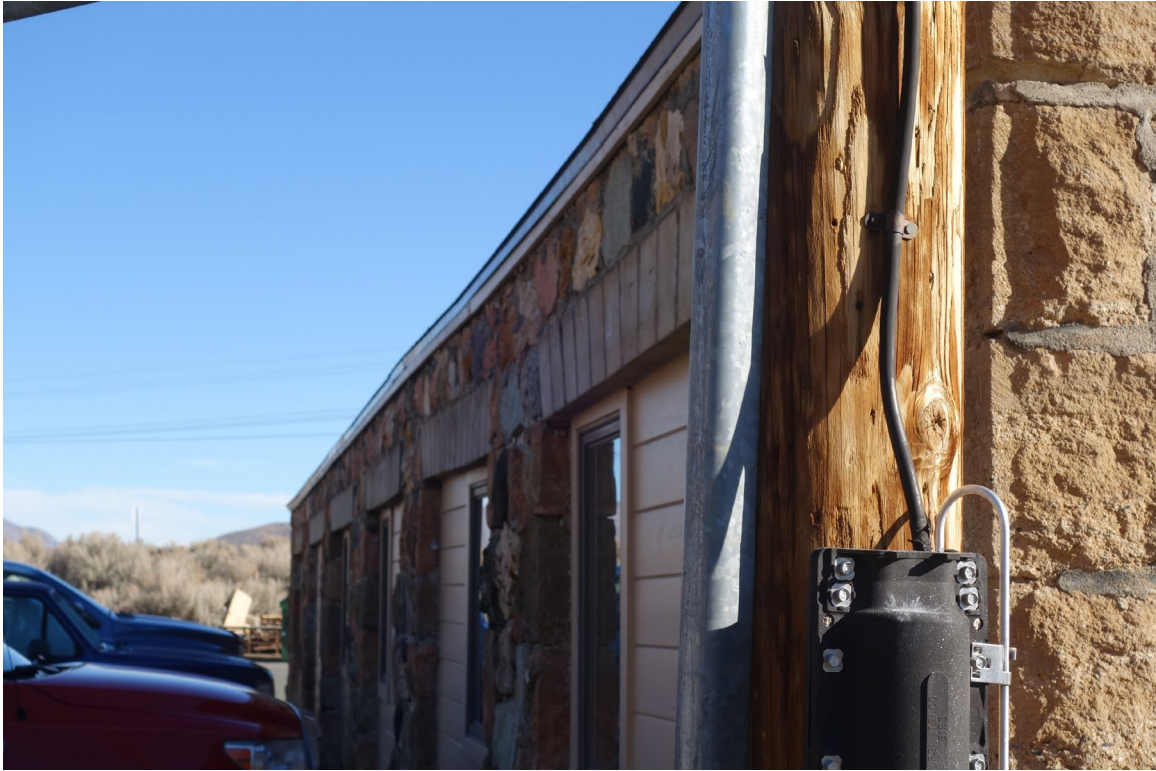
Building #18 Office (NDOC) - FCA Building #0438  
Description: View of apparent settling, North side of the Building.

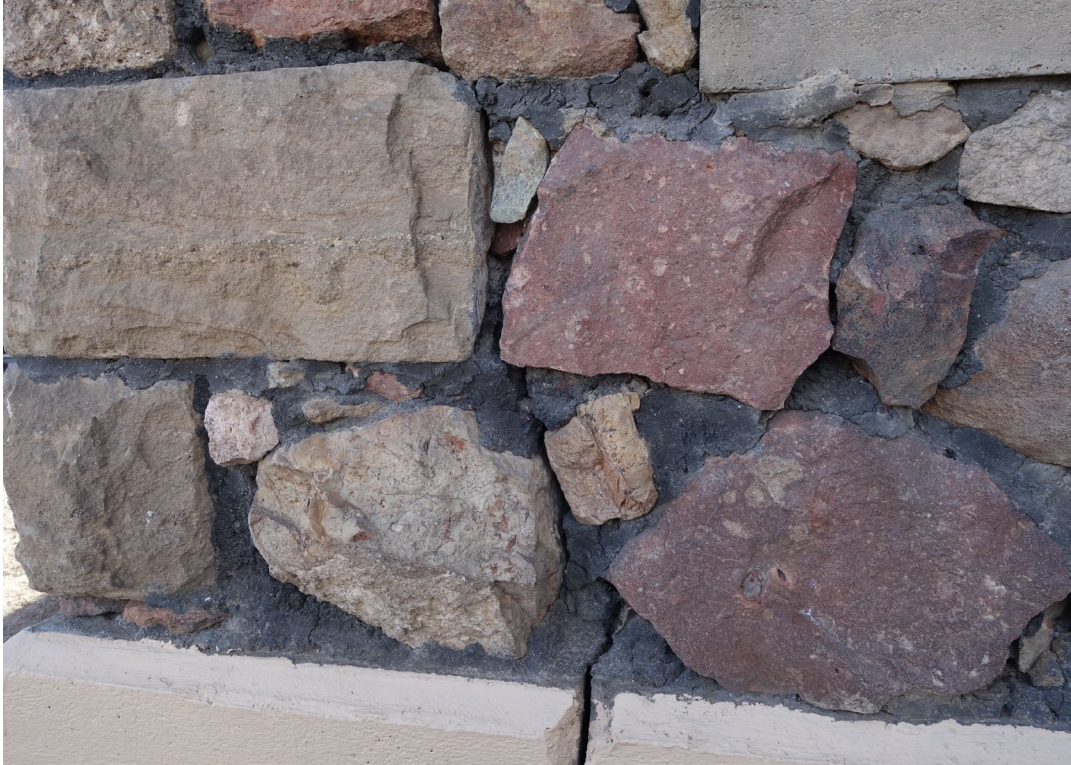
Building #89 Administration (NDOC) - FCA Building #0431  
Description: View of URM cracking.

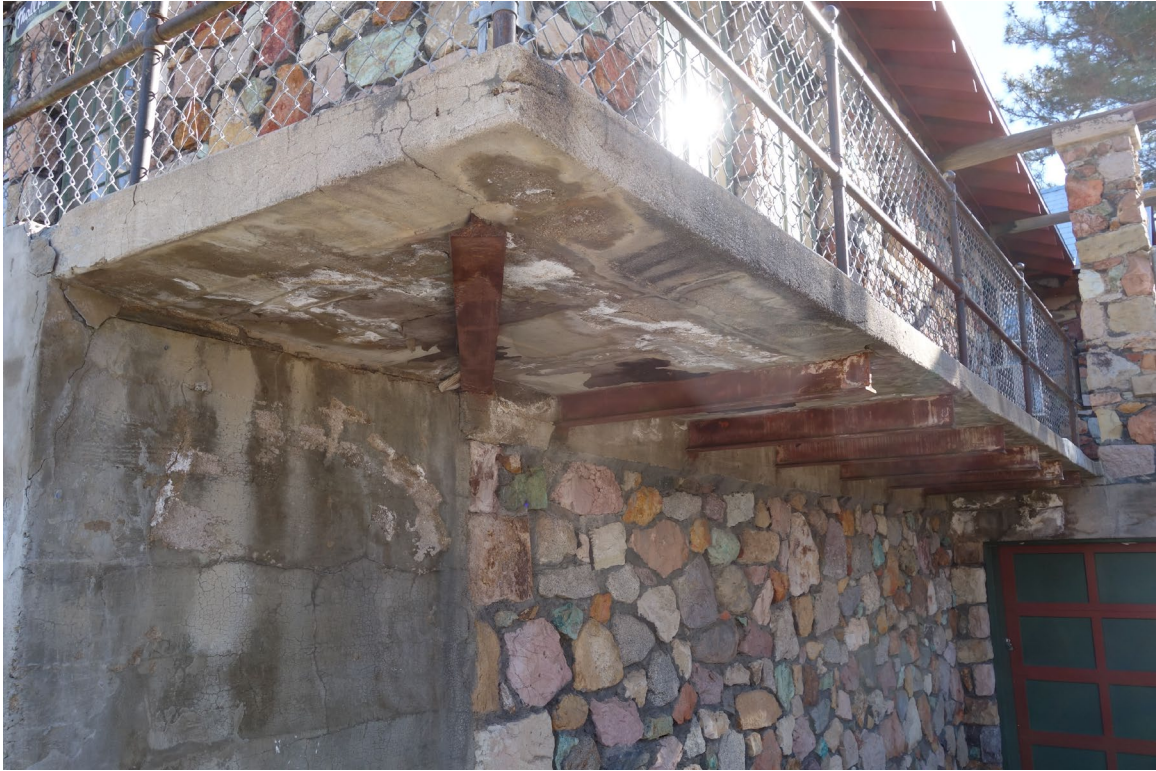
Building #3 Stewart Indian Administration Building - FCA Building #0420  
Description: View of structural repairs.

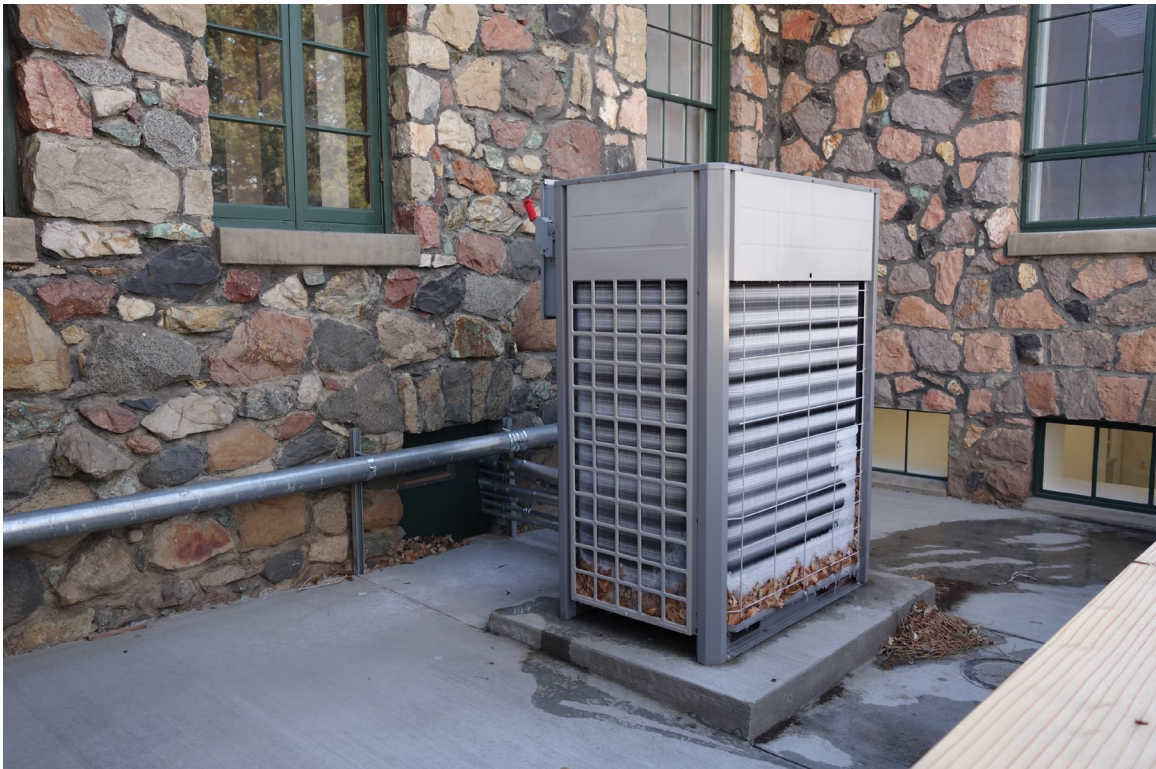
Building #1 Stewart Indian School Museum - FCA Building #0419  
Description: View of concrete apron repairs.
