State of Nevada
Department of Corrections
Carlin Conservation Camp
Facility Condition Analysis

CARLIN CONSERVATION CAMP

101 Susie Creek Road
Carlin, Nevada 89822

**STATE OF NEVADA PUBLIC WORKS DIVISION
FACILITY CONDITION ANALYSIS**

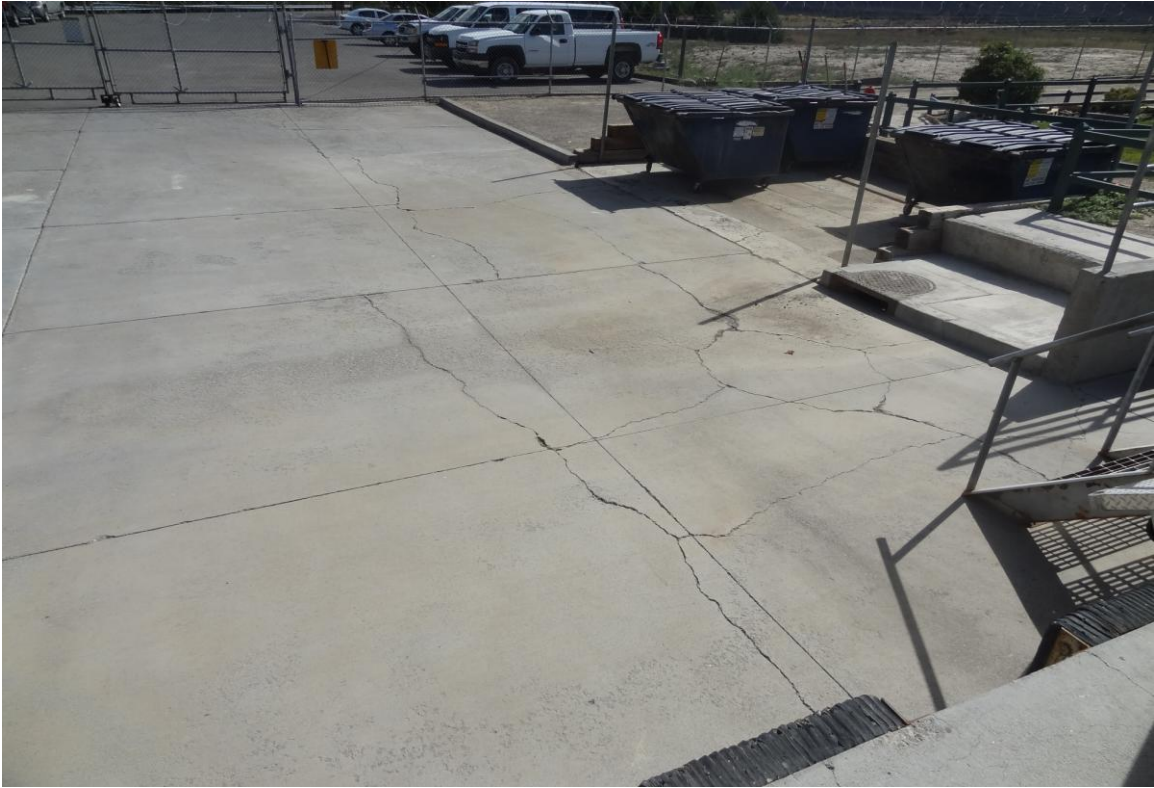
Carlin Conservation Camp Site – FCA Site #9973
Description: Loading dock area.

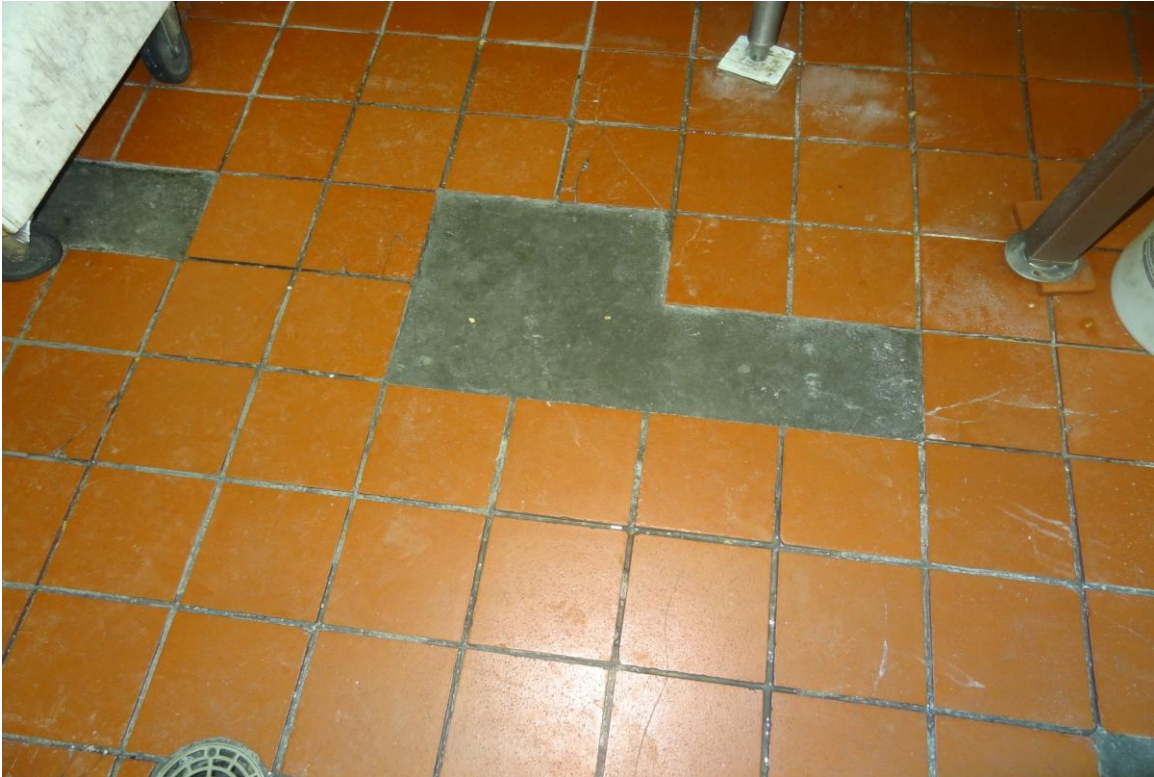
Carlin Conservation Camp Housing Unit – FCA Building #0697
Description: Missing culinary floor tiles.

REPLACE FLOORING**Project Index #: 0697INT1****Construction Cost \$161,724**

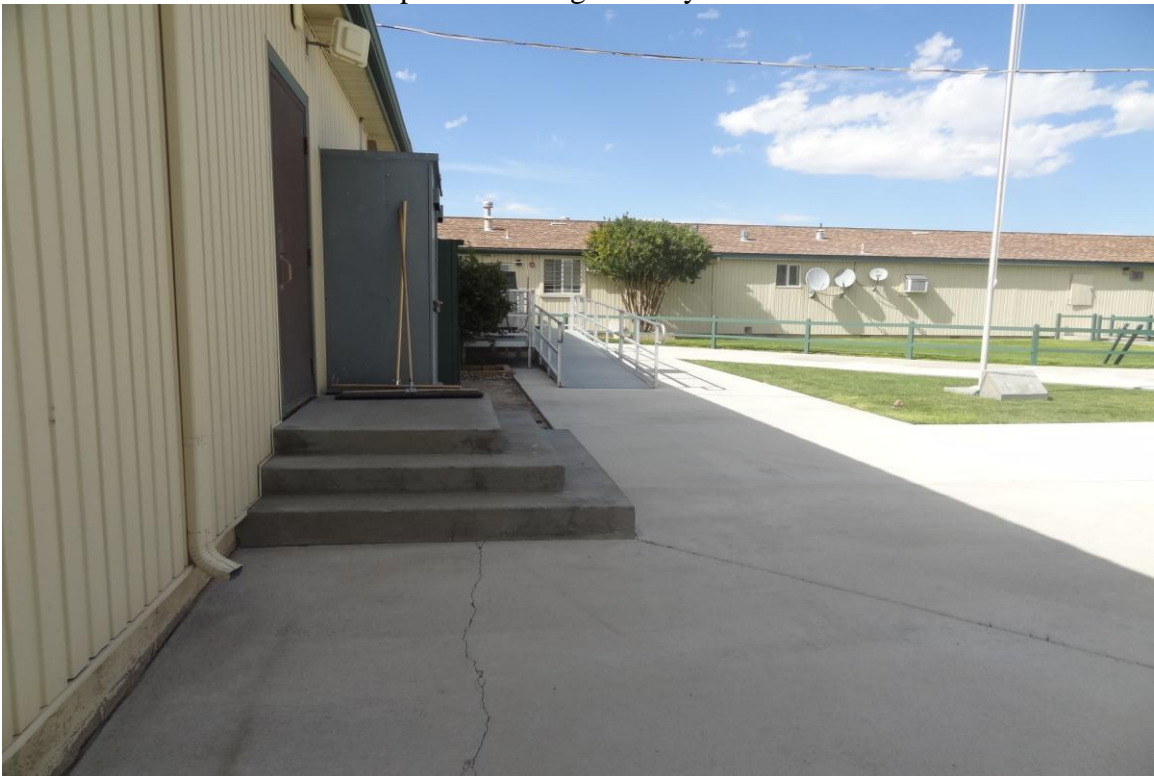
Carlin Conservation Camp Housing Unit – FCA Building #0697
Description: Exterior stairs in need of handrails.

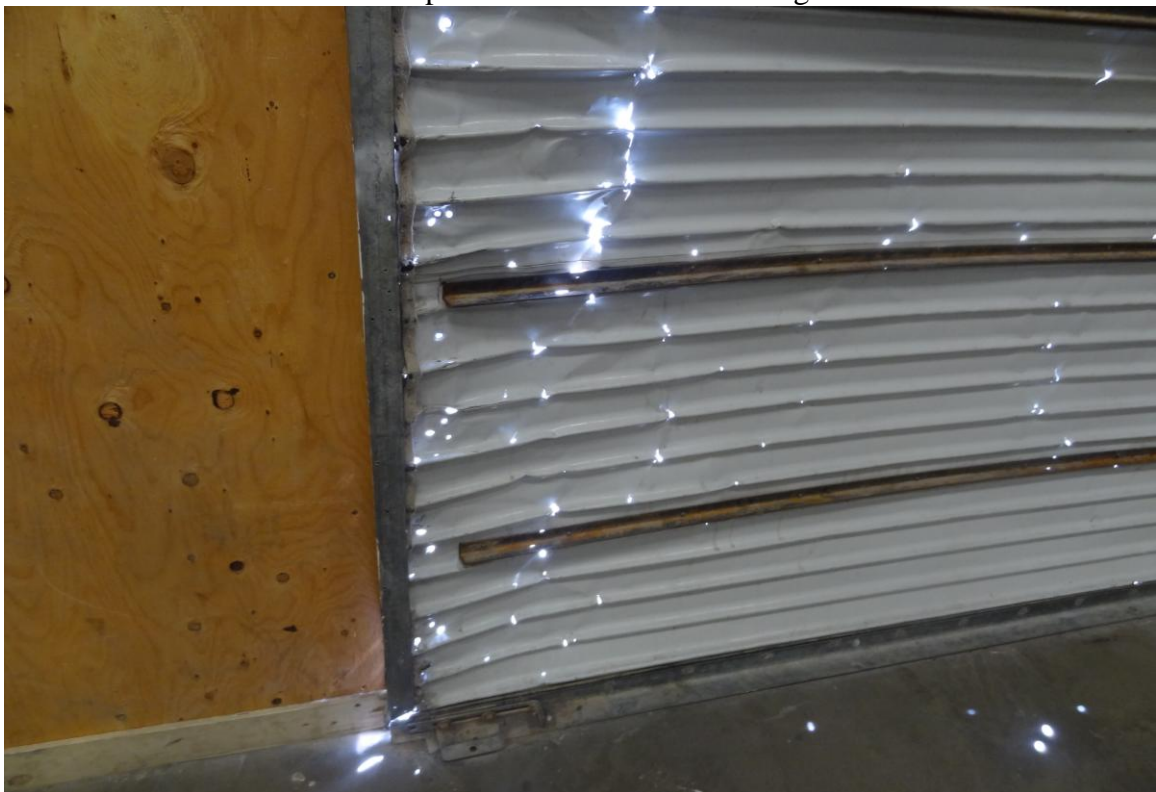
The existing 10'x16' sectional overhead door is damaged from abuse and is original to the building. It has holes, bent panels, and no longer operates properly. This project would provide funding for removal and disposal of the old overhead door and the purchase and installation of a new insulated sectional overhead door with a motor, including connections to utilities as required. This project or a portion there of was previously recommended in the FCA report dated 09/19/2000 and 9/29/2005. It has been amended accordingly to reflect conditions observed during the most recent survey date 09/17/2013.

CCC Multi-Purpose Building – FCA Building #1580
Description: Over head coiling door in need of replacement.

OVERHEAD DOOR REPLACEMENT**Project Index #: 1580EXT1****Construction Cost \$15,500**
