State of Nevada
Department of Corrections
Tonopah Conservation Camp
Facility Condition Analysis

TONOPAH CONSERVATION CAMP

Site Number: 9975
STATE OF NEVADA PUBLIC WORKS DIVISION
FACILITY CONDITION ANALYSIS

Report distributed in October 2017

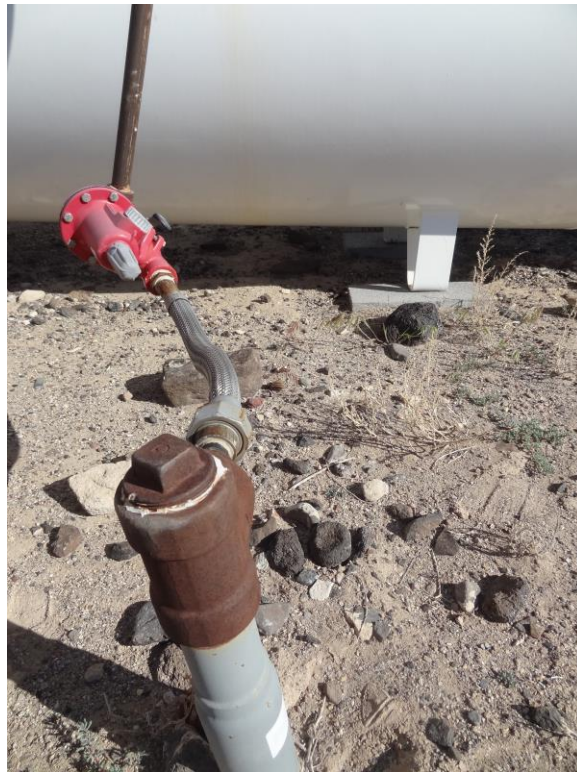
The propane tank farm has a damaged braided steel flex line after the pressure regulator. During the time of the survey there was a strong odor of gas. This project would provide for a licensed plumber to test all gas lines within the propane tank farm and repair any needed items. When completed, the licensed plumber should perform a manometer test on the gas lines. This project will provide for the replacement of the damaged flex line, the repair of any leaks and will certify the propane lines and tanks.

Tonopah Conservation Camp - Site #9975
Description: Gas line service needed.

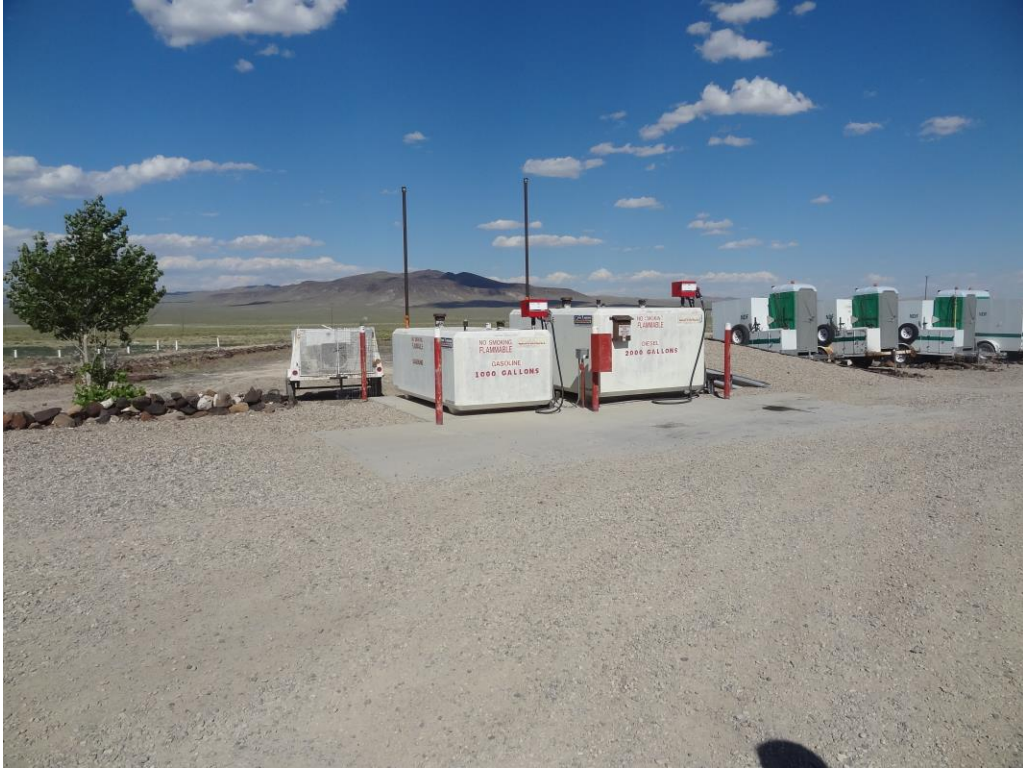
There are two above ground fuel tanks on the site, one for diesel and one for unleaded gasoline that do not have adequate bollard coverage. Per IFC 2012 Section 312 Vehicle Impact Protection, this project recommends that steel posts be installed, not less than 4 inches in diameter and filled with concrete. The spacing shall not be more than 4 feet between posts on center and located not less than 3 feet from each gas tank. This project would provide funding for ten new bollards to be located in-between the other bollards around the tanks.

Tonopah Conservation Camp - Site #9975
Description: Site bollards needed.

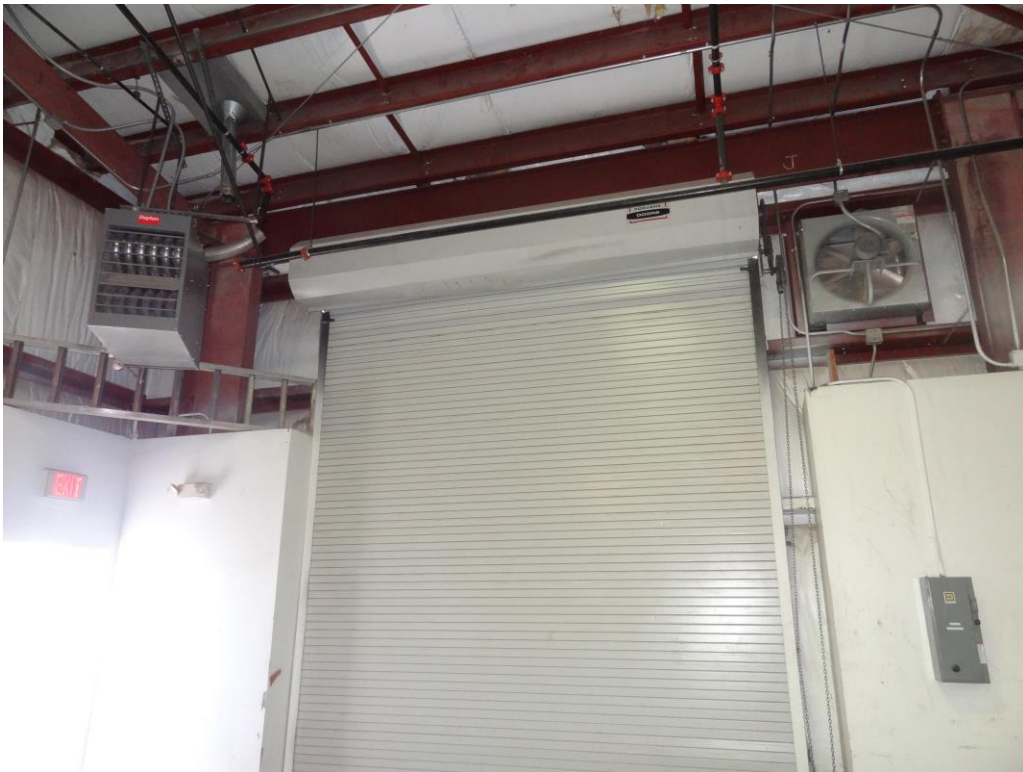
There is a heater flue in the building, which does not comply with UMC 2012 Chapter 8, Chimneys and Vents. The flue was installed with an improper flue and per Section 804 Direct-Vent Terminations, vent terminals for direct-vented appliances shall be installed in accordance with the manufacturer's installation instructions. The flue is disconnected, and some of the flue is aluminum flex duct and per 803.8 Vent Connector Construction, vent connectors shall be constructed of metal. The minimum thickness of the connector shall be (No. 28 gage) for galvanized steel. Per 801.18.2, flue passageways, the flue liner, chimney inner wall or vent inner wall shall be continuous and shall be free of cracks, gaps, perforations or other damage or deteriorations, which would allow the escape of combustion products, including gases, moisture and creosote. It is recommended that the flue be replaced. Replacements shall meet the manufacture's specifications and UMC 2012. The flue should be installed by a licensed contractor. This project would provide funds to replace and install 1 new flue to the existing heater.

NDF Industry Building - Building #2493
Description: Flue replacement needed.

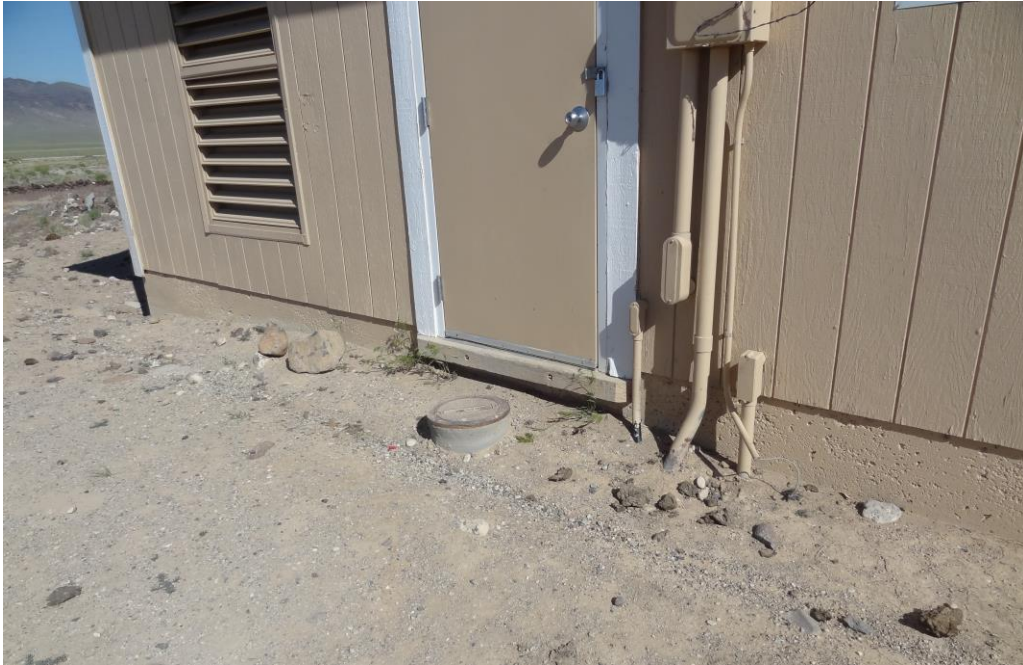
Pump House - Building #1621
Description: Exterior landing needed.

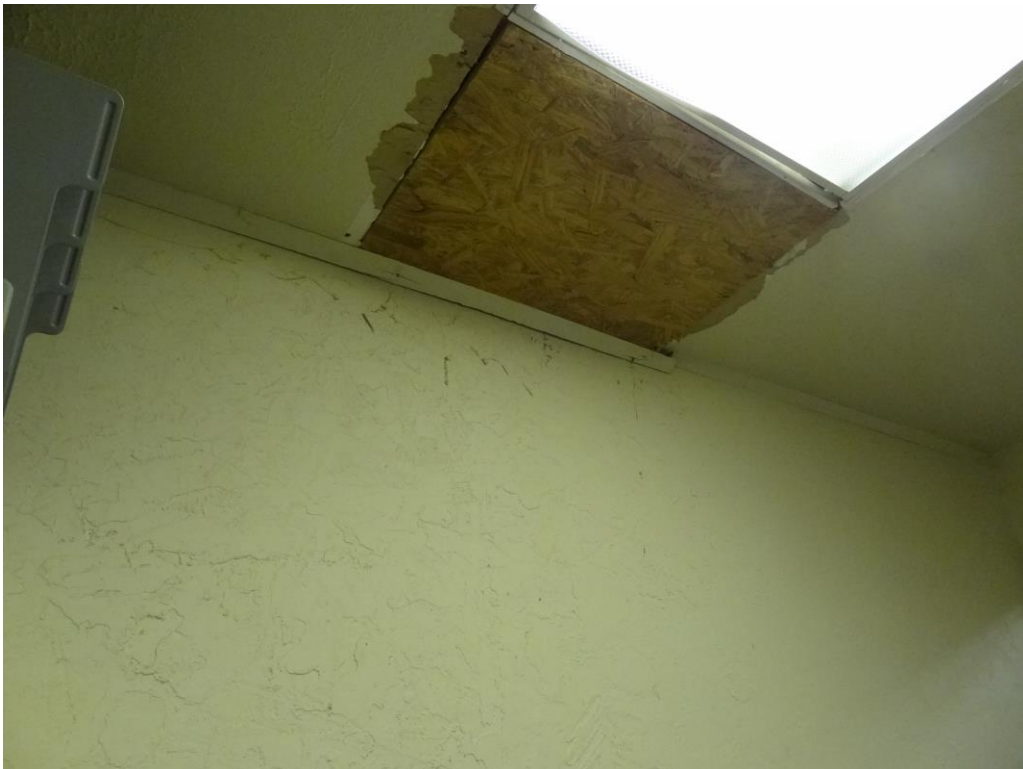
The fire rated ceiling in the equipment closet is damaged and should be scheduled for immediate repair. A square hole has been cut in the one hour fire rated assembly which compromises the fire protection design of the building. This project would provide for repair of the gypsum board ceiling with a 5/8" type X fire rated gypsum board to include tape, mud, texture and paint.

NDF Administration - Building #1620
Description: Fire rated ceiling repairs needed.

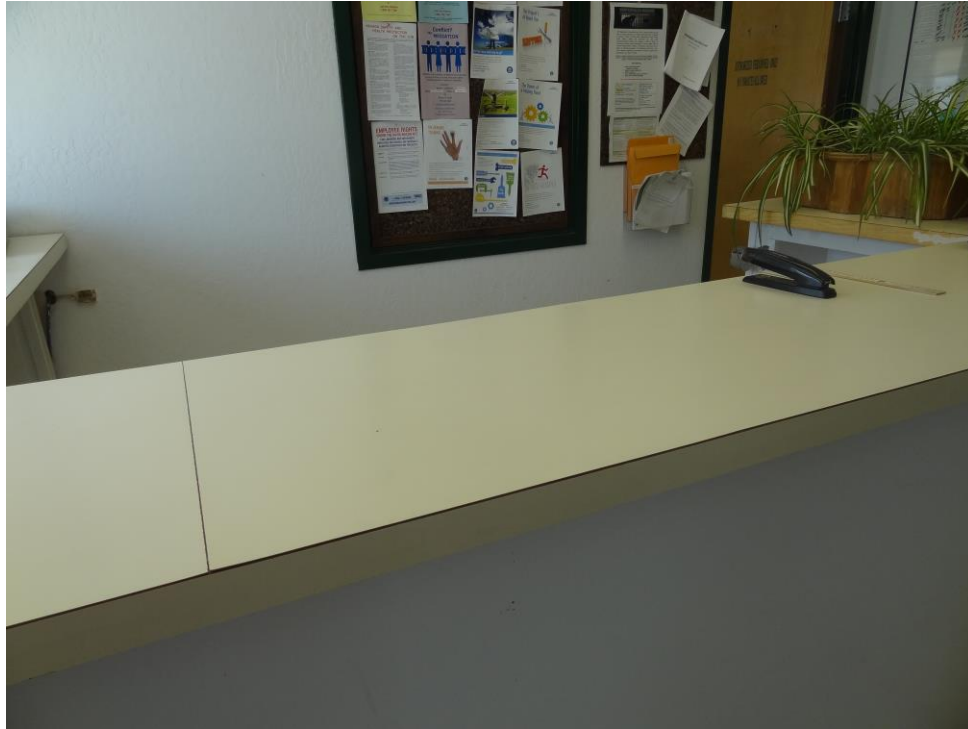
NDF Administration - Building #1620
Description: ADA accessible counter needed.

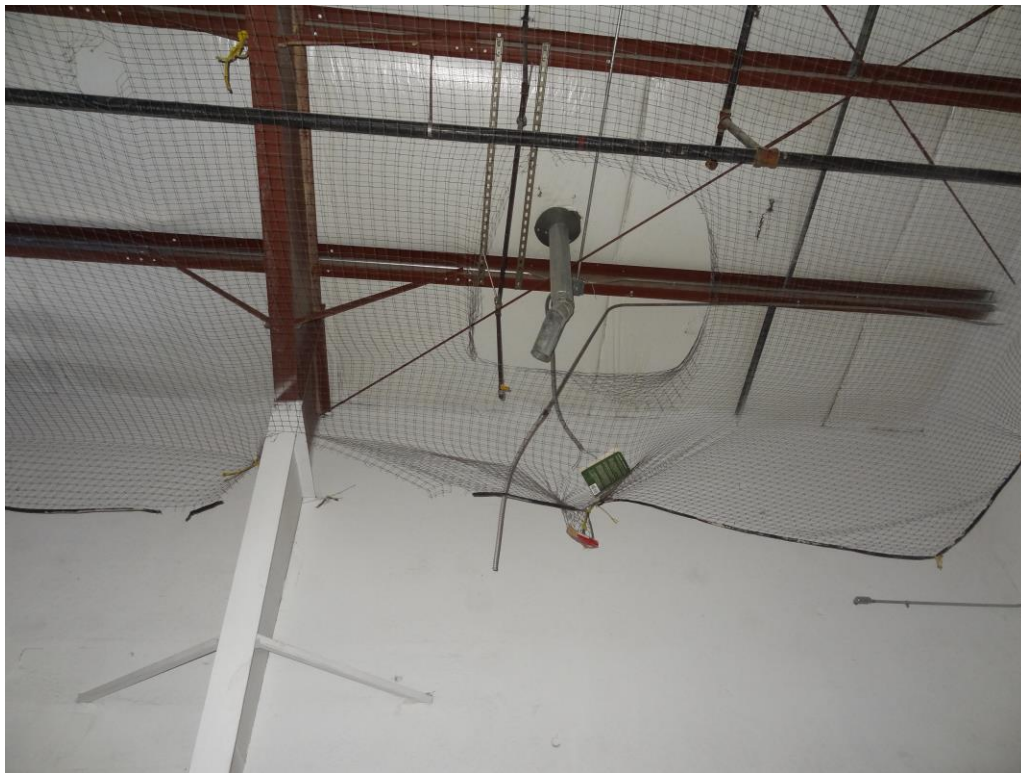
The gymnasium part of the building is heated by four ceiling mounted propane-fired heating units. They are original to the building and two of the units were missing at the time of the survey. They have reached the end of their useful life. This project provides for the disposal of the existing units and replacement with four new propane-fired units including connections to utilities.

Multi-Purpose - Building #1619
Description: Heater replacement needed.

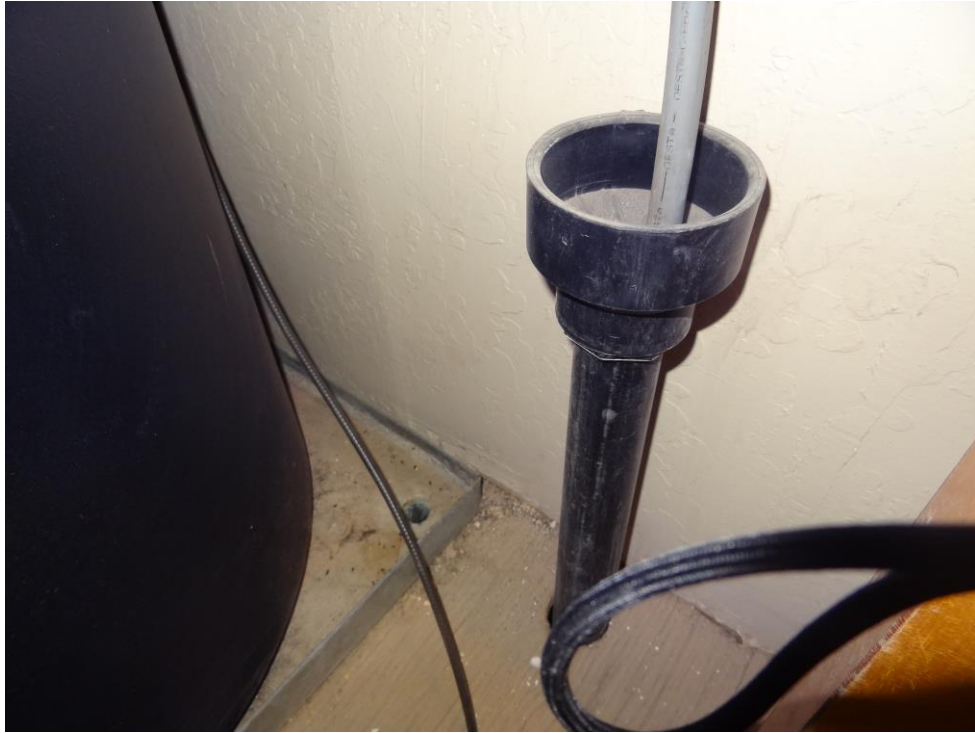
Multi-Purpose - Building #1619
Description: Plumbing replacement needed.

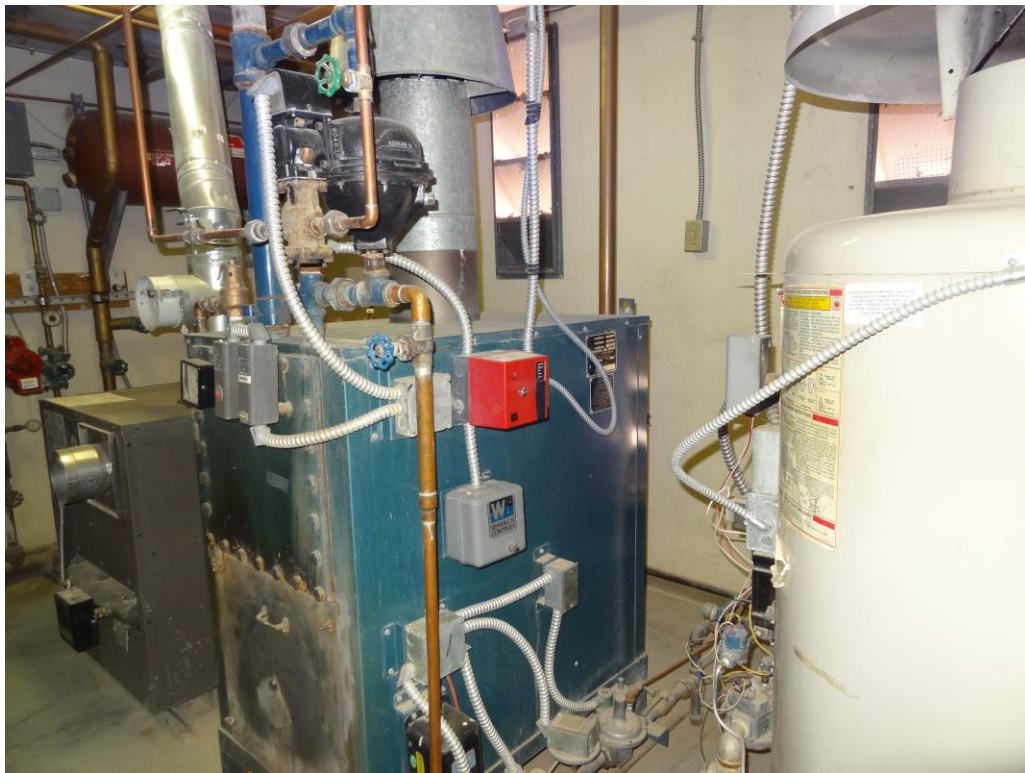
Housing Culinary Unit - Building #1618
Description: Boilers and heating system renovation needed.

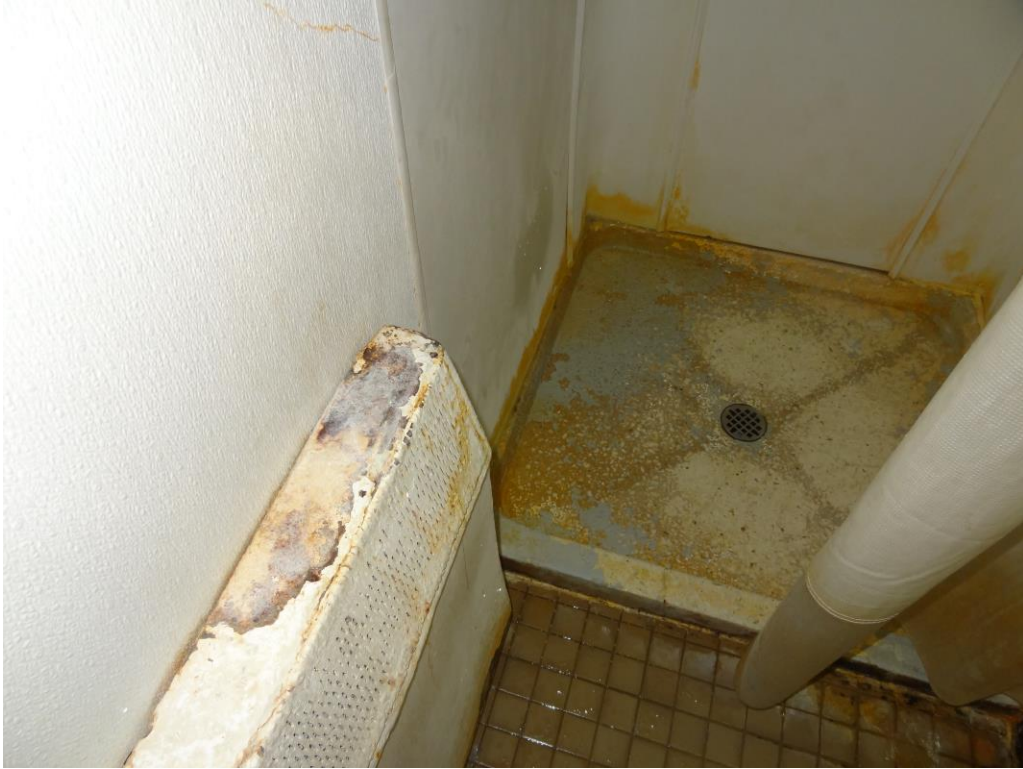
Housing Culinary Unit - Building #1618
Description: ADA restroom remodel needed.

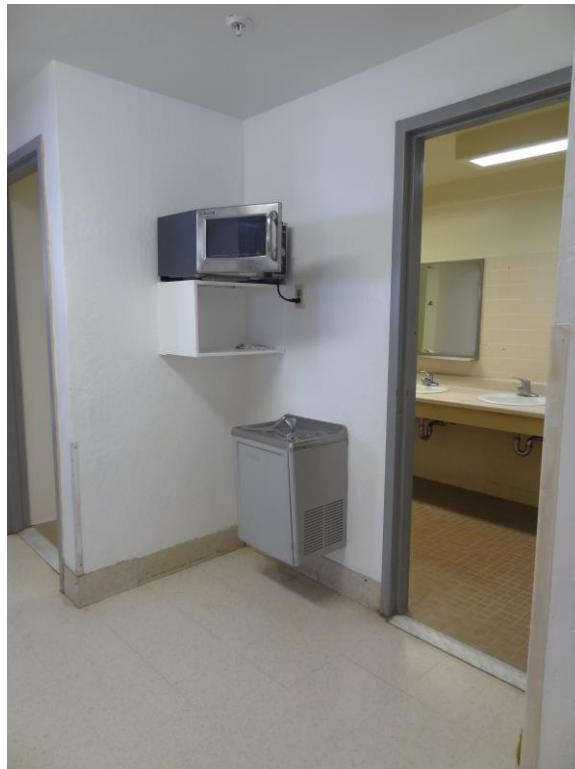
Housing Culinary Unit - Building #1618
Description: Dedicated circuits needed for microwaves.
