ELY CONSERVATION CAMP SITE

Site Number: 9976

**STATE OF NEVADA PUBLIC WORKS DIVISION
FACILITY CONDITION ANALYSIS**

Report distributed in May 2021

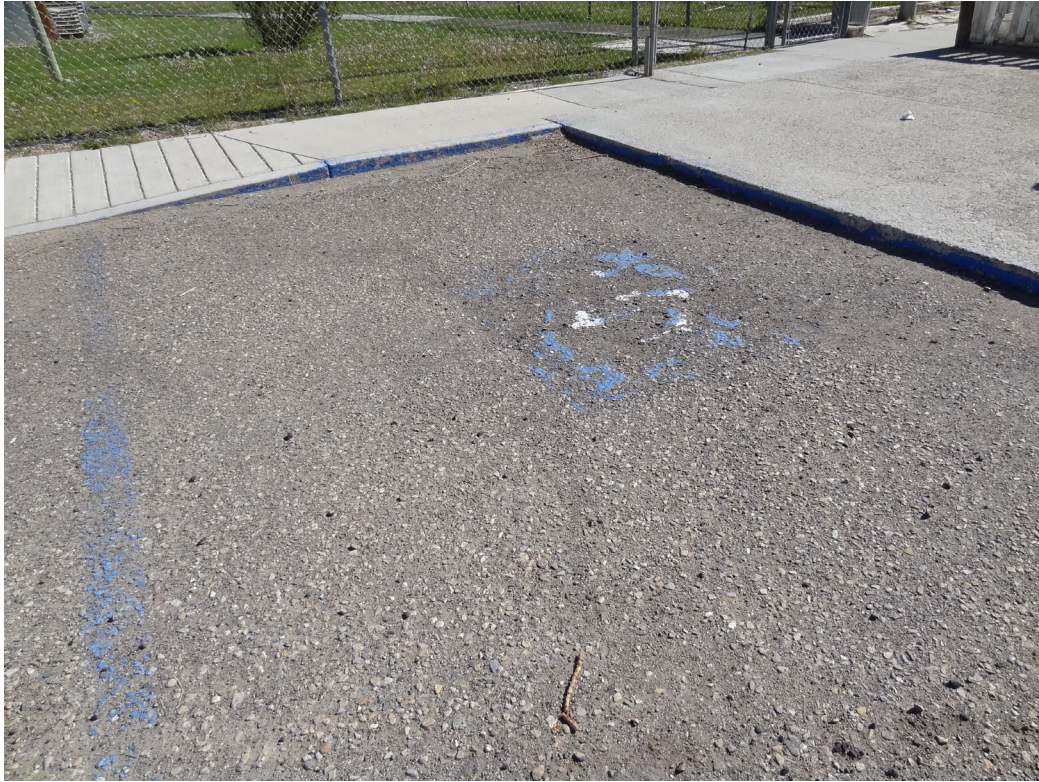
Ely Conservation Camp - Site #9976
Description: ADA Parking Space.

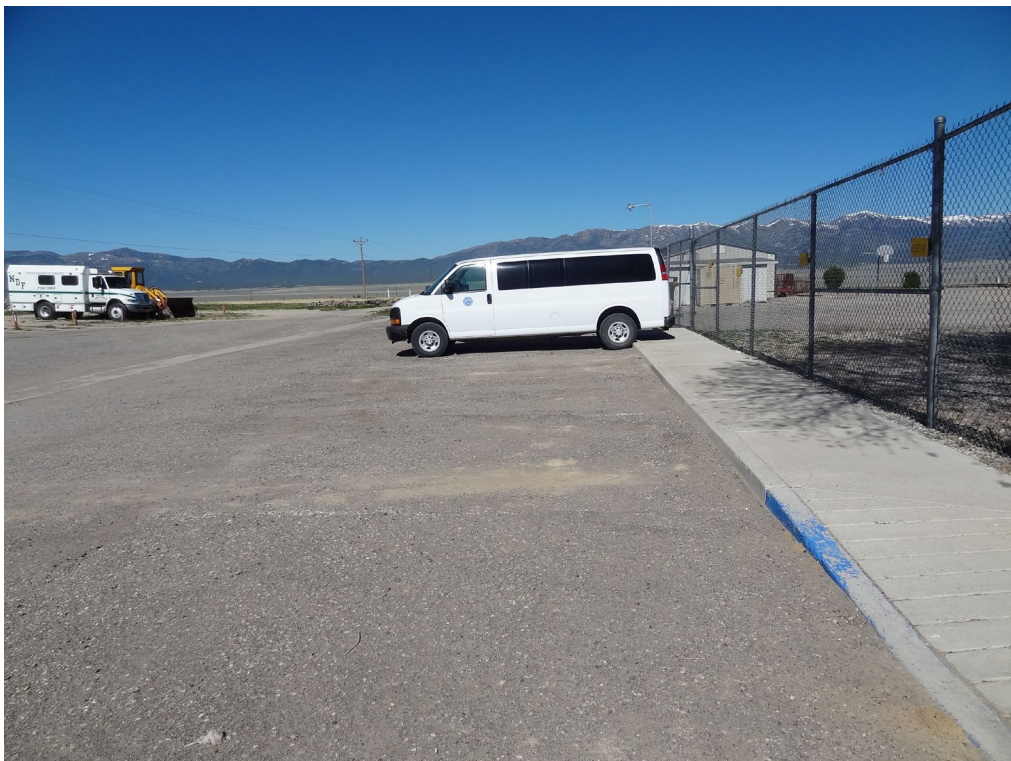
Ely Conservation Camp - Site #9976
Description: Install Pole Lighting in Parking Lot.

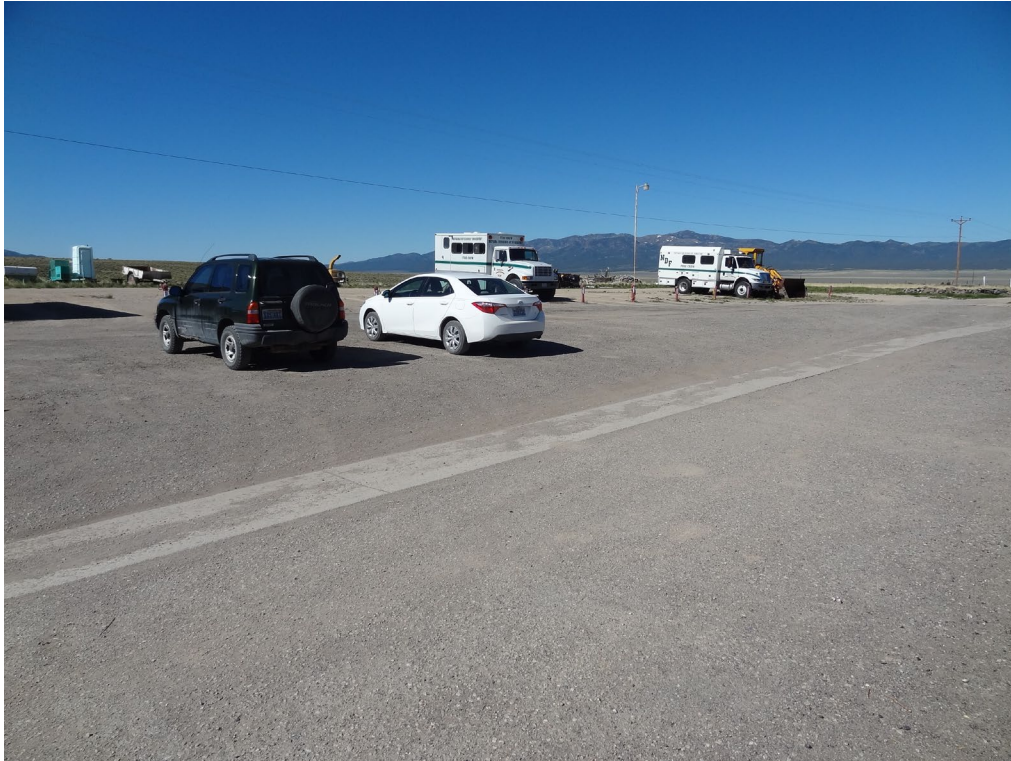
It is important to maintain the asphalt concrete paving on the site. This project would provide for patching, minor crack filling and slurry sealing of the paving site wide including loading zones, access roads and parking areas. Striping is included in this estimate. This project should be scheduled on a 5 year cyclical basis to maintain the integrity of the paving and prevent premature failure. This project should coincide with the ADA parking project.

Ely Conservation Camp - Site #9976
Description: Patch / Slurry Seal Asphalt Paving.

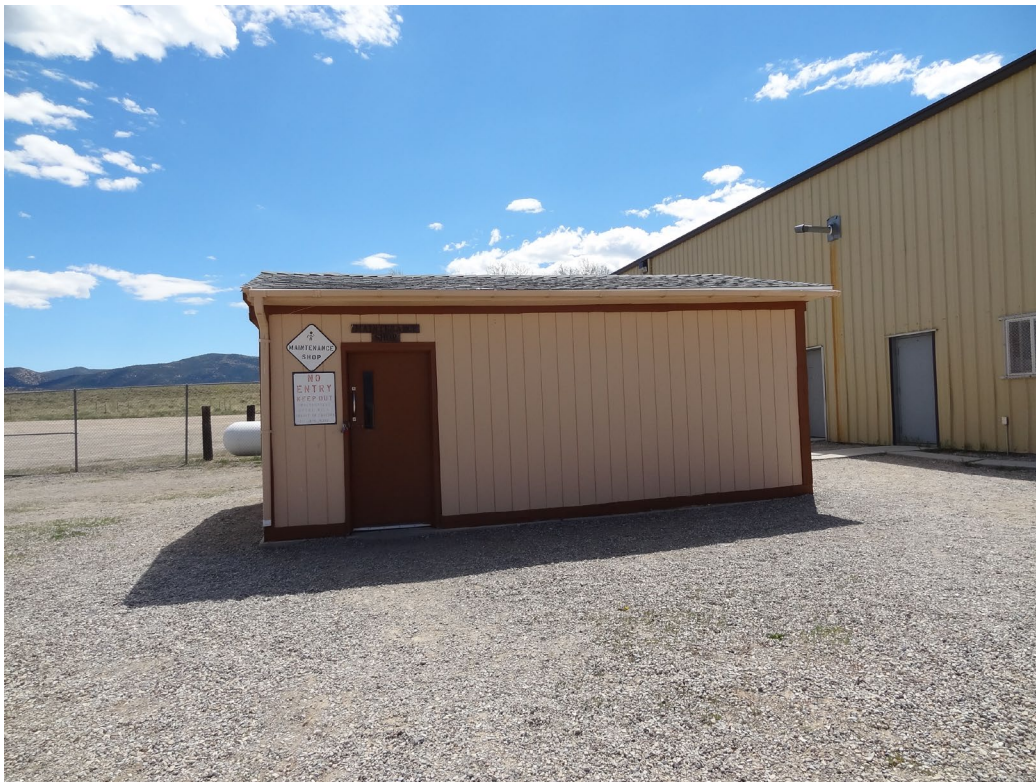
The exterior finishes are in good condition. It is important to maintain the finish, weather resistance, and appearance of the building. This project recommends work to protect the exterior building envelope, other than the roof, including painting, staining or other applied finishes, and caulking around windows, flashing, fixtures, and other penetrations to maintain the building in good, weather tight condition. It is recommended that this project be implemented in the next 8 to 9 years and for it to be scheduled on a cyclical basis based on environmental conditions.

Maintenance Shop - Building #2728
Description: Exterior of the Building

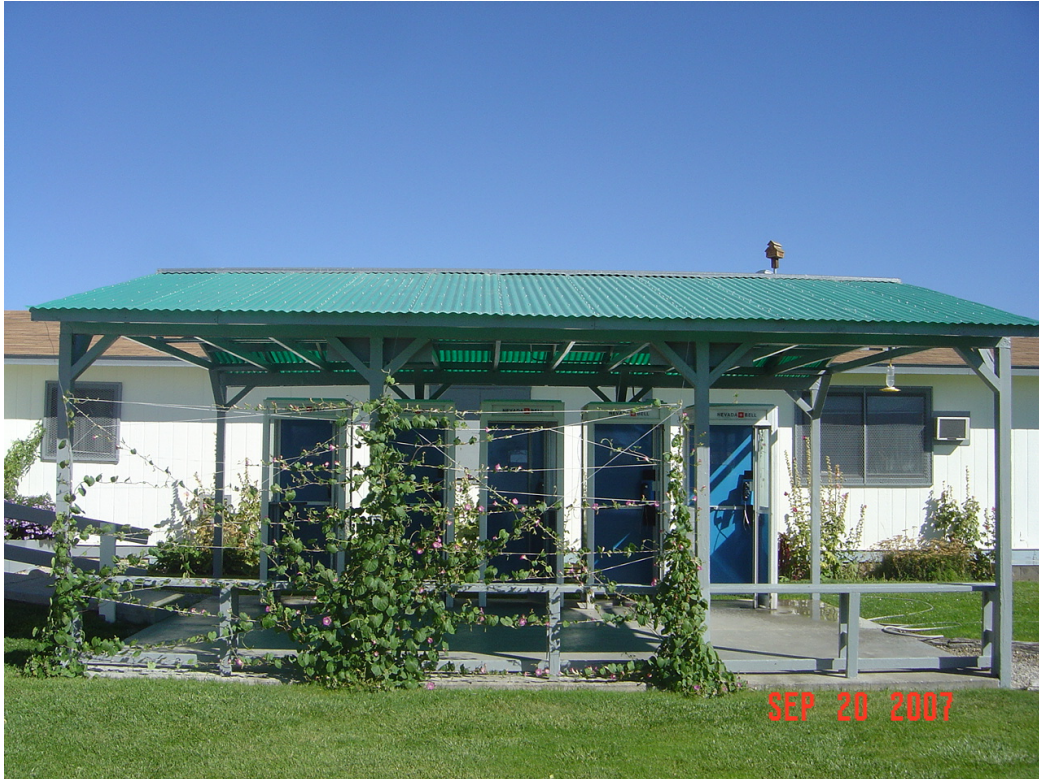
The Phone Ramada is an open wood framed post and beam structure with a fiberglass corrugated roof located along the south side of the housing unit. It provides protection for the bank of pay phones and is in excellent condition.

The exterior finishes are in fair condition. It is important to maintain the finish, weather resistance, and appearance of the building. This project recommends work to protect the exterior building envelope, other than the roof, including painting, staining or other applied finishes, and caulking around windows, flashing, fixtures, and other penetrations to maintain the building in good, weather tight condition. It is recommended that this project be implemented in the next 4 to 5 years and for it to be scheduled on a cyclical basis based on environmental conditions.

Phone Ramada - Building #2727
Description: Exterior of the Building.

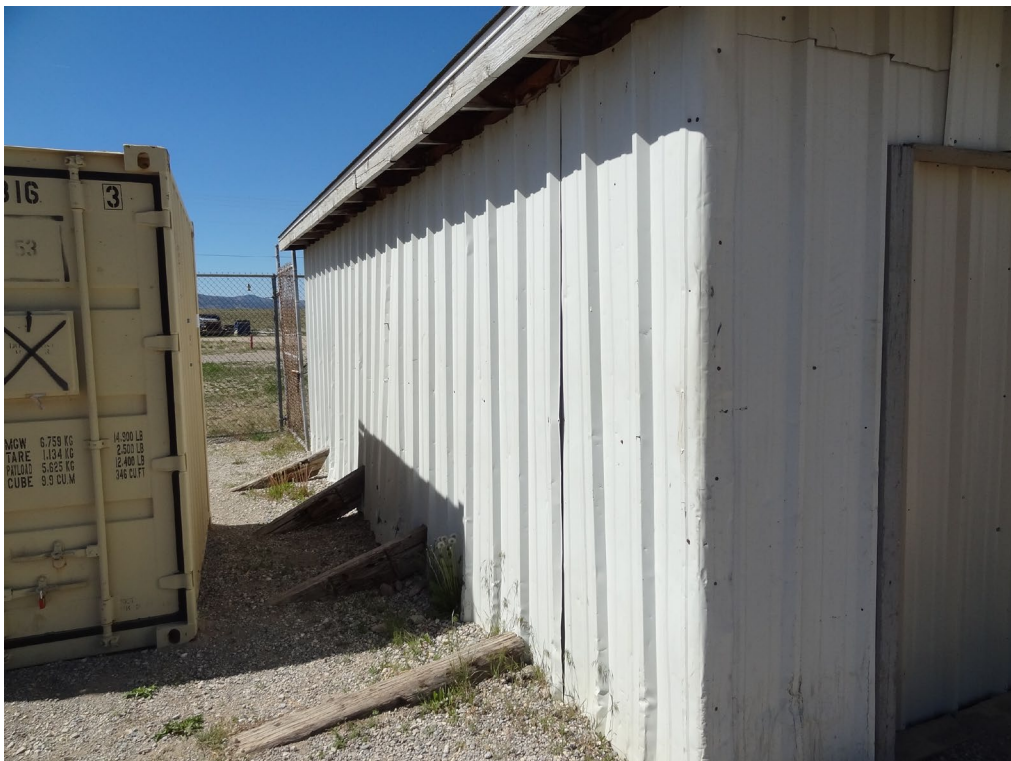
The painted / stained exterior finishes are in poor condition. It is important to maintain the finish, weather resistance, and appearance of the building. This project recommends work to protect the exterior building envelope, other than the roof, including painting, staining or other applied finishes, and caulking around windows, flashing, fixtures, and other penetrations to maintain the building in good, weather tight condition. It is recommended that this project be implemented in the next 2 to 3 years and for it to be scheduled on a cyclical basis based on environmental conditions.

Weight Room - Building #2131
Description: Exterior Condition of the Building.

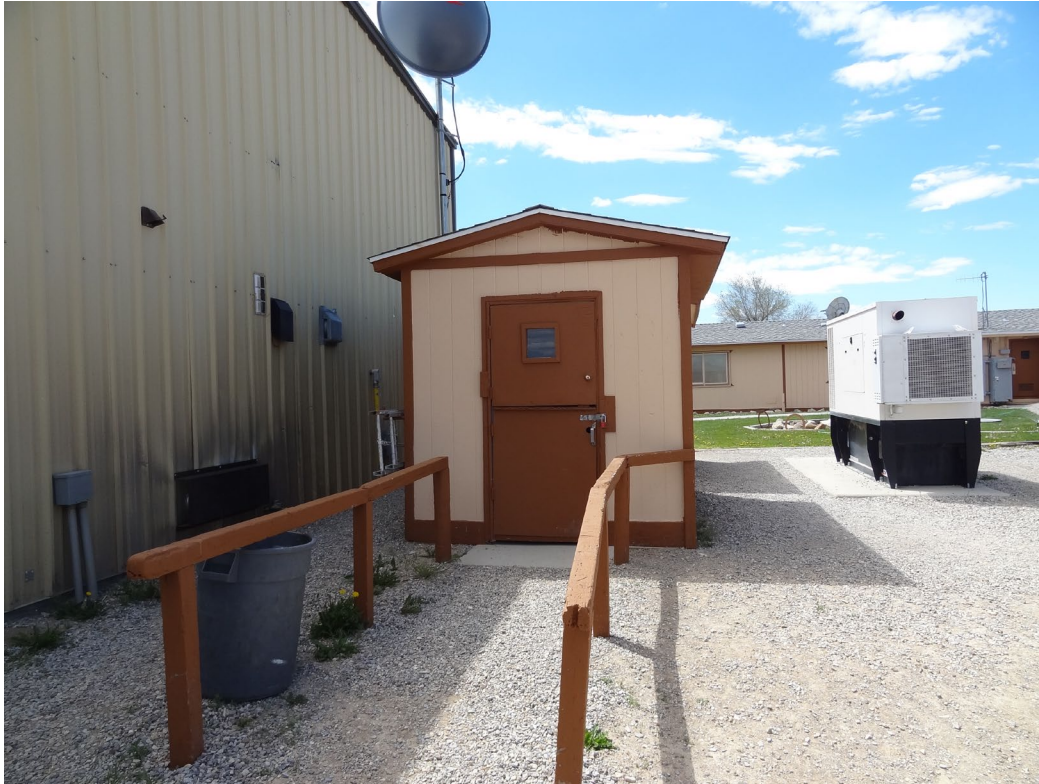
The exterior finishes are in good condition. It is important to maintain the finish, weather resistance, and appearance of the building. This project recommends work to protect the exterior building envelope, other than the roof, including painting, staining or other applied finishes, and caulking around windows, flashing, fixtures, and other penetrations to maintain the building in good, weather tight condition. It is recommended that this project be implemented in the next 8 to 9 years and for it to be scheduled on a cyclical basis based on environmental conditions.

Tool Shed - Building #2130
Description: Exterior of the Building.

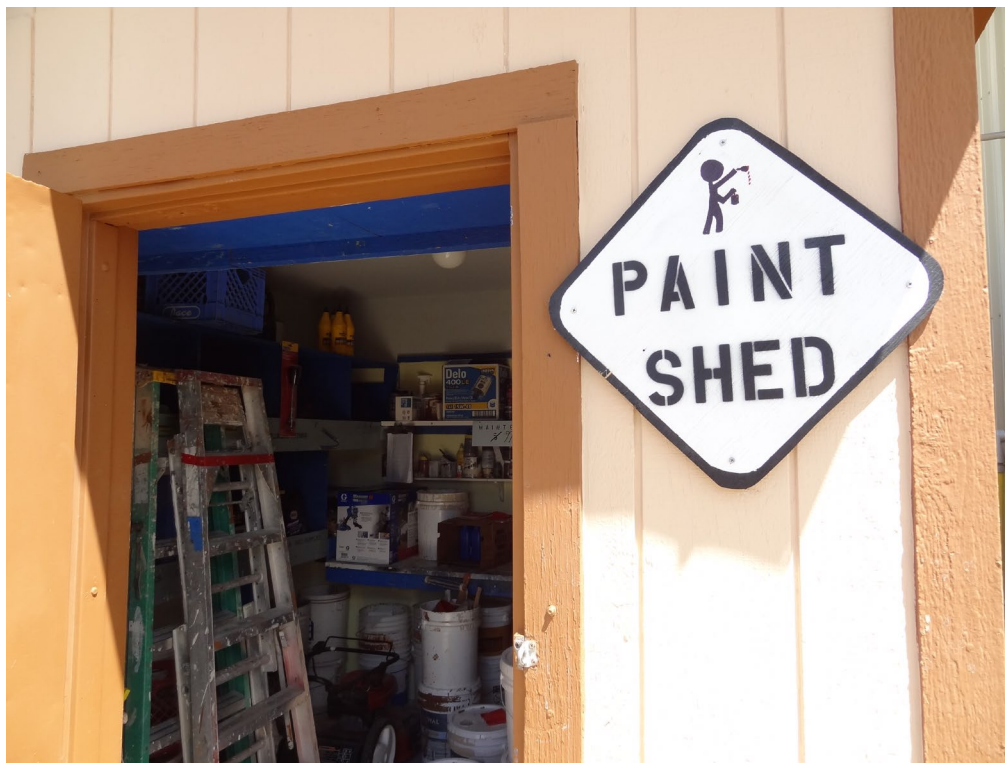
The exterior finishes are in good condition. It is important to maintain the finish, weather resistance, and appearance of the building. This project recommends work to protect the exterior building envelope, other than the roof, including painting, staining or other applied finishes, and caulking around windows, flashing, fixtures, and other penetrations to maintain the building in good, weather tight condition. It is recommended that this project be implemented in the next 8 to 9 years and for it to be scheduled on a cyclical basis based on environmental conditions.

Storage Shed - Building #2129
Description: Exterior of the Building.

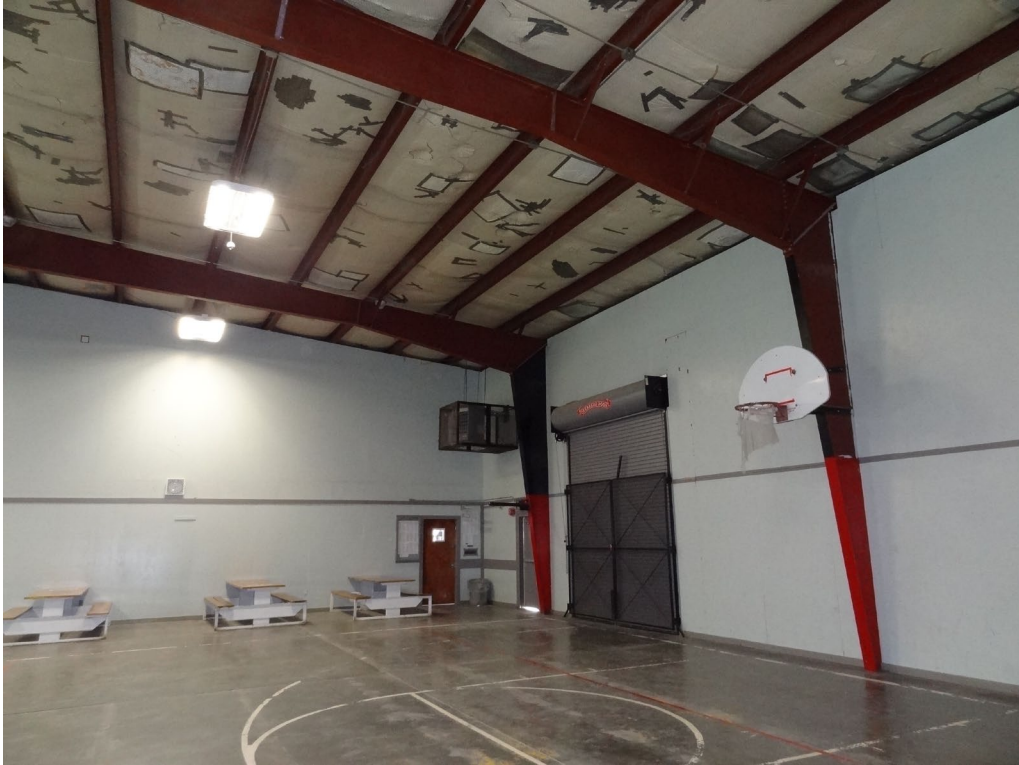
The interior finishes are in poor condition. It is recommended that the interior walls and ceilings be painted at least once in the next 2 to 3 years and every 5 to 7 years thereafter to maintain the integrity of the interior of the building. Prior to painting, all surfaces should be repaired and prepped. An epoxy-based paint should be utilized in wet areas for durability. This project or a portion thereof was previously recommended in the FCA report dated 08/21/2000 and 09/20/2007. It has been amended accordingly to reflect conditions observed during the most recent survey date of 05/24/2017.

Multi-Purpose / Gymnasium - Building #1389
Description: Interior of the Building.

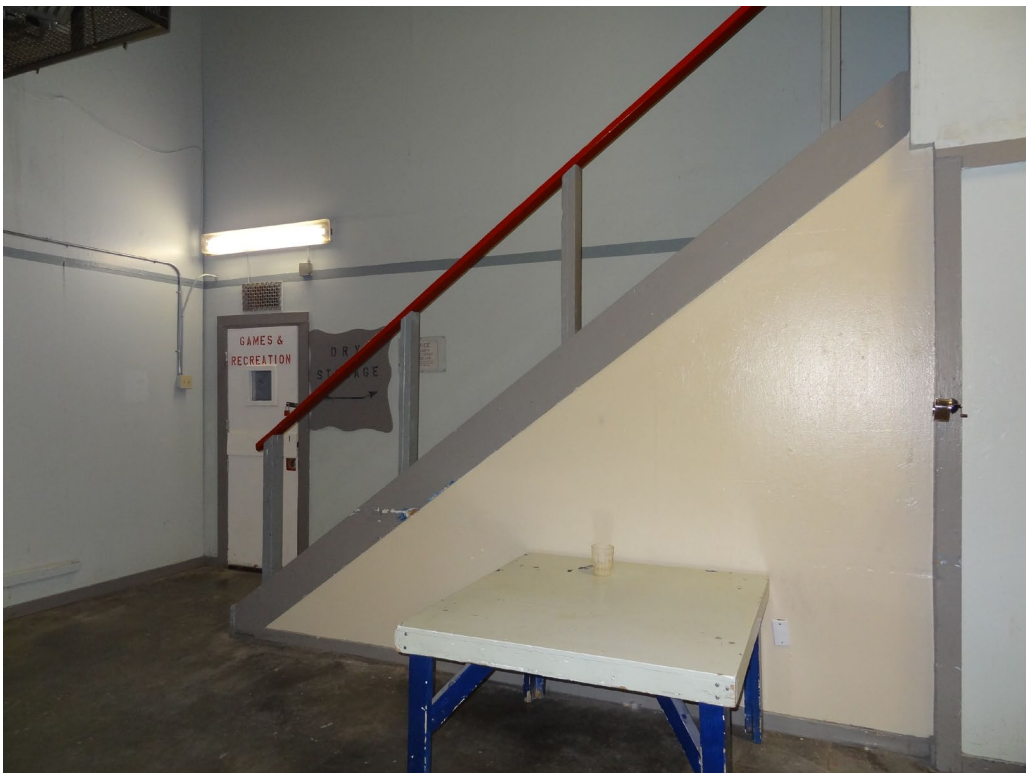
The handrails and guardrails at the stairway and storage mezzanine do not meet the building code requirements in their current configuration. This project would provide for the removal of the existing wood framed railing and replacement with new wood framed handrails and guardrail that will meet the 2018 IBC code Chapter 10, Section 1012 and 1013. This project or a portion thereof was previously recommended in the FCA report dated 09/20/2007. It has been amended accordingly to reflect conditions observed during the most recent survey date of 05/24/2017.

Multi-Purpose / Gymnasium - Building #1389
Description: Rebuild Handrails / Guardrails.

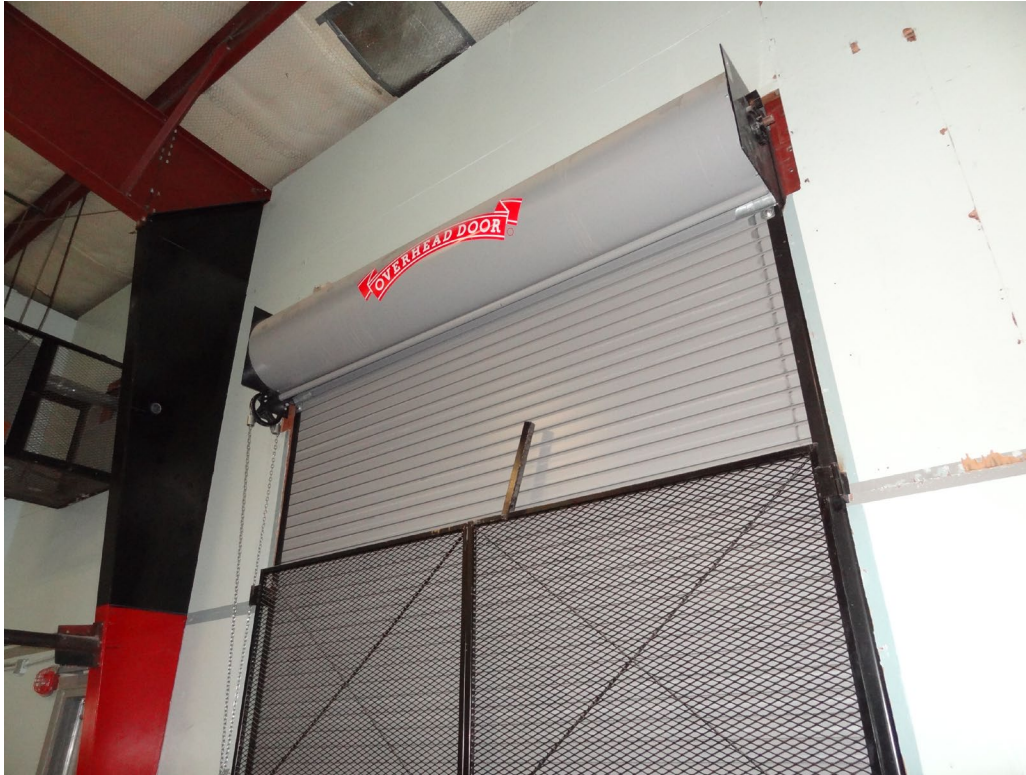
There is a 12'x12' overhead coiling door which is damaged and does not function properly. It is original to the building and should be scheduled for replacement. This project would provide for the removal and replacement of the manually operated overhead coiling door.

Multi-Purpose / Gymnasium - Building #1389
Description: Replace Overhead Coiling Door.

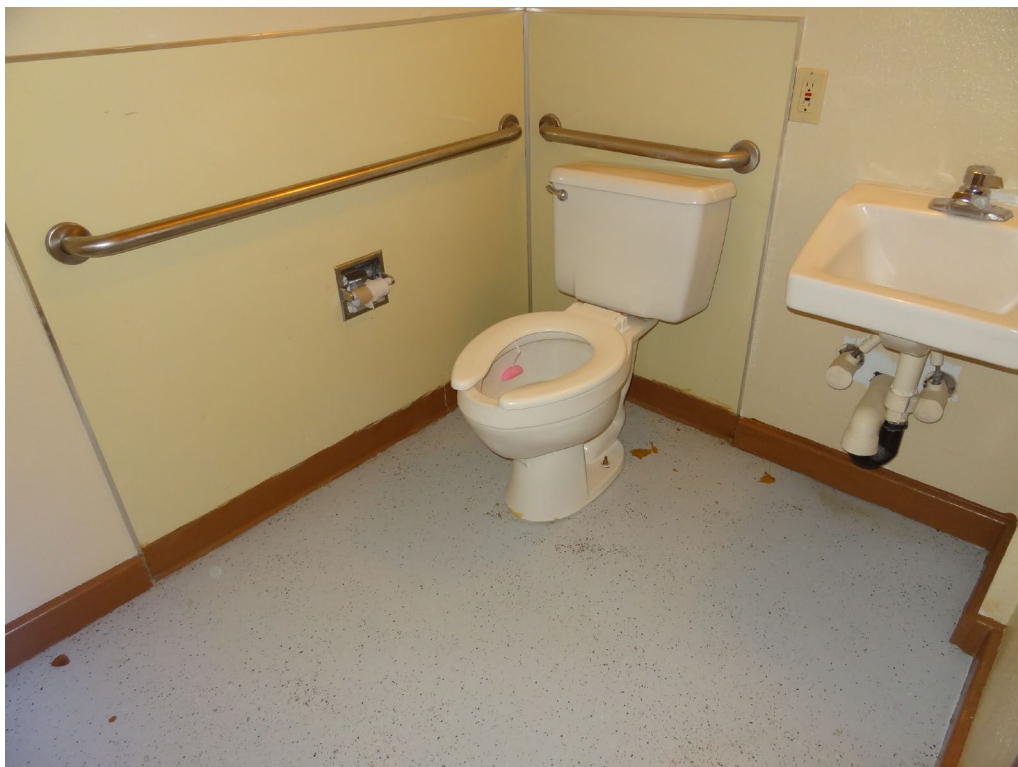
Administration / Housing / Culinary - Building #1388
Description: ADA Restroom Remodel.

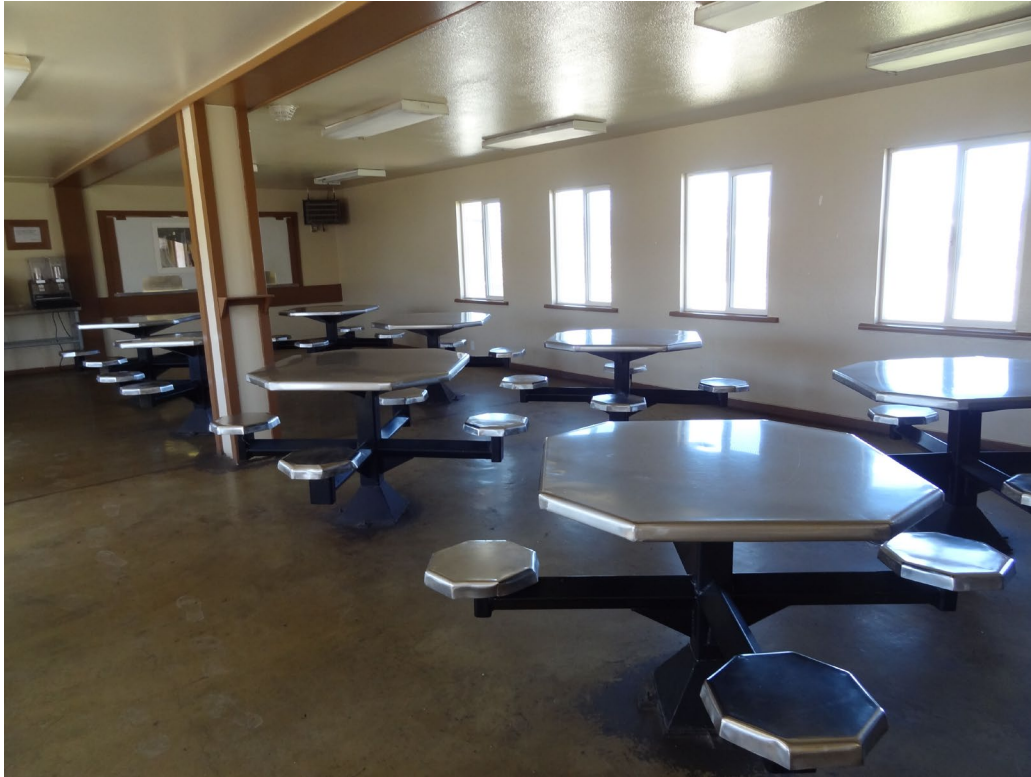
Administration / Housing / Culinary - Building #1388
Description: Install Fire Suppression System.

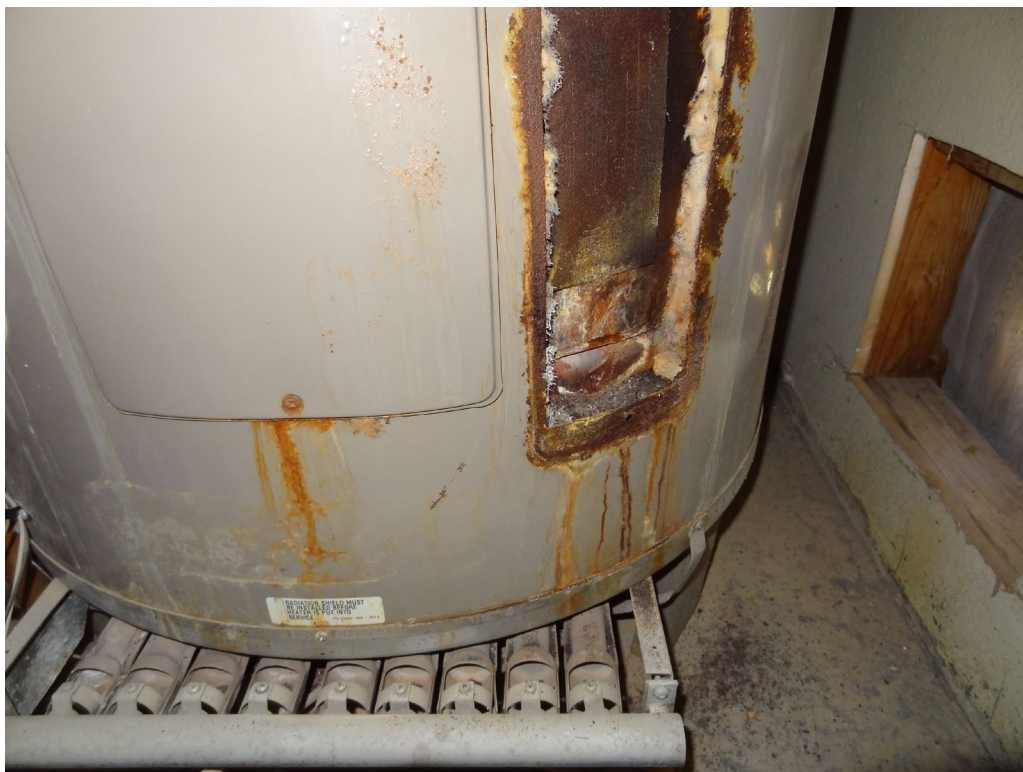
Administration / Housing / Culinary - Building #1388
Description: Replace Water Heaters.

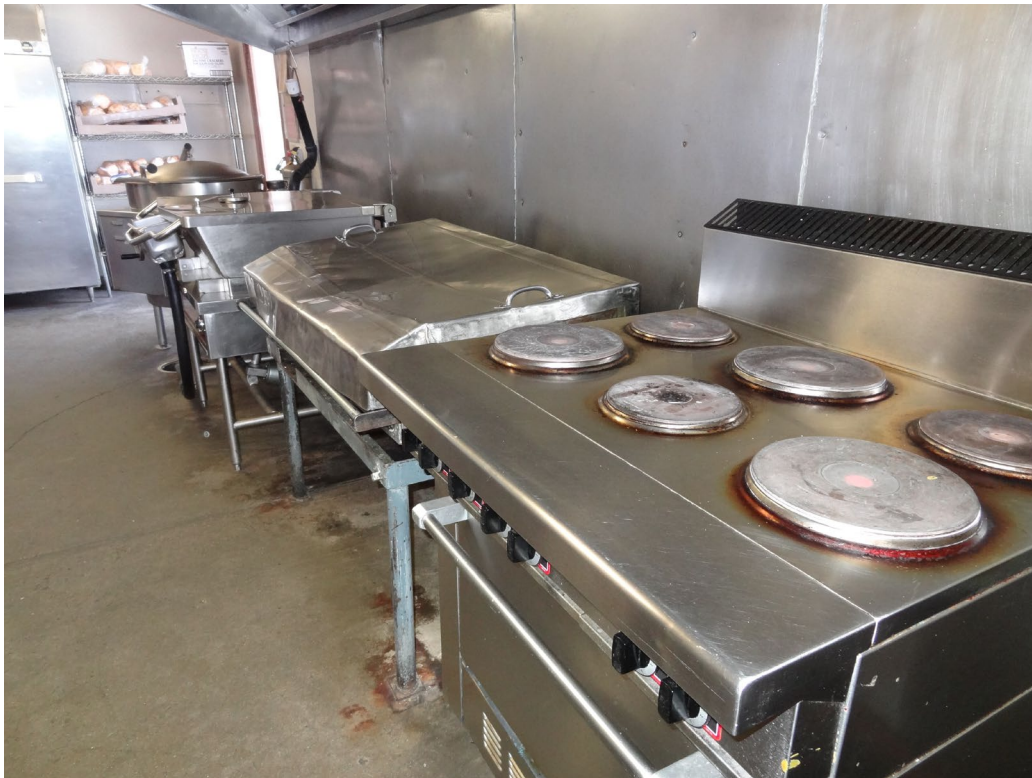
Administration / Housing / Culinary - Building #1388
Description: Replace Kitchen Equipment.

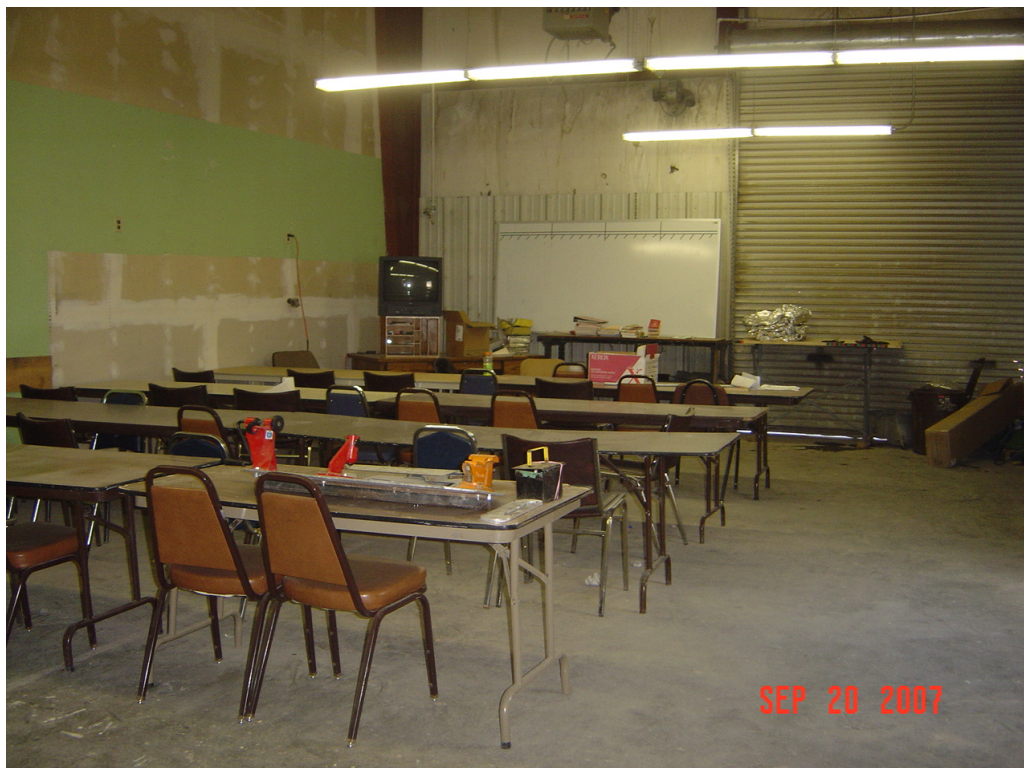
The interior finishes are in fair condition. It is recommended that the interior walls and ceilings be painted at least once in the next 4 to 5 years and every 5 to 7 years thereafter to maintain the integrity of the interior of the building. Prior to painting, all surfaces should be repaired and prepped. An epoxy-based paint should be utilized in wet areas for durability.

NDF Garage / Storage - Building #0882
Description: Interior of the Building.
