# **EAST SAHARA SITE**

**Site Number: 9977**

## **STATE OF NEVADA PUBLIC WORKS DIVISION FACILITY CONDITION ANALYSIS**

Report distributed in September 2022

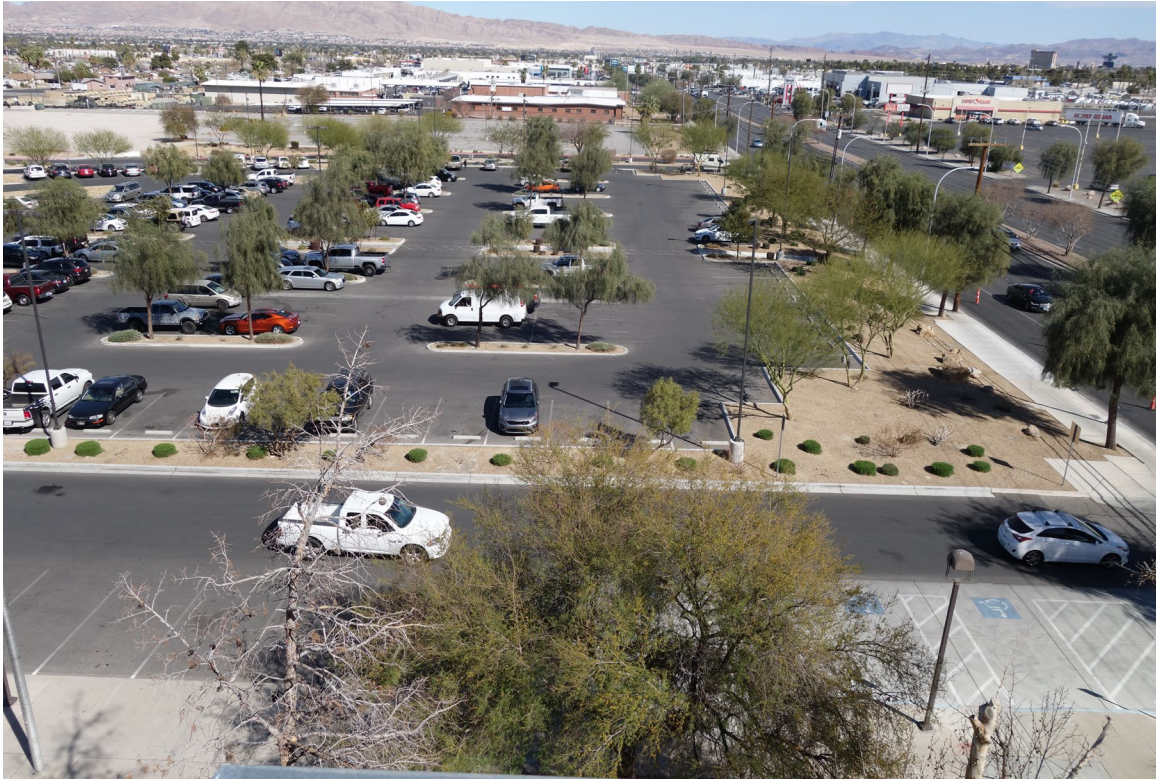
East Sahara Site – FCA Site #9977  
Description: Parking Area View to East.

It is important to maintain the asphalt concrete paving on the site. This project would provide for minor crack filling and slurry sealing of the paving site wide including loading zones, access roads and parking areas. Striping is included in this estimate. This project should be scheduled on a 5 year cyclical basis to maintain the integrity of the paving and prevent premature failure. 381,000 square feet of asphalt area was used to generate this estimate which includes the parking areas around and between the DMV and the Bradley buildings as well as the access roads.

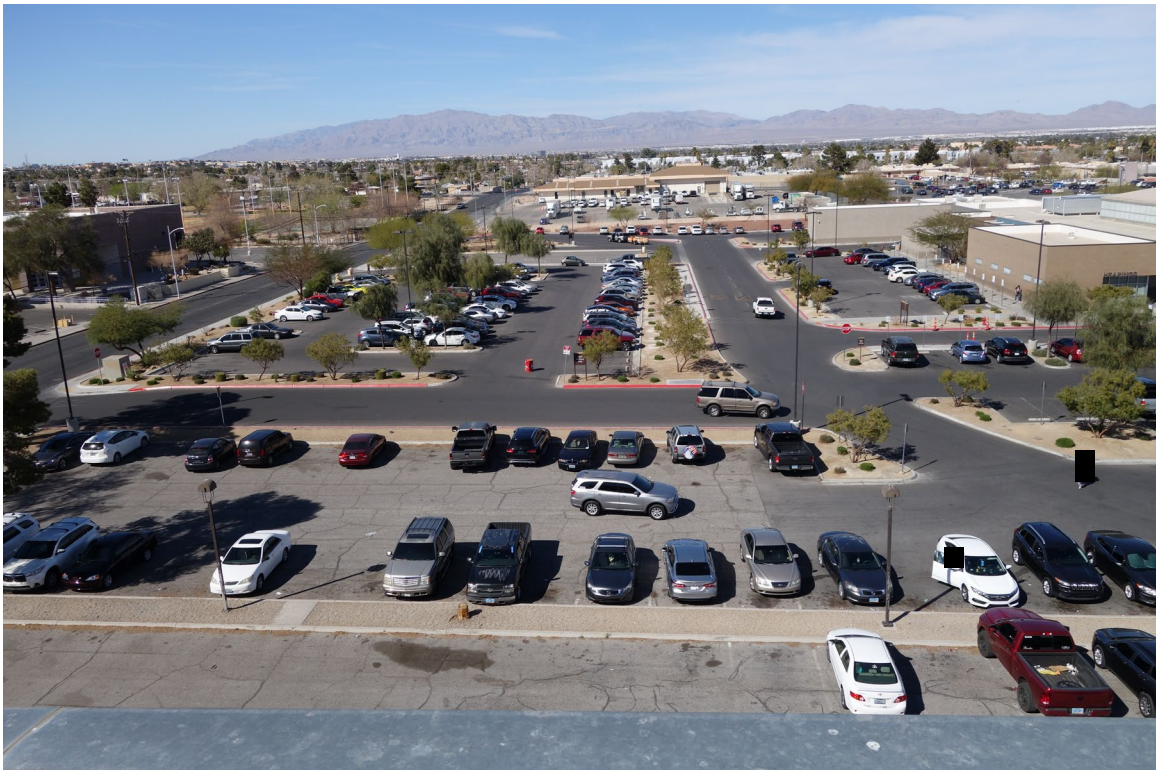
East Sahara Site – FCA Site #9977  
Description: Parking Area View to North.

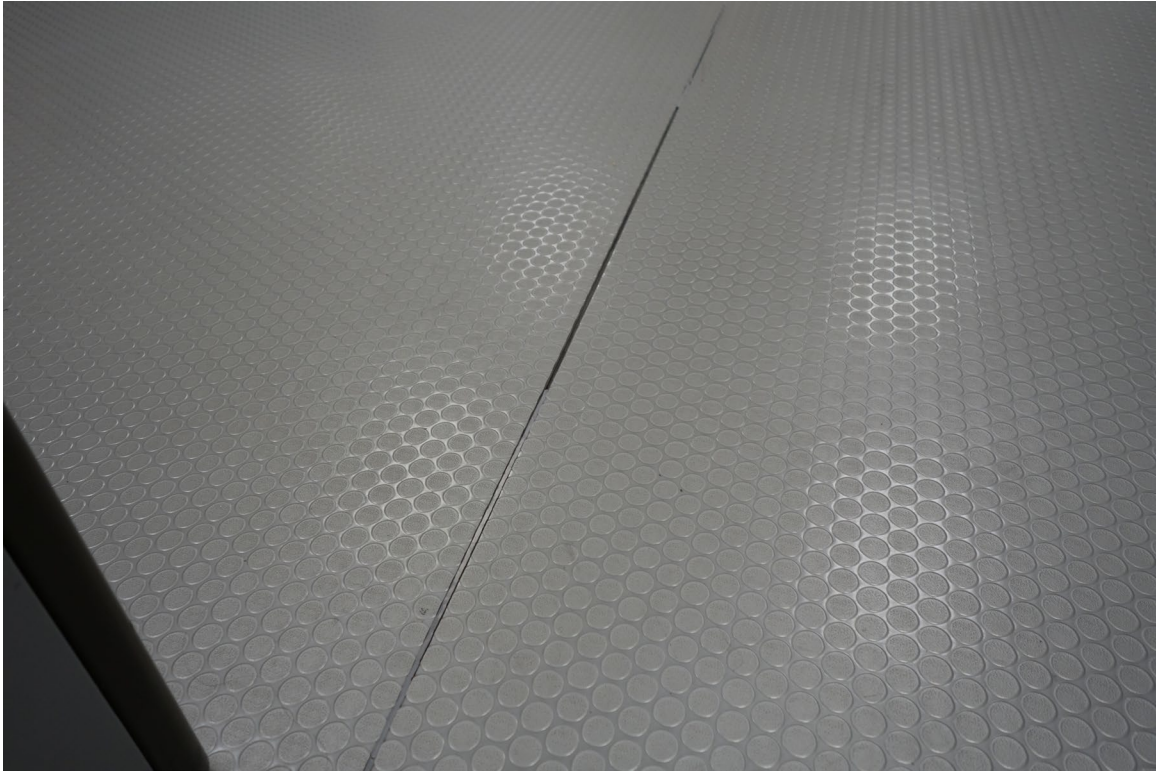
The seam welds in the sheet flooring system near the west entrance in the large vestibule area are separating. This allows moisture from cleaning operations to degrade the flooring adhesive. It is recommended that the seam welds be removed and re-welded in order to extend the flooring's useful life in the next 2 - 3 years.

DMV Office Building – FCA Building #3759  
Description: Seam Welding Repairs on Vinyl Flooring Needed.

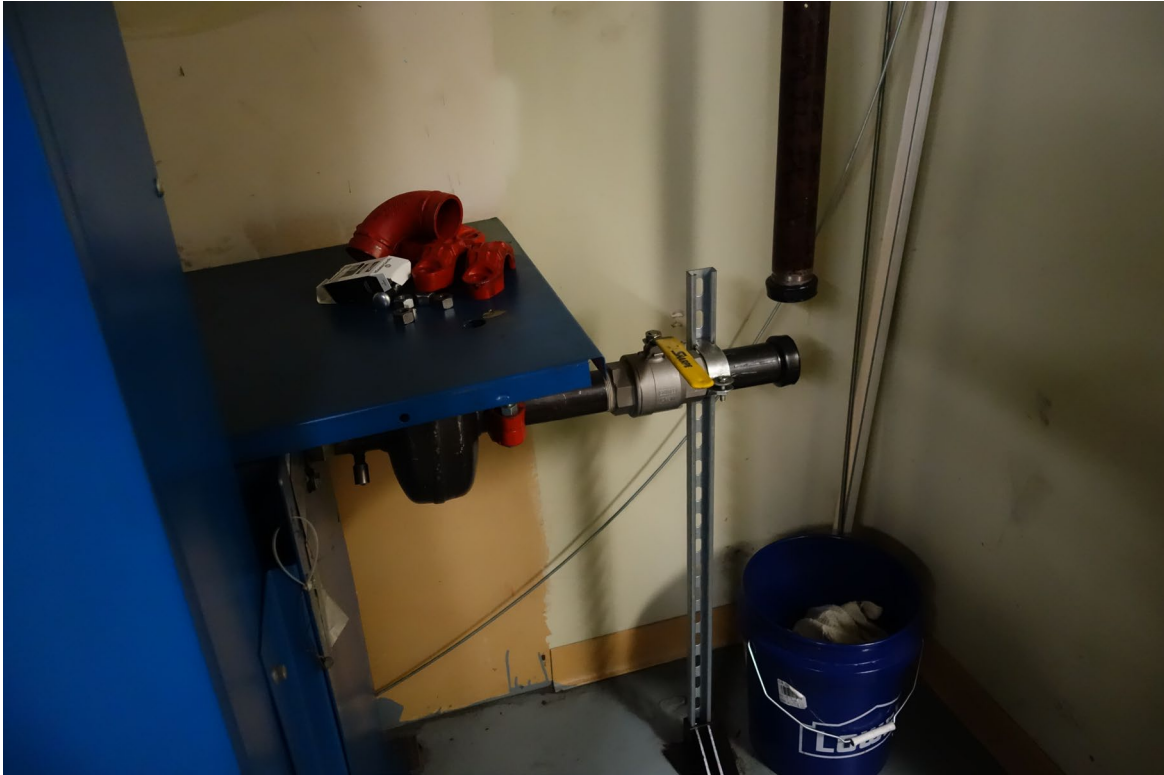
The two elevators in the building are non-functioning and the hydraulic piping has been disconnected to prevent use. Prior to occupancy, the two elevators must be completely refurbished or replaced. This project will fund the complete refurbishment of the elevators including shaft repairs, mechanical, electrical and controls upgrades.

Bradley Building (Vacant) – FCA Building #0266  
Description: Elevator Physically Disabled Pending Refurbishment.

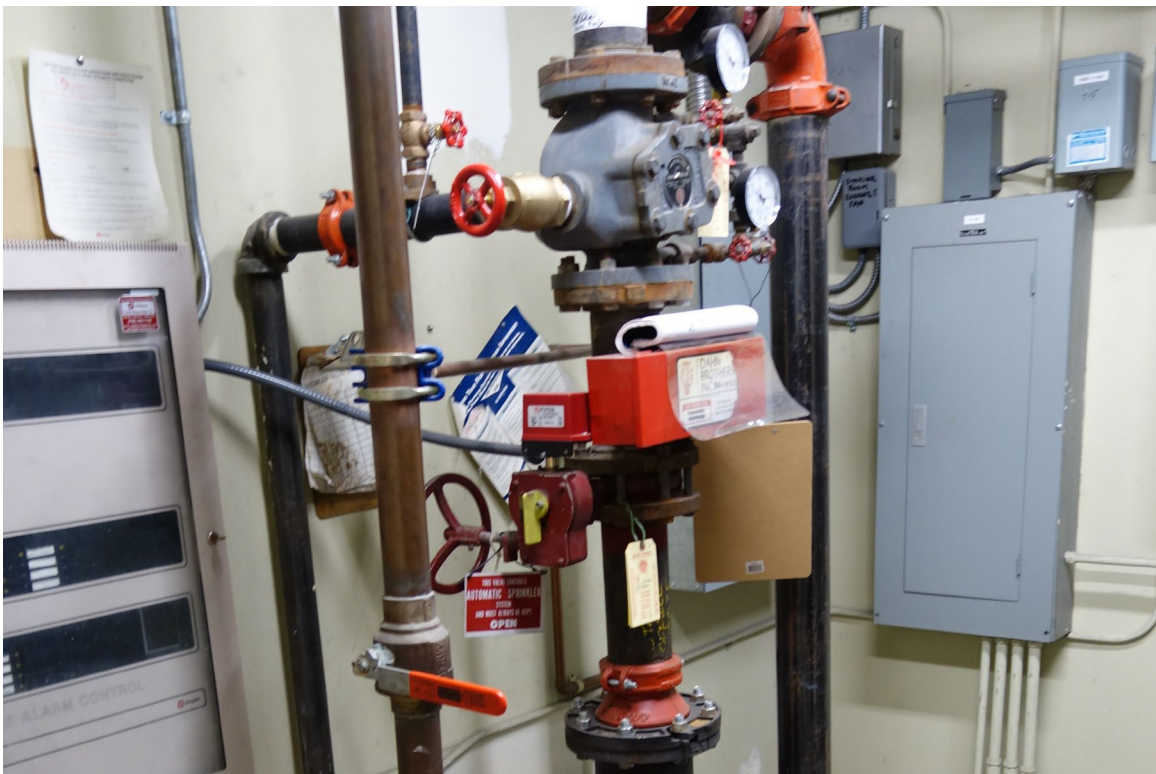
The fire suppression system and domestic water supply are on a common supply from the municipality. The domestic water supply in this building is not protected from the fire suppression system by a reduced pressure detector assembly (RPDA). Prior to occupancy, this project will provide funding for the installation of an RPDA.

Bradley Building (Vacant) – FCA Building #0266  
Description: Fire Riser Reduced Pressure Backflow Needed.

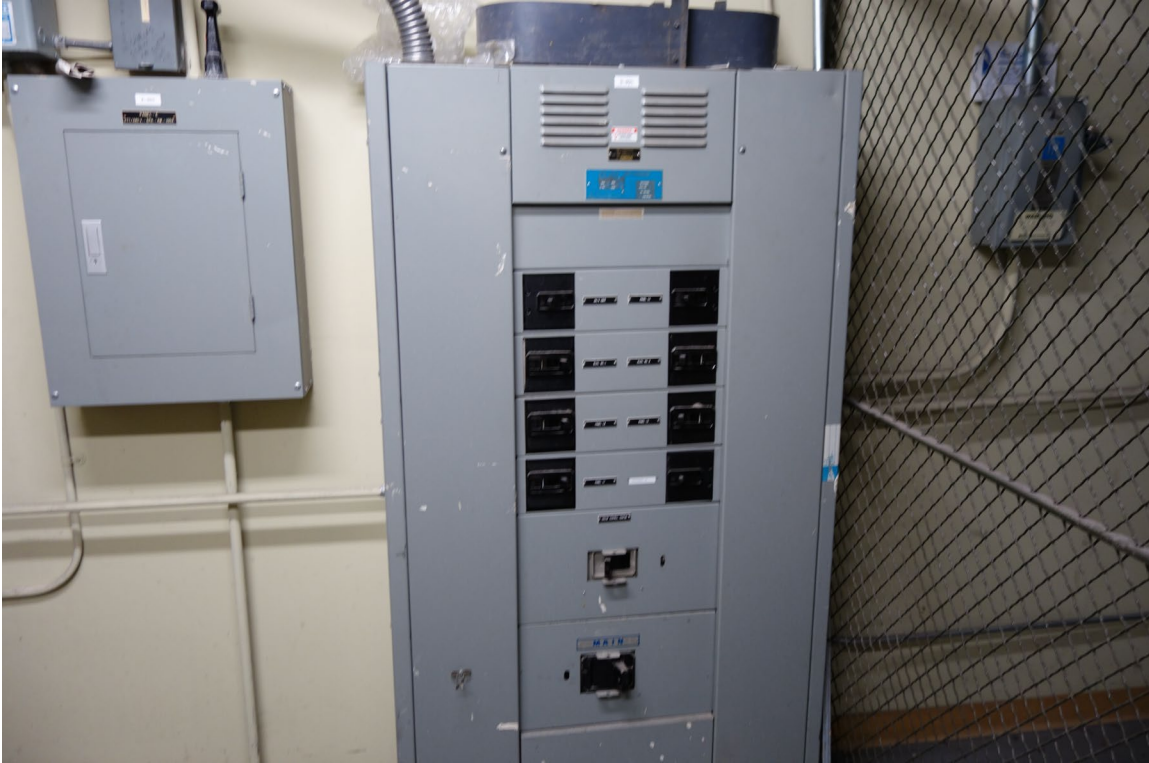
This building is over 45 years old and the electrical system is not compliant with NFPA 70e and a complete replacement is needed prior to occupancy. In addition, interior and exterior lighting, lighting controls and the phone / data systems need replacement. This project would provide funding to replace the electrical system, lighting and communication systems. Electrical coordination and Arc Flash studies are also included in this project.

Bradley Building (Vacant) – FCA Building #0266  
Description: Electrical Equipment Replacement Needed.

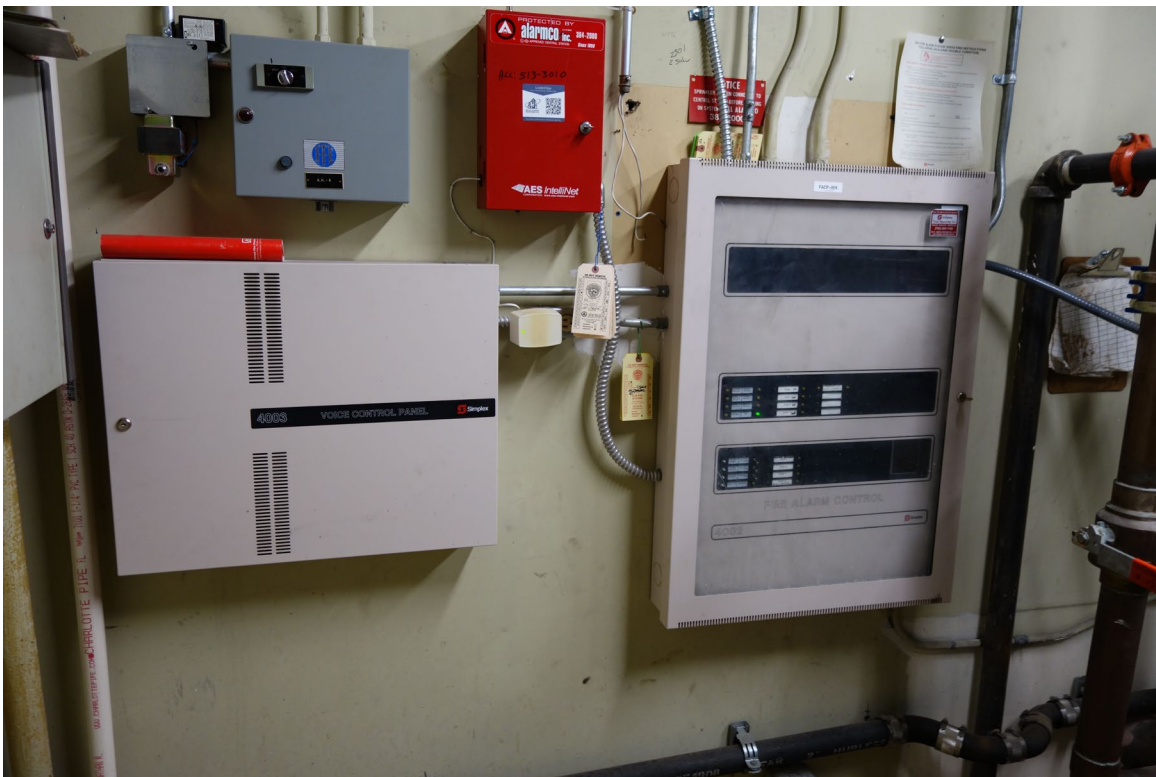
This building is equipped with an automatic fire detection and alarm system that is the original system and should be scheduled for replacement. It is recommended that the system be upgraded to current requirements to ensure the safety of the occupants. When completed, the new system will provide smoke detection, horns and strobes throughout the facility in accordance with the 2012 IBC Chapter 9, Section 907 and the State Fire Marshal's requirements.

Bradley Building (Vacant) – FCA Building #0266  
Description: Fire Alarm System Replacement Needed.

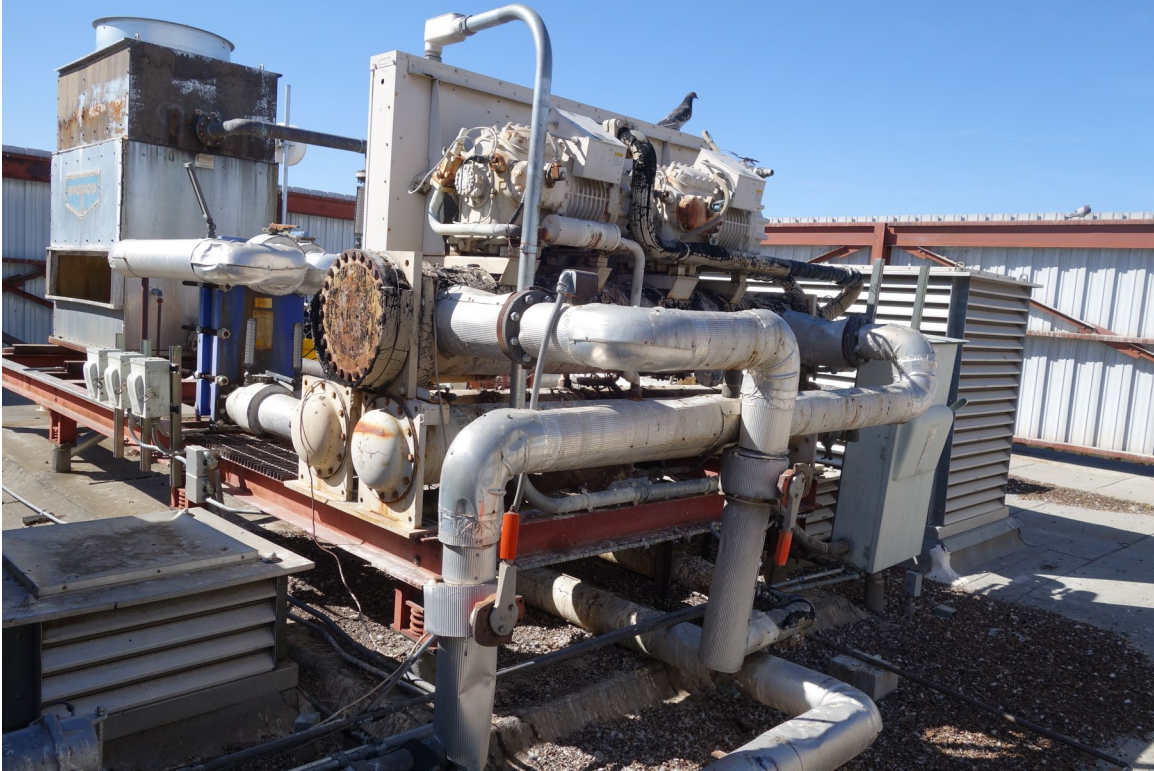
The building is equipped with a central heating and air conditioning system controlled by a combination pneumatic / direct digital control system. The HVAC equipment is original, is inoperable and is past the end of its useful life. A complete replacement is necessary prior to occupancy. The replacement includes replacement of all piping and air distribution system,

Bradley Building (Vacant) – FCA Building #0266  
Description: HVAC System Beyond Useful Life.

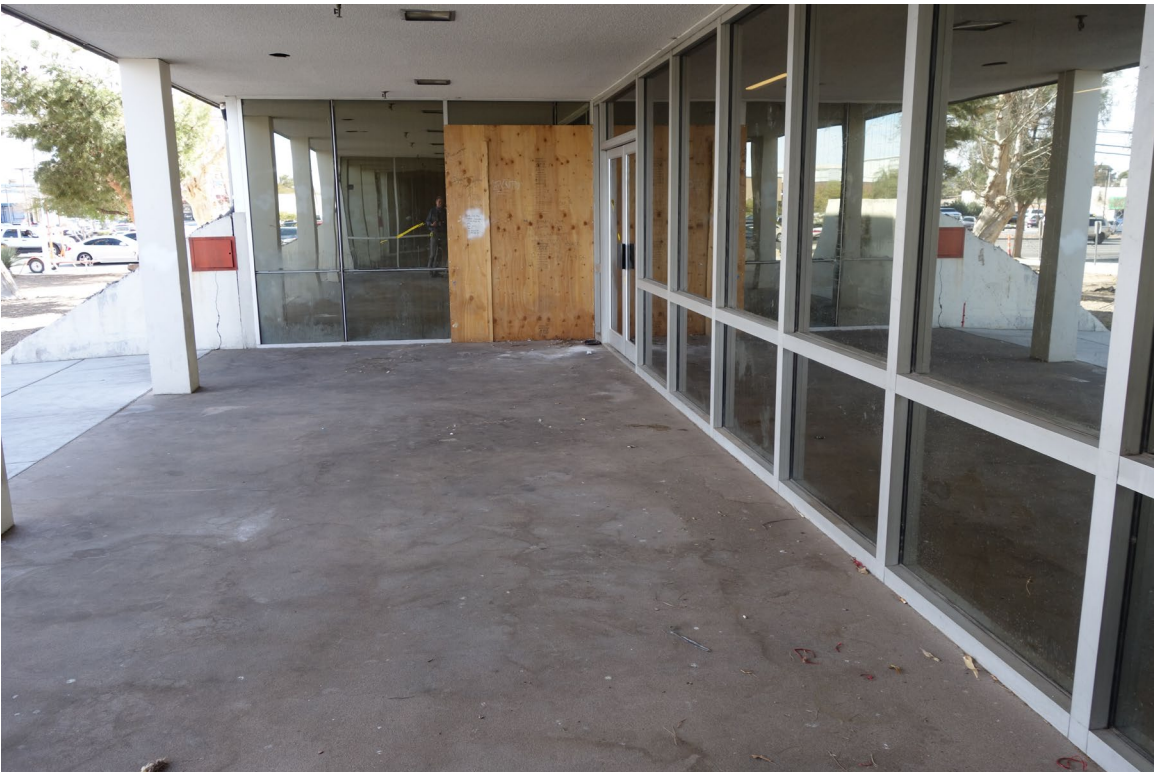
There is an exterior aluminum entrance as well as horizontal and vertical storefront window systems that are original to the building. They are damaged from age and general wear and tear and are a constant maintenance problem. This project would provide for the replacement and installation of new aluminum storefront systems including hardware. Removal and disposal of the existing storefronts is included in this estimate.

Bradley Building (Vacant) – FCA Building #0266  
Description: Storefront & Glazing Replacement Needed.
