State of Nevada  
Department of Administration / Buildings & Grounds Division  
Bradley Building – DMV – B & G Maintenance Office  
Facility Condition Analysis

# EAST SAHARA SITE

**Site Number: 9977, Building Number's: 0255, 0266, 0718, 2062**

## **STATE OF NEVADA PUBLIC WORKS BOARD FACILITY CONDITION ANALYSIS**

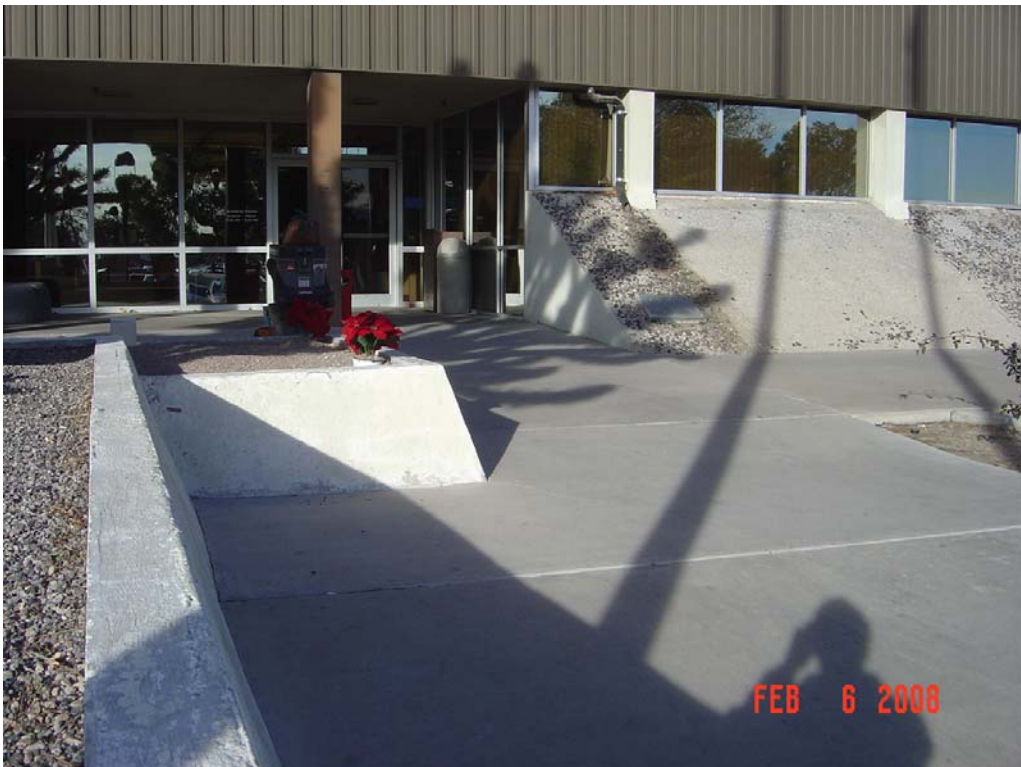
Bradley Building - Building #0266  
Description: Non ADA compliant entrance to the building.

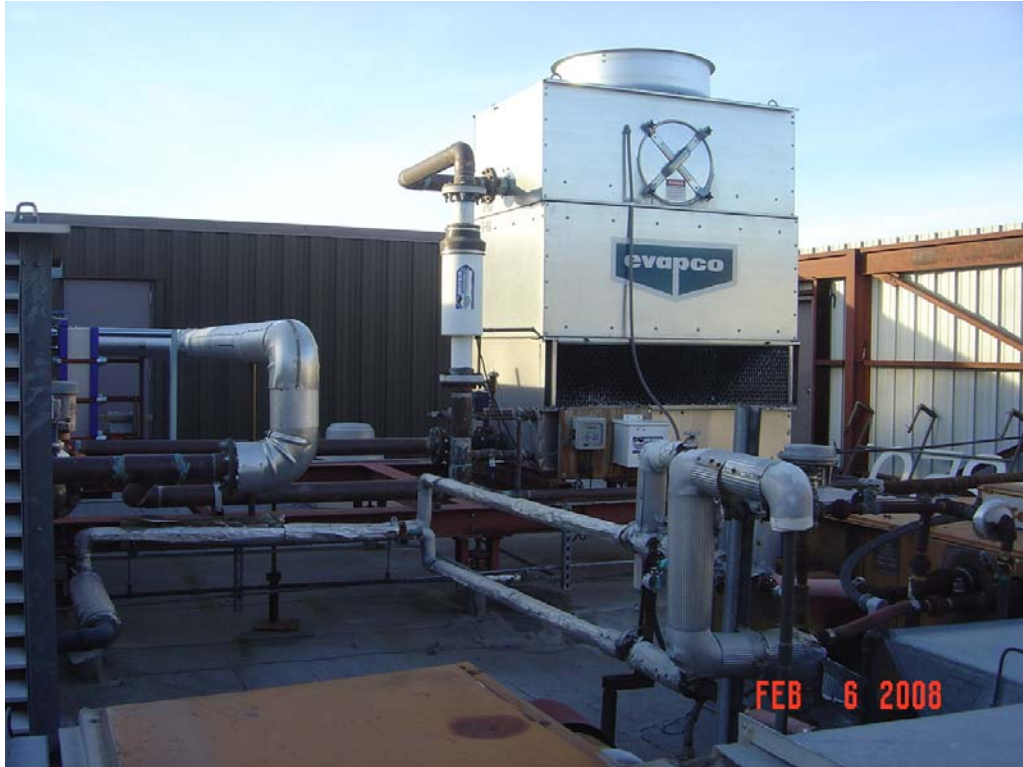
This project recommends a building-wide system upgrade which includes the boilers and duct system in the next two to three years. The cooling tower was replaced as observed at the 02/05/2008 survey and is removed from this project.

Bradley Building - Building #0266  
Description: Cooling tower on the roof.

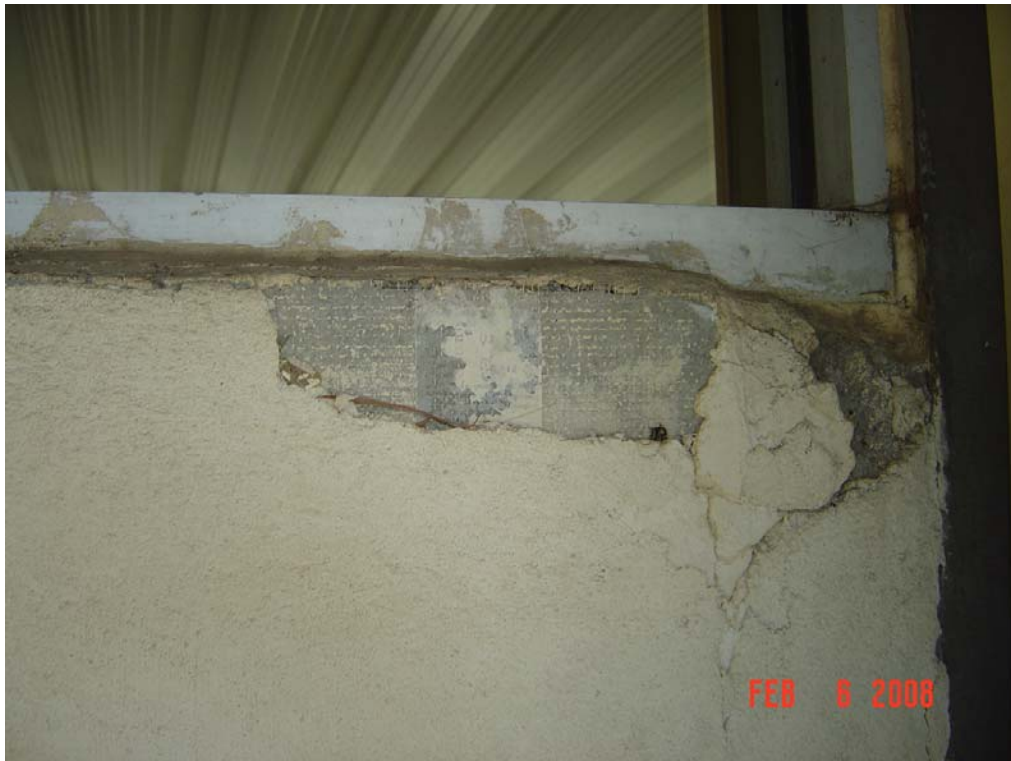
The EIFS (Exterior Insulation and Finish System) near the South building exit and at the column areas is showing signs of damage, cracking and appears to be failing. This project will provide for removal and repair of damaged areas.

Bradley Building - Building #0266  
Description: Damaged stucco at south exit door.

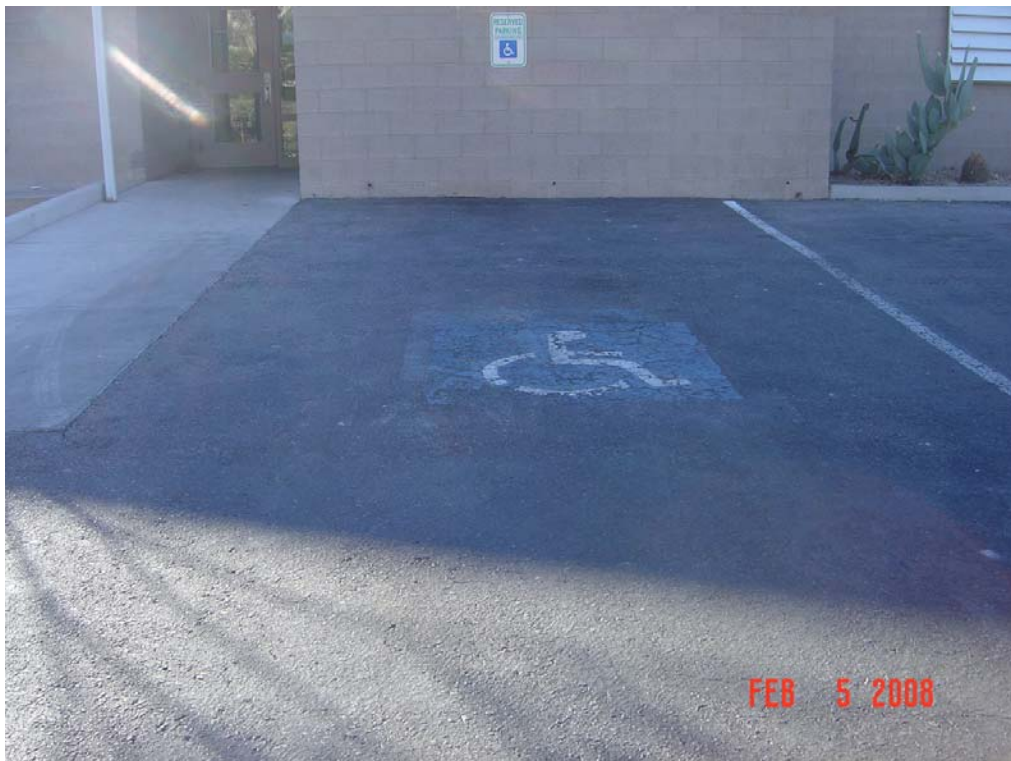
The accessible parking area in front of the building is too steep. The accessible route from the dedicated parking area to the front door of the building is too steep. The door hardware at the entrance is not compliant. It is recommended that lever hardware be installed on the entrance and office doors that require use by the public and that the parking area and access routes be made accessible.

B & G Maintenance / DOIT Garage - Building #0718  
Description: Existing "ADA" parking space.
