GOVERNOR'S MANSION SITE

600 Mountain Street
Carson City, Nevada 89701

STATE OF NEVADA PUBLIC WORKS DIVISION FACILITY CONDITION ANALYSIS

Report distributed in October 2021

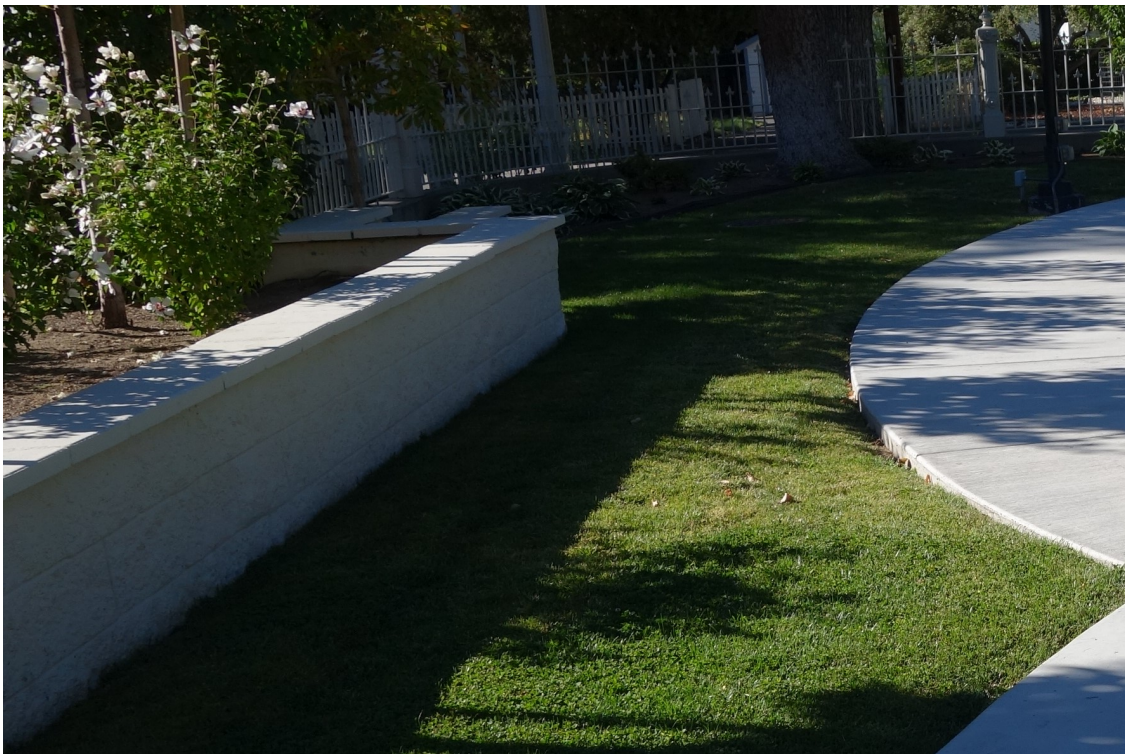
The painted concrete masonry unit (CMU) landscape walls around the site show varying degrees of wear including cracking, flaking and spalling. The top layer of paint and concrete is flaking off in many areas and is due for replacement. It is recommended that these walls be demolished and replaced with new decorative CMU walls and wall caps. This project or a portion thereof was previously recommended in the FCA report dated 05/15/2008. It has been amended accordingly to reflect conditions observed during the most recent survey date of 09/11/2018.

Governor's Mansion Site - Site #9978
Description: Landscape Walls Needing Replacement

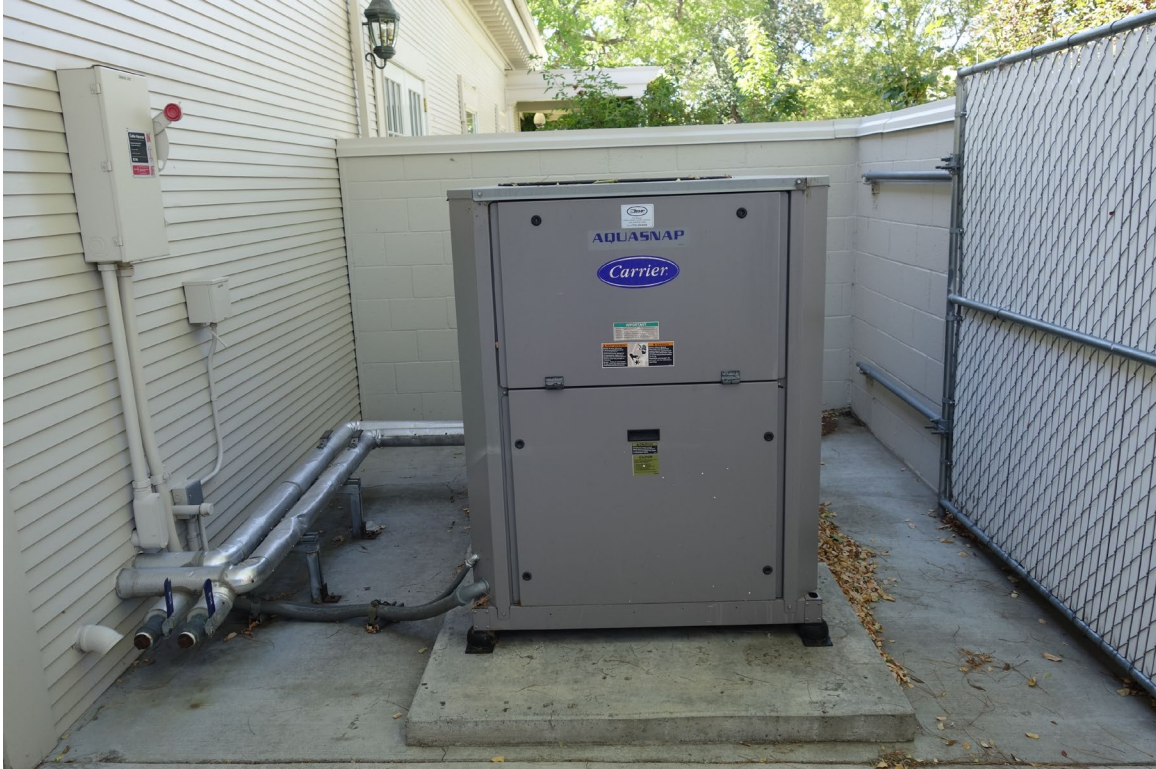
The existing HVAC system was last renovated in approximately 2002 with the installation of an air-cooled chiller, pumps, and rooftop units. The R-22 refrigerant in the cooling system is no longer EPA compliant and its production is mandated to be phased out completely by January 1, 2020. All of this equipment is reaching the end of its useful life and scheduled for replacement in the next 8 - 10 years. This project would provide for replacing the existing equipment with new, high efficiency equipment and cleaning the existing duct work and grilles. This project includes removal and disposal of the existing HVAC units and all required connections to utilities.

Governor's Mansion Nevada Room - Building #0707
Description: Air Cooled Chiller / HVAC Replacement Plan Recommended.

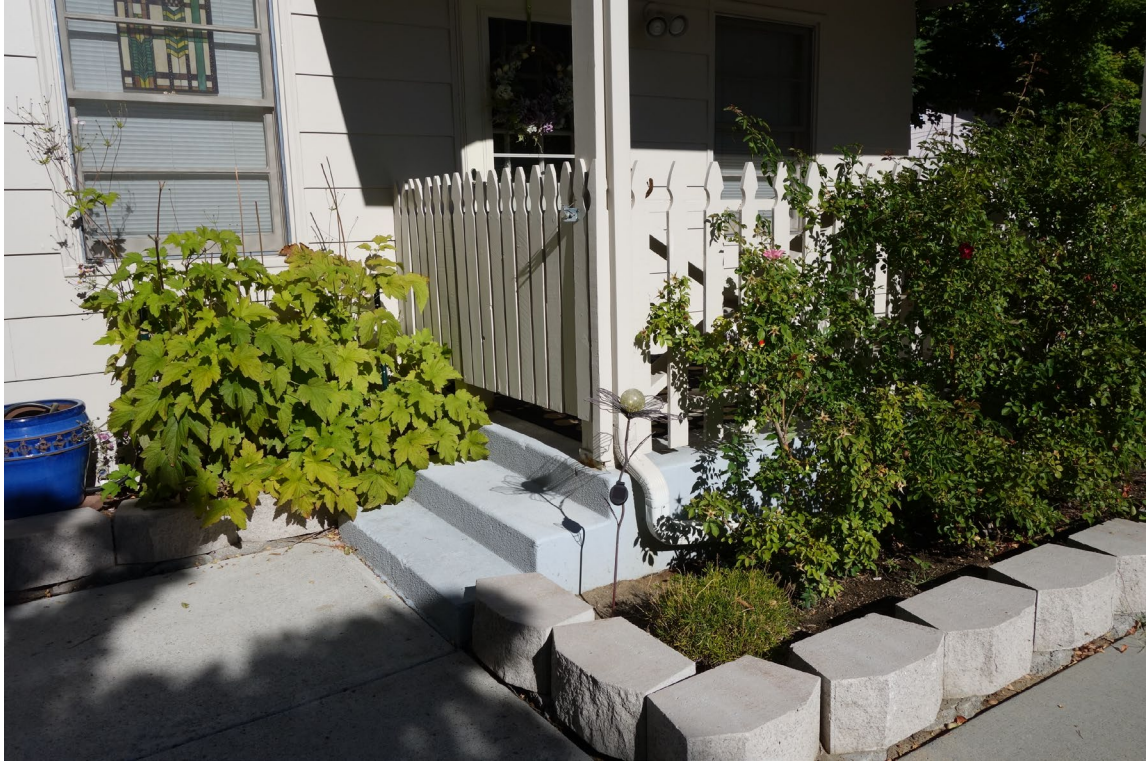
Governor's Mansion Guest Cottage - Building #0153
Description: Stairway Handrail Needed.

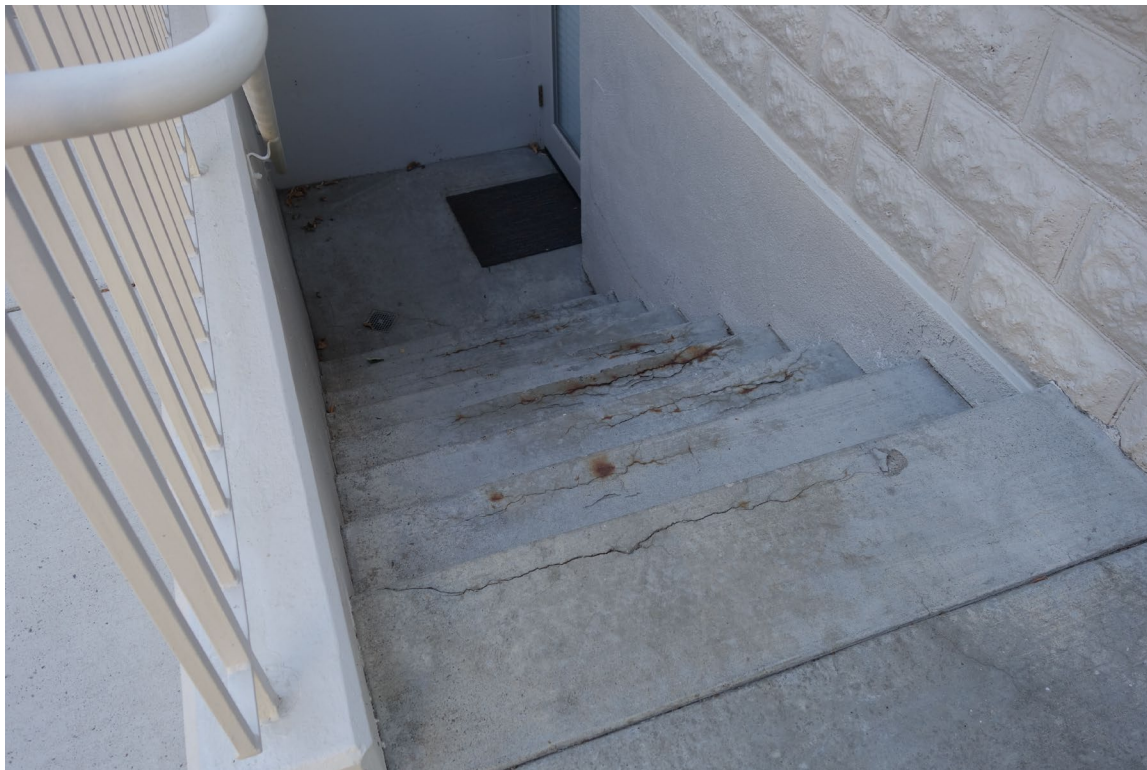
The concrete stairs that access the basement of the building are deteriorating. Spalling and cracking have occurred. Exposure to the elements is a contributing factor. A complete replacement is needed.

Governor's Mansion - Building #0151
Description: Basement Concrete Stair Replacement Needed.

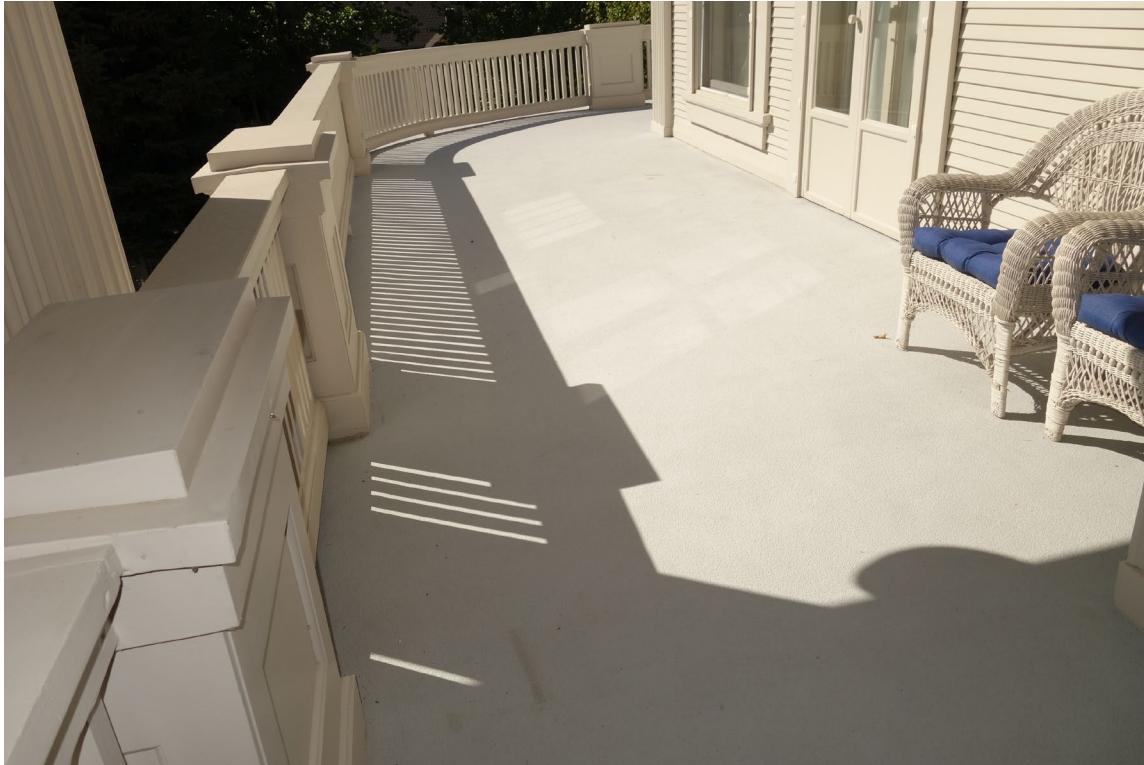
The material on the exterior second floor deck of the Mansion is cracking and failing. The second floor decking material no longer provides a waterproof barrier to the plywood decking and the area below. The plywood is warping and buckling causing the joints to separate which contributes to the failed waterproofing system. This project would provide for replacing the poured deck material and repairing any damaged plywood decking below it.

Governor's Mansion - Building #0151
Description: 2nd Floor Deck Material Repairs Needed.

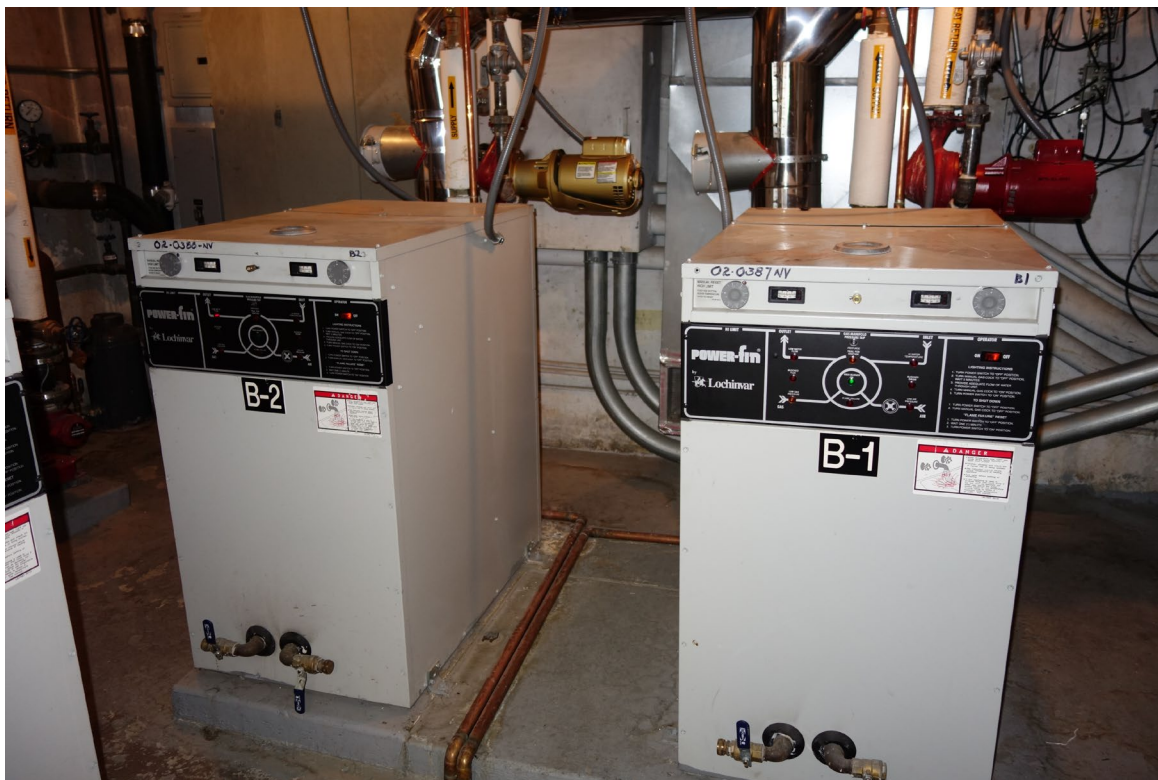
The existing HVAC system was last renovated in 2002 with the installation of new boilers, pumps, two rooftop units, and fan coils. All of this equipment is reaching the end of its useful life and scheduled for replacement in the next 8 - 10 years. This project would provide for replacing the existing equipment with new, high efficiency equipment and cleaning the existing duct work and grilles. This project includes removal and disposal of the existing HVAC units and all required connections to utilities.

Governor's Mansion - Building #0151
Description: HVAC Replacement Plan Recommended.
