DEPARTMENT OF ADMINISTRATION
STATE PUBLIC WORKS DIVISION
FACILITY CONDITION ASSESSMENT

PROPERTY PORTFOLIO REVIEW PROJECT ADDENDUM

NORTHWEST REGION
NORTHERN STATE AND COUNTY GOVERNMENT CAMPUS
9980 - LAKES CROSSING CENTER SITE
500 GALLETTI WAY
SPARKS, NV 89431-5526
WASHOE COUNTY

SURVEY DATE: 03/11/2025

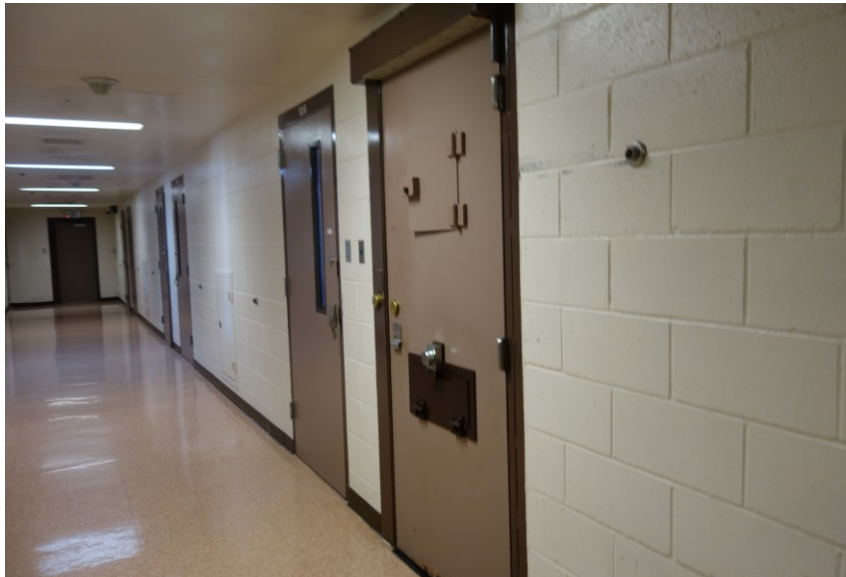
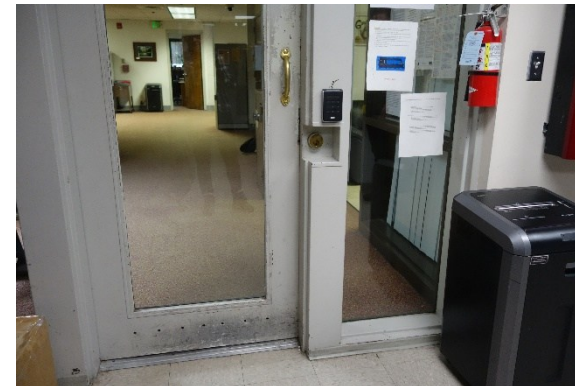
0342-SEC-1:INTERIOR DOOR REPLACEMENT

The interior doors are deteriorated from age and heavy use. Within the secured area, 115 doors require replacement, and 20 additional doors outside the secured area are also failing. Several fire-rated doors lack magnetic hold-open devices and are frequently propped open, compromising life safety. Many doors are loose in their frames with worn locking hardware. This project includes removal of existing doors and installation of new doors, frames, and hardware,

including 115 security-grade hollow metal doors and 20 solid-core wood doors.

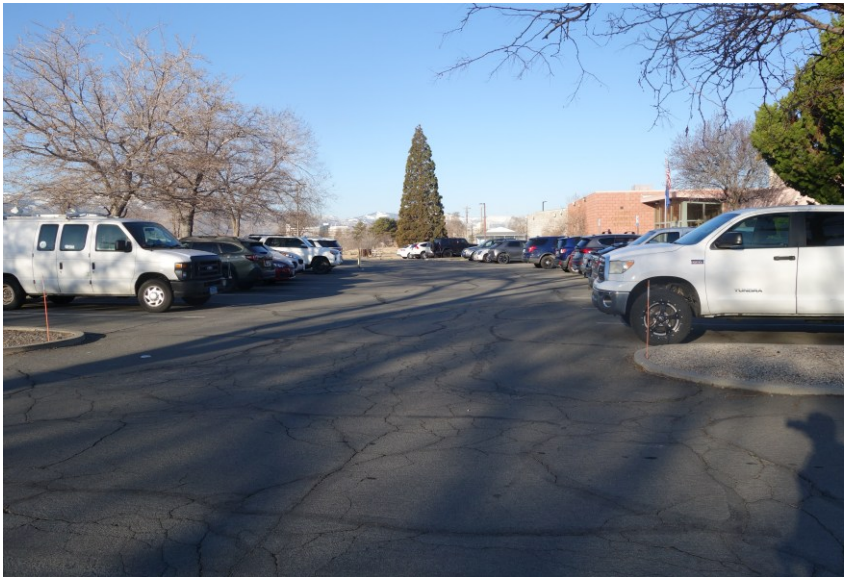
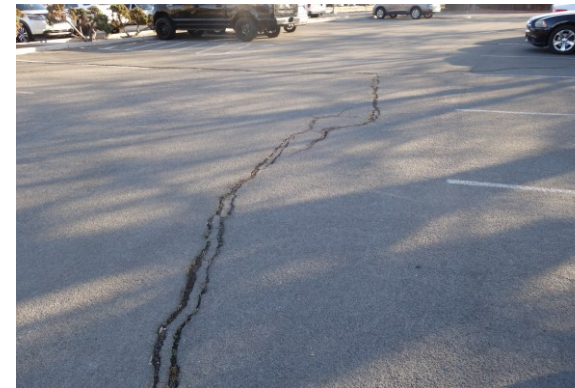
9980-SIT-4: PATCH, CRACK & SLURRY SEAL PARKING LOT

Regular maintenance of the asphalt concrete paving is important to preserve its condition and extend its service life. Based on survey observations, this project would include localized replacement of deteriorated pavement, minor crack filling, and slurry sealing across the site, along with restriping of parking and traffic markings as needed. These improvements help maintain the integrity of the paving and reduce the potential for premature failure.

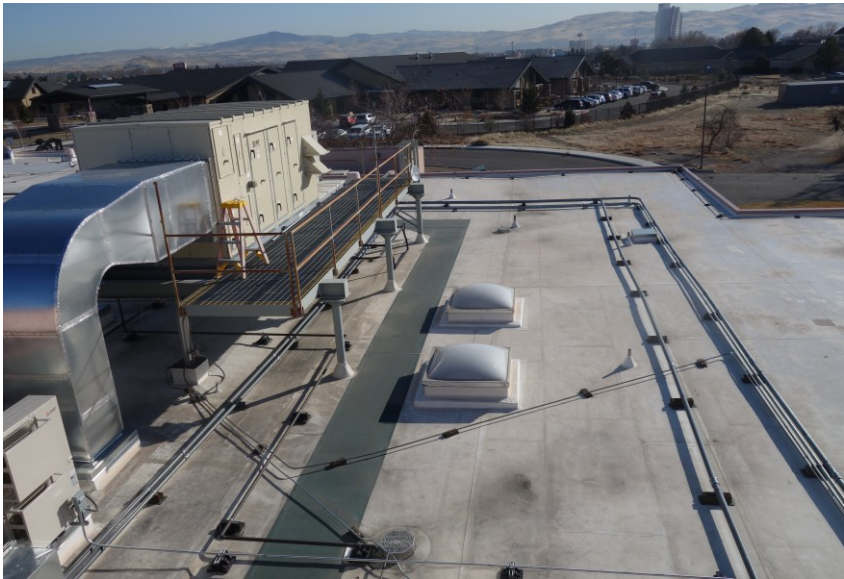
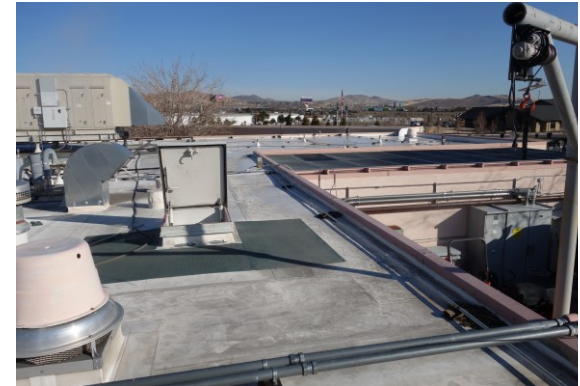
**REINSTATED BUILDING EXTERIOR - 12/10/2025
0342-EXT-3: ROOF REPLACEMENT**

This portion of the roof is Sika Sarnafil and expired on 8/25/2023. Roof replacement is recommended. Remove the existing roof and replace with a new single-ply membrane roof.

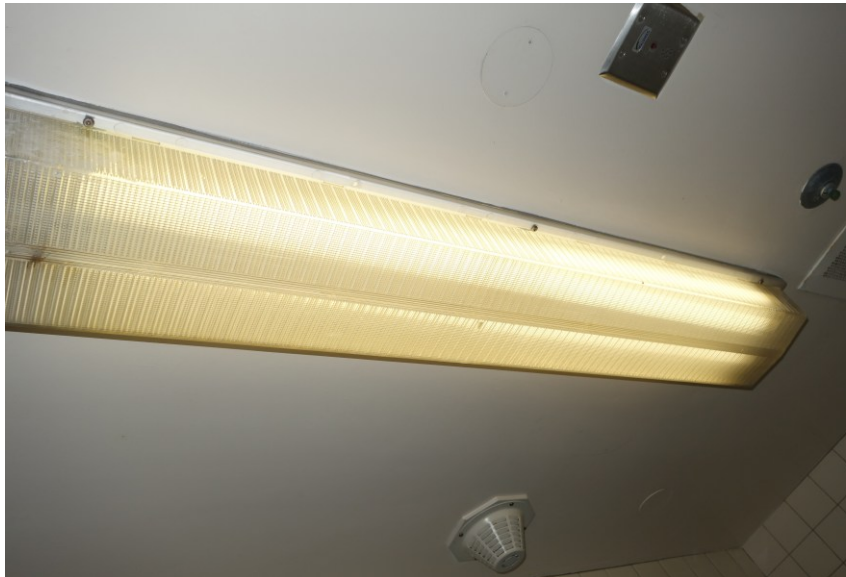
0342-SFT-6: UPGRADE LIGHTING IN CLIENT ROOMS

Client rooms are currently equipped with standard fixtures that pose ligature and self-harm risks. This project replaces existing room lighting with anti-ligature, tamper-resistant components designed for behavioral health and secure environments. Work includes removal of existing fixtures and installation of new ligature-resistant lighting fixtures. Wall and ceiling surfaces will be patched and refinished where needed.

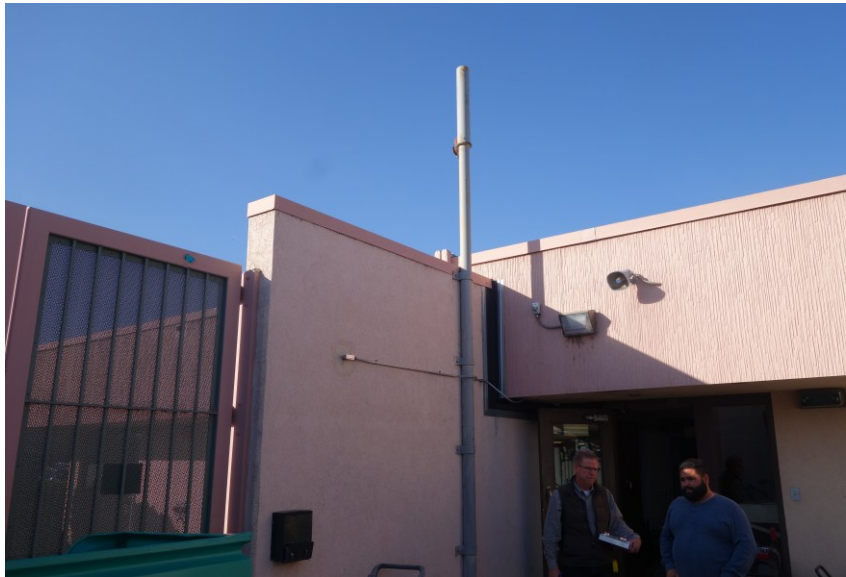
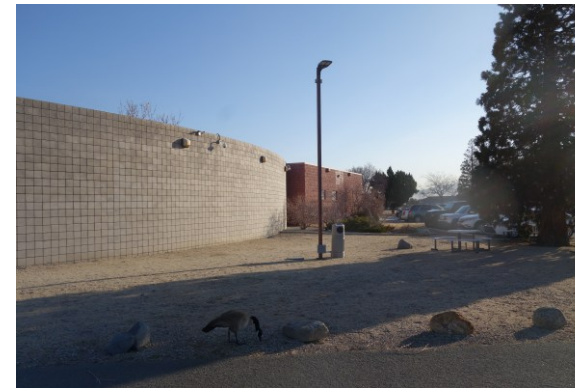
0342-SEC-2: VIDEO SECURITY SYSTEM REPLACEMENT

The video security system for the building and the site is outdated and should be scheduled for immediate replacement. The system is over ten years old and it is increasingly difficult to find replacement parts and experienced repairmen to service the equipment. The wiring and conduit are aging and in some areas were not installed properly resulting in premature wear and a higher probability of failure. Due to the security level of the facility is imperative that a

new system is installed for the safety of the staff, clients and the public. This project addresses replacement of the cameras, conduit and wiring throughout the facility with all digital equipment as well as sufficient storage capacity.

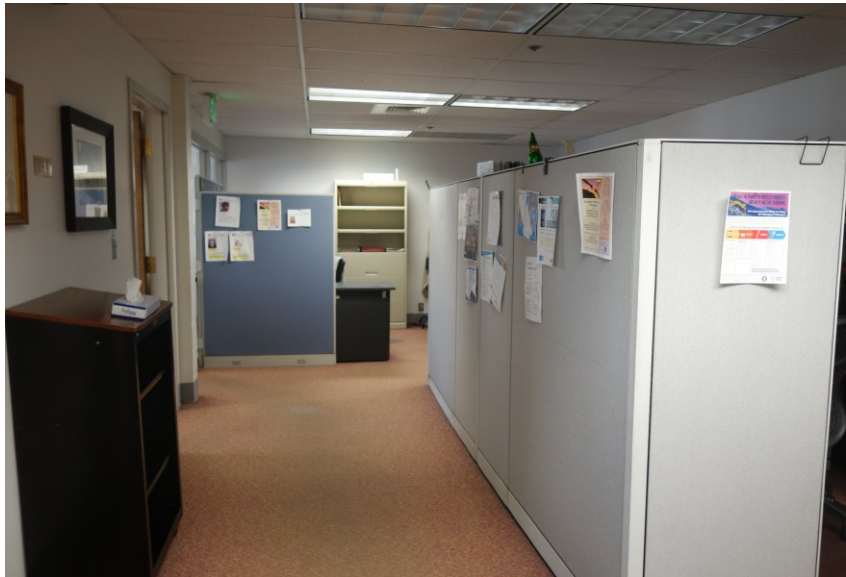
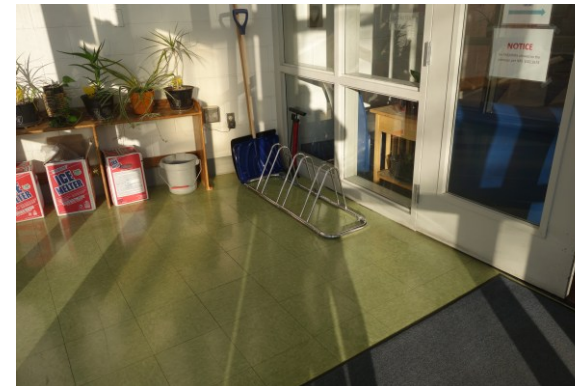
**REINSTATED BUILDING INTERIOR - 12/10/2025
0342-INT-5:FLOORING REPLACEMENT**

Portions of the building's carpet have been upgraded to LVT; however areas with original carpet remain and show signs of wear consistent with the end of their useful life. The front entry VCT is worn and cracked. A new durable and uniform finish flooring should be selected and installed. Work includes removal and disposal of existing flooring and installation of an appropriate flooring material suited to each area.

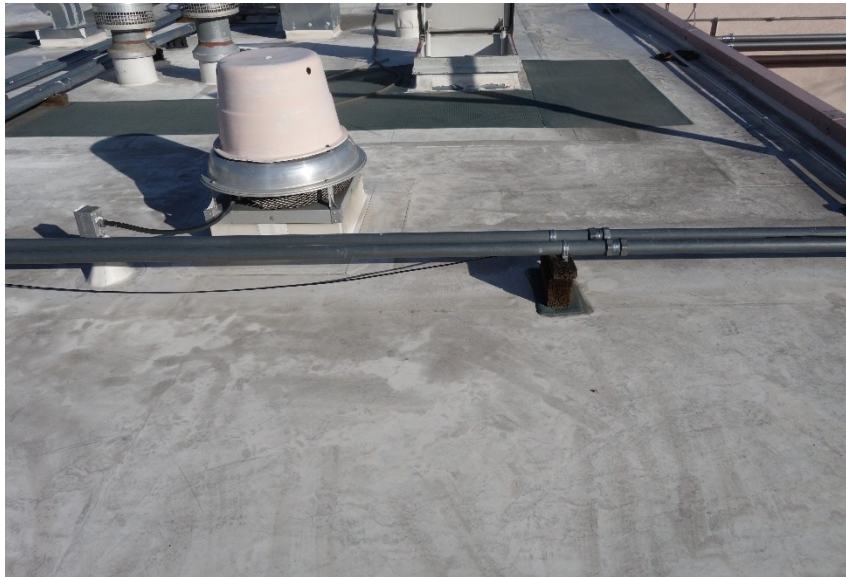
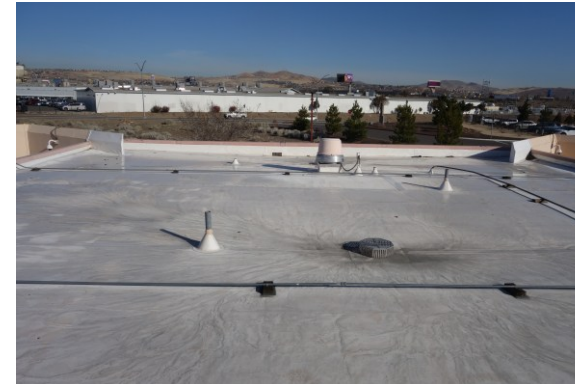
0342-EXT-4: REPLACE ROOF MEMBRANE

The portion of the roof that is Johns Manville membrane has exhibited signs of leakage, indicating deterioration of the existing membrane. The roof warranty expired on 5/17/2014. Based on survey observations, replacement of the affected membrane area is recommended. Work would generally include removal and disposal of the existing membrane and installation of a new, compatible roofing system, along with associated repairs needed to restore proper weather protection.

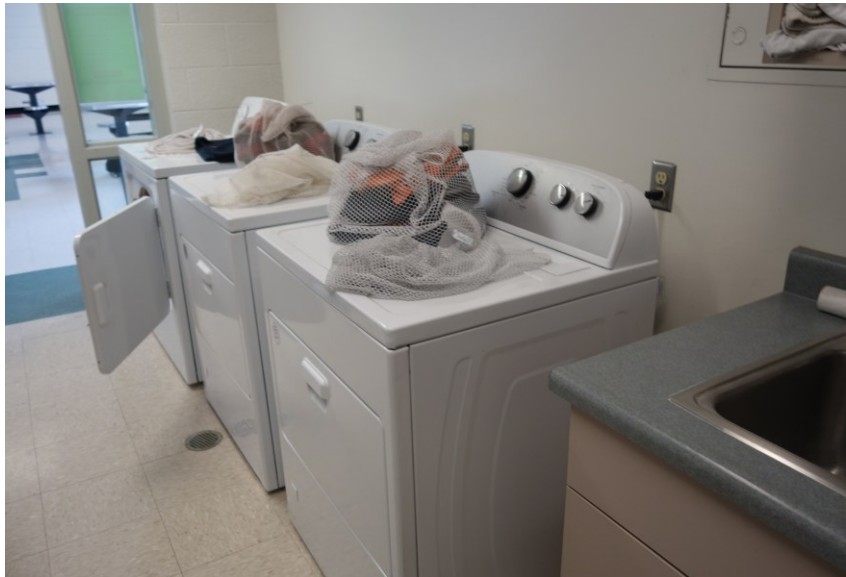
0342-SFT-5: LAUNDRY DRYER REPLACEMENT

The existing natural gas-fired clothes dryers have been noted as a potential fire risk due to the presence of a gas ignition source. Based on survey observations, replacement of the three gas dryers with three commercial electric units is recommended. Removal and disposal of the existing dryers would be included as part of this work. Cost includes: Dryer \$2,000, venting/exhaust adjustments \$2000, removal \$1000, electrical circuits \$1,000, contingency add \$1000.

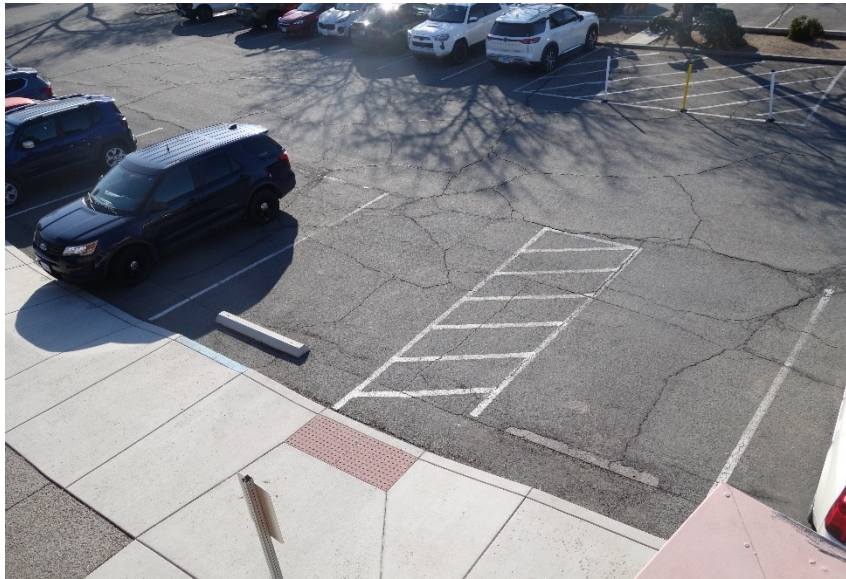
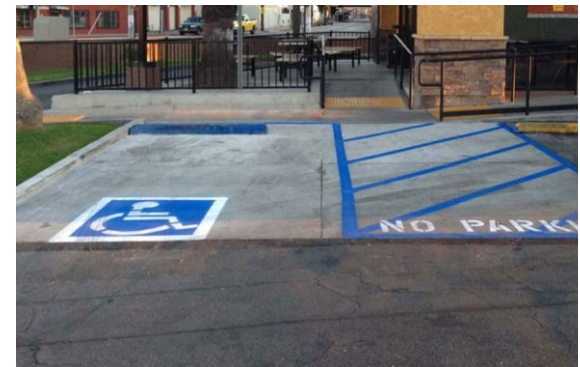
9980-ADA-5:ADA PARKING UPGRADE

The ADA parking stalls currently have one asphalt apron that has deteriorated and does not provide the stable, firm, and slip-resistant surface required for accessible routes. Asphalt in these areas has developed cracking, settlement, and irregular slopes that may impede safe access for individuals using mobility devices.

This project upgrades the existing asphalt apron to reinforced concrete, providing a durable, long-life, ADA-compliant surface.

Work includes demolition of the asphalt apron areas, installation of compacted base material, new concrete apron with corrected slopes, and restoration of ADA striping and signage. Typical apron size: 19' x 20' = 380'.

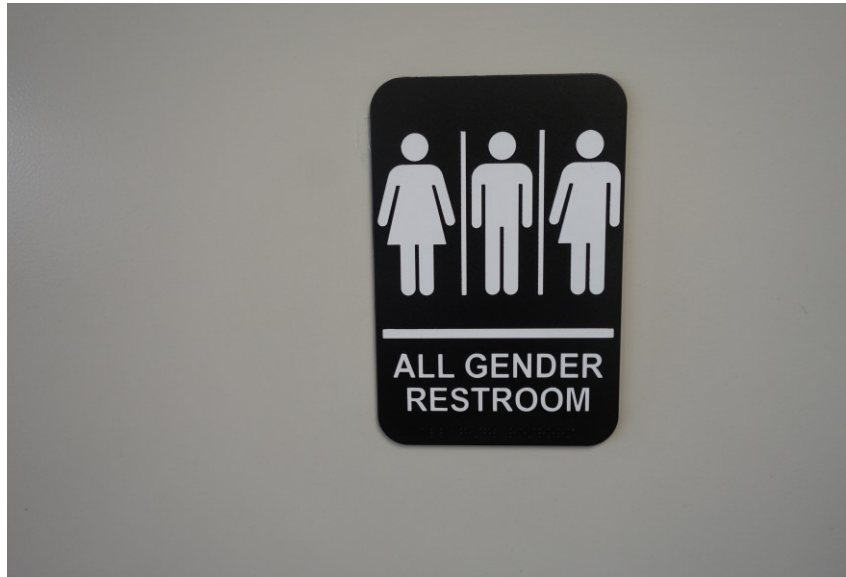
0342-ADA-2:ADA SIGNAGE

Building signage for permanent rooms and spaces appears inconsistent with ADA accessibility guidelines, including requirements for mounting height, location, character size, tactile/Braille elements, and contrast. Based on survey observations, installation or adjustment of signage may be needed to align with current accessibility standards. NRS 338.180, IBC 2018, ICC/ANSI A117.1, and the most current ADA Accessibility Guidelines were referenced for this survey item.

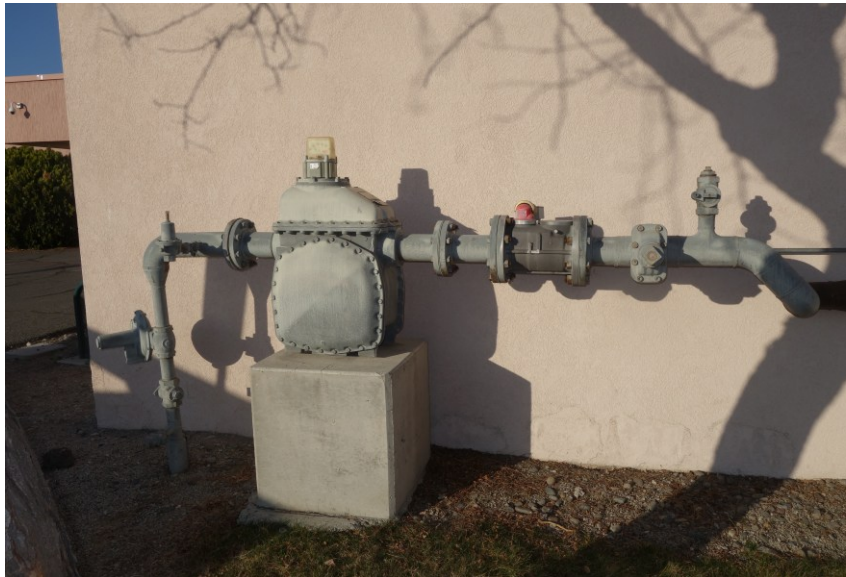
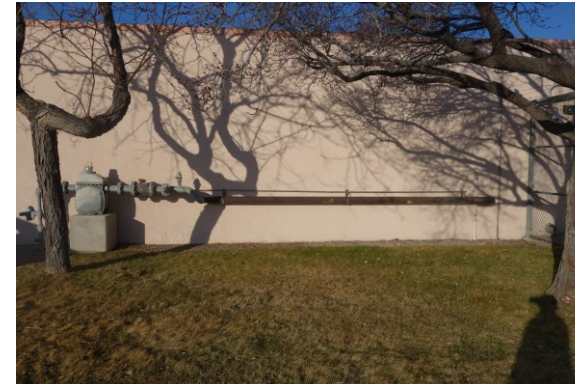
9980-SIT-3:INSTALL SITE BOLLARDS

The natural gas meter is located in a position vulnerable to vehicular impact and requires protective barriers. In accordance with 2024 IFC Section 312 (Vehicle Impact Protection), steel guard posts (bollards) should be installed around the meter to prevent vehicle-related damage. The proposed project would include installation of three bollards around the gas meter, with dimensions and spacing per code requirements.

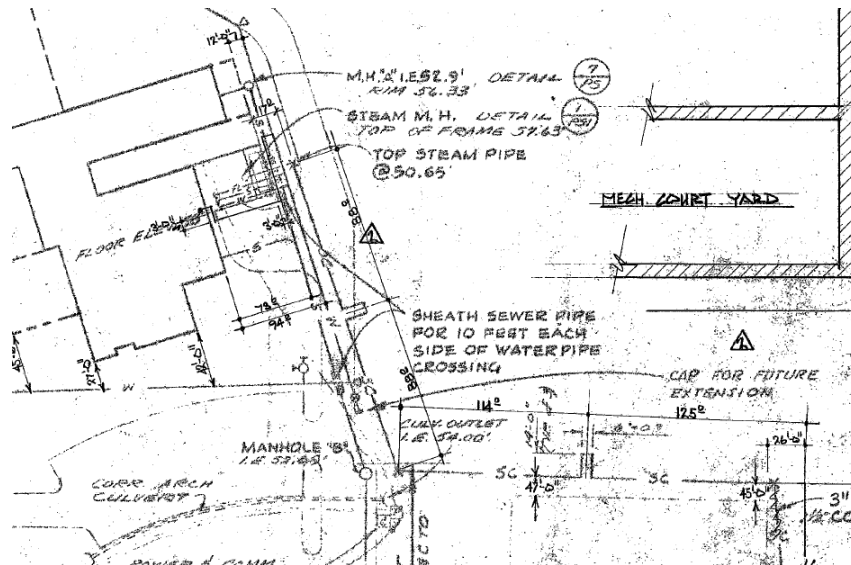
0342-PLM-3:SEWER SURVEY

The building has experienced recurring drainage problems and periodic backups, indicating that the floor main sewer line may be damaged or partially obstructed. This project provides for a comprehensive sewer main survey, including cleaning and jetting, CCTV camera inspection, mapping of the sewer line, and a written condition report identifying cracks, sags, root intrusion, blockages, or structural failures. Findings will determine whether spot repairs, relining, or full replacement are needed.

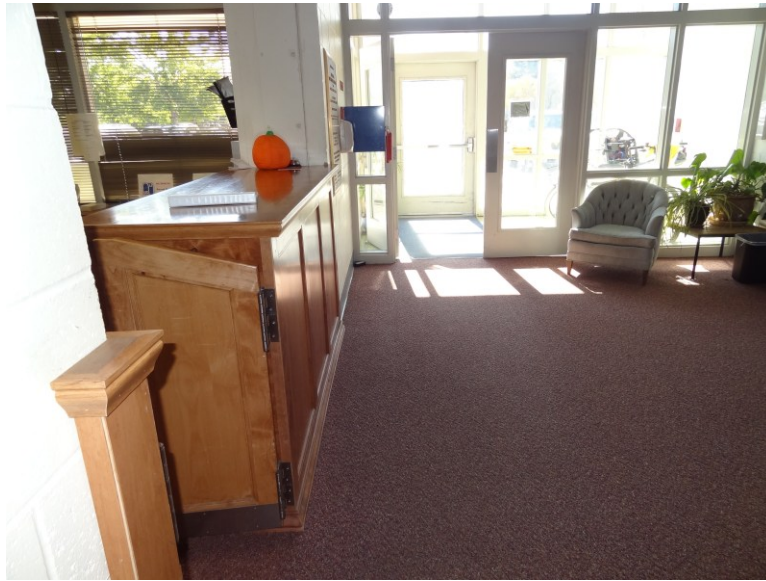
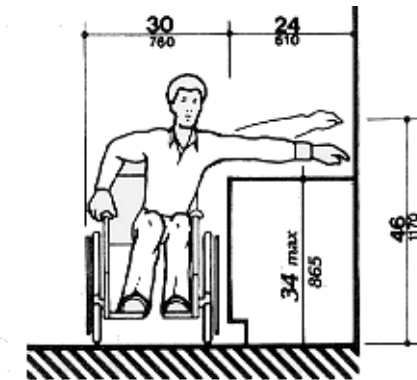
0342-ADA-4: ADA ACCESSIBLE COUNTER

The front office includes a public service counter that appears higher than the dimensions typically associated with accessible counter design. ADA accessibility guidelines generally require a portion of the counter to be at least 36 inches in length and no more than 36 inches above the finished floor. Based on survey observations, an accessible counter section may be needed to align with current accessibility standards. NRS 338.180, IBC 2018,

ICC/ANSI A117.1, and the most current ADA Accessibility Guidelines were referenced for this survey item.

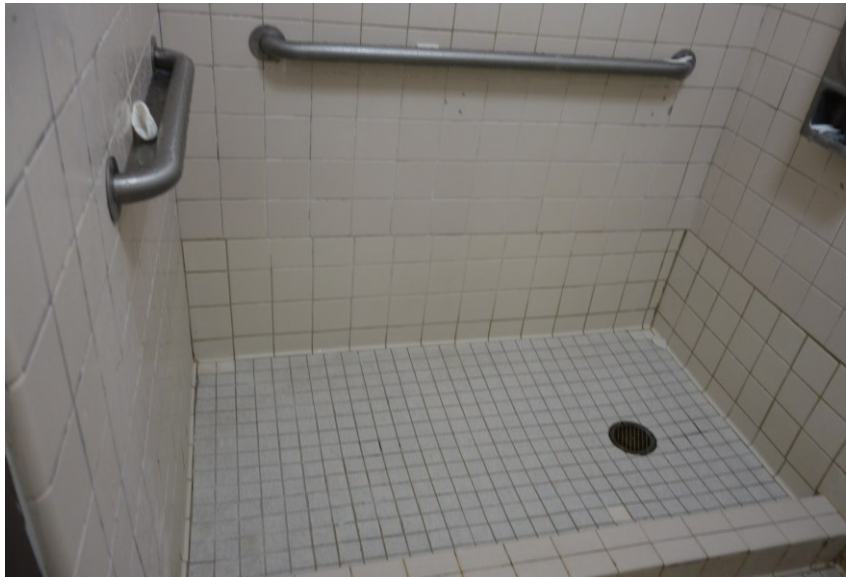
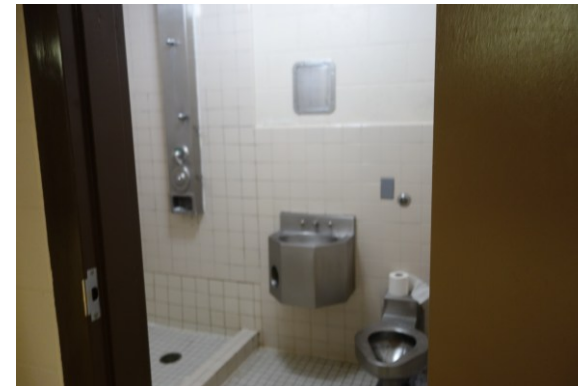
IN PROGRESS BUILDING INTERIOR - 12/10/2025
0342-INT-4: SHOWER UPGRADE

There are 16 shower stalls showing signs of failure and in need of replacement. This project provides for the installation of 16 stainless-steel shower cabinets to serve the housing units. Removal and disposal of existing materials are included.

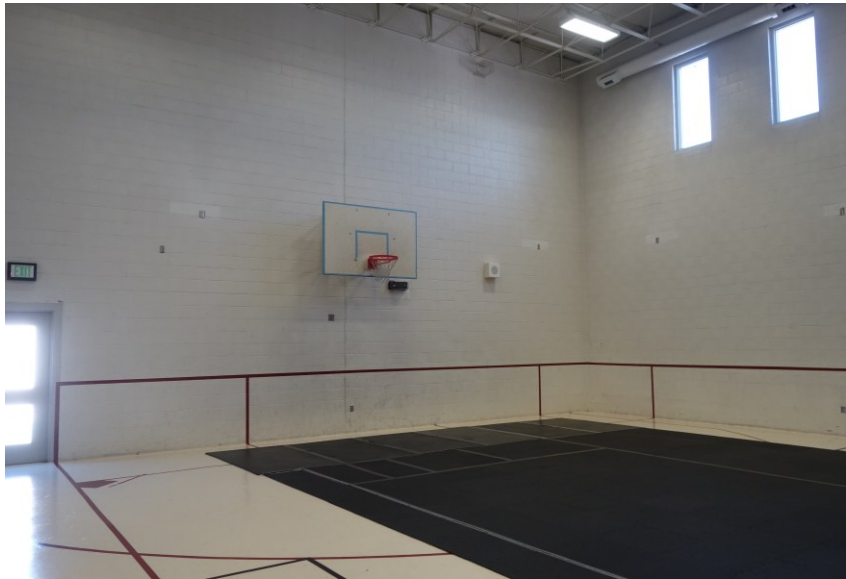
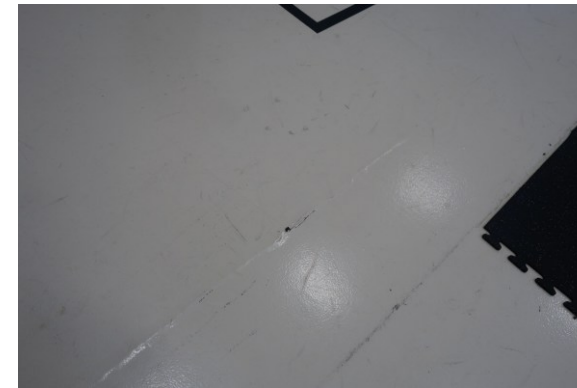
NEW BUILDING INTERIOR - 12/10/2025
0342-INT-7:REPLACE GYM FLOOR

The existing gym floor is deteriorated, with visible cracking, surface wear, and coating failure. The damaged flooring presents a safety risk for users and is no longer suitable for athletic activities. This project provides for the removal and disposal of the existing floor system and installation of new rubber athletic flooring designed for high-impact and multi-use environments. The new flooring will provide improved safety, durability, slip resistance, and ease of

maintenance. Subfloor preparation and leveling are included as needed.

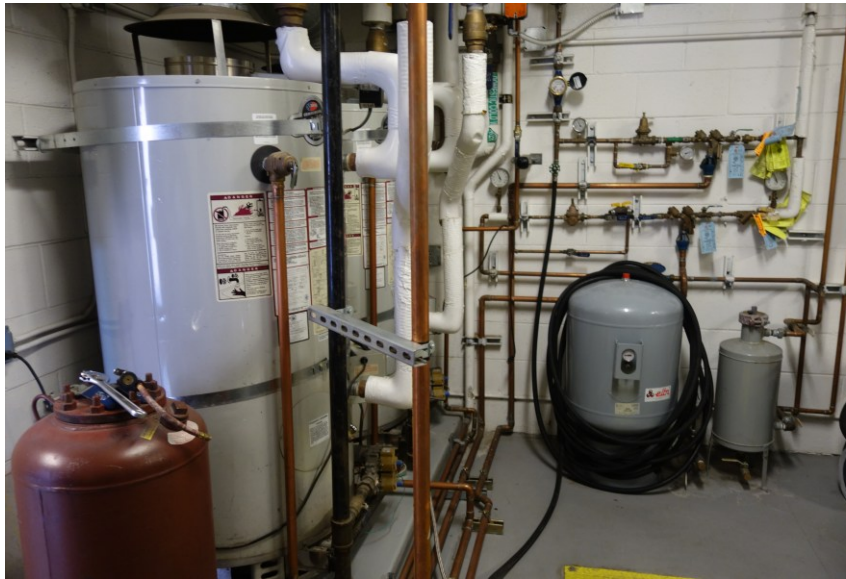
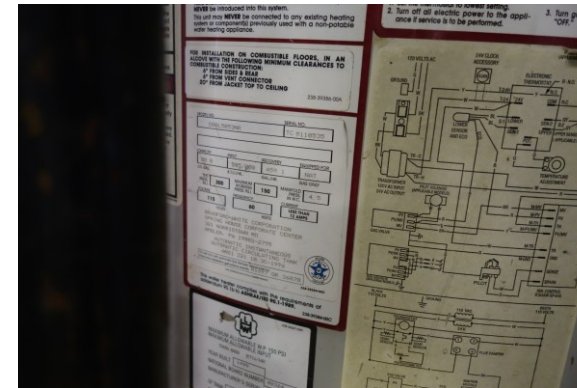
0342-PLM-2:WATER HEATER REPLACEMENT

There are two 80 gallon natural gas-fired water heater in the building. The average life span of a water heater is eight to ten years. With the passage of time and constant use, this unit is showing signs of wear and should be scheduled for replacement in the next 2 - 3 years. It is recommended that new gas-fired water heaters be installed. Removal and disposal of the existing equipment is included in this estimate.

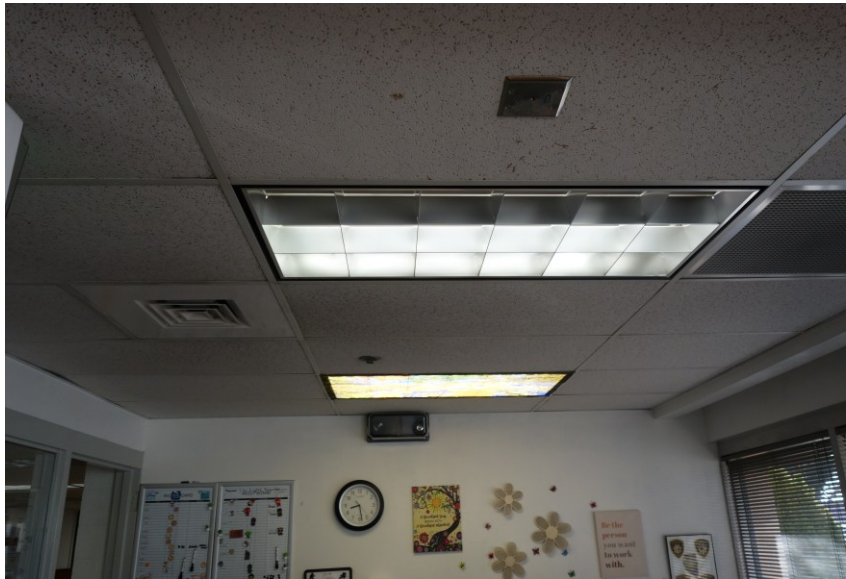
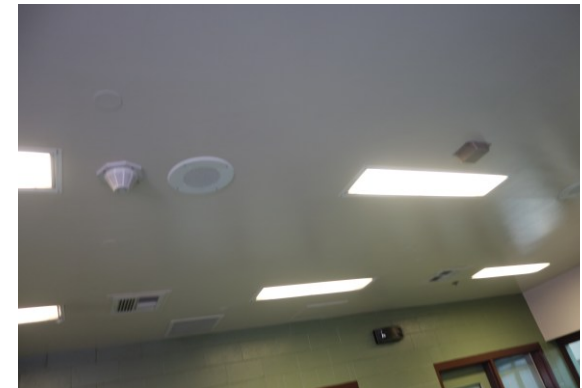
**IN PROGRESS ELECTRICAL - 12/10/2025
0342-ELE-2: LIGHTING UPGRADE**

The existing lighting fixtures are the older fluorescent type, are not energy efficient, and not detention-rated. This project will upgrade fixtures to higher efficiency units with a longer life cycle and lighting controls. Additional allowances for architectural repairs, demolition and exterior lighting.

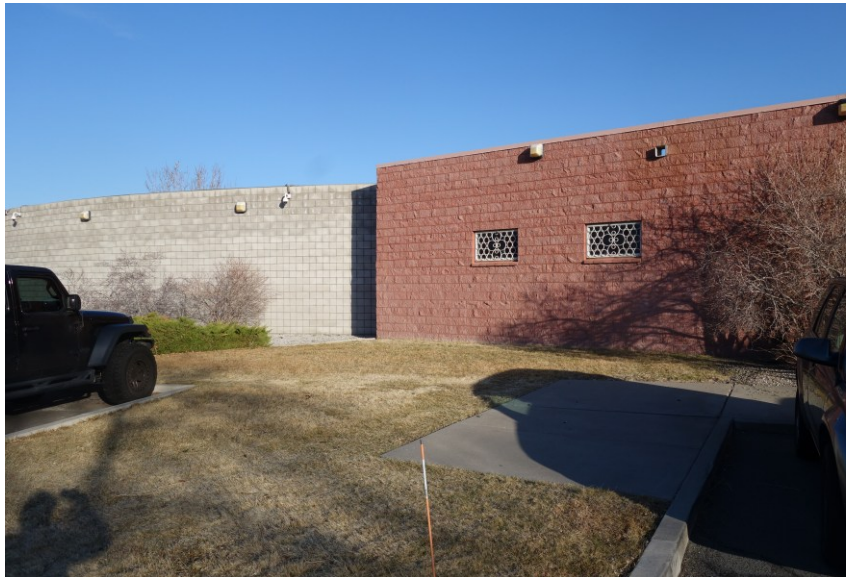
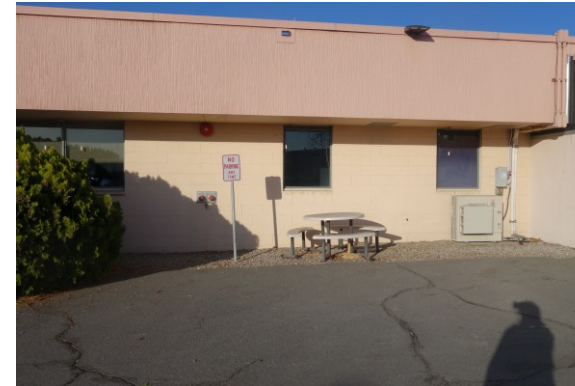
0342-EXT-2: EXTERIOR FINISHES

The exterior finishes appear to be in good condition at the time of the survey. To maintain weather resistance and overall appearance, periodic exterior maintenance is recommended. This includes repainting concrete masonry unit (CMU) and cement plaster walls, along with caulking around windows, flashing, fixtures, and other penetrations to help preserve the building envelope. Exterior maintenance should be planned on a cyclical basis to support long-

term protection of the structure. Costing includes: CMU (1 coat + 2 coats acrylic) \$3.00/sf, Stucco \$4.00/sf, Penetrations \$6.00/sf.

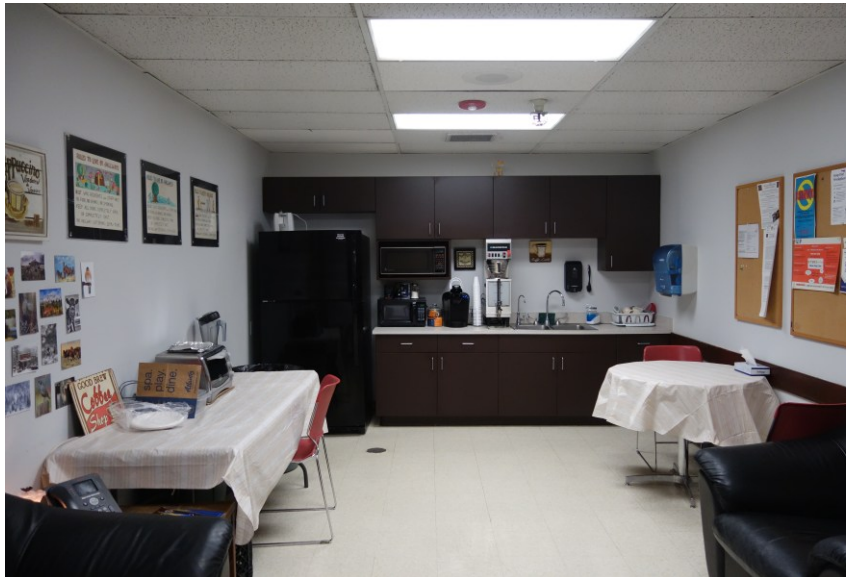
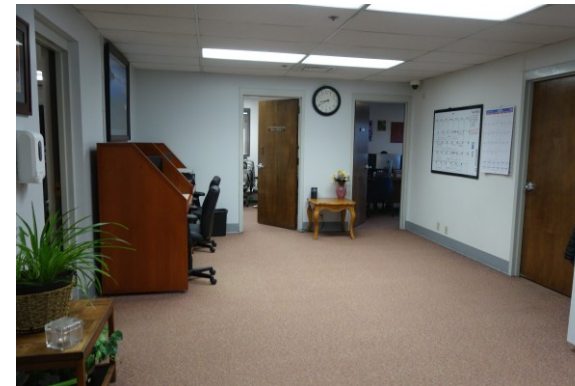
**REINSTATED BUILDING INTERIOR - 12/10/2025
0342-INT-2: INTERIOR FINISHES**

The interior finishes are in good condition. It is recommended that the interior walls and ceilings be painted at least once in the next 4 - 5 years and that this project be scheduled on a cyclical basis to maintain the integrity of the structure. Prior to painting, all surfaces should be repaired and prepped. An epoxy-based paint should be utilized in wet areas for durability.
