State of Nevada
Department of Health & Human Services
Division of Mental Health and Developmental Services
Sierra Regional Center
Facility Condition Analysis

SIERRA REGIONAL CENTER

605 South 21st Street
Sparks, Nevada 89431

Site Number: 9981
STATE OF NEVADA PUBLIC WORKS DIVISION
FACILITY CONDITION ANALYSIS

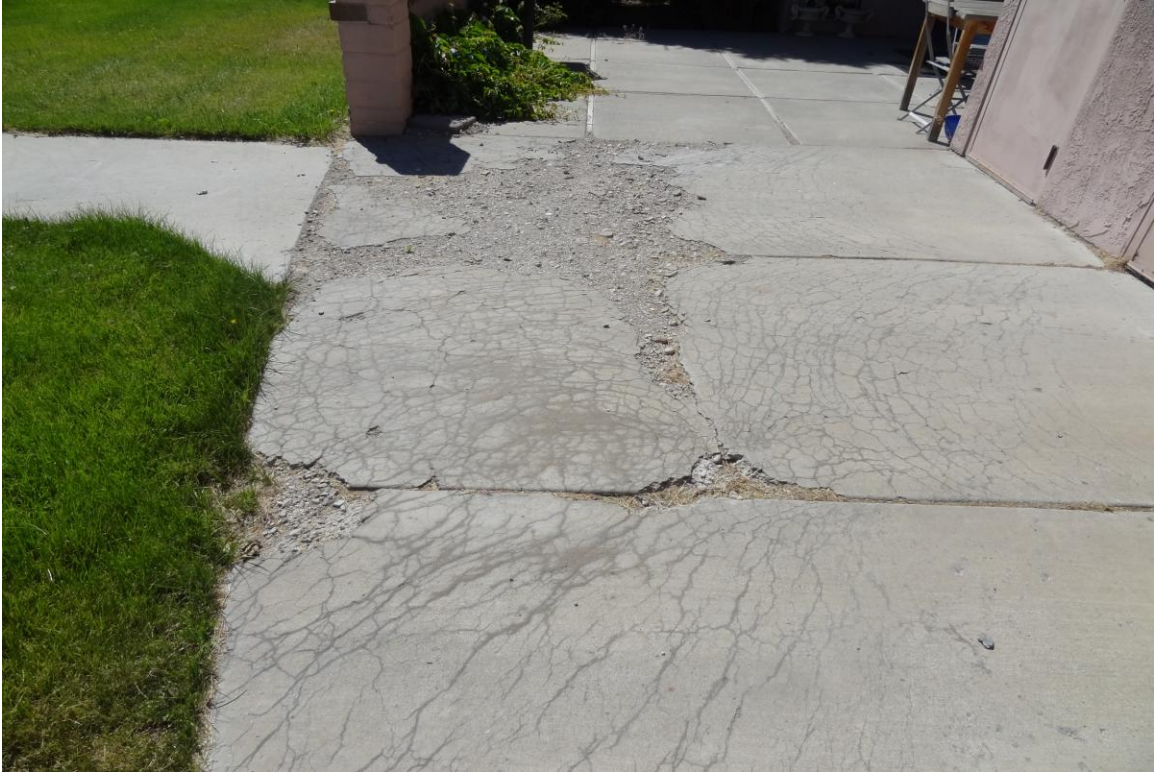
Many sidewalk sections serving the buildings and parking areas are deteriorated and failing. In some areas the concrete is spalling considerably and other areas are heaving and settling due to either expansive soils or tree roots. This project addresses removal and replacement of existing sidewalks as needed. 1,250 SF of 4" thick concrete sidewalk was used for this estimate. The 2012 IBC, ICC/ANSI A117.1 - 2009, NRS 338.180 and the most current version of the ADA Standards For Accessible Design were used as a reference for this project.

Sierra Regional Center Site – FCA Site #9981
Description: Damaged concrete walkway.

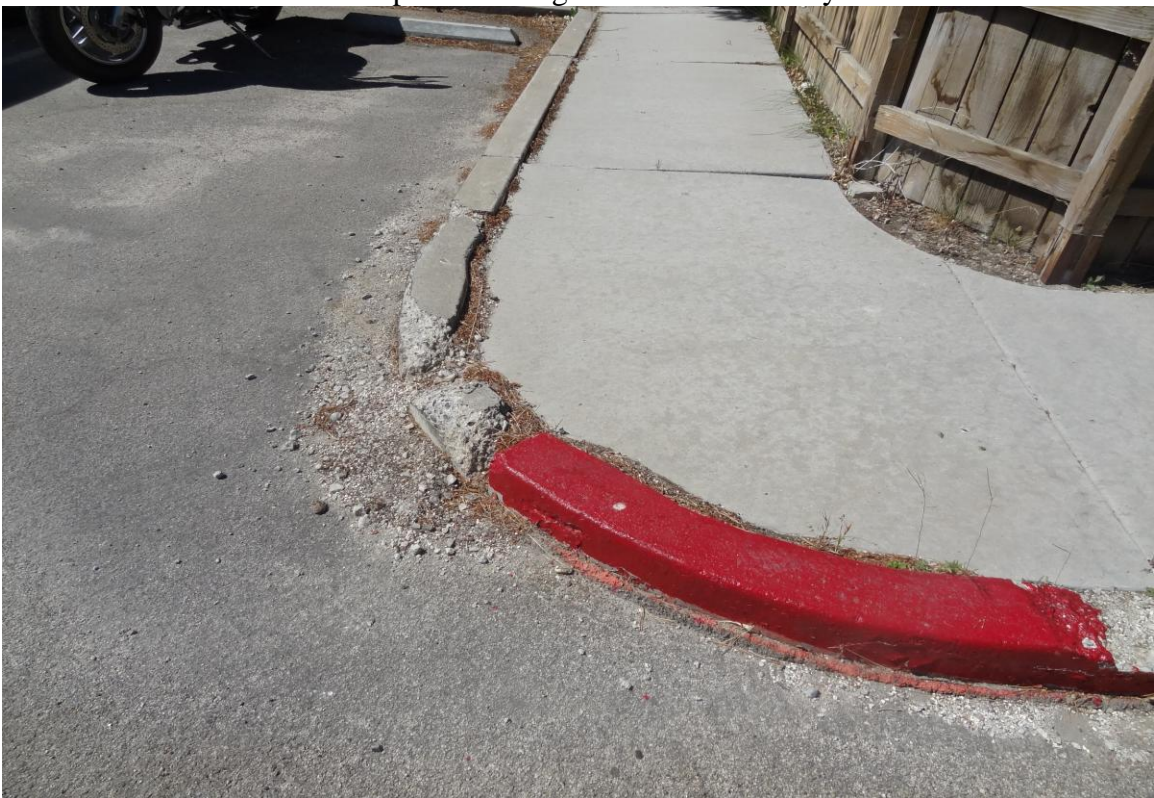
Sierra Regional Center Site – FCA Site #9981
Description: Damaged concrete curb and walkway.

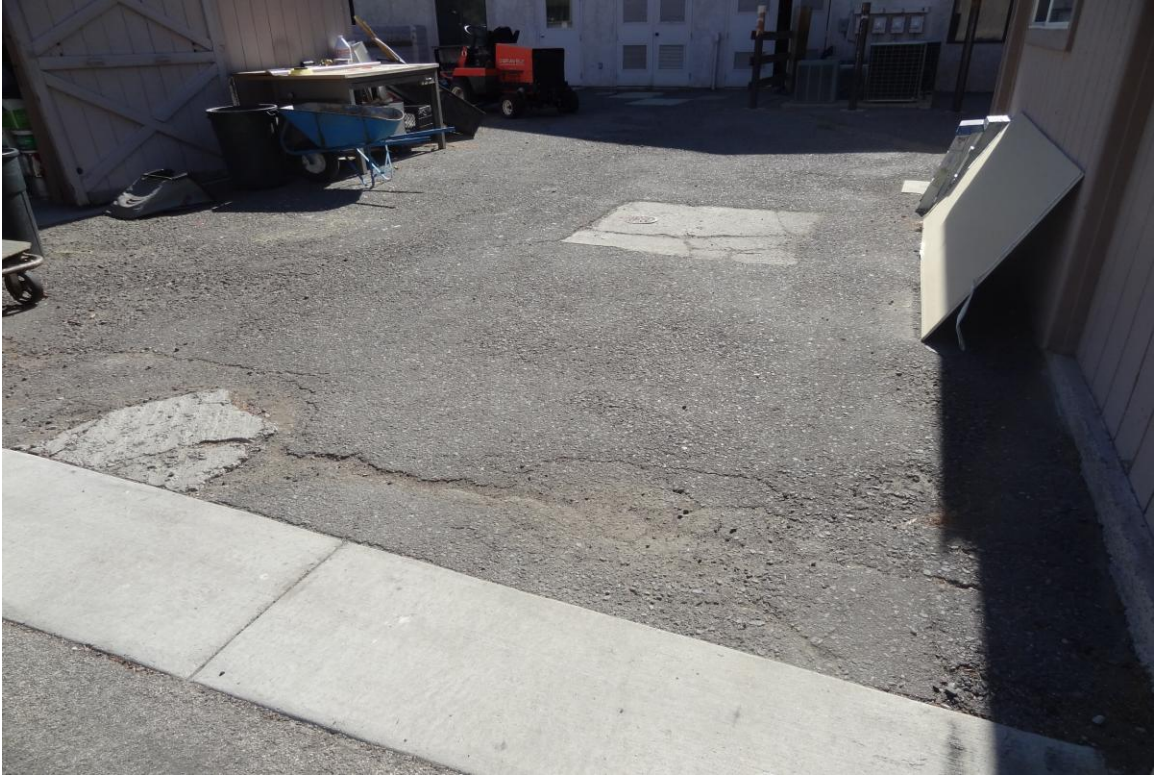
It is important to maintain the asphalt concrete paving on the site. This project would provide for minor crack filling and sealing of the paving site wide including access roads and parking areas. Striping is included in this estimate. This project should be scheduled on a 5 year cyclical basis to maintain the integrity of the paving and prevent premature failure. 150,000 square feet of asphalt area was used to generate this estimate.

Sierra Regional Center Site – FCA Site #9981
Description: Damaged AC paving in maintenance shop area.

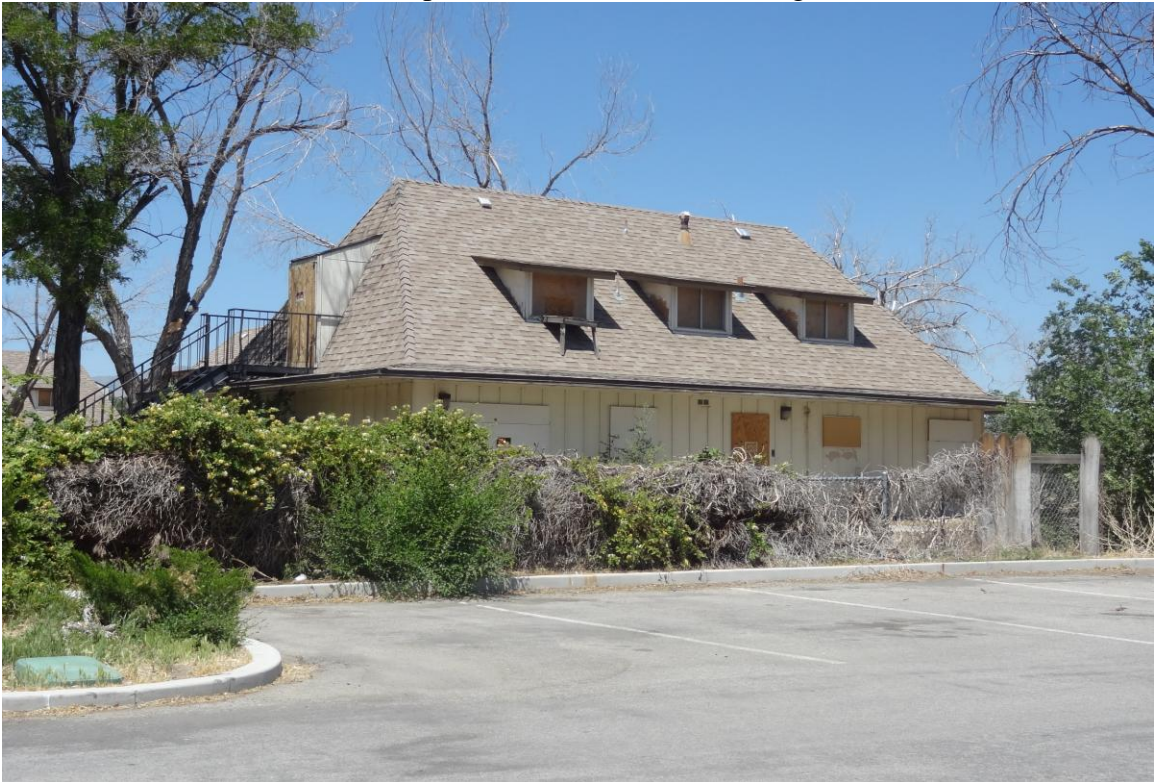
SRC ICF/MR 6-Bed Home – Building #16 (Vacant) – FCA Building #1957
Description: Exterior of the building.

The building contains numerous code and safety issues including but not limited to rodent infestation, broken windows, broken or missing electrical fixtures, dry rot and possible structural damage due to the age. The building is dilapidated and deteriorating and has reached the end of its useful life. This project would provide funding for the demolition of the building.
