State of Nevada
Department of Corrections
Northern Nevada Dairy Farm
Facility Condition Analysis

NORTHERN NEVADA DAIRY FARM

Site Number: 9982
STATE OF NEVADA PUBLIC WORKS BOARD
FACILITY CONDITION ANALYSIS

Report Printed in October 2008

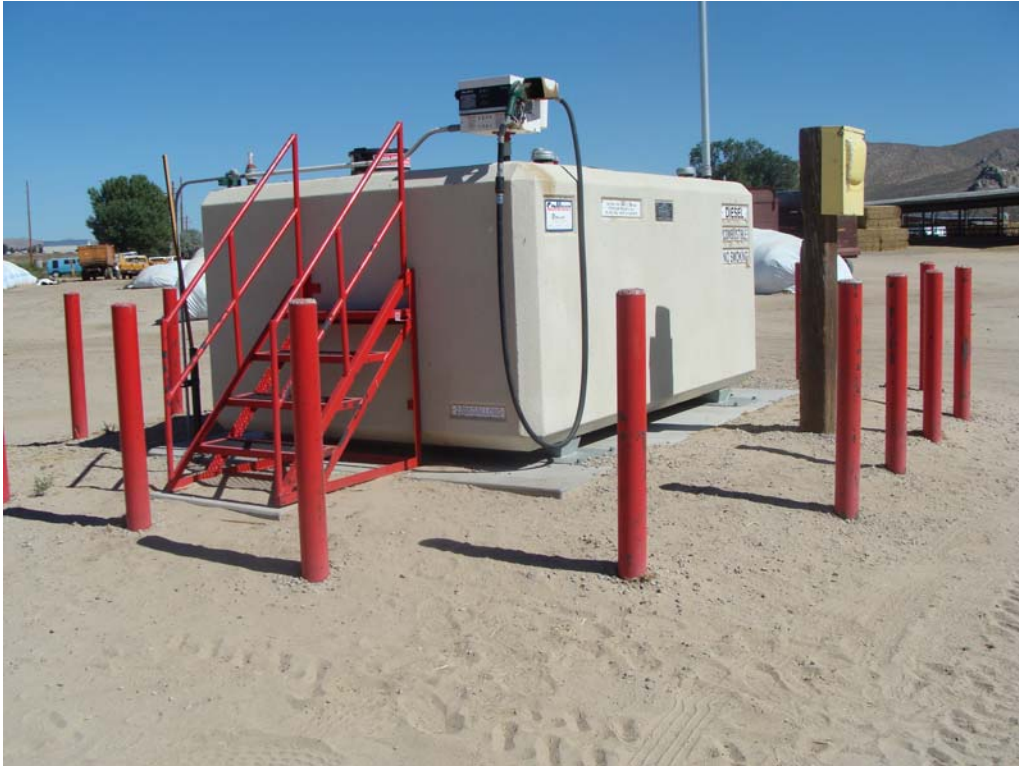
Northern Nevada Dairy Farm - Site #9982
Description: Above ground fuel tank.

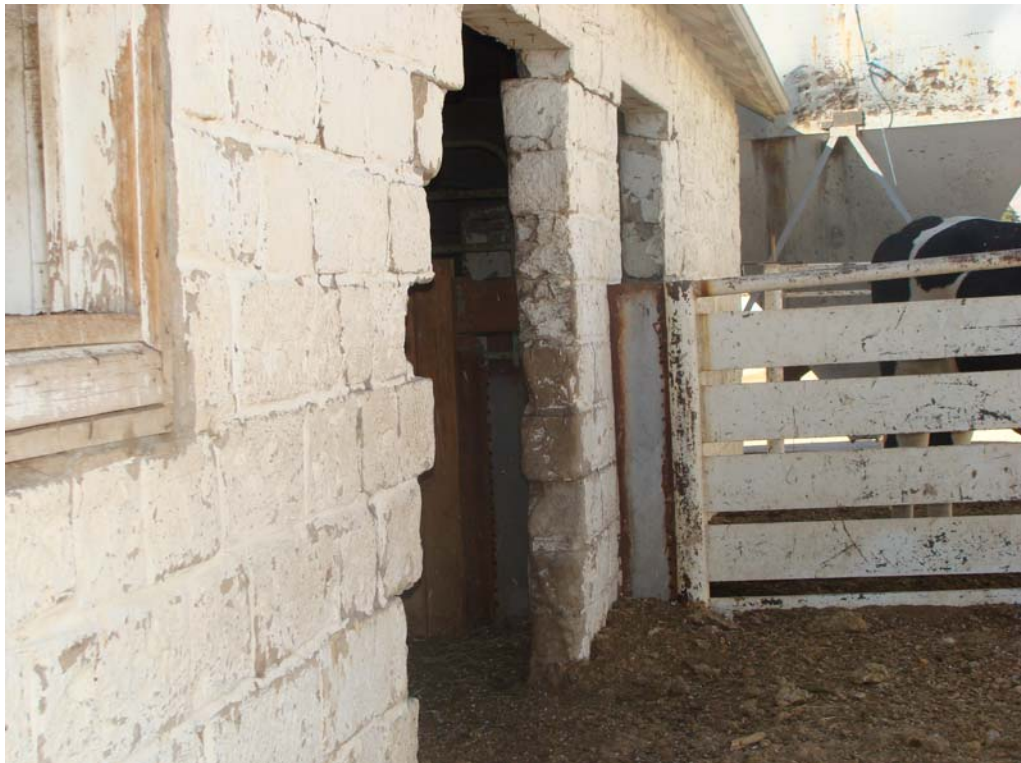
The building was constructed in 1916 out of unreinforced sandstone masonry. The walls are showing signs of failure including cracking, settling and crumbling. This project would provide for an investigation and assessment to be done by a licensed Structural Engineer to identify possible deficiencies and problems in the building and provide a report outlining issues and resolutions. Future projects may result from this report and are not included in this estimate.

Bull Barn - Building #1440
Description: Exterior of the building, note structural wall damage.

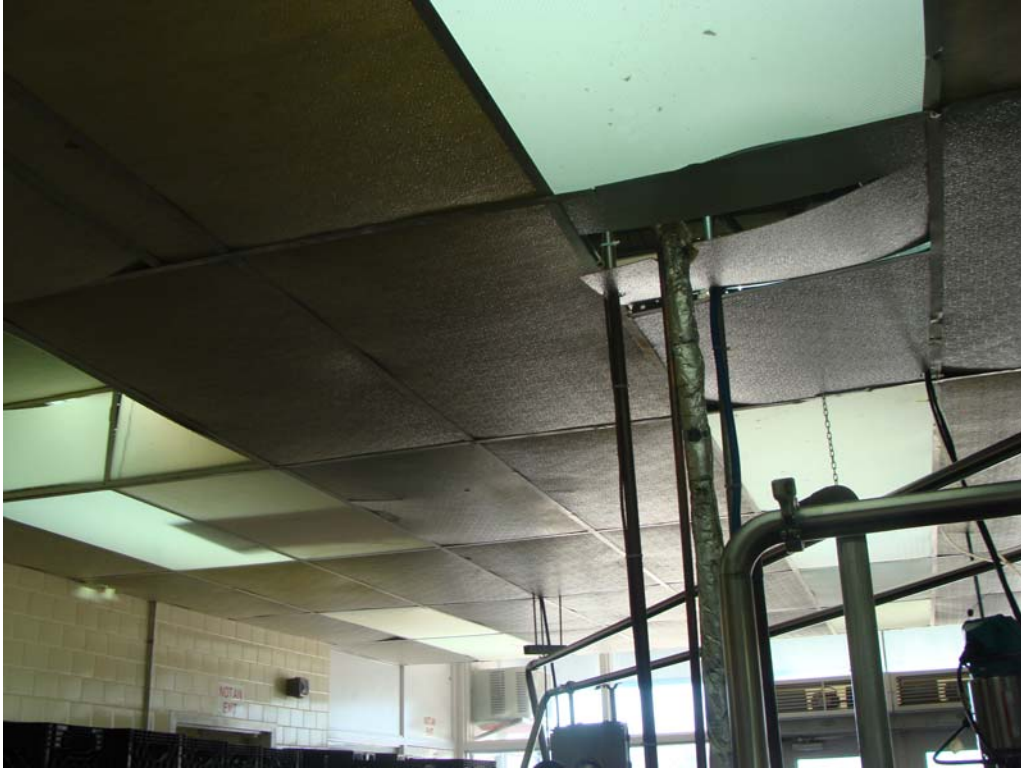
The processing room in this building has a suspended acoustical tile ceiling system. The t-bar framing is bent and rusted in many areas and a number of the ceiling tiles are damaged and stained. This project would provide for the replacement of the suspended acoustical tile ceiling system. Removal and disposal of the existing ceiling system is included in this estimate.

Dairy Barn - Building #1443
Description: Processing room ceiling in need of replacement.

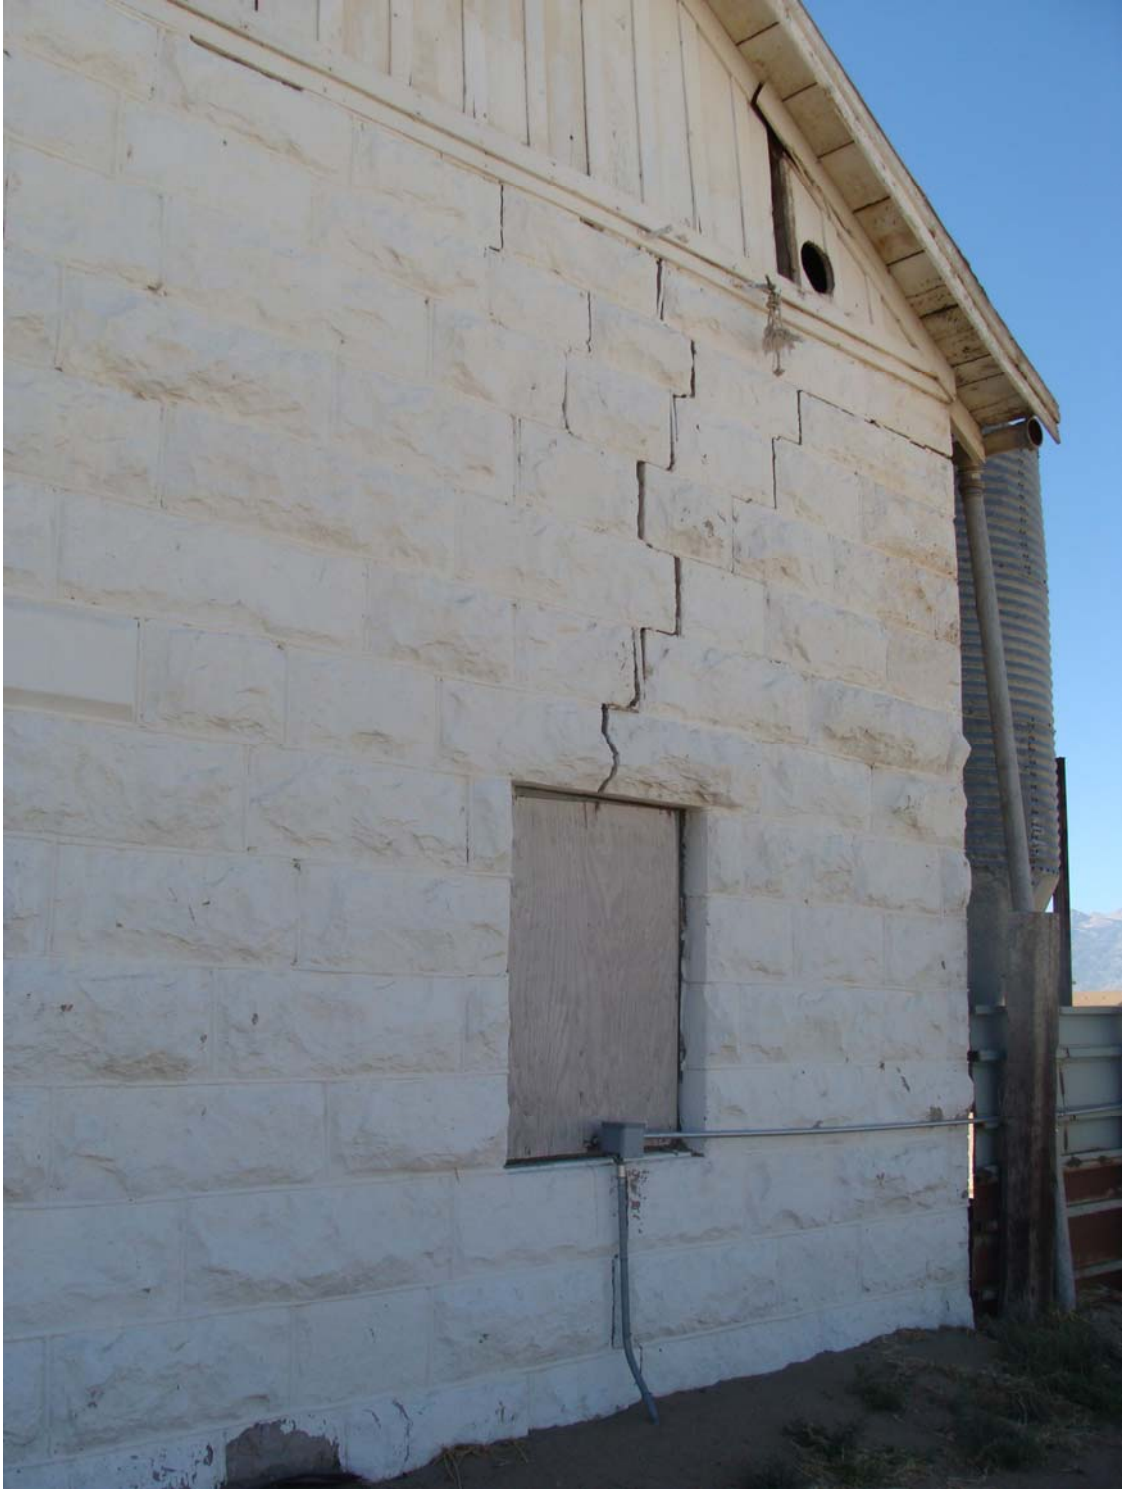
Old Dairy Barn / Hay Storage - Building #1444

The building was constructed in 1916 out of unreinforced masonry. The walls are showing signs of failure including cracking, settling and crumbling. This project would provide for an investigation and assessment to be done by a licensed Structural Engineer to identify possible deficiencies and problems in the building and provide a report outlining issues and resolutions. Future projects may result from this report and are not included in this estimate.

Description: Exterior of the building, note structural cracks above opening.

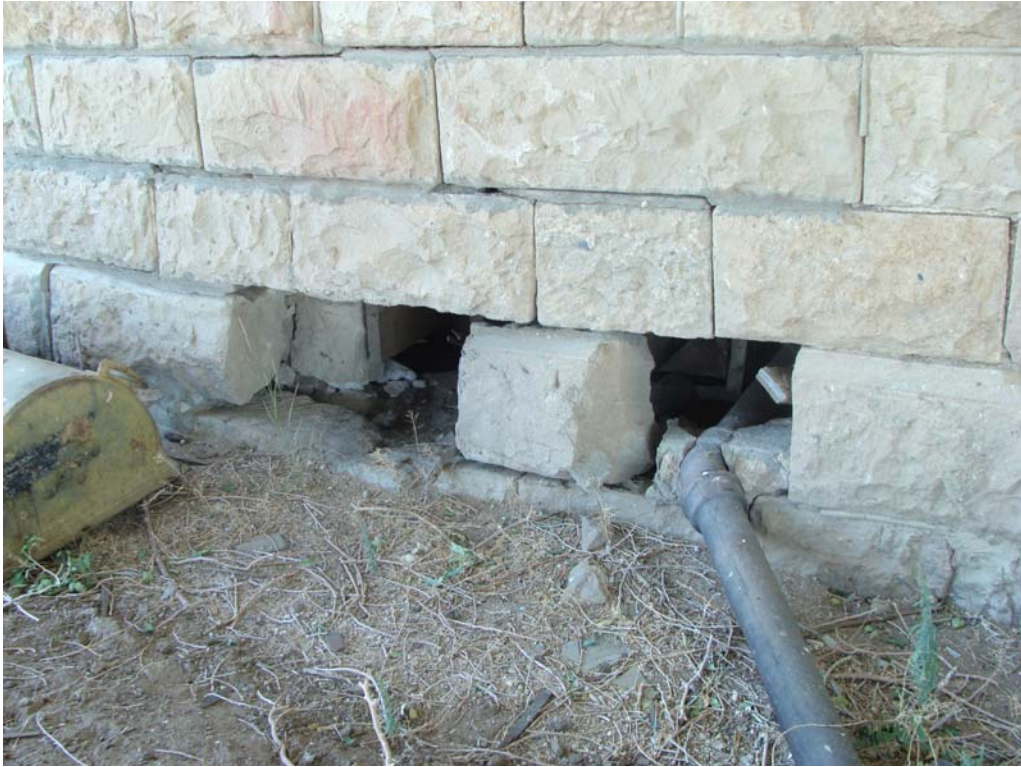
The building was constructed in 1916 out of unreinforced masonry. The walls are showing signs of failure including cracking, settling and crumbling. This project would provide for an investigation and assessment to be done by a licensed Structural Engineer to identify possible deficiencies and problems in the building and provide a report outlining issues and resolutions. Future projects may result from this report and are not included in this estimate. This project should coincide with the preservation project.

Ranch House - Building #1448
Description: Structural wall failure at foundation.

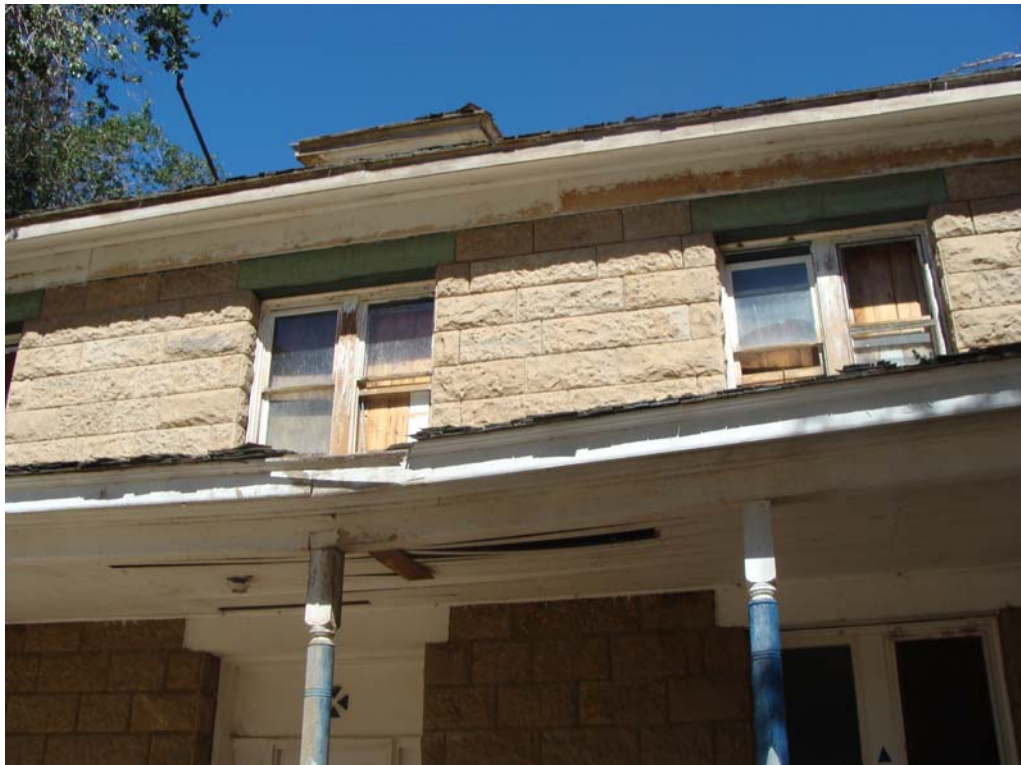
There are many areas of the sandstone walls, wood framed decks and roof which are showing signs of structural failure. These items will be addressed in the Facility Condition Analysis report. The facility replacement cost (FRC) reflects a complete restoration of this structure.

Ranch House - Building #1448
Description: Shed roof structural failure.

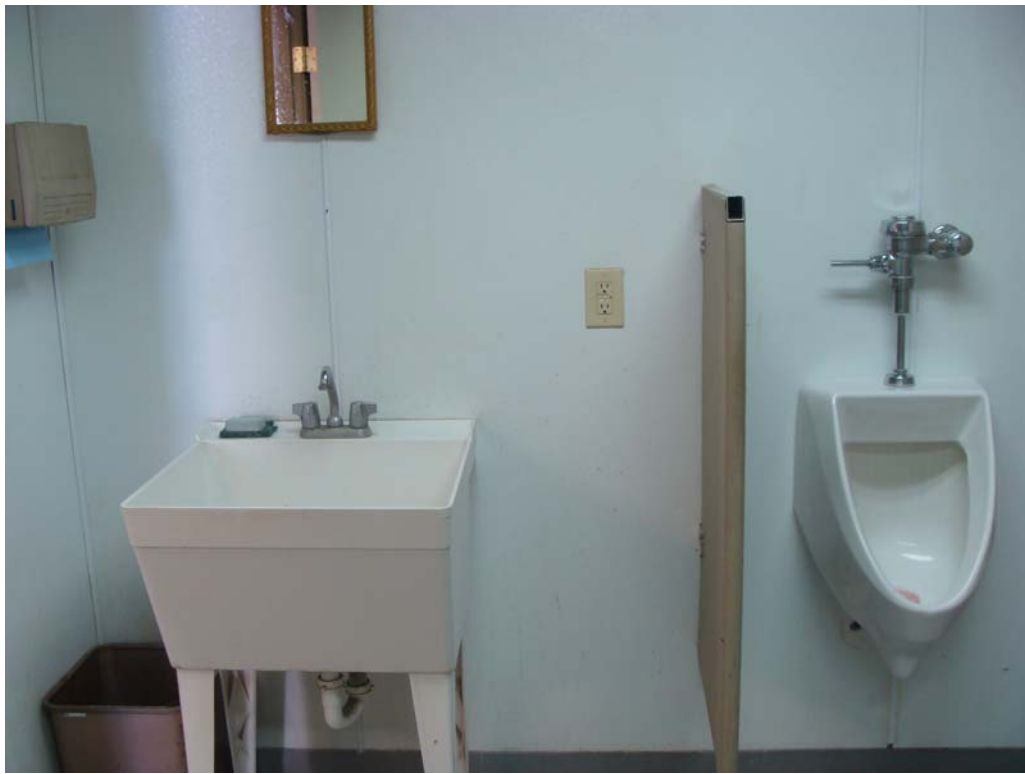
Maintenance Shop - Building #2915
Description: Non-ADA compliant restroom.
