State of Nevada
Department of Corrections & Department of Conservation & Natural Resources
Nevada Division of Forestry
Stewart Conservation Camp
Facility Condition Analysis

STEWART CONSERVATION CAMP

Site Number: 9984
STATE OF NEVADA PUBLIC WORKS BOARD
FACILITY CONDITION ANALYSIS

Report Printed in June 2008

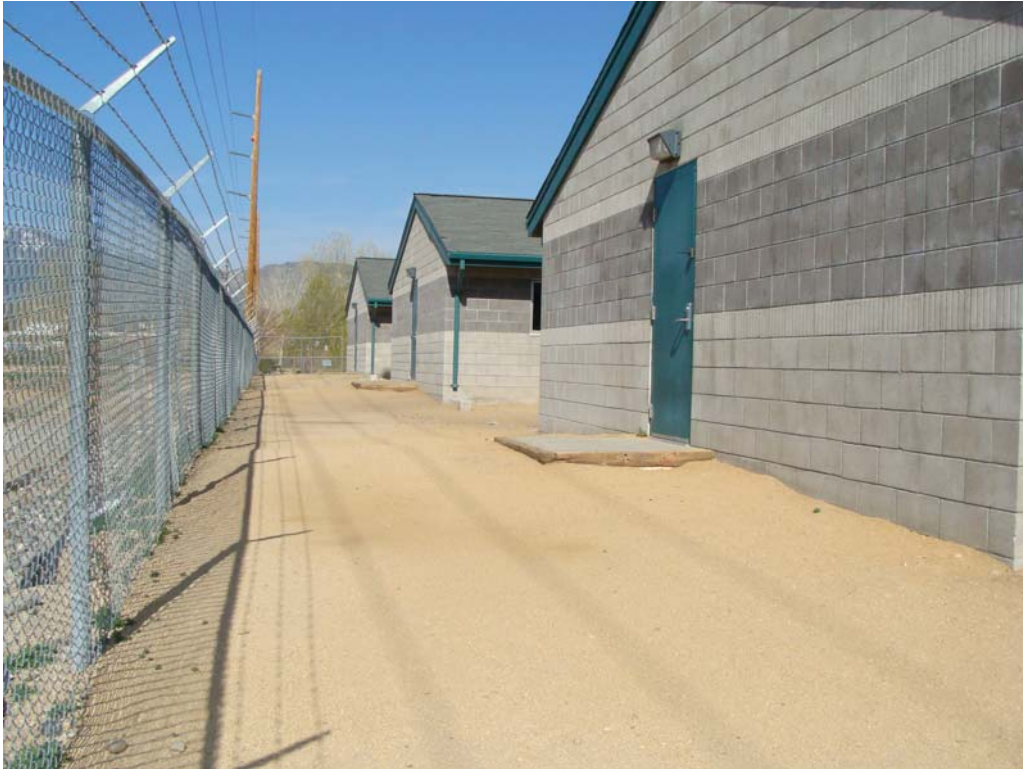
A large portion of the site is not covered by vegetation or rock and is a constant maintenance problem. The wind and water causes the dirt to erode which then must be replaced once a year in order to maintain the grade and protect the buildings. This project recommends covering the dirt areas with grass including an irrigation system. Another alternative could include planting of shrubs as a wind break. Xeriscaping may be another method but due to security concerns, having cobblestone or other objects in the landscaping may pose a risk to inmates and staff.

Stewart Conservation Camp - Site #9984
Description: Typical landscaping around the housing units.

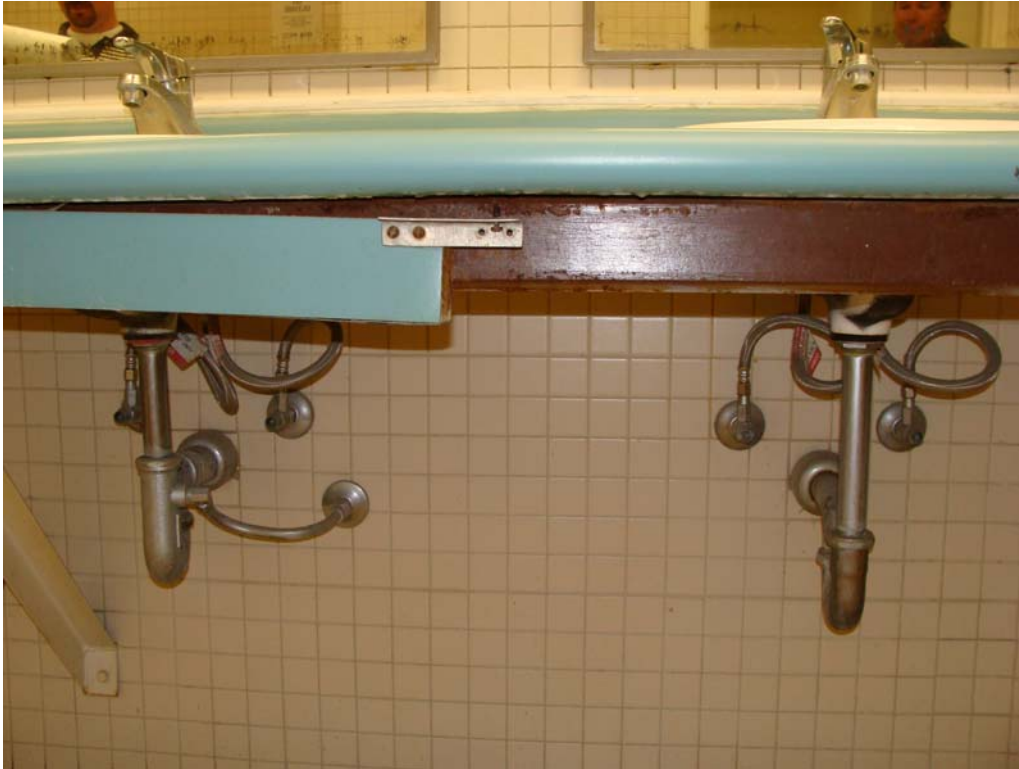
The restroom and shower room are in overall poor condition. The countertops in each room show signs of wear and deterioration. Extensive use, combined with repetitive water being spilled, has caused the laminate top to separate from the wooden underlayment and should be replaced. The tile on the floors and walls of the bathrooms are damaged and worn and should be replaced. This project provides for a complete remodel of the restroom and shower room which should include an ADA compliant toilet stall, shower and sink with all ADA complaint fixtures. The existing exhaust fans are undersized and should be replaced with commercial grade exhaust fans. The removal and disposal of the old fixtures and finishes is included in this estimate.

Housing Unit 5 - Building #2015
Description: Typical damaged countertops.

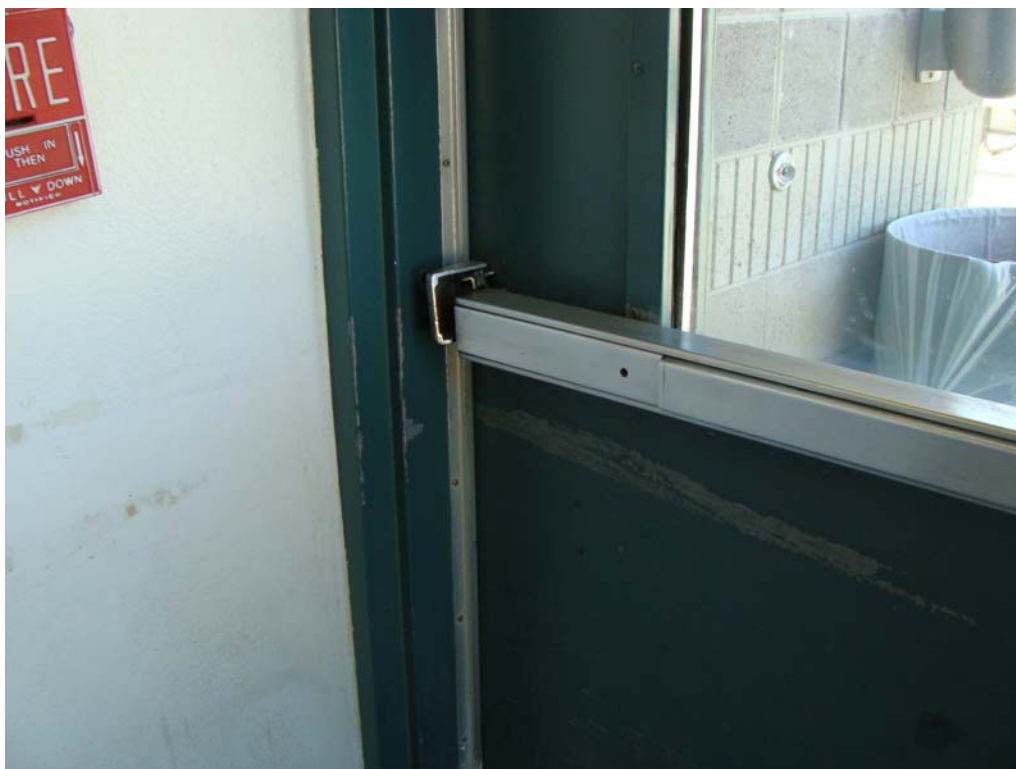
Housing Unit 4 - Building #2014
Description: Damaged door hardware.

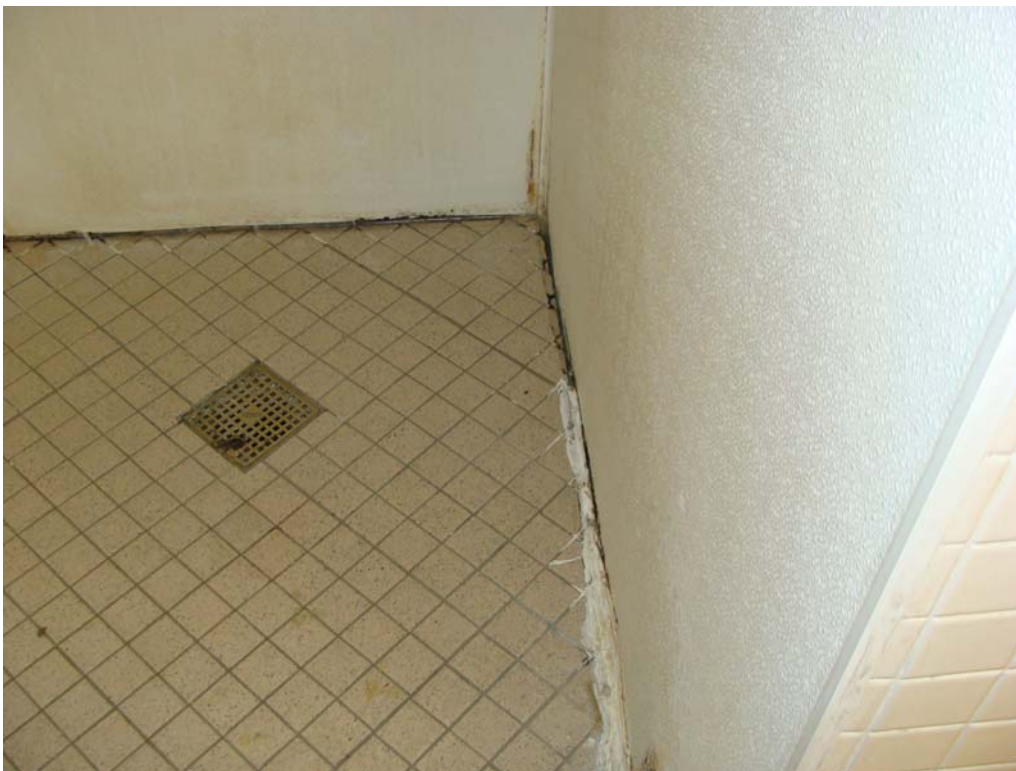
The restroom and shower room are in overall poor condition. The countertops in each room show signs of wear and deterioration. Extensive use, combined with repetitive water being spilled, has caused the laminate top to separate from the wooden underlayment and should be replaced. The tile on the floors and walls of the bathrooms are damaged and worn and should be replaced. This project provides for a complete remodel of the restroom and shower room which should include an ADA compliant toilet stall, shower and sink with all ADA complaint fixtures. The existing exhaust fans are undersized and should be replaced with commercial grade exhaust fans. The removal and disposal of the old fixtures and finishes is included in this estimate.

Housing Unit 3 - Building #2013
Description: Typical shower pan failures causing leaks.

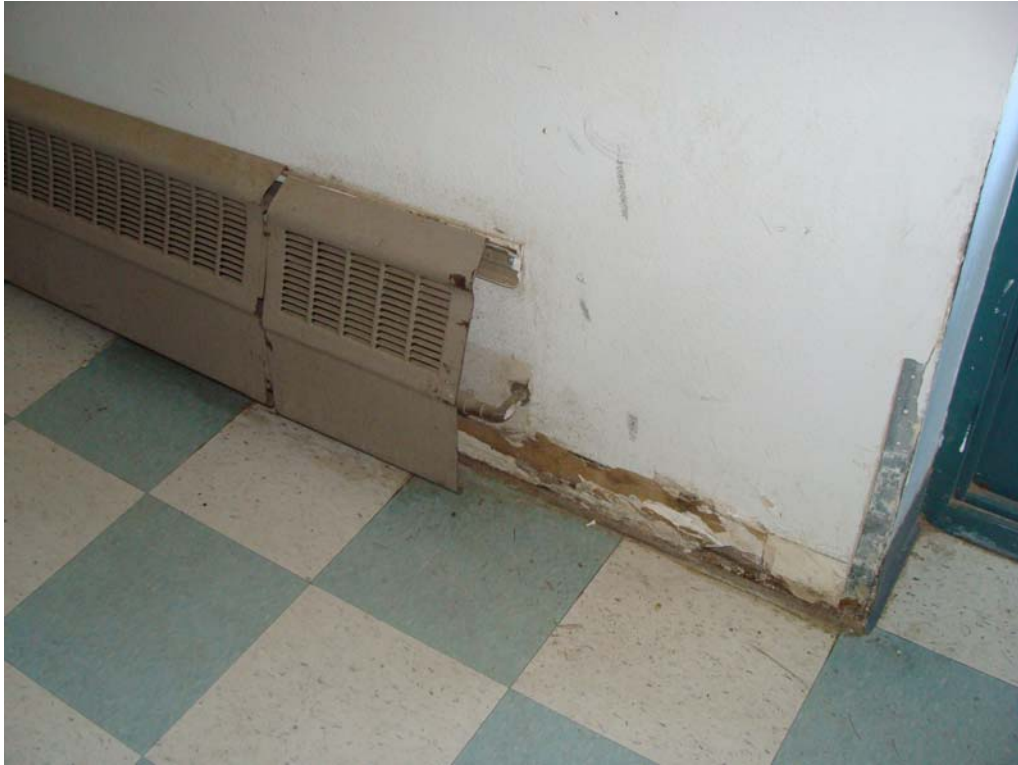
Housing Unit 3 - Building #2013
Description: Damaged hydronic wall heater and wall.

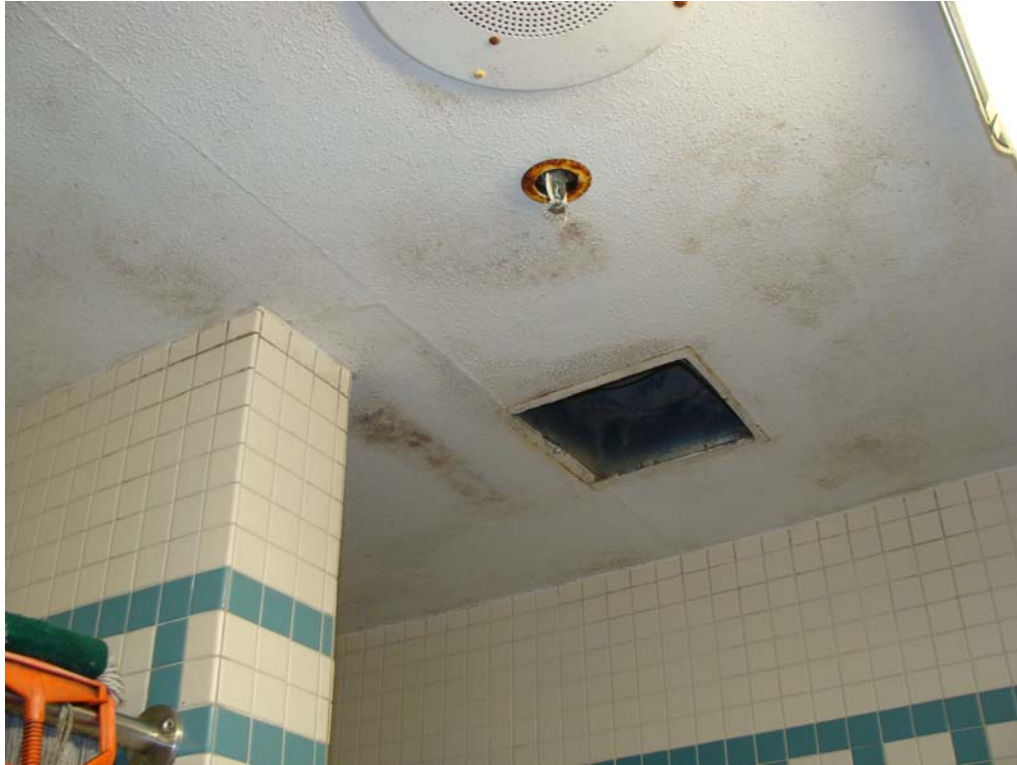
Housing Unit 2 - Building #2012
Description: Ceiling damaged by moisture.

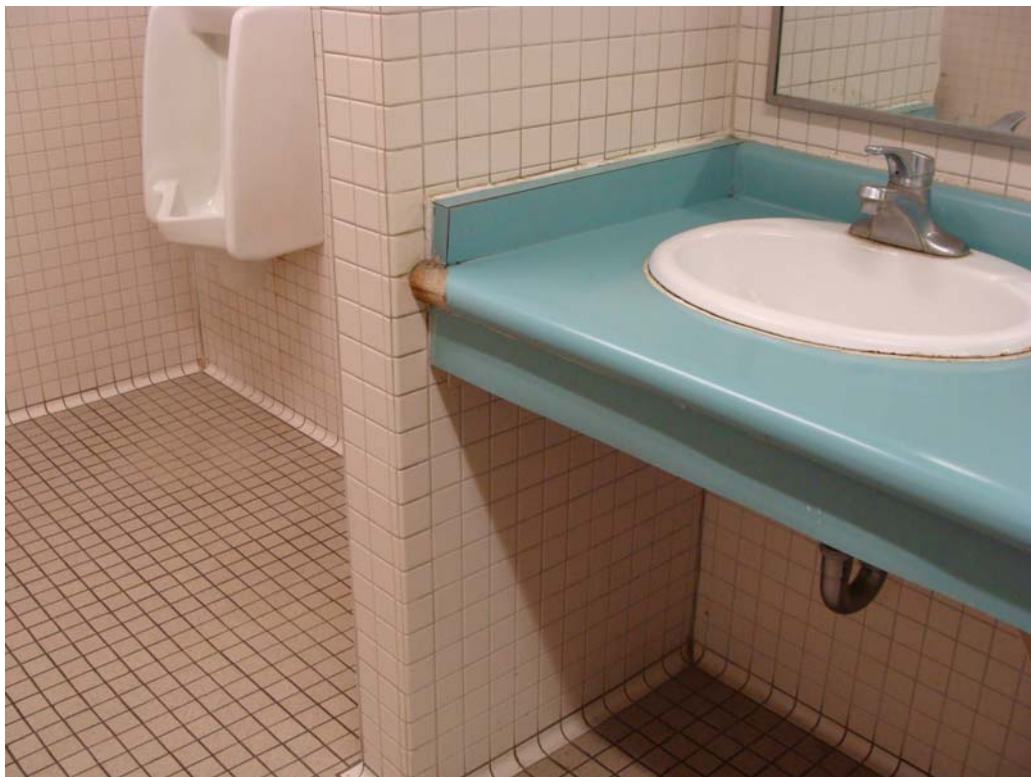
The restroom and shower room are in overall poor condition. The countertops in each room show signs of wear and deterioration. Extensive use, combined with repetitive water being spilled, has caused the laminate top to separate from the wooden underlayment and should be replaced. The tile on the floors and walls of the bathrooms are damaged and worn and should be replaced. This project provides for a complete remodel of the restroom and shower room which should include an ADA compliant toilet stall, shower and sink with all ADA complaint fixtures. The existing exhaust fans are undersized and should be replaced with commercial grade exhaust fans. The removal and disposal of the old fixtures and finishes is included in this estimate.

Housing Unit 2 - Building #2012
Description: Damaged countertop.

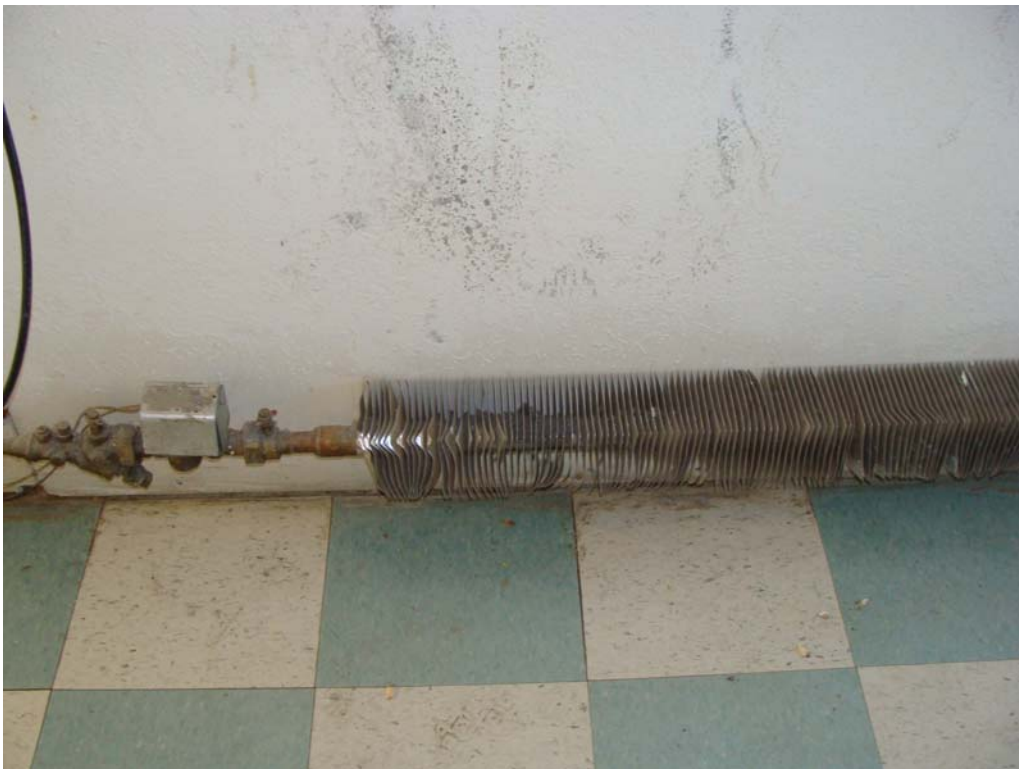
Housing Unit 1 - Building #2011
Description: Damaged hydronic wall heater.

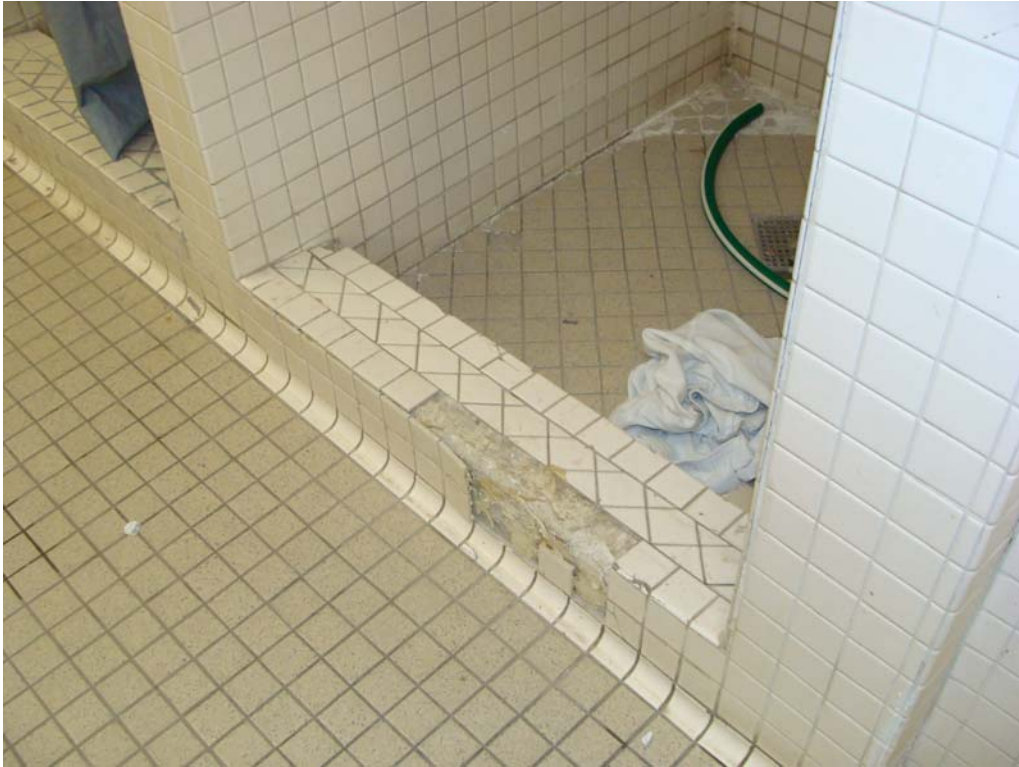
The restroom and shower room are in overall poor condition. The countertops in each room show signs of wear and deterioration. Extensive use, combined with repetitive water being spilled, has caused the laminate top to separate from the wooden underlayment and should be replaced. The tile on the floors and walls of the bathrooms are damaged and worn and should be replaced. This project provides for a complete remodel of the restroom and shower room which should include an ADA compliant toilet stall, shower and sink with all ADA complaint fixtures. The existing exhaust fans are undersized and should be replaced with commercial grade exhaust fans. The removal and disposal of the old fixtures and finishes is included in this estimate.

Housing Unit 1 - Building #2011
Description: Typical damaged showers.

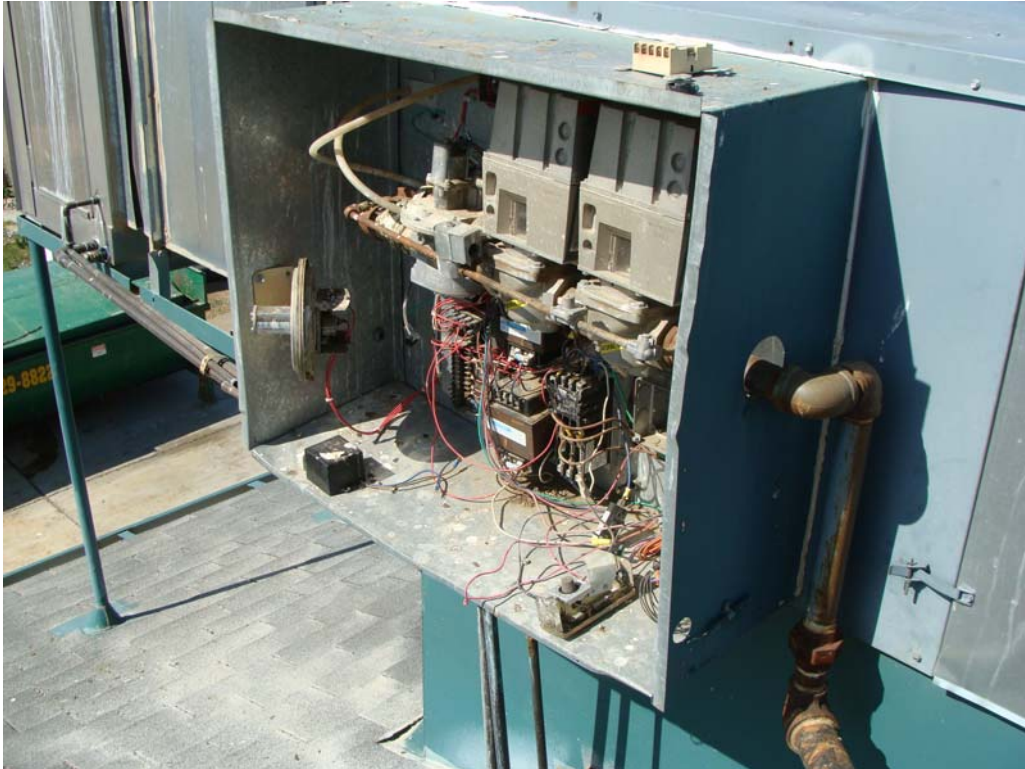
Culinary / Dining - Building #2010
Description: Inoperable roof mounted heating unit.

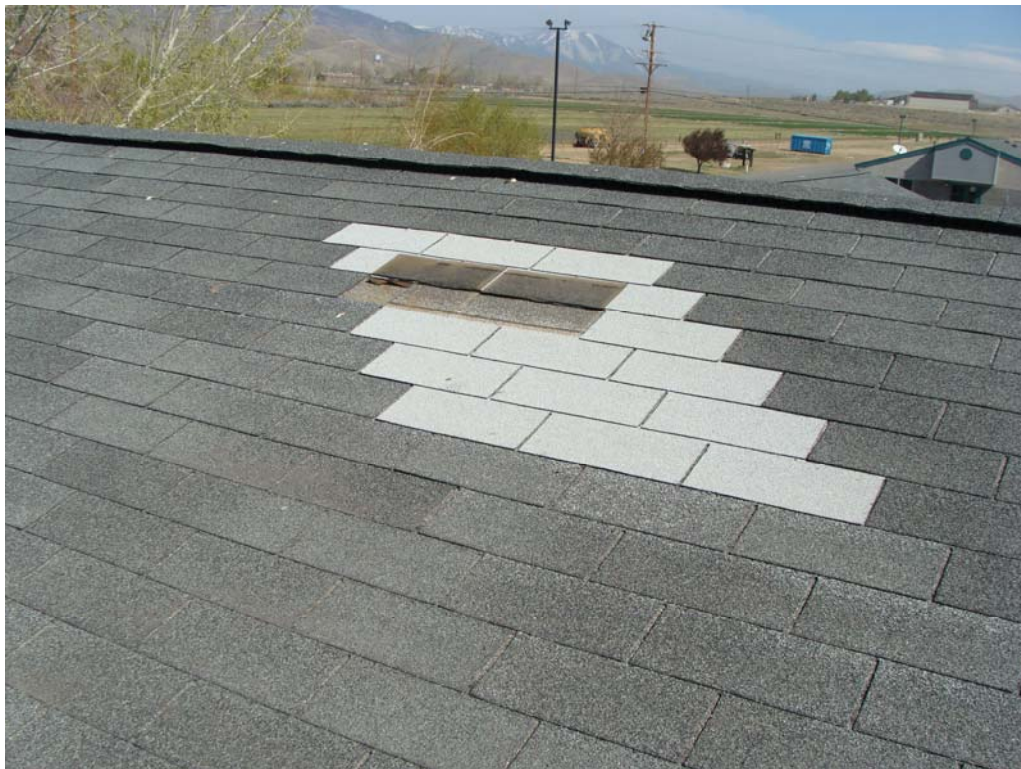
Culinary / Dining - Building #2010
Description: Damaged shingles.

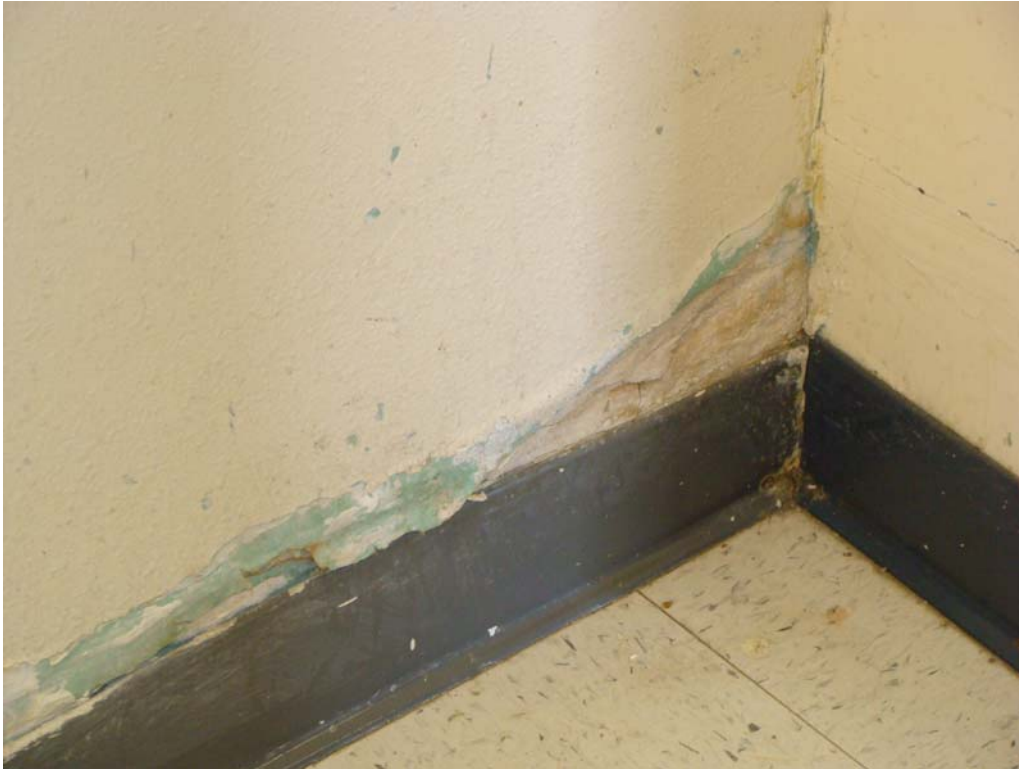
Culinary / Dining - Building #2010
Description: Moisture damage to wall.

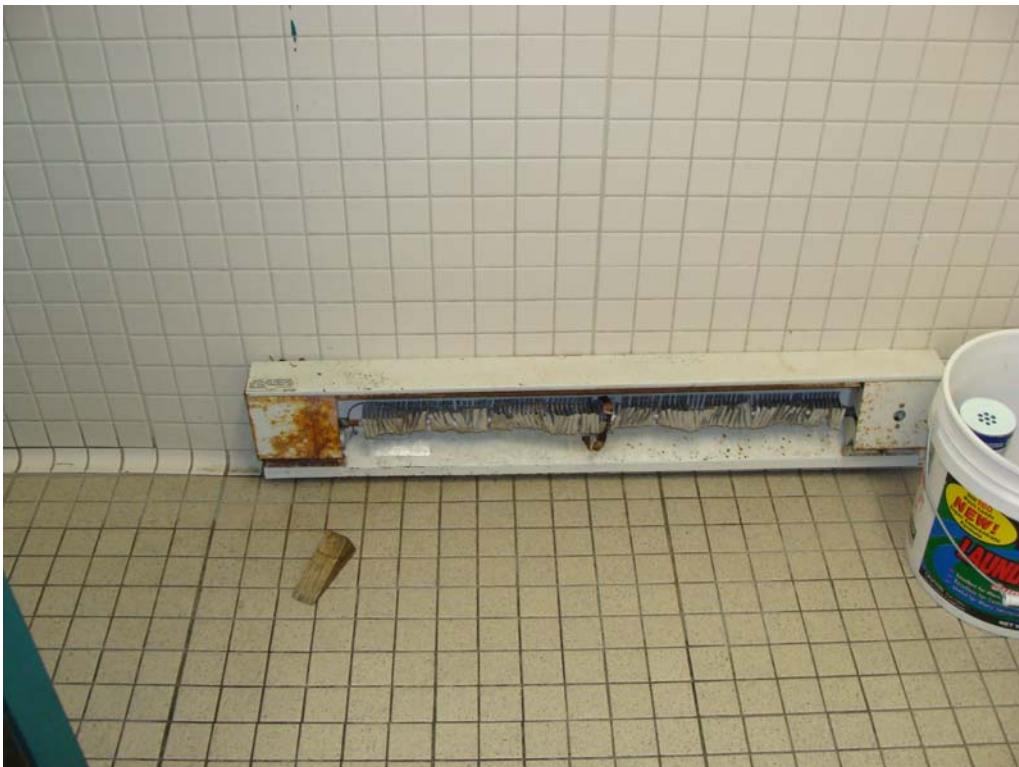
Culinary / Dining - Building #2010
Description: Damaged electric heater.

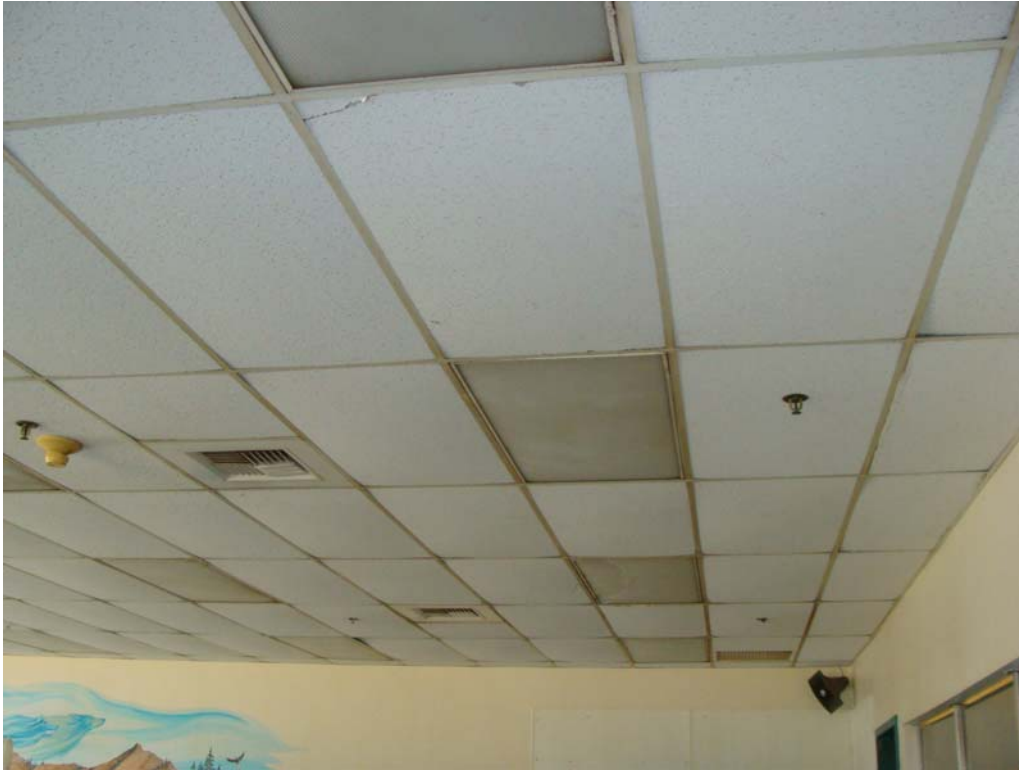
Culinary / Dining - Building #2010
Description: Dining room damaged ceiling tiles.

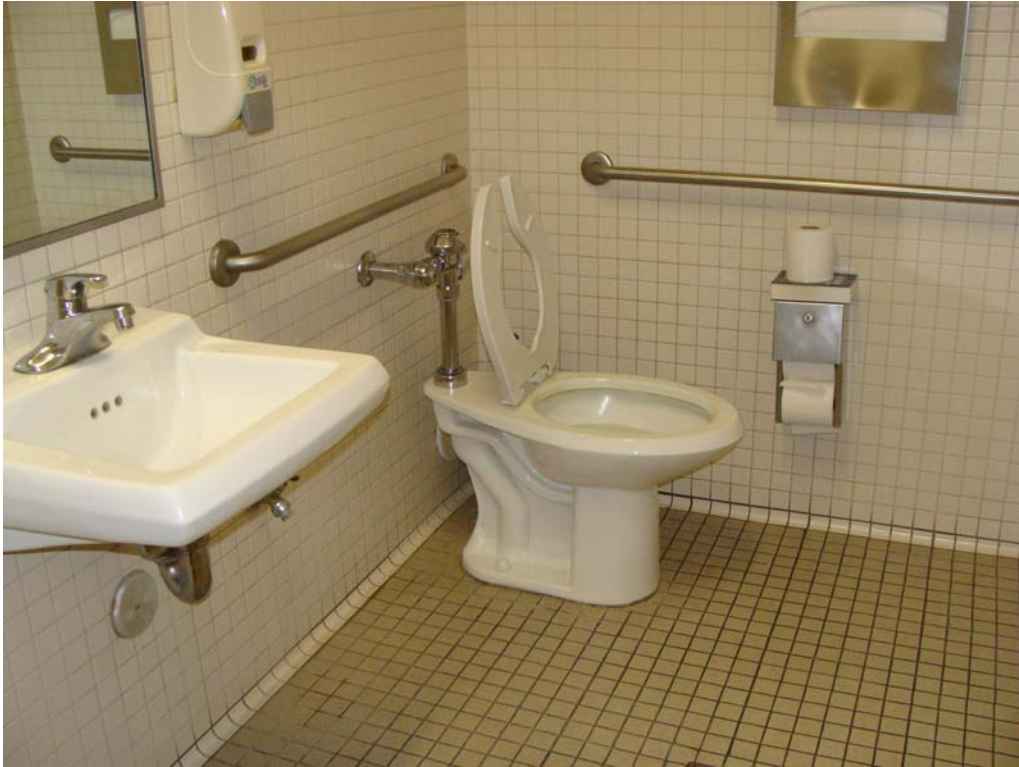
Control Room - Building #2009
Description: Non –ADA compliant Unisex restroom.

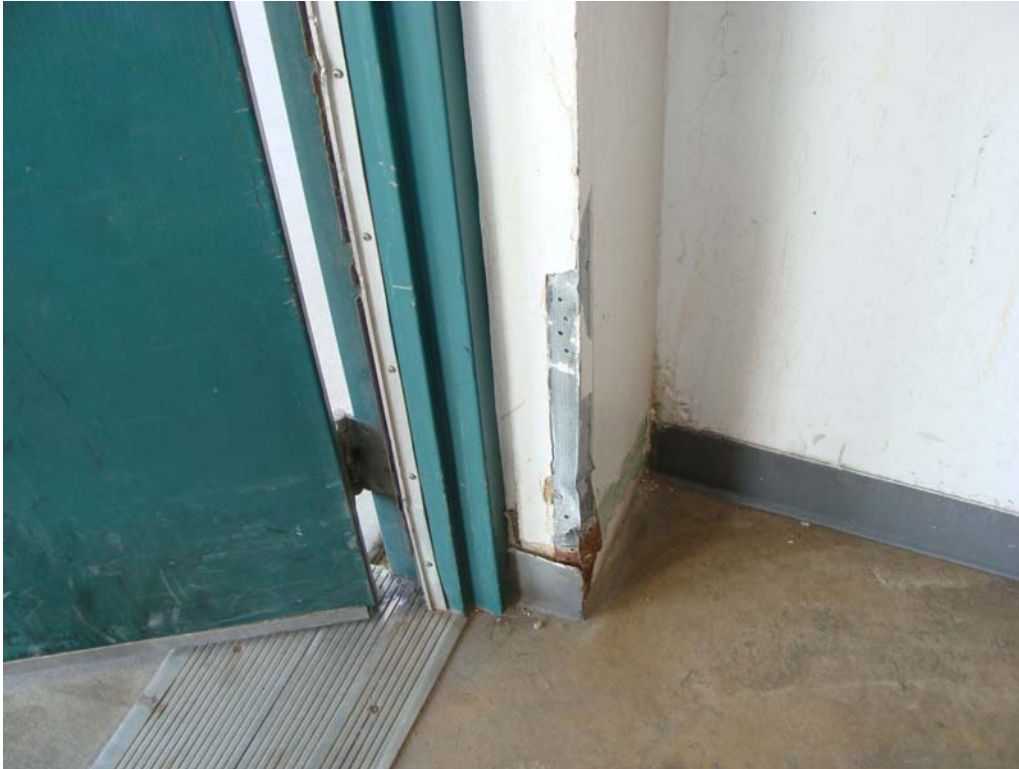
Multi-Use Building - Building #2008
Description: Door and wall damage.

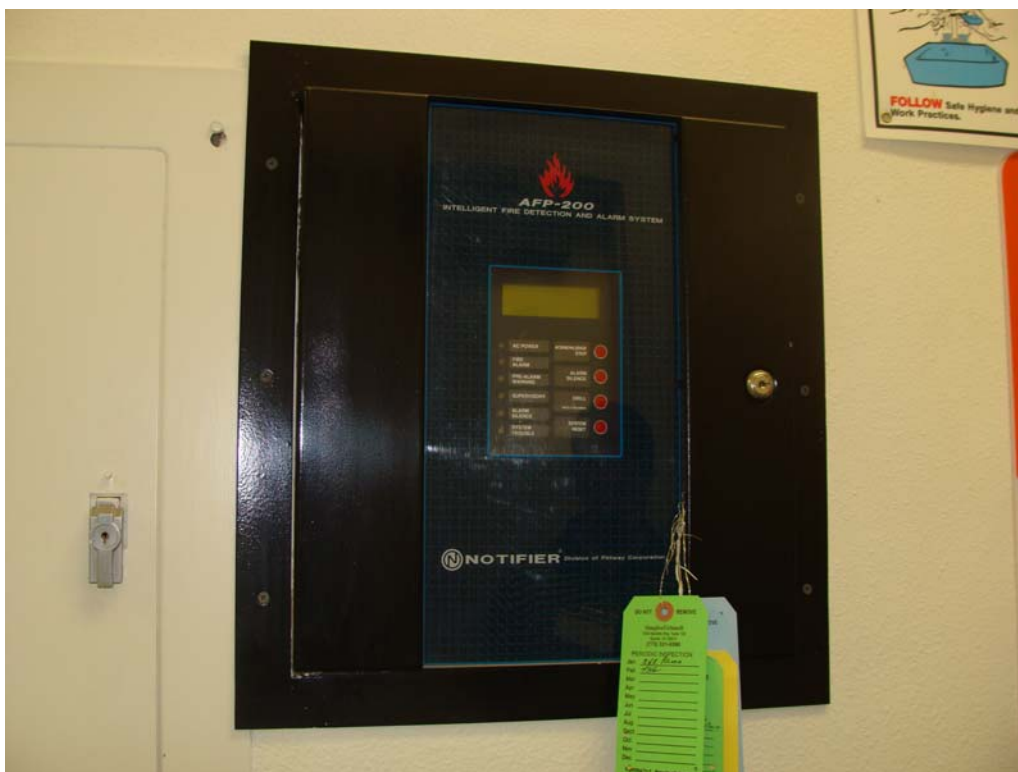
The fire alarm system was not operating at the time of the survey. The reason for the malfunction was not known at the time of the survey and the maintenance staff explained that there is no funding to repair the system. This project would provide funding for an inspection of the system by a certified fire alarm equipment inspector to determine the cause of the problem. Any future projects would come from report recommendations.

NDF Administration - Building #2007
Description: Inoperable fire alarm panel.
