# NORTHERN NEVADA ADULT MENTAL HEALTH SERVICES SITE

480 Galletti Way  
Sparks, Nevada 89431

**Site Number: 9985**  
**STATE OF NEVADA PUBLIC WORKS DIVISION**  
**FACILITY CONDITION ANALYSIS**

Report distributed in September 2021

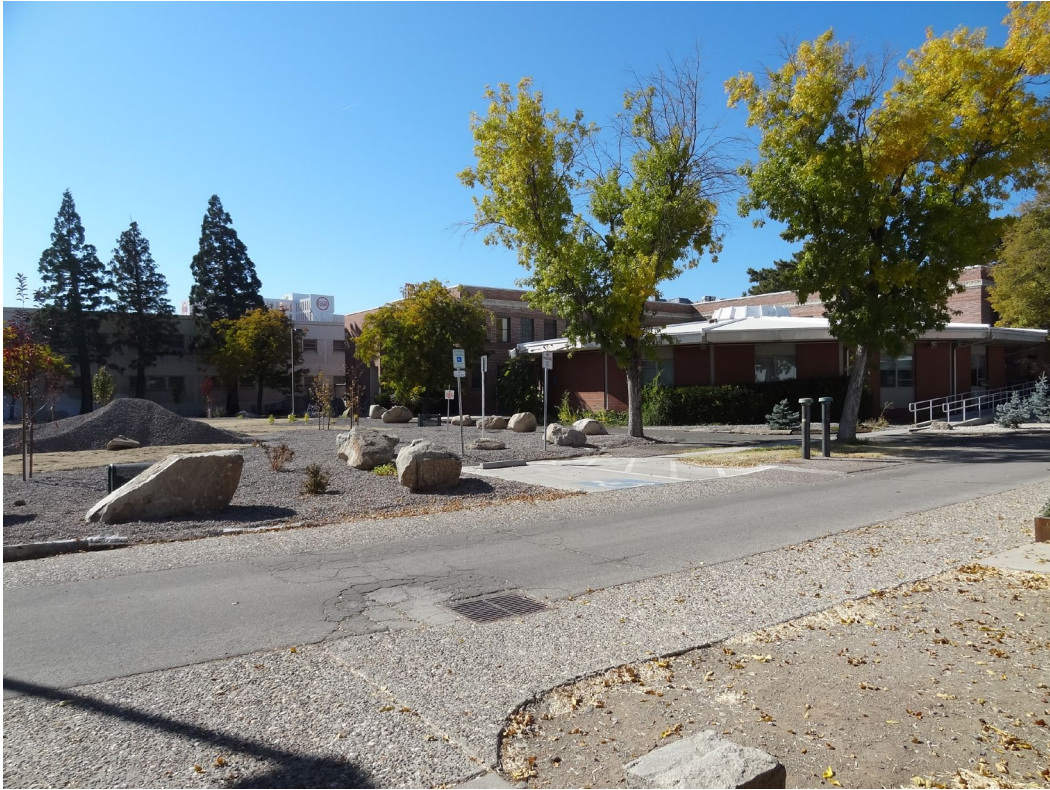
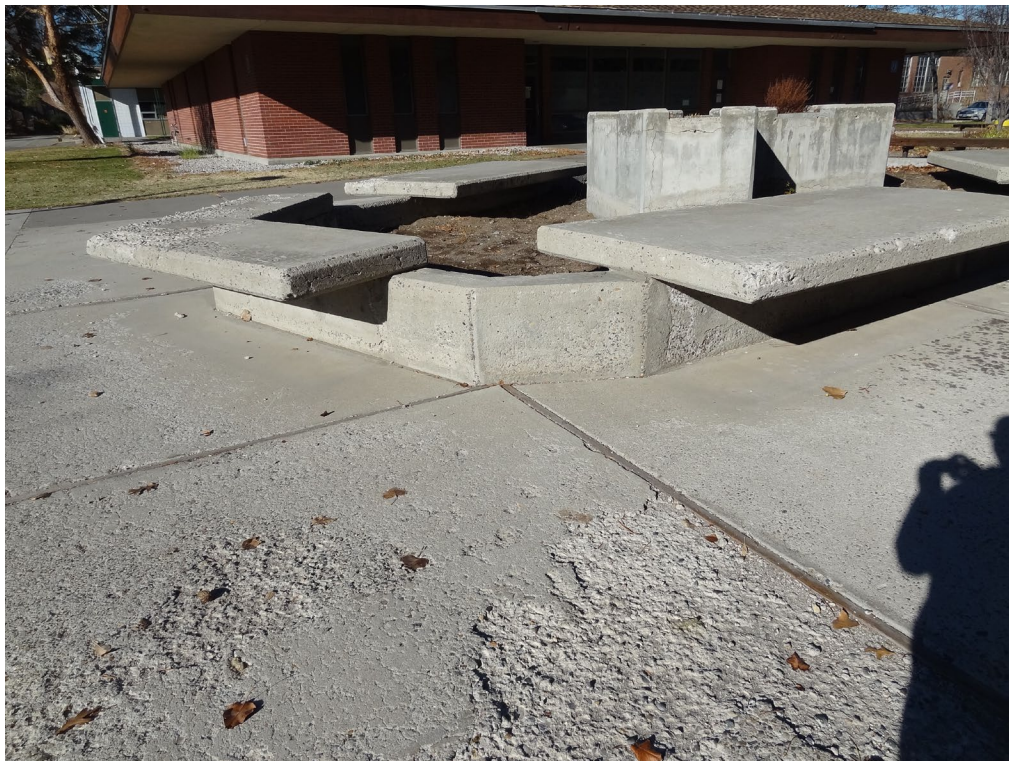
The site has a mix of PC concrete and asphalt concrete roads, parking lots and pedestrian paths. Many areas are damaged and have settled which have created incorrect slopes and trip hazards. There are limited ADA parking spaces and accessible routes to the public entrances. Some buildings have been recently demolished and may be ideal locations for new parking lots, circulation roads or accessible paths of travel. Additional parking is also necessary to accommodate growing outpatient caseloads and staff. This project would provide for repairing or replacing existing paving and installing new paving including all necessary accessibility upgrades based on a professionally designed sitewide plan. This project or a portion thereof was previously recommended in the FCA report dated 06/29/2006 and 06/05/2012. It has been amended accordingly to reflect conditions observed during the most recent survey date of 10/18/2017.

Northern Nevada Adult Mental Health Services Site – FCA Site #9985  
Description: Concrete & Paving Upgrade Sitewide.

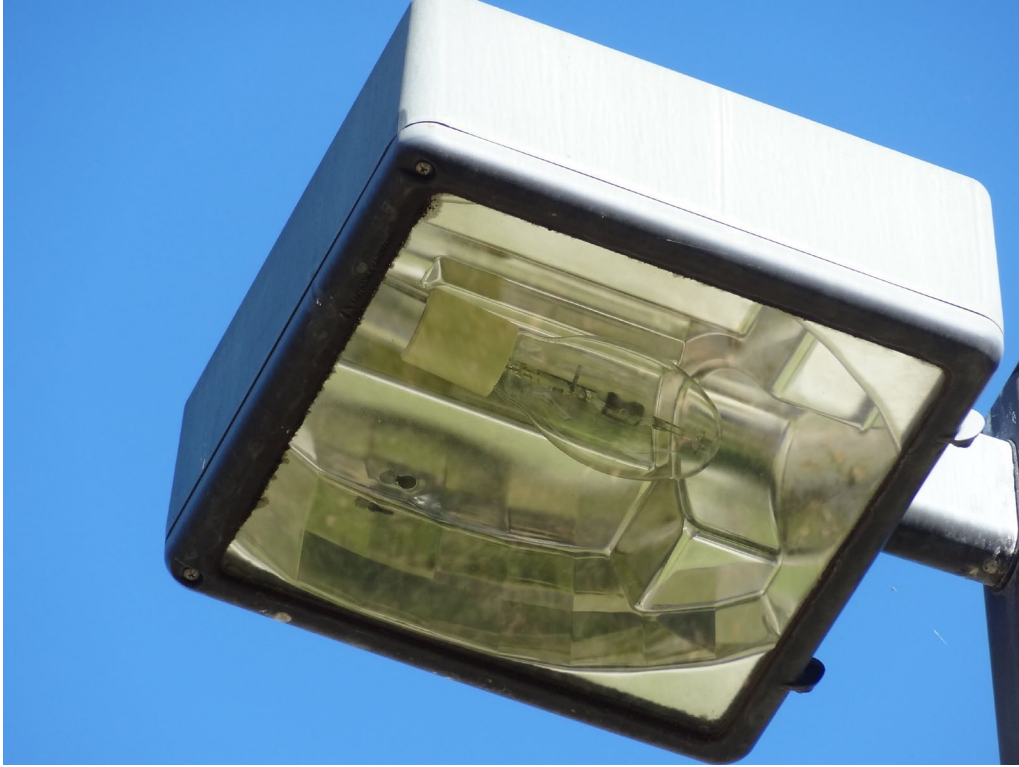
The existing site lighting around the campus is inadequate, old and are not energy efficient. This project would provide for the replacement of the exterior lighting fixtures with new LED light fixtures and lamps, using existing wiring and poles. In addition, this project includes adding & replacing walkway lighting bollards and building wall packs. The project includes trenching, wiring conduits and lighting controls.

Northern Nevada Adult Mental Health Services Site – FCA Site #9985  
Description: Sitewide Exterior Lighting Upgrades.

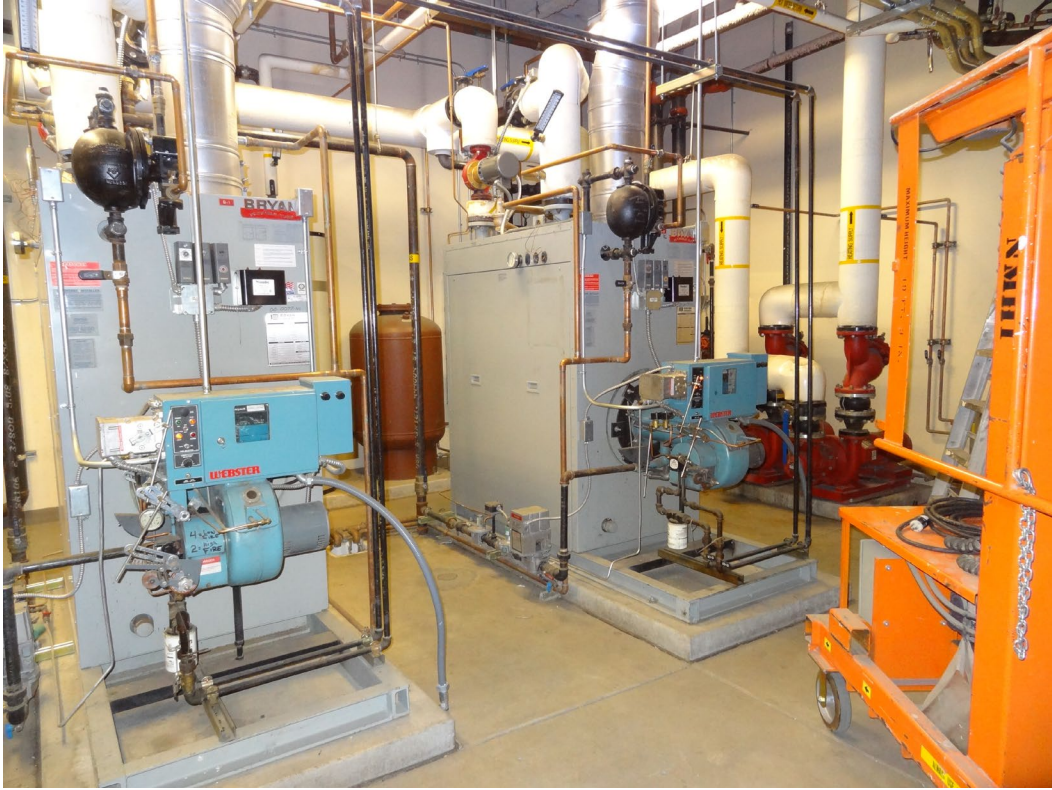
The mechanical systems in the building have reached the end of their useful life and need a complete renovation. This project includes removal and replacement of chillers, boilers, cooling tower, heat exchangers, pumps, pipes, water heaters and the entire Building Automation System. Cranes and rigging are included in this estimate.

Dini-Townsend Hospital – Building #25 – FCA Building #2449  
Description: Mechanical Room.

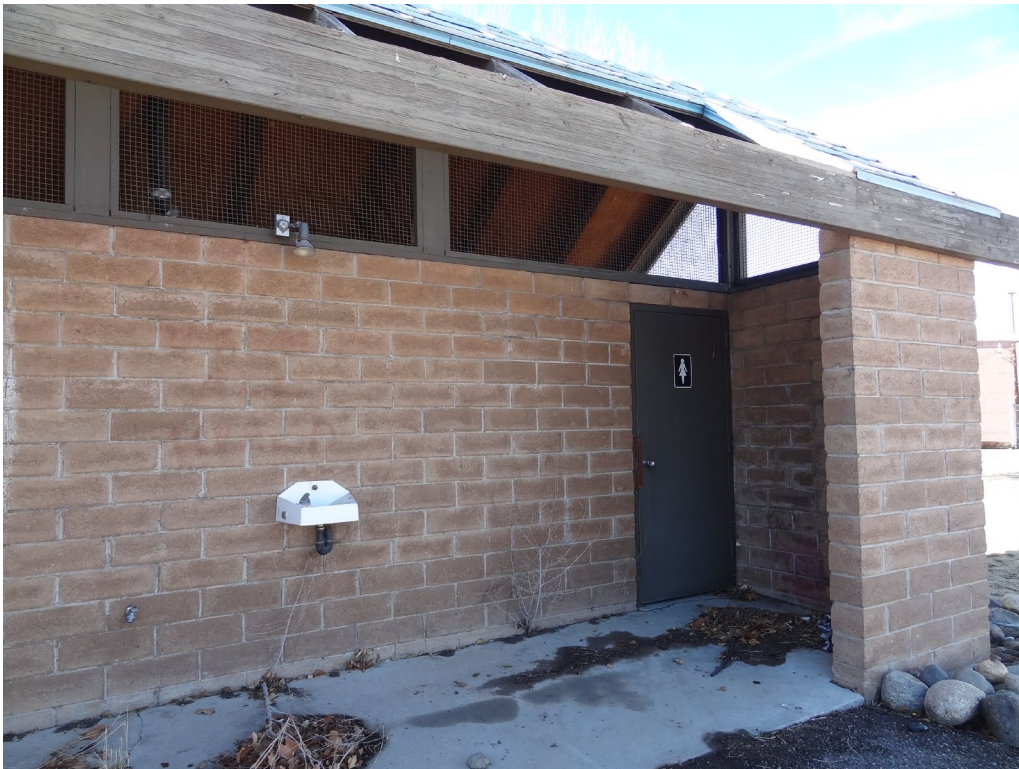
The Gazebo Restroom building is dilapidated and deteriorating and has reached the end of its useful life. It has been locked up and not used for several years and is no longer useful since the Dini-Townsend Hospital was built. This project would provide funding for the demolition of the building.

Gazebo Restroom – Building #27 – FCA Building #0521  
Description: Demolish Structure Recommendation.

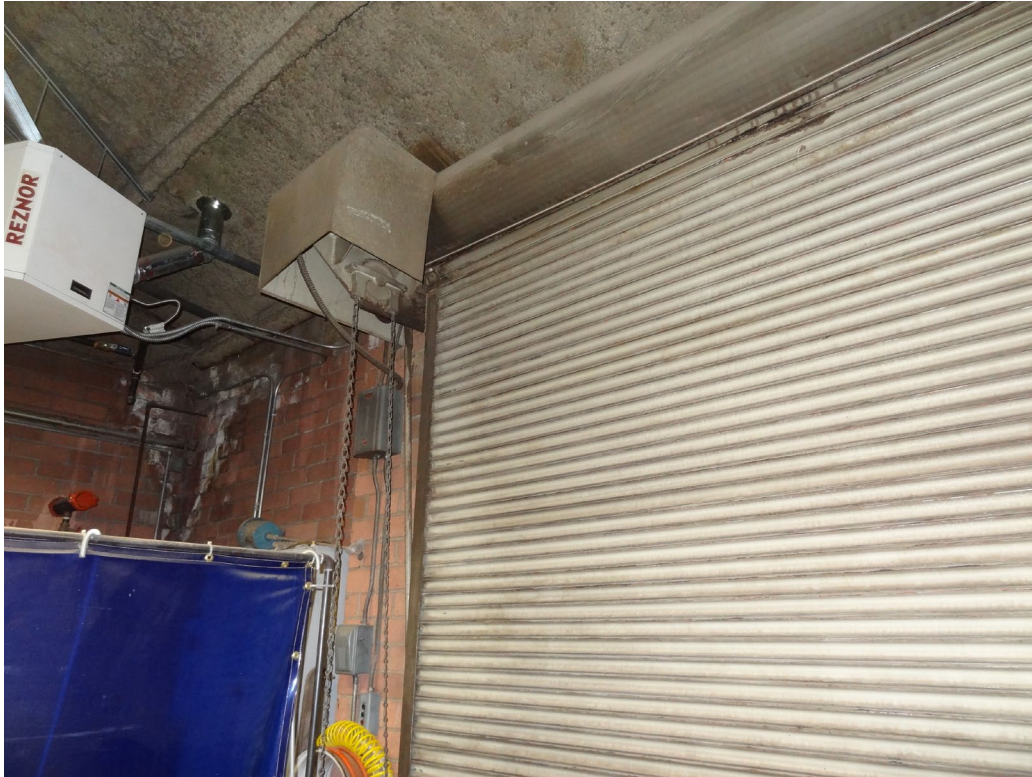
Maintenance / Housekeeping – Building #22 – FCA Building #0353  
Description: Overhead Door Replacement.

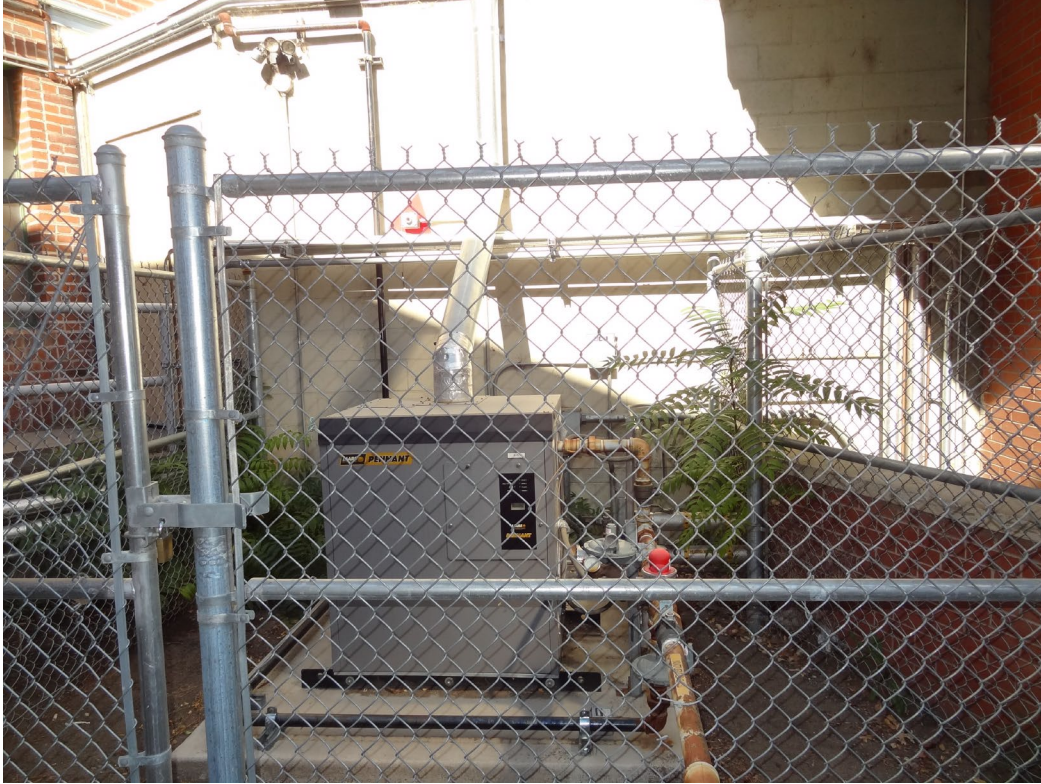
Medication Clinic – Building #5 – FCA Building #0352  
Description: Boiler Replacement.

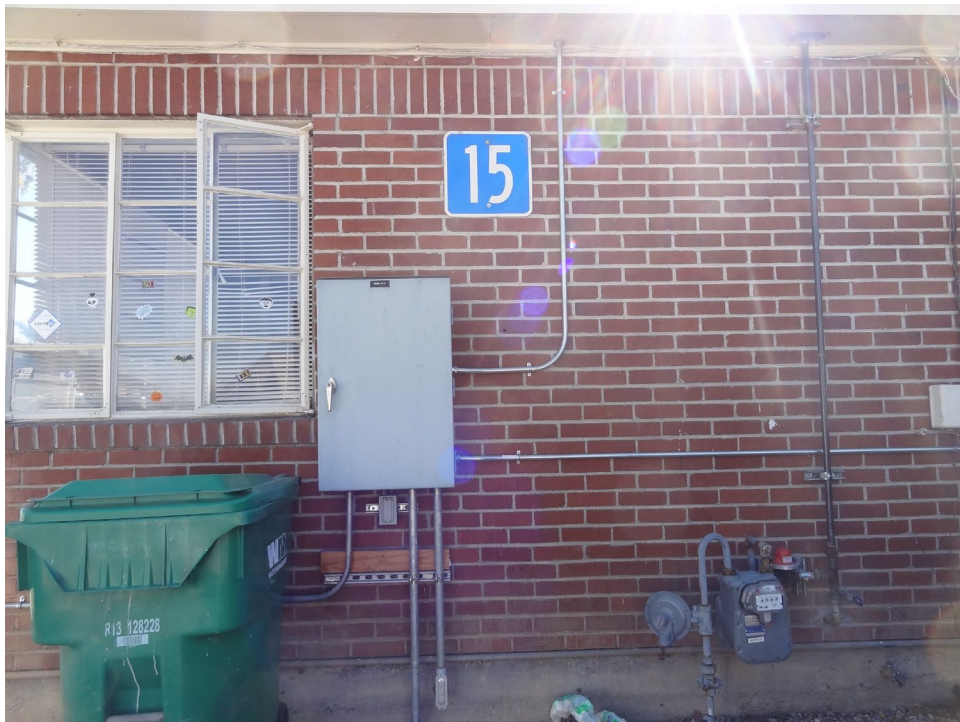
Group Home – Building #15 – FCA Building #0343  
Description: Exterior of the Building & Window Replacement.

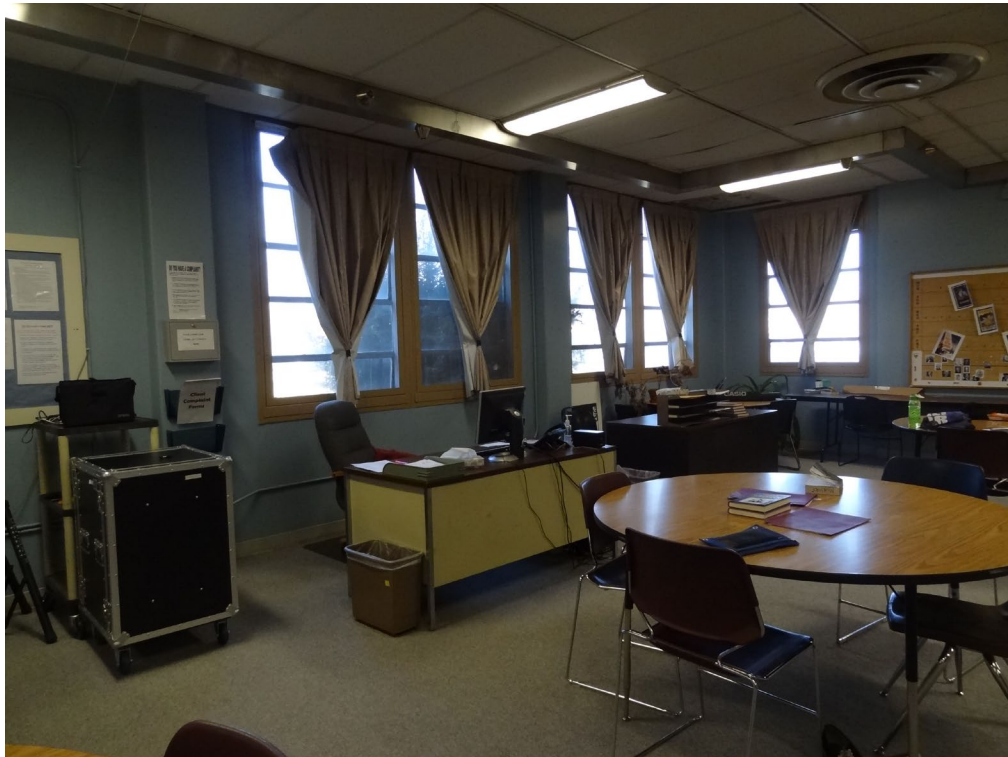
Building #8 – FCA Building #0340  
Description: Window Replacement.

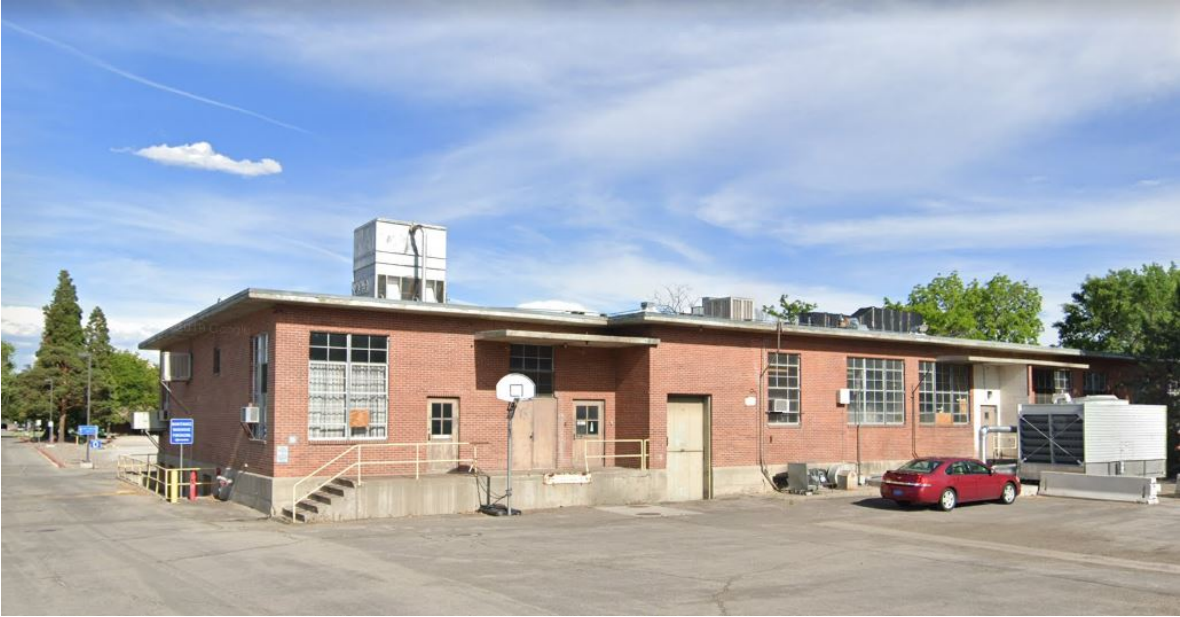
Building #10 – FCA Building #0339  
Description: Demolish Structure Recommendation.

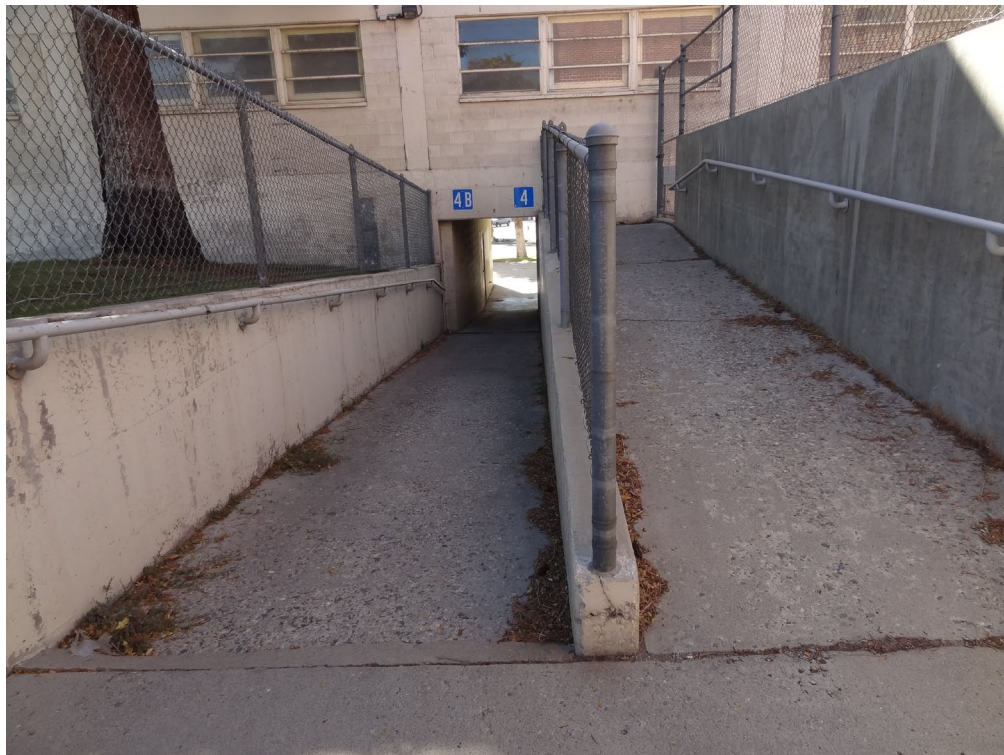
**Building #4 (Vacant) – FCA Building #0329**  
Description: Demolish Structure Recommendation.

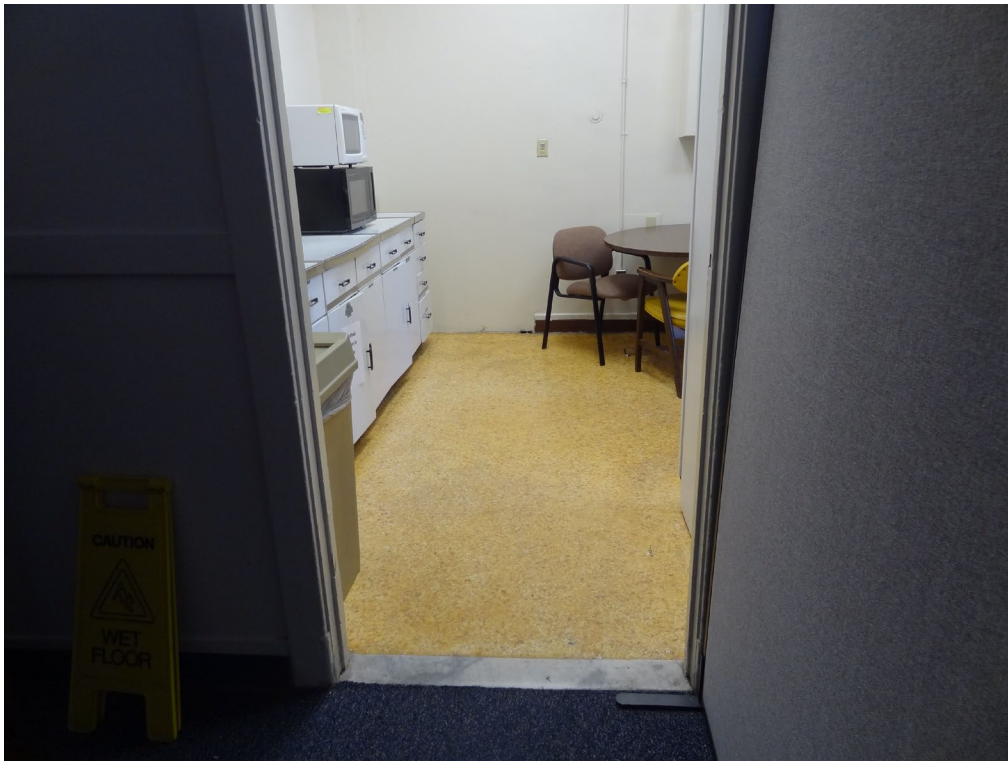
Administration – Building #1 – FCA Building #0326  
Description: Break Room Remodel.

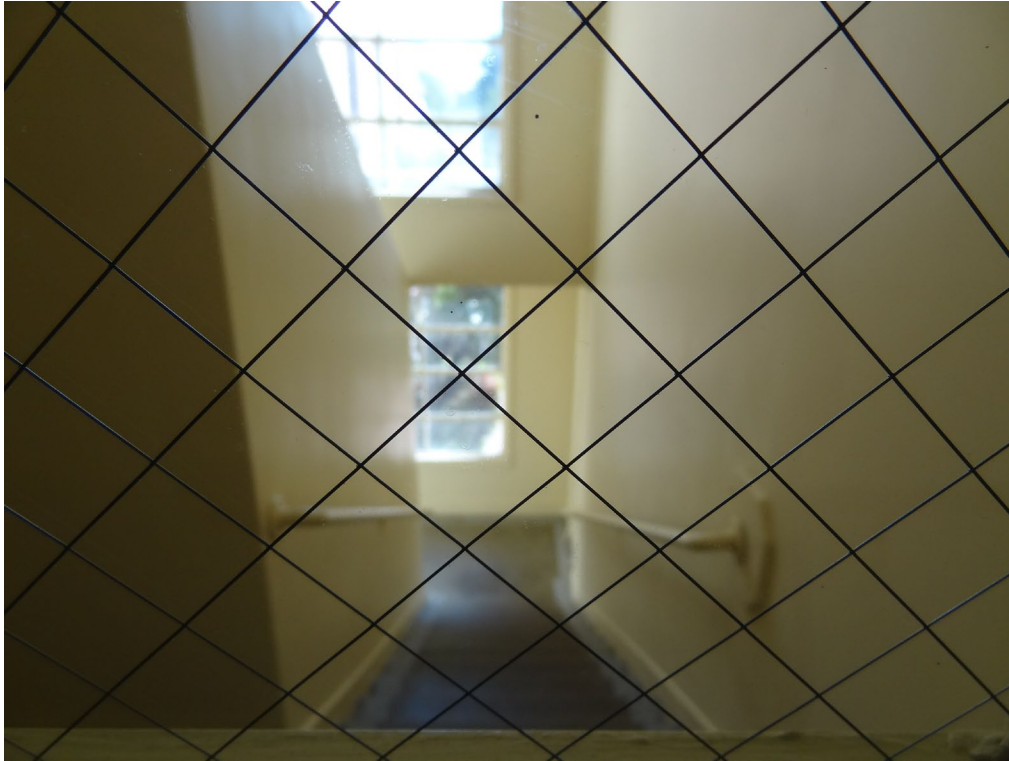
Administration – Building #1 – FCA Building #0326  
Description: Interior Stair Handrail Replacement.

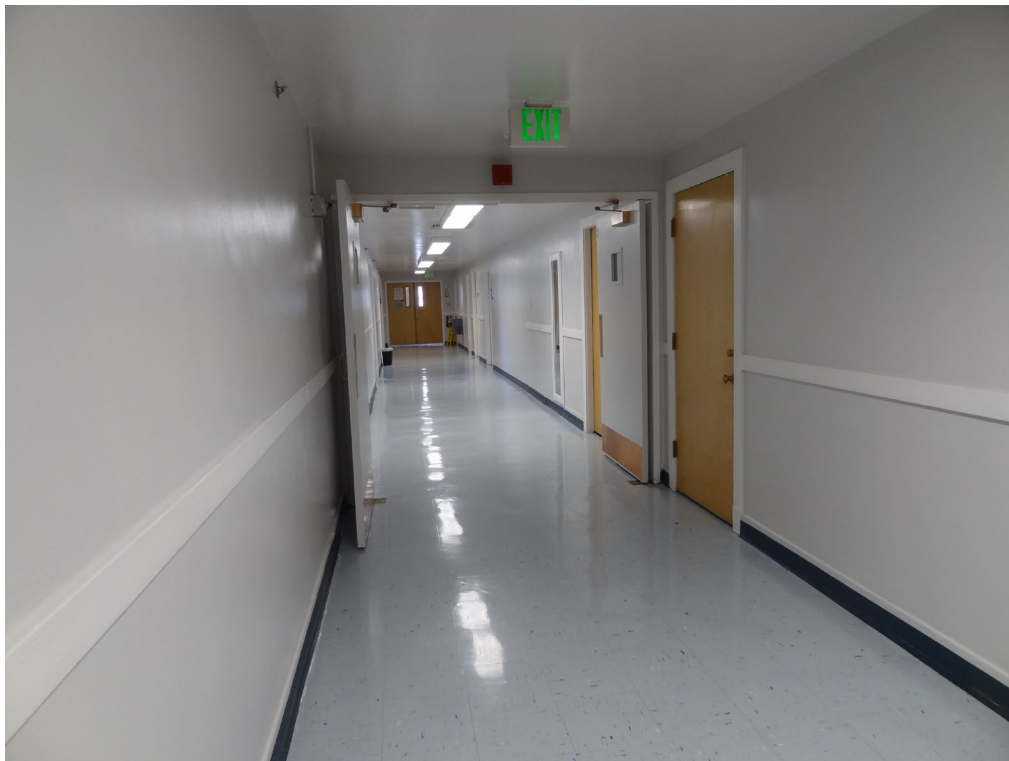
Administration – Building #1 – FCA Building #0326  
Description: Lever Hardware Installation.
