State of Nevada
Department of Corrections
Silver Springs Conservation Camp
Facility Condition Analysis

SILVER SPRINGS CONSERVATION CAMP

4950 Shirlee Avenue
Silver Springs, Nevada

Site Number: 9986
STATE OF NEVADA PUBLIC WORKS BOARD
FACILITY CONDITION ANALYSIS

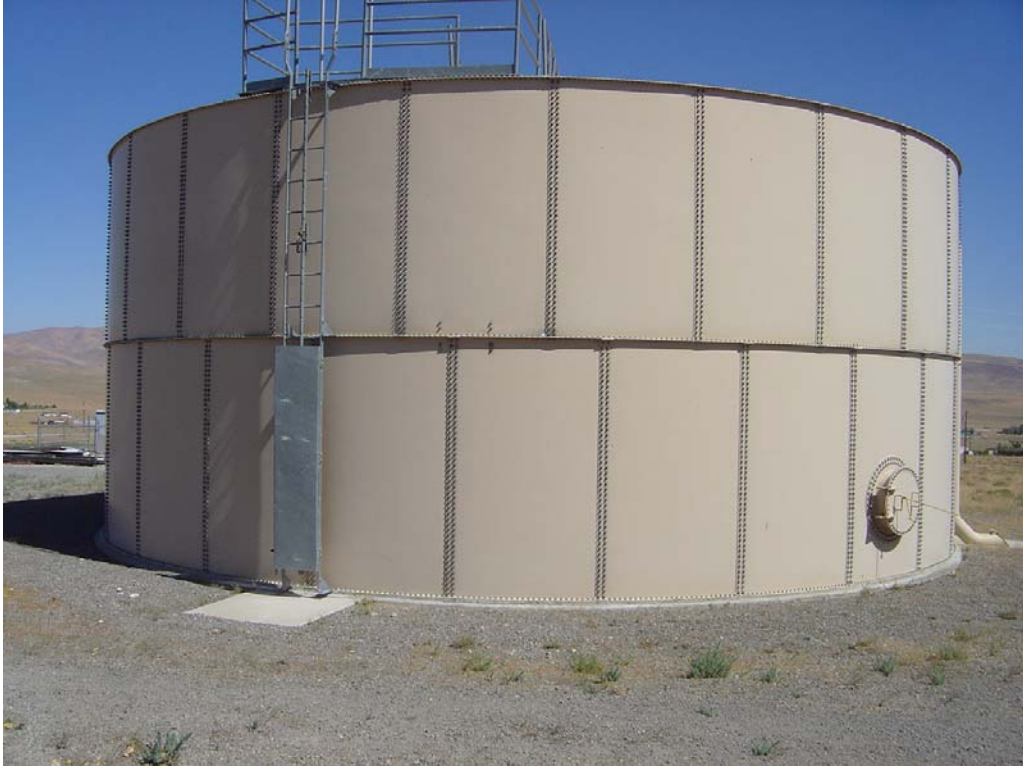
Silver Springs C.C. – Building #2690
Description: Water Tower

It is important to maintain the finish, weather resistance and appearance of the building. This project recommends work to protect the exterior of the water tank, other than the roof, including painting, staining, or other applied finishes, and caulking penetrations to maintain the building in good, weather tight condition. This structure should be painted every five to seven years to maintain it's integrity.

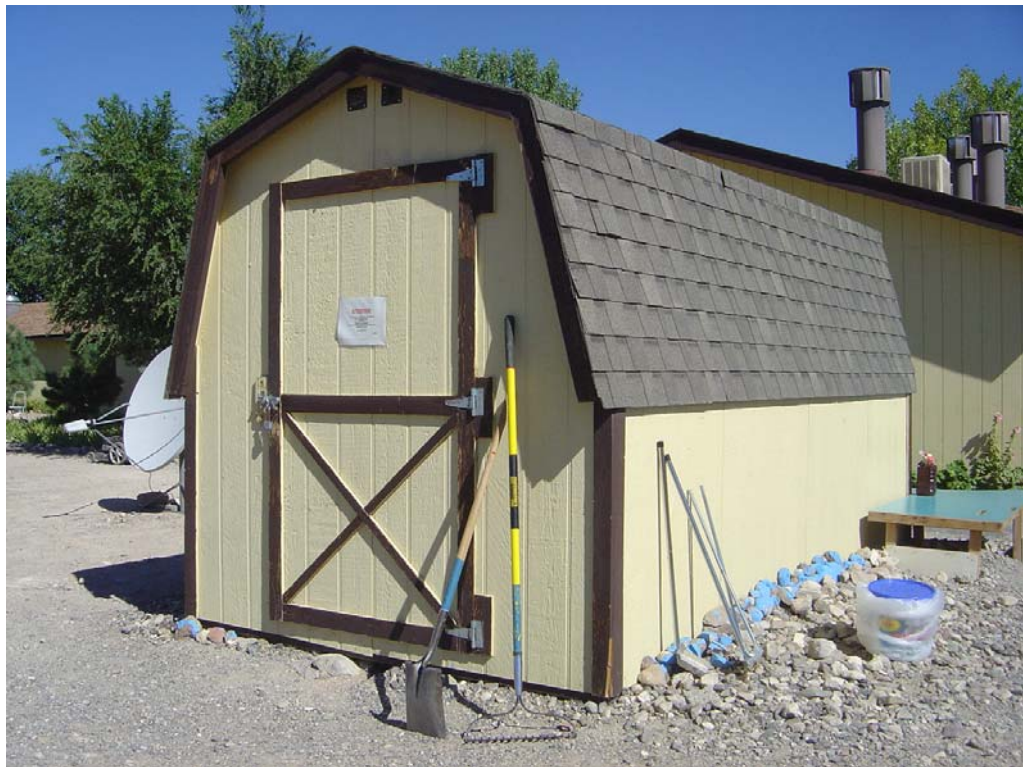
Silver Springs C.C. – Building #2689
Description: Tool Shed

It is important to maintain the finish, weather resistance and appearance of the building. This project recommends work to protect the exterior building envelope, other than the roof, including painting, staining, or other applied finishes, and caulking around windows, flashing, fixtures, and other penetrations to maintain the building in good, weather tight condition. This structure should be painted every five to seven years to maintain it's integrity.

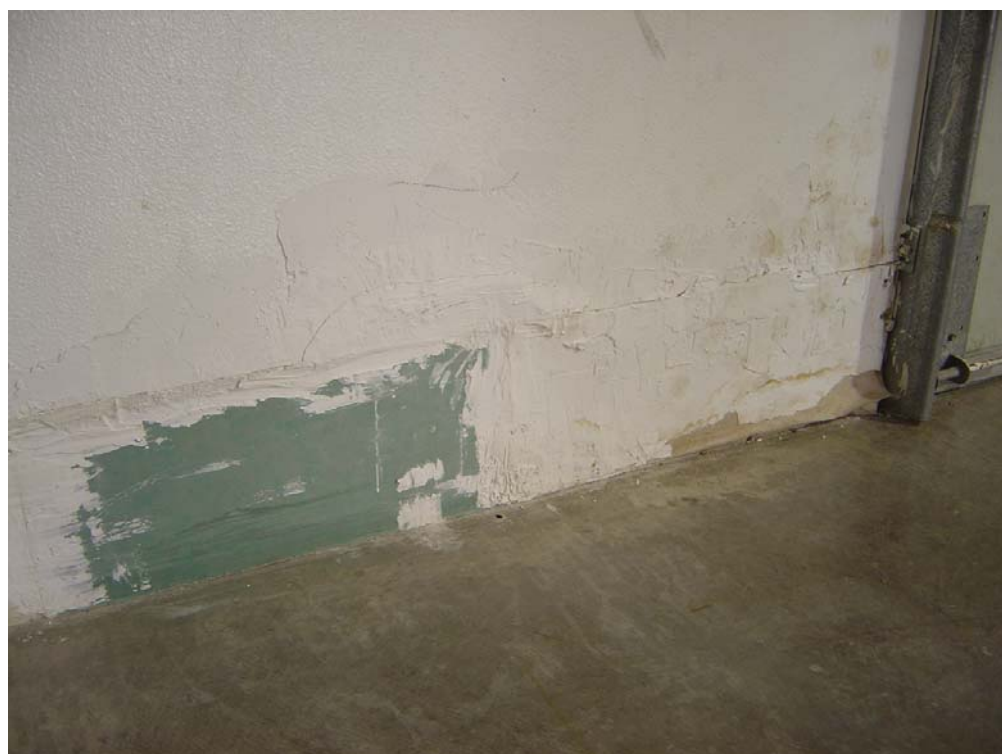
The wall and overhead door in the gymnasium area have been damaged. The extent of the damage within the wall is not known. The door should be replaced and the wall framing members should be exposed to inspect and repair as necessary.

Silver Springs C.C. – Building #1896
Description: Gypsum board damage by overhead door

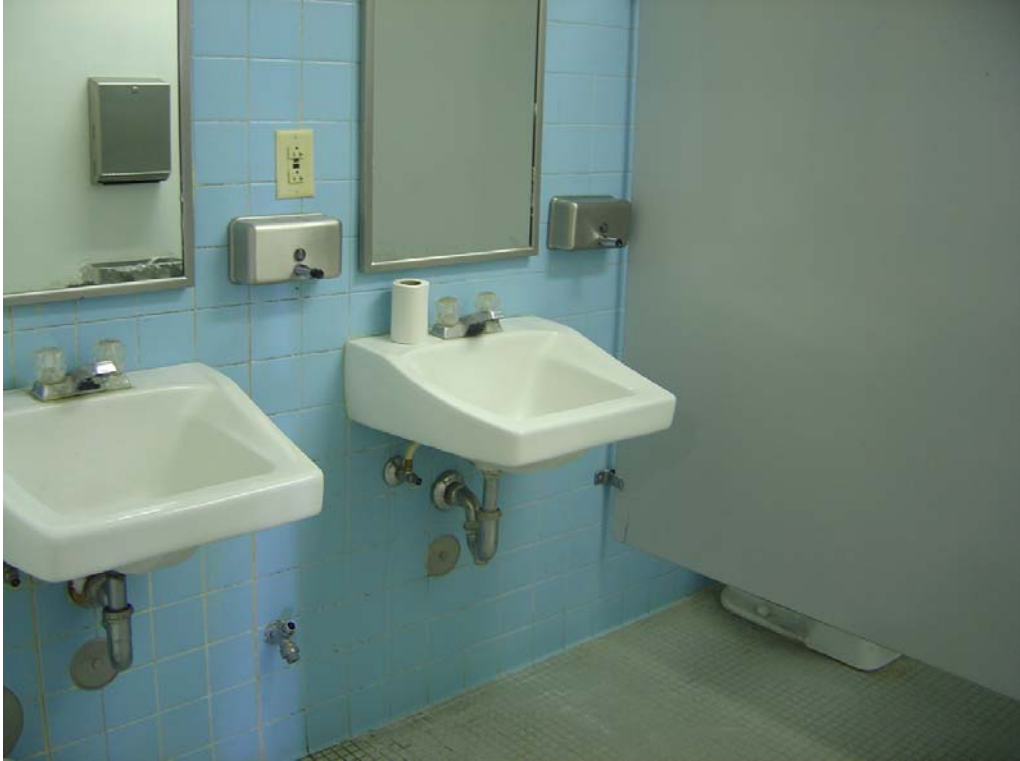
The water closet and lavatories in the restroom adjacent to the gym are worn from years of use. It is recommended that the fixtures in all the bathrooms be replaced. This estimate includes the removal and replacement of the toilet and two sinks including faucets.

Silver Springs C.C. – Building #1896
Description: The restrooms adjacent to the Gymnasium

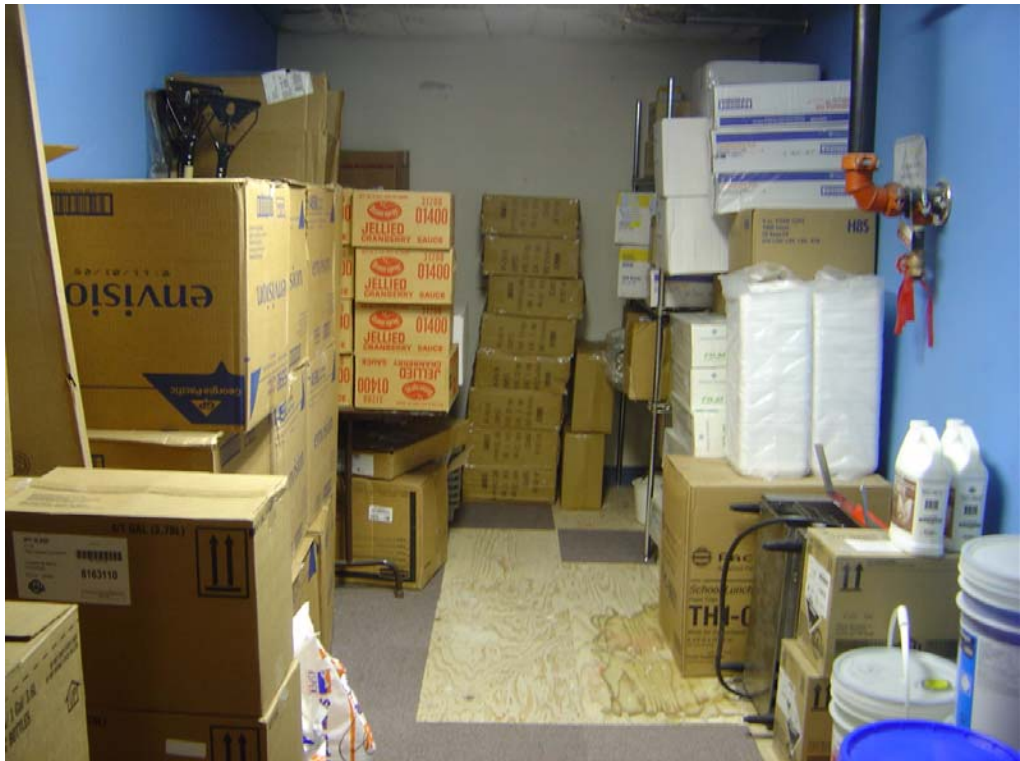
An upper level storage mezzanine has been constructed inside of the Building. The 2003 IBC has a minimum requirement of 125p.s.f. for light storage in non-residential spaces. There is no record of a CIP project or structural plans for this construction and it could be a potential safety issue due to collapse. This project recommends that a licensed engineer perform a structural investigation to assess the load carrying capacity of this area. Future projects would be based on this report.

Silver Springs C.C. – Building #1896
Description: Mezzanine storage area

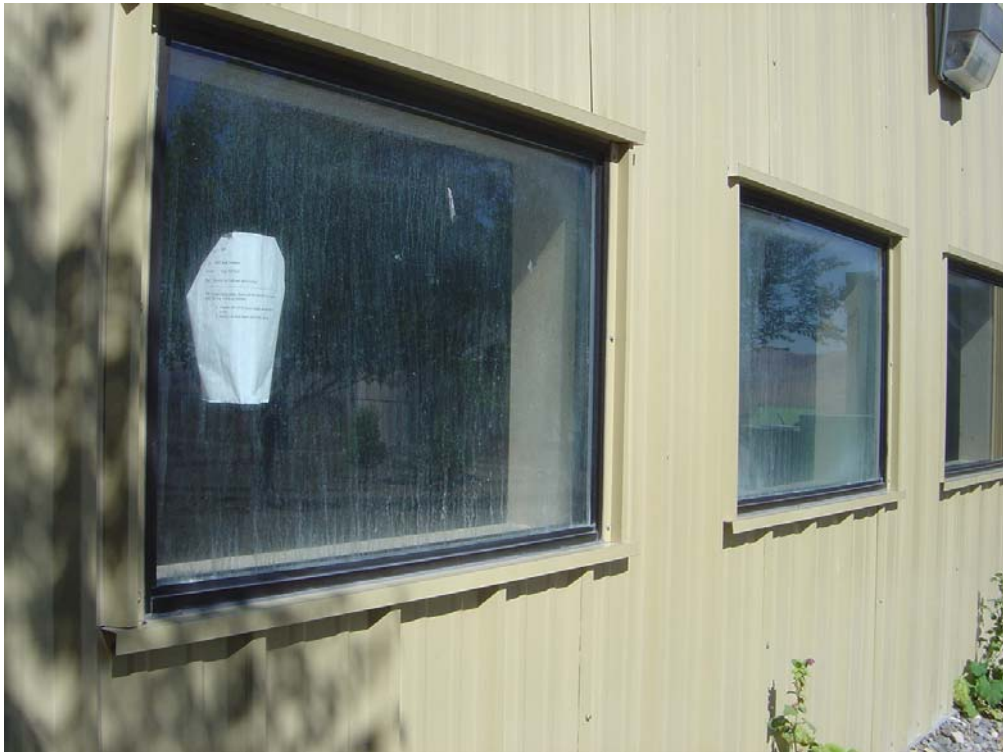
Silver Springs C.C. – Building #1895
Description: Windows in need of replacement

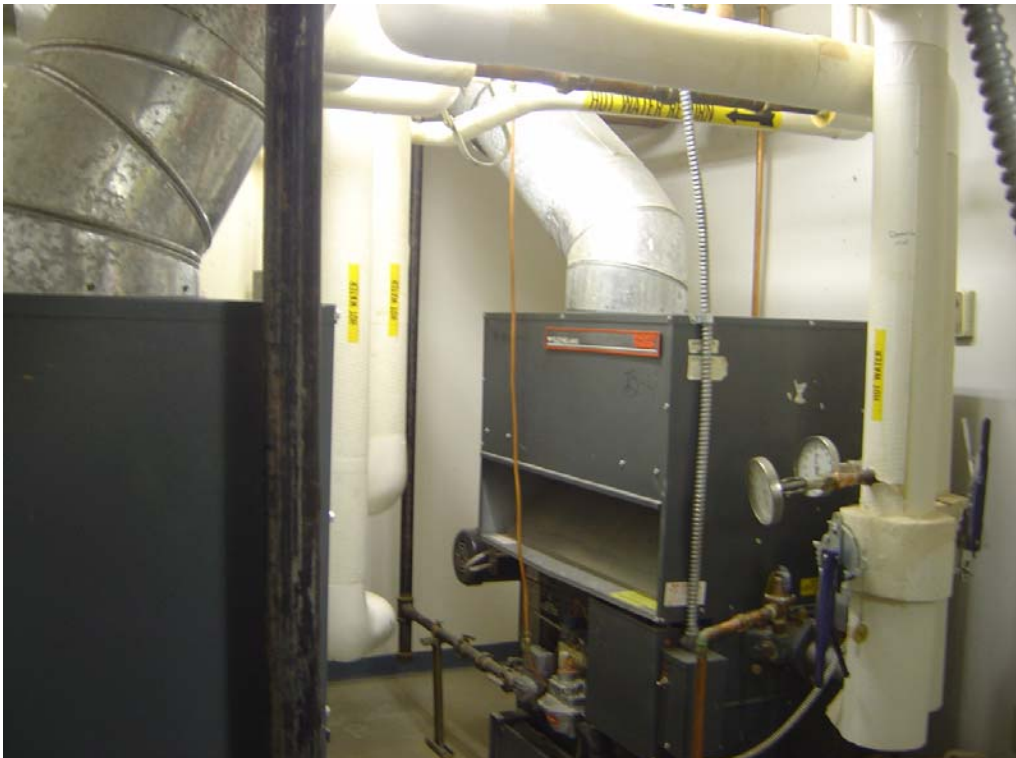
There are 4 existing gas fired boilers which provide heat for the entire building. They were installed in 1991 and are original to the housing unit. The life expectancy of these units is 20 to 25 years with proper maintenance and water treatment programs. This project would provide for the removal and replacement of the 4 boilers with 4 new 765 MBH gas fired boilers. This project should be requested in a CIP in about 8 to 10 years. This project does not address any piping replacement, only connections to existing systems.

Silver Springs C.C. – Building #0711
Description: The Boiler Room

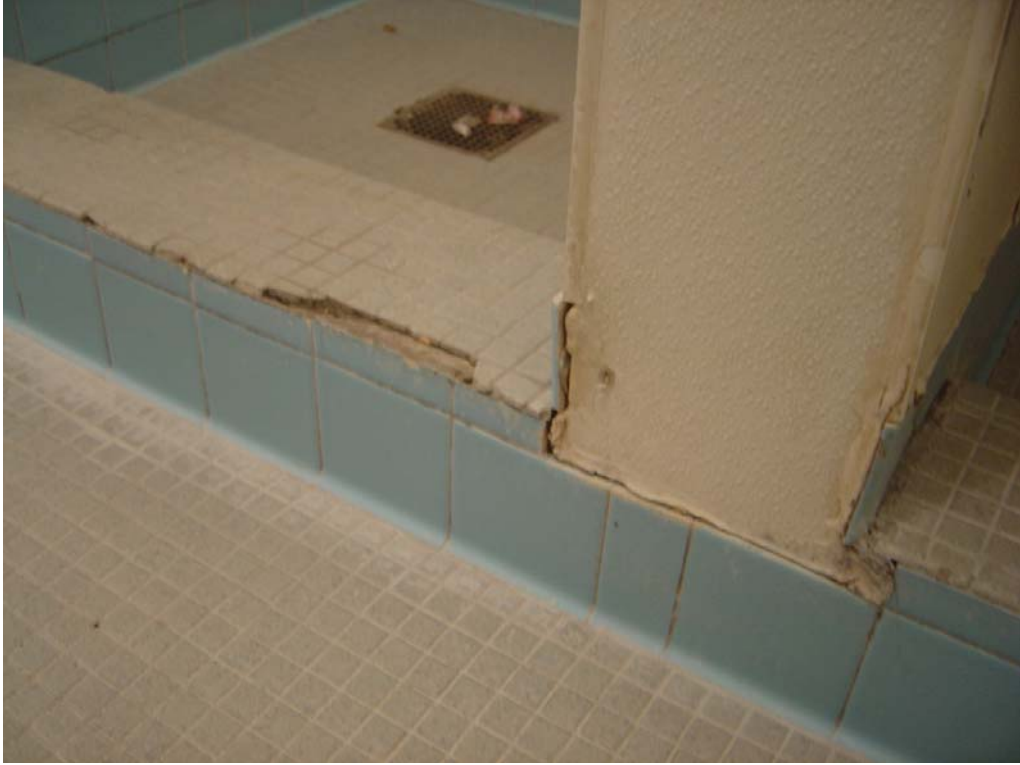
Silver Springs C.C. – Building #0711
Description: Damage to the showers, typical

This project also includes remodeling of the existing showers, with includes at a minimum removal of all tile and plumbing fixtures, gypsum board repair and installation of new stainless steel shower units.

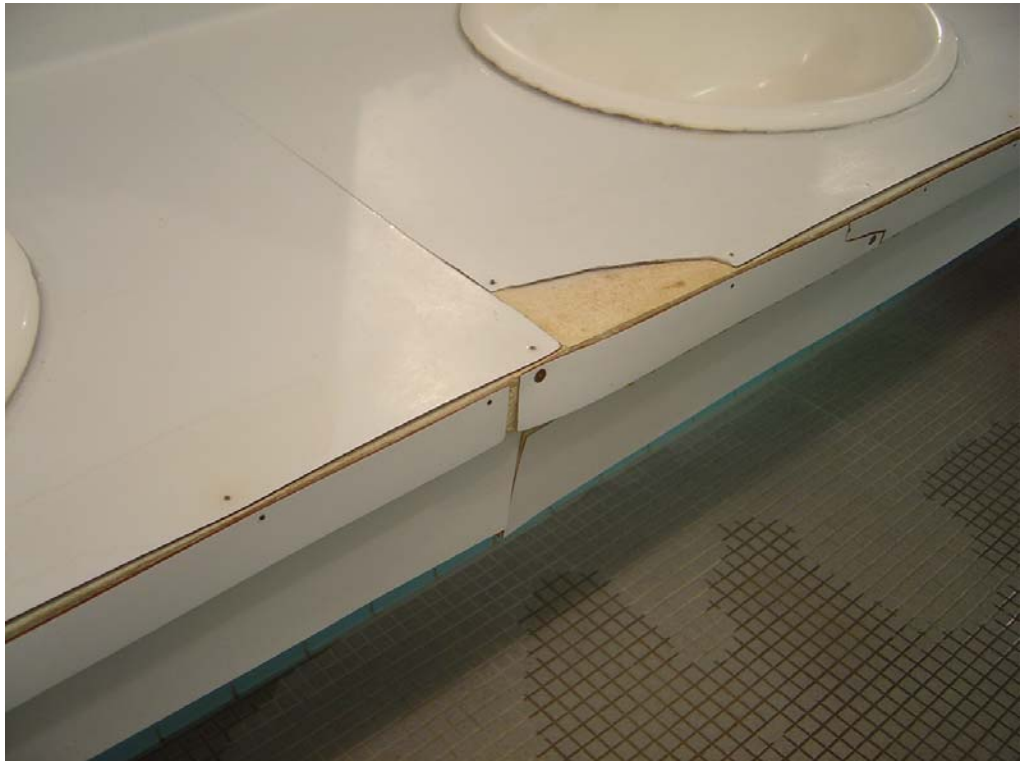
The countertops in the restrooms and shower rooms in each wing show signs of wear, deterioration and are damaged. There are three wings with restrooms. Extensive use, combined with repetitive water being spilled, has caused the laminate top to separate from the wooden underlayment and should be replaced.

Silver Springs C.C. – Building #0711
Description: Typical damage to countertops

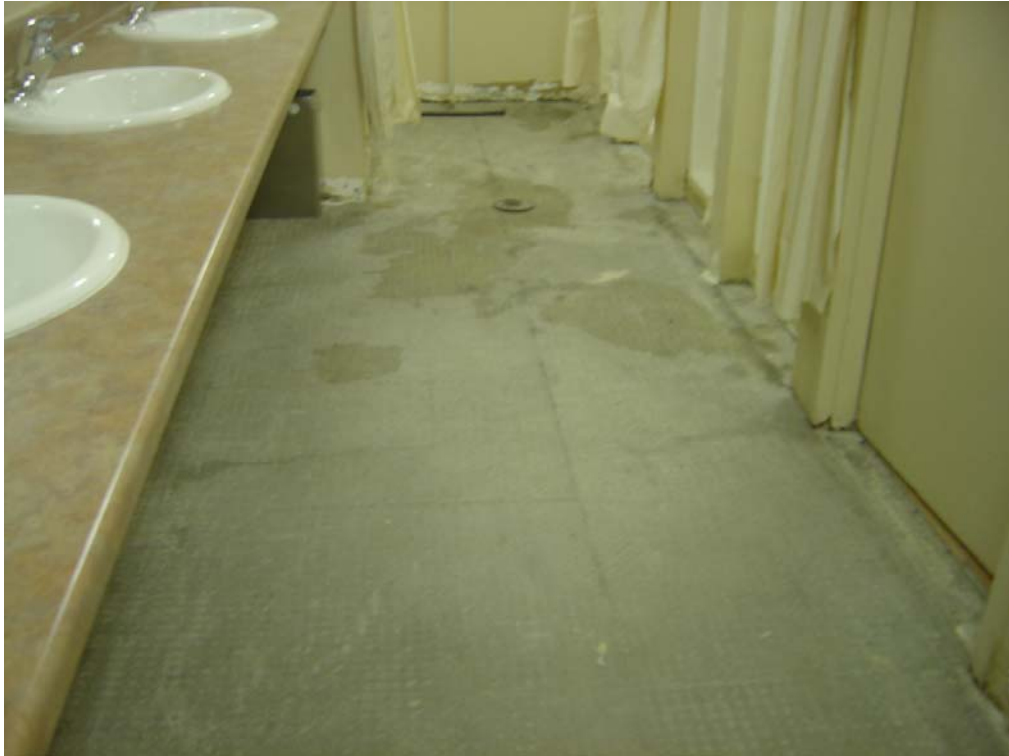
A problem exists with the drain system in the shower rooms. The drains clog frequently, possibly due to improper installation or debris. Because the floor is a concrete slab, the work to repair this problem is extensive. This portion of the project provides for an inspection of the waste lines with a video camera to determine the extent of the problem. Future projects may result from the findings and are not included in this estimate.

Silver Springs C.C. – Building #0711
Description: One of several floor drains with clogging issues

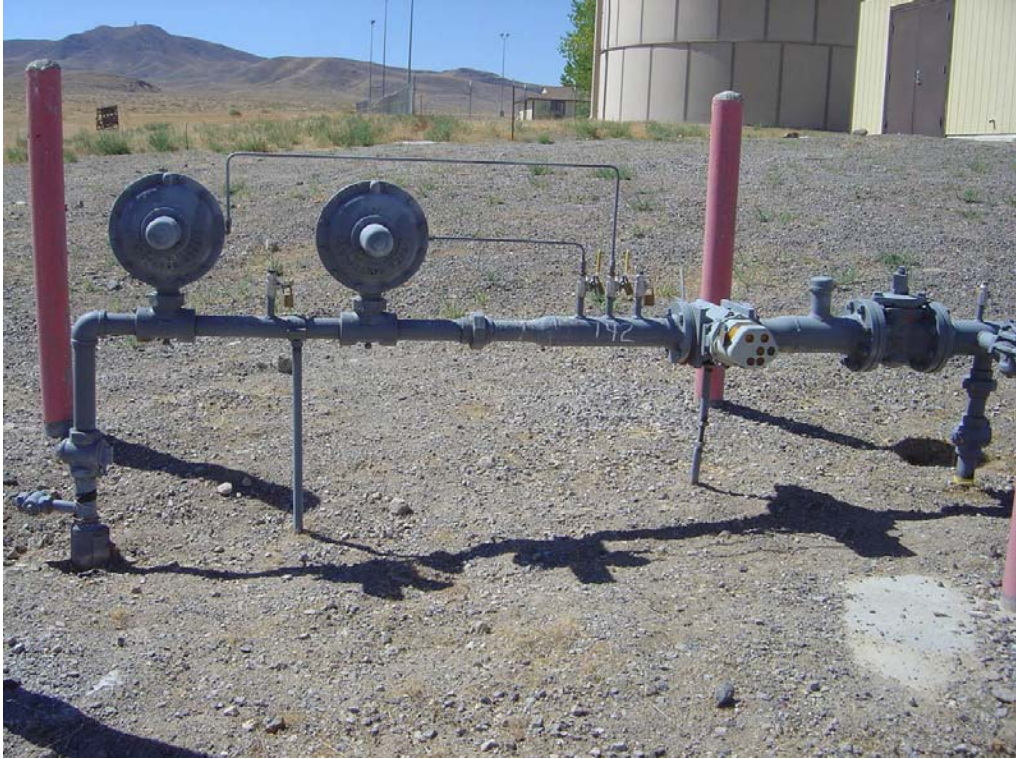
Silver Springs C.C. – Site #9986
Description: Gas main without seismic shut off valve

INSTALL SEISMIC GAS SHUT OFF VALVE
