State of Nevada  
Department of Corrections  
Northern Nevada Restitution Center  
Facility Condition Analysis

2595 East 2<sup>nd</sup> Street  
Reno, Nevada

**Site Number: 9987**  
**STATE OF NEVADA PUBLIC WORKS BOARD**  
**FACILITY CONDITION ANALYSIS**

Report Printed in September 2006

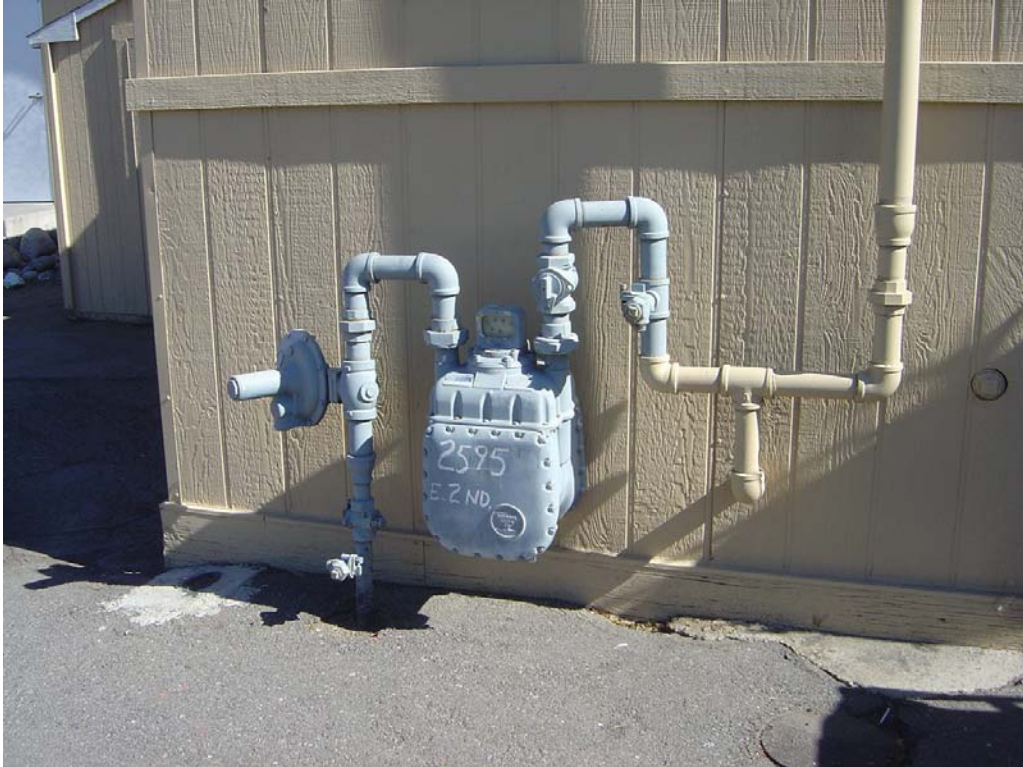
Northern Nevada Restitution Center – Building #1484  
Description: Need to install a Seismic Gas Shut Off

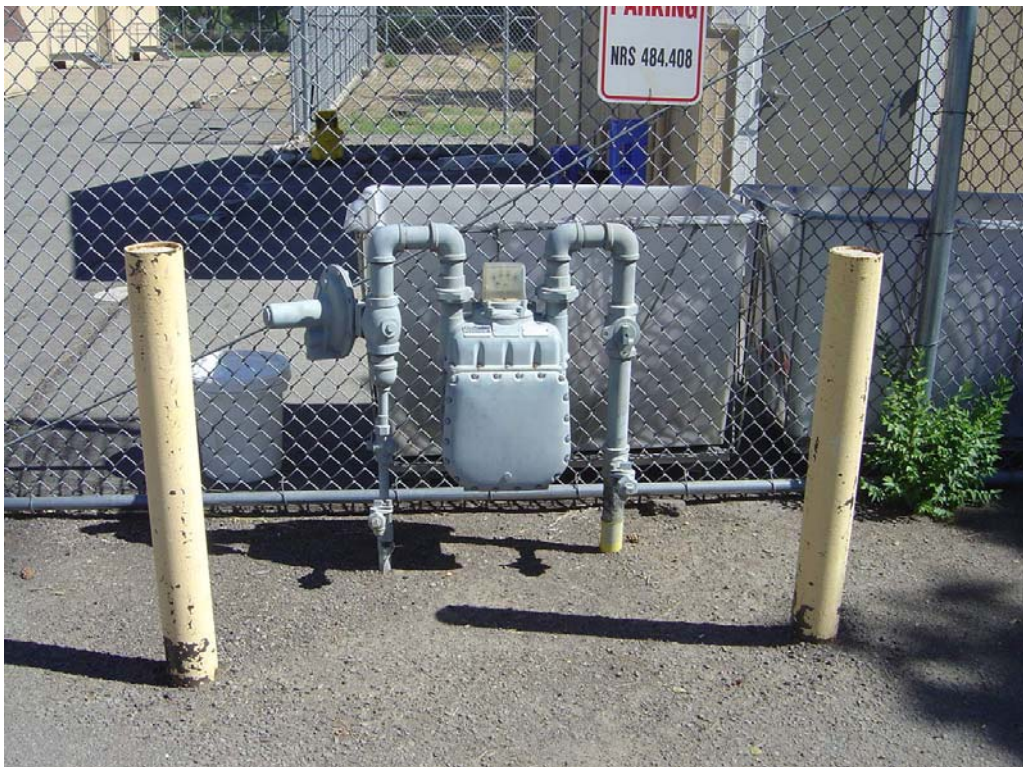
Northern Nevada Restitution Center – Site #9987  
Description: Need to install a Seismic Gas Shut Off Valve

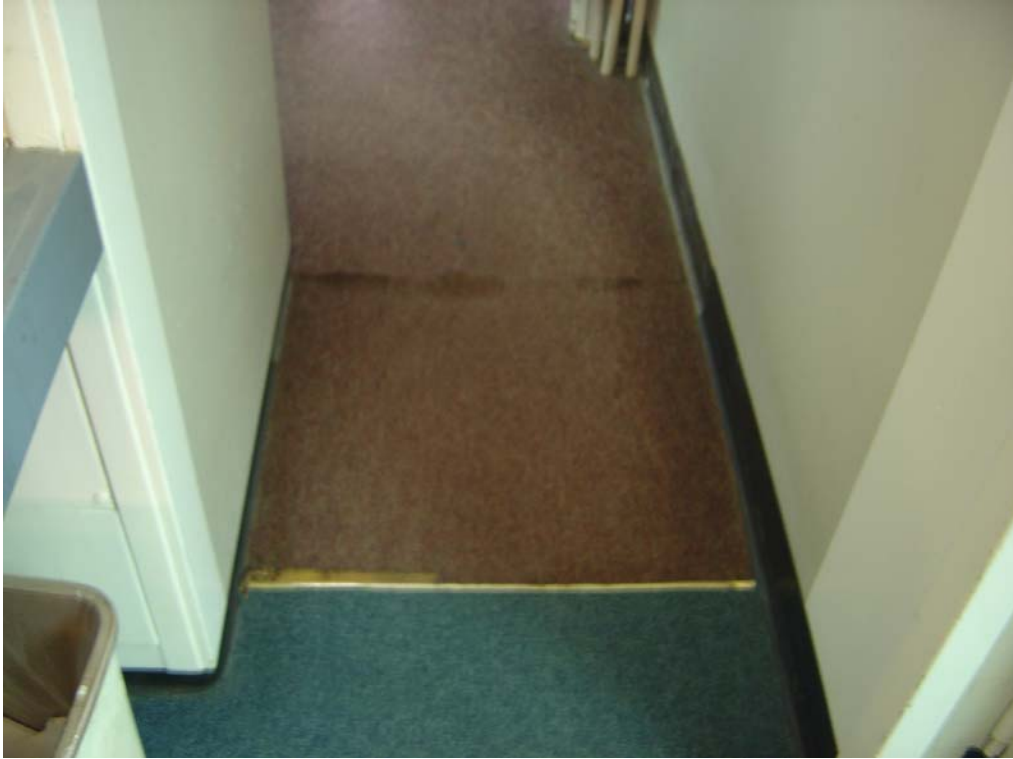
The interior floor covering is carpet and VCT. The flooring is showing signs of extreme wear. Several areas of the carpet are worn and tears are evident throughout and the VCT is loose and separating from the substrate creating a potential tripping hazard. There is water damage on the sub-base flooring in hallway. This project would provide funding for the replacement of the sub-base and the existing broad loom carpet with carpet tile and VCT.

Northern Nevada Restitution Center – Building #1484  
Description: Interior view of damaged and worn carpet

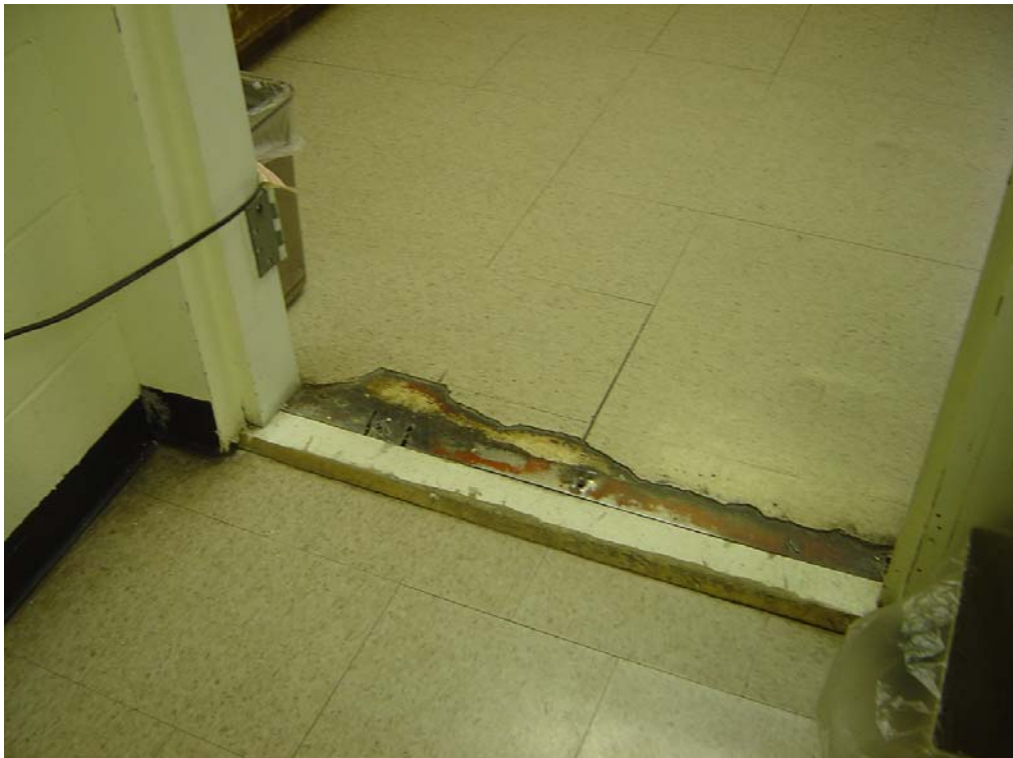
Northern Nevada Restitution Center – Building #1484  
Description: Interior view of damaged VCT

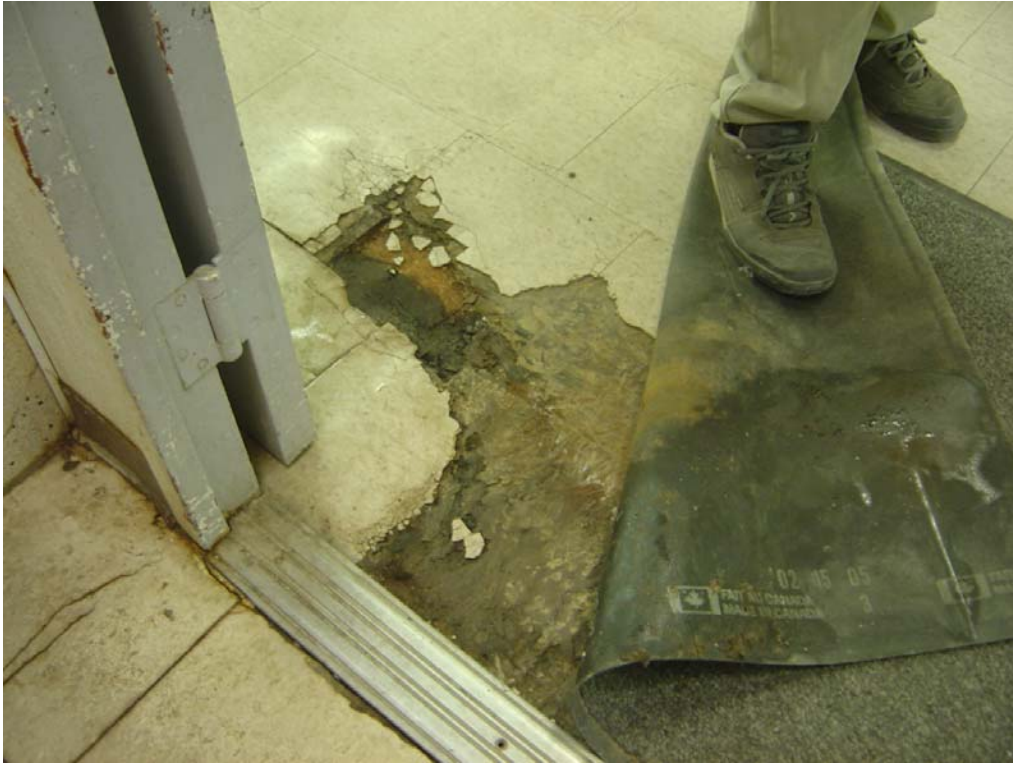
The Administration / Housing Unit is a metal walled structure with T1-11 siding, single-ply membrane roof on a concrete foundation. This structure was one of the many buildings purchased by the State from the Alaska pipeline project. The administrative offices, visitor's areas, restrooms and housing areas are located in this facility. The building is not ADA compliant but does have a fire sprinkler system and a new alarm system. There are several areas where the floor is spongy from water damage. This facility is in poor to fair shape.

Northern Nevada Restitution Center – Building #1484  
Description: Damaged sub flooring

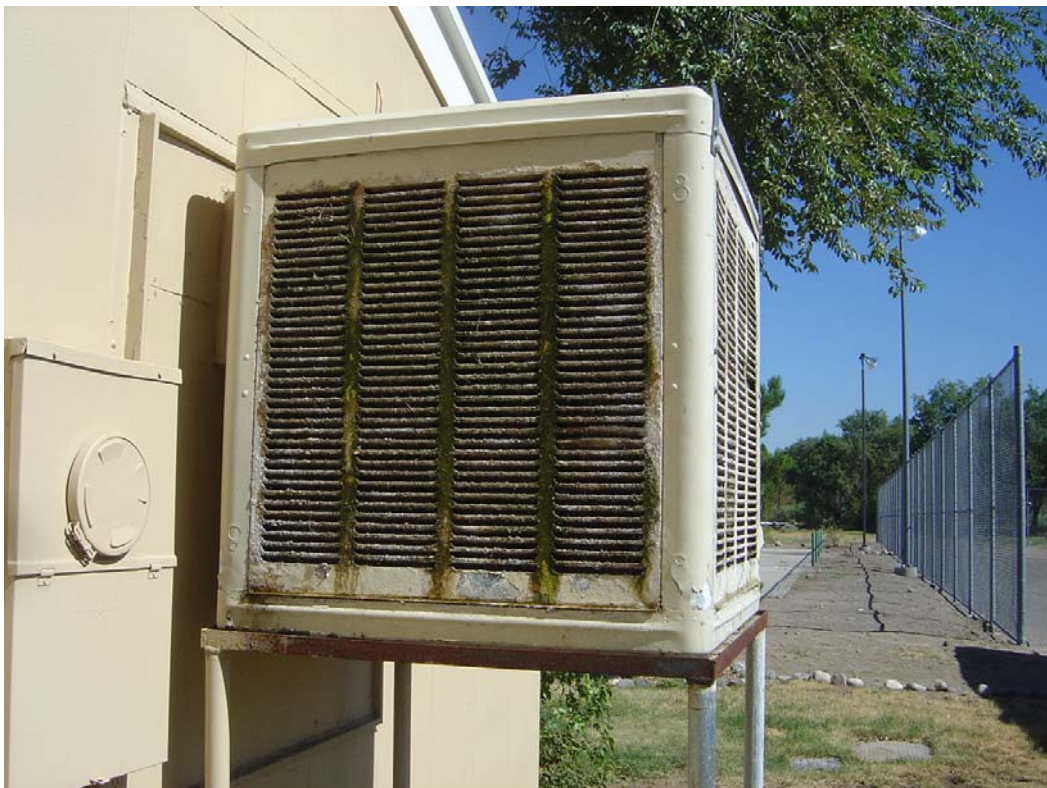
There are currently two evaporative coolers mounted on the roof of the Housing Unit, one for each wing. They are severely scaled and have reached the end of their serviceable life. This project would provide for two new evaporative coolers to be installed. Project includes removal and disposal of the old coolers and utility connections to the new units. This project or a portion there of was previously recommended in the FCA report dated 06/07/1999. It has been amended accordingly to reflect conditions observed during the most recent survey date of 07/26/2006.

Northern Nevada Restitution Center – Building #1895  
Description: Evaporative cooler is extremely scaled

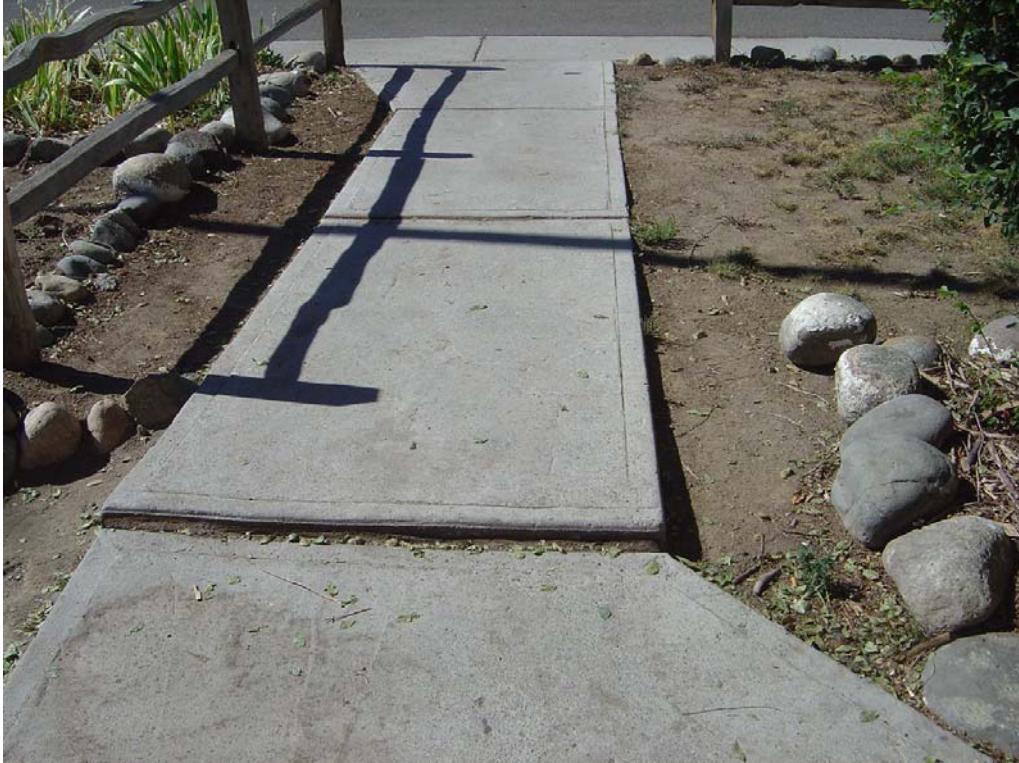
Northern Nevada Restitution Center – Building #1487  
Description: Sidewalk heaving at entrance to Culinary building

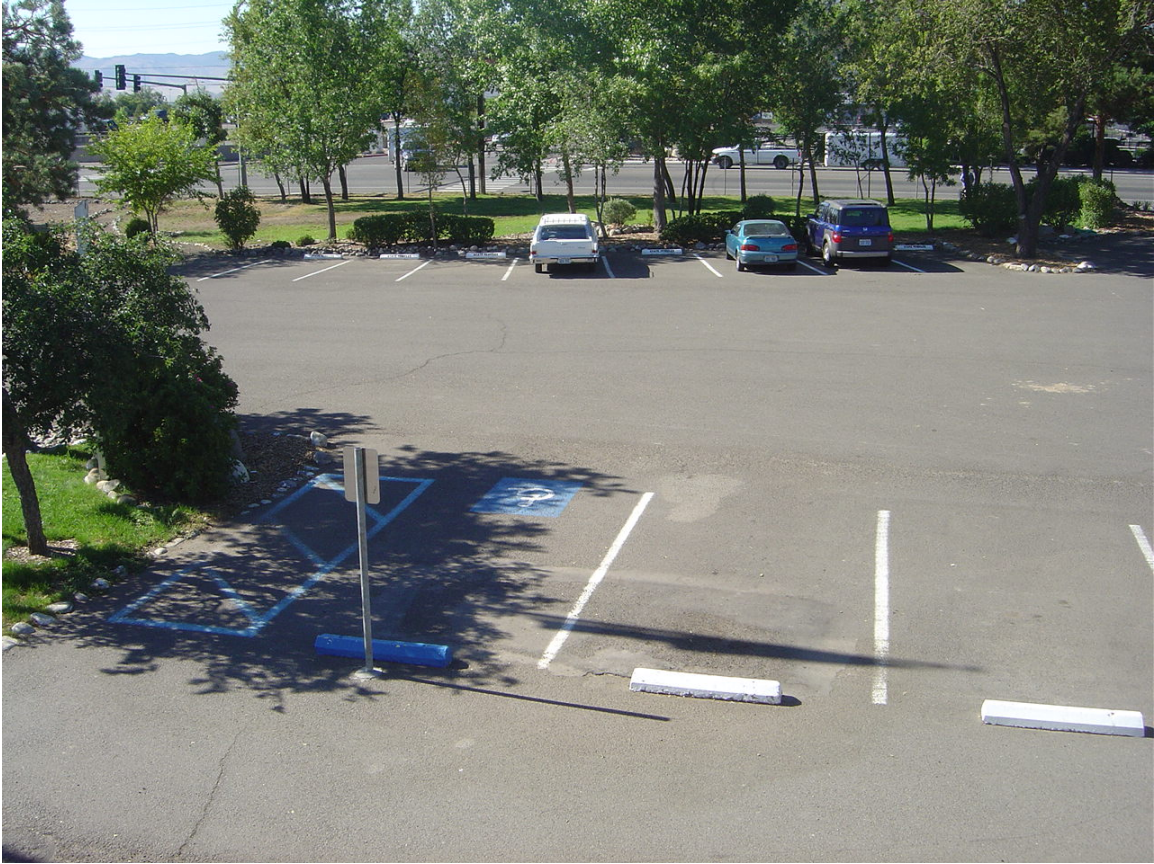
Northern Nevada Restitution Center – Site #9987  
Description: Parking area

The existing paved area around the building is in fair condition. This project recommends filling in the minor cracks, applying a slurry seal and re-striping the onsite parking area. This project or a portion there of was previously recommended in the FCA report dated 06/07/1999. It has been amended accordingly to reflect conditions observed during the most recent survey date of 07/26/2006.
