State of Nevada  
Department of Corrections

# **WARM SPRINGS CORRECTIONAL CENTER**

**Site Number: 9988**  
**STATE OF NEVADA PUBLIC WORKS DIVISION**  
**FACILITY CONDITION ANALYSIS**

Report distributed in January 2022

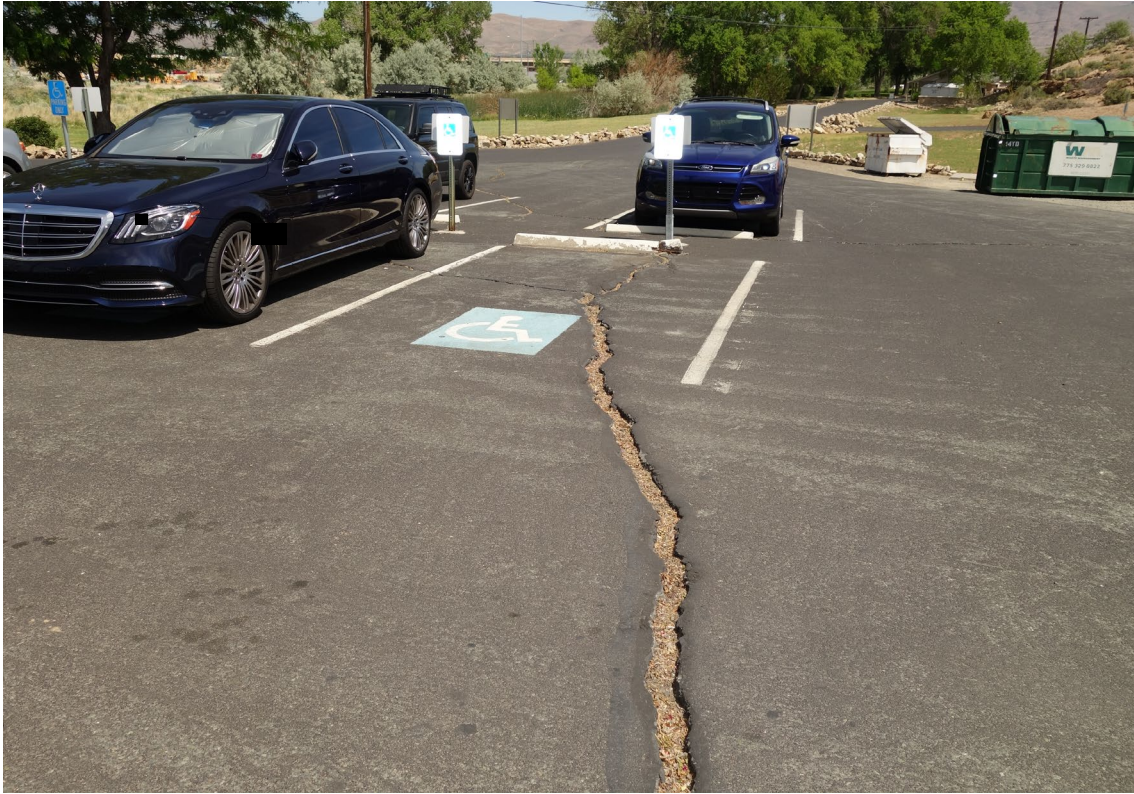
The Americans with Disabilities Act (ADA) provides for accessibility to sites and services for people with physical limitations. The existing ADA parking spaces and path of travel to the entrance of the building do not meet the requirements of the code. The slopes are out of compliance, the configuration of the spaces, loading zones and path of travel to the entrance are not compliant. This project provides funding to bring the existing ADA parking space up to code including removal of the asphalt and replacement with P.C. concrete, installing a concrete path of travel to the entrance, updated signage, re-striping, re-grading and any other necessary upgrades. The 2018 IBC, ICC/ANSI A117.1, NRS 338.180 and the most current version of the ADA Standards For Accessible Design were used as a reference for this project.

Warm Springs Correctional Center Site – FCA Site #9988  
Description: ADA Accessible Parking Upgrades Needed.

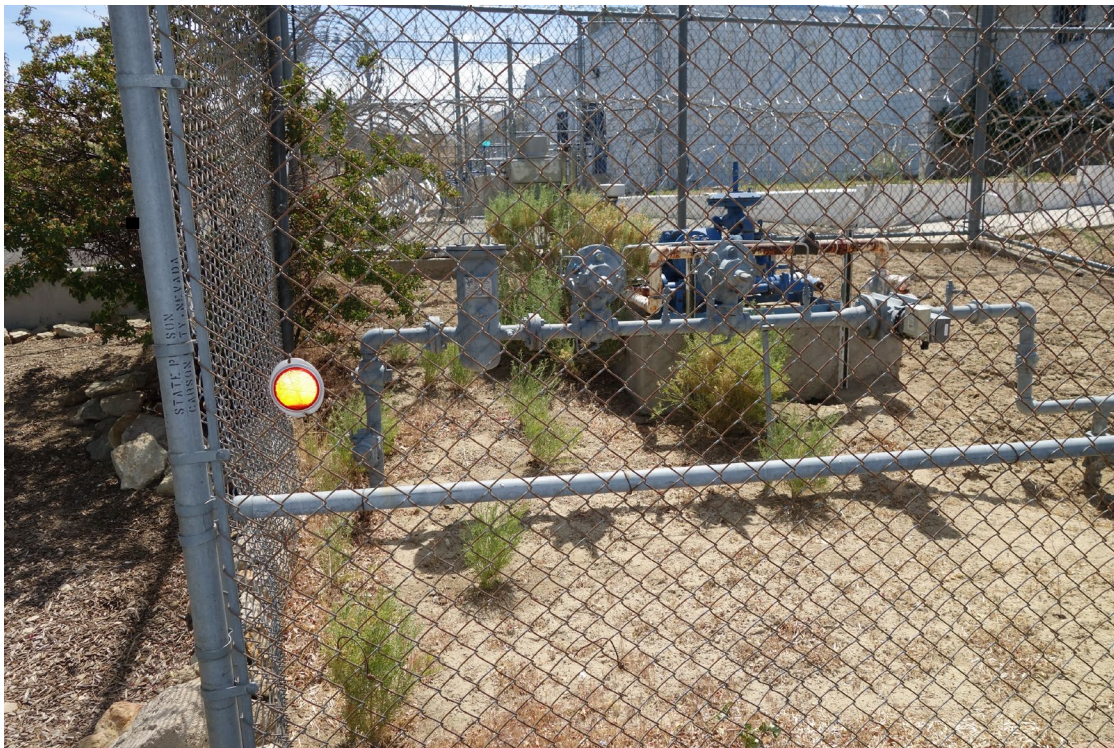
Warm Springs Correctional Center Site – FCA Site #9988  
Description: Seismic Gas Shut-Off Valve Needed.

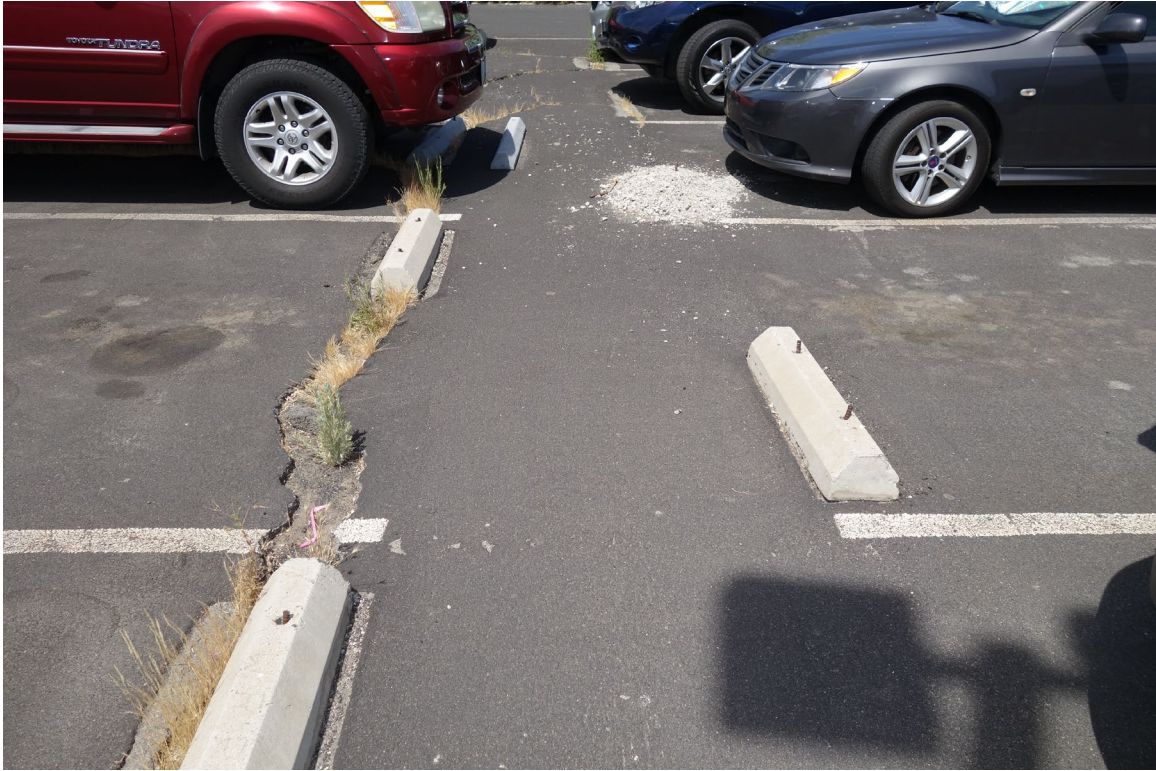
It is important to maintain the asphalt concrete paving on the site. This project would provide for major crack patching, minor crack filling and sealing of the paving site wide including access roads, parking areas and exercise yards. Striping is included in this estimate. This project should be scheduled on a 5 year cyclical basis to maintain the integrity of the paving and prevent premature failure. 180,000 square feet of asphalt area was used to generate this estimate.

Warm Springs Correctional Center Site – FCA Site #9988  
Description: Patch, Crack & Slurry Seal Asphalt Paving.

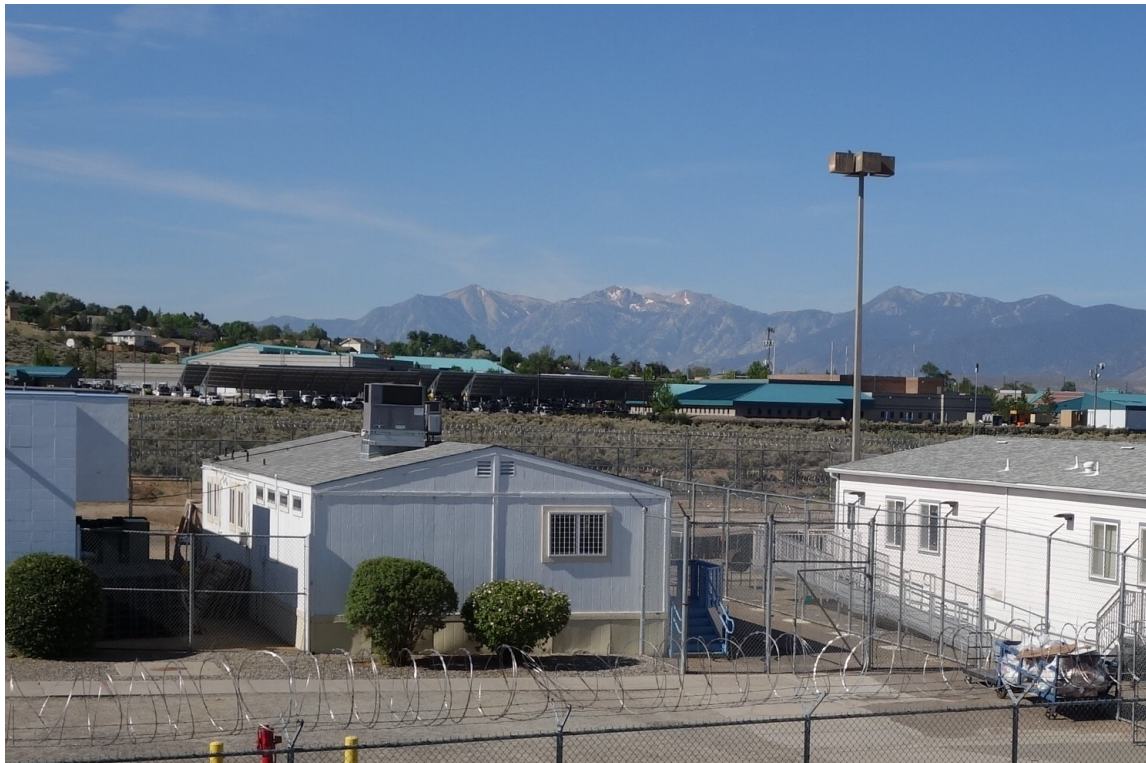
The exterior finishes were in fair condition. It is important to maintain the finish, weather resistance and appearance of the building. This project would provide funding to protect the exterior of the building excluding the roof. Included in the cost is sanding, priming and painting and caulking of the windows, flashing, fixtures and all other penetrations. It is recommended that the building be painted in the next 4 - 5 years and that this project be scheduled on a cyclical basis to maintain the integrity of the structure.

Re-Entry Education Building – FCA Building #4177  
Description: Exterior of the Building.

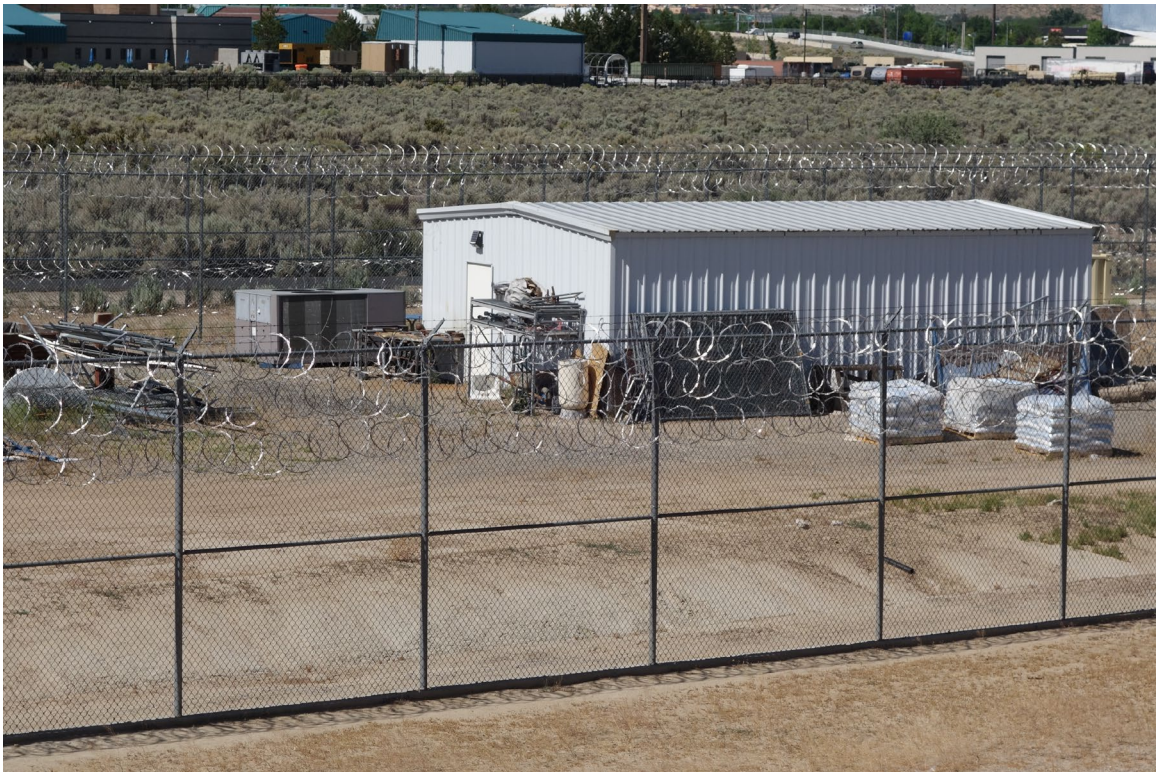
The exterior finishes were in fair condition. It is important to maintain the finish, weather resistance and appearance of the building. This project would provide funding to protect the exterior of the building excluding the roof. Included in the cost is the caulking and sealing flashing, fixtures and all other penetrations. It is recommended that the building be caulked and sealed in the next 4 - 6 years and that this project be scheduled on a cyclical basis to maintain the integrity of the structure.

Maintenance Facility – FCA Building #4176  
Description: Exterior of the Building.

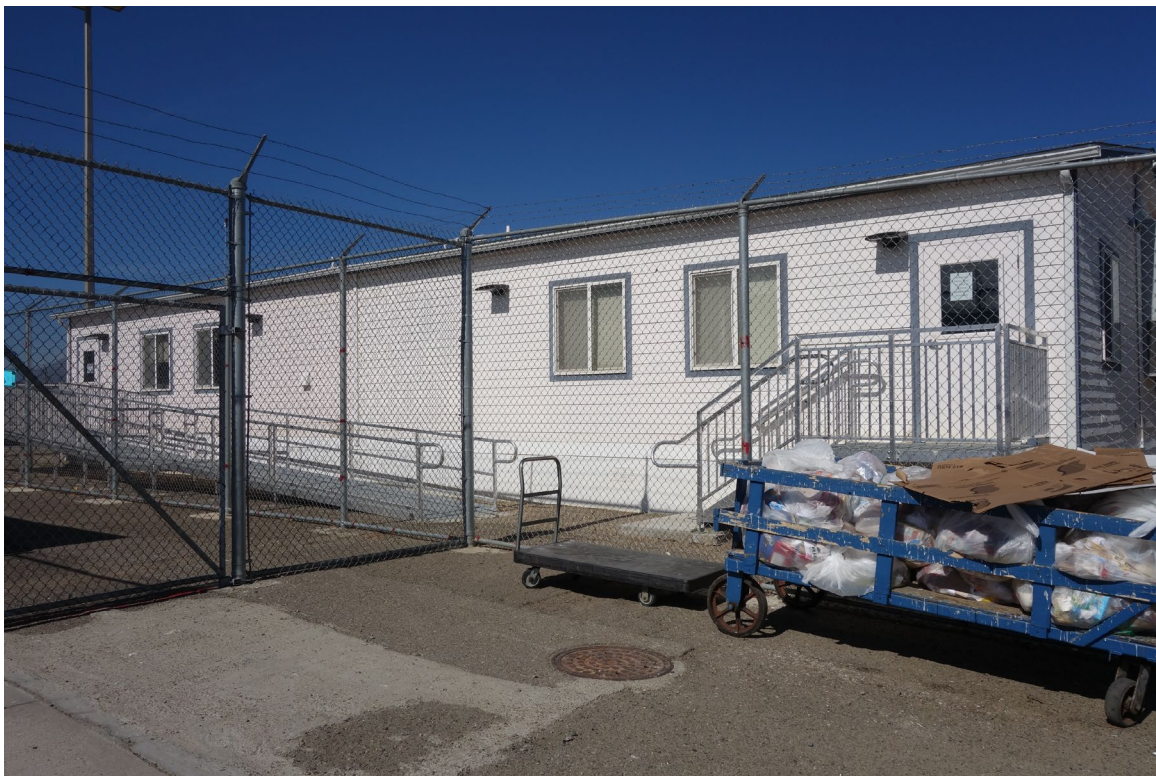
The exterior finishes were in good condition. It is important to maintain the finish, weather resistance and appearance of the building. This project would provide funding for the painting of the exterior of the building. Included in the cost is sanding, priming, filling in the cracks, caulking of the windows, flashing, fixtures and all other penetrations. It is recommended that the building be painted in the next 6 - 8 years and that this project be scheduled on a cyclical basis to maintain the integrity of the structure.

Modular Education Building (Vacant) – FCA Building #2545  
Description: Exterior of the Building.

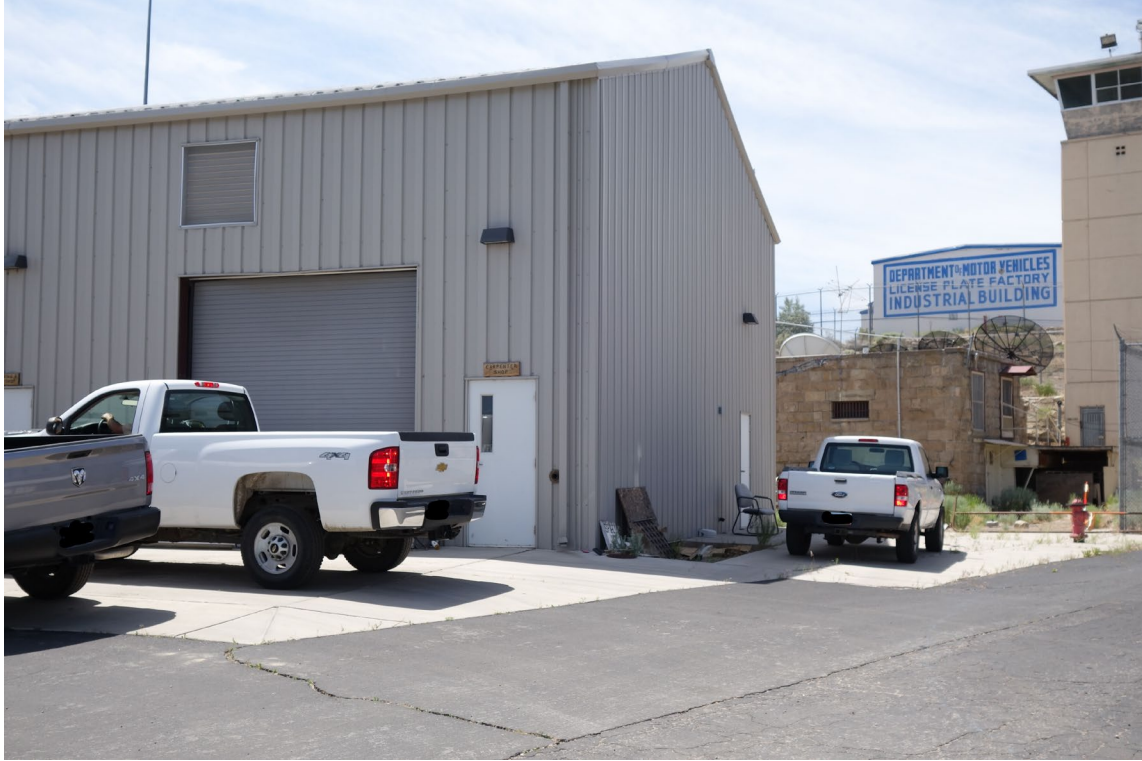
The exterior finishes were in good condition. It is important to maintain the finish, weather resistance and appearance of the building. This project would provide funding for the maintenance of the exterior of the building. Including in the cost is the sealing and caulking of the windows, flashing, fixtures and all other penetrations. It is recommended that the building be caulked and sealed in the next 6 - 8 years and that this project be scheduled on a cyclical basis to maintain the integrity of the structure.

Maintenance Shop (at NSP) – FCA Building #2171  
Description: Exterior of the Building.

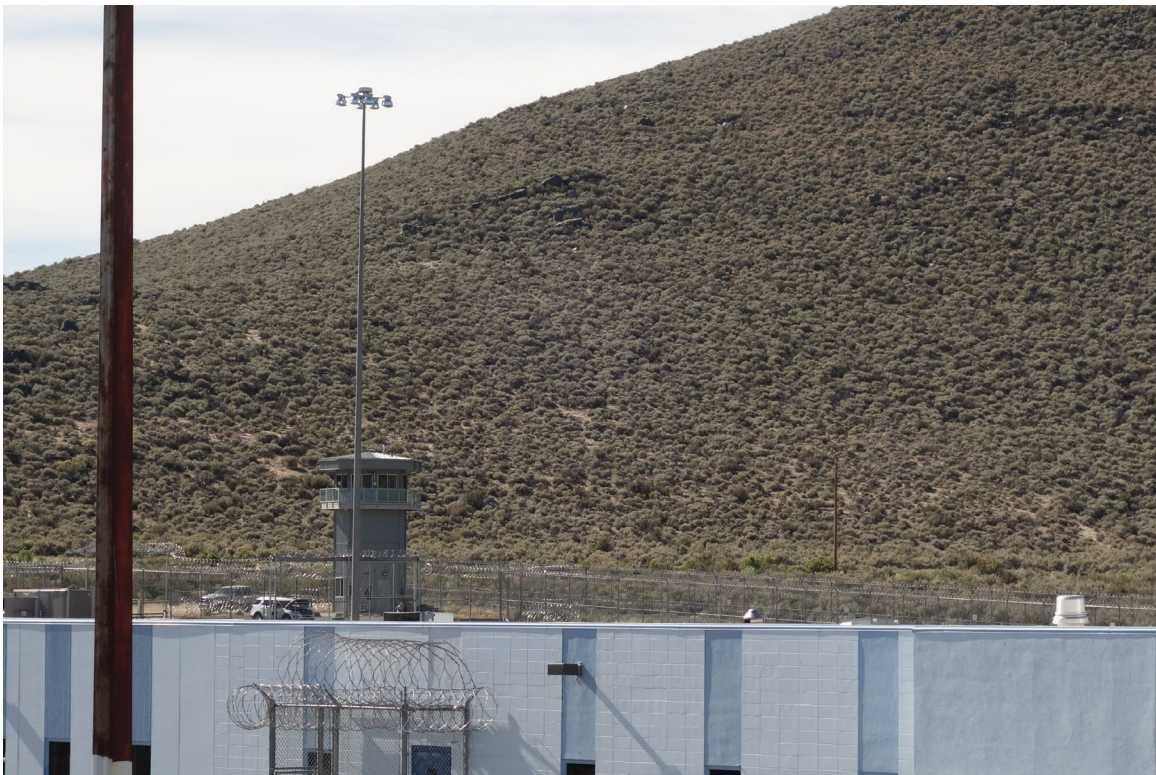
It is important to maintain the finish, weather resistance and appearance of the building. This project would provide funding to protect the exterior of the building excluding the roof. Included in the cost is the caulking and sealing of the metal panels, windows, flashing, fixtures and all other penetrations. It is recommended that the building be caulked and sealed in the next 4 - 6 years and that this project is scheduled on a cyclical basis to maintain the integrity of the structure.

Guard Tower 2 – FCA Building #2034  
Description: Exterior of the Tower.

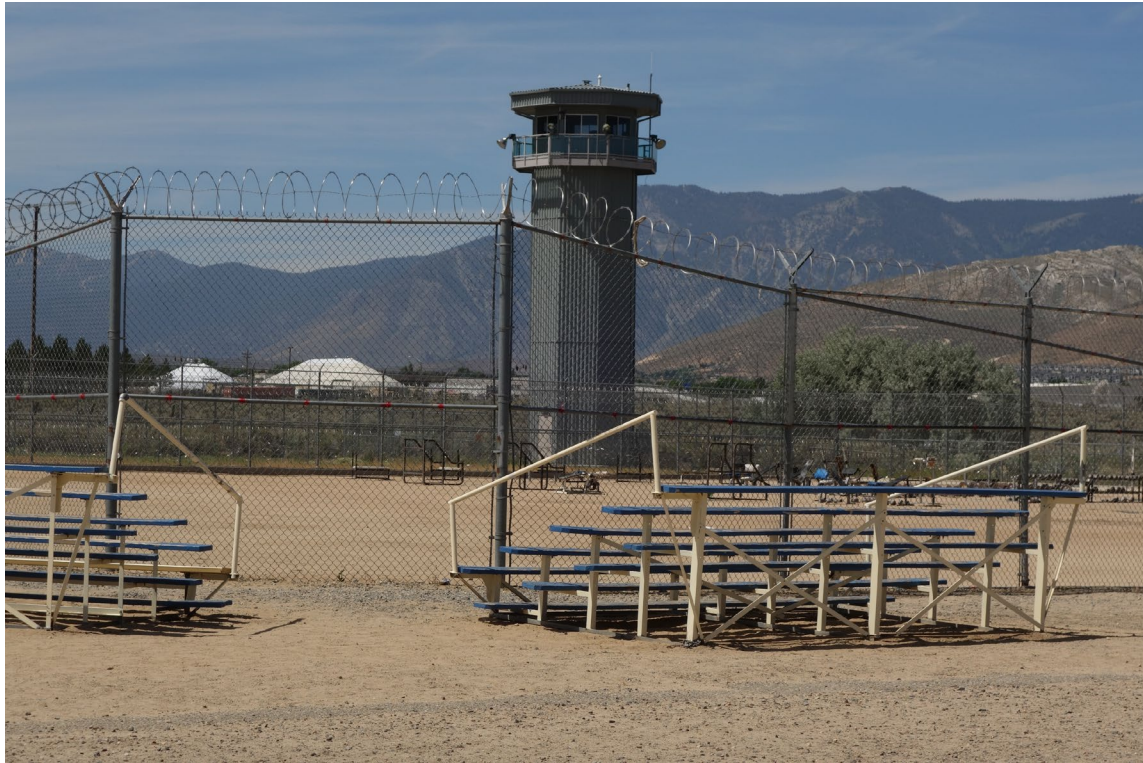
It is important to maintain the finish, weather resistance and appearance of the building. This project would provide funding to protect the exterior of the building excluding the roof. Included in the cost is the caulking and sealing of the metal panels, windows, flashing, fixtures and all other penetrations. It is recommended that the building be caulked and sealed in the next 4 - 6 years and that this project is scheduled on a cyclical basis to maintain the integrity of the structure.

Guard Tower 1 – FCA Building #2003  
Description: Exterior of the Tower.

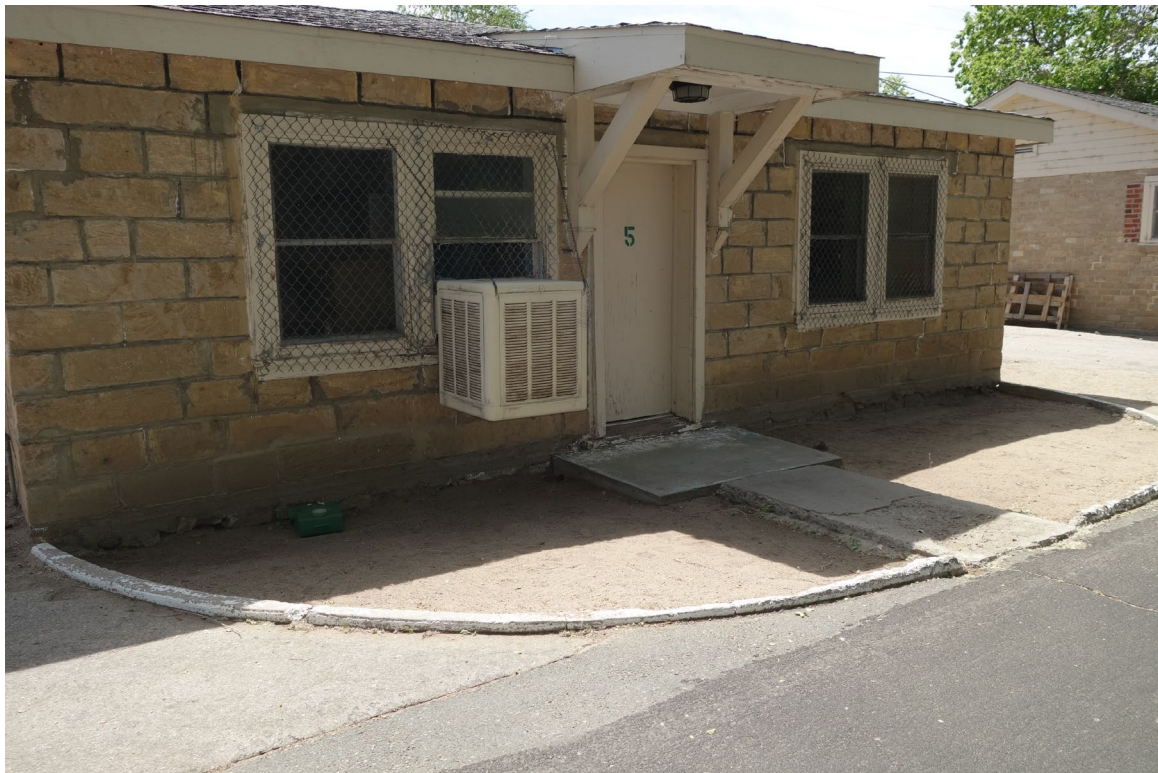
It is important to maintain the finish, weather resistance and appearance of the building which is over 50 years old. There are numerous areas where the mortar is failing, missing and not sealed properly. This project would provide funding to protect the exterior of the building excluding the roof. Included in the cost is sanding, priming and painting the wood finishes, re-pointing the stone where needed and caulking of the windows, flashing, fixtures and all other penetrations. It is recommended that the building be painted and re-pointed in the next 2 - 3 years and that this project is scheduled on a cyclical basis to maintain the integrity of the structure. This project should be coordinated with the Nevada State Historical Preservation Office for possible restrictions or requirements which are not included in this estimate.

Cottage #5 – FCA Building #0122  
Description: Exterior of the Building.

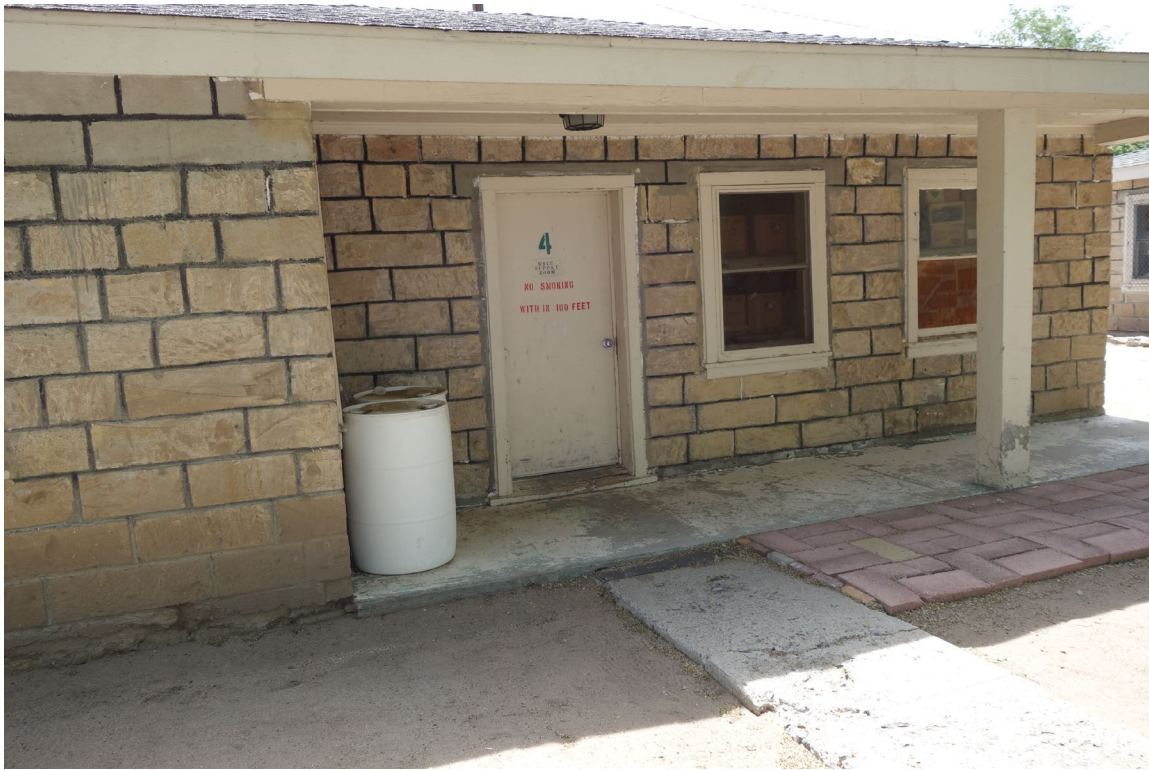
It is important to maintain the finish, weather resistance and appearance of the building which is over 50 years old. There are numerous areas where the mortar is failing, missing and not sealed properly. This project would provide funding to protect the exterior of the building excluding the roof. Included in the cost is sanding, priming and painting the wood finishes, re-pointing the stone where needed and caulking of the windows, flashing, fixtures and all other penetrations. It is recommended that the building be painted and re-pointed in the next 2 - 3 years and that this project is scheduled on a cyclical basis to maintain the integrity of the structure. This project should be coordinated with the Nevada State Historical Preservation Office for possible restrictions or requirements which are not included in this estimate.

Cottage #4 – FCA Building #0121  
Description: Exterior of the Building.

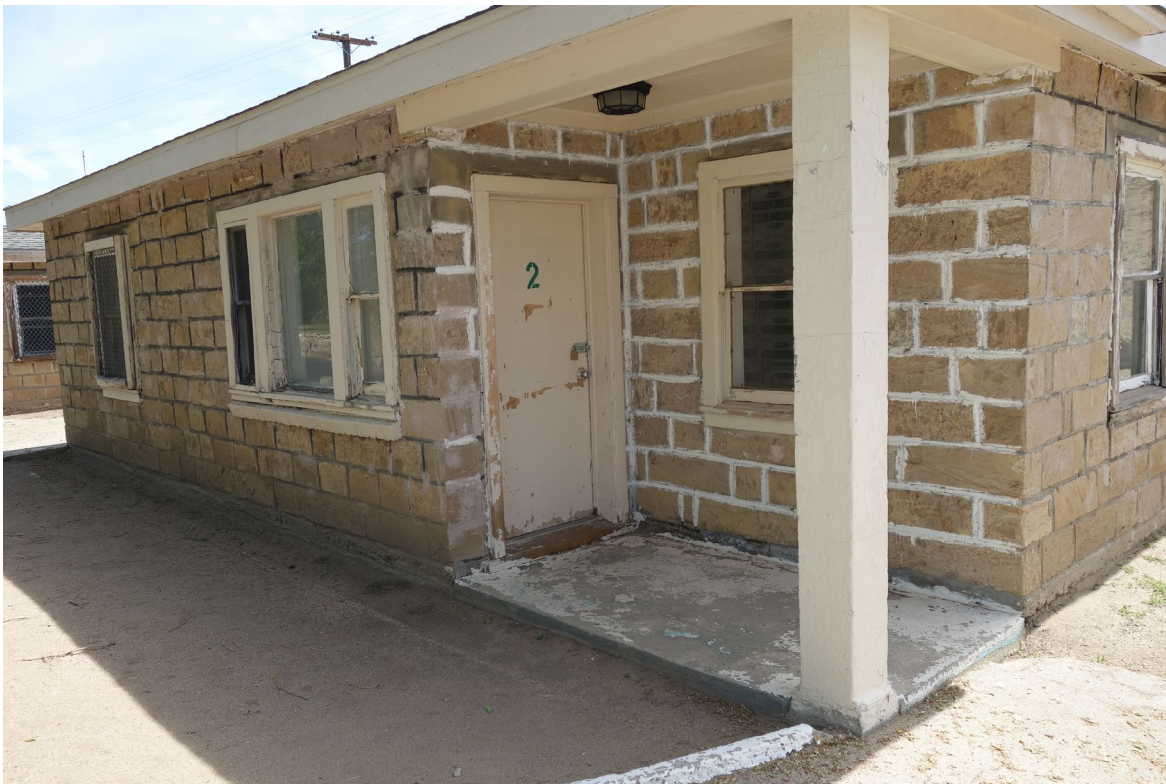
It is important to maintain the finish, weather resistance and appearance of the building which is over 50 years old. There are numerous areas where the mortar is failing, missing and not sealed properly. This project would provide funding to protect the exterior of the building excluding the roof. Included in the cost is sanding, priming and painting the wood finishes, re-pointing the stone where needed and caulking of the windows, flashing, fixtures and all other penetrations. It is recommended that the building be painted and re-pointed in the next 2 - 3 years and that this project is scheduled on a cyclical basis to maintain the integrity of the structure. This project should be coordinated with the Nevada State Historical Preservation Office for possible restrictions or requirements which are not included in this estimate.

Cottage #2 – FCA Building #0119  
Description: Exterior of the Building.

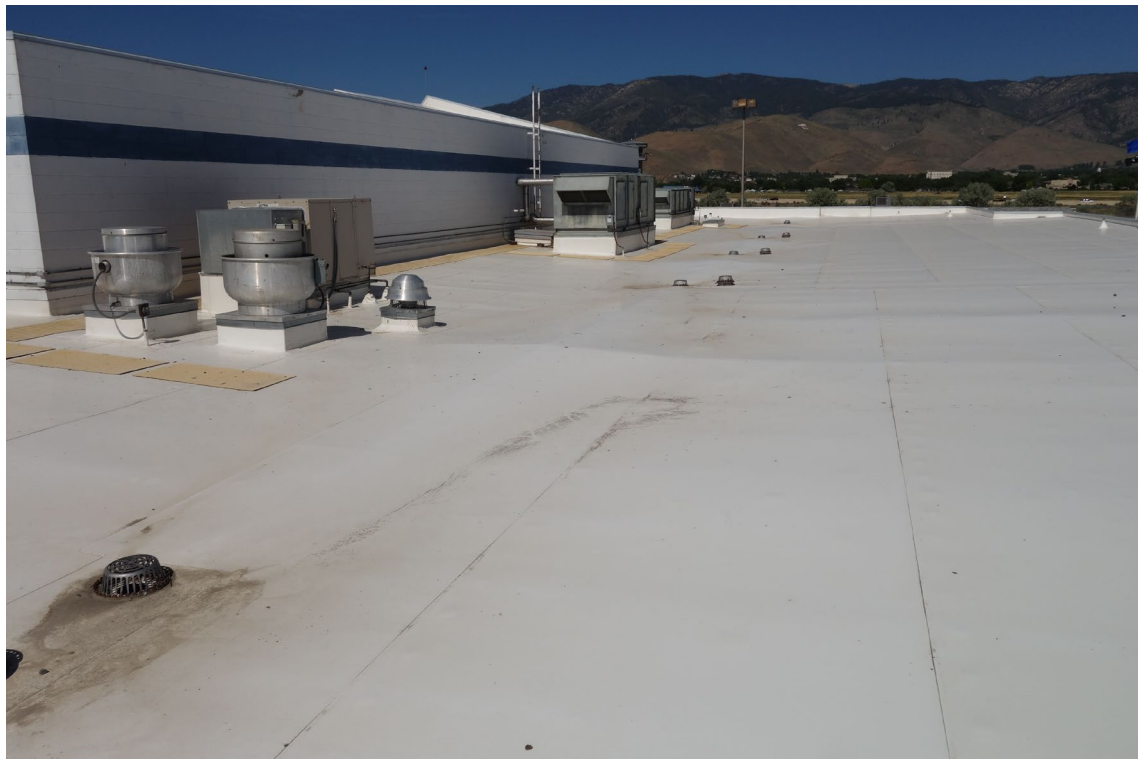
Multi-Purpose / Culinary / Infirmary – FCA Building #0118  
Description: HVAC Replacement Needed.

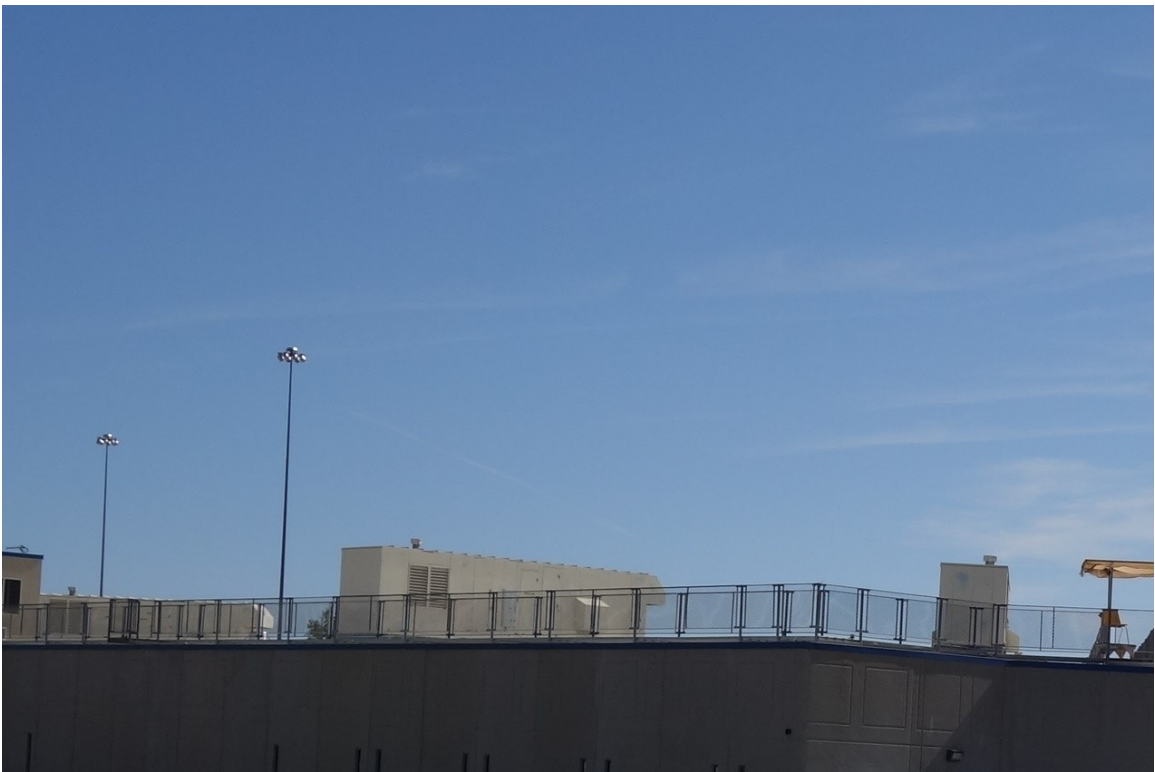
Housing Unit 4 – FCA Building #0117  
Description: Roof mounted HVAC Replacement Needed.

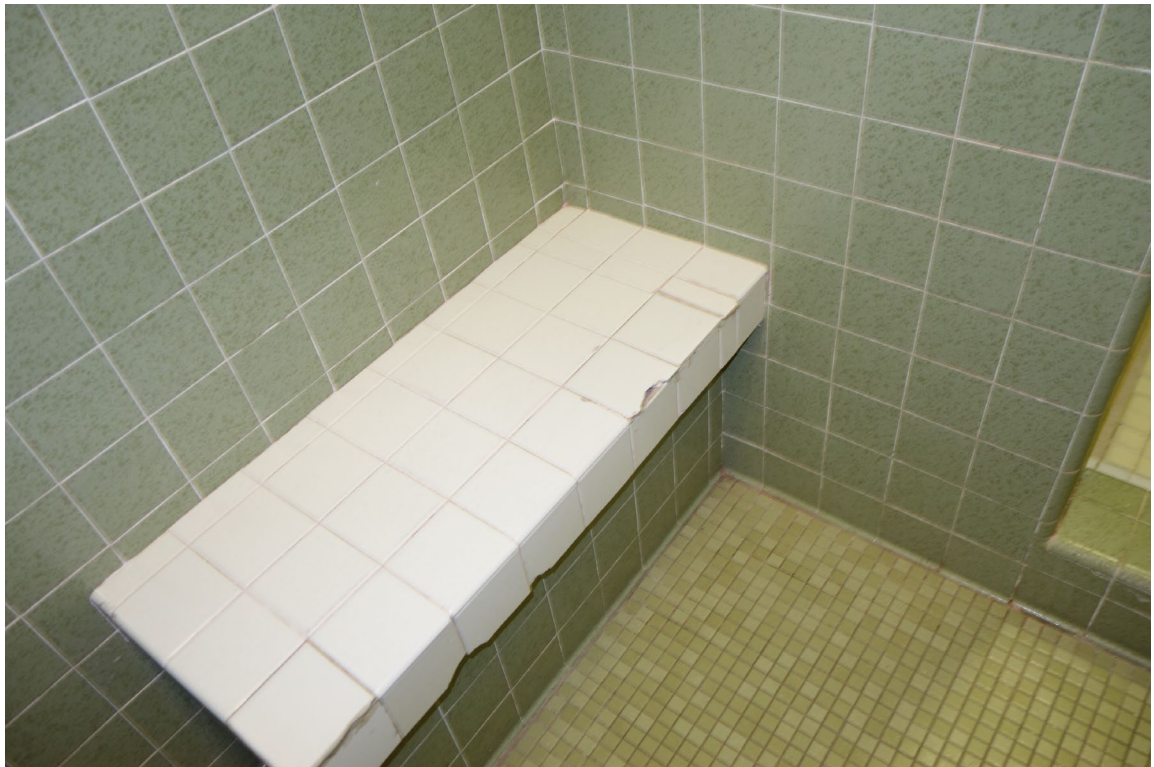
Housing Unit 2 – FCA Building #0116  
Description: Shower Remodel Needed.

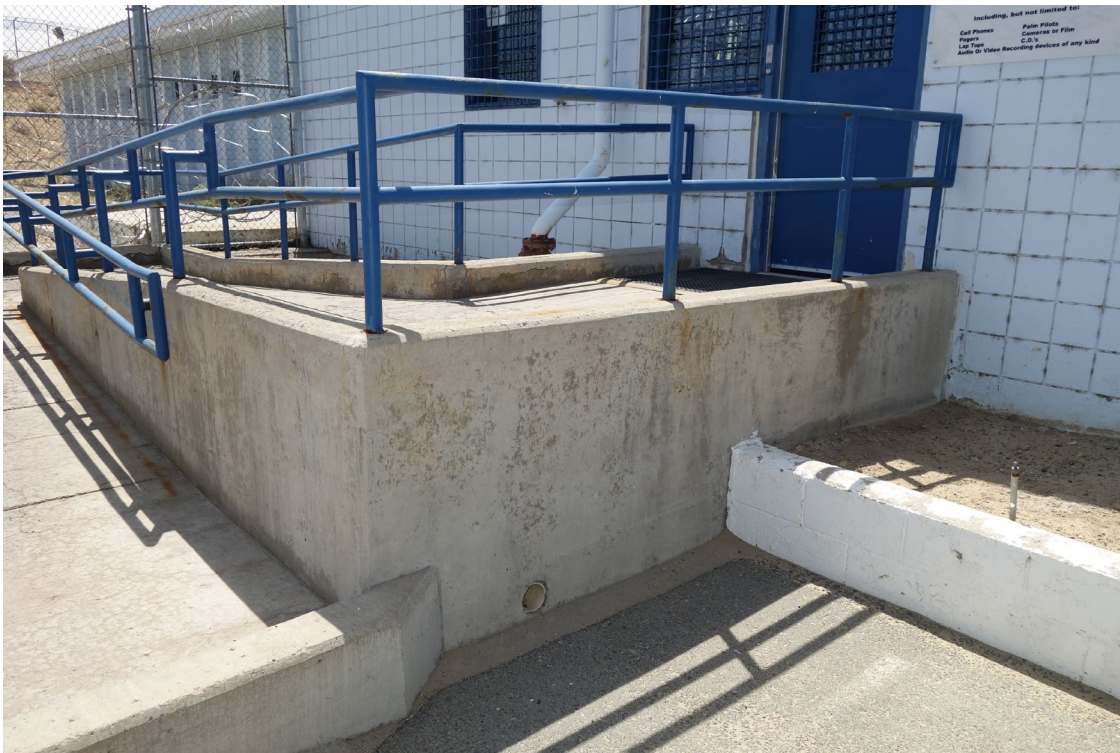
Administration / Gatehouse / Unit 1 – FCA Building #0115  
Description: ADA Accessible Entrance Ramp Replacement Needed.

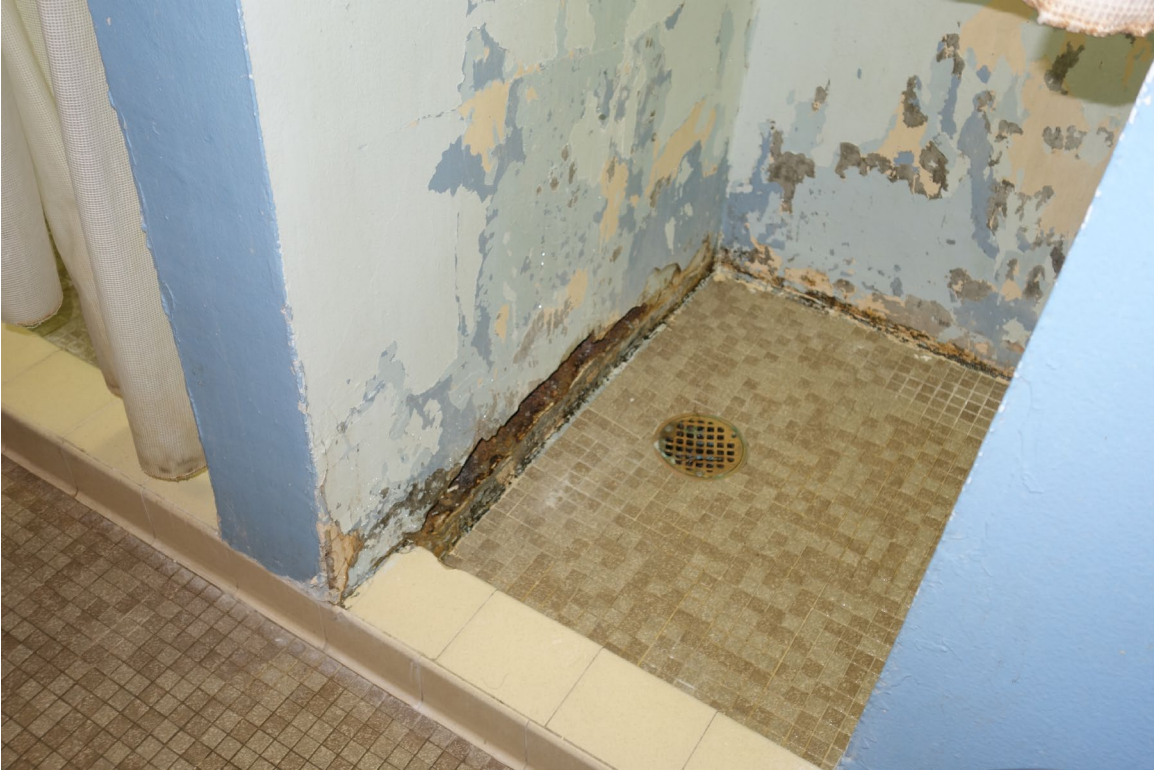
Administration / Gatehouse / Unit 1 – FCA Building #0115  
Description: Shower Replacements Needed.
